**Preliminary Advice**

Vehicle No	: XE1548U	Accident Date	: 06/07/2019
Make	: UD TRUCKS ESCOT V	Policy No.	: 29120984
Assignment Date	: 17/07/2019	Excess	: S\$750.00
Date of Inspection	: 18/07/2019	Est. Duration of Repair	: 7.00
Inspection At	: TAN CHONG INDUSTRIAL MACHINERY PTE LTD (JALAN BUROH) 23 JALAN BUROH SINGAPORE 619479

## VEHICLE DAMAGE INSPECTION REPORT

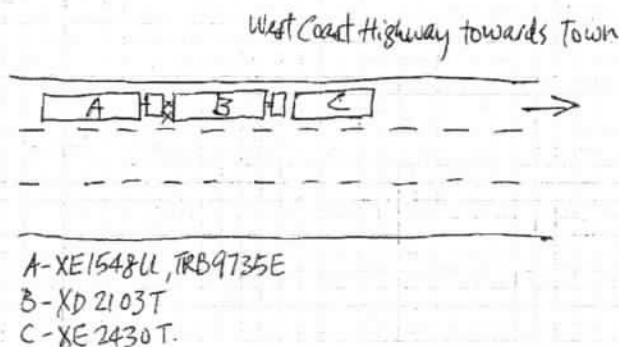
## SKETCH PLAN

I was travelling along West Coast Highway toward city, traffic was heavy. I was occupied with a 40 foot loaded container and on lane 3.

Suddenly, the vehicle in front of me did a E-brake, I tried but could not stop in time and hit into it. No damage to 3rd party vehicle but my vehicle front portion badly damaged. No one was injured.
