Your Ref: Porsche Macan
(chassis number WP1ZZZ95ZJLB14614)
Our Ref : CI/TP19012679/D

17 July 2019

INSPECTION REPORT OF AN UNREGISTERD PORSCHE MACAN MOTOR CAR WITH CHASSIS NUMBER WP1ZZZ95ZJLB14614

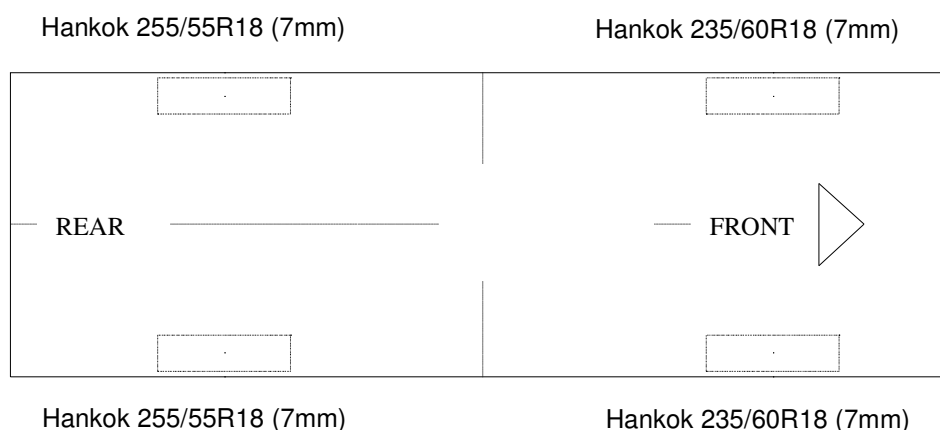
6. It was fitted with 18inch sport wheel rims that were wrapped with tyres that were observed to be of serviceable condition. The tyres were also sufficiently inflated for vehicular operation. The tyre brand, tyre size and approximate remaining tread depth of the Motor Car's 4 tyres were recorded as follows: -

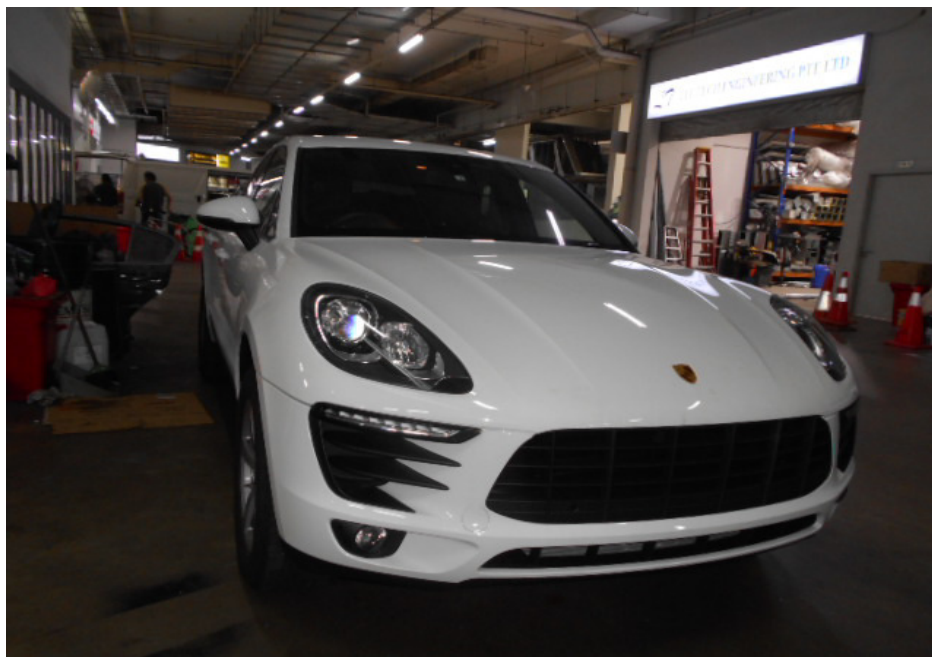
Photo 1 shows a general view of the front right body of the Motor Car at the time of my inspection. The Motor Car was observed to be in relatively good general condition with no loose exterior fittings observed.

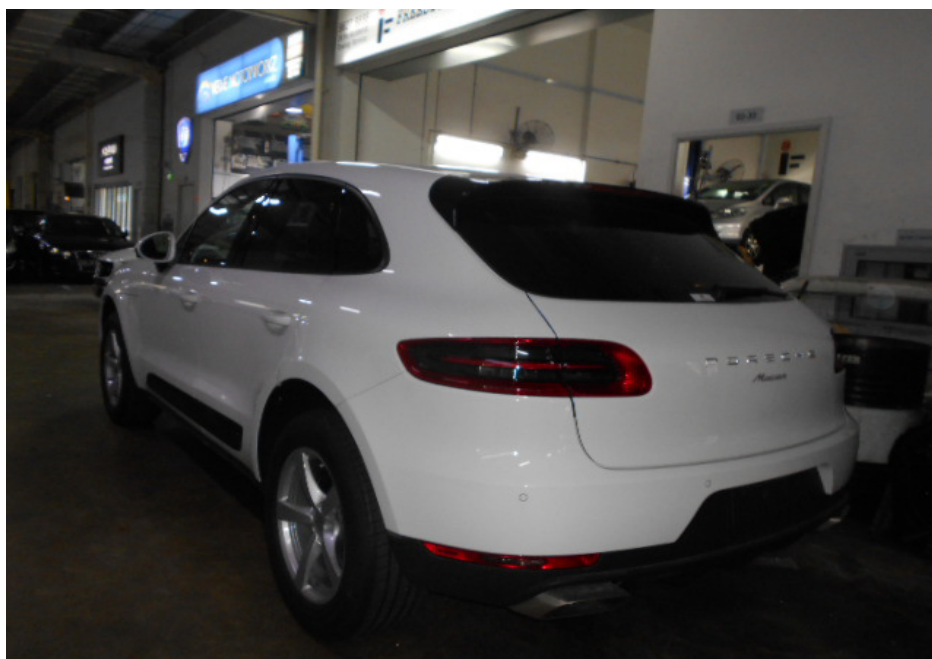
Photo 2 shows a general view of the rear left body of the Motor Car at the time of my inspection. The Motor Car was observed to be in relatively good general condition with no loose exterior fittings observed.

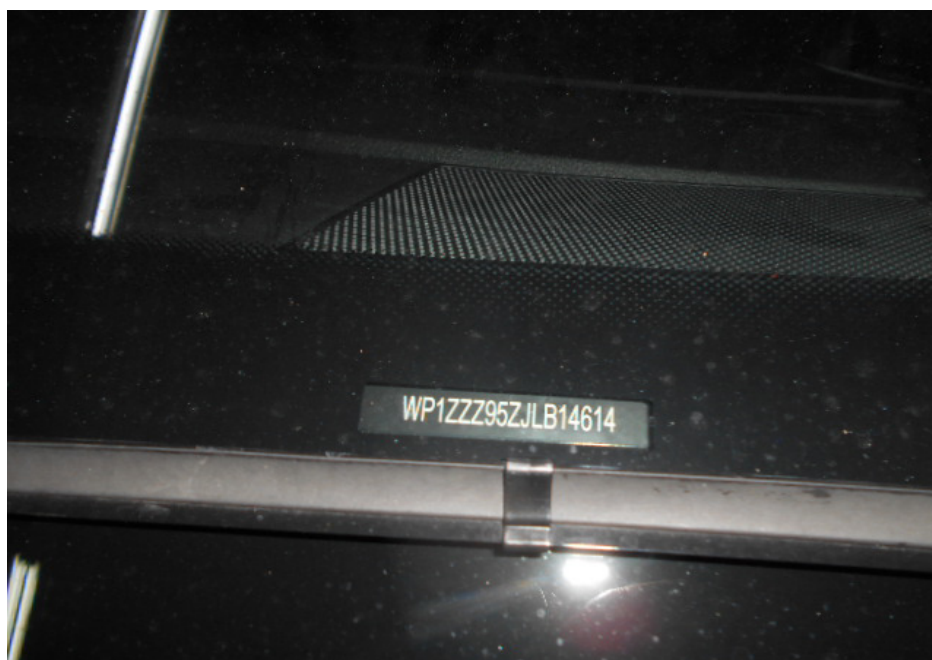
Photo 3 shows the chassis number of the Motor Car. The chassis number recorded was WP1ZZZ95ZJLB14614.

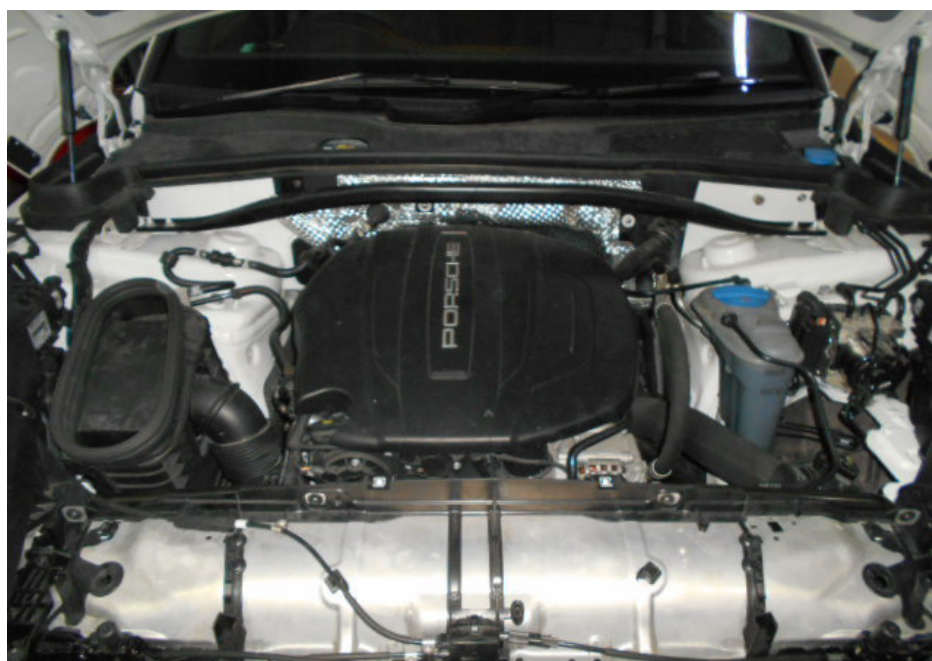
12. My examination of the engine compartment of the Motor Car revealed that the various parts and components inside the engine compartment were all intact and properly fitted. The engine oil, brake fluid and engine coolant were all found to be of sufficient level for operating purposes. Visually, there was also no contamination found to these fluids.
13. My checks on the underside of the Motor Car revealed no sign(s) or indication(s) of fluid leakage and/or fluid stain(s). The engine block and automatic transmission assembly were both secured properly. They were not mounted onto the structure/chassis body or any integral body part of the Motor Car. All undercarriage components of the Motor Car were also observed to be intact and secured in an appropriate manner.

Photo 4 shows a general view of the engine compartment of the Motor Car at the time of my inspection. The various parts and components inside the engine compartment were all observed to be intact and properly fitted. There was also no sign(s) or indication(s) of fluid leak and/or fluid stain found inside the engine compartment. The engine oil, brake fluid and engine coolant were all found to be of sufficient level for operating purposes. Visually, there was also no contamination found to these fluids.

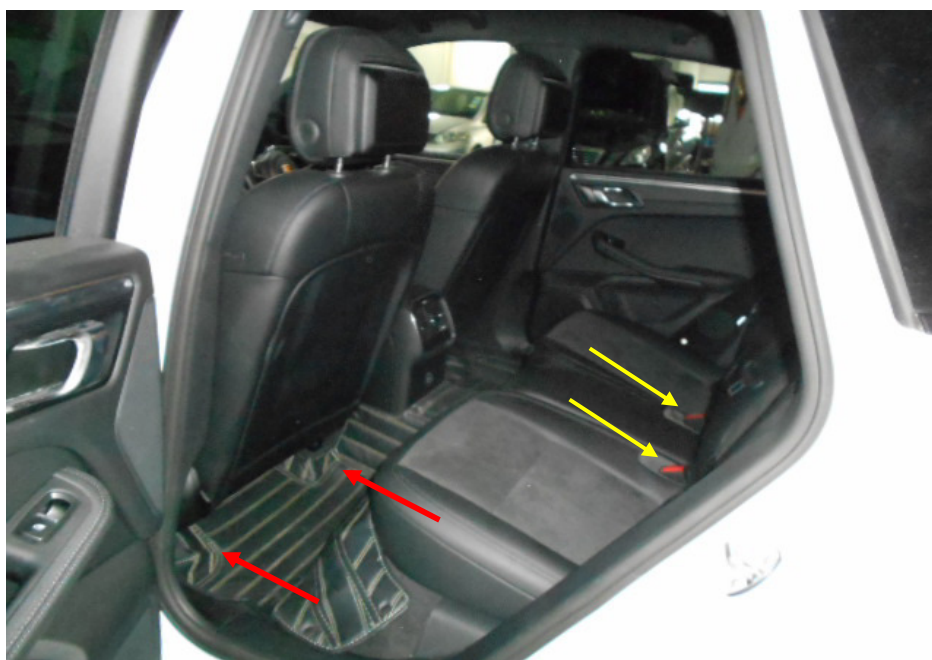
10. The seats of the Motor Car were found to be secured to the floor board of the Motor Car via seat rails bolted onto the floor board. Retractable seat belt reels and pre-tensioners were fitted on all seats of the Motor Car. The seat belt reels were able to be fastened securely into the respective pre-tensioners that were fixed to the side of all the seats.

Photo 5 shows the seats of the Motor Car, which were secured via seat rails (red arrows) to the floor board. All the seats of the Motor Car were fitted with a retractable seat belt reel and pre-tensioner (yellow arrows). The seat belts were also able to be fastened into the respective pretensions that were fitted on the side of each individual seat.

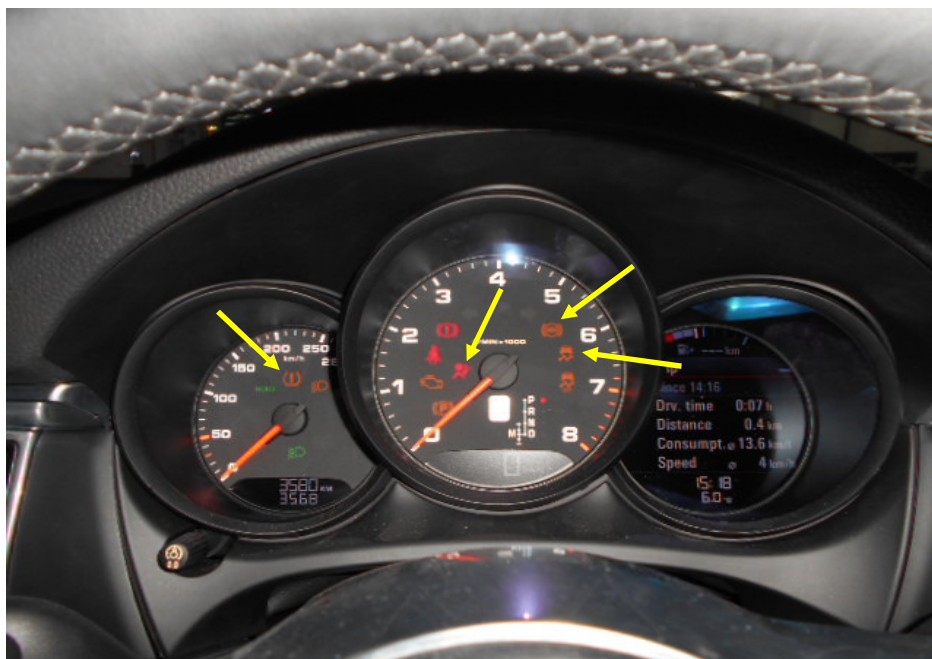
Photo 6 shows the warning lights for the various electronic safety features appearing on the instrument panel of the Motor Car during its self-test when the engine is cranked, in particular the ABS, SRS, TPM and TCS lights (arrowed).

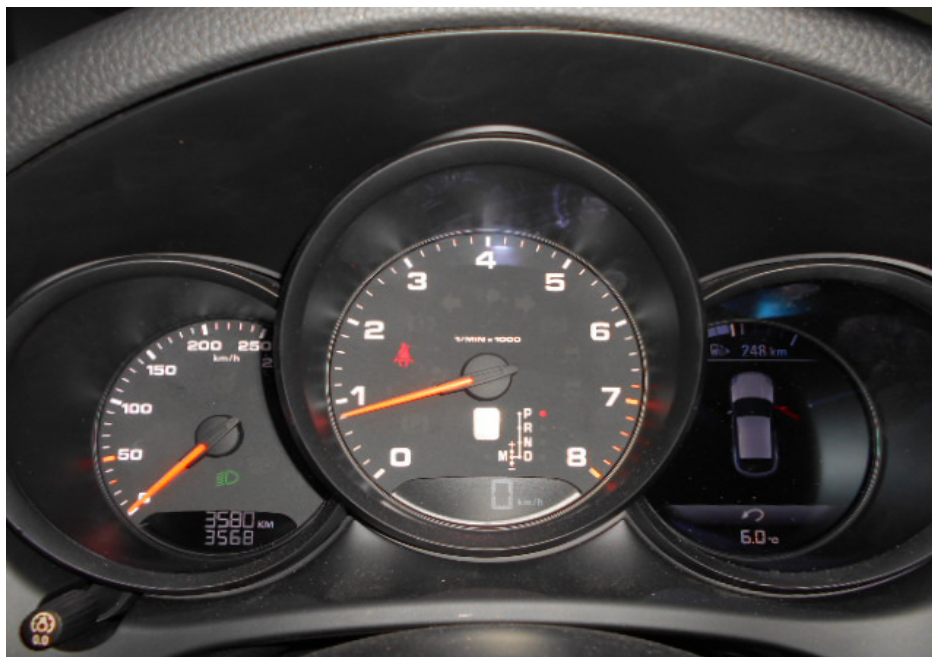
11. The Motor Car's automatic self-test of the functionality of its various electronic safety features like the Anti-Lock Brake System (ABS), Supplemental Restraint System (SRS), Tyre Pressure Monitor (TPM) and Traction Control System (TCS) during cranking of the engine had indicated that these electronic systems were in working condition. This was determined from the respective warning lights disappearing from the instrument panel after the self-test.

Photo 7 shows the respective warning lights no longer illuminated, indicating that there is no fault detected to the ABS, SRS, TPM and TCS systems of the Motor Car during the self-test. These electronic systems were hence in working condition at the time of my inspection.

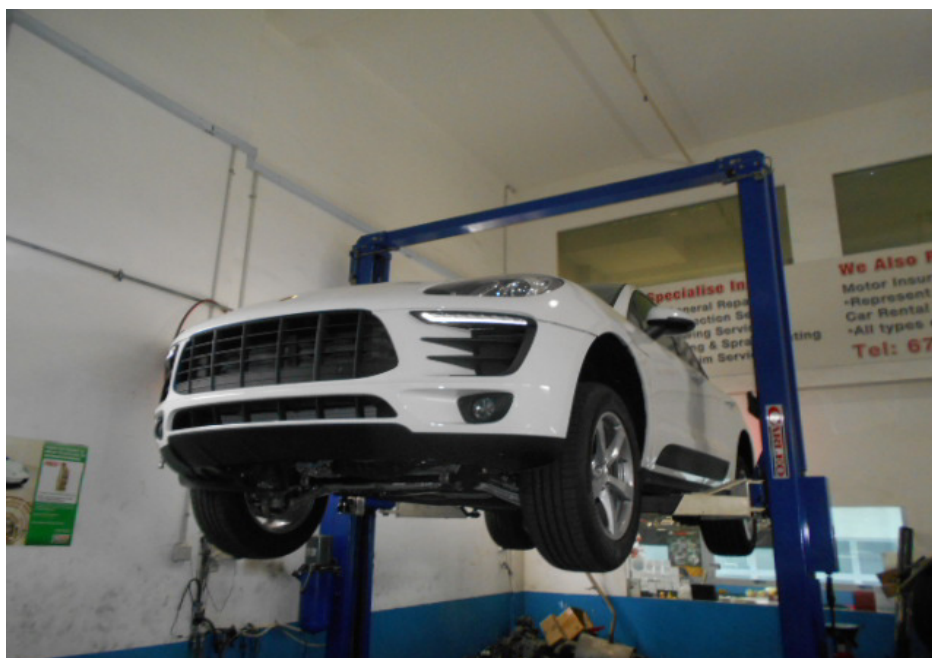
Photo 8 shows the Motor Car hoisted up for checks on its undercarriage. There was no sign(s) or indication(s) of fluid leakage and/or fluid stain(s) on the underside of the Motor Car. The undercarriage components of the Motor Car were also all observed to be intact and secured in an appropriate manner.

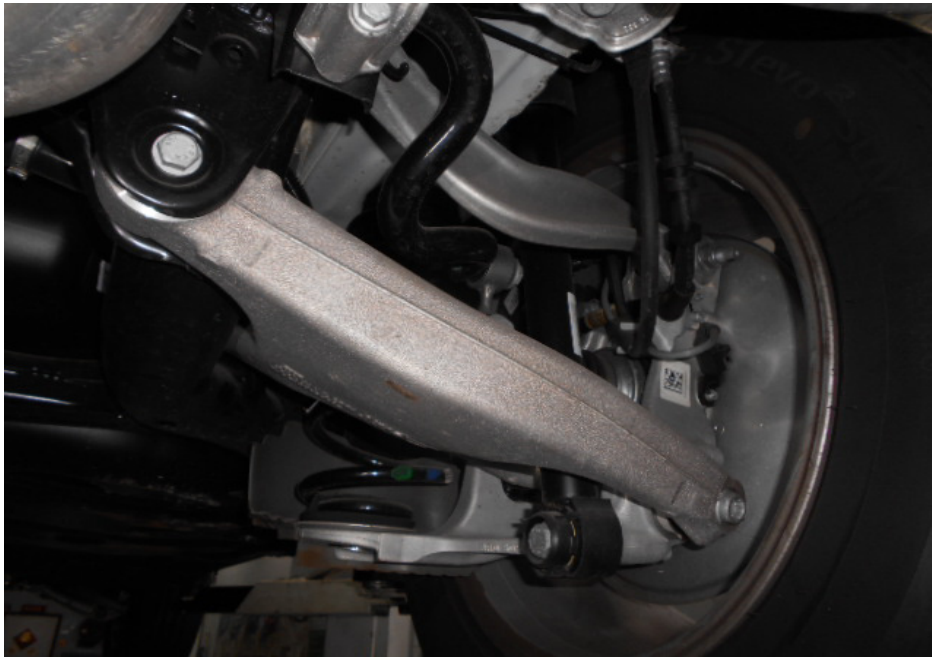
Photo 9 shows a general view of the control arms and linkages at the rear right wheel of the Motor Car. I did not observe any fluid leak and/or fluid stain on the underside of the Motor Car. All of the Motor Car's undercarriage components were observed to be intact and secured in an appropriate manner.

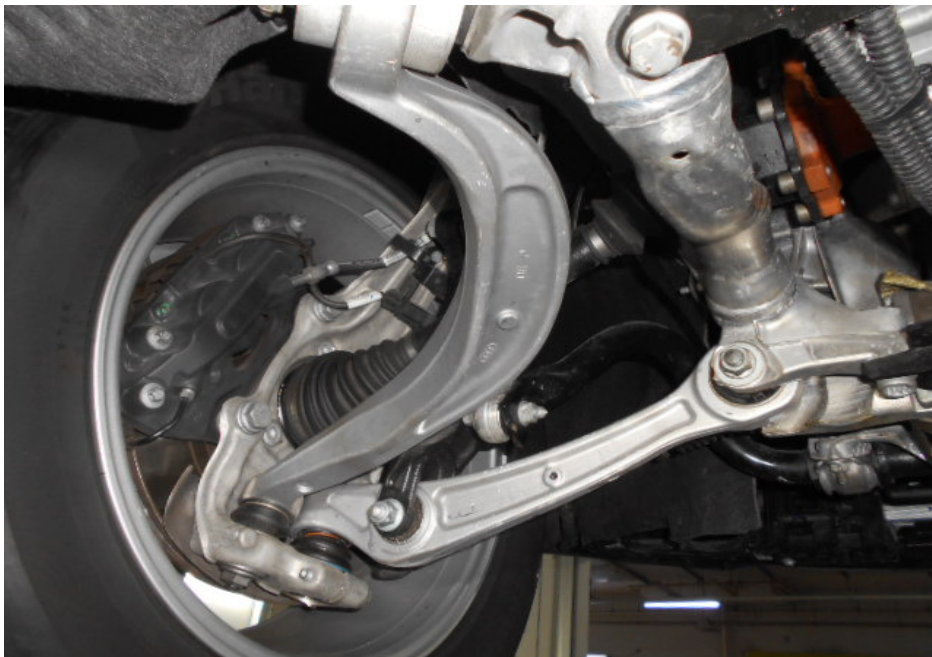
Photo 10 shows the various undercarriage components at the front left wheel of the Motor Car. The mechanical components, control arms and linkages were all found to be intact and secured in an appropriate manner.

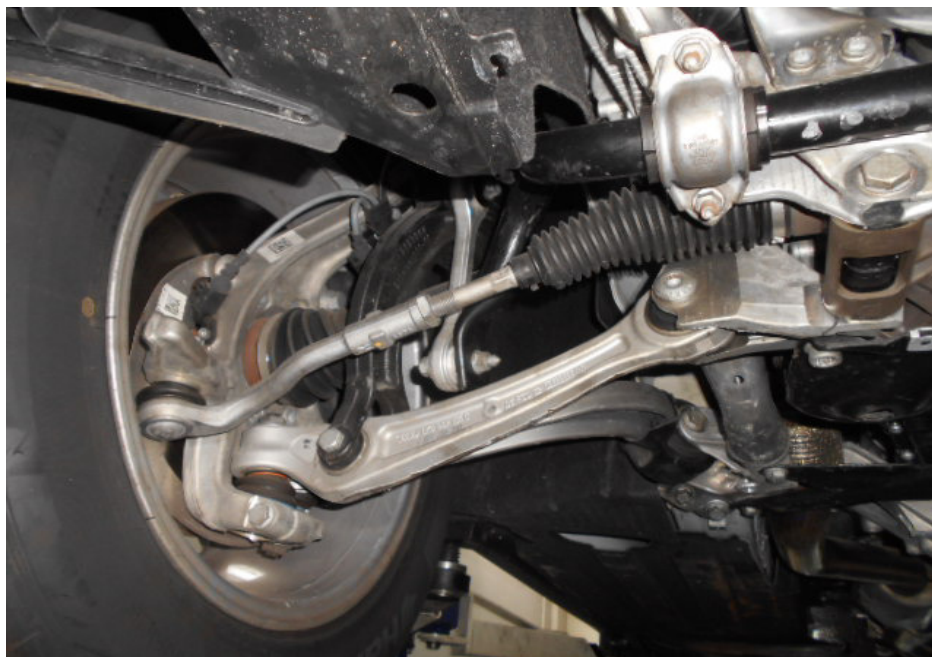
Photo 11 shows the various undercarriage components at the front right wheel of the Motor Car. The mechanical components, control arms and linkages were all found to be intact and secured in an appropriate manner. I also did not observe any fluid leak and/or fluid stain on the underside of the Motor Car.

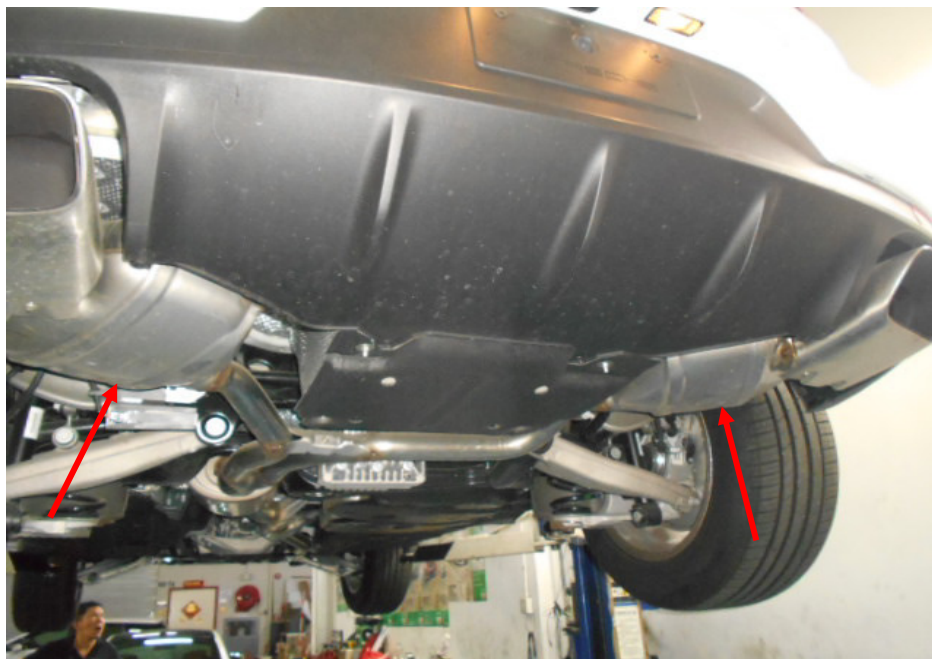
Photo 12 shows the Motor Car's rear exhaust mufflers (arrowed). My examination of the Motor Car's exhaust system revealed no sign(s) or indication(s) of any cut or weld marks along its exhaust pipes and on its rear mufflers.

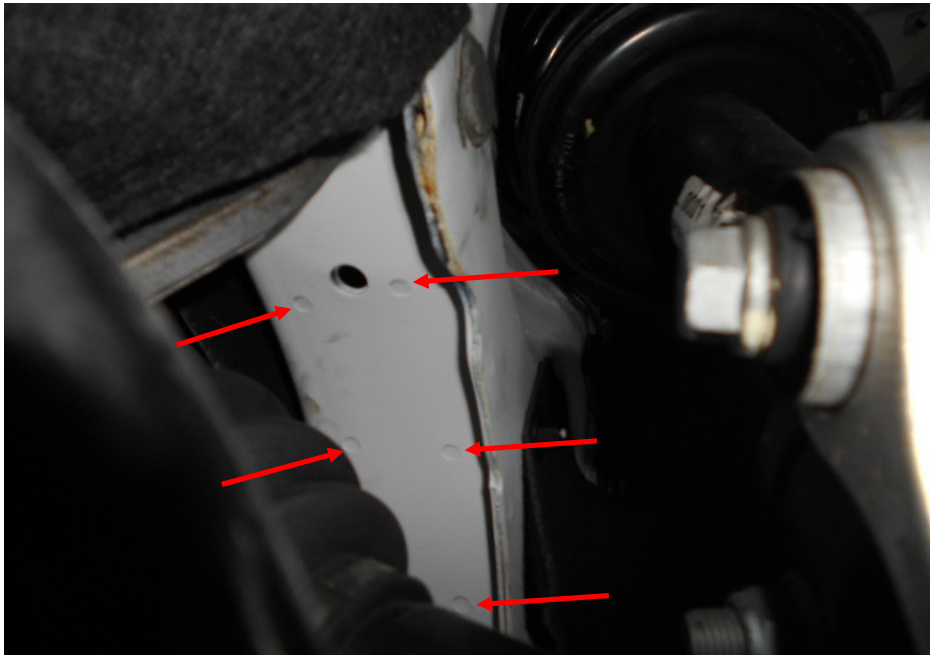
9. Visually, I did not find any weld marks, other than the original spot weld marks, on the structure/chassis body of the Motor Car. The original factory sealant at the joints along the structure/chassis body was also untouched, again indicating that no replacement of the chassis body was carried out; and that the structure/chassis body was originally fitted.

Photo 13 shows the structure/chassis body at the front left of the Motor Car. Visually, I did not find any weld marks other than original spot weld marks (arrowed) along the structure/chassis. This would indicate that no work was done on the structure/chassis body of the Motor Car and that the structure/chassis body was originally fitted.

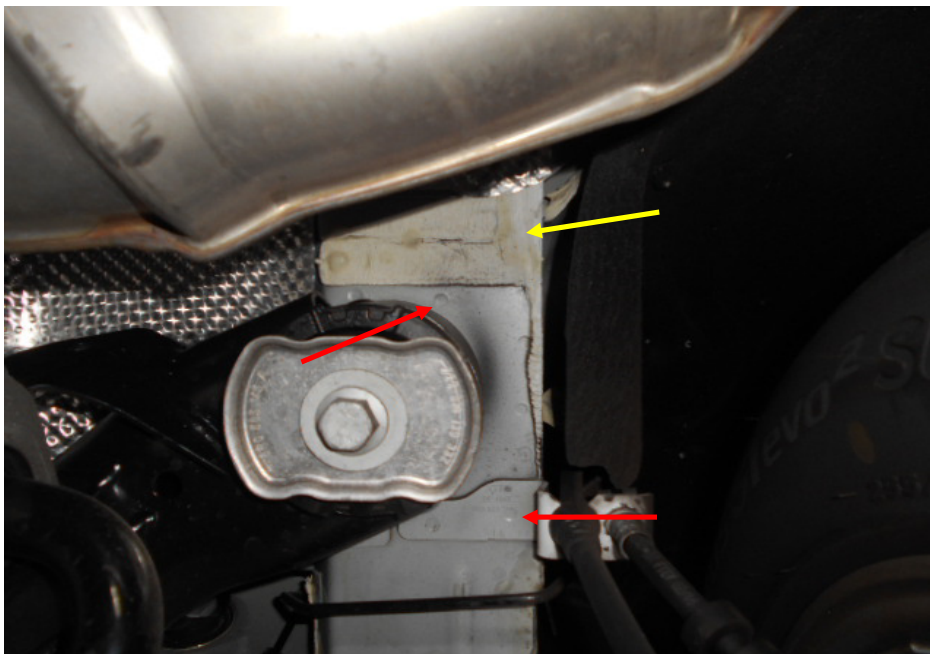
Photo 14 shows the structure/chassis body at the rear right of the Motor Car. The original factory sealant (yellow arrow) at the joints along the structure/chassis body was untouched, indicating no work was done on the structure/chassis body of the Motor Car and that the structure/chassis body was originally fitted. Visually, I also did not find any weld marks other than original spot weld marks (red arrow) along the structure/chassis.

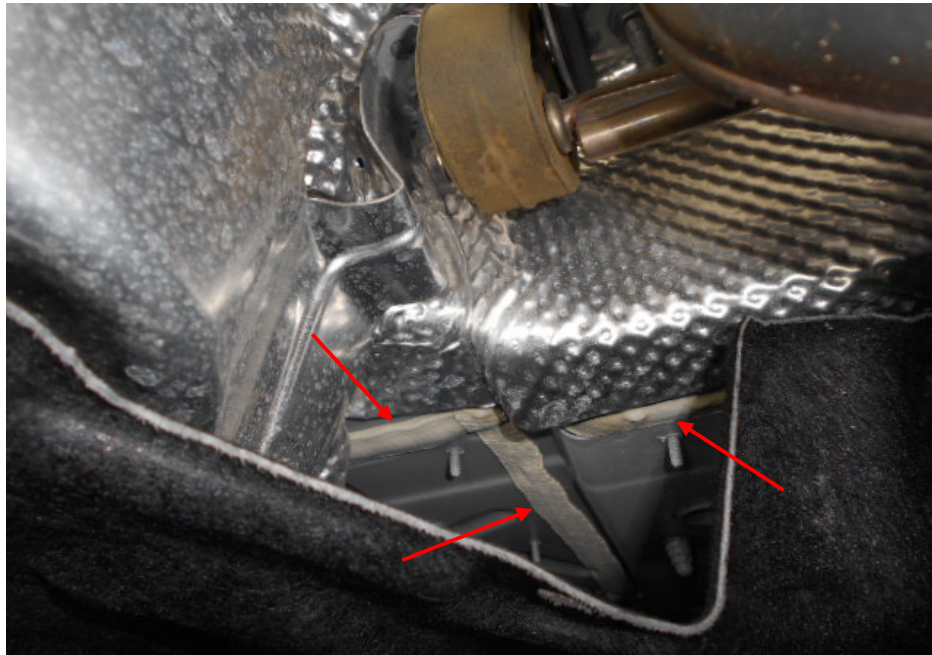
Photo 15 shows the underside left of the Motor Car. The original factory sealant at the joints (arrowed) along the floor board was untouched. Generally, I had found no work done on the structure/chassis body of the Motor Car and that the structure/chassis body was originally fitted.
