Your Ref: TP/IP/25947/2019
Our Ref : CI/TPD19012735/N

Fatal Accident Investigation Team

MECHANICAL INSPECTION REPORT OF MOTORCYCLE FBD 2381S

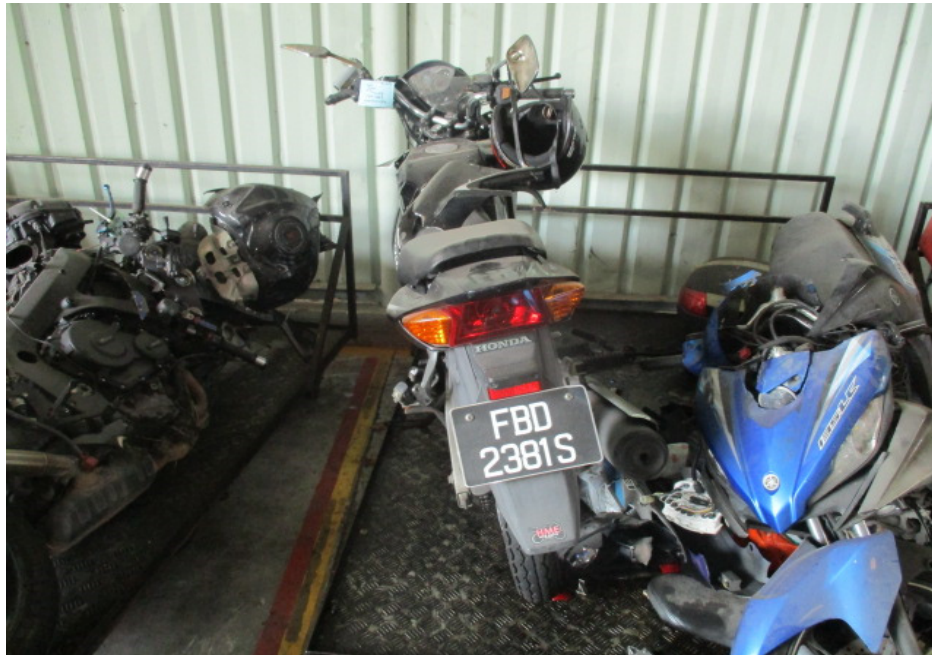
Photo 1 shows a general view of the rear body of the Motorcycle at the time of our inspection. The Motorcycle had sustained damages at its frontal portion and left body.

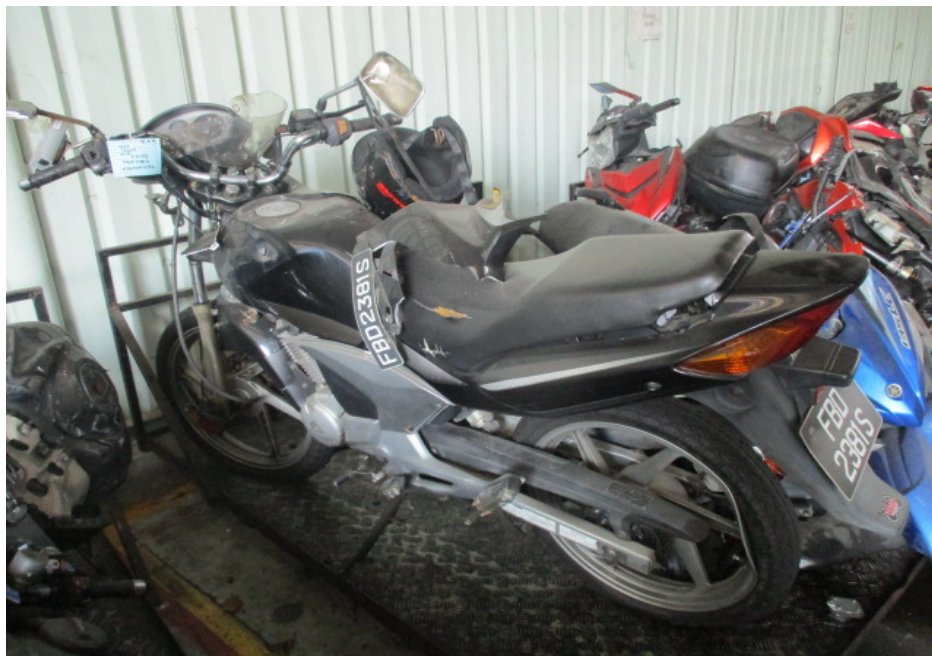
Photo 2 shows a general view of the left body of the Motorcycle at the time of our inspection. Body parts that were found to have been damaged include its headlamp assembly, front fork assembly, wheel rims, side mirrors, clutch lever, fuel tank, left side cover, gear shift pedal, seat and top box bracket, amongst others.

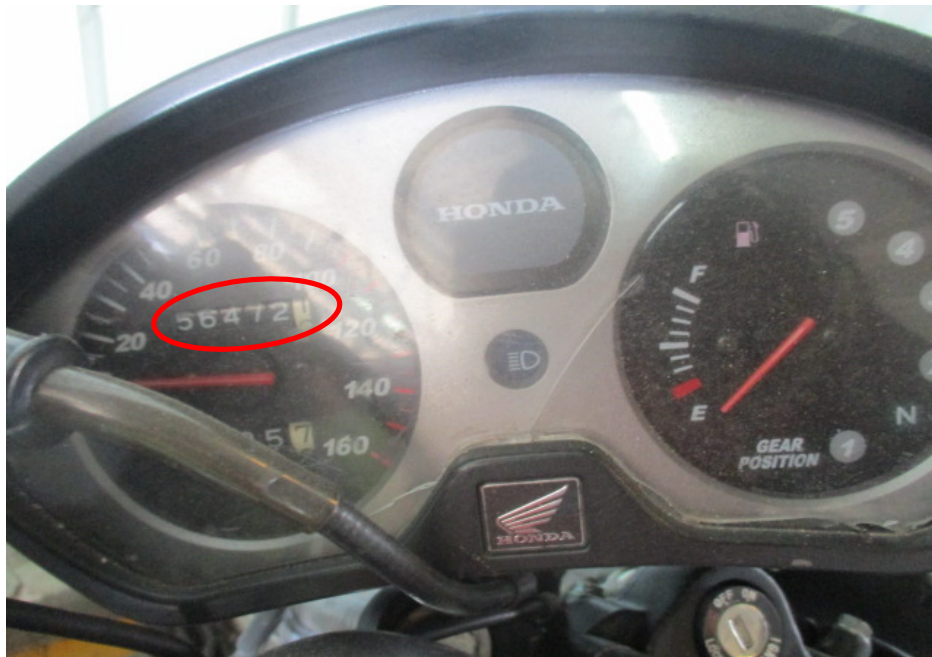
Photo 3 shows the damaged speedometer gauge of the Motorcycle. The mileage of the Motorcycle at the time of our inspection was 56, 472km (circled).

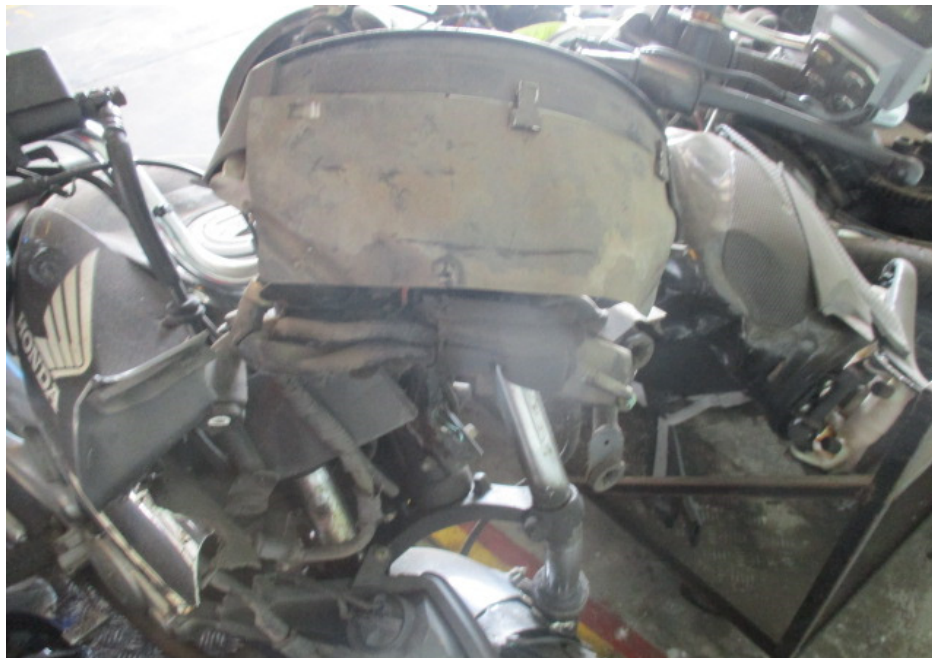
Photo 4 shows a general view of the front body of the Motorcycle at the time of our inspection. Body parts that were found to have been damaged include its headlamp assembly, fork assembly and speedometer gauge amongst others.

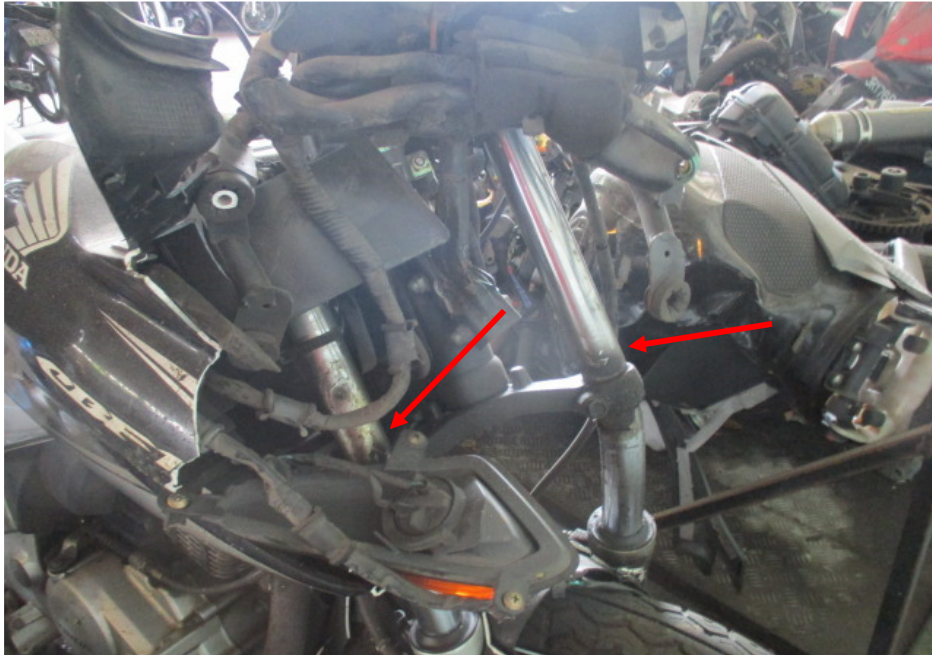
Photo 5 shows a closer view of the front forks (arrowed) which were amongst the body parts at the front body of the Motorcycle that had sustained damage as a result of the accident.

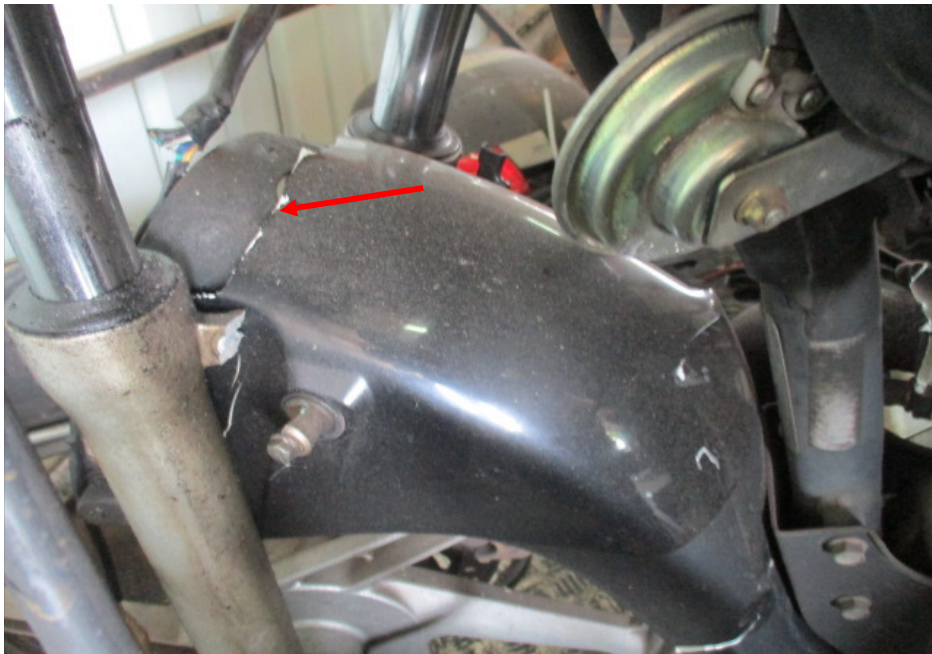
Photo 6 shows a closer view of the front mudguard (arrowed) which was amongst the body parts at the front body of the Motorcycle that had sustained damage as a result of the accident.

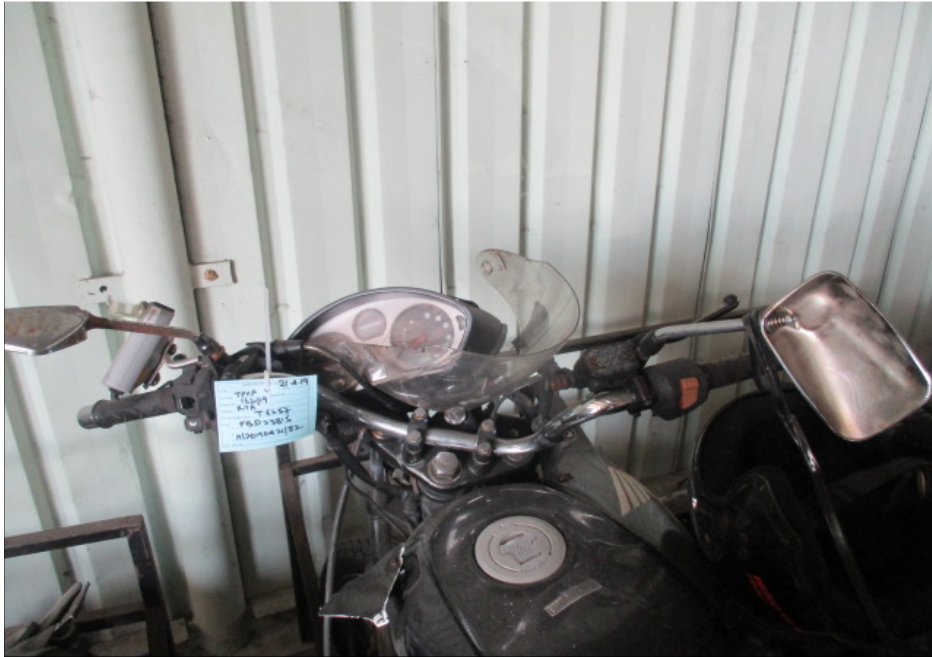
Photo 7 shows a closer view of the side mirrors, clutch lever, front brake lever, handlebars, handlebar grips and handlebar ends of the Motorcycle. These parts were amongst the body parts of the Motorcycle which were damaged as a result of the accident.

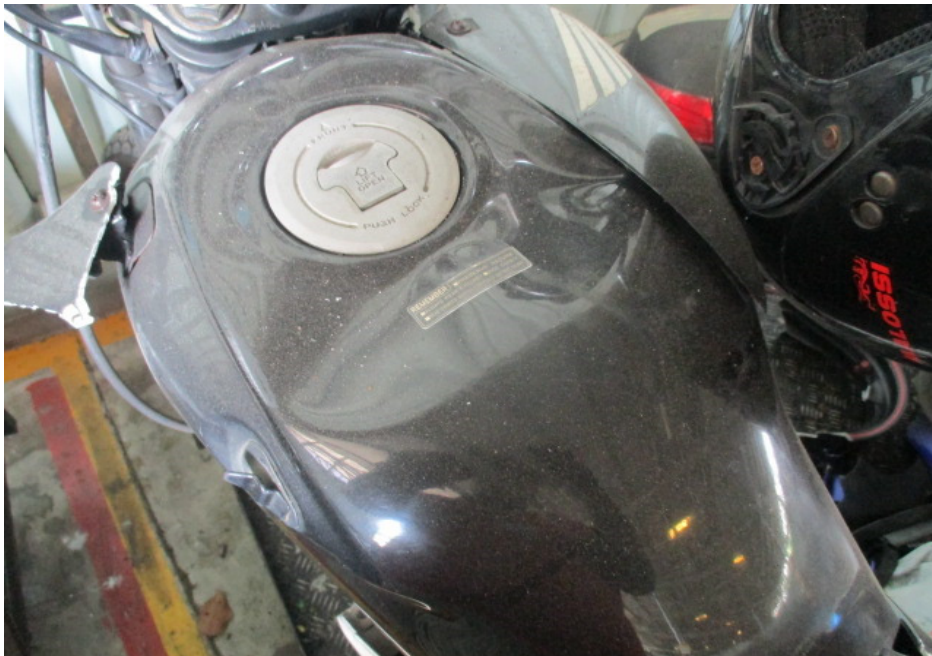
Photo 8 shows a closer view of the dented petrol tank, which was amongst the body parts of the Motorcycle that had sustained damage as a result of the accident.

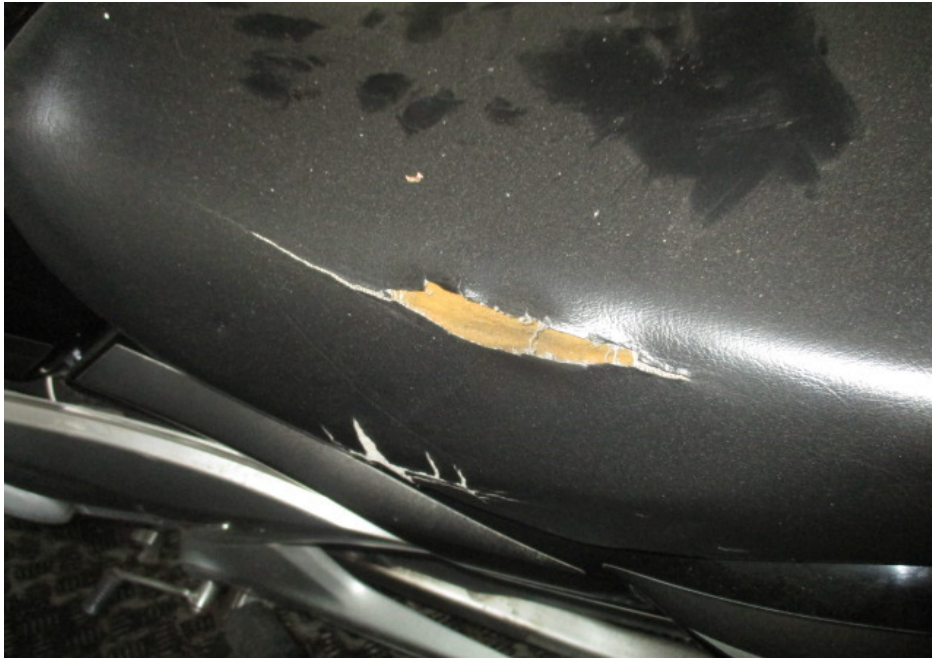
Photo 9 shows a closer view of the torn seat, which was amongst the body parts of the Motorcycle that had sustained damage as a result of the accident.

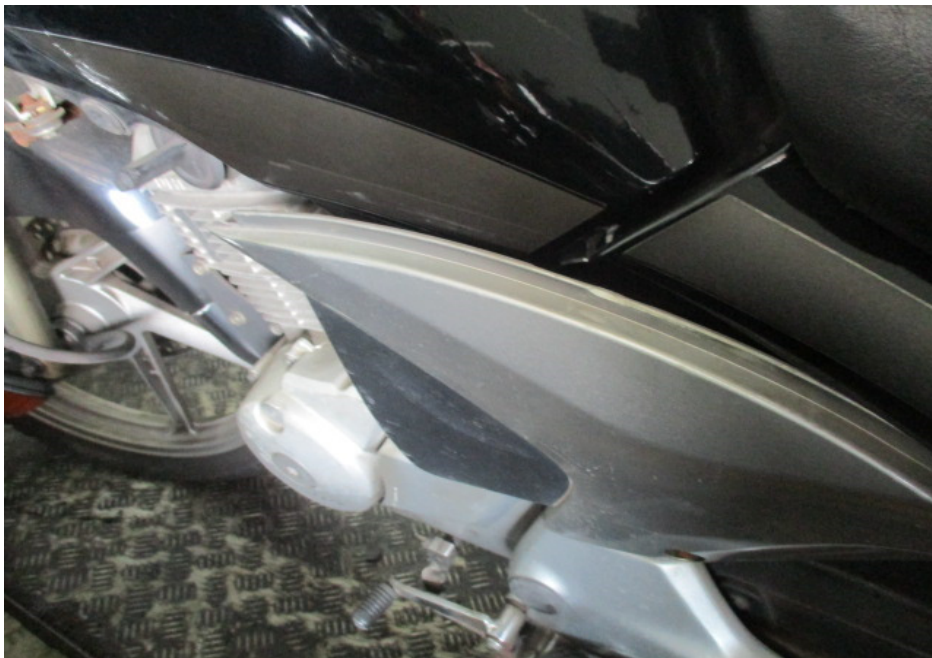
Photo 10 shows a closer view of the left side cover, which was amongst the body parts of the Motorcycle that had sustained damage as a result of the accident.

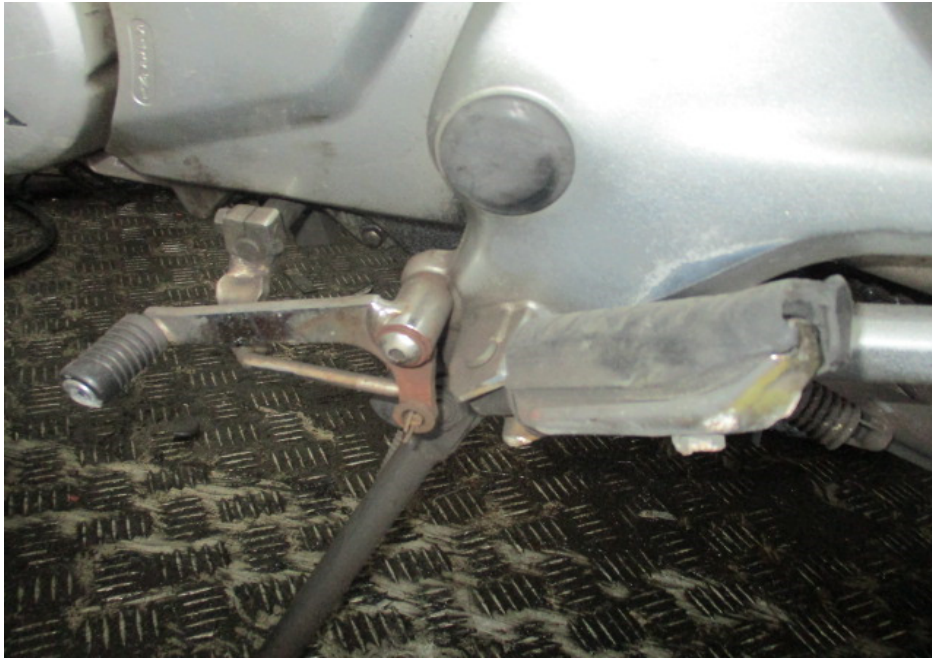
Photo 11 shows a closer view of the gear shift pedal and left front footrest which were amongst the body parts of the Motorcycle that had sustained damage as a result of the accident.

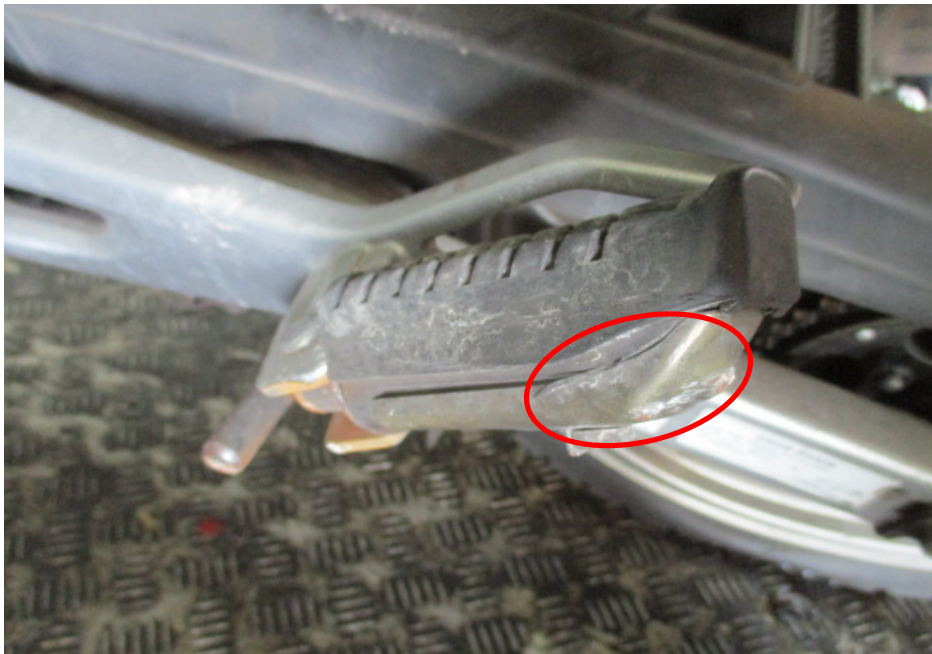
Photo 12 shows a closer view of the left pillion footrest which was amongst the body parts of the Motorcycle that had sustained damage as a result of the accident (circled).

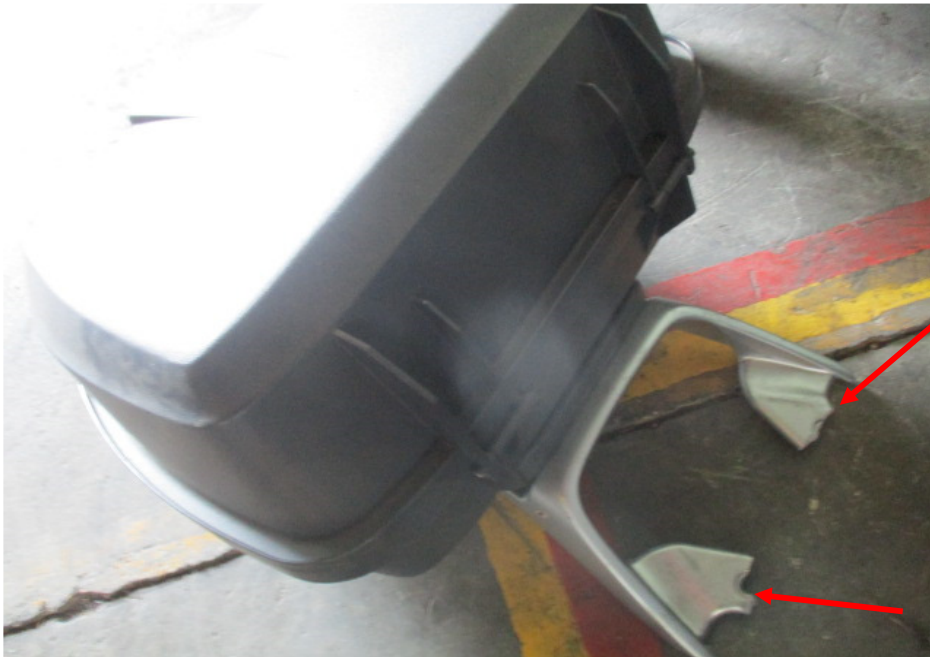
Photo 13 shows the top box bracket of the Motorcycle which had broken off as a result of the accident (arrowed).

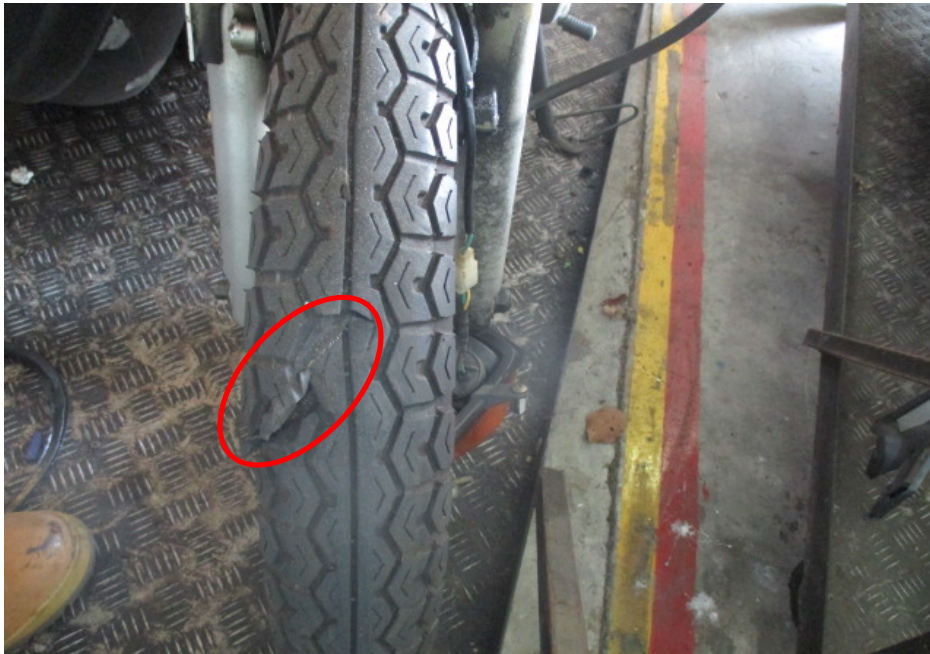
7. We also observed a cut/tear on the tread area of the front tyre that had penetrated into the core of the tyre resulting in the front tyre to be punctured. The lines of the cut/tear were noted to be of a clean slicing type, suggesting that the cut/tear was by a sharp edge object. This would then indicate that the cut/tear of the Motorcycle's front tyre was a result of the accident and did not occur prior to the accident.
8. The tyre brand, tyre size and remaining tread depth of the 2 tyres of the Motorcycle were recorded as follows:-

Photo 14 shows the front tyre of the Motorcycle at the time of our inspection. The pattern of the tread was clearly visible with remaining tread depth of approximately 3mm. We had observed a cut/tear on the tread area of this tyre (circled), which had penetrated into the core of the tyre resulting in the front tyre to be punctured.

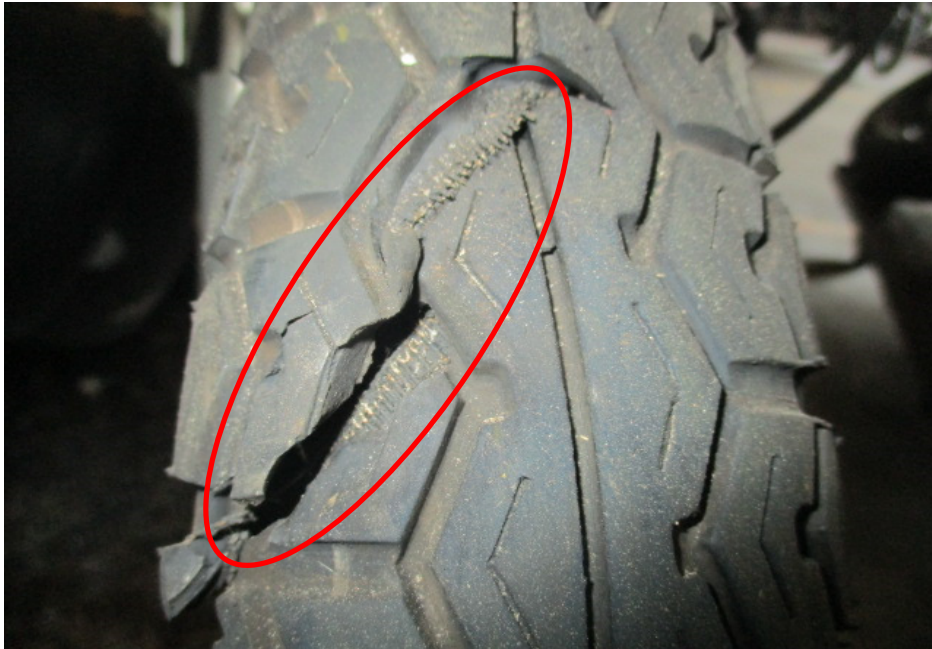
Photo 15 shows a close up view of the cut/tear on the front tyre of the Motorcycle (circled). The lines of the cut/tear were noted to be of a clean slicing type, suggesting that the cut/tear was by a sharp edge object. This would then indicate that the cut/tear of the Motorcycle's front tyre was a result of the accident and did not occur prior to the accident.

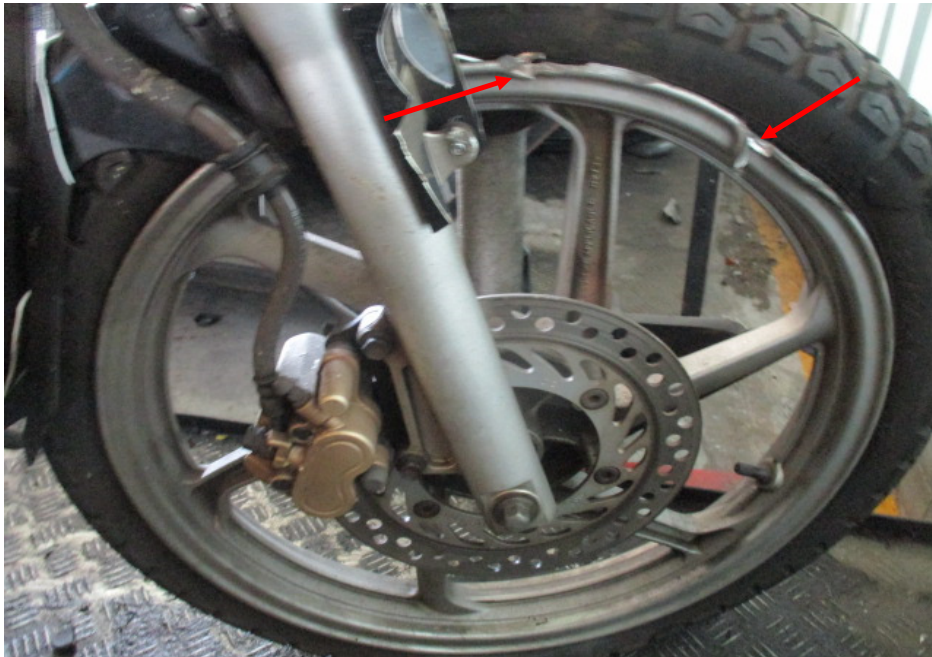
Photo 16 shows the bent front wheel rim of the Motorcycle at the time of our inspection (arrowed).

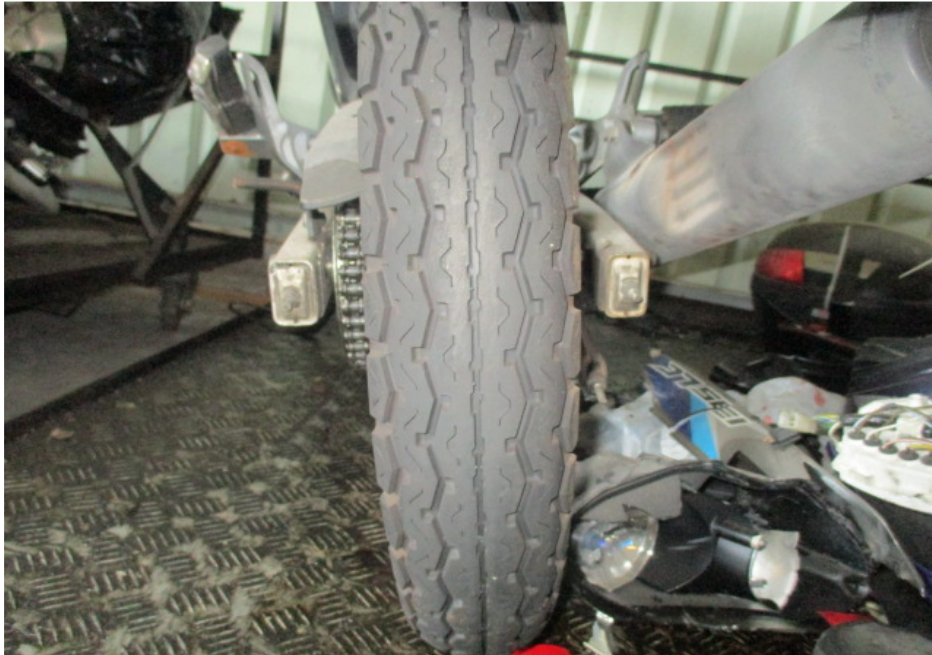
6. We did not observe any tear, burst mark(s) and/or punctured hole(s) on the sidewalls as well as across the tread of the rear tyre. However we did observe that the rear tyre was deflated.

Photo 17 shows the condition of the Motorcycle's rear tyre. The pattern of the tread was clearly visible with remaining tread depth of approximately 5mm. We did not observe any tear, burst mark(s) and/or punctured hole(s) on the sidewalls as well as across the tread of the rear tyre. However we did observe that the rear tyre was deflated.

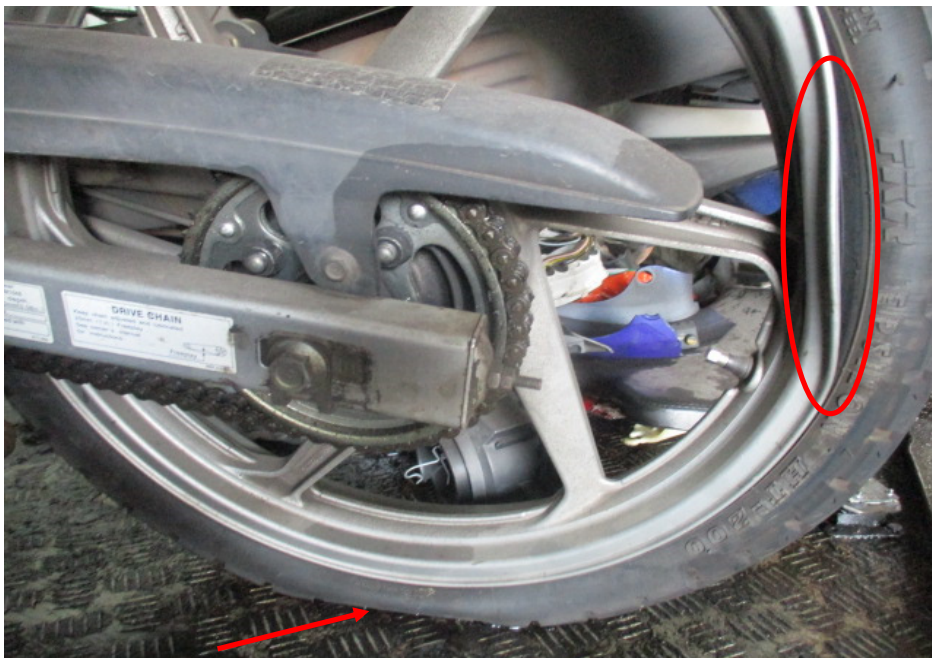
Photo 18 shows the deflated rear tyre (arrowed) and the bent rear wheel rim (circled) of the Motorcycle at the time of our inspection.

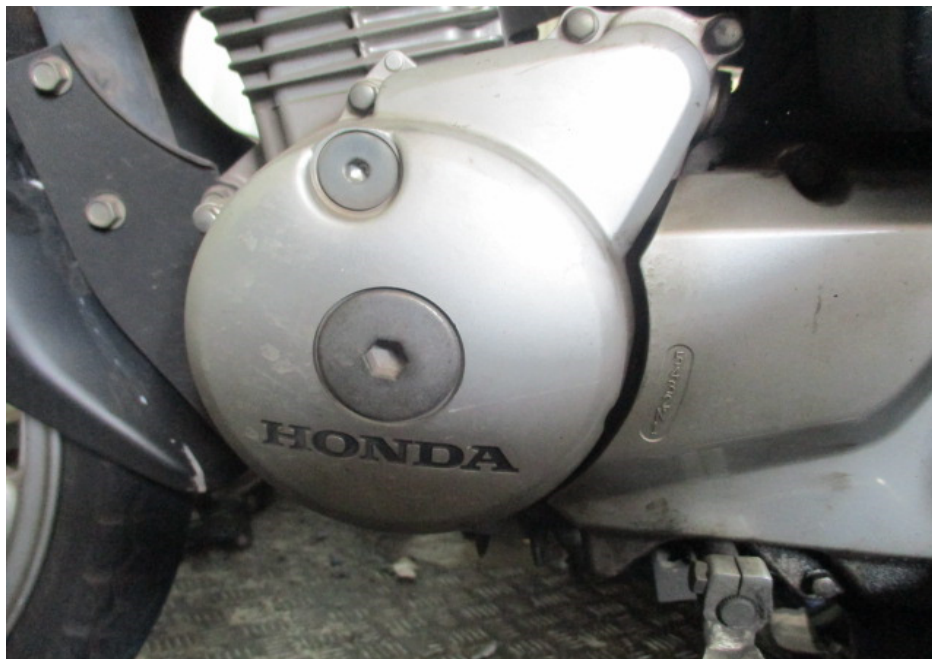
Photo 19 shows the left side of the engine of the Motorcycle at the time of our inspection. The various engine related parts and components were found to be intact with no visible damage. There was also no sign(s) or indication(s) of fluid leak observed around the left engine area of the Motorcycle.

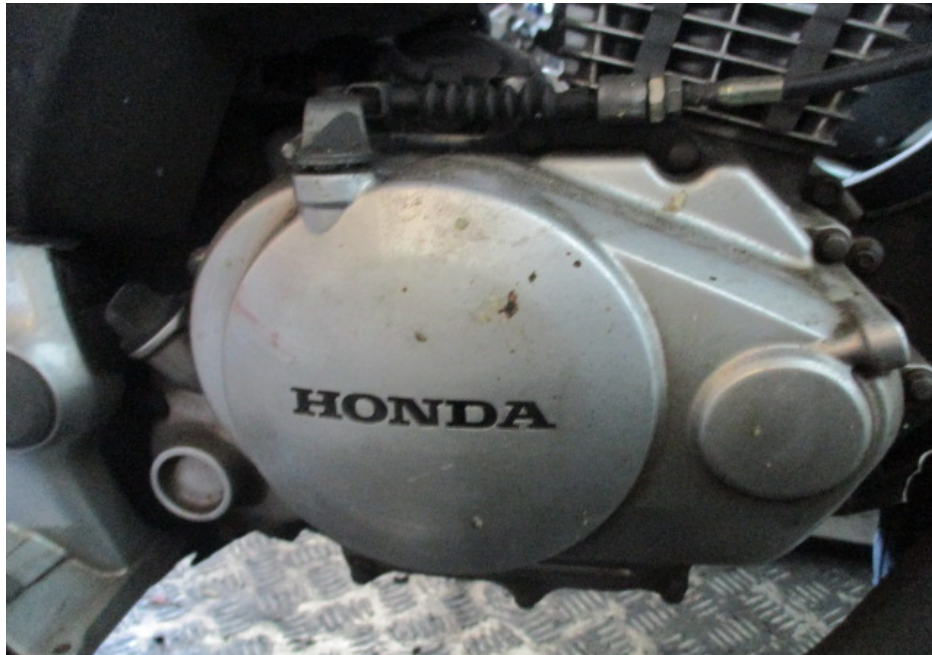
Photo 20 shows the right side of the engine of the Motorcycle at the time of our inspection. The various engine related parts and components were found to be intact with no visible damage. There was also no sign(s) or indication(s) of fluid leak observed around the right engine area of the Motorcycle.

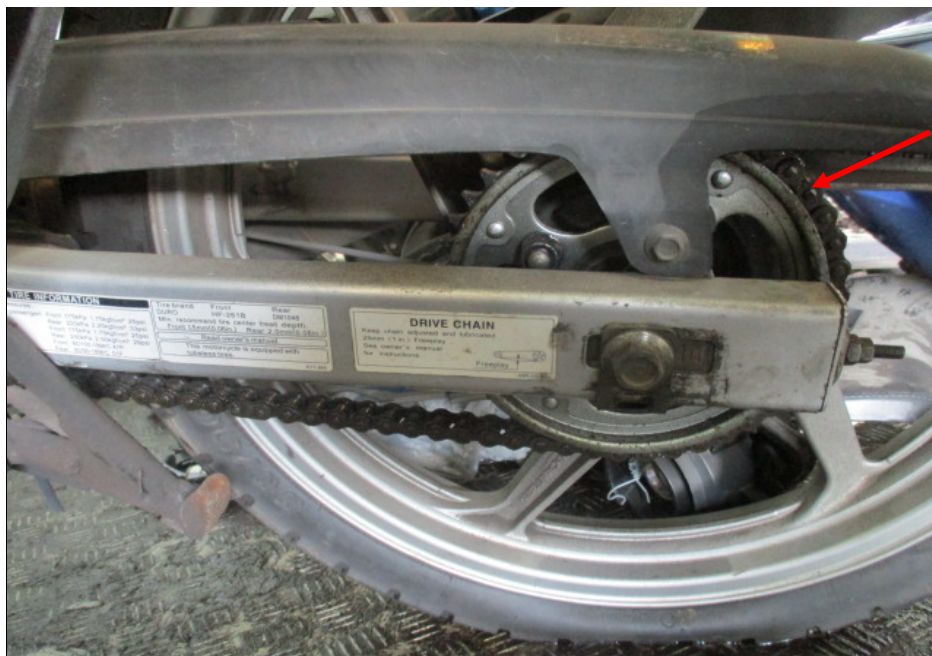
Photo 21 shows the gear chain (arrowed) of the Motorcycle, which was observed to be intact with no misalignment. It was also adequately lubricated for operating purposes. The gear chain rotates the rear wheel of the Motorcycle.

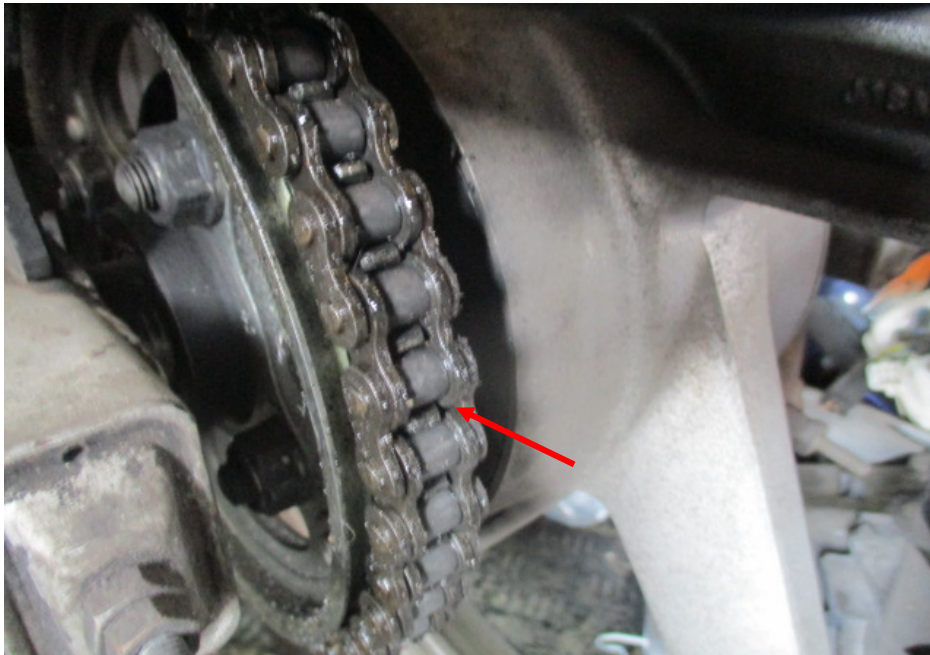
Photo 22 shows the closer view of the gear chain (arrowed) of the Motorcycle, which was observed to be intact with no misalignment. It was also adequately lubricated for operating purposes.

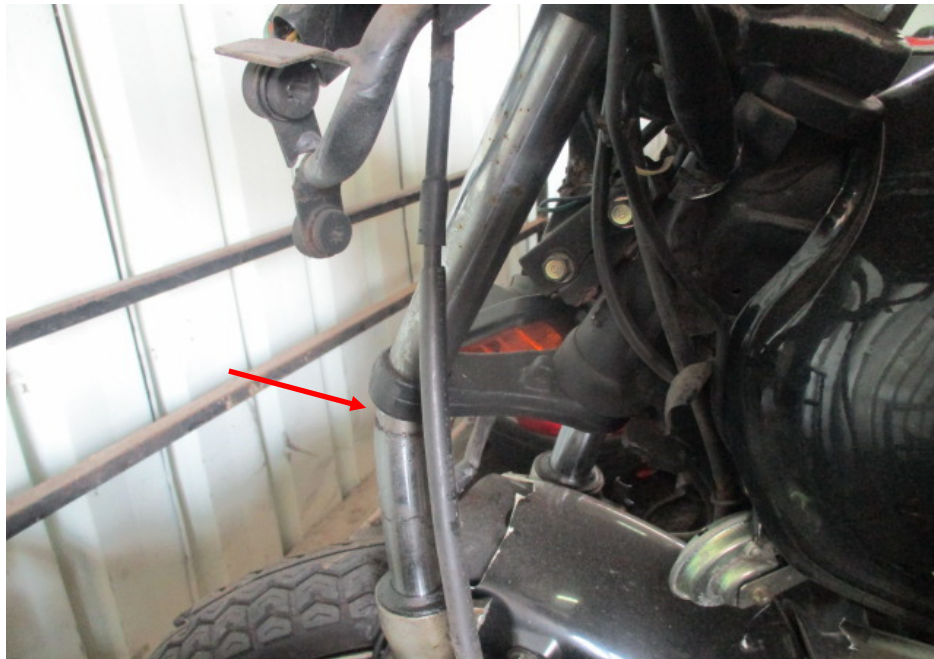
12. For this case, we were not able to conduct any test(s) on the steering system of the Motorcycle due to the damage of its front fork. The front fork was found to be bent inwards as a result of the accident.

Photo 23 shows the front left fork of the Motorcycle. The front left fork (arrowed) was observed to be dislodged as a result of the accident. We were hence not able to conduct any tests on the steering system of the Motorcycle.

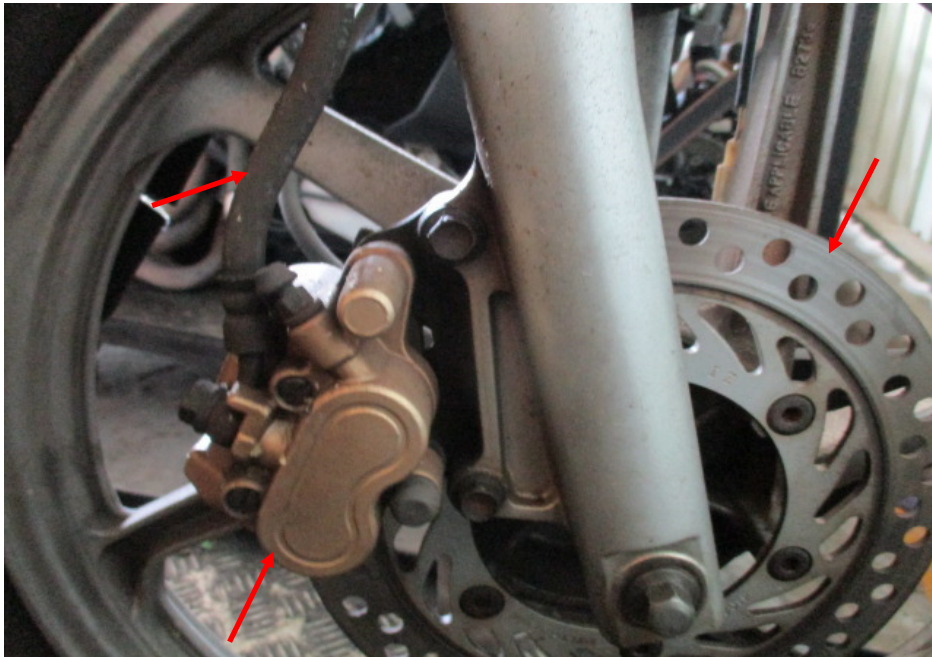
Photo 24 shows a close up view of the front brake caliper, front brake disc and front brake hose (arrowed) of the Motorcycle, which are all part of the components in the hydraulic front brake system of the Motorcycle. Our visual checks of these various components had revealed all to be intact with no visible damage. No leakage of brake fluid was also observed.

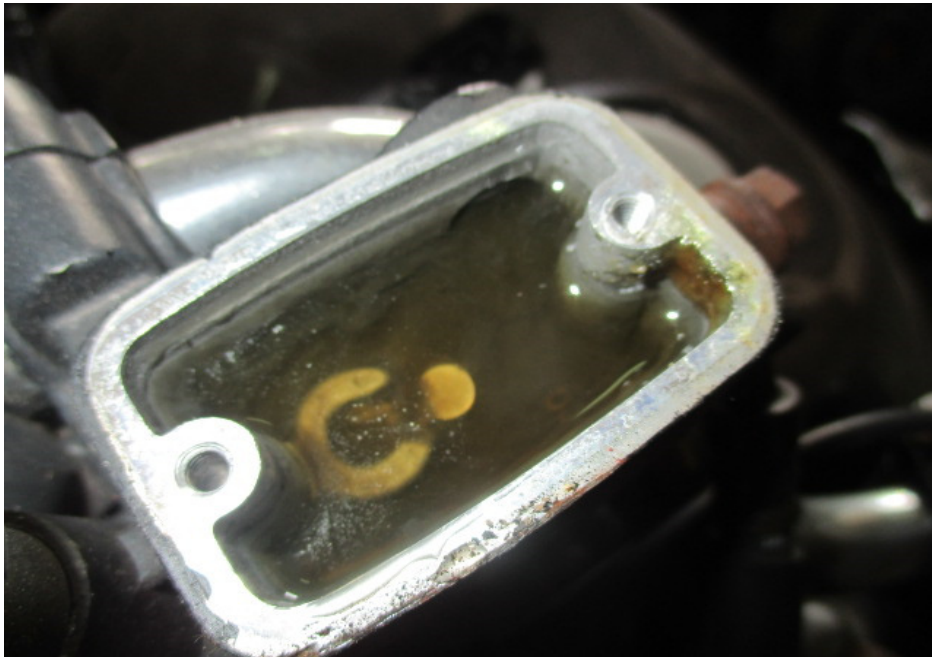
Photo 25 shows the brake fluid reservoir for the front brake of the Motorcycle. The brake fluid was observed to be without contamination and of sufficient level for operational purposes.

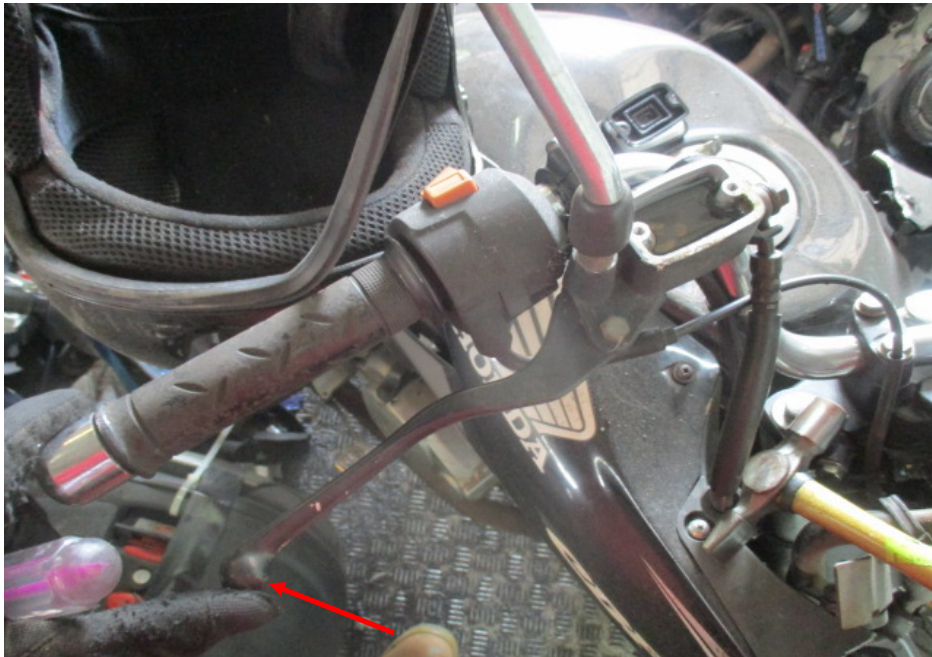
14. Static brake tests conducted on the Motorcycle had appear to indicate that the braking system of the Motorcycle was in serviceable condition. There was some resistance felt (spongy like feel) upon pressing the brake lever. This would indicate that there was no leakage of pressure/vacuum in the brake system.

Photo 26 shows the front brake lever being depressed. There was some resistance felt (spongy like feel) upon pressing the front brake lever (arrowed). This would indicate that there is no leakage of pressure/vacuum in the brake system.

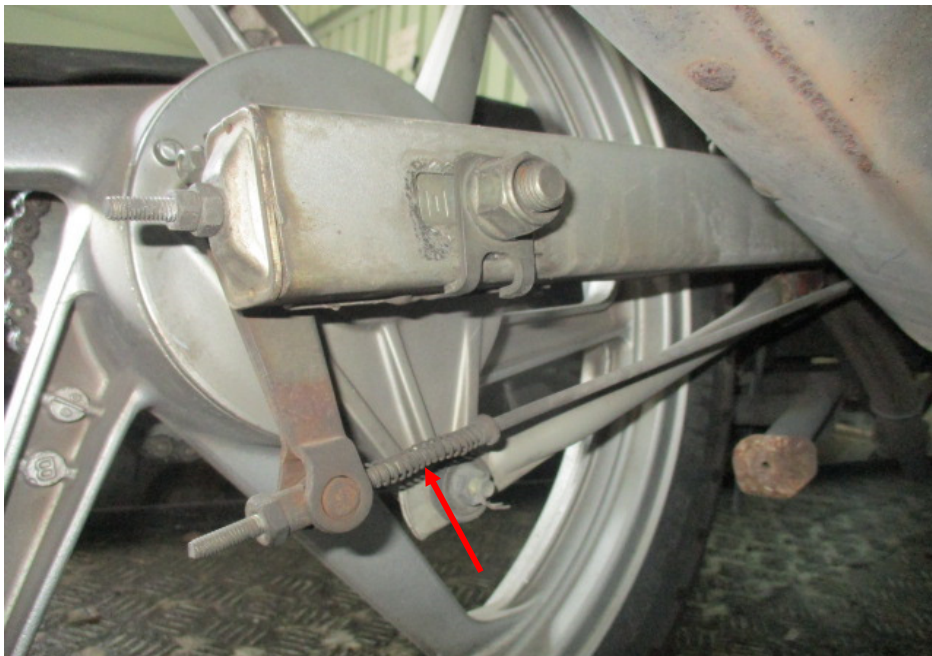
Photo 27 shows the rear wheel of the Motorcycle. The type of brake system for the rear wheel was of a mechanical type, controlled by the brake foot pedal of the Motorcycle. Our checks of the cable (arrowed), spring and drum which are all part of the components in the rear brake system of the Motorcycle reveal all to be intact and without damage.
