Your Ref: TP/IP/38815/2019
Our Ref : CI/TPD19012744/P

MECHANICAL INSPECTION REPORT OF POLICE MOTOR CAR QX 1024Y

1. I refer to your request on 08th July 2019 to conduct a physical inspection of a Motor Car bearing registration number QX 1024Y (herein referred to as “**Police Car**”), which was involved in a road traffic accident on 19th June 2019
2. The objective of the inspection is to determine if there was any possible mechanical failure to the Police Car that may have contributed to the accident.
3. Following the request, I had carried out a physical inspection of the Police Car on 29th July 2019 at the premises of Traffic Police vehicle pound, 517 Airport Road Singapore 539942. I now set out below my observations and comments with respect to this inspection.

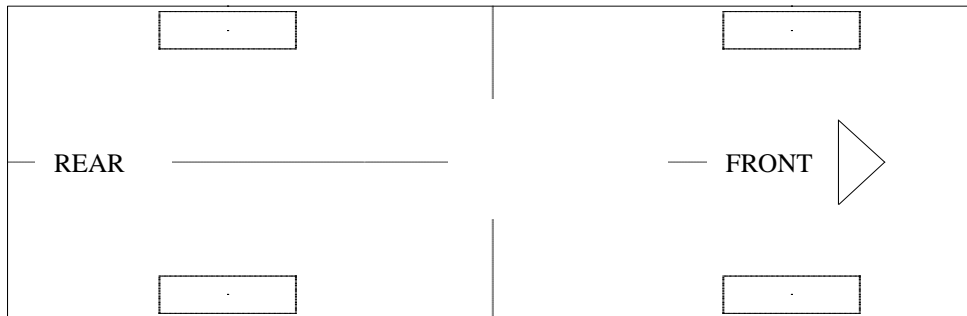
6. The condition of the Police Car's 4 tyres was observed to be in serviceable condition. I did not find any tear, cut or burst mark(s) on the outer and the inner sidewalls as well as across the tread of the 4 tyres. The 4 tyres were also observed to be sufficiently inflated for vehicular operation. The tyre brand, tyre size and remaining tread depth of the 4 tyres were recorded as follows:-

Falken 205/55R16 (3.2mm)

Falken 205/55R16 (4.3mm)

Falken 205/55R16 (4.4mm)

Falken 205/55R16 (5.9mm)

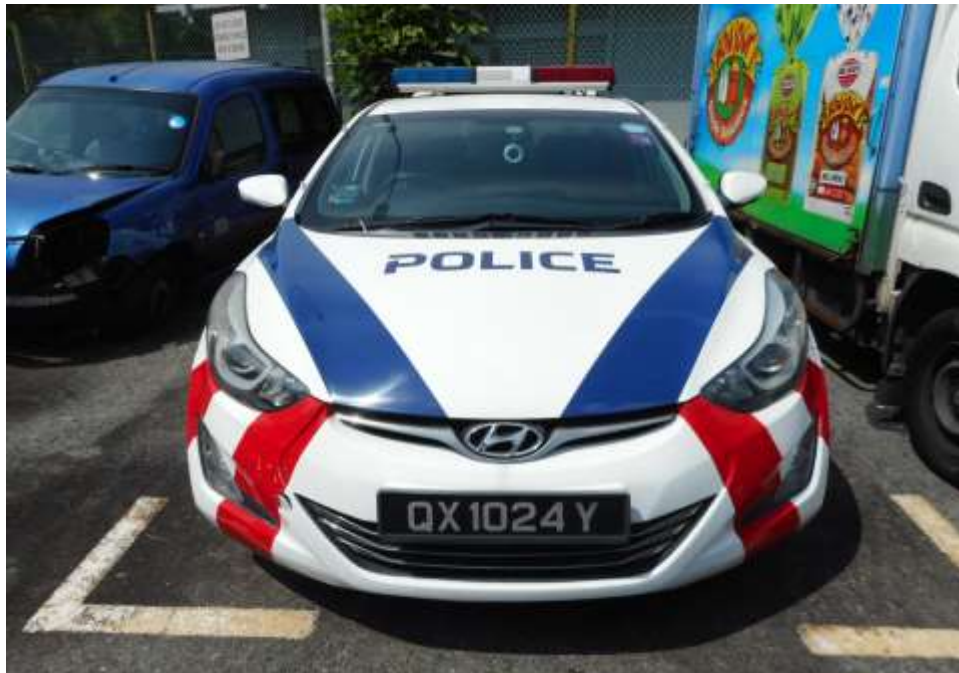
Photo 1 shows a front general view of the Police Car's at the time of my inspection. The front portion of the Police Car observed to have sustained minor damages at its frontal portion. Its front bumper was damage as a result of the accident at the time of my inspection. The mileage of the Police Car at the time of my inspection was recorded to be 116,671km.

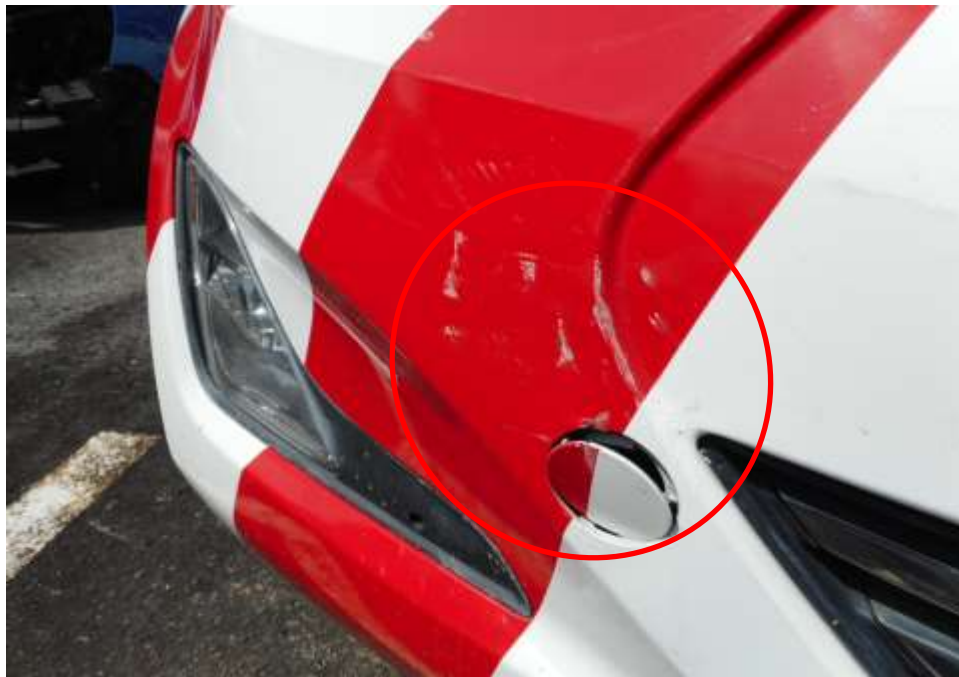
Photo 2 shows a close up view of the Police Car's at the time of my inspection. The front portion of the Police Car observed to have sustained minor damages at its frontal portion. Its front bumper (circled) was damage as a result of the accident at the time of my inspection.

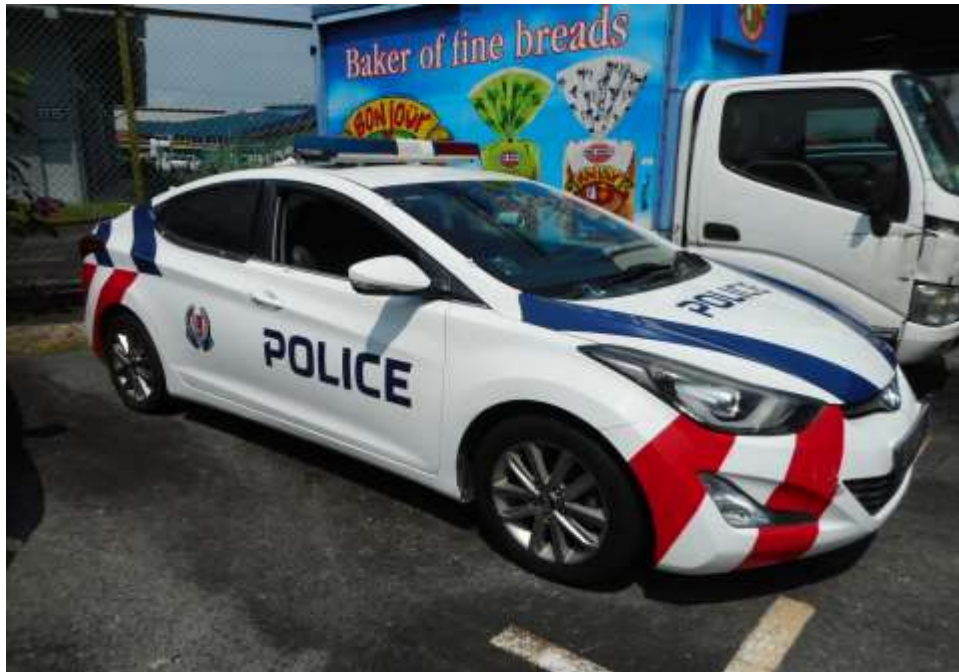
Photo 3 shows a general view of the Police Car's right body panel at the time of my inspection. The right portion of the Police Car was observed to have been unaffected by the accident.

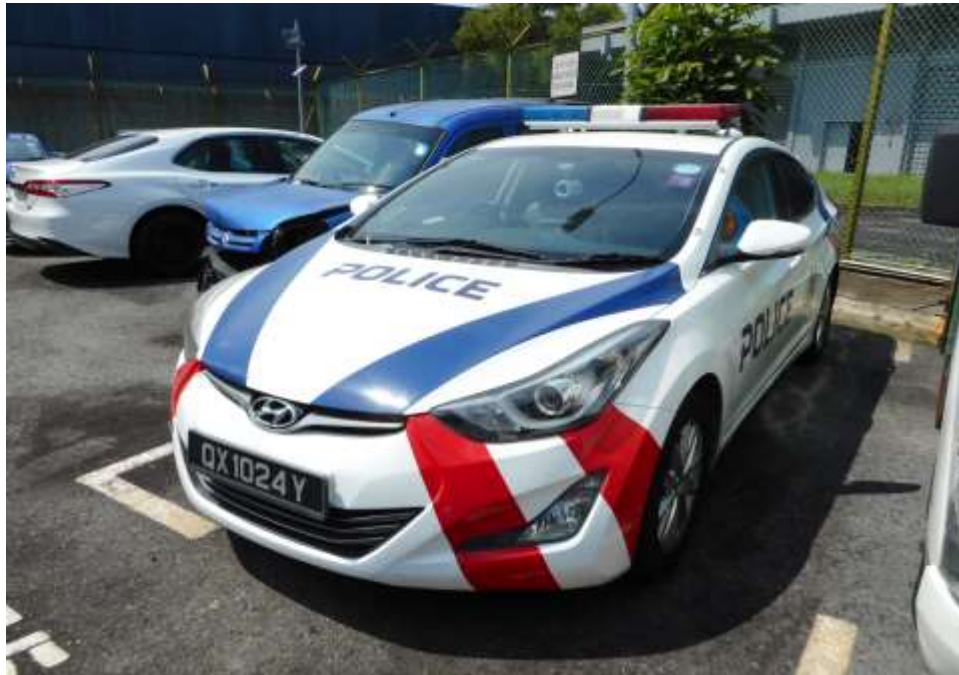
Photo 4 shows a general view of the Police Car's left body panel at the time of my inspection. The left portion of the Police Car was observed to have been unaffected by the accident.

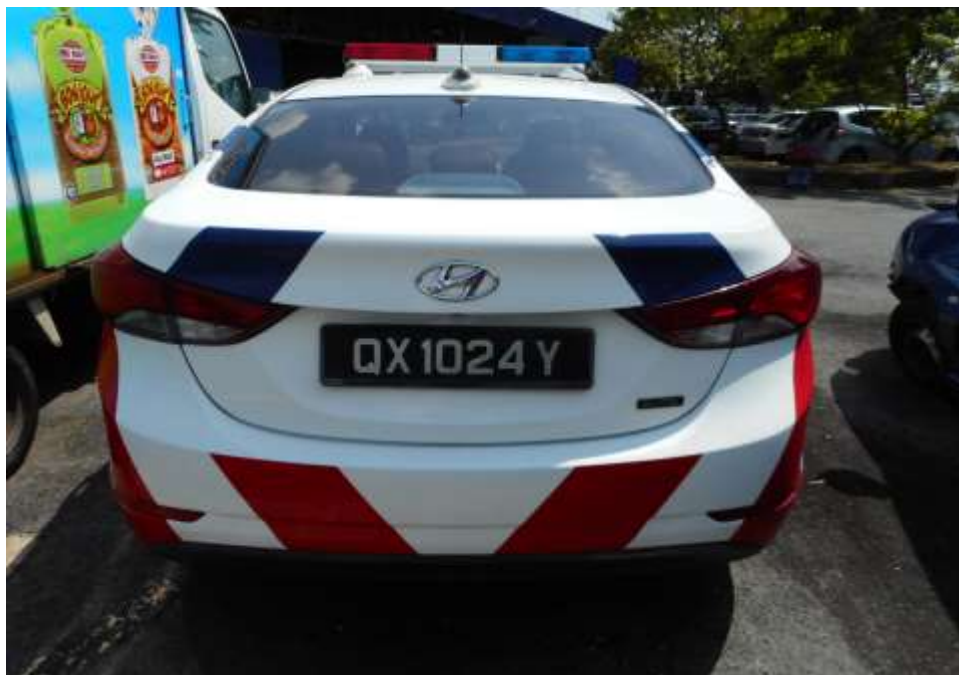
Photo 5 shows a general view of the Police Car's rear body at the time of my inspection. The rear portion of the Police Car was observed to have been unaffected by the accident.

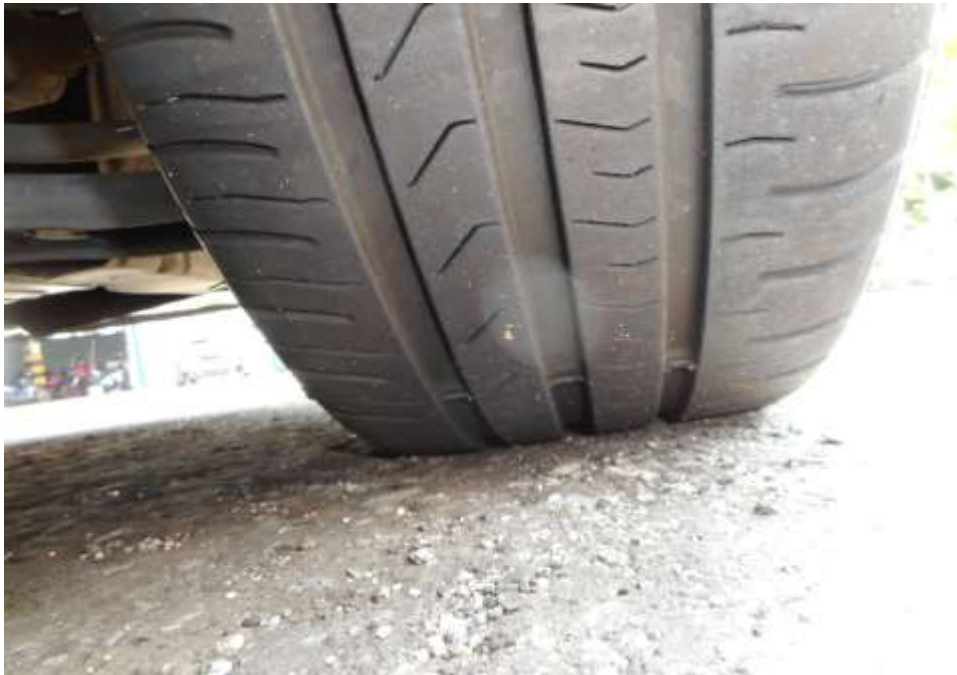
Photo 6 shows the condition of the front right tyre of the Police Car, which was observed to be in serviceable condition with remaining tread depth of approximately 5.9mm. The tyre was sufficiently inflated for vehicular operation with no tear, cut or burst mark(s) on the outer and the inner sidewalls as well as across the tread. The 4 tyres of the Police Car were wrapped around standard alloy wheel rims without any damage.

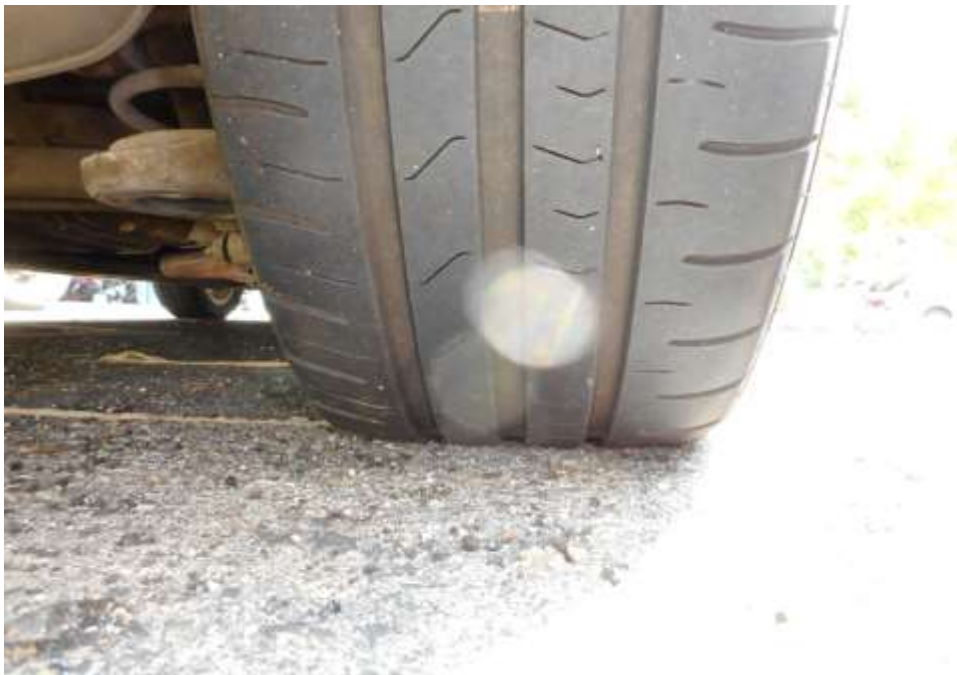
Photo 7 shows the condition of the rear right tyre of the Police Car, which was observed to be in serviceable condition with remaining tread depth of approximately 4.4mm. The tyre was also observed to be sufficiently inflated for vehicular operation with no tear, cut or burst mark(s).

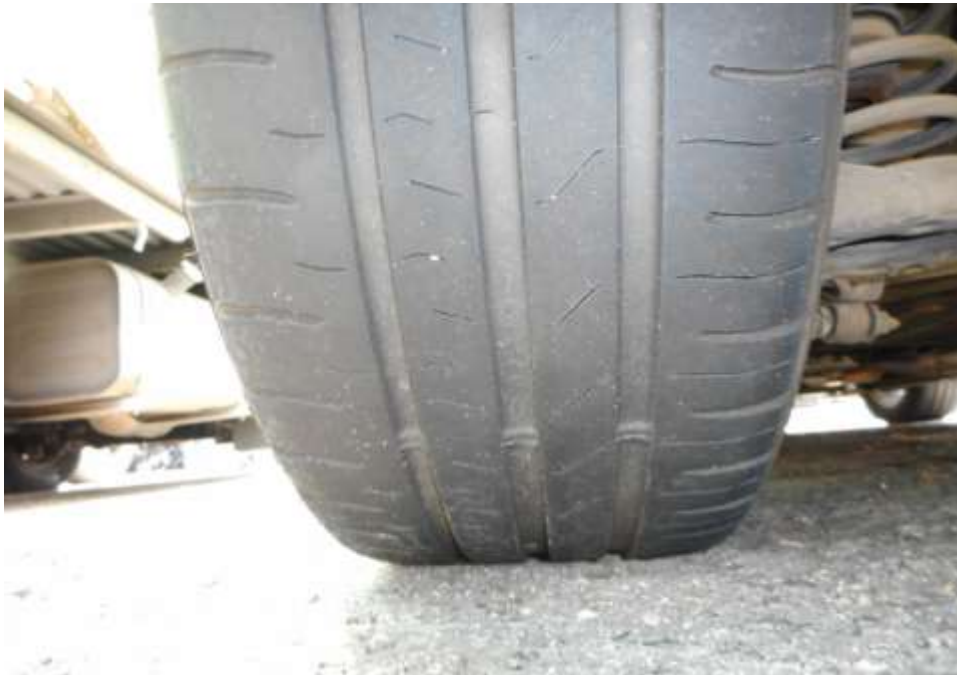
Photo 8 shows the condition of the rear left tyre of the Police Car, which was observed to be in serviceable condition with remaining tread depth of approximately 3.2mm. The tyre was also observed to be sufficiently inflated for vehicular operation with no tear, cut or burst mark(s).

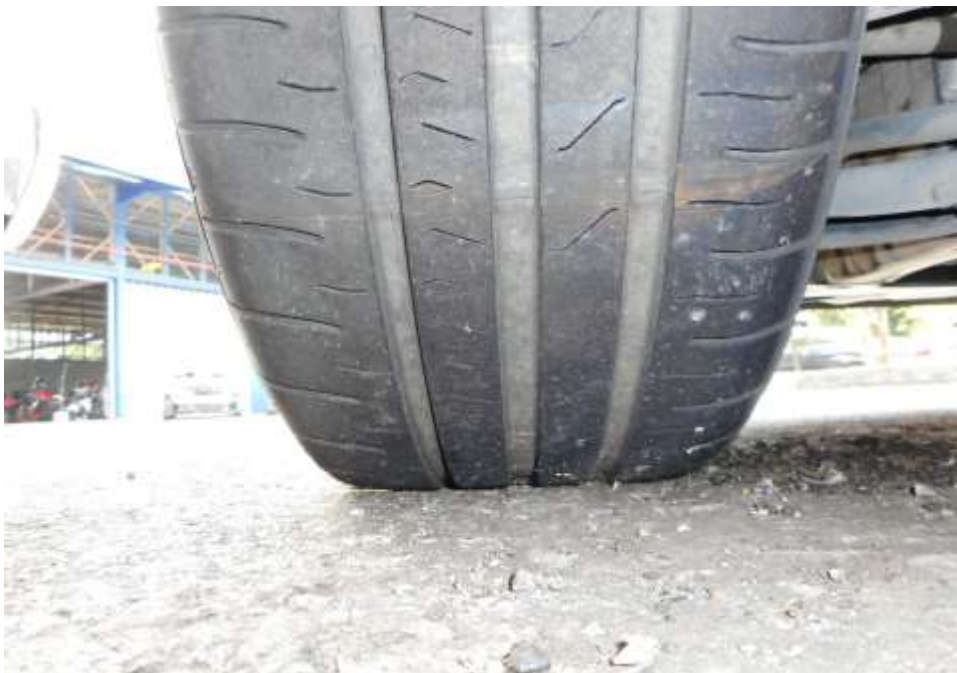
Photo 9 shows the condition of the front left tyre of the Police Car, which was observed to be in serviceable condition with remaining tread depth of approximately 4.3mm. The tyre was also observed to be sufficiently inflated for vehicular operation with no tear, cut or burst mark(s).

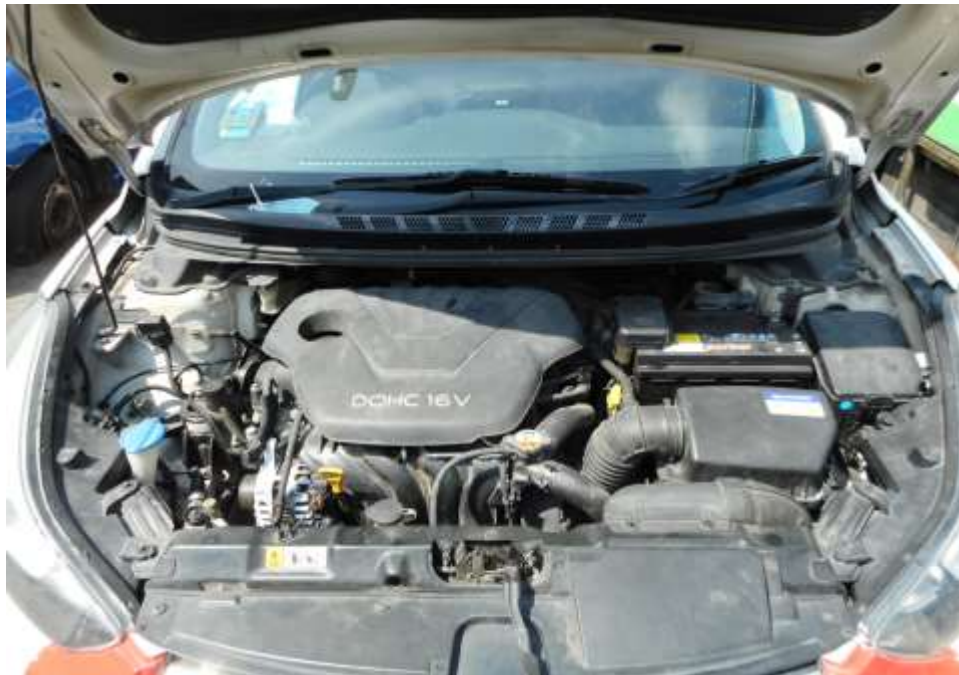
Photo 10 shows a general view of the Police Car's engine compartment. The various parts and components inside the engine compartment were unaffected by the accident. There was also no sign(s) or indication(s) of fluid leakage and/or fluid stain within the engine compartment.

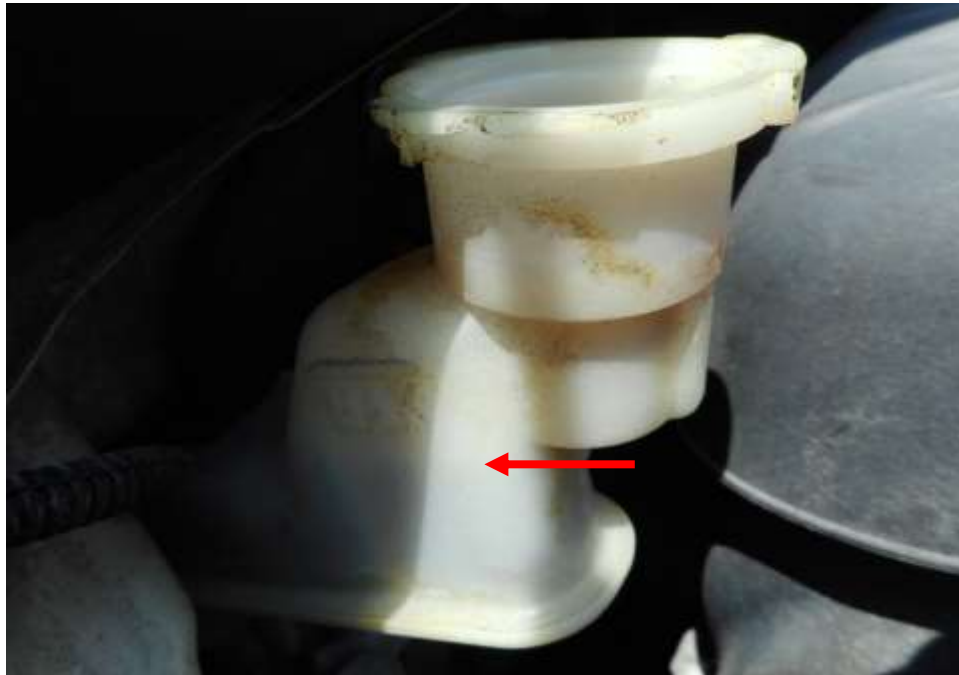
Photo 11 shows the brake fluid reservoir of the Police Car at the time of my inspection. The brake fluid was observed to be of sufficient level (arrowed) and without any visible contamination.

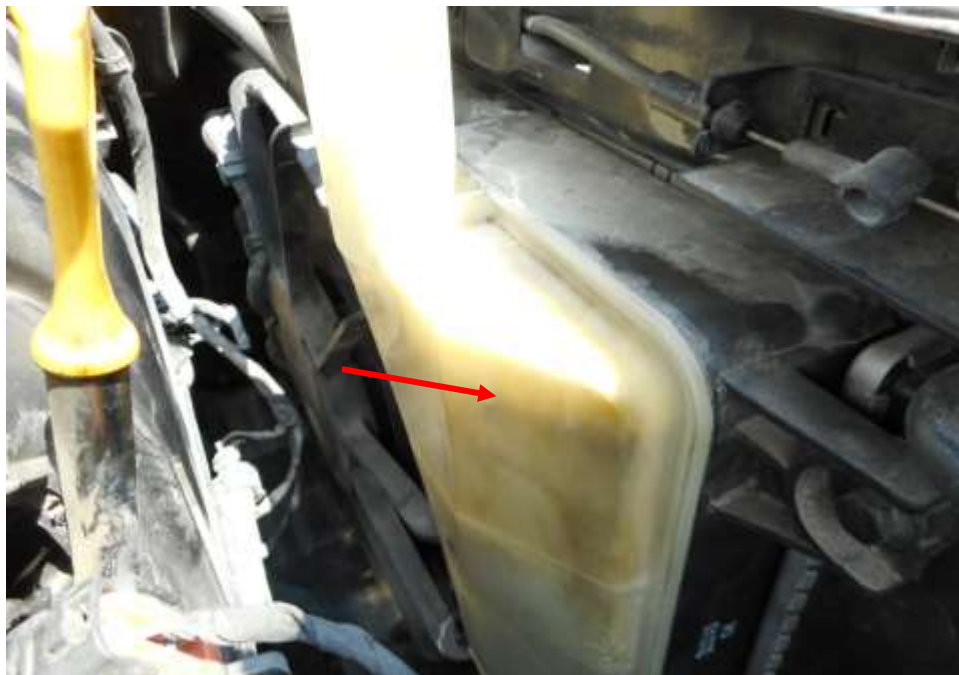
Photo 12 shows checks being carried out to the engine coolant of the Police Car at the time of my inspection. The engine coolant was observed to be of sufficient level (arrowed) and without any visible contamination.

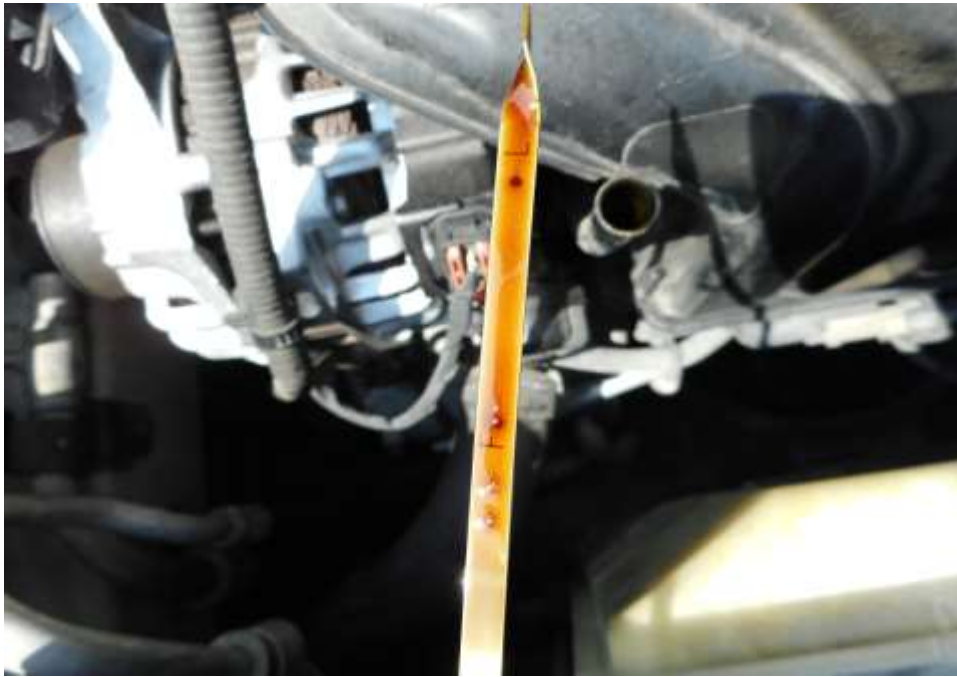
Photo 13 shows the engine oil dip stick of the Police Car at the time of my inspection. The engine oil was observed to be of sufficient level and without any visible contamination.

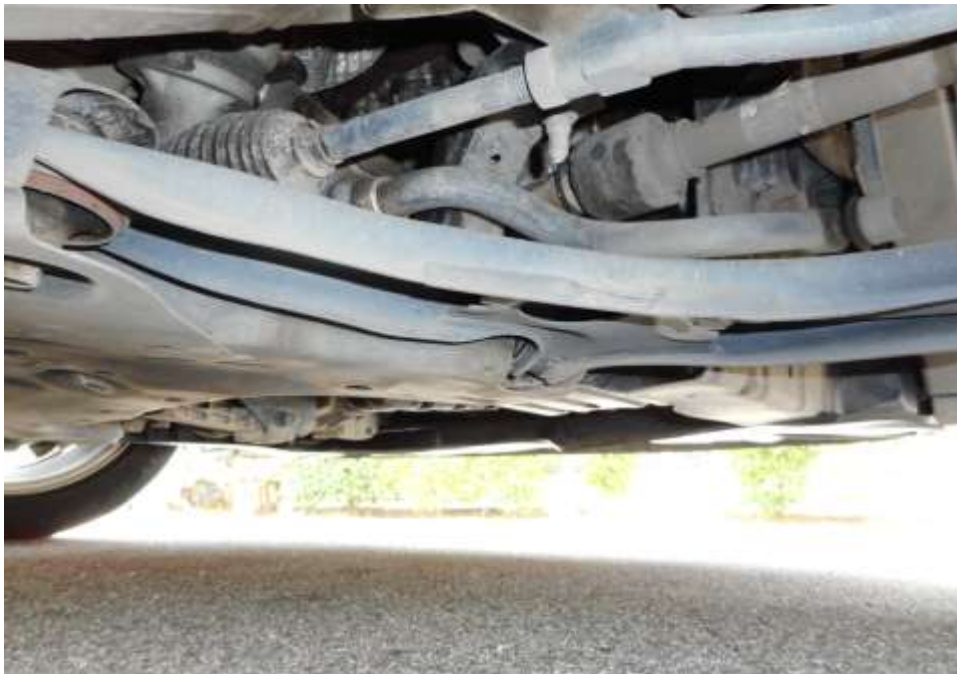
Photo 14 shows the undercarriage of the Police Car, at the area where the engine housing and transmission housing are located. I did not find any sign(s) or indication(s) of fluid leak and/or fluid stain(s) on the underside of the Police Car.

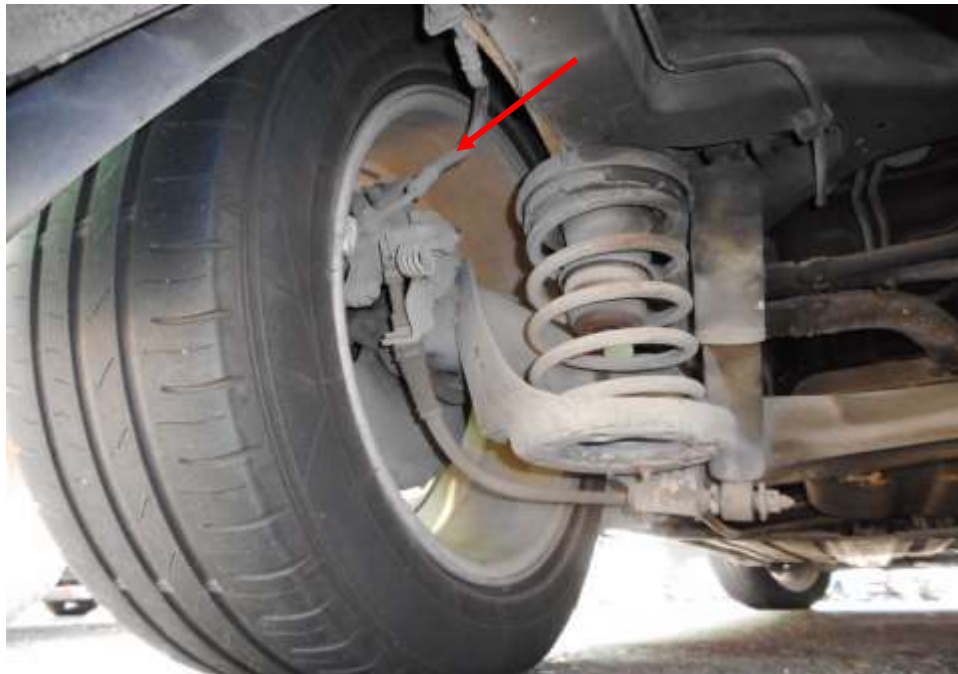
Photo 15 shows the brake hose/pipe (arrowed) at the rear left wheel of the Police Car. I did not observe any leakage of brake fluid at the time of my inspection of the Police Car. Static tests of the Police Car's braking system had indicated that there was no internal leakage of pressure/vacuum. The undercarriage components of the Police Car were also all found to be intact and without any visible damage.

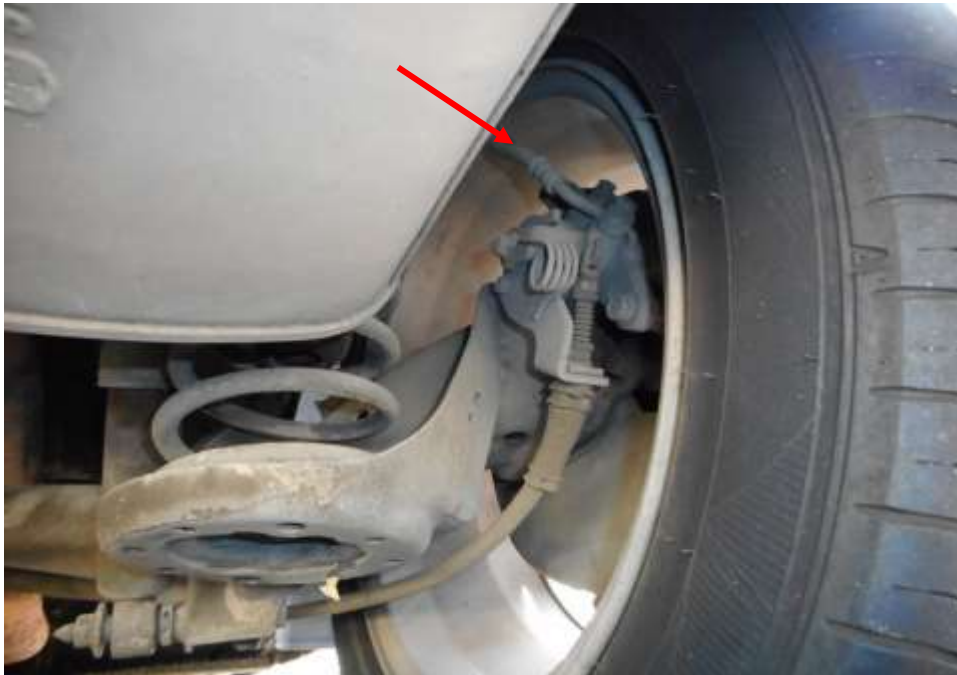
Photo 16 shows the brake hose/pipe (arrowed) at the rear right wheel of the Police Car. I did not observe any leakage of brake fluid at the time of my inspection of the Police Car. Static tests of the Police Car's braking system had indicated that there was no internal leakage of pressure/vacuum. The undercarriage components of the Police Car were also all found to be intact and without any visible damage.

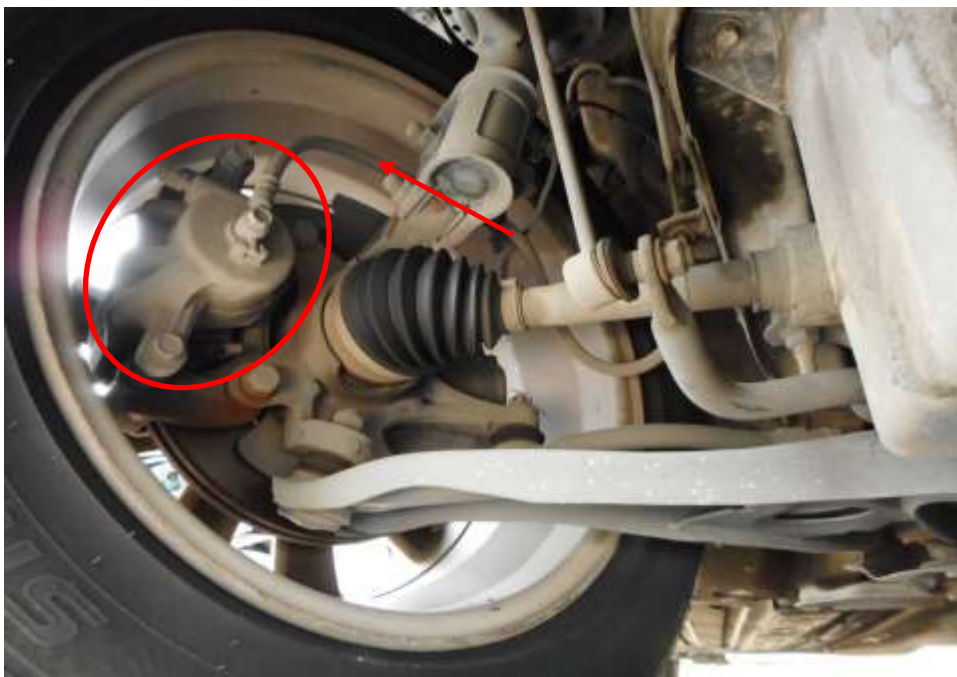
Photo 17 shows the brake hose/pipe (arrowed) at the front right wheel of the Police Car. No leakage of brake fluid was observed. Visual examination of the various components of the braking system like the brake caliper (circled), brake booster, brake pedal etc had revealed all to be intact and without visible damage.

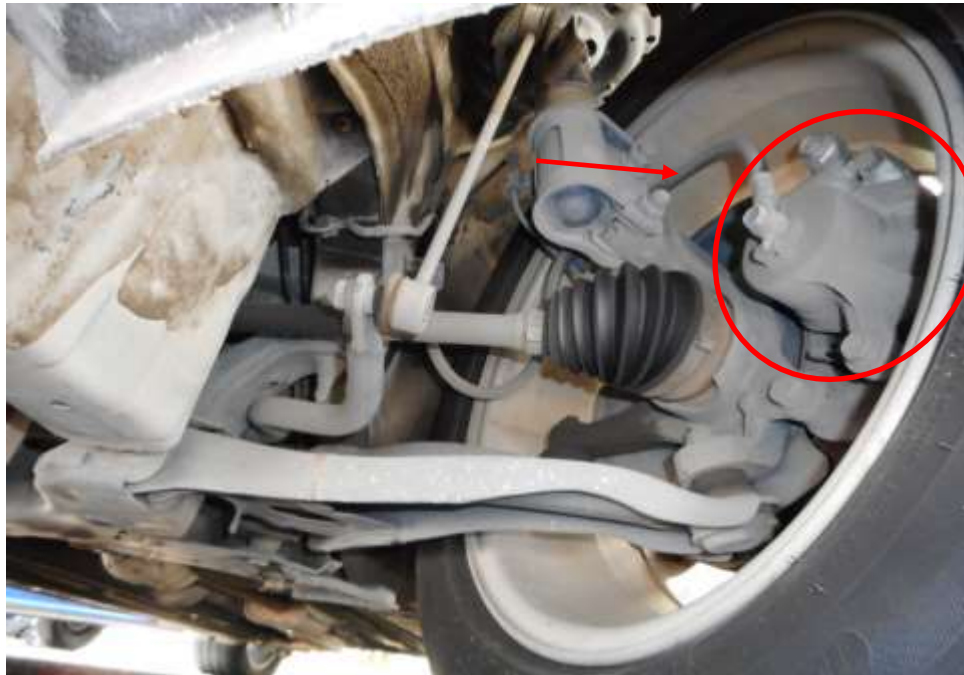
Photo 18 shows the brake hose/pipe (arrowed) at the front left wheel of the Police Car. No leakage of brake fluid was observed. Visual examination of the various components of the braking system like the brake caliper (circled), brake booster, brake pedal etc had revealed all to be intact and without visible damage.

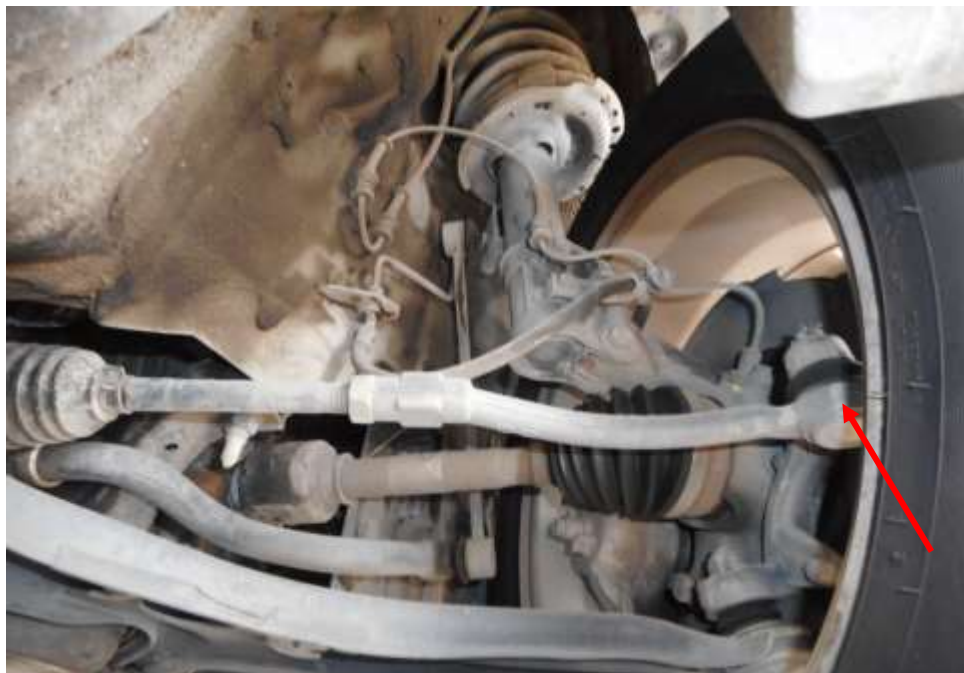
Photo 19 shows the various undercarriage components at the front right wheel of the Police Car, in particular the steering tie rod (arrowed). The various steering components were all found to be intact, suggesting that the steering system of the Police Car was likely to be in serviceable condition at the material time of accident. There was also no sign of fluid stain observed on the various undercarriage components at the front right wheel of the Police Car.

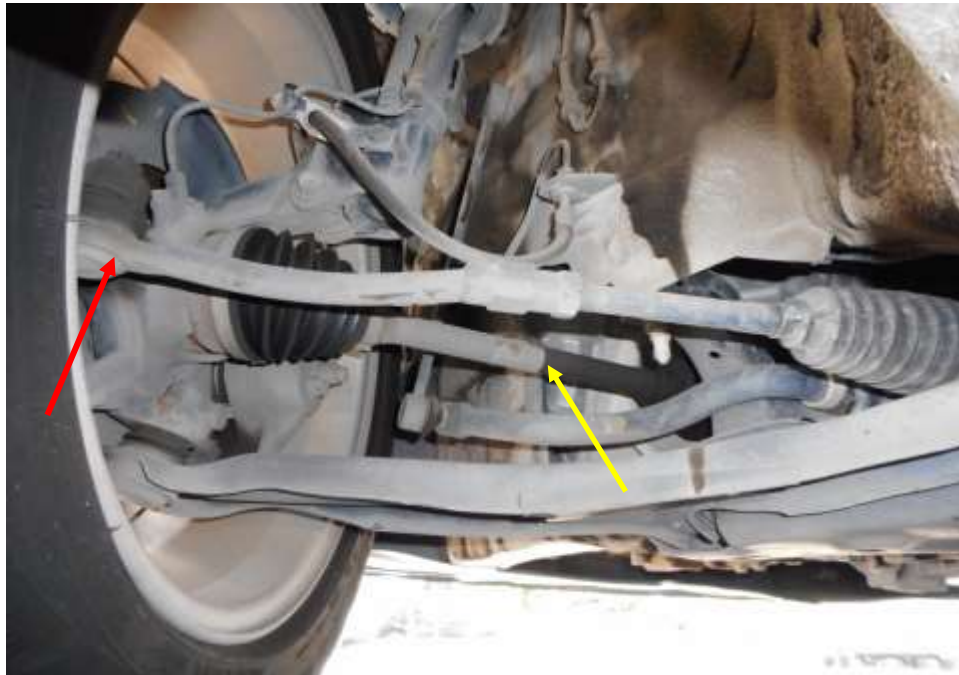
Photo 20 shows the various undercarriage components at the front left wheel of the Police Car, which had included the steering tie rod (red arrow) and front left drive shaft (yellow arrow). The various undercarriage components of the Police Car were all found to be intact without any visible damage.

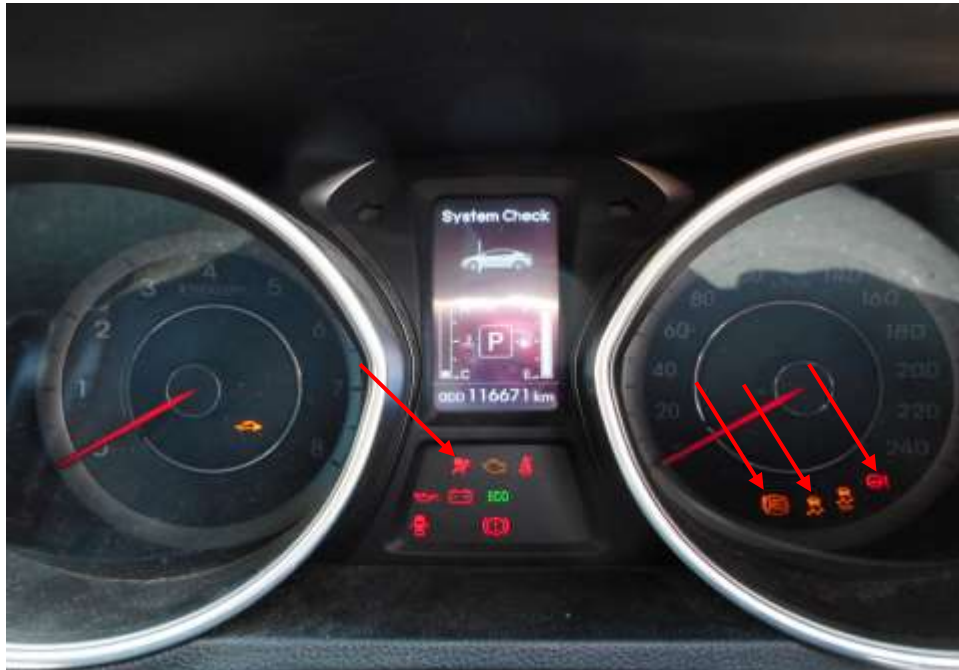
Photo 21 shows the warning light for Anti-Lock Brake System (ABS), Electric Power Steering System (EPS), Supplemental Restraint System (SRS) and Traction Control (TC) appearing on the instrument panel of the Police Car during the self-test of its various electronic operating systems when its engine was cranked.

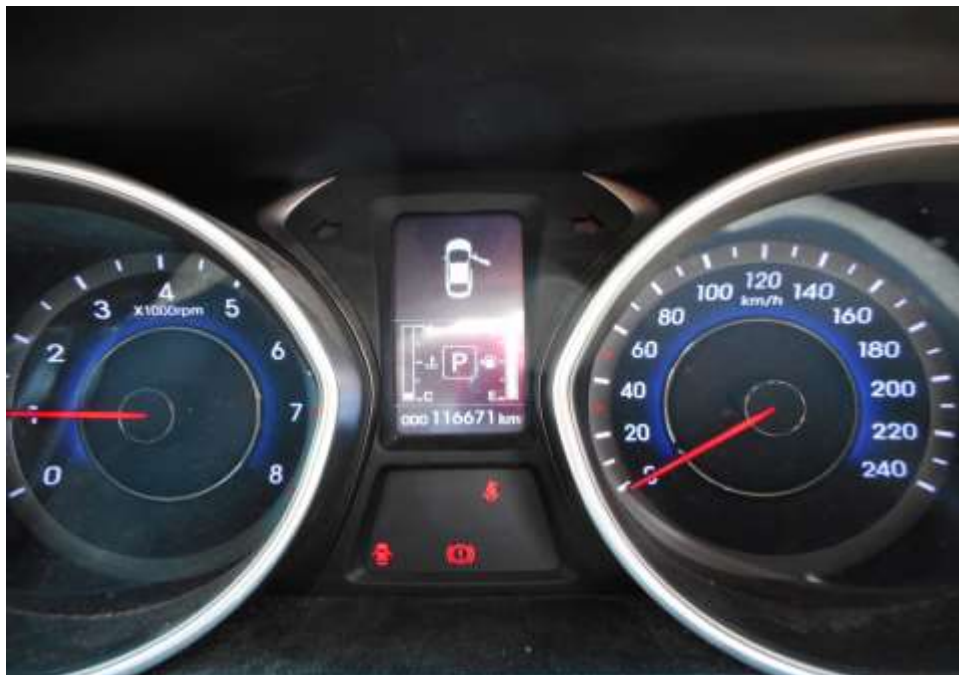
Photo 22 shows no warning lights illuminated on the instrument panel of the Police Car after the engine was cranked. This would suggest that there was no abnormality to the various electronic operating systems of the Police Car, like the ABS, EPS, SRS and TC etc.

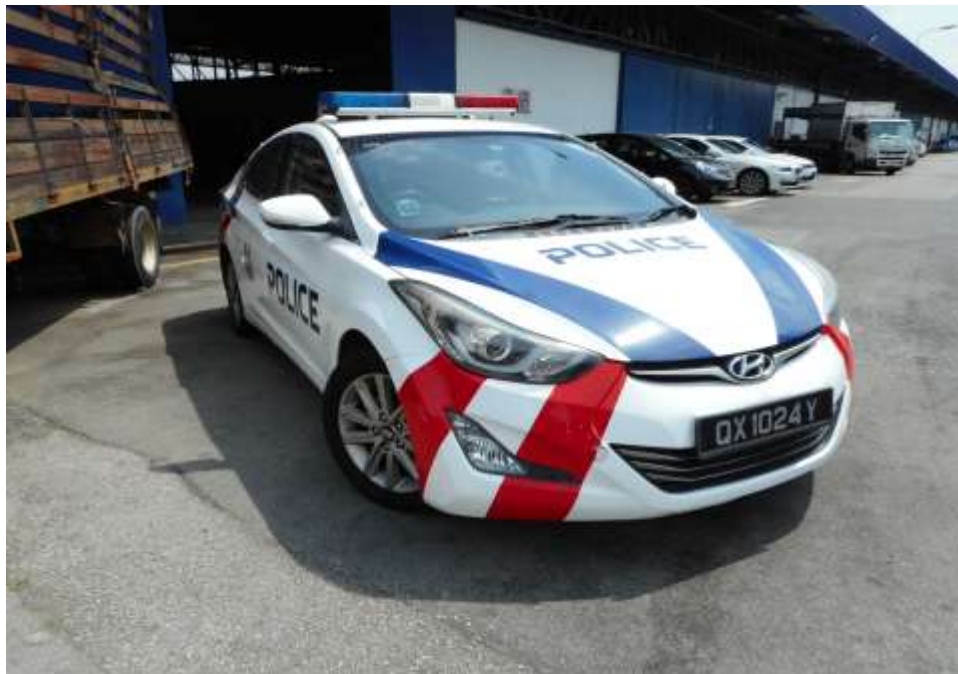
Photo 23 shows the front right wheel of the Police Car turned to its full left. During my steering system test, I did not experience any abnormal free play and/or resistance when I had turned the steering wheel towards the left and right. This would suggest that the steering system of the Police Car was likely to be in serviceable condition at the material time of accident.

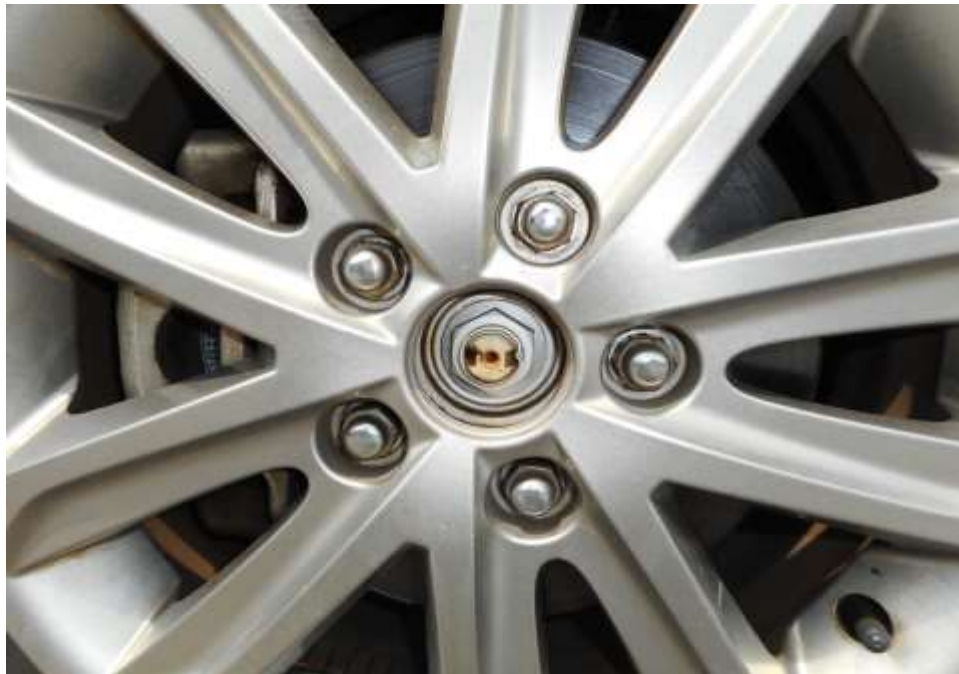
Photo 24 shows general view of the front left brake disc (arrowed) at the front left wheel of the Police Car after carrying out the operation tests. Visual examination of the brake disc shows no existing rust on the surface of the disc, as this is caused by the brake pads depressing against the brake discs when the brakes was applied to stop the vehicle. This is under the serviceable condition of the braking system

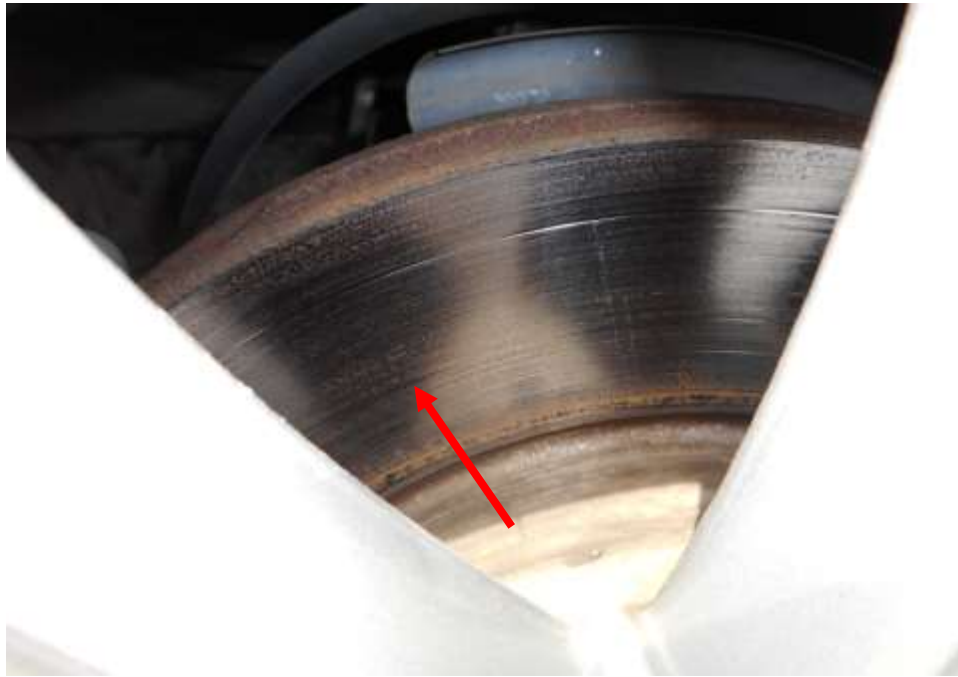
Photo 25 shows the close up view of the front left brake disc (arrowed) at the front left wheel of the Police Car after carrying out the operation tests. Visual examination of the brake disc shows no existing rust on the surface of the disc, as this is caused by the brake pads depressing against the brake discs when the brakes was applied to stop the vehicle. This is under the serviceable condition of the braking system

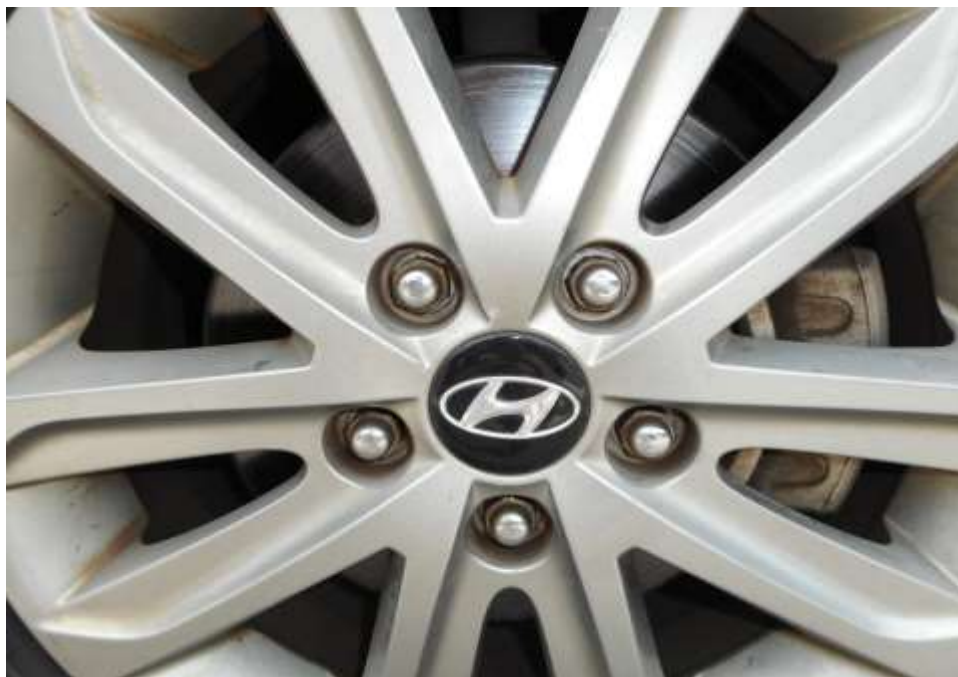
Photo 26 shows general view of the front right brake disc (arrowed) at the front right wheel of the Police Car after carrying out the operation tests. Visual examination of the brake disc shows no existing rust on the surface of the disc, as this is caused by the brake pads depressing against the brake discs when the brakes was applied to stop the vehicle. This is under the serviceable condition of the braking system

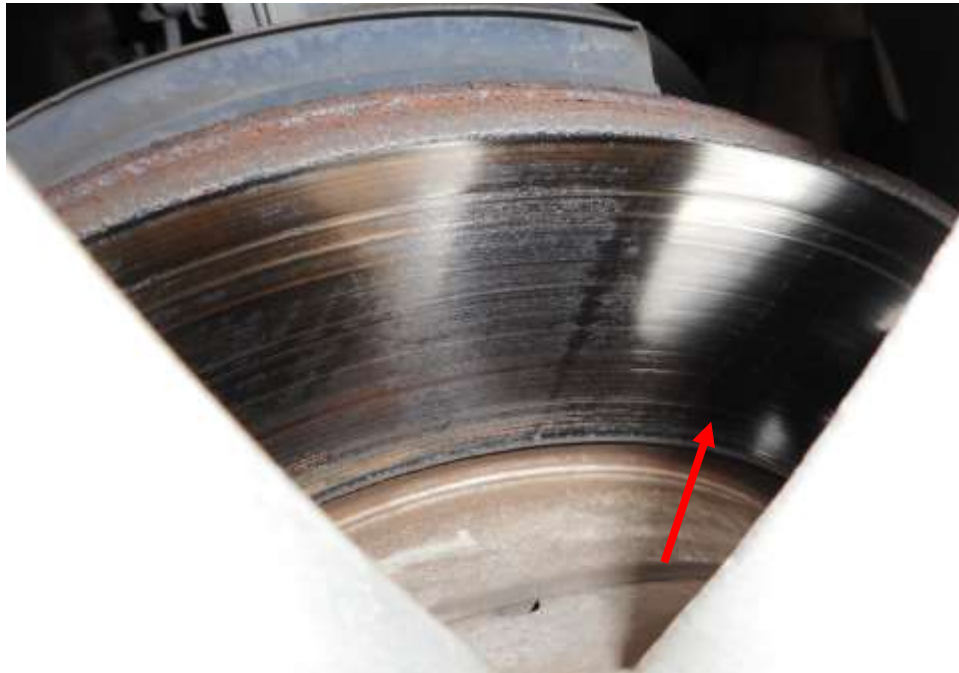
Photo 27 shows the close up view of the front right brake disc (arrowed) at the rear right wheel of the Police Car after carrying out the operation tests. Visual examination of the brake disc shows no existing rust on the surface of the disc, as this is caused by the brake pads depressing against the brake discs when the brakes was applied to stop the vehicle. This is under the serviceable condition of the braking system

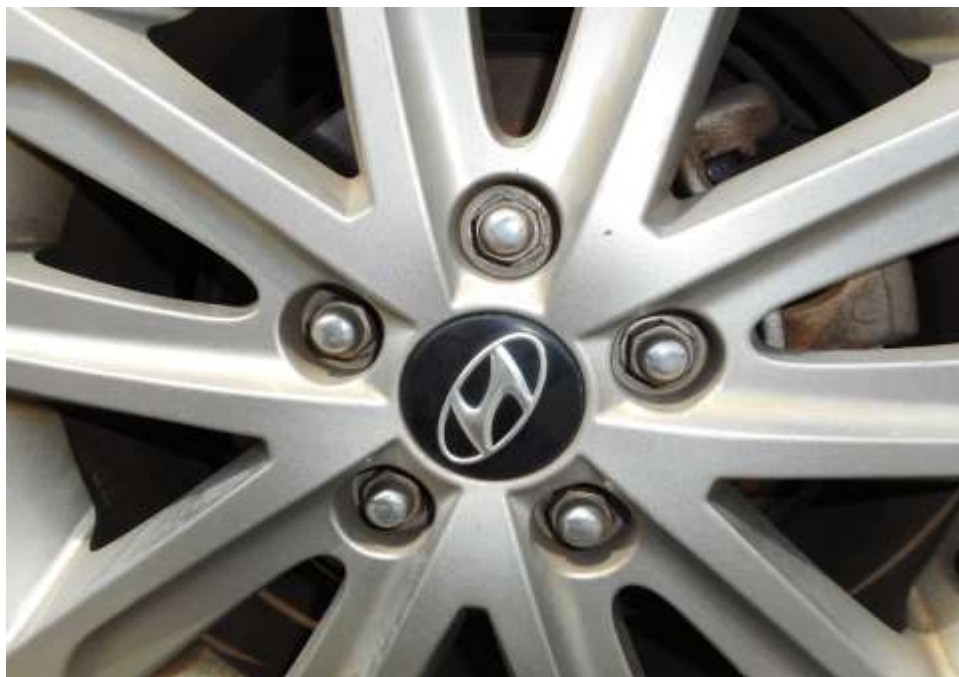
16. However, the braking efficiency of the Police Car appears to have been compromised the brake discs had rust build up on the surface due to oxidation of metal occurs as the prolonged stationary impoundment of the Police Car, under rain and shine environment which causes rust to build up. In normal circumstances, the rust will be worn away by the engagement of the brake pads to the brake discs as soon as driving occurs. However for this particular case the rust had remained after driving.

17. The rust had formed a layer between the frictional material of the brake pads and the disc brake surface, preventing the frictional material from coming into contact directly with the brake pads and brake discs. More effort would then be needed to press the brake pads towards the surface of the brake discs. This was the case for the Police Car that I had inspected where more effort was required to stop the rotation of the rear wheels. See photo 24 - 31 below

Photo 28 shows general view of the rear left brake disc (arrowed) at the rear left wheel of the Police Car after carrying out the operation tests. Visual examination of the brake disc shows the existing rust on the surface of the disc, this is caused by the brake pads not depressing against the brake discs when the brakes was applied to stop the vehicle. This affect has greatly decreased the braking efficiency of the braking system.

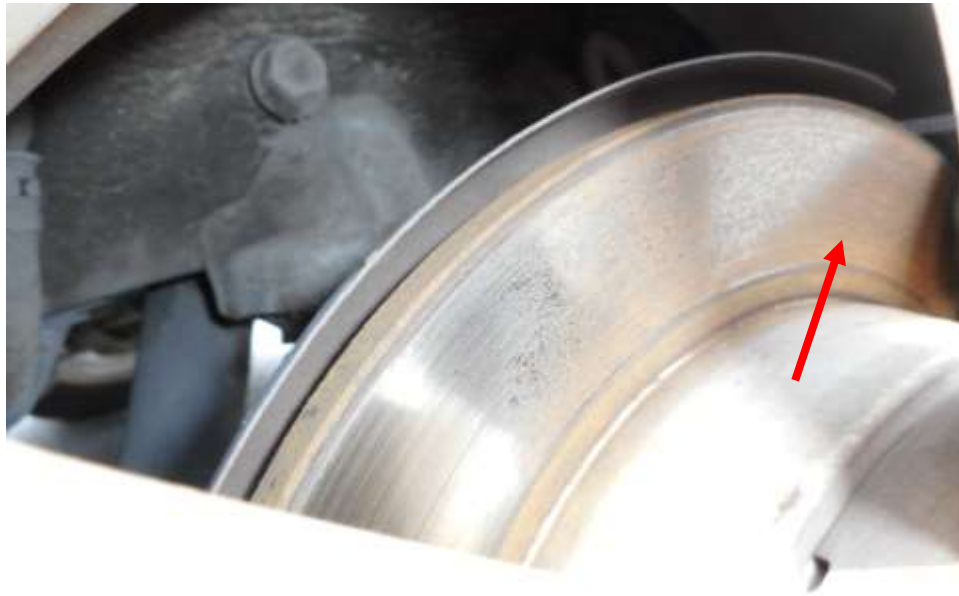
Photo 29 shows the close up view of the rear left brake disc (arrowed) at the rear left wheel of the Police Car after carrying out the operation tests. Visual examination of the brake disc shows the existing rust on the surface of the disc, this is caused by the brake pads not depressing against the brake discs when the brakes was applied to stop the vehicle. This affect has greatly decreased the braking efficiency of the braking system.
