Your Ref: TP/IP/38815/2019
Our Ref : CI/TPD19012744/P

MECHANICAL INSPECTION REPORT OF POLICE MOTOR CAR QX 1024Y

1. I refer to your request on 08th July 2019 to conduct a physical inspection of a Motor Car bearing registration number QX 1024Y (herein referred to as “**Police Car**”), which was involved in a road traffic accident on 19th June 2019
2. The objective of the inspection is to determine if there was any possible mechanical failure to the Police Car that may have contributed to the accident.
3. Following the request, I had carried out a physical inspection of the Police Car on 29th July 2019 at the premises of Traffic Police vehicle pound, 517 Airport Road Singapore 539942. I now set out below my observations and comments with respect to this inspection.

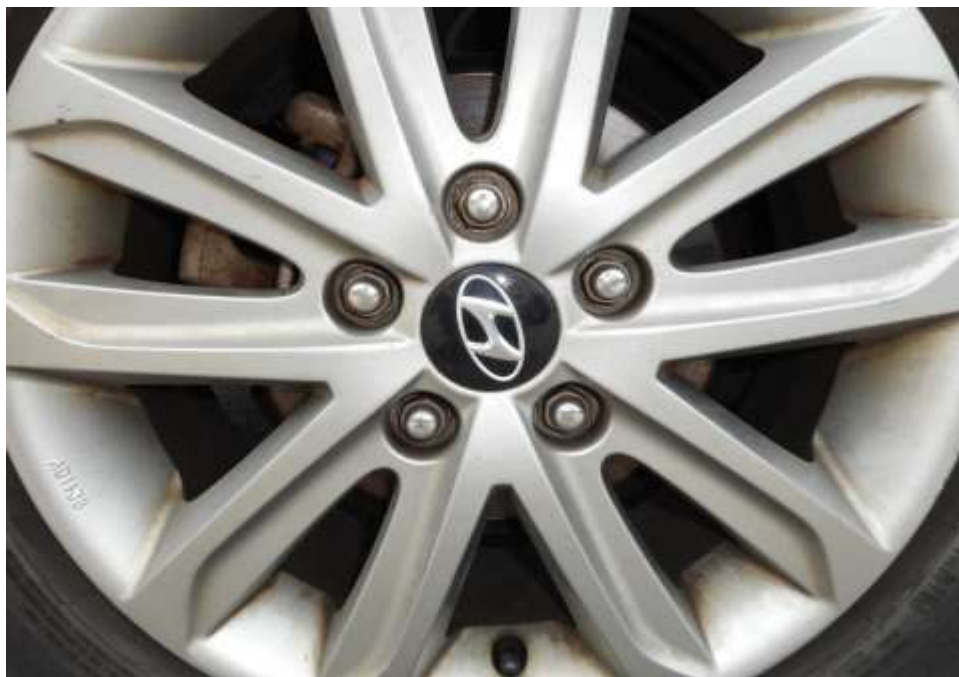
16. However, the braking efficiency of the Police Car appears to have been compromised the brake discs had rust build up on the surface due to oxidation of metal occurs as the prolonged stationary impoundment of the Police Car, under rain and shine environment which causes rust to build up. In normal circumstances, the rust will be worn away by the engagement of the brake pads to the brake discs as soon as driving occurs. However for this particular case the rust had remained after driving.

17. The rust had formed a layer between the frictional material of the brake pads and the disc brake surface, preventing the frictional material from coming into contact directly with the brake pads and brake discs. More effort would then be needed to press the brake pads towards the surface of the brake discs. This was the case for the Police Car that I had inspected where more effort was required to stop the rotation of the rear wheels. See photo 24 - 31 below

Photo 30 shows general view of the rear right brake disc (arrowed) at the rear right wheel of the Police Car after carrying out the operation tests. Visual examination of the brake disc shows the existing rust on the surface of the disc, this is caused by the brake pads not depressing against the brake discs when the brakes was applied to stop the vehicle. This affect has greatly decreased the braking efficiency of the braking system.

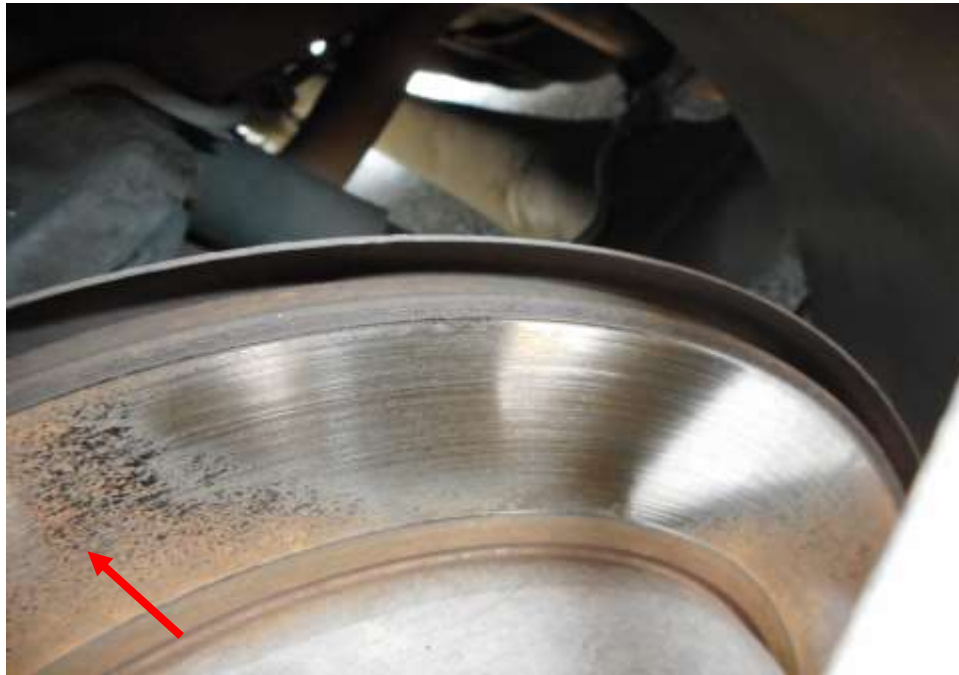
Photo 31 shows the close up view of the rear right brake disc (arrowed) at the rear right wheel of the Police Car after carrying out the operation tests. Visual examination of the brake disc shows the existing rust on the surface of the disc, this is caused by the brake pads not depressing against the brake discs when the brakes was applied to stop the vehicle. This affect has greatly decreased the braking efficiency of the braking system.
