Your Ref: TP/IP/40595/2019
Our Ref : CI/TPD19012745/P

8th October 2019

MECHANICAL INSPECTION REPORT OF TIPPER LORRY XD 6857A

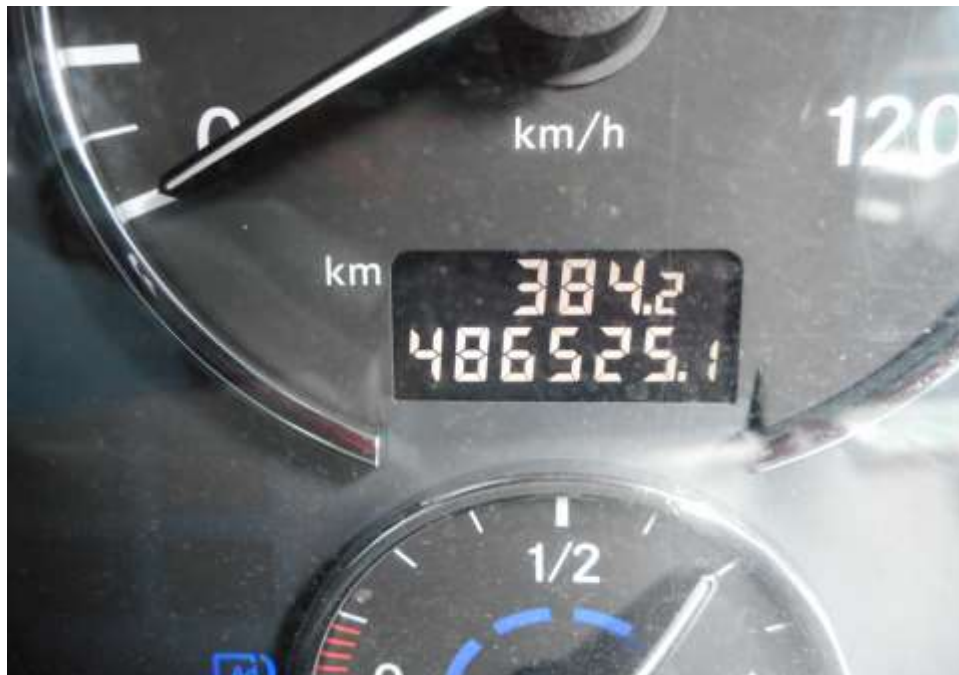
4. The mileage of the Tipper Lorry at the time of my inspection was 486,525km.
5. The Tipper Lorry was observed it did not sustain damage at the time of my inspection.

Photo 1 shows a general view of the instrument cluster of the Tipper Lorry at the time of my inspection. The mileage of the Tipper Lorry was 486,525km

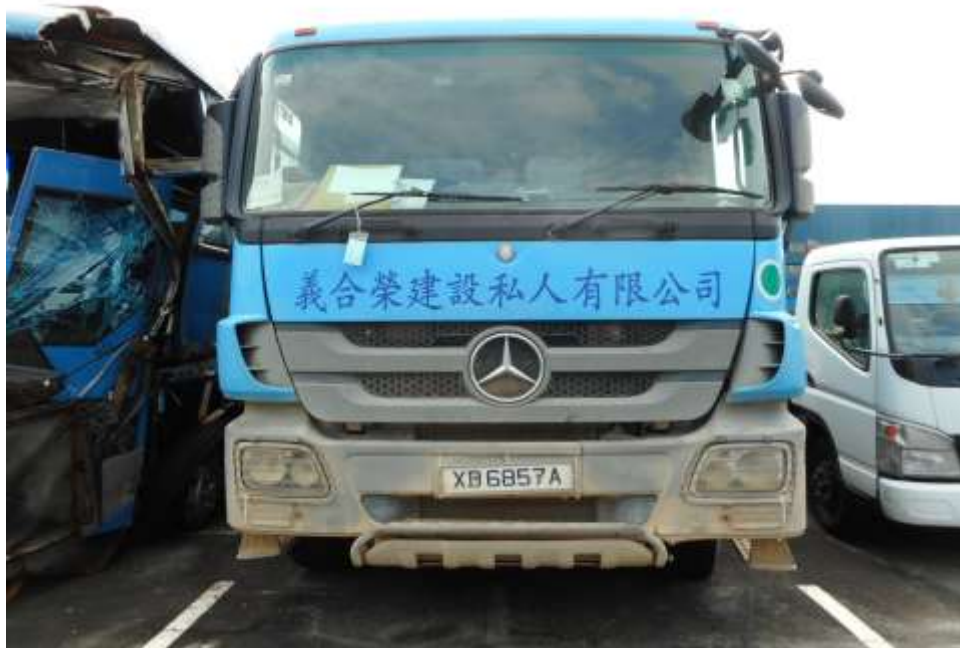
Photo 2 shows a general view of the front body of the Tipper Lorry at the time of my inspection. The Tipper Lorry was observed to not sustain any damage

15. During the operational test, the various transmission gears of the Tipper Lorry were able to be engaged without any difficulty by stepping on the clutch pedal and manually shifting the gear lever. There were no abnormal sounds heard and/or abnormal behaviour of the Tipper Lorry's engine system. It was able to move forward and backward normally. The braking system was also found to be in working condition as the Tipper Lorry was able to slow down and come to a complete stop upon depressing of the brake pedal. See photo 2 & 24.

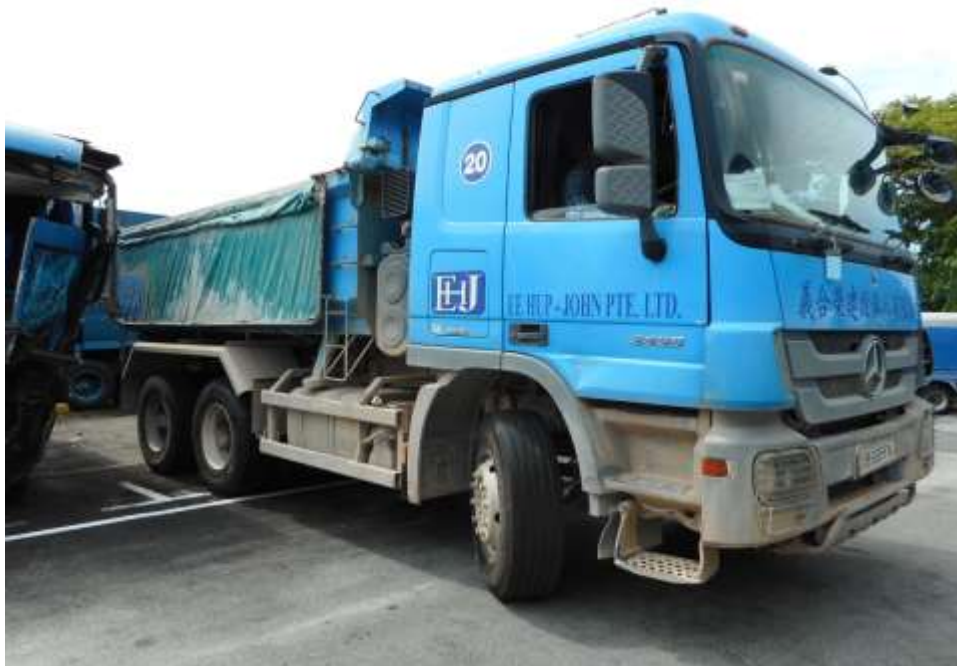
Photo 3 shows a general view of the front right body of the Tipper Lorry at the time of my inspection, observed to have been unaffected by the accident.

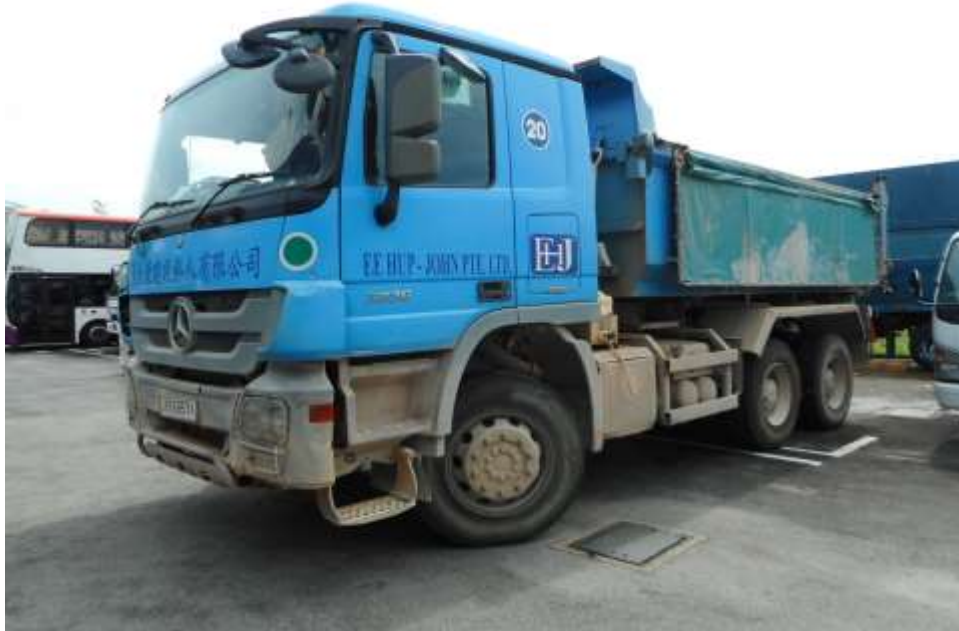
Photo 4 shows a general view of the front right body of the Tipper Lorry at the time of my inspection, observed to have been unaffected by the accident.

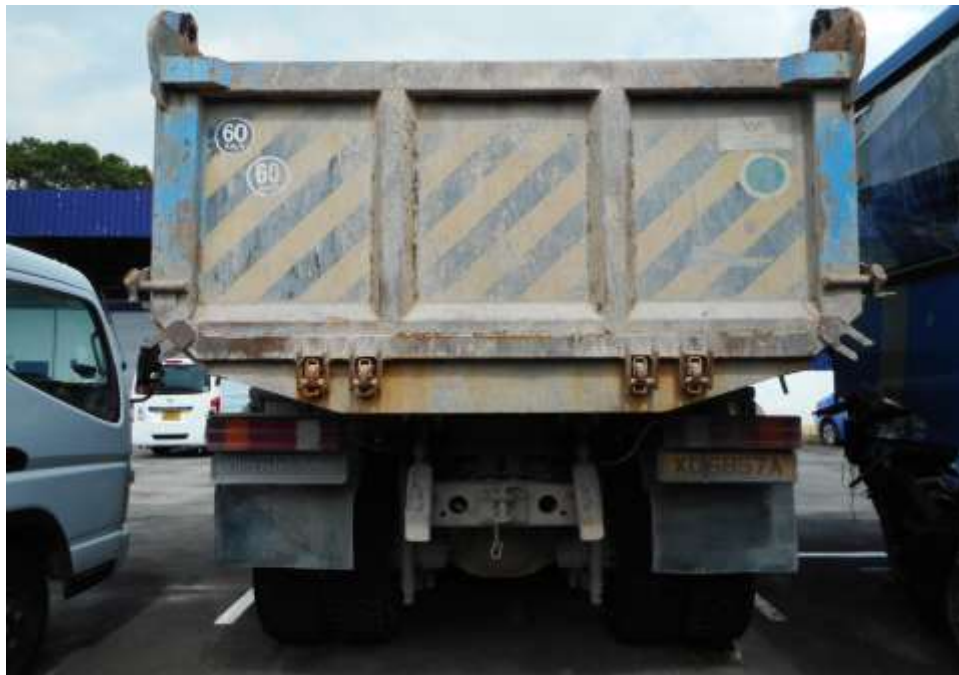
Photo 5 shows a general view of the Tipper Lorry's rear body at the time of my inspection. There was no damage found to the rear portion of the Tipper Lorry.

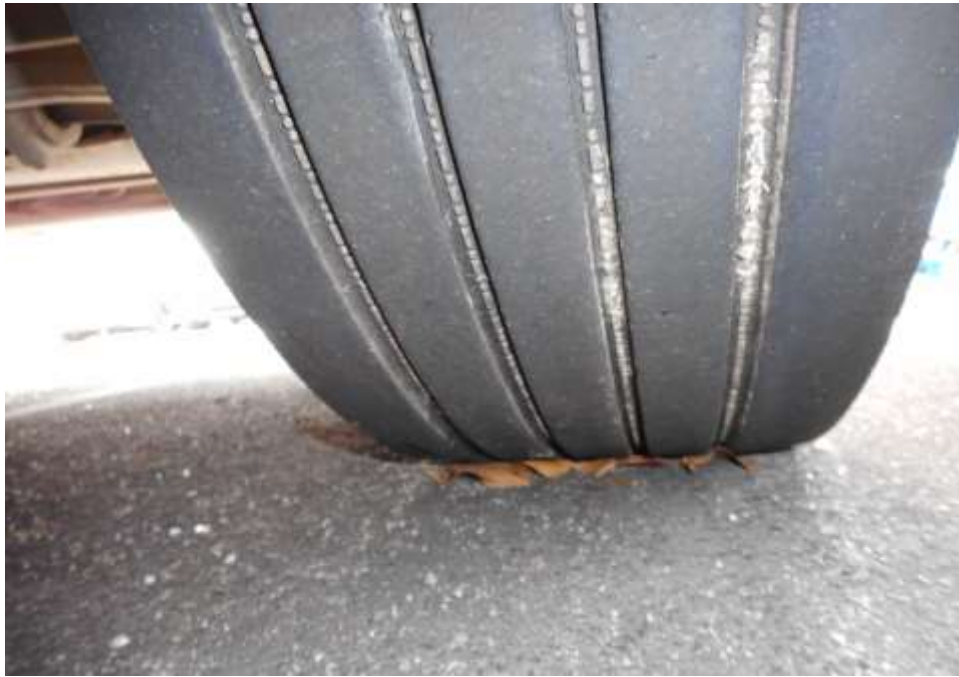
Photo 6 shows the condition of the front right tyre of the Tipper Lorry, which was observed to be in serviceable condition with remaining tread depth of approximately 7.7 mm. The tyre, which was wrapped around standard steel wheel rim, was also observed to be sufficiently inflated for vehicular operation. There was no tear, cut or burst mark(s) on the outer and the inner sidewalls as well as across the tread of the 10 tyres that were fitted on the Tipper Lorry.

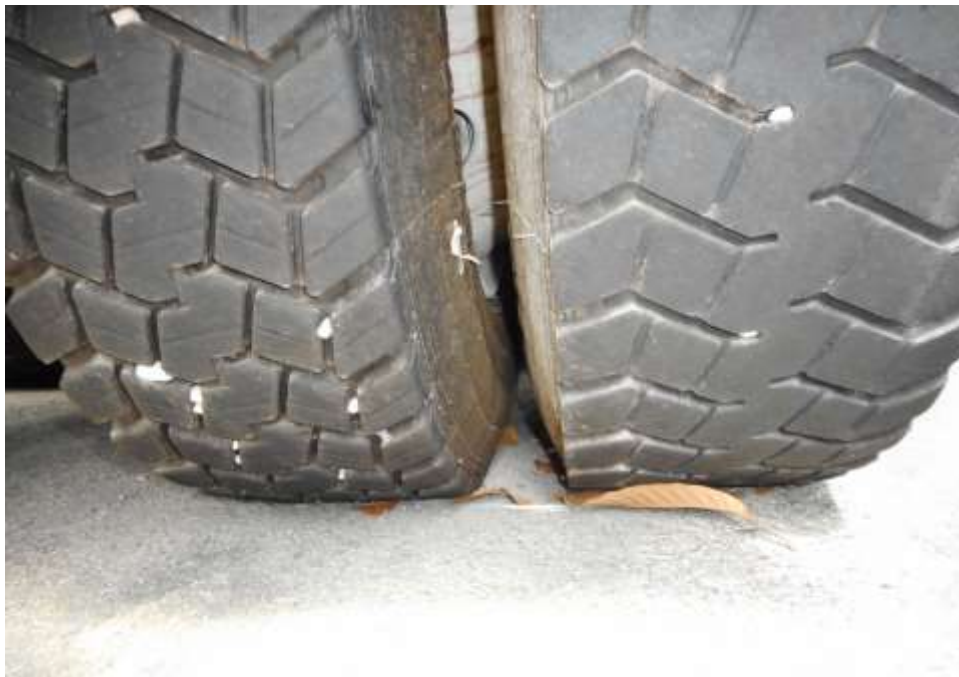
Photo 7 shows the condition of the rear right tyre of the Tipper Lorry, which was observed to be in serviceable condition with remaining tread depth of approximately 10.7mm. The tyre, which was wrapped around standard steel wheel rim, was also observed to be sufficiently inflated for vehicular operation.

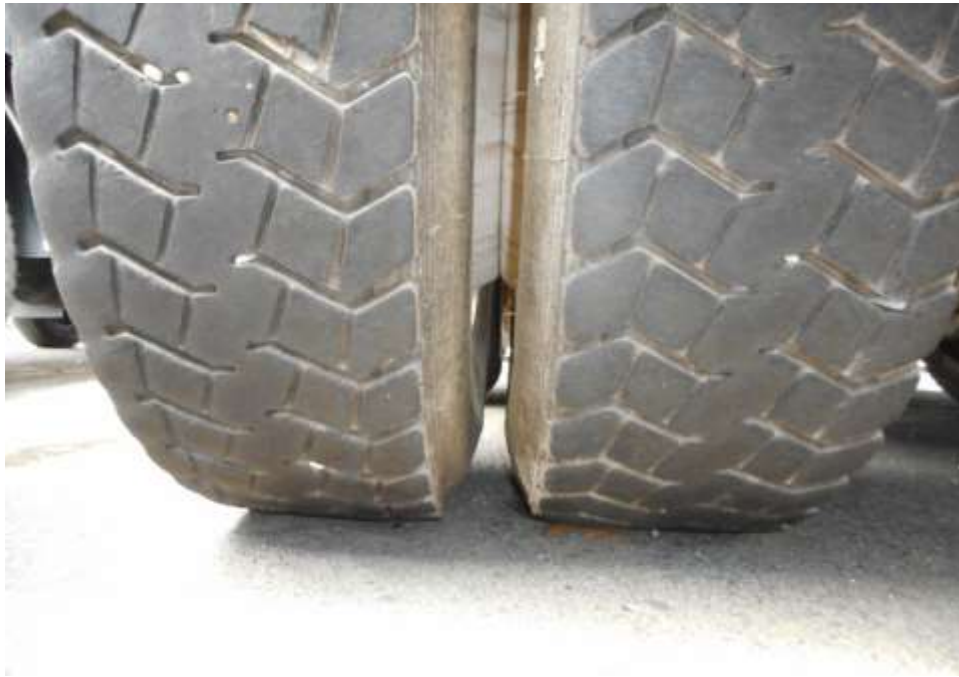
Photo 8 shows the condition of the rear left tyres of the Tipper Lorry, which was observed to be in serviceable condition with remaining tread depth of approximately 8.5mm. The tyres, which were wrapped around standard steel wheel rim, were also observed to be sufficiently inflated for vehicular operation. There was also no damage found on all 10 steel wheel rims of the Tipper Lorry.

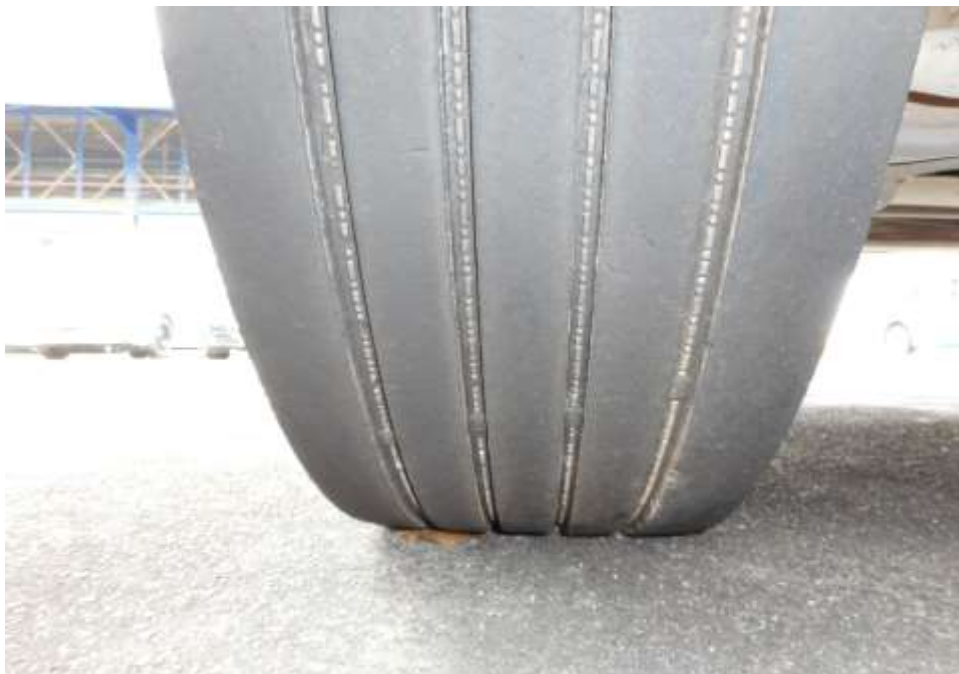
Photo 9 shows the condition of the front left tyres of the Tipper Lorry, which were observed to be in serviceable condition with remaining tread depth of approximately 8.3mm. There was also no tear, cut or burst mark(s) on the outer and the inner sidewalls as well as across the tread of the 10 tyres that were fitted on the Tipper Lorry.

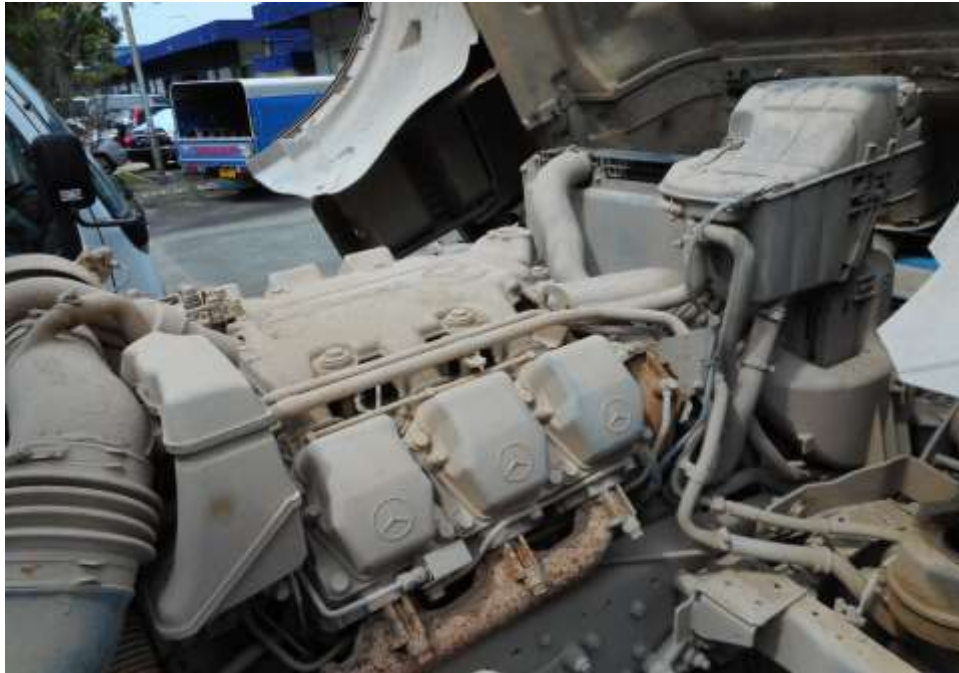
Photo 10 shows a general view of the Tipper Lorry's engine compartment, which was accessed by lifting the front cabin of the Tipper Lorry. The various parts and components inside the engine compartment were unaffected by the accident. There was also no sign(s) or indication(s) of fresh fluid leakage and/or fluid stain within the engine compartment

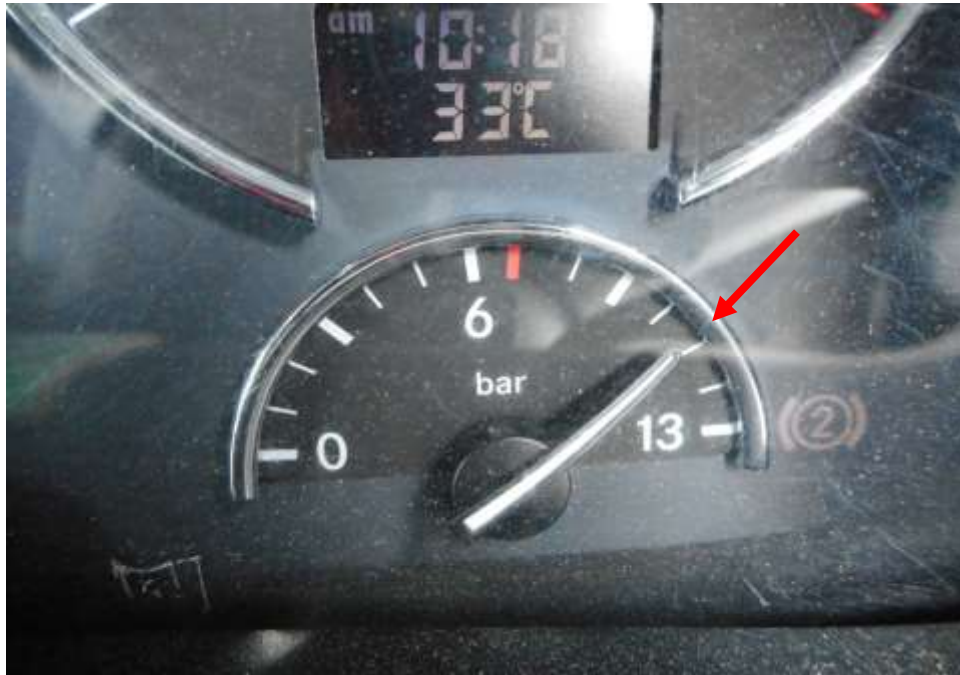
Photo 11 shows the air in the air brake cylinders of the Tipper Lorry at the time of my inspection. The air in the cylinder was observed to be of sufficient level & serviceable at the time of the accident.

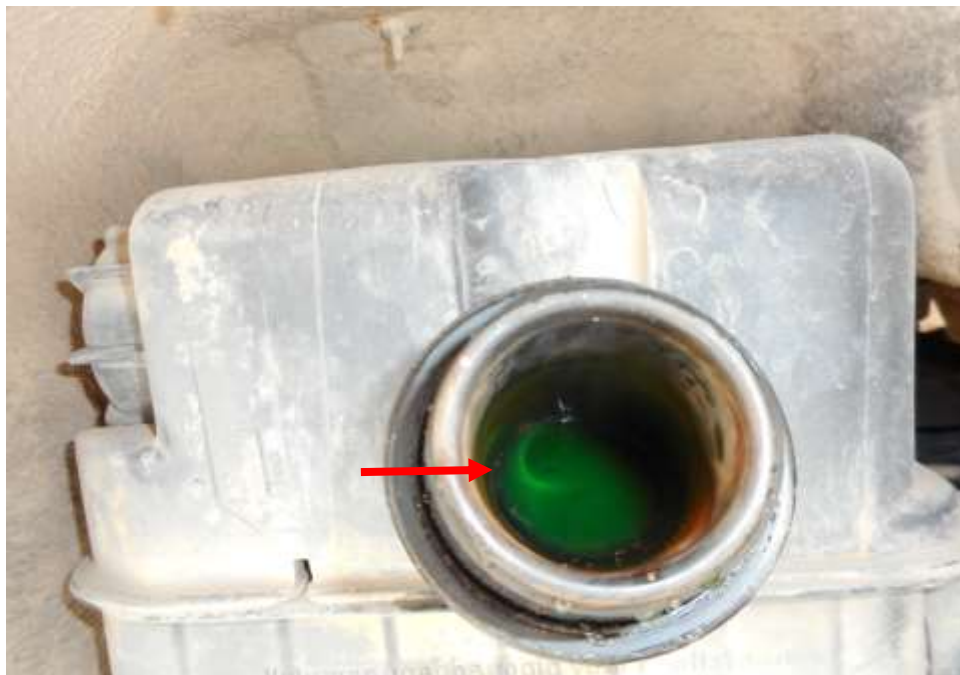
Photo 12 shows the engine coolant reservoir of the Tipper Lorry at the time of my inspection. The engine coolant was observed to be of sufficient level (arrowed) and without any visible contamination.

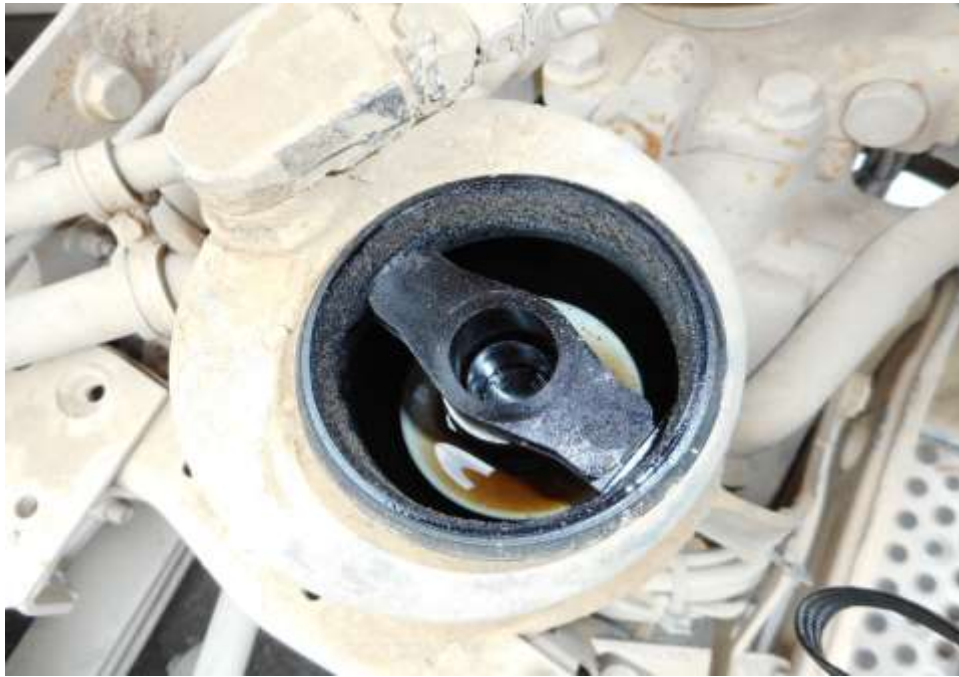
Photo 13 shows the power steering fluid reservoir of the Tipper Lorry at the time of my inspection. The power steering fluid was observed to be of sufficient level and without any visible contamination.

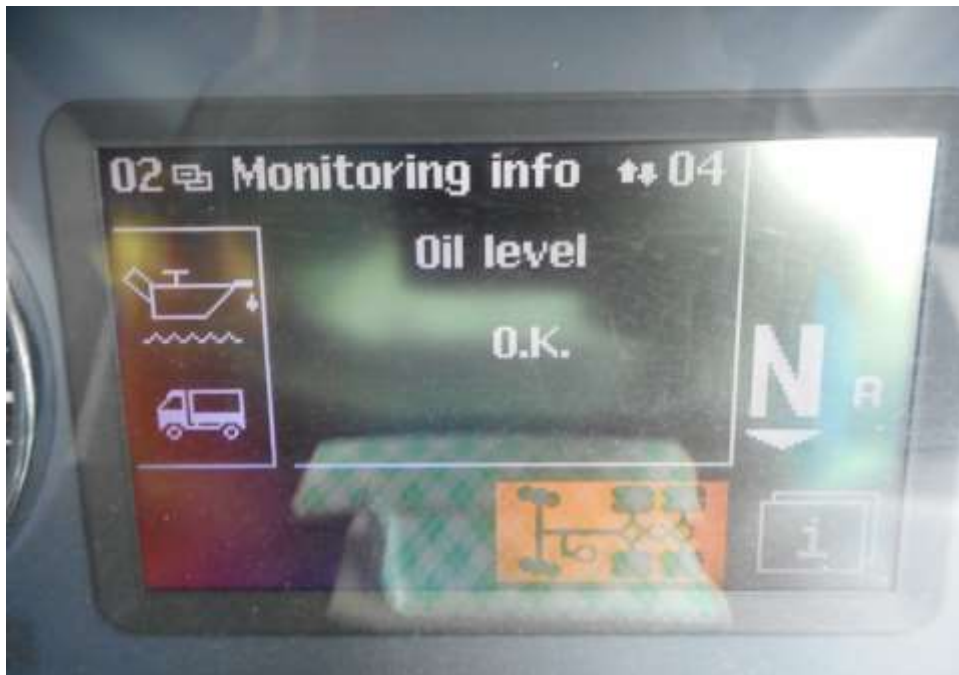
Photo 14 shows the engine oil level display of the Tipper Lorry at the time of my inspection. The engine oil was observed to be of sufficient level.

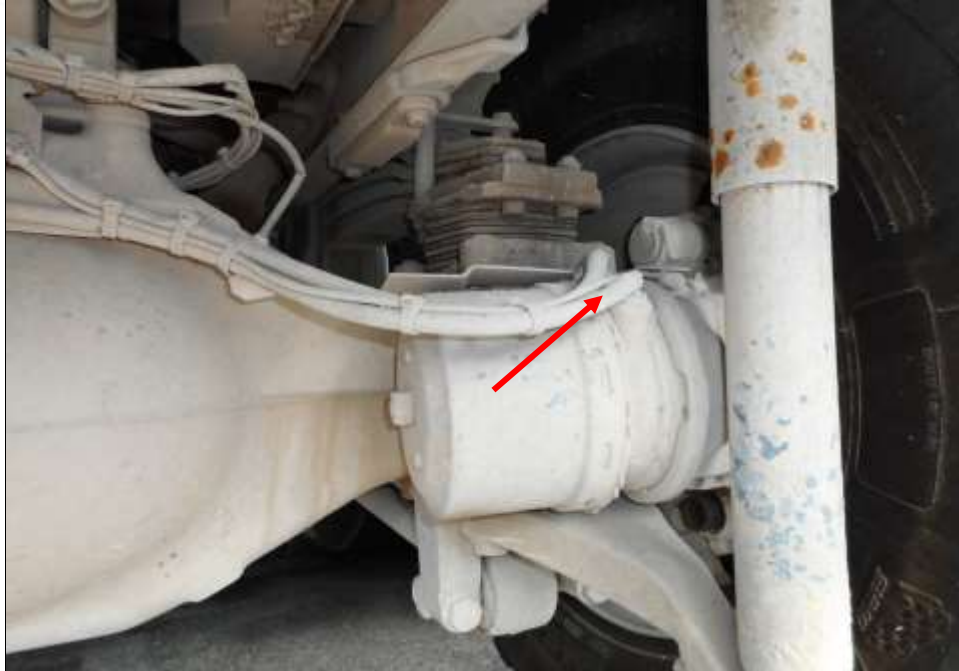
Photo 16 shows the brake pipe (arrowed) at the rear right wheel of the Tipper Lorry. I did not observe any leakage of brake fluid at the time of my inspection of the Tipper Lorry. My static tests of the Tipper Lorry's braking system, along with my visual examination of the various mechanical components in the braking system, had indicated that there was no internal leakage of pressure/vacuum. Hence the braking system of the Tipper Lorry was likely to be in serviceable condition at the material time of accident.

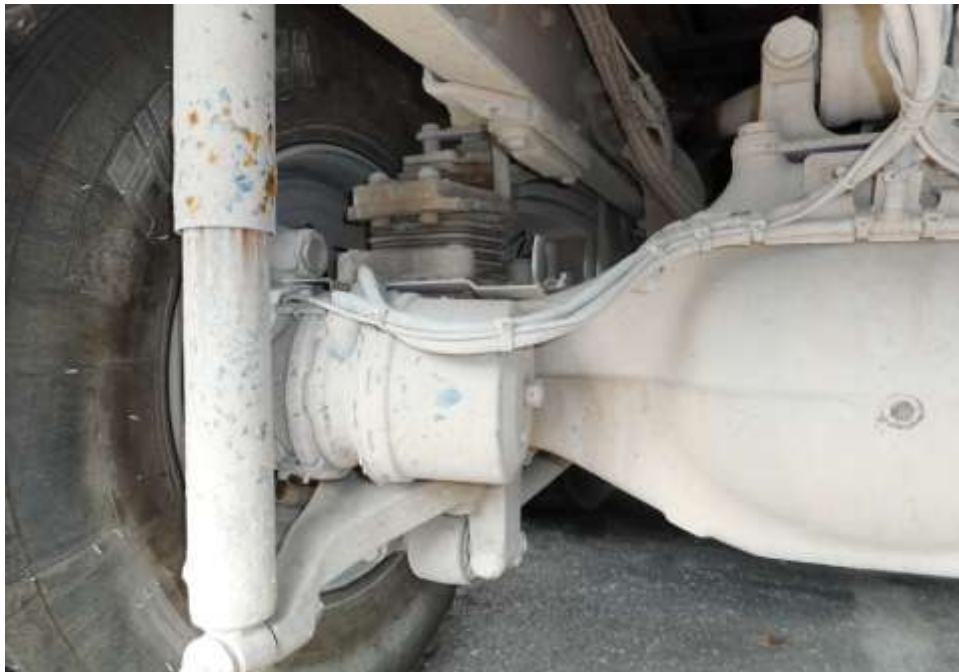
Photo 17 shows the brake pipe (arrowed) at the rear left wheel of the Tipper Lorry. I did not observe any leakage of brake fluid at the time of my inspection of the Tipper Lorry. My static tests of the Tipper Lorry's braking system, along with my visual examination of the various mechanical components in the braking system, had indicated that there was no internal leakage of pressure/vacuum. Hence the braking system of the Tipper Lorry was likely to be in serviceable condition at the material time of accident.

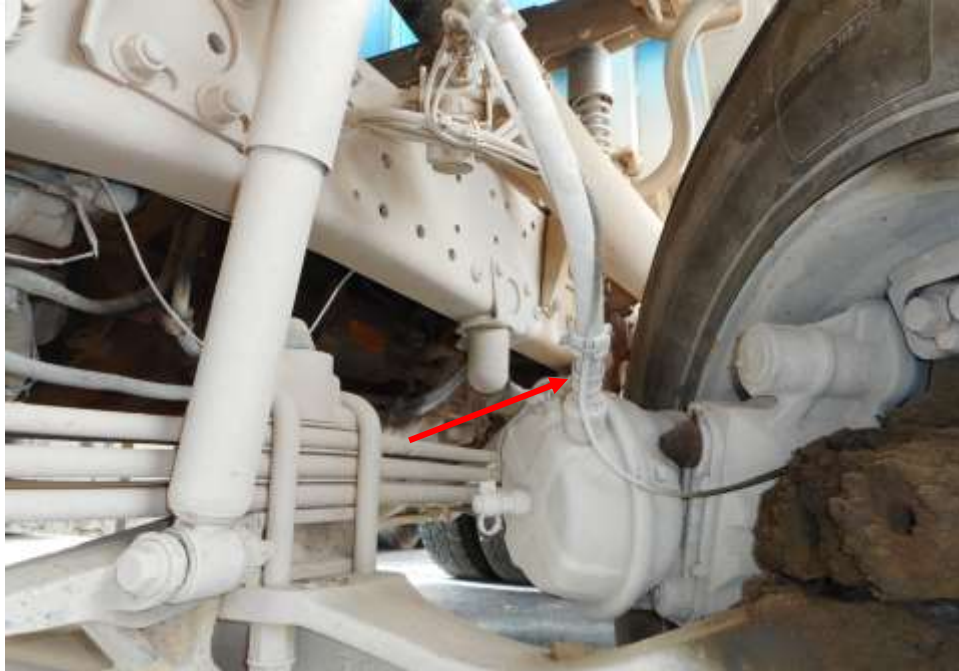
Photo 18 shows the brake pipe (arrowed) at the front left wheel of the Tipper Lorry. I did not observe any leakage of brake fluid at the time of my inspection of the Tipper Lorry. My static tests of the Tipper Lorry's braking system, along with my visual examination of the various mechanical components in the braking system, had indicated that there was no internal leakage of pressure/vacuum. Hence the braking system of the Tipper Lorry was likely to be in serviceable condition at the material time of accident.

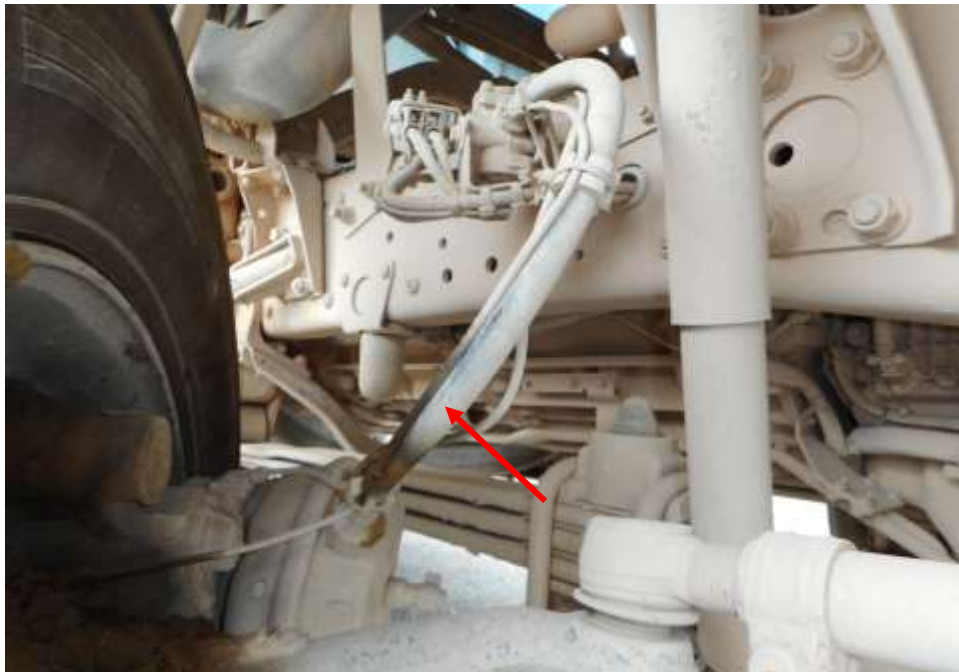
Photo 19 shows the brake pipe (arrowed) at the front right wheel of the Tipper Lorry. I did not observe any leakage of brake fluid at the time of my inspection of the Tipper Lorry. My static tests of the Tipper Lorry's braking system, along with my visual examination of the various mechanical components in the braking system had indicated that there was no internal leakage of pressure/vacuum. Hence the braking system of the Tipper Lorry was likely to be in serviceable condition at the material time of accident.

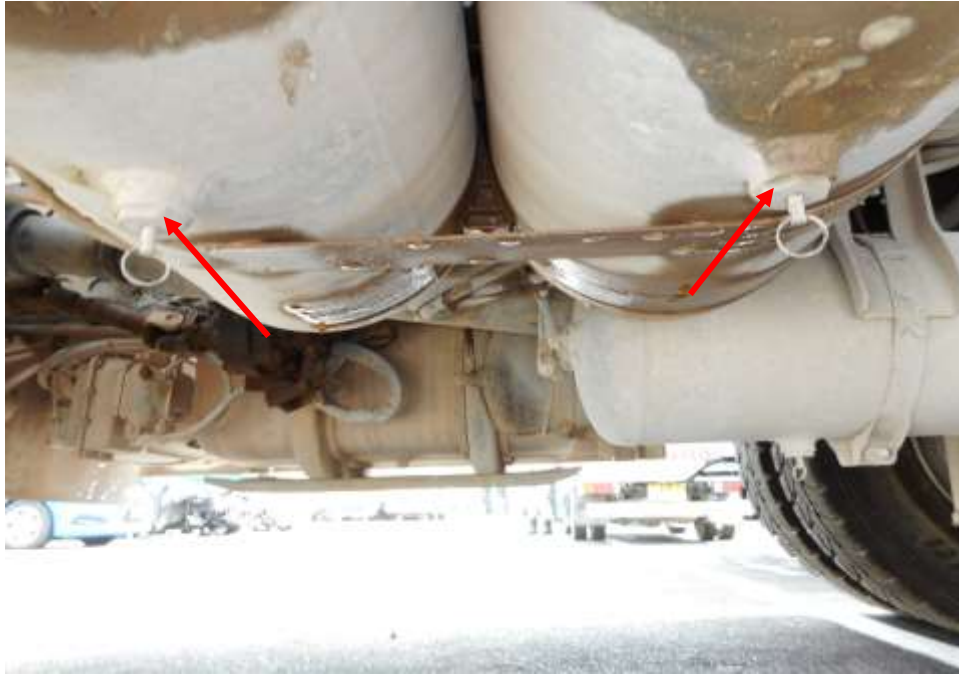
Photo 20 shows the air brake cylinders (arrowed) at the undercarriage of the Tipper Lorry. I did not observe any leakage of air brake fluid at the time of my inspection of the Tipper Lorry. My static tests of the Tipper Lorry's braking system, along with my visual examination of the various mechanical components in the braking system had indicated that there was no internal leakage of pressure/vacuum. Hence the braking system of the Tipper Lorry was likely to be in serviceable condition at the material time of accident.

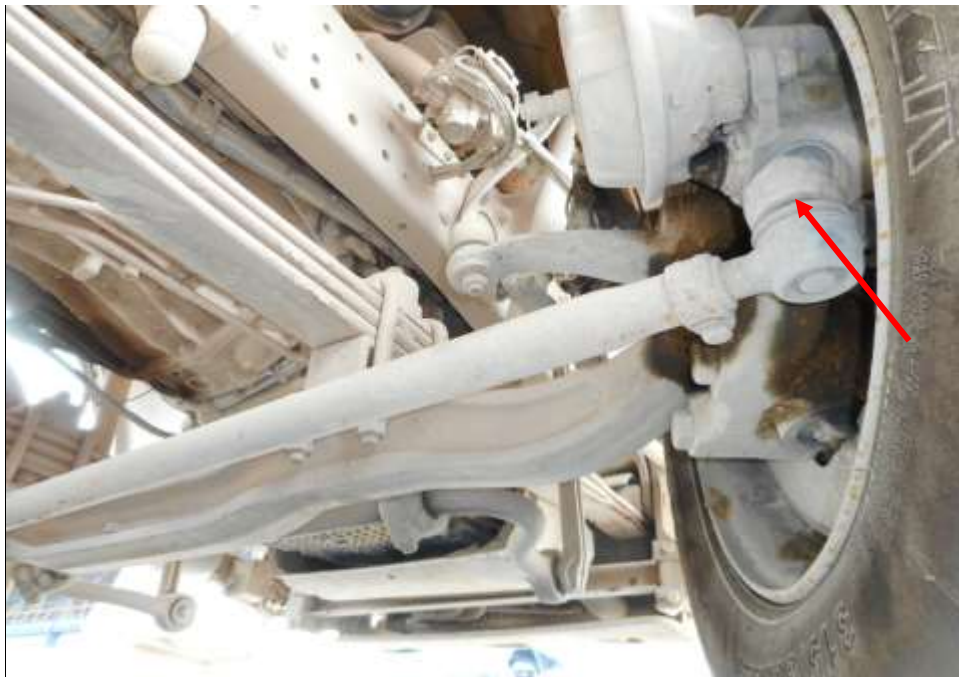
Photo 21 shows the various undercarriage components at the front right wheel of the Tipper Lorry, in particular the steering tie rod end (arrowed). The various steering components were all found to be intact, suggesting that the steering system of the Tipper Lorry was likely to be in serviceable condition at the material time of accident. There was also no sign of fluid stain(s) observed on the various undercarriage components.

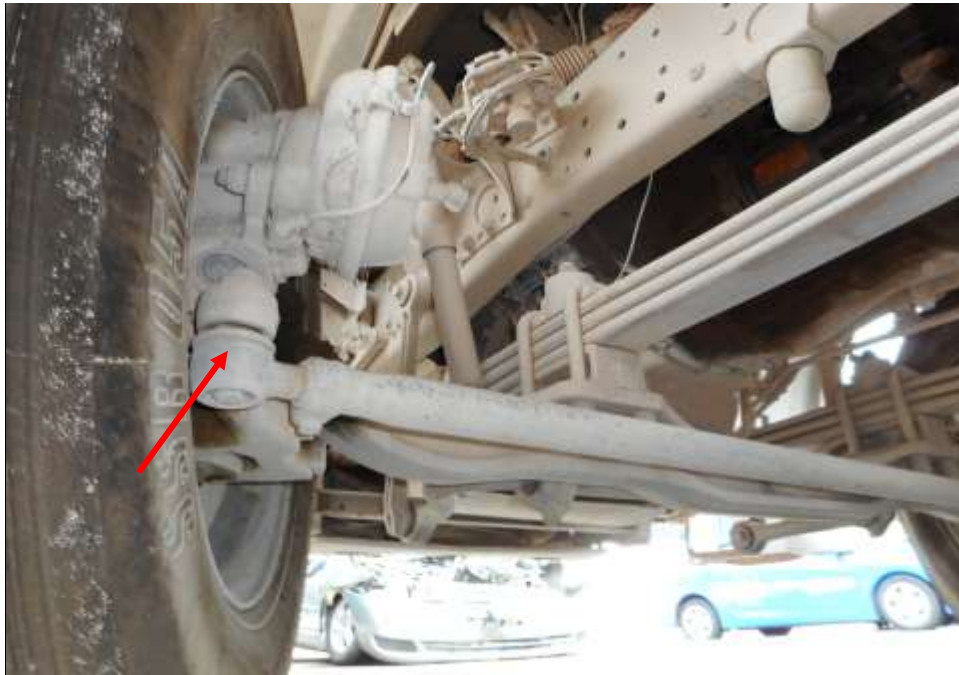
Photo 22 shows the various undercarriage components at the front left wheel of the Tipper Lorry, in particular the steering tie rod end (arrowed). The various undercarriage components of the Tipper Lorry were all found to be intact without any visible damage. There was also no sign of fluid stain(s) observed on the various undercarriage components.

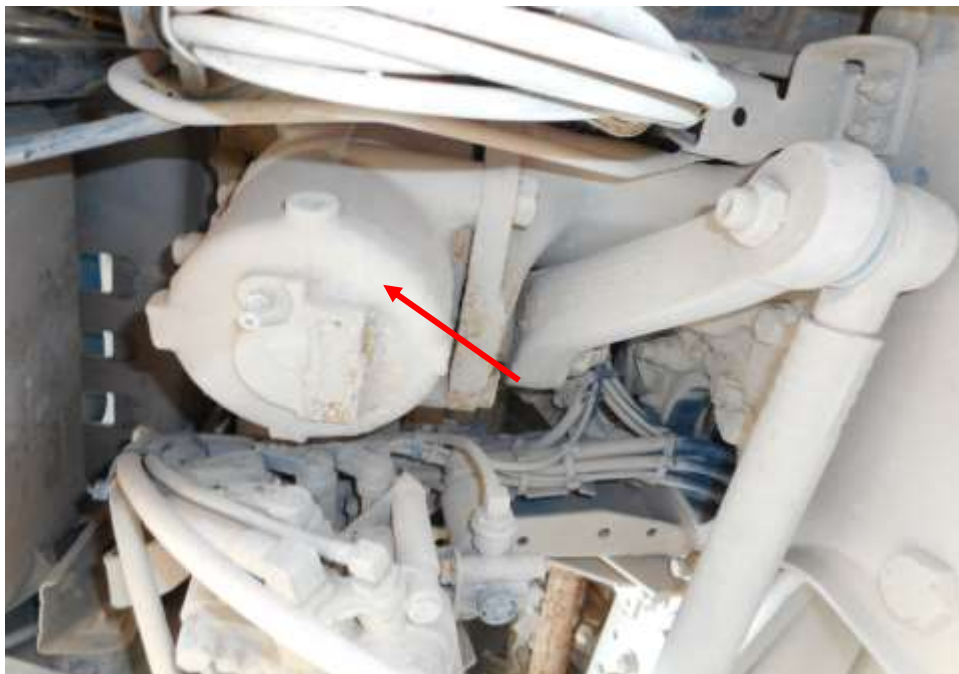
Photo 23 shows the steering box component (arrowed) at the undercarriage of the Tipper Lorry was found to be intact without any visible damage. There was also no sign of fluid stain(s) observed on the various undercarriage components.

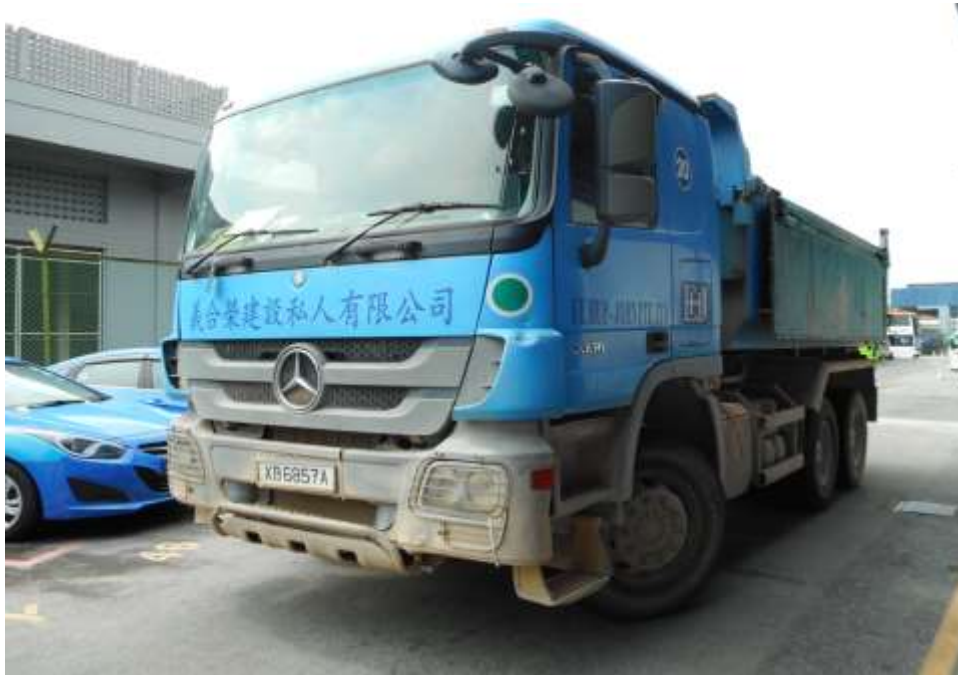
Photo 24 shows the front left wheel of the Tipper Lorry turned to its full right. During my steering system test, I did not experience any abnormal free play and/or resistance when I had turned the steering wheel towards full left and full right. This would suggest that the steering system of the Tipper Lorry was likely to be in serviceable condition at the material time of accident.

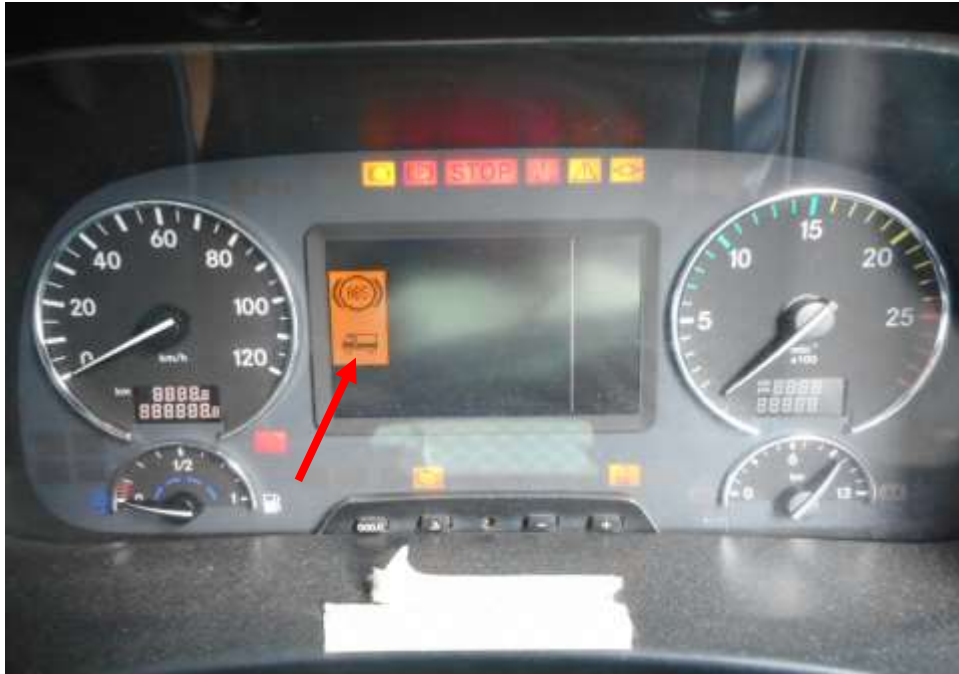
Photo 25 shows the warning light for Anti-Lock Brake System (ABS) (arrowed) appearing on the instrument panel of the Tipper Lorry during the self-test of its various electronic operating systems when its engine was cranked.

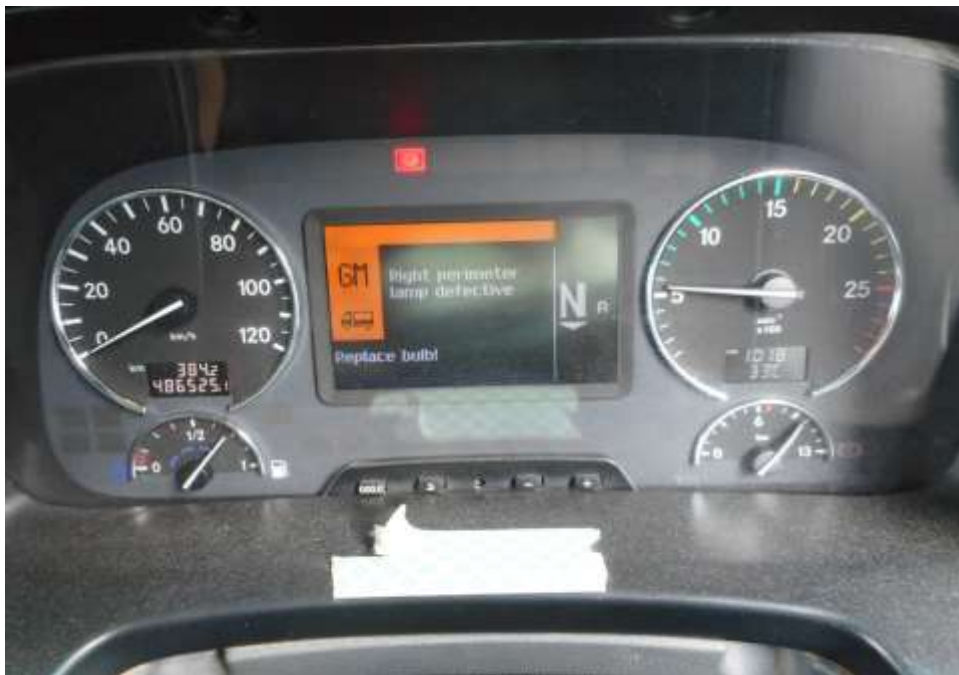
Photo 26 shows no warning lights illuminated on the instrument panel of the Tipper Lorry after the engine was cranked. This would suggest that there was no abnormality to the various electronic operating systems of the Tipper Lorry, like the ABS etc.
