Your Ref: TP/IP/37427/2019  
Our Ref : CI/TPD19012747/P

**Fatal Accident Investigation Team**

**MECHANICAL INSPECTION REPORT OF MOTOR VAN GBE 3035E**

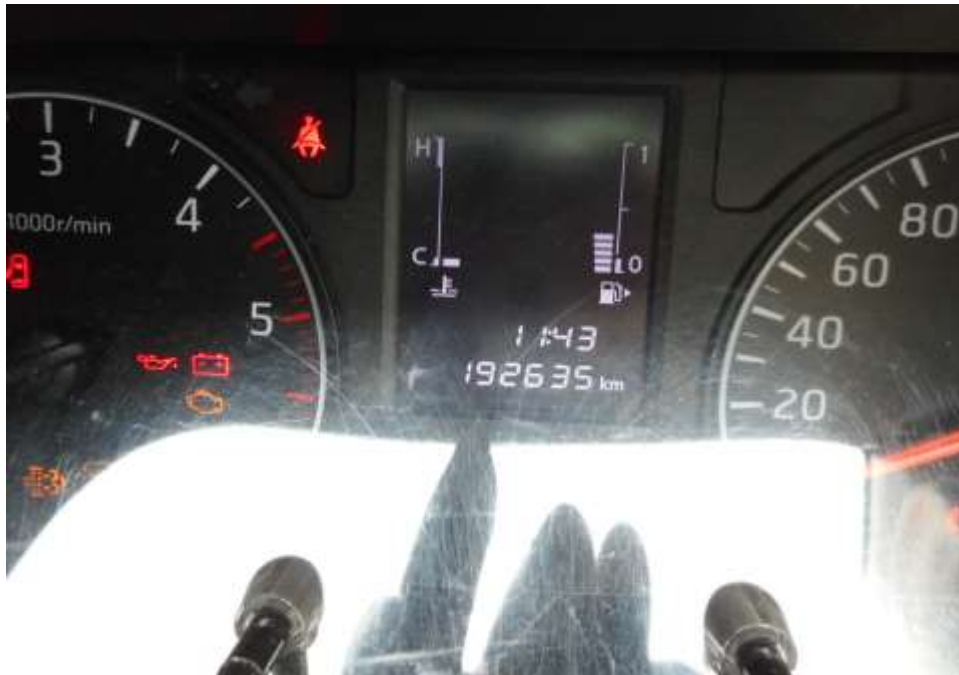
**Photo 1** shows a general view of the instrument cluster of the Motor Van at the time of my inspection. The mileage of the Motor Van was 192,635km

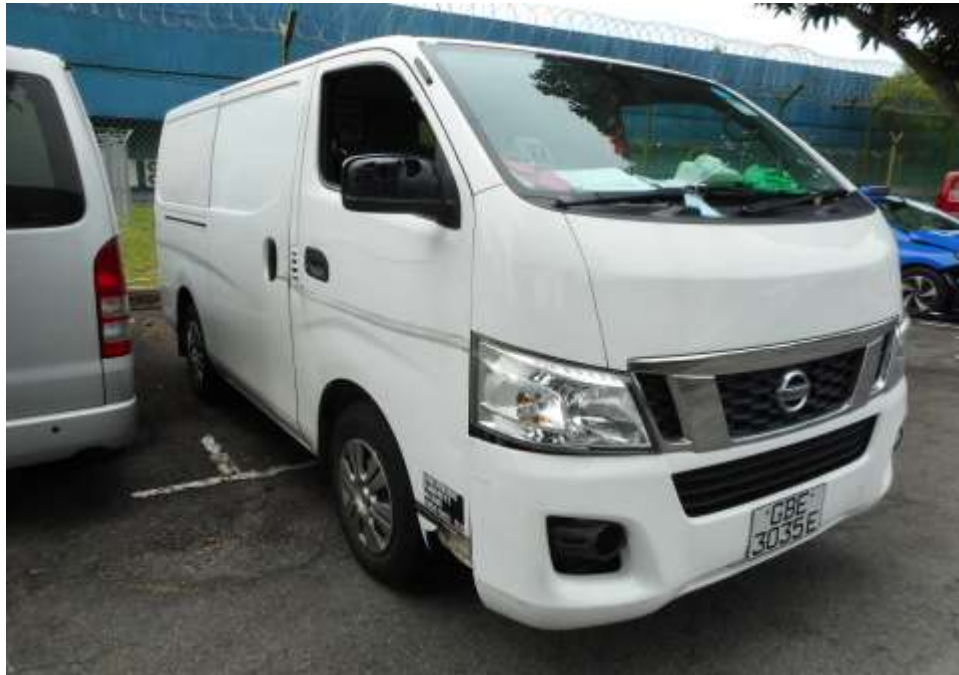
4. The mileage of the Motor Van at the time of my inspection was 192,635km.
5. The Motor Van appeared to have sustained moderate damage at its front right portion. Its front right door, right rear view mirror and front bumper were damaged at the time of my inspection as a result of the accident.

**Photo 2** shows a general view of the Motor Van's right portion at the time of my inspection. The Motor Van sustained moderate damage at its front right portion. Its front right door, right rear view mirror and front bumper were damage at the time of my inspection as a result of the accident.

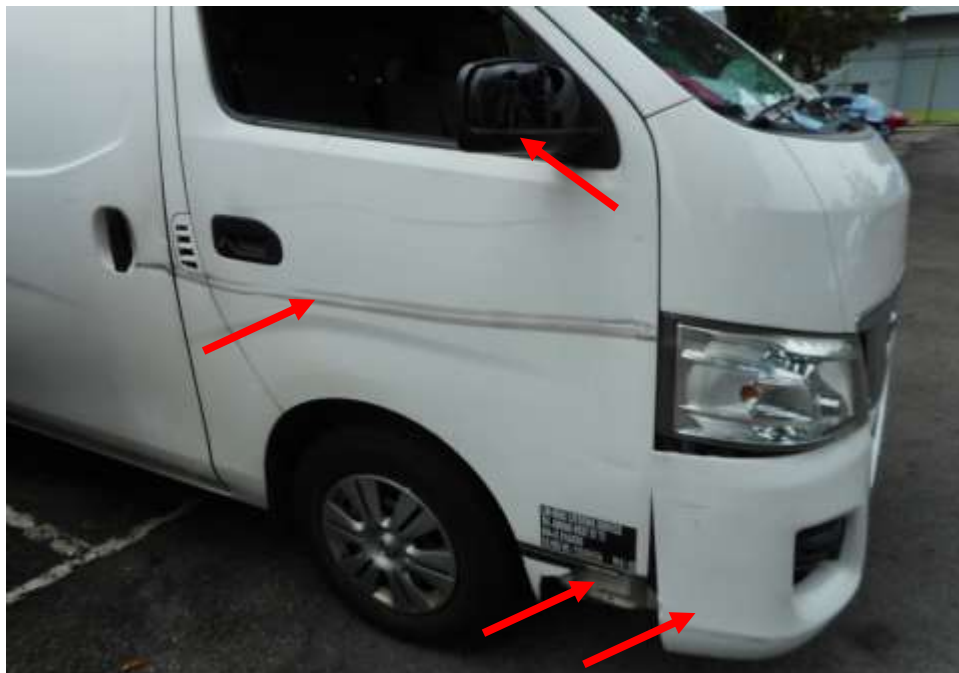
**Photo 3** shows a close up view of the Motor Van's right portion at the time of my inspection. The Motor Van sustained moderate damage at its front right portion. Its front right door, right rear view mirror and front bumper (arrowed) were damage at the time of my inspection as a result of the accident.

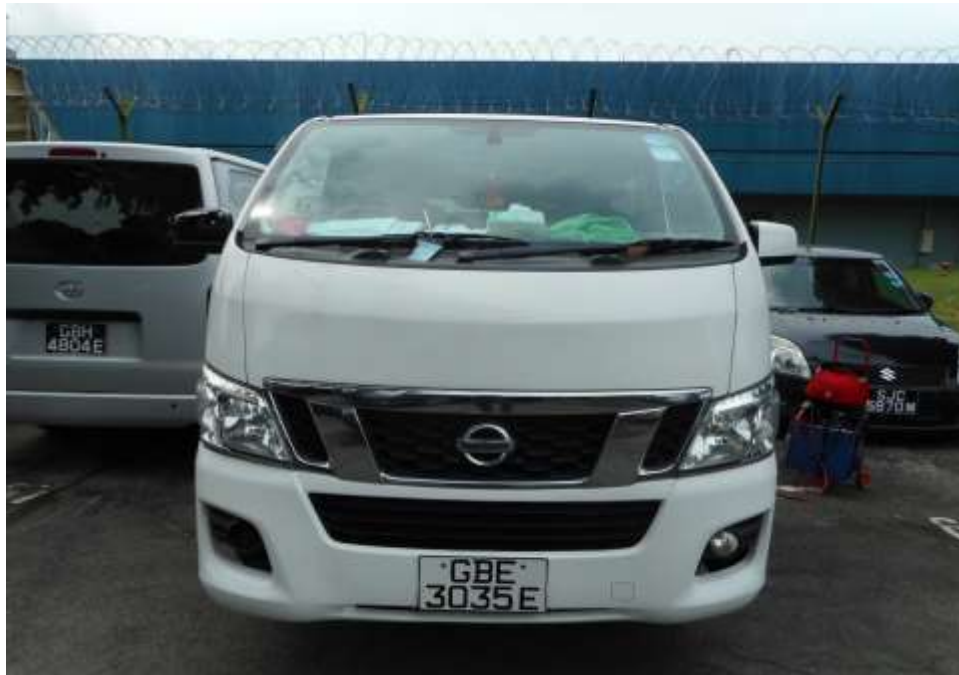
**Photo 4** shows a general view of the front body of the Motor Van at the time of my inspection. The Motor Van was observed to be in good general condition.

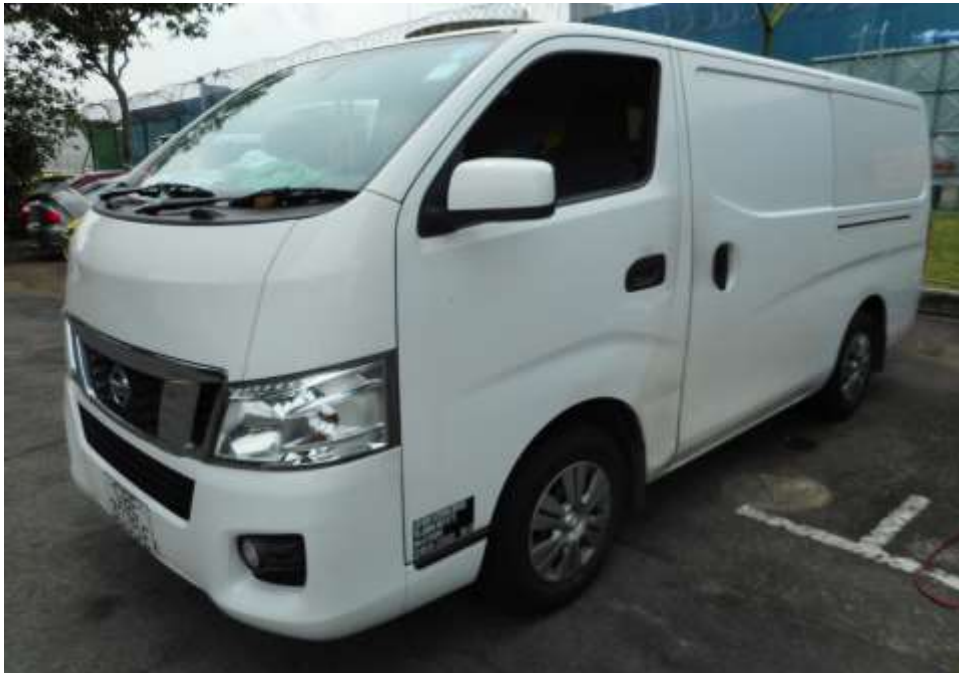
**Photo 5** shows a general view of the front left body of the Motor Van at the time of my inspection. The Motor Van was observed to be in good general condition.

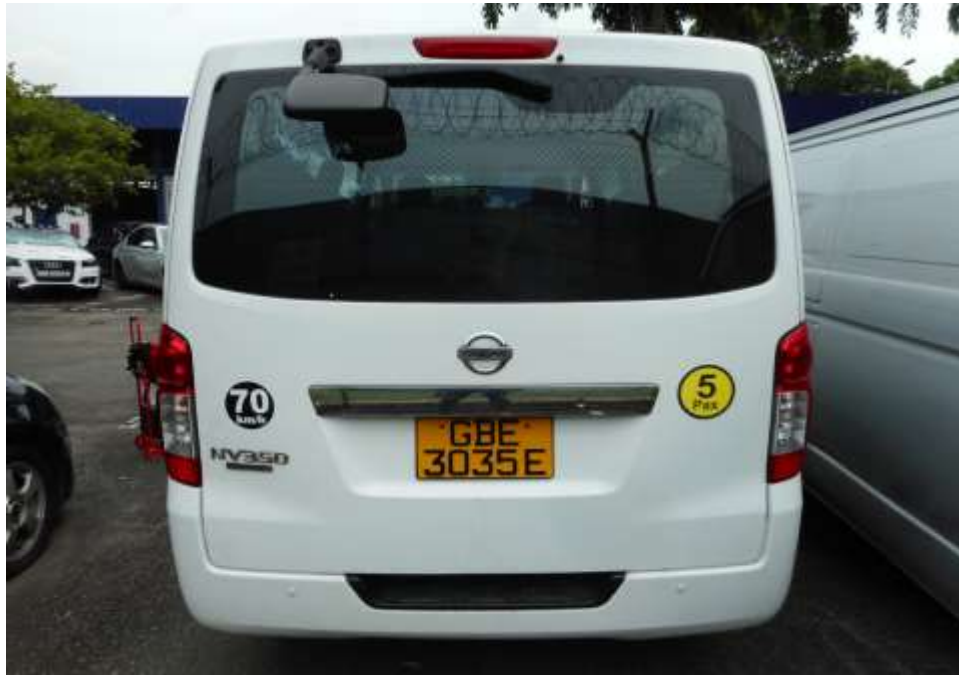
**Photo 6** shows a general view of the rear body of the Motor Van at the time of my inspection. The Motor Van was observed to be in good general condition.

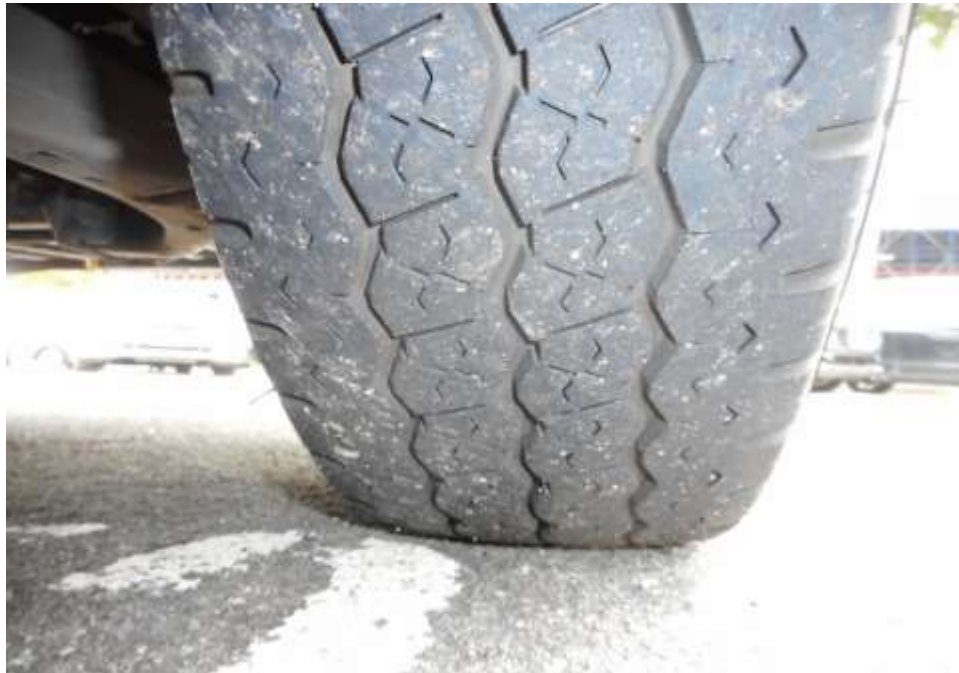
**Photo 7** shows the condition of the front right tyre of the Motor Van, which was observed to be in serviceable condition with remaining tread depth of approximately 5.1mm. The tyre, which was wrapped around standard steel wheel rim, was also observed to be sufficiently inflated for vehicular operation. There was no tear, cut or burst mark(s) on the outer and the inner sidewalls as well as across the tread of the 4 tyres that were fitted on the Motor Van.

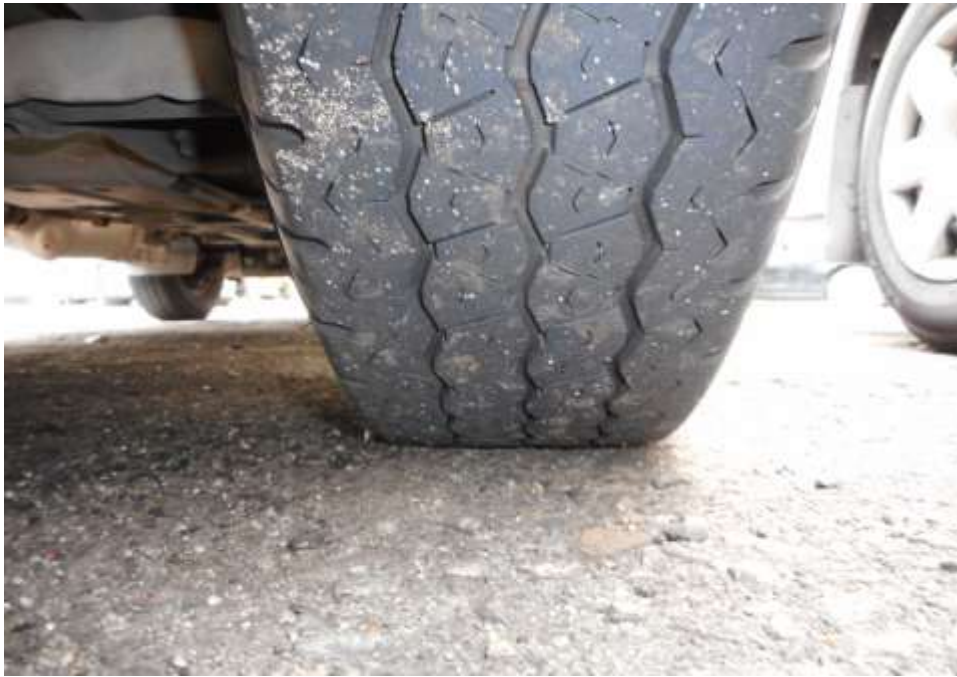
**Photo 8** shows the condition of the rear right tyre of the Motor Van, which was observed to be in serviceable condition with remaining tread depth of approximately 4.7mm. The tyre, which was wrapped around standard steel wheel rim, was also observed to be sufficiently inflated for vehicular operation.

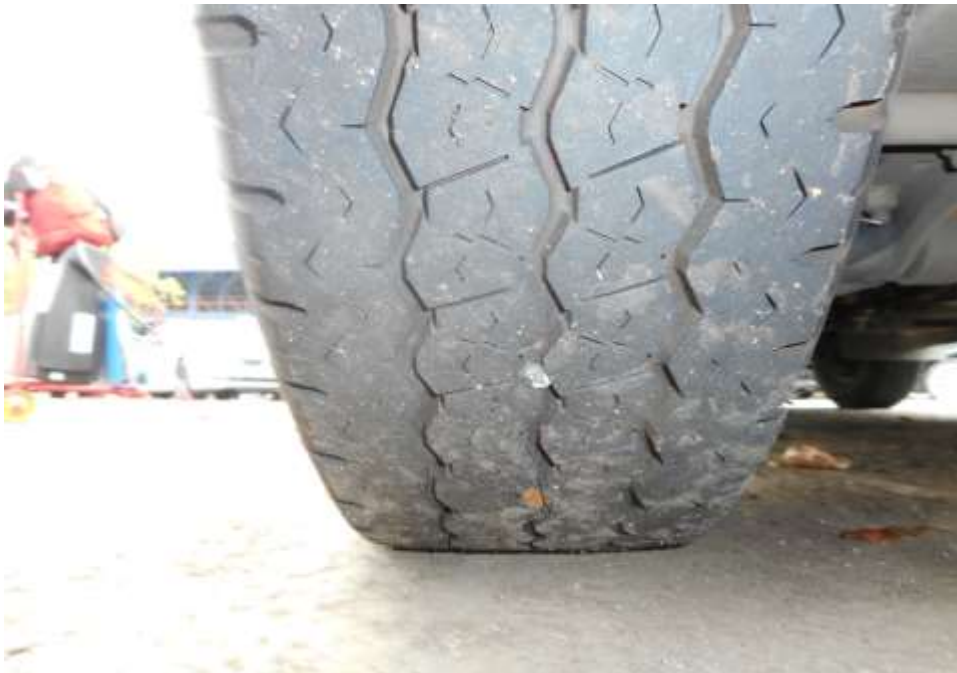
**Photo 9** shows the condition of the rear left tyres of the Motor Van, which was observed to be in serviceable condition with remaining tread depth of approximately 4.6mm. The tyres, which were wrapped around standard steel wheel rim, were also observed to be sufficiently inflated for vehicular operation. There was also no damage found on all 4 steel wheel rims of the Motor Van.

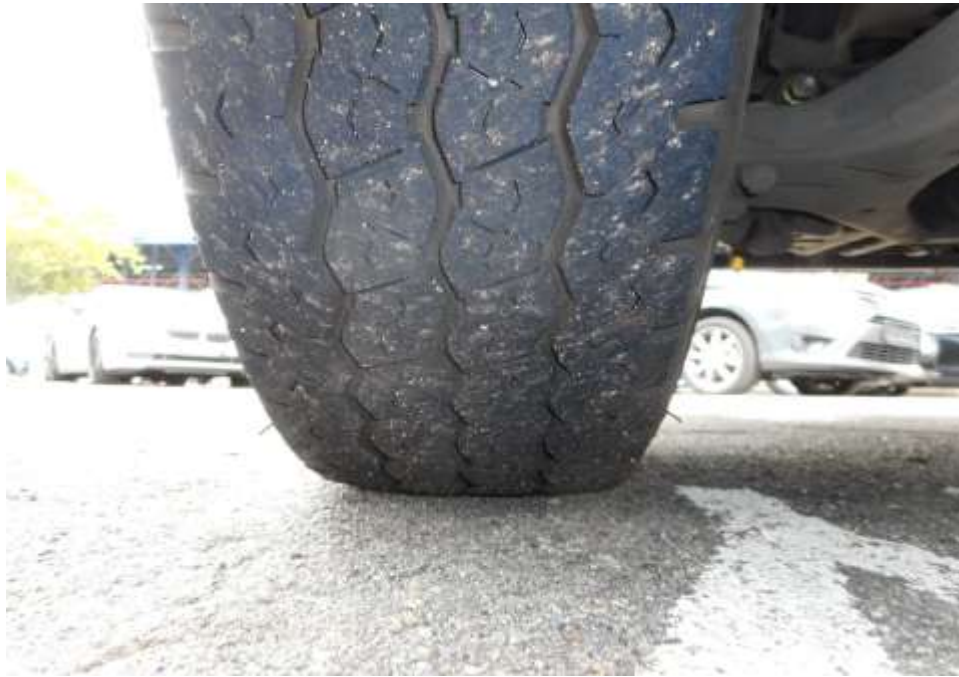
**Photo 10** shows the condition of the rear right tyres of the Motor Van, which were observed to be in serviceable condition with remaining, tread depth of approximately 5.4mm. There was also no tear, cut or burst mark(s) on the outer and the inner sidewalls as well as across the tread of the 4 tyres that were fitted on the Motor Van.

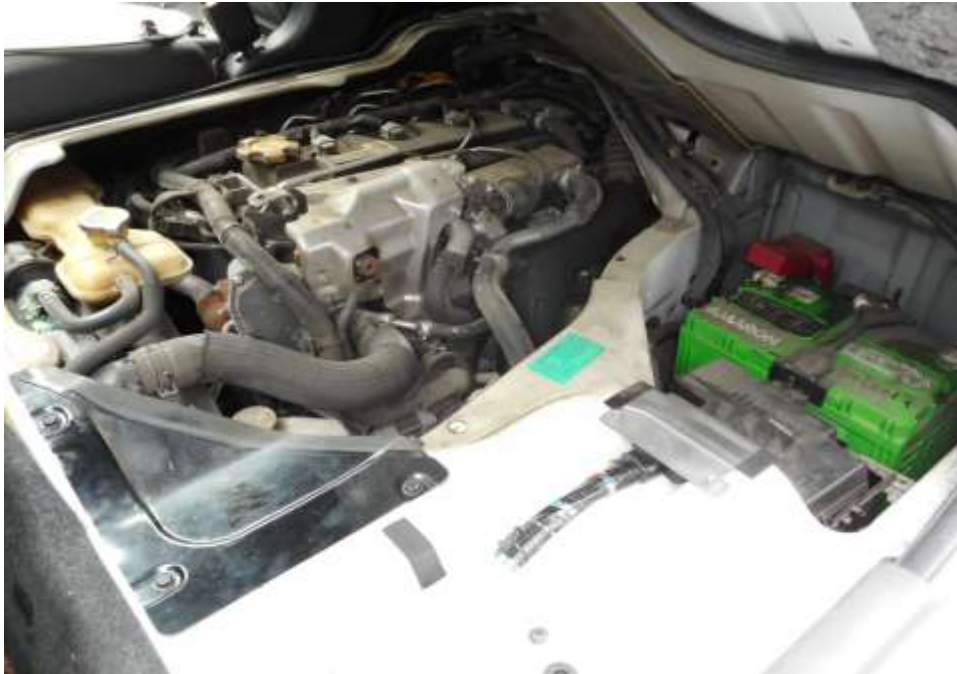
**Photo 11** shows a general view of the Motor Van's engine compartment, which was accessed by lifting the front cabin of the Motor Van. The various parts and components inside the engine compartment were unaffected by the accident. There was also no sign(s) or indication(s) of fresh fluid leakage and/or fluid stain within the engine compartment

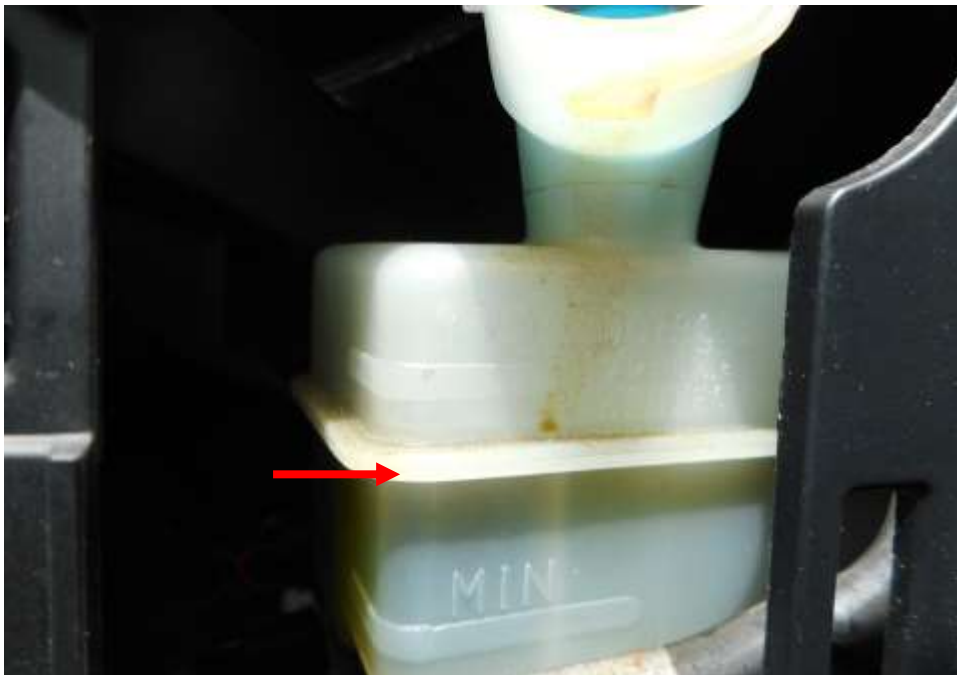
**Photo 12** shows the brake fluid reservoir of the Motor Van at the time of my inspection. The brake fluid was observed to be of sufficient level (arrowed) and without any visible contamination.

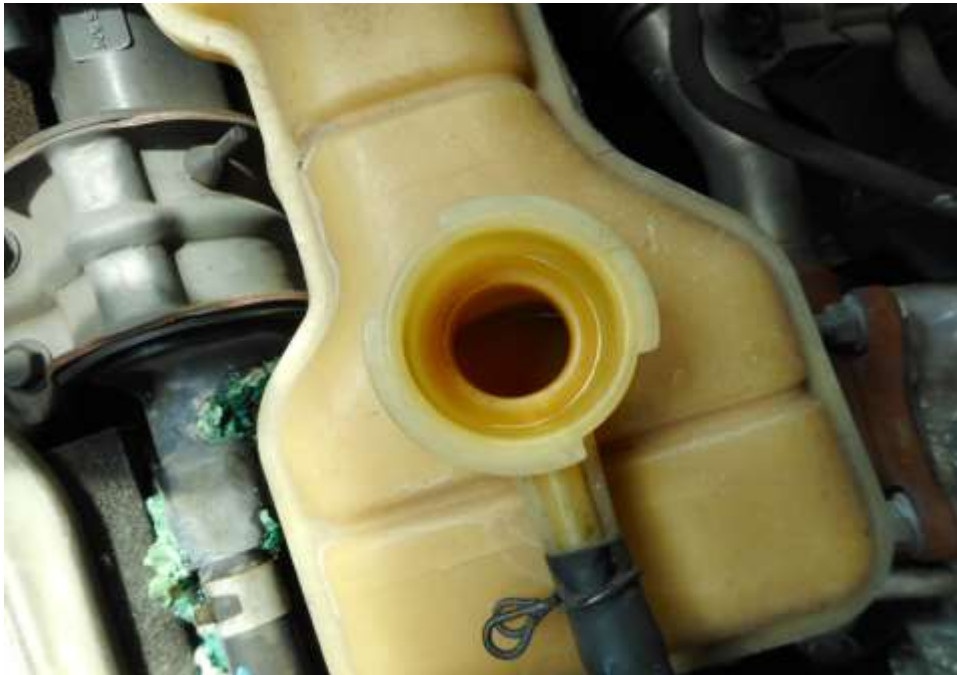
**Photo 13** shows the engine coolant reservoir of the Motor Van at the time of my inspection. The engine coolant was observed to be of sufficient level and without any visible contamination.

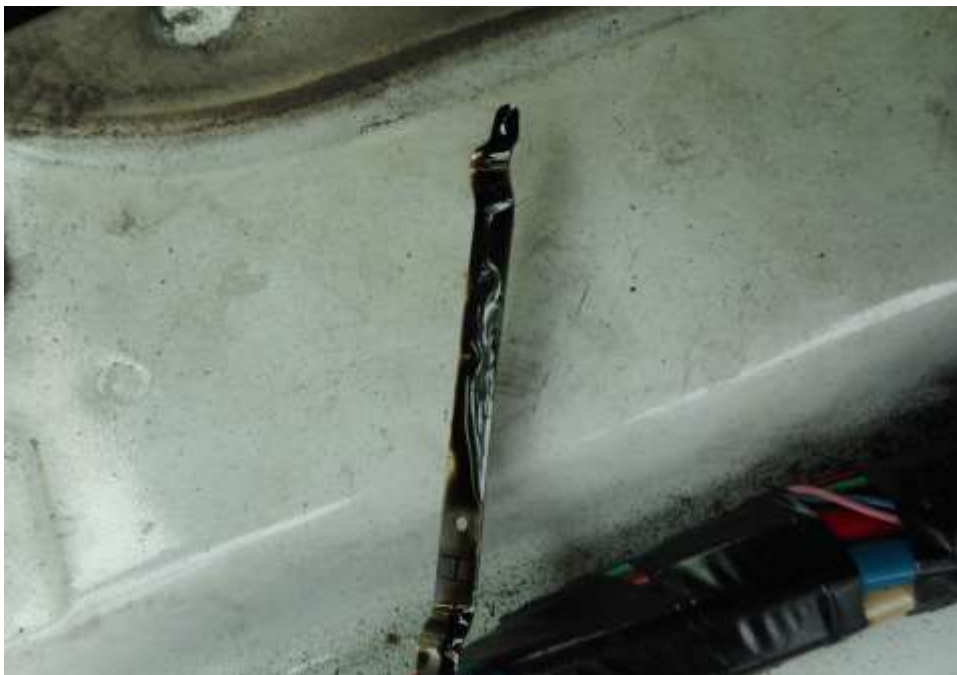
**Photo 14** shows the engine dip stick of the Motor Van at the time of my inspection. The engine oil was observed to be of sufficient level and without any visible contamination.

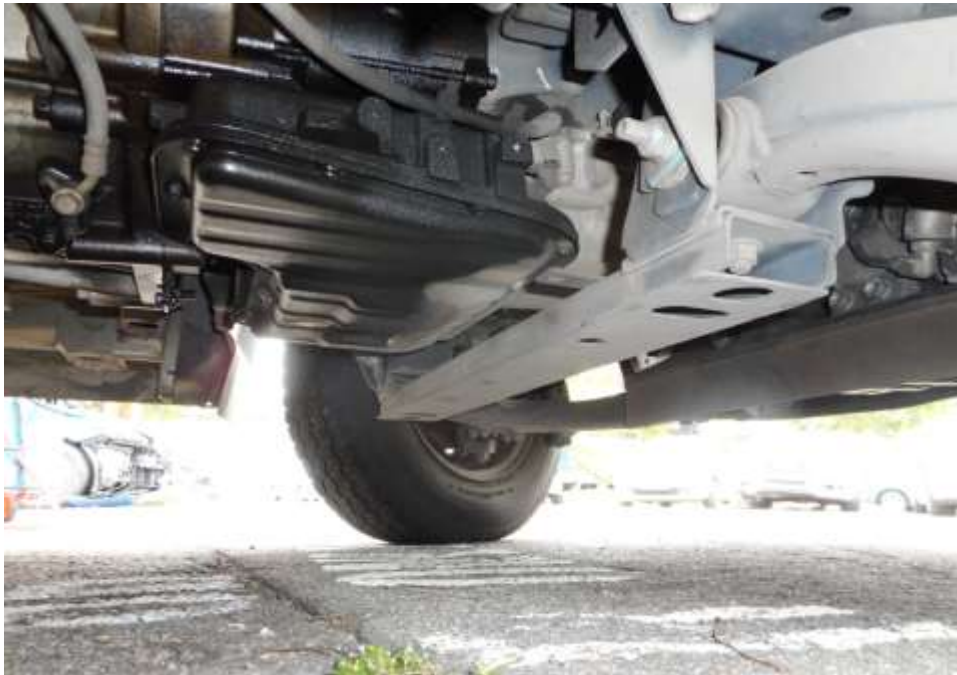
**Photo 15** shows the undercarriage of the Motor Van, at the area where the engine housing and transmission housing are located. I did not find any sign(s) or indication(s) of fluid leak and/or fluid stain(s) on the underside of the Motor Van.

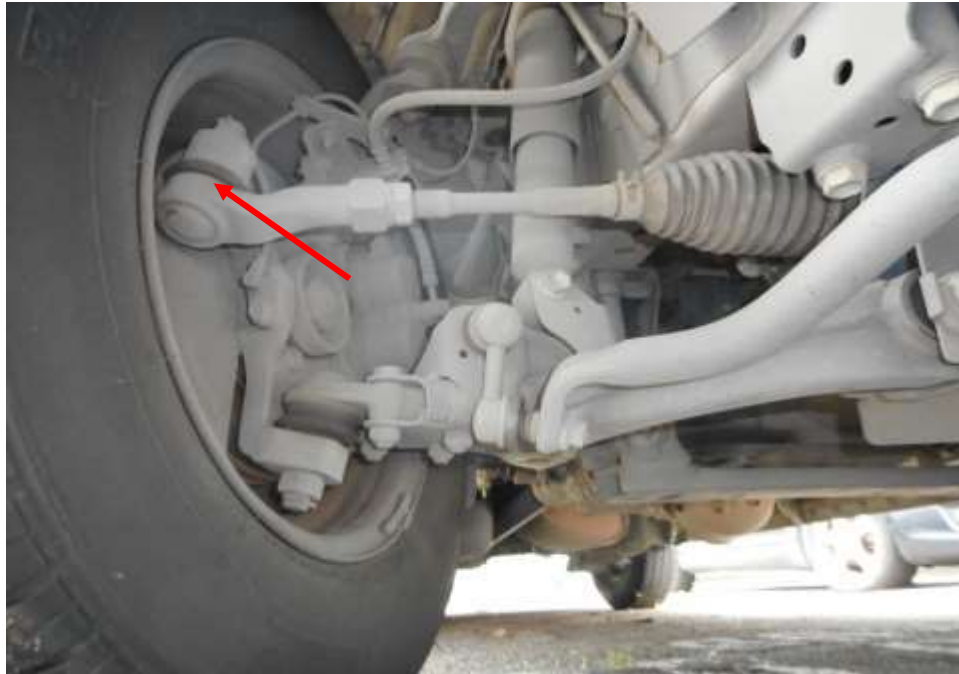
**Photo 16** shows the various undercarriage components at the front right wheel of the Motor Van, in particular the steering tie rod end (arrowed). The various steering components were all found to be intact, suggesting that the steering system of the Motor Van was likely to be in serviceable condition at the material time of accident. There was also no sign of fluid stain(s) observed on the various undercarriage components.

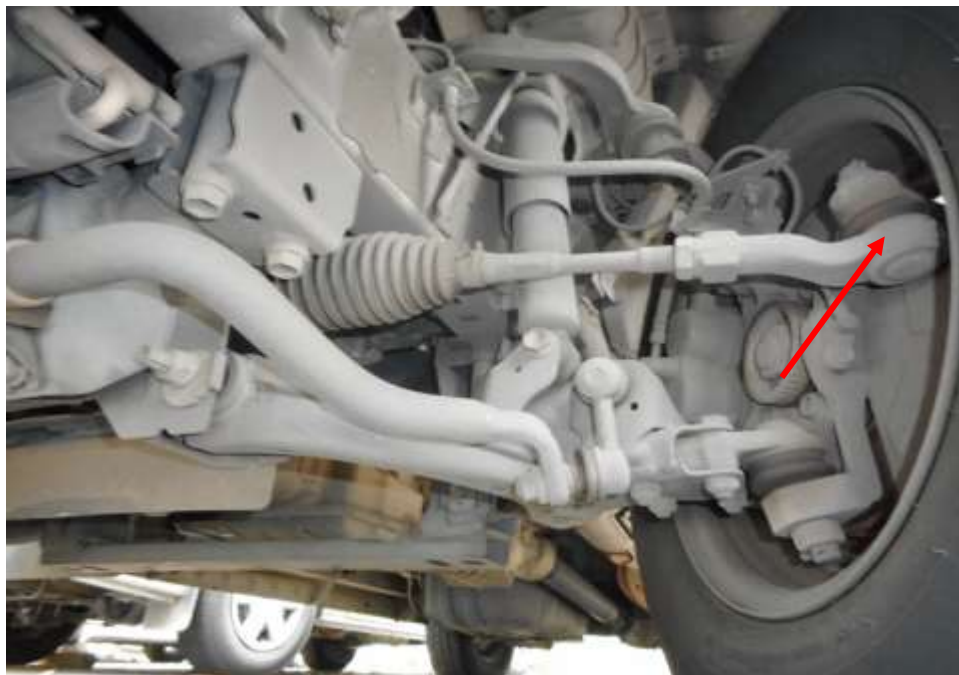
**Photo 17** shows the various undercarriage components at the front left wheel of the Motor Van, in particular the steering tie rod end (arrowed). The various Undercarriage components of the Motor Van were all found to be intact without any visible damage. There was also no sign of fluid stain(s) observed on the various undercarriage components.

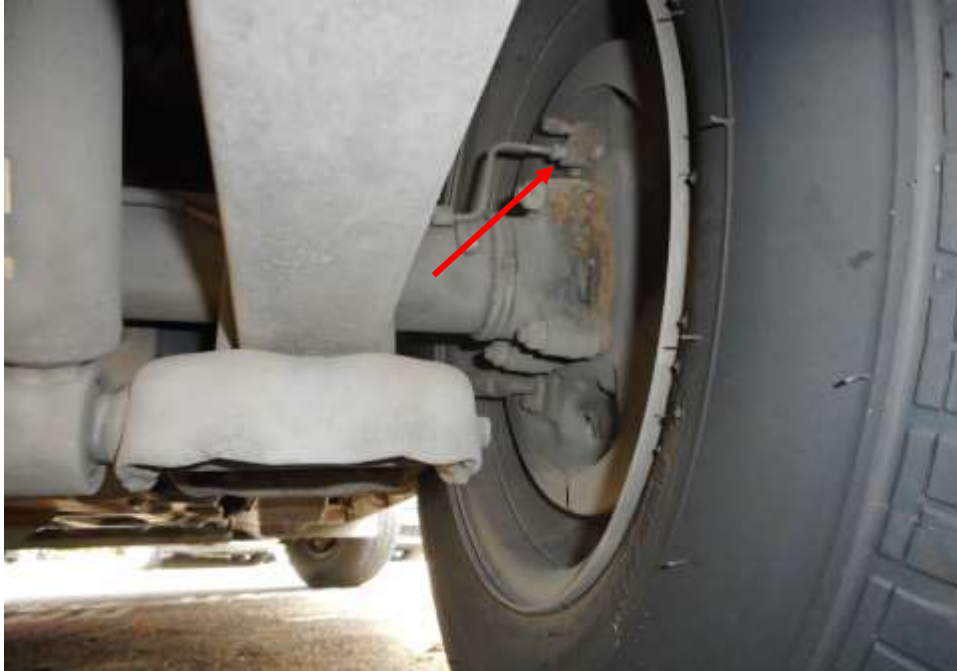
**Photo 18** shows the brake pipe (arrowed) at the rear right wheel of the Motor Van. I did not observe any leakage of brake fluid at the time of my inspection of the Motor Van. My static tests of the Motor Van's braking system, along with my visual examination of the various mechanical components in the braking system, had indicated that there was no internal leakage of pressure/vacuum. Hence the braking system of the Motor Van was likely to be in serviceable condition at the material time of accident.

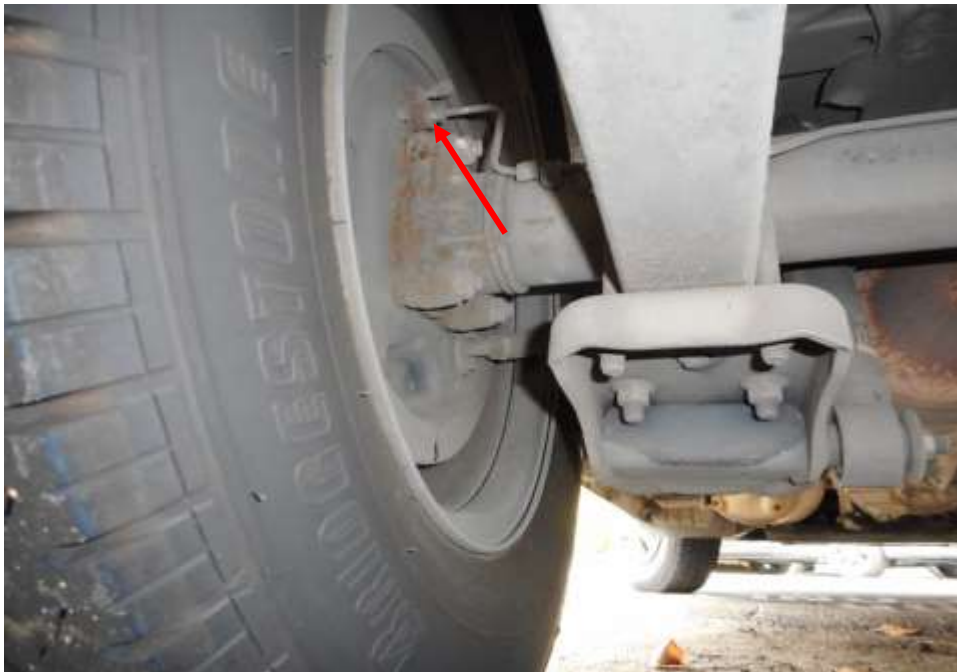
**Photo 19** shows the brake pipe (arrowed) at the rear left wheel of the Motor Van. I did not observe any leakage of brake fluid at the time of my inspection of the Motor Van. My static tests of the Motor Van's braking system, along with my visual examination of the various mechanical components in the braking System had indicated that there was no internal leakage of pressure/vacuum. Hence the braking system of the Motor Van was likely to be in serviceable condition at the material time of accident.

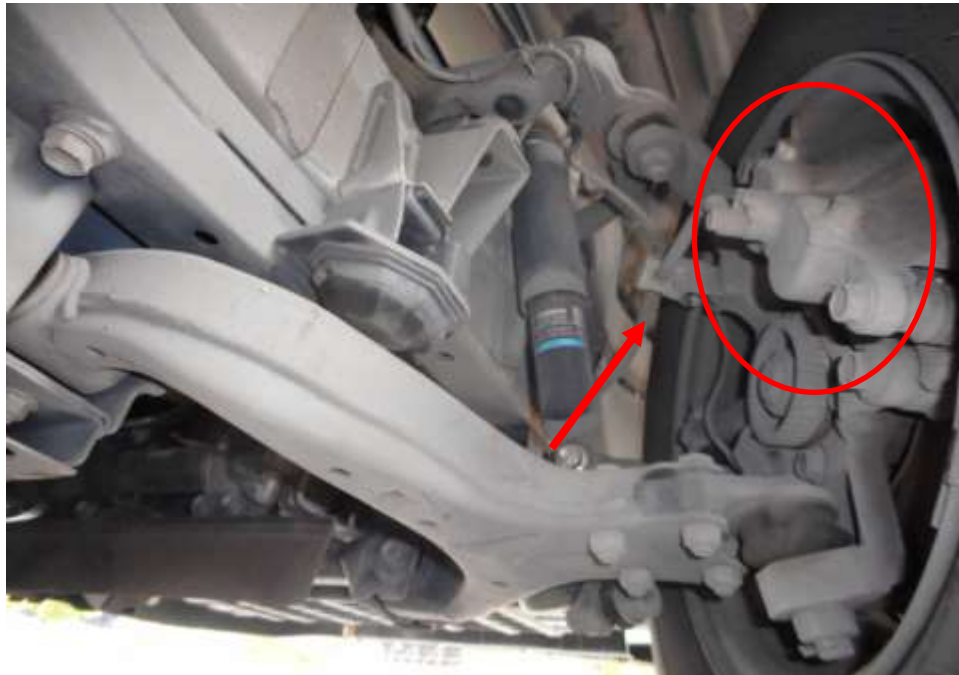
**Photo 20** shows the brake hose/pipe (arrowed) at the front right wheel of the Motor Van. No leakage of brake fluid was observed. Visual examination of the various components of the braking system like the brake caliper (circled), brake booster, brake pedal etc had revealed all to be intact and without visible damage at the time of accident. There was also no sign of fluid stain(s) observed on the various undercarriage components.

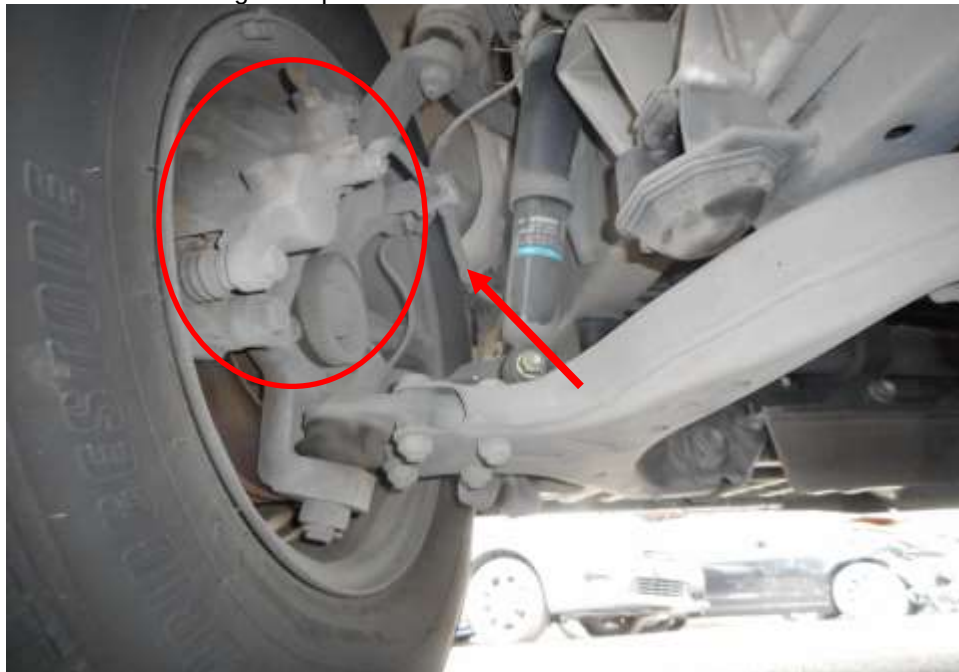
**Photo 21** shows the brake hose/pipe (arrowed) at the front left wheel of the Motor Van. No leakage of brake fluid was observed. Visual examination of the various components of the braking system like the brake caliper (circled), brake booster, brake pedal etc had revealed all to be intact and without visible damage at the time of accident. There was also no sign of fluid stain(s) observed on the various undercarriage components.

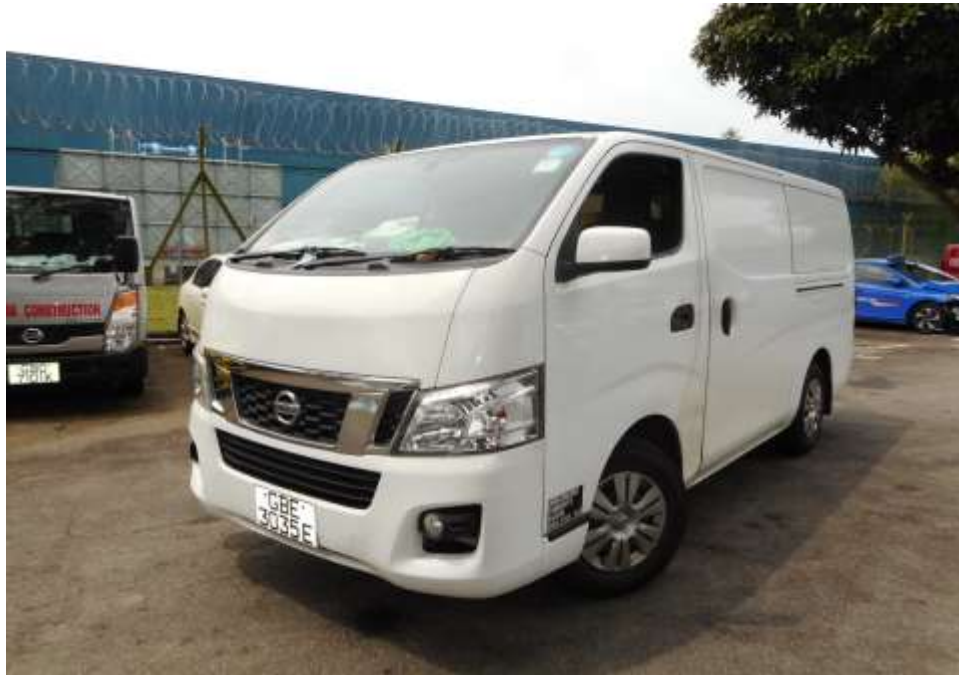
**Photo 22** shows the front left wheel of the Motor Van turned to its full right. During my steering system test, I did not experience any abnormal free play and/or resistance when I had turned the steering wheel towards full left and full right. This would suggest that the steering system of the Motor Van was likely to be in serviceable condition at the material time of accident.

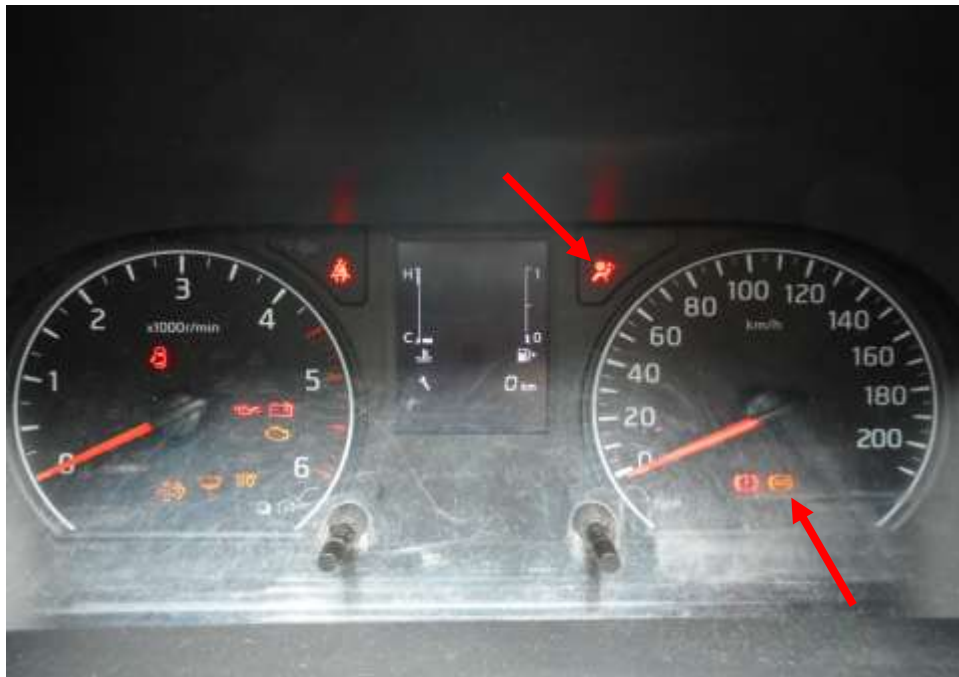
**Photo 23** shows the warning light for Anti-Lock Brake System (ABS) and Supplemental Restraint System (SRS) appearing on the instrument panel of the Motor Van during the self-test of its various electronic operating systems when its engine was cranked.

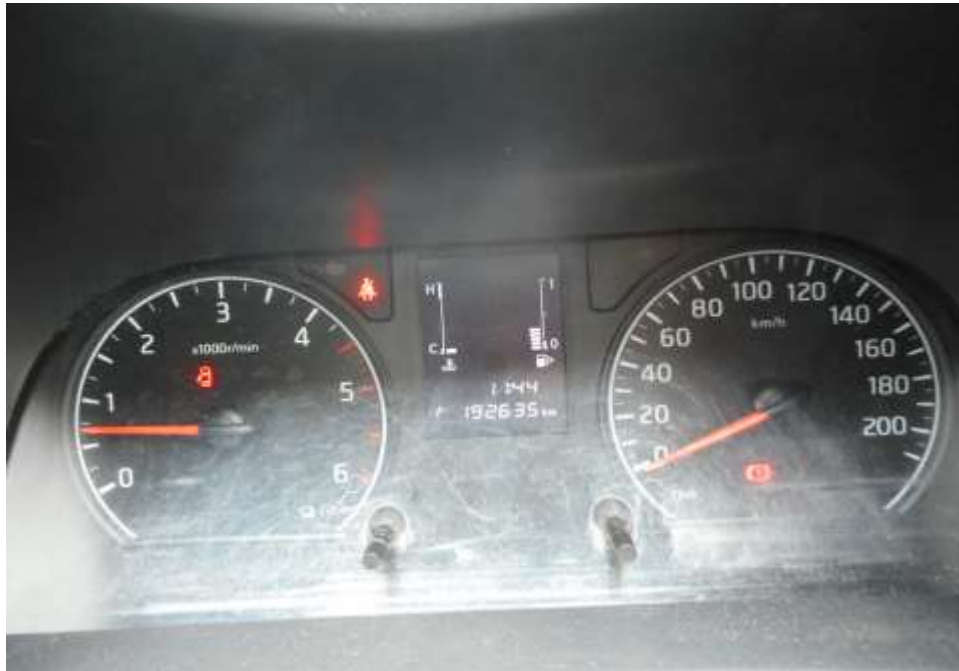
**Photo 24** shows no warning lights illuminated on the instrument panel of the Motor Van after the engine was cranked. This would suggest that there was no abnormality to the various electronic operating systems of the Motor Van, like the ABS and SRS...Etc
