Your Ref: TP/IP/36651/2019  
Our Ref : CI/TPD19012749/P

**Fatal Accident Investigation Team**

**MECHANICAL INSPECTION REPORT OF GARBAGE TRUCK XB 6910D**

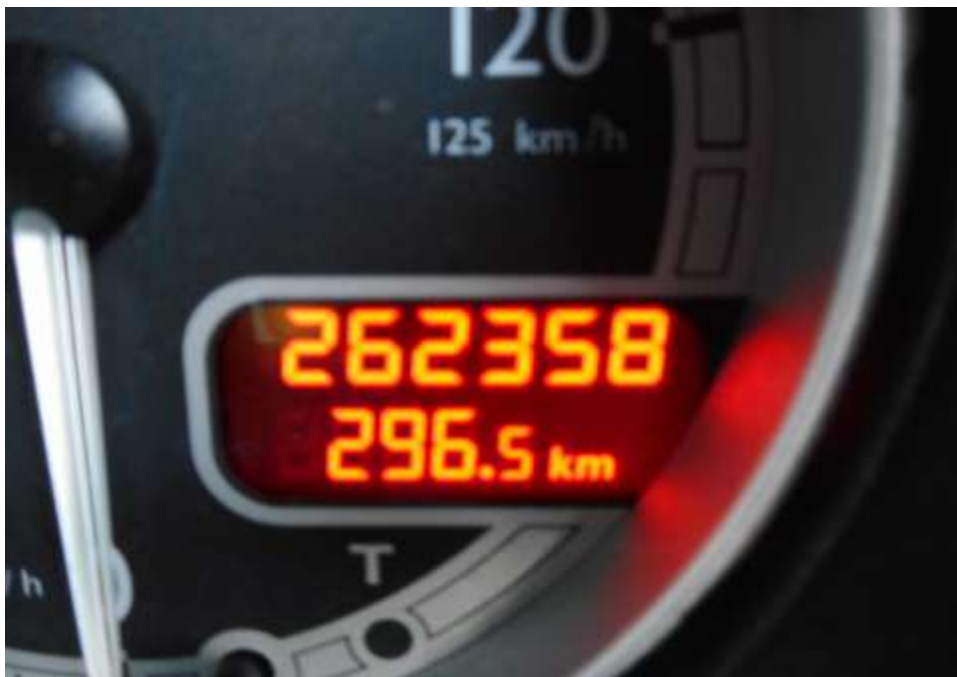
**Photo 1** shows a general view of the instrument cluster of the Garbage truck at the time of my inspection. The mileage of the Garbage truck was 262,358km

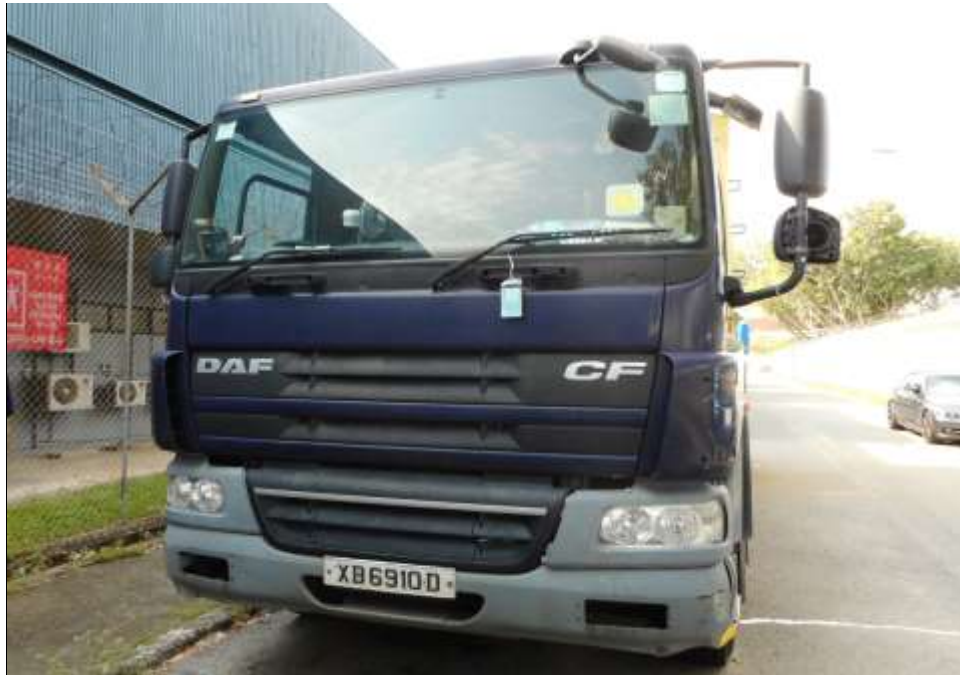
**Photo 2** shows a general view of the front body of the Garbage truck at the time of my inspection. The Garbage truck was observed to be intact and unaffected by the accident.

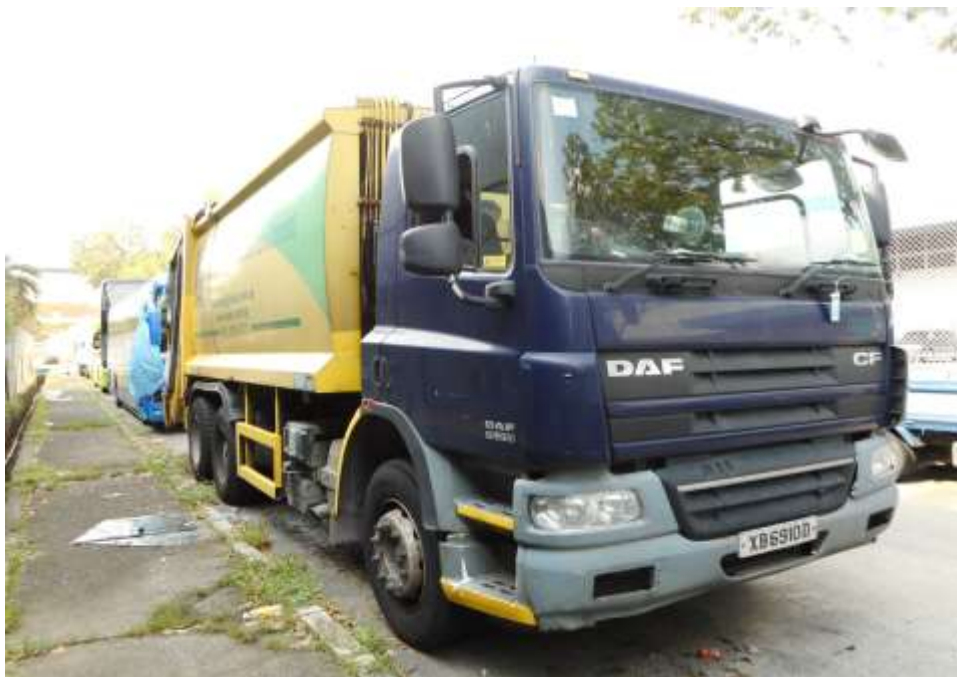
**Photo 3** shows a general view of the right body of the Garbage truck at the time of my inspection. The Garbage truck was observed to be in good general condition.

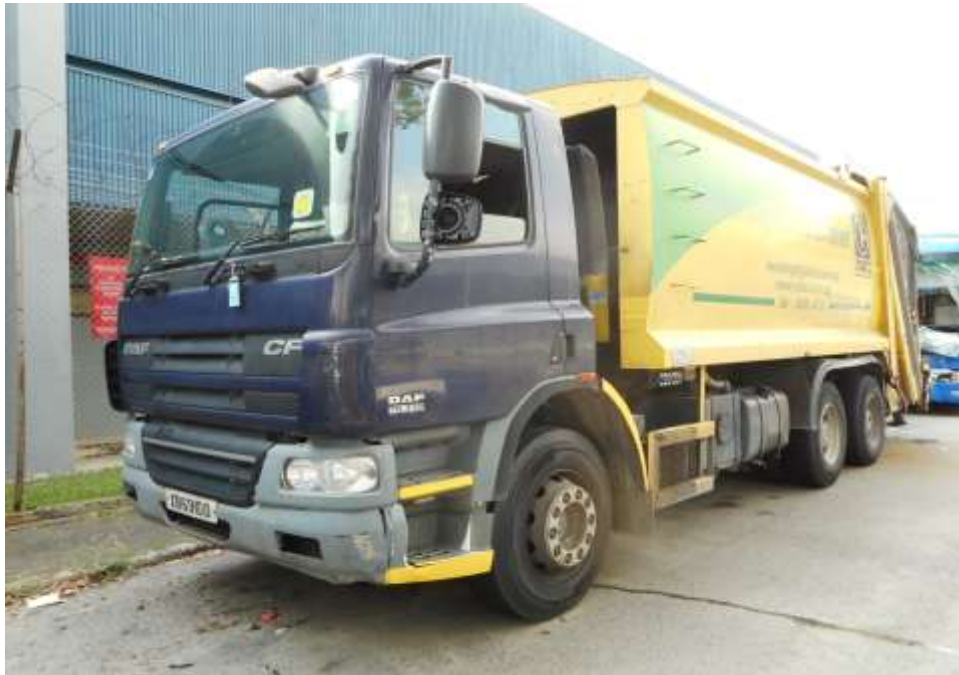
**Photo 4** shows a general view of the left body of the Garbage truck at the time of my inspection. The Garbage truck was observed to be intact and unaffected by the accident.

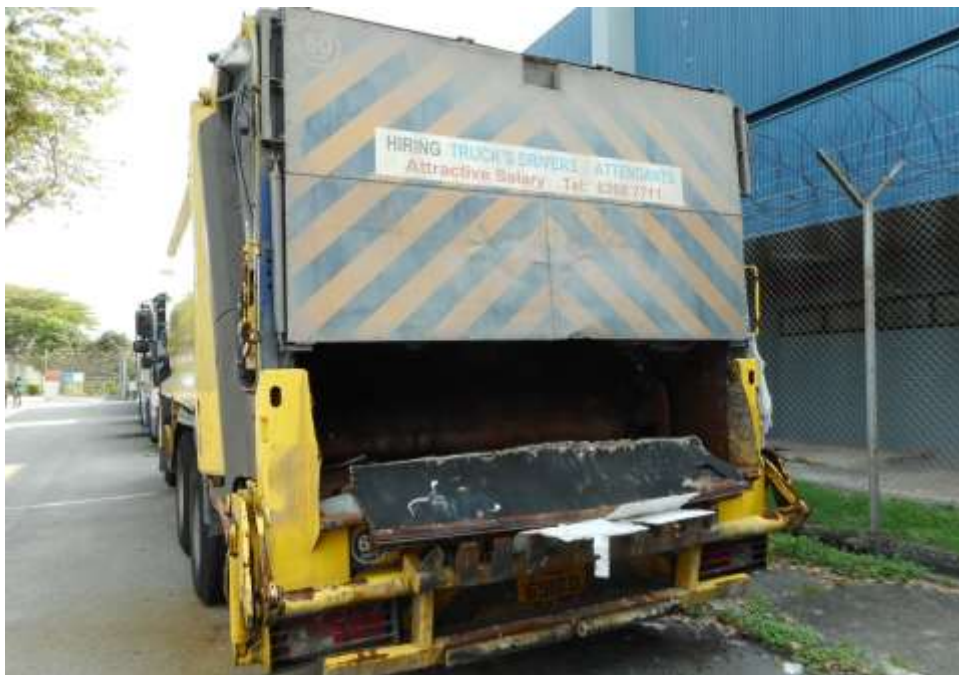
**Photo 5** shows a general view of the rear body of the Garbage truck at the time of my inspection. The Garbage truck was observed to be intact and unaffected by the accident.

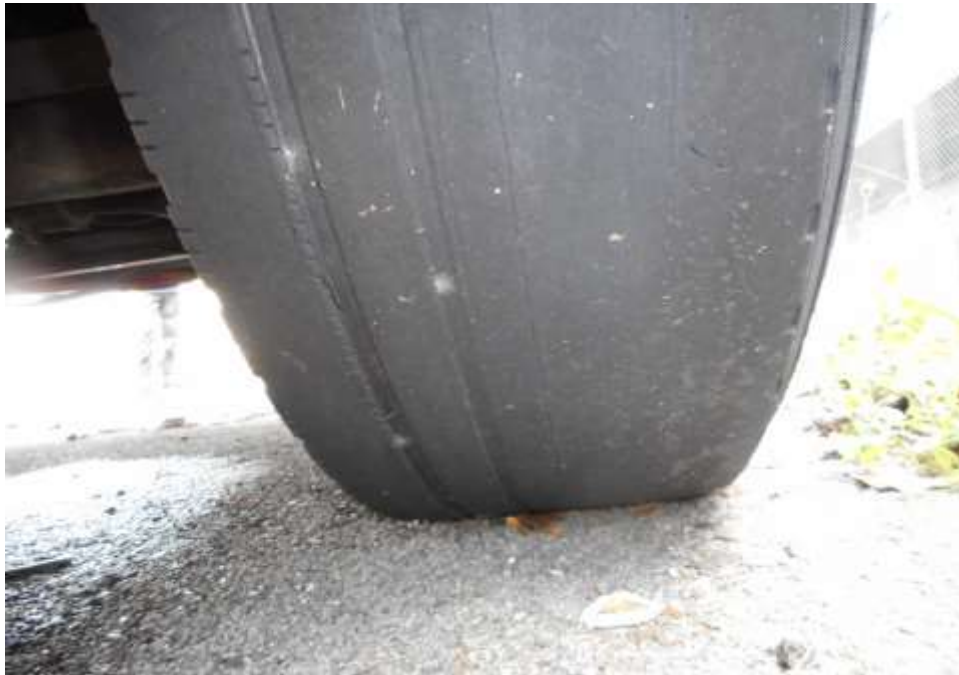
**Photo 6** shows the condition of the front right tyre of the Garbage truck, which was observed to be in unserviceable condition with remaining tread depth of approximately 0 mm. The tyre, which was wrapped around standard steel wheel rim, was also observed to be sufficiently inflated for vehicular operation. There was no tear, cut or burst mark(s) on the outer and the inner sidewalls as well as across the tread of the 10 tyres that were fitted on the Garbage truck.

18. The front left tyres and 8 rear tyres fitted on the Garbage truck were also found to be in serviceable condition. I did not find any tear, cut or burst mark(s) on the outer and the inner sidewalls as well as across the tread of the 9 tyres. 9 tyres were also observed to be sufficiently inflated for vehicular operation with remaining tread depth of approximately 9.8 mm – 11 mm. However the tread depth of the front right tyre was observed to be in unserviceable condition with a remaining tread depth of 0 mm.

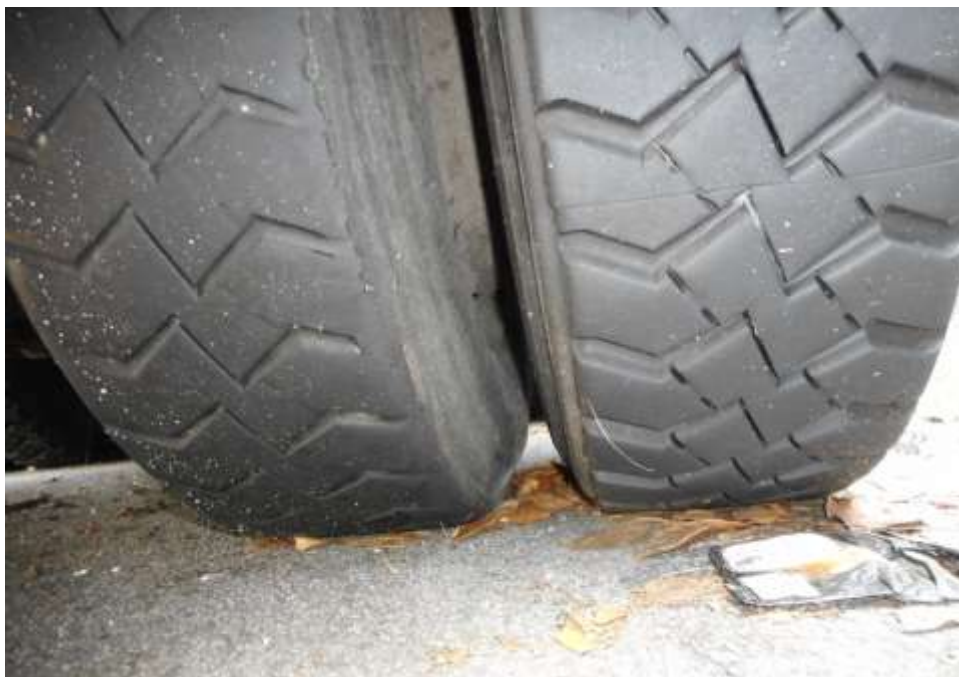
**Photo 7** shows the condition of the rear right tyre of the Garbage truck, which was observed to be in serviceable condition with remaining tread depth of approximately 11mm. The tyre, which was wrapped around standard steel wheel rim, was also observed to be sufficiently inflated for vehicular operation.

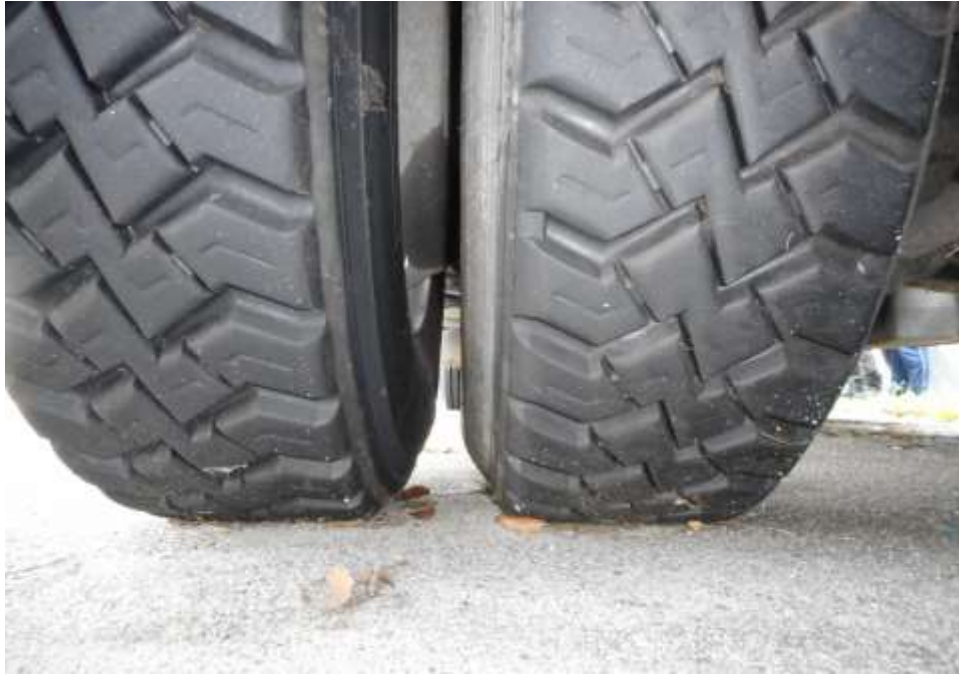
**Photo 8** shows the condition of the rear left tyres of the Garbage truck, which was observed to be in serviceable condition with remaining tread depth of approximately 9.8mm. The tyres, which were wrapped around standard steel wheel rim, were also observed to be sufficiently inflated for vehicular operation. There was also no damage found on all 10 steel wheel rims of the Garbage truck.

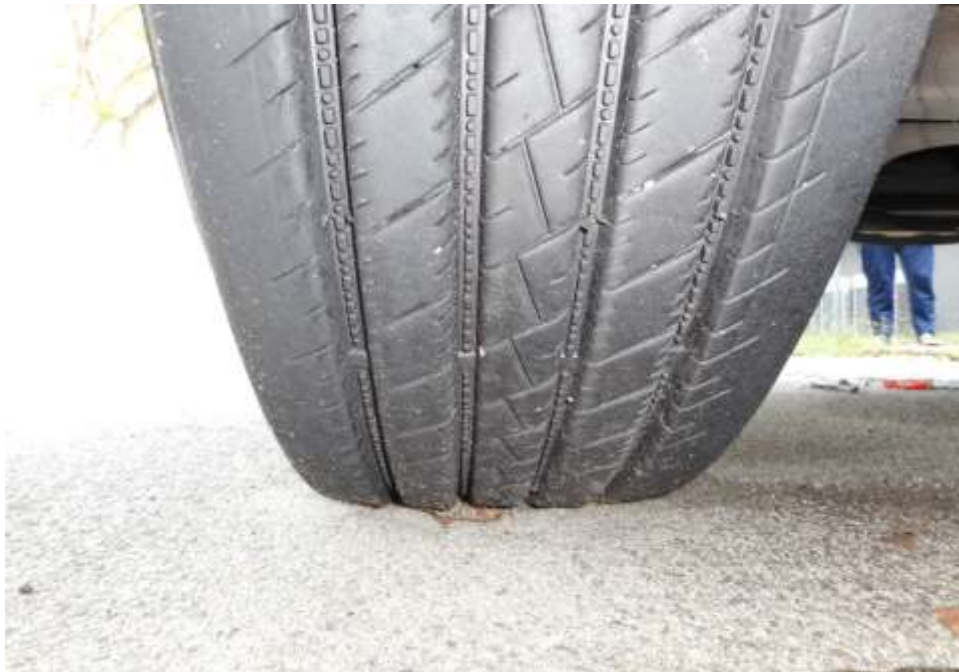
**Photo 9** shows the condition of the front left tyres of the Garbage truck, which were observed to be in serviceable condition with remaining tread depth of approximately 10.3mm. There was also no tear, cut or burst mark(s) on the outer and the inner sidewalls as well as across the tread of the 10 tyres that were fitted on the Garbage truck.

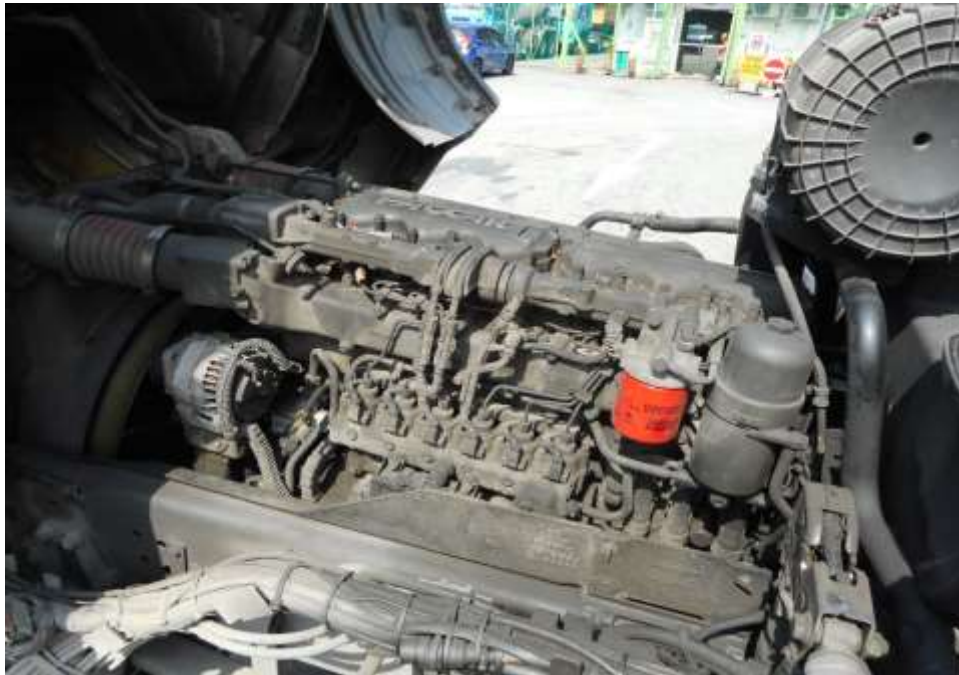
**Photo 10** shows a general view of the Garbage truck's engine compartment, which was accessed by lifting the front cabin of the Garbage truck. The various parts and components inside the engine compartment were unaffected by the accident. There was also no sign(s) or indication(s) of fresh fluid leakage and/or fluid stain within the engine compartment

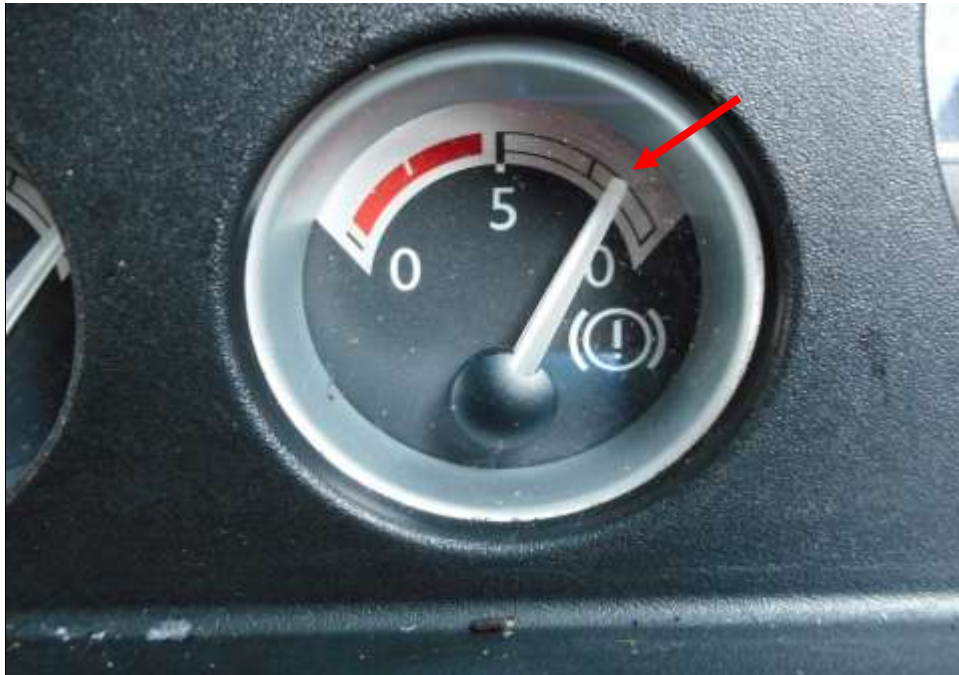
**Photo 11** shows the air in the air brake cylinders of the Garbage truck at the time of my inspection. The air in the cylinder was observed to be of sufficient level & serviceable at the time of the accident.

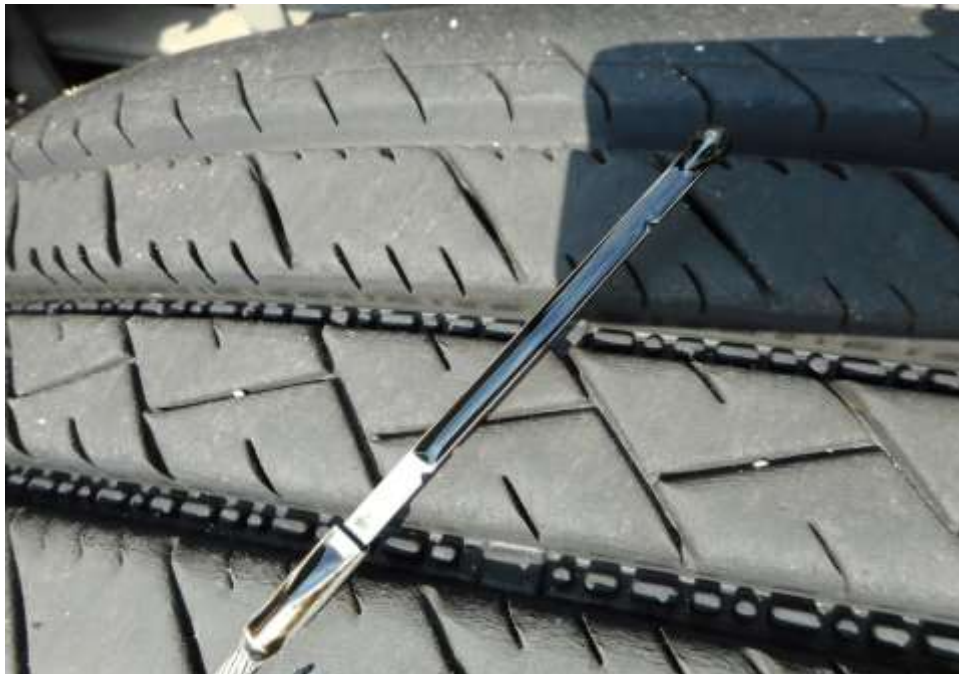
**Photo 12** shows the engine oil dip stick of the Garbage truck at the time of my inspection. The engine oil was observed to be of sufficient level and without any visible contamination.

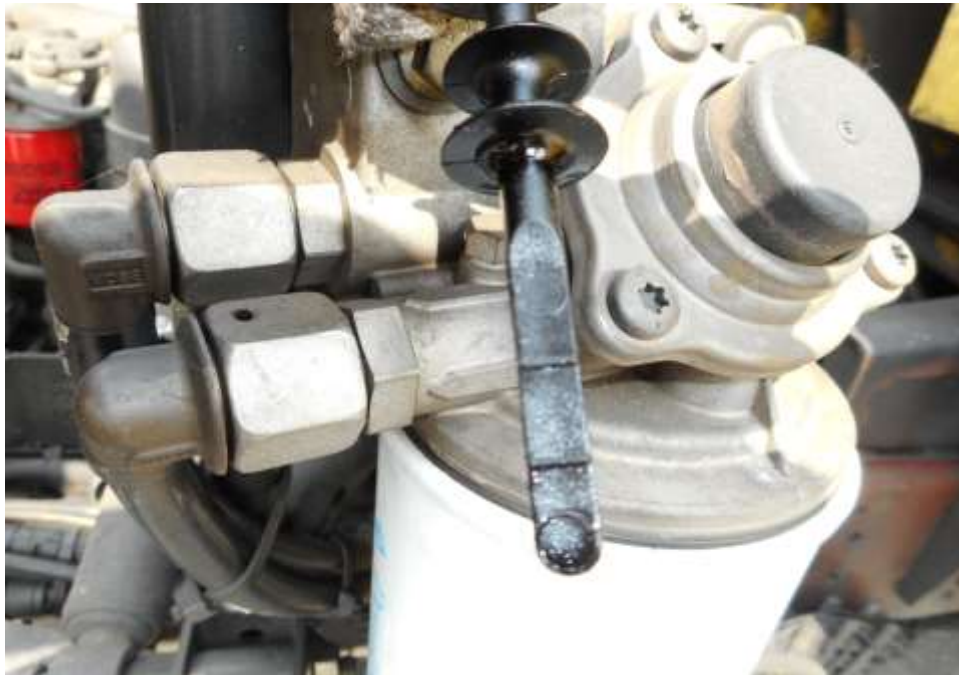
**Photo 13** shows the power steering fluid dip stick of the Garbage truck at the time of my inspection. The power steering fluid was observed to be of low level and without any visible contamination.

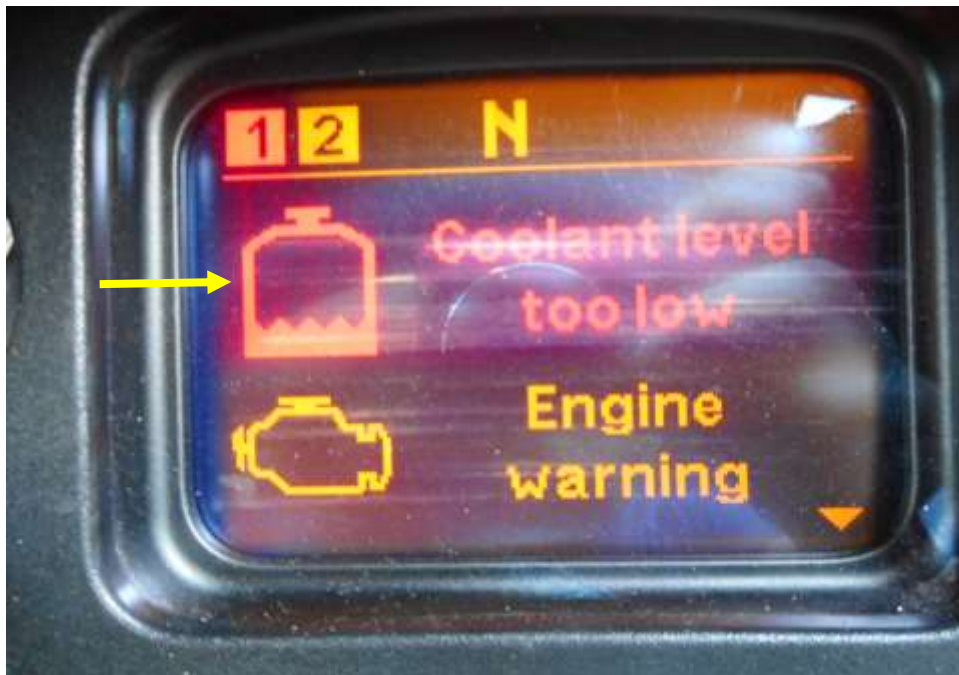
9. Upon examination of Garbage truck's engine compartment, I had observed all the parts and components inside the engine compartment to be intact and unaffected by the accident. The engine oil fluid was found to be of sufficient level for operating purpose. However the engine coolant was observed to be low level and leaking from the radiator and the Power steering fluid was also observed to be of low level. Visually, there was also no contamination found to these fluids.

**Photo 14** shows the engine coolant reservoir of the Garbage truck at the time of my inspection. The engine coolant was observed to be of low level (arrowed)

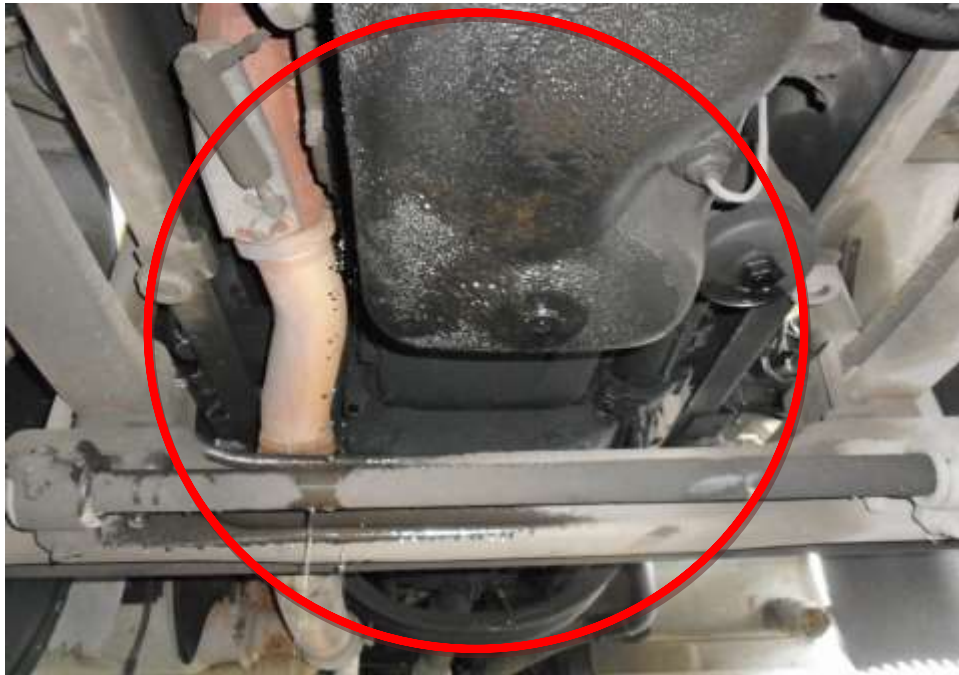
11. My subsequent checks on the underside of the Garbage truck also revealed no fluid stain. Visually, the various undercarriage components of the Prime Mover were all observed to be intact and without any visible damage. However fresh coolant fluid was observed leaking from the radiator. See photo 10 – 15 below.

**Photo 15** shows the undercarriage of the Garbage truck at the area where the engine housing located. Observed were fresh coolant fluid leakage and/or fluid stain(s) on the underside of the Garbage truck (circled)

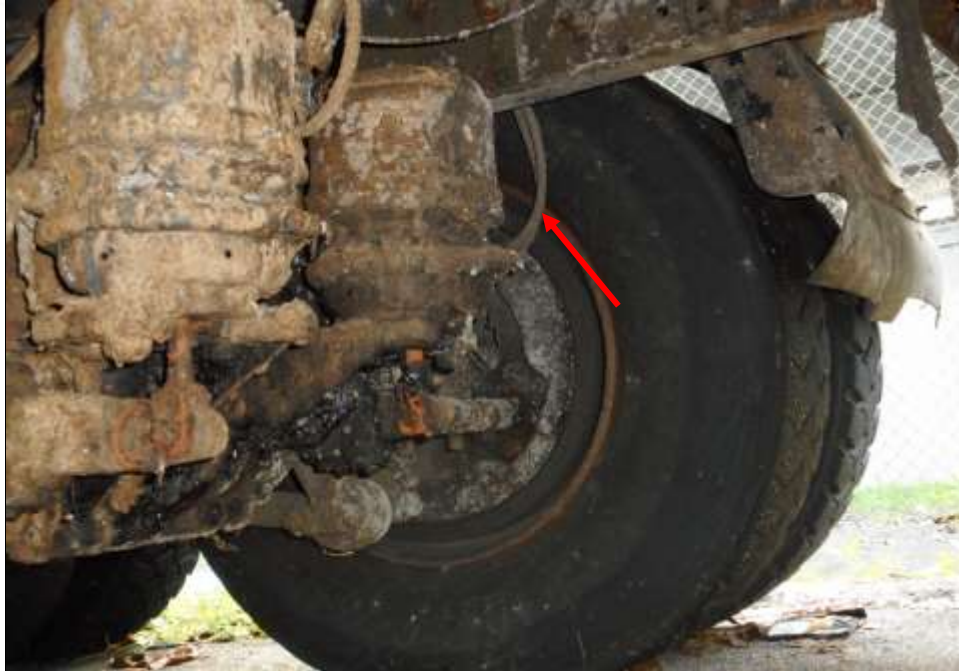
**Photo 16** shows the brake pipe (arrowed) at the rear right wheel of the Garbage truck. I did not observe any leakage of brake fluid at the time of my inspection of the Garbage truck. My static tests of the Garbage truck's braking system, along with my visual examination of the various mechanical components in the braking system, had indicated that there was no internal leakage of pressure/vacuum. Hence the braking system of the Garbage truck was likely to be in serviceable condition at the material time of accident.

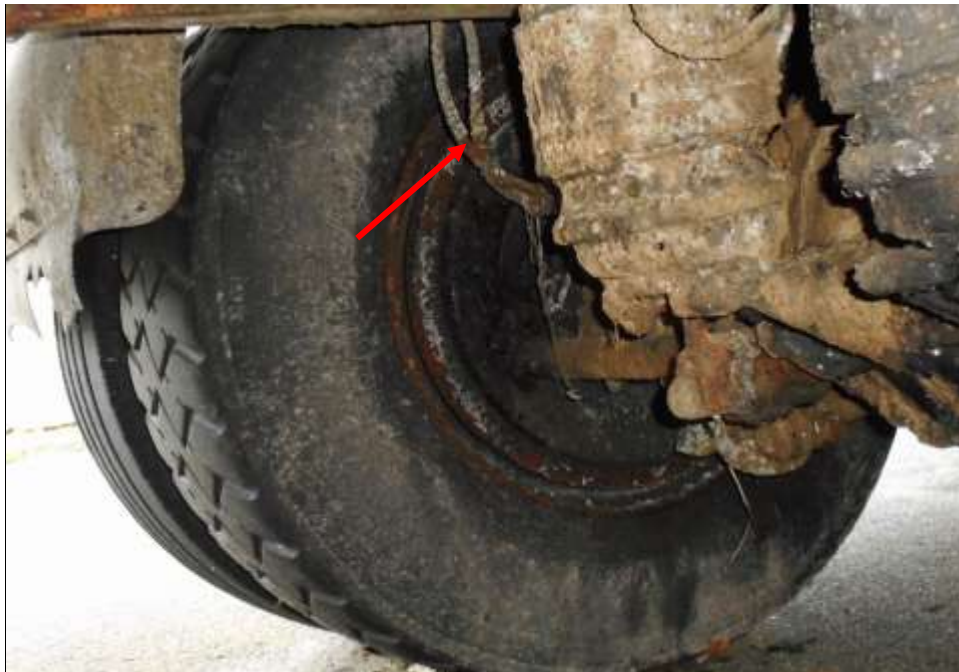
**Photo 17** shows the brake pipe (arrowed) at the rear left wheel of the Garbage truck. I did not observe any leakage of brake fluid at the time of my inspection of the Garbage truck. My static tests of the Garbage truck's braking system, along with my visual examination of the various mechanical components in the braking system, had indicated that there was no internal leakage of pressure/vacuum. Hence the braking system of the Garbage truck was likely to be in serviceable condition at the material time of accident.

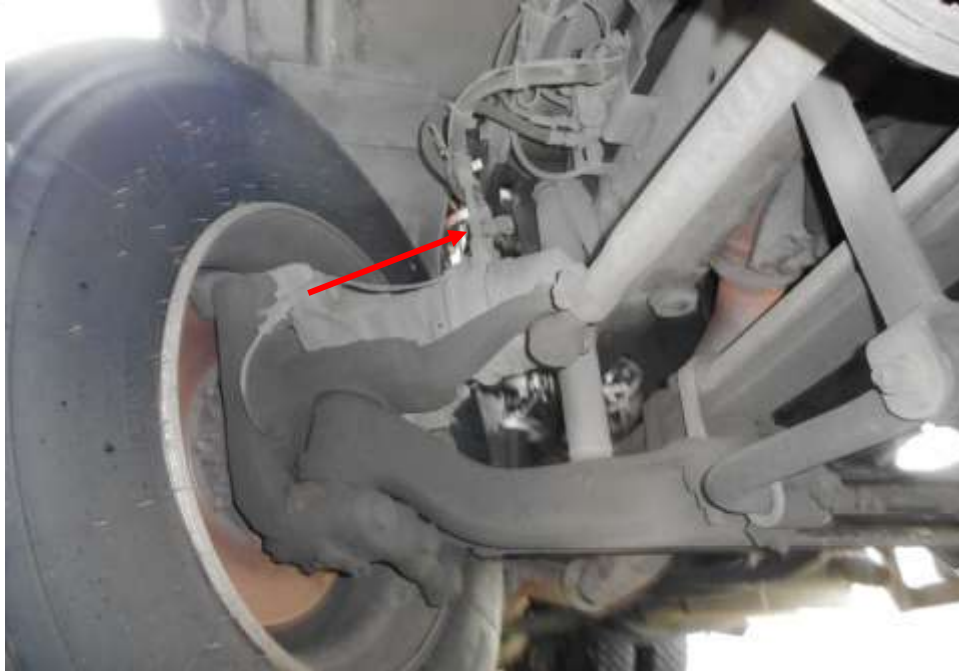
**Photo 18** shows the brake pipe (arrowed) at the front right wheel of the Garbage truck. I did not observe any leakage of brake fluid at the time of my inspection of the Garbage truck. My static tests of the Garbage truck's braking system, along with my visual examination of the various mechanical components in the braking system, had indicated that there was no internal leakage of pressure/vacuum. Hence the braking system of the Garbage truck was likely to be in serviceable condition at the material time of accident.

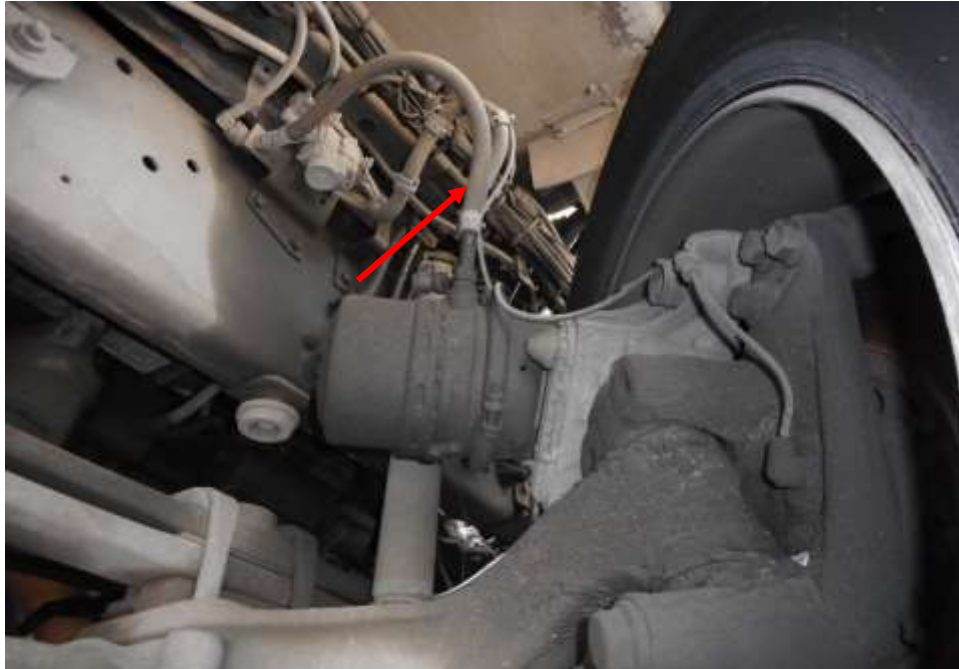
**Photo 19** shows the brake pipe (arrowed) at the front left wheel of the Garbage truck. I did not observe any leakage of brake fluid at the time of my inspection of the Garbage truck. My static tests of the Garbage truck's braking system, along with my visual examination of the various mechanical components in the braking system had indicated that there was no internal leakage of pressure/vacuum. Hence the braking system of the Garbage truck was likely to be in serviceable condition at the material time of accident.

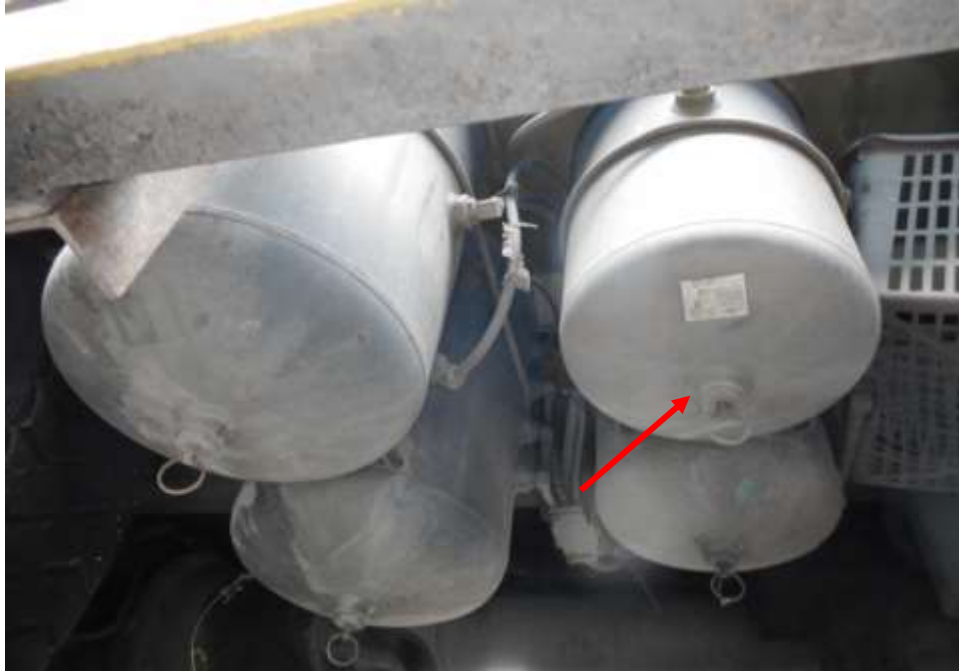
**Photo 20** shows the air brake cylinder (arrowed) at the undercarriage of the Garbage truck. I did not observe any leakage of air brake fluid at the time of my inspection of the Garbage truck. My static tests of the Garbage truck's braking system, along with my visual examination of the various mechanical components in the braking system had indicated that there was no internal leakage of pressure/vacuum. Hence the braking system of the Garbage truck was likely to be in serviceable condition at the material time of accident.

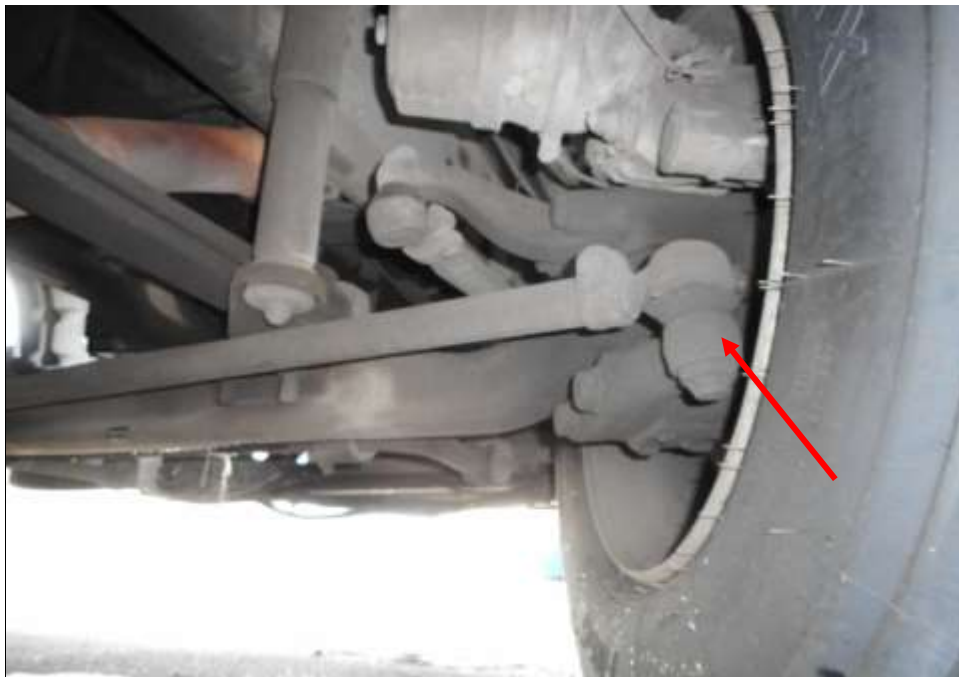
**Photo 21** shows the various undercarriage components at the front right wheel of the Garbage truck, in particular the steering tie rod end (arrowed). The various steering components were all found to be intact, suggesting that the steering system of the Garbage truck was likely to be in serviceable condition at the material time of accident. There was also no sign of fluid stain(s) observed on the various undercarriage components.

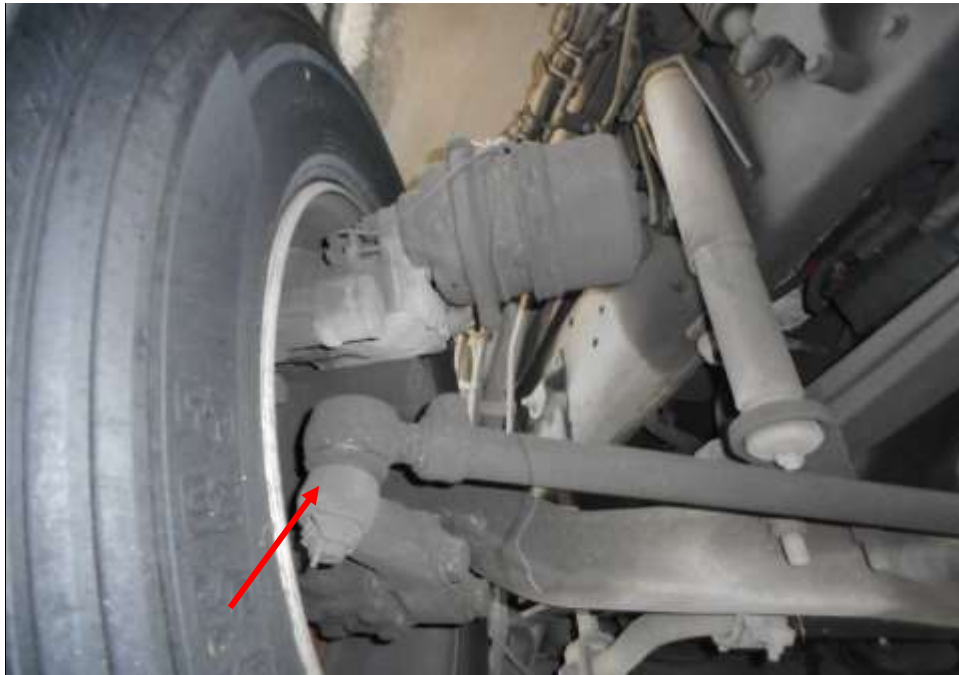
**Photo 22** shows the various undercarriage components at the front left wheel of the Garbage truck, in particular the steering tie rod end (arrowed). The various undercarriage components of the Garbage truck were all found to be intact without any visible damage. There was also no sign of fluid stain(s) observed on the various undercarriage components.

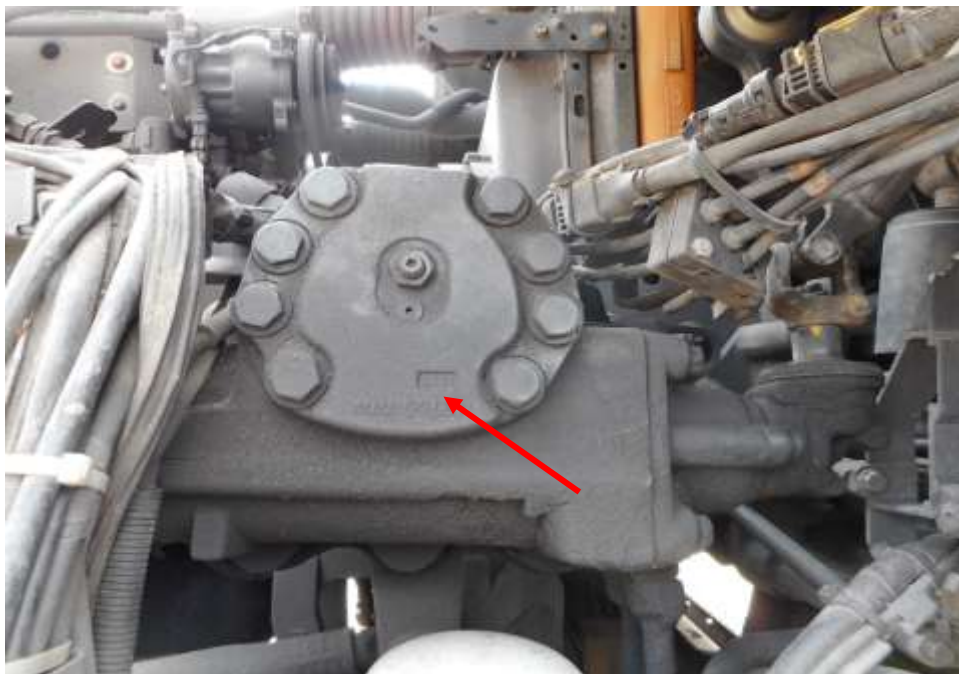
**Photo 23** shows the steering box component (arrowed) at the undercarriage of the Garbage truck was found to be intact without any visible damage. There was also no sign of fluid stain(s) observed on the various undercarriage components.

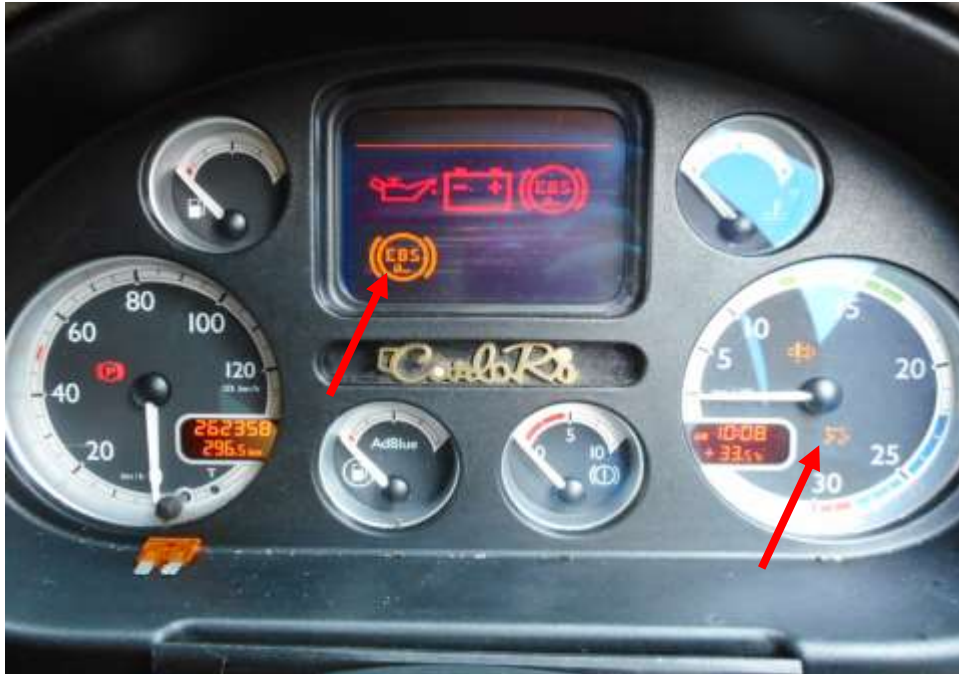
**Photo 25** shows the warning light for Anti-Lock Brake System (ABS) and Traction Control System (TC) (arrowed) appearing on the instrument panel of the Garbage truck during the self-test of its various electronic operating systems when its engine was cranked.

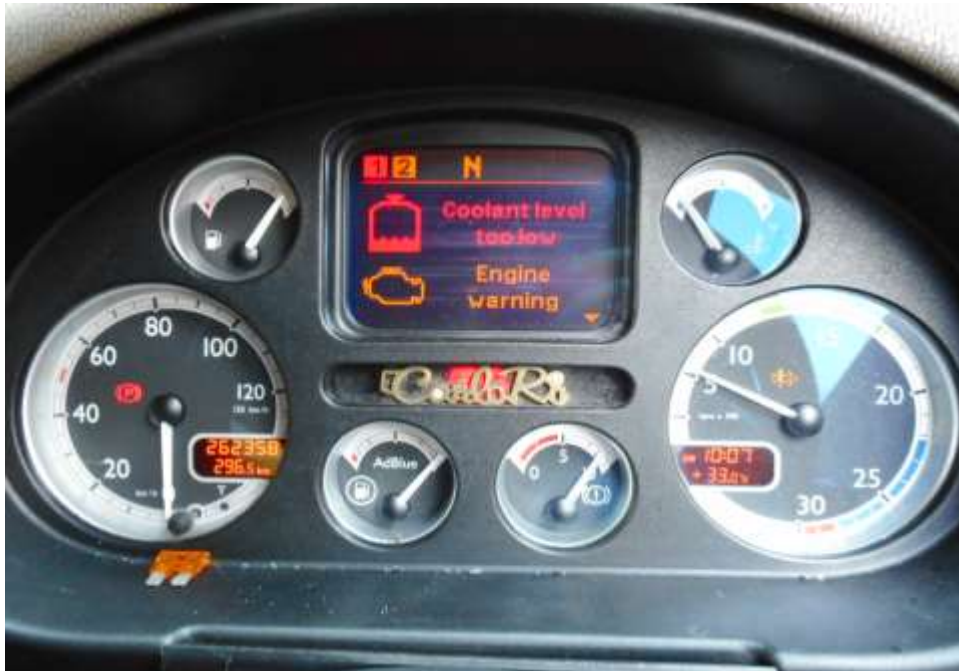
**Photo 26** shows no warning lights illuminated on the instrument panel of the Garbage truck after the engine was cranked. This would suggest that there was no abnormality to the various electronic operating systems of the Garbage truck, like the ABS & TC etc.
