Your Ref: TP/IP/40685/2019
Our Ref : CI/TPD19012750/P

30th July 2019

MECHANICAL INSPECTION REPORT OF MOTOR LORRY GBJ 253K

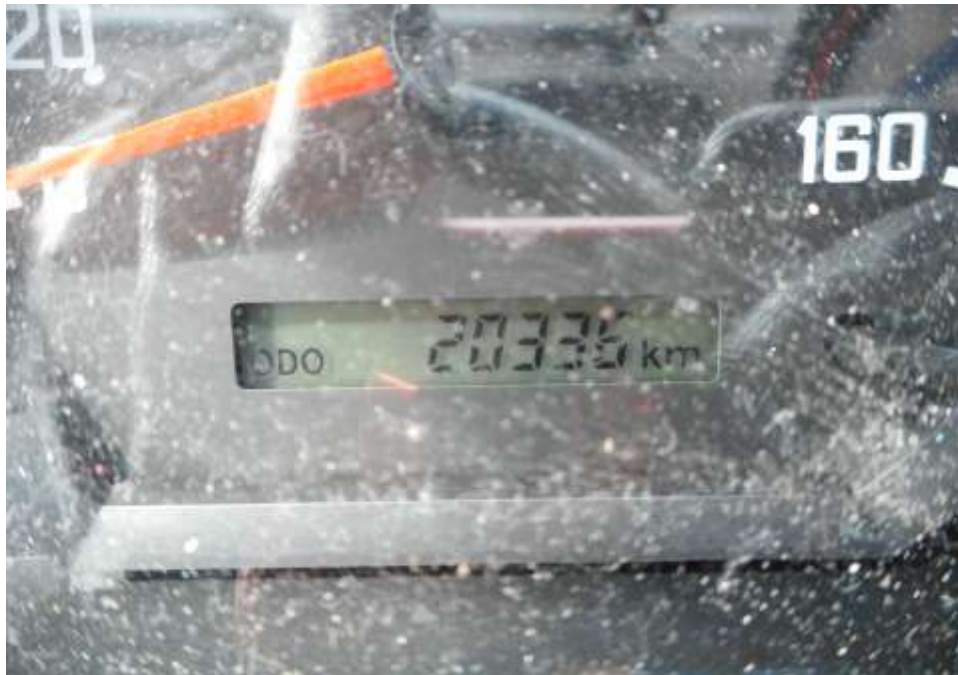
Photo 1 shows a general view of the instrument cluster of the Motor Lorry at the time of my inspection. The mileage of the Motor Lorry was 20,336km

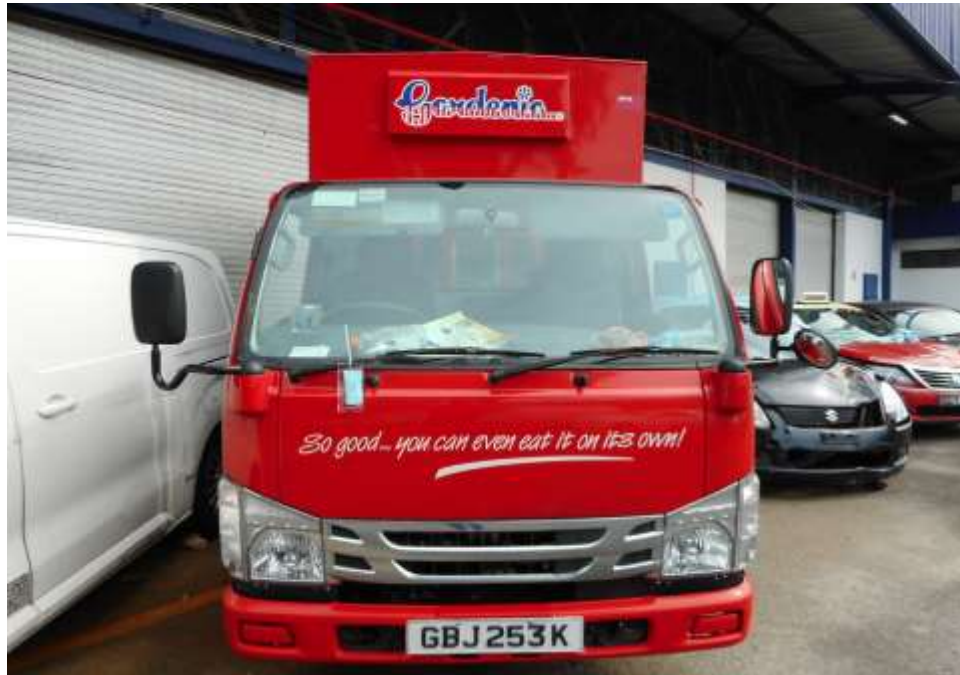
Photo 2 shows a general view of the Motor Lorry's frontal portion at the time of my inspection. There was moderate damage found at its left portion. Its left cabin panel were damage as a result of the accident.

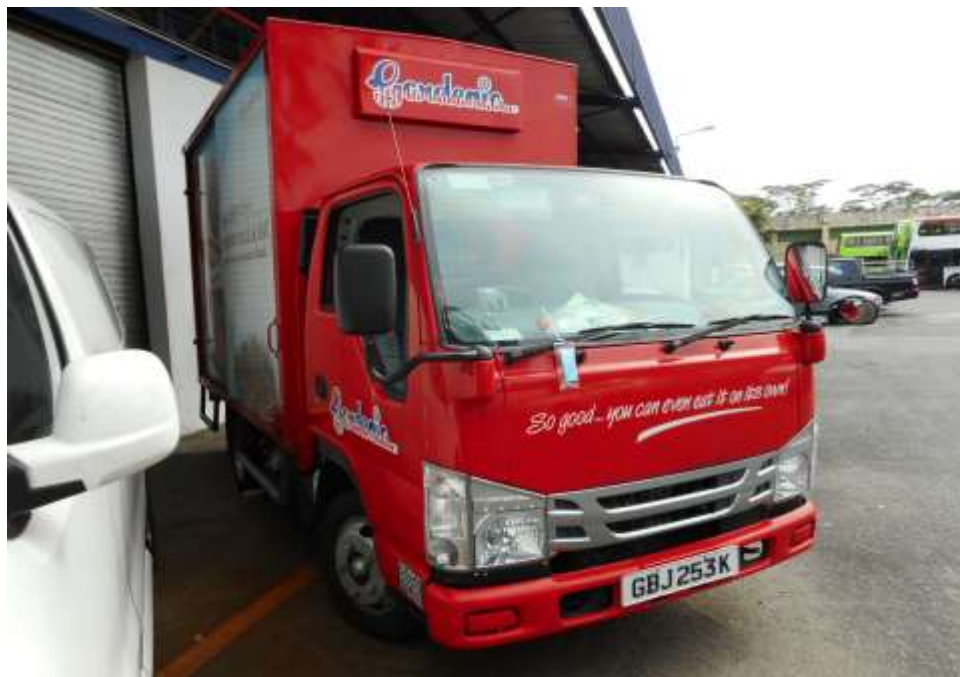
Photo 3 shows a general view of the right body of the Motor Lorry at the time of my inspection. The Motor Lorry was observed to be intact and unaffected by the accident.

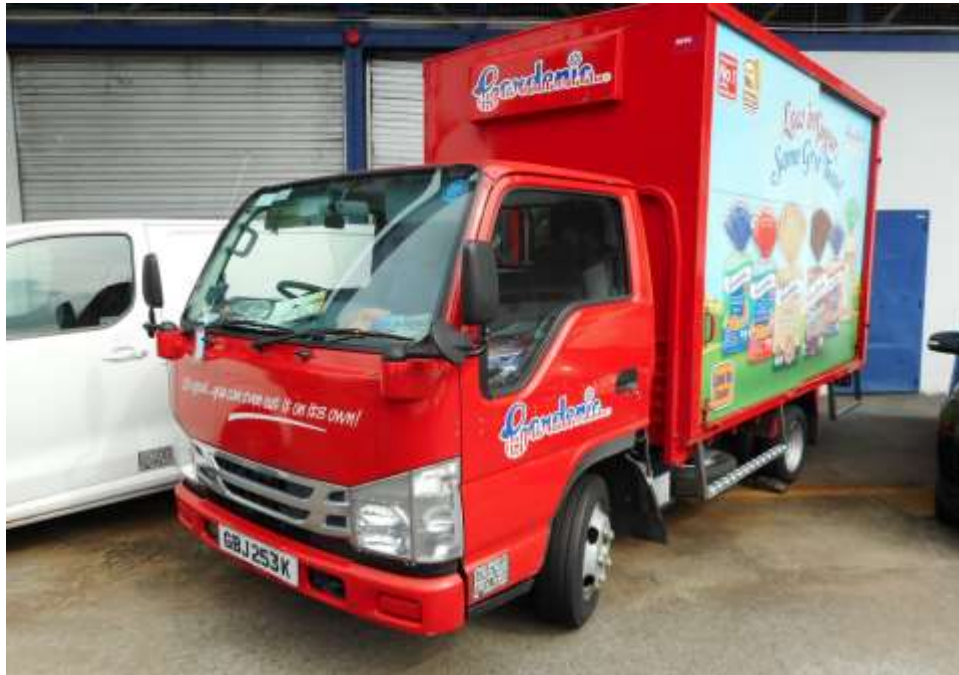
Photo 4 shows a general view of the left body of the Motor Lorry at the time of my inspection. The Motor Lorry was observed to be intact and unaffected by the accident.

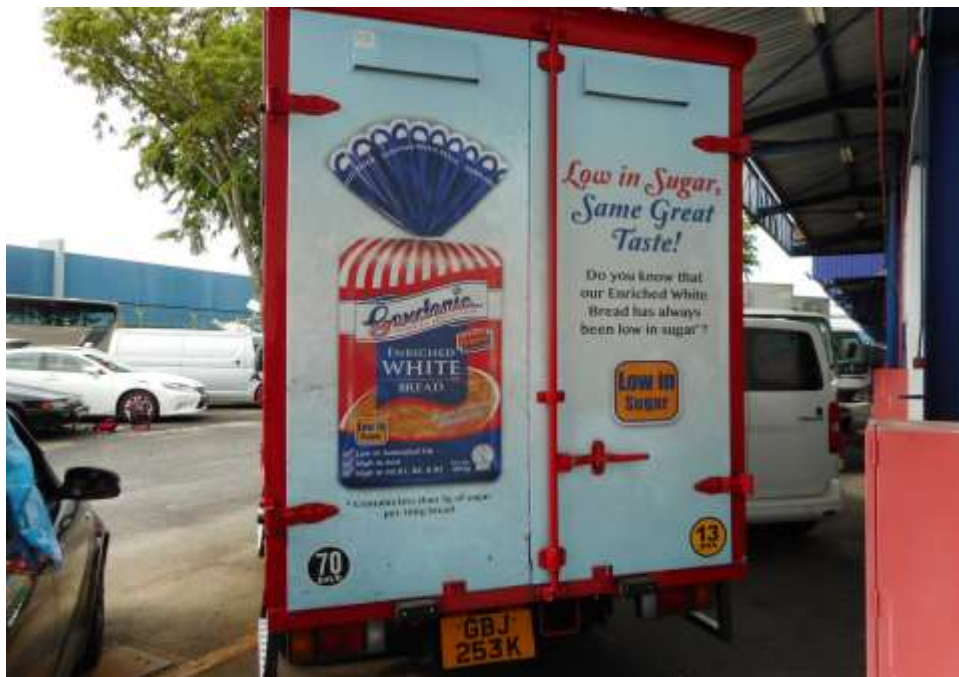
Photo 5 shows a general view of the rear body of the Motor Lorry at the time of my inspection. The Motor Lorry was observed to be intact and unaffected by the accident.

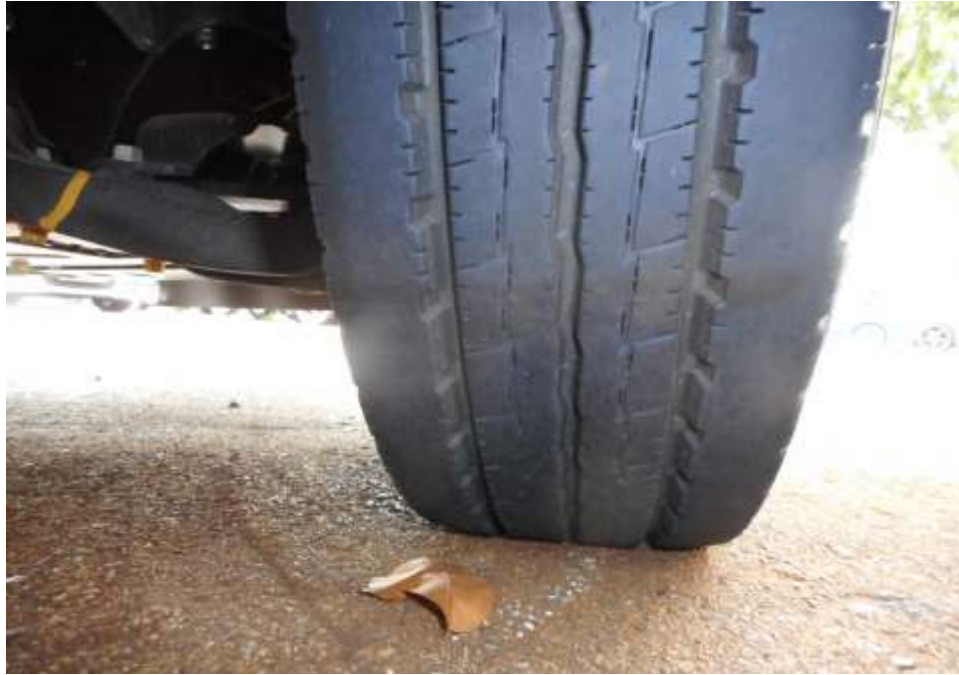
Photo 6 shows the condition of the front right tyre of the Motor Lorry, which was observed to be in serviceable condition with remaining tread depth of approximately 7.5mm. The tyre, which was wrapped around standard steel wheel rim, was also observed to be sufficiently inflated for vehicular operation. There was no tear, cut or burst mark(s) on the outer and the inner sidewalls as well as across the tread of the 6 tyres that were fitted on the Motor Lorry.

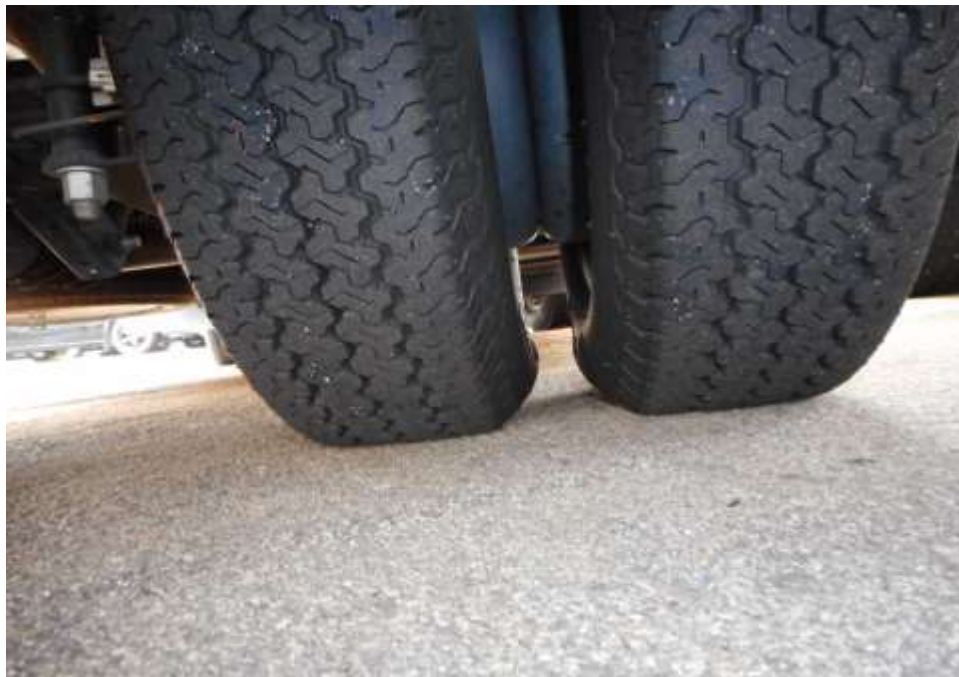
Photo 7 shows the condition of the rear right tyre of the Motor Lorry, which was observed to be in serviceable condition with remaining tread depth of approximately 6mm. The tyre, which was wrapped around standard steel wheel rim, was also observed to be sufficiently inflated for vehicular operation.

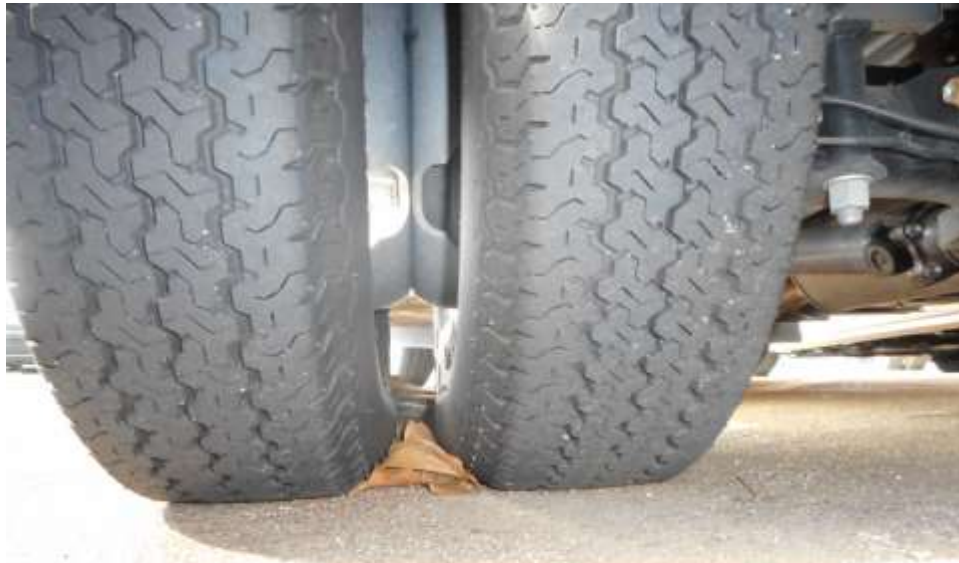
Photo 8 shows the condition of the rear left tyres of the Motor Lorry, which was observed to be in serviceable condition with remaining tread depth of approximately 6.3mm. The tyres, which were wrapped around standard steel wheel rim, were also observed to be sufficiently inflated for vehicular operation. There was also no damage found on all 6 steel wheel rims of the Motor Lorry.

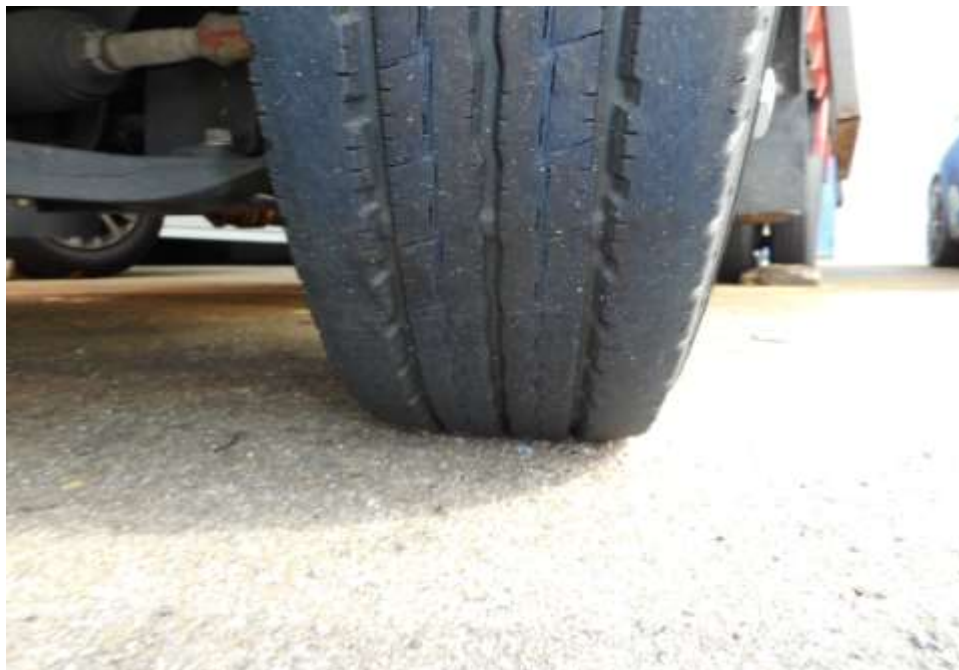
Photo 9 shows the condition of the rear right tyres of the Motor Lorry, which were observed to be in serviceable condition with remaining, tread depth of approximately 7.8mm. There was also no tear, cut or burst mark(s) on the outer and the inner sidewalls as well as across the tread of the 6 tyres that were fitted on the Motor Lorry.

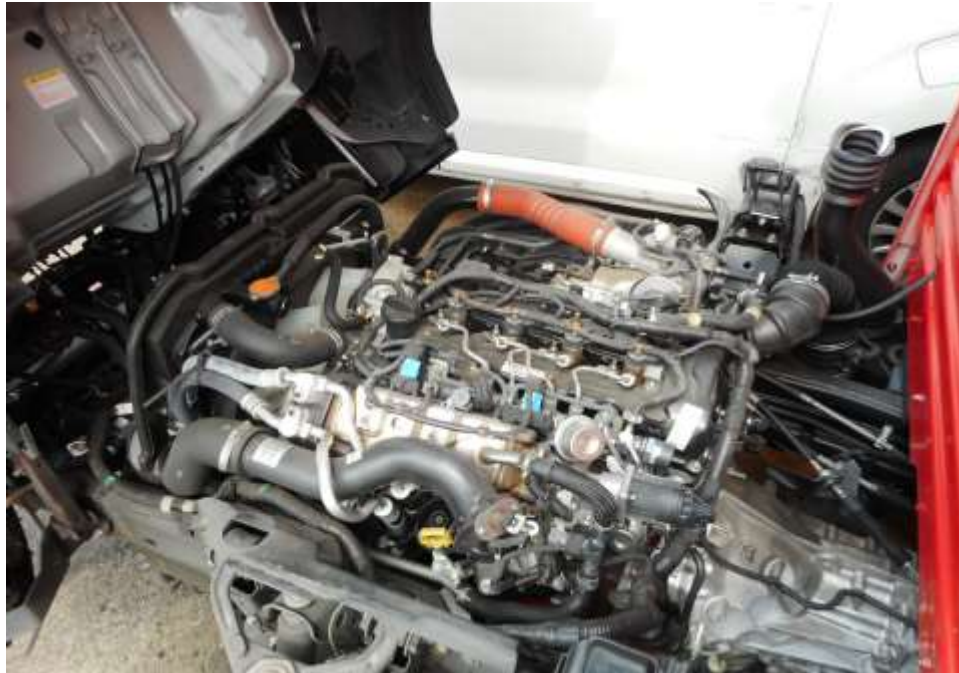
Photo 10 shows a general view of the Motor Lorry's engine compartment, which was accessed by lifting the front cabin of the Motor Lorry. The various parts and components inside the engine compartment were unaffected by the accident. There was also no sign(s) or indication(s) of fresh fluid leakage and/or fluid stain within the engine compartment (photograph shows the engine compartment as viewed from the left front side of the Motor Lorry).

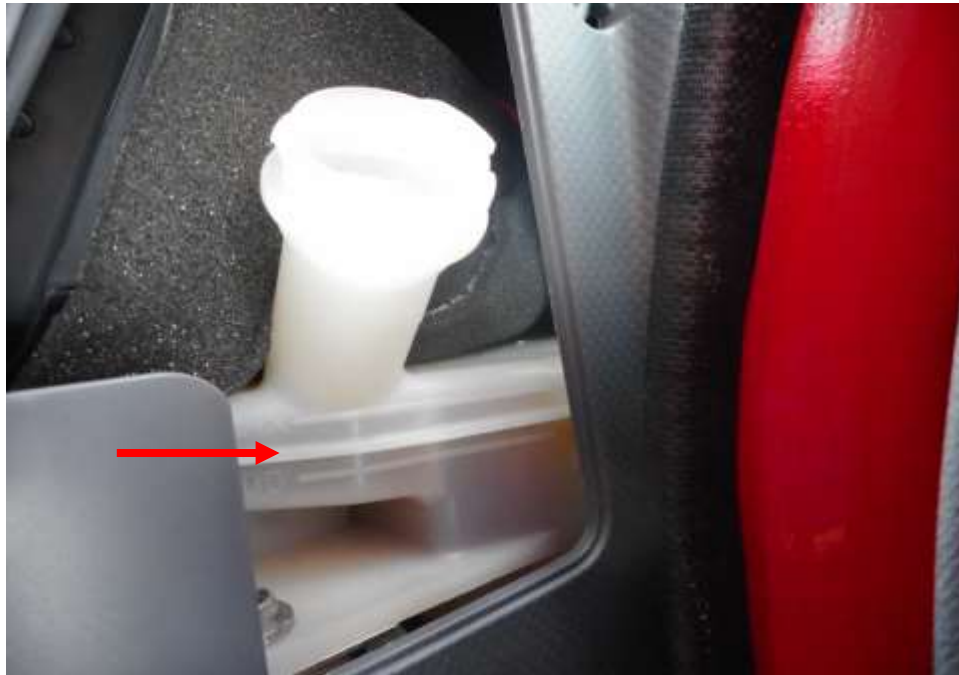
Photo 11 shows the brake fluid reservoir of the Motor Lorry at the time of my inspection. The brake fluid was observed to be of sufficient level (arrowed) and without any visible contamination.

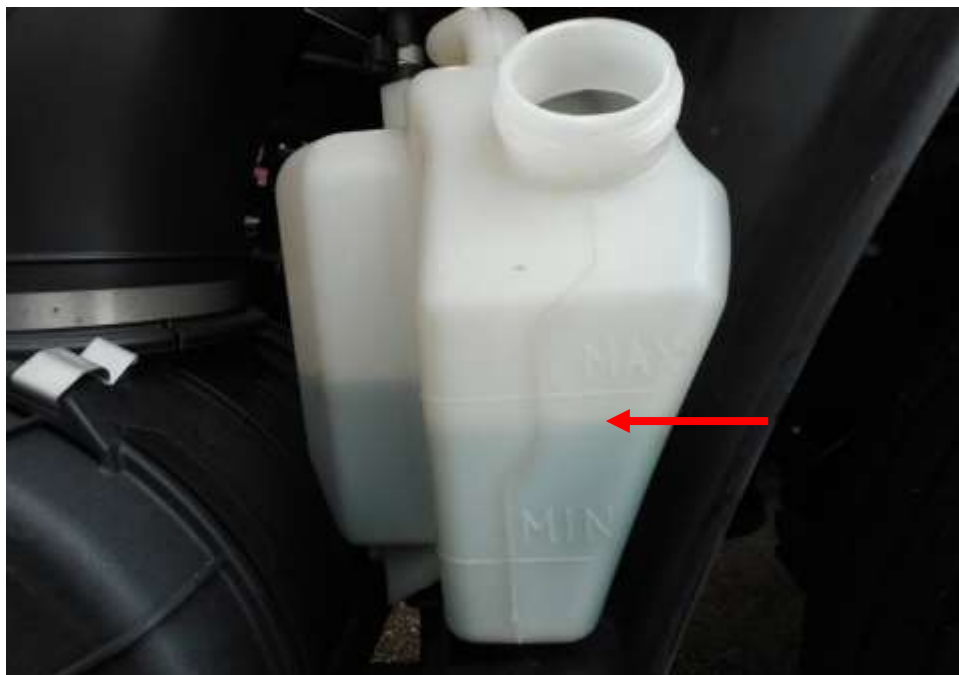
Photo 12 shows the engine coolant reservoir of the Motor Lorry at the time of my inspection. The engine coolant was observed to be of sufficient level (arrowed) and without any visible contamination.

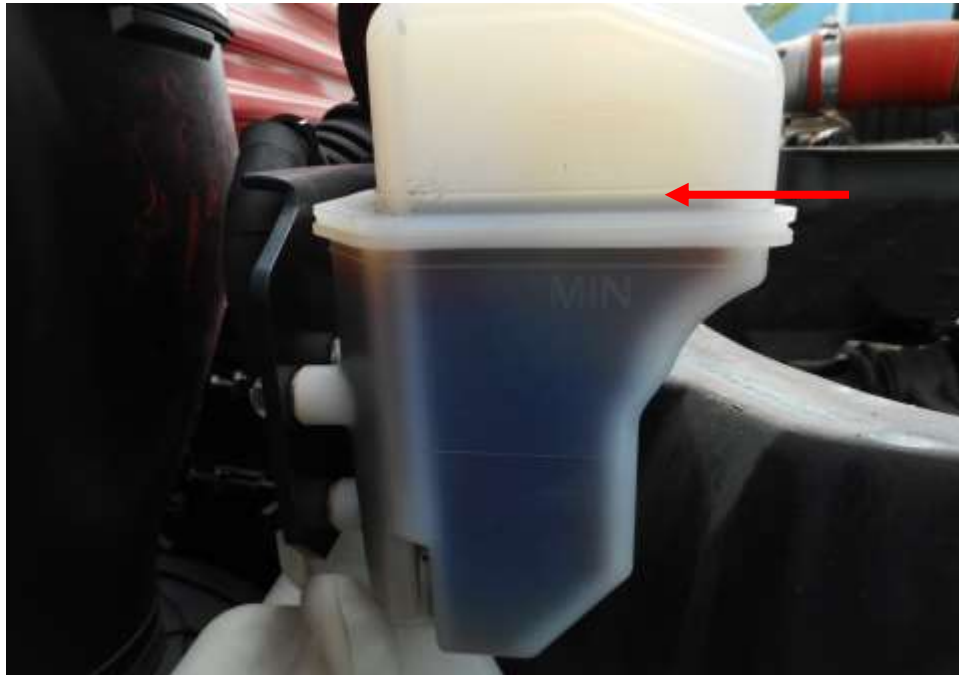
Photo 13 shows the power steering fluid reservoir of the Motor Lorry at the time of my inspection. The power steering fluid was observed to be of sufficient level (arrowed) and without any visible contamination.

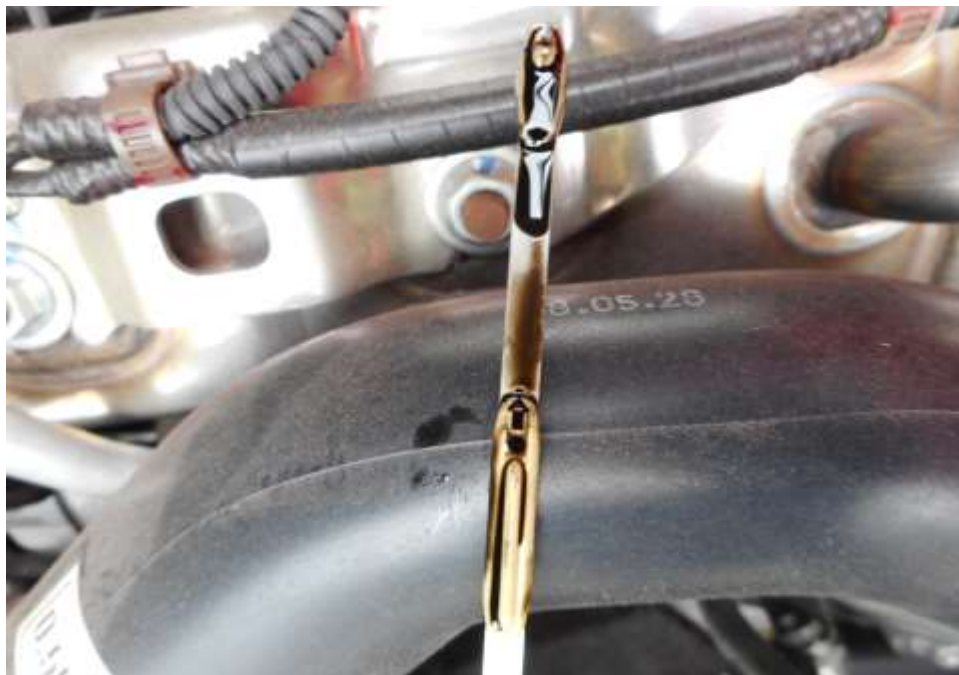
Photo 14 shows the engine dip stick of the Motor Lorry at the time of my inspection. The engine oil was observed to be of sufficient level and without any visible contamination.

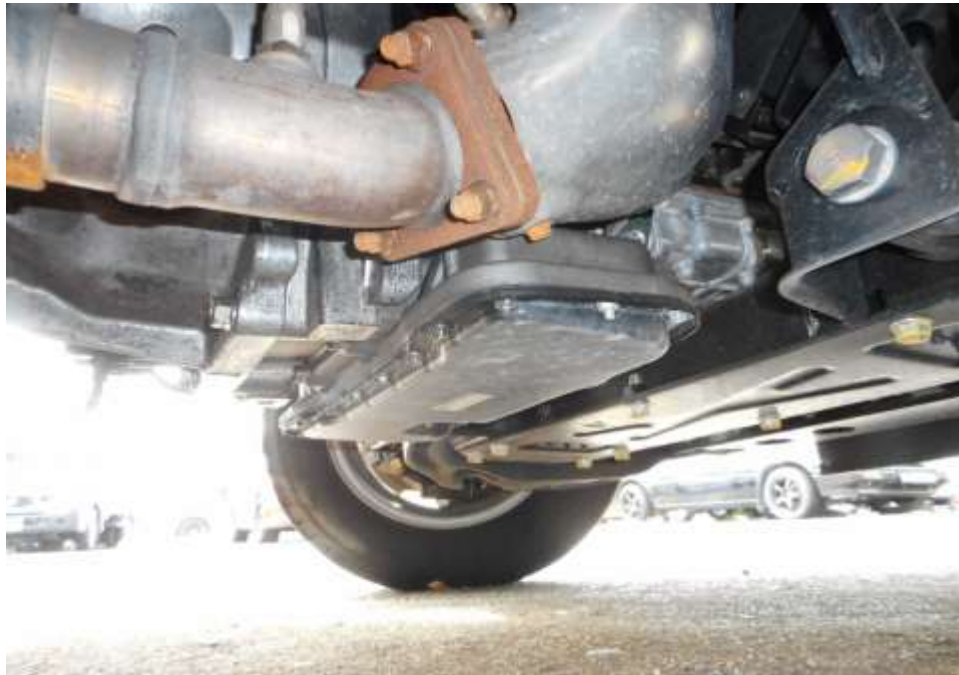
Photo 15 shows the undercarriage of the Motor Lorry, at the area where the engine housing and transmission housing are located. I did not find any sign(s) or indication(s) of fluid leak and/or fluid stain(s) on the underside of the Motor Lorry.

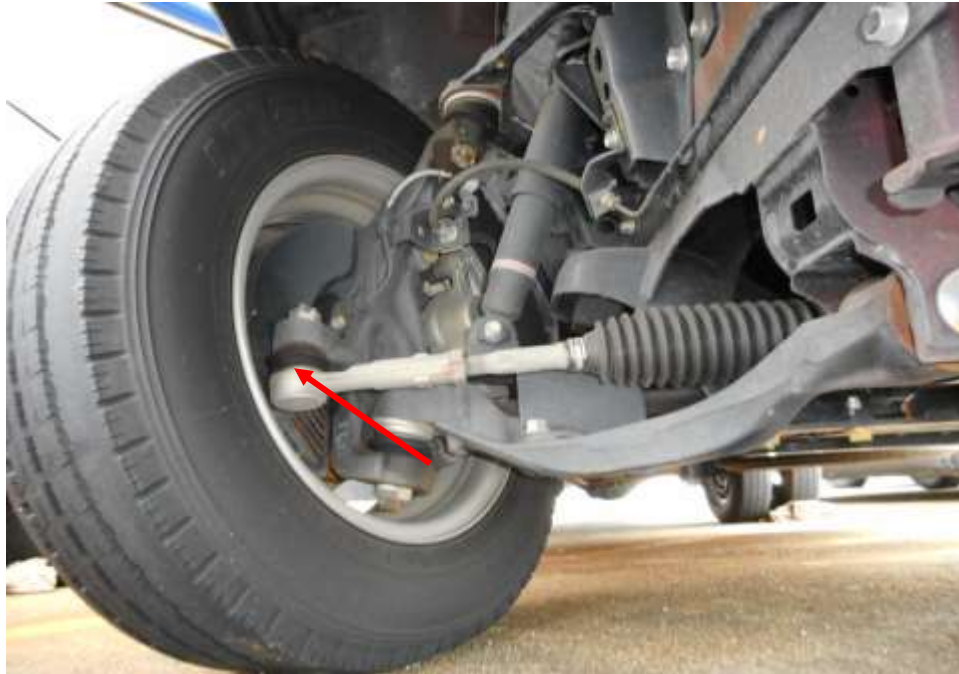
Photo 16 shows the various undercarriage components at the front right wheel of the Motor Lorry, in particular the steering tie rod end (arrowed). The various steering components were all found to be intact, suggesting that the steering system of the Motor Lorry was likely to be in serviceable condition at the material time of accident. There was also no sign of fluid stain(s) observed on the various undercarriage components.

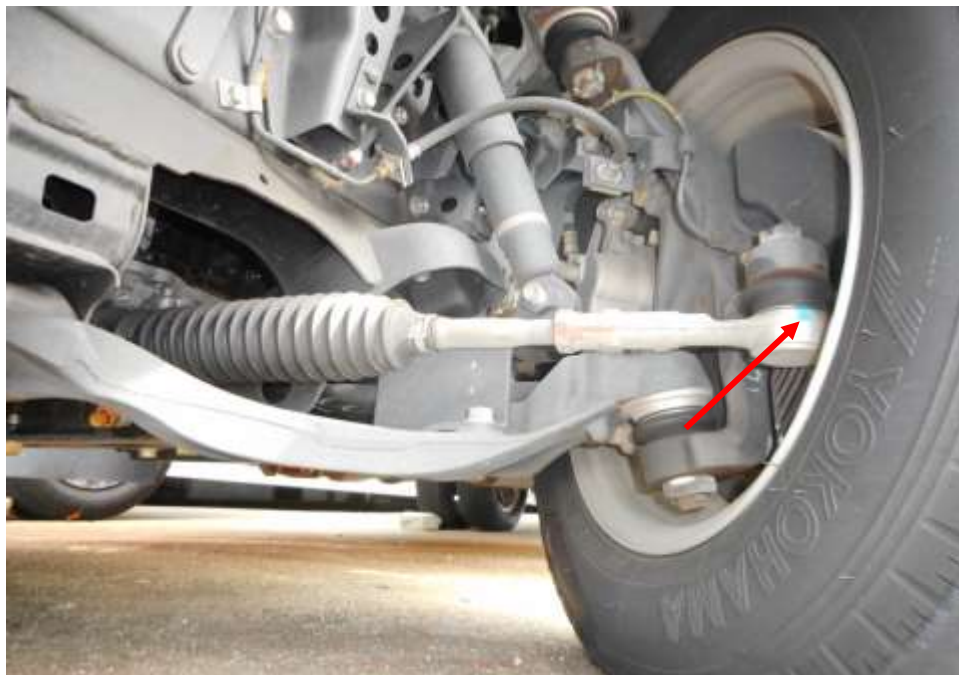
Photo 17 shows the various undercarriage components at the front left wheel of the Motor Lorry, in particular the steering tie rod end (arrowed). The various Undercarriage components of the Motor Lorry were all found to be intact without any visible damage. There was also no sign of fluid stain(s) observed on the various undercarriage components.

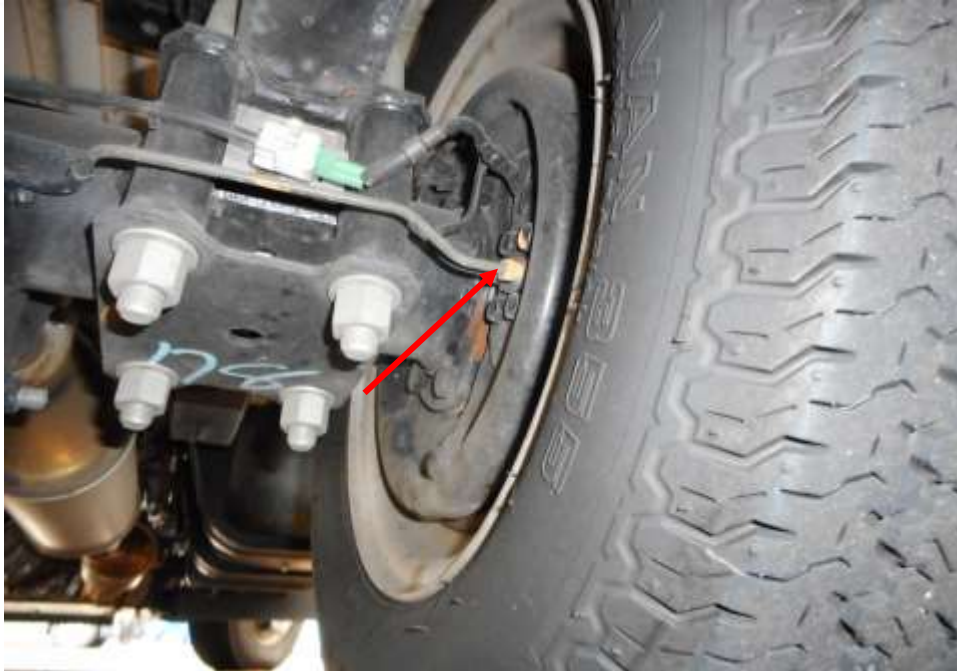
Photo 18 shows the brake pipe (arrowed) at the rear right wheel of the Motor Lorry. I did not observe any leakage of brake fluid at the time of my inspection of the Motor Lorry. My static tests of the Motor Lorry's braking system, along with my visual examination of the various mechanical components in the braking system, had indicated that there was no internal leakage of pressure/vacuum. Hence the braking system of the Motor Lorry was likely to be in serviceable condition at the material time of accident.

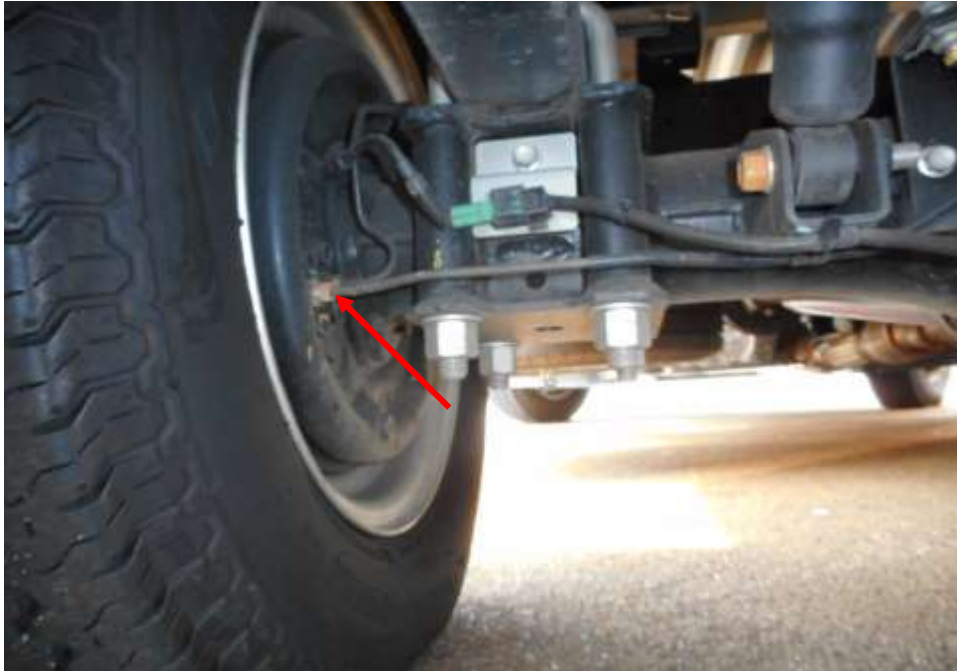
Photo 19 shows the brake pipe (arrowed) at the rear left wheel of the Motor Lorry. I did not observe any leakage of brake fluid at the time of my inspection of the Motor Lorry. My static tests of the Motor Lorry's braking system, along with my visual examination of the various mechanical components in the braking System had indicated that there was no internal leakage of pressure/vacuum. Hence the braking system of the Motor Lorry was likely to be in serviceable condition at the material time of accident.

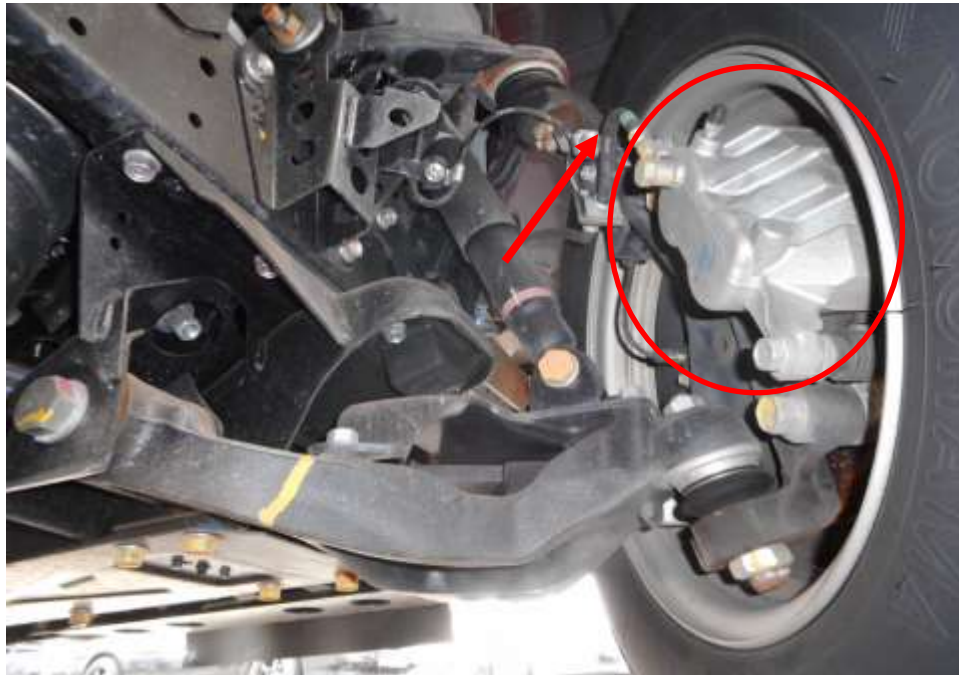
Photo 20 shows the brake hose/pipe (arrowed) at the front right wheel of the Motor Lorry. No leakage of brake fluid was observed. Visual examination of the various components of the braking system like the brake caliper (circled), brake booster, brake pedal etc had revealed all to be intact and without visible damage at the time of accident. There was also no sign of fluid stain(s) observed on the various undercarriage components.

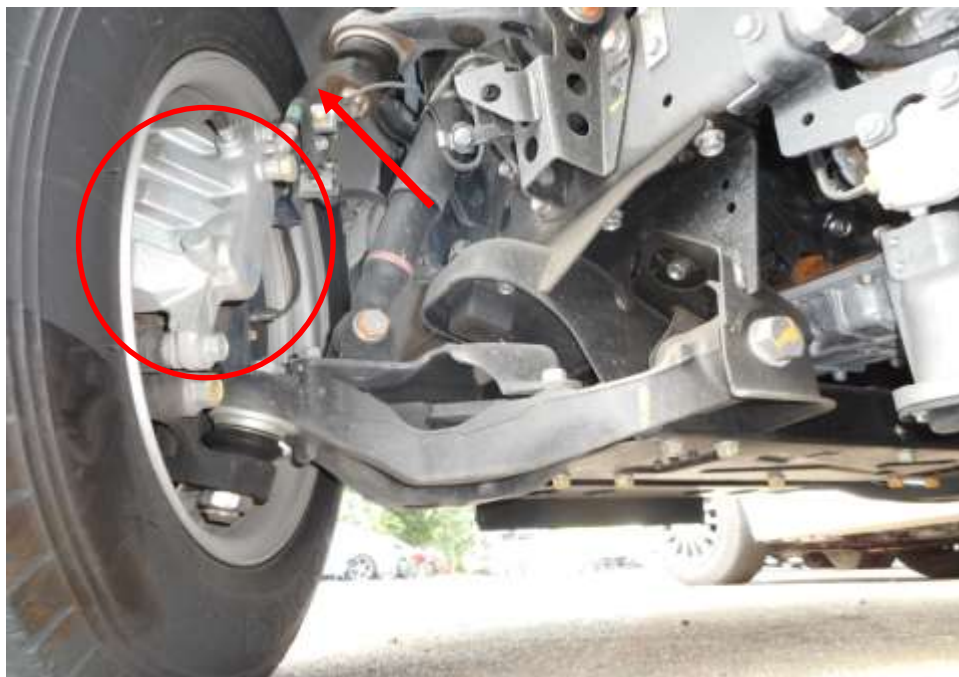
Photo 21 shows the brake hose/pipe (arrowed) at the front left wheel of the Motor Lorry. No leakage of brake fluid was observed. Visual examination of the various components of the braking system like the brake caliper (circled), brake booster, brake pedal etc had revealed all to be intact and without visible damage at the time of accident. There was also no sign of fluid stain(s) observed on the various undercarriage components.

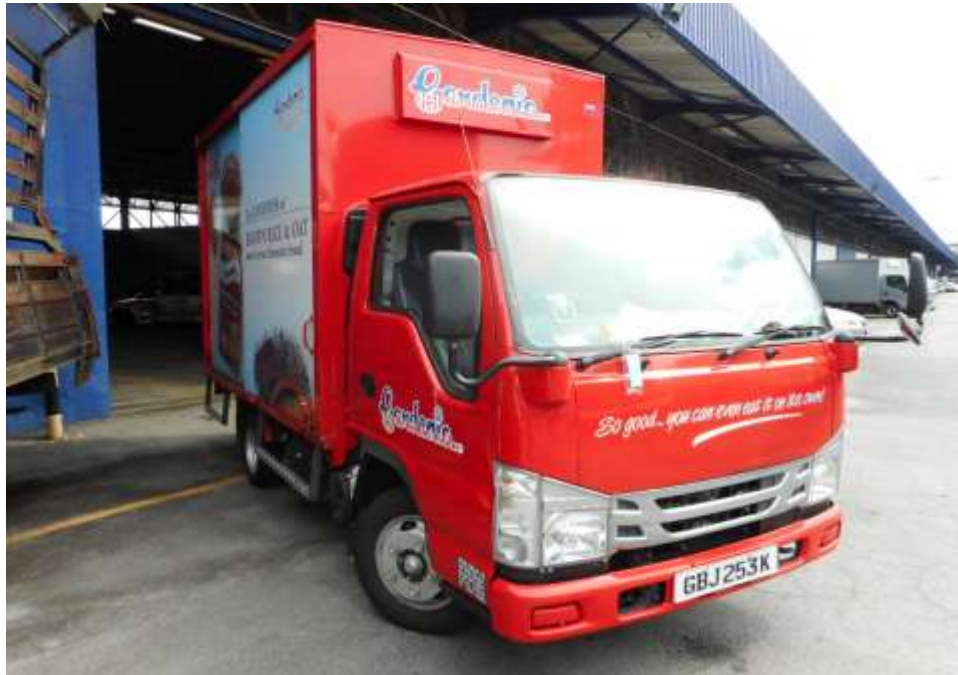
Photo 22 shows the front right wheel of the Motor Lorry turned to its full left. During my steering system test, I did not experience any abnormal free play and/or resistance when I had turned the steering wheel towards full left and full right. This would suggest that the steering system of the Motor Lorry was likely to be in serviceable condition at the material time of accident.

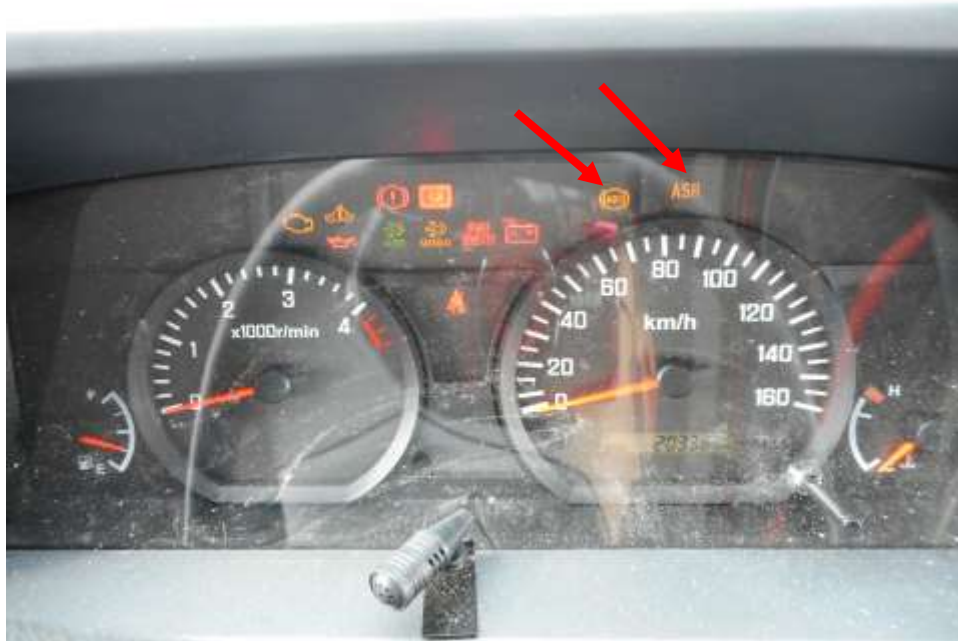
Photo 23 shows the warning light for Anti-Lock Brake System (ABS) and Traction Control (TC) (arrowed) appearing on the instrument panel of the Motor Lorry during the self-test of its various electronic operating systems when its engine was cranked.

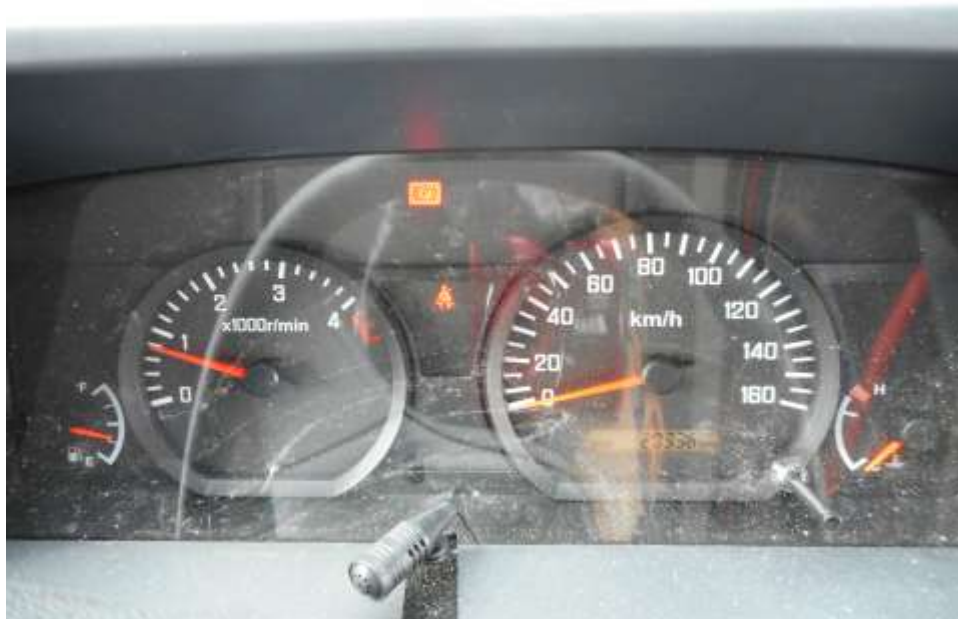
Photo 24 shows no warning lights illuminated on the instrument panel of the Motor Lorry after the engine was cranked. This would suggest that there was no abnormality to the electronic operating systems of the Motor Lorry, like the ABS and Traction Control (TC).
