13th September 2019

Fatal Accident Investigation Team

MECHANICAL INSPECTION REPORT OF MOTOR LORRY XD 2090X

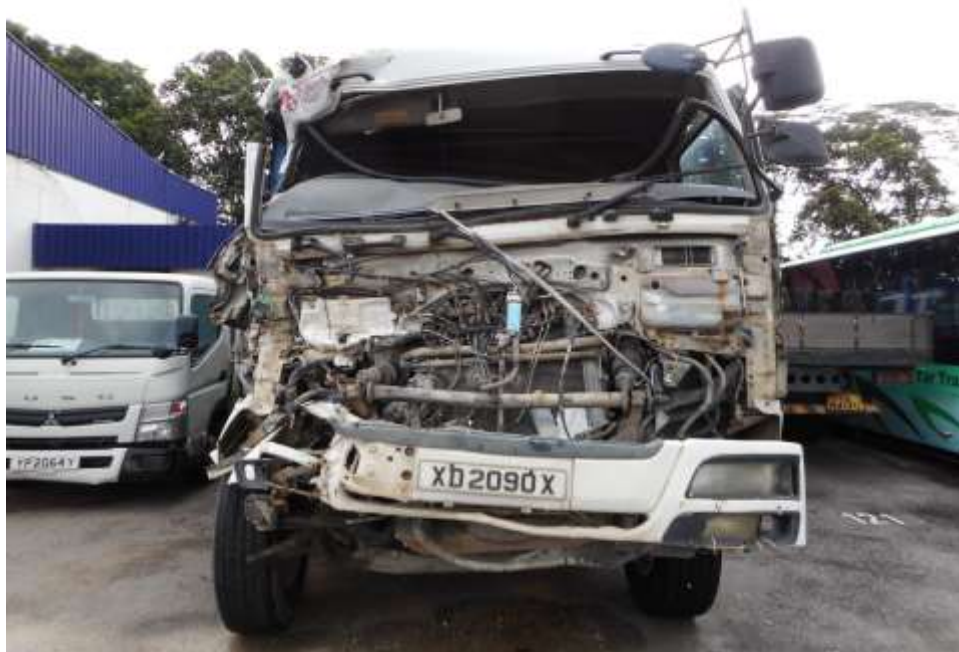
4. The mileage of the Motor Lorry was not recorded due to the damage to its engine and ignition system as a result of the accident.
5. The Motor Lorry was observed to have sustained extensive damages at its frontal portion. Its whole front cabin, front windscreen, front left and right door, front bumper, its ignition system, engine system and steering system were damaged as a result of the accident at the time of my inspection.

Photo 1 shows a general view of the front body of the Motor Lorry at the time of my inspection. The Motor Lorry was observed to have sustained extensive damages at its frontal portion. Its whole front cabin, front windscreen, front left and right door, front bumper, its ignition system, engine system and steering system were damaged as a result of the accident

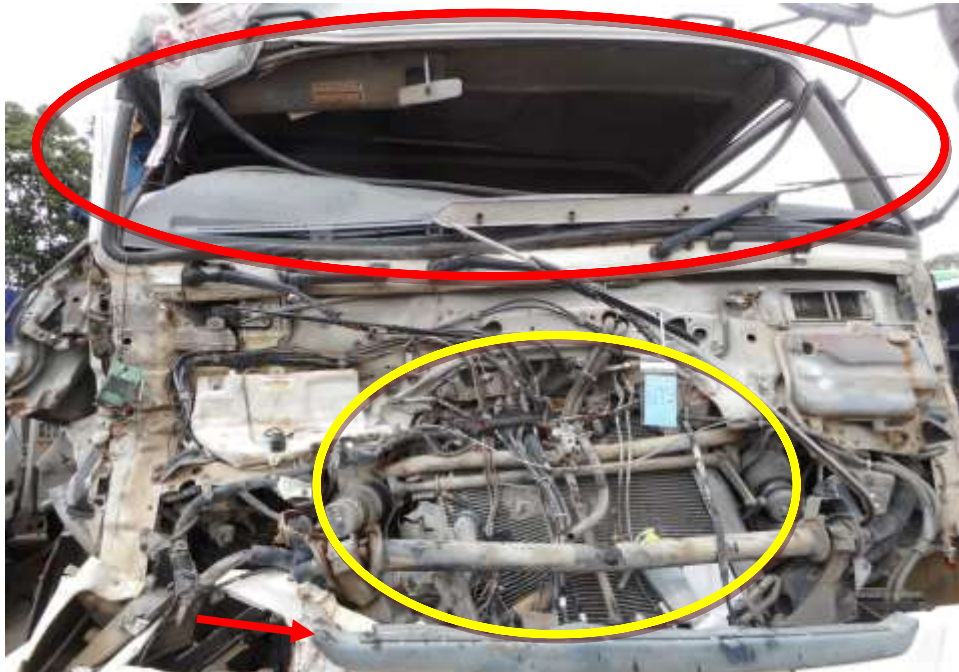
Photo 2 shows a close up view of the front body of the Motor Lorry at the time of my inspection. Its whole front cabin, front windscreen (red circle), front bumper, its ignition system and engine system (yellow circle) were damaged as a result of the accident

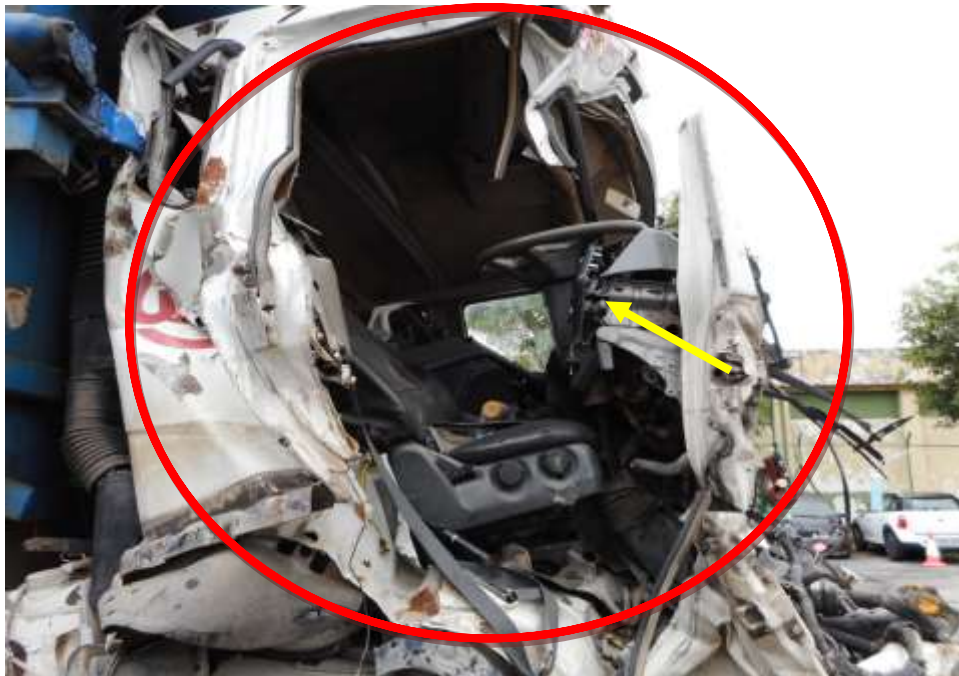
Photo 3 shows a close up view of the front right body of the Motor Lorry at the time of my inspection. Its whole front cabin, front right door (circled) and steering system (yellow arrow) were damaged as a result of the accident

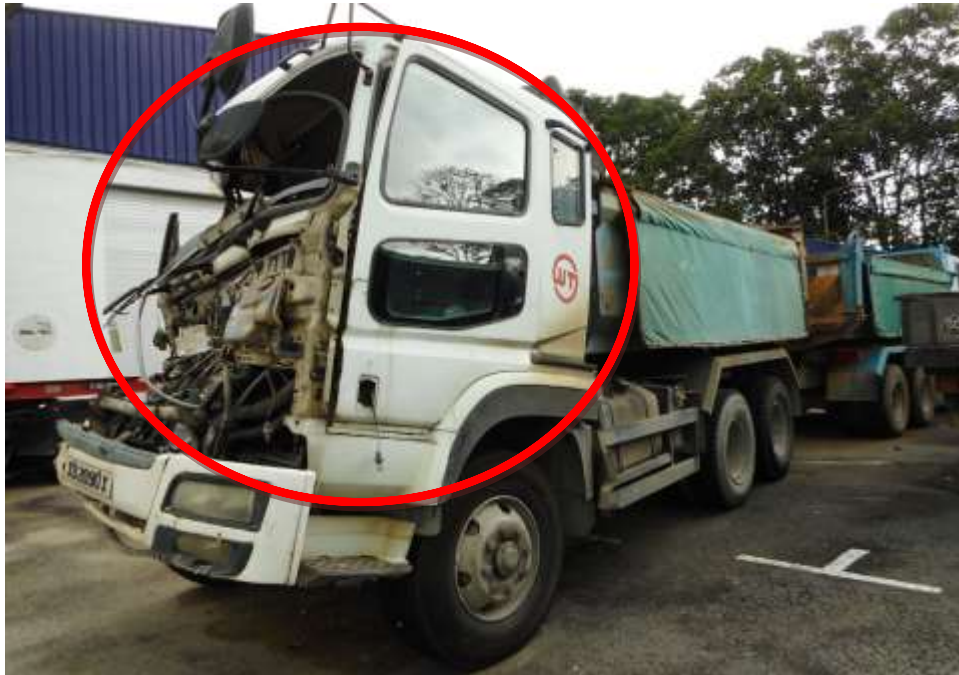
Photo 4 shows a close up view of the front left body of the Motor Lorry at the time of my inspection. Its whole front cabin, front left door (circled) were damaged as a result of the accident

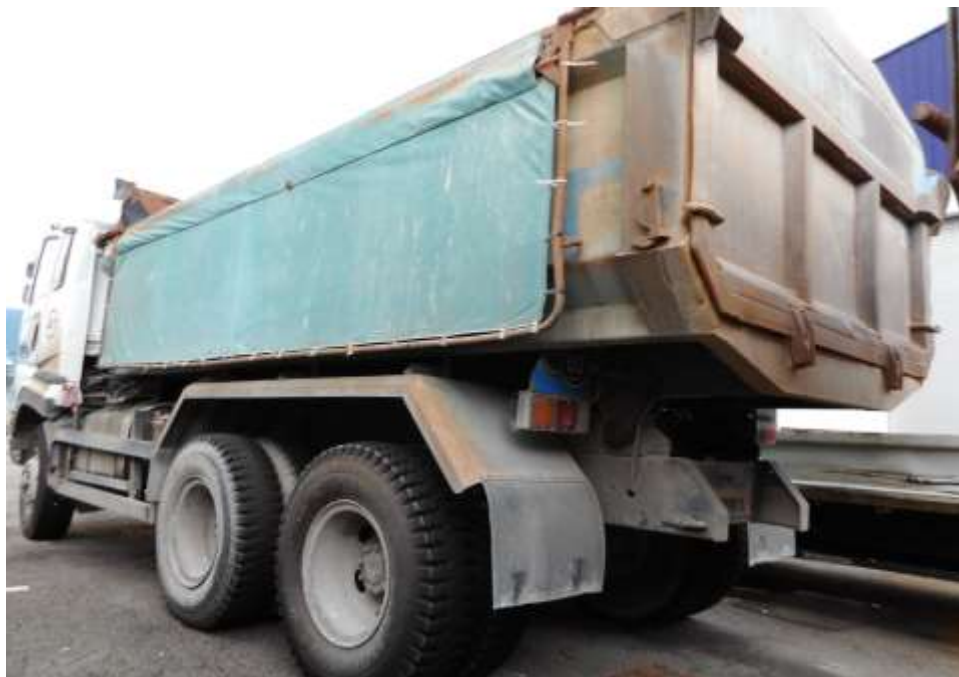
Photo 5 shows a general view of the Motor Lorry's rear body at the time of my inspection. The rear portion of the Motor Lorry appears be unaffected to the accident.

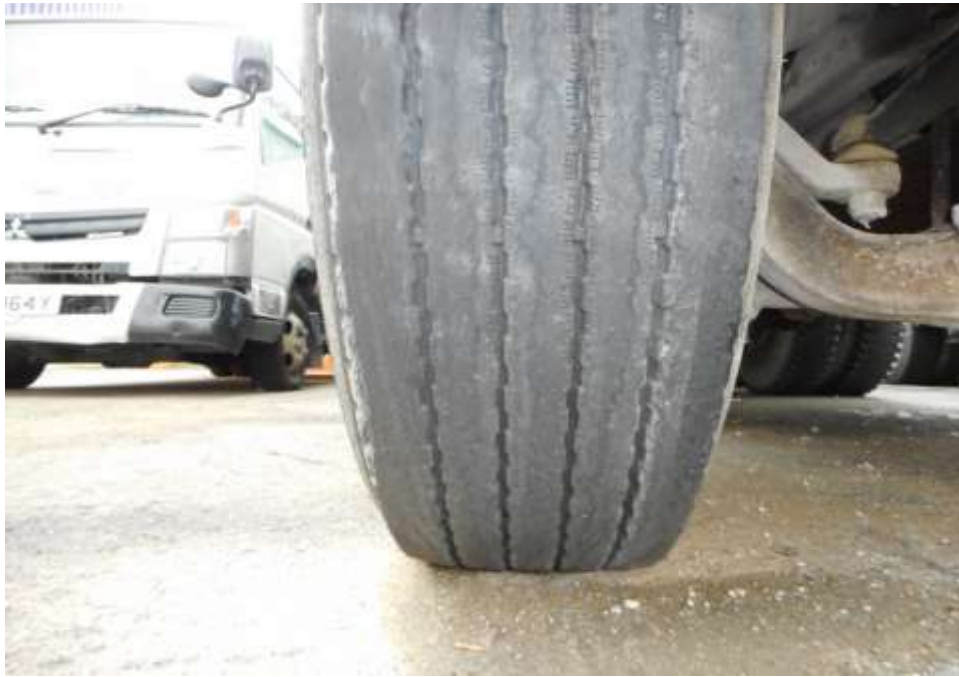
Photo 6 shows the condition of the front right tyre of the Motor Lorry, which was observed to be in serviceable condition with remaining tread depth of approximately 6.2 mm. The tyre, which was wrapped around standard steel wheel rim, was also observed to be sufficiently inflated for vehicular operation. There was no tear, cut or burst mark(s) on the outer and the inner sidewalls as well as across the tread of the 10 tyres that were fitted on the Motor Lorry.

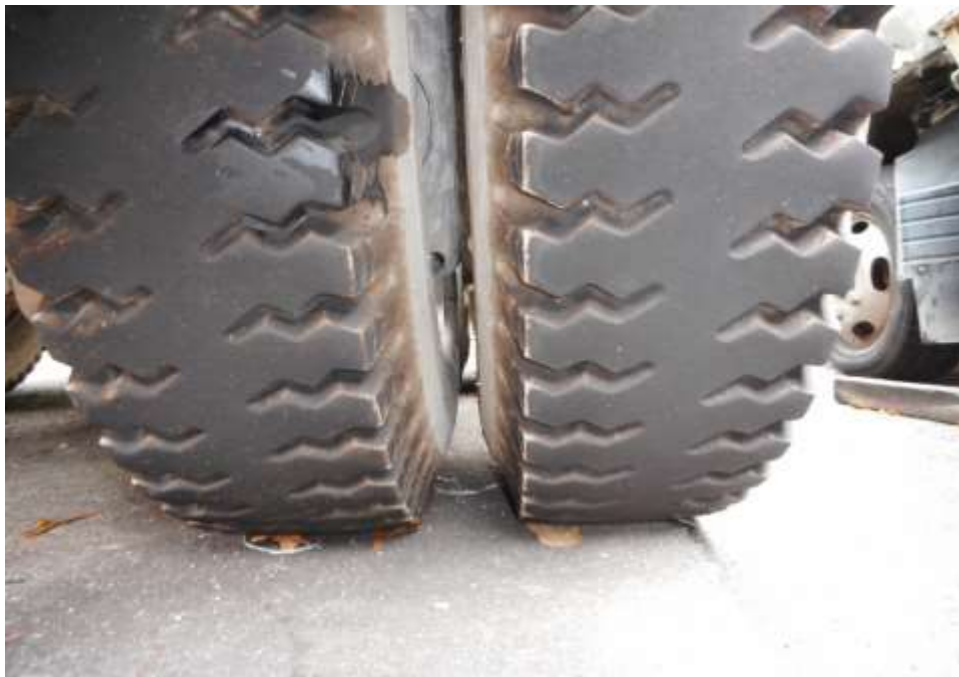
Photo 7 shows the condition of the rear right tyre of the Motor Lorry, which was observed to be in serviceable condition with remaining tread depth of approximately 11.4mm.

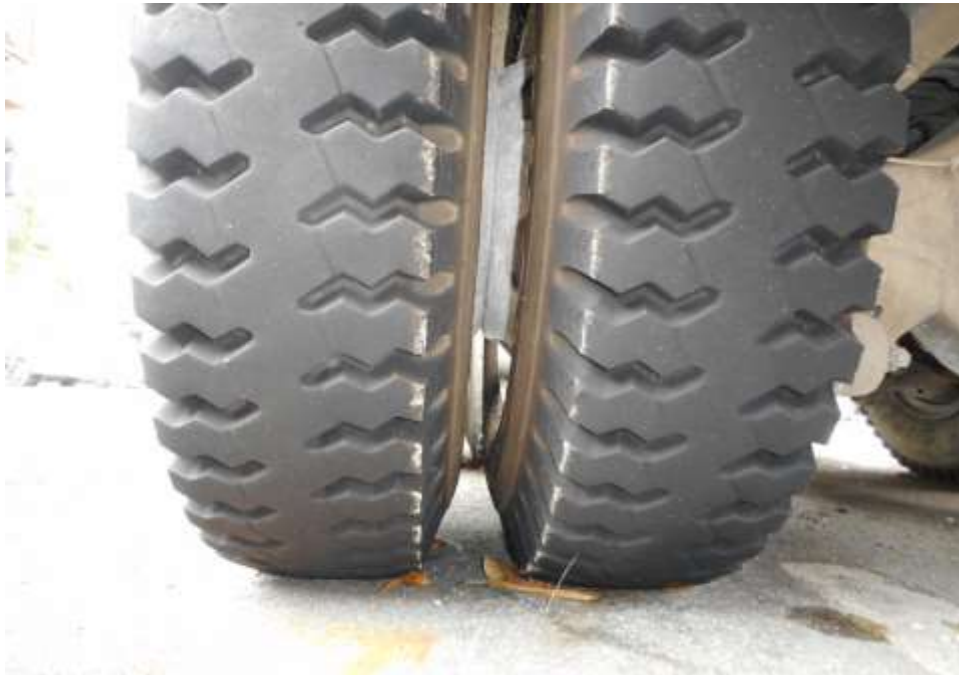
Photo 8 shows the condition of the rear left tyres of the Motor Lorry, which was observed to be in serviceable condition with remaining tread depth of approximately 11.8mm. The tyres, which were wrapped around standard steel wheel rim, were also observed to be sufficiently inflated for vehicular operation. There was also no damage found on all 10 steel wheel rims of the Motor Lorry.

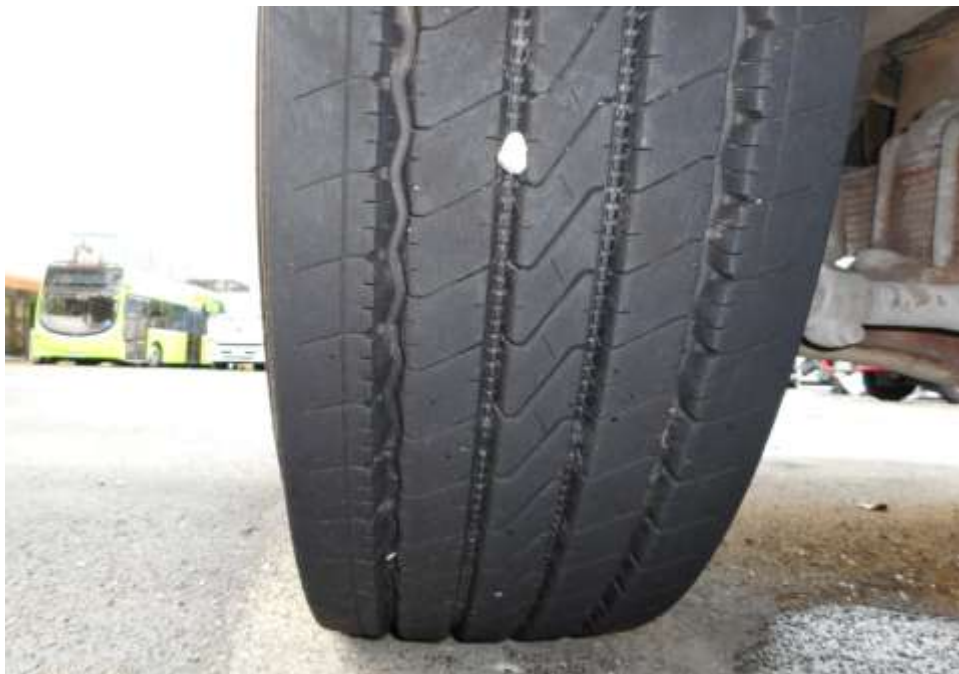
Photo 9 shows the condition of the front left tyres of the Motor Lorry, which were observed to be in serviceable condition with remaining tread depth of approximately 11.1mm.

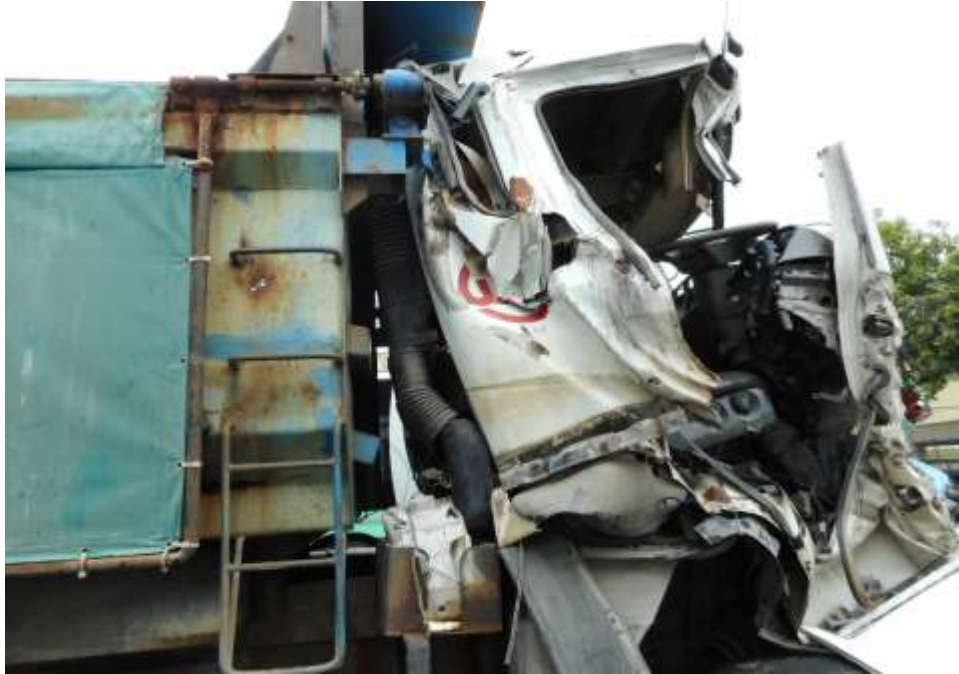
8. The examination of the Motor Lorry's engine compartment beneath the lorry's cabin was unable to be conducted due to the extensive damage sustained to the cabin of the Motor Lorry. (Unable to be lifted) See photo 10 below.

Photo 10 shows the Motor Lorry's deformed front cabin as a result of the accident. (Unable to be lifted)

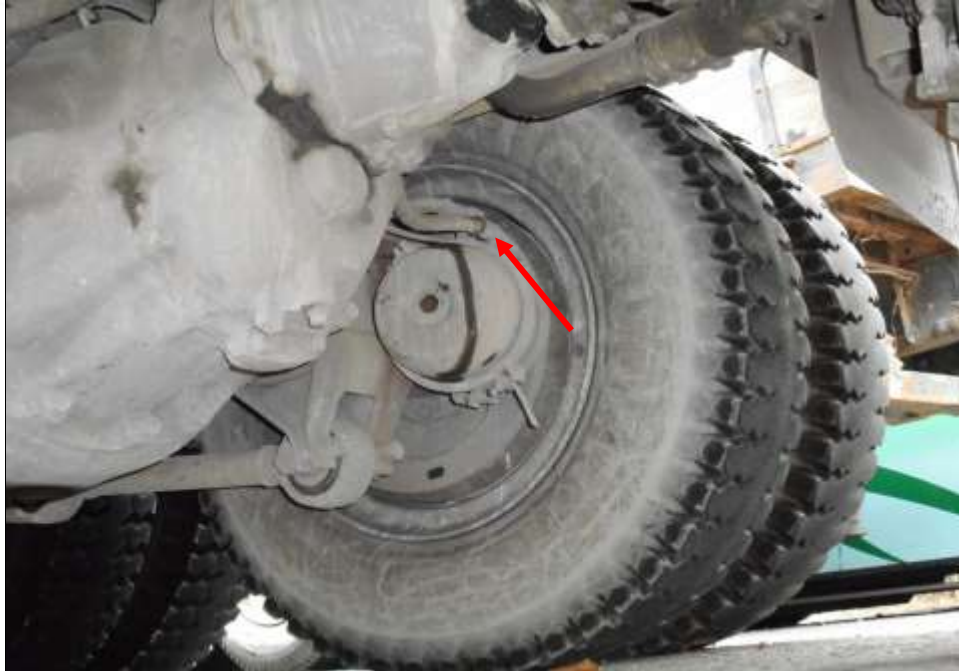
Photo 11 shows the brake pipe (arrowed) at the rear right wheel of the Motor Lorry. I did not observe any leakage of brake fluid at the time of my inspection of the Motor Lorry. My static tests of the Motor Lorry's braking system, along with my visual examination of the various mechanical components in the braking system, had indicated that there was no internal leakage of pressure/vacuum. Hence the braking system of the Motor Lorry was likely to be in serviceable condition at the material time of accident.

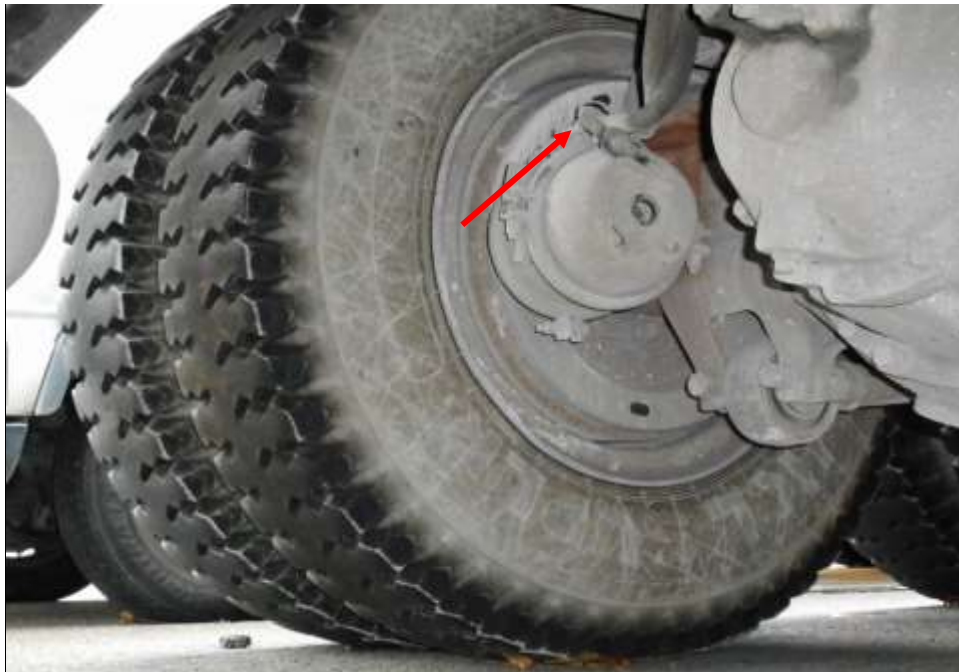
Photo 12 shows the brake pipe (arrowed) at the rear left wheel of the Motor Lorry. I did not observe any leakage of brake fluid at the time of my inspection of the Motor Lorry. My static tests of the Motor Lorry's braking system, along with my visual examination of the various mechanical components in the braking system, had indicated that there was no internal leakage of pressure/vacuum. Hence the braking system of the Motor Lorry was likely to be in serviceable condition at the material time of accident.

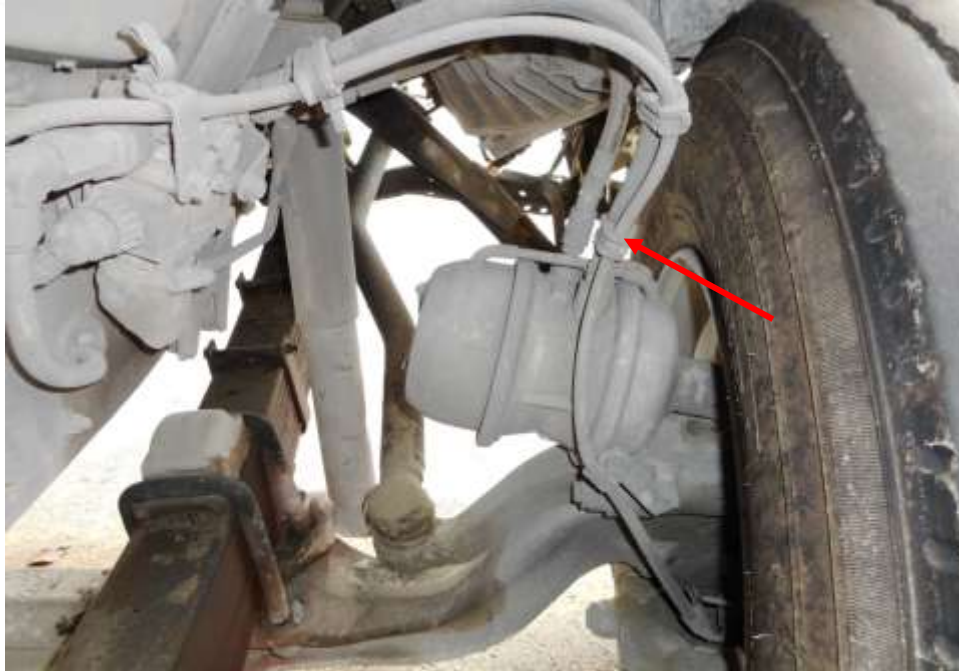
Photo 13 shows the brake pipe (arrowed) at the front right wheel of the Motor Lorry. I did not observe any leakage of brake fluid at the time of my inspection of the Motor Lorry. My static tests of the Motor Lorry's braking system, along with my visual examination of the various mechanical components in the braking system, had indicated that there was no internal leakage of pressure/vacuum. Hence the braking system of the Motor Lorry was likely to be in serviceable condition at the material time of accident.

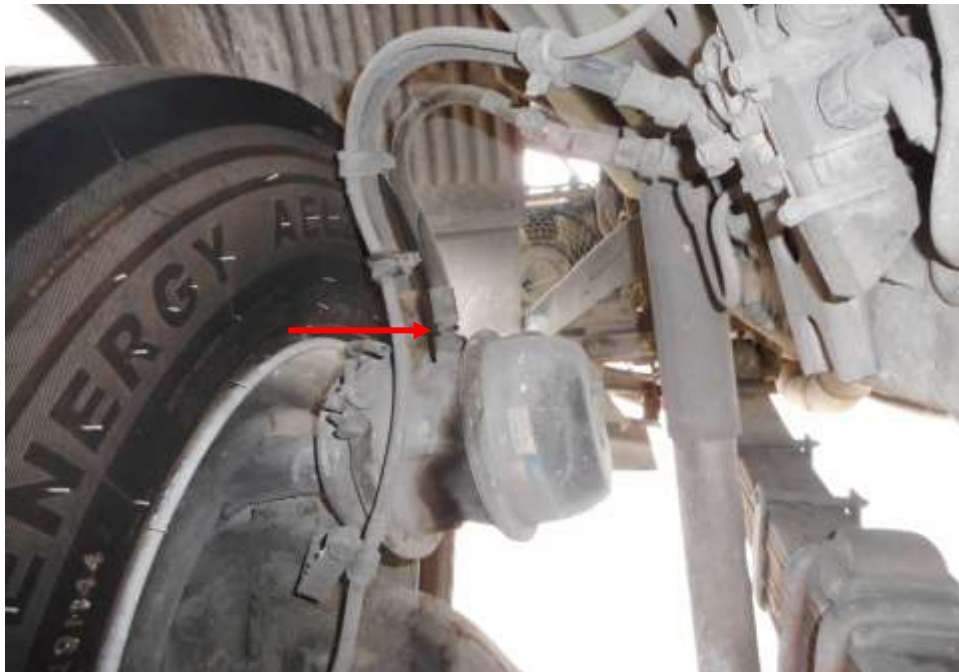
Photo 14 shows the brake pipe (arrowed) at the front left wheel of the Motor Lorry. I did not observe any leakage of brake fluid at the time of my inspection of the Motor Lorry. My static tests of the Motor Lorry's braking system, along with my visual examination of the various mechanical components in the braking system had indicated that there was no internal leakage of pressure/vacuum. Hence the braking system of the Motor Lorry was likely to be in serviceable condition at the material time of accident.

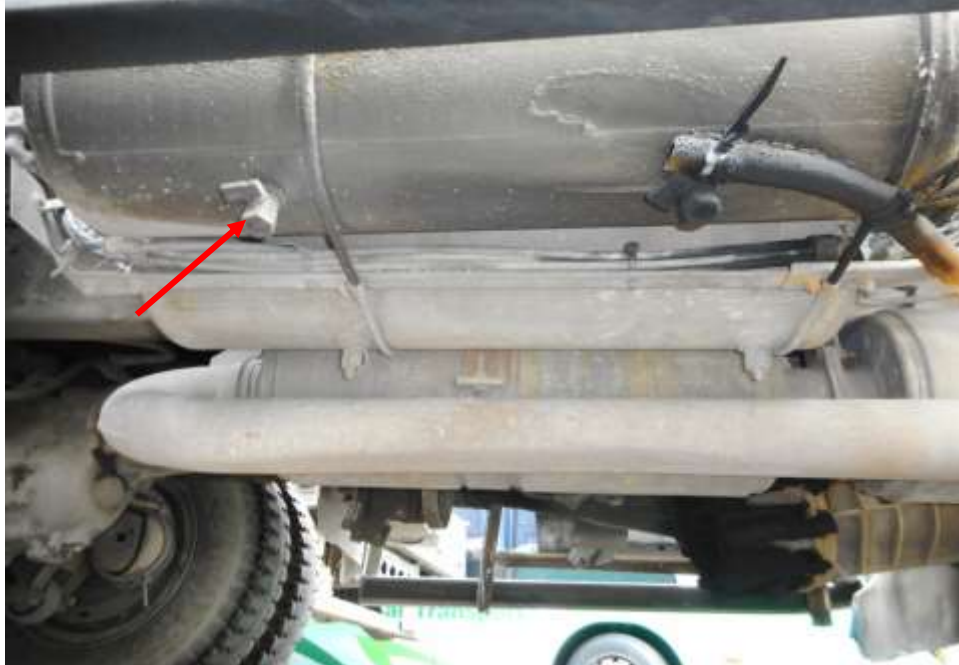
Photo 15 shows the air brake cylinder (arrowed) at the undercarriage of the Motor Lorry. I did not observe any leakage of air brake fluid at the time of my inspection of the Motor Lorry. My static tests of the Motor Lorry's braking system, along with my visual examination of the various mechanical components in the braking system had indicated that there was no internal leakage of pressure/vacuum. Hence the braking system of the Motor Lorry was likely to be in serviceable condition at the material time of accident.

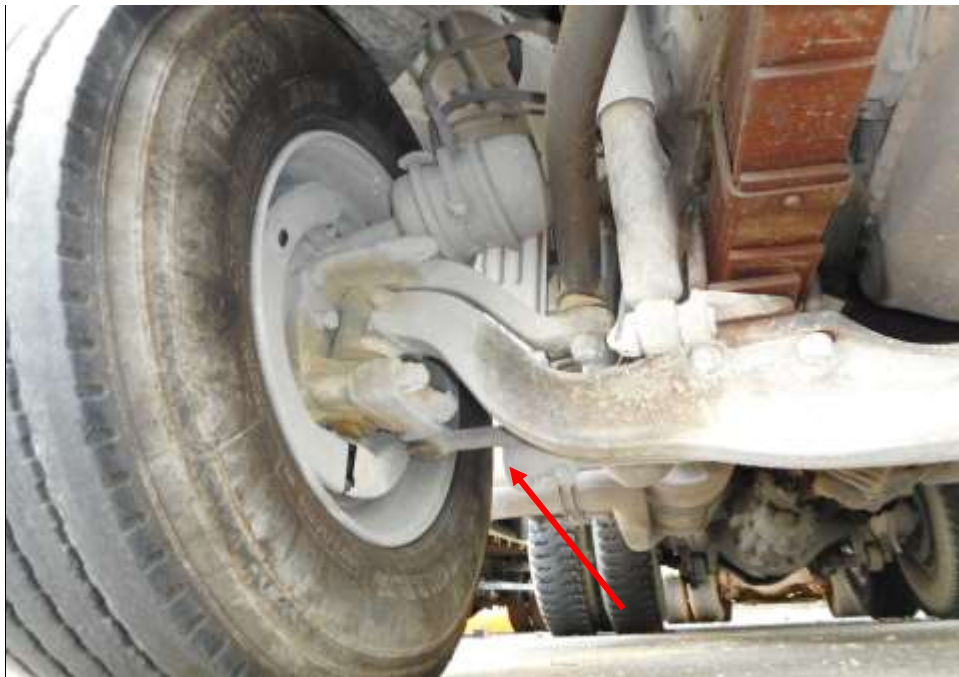
Photo 16 shows the various undercarriage components at the front right wheel of the Motor Lorry, in particular the steering tie rod end (arrowed). The various steering components were all found to be intact, suggesting that the steering system of the Motor Lorry was likely to be in serviceable condition at the material time of accident. There was also no sign of fluid stain(s) observed on the various undercarriage components.

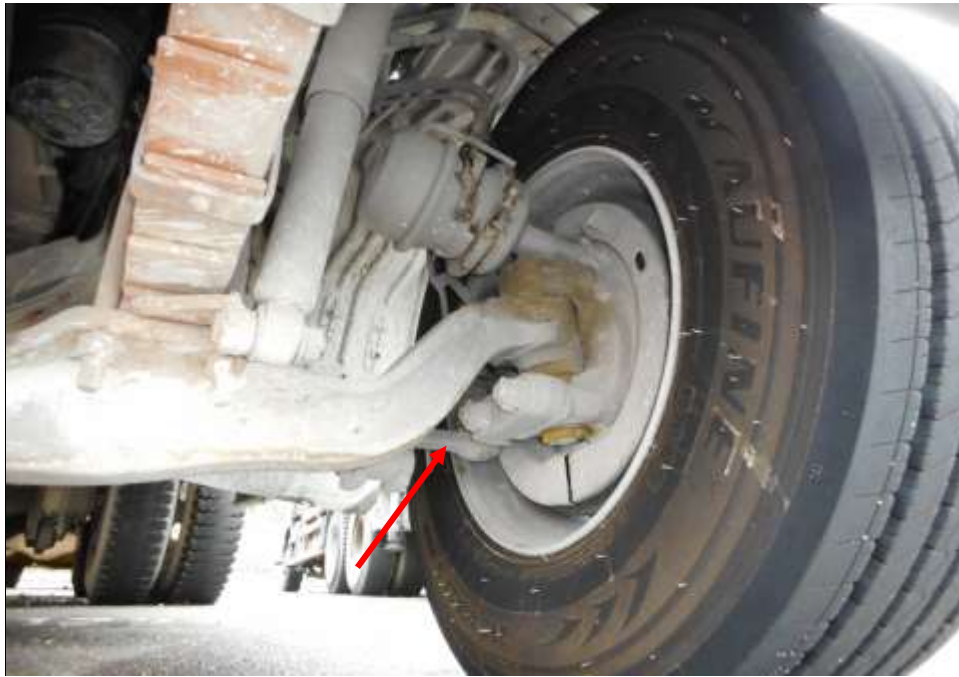
Photo 17 shows the various undercarriage components at the front left wheel of the Motor Lorry, in particular the steering tie rod end (arrowed). The various undercarriage components of the Motor Lorry were all found to be intact without any visible damage. There was also no sign of fluid stain(s) observed on the various undercarriage components.

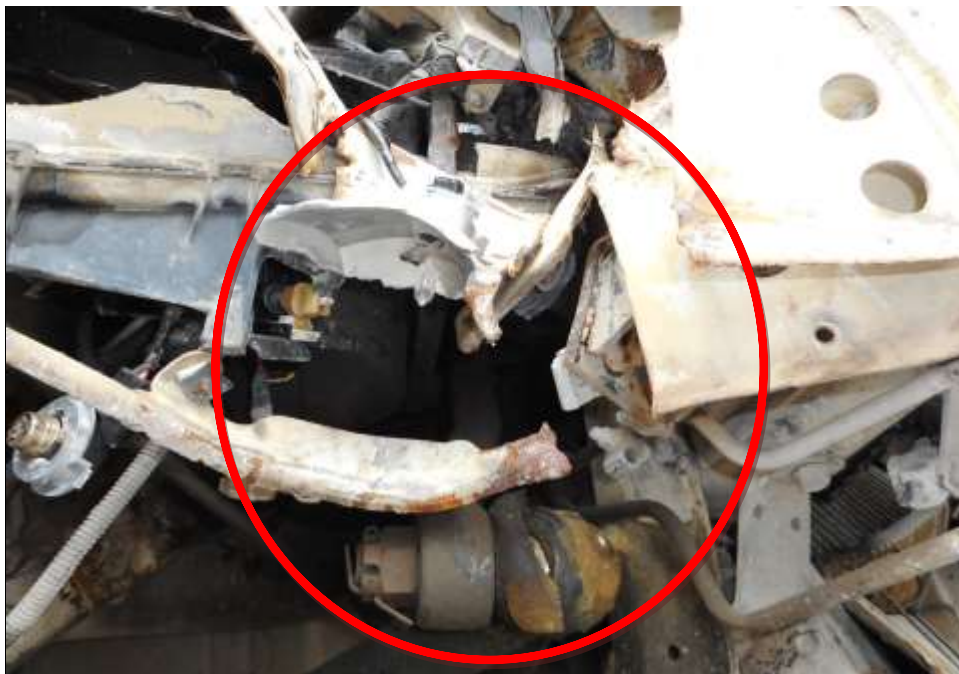
9. Static tests on the braking and steering system of the Motor Lorry was not conducted due to the damage sustained to the Motor Lorry's cabin as a result of the accident (unable to be tested)
10. My visual examination of the various steering components which had included the tie rods, tie rod ends and ball joints had revealed that these components were all intact. However the steering box was observed to be damaged as a result of the accident. See photo 11 - 18 below.

Photo 18 shows the steering box component (circled) at the undercarriage of the Motor Lorry was found to be damaged as a result of the accident.
