Your Ref: TP/IP/40513/2019
Our Ref : CI/TPD19012752/P

3rd December 2019

MECHANICAL INSPECTION REPORT OF GARBAGE TRUCK XD 4956K

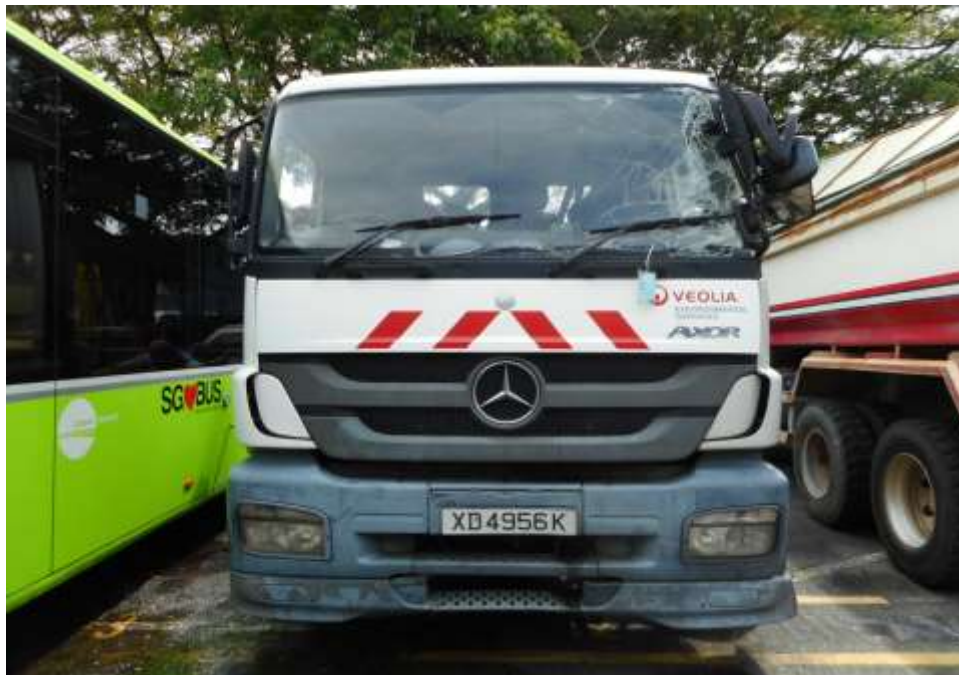
4. The mileage of the Garbage Truck at the time of my inspection was not recorded due to the damage in the ignition system as a result of the accident.
5. The Garbage Truck was observed to have sustained moderate damage at its front and left portion. Its front windscreen, left rear-view mirror, left door, rear left brake lamp and rear body panel was damaged as a result of the accident.

Photo 1 shows a general view of the front body of the Garbage Truck at the time of my inspection. The Garbage Truck was observed to have sustained moderate damage at its front and left portion. Its front windscreen, left rear-view mirror, left door, rear left brake lamp and rear body panel was damaged as a result of the accident.

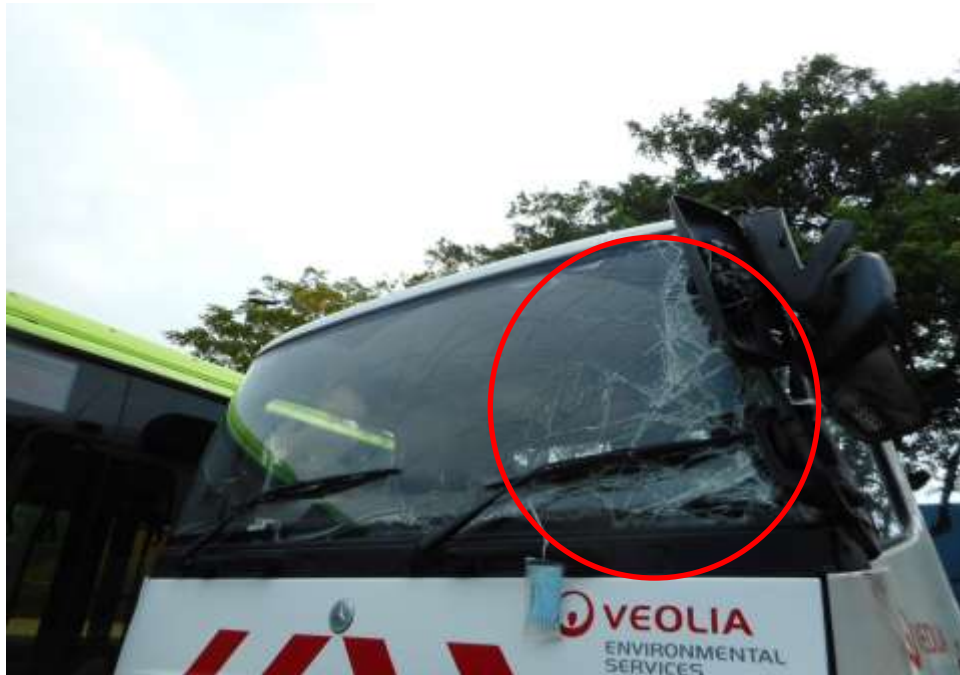
Photo 2 shows a close up view of the front body of the Garbage Truck at the time of my inspection. The Garbage Truck was observed to have sustained moderate damage at its front and left portion. Its front windscreen (circled) was damaged as a result of the accident

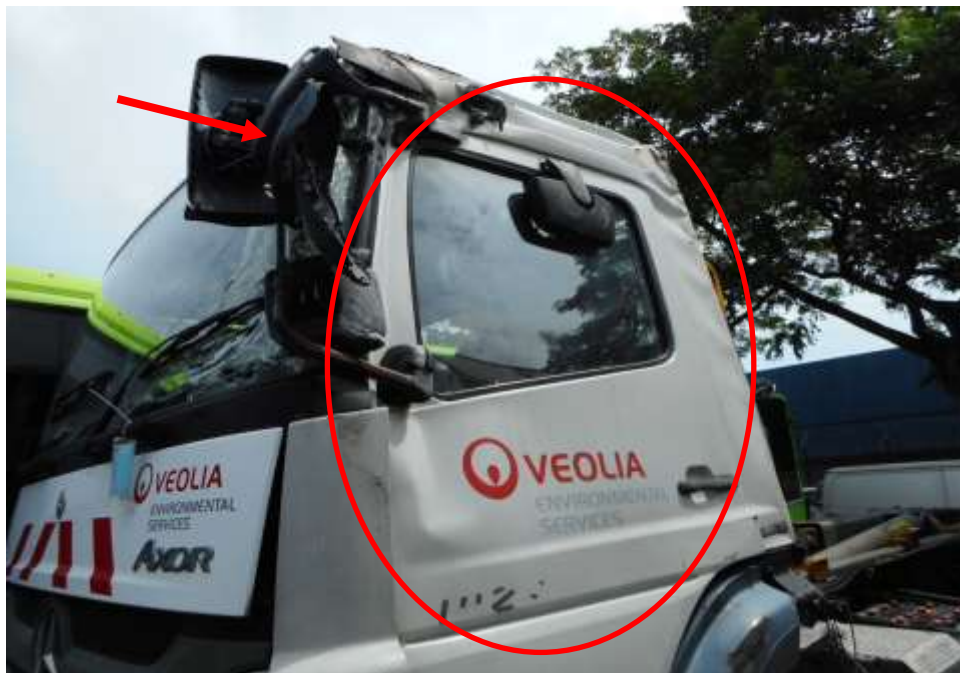
Photo 3 shows a close up view of the left body of the Garbage Truck at the time of my inspection. The Garbage Truck was observed to have sustained moderate damage at its front and left portion. Its left door (circled) and left rear-view mirror (arrowed) was damaged as a result of the accident

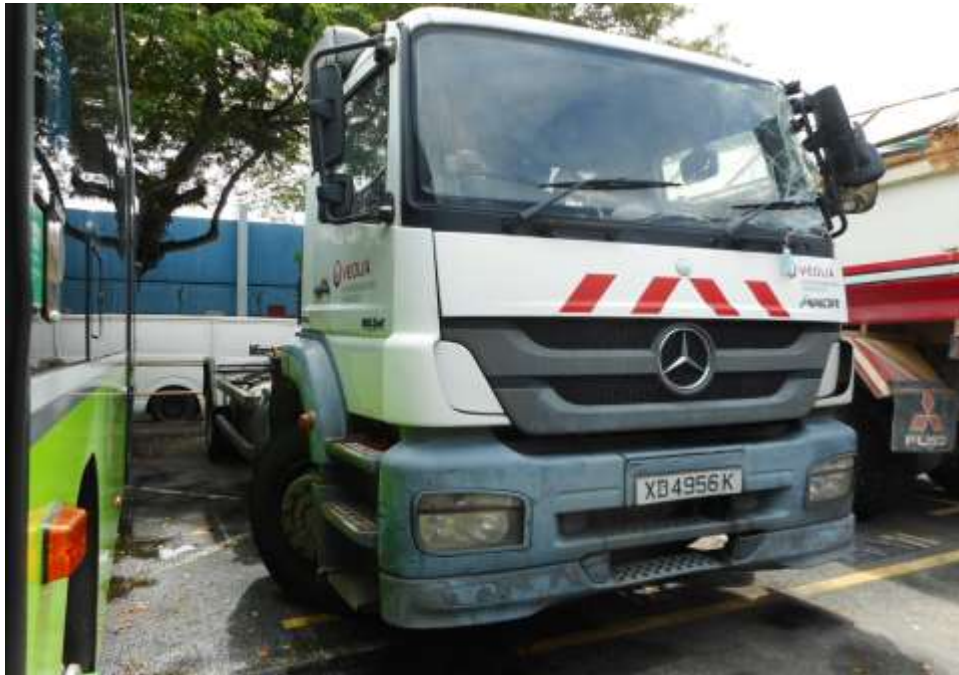
Photo 4 shows a general view of the front right body of the Garbage Truck at the time of my inspection, observed to have been unaffected by the accident.

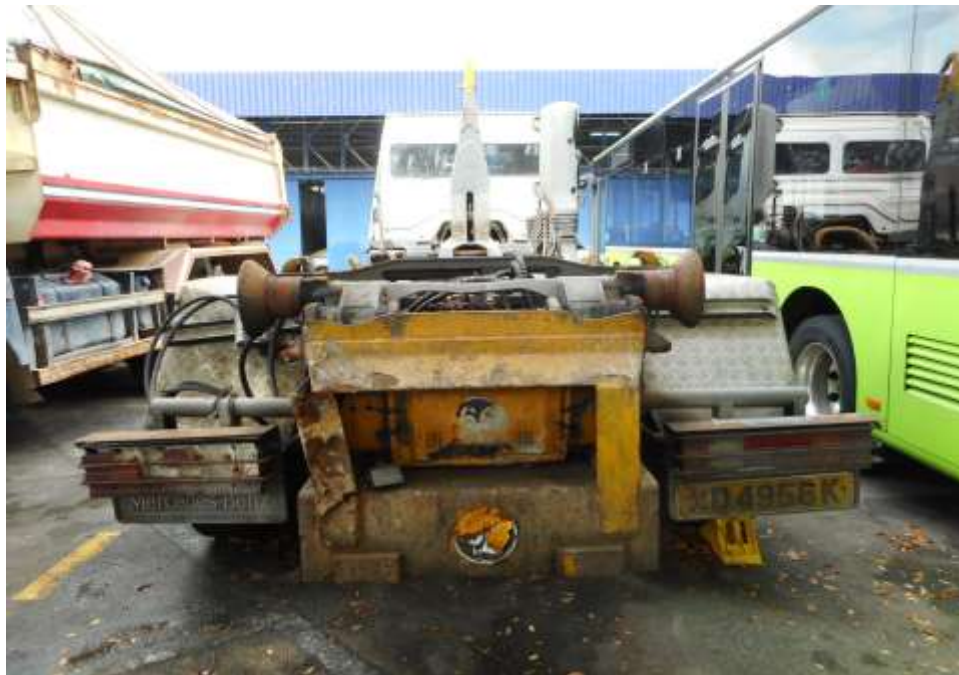
Photo 5 shows a general view of the Garbage Truck's rear body at the time of my inspection. Its rear left brake lamp and rear body panel was damaged as a result of the accident.

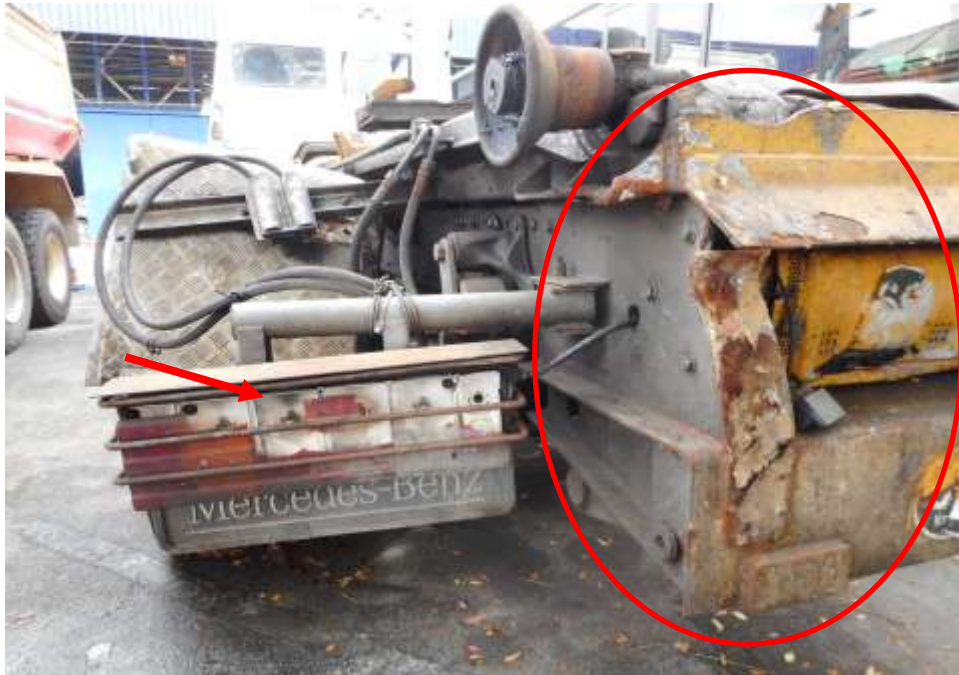
Photo 6 shows a close up view of the Garbage Truck's rear body at the time of my inspection. Its rear left brake lamp (arrowed) and rear body panel (circled) was damaged as a result of the accident.

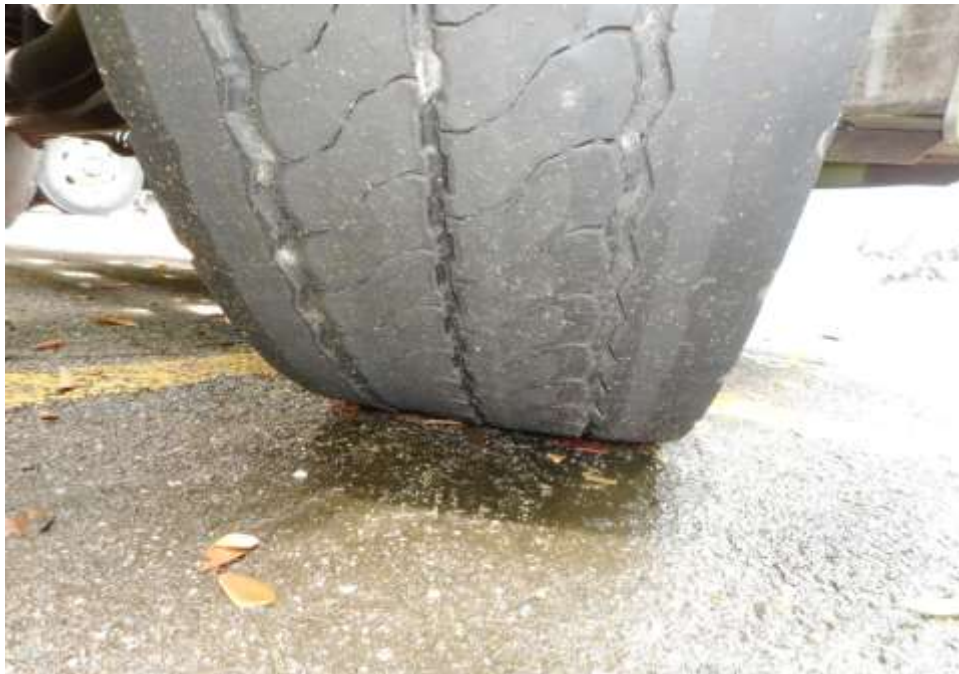
Photo 7 shows the condition of the front right tyre of the Garbage Truck, which was observed to be in serviceable condition with remaining tread depth of approximately 3.9 mm. The tyre, which was wrapped around standard steel wheel rim, was also observed to be sufficiently inflated for vehicular operation. There was no tear, cut or burst mark(s) on the outer and the inner sidewalls as well as across the tread of the 6 tyres that were fitted on the Garbage Truck.

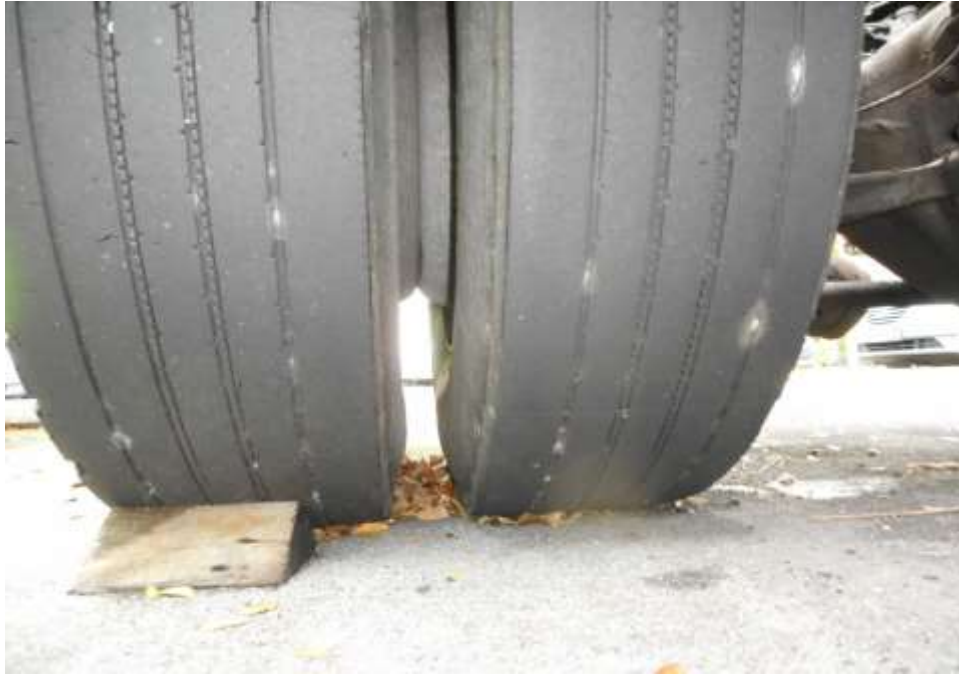
Photo 8 shows the condition of the rear right tyre of the Garbage Truck, which was observed to be in serviceable condition with remaining tread depth of approximately 3.5mm. The tyre, which was wrapped around standard steel wheel rim, was also observed to be sufficiently inflated for vehicular operation.

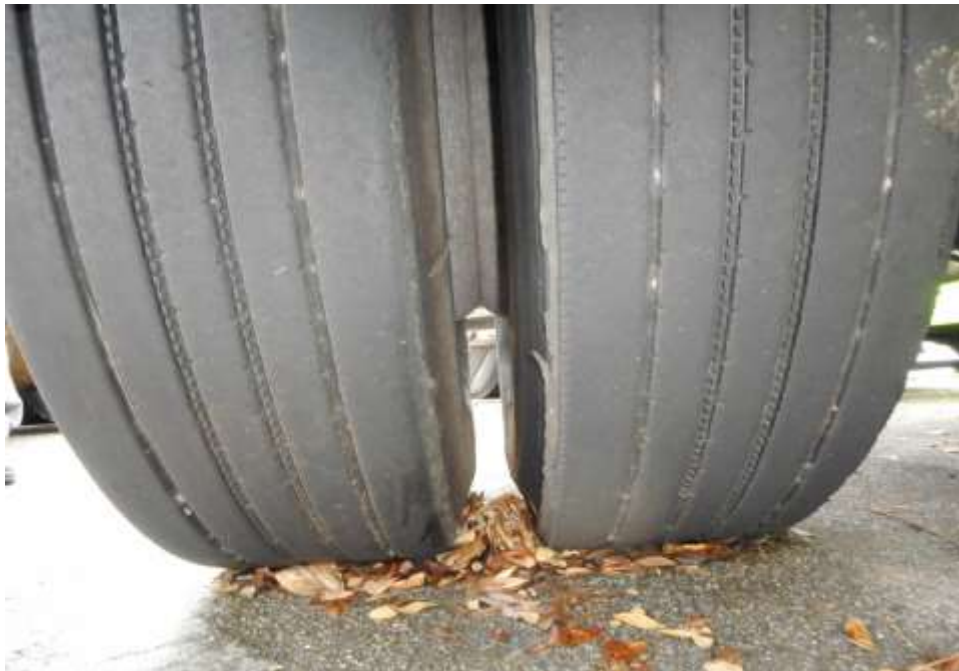
Photo 9 shows the condition of the rear left tyres of the Garbage Truck, which was observed to be in serviceable condition with remaining tread depth of approximately 4.6mm. The tyres, which were wrapped around standard steel wheel rim, were also observed to be sufficiently inflated for vehicular operation. There was also no damage found on all 6 steel wheel rims of the Garbage Truck.

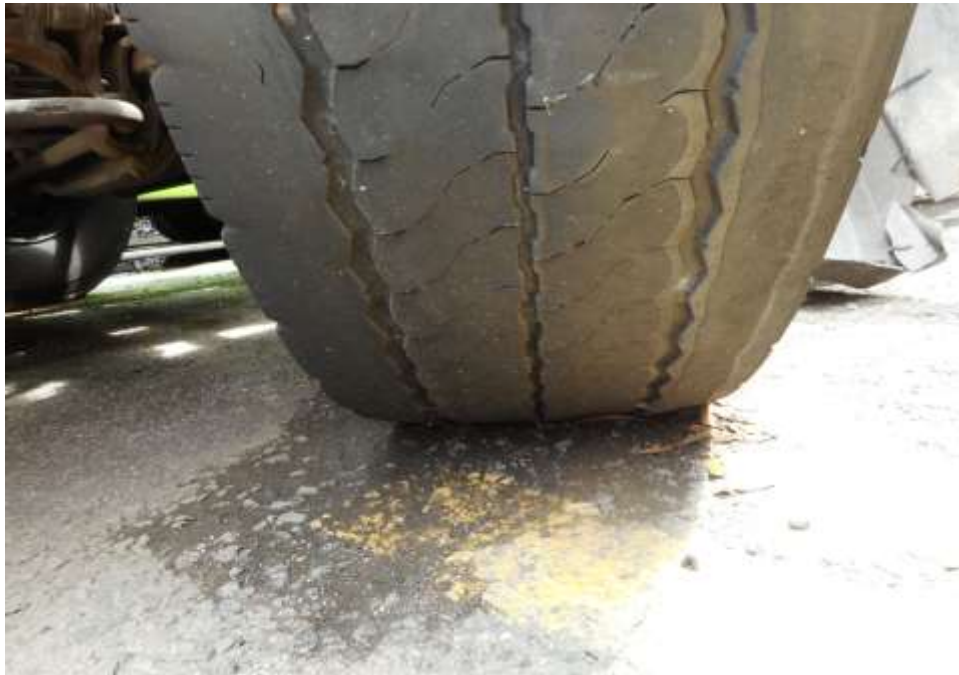
Photo 10 shows the condition of the front left tyres of the Garbage Truck, which were observed to be in serviceable condition with remaining tread depth of approximately 4.9mm. There was also no tear, cut or burst mark(s) on the outer and the inner sidewalls as well as across the tread of the 6 tyres that were fitted on the Garbage Truck.

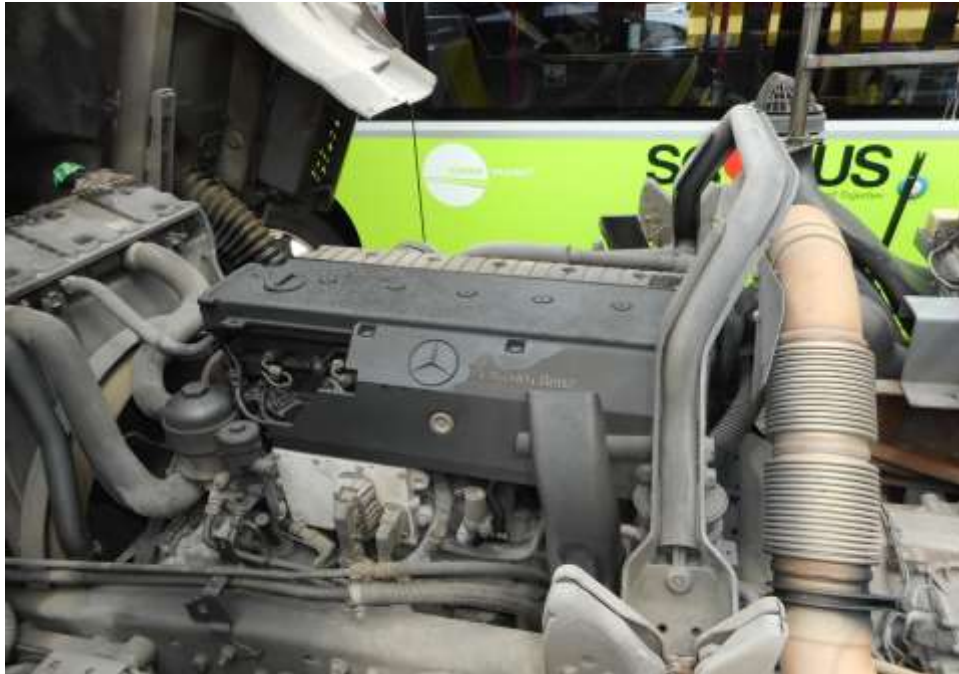
9. Further examination of the engine compartment revealed, there was no sign(s) or indication(s) of fresh fluid leakage. However observed old fluid stain on the engine cover of the Garbage Truck.

Photo 11 shows a general view of the Garbage Truck's engine compartment, which was accessed by lifting the front cabin of the Garbage Truck. The various parts and components inside the engine compartment were intact. There was also no sign(s) or indication(s) of fresh fluid leakage. However there was old fluid stain on the engine cover.

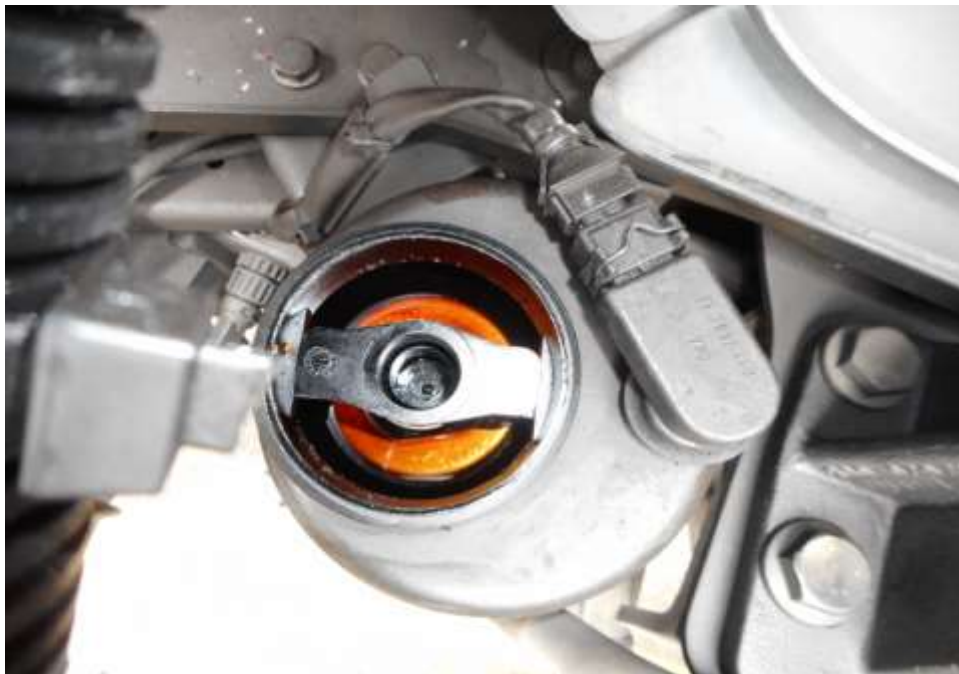
Photo 12 shows the power steering fluid reservoir of the Garbage Truck at the time of my inspection. The power steering fluid was observed to be of sufficient level and without any visible contamination.

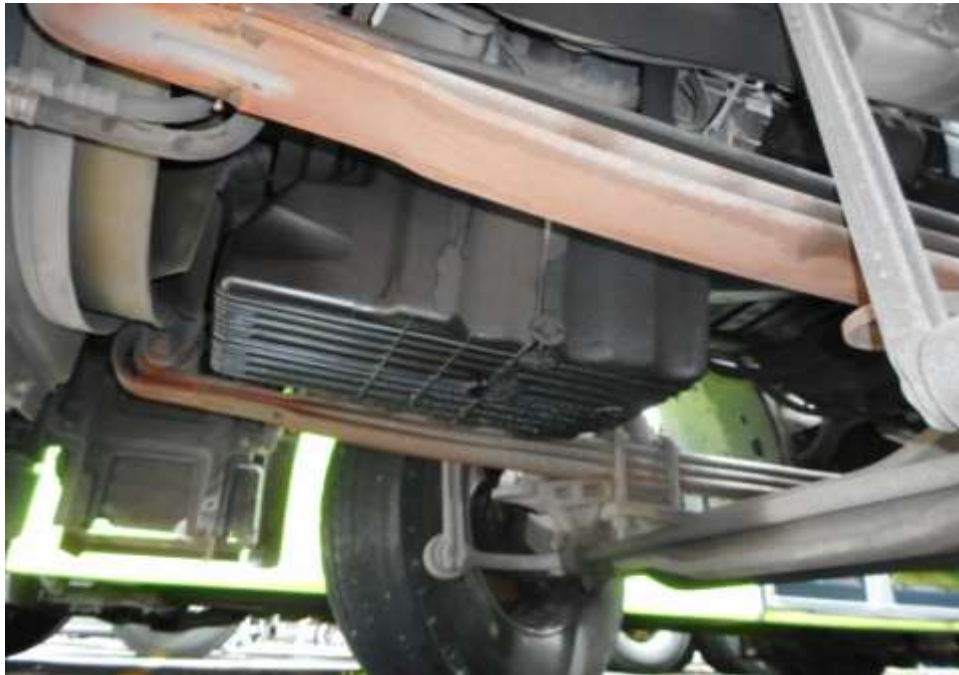
Photo 13 shows the undercarriage of the Garbage Truck, at the area where the engine housing located. I did find old fluid stain(s) on the underside oil sump of the Garbage Truck.

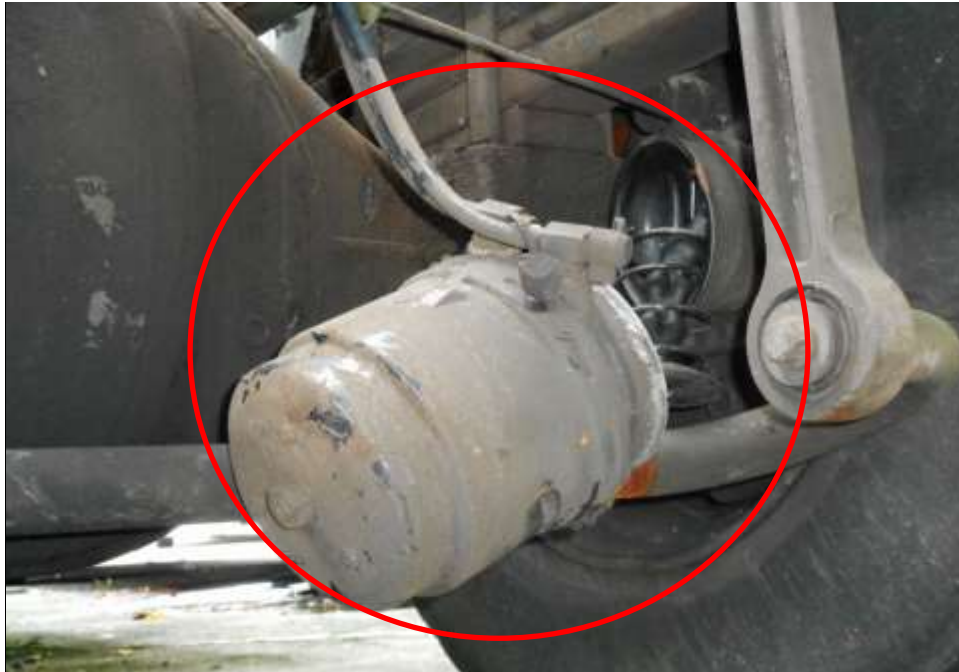
12. Static brake and steering tests on the braking and steering system of the Garbage Truck was not conducted as the Garbage Truck was not able to be started due to the damage in the ignition system. My visual examination of the various steering components which had included the rack and pinion, tie rods, tie rod ends and ball joints had revealed that these components were all generally intact. However the rear right brake cylinder was damage due to the impact caused by the accident. See photo 14 - 22 below.

Photo 14 shows the brake cylinder of the (circled) the rear right wheel of the Garbage Truck. It was damaged was due to the impact caused by the result of the accident.

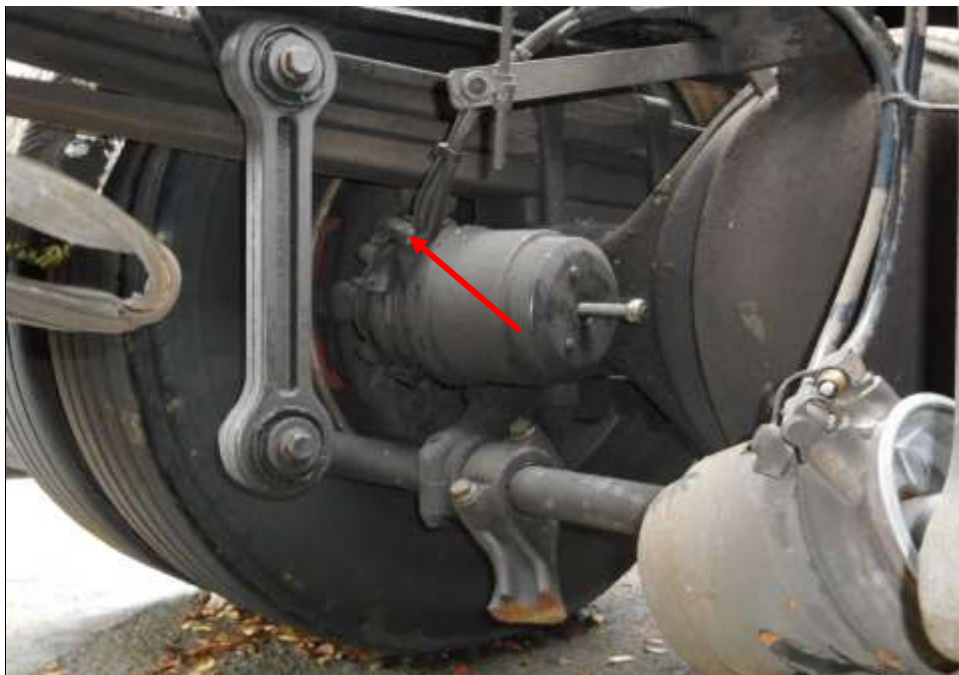
Photo 15 shows the brake pipe (arrowed) at the rear left wheel of the Garbage Truck. I did not observe any leakage of air at the time of my inspection of the Garbage Truck.

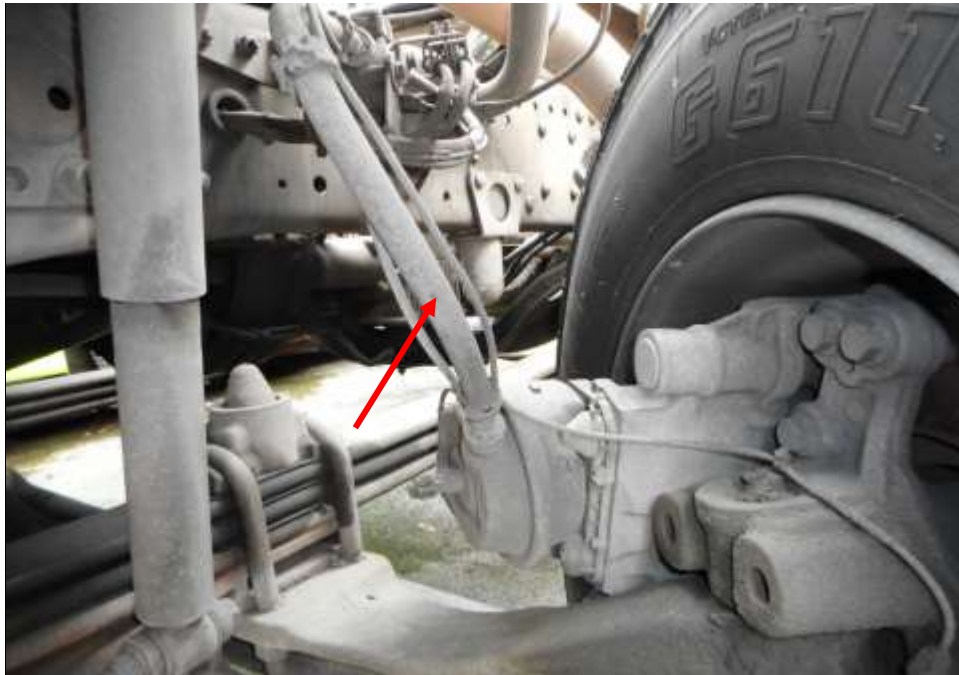
Photo 16 shows the brake pipe (arrowed) at the front left wheel of the Garbage Truck. I did not observe any leakage of air at the time of my inspection of the Garbage Truck.

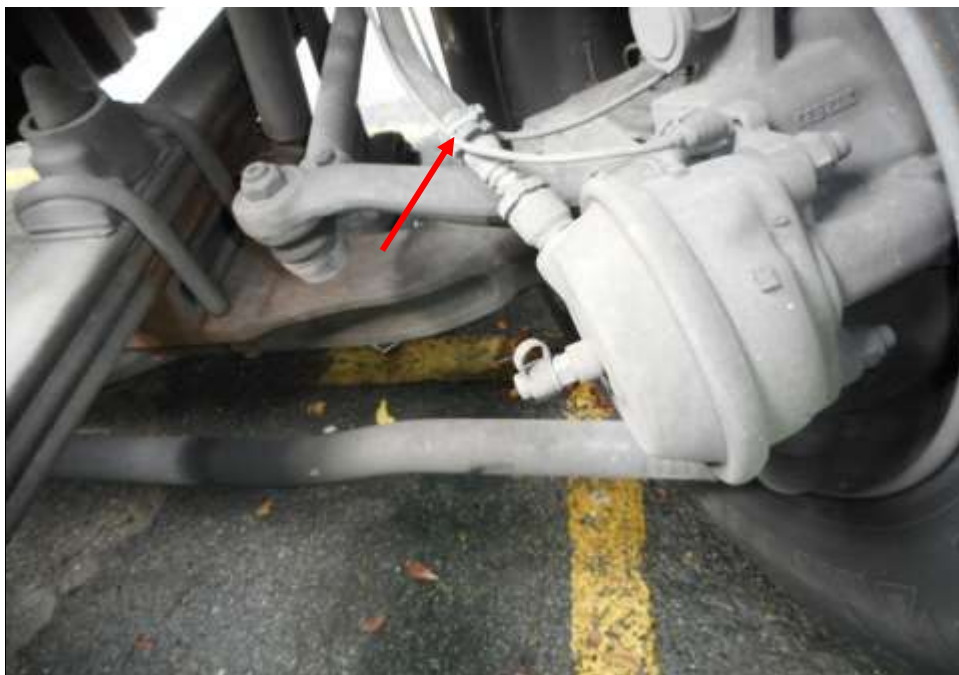
Photo 17 shows the brake pipe (arrowed) at the front right wheel of the Garbage Truck. I did not observe any leakage of brake fluid at the time of my inspection of the Garbage Truck.

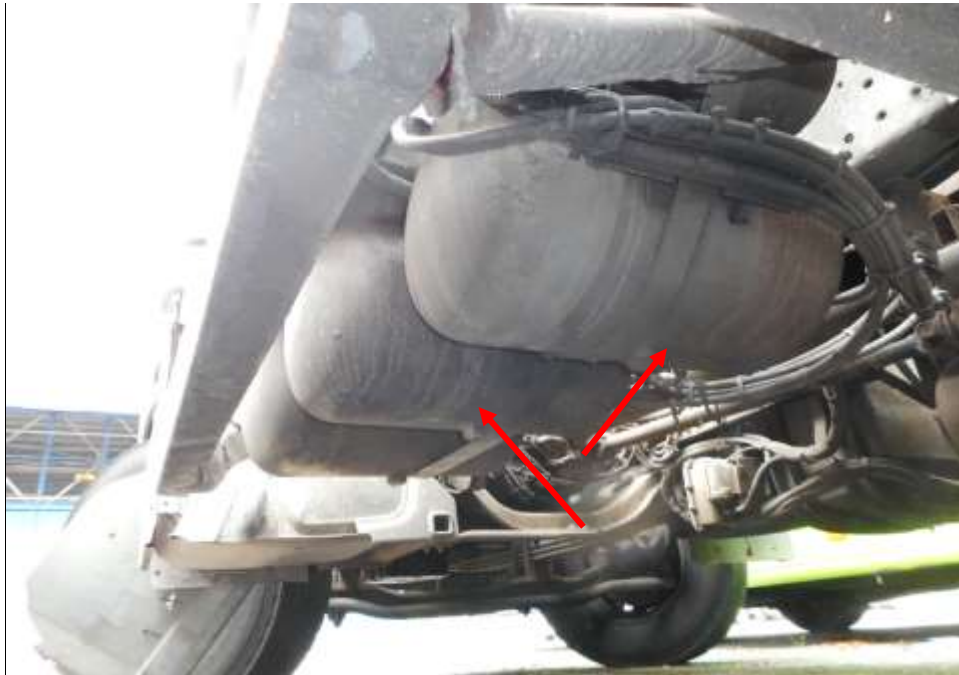
Photo 18 shows the air brake cylinders (arrowed) at the undercarriage of the Garbage Truck. I did not observe any leakage of air brake fluid at the time of my inspection of the Garbage Truck.

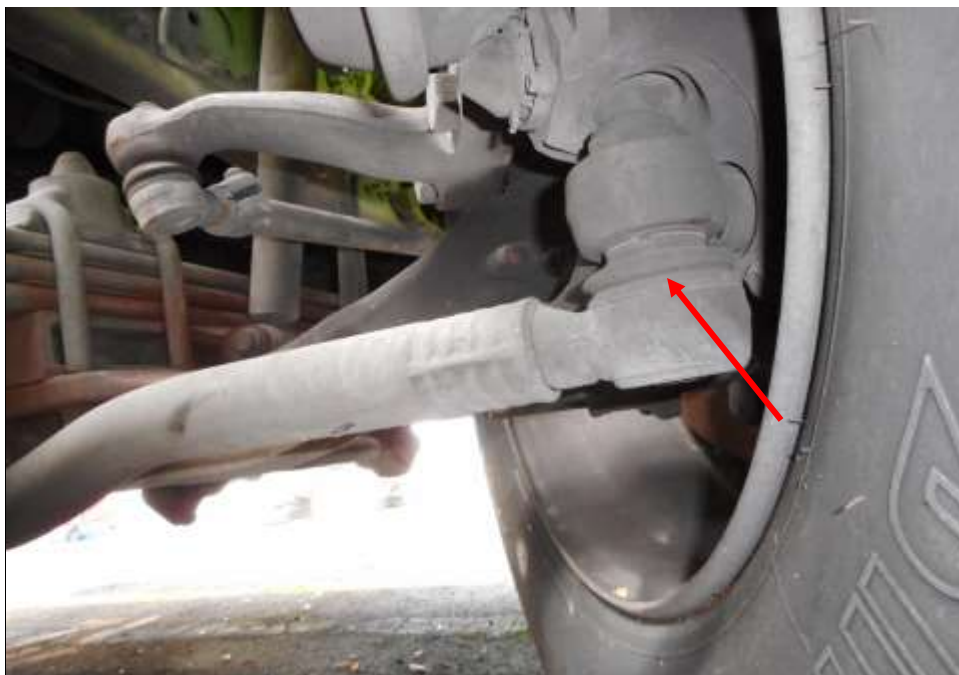
Photo 19 shows the various undercarriage components at the front right wheel of the Garbage Truck, in particular the steering tie rod end (arrowed). The various steering components were all found to be intact, suggesting that the steering system of the Garbage Truck was likely to be in serviceable condition at the material time of accident. There was also no sign of fluid stain(s) observed on the various undercarriage components.

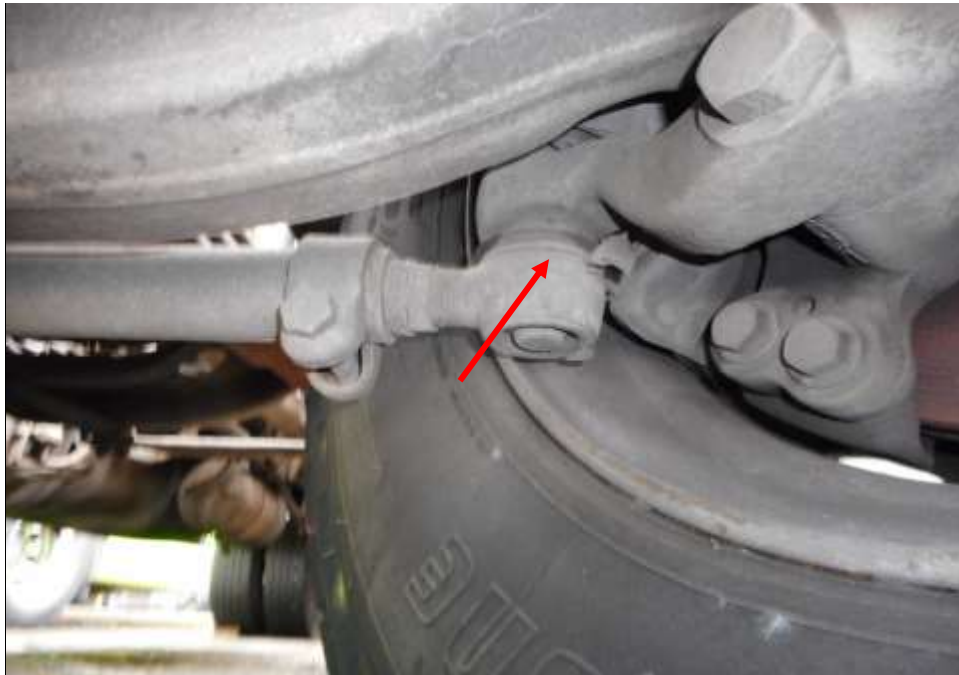
Photo 20 shows the various undercarriage components at the front left wheel of the Garbage Truck, in particular the steering tie rod end (arrowed). The various undercarriage components of the Garbage Truck were all found to be intact without any visible damage. There was also no sign of fluid stain(s) observed on the various undercarriage components.

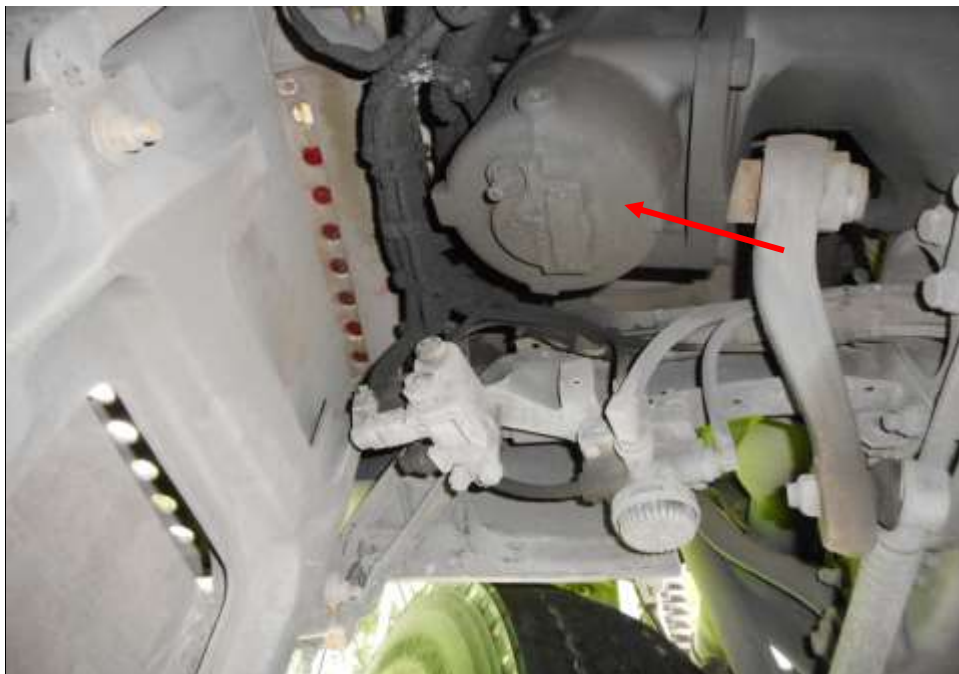
Photo 21 shows the steering box component (arrowed) at the undercarriage of the Garbage Truck was found to be intact without any visible damage. There was also no sign of fluid stain(s) observed, only rust found on the surface of the component.

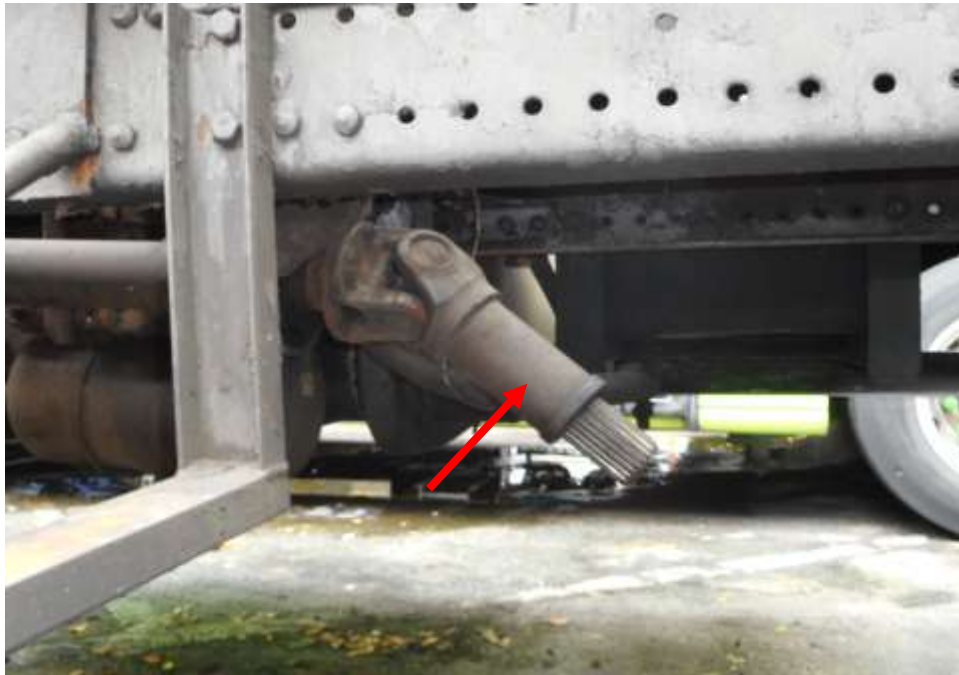
Photo 22 shows the driveshaft component (arrowed) at the undercarriage of the Garbage Truck was found to be damage as a result of the accident.
