Your Ref: TP/IP/37759/2019  
Our Ref : CI/TPD19012879/N

15 July 2019

**Fatal Accident Investigation Team**

**INSPECTION REPORT OF MOTORCYCLE FBJ 4003P**

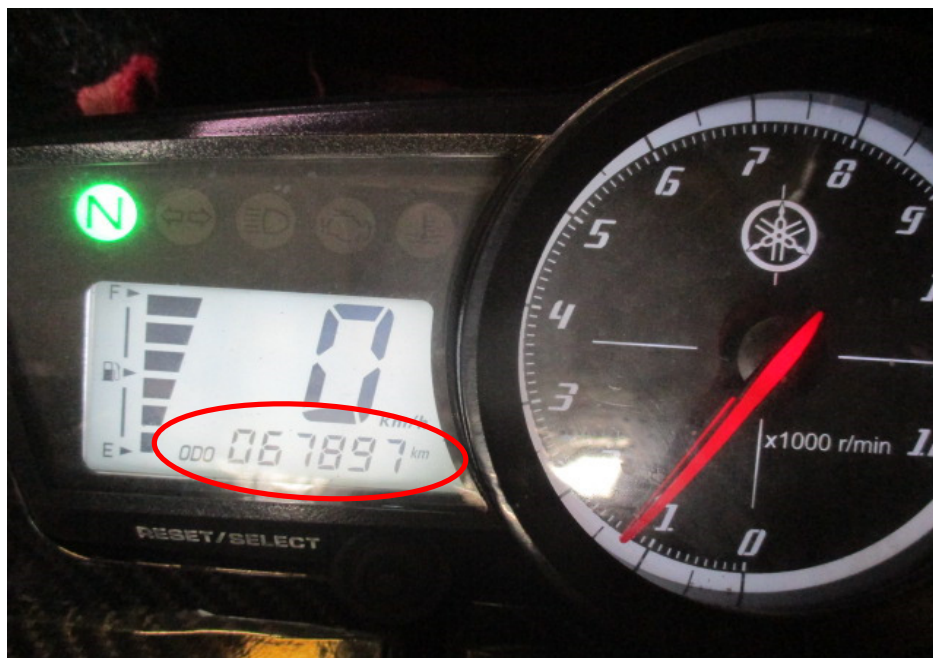
**Photo 1** shows the speedometer gauge of the Motorcycle where the mileage recorded at the time of our inspection was 67, 897km (circled).

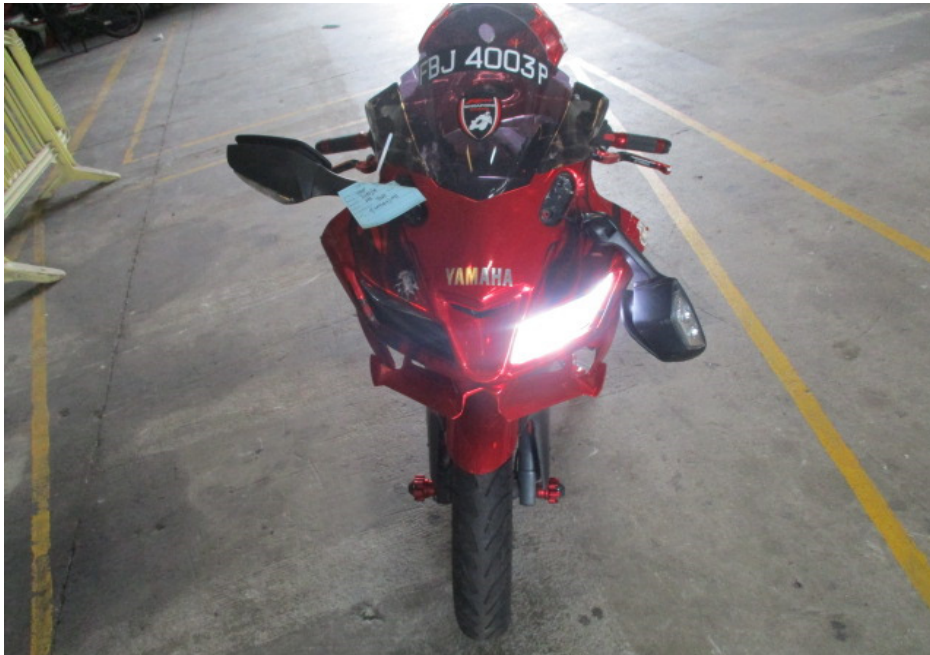
**Photo 2** shows a general view of the frontal portion of the Motorcycle at the time of our inspection. The Motorcycle was observed to have sustained damages all around.

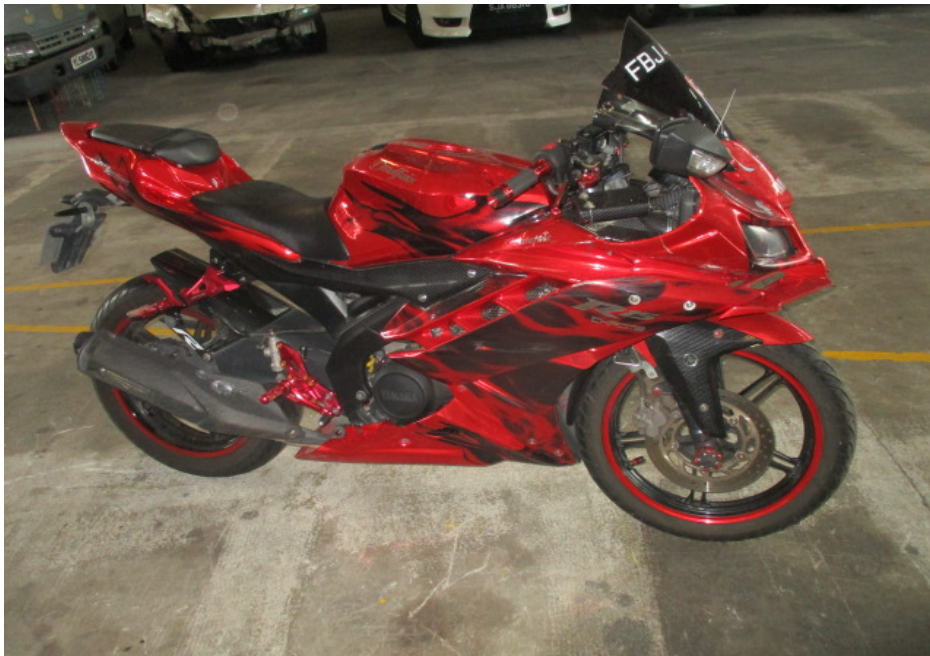
**Photo 3** shows a general view of the right body of the Motorcycle at the time of our inspection. The Motorcycle was observed to have sustained damages all around.

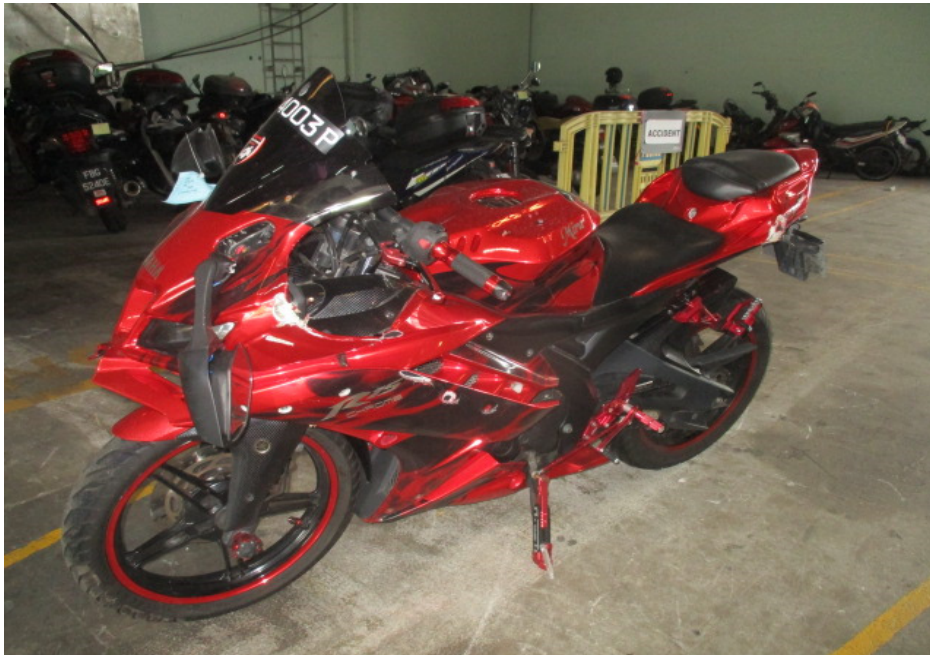
4. The mileage of the Motorcycle at the time of our inspection was 67, 897km.
5. The Motorcycle was observed to have sustained damages all around. The body parts that were found to have been damaged include its windshield, head cowlings, side cowlings, left handlebar, left side mirror, side stand, gear shift pedal, left front footrest, left pillion foot peg and left rear side cover, amongst others.

**Photo 4** shows a general view of the left body of the Motorcycle at the time of our inspection. The Motorcycle was observed to have sustained damages all around. Amongst the body parts that were found to have been damaged include its windshield, head cowlings, side cowlings, left handlebar, left side mirror, side stand, gear shift pedal, left front footrest, left pillion foot peg and left rear side cover, amongst others.

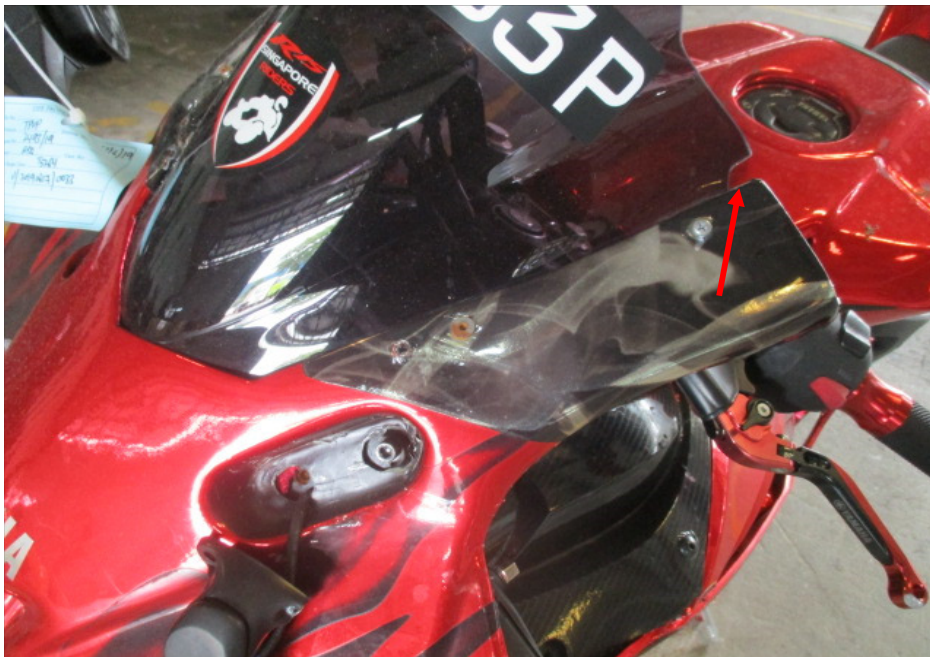
**Photo 5** shows a closer view of the cracked windshield (arrowed) which was amongst the body parts at the front body of the Motorcycle that had sustained damage as a result of the accident.

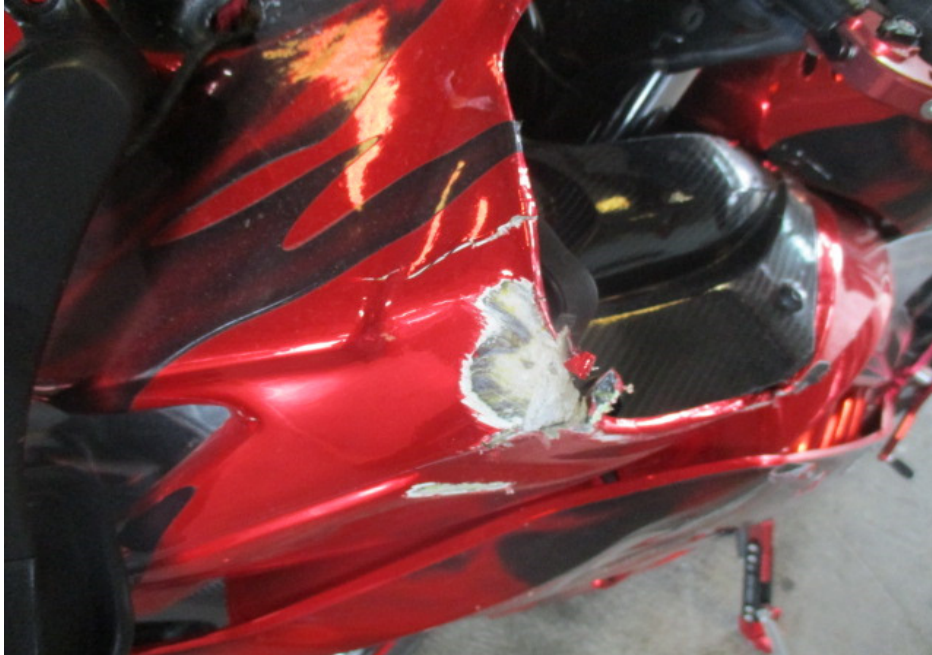
**Photo 6** shows a close up view of the head cowl which was amongst the body parts of the Motorcycle that had sustained damage as a result of the accident.

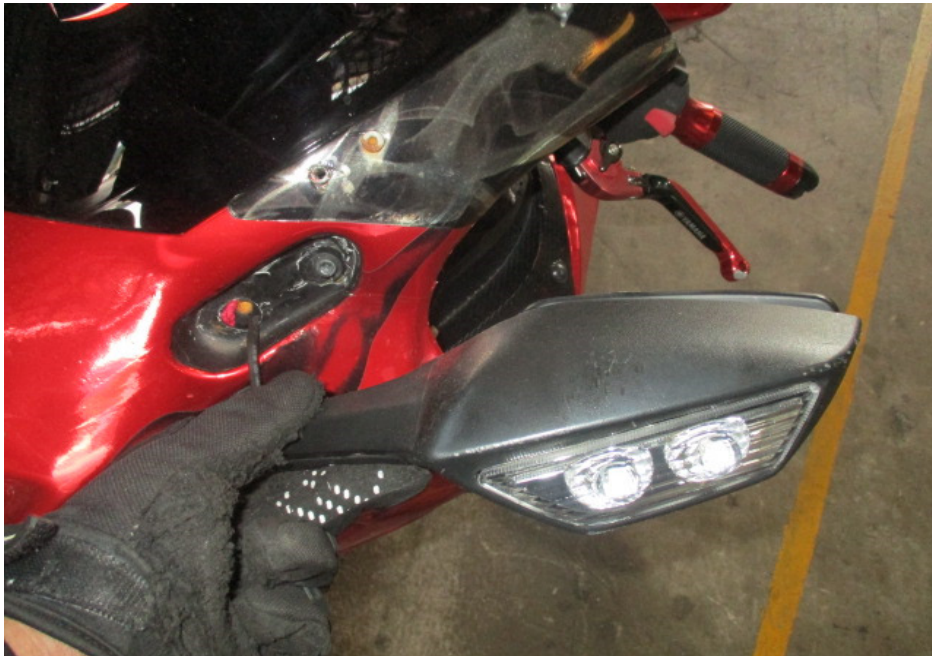
**Photo 7** shows a closer view of the dislodged left side mirror which was amongst the body parts at the front body of the Motorcycle that had sustained damage as a result of the accident.

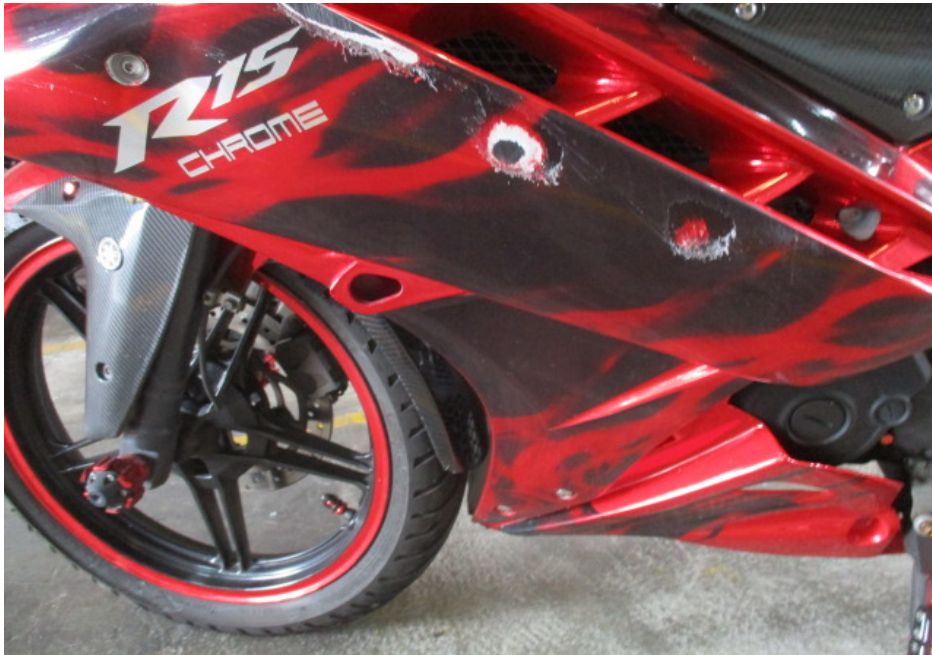
**Photo 8** shows a closer view of the left cowling of the Motorcycle that had sustained damages of grazing nature as a result of the accident.

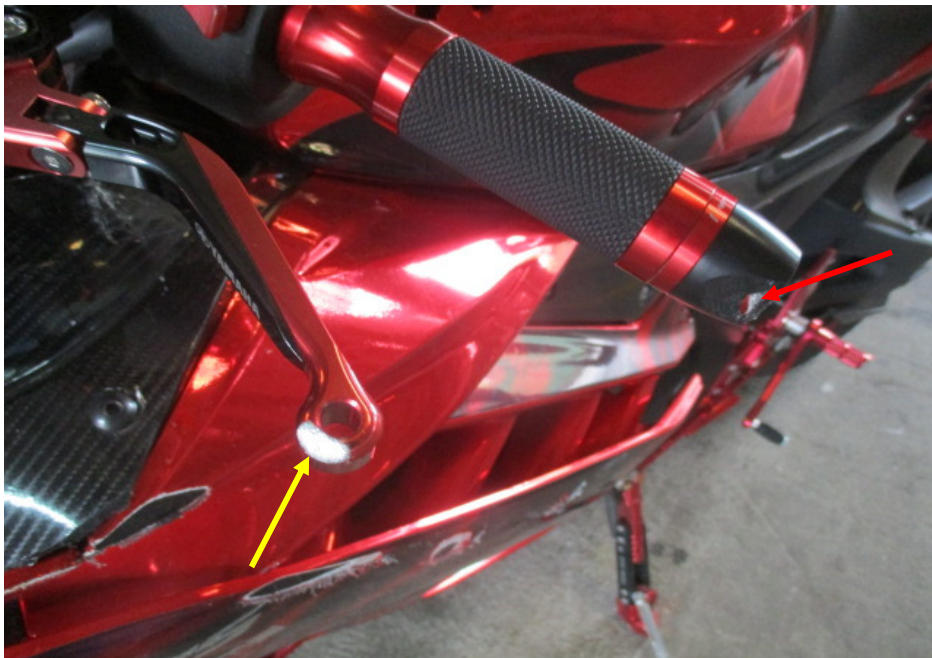
**Photo 9** shows a closer view of the left handlebar end and clutch lever (arrowed) which were amongst the body parts of the Motorcycle that had sustained damage as a result of the accident.

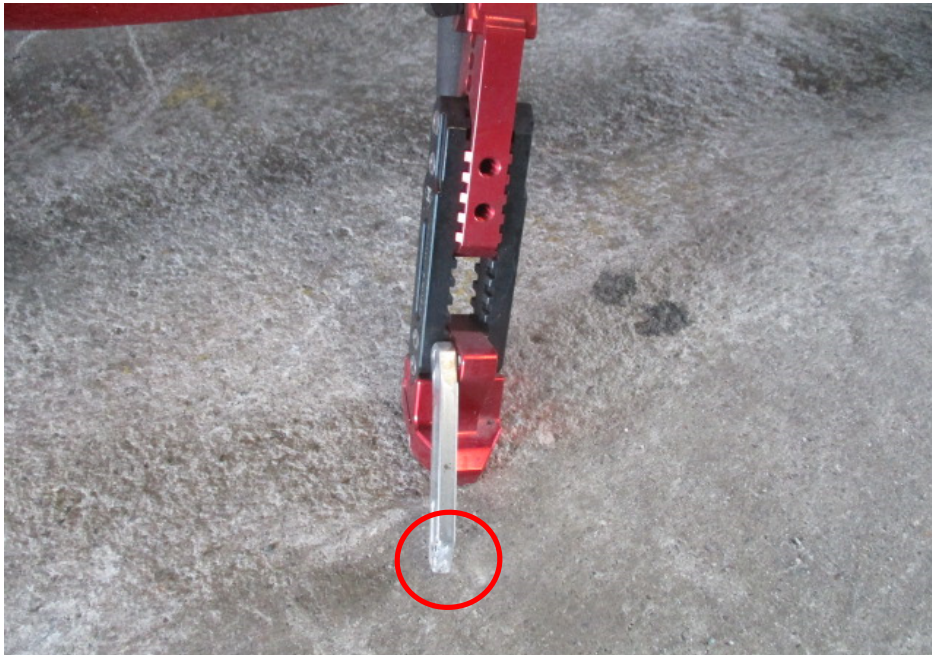
**Photo 10** shows a closer view of the side stand of the Motorcycle that had sustained damages of grazing nature as a result of the accident (circled).

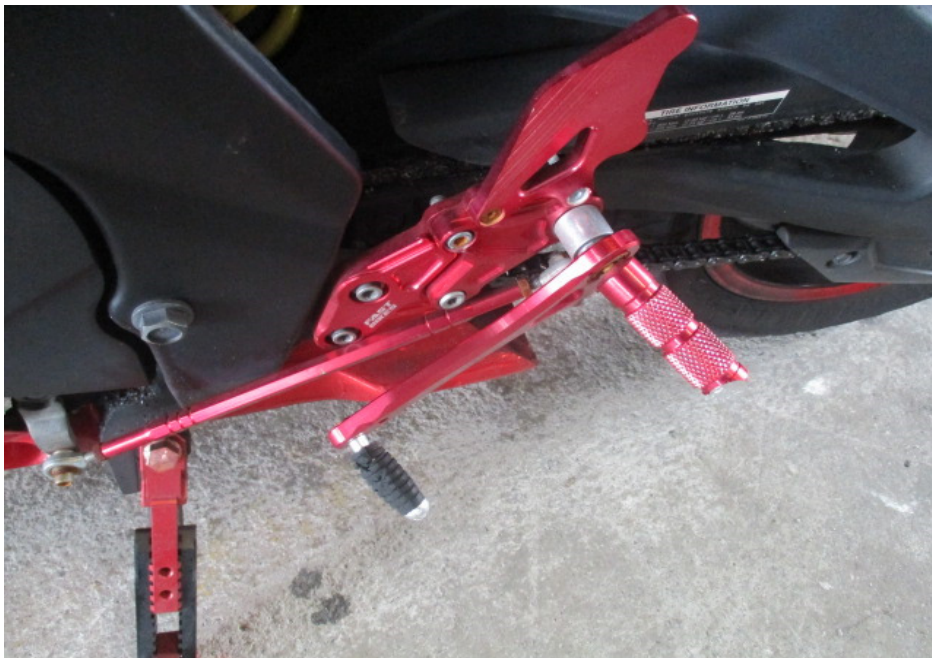
**Photo 11** shows a closer view of the gear shift pedal and left front footrest which were amongst the body parts of the Motorcycle that had sustained damage as a result of the accident.

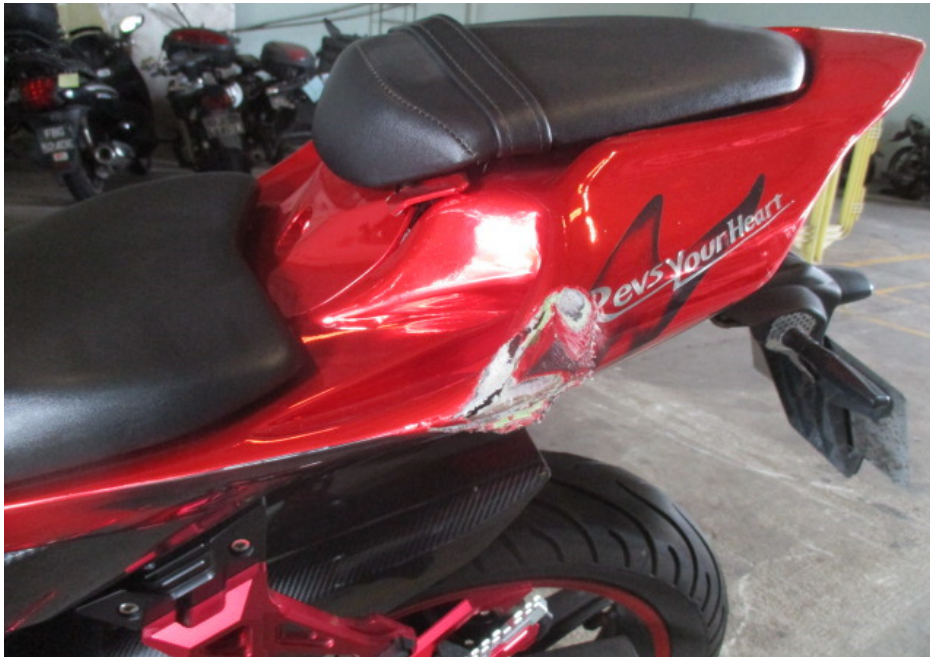
**Photo 12** shows the cracked left rear side cover of the Motorcycle as a result of the accident.

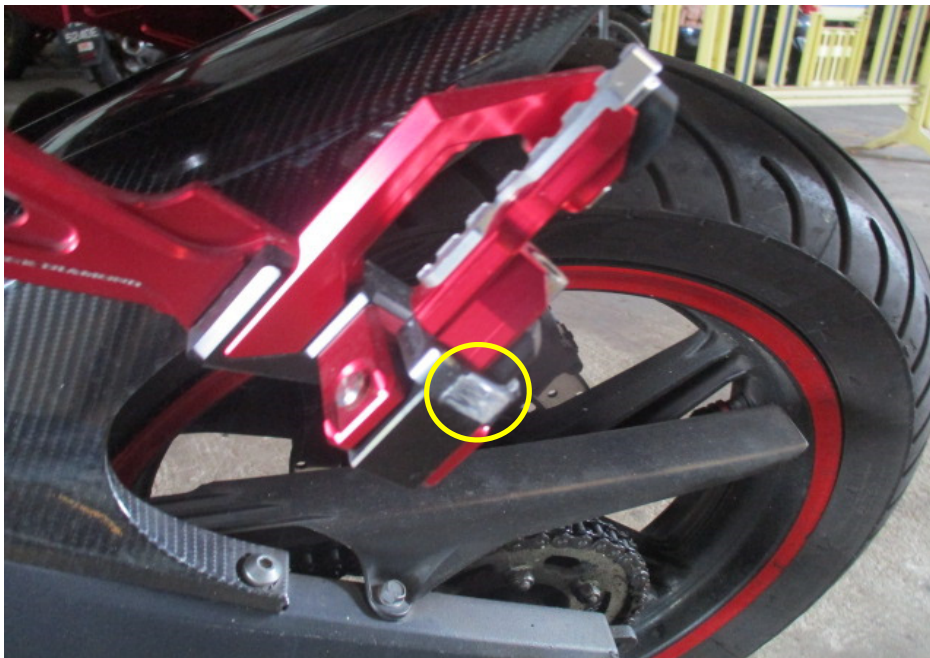
**Photo 13** shows a closer view of the left pillion foot peg which was amongst the body parts of the Motorcycle that had sustained damages of grazing nature as a result of the accident (circled).

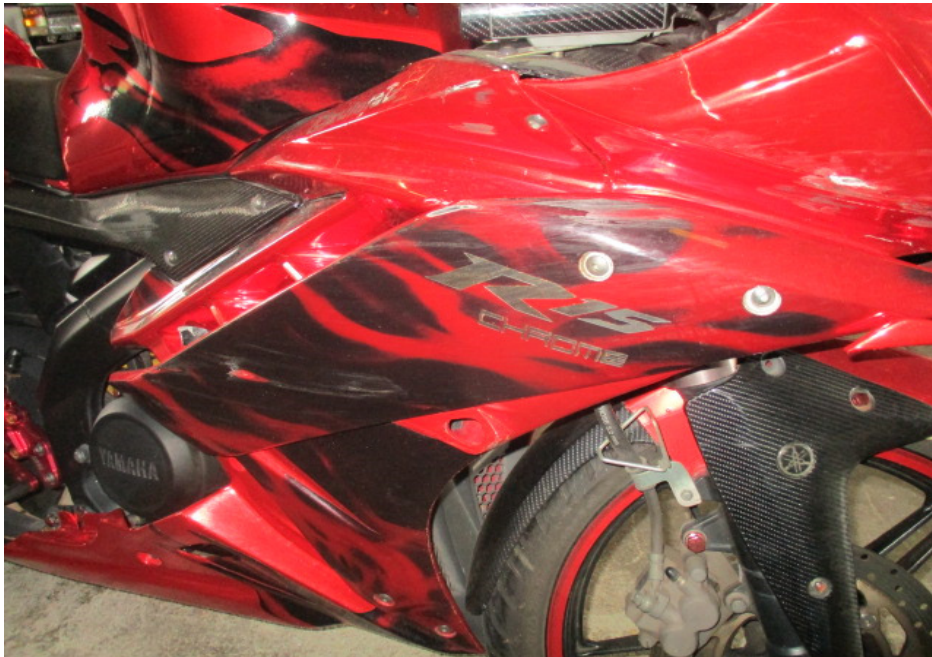
**Photo 14** shows a closer view of the right cowling of the Motorcycle that had sustained damages of grazing nature as a result of the accident.

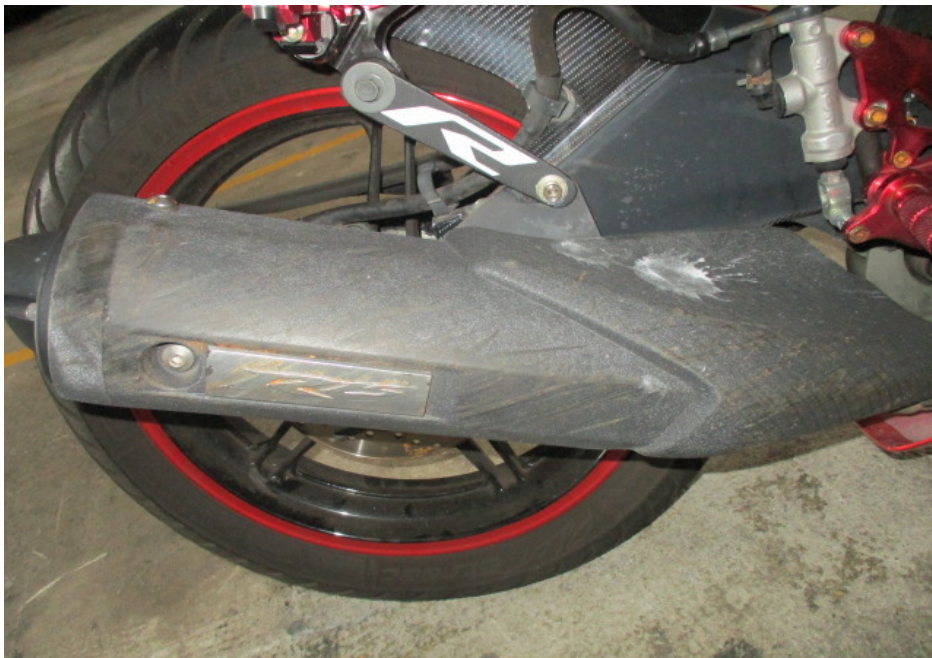
**Photo 15** shows a closer view of the exhaust muffler of the Motorcycle that had sustained damages of grazing nature as a result of the accident.

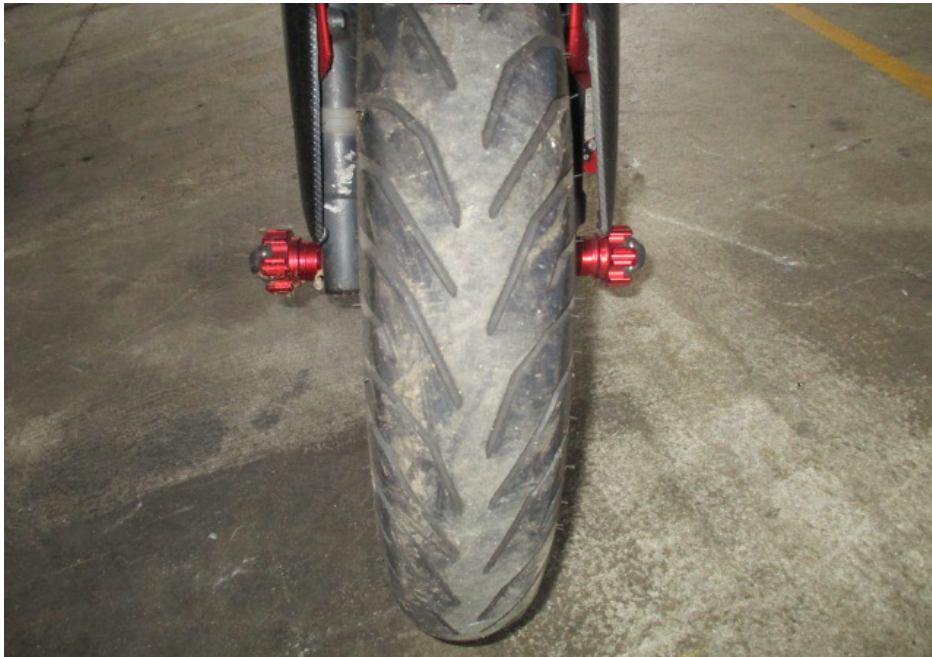
**Photo 16** shows the condition of the Motorcycle's front tyre. The front tyre was observed to be in serviceable condition with remaining tread depth of approximately 3mm. There was no tear, burst mark(s) and/or punctured hole(s) on the sidewalls as well as across the tread of the front tyre.

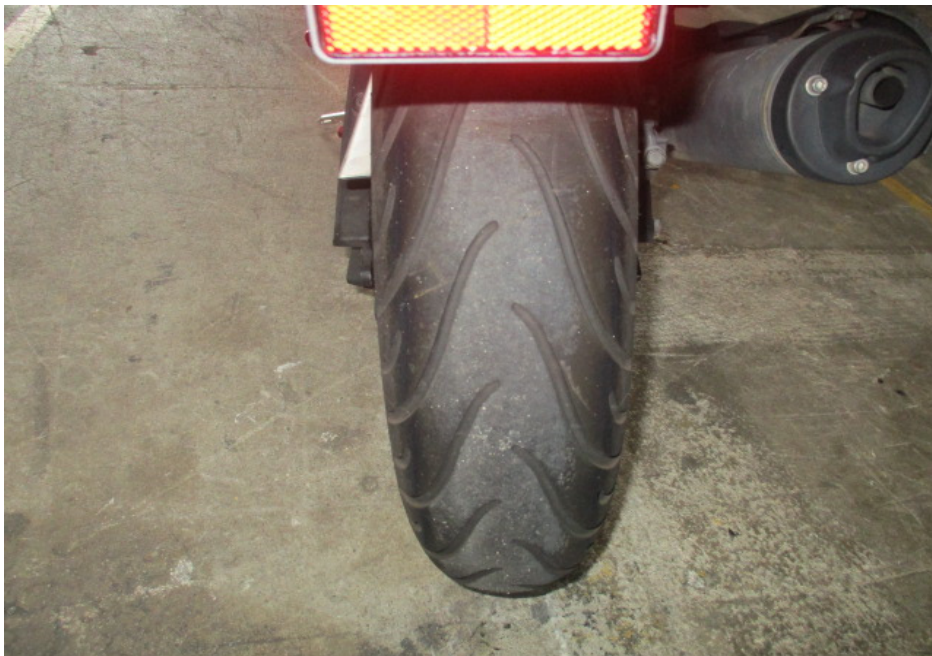
**Photo 17** shows the condition of the Motorcycle's rear tyre. The rear tyre was observed to be in serviceable condition with remaining tread depth of approximately 3mm. The tyre was also observed to be sufficiently inflated for vehicular operation. We did not observe any tear, burst mark(s) and/or punctured hole(s) on the sidewalls as well as across the tread of the rear tyre.

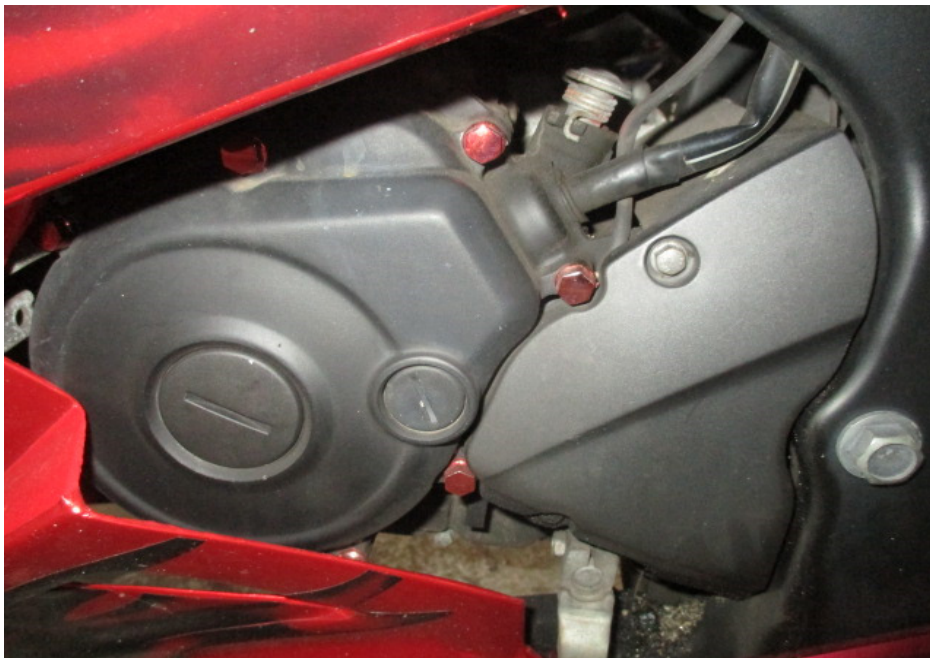
**Photo 18** shows the left side of the engine of the Motorcycle at the time of our inspection. The various engine related parts and components were found to be intact with no visible damage. There was also no sign(s) or indication(s) of fluid leak observed around the left engine area of the Motorcycle.

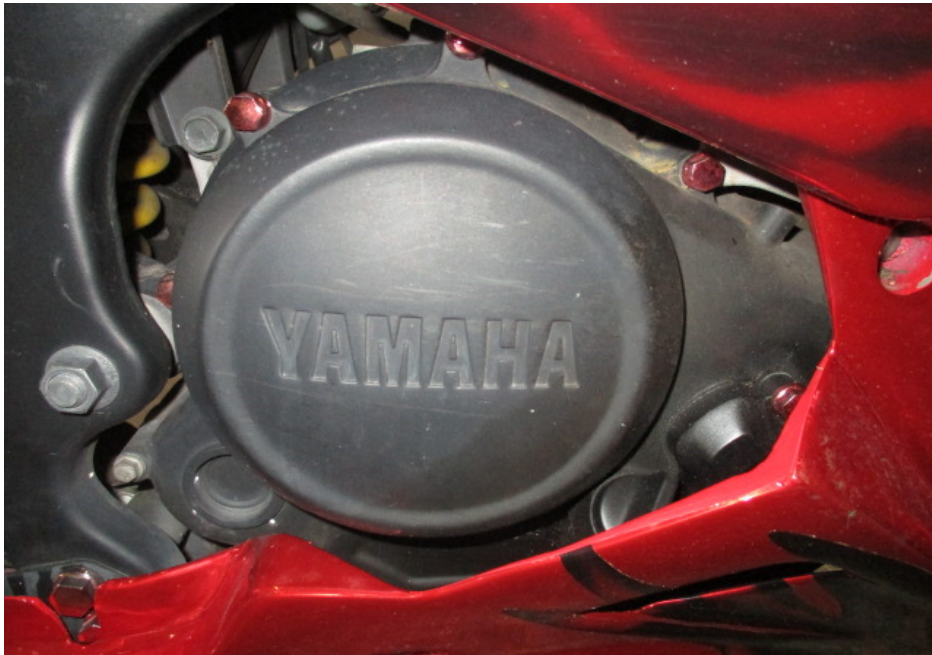
**Photo 19** shows the right side of the engine of the Motorcycle at the time of our inspection. The various engine related parts and components were found to be intact with no visible damage. There was also no sign(s) or indication(s) of fluid leak observed around the right engine area of the Motorcycle.

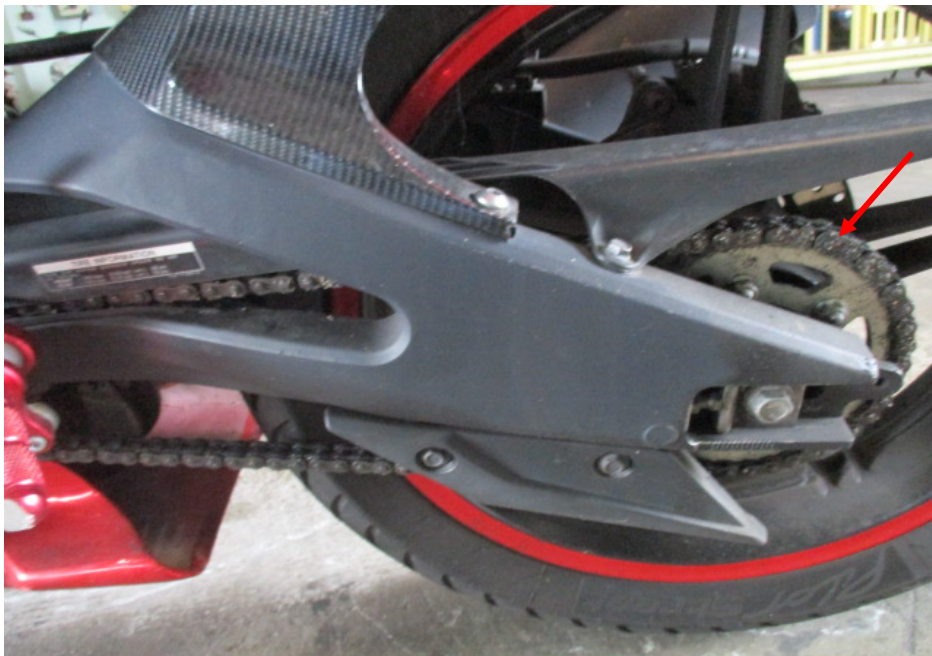
**Photo 20** shows the general view of the gear train (arrowed) of the Motorcycle, which was observed to be intact with no misalignment. It was also adequately lubricated for operating purposes.

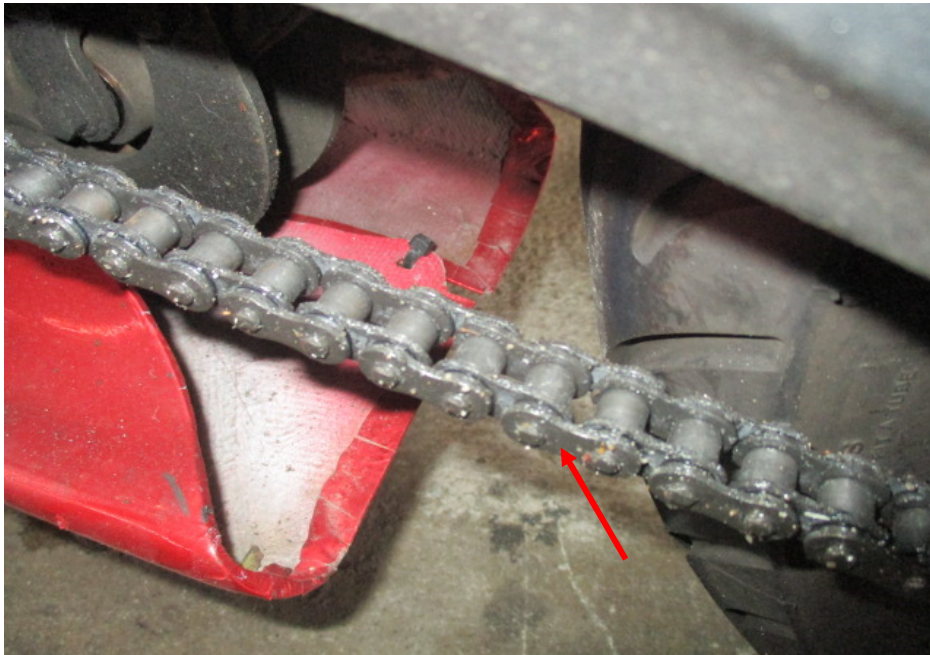
**Photo 21** shows a closer view of the gear train (arrowed) of the Motorcycle, which was observed to be intact with no misalignment. It was also adequately lubricated for operating purposes.

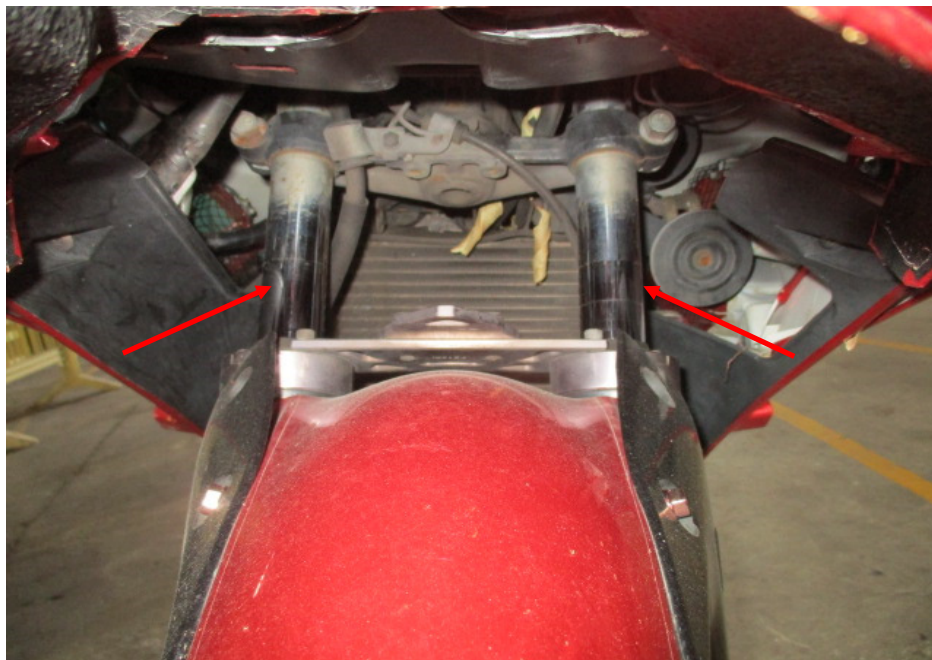
**Photo 22** shows the front fork (arrowed) of the Motorcycle. The front fork and fork bracket of the Motorcycle were both found to be intact and undamaged. Turning the Motorcycle's handle bar towards the left and right did not produce any abnormal free play and/or resistance. The steering system of the Motorcycle was in serviceable condition at the time of our inspection.

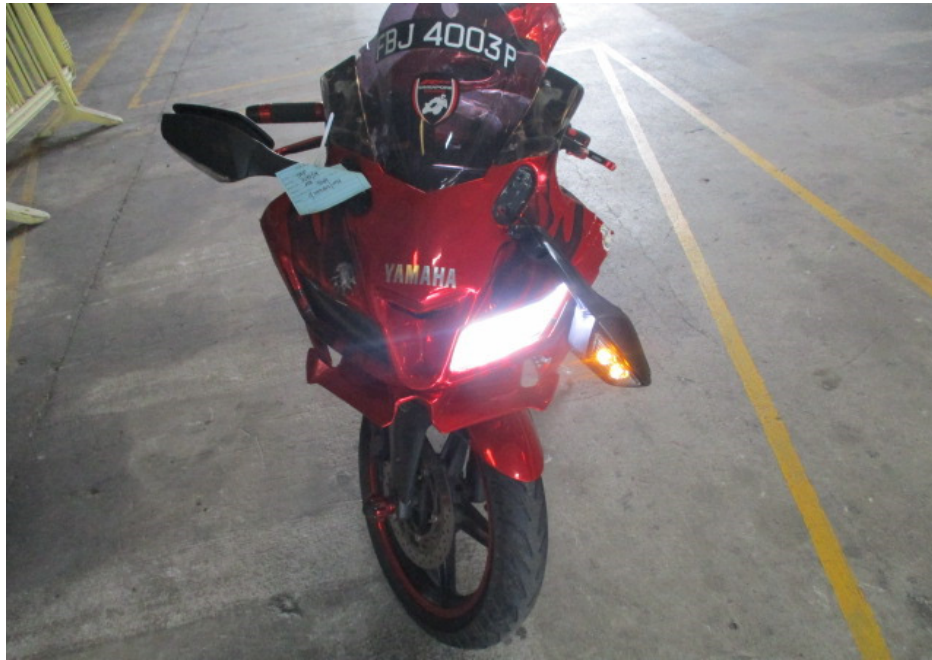
**Photo 23** shows the front wheel of the Motorcycle turned towards its full left. Turning the Motorcycle's handle bar towards the left and right did not produce any abnormal free play and/or resistance. This would indicate that the steering system of the Motorcycle was in serviceable condition at the time of our inspection.

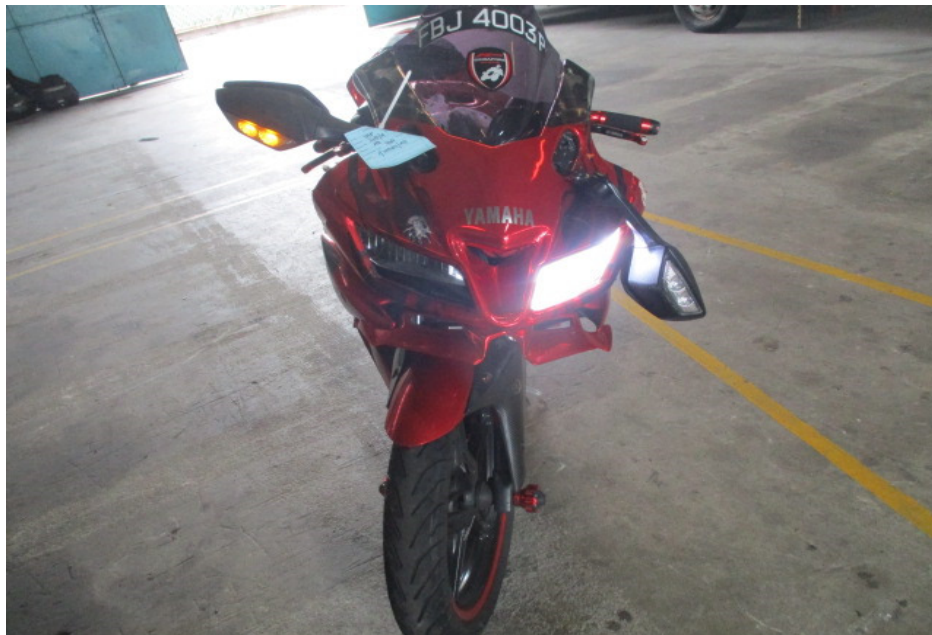
**Photo 24** shows the front wheel of the Motorcycle turned towards its full right. Turning the Motorcycle's handle bar towards the left and right did not produce any abnormal free play and/or resistance. This would indicate that the steering system of the Motorcycle was in serviceable condition at the time of our inspection.

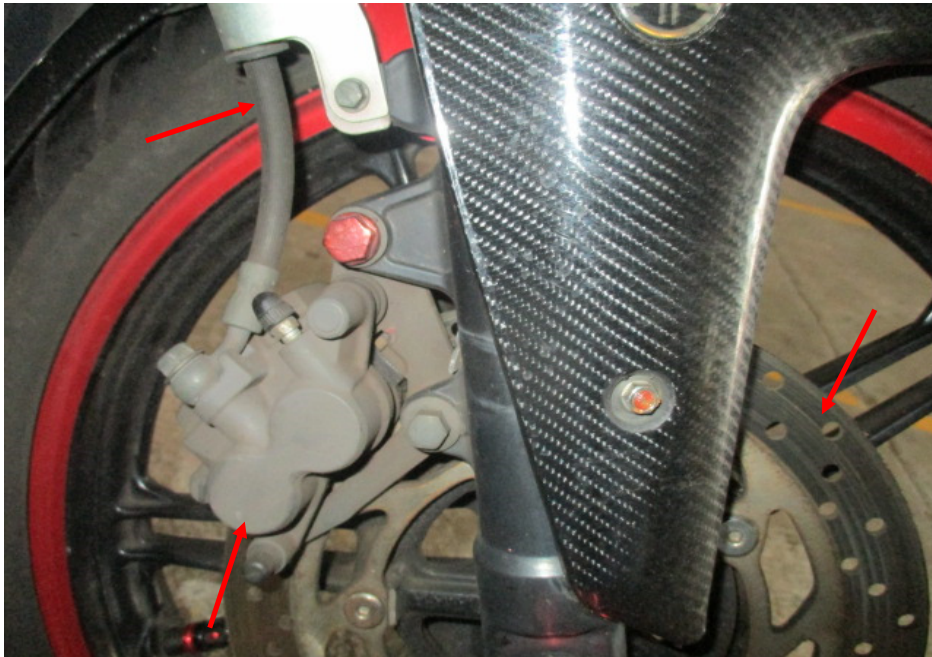
**Photo 25** shows a close up view of the front brake caliper, front brake disc and front brake hose (arrowed) of the Motorcycle, which are all part of the components in the hydraulic front brake system of the Motorcycle. Our visual checks of these various components had revealed all to be intact with no visible damage. No leakage of brake fluid was also observed.

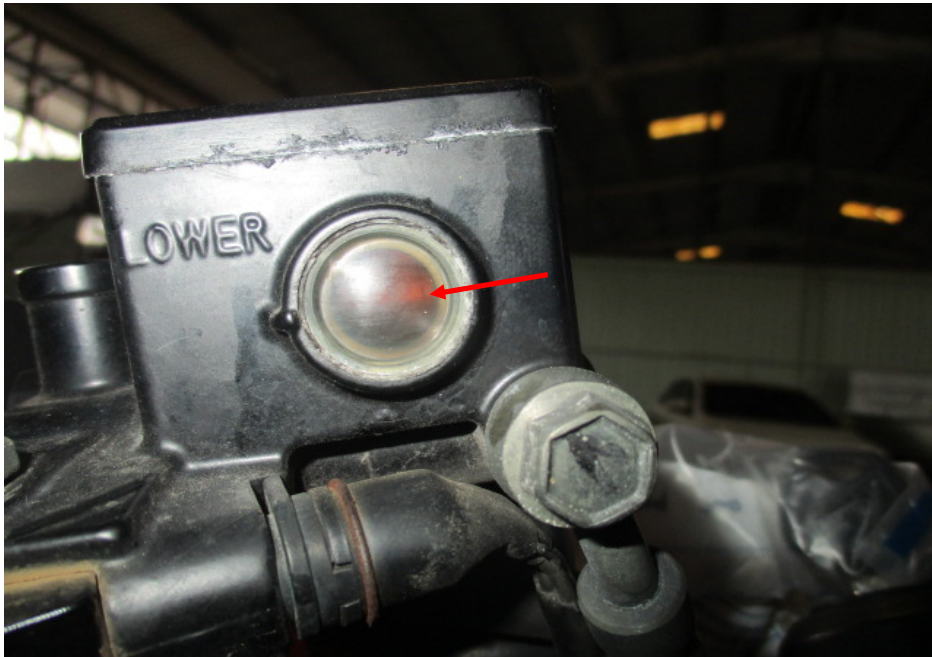
**Photo 26** shows the brake fluid reservoir for the front brake of the Motorcycle. The brake fluid was observed to be of sufficient level and without contamination for operational purposes (arrowed).

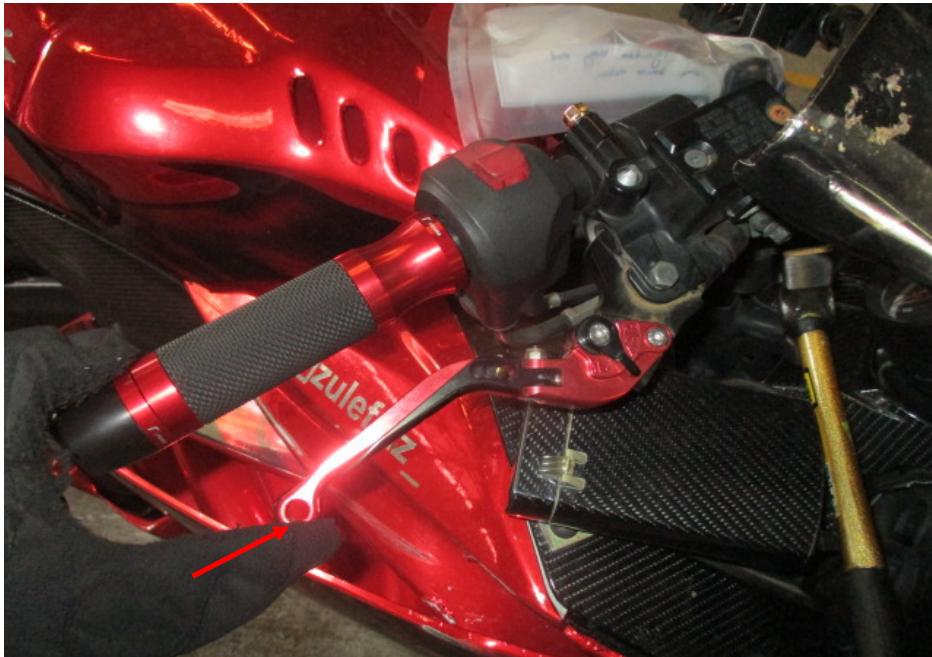
**Photo 27** shows the front brake lever being depressed. There was some resistance felt (spongy like feel) upon pressing the front brake lever (arrowed). This would indicate that there is no leakage of pressure/vacuum in the brake system.

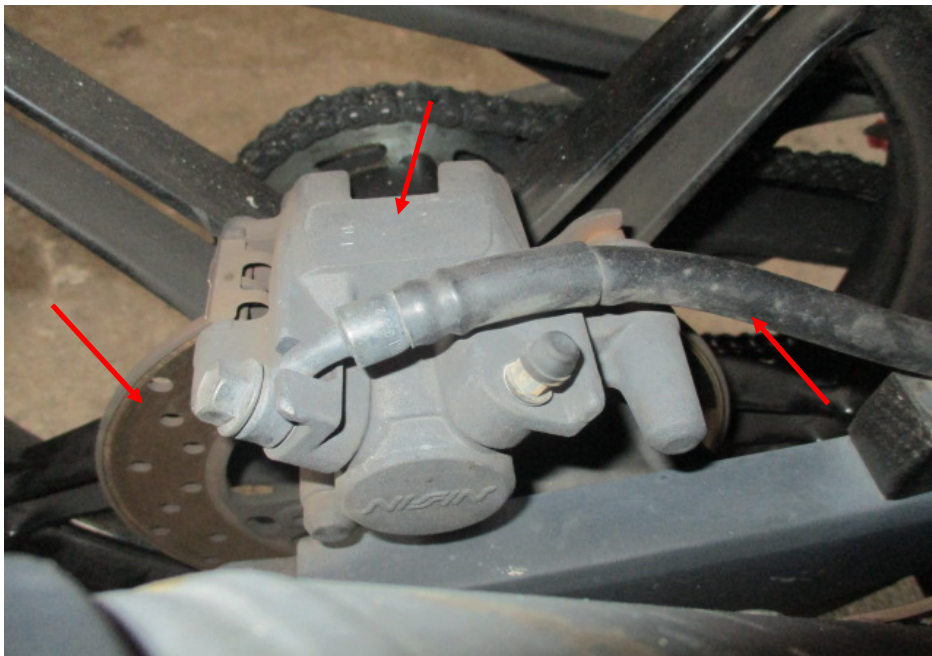
**Photo 28** shows a close up view of the rear brake caliper, rear brake disc and rear brake hose (arrowed) of the Motorcycle, which are all part of the components in the hydraulic rear brake system of the Motorcycle. Our visual checks of these various components had revealed all to be intact with no visible damage. No leakage of brake fluid was also observed.
