Your Ref: TP/IP/38627/2019  
Our Ref : CI/TPD19012881/N

**Fatal Accident Investigation Team**

**INSPECTION REPORT OF MOTORCYCLE PNQ 8131**

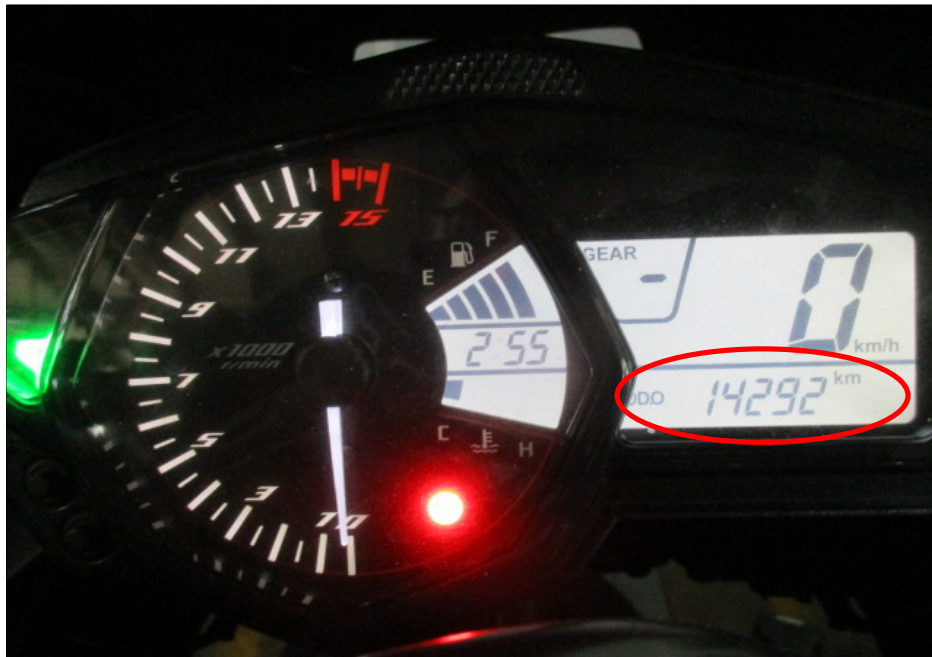
**Photo 1** shows the speedometer gauge of the Motorcycle where the mileage recorded at the time of our inspection was 14, 292km (circled).

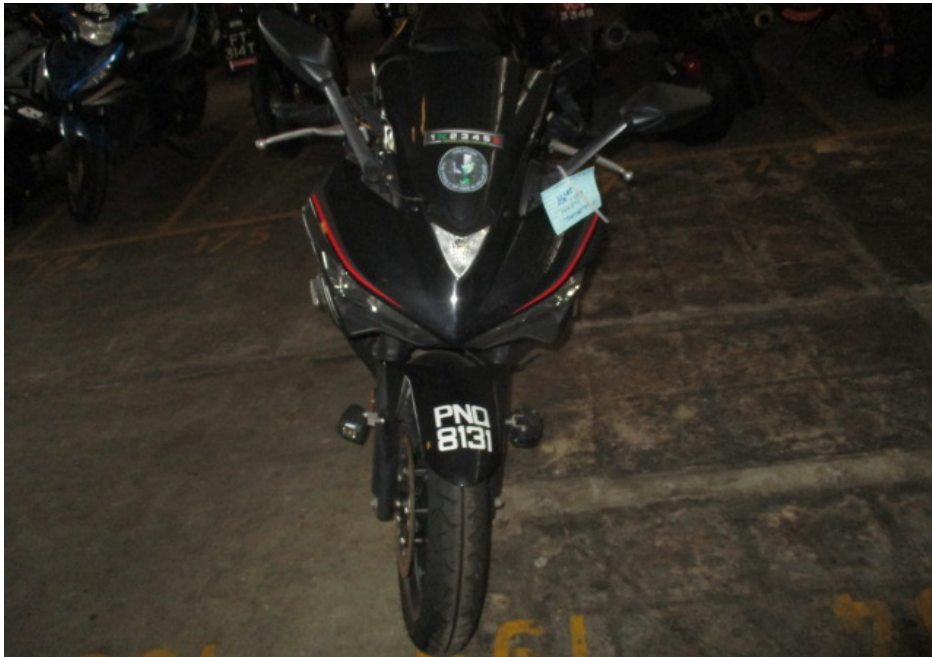
**Photo 2** shows a general view of the frontal portion of the Motorcycle at the time of our inspection. The Motorcycle was observed to have sustained damages all around.

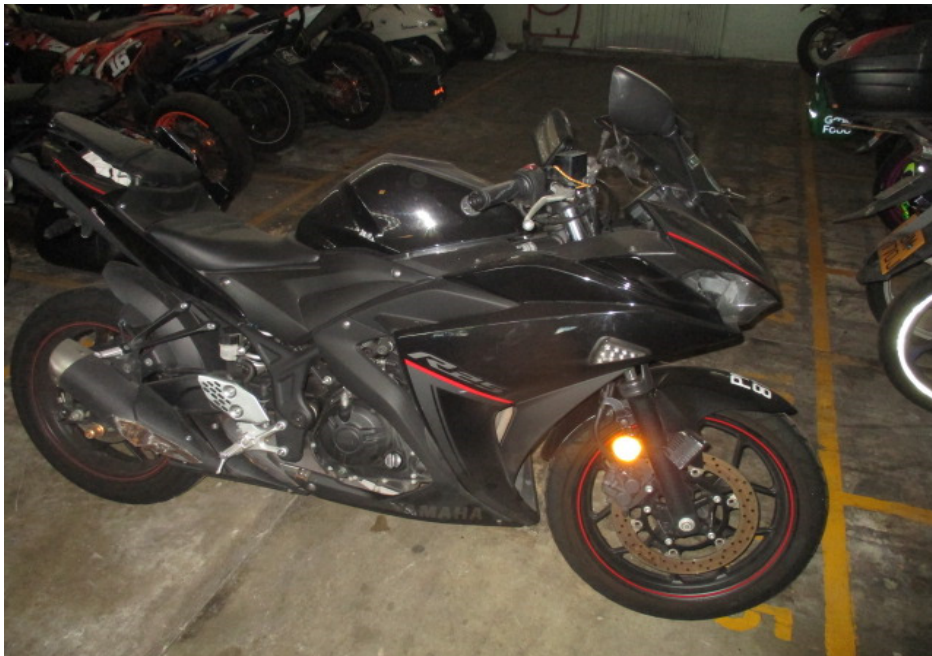
**Photo 3** shows a general view of the right body of the Motorcycle at the time of our inspection. The Motorcycle was observed to have sustained damages all around.

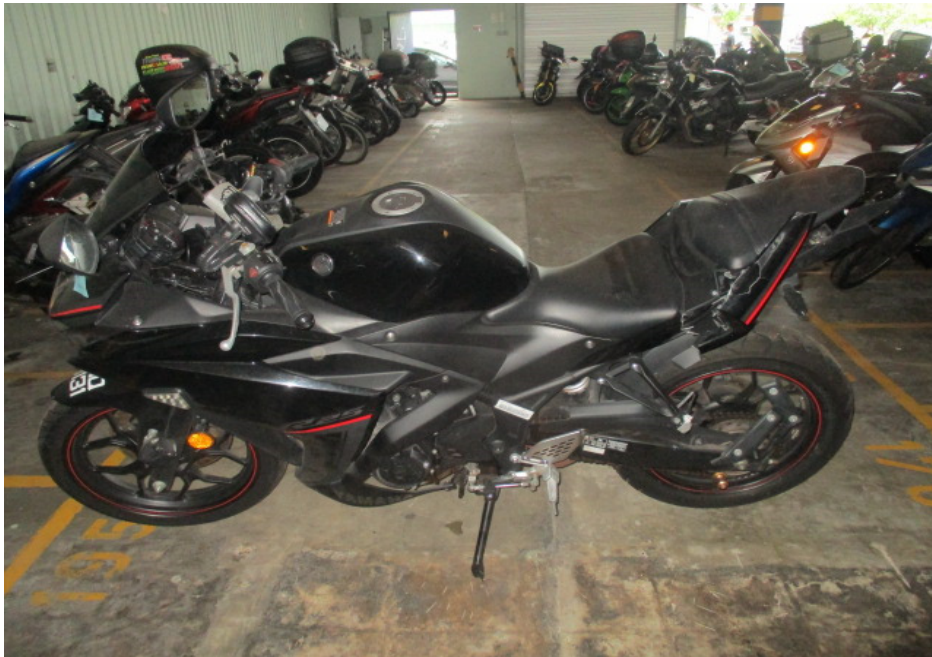
**Photo 4** shows a general view of the left body of the Motorcycle at the time of our inspection. The Motorcycle was observed to have sustained damages all around.

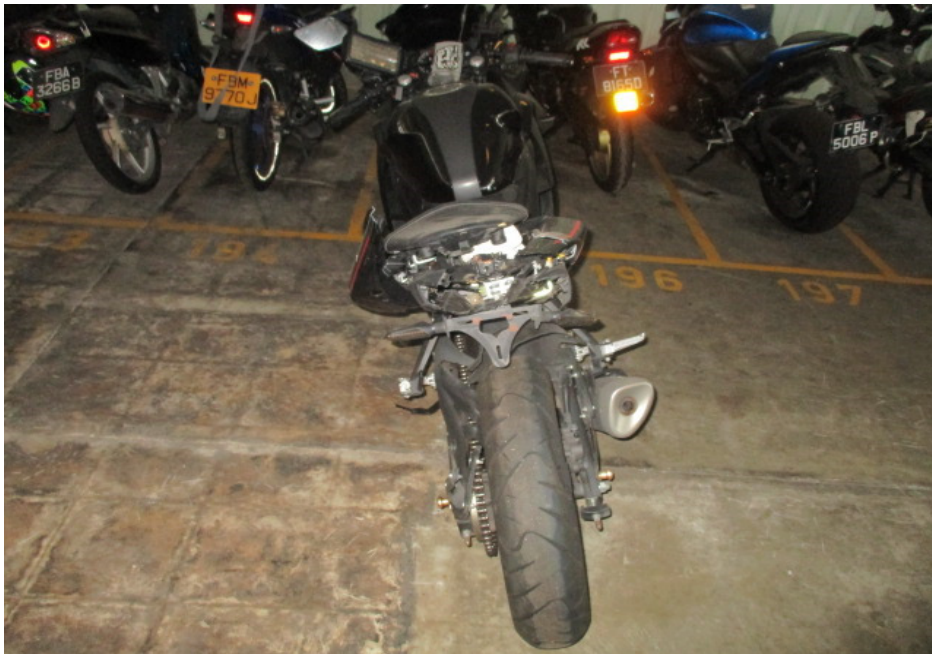
**Photo 5** shows a general view of the rear portion of the Motorcycle at the time of our inspection. The Motorcycle was observed to have sustained damages all around. Amongst the body parts that were found to have been damaged include its head cowl, right cowl, rear brake pedal, right front footrest, left pillion foot peg, rear side covers, exhaust muffler and rear hugger, amongst others.

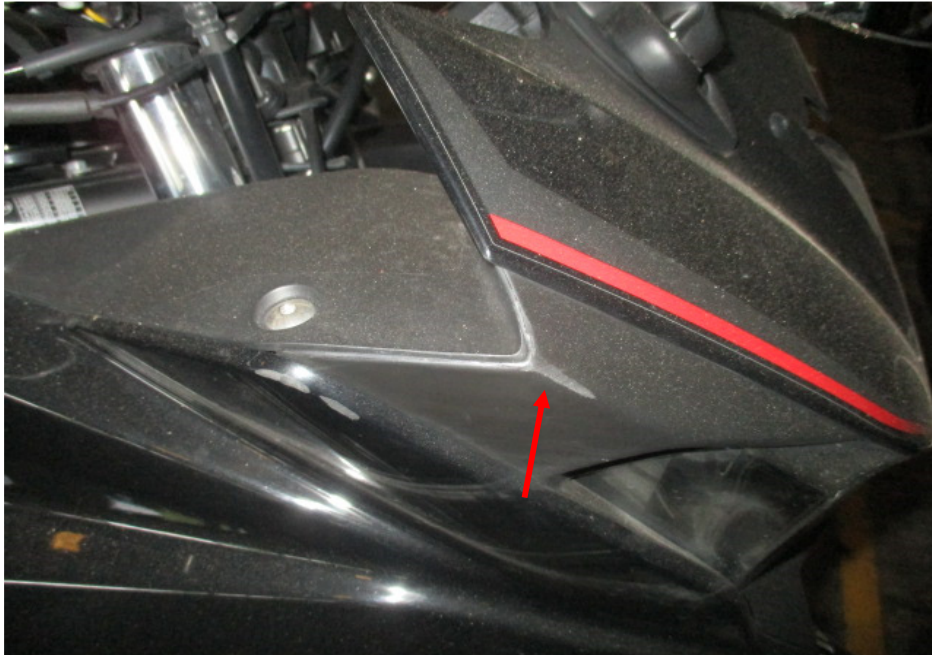
**Photo 6** shows a close up view of the head cowl (arrowed) which was amongst the body parts of the Motorcycle that had sustained damage as a result of the accident.

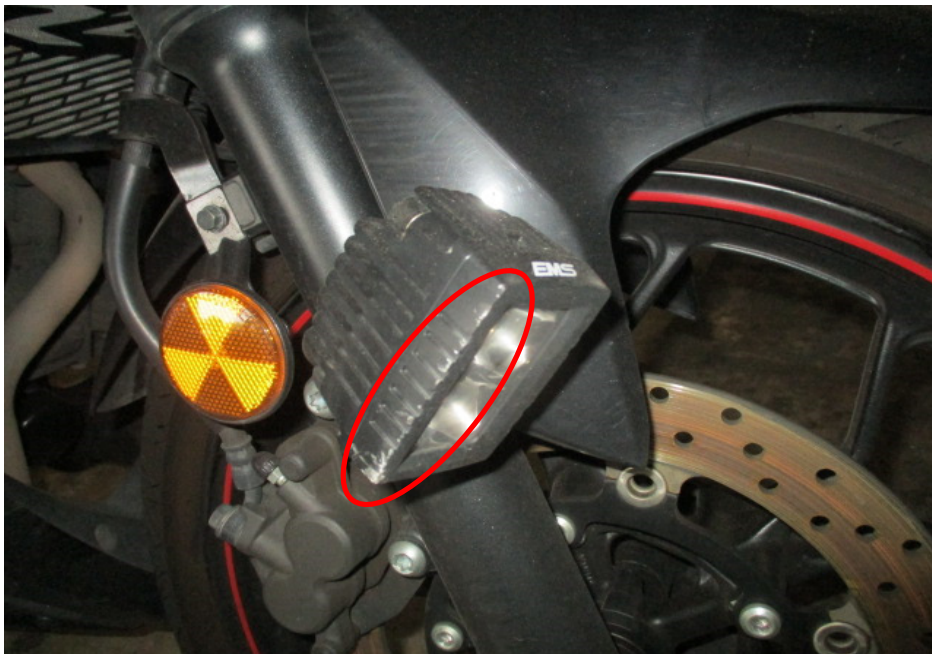
**Photo 7** shows a closer view of the right fog lamp (circled) which was amongst the body parts at the front body of the Motorcycle that had sustained damage as a result of the accident.

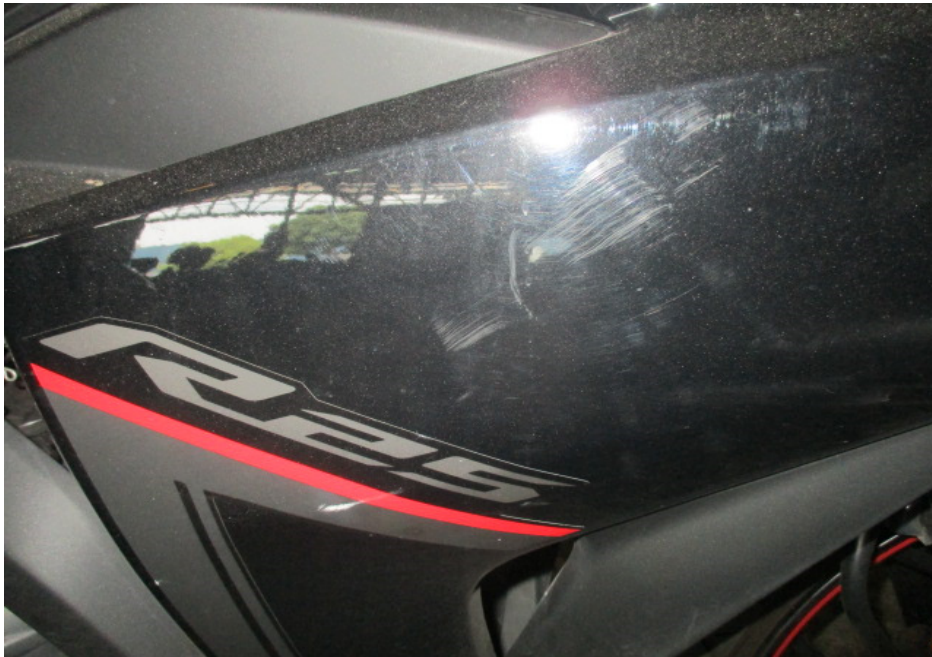
**Photo 8** shows a closer view of the right cowling of the Motorcycle that had sustained damages of grazing nature as a result of the accident.

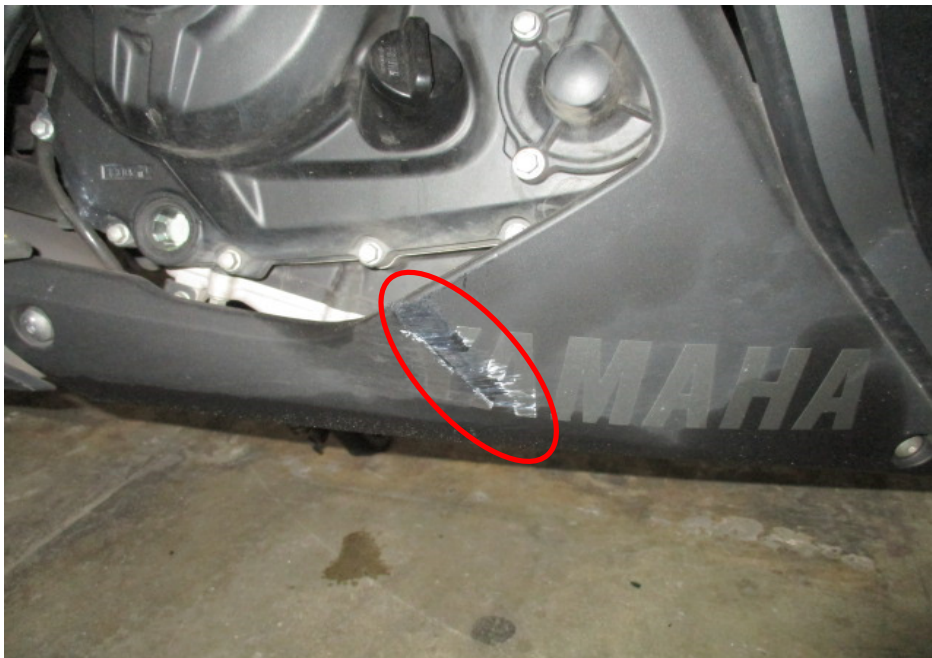
**Photo 9** shows a closer view of the right bottom cowling (circled) which was amongst the body parts of the Motorcycle that had sustained damage as a result of the accident.

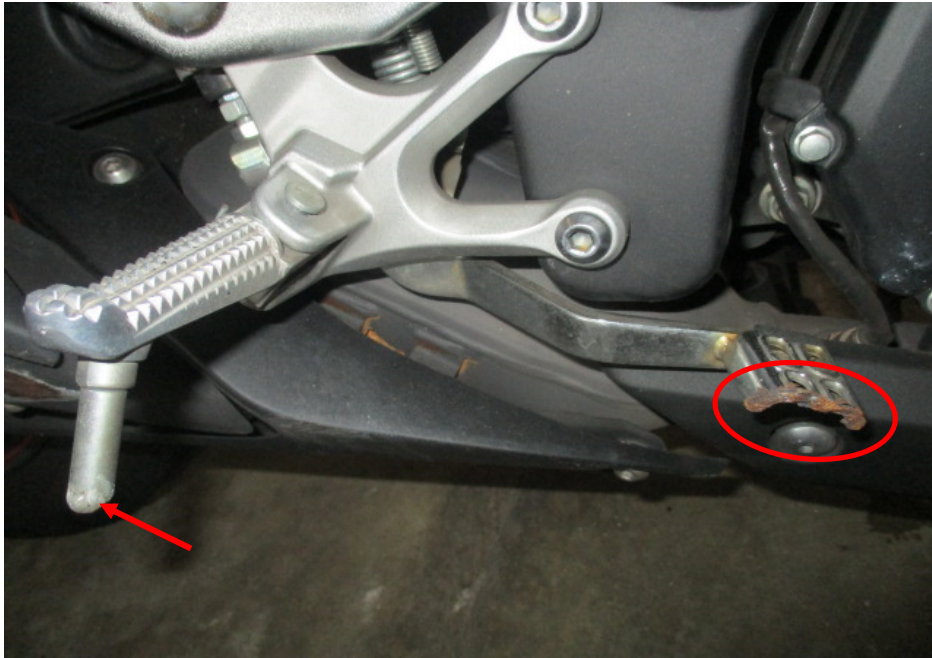
**Photo 10** shows a closer view of the rear brake pedal (circled) and right front footrest (arrowed) which were amongst the body parts of the Motorcycle that had sustained damage as a result of the accident.

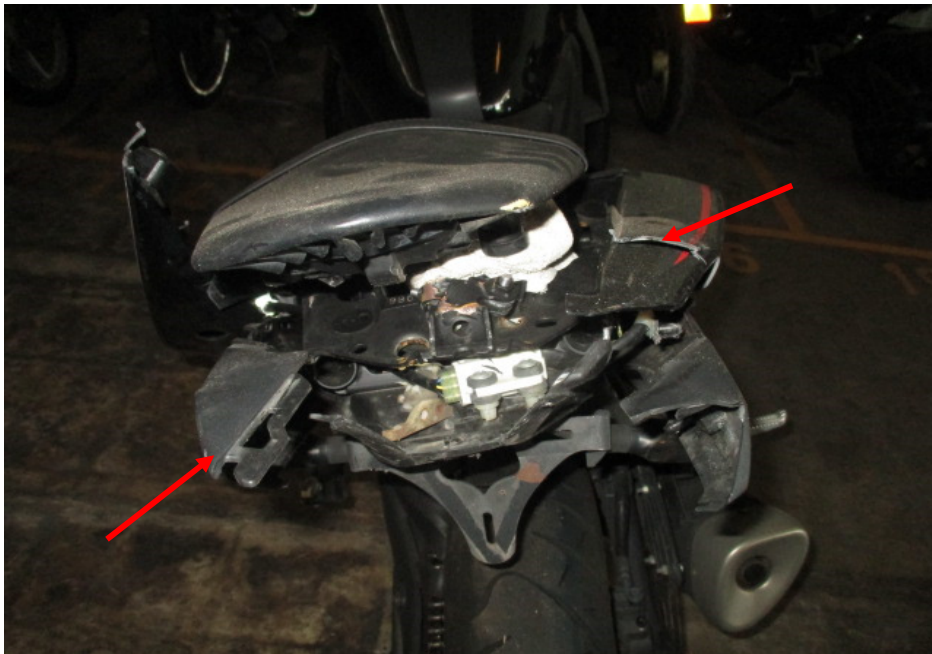
**Photo 11** shows the cracked rear side covers (circled) of the Motorcycle as a result of the accident.

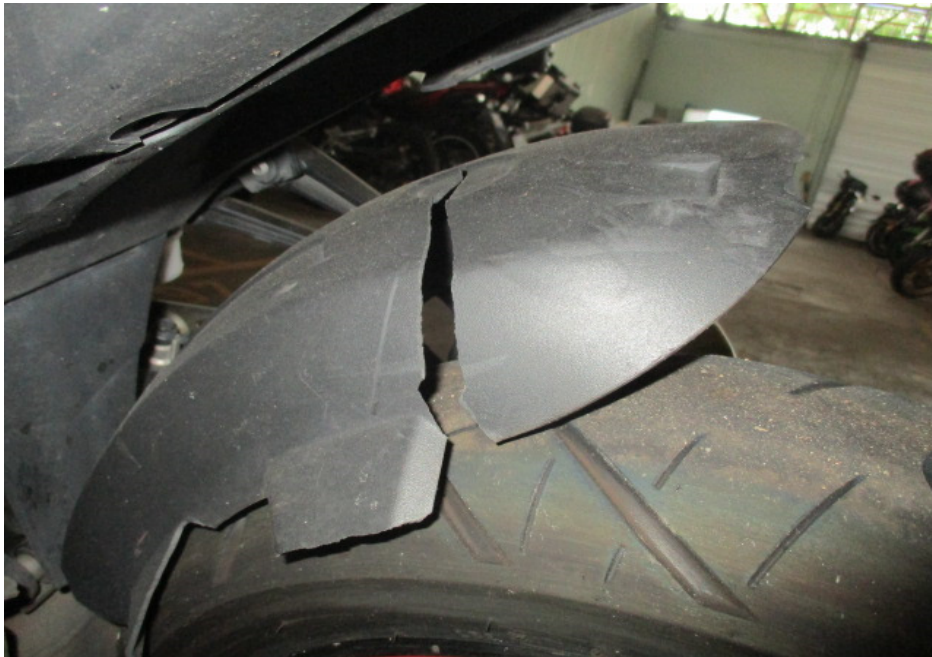
**Photo 12** shows a closer view of the cracked rear hugger of the Motorcycle as a result of the accident.

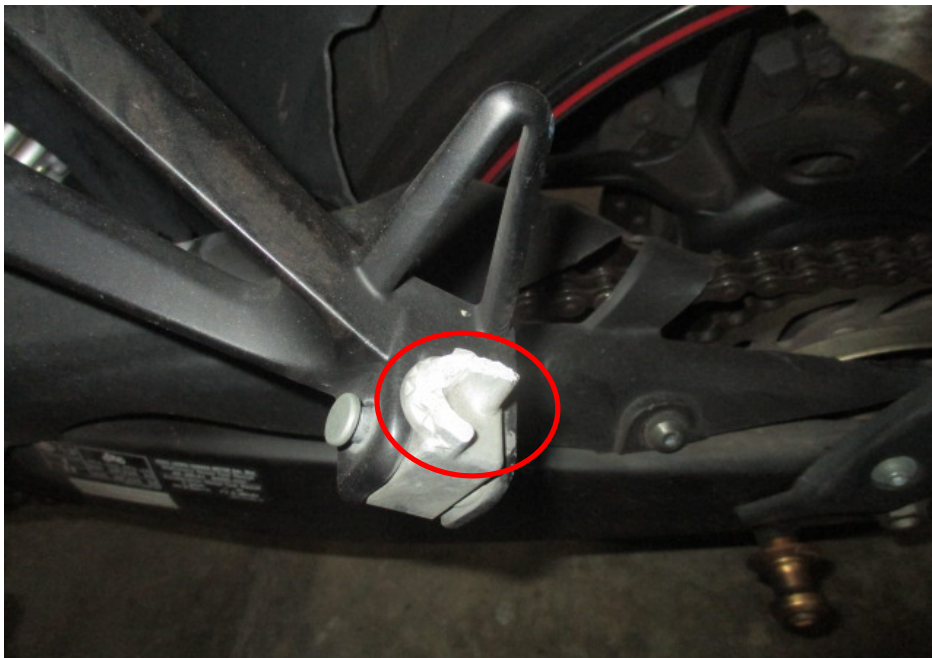
**Photo 13** shows a closer view of the broken left pillion foot peg (circled) of the Motorcycle as a result of the accident.

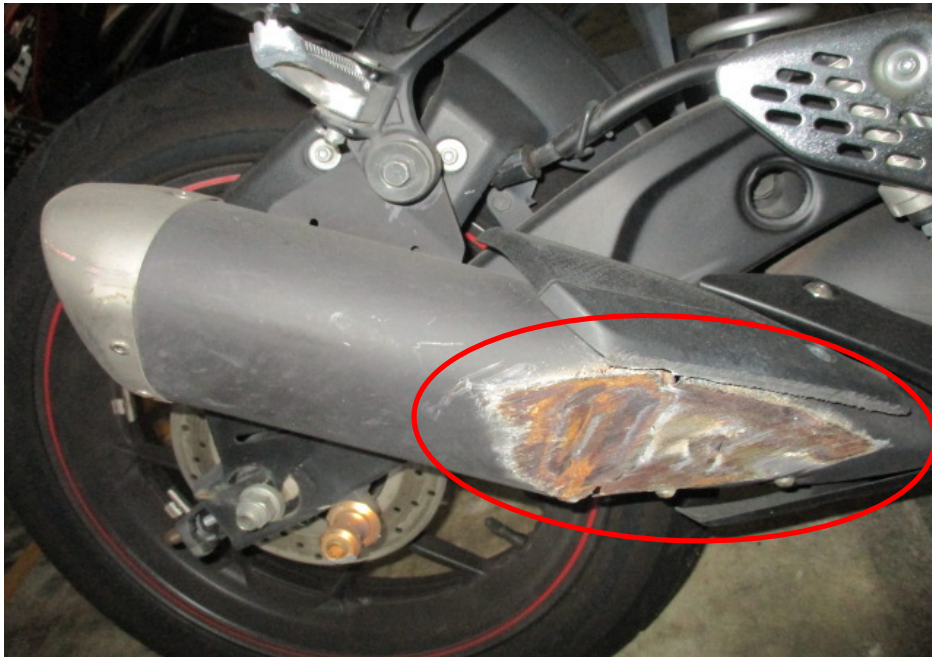
**Photo 14** shows a closer view of the exhaust muffler and exhaust muffler heat shield (circled) of the Motorcycle that had sustained damages of grazing nature as a result of the accident.

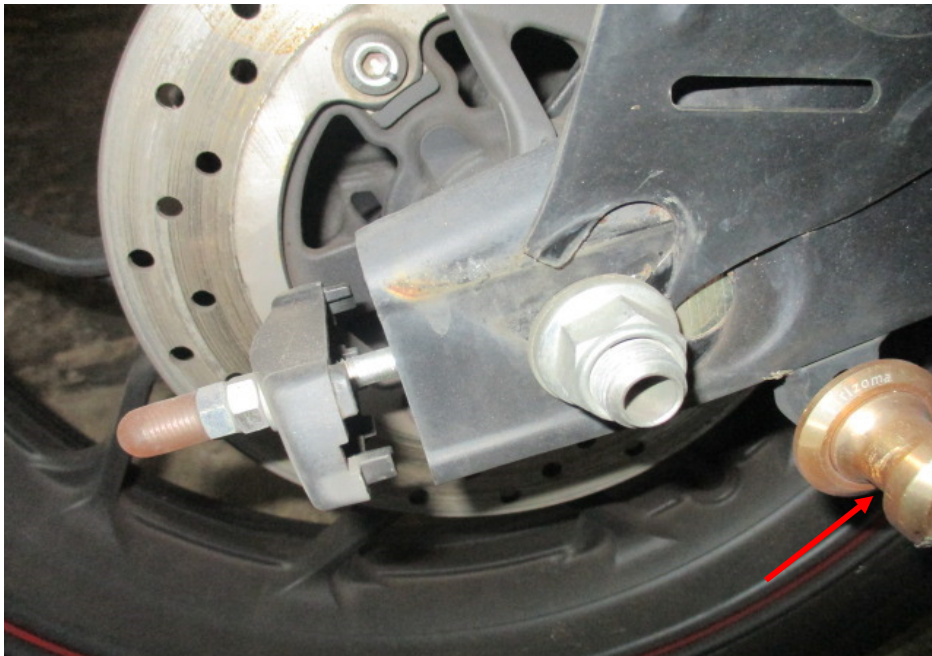
**Photo 15** shows a close up view of the right swingarm spool of the Motorcycle which was observed to be bent as a result of the accident (arrowed).

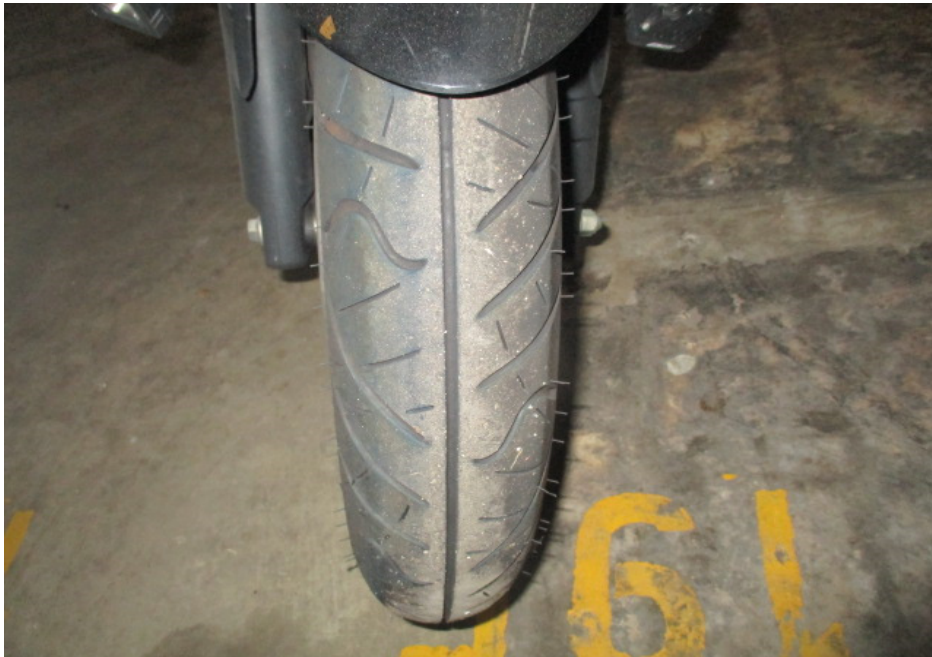
**Photo 16** shows the condition of the Motorcycle's front tyre. The front tyre was observed to be in serviceable condition with remaining tread depth of approximately 3mm. There was no tear, burst mark(s) and/or punctured hole(s) on the sidewalls as well as across the tread of the front tyre.

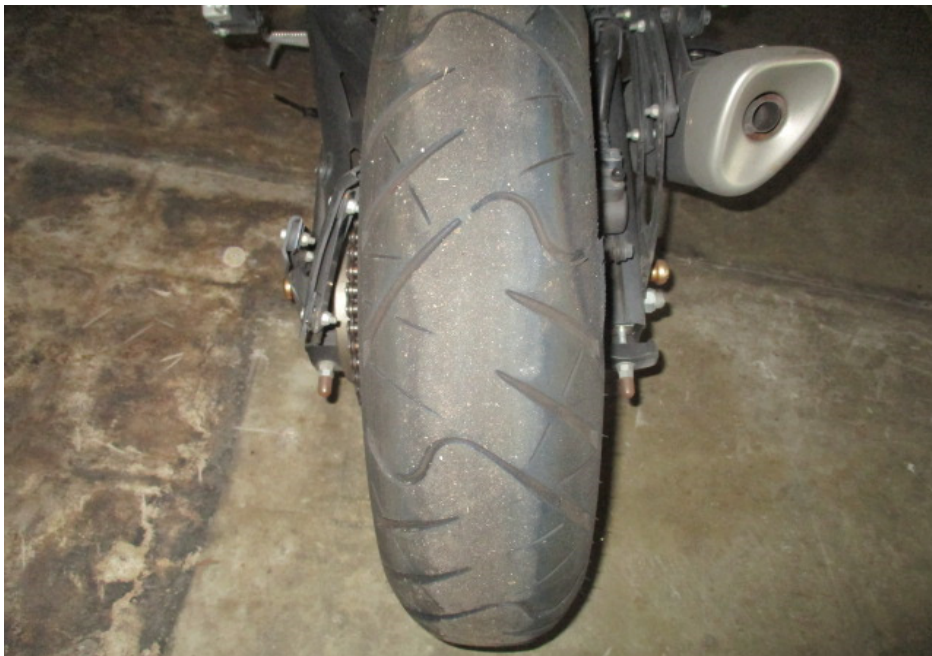
**Photo 17** shows the condition of the Motorcycle's rear tyre. The rear tyre was observed to be in serviceable condition with remaining tread depth of approximately 3mm. The tyre was also observed to be sufficiently inflated for vehicular operation. We did not observe any tear, burst mark(s) and/or punctured hole(s) on the sidewalls as well as across the tread of the rear tyre.

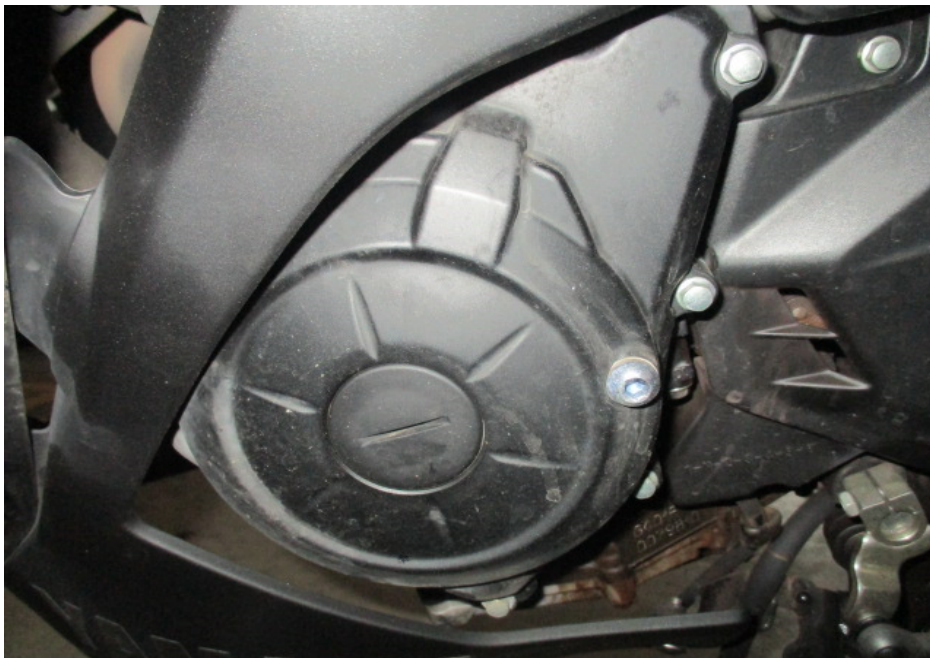
**Photo 18** shows the left side of the engine of the Motorcycle at the time of our inspection. The various engine related parts and components were found to be intact with no visible damage. There was also no sign(s) or indication(s) of fluid leak observed around the left engine area of the Motorcycle.

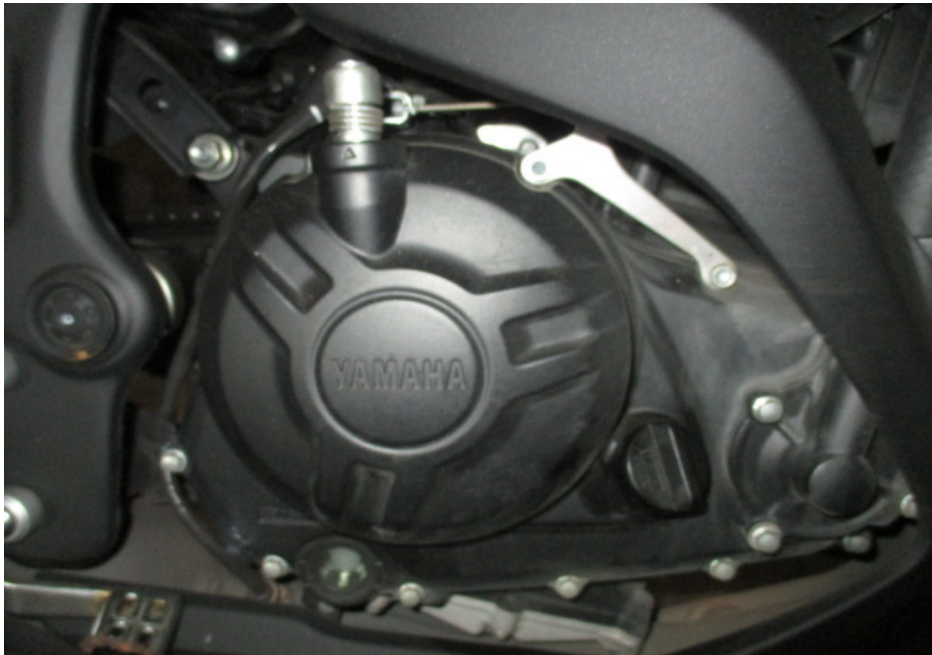
**Photo 19** shows the right side of the engine of the Motorcycle at the time of our inspection. The various engine related parts and components were found to be intact with no visible damage. There was also no sign(s) or indication(s) of fluid leak observed around the right engine area of the Motorcycle.

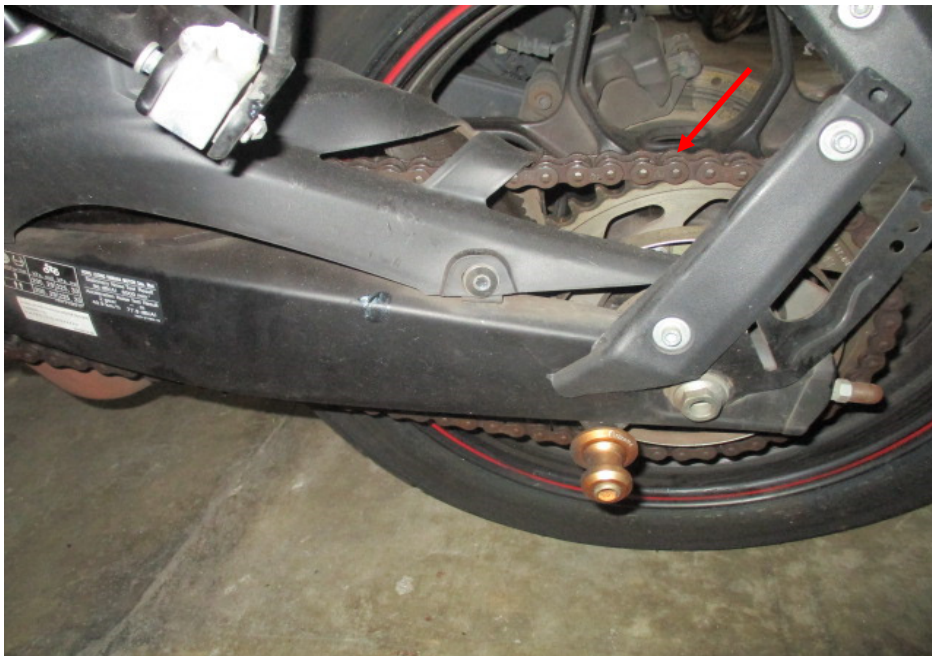
**Photo 20** shows the general view of the gear train (arrowed) of the Motorcycle, which was observed to be intact with no misalignment. It was also adequately lubricated for operating purposes.

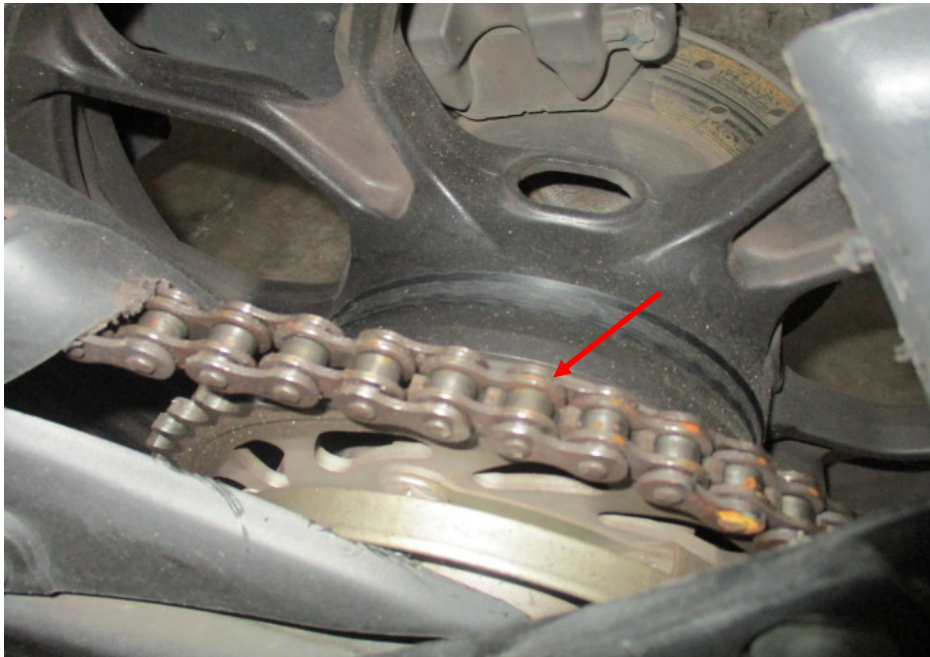
**Photo 21** shows a closer view of the gear train (arrowed) of the Motorcycle, which was observed to be intact with no misalignment. It was also adequately lubricated for operating purposes.

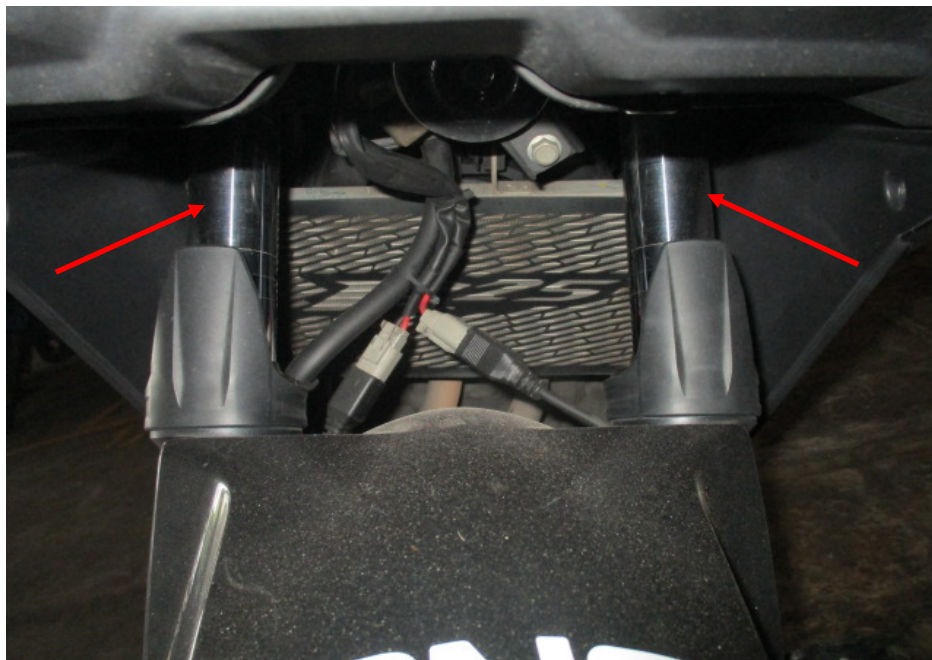
**Photo 22** shows the front fork (arrowed) of the Motorcycle. The front fork and fork bracket of the Motorcycle were both found to be intact and undamaged. Turning the Motorcycle's handle bar towards the left and right did not produce any abnormal free play and/or resistance. The steering system of the Motorcycle was in serviceable condition at the time of our inspection.

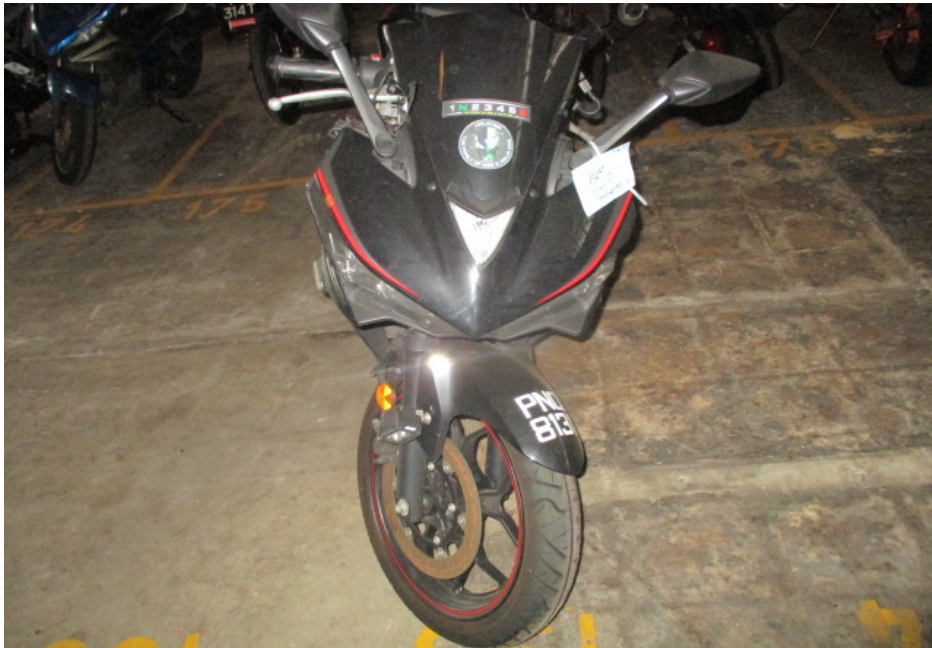
**Photo 23** shows the front wheel of the Motorcycle turned towards its full left. Turning the Motorcycle's handle bar towards the left and right did not produce any abnormal free play and/or resistance. This would indicate that the steering system of the Motorcycle was in serviceable condition at the time of our inspection.

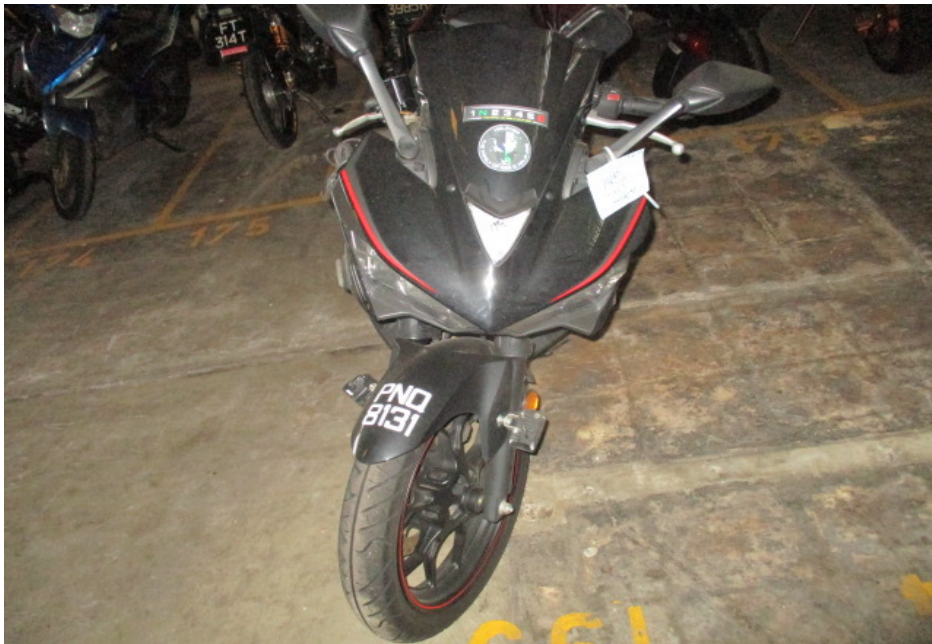
**Photo 24** shows the front wheel of the Motorcycle turned towards its full right. Turning the Motorcycle's handle bar towards the left and right did not produce any abnormal free play and/or resistance. This would indicate that the steering system of the Motorcycle was in serviceable condition at the time of our inspection.

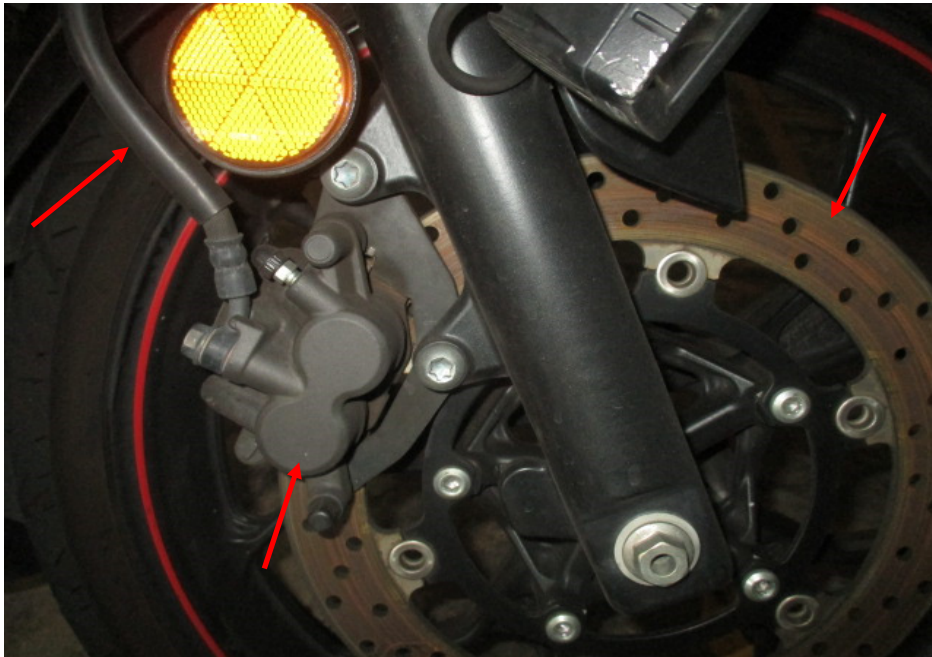
**Photo 25** shows a close up view of the front brake caliper, front brake disc and front brake hose (arrowed) of the Motorcycle, which are all part of the components in the hydraulic front brake system of the Motorcycle. Our visual checks of these various components had revealed all to be intact with no visible damage. No leakage of brake fluid was also observed.

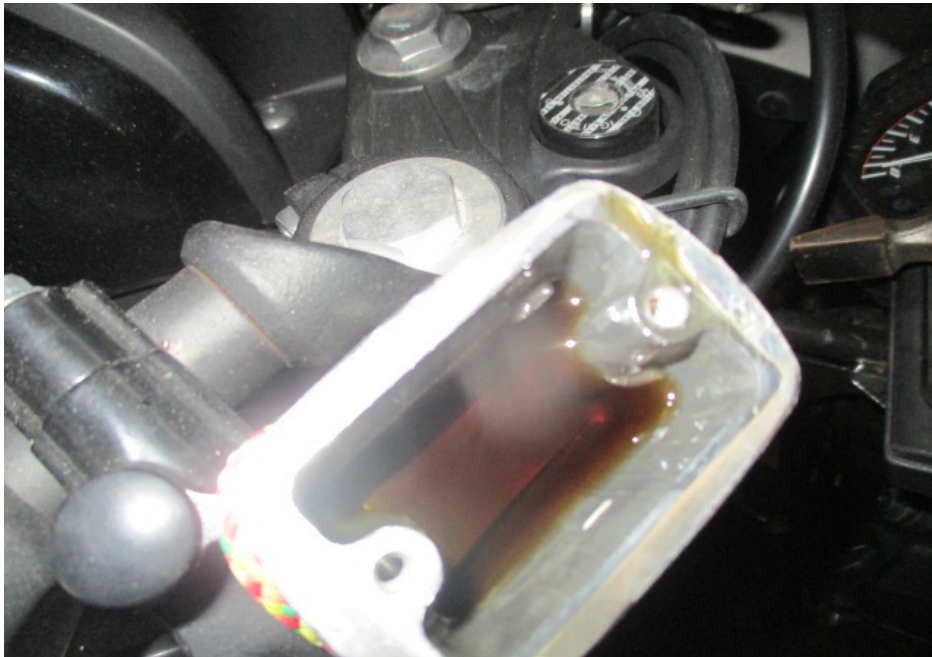
**Photo 26** shows the brake fluid reservoir for the front brake of the Motorcycle. The brake fluid was observed to be of sufficient level and without contamination for operational purposes.

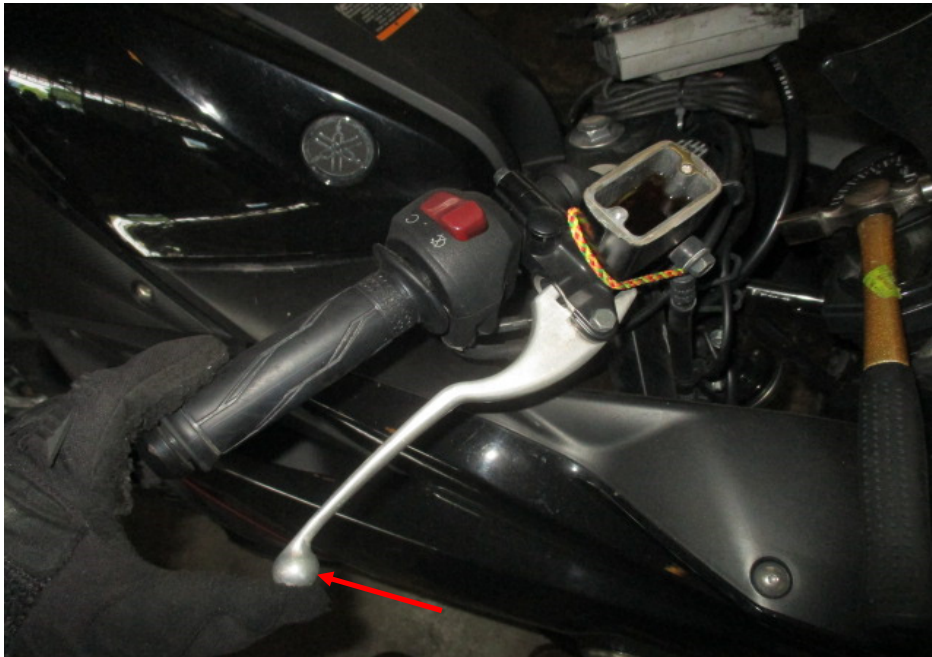
**Photo 27** shows the front brake lever being depressed. There was some resistance felt (spongy like feel) upon pressing the front brake lever (arrowed). This would indicate that there is no leakage of pressure/vacuum in the brake system.

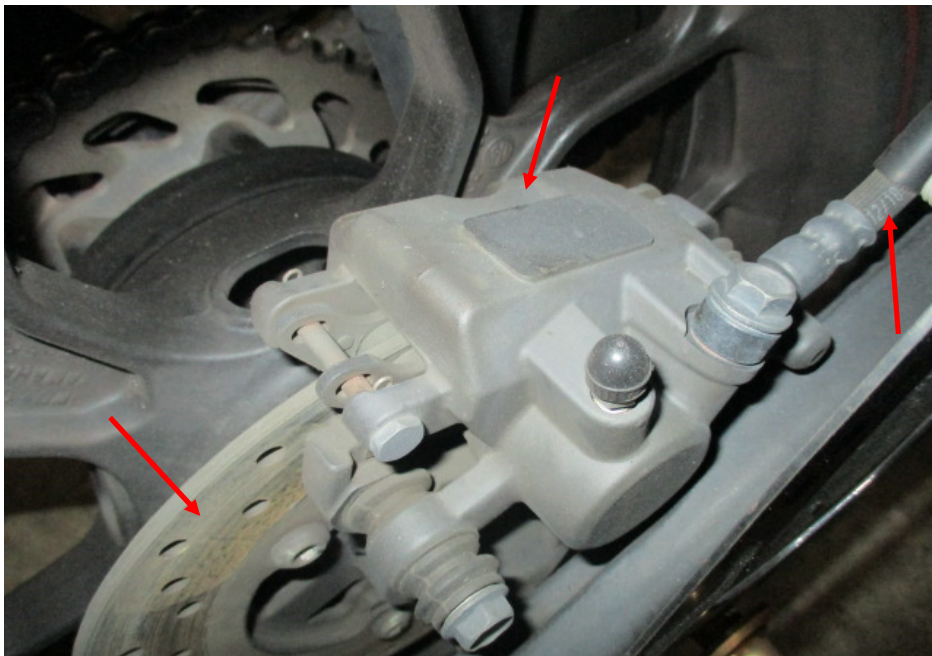
**Photo 28** shows a close up view of the rear brake caliper, rear brake disc and rear brake hose (arrowed) of the Motorcycle, which are all part of the components in the hydraulic rear brake system of the Motorcycle. Our visual checks of these various components had revealed all to be intact with no visible damage. No leakage of brake fluid was also observed.
