Your Ref: TP/IP/38627/2019  
Our Ref : CI/TPD19012882/N

**Fatal Accident Investigation Team**

**INSPECTION REPORT OF MOTORCYCLE FW 3550S**

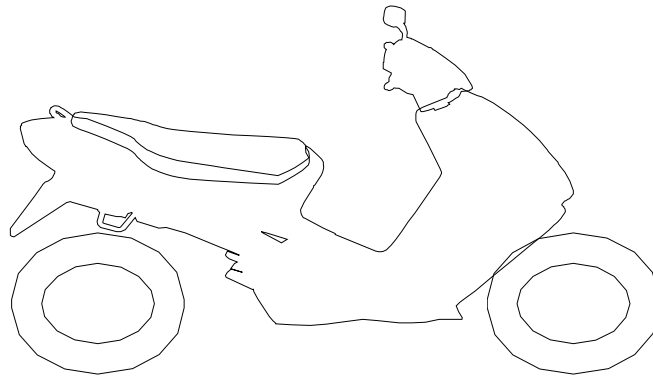
Duro 110/70 - 17 (3mm)

Maxxis 90/80 - 17 (4mm)

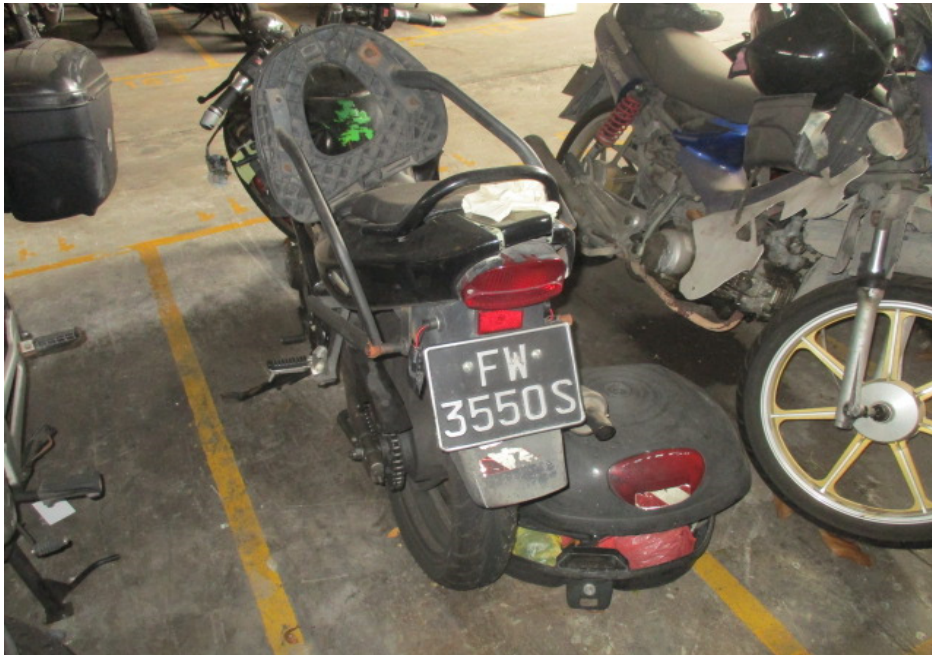
**Photo 1** shows a general view of the rear body of the Motorcycle at the time of our inspection. The Motorcycle was observed to have sustained damages all around.

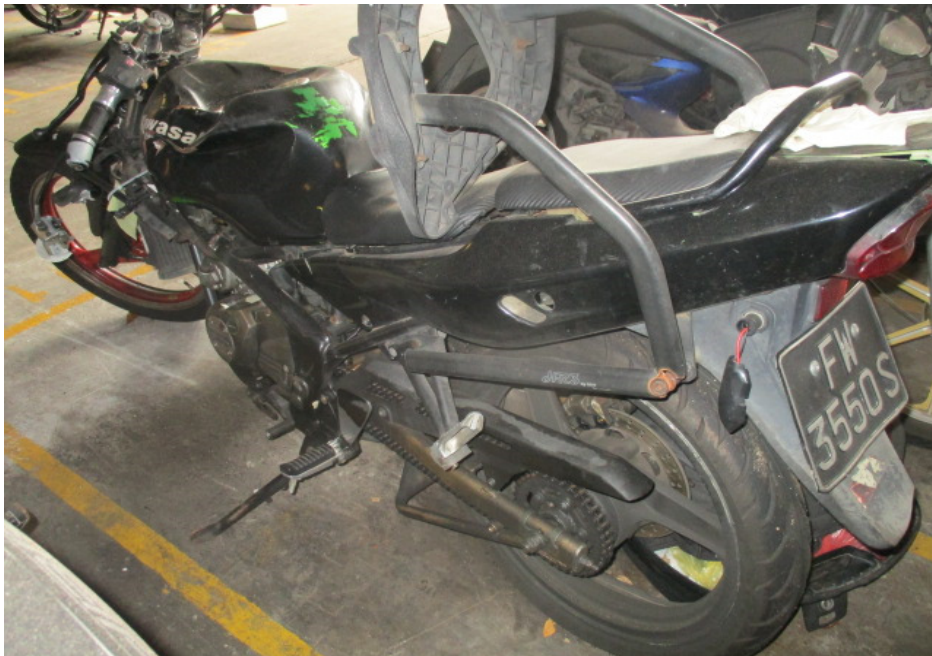
**Photo 2** shows a general view of the left rear body of the Motorcycle at the time of our inspection. The Motorcycle was observed to have sustained damages all around.

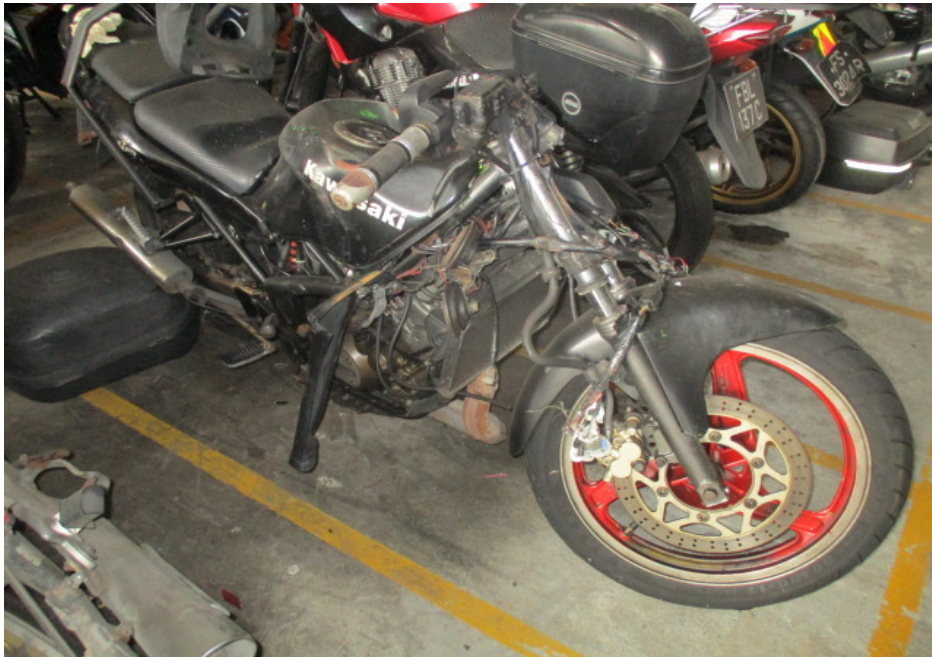
**Photo 3** shows a general view of the right front body of the Motorcycle at the time of our inspection. The Motorcycle was observed to have sustained damages all around.

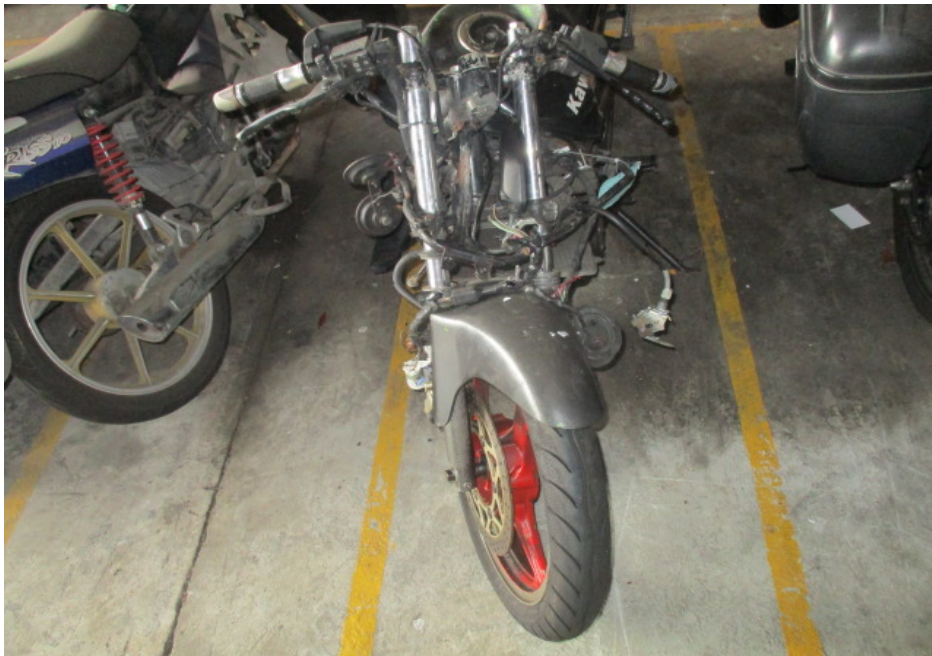
**Photo 4** shows a general view of the front body of the Motorcycle at the time of our inspection. The Motorcycle was observed to have sustained damages all around. The body parts that were found to have been damaged include its speedometer gauge, headlight assembly, side cowlings, front mudguard, side mirrors, clutch lever, front brake lever, handlebars, petrol tank, rear brake pedal, exhaust muffler and rear side covers, amongst others.

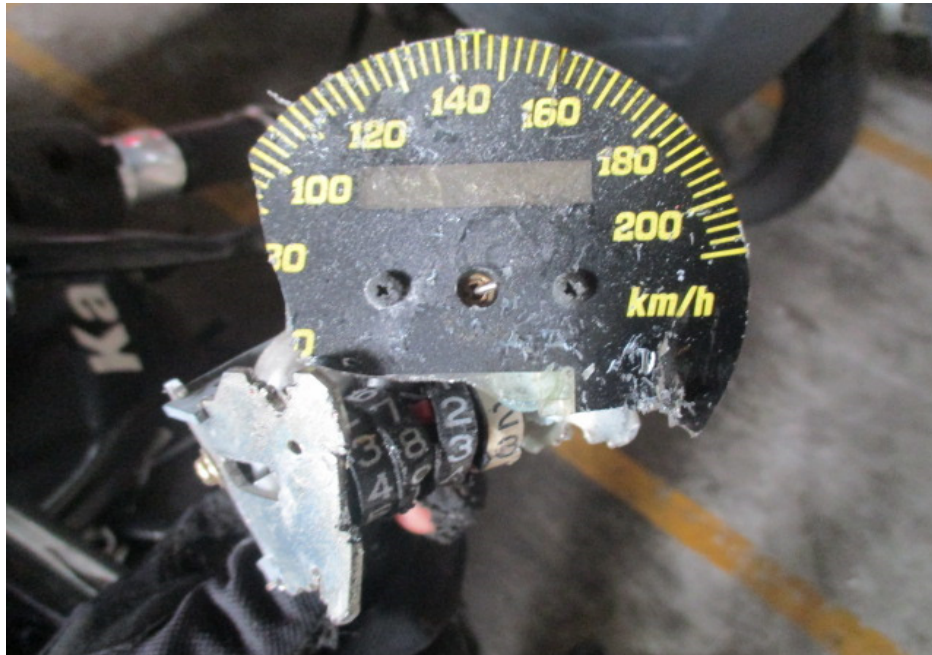
**Photo 5** shows a closer view of the damaged speedometer gauge of the Motorcycle. The mileage of the Motorcycle at the time of our inspection was not recorded due to the damage sustained to the speedometer display screen as a result of the accident.

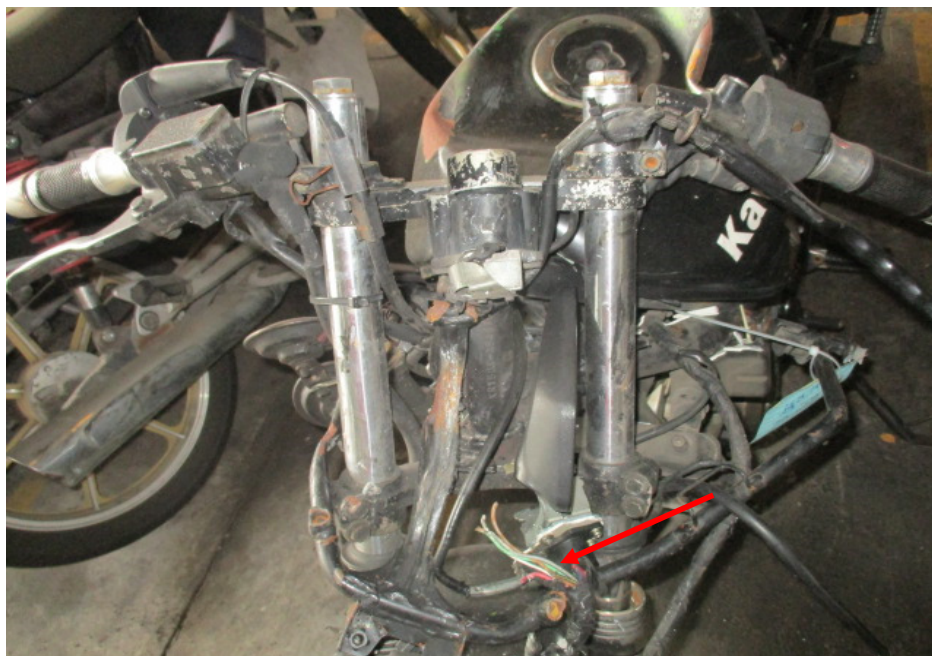
**Photo 6** shows a closer view of the headlight assembly (arrowed) which was amongst the body parts at the front body of the Motorcycle that had sustained damage as a result of the accident.

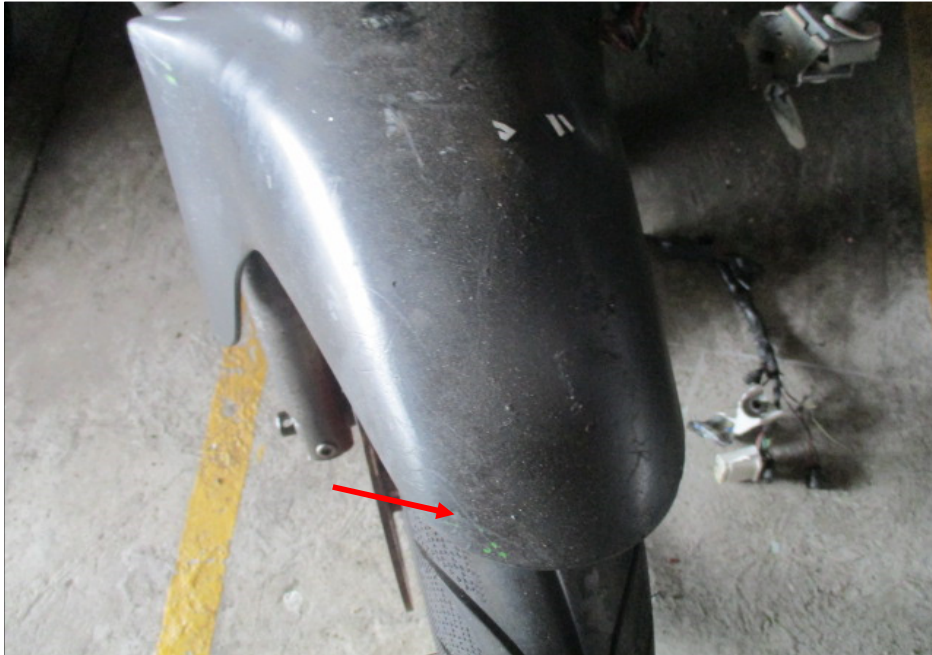
**Photo 7** shows a closer view of the front mudguard (arrowed) which was amongst the body parts at the front body of the Motorcycle that had sustained damage as a result of the accident.

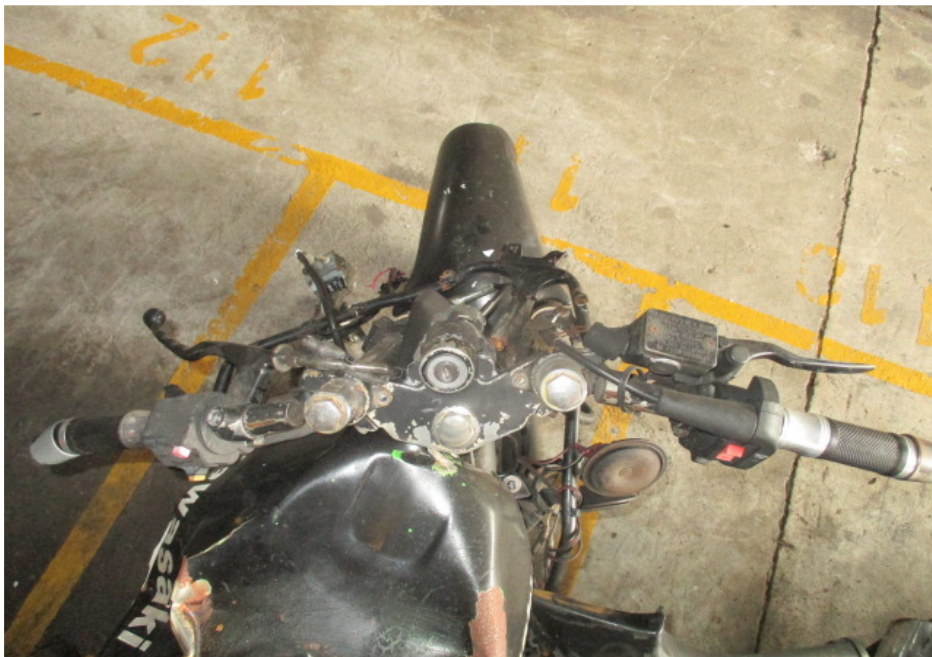
**Photo 8** shows a closer view of the side mirrors, clutch lever, front brake lever, handlebars and handlebar ends of the Motorcycle. These parts were amongst the body parts of the Motorcycle which were damaged as a result of the accident.

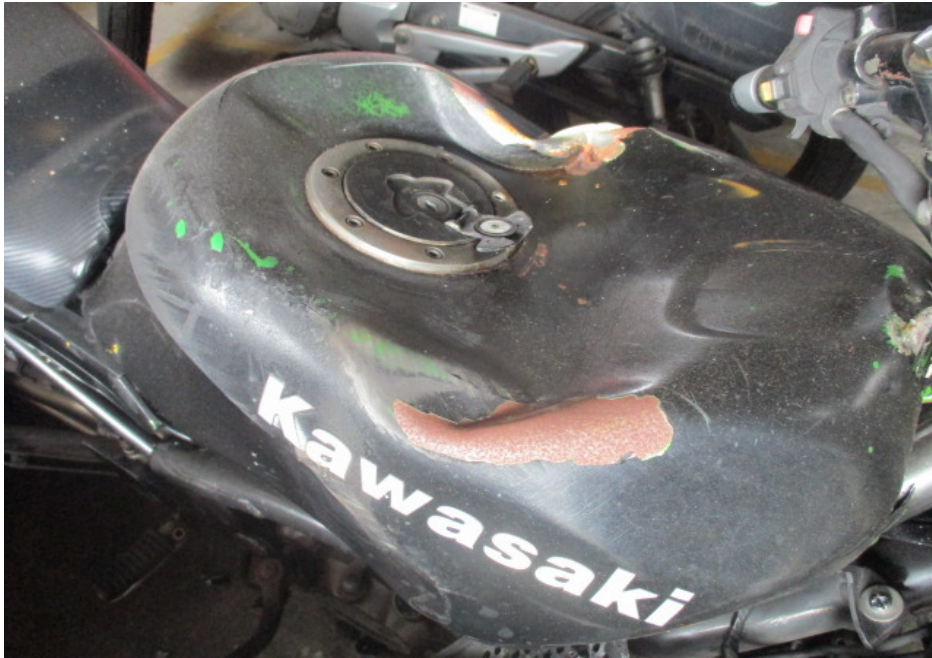
**Photo 9** shows a closer view of the petrol tank, which was amongst the body parts of the Motorcycle that had sustained damage as a result of the accident.

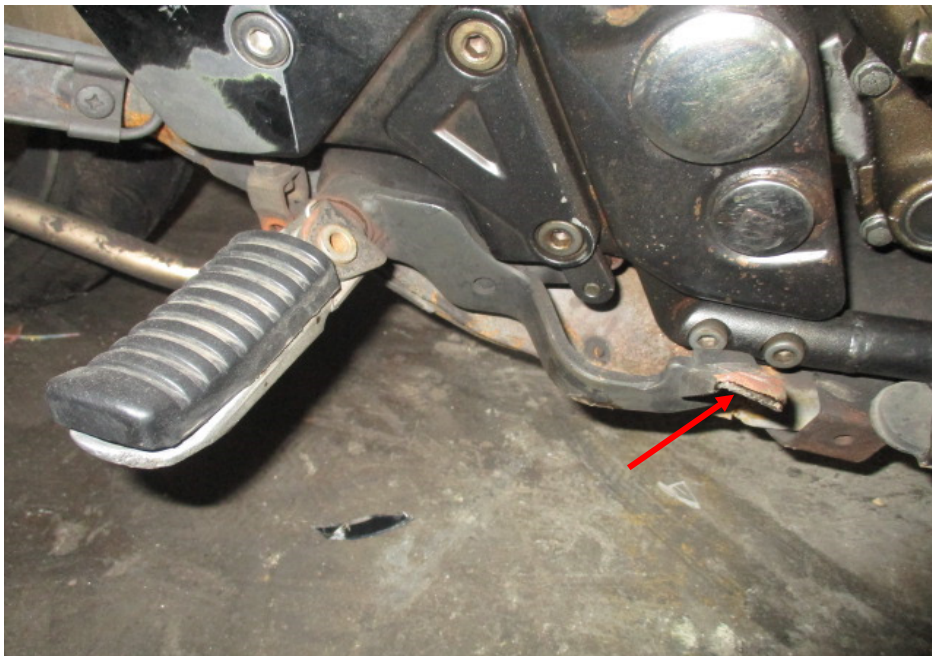
**Photo 10** shows a closer view of the rear brake pedal (arrowed) which was amongst the body parts of the Motorcycle that had sustained damage as a result of the accident.

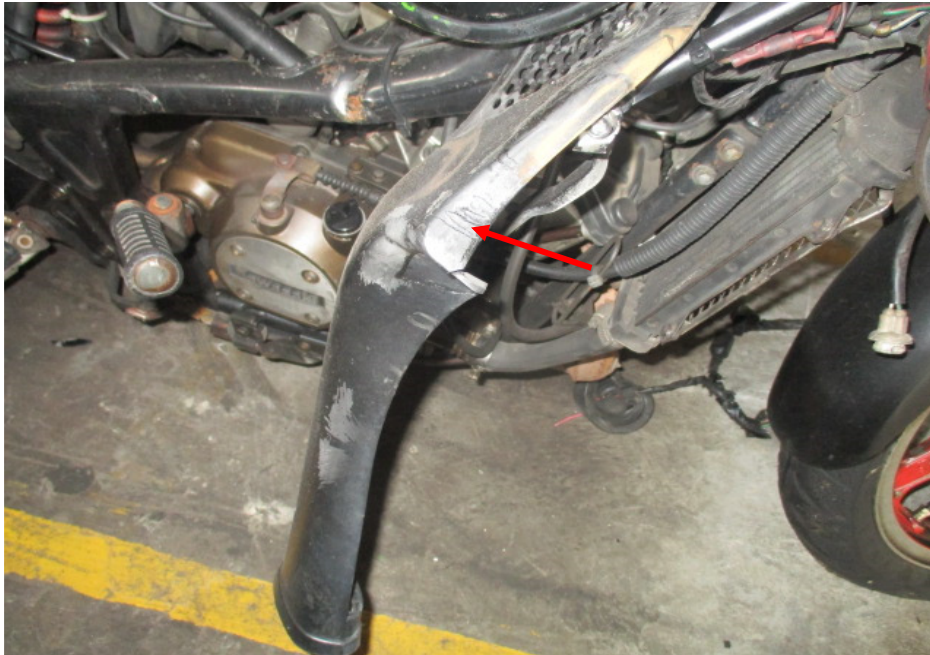
**Photo 11** shows the right cowling of the Motorcycle which had sustained extensive damages (arrowed) as a result of the accident.

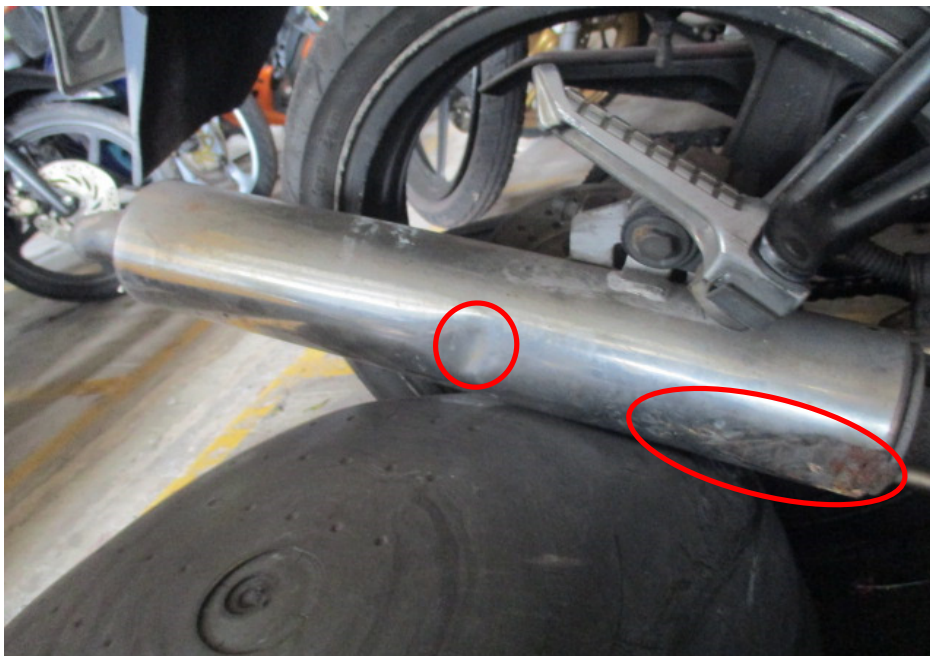
**Photo 12** shows the exhaust muffler of the Motorcycle which was observed to be dented as a result of the accident (circled).

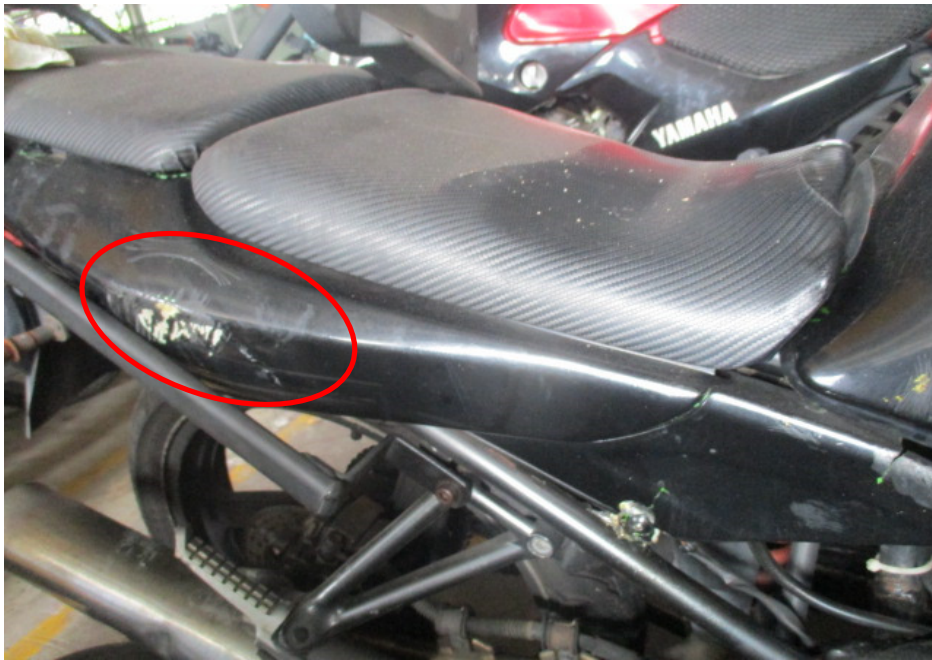
**Photo 13** shows the right rear side cover (circled) which was amongst the body parts of the Motorcycle that had sustained damage as a result of the accident.

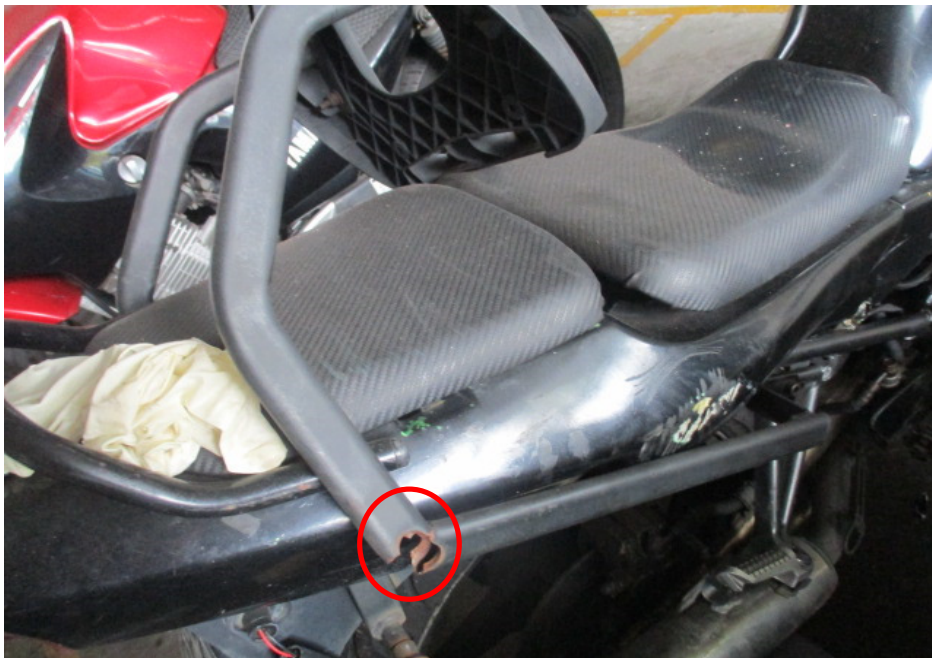
**Photo 14** shows the top box rack (circled) which was amongst the body parts of the Motorcycle that had sustained damage as a result of the accident.

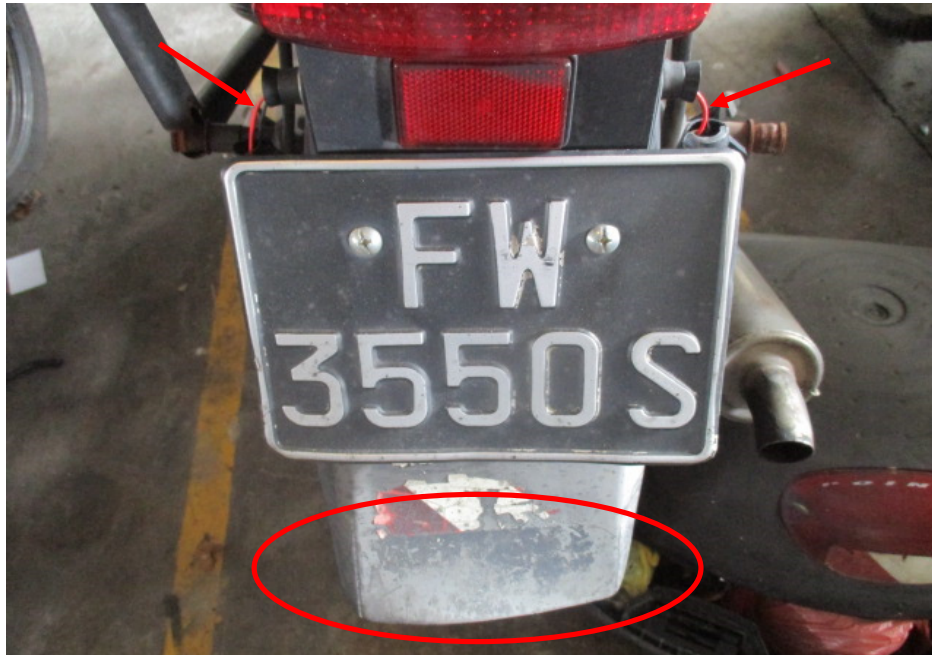
**Photo 15** shows the dislodged rear signal lamps (arrowed) and deformed rear mudguard (circled) which was amongst the body parts at the rear of the Motorcycle that had sustained damage as a result of the accident.

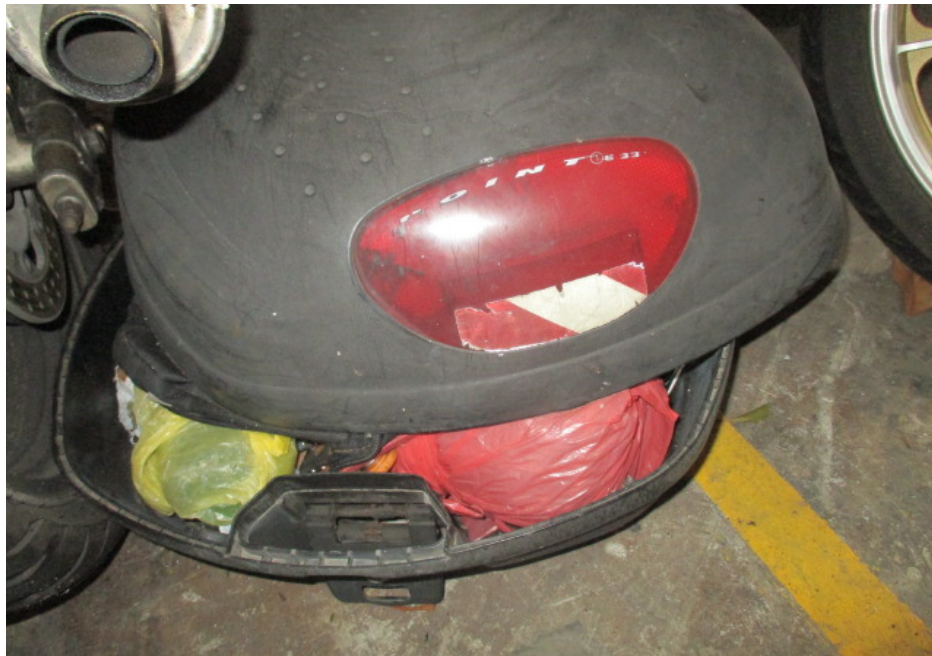
**Photo 16** shows the broken top box which was amongst the body parts at the rear of the Motorcycle that had sustained damage as a result of the accident.

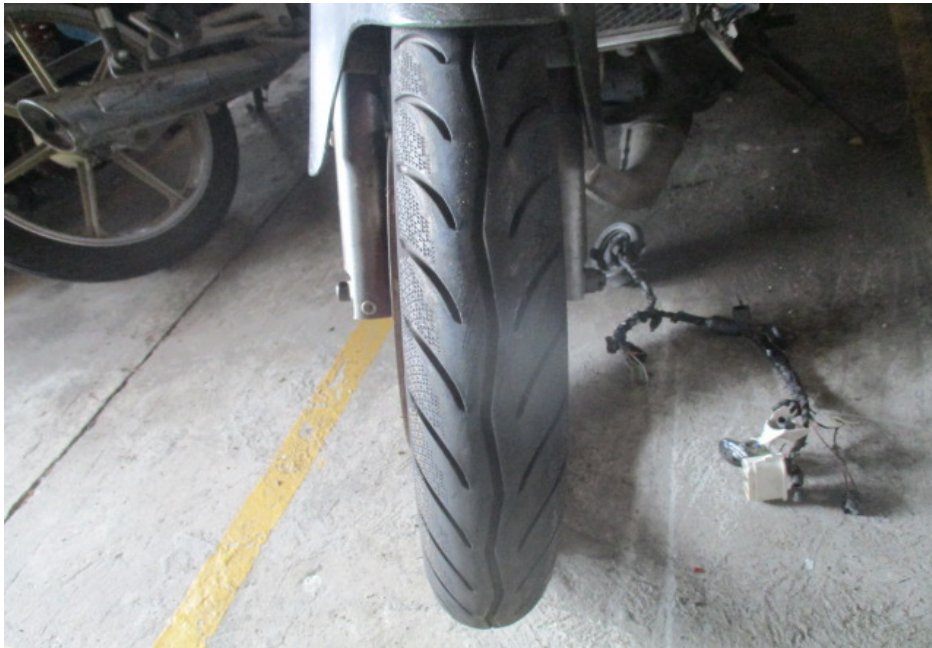
**Photo 17** shows the front tyre of the Motorcycle at the time of our inspection. The front tyre was observed to be in serviceable condition with remaining tread depth of approximately 4mm. The tyre was also observed to be sufficiently inflated for vehicular operation. We did not observe any tear, burst mark(s) and/or punctured hole(s) on the sidewalls as well as across the tread of the front tyre.

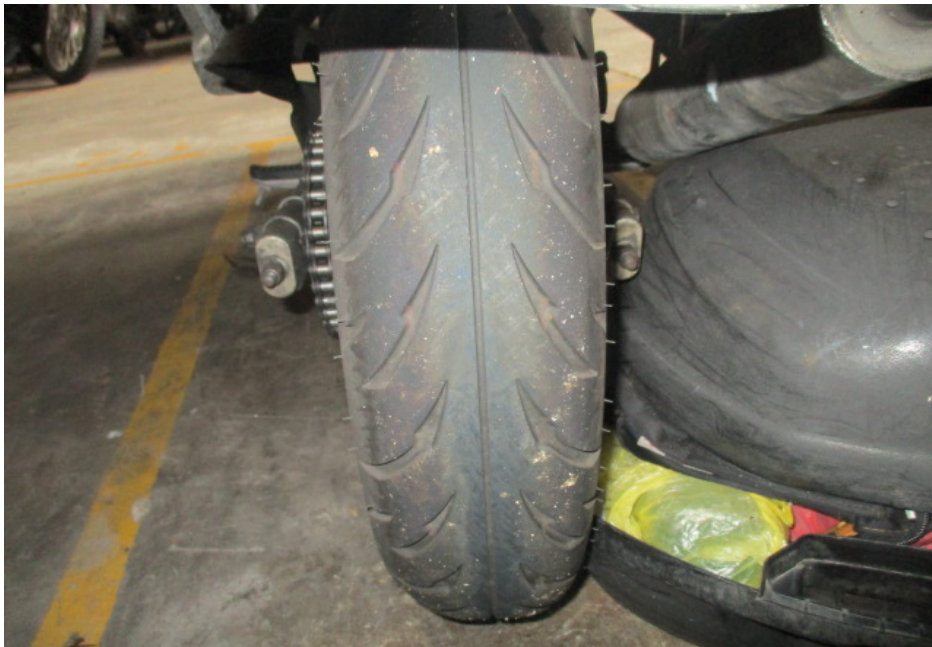
**Photo 18** shows the condition of the Motorcycle's rear tyre. The rear tyre was observed to be in serviceable condition with remaining tread depth of approximately 3mm. The tyre was also observed to be sufficiently inflated for vehicular operation. We did not observe any tear, burst mark(s) and/or punctured hole(s) on the sidewalls as well as across the tread of the rear tyre.

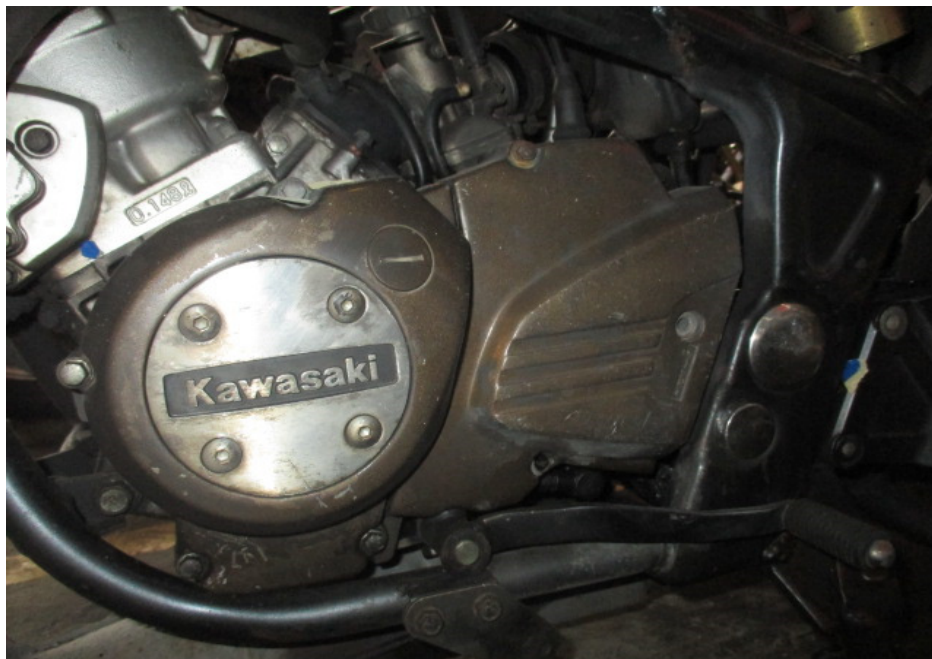
**Photo 19** shows the left side of the engine of the Motorcycle at the time of our inspection. The various engine related parts and components were found to be intact with no visible damage. There was also no sign(s) or indication(s) of fluid leak observed around the left engine area of the Motorcycle.

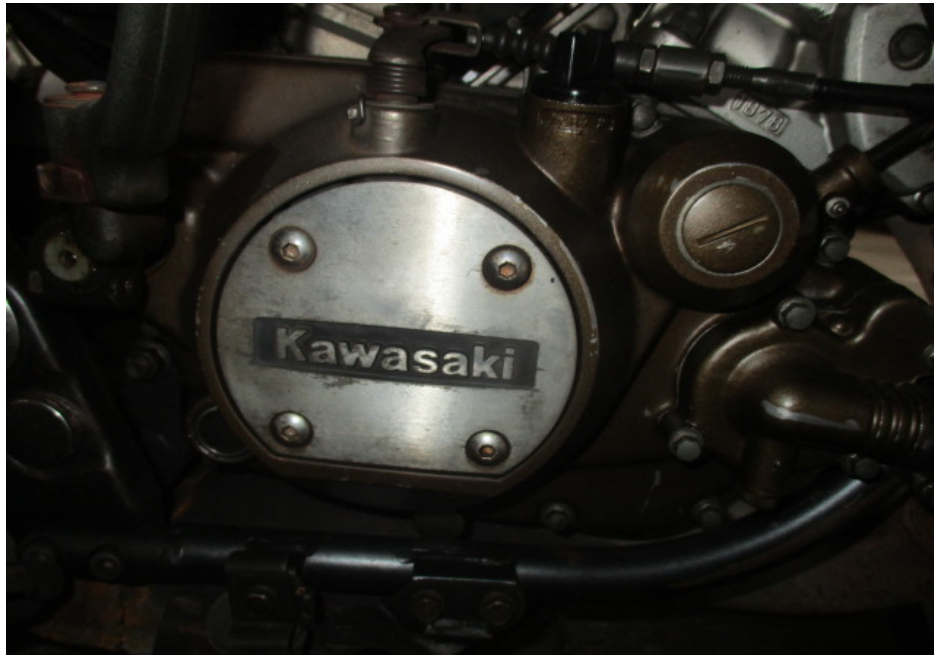
**Photo 20** shows the right side of the engine of the Motorcycle at the time of our inspection. The various engine related parts and components were found to be intact with no visible damage. There was also no sign(s) or indication(s) of fluid leak observed around the right engine area of the Motorcycle.

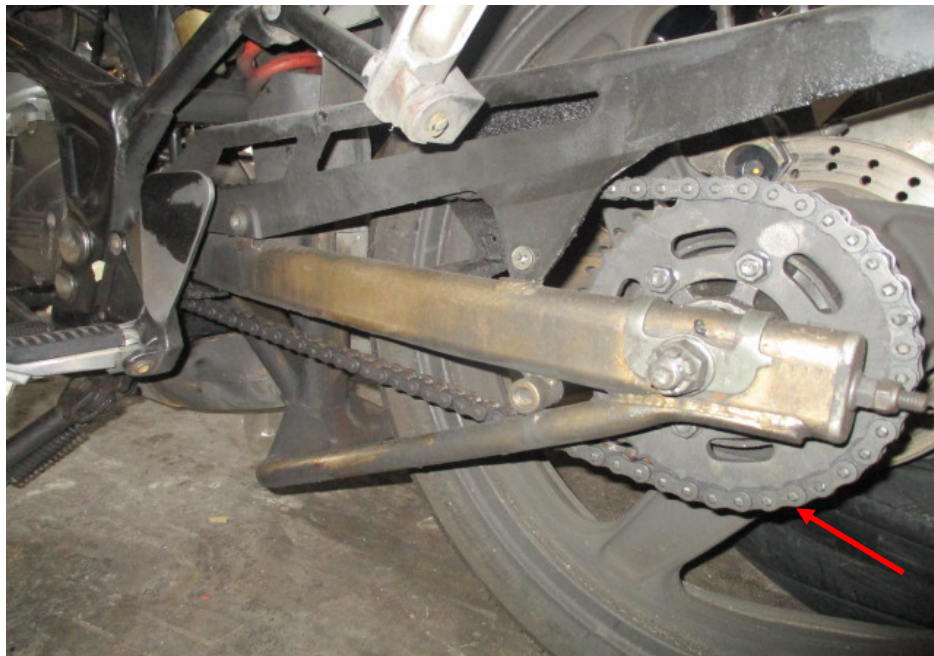
**Photo 21** shows the general view of the gear train (arrowed) of the Motorcycle, which was observed to be intact with no misalignment. It was also adequately lubricated for operating purposes.

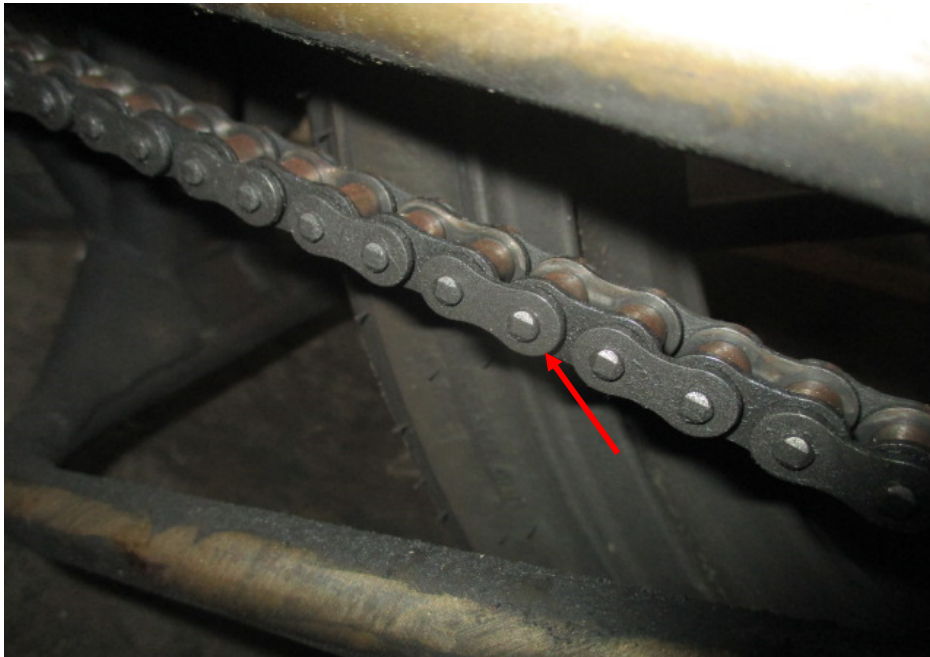
**Photo 22** shows a closer view of the gear train (arrowed) of the Motorcycle, which was observed to be intact with no misalignment. It was also adequately lubricated for operating purposes.

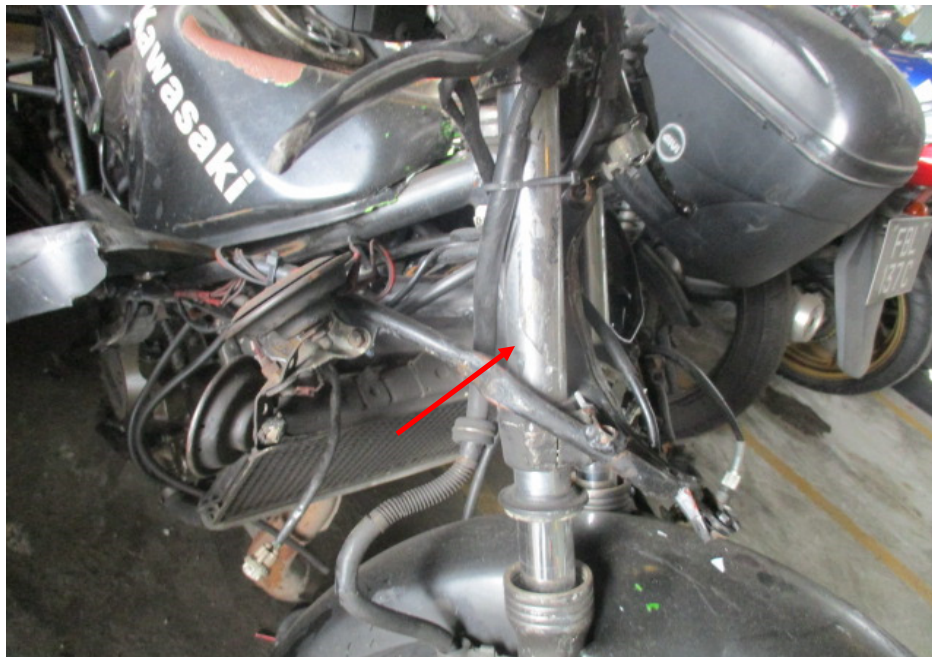
11. For this case, we were not able to conduct any test(s) on the steering system of the Motorcycle due to the damage of its front fork. The front fork was found to be bent inwards as a result of the accident.

**Photo 23** shows the front forks of the Motorcycle. The right front fork (arrowed) was observed to be bent inwards as a result of the accident. We were hence not able to conduct any tests on the steering system of the Motorcycle.

16. For this particular case, we were unable to determine whether there was any possible mechanical failure to the Motorcycle that may have contributed to the accident. This was mainly due to the extent of damage that it had sustained. Its steering system was damaged as a result of the accident.
17. The 2 tyres of the Motorcycle were found to be in serviceable condition. There was no tear, cut or burst mark(s) on the outer and the inner sidewalls as well as across the tread of the 2 tyres. The 2 tyres were sufficiently inflated for vehicular operation with remaining tread depths of approximately 4mm and 3mm each.

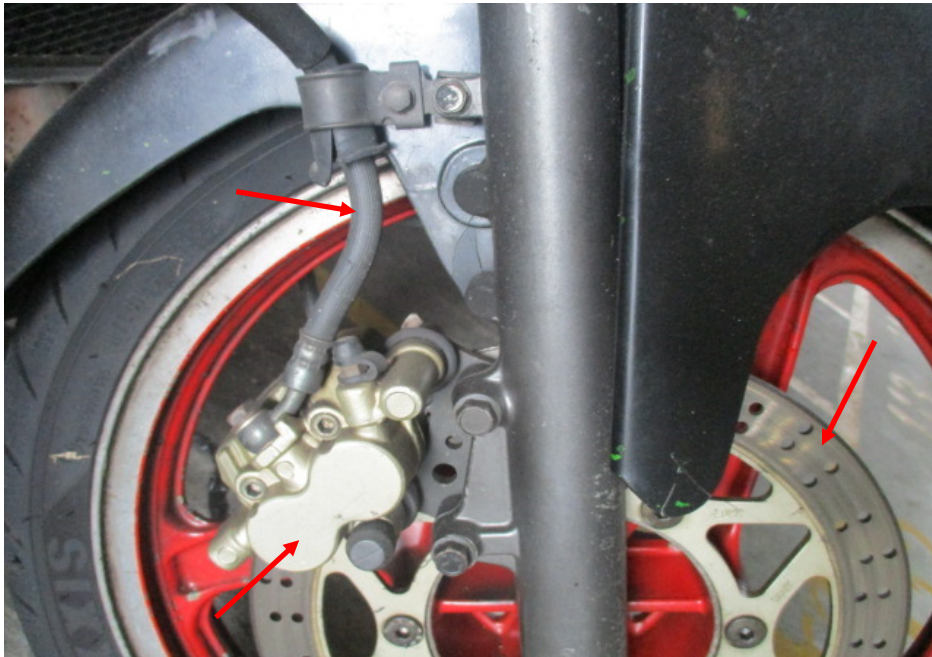
**Photo 24** shows a close up view of the front brake caliper, front brake disc and front brake hose (arrowed) of the Motorcycle, which are all part of the components in the hydraulic front brake system of the Motorcycle. Our visual checks of these various components had revealed all to be intact with no visible damage. No leakage of brake fluid was also observed.

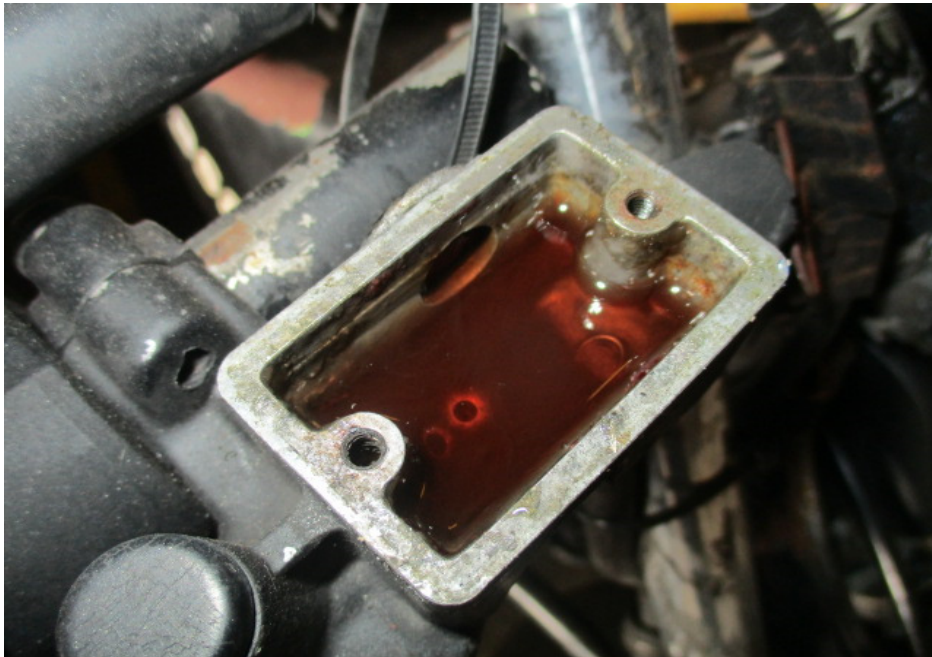
**Photo 25** shows the brake fluid reservoir for the front brake of the Motorcycle. The brake fluid was observed to be of sufficient level and without contamination for operational purposes (arrowed).

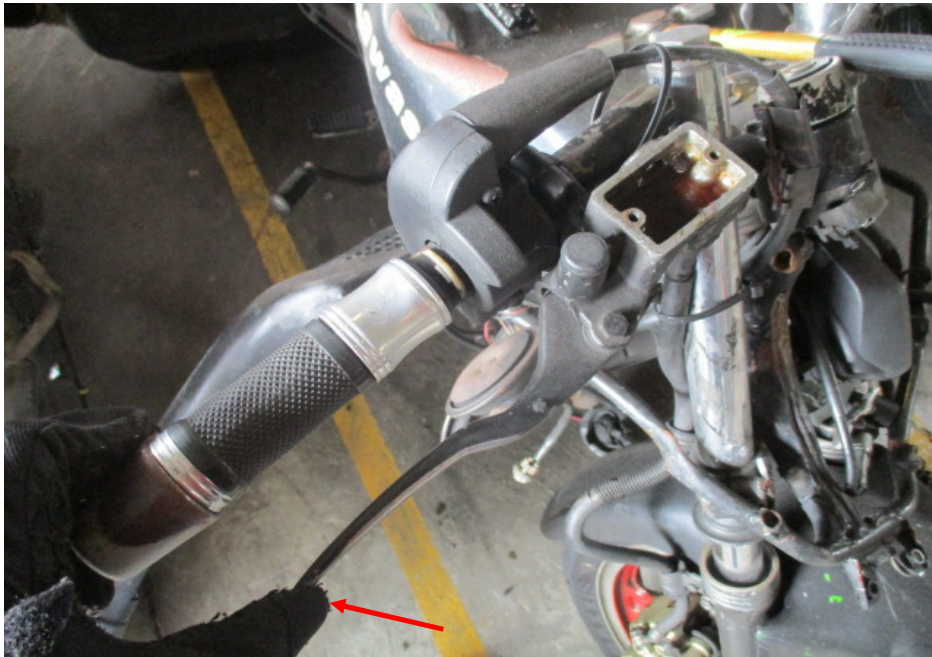
**Photo 26** shows the front brake lever being depressed. There was some resistance felt (spongy like feel) upon pressing the front brake lever (arrowed). This would indicate that there is no leakage of pressure/vacuum in the brake system.

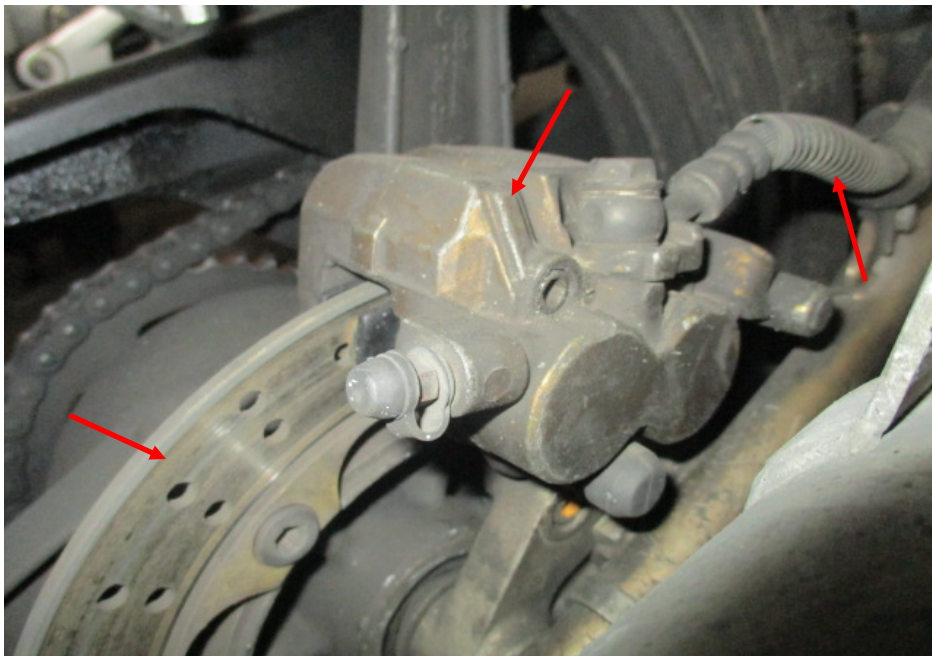
**Photo 27** shows a close up view of the rear brake caliper, rear brake disc and rear brake hose (arrowed) of the Motorcycle, which are all part of the components in the hydraulic rear brake system of the Motorcycle. Our visual checks of these various components had revealed all to be intact with no visible damage. No leakage of brake fluid was also observed.
