Your Ref: TP/IP/37529/2019  
Our Ref : CI/TPD19012883/N

2 August 2019

**Fatal Accident Investigation Team**

**INSPECTION REPORT OF MOTORCYCLE FBG 8685K**

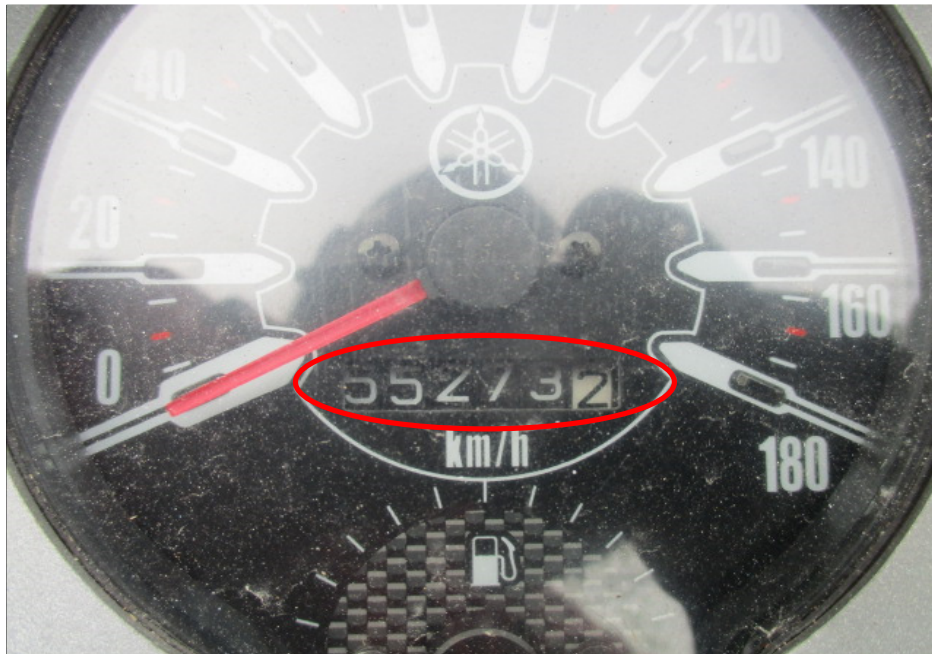
**Photo 1** shows the speedometer gauge of the Motorcycle where the mileage recorded at the time of our inspection was 55, 273km (circled).

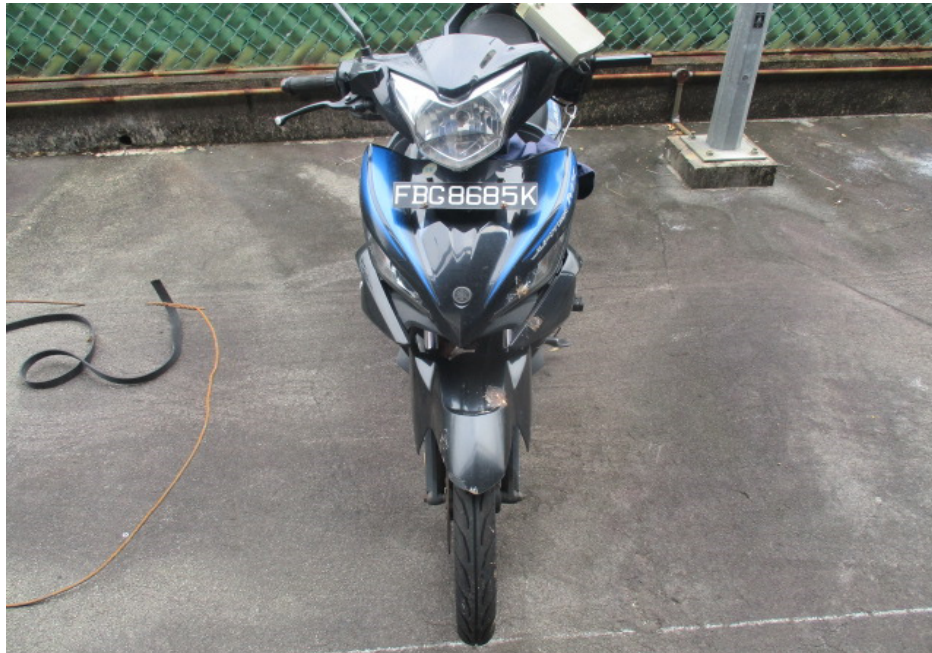
**Photo 2** shows a general view of the front portion of the Motorcycle at the time of our inspection. The Motorcycle was observed to have sustained damages all around.

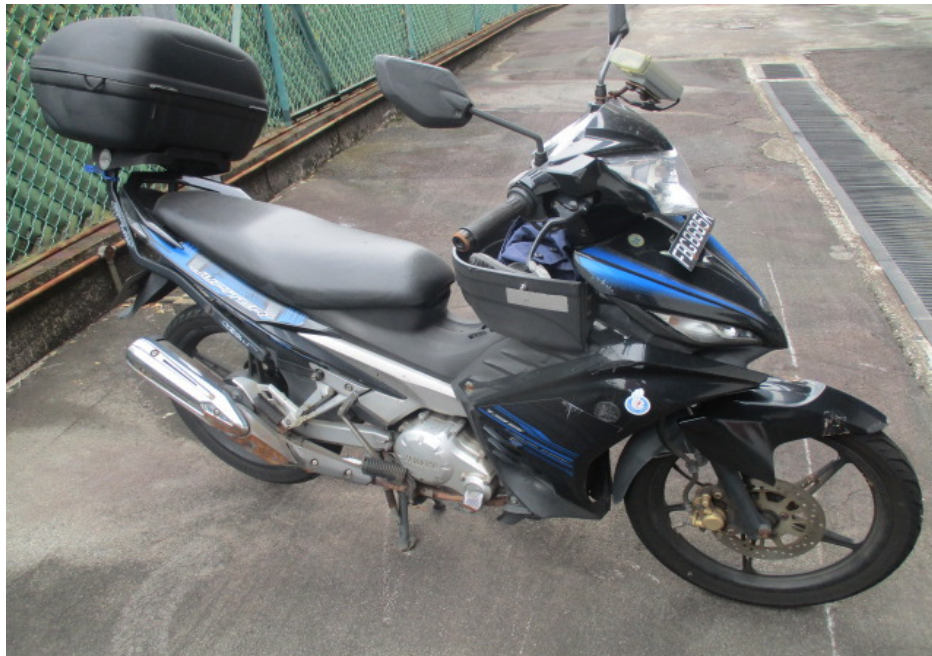
4. The mileage of the Motorcycle at the time of our inspection was 55, 273km.
5. The Motorcycle was observed to have sustained damages all around. The body parts that were found to have been damaged include its headlight cowl, front cowling, front mudguard, side cowlings, front brake lever, right side mirror, right front footrest, rear brake pedal, right rear side cover and exhaust muffler, amongst others

**Photo 3** shows a general view of the right body of the Motorcycle at the time of our inspection. The Motorcycle was observed to have sustained damages all around. Amongst the body parts that were found to have been damaged include its headlight cowl, front cowl, front mudguard, side cowlings, front brake lever, right side mirror, right front footrest, rear brake pedal, right rear side cover and exhaust muffler, amongst others.

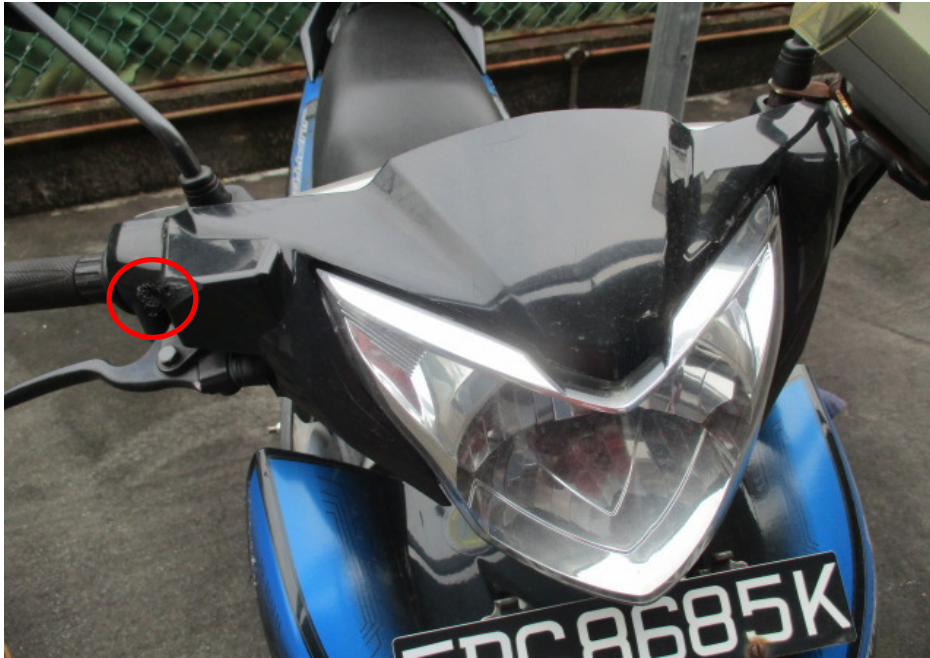
**Photo 4** shows a closer view of the headlight cowl which was amongst the body parts at the front body of the Motorcycle that had sustained damage of grazing nature (circled) as a result of the accident.

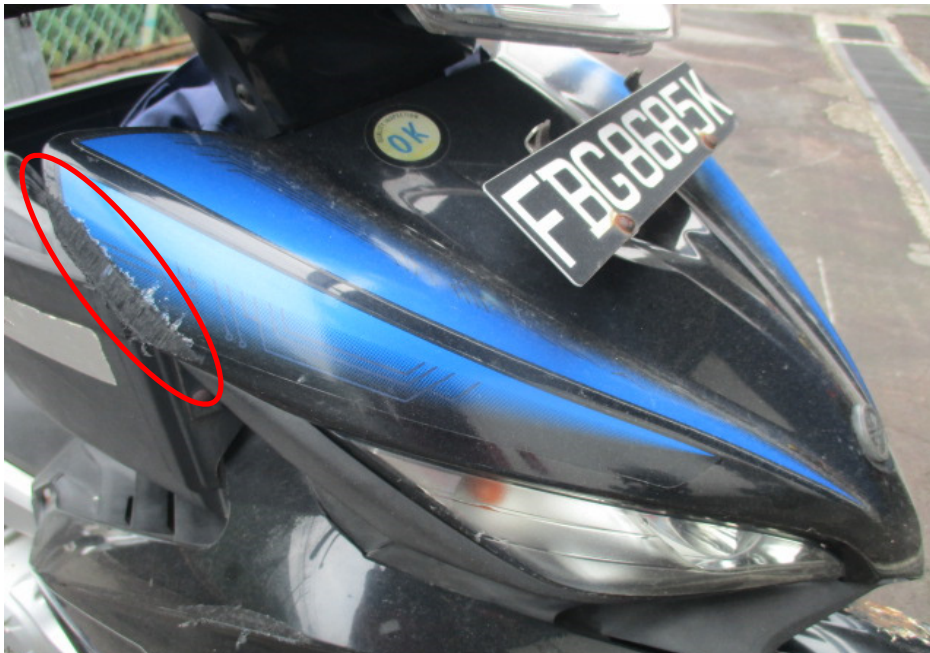
**Photo 5** shows a close up view of the front cowling (circled) which was amongst the body parts of the Motorcycle that had sustained damage as a result of the accident.

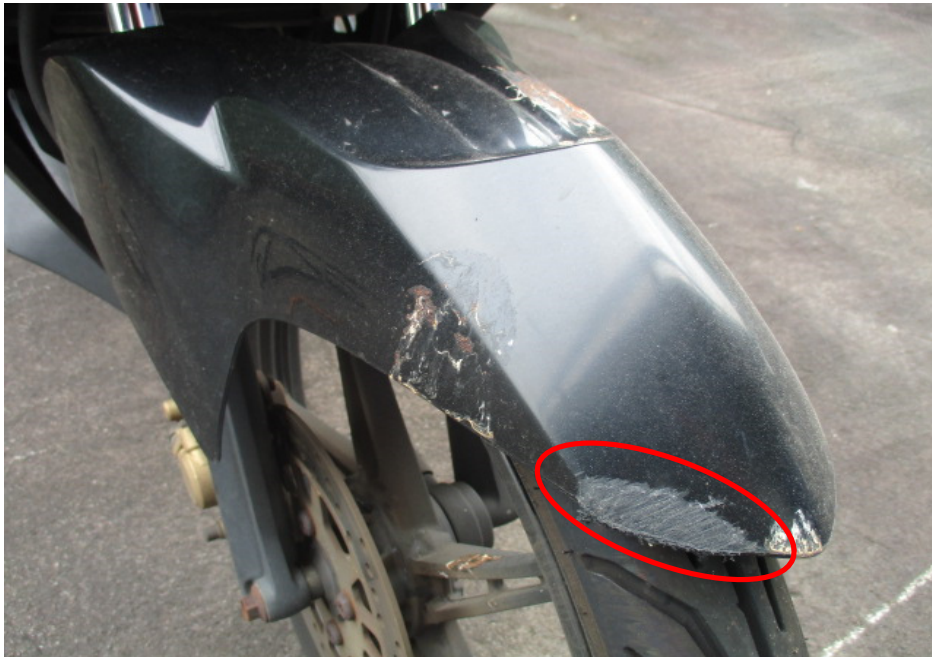
**Photo 6** shows a closer view of the front mudguard (circled) which was amongst the body parts at the front body of the Motorcycle that had sustained damage as a result of the accident.

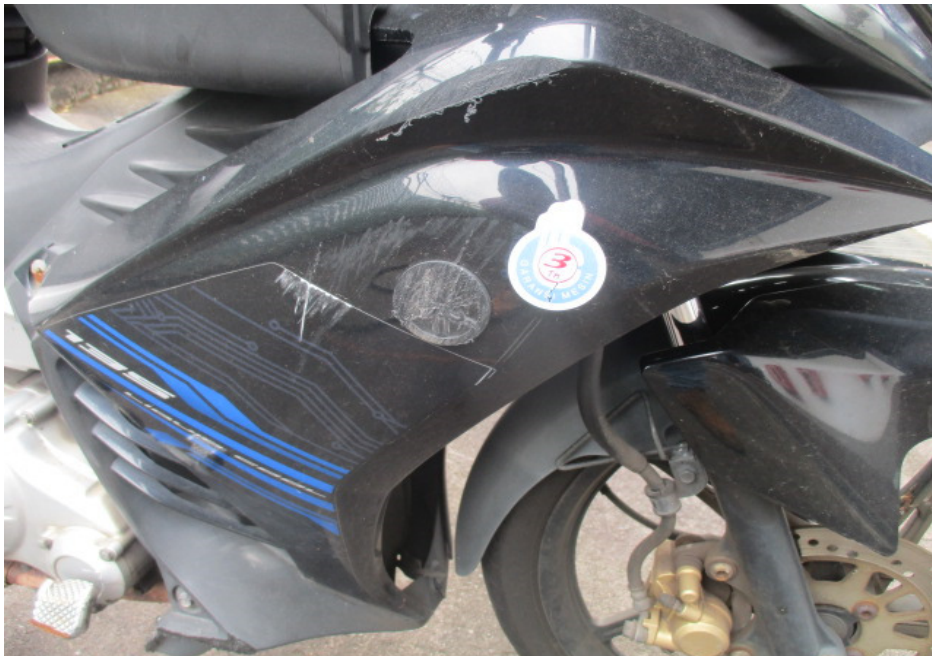
**Photo 7** shows a closer view of the right cowling of the Motorcycle that had sustained damages as a result of the accident.

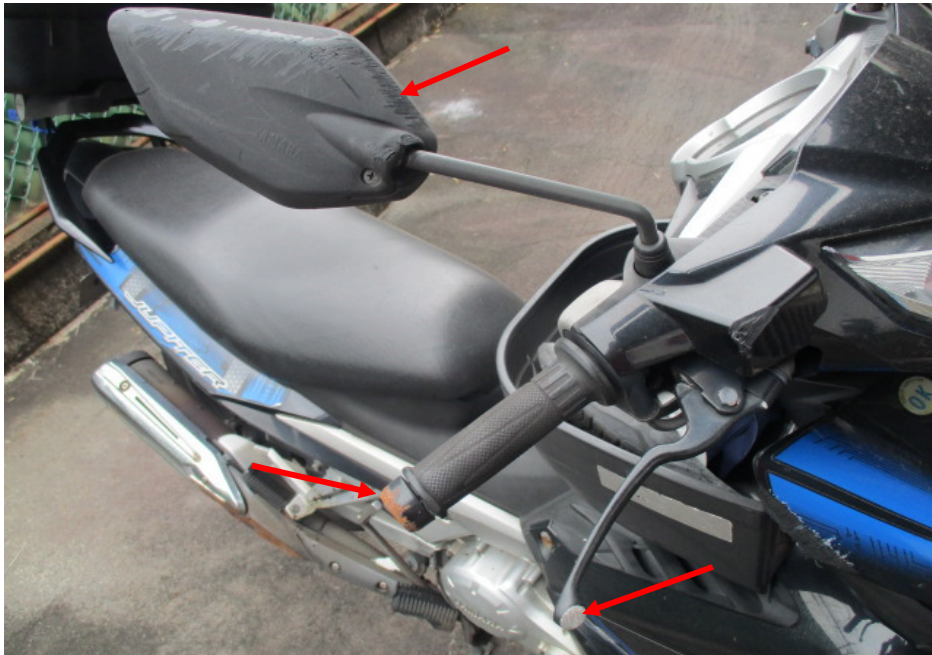
**Photo 8** shows a closer view of the front brake lever, right handlebar end and right side mirror (circled) which were amongst the body parts of the Motorcycle that had sustained damage as a result of the accident.

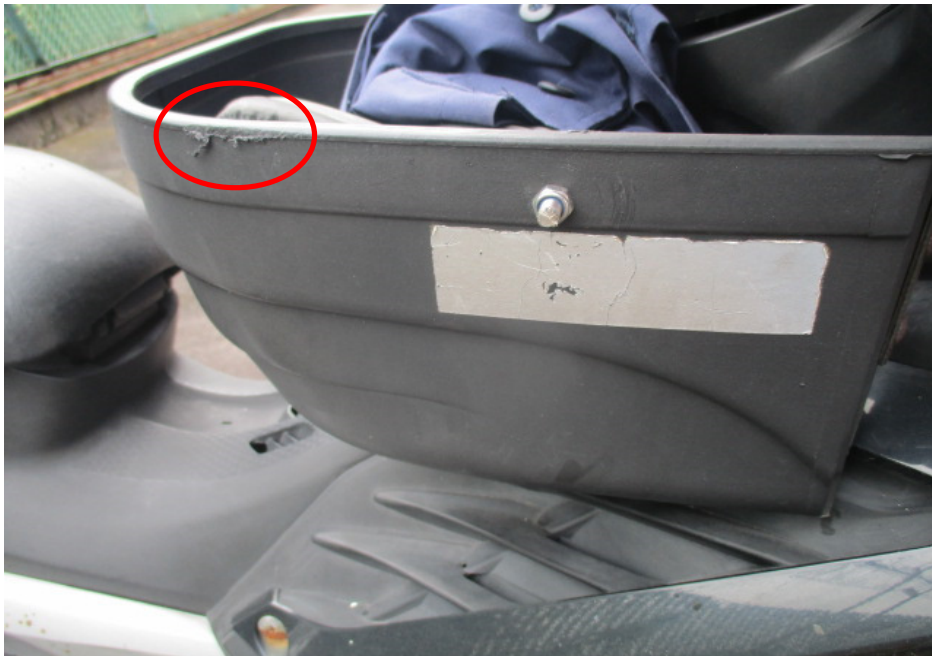
**Photo 9** shows a closer view of the front box which was amongst the body parts of the Motorcycle that had sustained damage of grazing nature (circled) as a result of the accident.

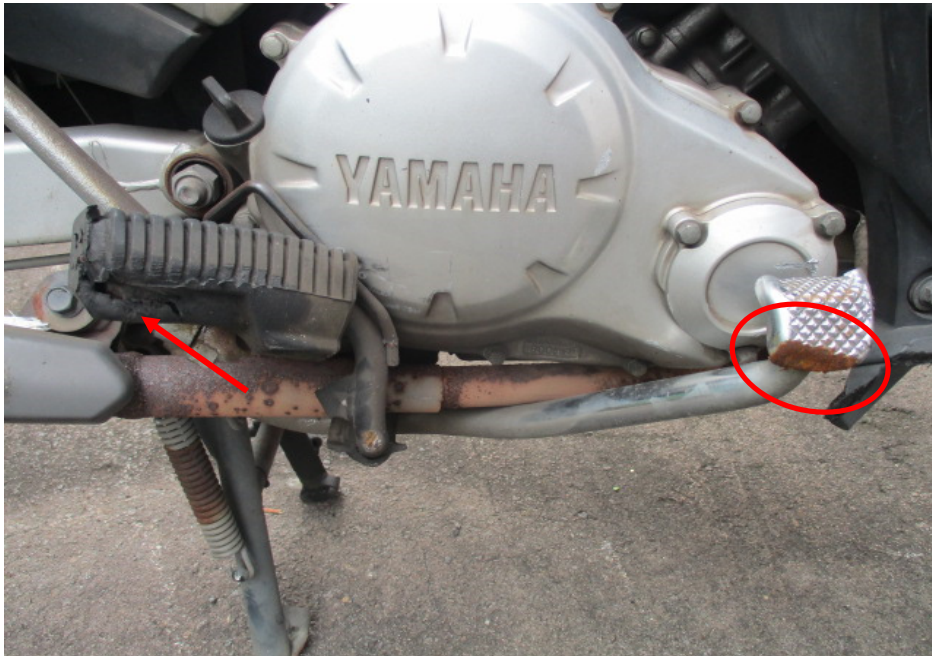
**Photo 10** shows a closer view of the right front footrest (arrowed) and rear brake pedal (circled) which was amongst the body parts of the Motorcycle that had sustained damage as a result of the accident.

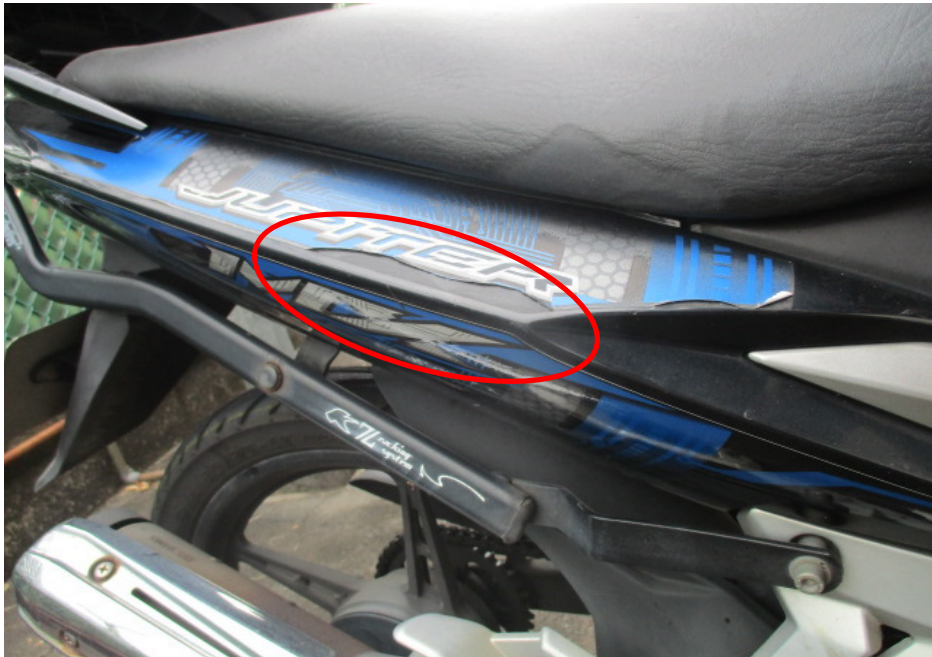
**Photo 11** shows the right rear side cover of the Motorcycle which was observed to be missing as a result of the accident (circled).

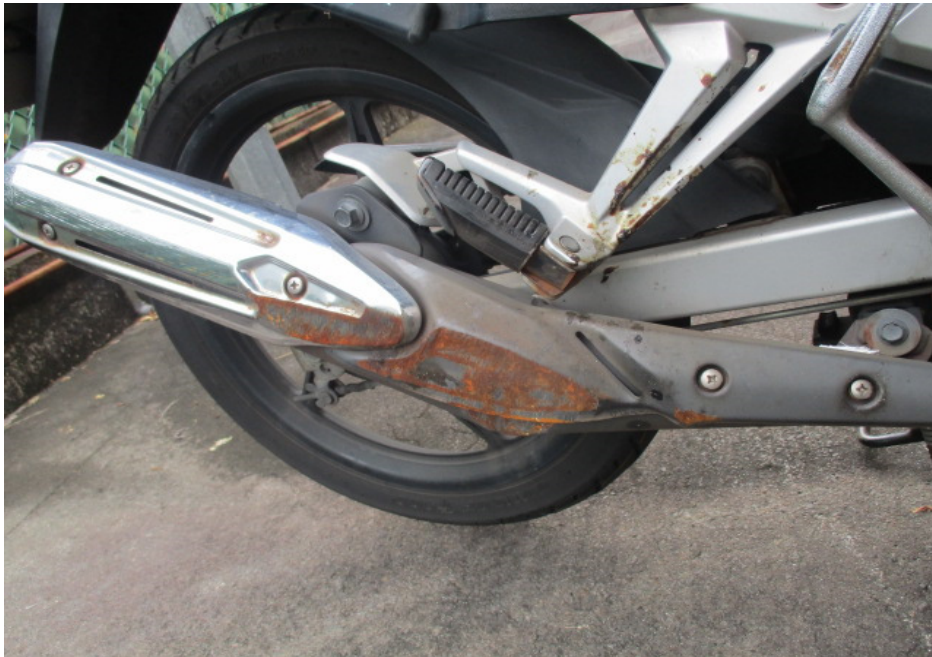
**Photo 12** shows the exhaust muffler and exhaust muffler heat shield which were amongst the body parts of the Motorcycle that had sustained damages of grazing nature as a result of the accident.

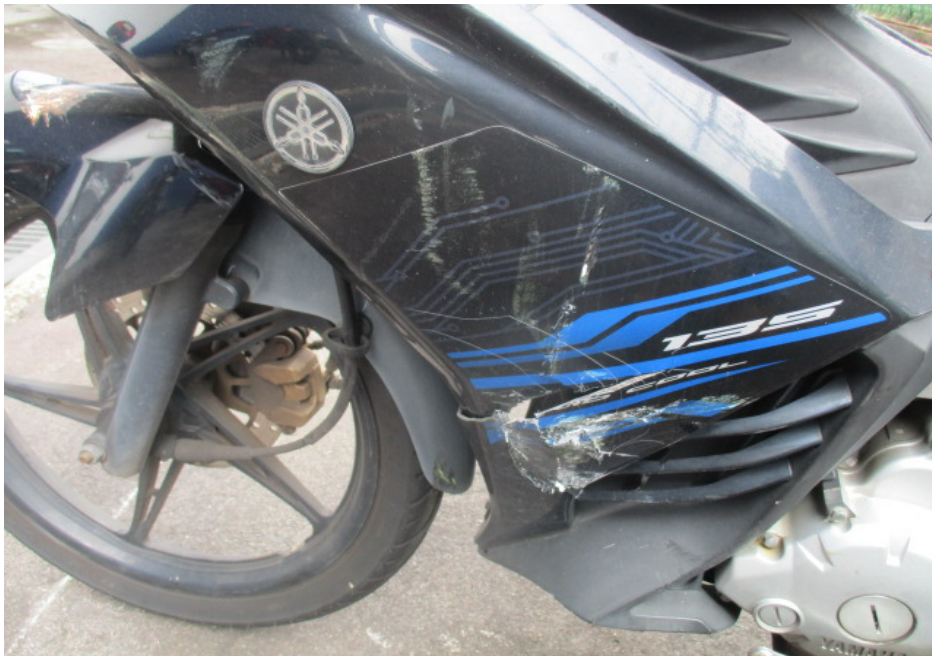
**Photo 13** shows a closer view of the left cowling of the Motorcycle that had sustained damages as a result of the accident.

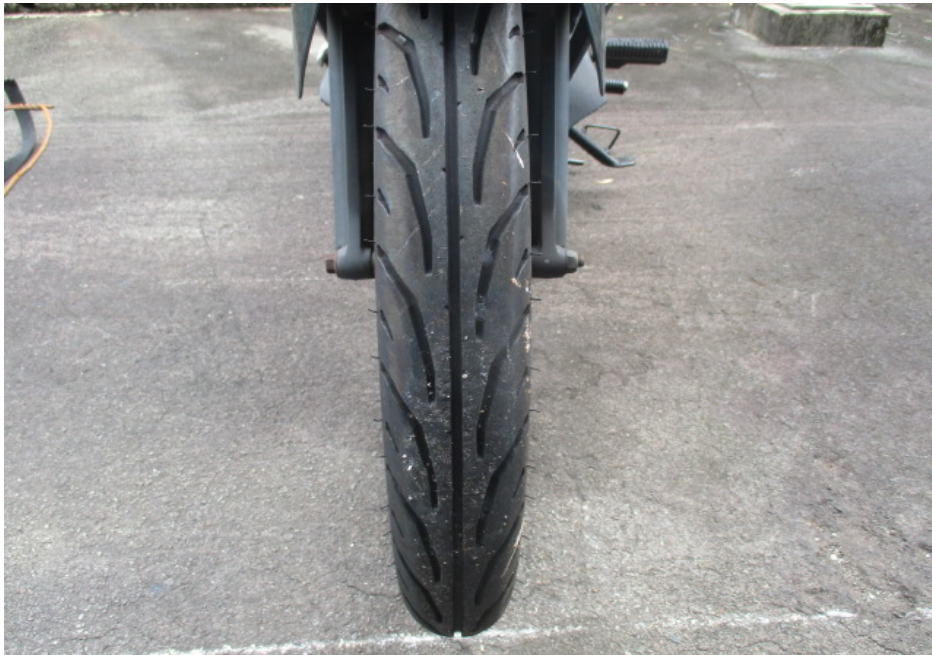
Dunlop 80/90 - 17 (3mm)

**Photo 14** shows the condition of the Motorcycle's front tyre. The front tyre was observed to be in serviceable condition with remaining tread depth of approximately 3mm. There was no tear, burst mark(s) and/or punctured hole(s) on the sidewalls as well as across the tread of the front tyre.

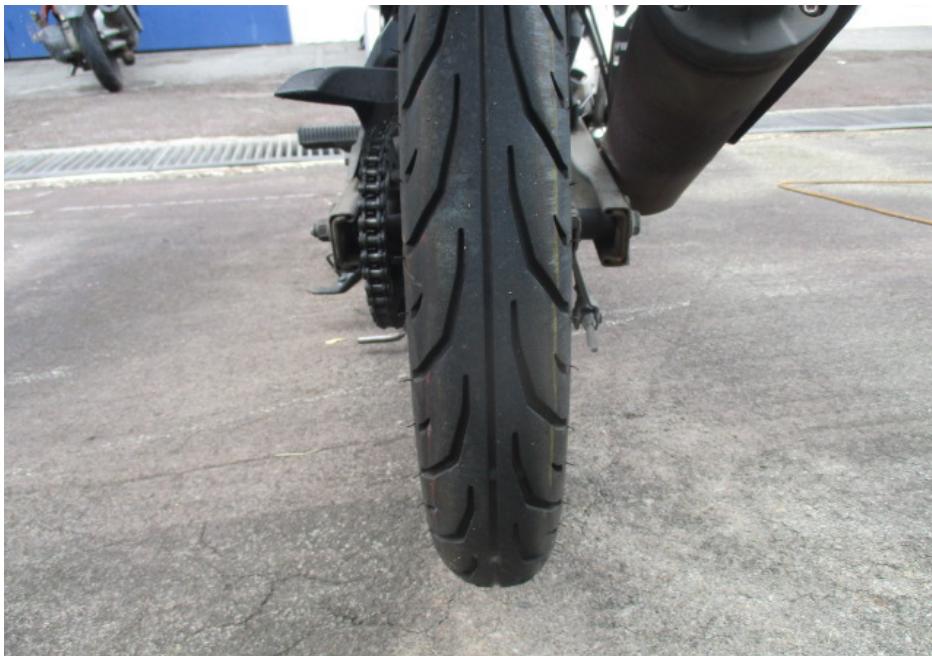
Dunlop 70/90 - 17 (3mm)

**Photo 15** shows the condition of the Motorcycle's rear tyre. The rear tyre was observed to be in serviceable condition with remaining tread depth of approximately 3mm. The tyre was also observed to be sufficiently inflated for vehicular operation. We did not observe any tear, burst mark(s) and/or punctured hole(s) on the sidewalls as well as across the tread of the rear tyre.

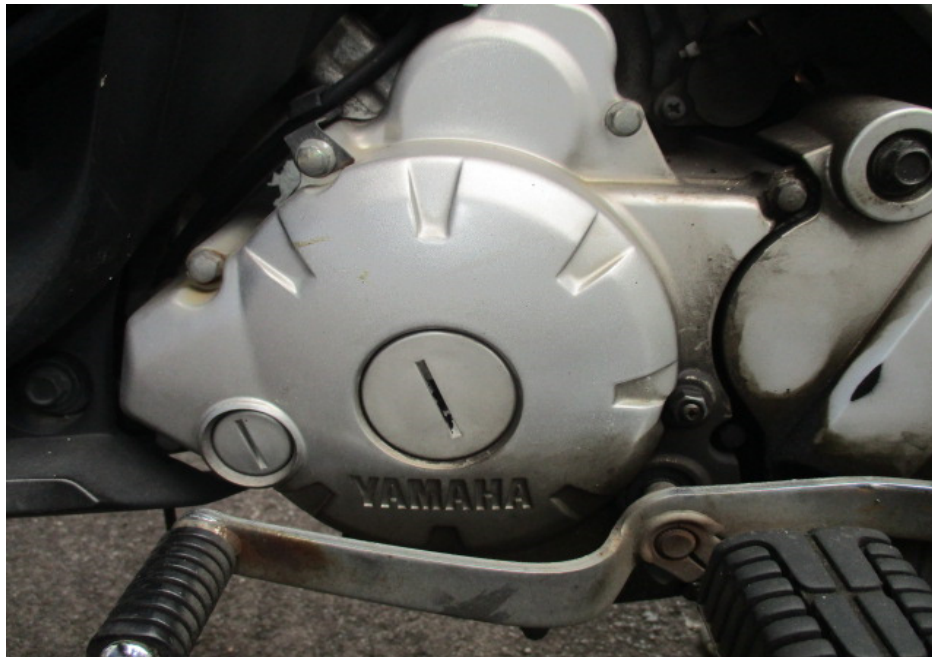
**Photo 16** shows the left side of the engine of the Motorcycle at the time of our inspection. The various engine related parts and components were found to be intact with no visible damage. There was also no sign(s) or indication(s) of fluid leak observed around the left engine area of the Motorcycle.

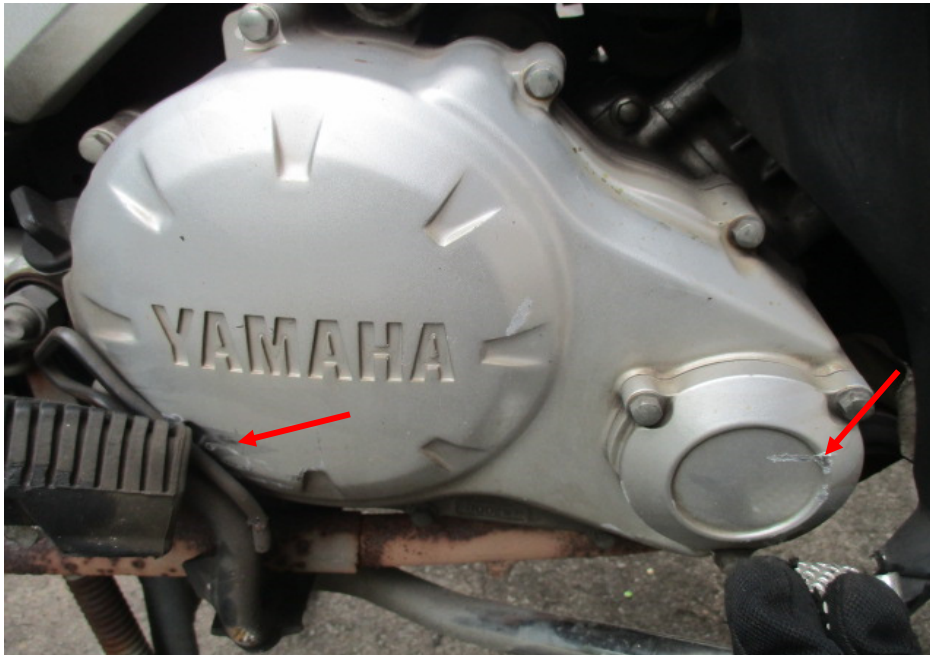
**Photo 17** shows the right side of the engine of the Motorcycle at the time of our inspection. The various left engine components had sustained damage of grazing nature as a result of the accident (arrowed) however the engine components were still intact. There was also no fluid leak and/or fluid stain found around the right engine area of the Motorcycle.

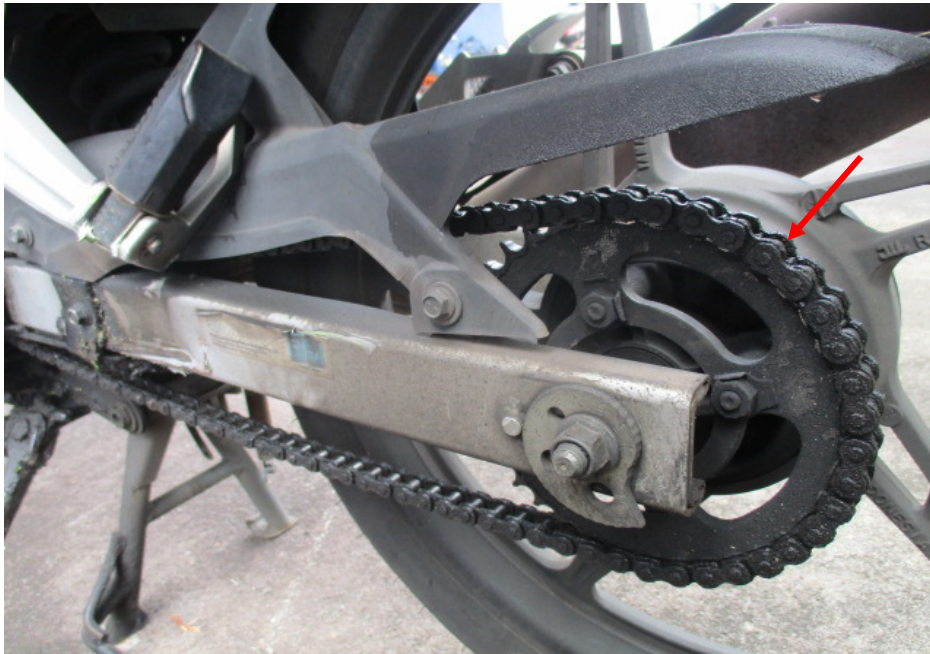
**Photo 18** shows the general view of the gear train (arrowed) of the Motorcycle, which was observed to be intact with no misalignment. It was also adequately lubricated for operating purposes.

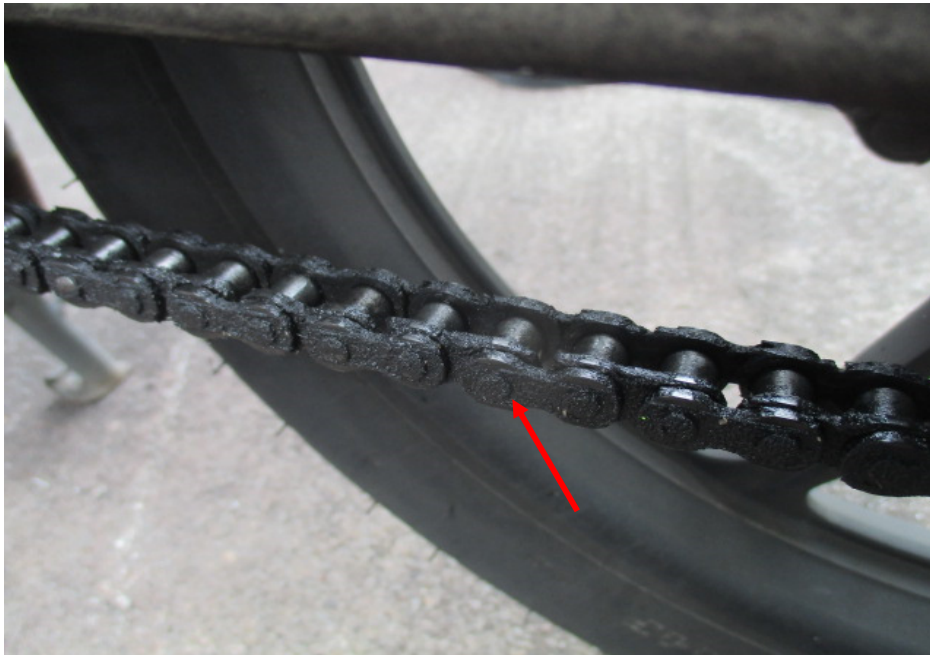
**Photo 19** shows a closer view of the gear train (arrowed) of the Motorcycle, which was observed to be intact with no misalignment. It was also adequately lubricated for operating purposes.

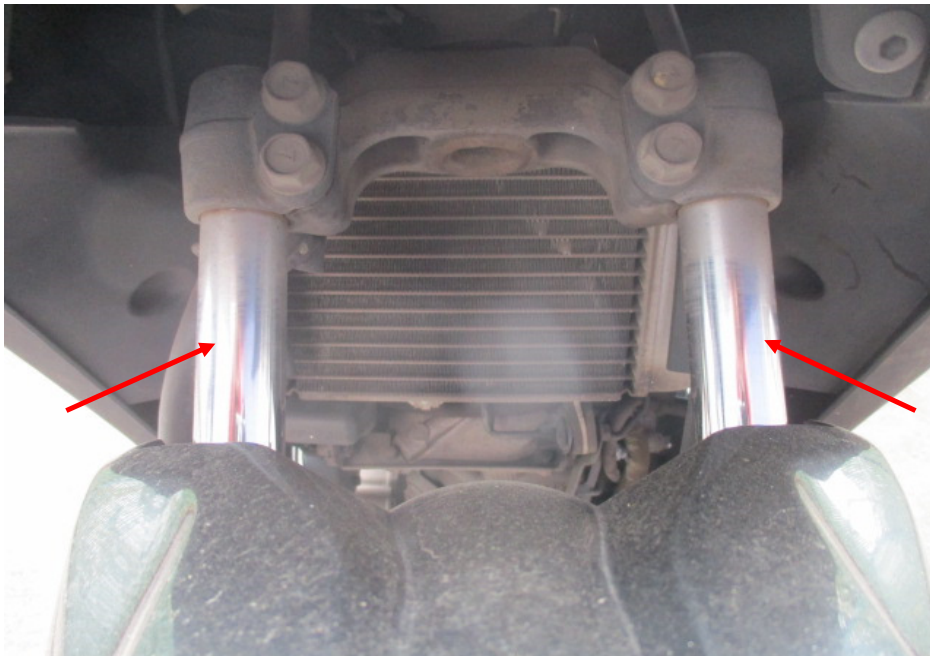
**Photo 20** shows the front fork (arrowed) of the Motorcycle. The front fork and fork bracket of the Motorcycle were both found to be intact and undamaged. Turning the Motorcycle's handle bar towards the left and right did not produce any abnormal free play and/or resistance. The steering system of the Motorcycle was in serviceable condition at the time of our inspection.

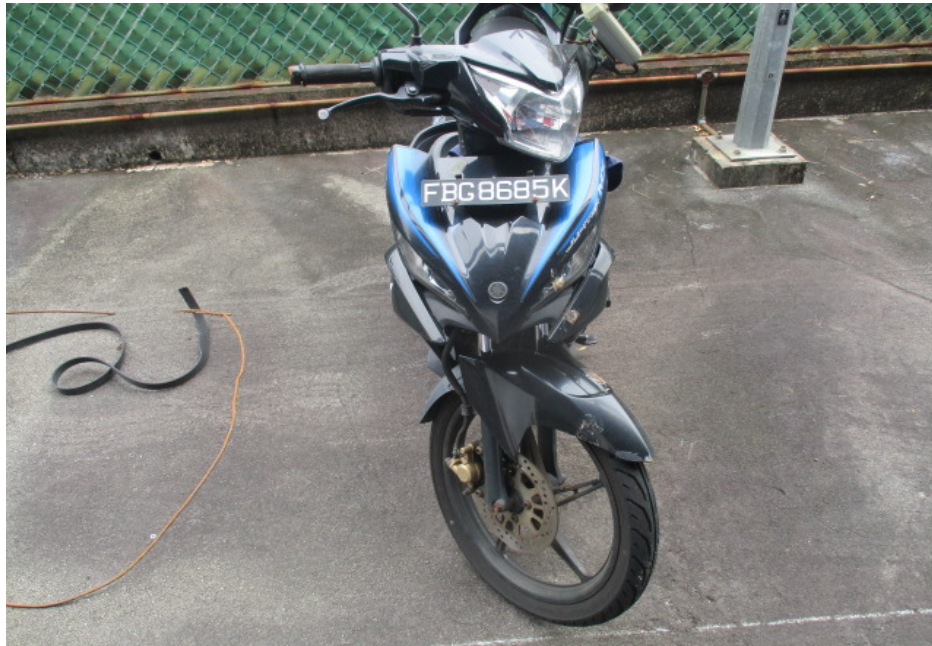
**Photo 21** shows the front wheel of the Motorcycle turned towards its full left. Turning the Motorcycle's handle bar towards the left and right did not produce any abnormal free play and/or resistance. This would indicate that the steering system of the Motorcycle was in serviceable condition at the time of our inspection.

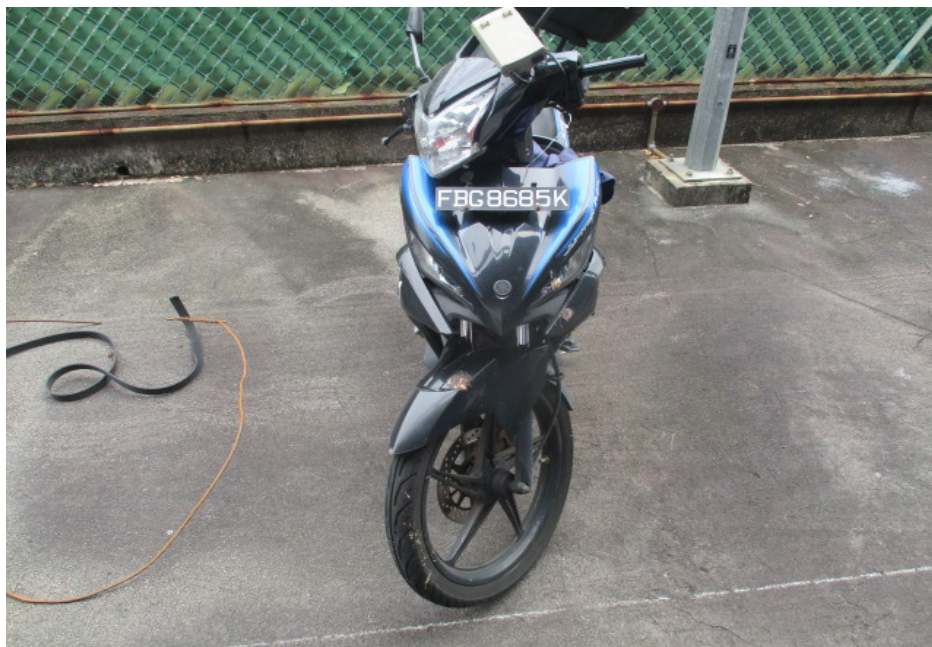
**Photo 22** shows the front wheel of the Motorcycle turned towards its full right. Turning the Motorcycle's handle bar towards the left and right did not produce any abnormal free play and/or resistance. This would indicate that the steering system of the Motorcycle was in serviceable condition at the time of our inspection.

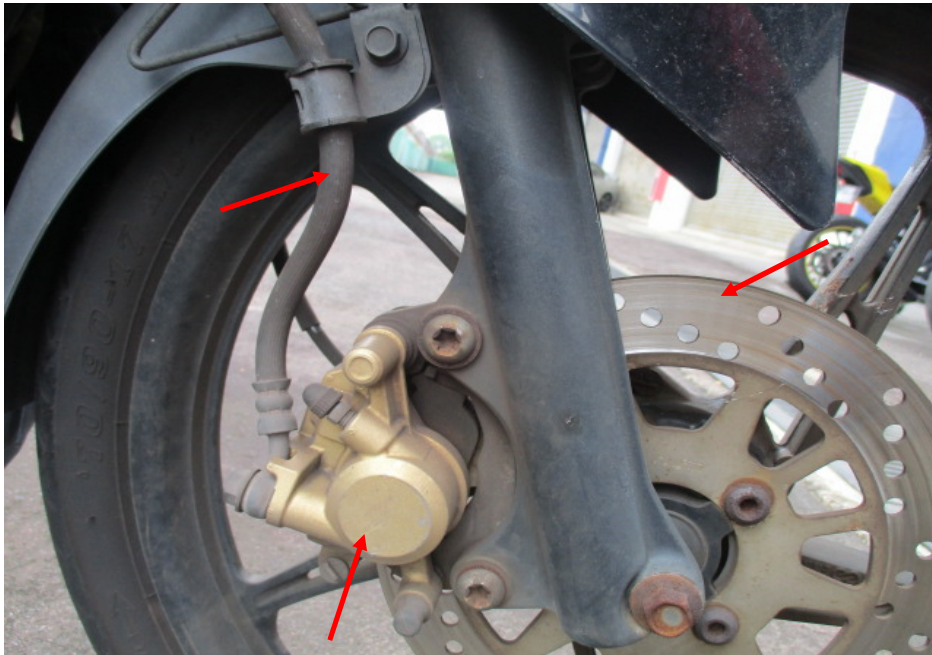
**Photo 23** shows a close up view of the front brake caliper, front brake disc and front brake hose (arrowed) of the Motorcycle, which are all part of the components in the hydraulic front brake system of the Motorcycle. Our visual checks of these various components had revealed all to be intact with no visible damage. No leakage of brake fluid was also observed.

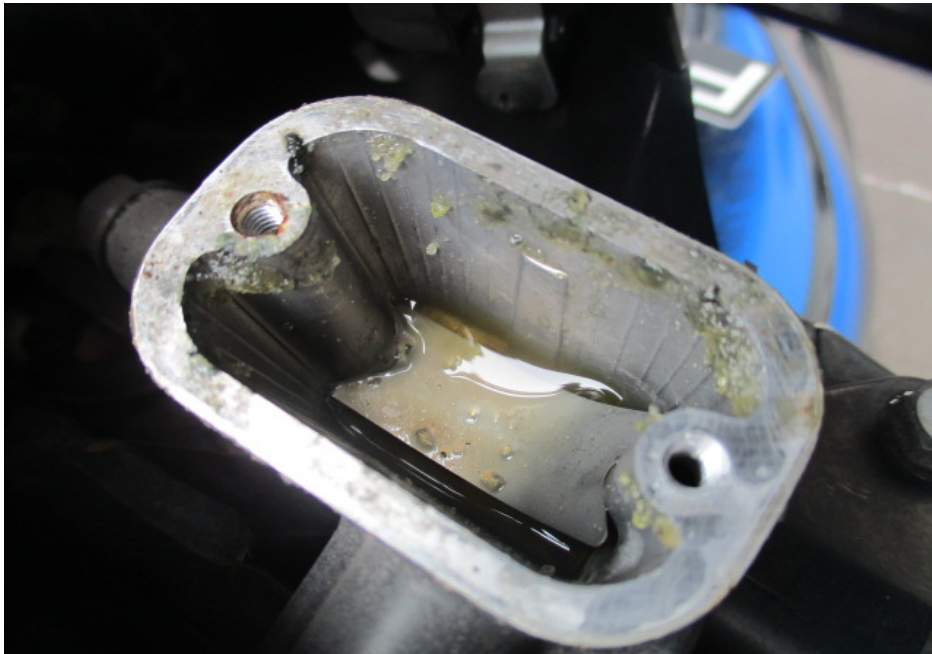
**Photo 24** shows the brake fluid reservoir for the front brake of the Motorcycle. The brake fluid was observed to be without contamination however it was of insufficient level for operational purposes.

17. For this case, although the brake fluid for the front braking system was found to be of insufficient level, our operational test had indicated that the front braking system was still in serviceable condition and the front wheel was able to stop rotating when the front brake lever was depressed.

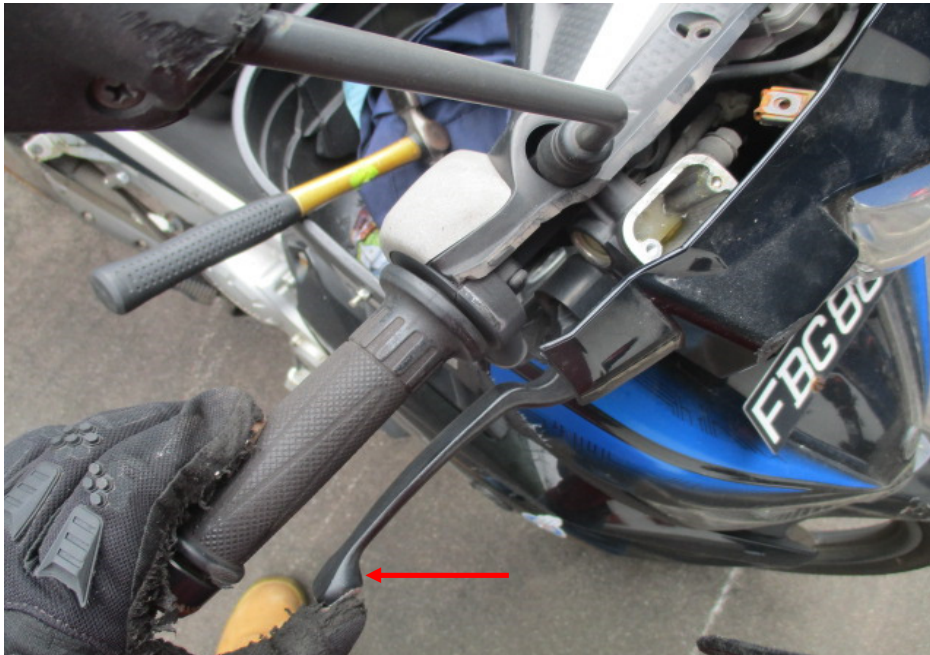
13. Static brake tests conducted on the Motorcycle had appear to indicate that the front braking system of the Motorcycle was in serviceable condition. There was some resistance felt (spongy like feel) upon pressing the brake lever. This would indicate that there was no leakage of pressure/vacuum in the front brake system.

**Photo 25** shows the front brake lever being depressed. There was some resistance felt (spongy like feel) upon pressing the front brake lever (arrowed). This would indicate that there is no leakage of pressure/vacuum in the brake system.

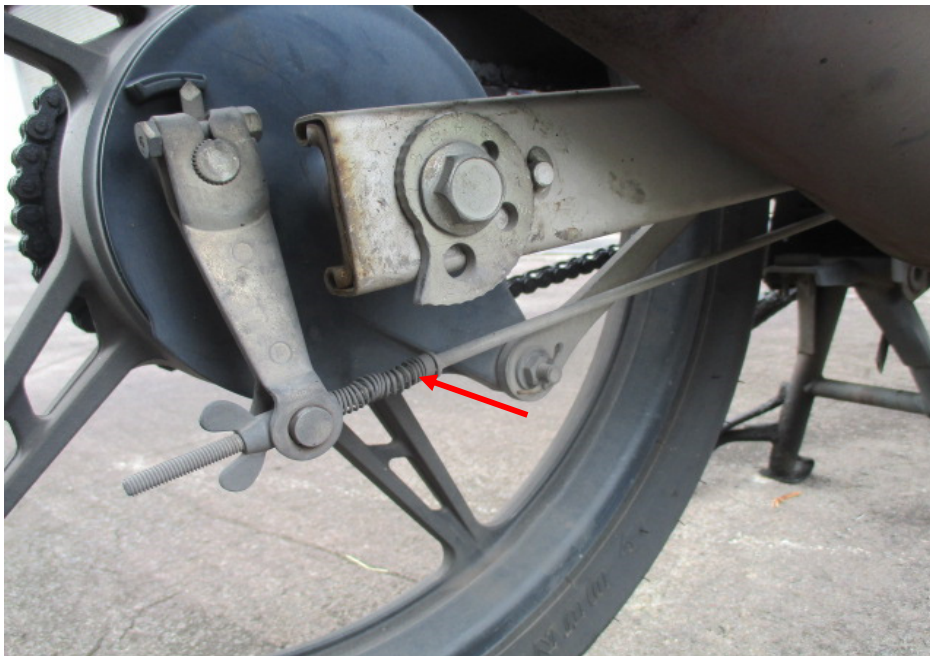
**Photo 26** shows the rear wheel of the Motorcycle. The type of brake system for the rear wheel was of a mechanical type, controlled by the brake foot pedal of the Motorcycle. Our checks of the cable (arrowed), spring and drum which are all part of the components in the rear brake system of the Motorcycle reveal all to be intact and without damage.
