Your Ref: OD/ 600680  
Our Ref : CS/MSG 19012928/Pqf3

**TECHNICAL INVESTIGATION REPORT OF FIRE INCIDENT INVOLVING THE  
INSURED VEHICLE SDT 2012A ON 17<sup>th</sup> July 2019**

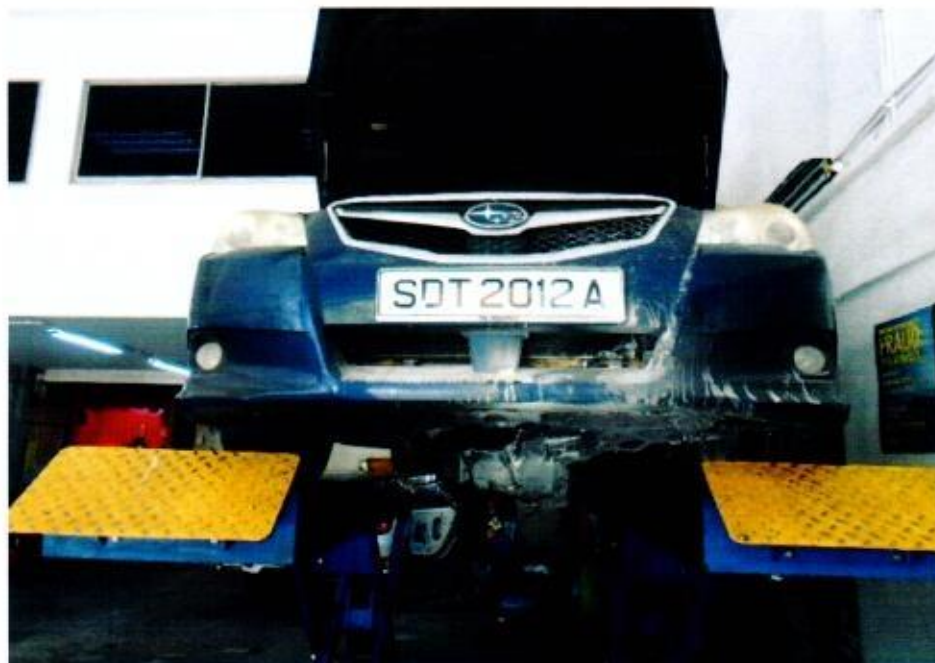
**Photo 1** shows the general view of the front portion of the Insured Vehicle at the time of our inspection. The fire damage to the Insured Vehicle was confined to its front undercarriage portion. Its undercarriage splash shield, engine compartment firewall insulator, timing cover and condenser and original harness are amongst the body parts that were found to have been affected as a result of the fire.

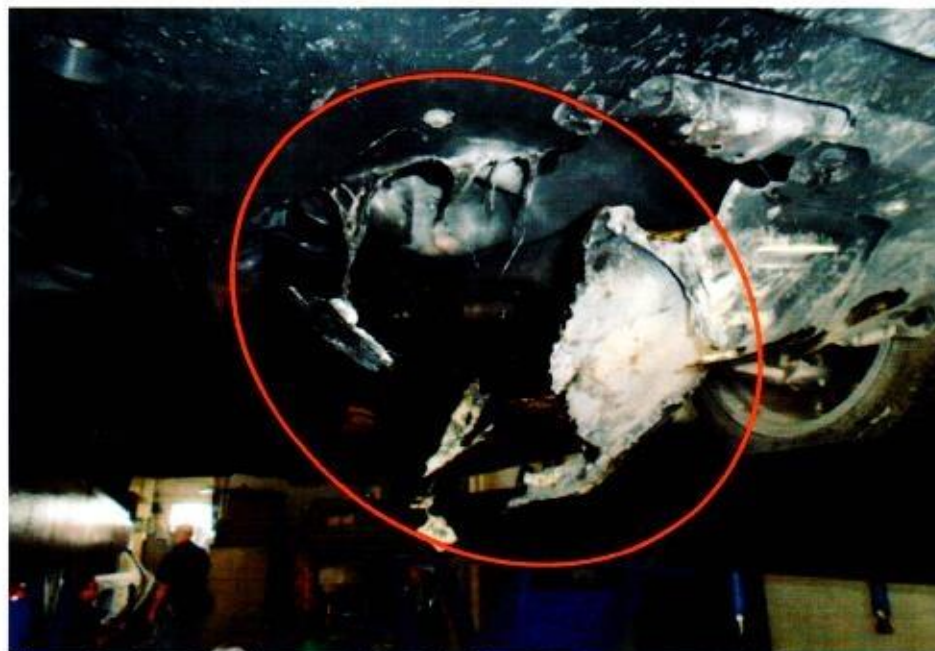
**Photo 2** shows the close up view of the front undercarriage portion of the Insured Vehicle at the time of our inspection. The fire damage to the Insured Vehicle was confined to its front undercarriage portion. Its front splash shield (circled) was amongst the body parts that were found to have been affected as a result of the fire.

20. During our inspection of the Insured Vehicle, we observed that the undercarriage splash shield of the Insured Vehicle was burned and melted as a result of the fire, which had exposed the undercarriage components of the Insured Vehicle.

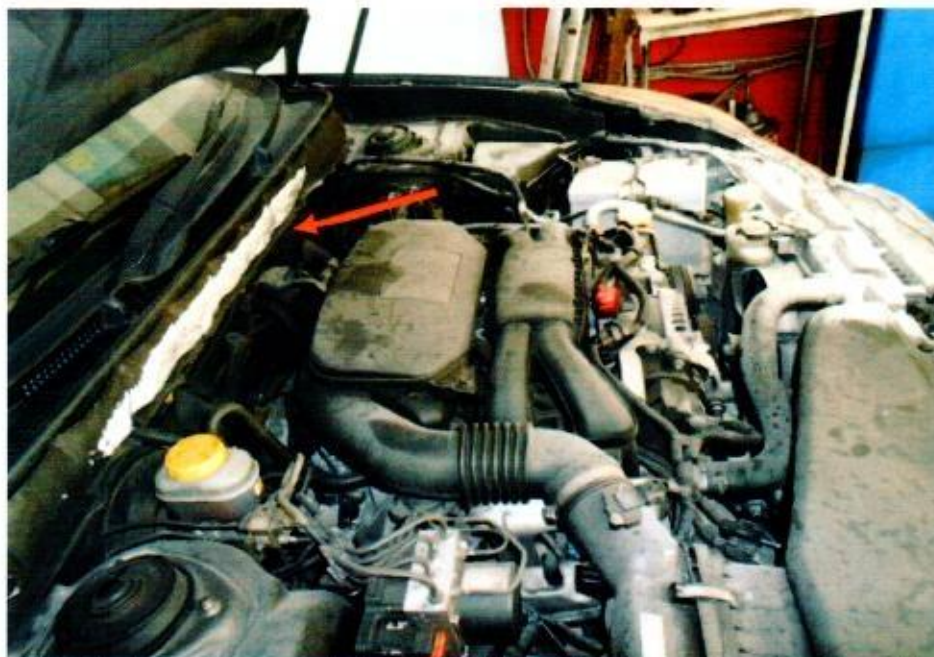
**Photo 3** shows the general view of the front engine compartment portion of the Insured Vehicle at the time of our inspection. The fire damage to the Insured Vehicle was confined to its front undercarriage portion and. Its engine compartment firewall insulator (arrowed) was amongst the body parts that were found to have been affected as a result of the fire.

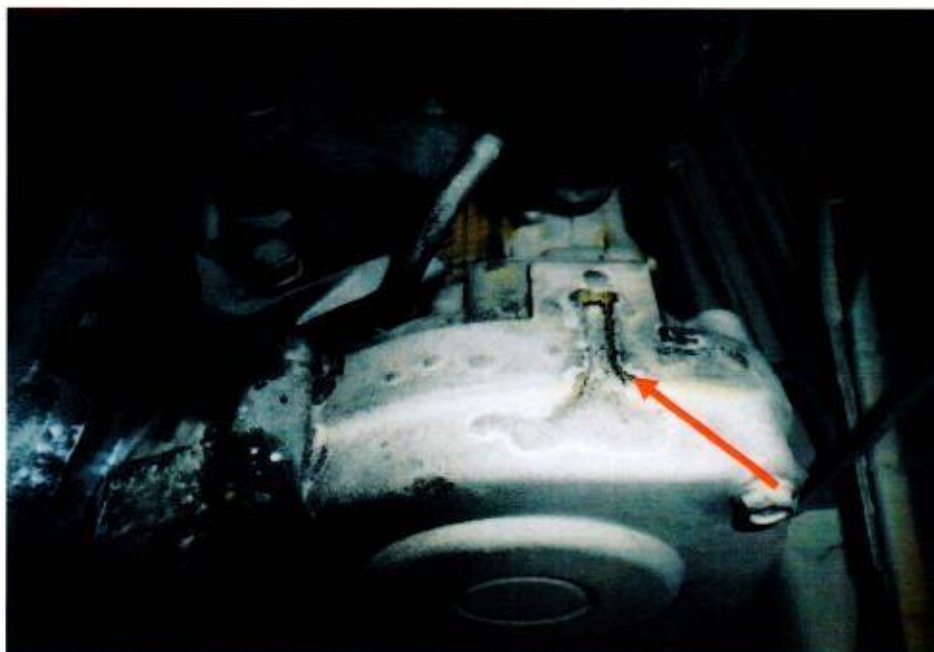
**Photo 4** shows the damage of heat nature to the timing case cover (arrowed) in the engine compartment portion of the Insured Vehicle at the time of our inspection. This was amongst the body parts that were found to have been affected as a result of the fire.

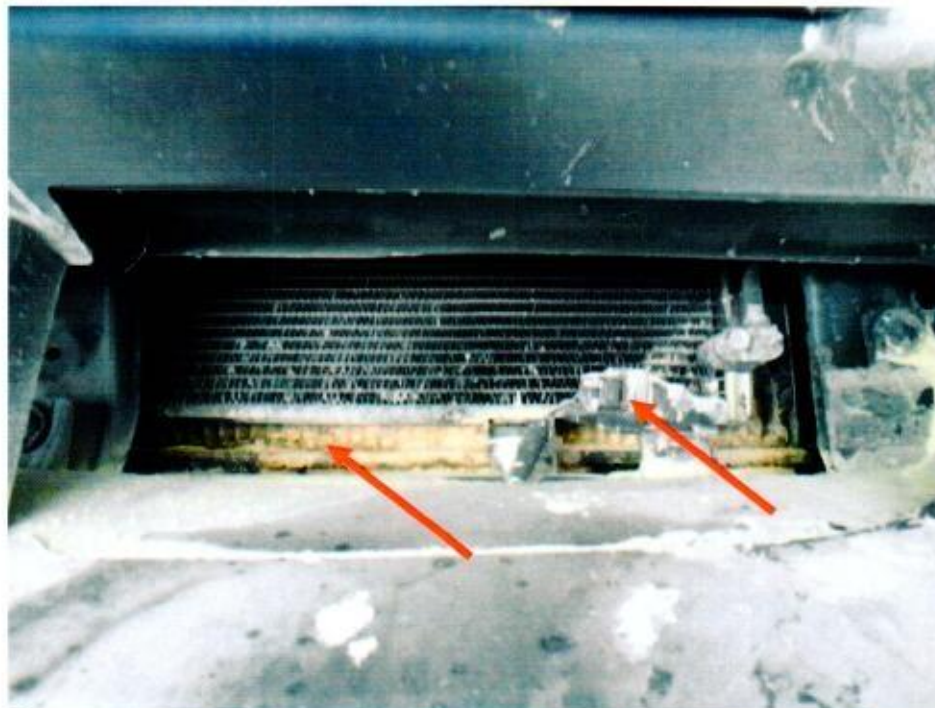
**Photo 5** shows the damage of heat nature to the condenser and original wiring harness in the engine compartment portion of the Insured Vehicle at the time of our inspection. This was amongst the body parts that were found to have been affected as a result of the fire

18. Fire due to an electrical short circuit to the Insured Vehicle was unlikely as no burnt wirings was observed, except for a stretch of wiring harness that was slightly melted due to the heat and the characteristic of hot air rising from the burning area of the undercarriage portion of the Insured Vehicle.

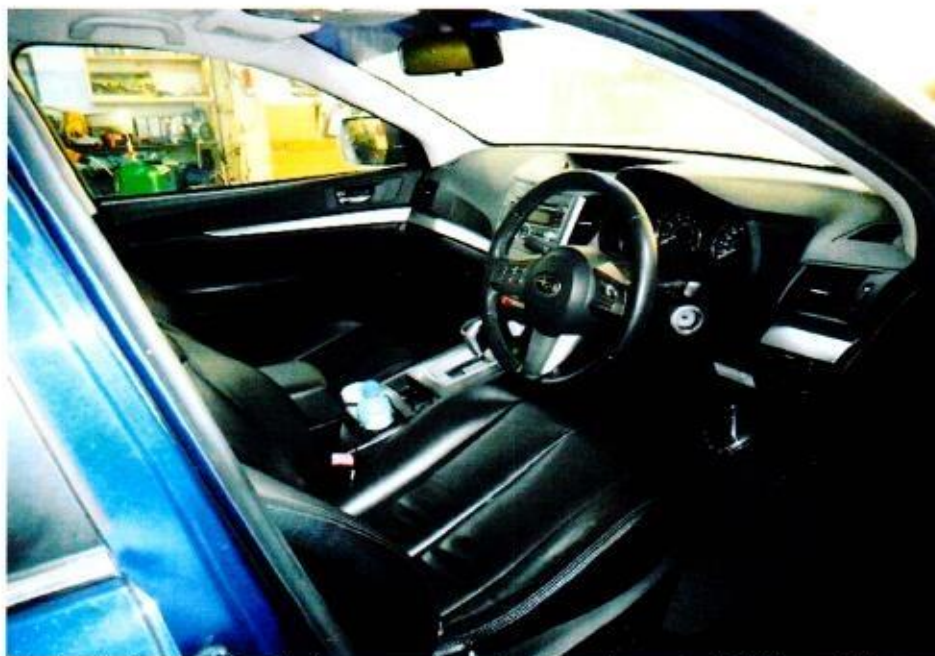
**Photo 6** shows the interior compartment of the Insured Vehicle, which was observed to be unaffected by the fire.

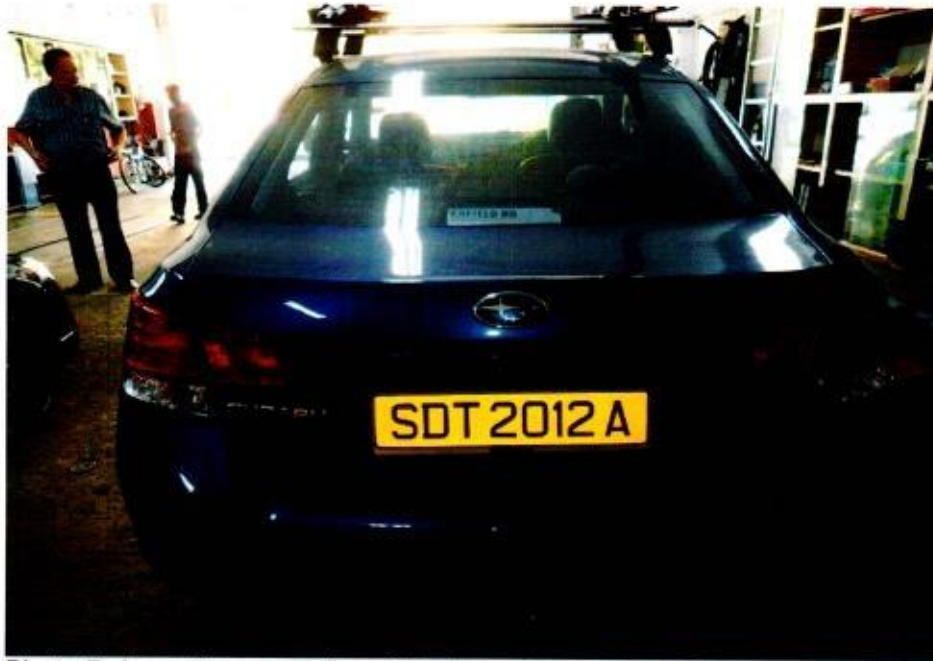
**Photo 7** shows the rear portion of the Insured Vehicle, which was observed to be unaffected by the fire.

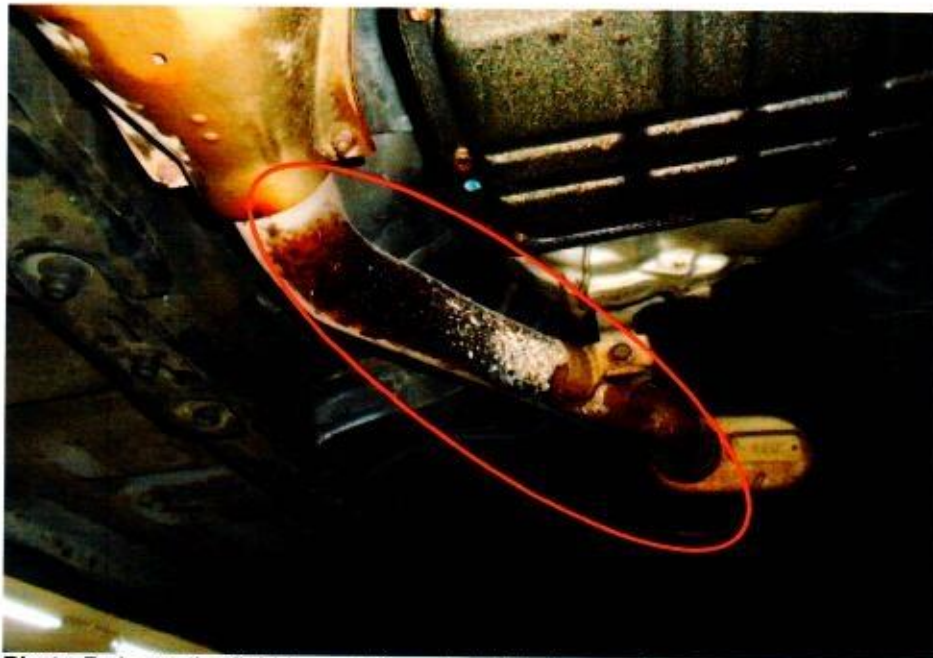
22. The presence of fluid burned marks on the exhaust pipe, would suggest that the fluid contacted onto the surface of the heated exhaust piping than had left a stain after burning. It is a sign of Automatic Transmission Fluid leakage on the heated exhaust and this physical evidence would then appear to suggest that the cause of fire to the Insured Vehicle could have possibly been due to leakage of fluids onto heated surface and the fire spread around the undercarriage of the Insured Vehicle by the burning of the undercarriage splash board which is made of a combustible material. Whitish burn marks were also observed on the exhaust piping, this was caused by high heat intensity from the fire. See photos 7 & 8 below.

**Photo 7** shows the fluid burn stain and whitish burn marks on the exhaust pipe of the Insured Vehicle (circled). Such marks are a result of burned fluid and exposure to prolonged heat intensity, which may indicate where the fire had started.

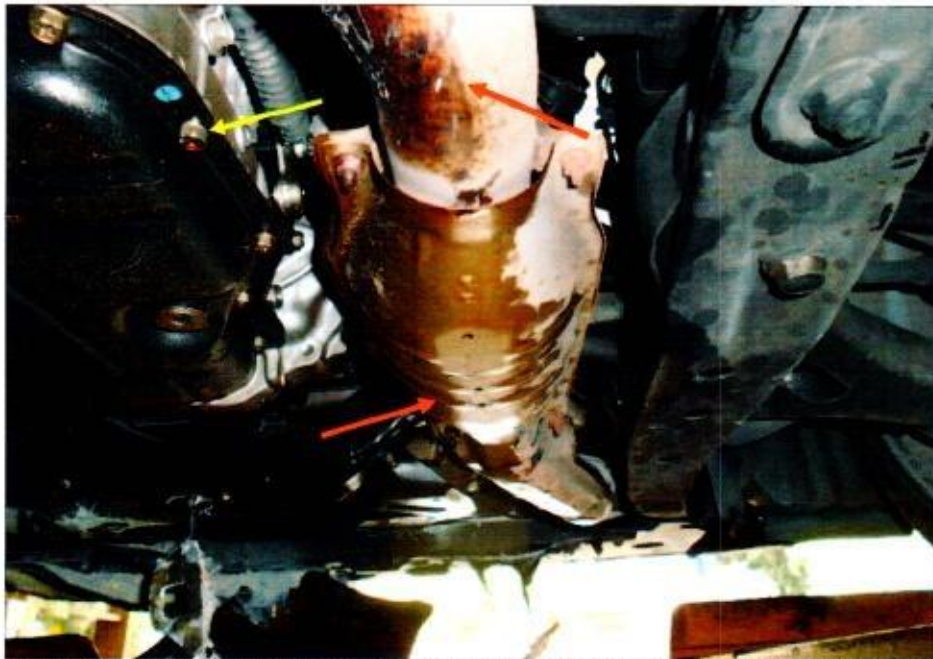
21. We observed Automatic Transmission Fluid around the surface of the fluid pan and the securing screws of the Insured Vehicle, the cause of the leakage would be from the gaps in between the gasket of the fluid pan. We also observed burned stained marks on the exhaust piping which is location right beside the fluid pan.

Photo 8 shows the fluid burn marks on the exhaust pipe at the undercarriage portion of the Insured Vehicle. This is the immediate vicinity where the fire to the Insured Vehicle had likely started. The transmission fluid residue can be seen on the screws of the transmission fluid sump (yellow arrow), the presence of fluid burn marks on the exhaust pipe was a sign of transmission fluid leakage onto the heated exhaust (red arrows) and this physical evidence would then appear to suggest that the cause of fire to the Insured Vehicle could have possibly been due to leakage of transmission fluids from the gasket of the fluid pan onto heated exhaust pipe surface.

24. Having investigated and technically analysed the damages of burnt nature to the Insured Vehicle, we are of the view that the cause of fire to the Insured Vehicle was of leakage of fluid which contacted on to hot surface that caused the self-ignition of fire. For this particular case, the fire had originated from the undercarriage area between the Automatic transmission fluid sump and the exhaust piping, somewhere around the undercarriage middle portion of the Insured Vehicle.
