Your Ref: D19/4634M/PTE/JS  
Our Ref : CS/FCI19013015/D

**M/s First Capital Insurance Limited**

**MECHANICAL INSPECTION REPORT OF INSURED VEHICLE SJA 29U**

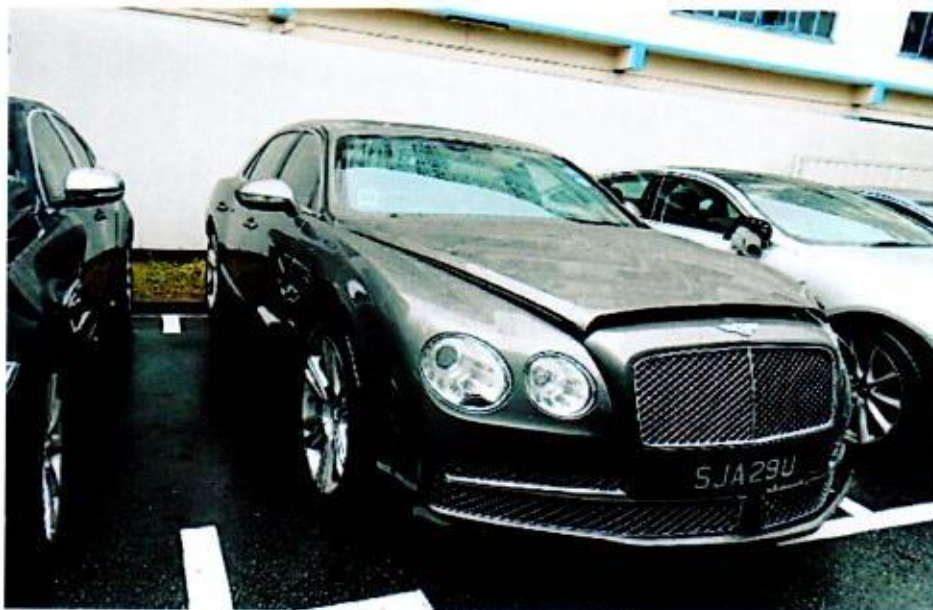
**Photo 1** shows a general view of the front right body of the Insured Vehicle at the time of my inspection. The mileage of the Insured Vehicle at the time of my inspection was recorded to be 103,924km.

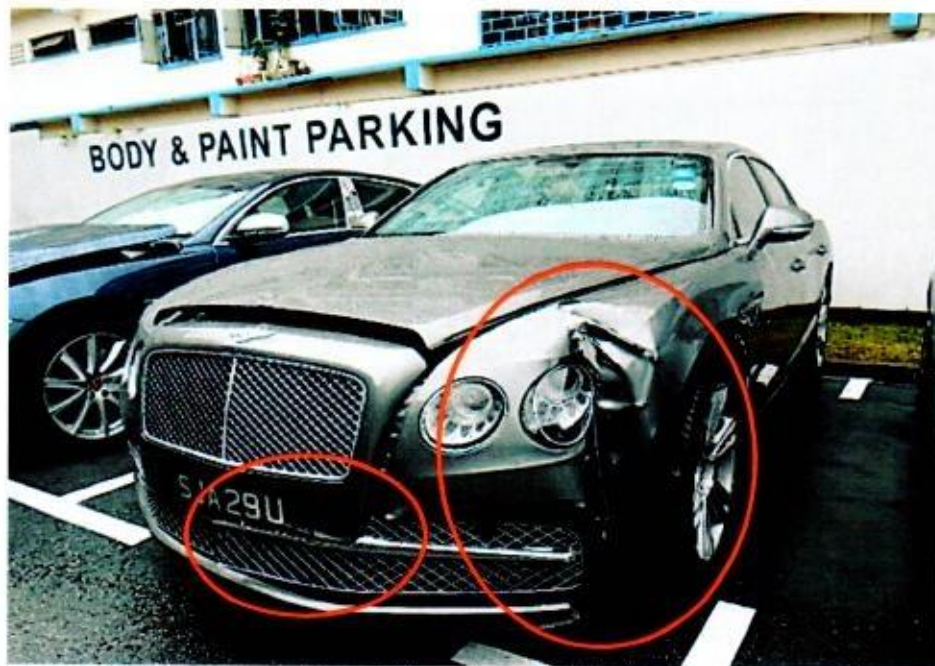
5. The Insured Vehicle was observed to have sustained damages at its left front body, left rear body, rear body and right rear body. Its undercarriage was also affected as a result of the accident. Amongst the body parts found damage were its front bumper, front left headlamp, front left fender, front left wheel rim, rear left wheel rim, rear left fender, rear bumper, rear bootlid, rear right taillamp, rear right fender, rear right exhaust and rear end panel etc.

**Photo 2** shows a general view of the damage (circled) at the left front body of the Insured Vehicle. The front bumper, front left headlamp, front bumper lower grille and front left fender were amongst the body parts that were found to be damaged as a result of the accident.

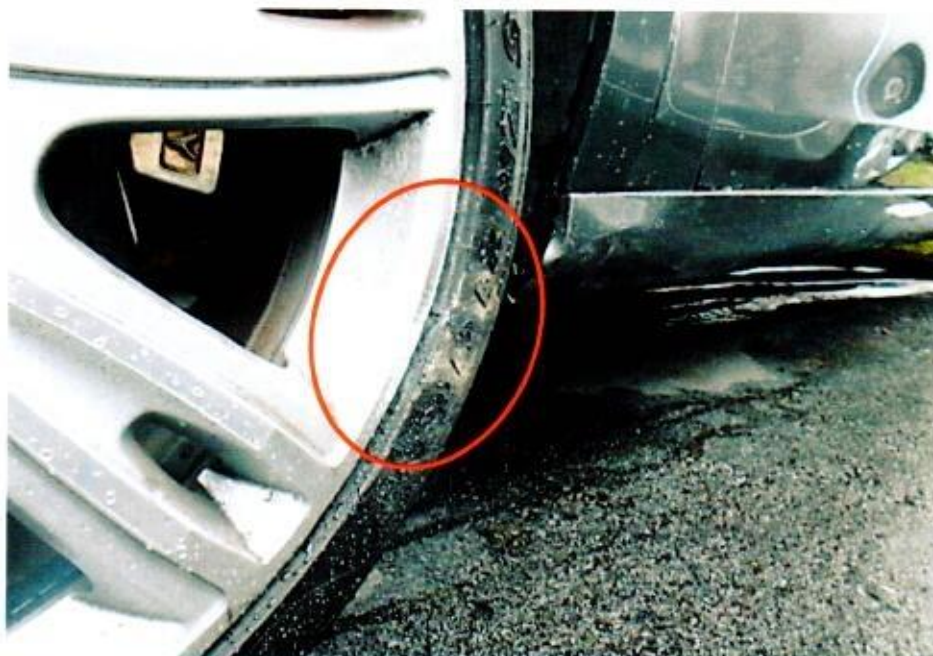
7. The 4 tyres were observed to be wrapped around alloy wheel rims that were found to be without any damage apart for some cut/grazing nature damage on the outer spokes of the front left wheel rim and rear left which rim, which was a result of this accident. See photo 1 – 5 below.

**Photo 3** shows a general view of the damage (circled) to the front left wheel rim of the Insured Vehicle. The 4 tyres fitted on the Insured Vehicle were all found to be in serviceable condition with remaining tread depth of approximately 5mm each with no tear, cut or burst mark(s) on the outer and the inner sidewalls as well as across the tread of the 4 tyres.

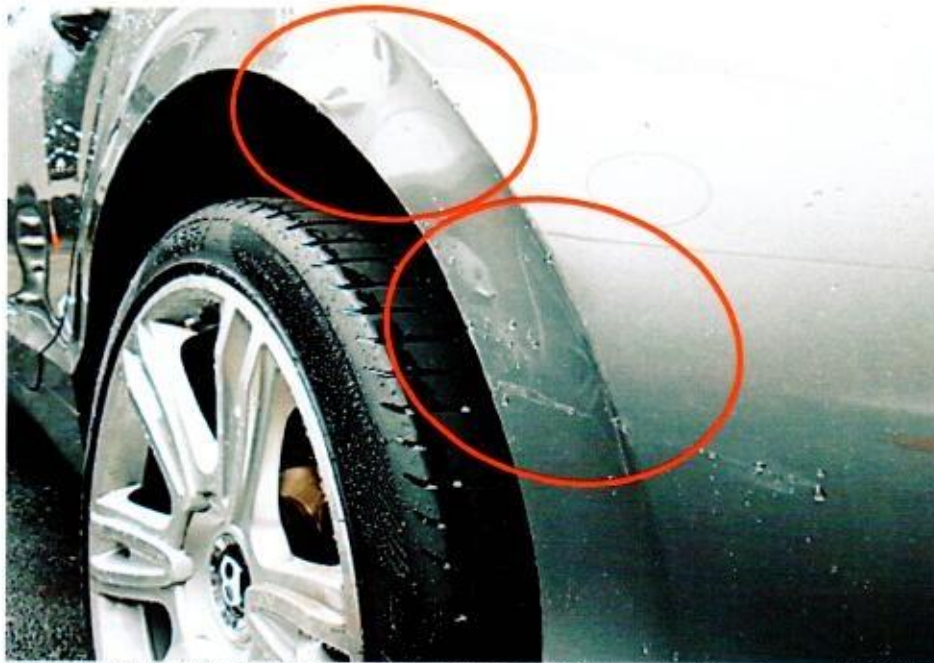
Photo 4 shows the damage (circled) at the rear left fender of the Insured Vehicle.

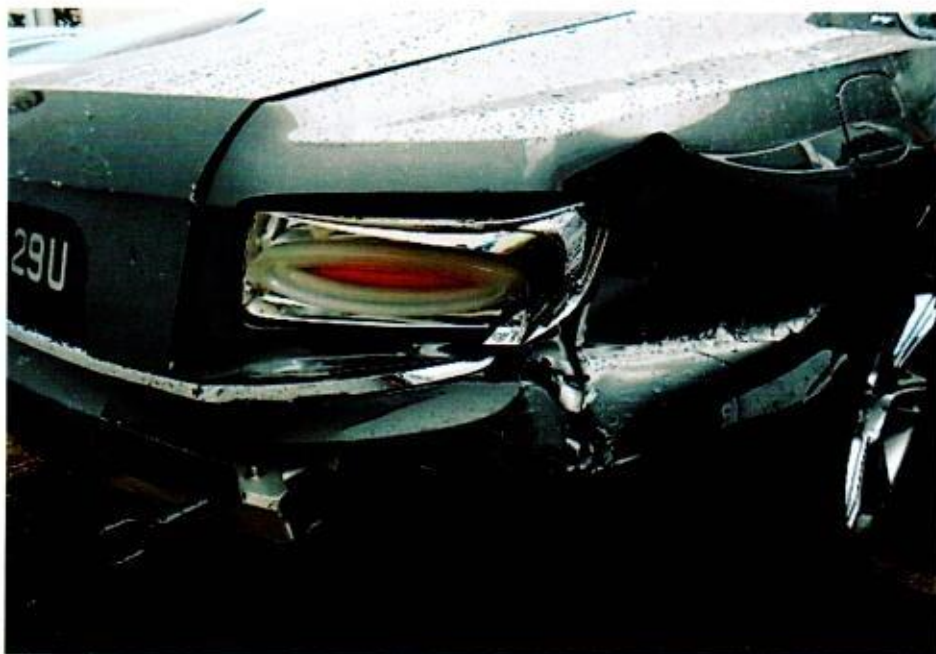
Photo 5 shows the damage at the right rear body of the Insured Vehicle. Its rear bumper, rear bumper reinforcement, rear bootlid, rear right taillamp and rear right fender were amongst the body parts that were damaged as a result of the accident.

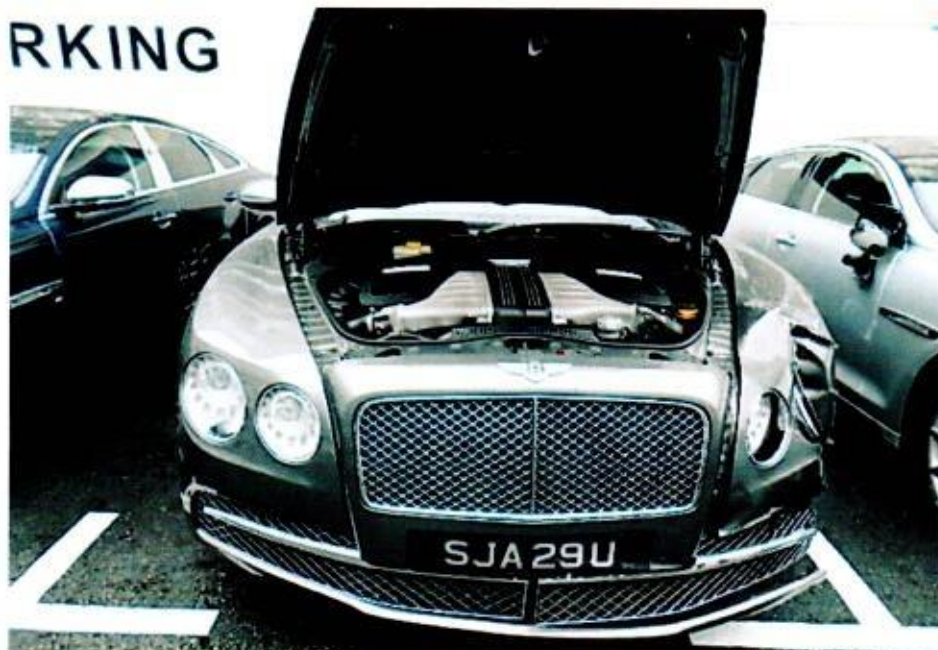
8. Upon examination of the engine compartment of the Insured Vehicle, I had observed all the parts and components inside the engine compartment to be intact and unaffected by the accident. The brake fluid, power steering fluid and engine coolant were all found to be of sufficient level for operating purposes. Visually, there was also no contamination found to these fluids.
9. Further examination of the engine compartment revealed no sign(s) or indication(s) of fluid leakage and/or fluid stain within the engine compartment of the Insured Vehicle. See photo 6 – 9 below.

**Photo 6** shows a general view of the Insured Vehicle's engine compartment. The various parts and components inside the engine compartment were unaffected by the accident. There was also no sign(s) or indication(s) of fluid leakage and/or fluid stain within the engine compartment.

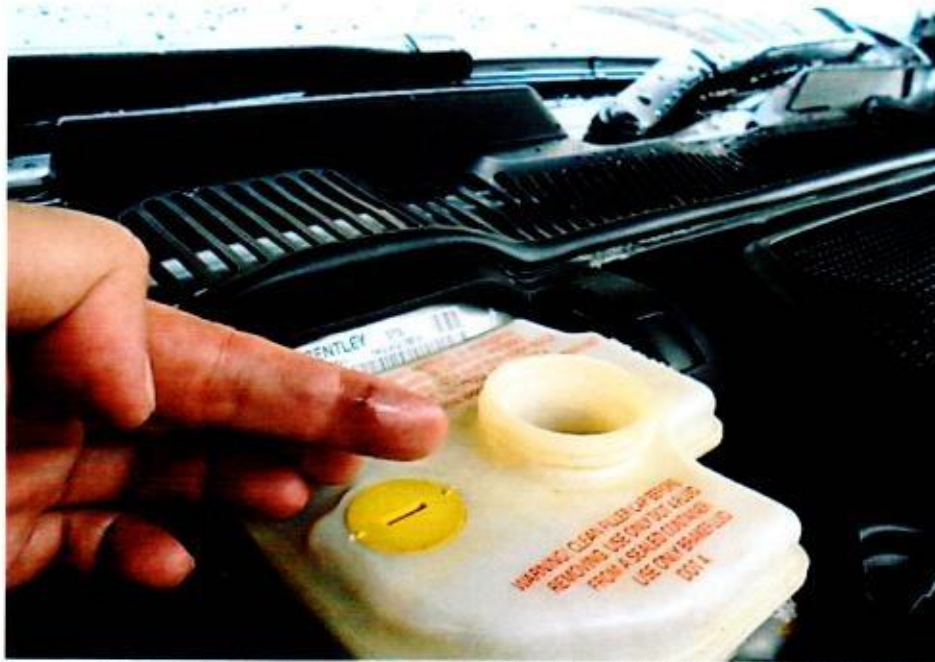
**Photo 7** shows the brake fluid reservoir of the Insured Vehicle at the time of my inspection. I had found the brake fluid to be of sufficient level and without any visible contamination for operating purposes.

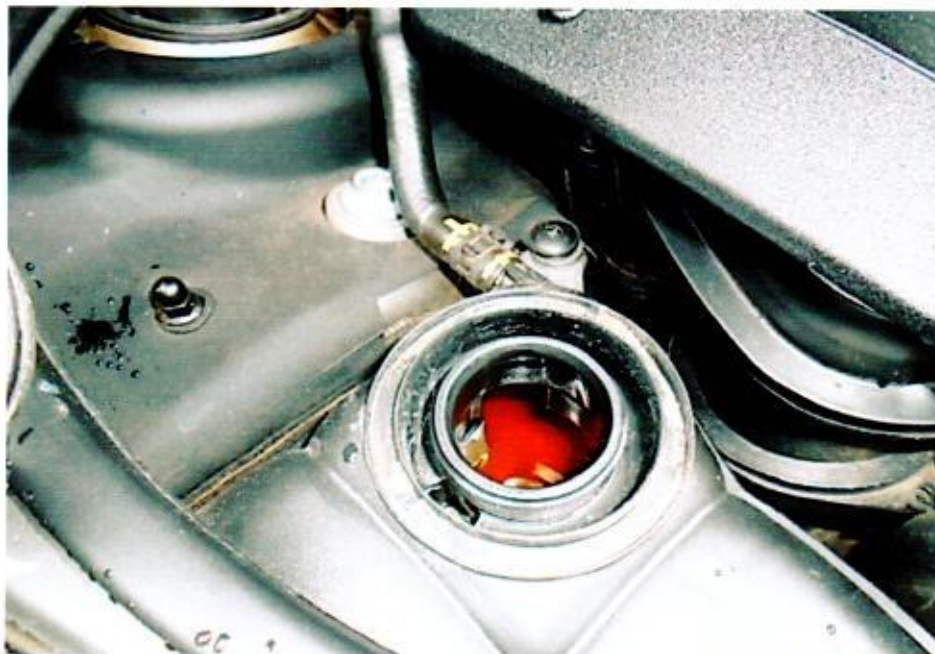
**Photo 8** shows the engine coolant reservoir of the Insured Vehicle at the time of my inspection. I had found the engine coolant to be of sufficient level and without any visible contamination.

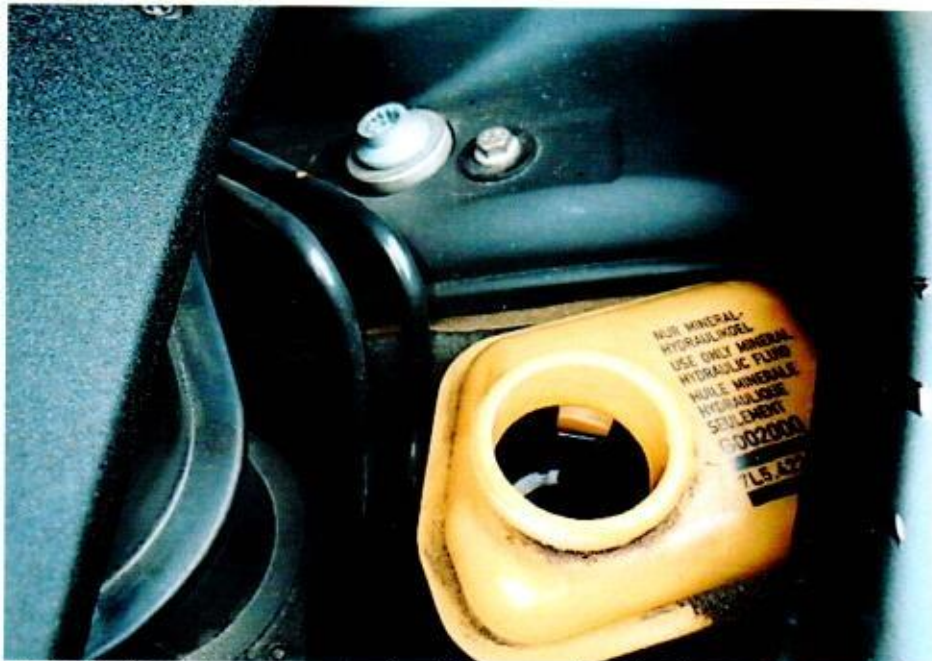
Photo 9 shows the power steering fluid reservoir of the Insured Vehicle at the time of my inspection. I had found the power steering fluid to be of sufficient level and without any visible contamination for operating purposes.

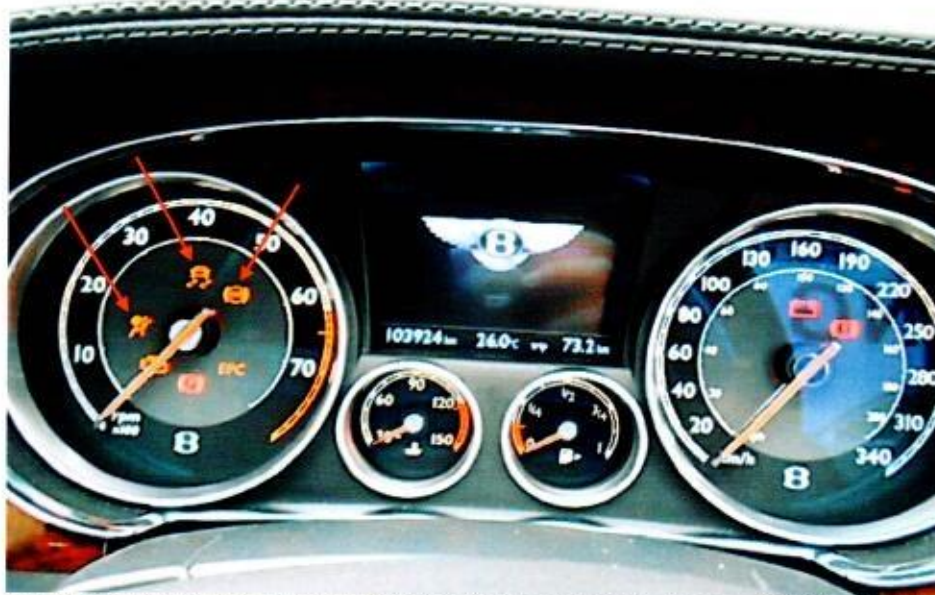
10. The Insured Vehicle's automatic self-test of the functionality of its various electronic operating systems like the Anti-Lock Brake System (ABS), Traction Control (TC) and Supplemental Restraint System (SRS) during cranking of the engine had indicated that these systems were in working condition and without abnormality. This can be established from the warning lights disappearing from the instrument panel after the self-test.

**Photo 10** shows the warning light for Anti-Lock Brake System (ABS), Traction Control (TC) and Supplemental Restraint System (SRS) appearing on the instrument panel of the Insured Vehicle during the self-test of its various electronic operating systems when its engine was cranked.

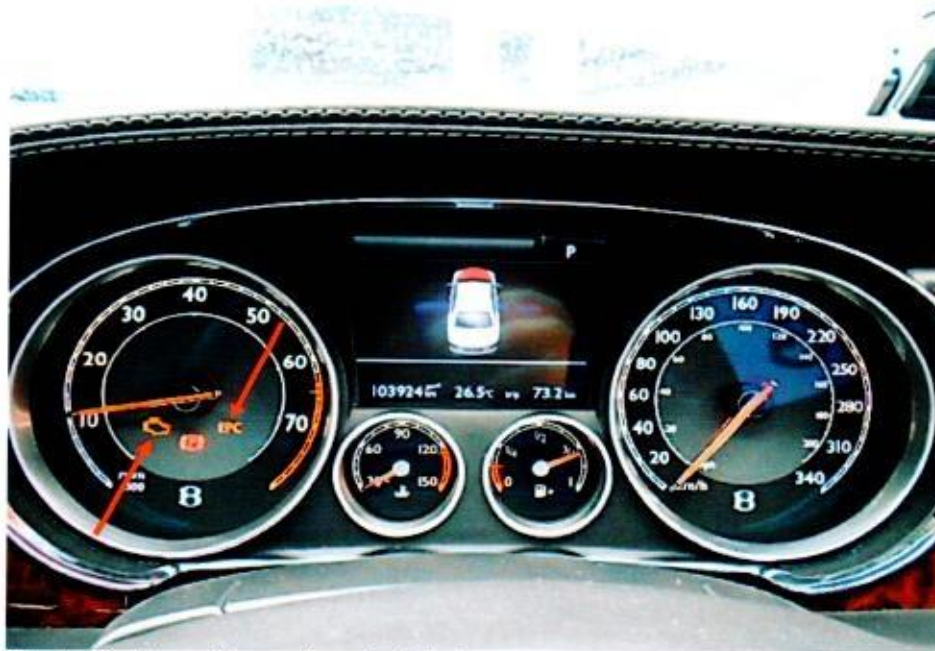
11. The engine check light and EPC (electronic power control) light had however remained lighted up after the self-test. The EPC refers to a fault(s) in either one or more electric operating system of the Insured Vehicle. The illumination of the engine check light accompanies the illumination of the EPC light, indicating that the engine of the Insured Vehicle is operating in safe mode where power is restricted. Given the extent of damage that the Insured Vehicle had sustained, it would not be unusual for the safe mode to be triggered hence the cause of the fault(s) was likely a result of the accident. See photo 10 & 11 below.

**Photo 11** shows the engine check light and EPC light still illuminated after the self-test. This indicates a fault to either one or more electric operating system of the Insured Vehicle. The illumination of the engine check light accompanies the illumination of the EPC light. The ABS, TC and SRS lights were however no longer illuminated indicating that these electronic operating systems were in working condition and without abnormality.

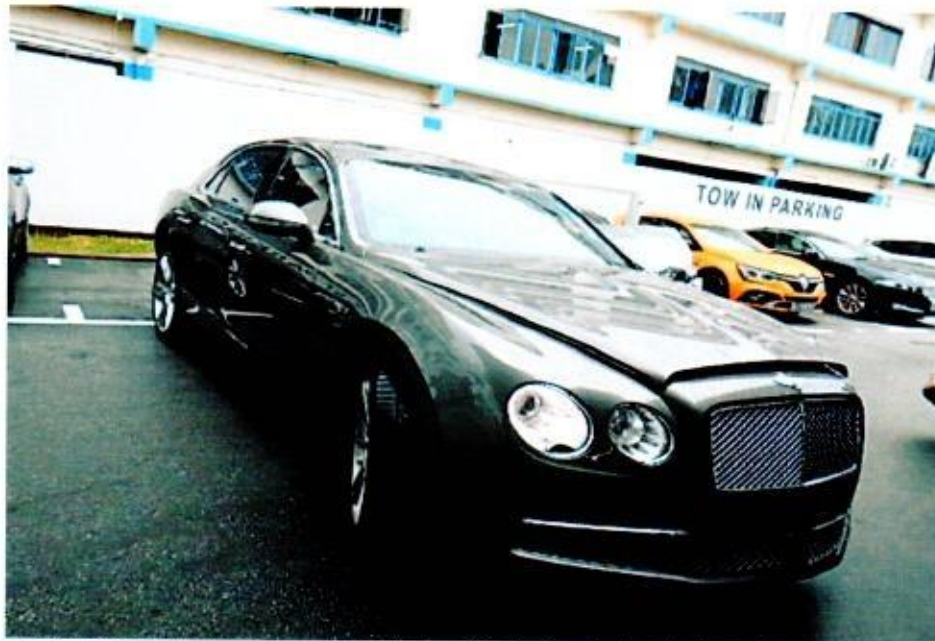
14. Static test on the steering system of the Insured Vehicle also revealed no abnormality to the steering system. I did not experience any abnormal free play and/or other resistance when turning the steering wheel left and right to full lock positions. The front wheels were also able to turn in accordance to the direction that the steering wheel was turned.

**Photo 12** shows the Insured Vehicle, with its front wheels turned to its full right, after it was driven forward from its original position. As part of my tests on the braking system and steering system of the Insured Vehicle, I had driven the Insured Vehicle forward and stopped, thereafter reverse and stopped. In general, I had found the braking system and steering system to be operating normally. The Insured Vehicle was able to stop effectively, and the steering wheel was able to turn without any abnormal free play and/or other resistance. The front wheels were able to turn in the direction that the steering wheel was turned.

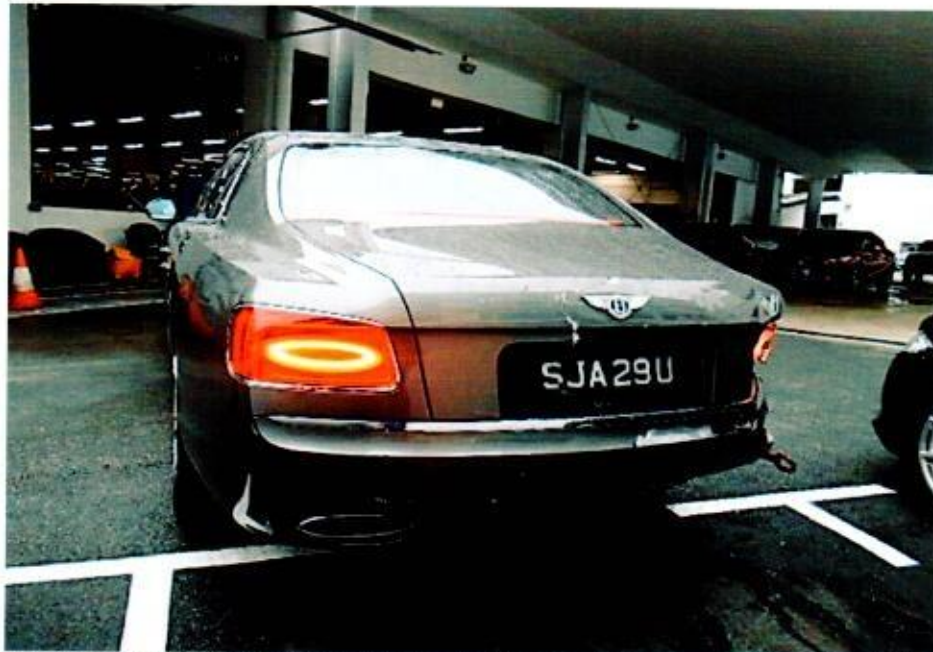
15. I subsequently shifted the transmission of the Insured Vehicle to "D" mode by manually downshifting the gear selector. The Insured Vehicle moved forward when I stepped on the accelerator pedal. Whilst moving, I stepped on the brake pedal and noted that the Insured Vehicle was able to stop effectively. The transmission was then selected to "R" mode and the Insured Vehicle reversed when I stepped on the accelerator pedal. The Insured Vehicle was able to stop effectively again when I stepped on the brake pedal. The same cycle was repeated 3 times, and on all occasions, I was able to bring the Insured Vehicle to a complete stop effectively. See photo 12 & 13 below.

**Photo 13** shows the Insured Vehicle after it was driven forward from its original position. In general, I had found the braking system and steering system of the Insured Vehicle to be operating normally.

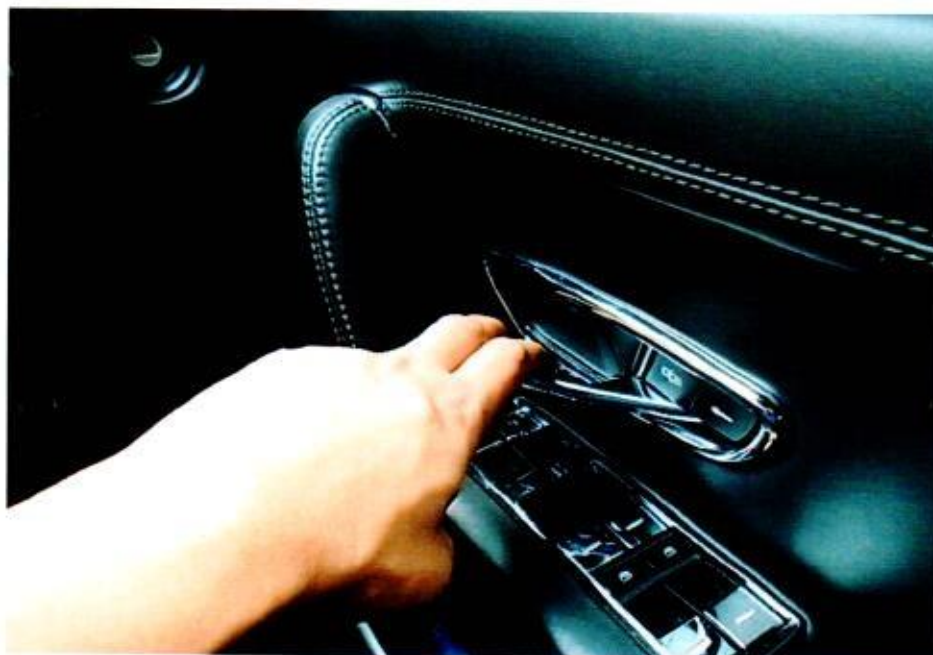
16. The front right door of the Insured Vehicle was checked, and it was observed that the hinges and locking mechanism were all properly fitted and in serviceable condition. Whilst seated on the driver's seat with the front right door closed, I had exerted some force by leaning onto the front right door and it was noted that the front right door remained closed and did not open. It could only be opened by manually pulling the inner handle and pushing the front right door outwards. When opened, the hinges were able to securely hold the front right door in an open position. Generally, I did not find any loose swinging of the front right door during my checks and tests. There was no issue/fault with the condition of the Insured Vehicle's front right door that could have suggested any malfunction of the front right door. See photo 14 & 15 below.

**Photo 14** shows the inner handle of the Insured Vehicle's front right door. Whilst seated inside the Insured Vehicle, the front right door could only be opened by manually pulling the inner handle and pushing the front right door outwards. Exerting some force by leaning onto the front right door without pulling the inner handle will not open the front right door. I had found no issue/fault with the condition of the Insured Vehicle's front right door that could have suggested malfunction of the front right door.

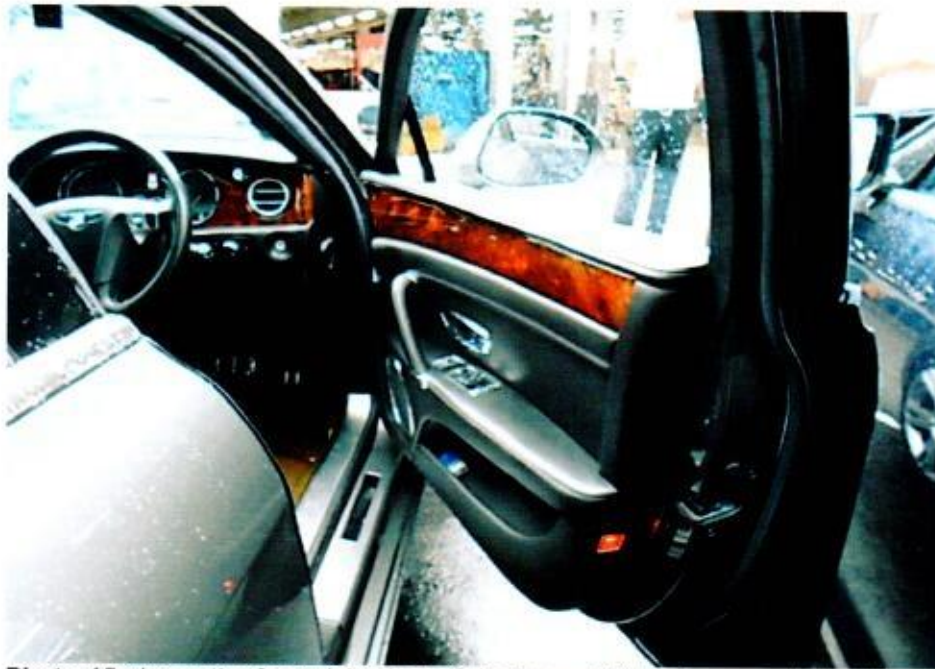
Photo 15 shows the front right door of the Insured Vehicle opened. The hinges were able to securely hold the front right door open. Generally, I did not find any loose swinging of the front right door during my checks and tests.

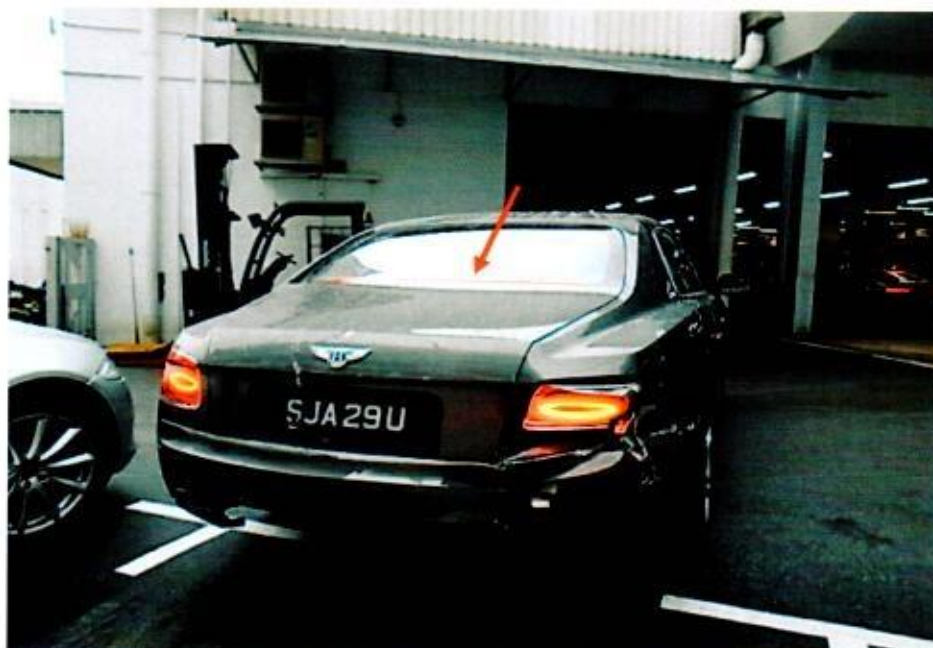
21. At the time of my inspection of the Insured Vehicle, I had checked on the working condition of the Insured Vehicle's brake light. It was noted that when the brake pedal of the Insured Vehicle was depressed, the brake light at the rear left taillamp and the rear right taillamp will light up together with the third brake light, which covers almost the entire width at the bottom part of the rear windscreen. Based on this observation, it can be ascertained that the brake lights of the Insured Vehicle were in working condition and will light up when the brake pedal was depressed. See photo 16 & 17 below.

**Photo 16** shows the brake light at the rear left taillamp and the rear right taillamp of the Insured Vehicle lighted up together with the third brake light (arrowed) when the brake pedal was depressed. From my observations, it can be ascertained that the brake lights of the Insured Vehicle were in working condition.

22. Co-relating my findings that the brake lights of the Insured Vehicle were in working condition with the events seen in the video recording (paragraph 20 above), it would appear that the brake pedal of the Insured Vehicle was not depressed at the time when the Insured Vehicle was reversing at speed and at the time when it was moving forward at speed. This also takes into consideration that just prior to the accident, the brake lights were lighted up whenever the Insured Vehicle was coming to a stop during adjustment manoeuvres by the driver (paragraph 18 above). The accident could be a result of the driver inadvertently stepping on the accelerator pedal instead of the brake pedal. The accident does not seem to be a result of any mechanical fault(s) to the Insured Vehicle.

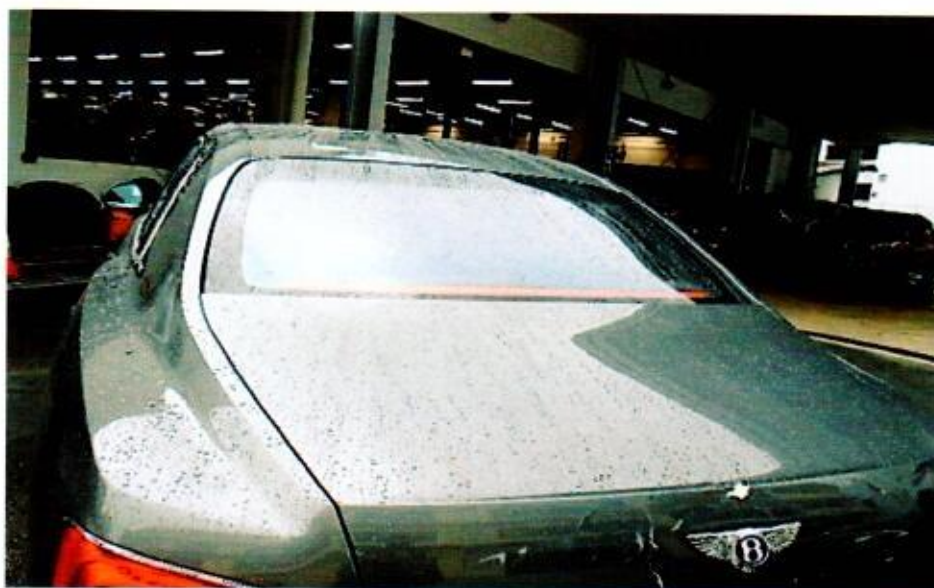
**Photo 17** shows a closer view of the Insured Vehicle's third brake light, which lights up when the brake pedal was depressed. The third brake light covers almost the entire width at the bottom part of the rear windscreen.
