Your Ref: D19/4634M/PTE/JS
Our Ref : CS/FCI19013015/D

31 July 2019

MECHANICAL INSPECTION REPORT OF INSURED VEHICLE SJA 29U

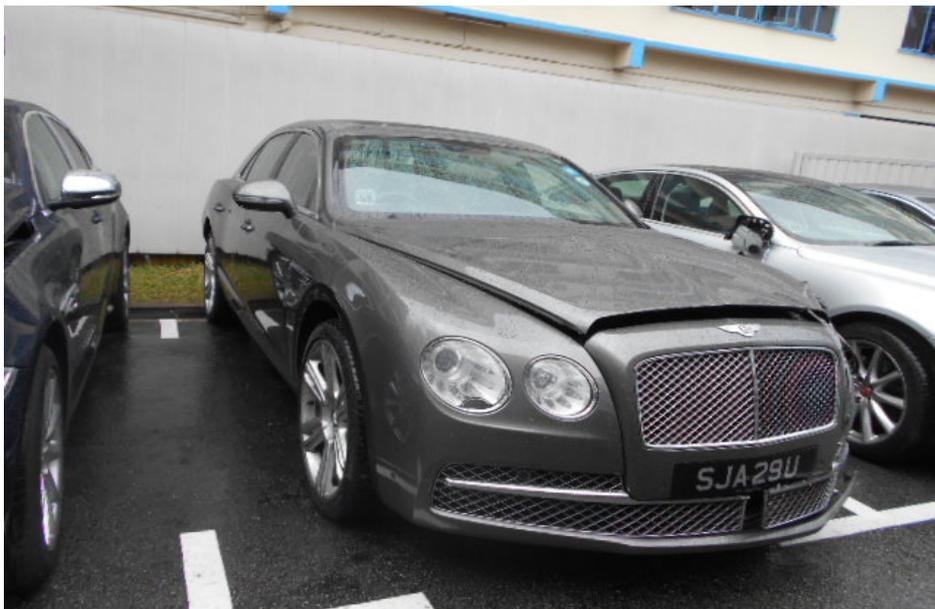
Photo 1 shows a general view of the front right body of the Insured Vehicle at the time of my inspection. The mileage of the Insured Vehicle at the time of my inspection was recorded to be 103,924km.

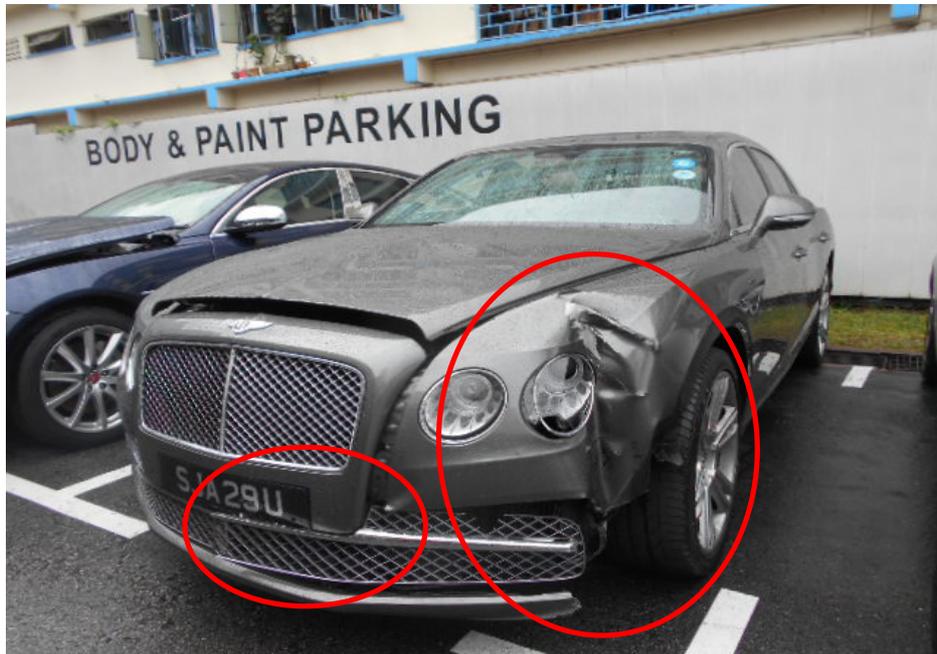
5. The Insured Vehicle was observed to have sustained damages at its left front body, left rear body, rear body and right rear body. Its undercarriage was also affected as a result of the accident. Amongst the body parts found damage were its front bumper, front left headlamp, front left fender, front left wheel rim, rear left wheel rim, rear left fender, rear bumper, rear bootlid, rear right taillamp, rear right fender, rear right exhaust and rear end panel etc.

Photo 2 shows a general view of the damage (circled) at the left front body of the Insured Vehicle. The front bumper, front left headlamp, front bumper lower grille and front left fender were amongst the body parts that were found to be damaged as a result of the accident.

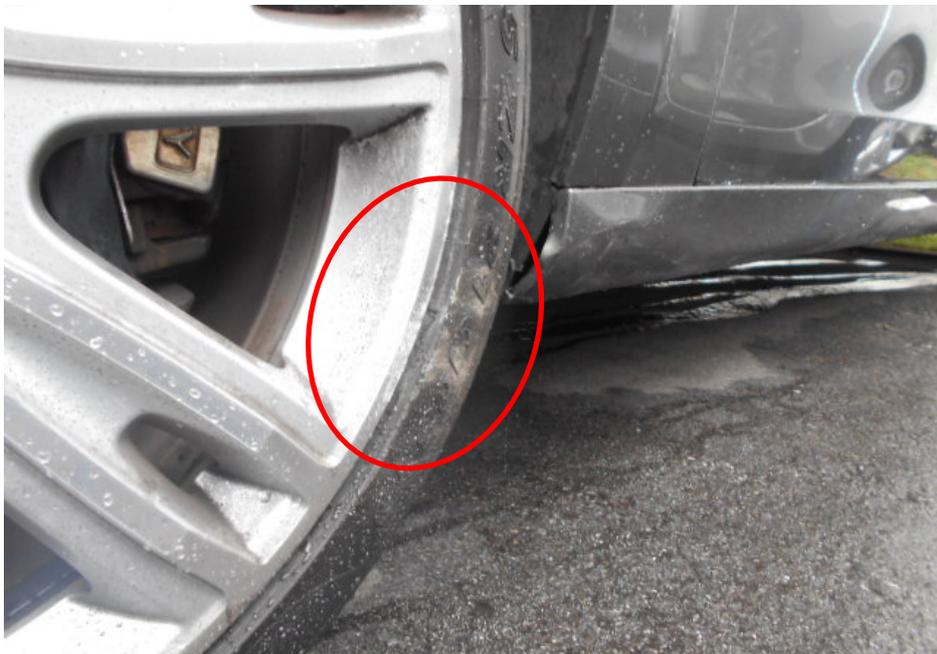
7. The 4 tyres were observed to be wrapped around alloy wheel rims that were found to be without any damage apart for some cut/grazing nature damage on the outer spokes of the front left wheel rim and rear left which rim, which was a result of this accident. See photo 1 – 5 below.

Photo 3 shows a general view of the damage (circled) to the front left wheel rim of the Insured Vehicle. The 4 tyres fitted on the Insured Vehicle were all found to be in serviceable condition with remaining tread depth of approximately 5mm each with no tear, cut or burst mark(s) on the outer and the inner sidewalls as well as across the tread of the 4 tyres.

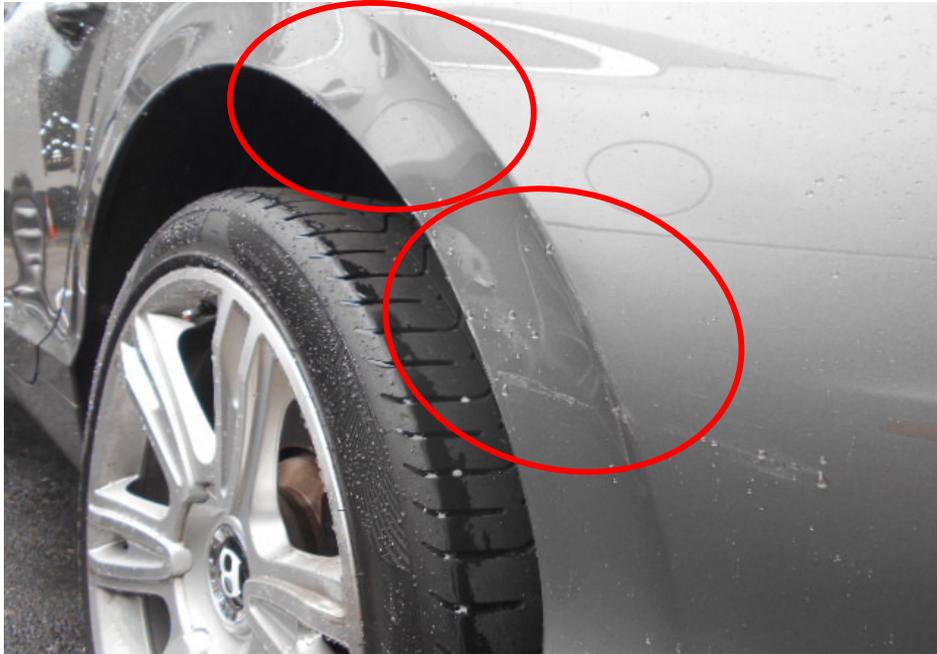
Photo 4 shows the damage (circled) at the rear left fender of the Insured Vehicle.

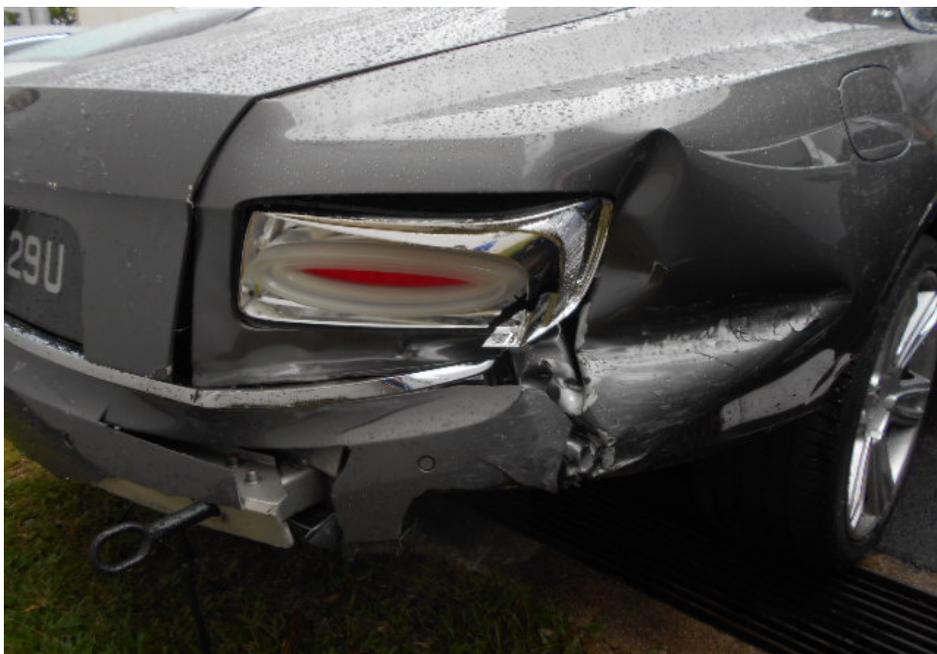
Photo 5 shows the damage at the right rear body of the Insured Vehicle. Its rear bumper, rear bumper reinforcement, rear bootlid, rear right taillamp and rear right fender were amongst the body parts that were damaged as a result of the accident.

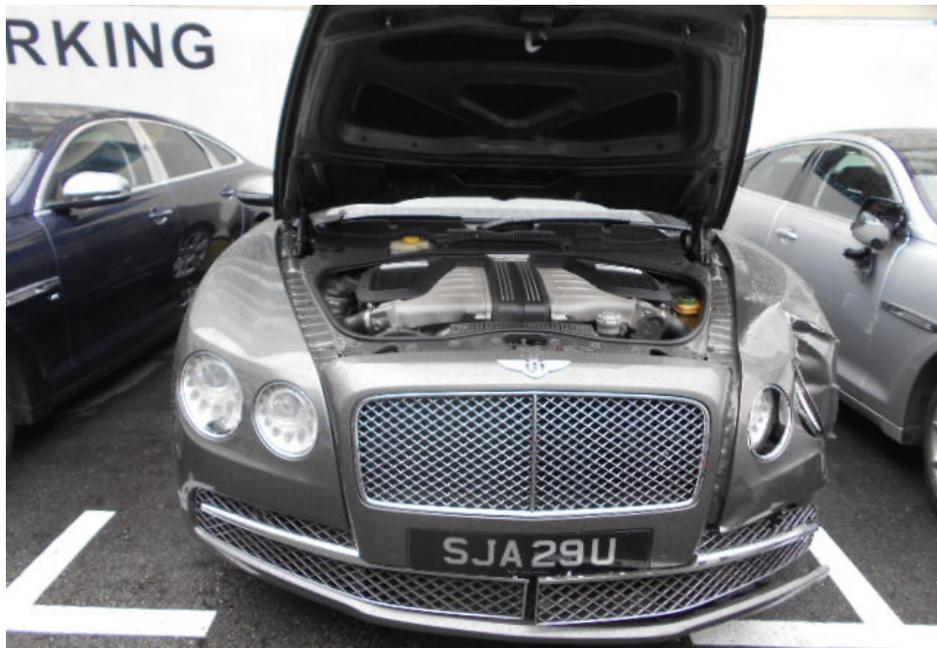
8. Upon examination of the engine compartment of the Insured Vehicle, I had observed all the parts and components inside the engine compartment to be intact and unaffected by the accident. The brake fluid, power steering fluid and engine coolant were all found to be of sufficient level for operating purposes. Visually, there was also no contamination found to these fluids.
9. Further examination of the engine compartment revealed no sign(s) or indication(s) of fluid leakage and/or fluid stain within the engine compartment of the Insured Vehicle. See photo 6 – 9 below.

Photo 6 shows a general view of the Insured Vehicle's engine compartment. The various parts and components inside the engine compartment were unaffected by the accident. There was also no sign(s) or indication(s) of fluid leakage and/or fluid stain within the engine compartment.

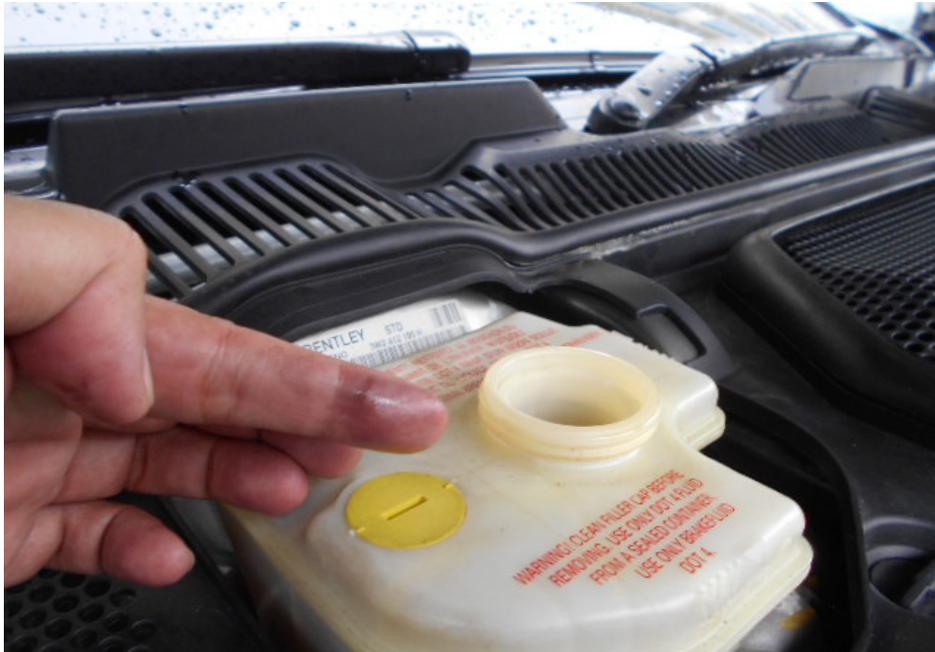
Photo 7 shows the brake fluid reservoir of the Insured Vehicle at the time of my inspection. I had found the brake fluid to be of sufficient level and without any visible contamination for operating purposes.

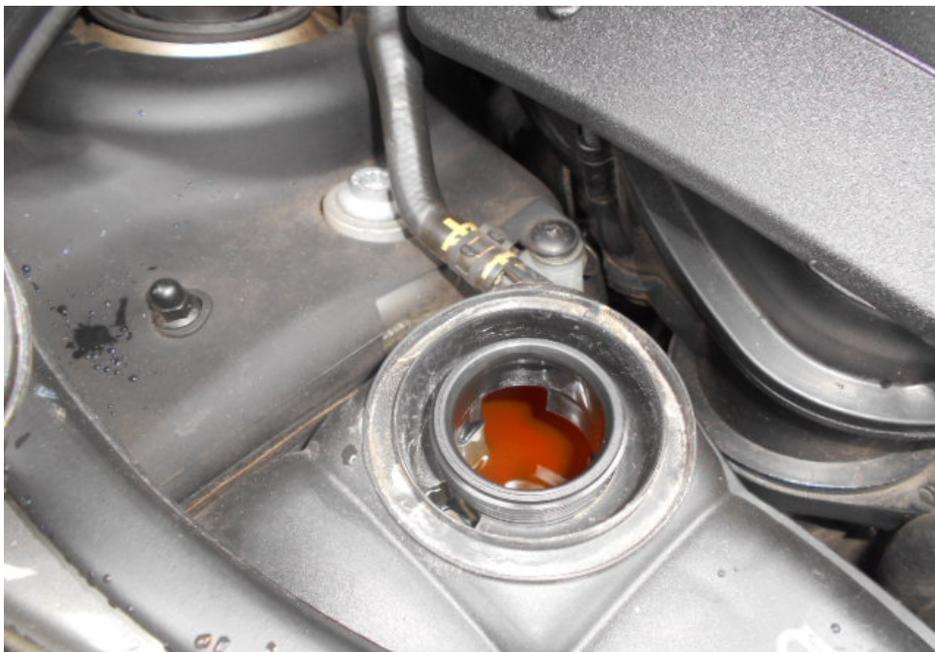
Photo 8 shows the engine coolant reservoir of the Insured Vehicle at the time of my inspection. I had found the engine coolant to be of sufficient level and without any visible contamination.

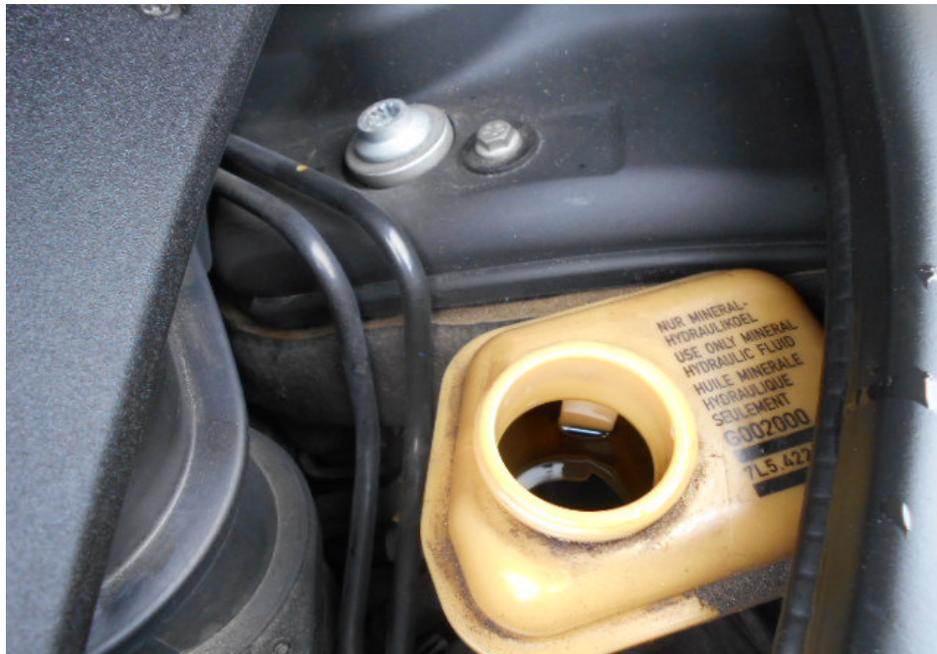
Photo 9 shows the power steering fluid reservoir of the Insured Vehicle at the time of my inspection. I had found the power steering fluid to be of sufficient level and without any visible contamination for operating purposes.

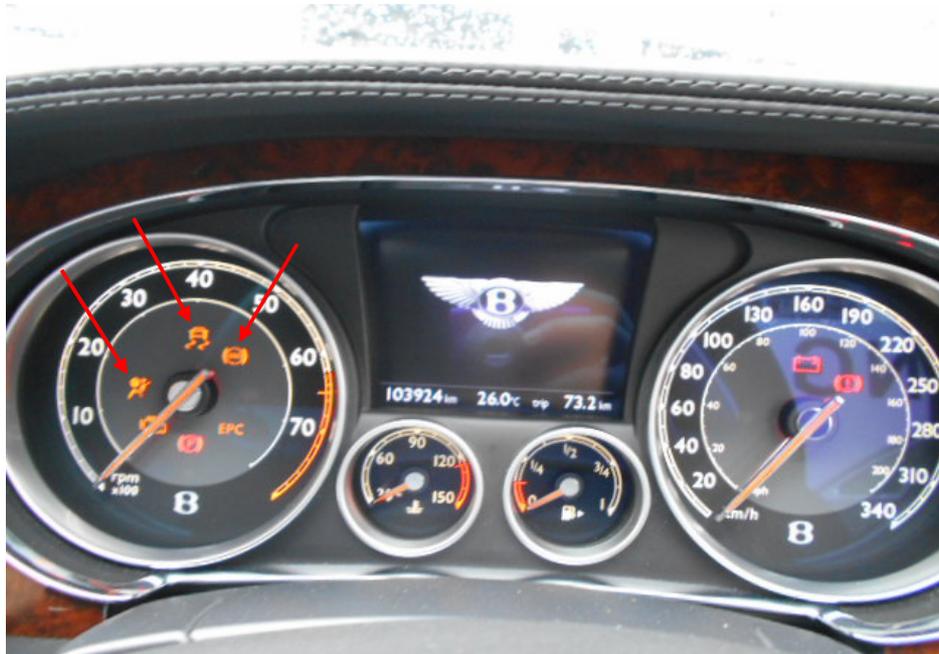
10. The Insured Vehicle's automatic self-test of the functionality of its various electronic operating systems like the Anti-Lock Brake System (ABS), Traction Control (TC) and Supplemental Restraint System (SRS) during cranking of the engine had indicated that these systems were in working condition and without abnormality. This can be established from the warning lights disappearing from the instrument panel after the self-test.

Photo 10 shows the warning light for Anti-Lock Brake System (ABS), Traction Control (TC) and Supplemental Restraint System (SRS) appearing on the instrument panel of the Insured Vehicle during the self-test of its various electronic operating systems when its engine was cranked.

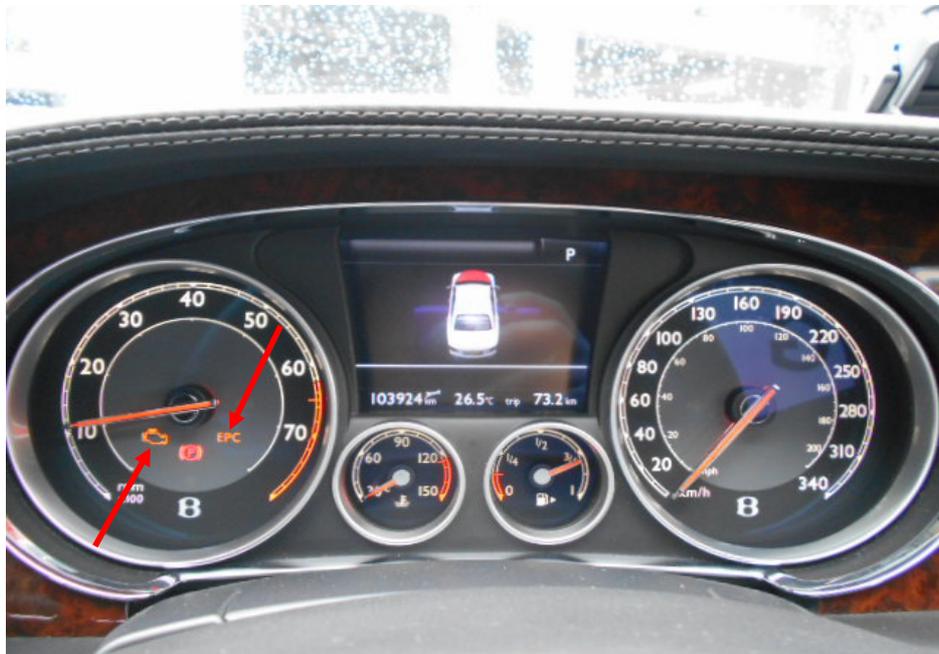
11. The engine check light and EPC (electronic power control) light had however remained lighted up after the self-test. The EPC refers to a fault(s) in either one or more electric operating system of the Insured Vehicle. The illumination of the engine check light accompanies the illumination of the EPC light, indicating that the engine of the Insured Vehicle is operating in safe mode where power is restricted. Given the extent of damage that the Insured Vehicle had sustained, it would not be unusual for the safe mode to be triggered hence the cause of the fault(s) was likely a result of the accident. See photo 10 & 11 below.

Photo 11 shows the engine check light and EPC light still illuminated after the self-test. This indicates a fault to either one or more electric operating system of the Insured Vehicle. The illumination of the engine check light accompanies the illumination of the EPC light. The ABS, TC and SRS lights were however no longer illuminated indicating that these electronic operating systems were in working condition and without abnormality.

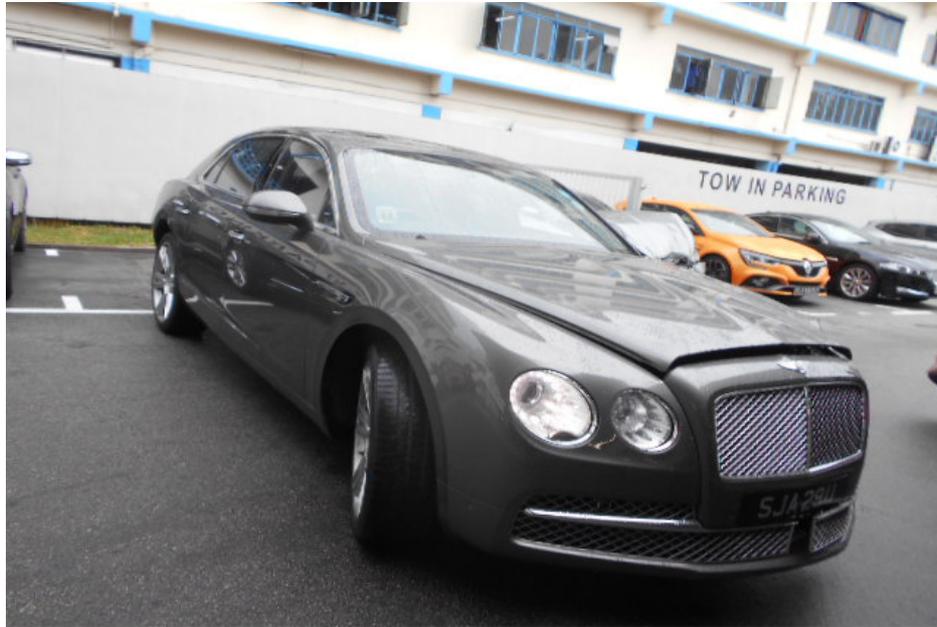
15. I subsequently shifted the transmission of the Insured Vehicle to "D" mode by manually downshifting the gear selector. The Insured Vehicle moved forward when I stepped on the accelerator pedal. Whilst moving, I stepped on the brake pedal and noted that the Insured Vehicle was able to stop effectively. The transmission was then selected to "R" mode and the Insured Vehicle reversed when I stepped on the accelerator pedal. The Insured Vehicle was able to stop effectively again when I stepped on the brake pedal. The same cycle was repeated 3 times, and on all occasions, I was able to bring the Insured Vehicle to a complete stop effectively. See photo 12 & 13 below.

Photo 12 shows the Insured Vehicle, with its front wheels turned to its full right, after it was driven forward from its original position. As part of my tests on the braking system and steering system of the Insured Vehicle, I had driven the Insured Vehicle forward and stopped, thereafter reverse and stopped. In general, I had found the braking system and steering system to be operating normally. The Insured Vehicle was able to stop effectively, and the steering wheel was able to turn without any abnormal free play and/or other resistance. The front wheels were able to turn in the direction that the steering wheel was turned.

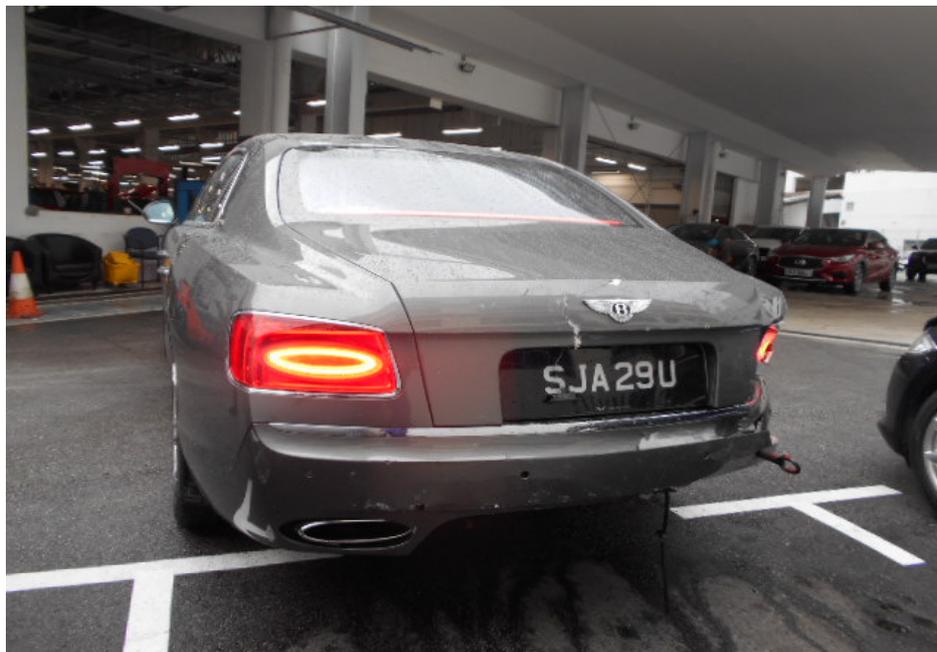
Photo 13 shows the Insured Vehicle after it was driven forward from its original position. In general, I had found the braking system and steering system of the Insured Vehicle to be operating normally.

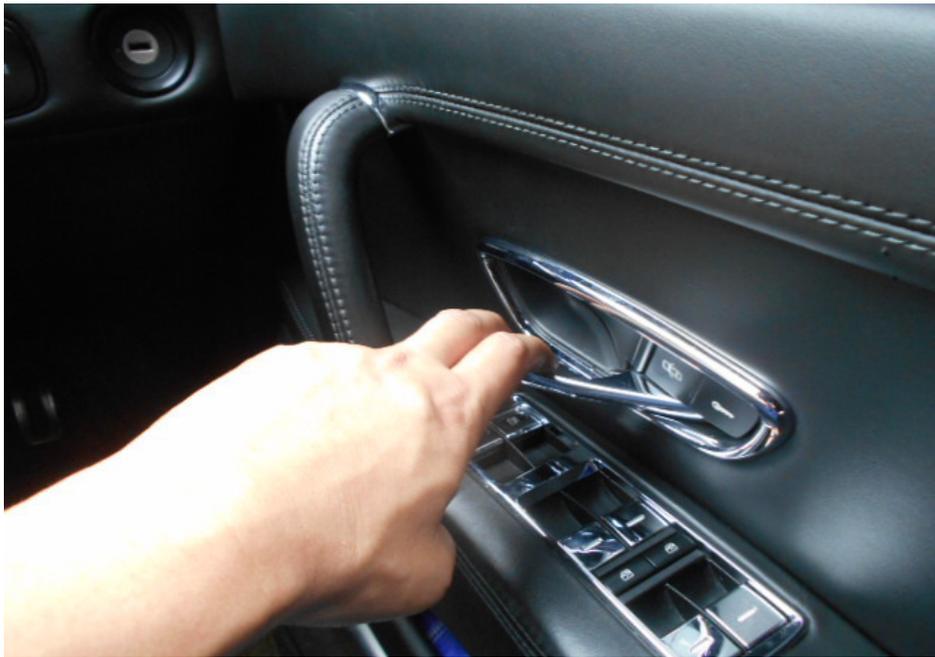
16. The front right door of the Insured Vehicle was checked, and it was observed that the hinges and locking mechanism were all properly fitted and in serviceable condition. Whilst seated on the driver's seat with the front right door closed, I had exerted some force by leaning onto the front right door and it was noted that the front right door remained closed and did not open. It could only be opened by manually pulling the inner handle and pushing the front right door outwards. When opened, the hinges were able to securely hold the front right door in an open position. Generally, I did not find any loose swinging of the front right door during my checks and tests. There was no issue/fault with the condition of the Insured Vehicle's front right door that could have suggested any malfunction of the front right door. See photo 14 & 15 below.

Photo 14 shows the inner handle of the Insured Vehicle's front right door. Whilst seated inside the Insured Vehicle, the front right door could only be opened by manually pulling the inner handle and pushing the front right door outwards. Exerting some force by leaning onto the front right door without pulling the inner handle will not open the front right door. I had found no issue/fault with the condition of the Insured Vehicle's front right door that could have suggested malfunction of the front right door.

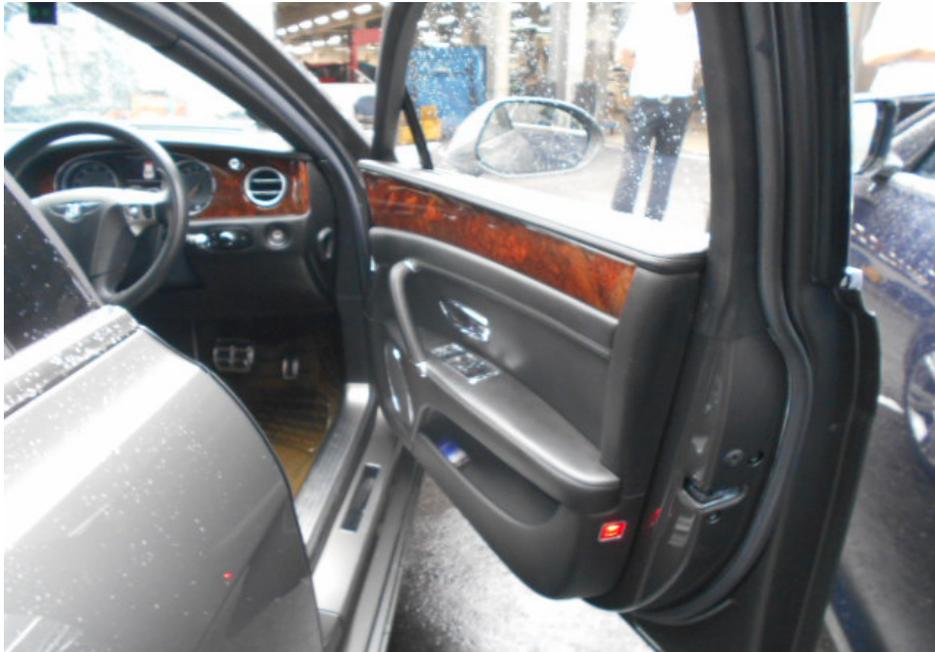
Photo 15 shows the front right door of the Insured Vehicle opened. The hinges were able to securely hold the front right door open. Generally, I did not find any loose swinging of the front right door during my checks and tests.

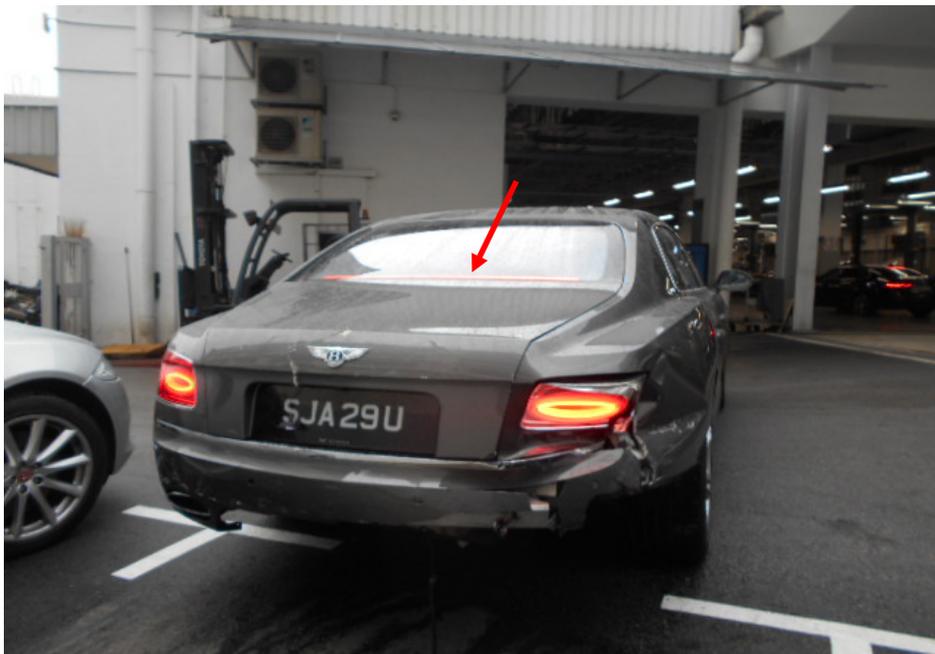
21. At the time of my inspection of the Insured Vehicle, I had checked on the working condition of the Insured Vehicle's brake light. It was noted that when the brake pedal of the Insured Vehicle was depressed, the brake light at the rear left taillamp and the rear right taillamp will light up together with the third brake light, which covers almost the entire width at the bottom part of the rear windscreen. Based on this observation, it can be ascertained that the brake lights of the Insured Vehicle were in working condition and will light up when the brake pedal was depressed. See photo 16 & 17 below.

Photo 16 shows the brake light at the rear left taillamp and the rear right taillamp of the Insured Vehicle lighted up together with the third brake light (arrowed) when the brake pedal was depressed. From my observations, it can be ascertained that the brake lights of the Insured Vehicle were in working condition.

22. Co-relating my findings that the brake lights of the Insured Vehicle were in working condition with the events seen in the video recording (paragraph 20 above), it would appear that the brake pedal of the Insured Vehicle was not depressed at the time when the Insured Vehicle was reversing at speed and at the time when it was moving forward at speed. This also takes into consideration that just prior to the accident, the brake lights were lighted up whenever the Insured Vehicle was coming to a stop during adjustment manoeuvres by the driver (paragraph 18 above). The accident could be a result of the driver inadvertently stepping on the accelerator pedal instead of the brake pedal. The accident does not seem to be a result of any mechanical fault(s) to the Insured Vehicle.

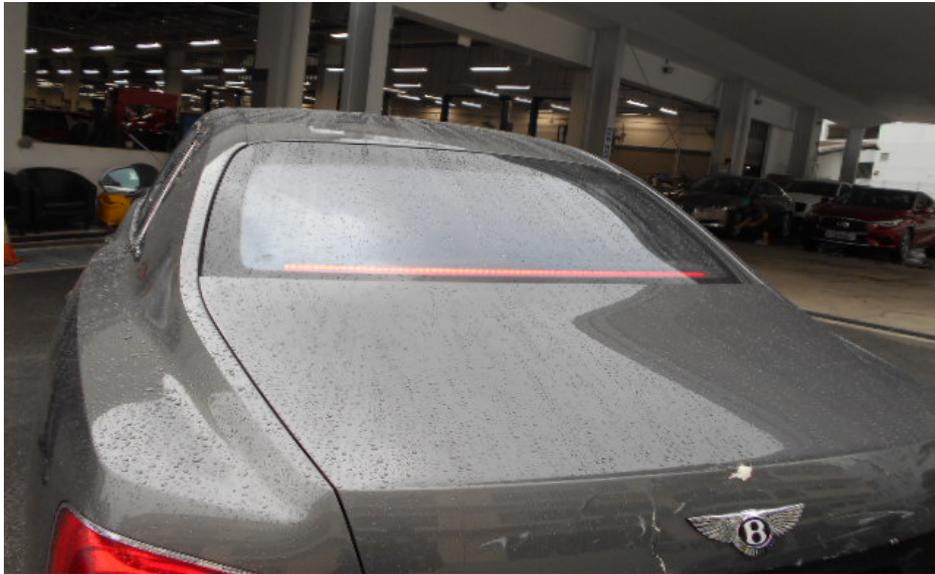
Photo 17 shows a closer view of the Insured Vehicle's third brake light, which lights up when the brake pedal was depressed. The third brake light covers almost the entire width at the bottom part of the rear windscreen.
