Your ref: D19004839MFSH

**INITIAL INSPECTION REPORT OF VEHICLE NO. SMJ 8179J**

## **ESTIMATE TO REPAIR HONDA FREED - SMJ8179J**

### ADJUSTMENT ON REPAIR COST FOR VEHICLE NO. SMJ 8179J

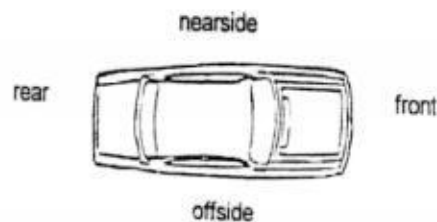
The vehicle sustained damages at the rear portion

Comments/Present Status:  
Damages Consistent
