INITIAL INSPECTION REPORT OF VEHICLE NO. SLZ 9418R

We thank for your instruction on 30/7/2019

ADJUSTMENT ON REPAIR COST FOR VEHICLE NO. SLZ 9418R

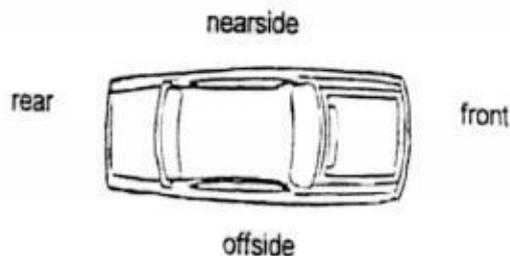
Description of Damage:

The vehicle sustained damages at the rear o/s portion and front portion

Comments/Present Status:

Damages Consistent
