## AUTOMOBILE ASSESSMENT REPORT

### ASSESSMENT OF VEHICLE NO. SLG 4889 Y

DATE OF LOSS: 06-Nov-2018

Registration No.:	SLG 4889 Y
Make & Model:	MERCEDES BENZ C200 AMG
Year of Registration:	2016
Engine Capacity:	1991
Chassis No.:	WDD2053422F338693
Engine No.:	27492030514463
Colour:	GREEN
Mileage (km):	26353

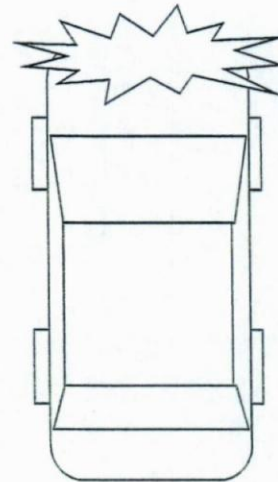
At the time of the inspection, the vehicle sustained damages to the FRONT portion.
