Your Ref : 5746196500SG (003)
Our Ref : CI/AIG19013457/N

4 June 2019

**AUTOMOBILE TECHNICAL INVESTIGATION REPORT OF ACCIDENT
INVOLVING SHC 6960D AND SKG 882D ON 17 JANUARY 2019**

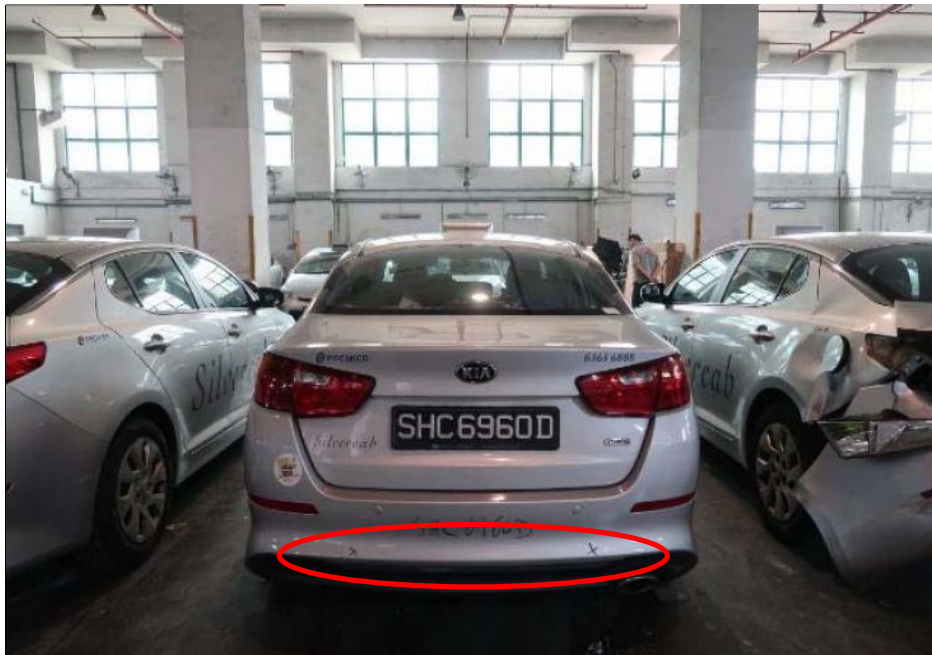
7. From our examination of the photographs provided to us, the damage to the Taxi was observed to be confined to its rear bottom portion. We observed paint graze marks as well as circular blackish marks on the bottom portion of the Taxi's rear bumper. However we noted that the rear bumper was not misaligned at its corner edges. See photos 1 - 7 below.

Photo 1 shows the general view of the rear of the Taxi from the photograph provided to us. The damage to the Taxi was observed to be confined to its bottom portion (circled).

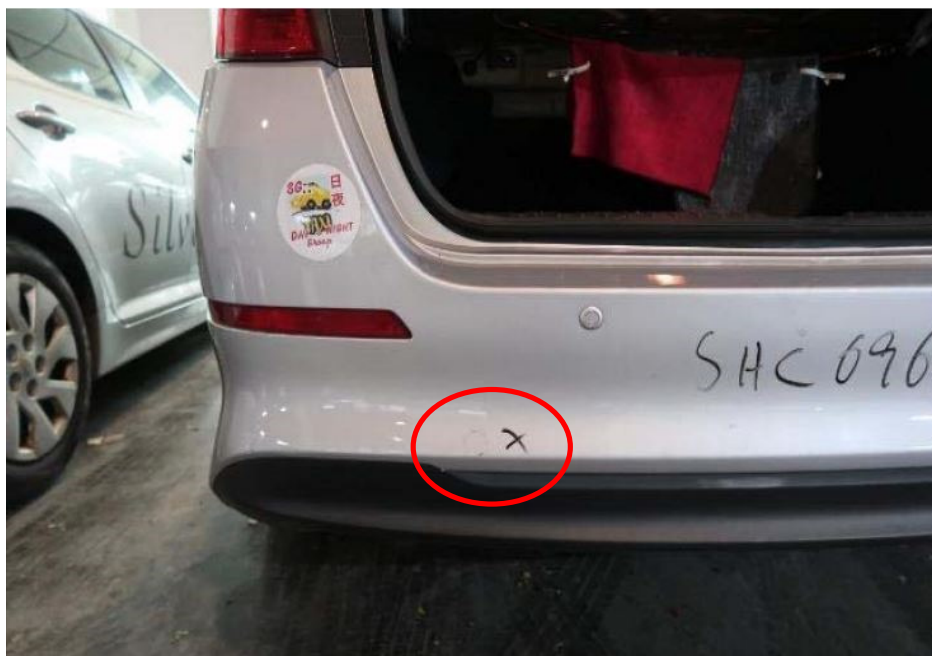
Photo 2 shows a closer view of the left bottom portion of the Taxi's rear bumper. We observed paint graze marks as well as circular blackish marks on the left bottom portion of the Taxi's rear bumper (circled).

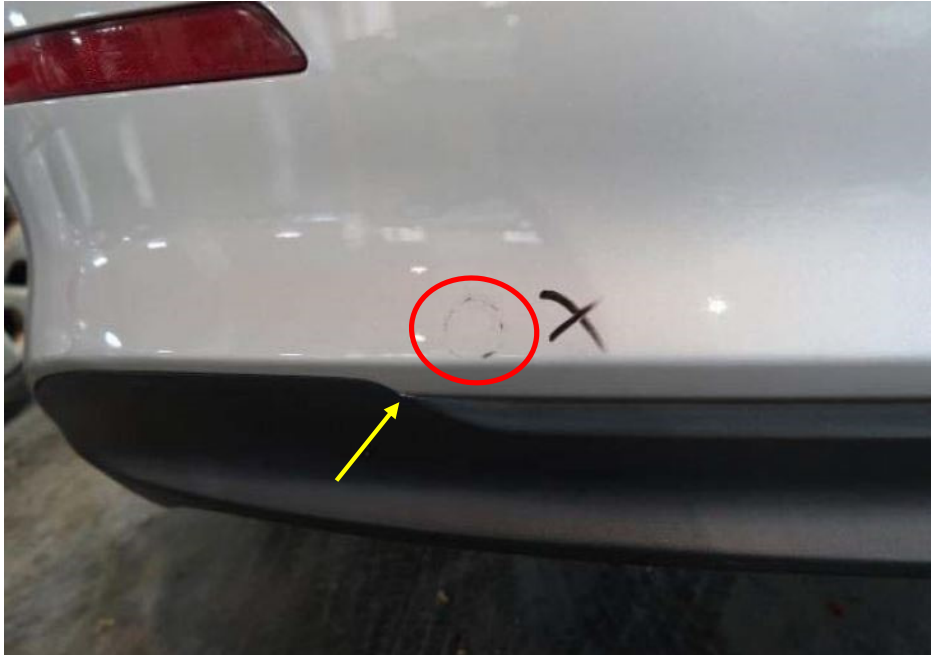
Photo 3 shows a close up view of the paint graze marks (arrowed) as well as circular blackish marks (circled) on the left bottom portion of the Taxi's rear bumper.

- a) the circular blackish marks on the bottom portion of the Taxi's rear bumper were caused by an object that is of a similar circular shape, pressing onto the rear portion of the Taxi. If one was to consider the rectangular shape of the Nissan's front tow cover, it would then appear that these circular blackish marks were unlikely to be caused by the front tow cover of the Nissan;

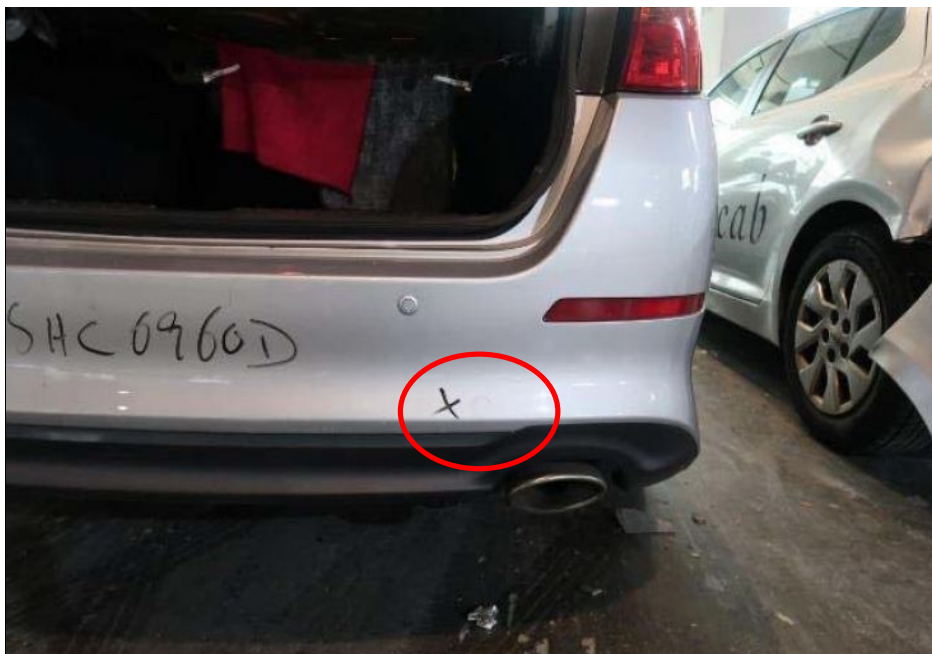
Photo 4 shows a closer view of the right bottom portion of the Taxi's rear bumper. We observed paint graze marks as well as circular blackish marks on the right bottom portion of the Taxi's rear bumper (circled).

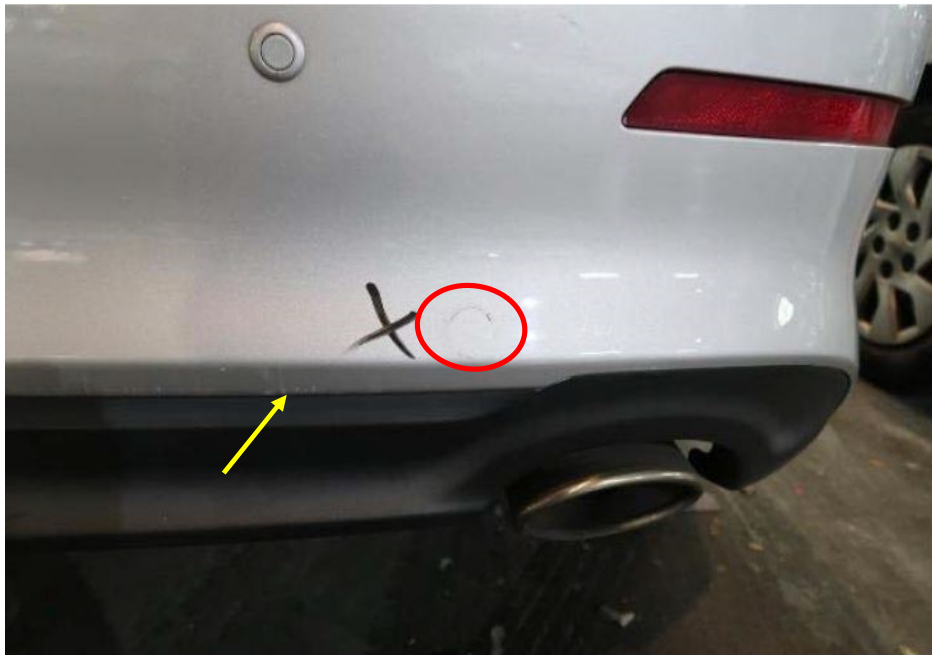
Photo 5 shows a close up view of the paint graze marks (arrowed) as well as circular blackish marks (circled) on the right bottom portion of the Taxi's rear bumper.

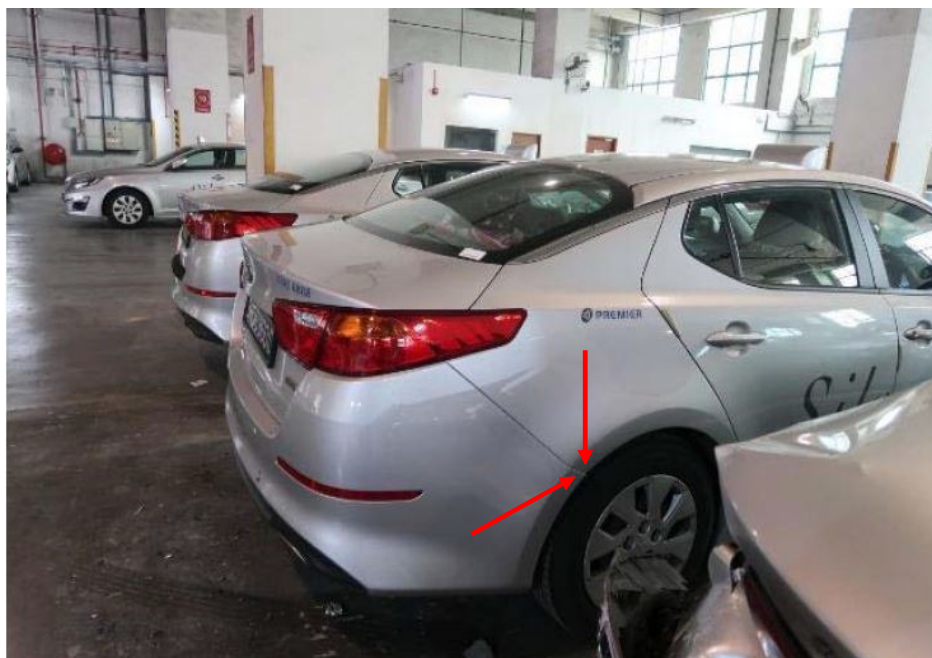
Photo 6 shows a close up view of the right corner edge of the rear bumper of the Taxi. We observed that there was no misalignment at the corner edges (red arrows).

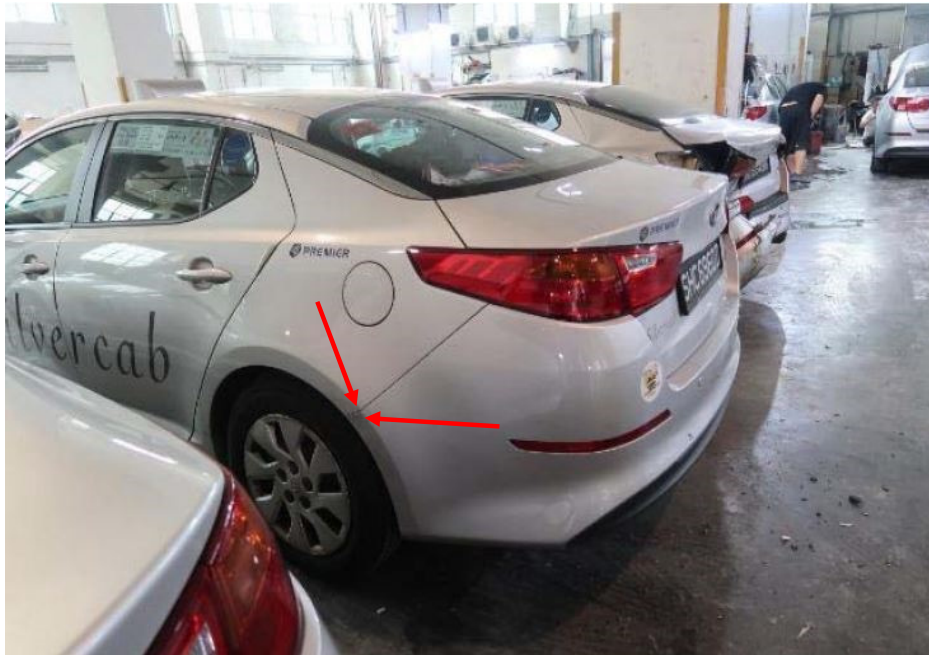
Photo 7 shows a close up view of the left corner edge of the rear bumper of the Taxi. We observed that there was no misalignment at the corner edges (red arrows).

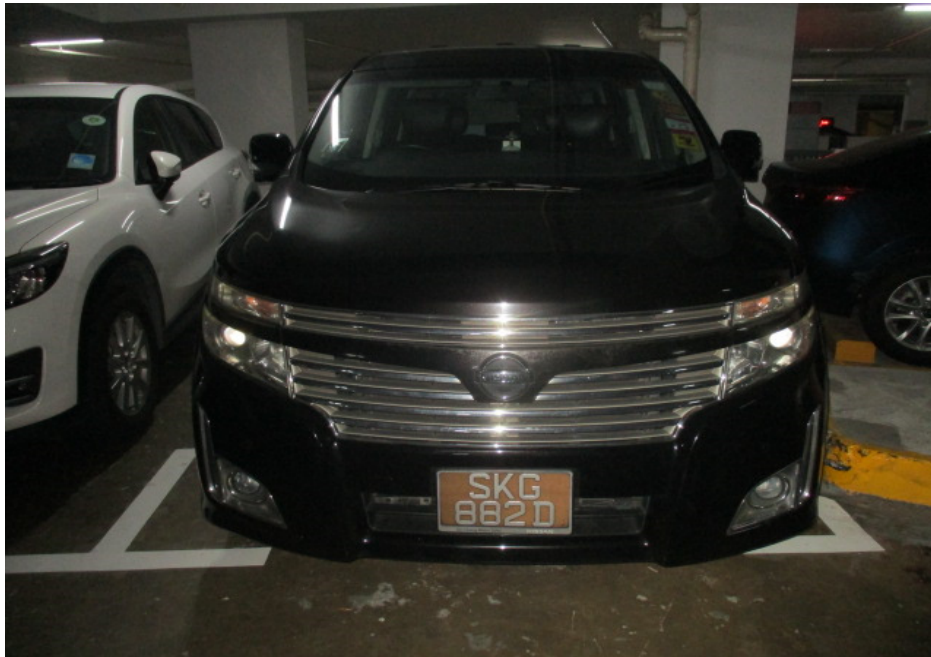
8. The Nissan was physically inspected at the premises of The Pinnacle located at 1G Cantonment Rd, Singapore 085301.
9. The mileage recorded was 189, 163km.
10. At the time of our inspection, we observed white graze marks on the right front tow cover as well as below the front bumper grille of the Nissan. We also found scuff marks on the left portion of the Nissan's front bumper. Closer examination of the front number plate revealed that the right lower portion was bent inwards. However, it was also noted that the front bumper was not misaligned at its corner edges. See photos 8 - 14 below.

Photo 8 shows the general view of the front portion of the Nissan upon our physical inspection.

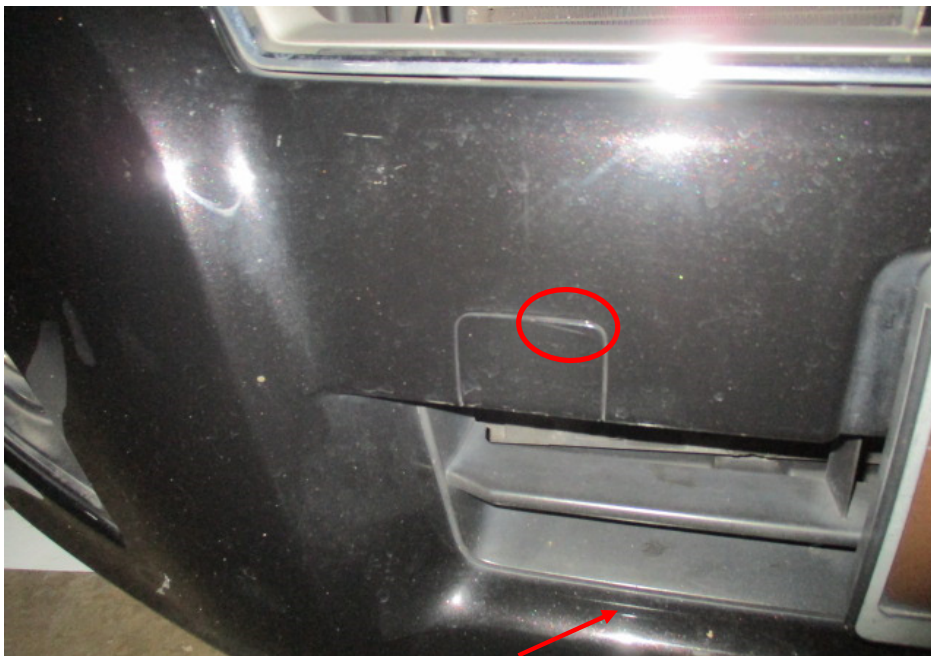
Photo 9 shows the white graze marks on the right front tow cover (circled) and below the front bumper grille (arrowed) of the Nissan.

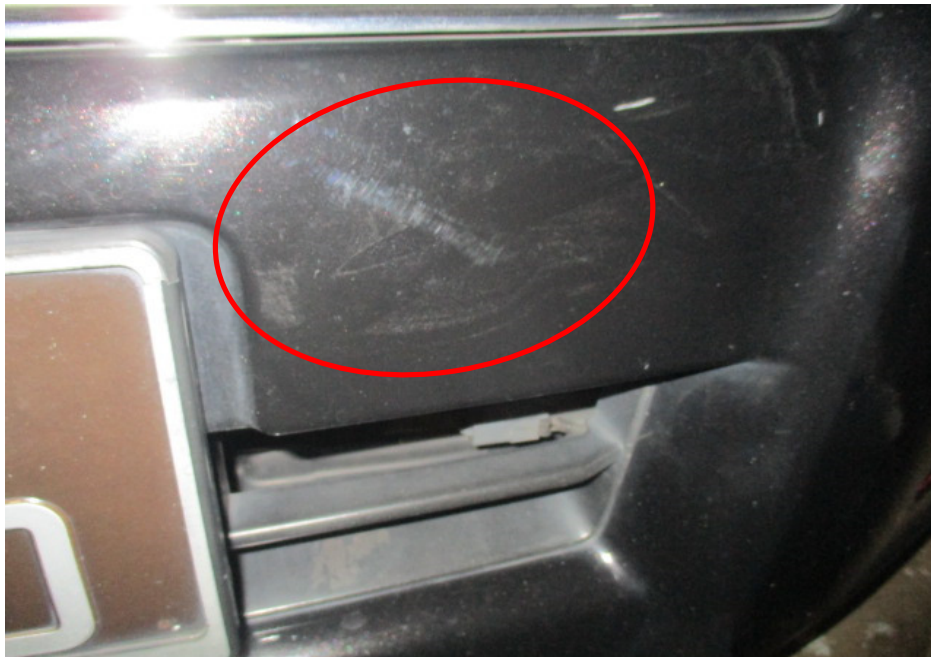
Photo 10 shows a close up view of the scuff marks on the left portion of the Nissan's front bumper (circled).

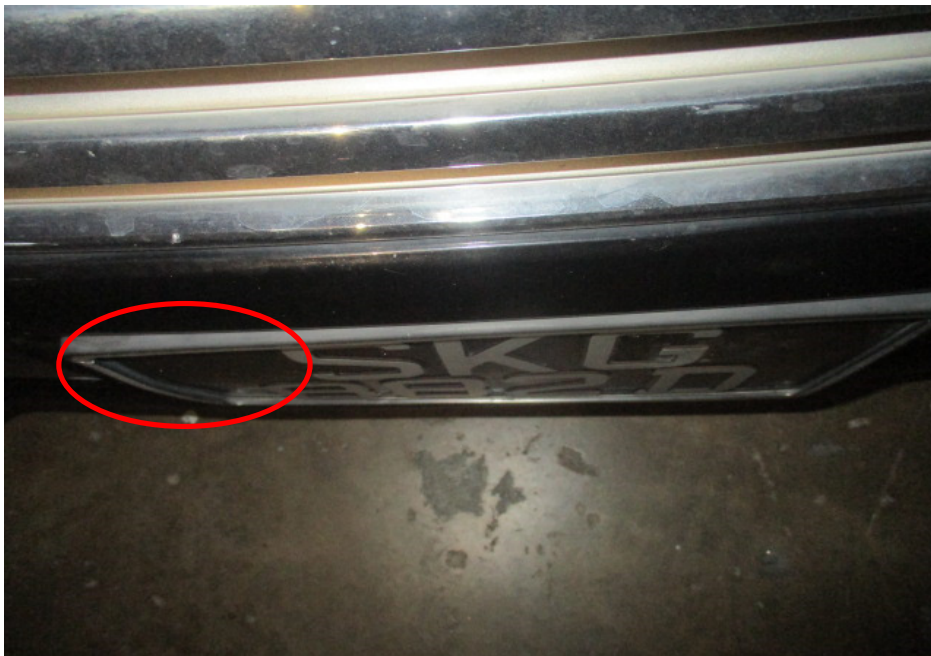
Photo 11 shows upon closer examination of the front number plate of the Nissan, we observed that the right lower portion was bent inwards (circled).

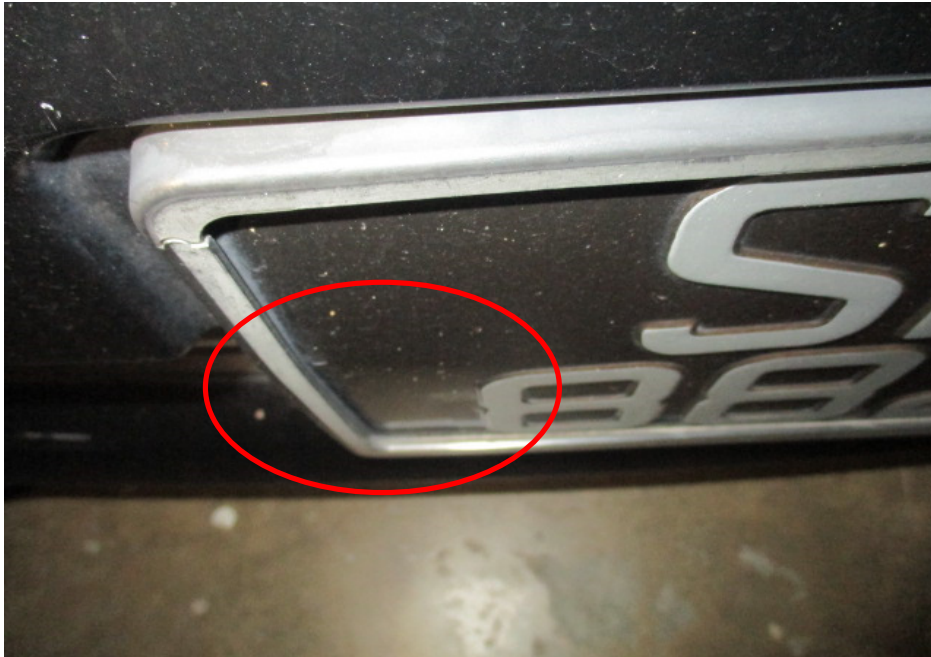
Photo 12 shows a close up view of the right lower portion of the Nissan's front number plate which was observed to be bent inwards (circled)

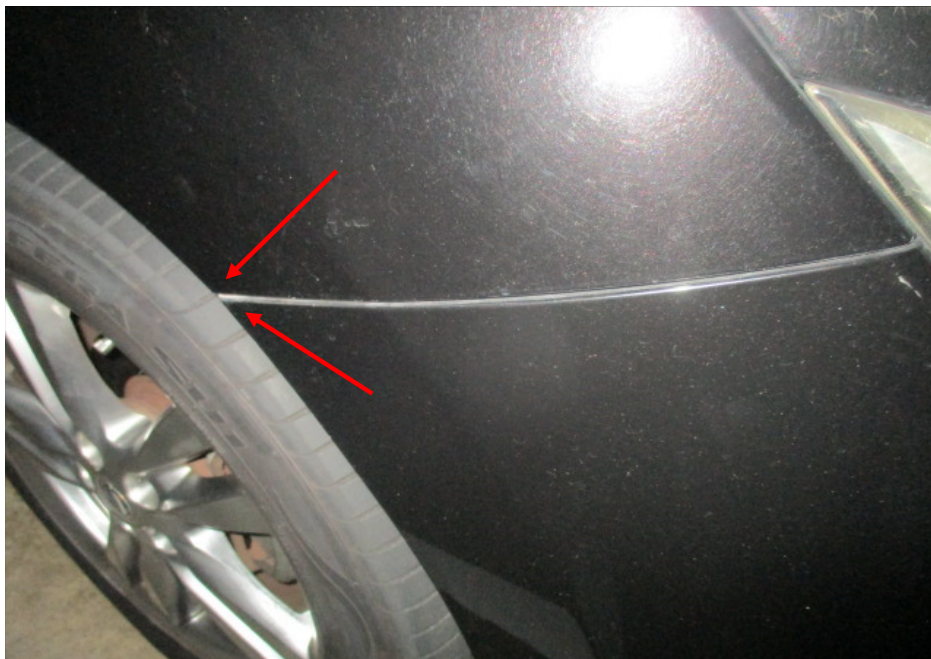
Photo 13 shows a close up view of the right corner edge of the front bumper of the Nissan. We observed that there was no misalignment at the corner edges (red arrows).

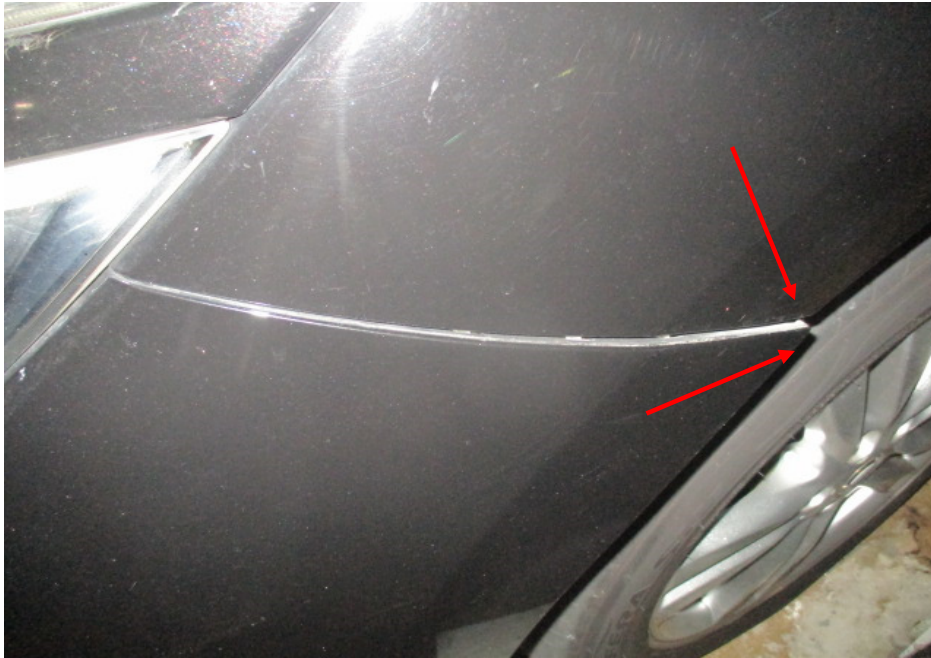
Photo 14 shows a close up view of the left corner edge of the front bumper of the Nissan. We observed that there was no misalignment at the corner edges (red arrows).

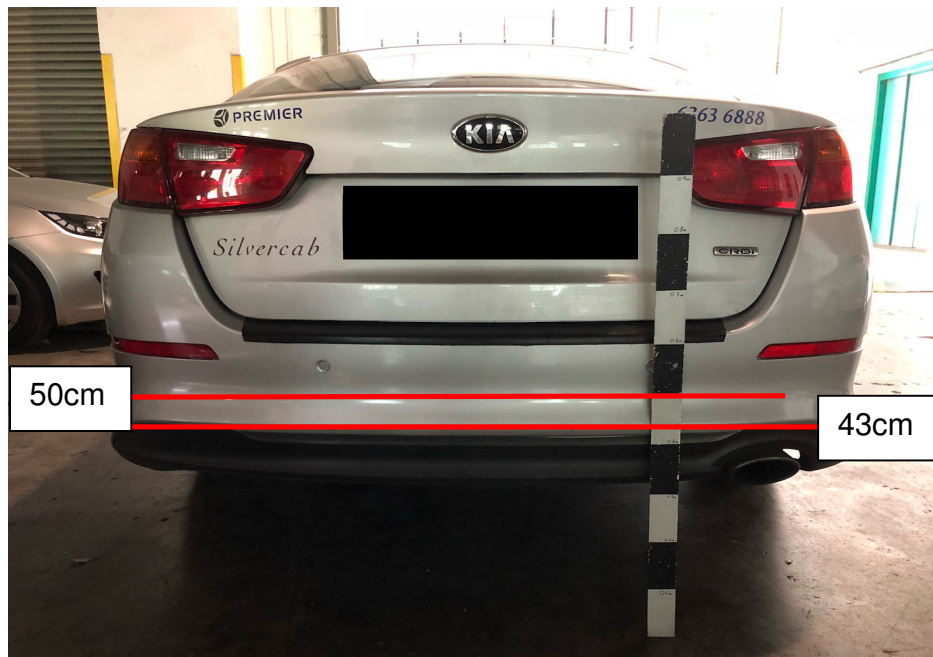
Photo 15 shows the height measurement being conducted on the rear portion of the Taxi (using a similar make and model). The height range of the circular blackish marks on the bottom portion of the rear bumper was measured to be approximately between 43cm and 50cm above ground level.

- b) the height range of the circular blackish marks on the bottom portion of the rear bumper of the Taxi was measured to be approximately between 43cm and 50cm above ground level;

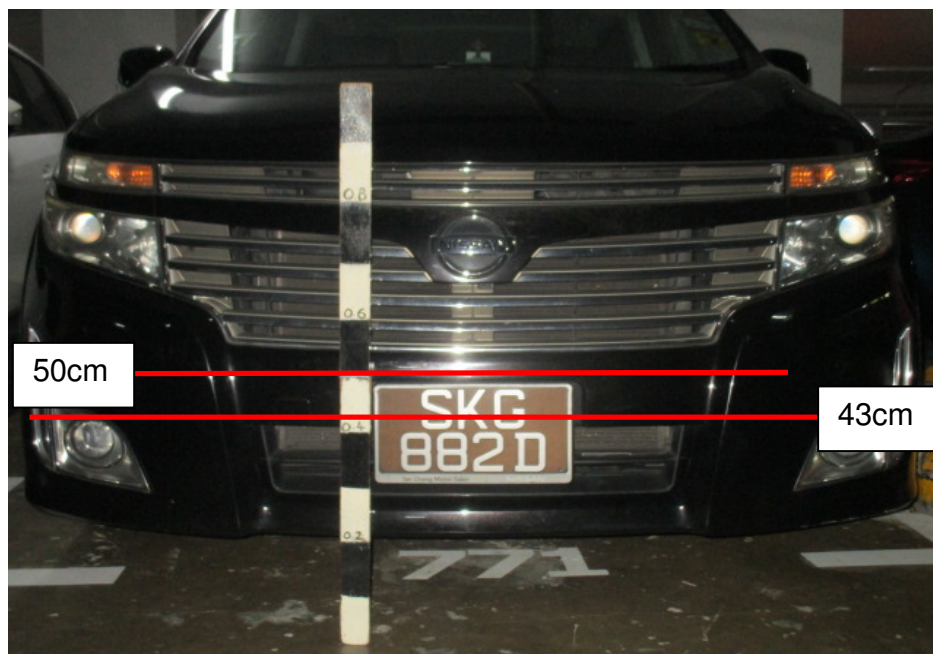
Photo 16 shows the height measurement being conducted on the front portion of the Nissan. At the height range of between 43cm and 50cm above ground level, there were no body parts of the Nissan that corresponded to the height range of the circular black marks found on the bottom portion of the Taxi's rear bumper.

- c) at the height range of between 43cm and 50cm above ground level, there were no body parts of the Nissan that corresponded to the height range of the circular black marks found on the bottom portion of the Taxi's rear bumper;

- d) the height measurements appear to support the findings of no possible contact between the rear bumper of the Taxi and the front portion of the Nissan. The damage observed on the rear bumper of the Taxi was not a result of this contact and did not correspond to the damage observed on the front portion of the Nissan.
