Your Ref: S9M01VI3  
Our Ref : CI/ASM19013517/D

### **AUTOMOBILE INSPECTION REPORT OF INSURED VEHICLE SLD 7912J**

Vehicle Registration No. : SLD 7912J  
Make / Model : Volkswagen Scirocco R 2.0 AT  
Chassis No : WVVZZZ13ZDV016226  
Year of Registration : 2013 (February)  
Mileage : 126,804km

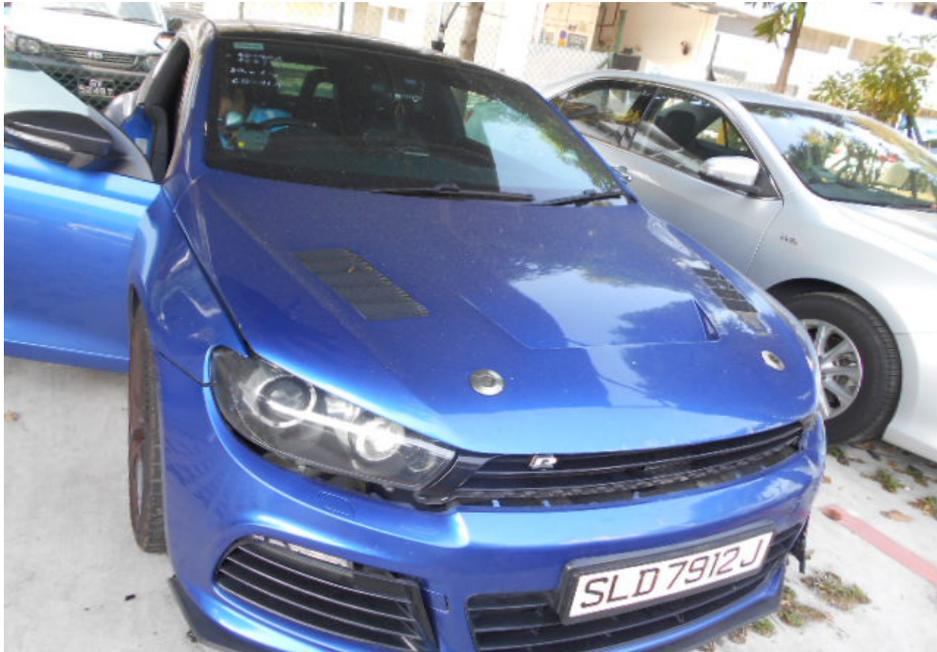
**Photo 1** shows the front right body of the insured vehicle at the time of my inspection. Exteriously, the insured vehicle had sustained minor impact damages that were confined to its frontal portion. Without dismantling of any exterior body parts, I had observed damage to its front bumper and front radiator grille.

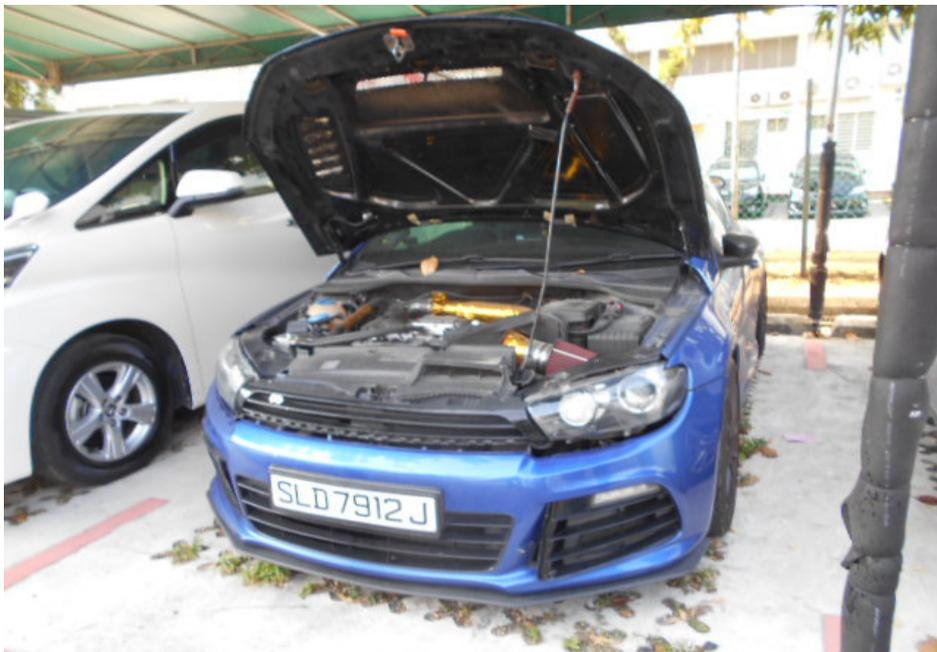
**Photo 2** shows the front left body of the insured vehicle at the time of my inspection. Exteriously, the insured vehicle had sustained minor impact damages that were confined to its frontal portion. Without dismantling of any exterior body parts, I had observed damage to its front bumper and front radiator grille.

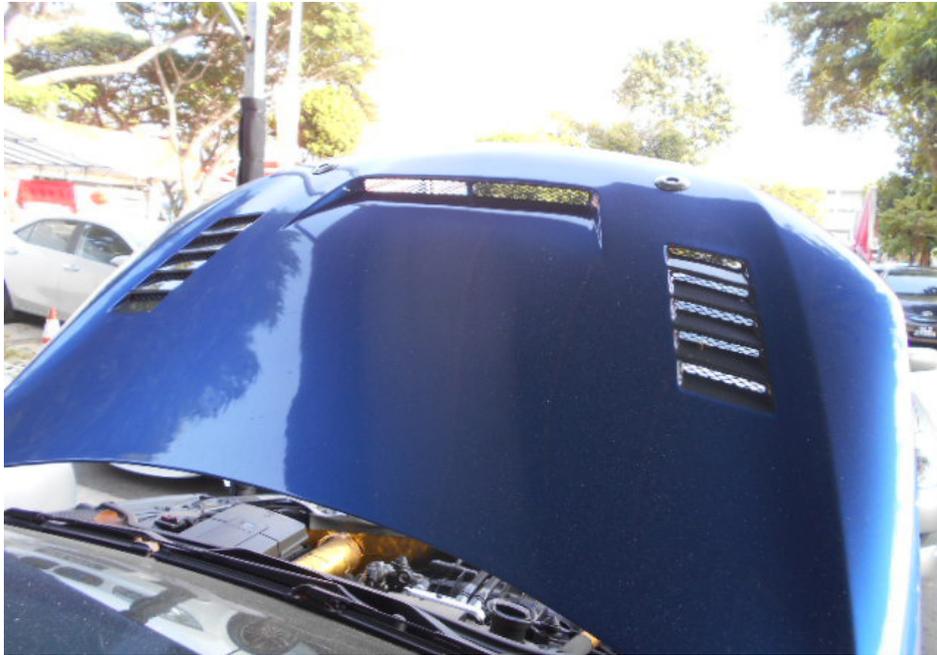
**Photo 3** shows the non-standard front bonnet that was fitted on the insured vehicle.

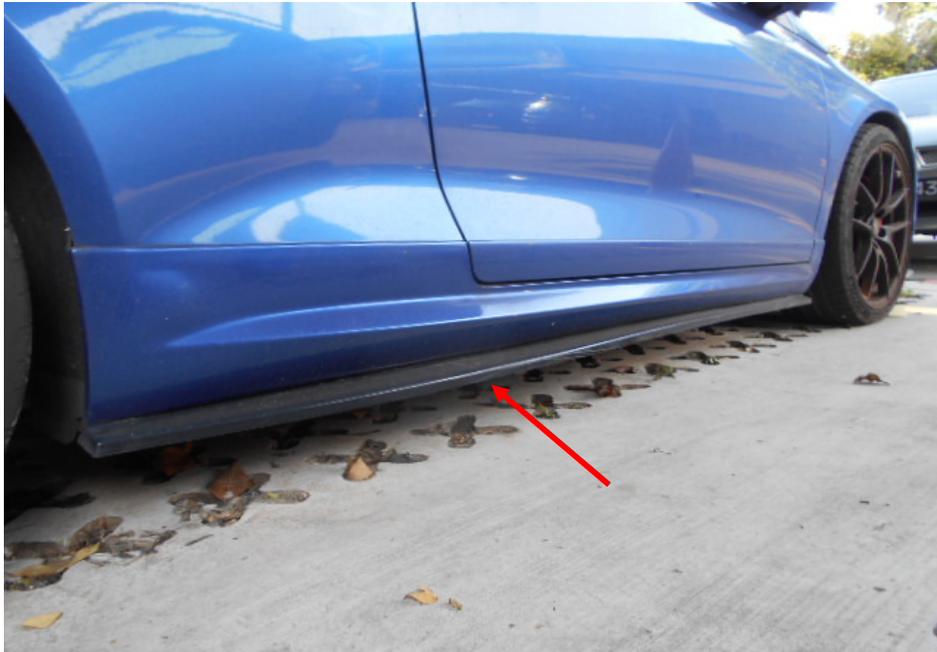
**Photo 4** shows the right side lower skirt (arrowed) that was fitted on the insured vehicle. From my observations, the insured vehicle was fitted with a complete set of aftermarket bodykit, which had included a front bumper lower spoiler, left side and right side lower skirt, and rear bumper lower spoiler.

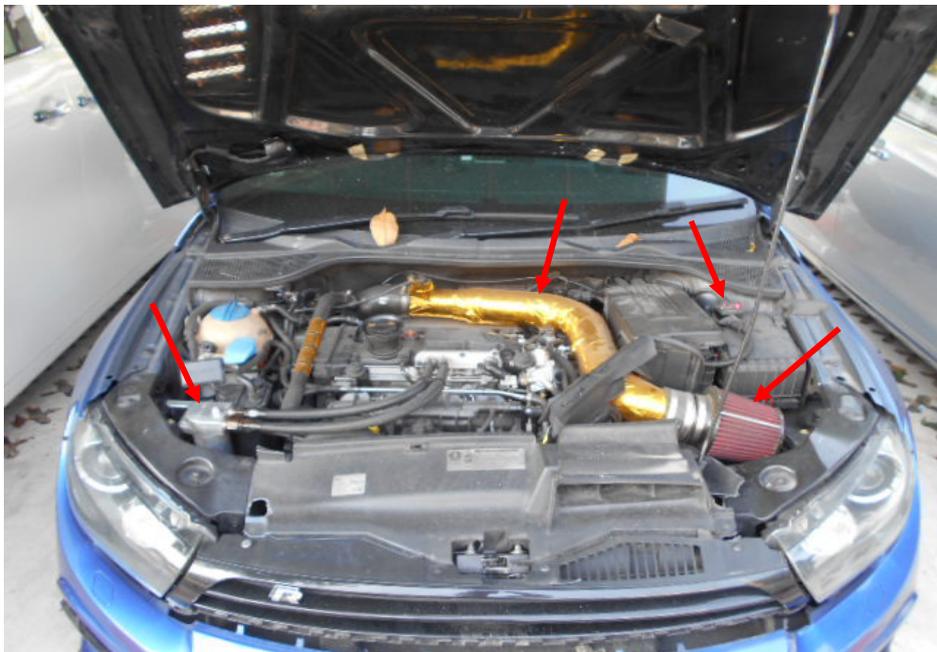
**Photo 5** shows a general view of the engine compartment of the insured vehicle. Several modifications and additional non-standard parts fitted. This includes an aftermarket air intake system with all piping; an additionally fitted oil catch can; and an additionally fitted high ampere fuse/controller.

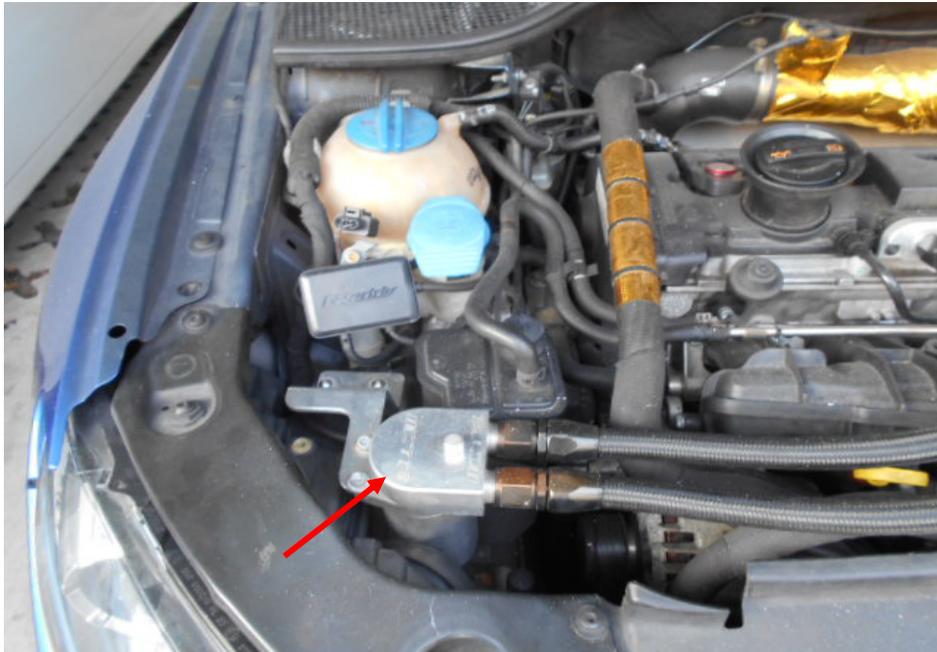
**Photo 6** shows the additionally fitted non-standard oil catch can (arrowed) that was fitted on the insured vehicle at the time of my inspection.

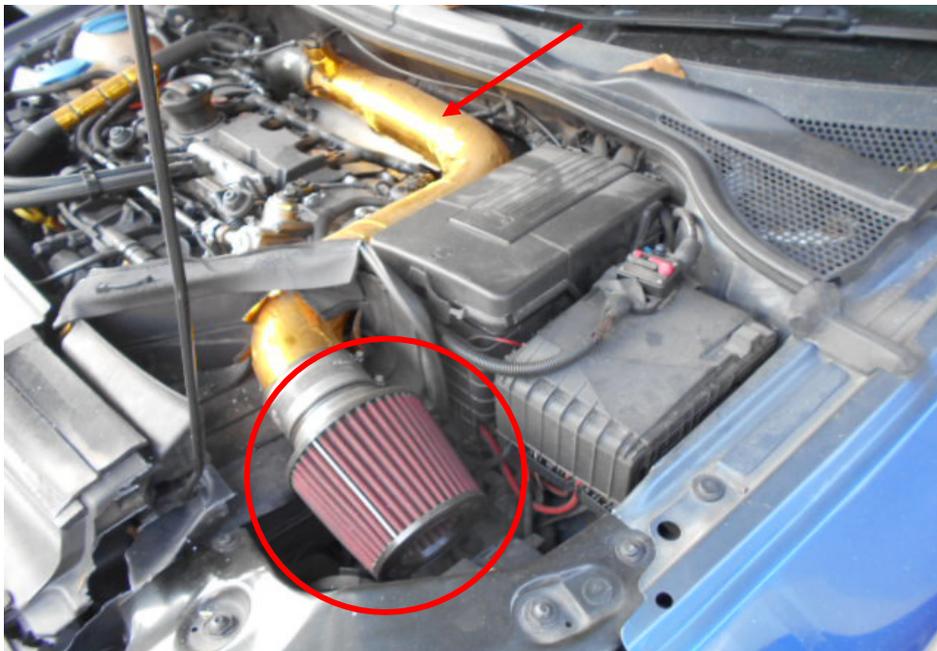
**Photo 7** shows the aftermarket air intake system with all piping (circled and arrowed) that was fitted on the insured vehicle at the time of my inspection.

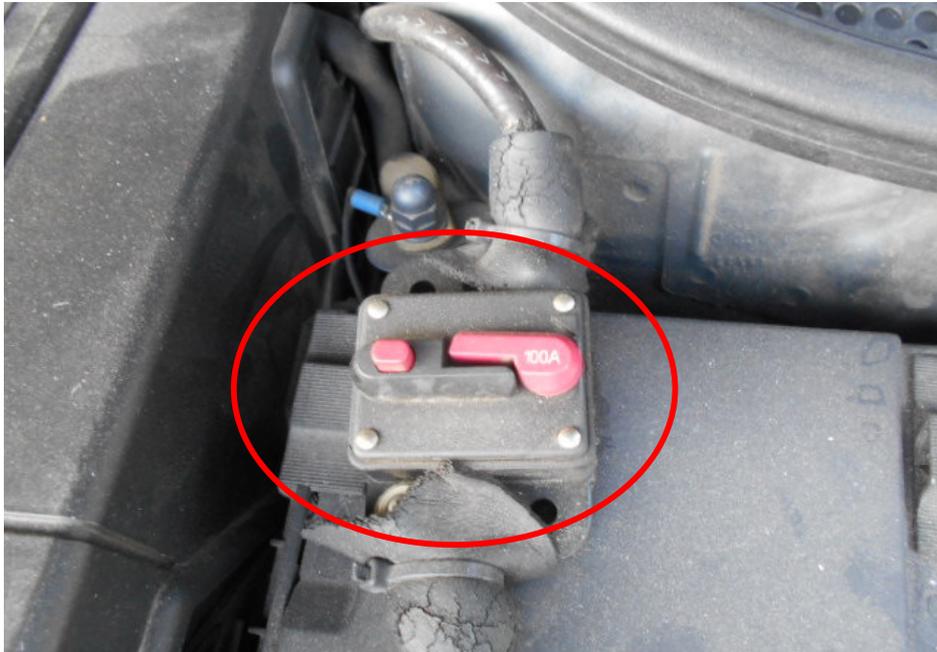
**Photo 8** shows the additionally fitted non-standard high ampere fuse/controller (circled) that was found fitted inside the engine compartment of the insured vehicle.

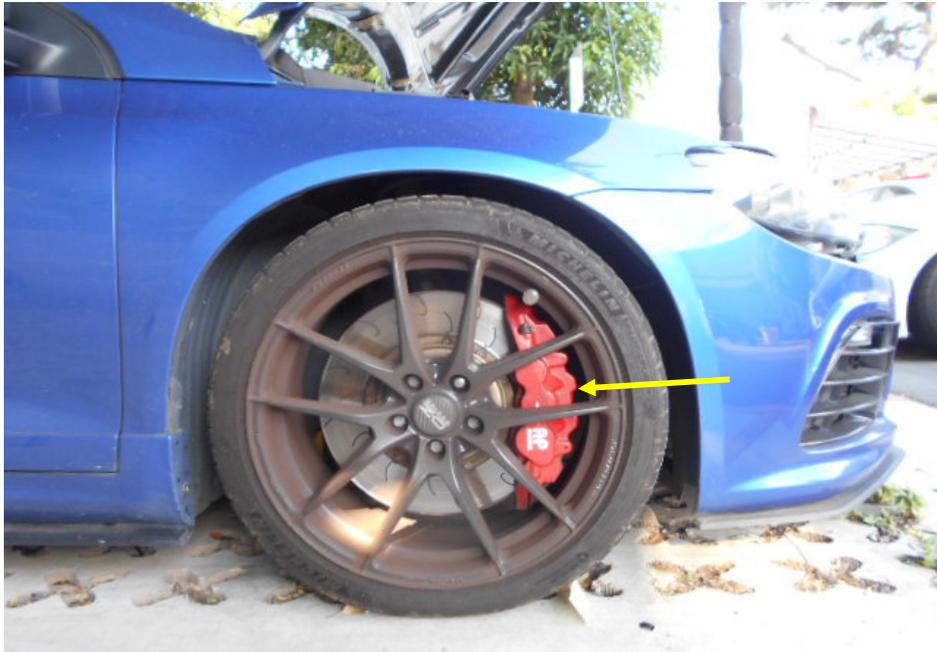
**Photo 9** shows the aftermarket front brake caliper (arrowed) was fitted on the insured vehicle. The front brake system of the insured vehicle was observed to be of an aftermarket brand.

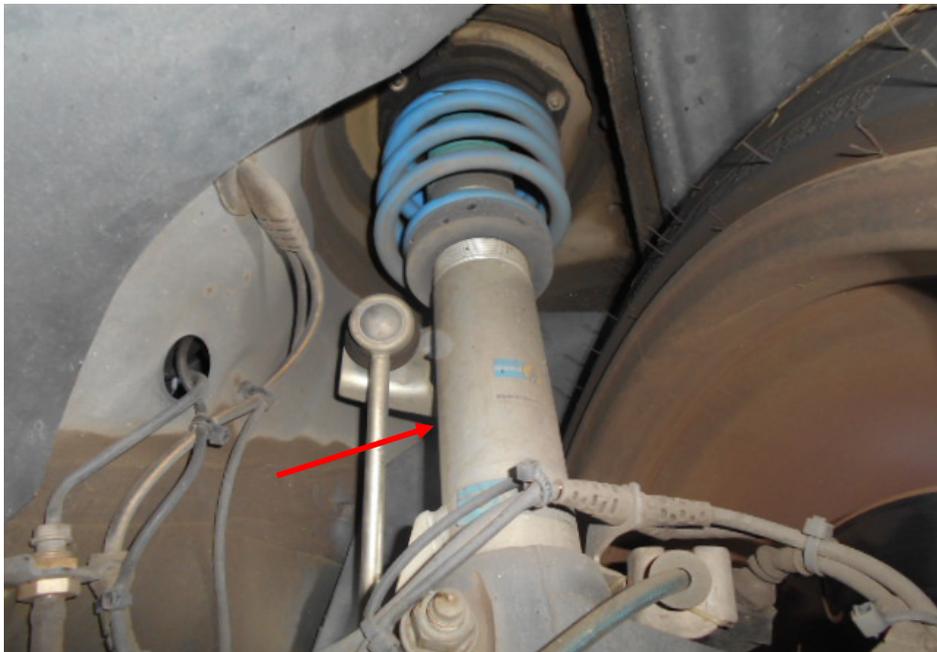
**Photo 10** shows the aftermarket front right suspension (arrowed) of the insured vehicle. The insured vehicle was fitted with aftermarket front and rear suspension system.

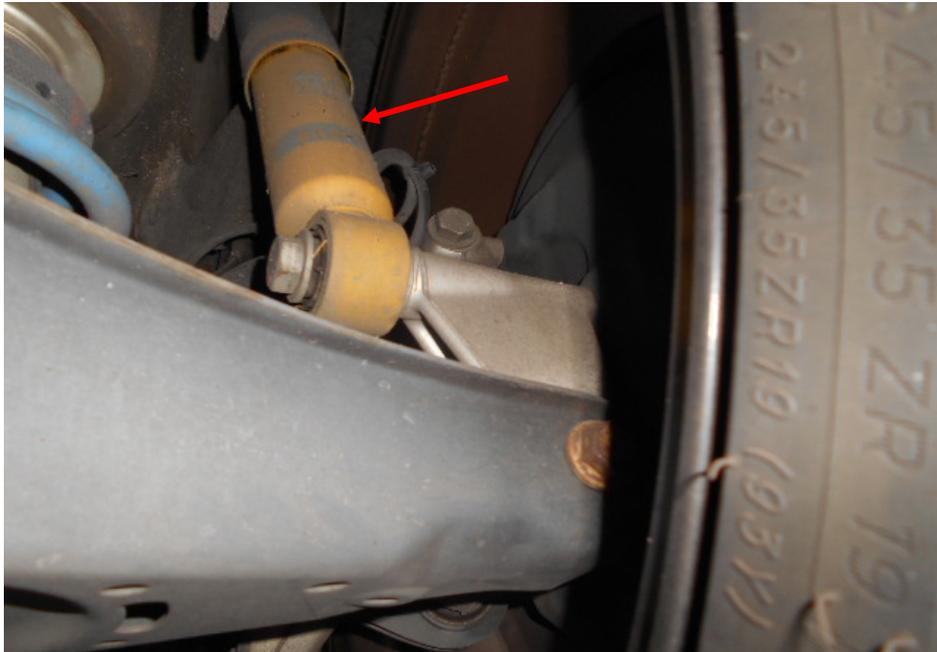
**Photo 11** shows the aftermarket rear right suspension (arrowed) that was fitted on the insured vehicle at the time of my inspection.

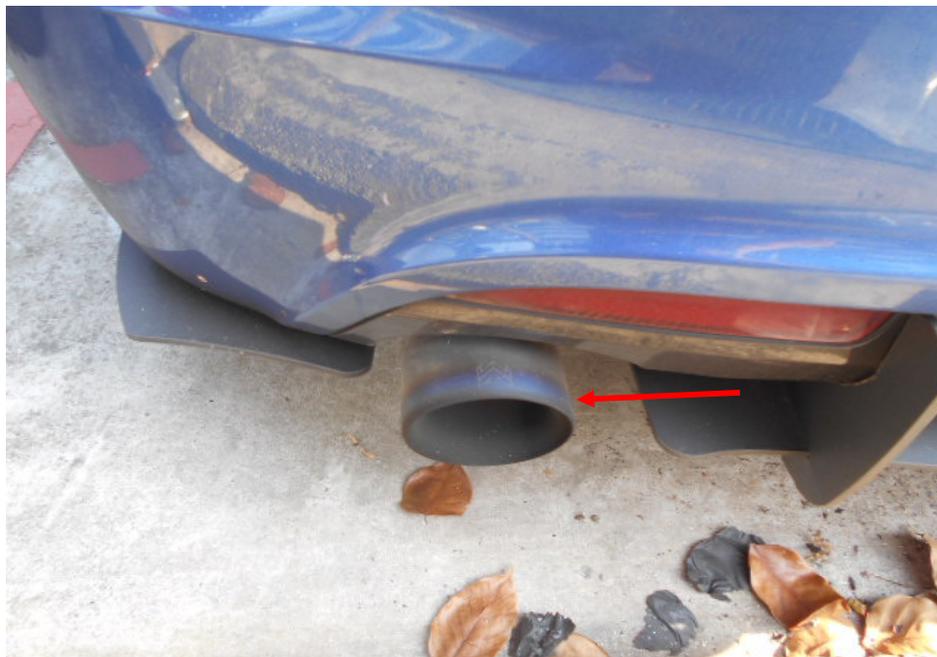
**Photo 12** shows the rear left exhaust muffler (arrowed) that was fitted on the insured vehicle. The rear section of the insured vehicle's exhaust system was found to be of aftermarket type.

<b>Modification/additionally fitted non-standard part</b>	<b>LTA's guideline</b>	<b>Effect(s) on insured vehicle</b>
Full set of bodykit	Compliant	Cosmetic
Aftermarket front and rear suspension system	Compliant	Overall stability enhanced
Aftermarket air intake system	Compliant	Overall engine performance enhanced
Aftermarket rear exhaust system (Armytrix brand)	Not compliant	Overall engine performance enhanced

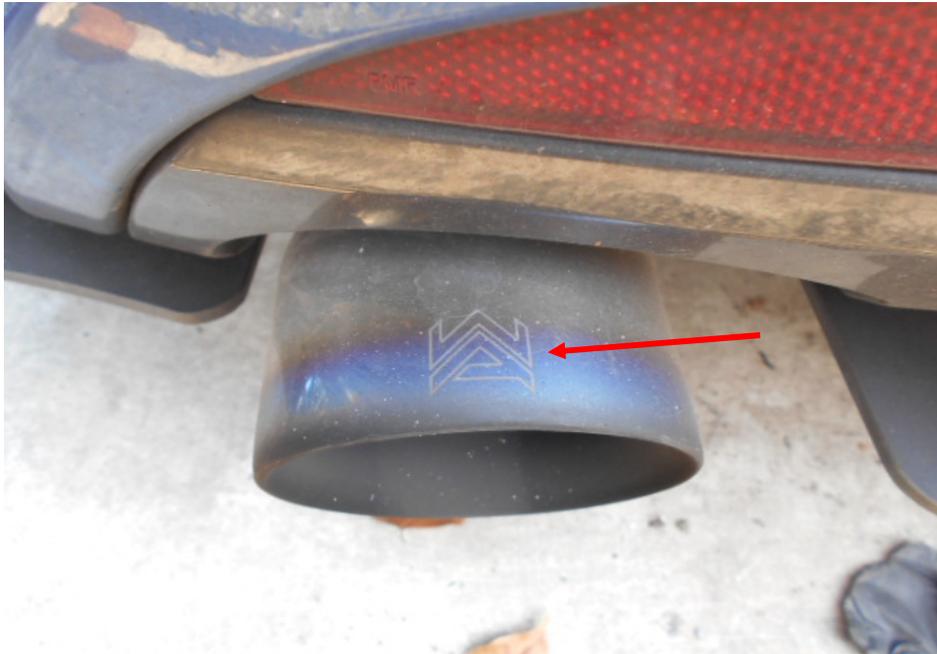
**Photo 13** shows a closer view of the rear left exhaust muffler that was fitted on the insured vehicle. The logo (arrowed) imprinted on the rear exhaust tip indicates that the brand of the rear exhaust fitted on the insured vehicle is "Armytrix".

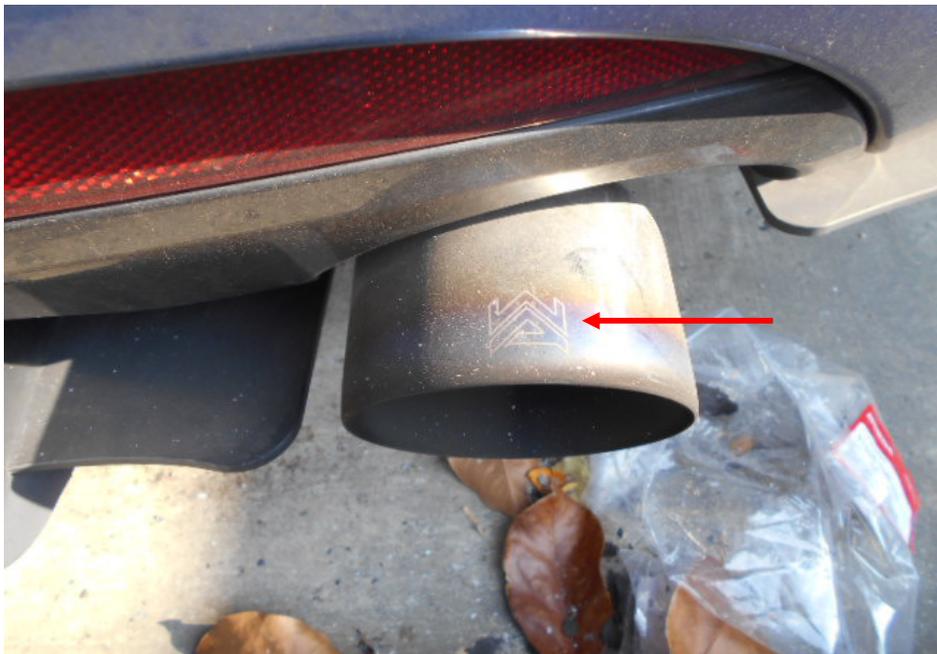
**Photo 14** shows the rear right exhaust muffler that was fitted on the insured vehicle. The logo (arrowed) imprinted on the rear exhaust tip indicates that the brand of the rear exhaust fitted on the insured vehicle is "Armytrix".

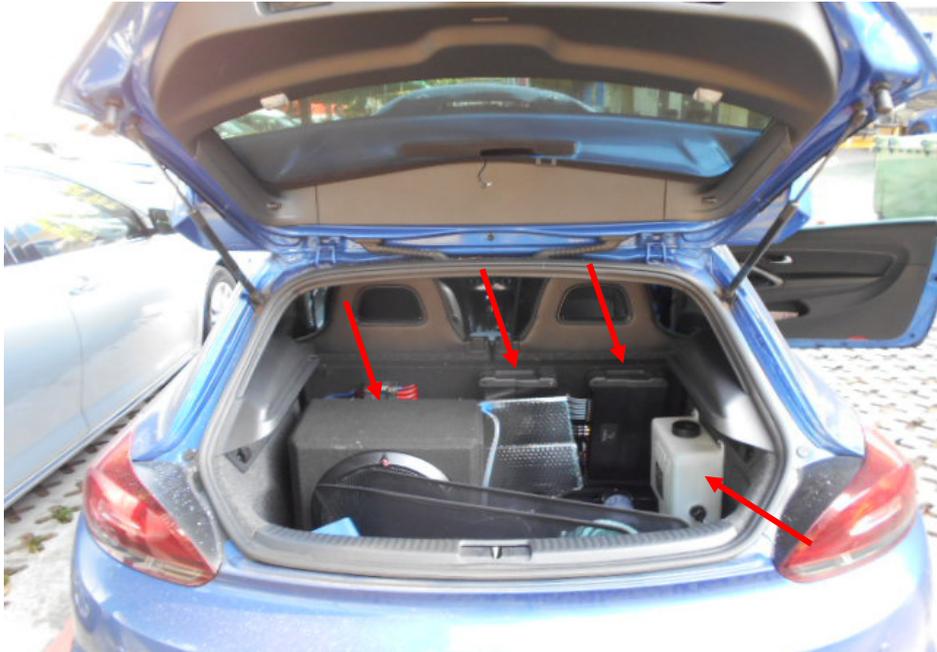
**Photo 15** shows a general view of the rear boot compartment of the insured vehicle. I had found an additionally fitted sound woofer; 2 additionally fitted amplifiers; and an additionally fitted water/methanol injection system (arrowed).

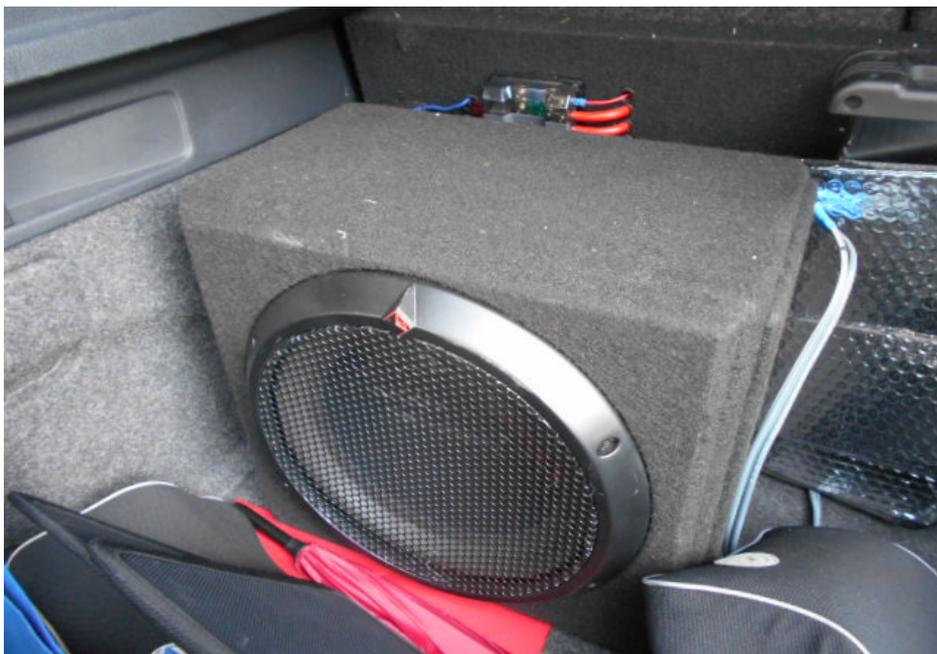
**Photo 16** shows a closer view of the additionally fitted sound woofer that was fitted inside the rear boot compartment of the insured vehicle.

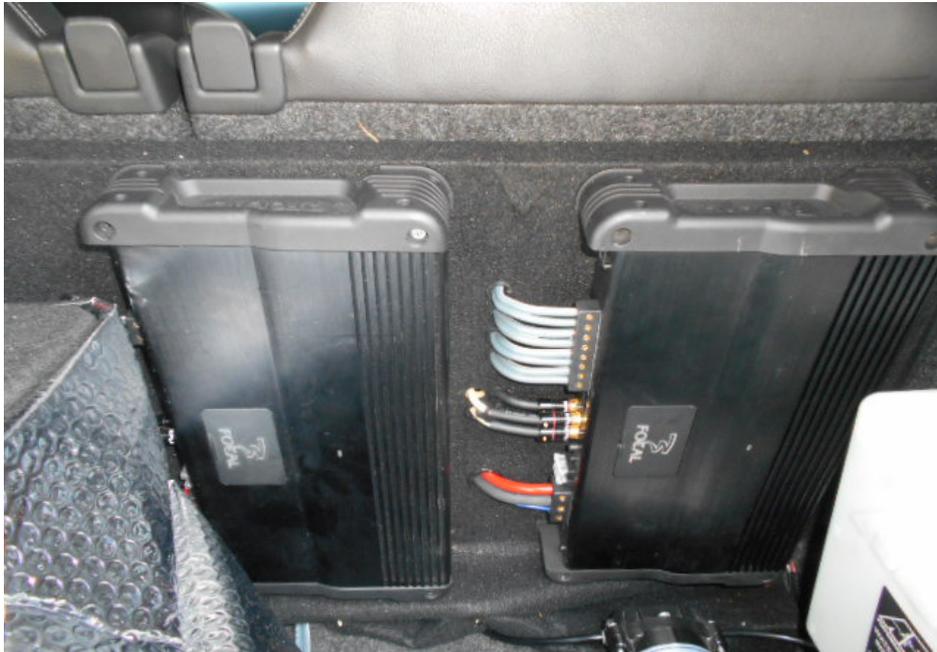
**Photo 17** shows a closer view of the 2 additionally fitted amplifiers that were fitted inside the rear boot compartment of the insured vehicle.

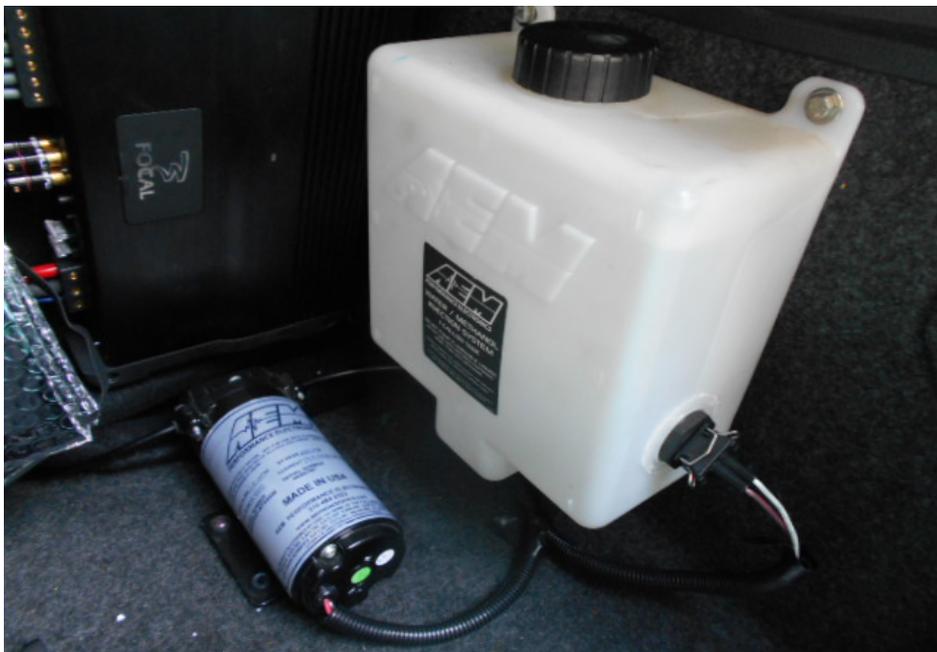
**Photo 18** shows a closer view of the additionally fitted water/methanol injection system fitted inside the rear boot compartment of the insured vehicle at the time of my inspection.

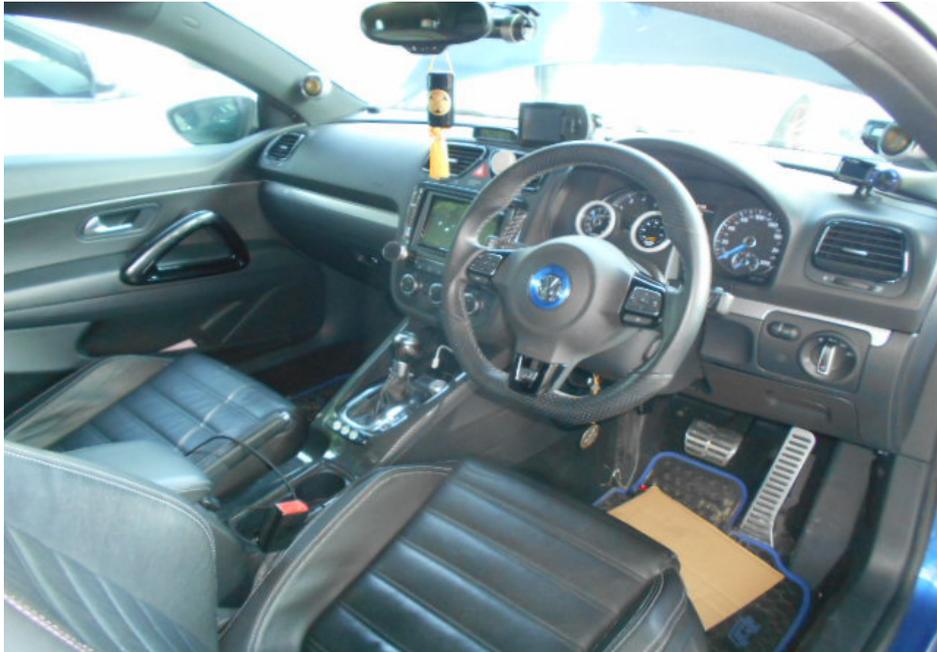
**Photo 19** shows a general view of the interior compartment of the insured vehicle. I had observed additional speakers; an aftermarket head unit; and multiple additional gauges, meters and controllers fitted inside the interior compartment of the insured vehicle.

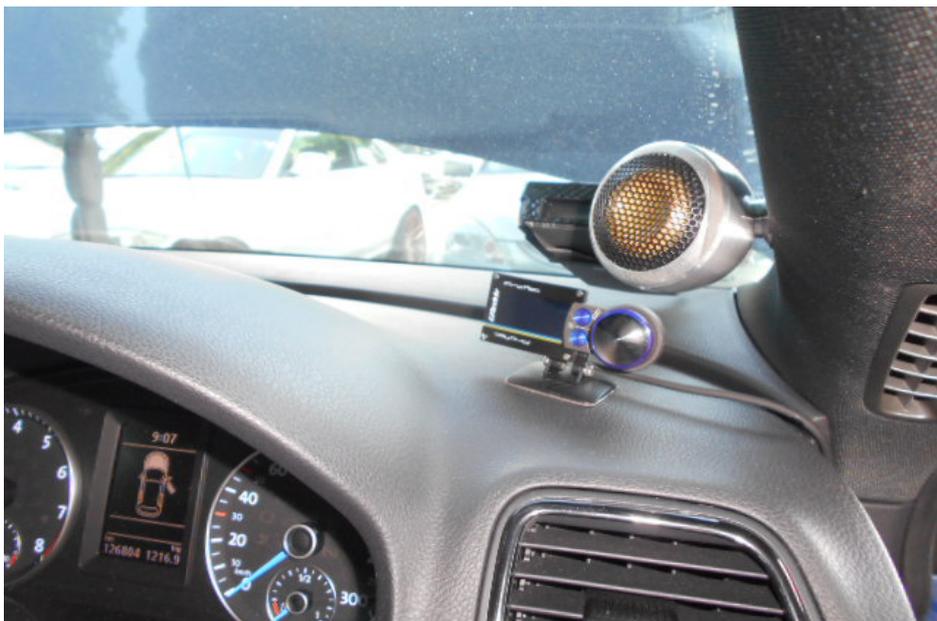
**Photo 20** shows the additional speakers and one of additional gauges, meters and controllers fitted inside the interior compartment of the insured vehicle.

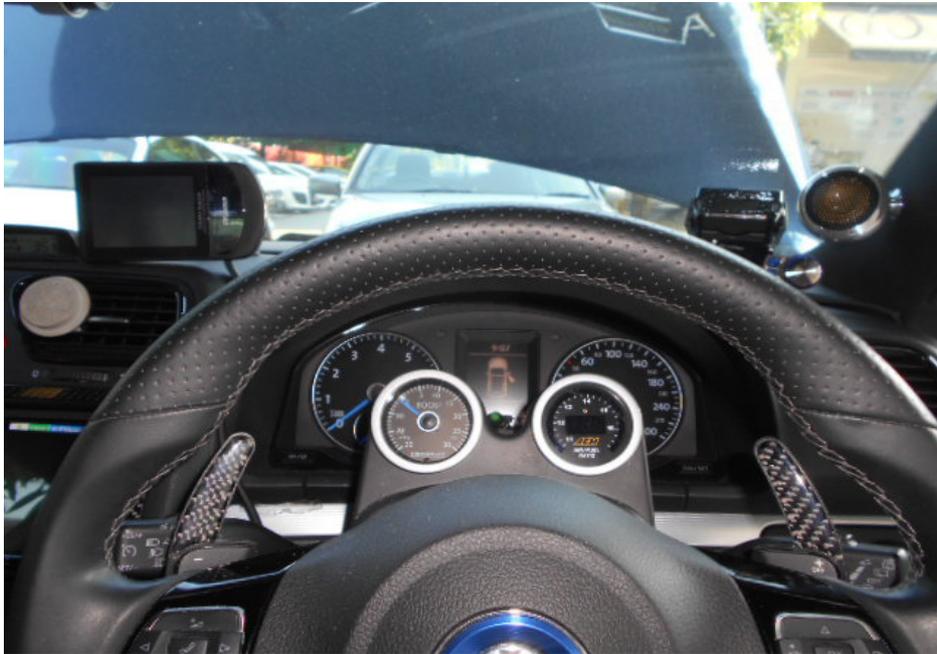
**Photo 21** shows further additional gauges, meters and controllers that were fitted inside the interior compartment of the insured vehicle.

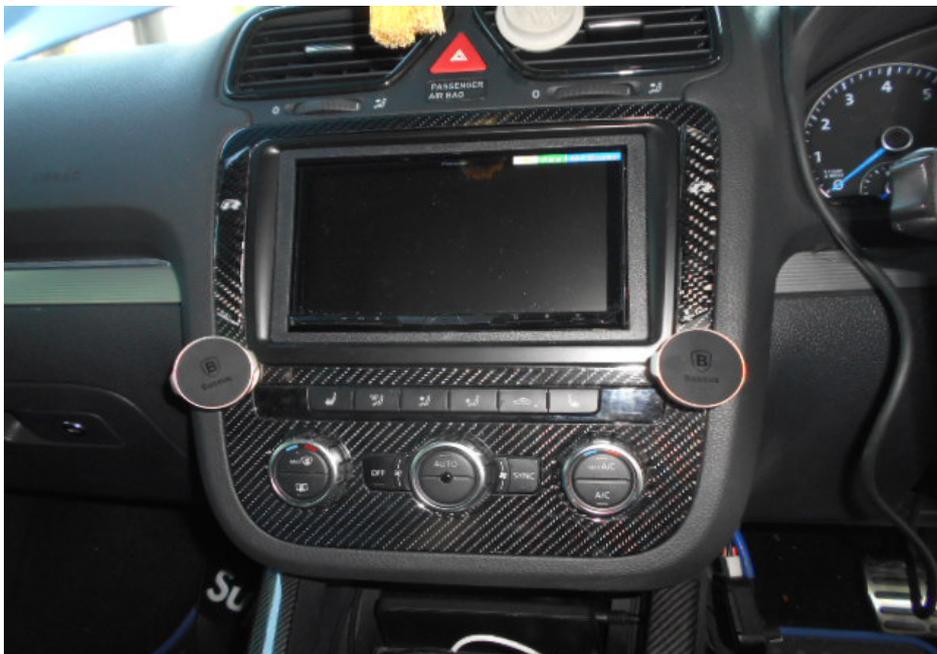
**Photo 22** shows the aftermarket head unit that was fitted inside the interior compartment of the insured vehicle at the time of my inspection.

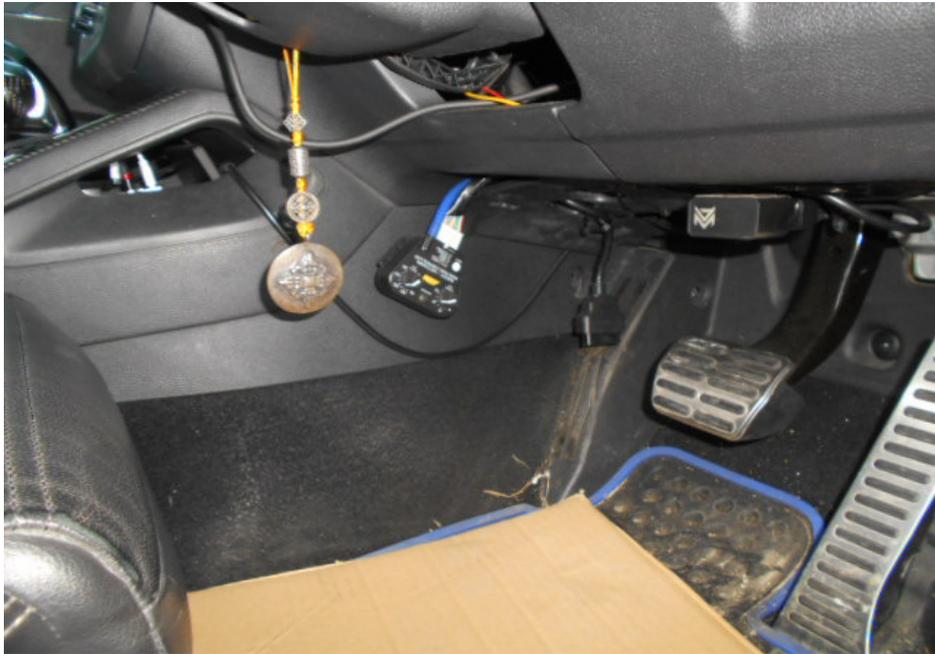
**Photo 23** shows more additional controllers that were fitted inside the interior compartment of the insured vehicle.
