Your Ref: 230021  
Our Ref : CS/MSG19013717/D

26 August 2019

**TECHNICAL INVESTIGATION REPORT OF FIRE INCIDENT INVOLVING THE  
INSURED VEHICLE SGZ 229M ON 01 AUGUST 2019**

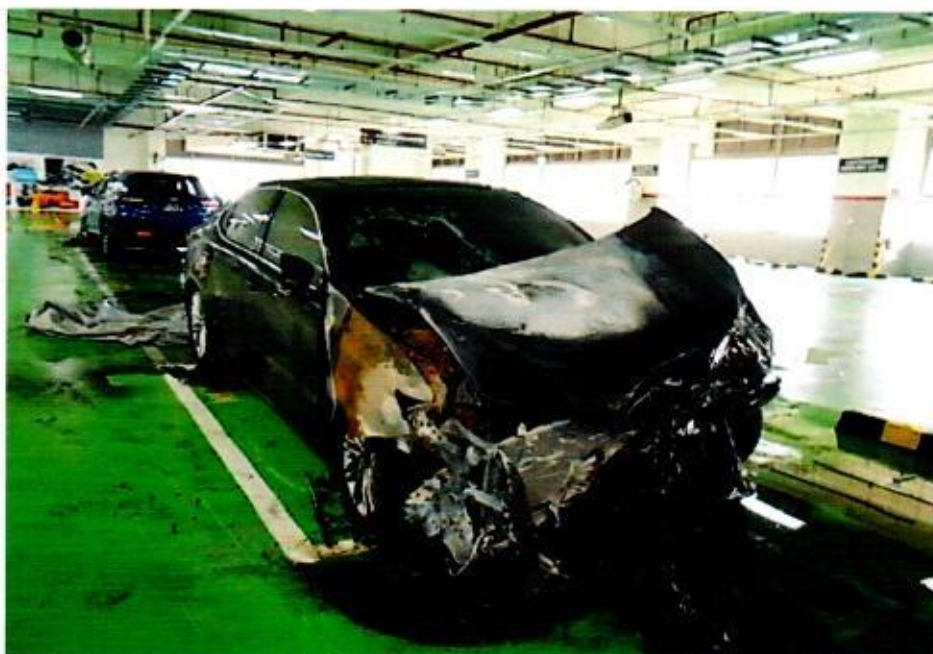
**Photo 1** shows a general view of the front right portion of the Insured Vehicle at the time of my inspection. The fire damage to the Insured Vehicle was confined to its frontal portion. Its front bonnet, front bumper, front right fender, front right headlamp and front windscreen were amongst the body parts that were found to have been affected as a result of the fire. Apart for the fire damage, the Insured Vehicle was also observed to have sustained impact damage at its frontal portion. The impact damage pattern suggests that the direction of impact was from the front left to front right of the Insured Vehicle.

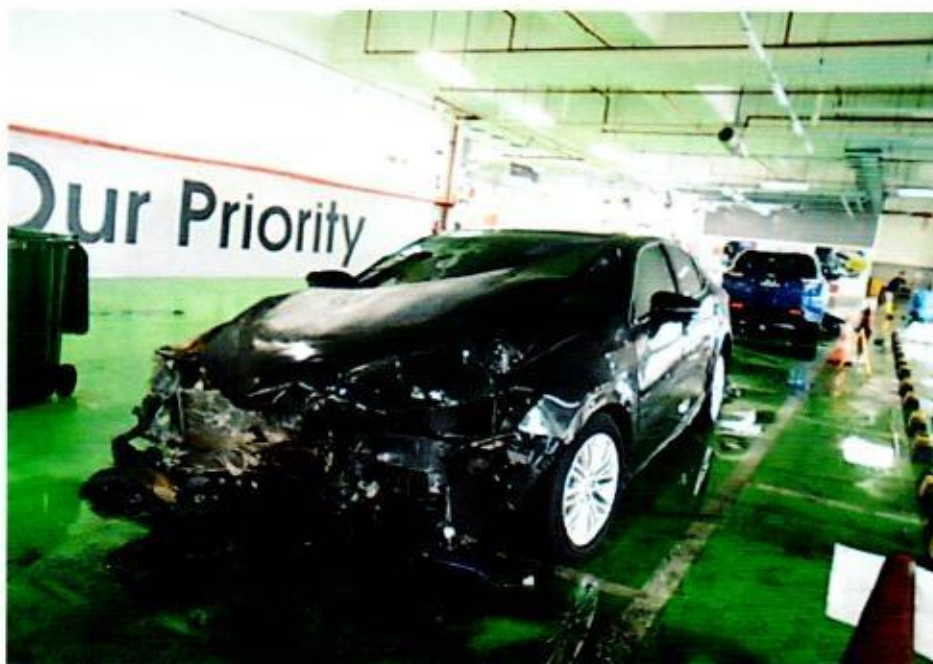
**Photo 2** shows a general view of the front left portion of the Insured Vehicle at the time of my inspection. The fire damage to the Insured Vehicle was confined to its frontal portion. Its front bonnet and front left headlamp were amongst the body parts that were found to have been affected as a result of the fire. Apart for the fire damage, the Insured Vehicle was also observed to have sustained impact damage at its frontal portion.

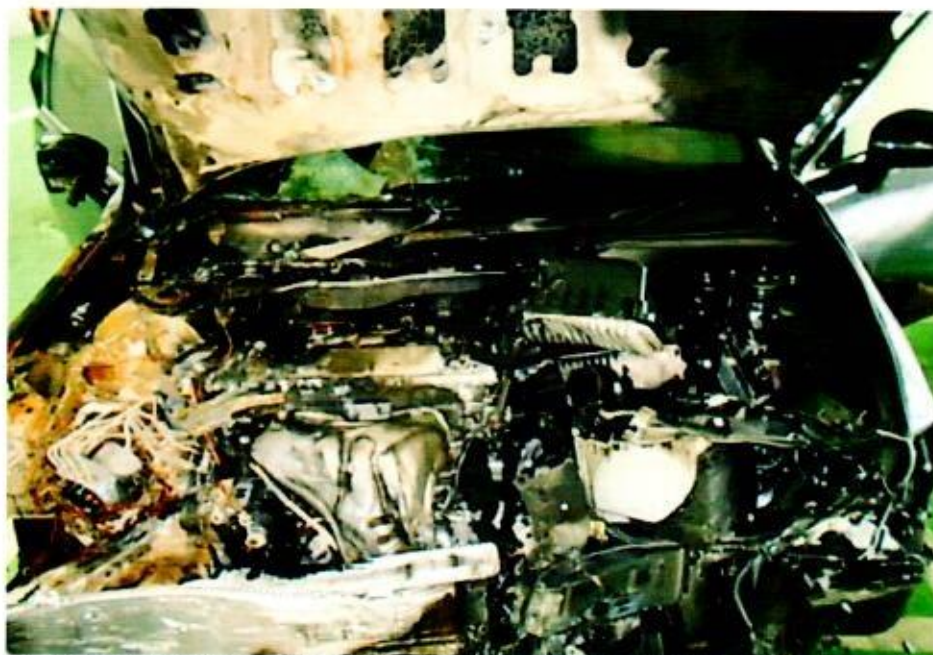
**Photo 3** shows the engine compartment of the Insured Vehicle at the time of my inspection. The engine compartment of the Insured Vehicle was observed to be burnt. The parts at the right side of the engine compartment had sustained more severe fire damage as compared to the parts at the left side.

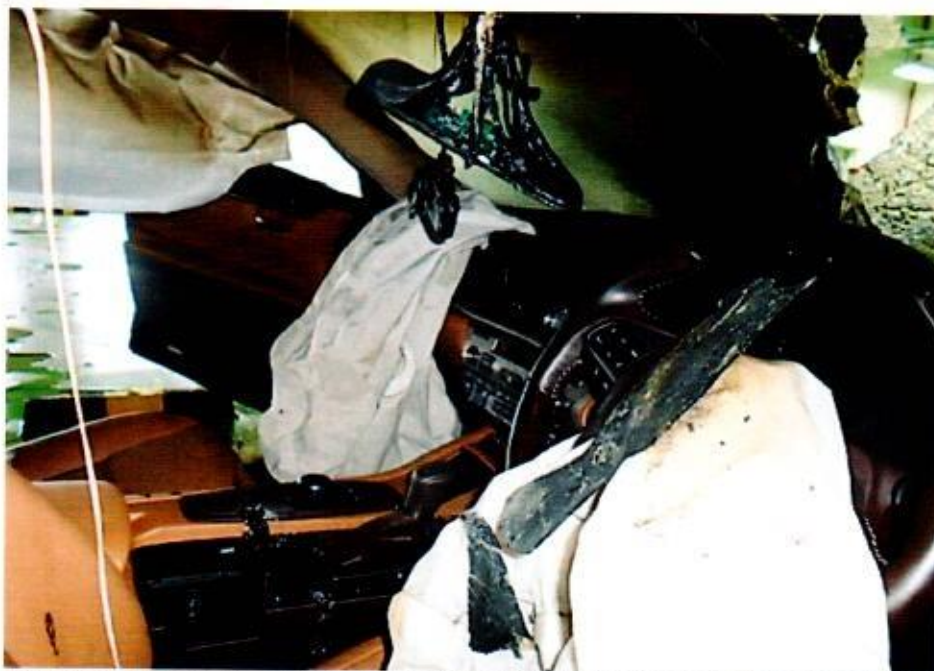
**Photo 4** shows the interior compartment of the Insured Vehicle, which was observed to be partially burnt at the front area. The front dashboard and roof upholstery were amongst the parts that were found to have been burnt and/or melted as a result of the fire. The driver's airbag, front left passenger airbag and curtain airbag were also observed to have been activated.

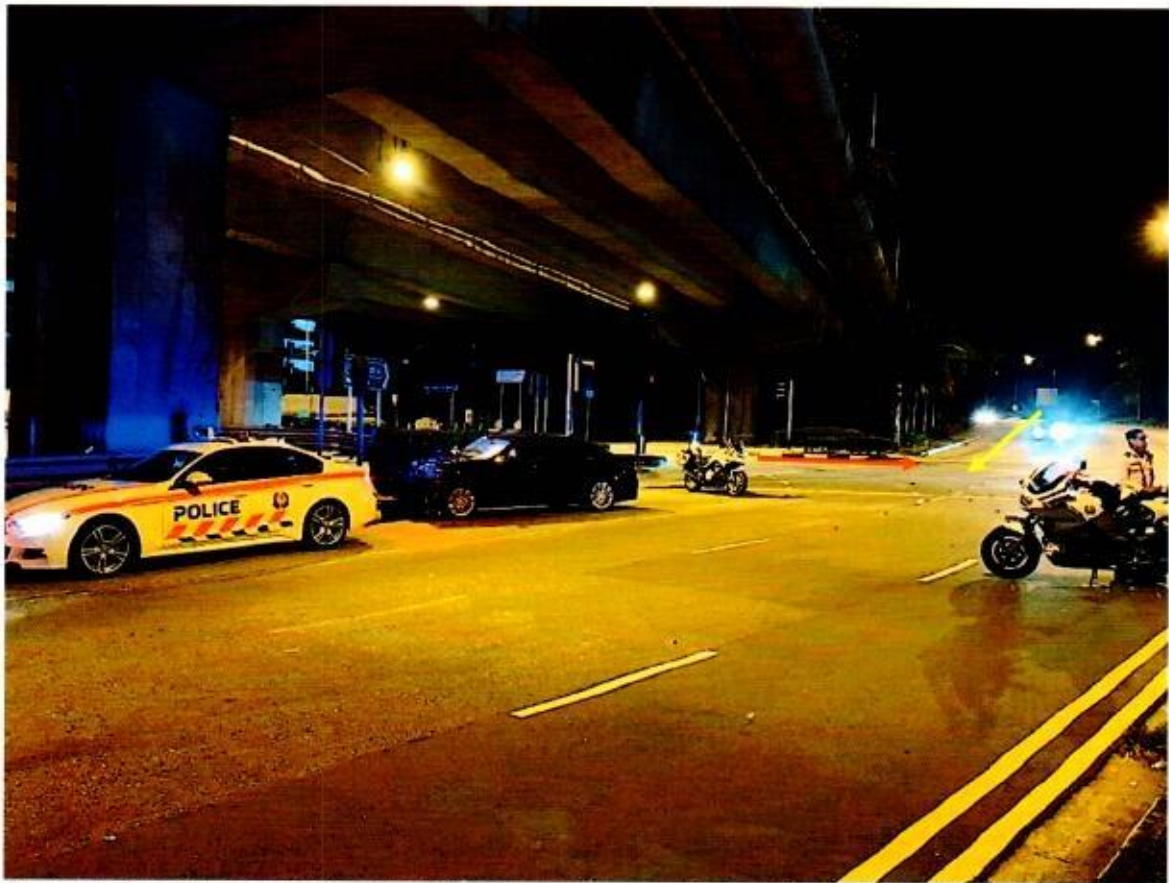
**Photo 5** shows the accident scene (photograph taken by Madam Suguna's husband). The Insured Vehicle could be seen stopped on the extreme right lane of Upper Changi Road East. Traffic Police Officers were also at scene. From what I was able to gather, the travel direction of the Insured Vehicle and the Premier motor taxi SHB 8588M prior to the accident is shown by the red arrow and yellow arrow respectively. Generally, my review of the accident scene photographs had showed information that corresponded to the information that Madam Suguna had related to me during my interview with her on 06 August 2019.

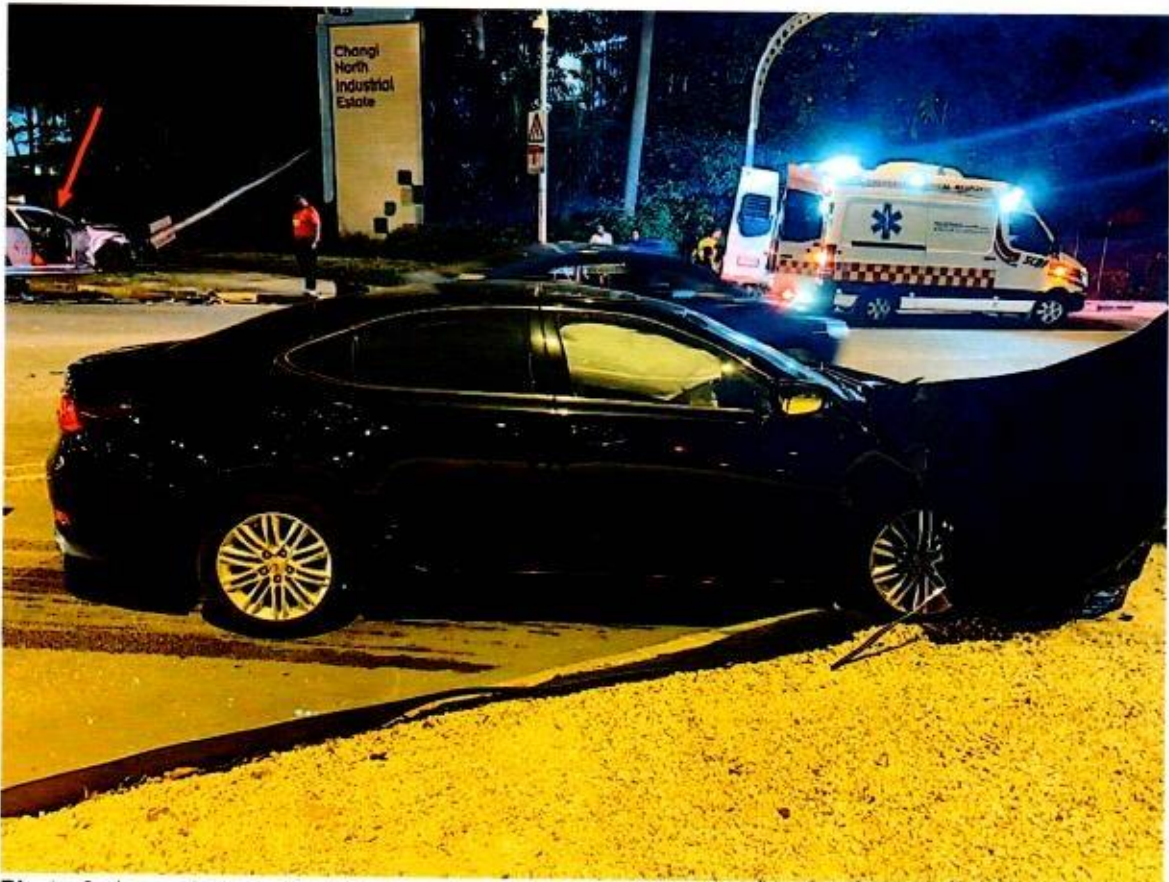
**Photo 6** shows the Insured Vehicle stopped on the extreme right lane of Upper Changi Road East in the direction of Singapore Expo. The front bonnet was observed to be partially dislodged and its front right wheel mounted the divider road kerb. There was no damage of fire nature seen on the Insured Vehicle at the accident scene. The Premier motor taxi SHB 8588M (arrowed), on the other hand, had stopped almost fully mounting the grass verge and pedestrian walkway at the slip road of Upper Changi Road North onto Upper Changi Road East. Its frontal portion had also collided into a lamppost at the grass verge.

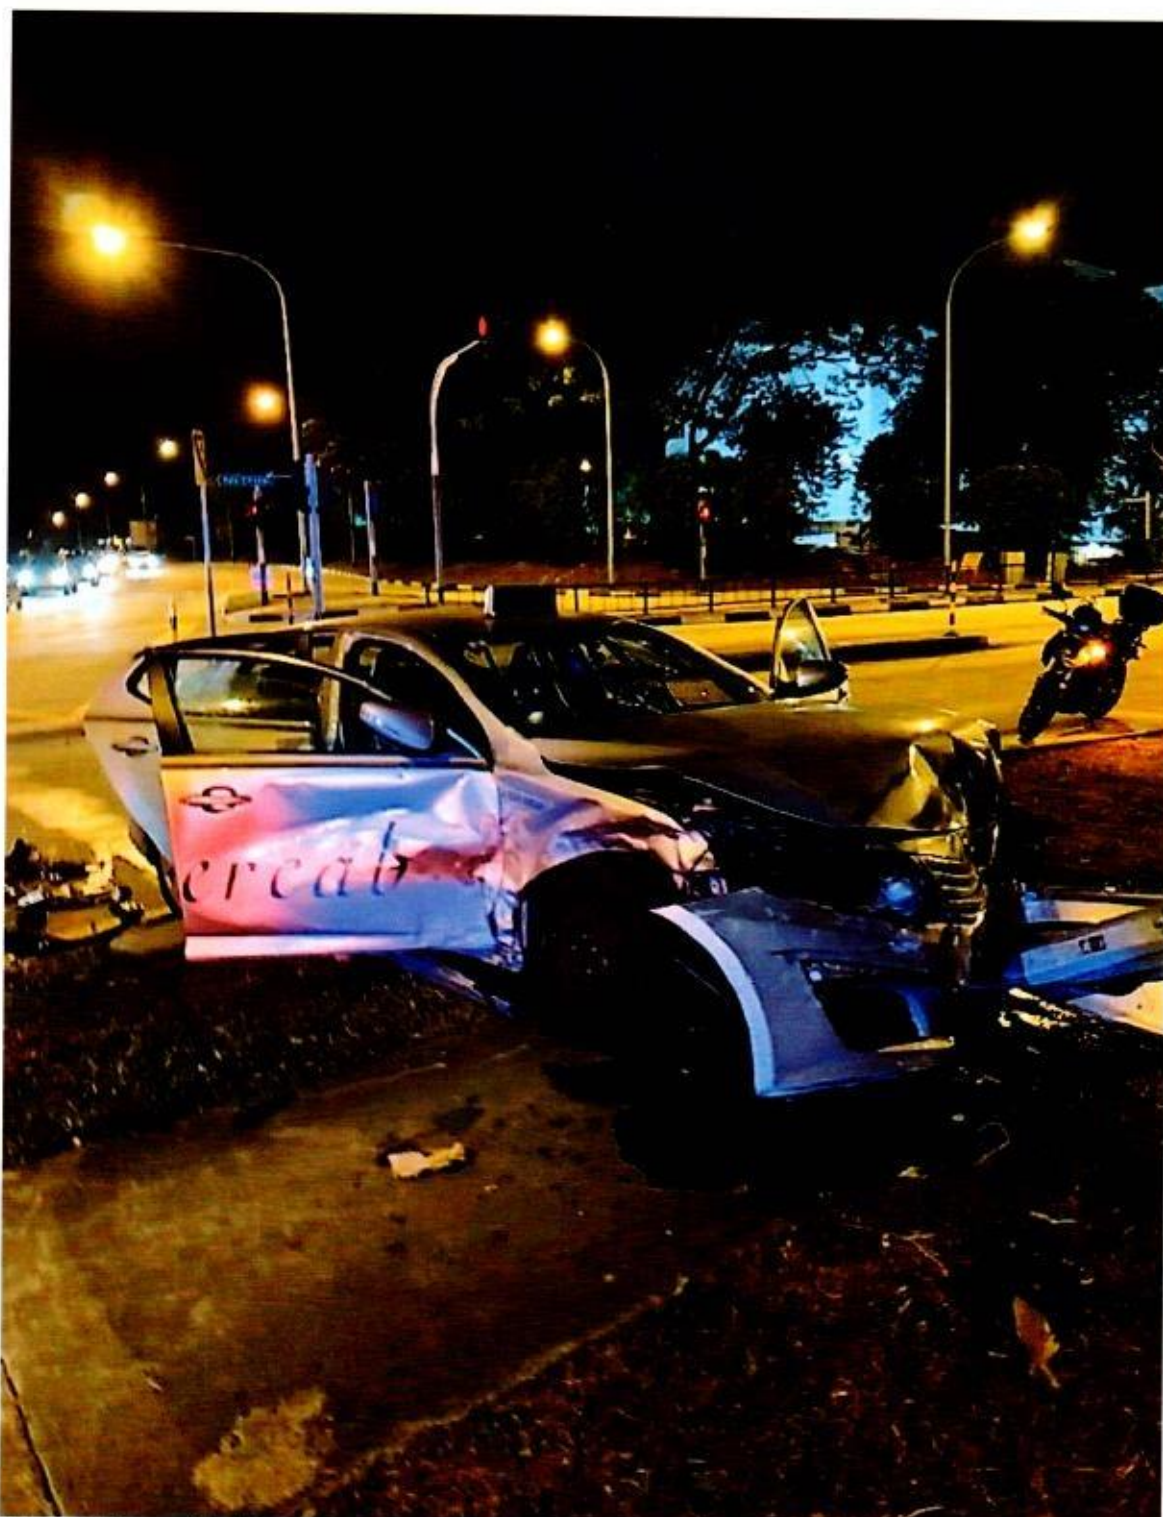
**Photo 7** shows the Premier motor taxi SHB 8588M at its stopped position. Its frontal portion had collided into a lamppost after the accident with the Insured Vehicle. Leaked fluid from the motor taxi could also be seen on the ground beneath the frontal portion of the motor taxi. Overall, the extent of damage to the Premier motor taxi SHB 8588M was relatively severe with damages at its frontal portion and its right side.

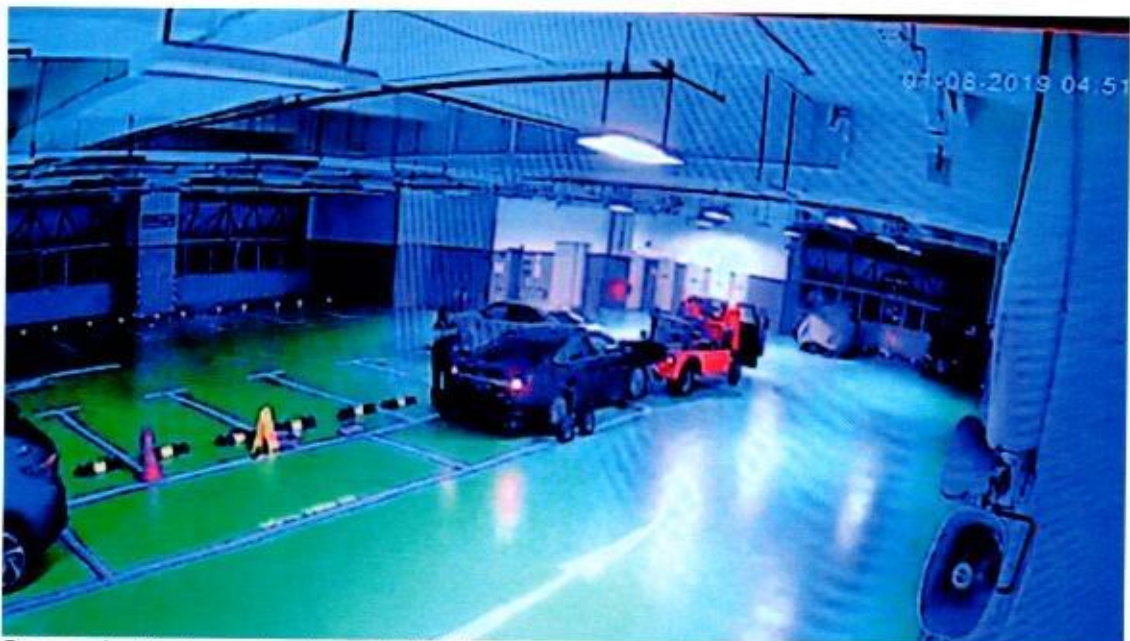
**Screenshot 1** shows the Insured Vehicle having arrived at the premise of M/s Borneo Motors (S) Pte Ltd. After removing the tow fork and setting the Insured Vehicle on the ground, the tow truck was seen driving off. This was about 0448hrs or thereabouts.

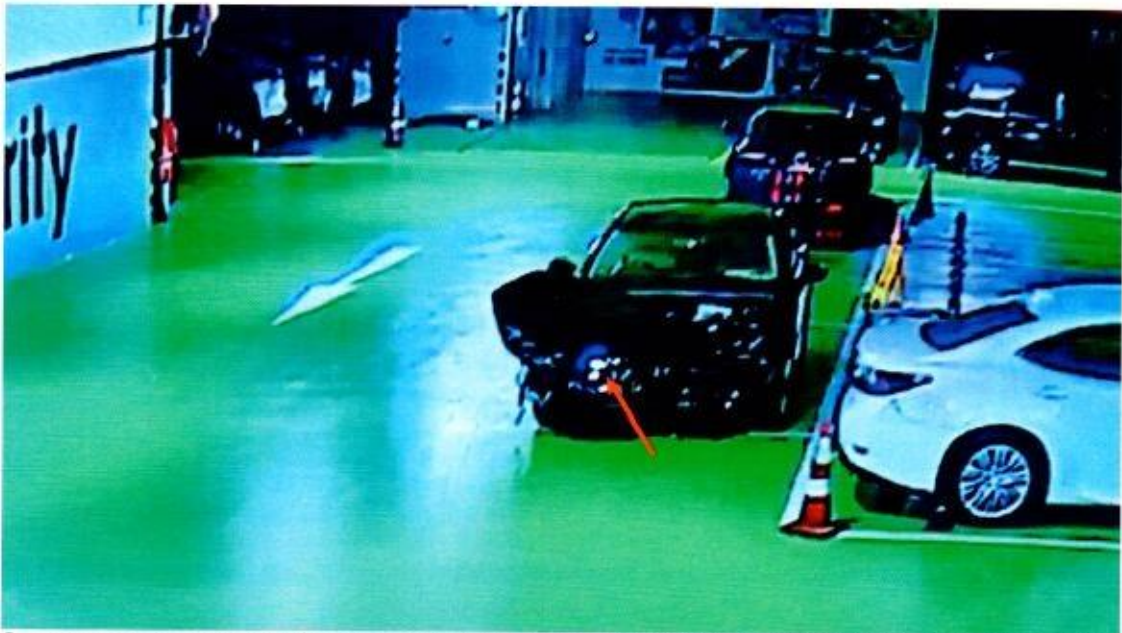
**Screenshot 2** shows the Insured Vehicle when flames (arrowed) were seen at the front right side of its engine compartment. This was about 0557hrs, approximately one hour after it was towed into Borneo Motors (S) Pte Ltd. From the video recordings that I had reviewed, between the time when the tow truck left the premise of M/s Borneo Motors (S) Pte Ltd till the time when smoke was first seen coming from the Insured Vehicle, there was no abnormal event ie no one walked by or walked near to the Insured Vehicle. The Insured Vehicle was basically untouched during this period.

26. Firstly, the events seen in the video recordings indicated that the fire to the Insured Vehicle had originated within the engine compartment, at the front right area. This was established given that flames were first seen at this area of the Insured Vehicle. See screenshot 2 above.

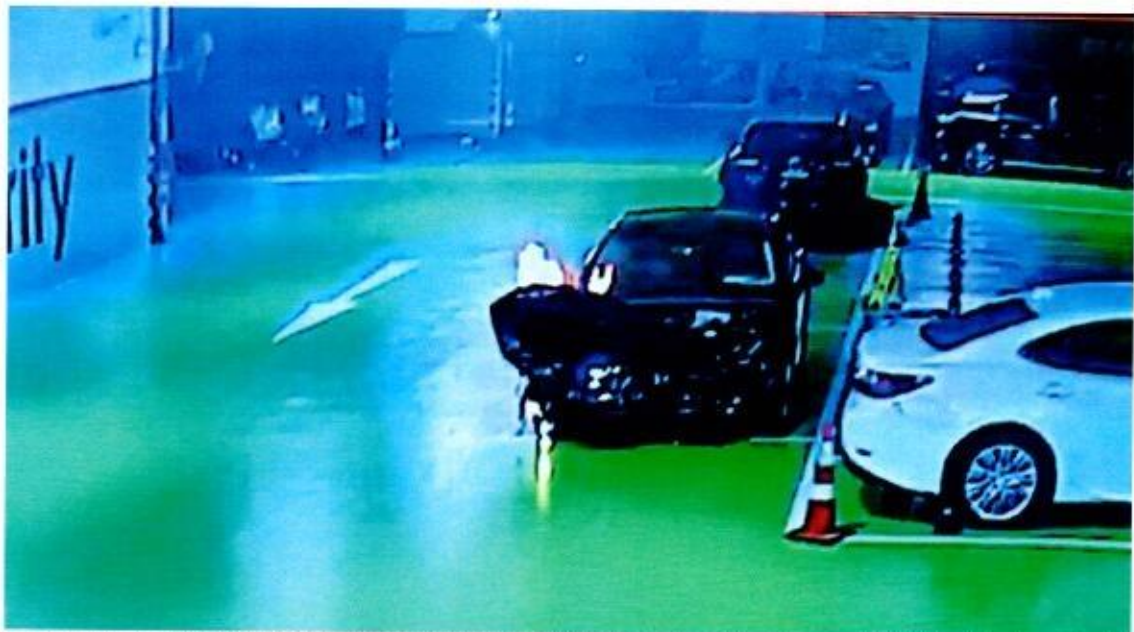
**Screenshot 3** shows flames spread onto the exterior body of the Insured Vehicle. First, onto the front right fender and thereafter onto the front bonnet.

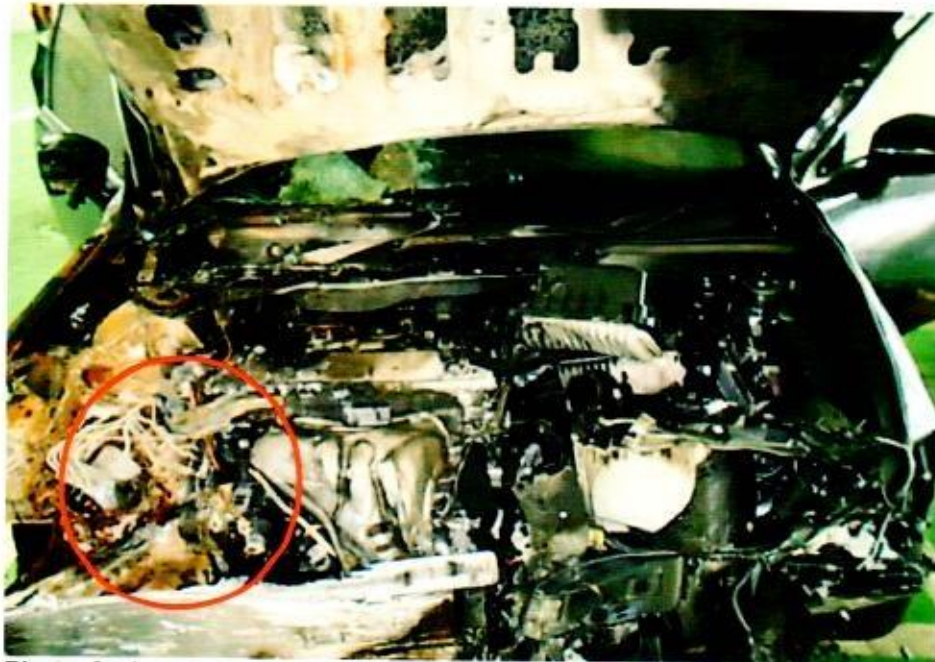
**Photo 8** shows a general view of where the fire to the Insured Vehicle had originated, which was around the front right area of the engine compartment (circled). This was established given that the video recordings that I had reviewed showed flames were first seen at this area of the Insured Vehicle.

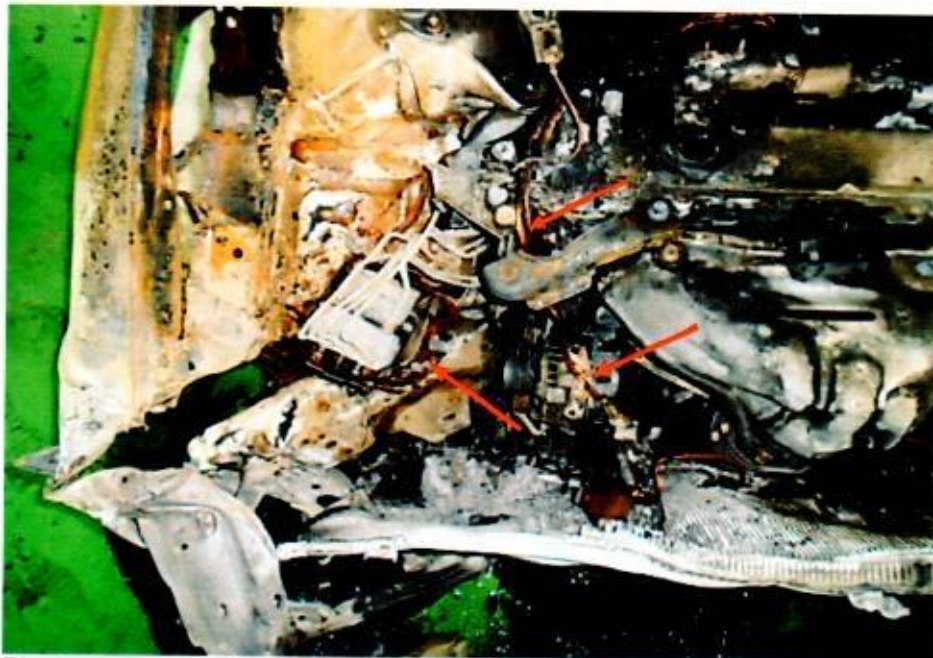
**Photo 9** shows the wirings around the front right area of the engine compartment, which was where the fire to the Insured Vehicle had originated. Several stretches of wirings (arrowed) were observed to be completely burned to its bare copper state. The bright reddish colour of the copper wires suggest that the wirings were exposed to high heat. Such condition normally indicates internal heating of copper wires, which is a sign of an electrical short circuit occurring.

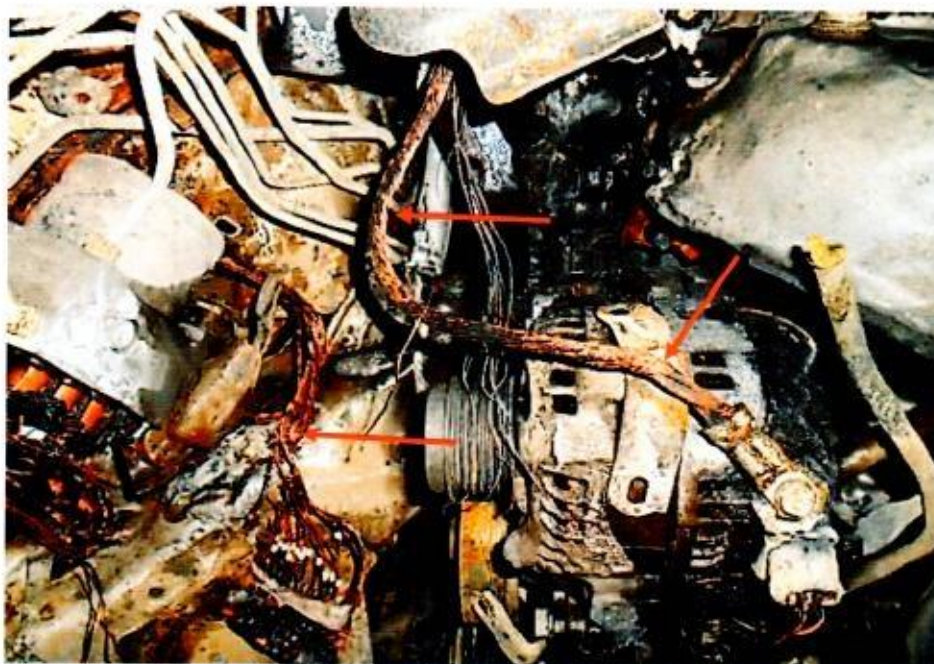
**Photo 10** shows a closer view of the wirings (arrowed) that were completely burned to its bare copper state. The bright reddish colour of the copper wires suggest that the wirings were exposed to high heat. These wirings were original wire cable for the alternator and wire harness for the ABS control module of the Insured Vehicle.

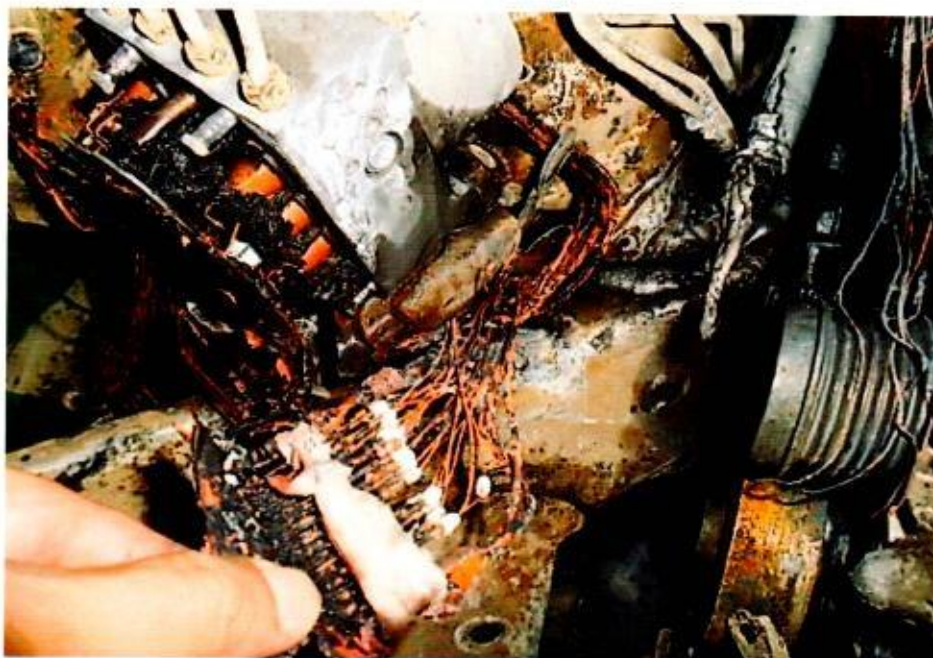
**Photo 11** shows the wiring harness for the ABS control module of the Insured Vehicle. The wirings were observed to be burnt to its bare copper state, indicating internal heating of copper wires, which is a sign of an electrical short circuit occurring. In general, the condition of the wirings seen at the area where the fire had originated suggest that the cause of fire to the Insured Vehicle was due to electrical in nature.

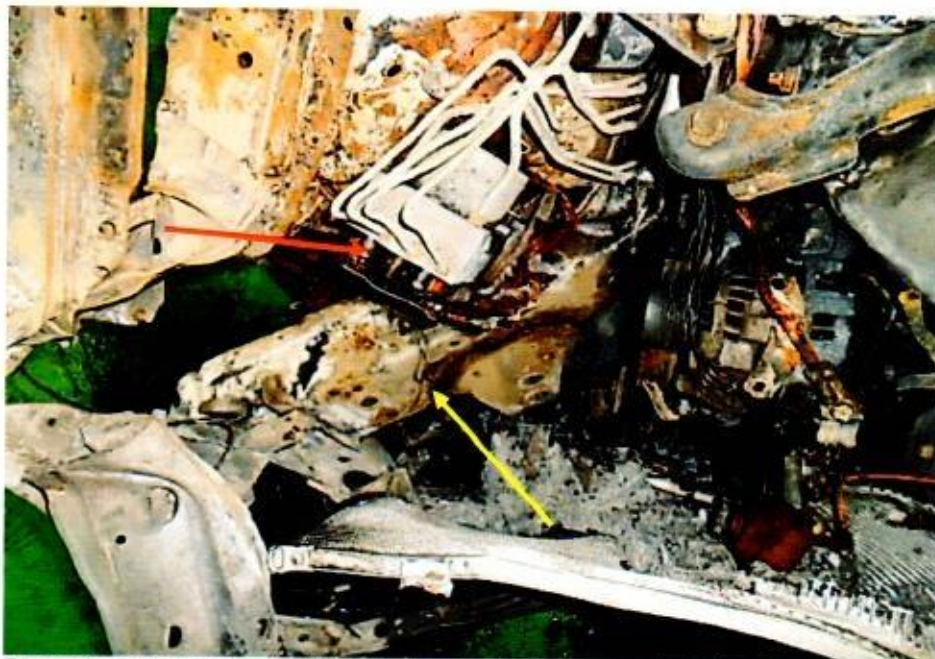
28. For this case, the Insured Vehicle was involved in an accident prior to the fire. The impact force arising from the collision had resulted in its front right chassis to be badly bent. The ABS control module of the Insured Vehicle was fitted onto a section of the front right chassis. As a consequence of the front right chassis bending, the ABS control module was also shifted towards the right. This could have caused slight instability to the current/voltage along the wiring harness of the ABS control module, ultimately leading to the fire a few hours after the accident. See photo 12 below.

Photo 12 shows the front right chassis (yellow arrow) of the Insured Vehicle badly bent. This was a result of the collision with the Premier motor taxi SHB 8588M. The ABS control module (red arrow) was also shifted towards the right as a result of the collision. This could have caused slight instability to the current/voltage along the wiring harness of the ABS control module, ultimately leading to the fire a few hours after the accident.
