NTUC INCOME INSURANCE CO-OPERATIVE LTD Ref: NS/INC19013743/K1vf3n2

### 1. Policy Particulars :- THIRD PARTY CLAIM

## ADJUSTMENT ON REPAIR COST FOR VEHICLE NO. SHA 3679Y

Report Ref No. NS/INC19013743/K1vf3n2

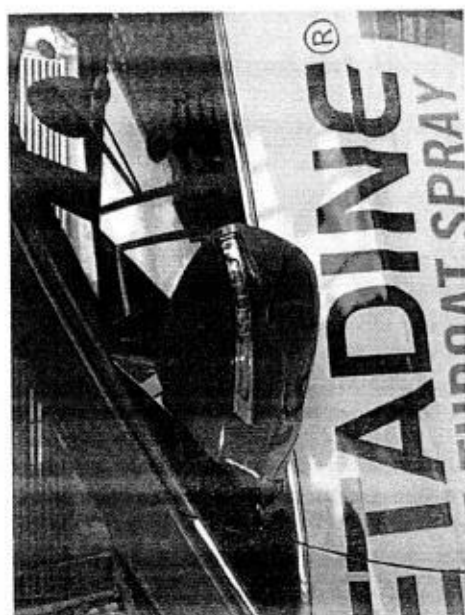
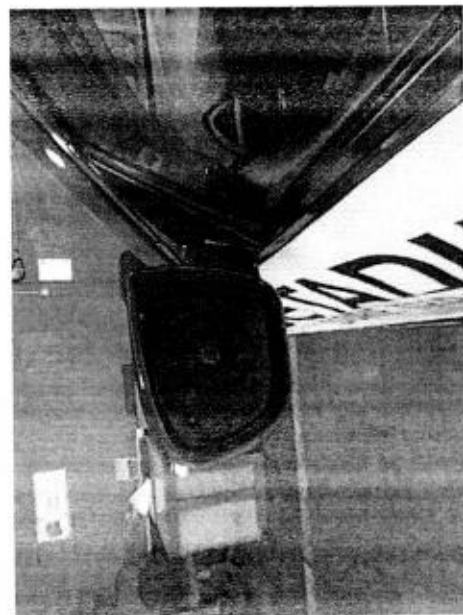
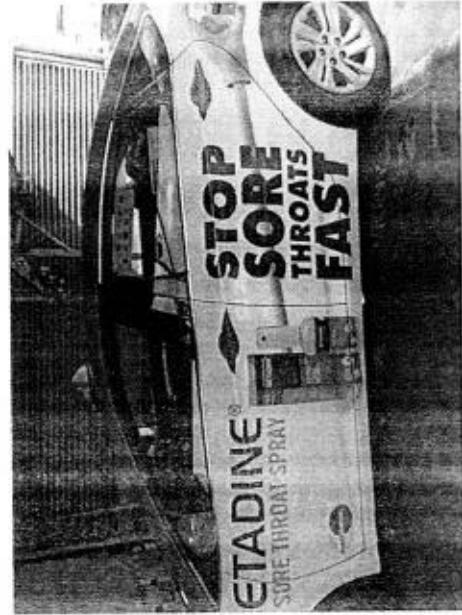
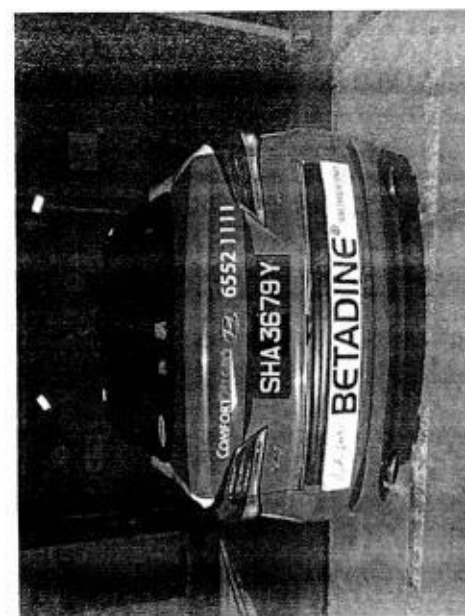
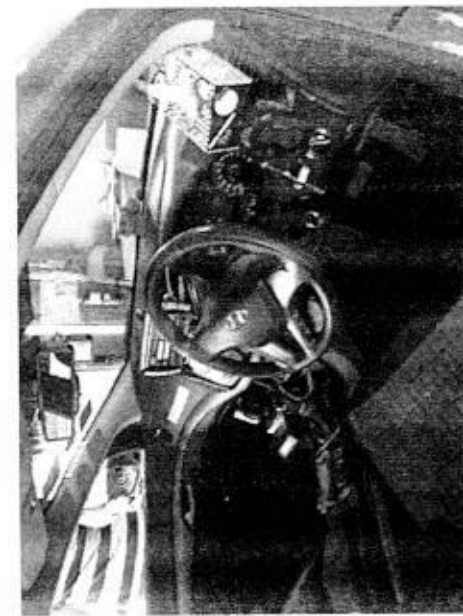
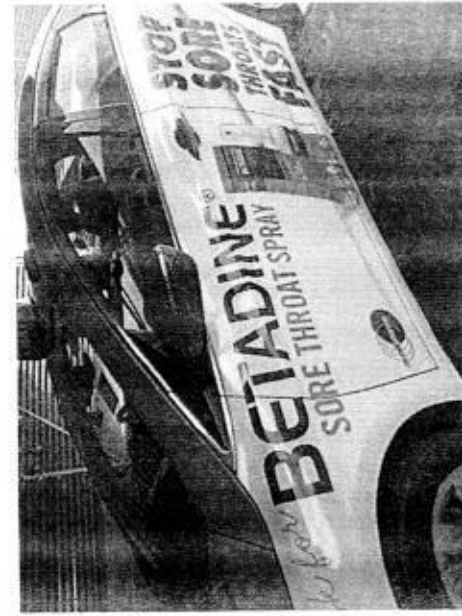
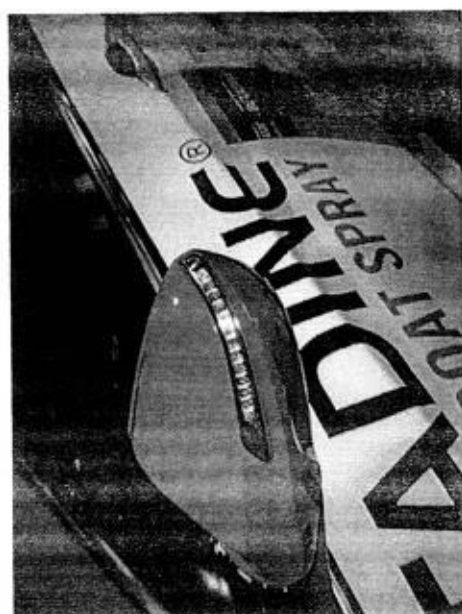
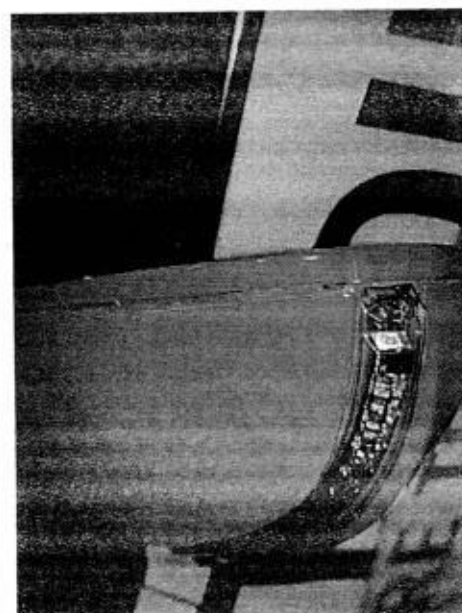
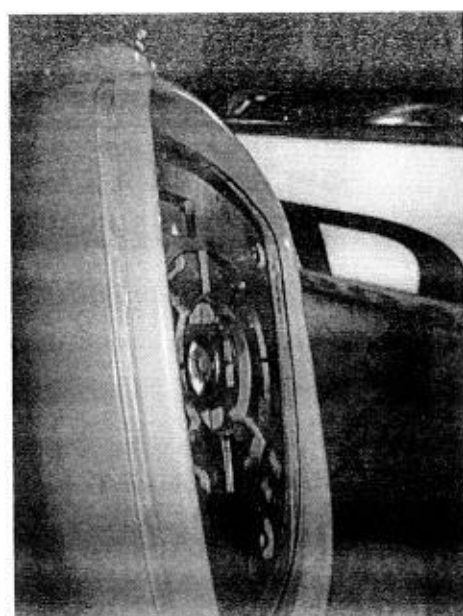
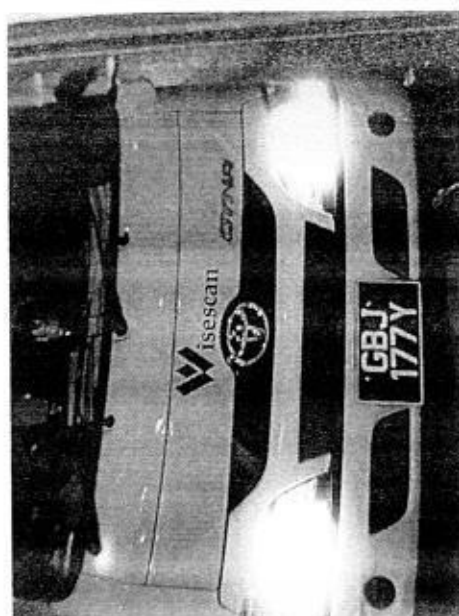
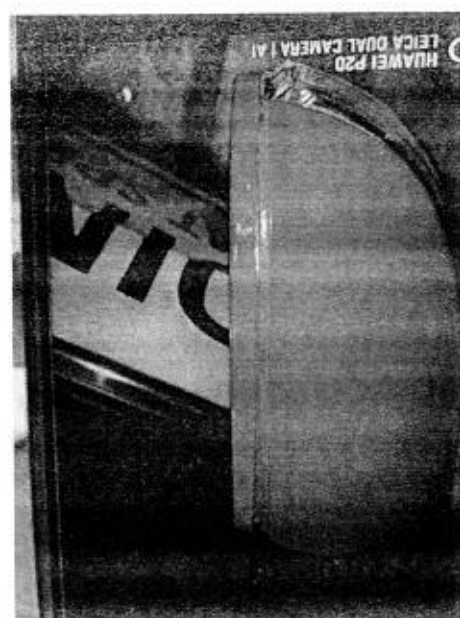
THE VEHICLE SUSTAINED DAMAGES AT THE N/S WING MIRROR. DAMAGES SEE DETAILS.
---

Qty	Description of Parts	Condition	Estimate By Workshop (\$)	Our Adjusted (\$)
1	<b><u>REPLACEMENT OF PARTS</u></b>	CRACKED		
	FRONT DOOR MIRROR (LH)		670.00	670.00
	LESS 20% DISCOUNT		-134.00	-134.00
			536.00	536.00
	<b><u>LABOUR</u></b>	NOT NECESSARY		
	PANEL BEATING.		100.00	50.00
	SPRAY PAINTING CHARGE.		100.00	50.00
	WIRING CHARGE.		30.00	-
			230.00	100.00
<b>GRAND TOTAL</b>			<b>766.00</b>	<b>636.00</b>
<b>RECOMMENDED COST OF LUMP SUM REPAIRS (TO ITS PRE-ACCIDENT CONDITION) (CONFIRMED)</b>				<b>500.00</b>
