Your Ref: BMW 320i  
(chassis number WBA8G32090A062582)  
Our Ref : CI/TP19013840/D

08 August 2019

**INSPECTION REPORT OF AN UNREGISTERD BMW 320i MOTOR CAR WITH CHASSIS NUMBER WBA8G32090A062582**

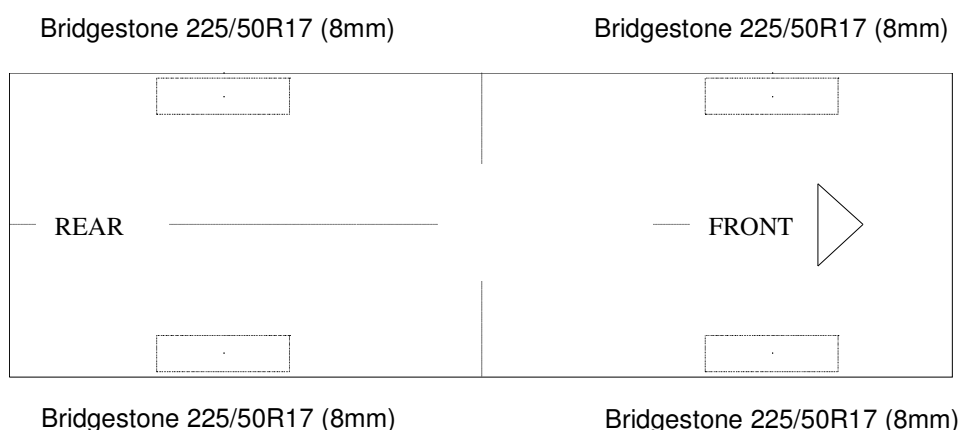
6. It was fitted with 17inch sport wheel rims that were wrapped with tyres that were observed to be of serviceable condition. The tyres were also sufficiently inflated for vehicular operation. The tyre brand, tyre size and approximate remaining tread depth of the 4 tyres of the Motor Car were recorded as follows: -

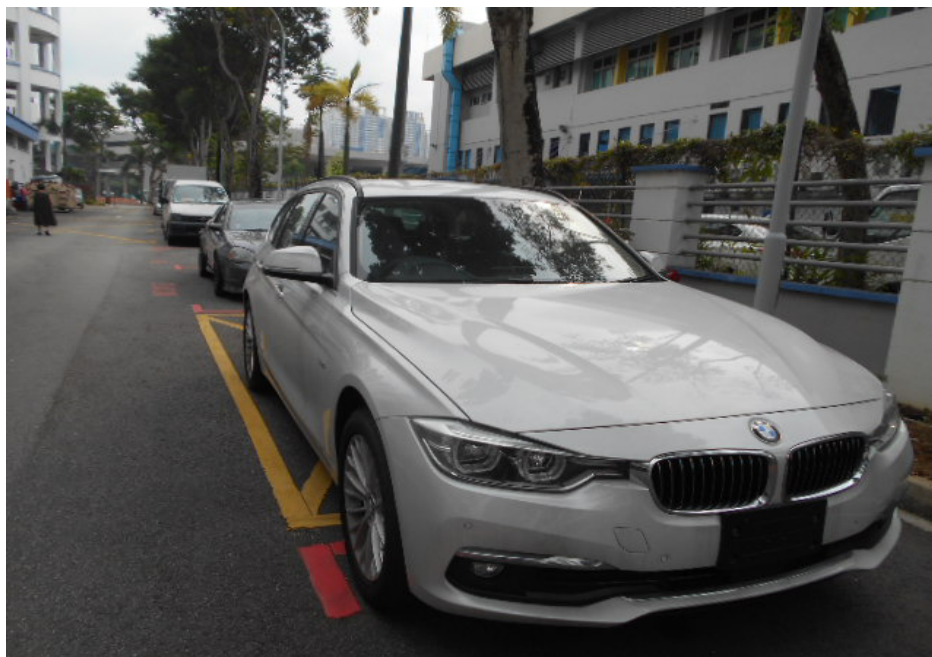
**Photo 1** shows a general view of the front right body of the Motor Car at the time of my inspection. The Motor Car was observed to be in relatively good general condition with no loose exterior fittings observed.

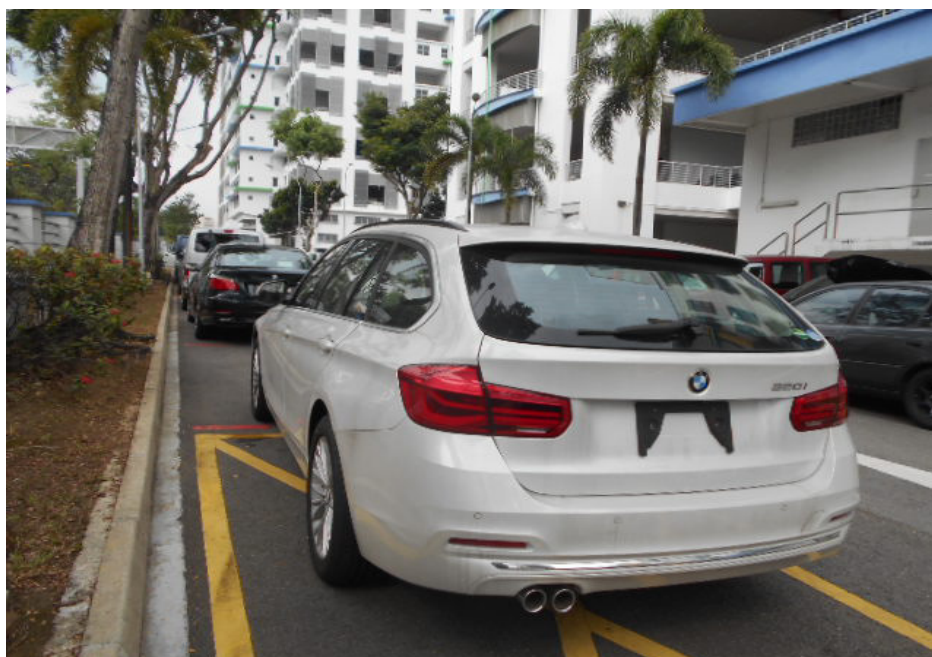
**Photo 2** shows a general view of the rear left body of the Motor Car at the time of my inspection. The Motor Car was observed to be in relatively good general condition with no loose exterior fittings observed.

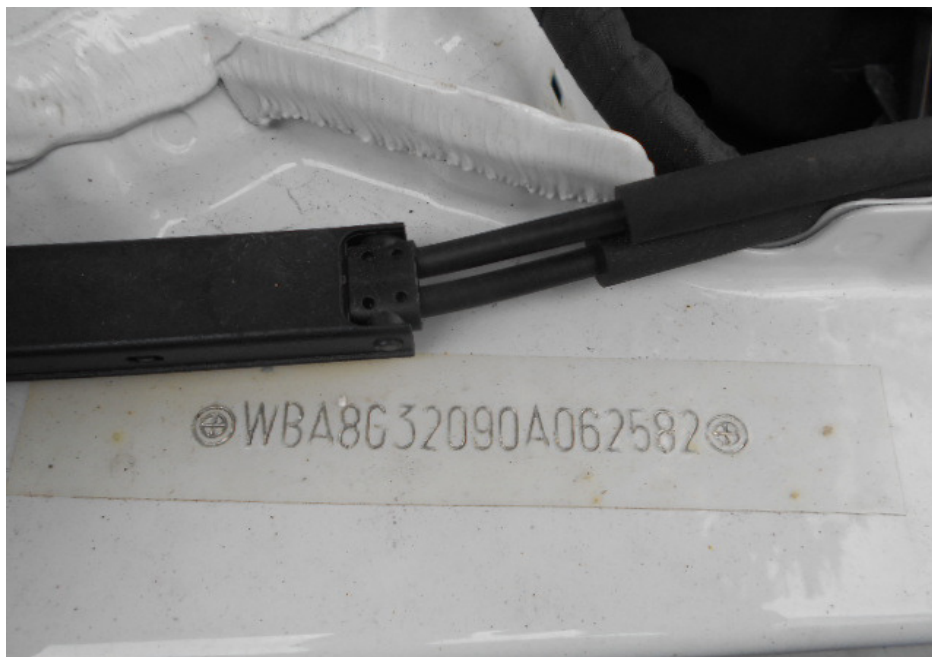
**Photo 3** shows the chassis number of the Motor Car. The chassis number recorded was WBA8G32090A062582.

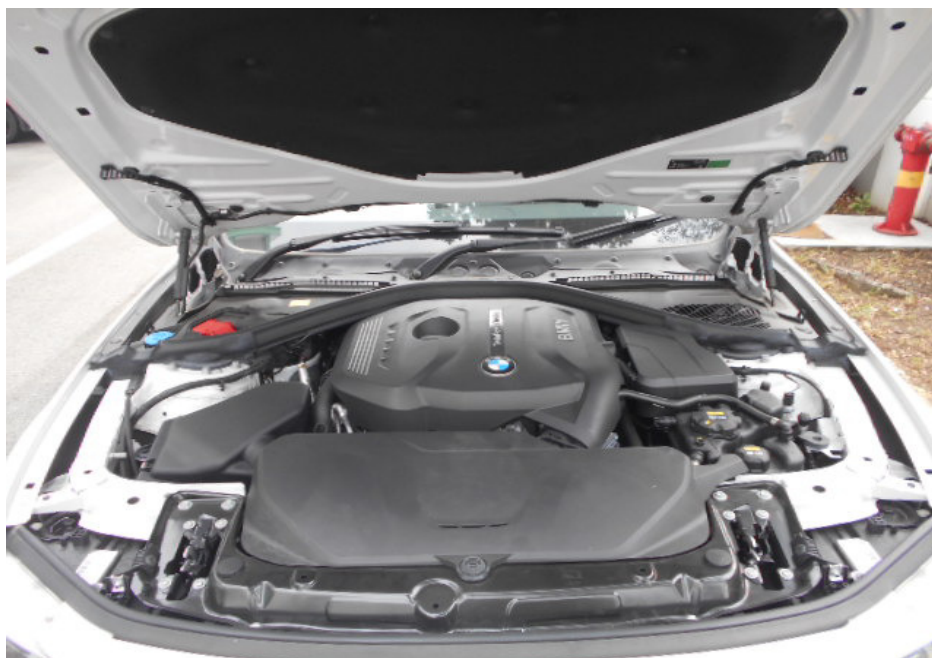
12. My examination of the engine compartment of the Motor Car revealed that the various parts and components inside the engine compartment were all intact and properly fitted. The various operating fluids like the brake fluid and engine coolant were all found to be of sufficient level for operating purposes. Visually, there was also no contamination found to these fluids.
13. My checks on the underside of the Motor Car revealed no sign(s) or indication(s) of fluid leakage and/or fluid stain(s). The engine block and automatic transmission assembly were both secured properly. They were not mounted onto the chassis/structural body or any integral body part of the Motor Car. All undercarriage components of the Motor Car were also observed to be intact and secured in an appropriate manner.

**Photo 4** shows a general view of the engine compartment of the Motor Car at the time of my inspection. The various parts and components inside the engine compartment were all observed to be intact and properly fitted. There was also no sign(s) or indication(s) of fluid leak and/or fluid stain found within the engine compartment.

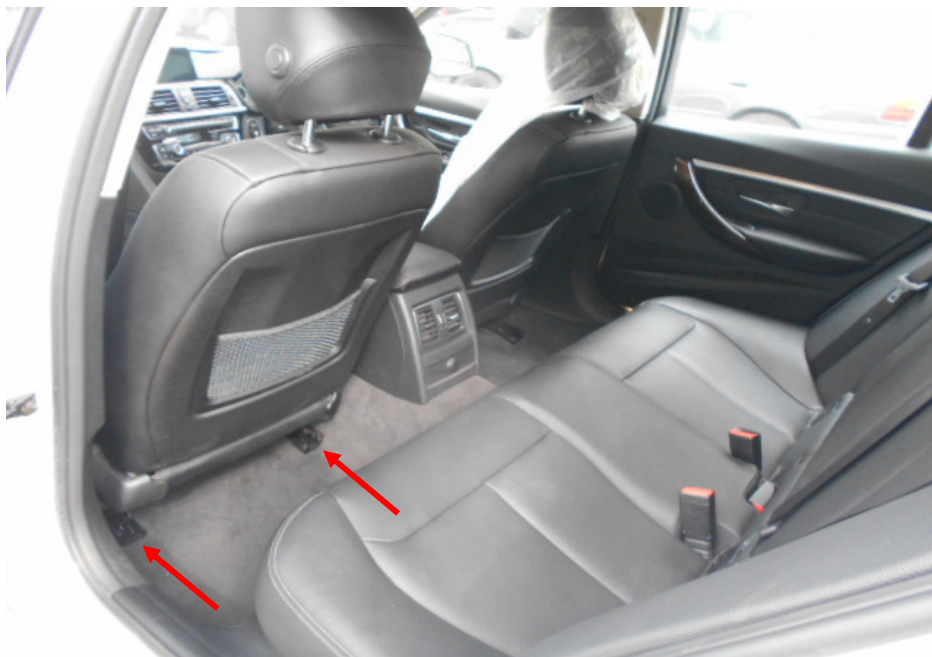
10. The seats of the Motor Car were found to be secured to the floor board of the Motor Car via seat rails bolted onto the floor board. Retractable seat belt reels and pre-tensioners were fitted on all seats of the Motor Car. The seat belt reels were able to be fastened securely to the respective pre-tensioner that is fixed to the side of all the seats.

**Photo 5** shows the seats of the Motor Car, which were secured via seat rails (arrowed) to the floor board. All the seats of the Motor Car were fitted with a retractable seat belt reel and pre-tensioner. The seat belts were also able to be fastened to the pretension that were fitted on the side of each individual seat.

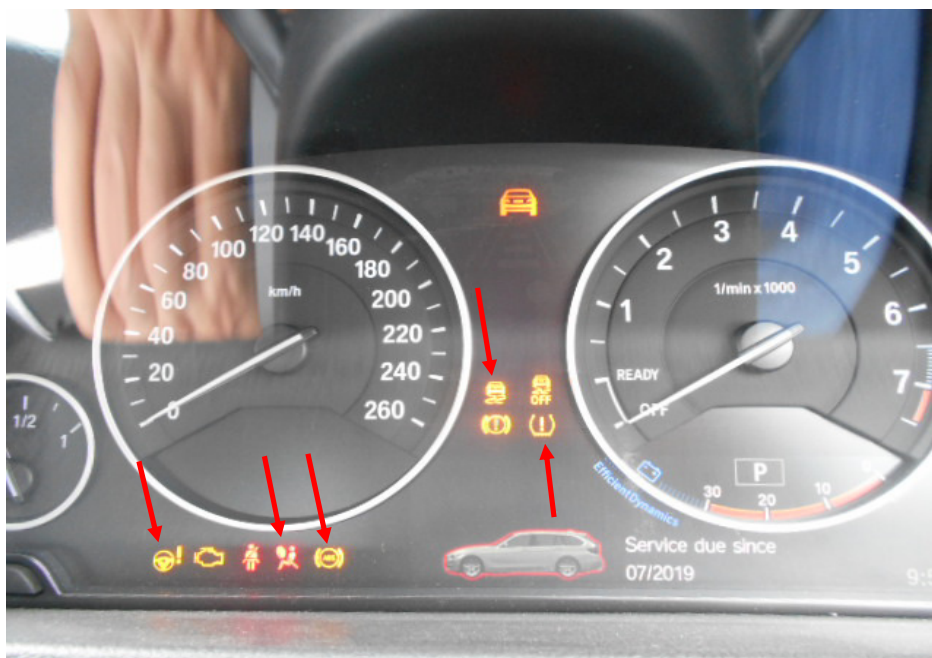
**Photo 6** shows the warning lights for the various electronic safety features appearing on the instrument panel of the Motor Car during its self-test when the engine is cranked, in particular the ABS, SRS, IAS, TPM and DSC lights (arrowed).

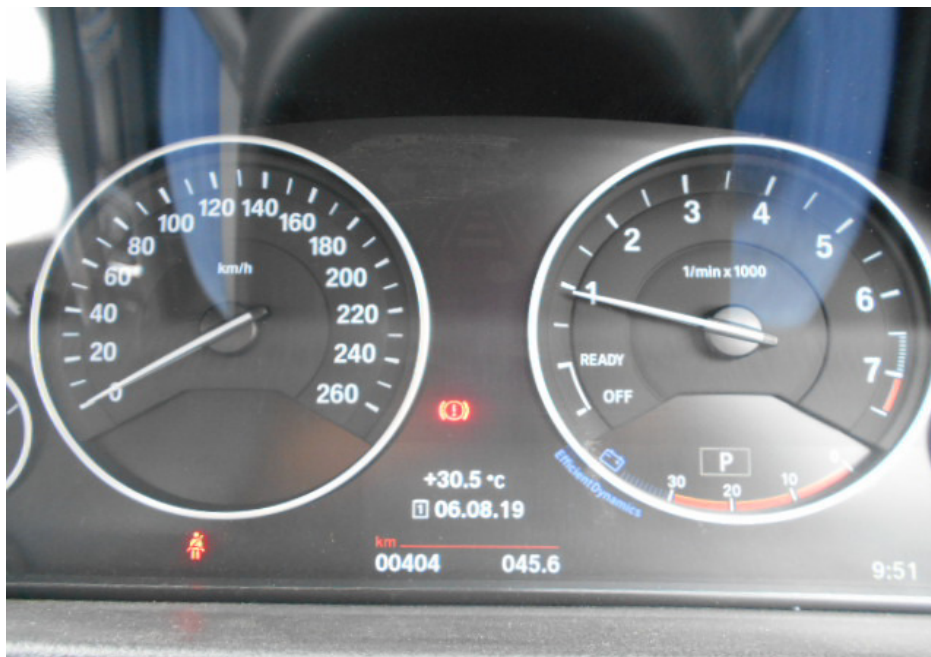
11. The Motor Car's automatic self-test of the functionality of its various electronic safety features like the Anti-Lock Brake System (ABS), Supplemental Restraint System (SRS), Integral Active Steering (IAS), Tyre Pressure Monitor (TPM) and Dynamic Stability Control (DSC) during cranking of the engine had indicated that these electronic systems were in working condition. This was determined from the respective warning lights disappearing from the instrument panel after the self-test.

**Photo 7** shows the respective warning lights no longer illuminated, indicating that there is no fault detected to the ABS, SRS, IAS, TPM and DSC systems of the Motor Car during the self-test. These electronic systems were hence in working condition at the time of my inspection.

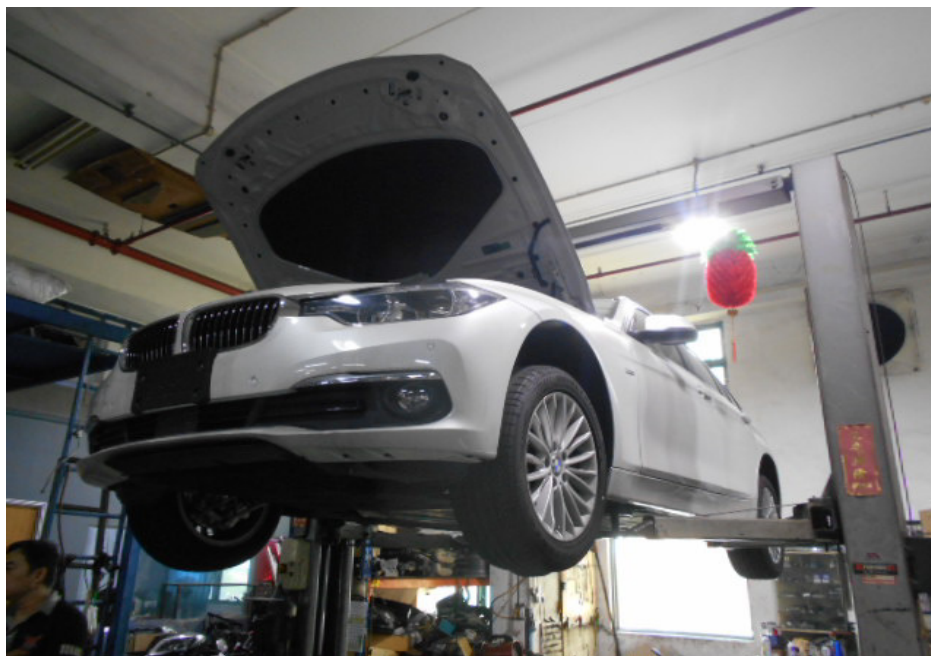
**Photo 8** shows the Motor Car hoisted up for checks on its undercarriage. There was no sign(s) or indication(s) of fluid leakage and/or fluid stain(s). The undercarriage components of the Motor Car were also all observed to be intact and secured in an appropriate manner.

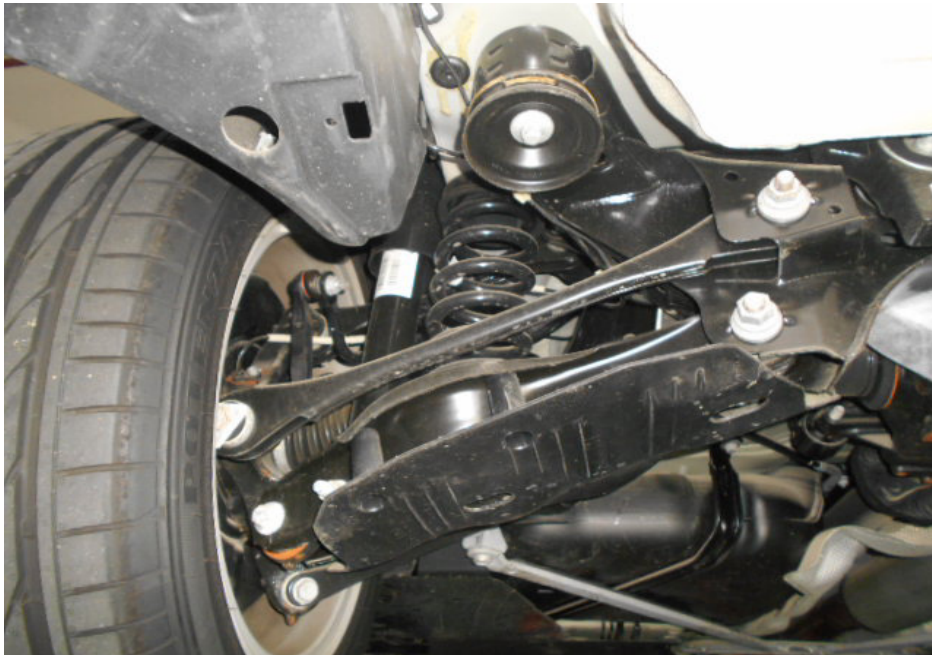
**Photo 9** shows a general view of the control arms and linkages at the rear left wheel of the Motor Car. I did not observe any fluid leak and/or fluid stain on the underside of the Motor Car. All of the Motor Car's undercarriage components were observed to be intact and secured in an appropriate manner.

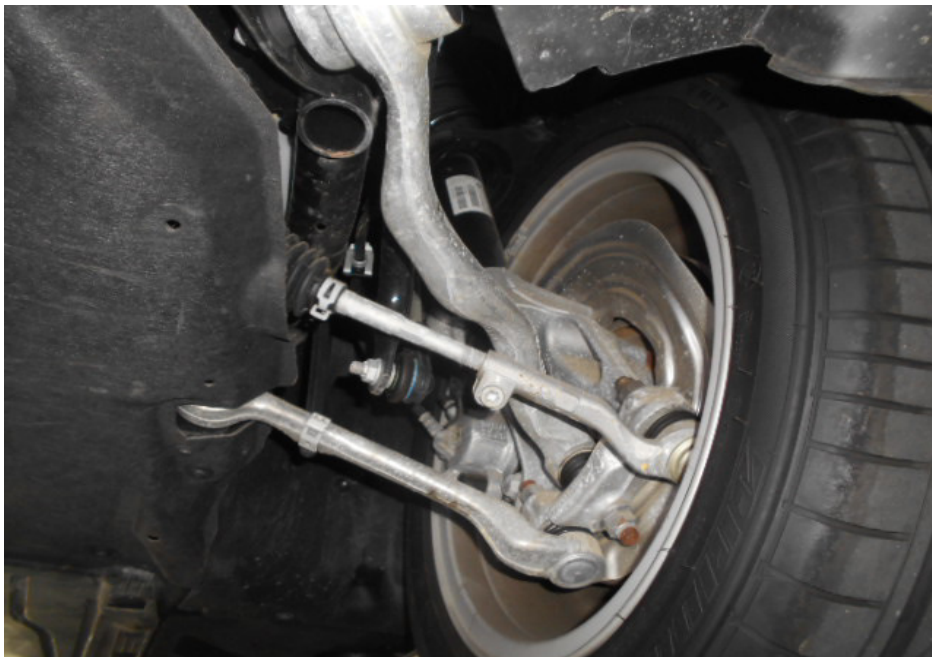
**Photo 10** shows the various undercarriage components at the front left wheel of the Motor Car. The mechanical components, control arms and linkages were all found to be intact and secured in an appropriate manner.

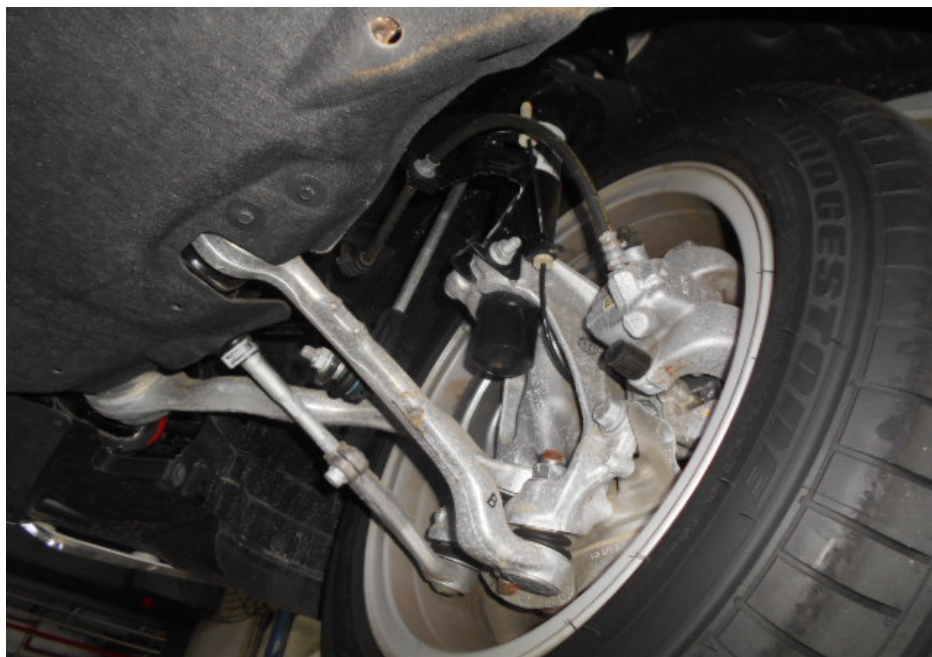
**Photo 11** shows the various undercarriage components at the front right wheel of the Motor Car. The mechanical components, control arms and linkages were all found to be intact and secured in an appropriate manner.

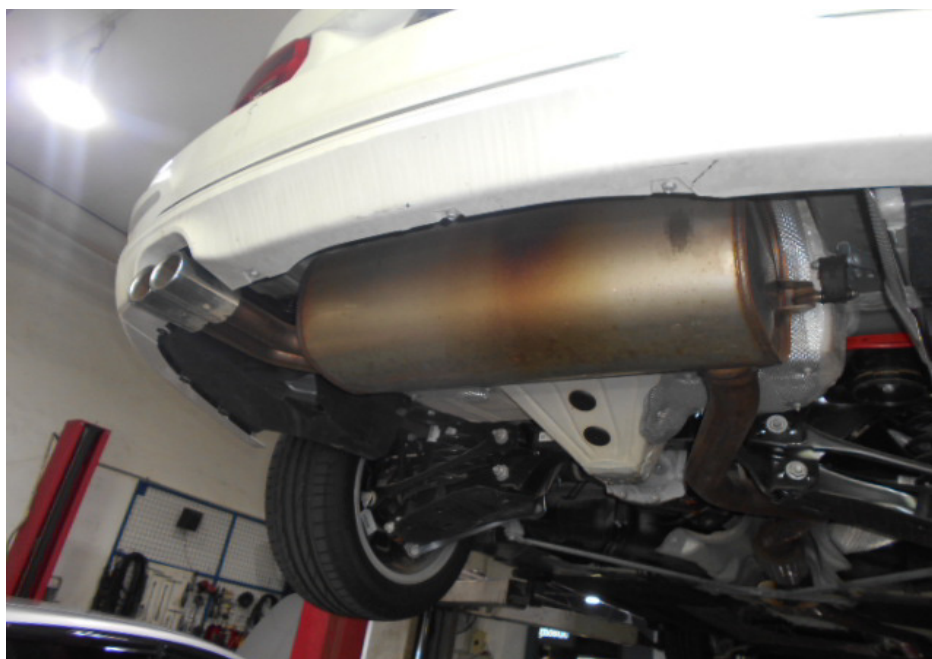
**Photo 12** shows the Motor Car's rear exhaust muffler. My examination of the Motor Car's exhaust system revealed no sign(s) or indication(s) of any cut or weld marks along its exhaust pipes and on its rear mufflers.

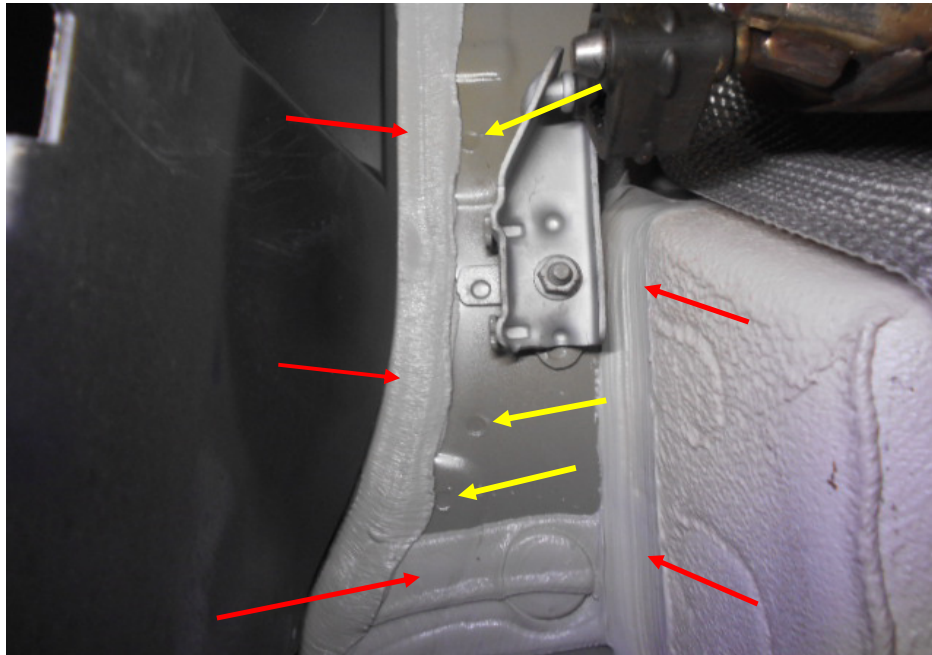
9. Visually, I did not find any weld marks, other than the original spot weld marks, on the chassis/structural body of the Motor Car. The original factory sealant at the joints along the chassis/structural body was also untouched, again indicating that no replacement of the chassis/structural body was carried out; and that the chassis/structural body was originally fitted.

**Photo 13** shows the chassis/structural body at the rear left underside of the Motor Car. Visually, I did not find any weld marks other than original spot weld marks (yellow arrow) on the chassis/structural body of the Motor Car. The original factory sealant (red arrow) at the joints along the chassis/structural body was also untouched, indicating no work was done on the chassis/structural body of the Motor Car and that the chassis/structural body was originally fitted.

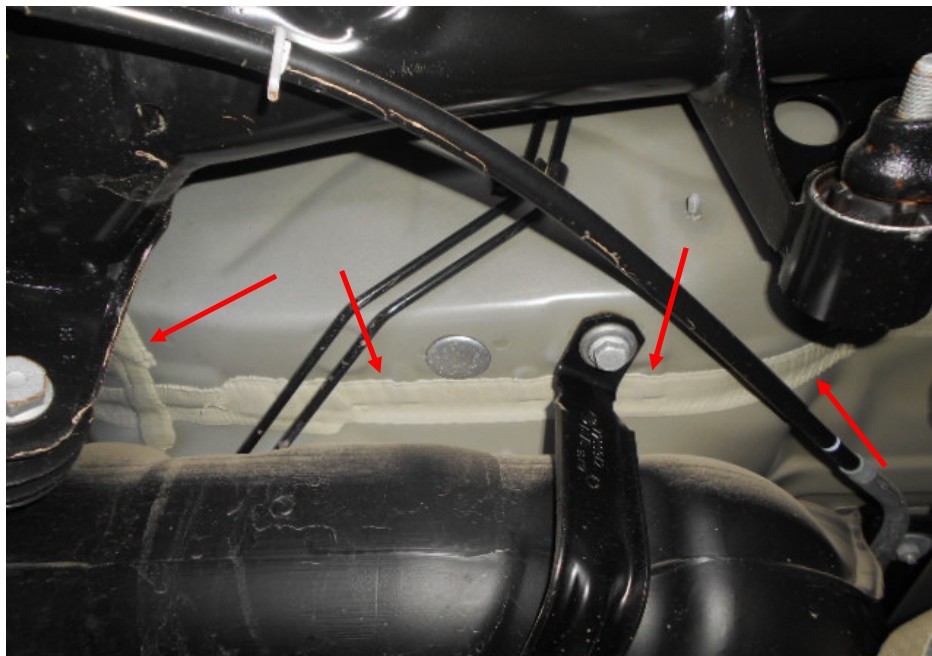
**Photo 14** shows the chassis/structural body at the centre underside of the Motor Car. Visually. The original factory sealant (arrowed) at the joints along the chassis/structural body was untouched, indicating no work was done on the chassis/structural body of the Motor Car and that the chassis/structural body was originally fitted.

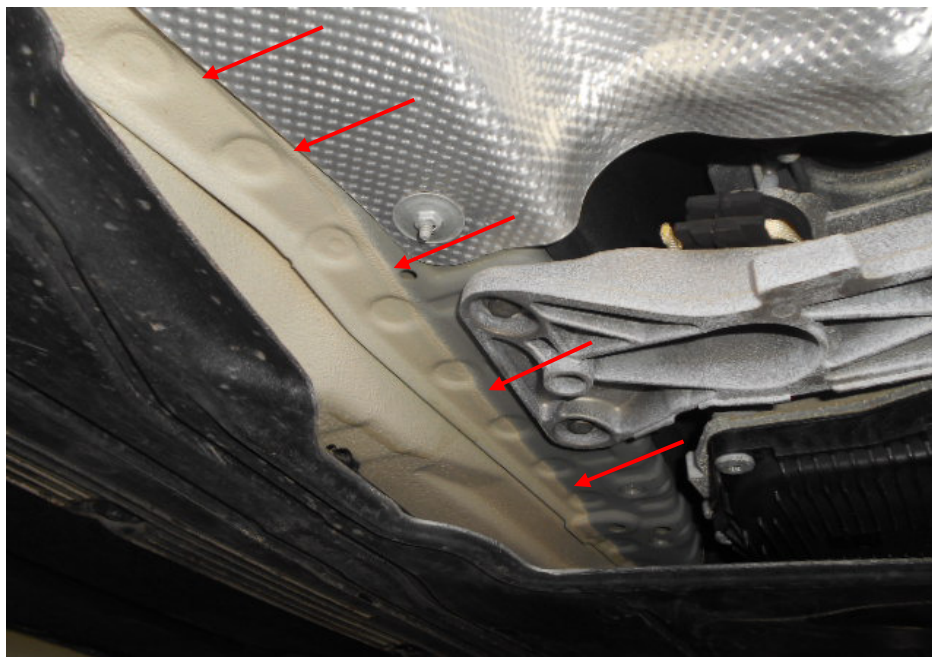
**Photo 15** shows the chassis/structural body at the left centre underside of the Motor Car. The original factory sealant (arrowed) at the joints along the chassis/structural body was untouched, indicating no work was done on the chassis/structural body of the Motor Car and that the chassis/structural body was originally fitted.

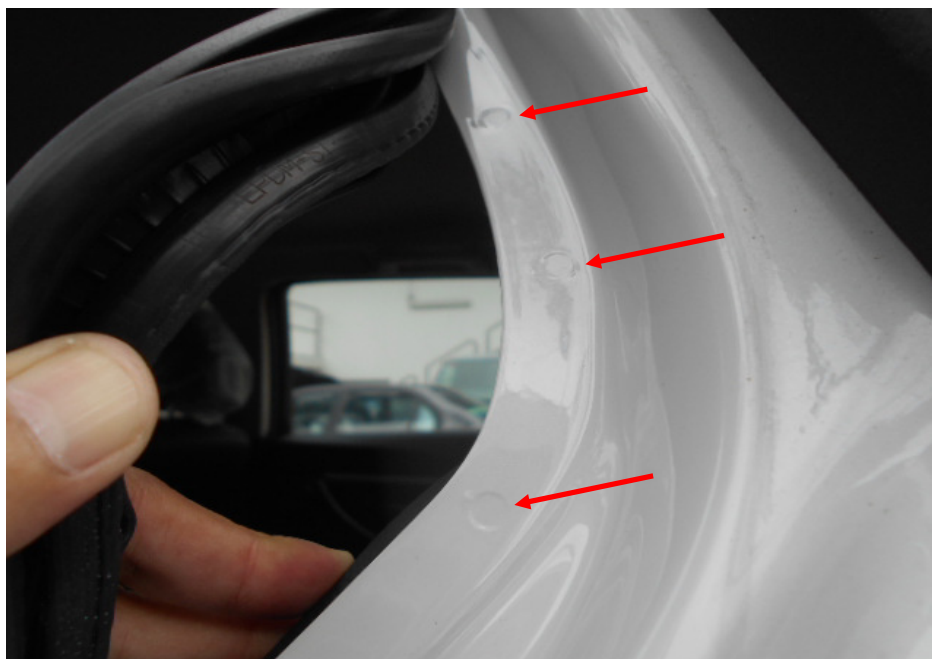
**Photo 16** shows the rear left "C" pillar of the Motor Car. I did not find any weld marks other than original spot weld marks (arrowed) on the body panels of the Motor Car, indicating that there was no re-welding works carried out; and that the body panels of the Motor Car were originally fitted

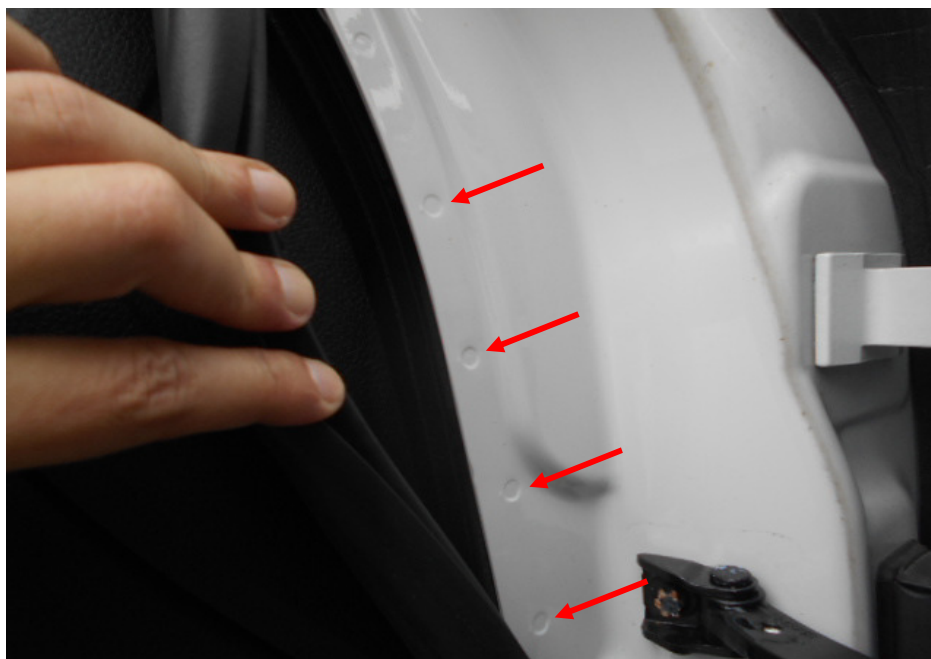
**Photo 17** shows the front right “A” pillar of the Motor Car. I did not find any weld marks other than original spot weld marks (arrowed) on the body panels of the Motor Car, indicating that there was no re-welding works carried out; and that the body panels of the Motor Car were originally fitted.
