Your Ref: Mercedes Benz GLA 220  
(chassis number WDC1569472J506905)  
Our Ref : CI/TP19013841/D

08 August 2019

**INSPECTION REPORT OF AN UNREGISTERD MERCEDES BENZ GLA 220  
MOTOR CAR WITH CHASSIS NUMBER WDC1569472J506905**

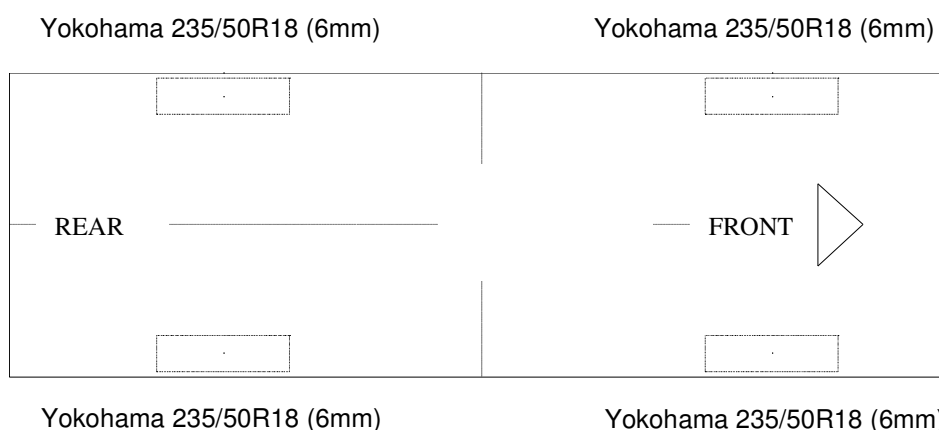
6. It was fitted with 18inch sport wheel rims that were wrapped with tyres that were observed to be of serviceable condition. The tyres were also sufficiently inflated for vehicular operation. The tyre brand, tyre size and approximate remaining tread depth of the 4 tyres of the Motor Car were recorded as follows: -

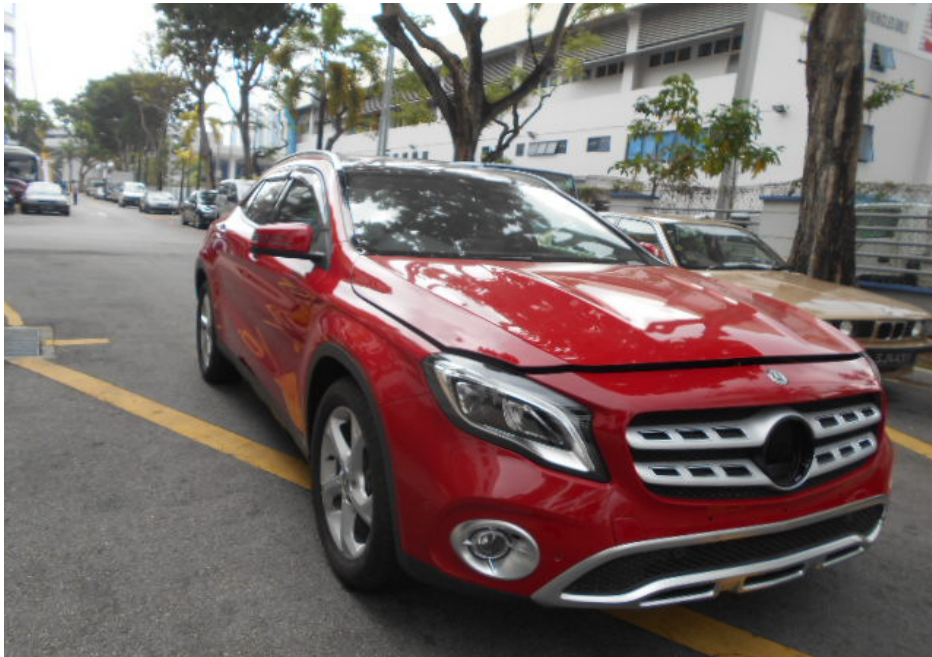
**Photo 1** shows a general view of the front right body of the Motor Car at the time of my inspection. The Motor Car was observed to be in relatively good general condition with no loose exterior fittings observed.

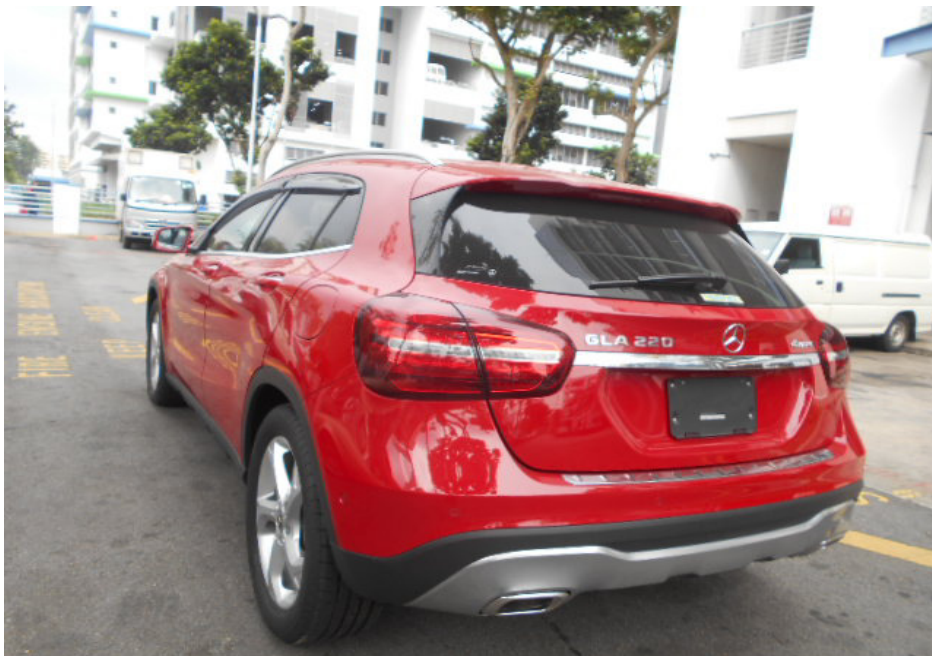
**Photo 2** shows a general view of the rear left body of the Motor Car at the time of my inspection. The Motor Car was observed to be in relatively good general condition with no loose exterior fittings observed.

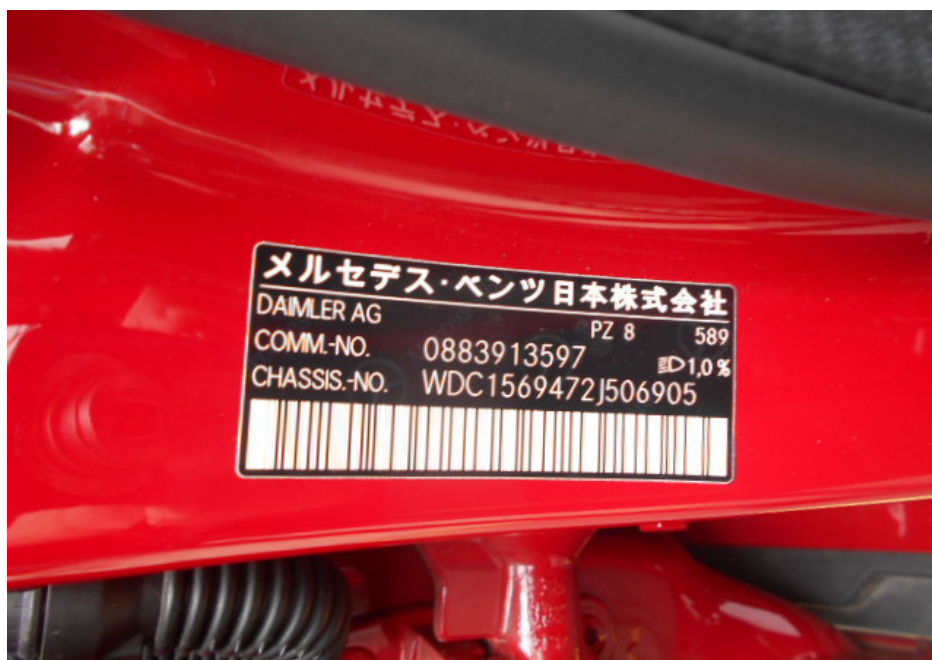
**Photo 3** shows the chassis number of the Motor Car. The chassis number recorded was WDC1569472J506905.

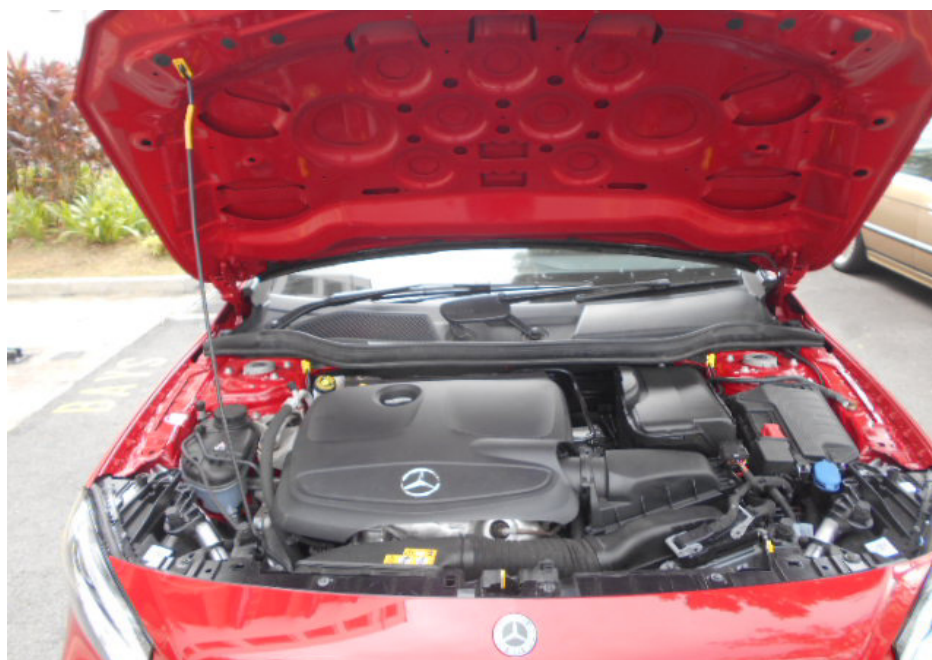
12. My examination of the engine compartment of the Motor Car revealed that the various parts and components inside the engine compartment were all intact and properly fitted. The various operating fluids like the brake fluid and engine coolant were all found to be of sufficient level for operating purposes. Visually, there was also no contamination found to these fluids.
13. My checks on the underside of the Motor Car revealed no sign(s) or indication(s) of fluid leakage and/or fluid stain(s). The engine block and automatic transmission assembly were both secured properly. They were not mounted onto the chassis/structural body or any integral body part of the Motor Car. All undercarriage components of the Motor Car were also observed to be intact and secured in an appropriate manner.

**Photo 4** shows a general view of the engine compartment of the Motor Car at the time of my inspection. The various parts and components inside the engine compartment were all observed to be intact and properly fitted. There was also no sign(s) or indication(s) of fluid leak and/or fluid stain found within the engine compartment.

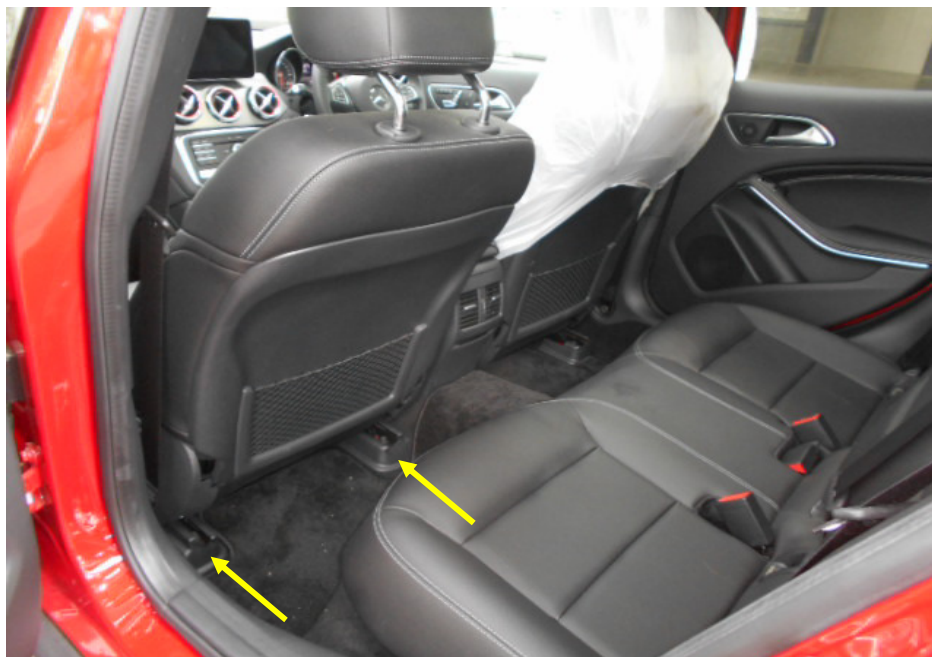
10. The seats of the Motor Car were found to be secured to the floor board of the Motor Car via seat rails bolted onto the floor board. Retractable seat belt reels and pre-tensioners were fitted on all seats of the Motor Car. The seat belt reels were able to be fastened securely to the respective pre-tensioner that is fixed to the side of all the seats.

**Photo 5** shows the seats of the Motor Car, which were secured via seat rails (arrowed) to the floor board. All the seats of the Motor Car were fitted with a retractable seat belt reel and pre-tensioner. The seat belts were also able to be fastened to the pretension that were fitted on the side of each individual seat.

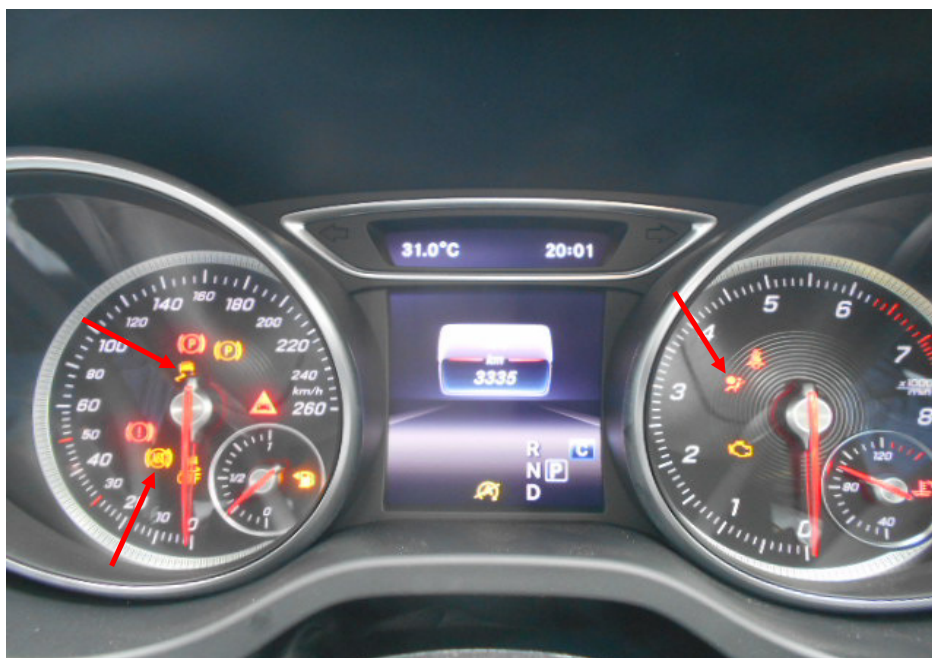
**Photo 6** shows the warning lights for the various electronic safety features appearing on the instrument panel of the Motor Car during its self-test when the engine is cranked, in particular the ABS, SRS and TCS lights (arrowed).

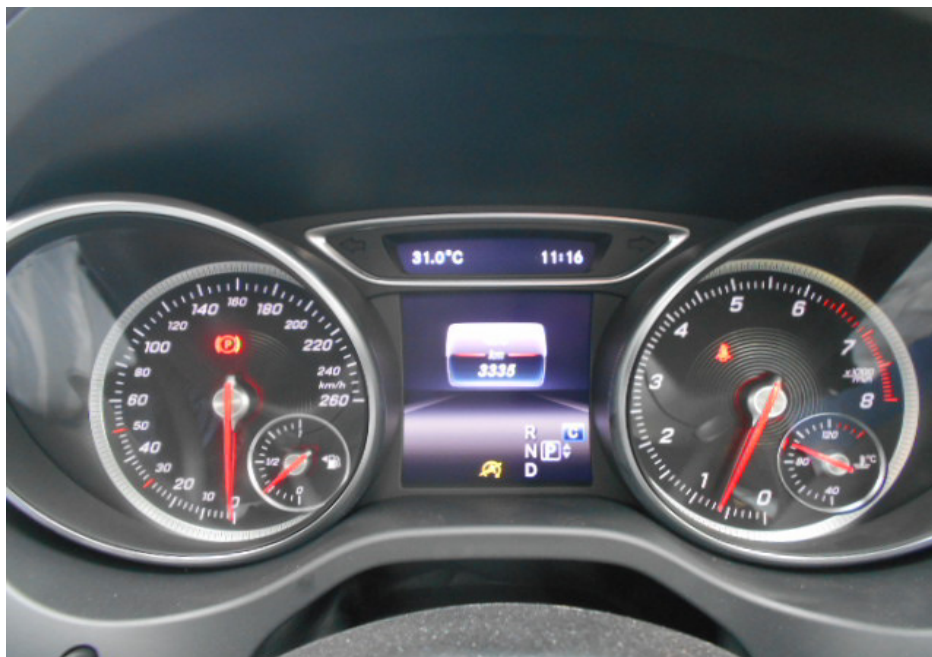
11. The Motor Car's automatic self-test of the functionality of its various electronic safety features like the Anti-Lock Brake System (ABS), Supplemental Restraint System (SRS) and Traction Control System (TCS) during cranking of the engine had indicated that these electronic systems were in working condition. This was determined from the respective warning lights disappearing from the instrument panel after the self-test.

**Photo 7** shows the respective warning lights no longer illuminated, indicating that there is no fault detected to the ABS, SRS and TCS systems of the Motor Car during the self-test. These electronic systems were hence in working condition at the time of my inspection.

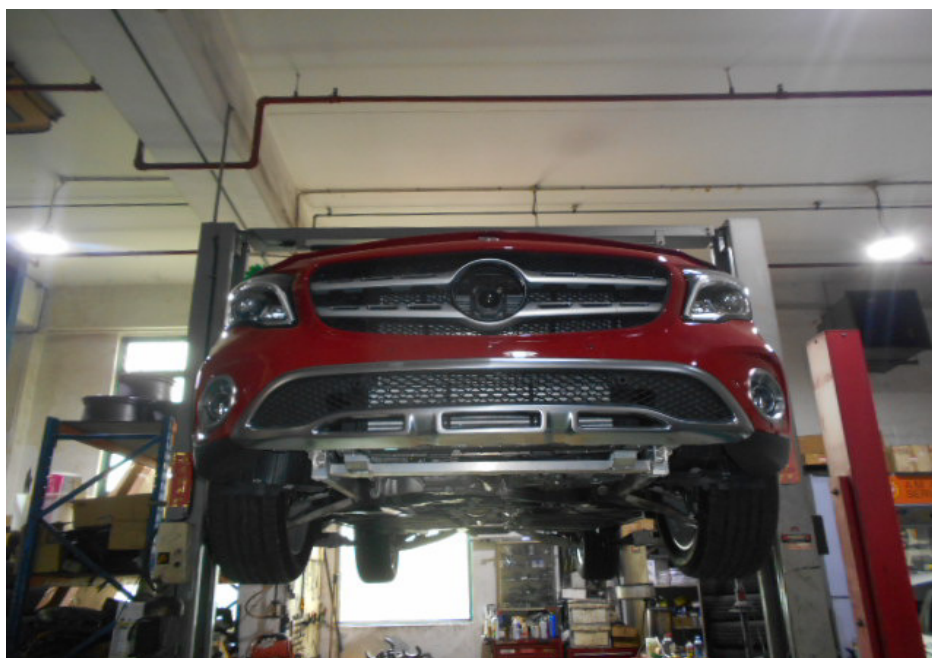
**Photo 8** shows the Motor Car hoisted up for checks on its undercarriage. There was no sign(s) or indication(s) of fluid leakage and/or fluid stain(s). The undercarriage components of the Motor Car were also all observed to be intact and secured in an appropriate manner.

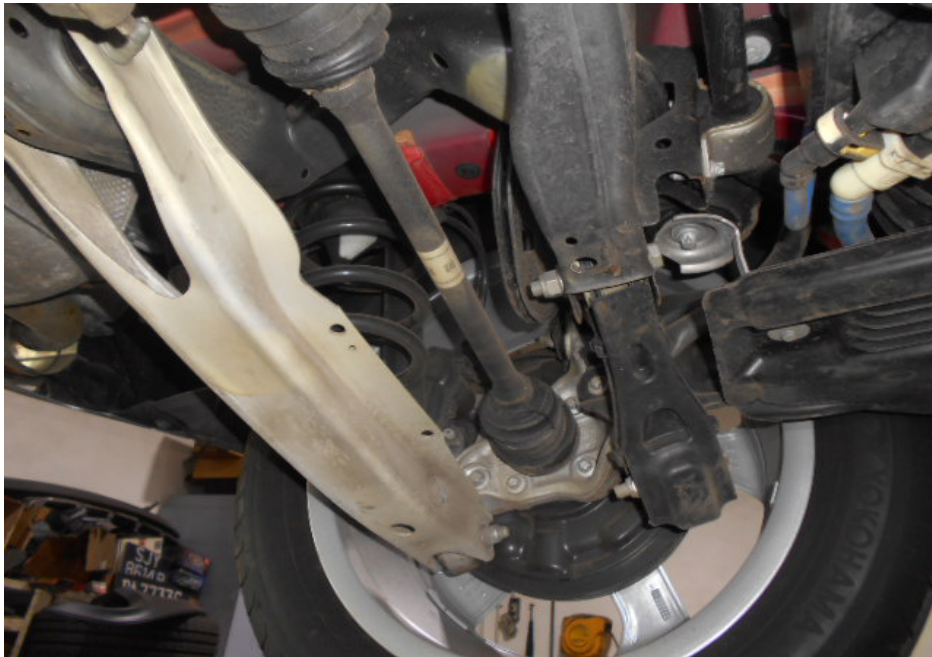
**Photo 9** shows a general view of the control arms and linkages at the rear left wheel of the Motor Car. I did not observe any fluid leak and/or fluid stain on the underside of the Motor Car. All of the Motor Car's undercarriage components were observed to be intact and secured in an appropriate manner.

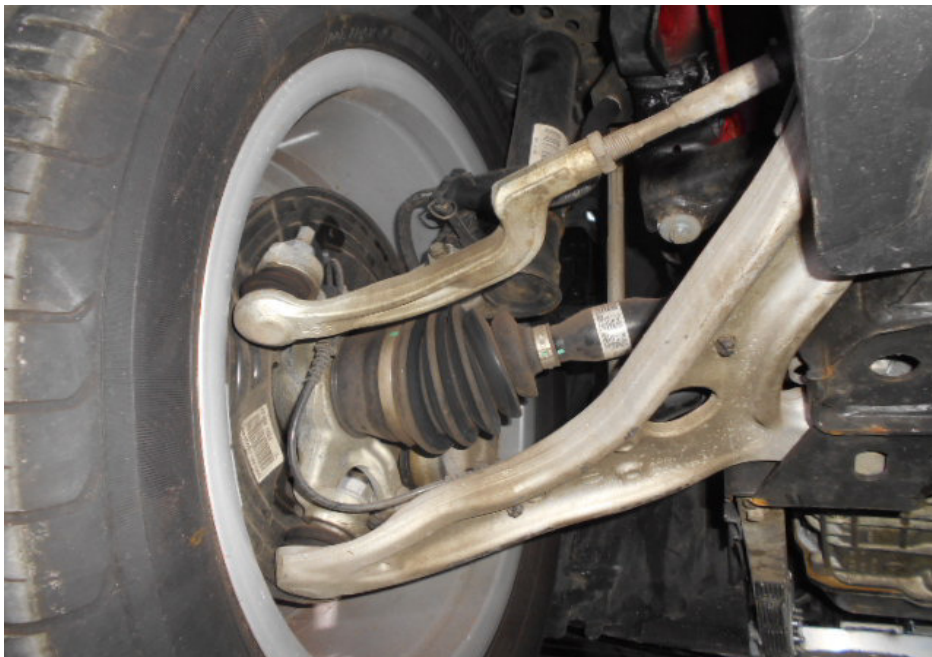
**Photo 10** shows the various undercarriage components at the front left wheel of the Motor Car. The mechanical components, control arms and linkages were all found to be intact and secured in an appropriate manner.

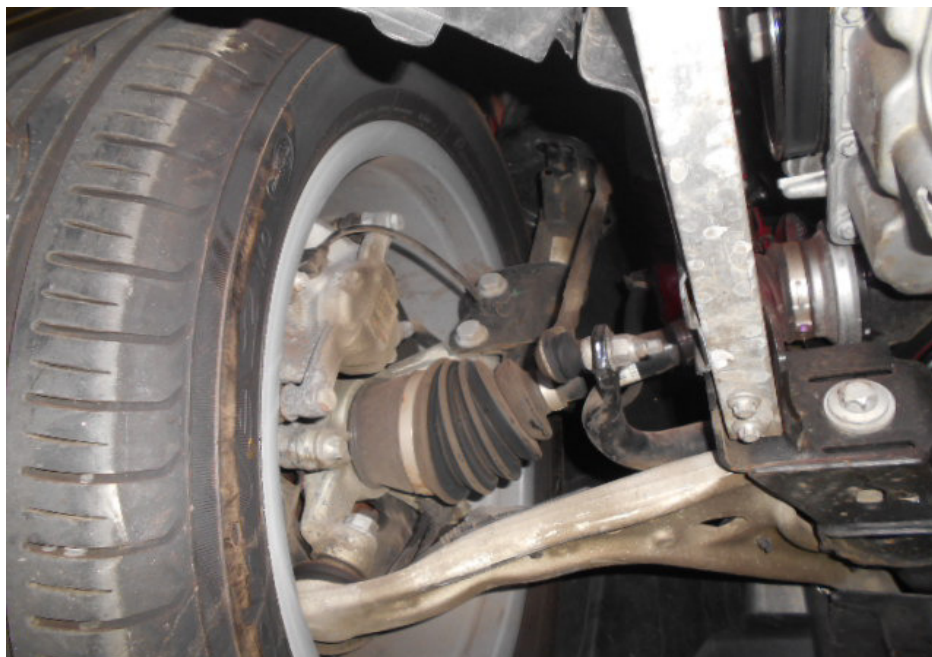
**Photo 11** shows the various undercarriage components at the front right wheel of the Motor Car. The mechanical components, control arms and linkages were all found to be intact and secured in an appropriate manner.

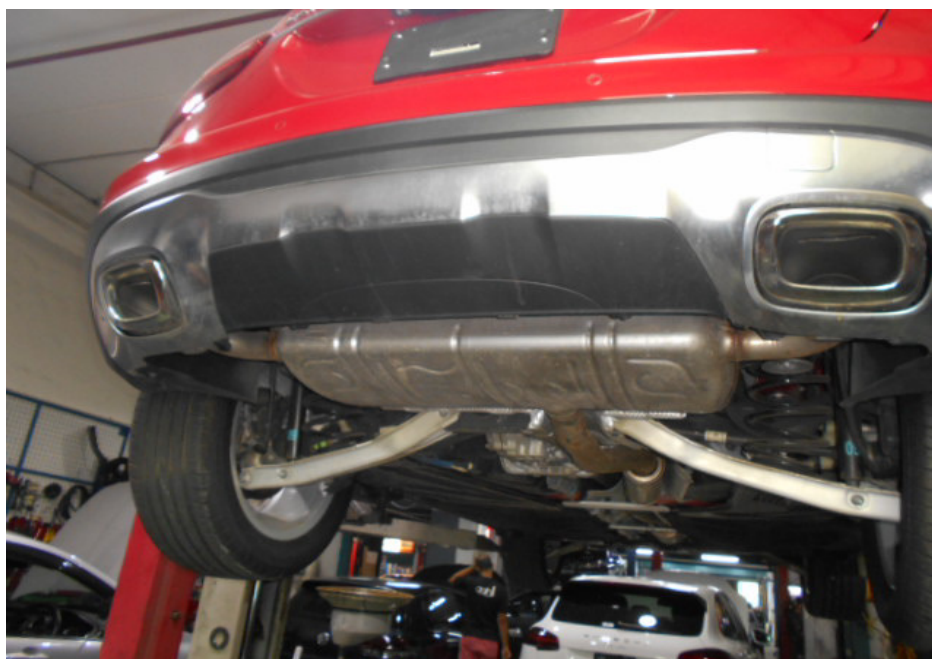
**Photo 12** shows the Motor Car's rear exhaust muffler. My examination of the Motor Car's exhaust system revealed no sign(s) or indication(s) of any cut or weld marks along its exhaust pipes and on its rear mufflers.

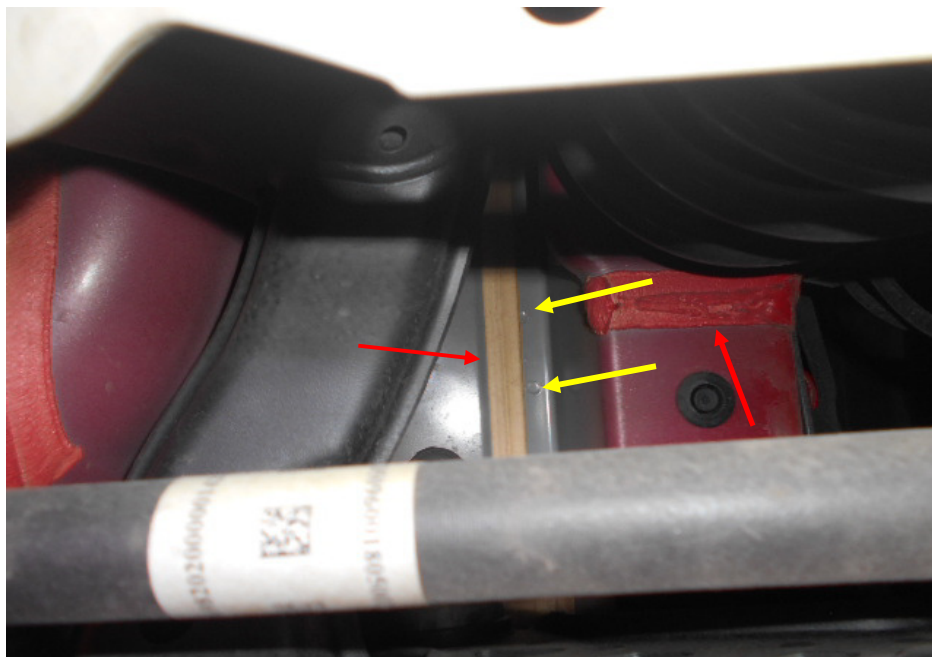
9. Visually, I did not find any weld marks, other than the original spot weld marks, on the chassis/structural body of the Motor Car. The original factory sealant at the joints along the chassis/structural body was also untouched, again indicating that no replacement of the chassis/structural body was carried out; and that the chassis/structural body was originally fitted.

**Photo 13** shows the chassis/structural body at the rear right underside of the Motor Car. Visually, I did not find any weld marks other than original spot weld marks (yellow arrow) on the chassis/structural body of the Motor Car. The original factory sealant (red arrow) at the joints along the chassis/structural body was also untouched, indicating no work was done on the chassis/structural body of the Motor Car and that the chassis/structural body was originally fitted.

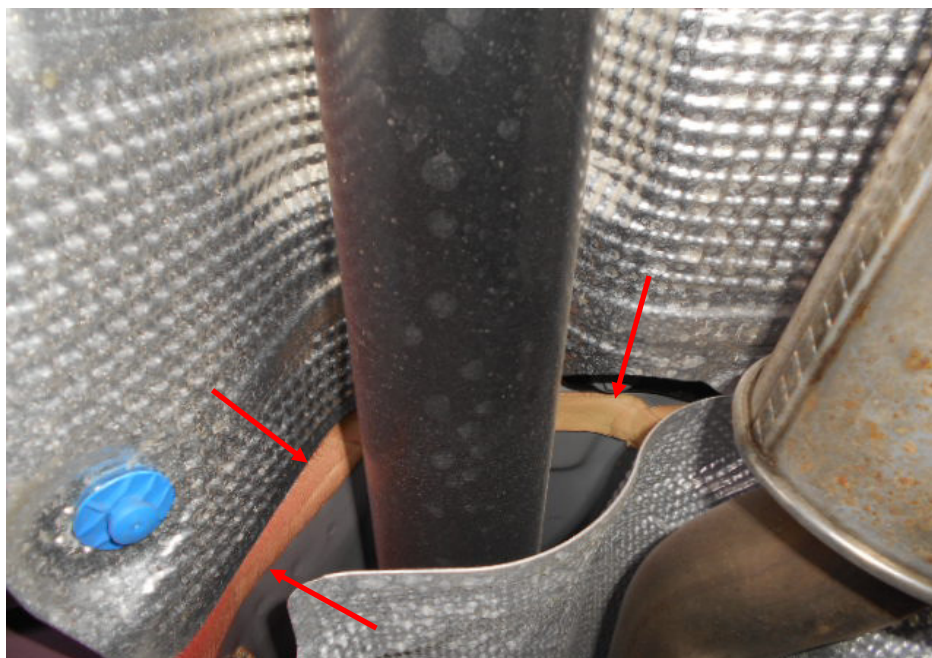
**Photo 14** shows the chassis/structural body at the centre underside of the Motor Car. Visually, The original factory sealant (arrowed) at the joints along the chassis/structural body was untouched, indicating no work was done on the chassis/structural body of the Motor Car and that the chassis/structural body was originally fitted.

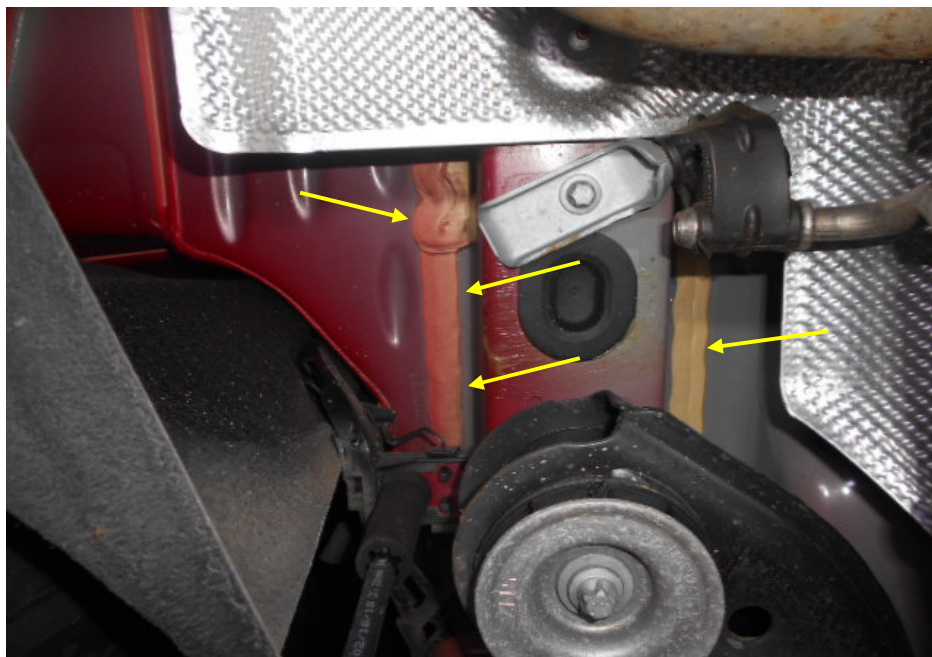
**Photo 15** shows the chassis/structural body at the rear left underside of the Motor Car. The original factory sealant (arrowed) at the joints along the chassis/structural body was untouched, indicating no work was done on the chassis/structural body of the Motor Car and that the chassis/structural body was originally fitted.

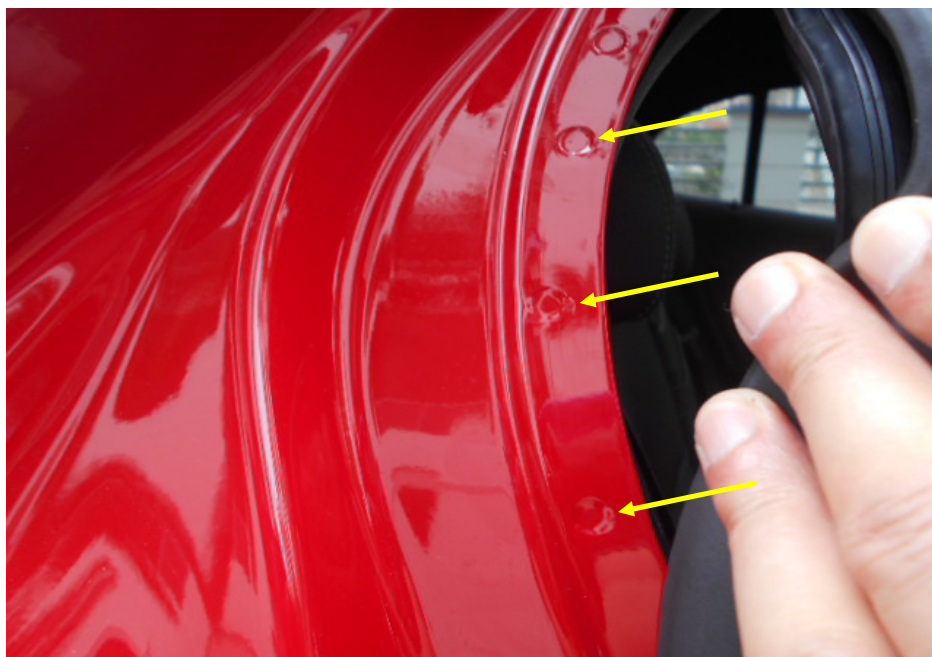
**Photo 16** shows the rear right "C" pillar of the Motor Car. I did not find any weld marks other than original spot weld marks (arrowed) on the body panels of the Motor Car, indicating that there was no re-welding works carried out; and that the body panels of the Motor Car were originally fitted.

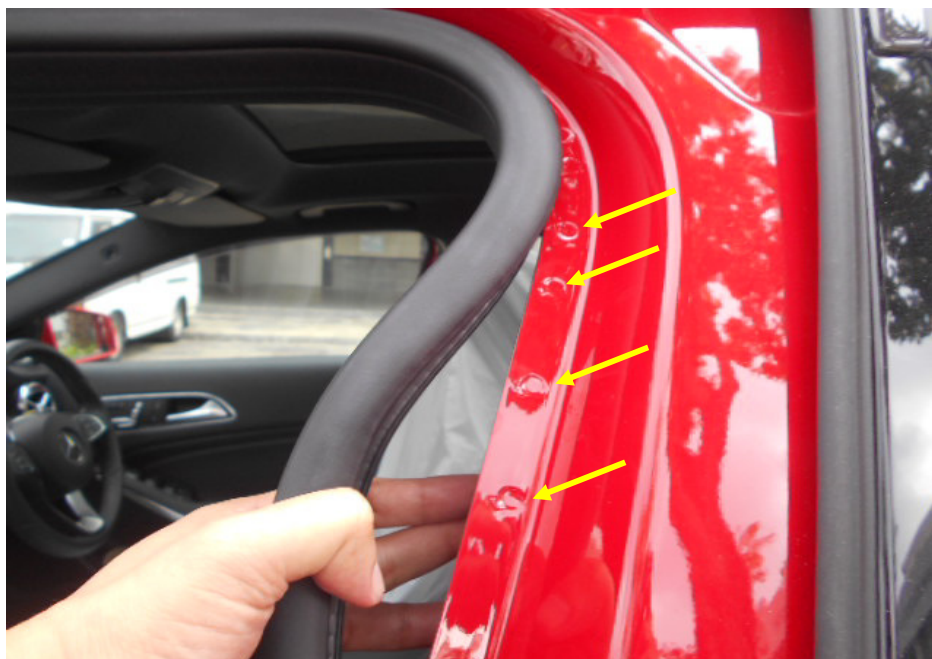
**Photo 17** shows the left side "B" pillar of the Motor Car. I did not find any weld marks other than original spot weld marks (arrowed) on the body panels of the Motor Car, indicating that there was no re-welding works carried out; and that the body panels of the Motor Car were originally fitted.
