Your Ref: Porsche Cayenne
(chassis number WP1ZZZ92ZJKA03532)
Our Ref : CI/TP19013842/D

08 August 2019

INSPECTION REPORT OF AN UNREGISTERD PORSCHE CAYENNE MOTOR CAR WITH CHASSIS NUMBER WP1ZZZ92ZJKA03532

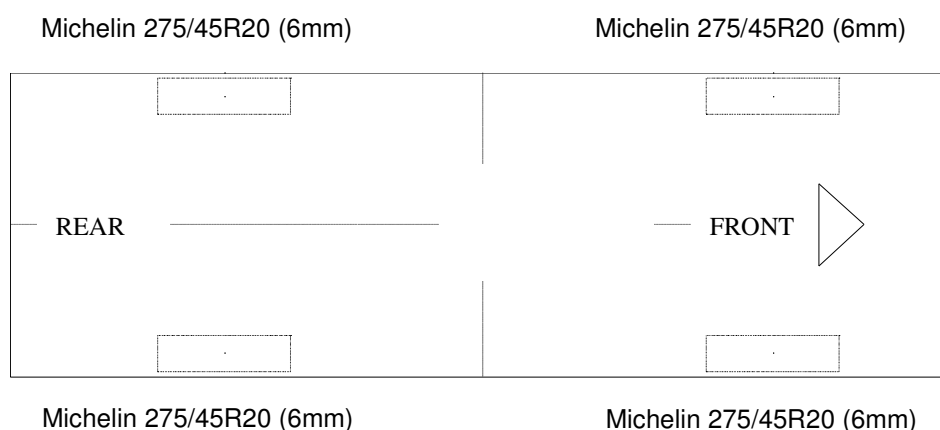
6. It was fitted with 20inch sport wheel rims that were wrapped with tyres that were observed to be of serviceable condition. The tyres were also sufficiently inflated for vehicular operation. The tyre brand, tyre size and approximate remaining tread depth of the 4 tyres of the Motor Car were recorded as follows: -

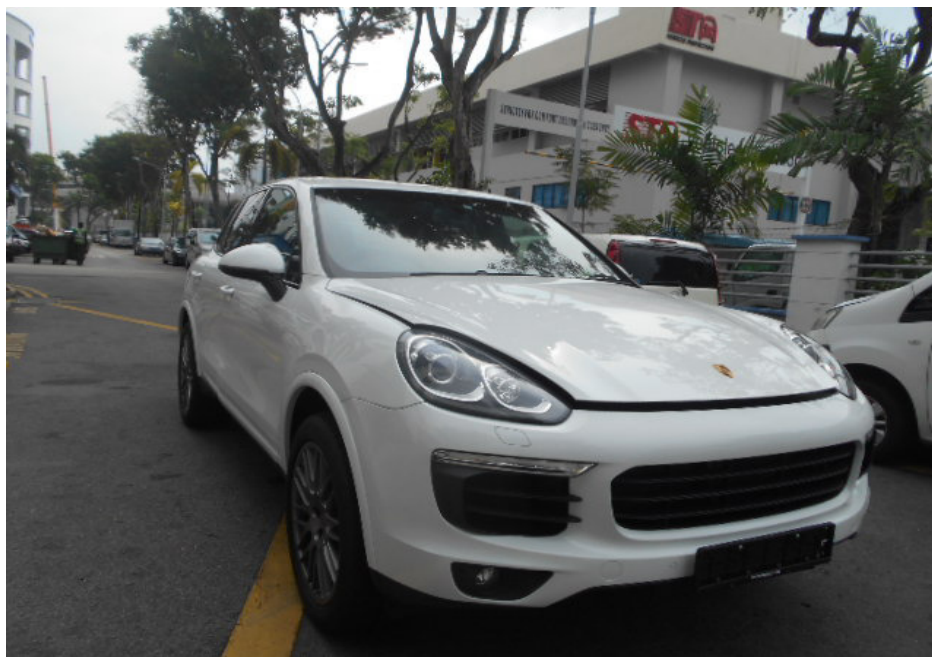
Photo 1 shows a general view of the front right body of the Motor Car at the time of my inspection. The Motor Car was observed to be in relatively good general condition with no loose exterior fittings observed.

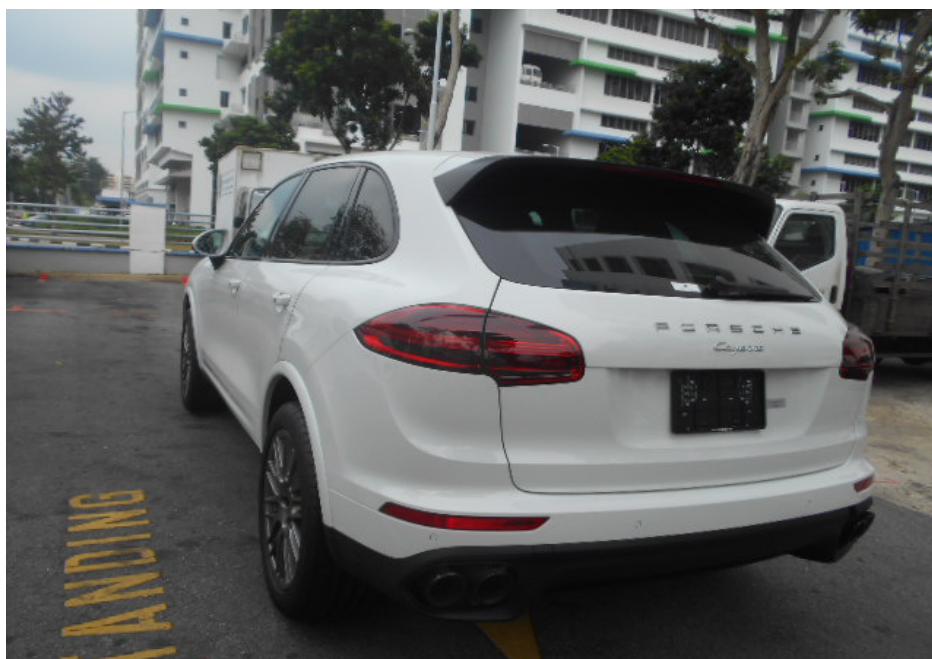
Photo 2 shows a general view of the rear left body of the Motor Car at the time of my inspection. The Motor Car was observed to be in relatively good general condition with no loose exterior fittings observed.

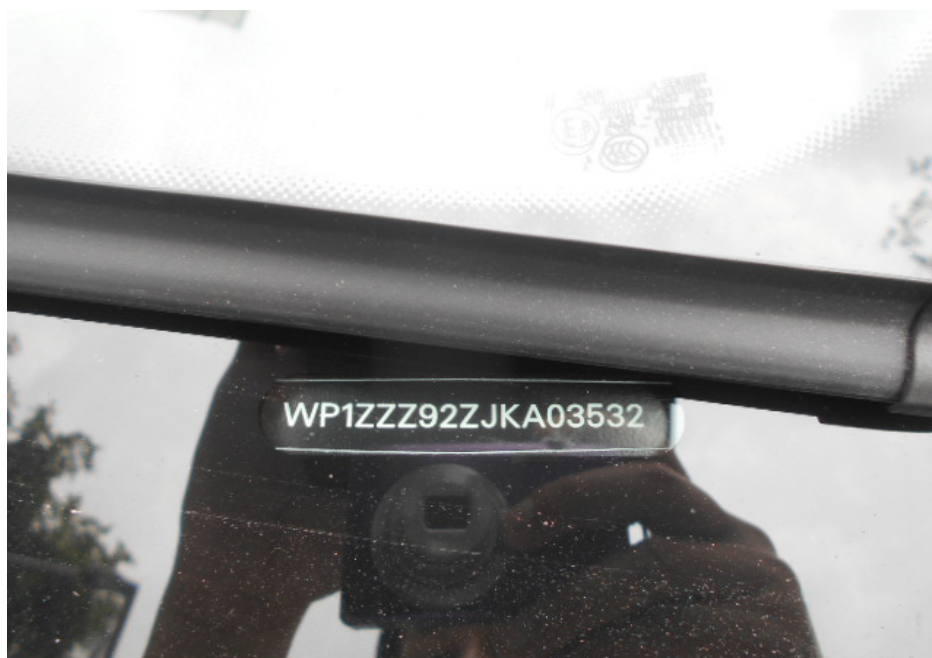
Photo 3 shows the chassis number of the Motor Car. The chassis number recorded was WP1ZZZ92ZJKA03532.

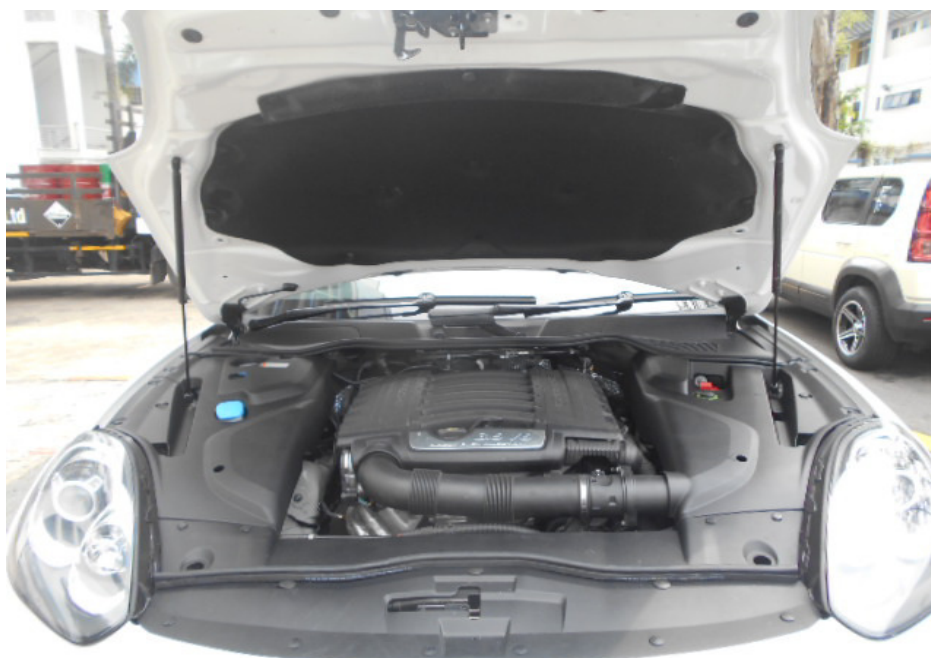
12. My examination of the engine compartment of the Motor Car revealed that the various parts and components inside the engine compartment were all intact and properly fitted. The various operating fluids like the brake fluid and engine coolant were all found to be of sufficient level for operating purposes. Visually, there was also no contamination found to these fluids.
13. My checks on the underside of the Motor Car revealed no sign(s) or indication(s) of fluid leakage and/or fluid stain(s). The engine block and automatic transmission assembly were both secured properly. They were not mounted onto the chassis/structural body or any integral body part of the Motor Car. All undercarriage components of the Motor Car were also observed to be intact and secured in an appropriate manner.

Photo 4 shows a general view of the engine compartment of the Motor Car at the time of my inspection. The various parts and components inside the engine compartment were all observed to be intact and properly fitted. There was also no sign(s) or indication(s) of fluid leak and/or fluid stain found within the engine compartment.

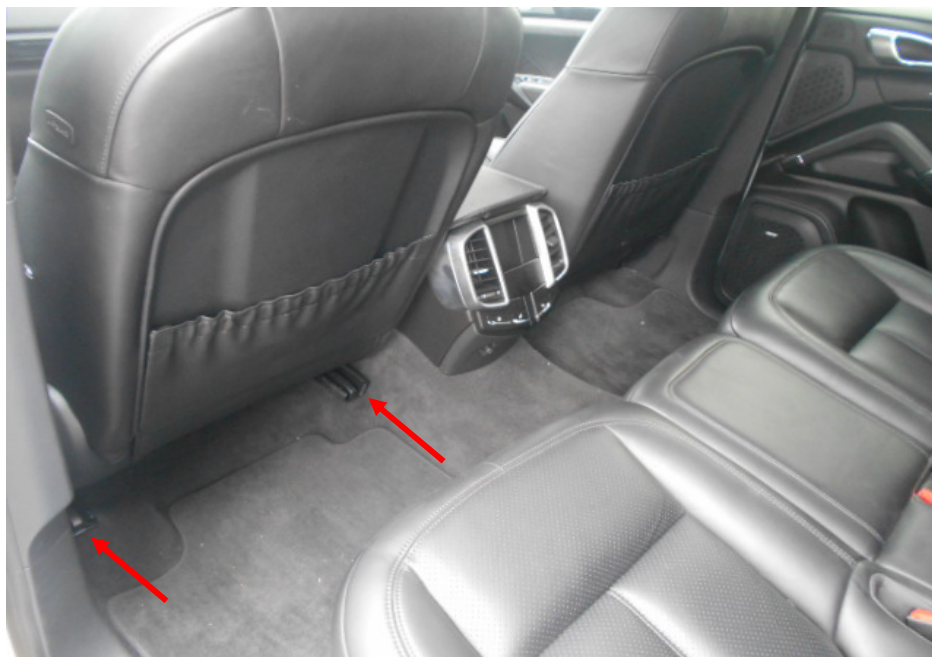
10. The seats of the Motor Car were found to be secured to the floor board of the Motor Car via seat rails bolted onto the floor board. Retractable seat belt reels and pre-tensioners were fitted on all seats of the Motor Car. The seat belt reels were able to be fastened securely to the respective pre-tensioner that is fixed to the side of all the seats.

Photo 5 shows the seats of the Motor Car, which were secured via seat rails (arrowed) to the floor board. All the seats of the Motor Car were fitted with a retractable seat belt reel and pre-tensioner. The seat belts were also able to be fastened to the pretension that were fitted on the side of each individual seat.

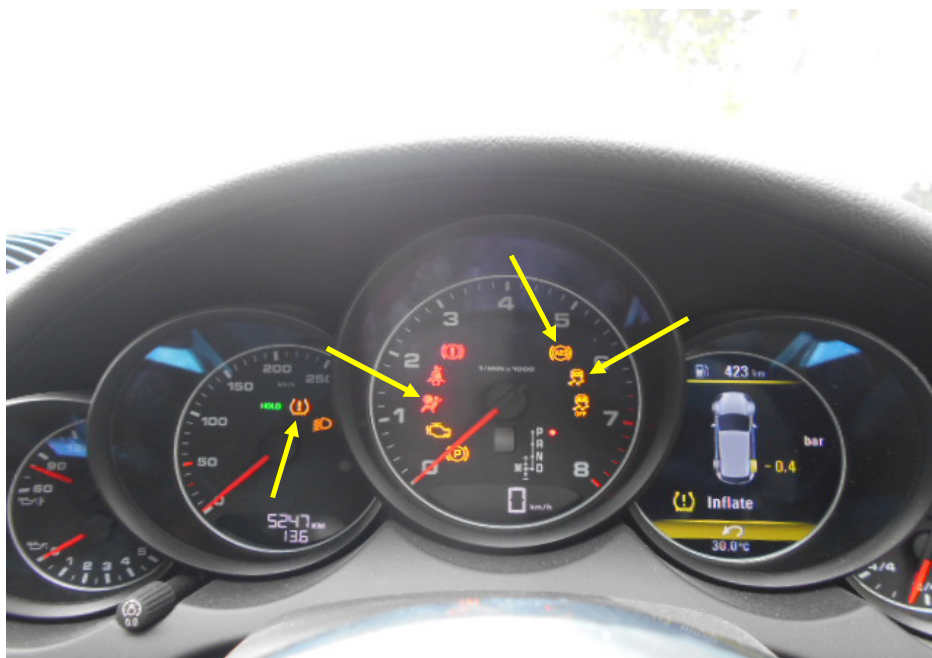
Photo 6 shows the warning lights for the various electronic safety features appearing on the instrument panel of the Motor Car during its self-test when the engine is cranked, in particular the ABS, SRS, TPM and TCS lights (arrowed).

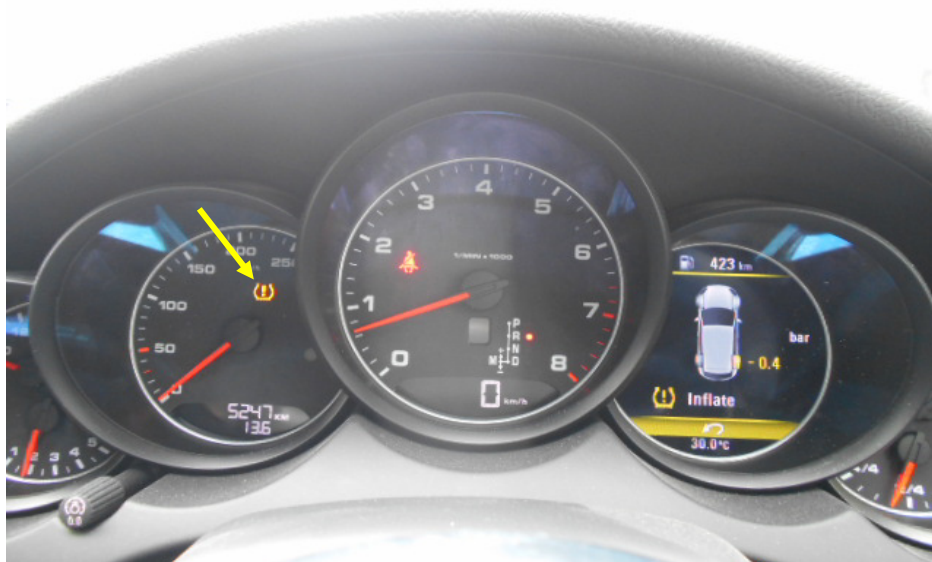
11. The Motor Car's automatic self-test of the functionality of its various electronic safety features like the Anti-Lock Brake System (ABS), Supplemental Restraint System (SRS), Tyre Pressure Monitor (TPM) and Traction Control System (TCS) during cranking of the engine had indicated that these electronic systems were in working condition.

Photo 7 shows the respective warning lights no longer illuminated except for the Tyre Pressure Monitor (TPM) warning light (arrowed), which remained lighted to alert the vehicle operator that air pressure of the rear right tyre was below the pre-set limit. The self-test had indicated that there is no fault detected to the ABS, SRS, TPM and TCS systems of the Motor Car. These electronic systems were hence found to be in working condition at the time of my inspection.

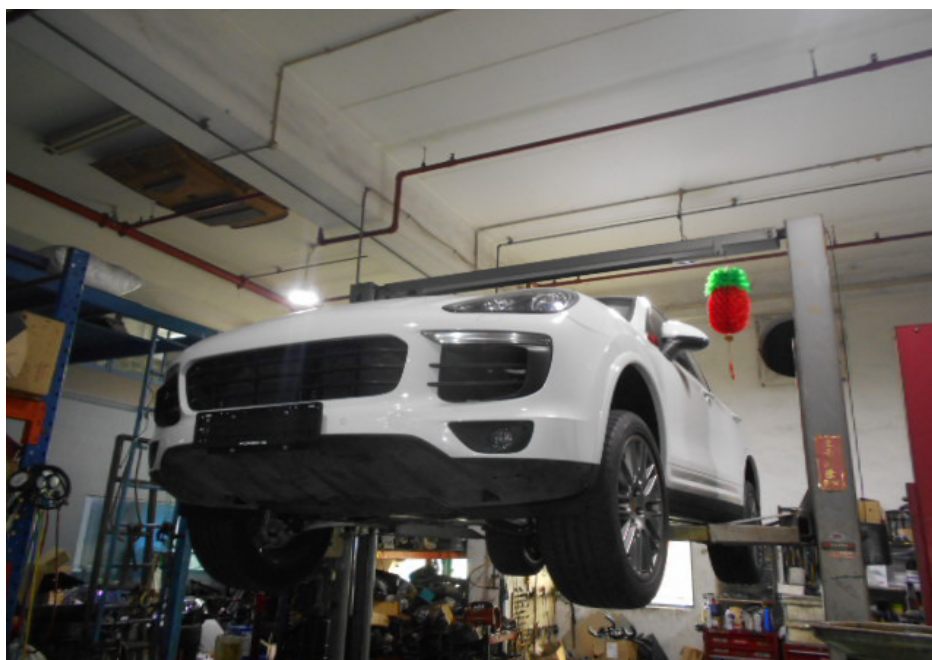
Photo 8 shows the Motor Car hoisted up for checks on its undercarriage. There was no sign(s) or indication(s) of fluid leakage and/or fluid stain(s). The undercarriage components of the Motor Car were also all observed to be intact and secured in an appropriate manner.

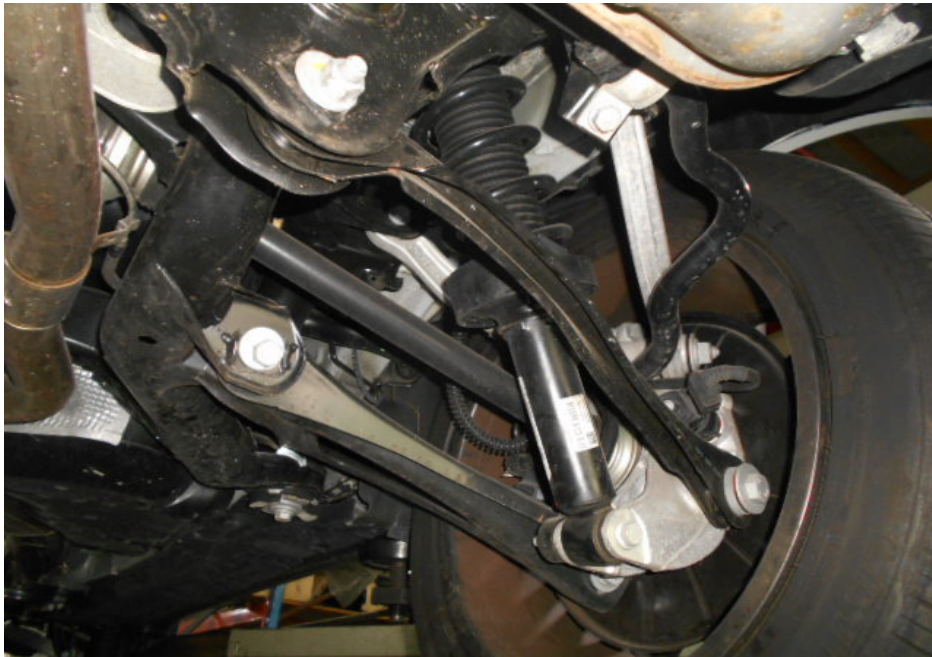
Photo 9 shows a general view of the control arms and linkages at the rear right wheel of the Motor Car. I did not observe any fluid leak and/or fluid stain on the underside of the Motor Car. All of the Motor Car's undercarriage components were observed to be intact and secured in an appropriate manner.

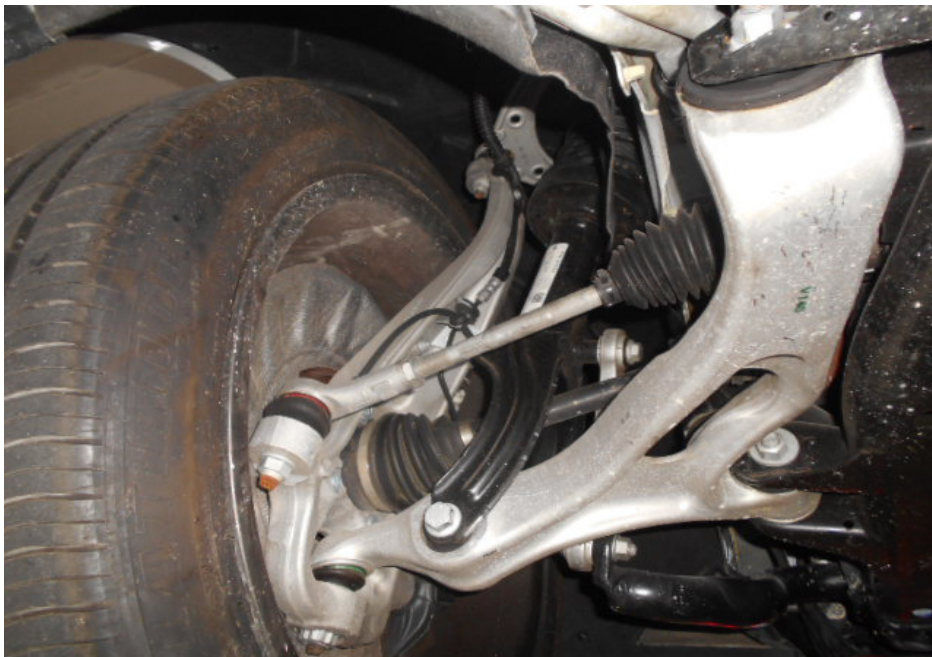
Photo 10 shows the various undercarriage components at the front left wheel of the Motor Car. The mechanical components, control arms and linkages were all found to be intact and secured in an appropriate manner.

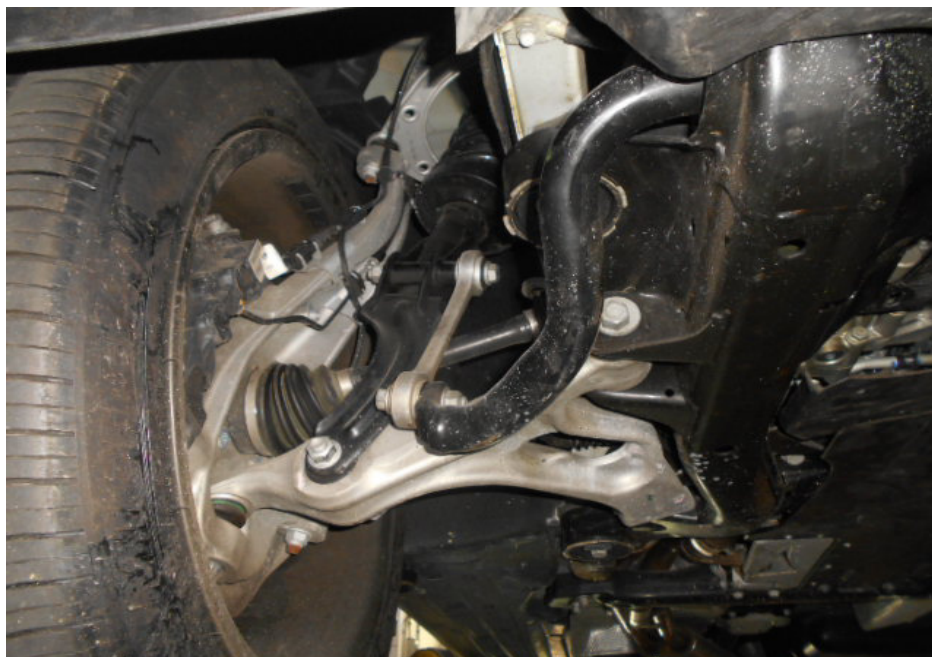
Photo 11 shows the various undercarriage components at the front right wheel of the Motor Car. The mechanical components, control arms and linkages were all found to be intact and secured in an appropriate manner.

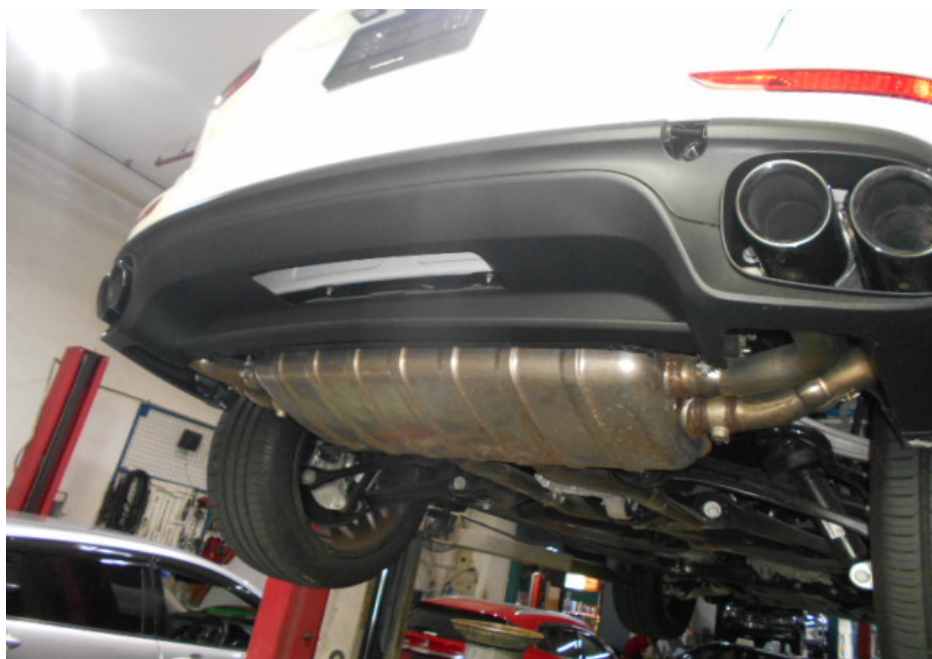
Photo 12 shows the Motor Car's rear exhaust muffler. My examination of the Motor Car's exhaust system revealed no sign(s) or indication(s) of any cut or weld marks along its exhaust pipes and on its rear mufflers.

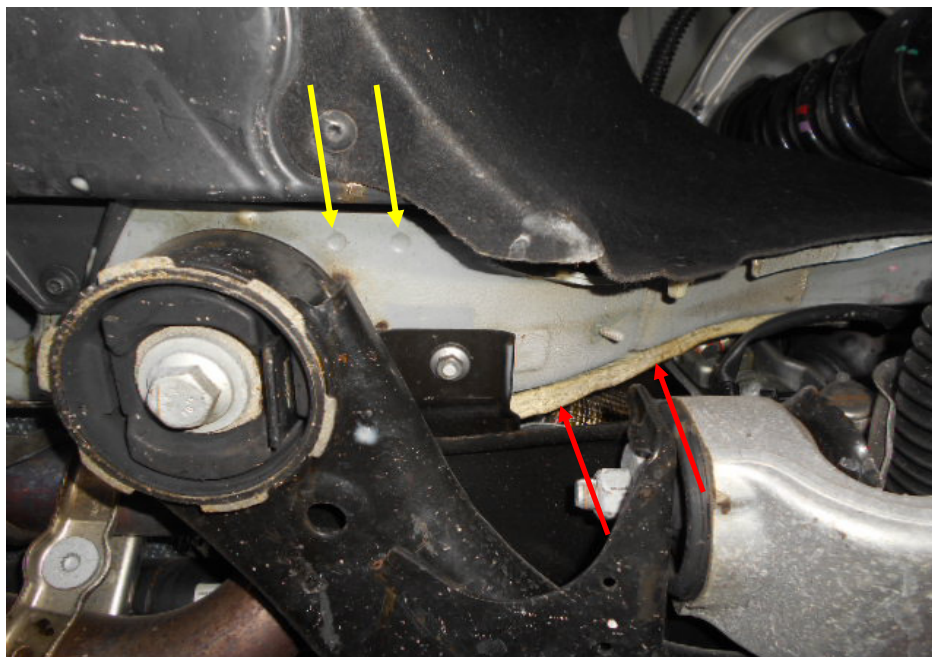
9. Visually, I did not find any weld marks, other than the original spot weld marks, on the chassis/structural body of the Motor Car. The original factory sealant at the joints along the chassis/structural body was also untouched, again indicating that no replacement of the chassis/structural body was carried out; and that the chassis/structural body was originally fitted.

Photo 13 shows the chassis/structural body at the front right underside of the Motor Car. Visually, I did not find any weld marks other than original spot weld marks (yellow arrow) on the chassis/structural body of the Motor Car. The original factory sealant (red arrow) at the joints along the chassis/structural body was also untouched, indicating no work was done on the chassis/structural body of the Motor Car and that the chassis/structural body was originally fitted.

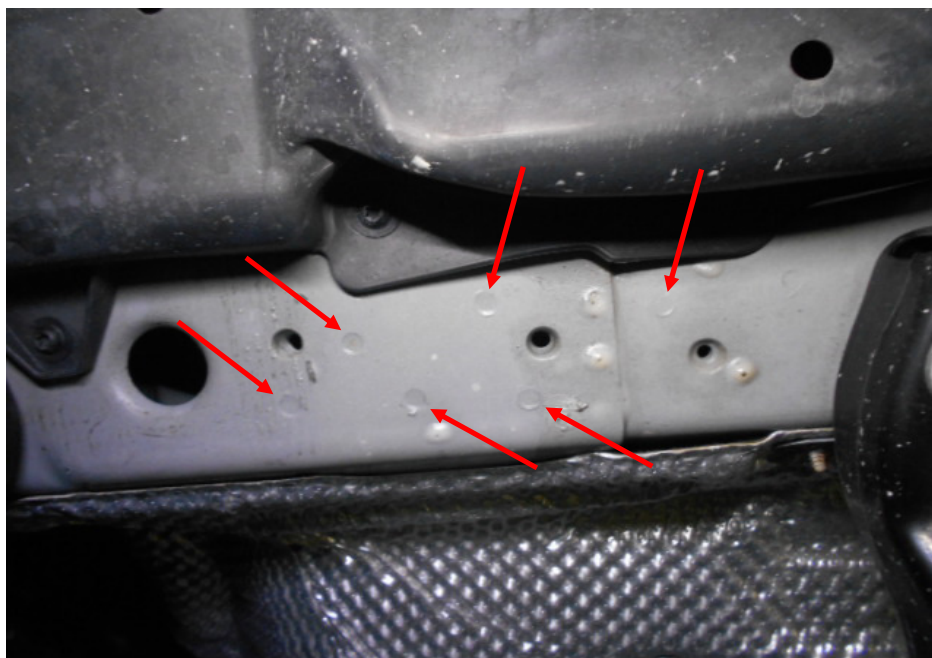
Photo 14 shows the chassis/structural body at the front left underside of the Motor Car. Visually, I did not find any weld marks other than original spot weld marks (arrowed) on the chassis/structural body of the Motor Car, indicating no work was done on the chassis/structural body of the Motor Car and that the chassis/structural body was originally fitted.

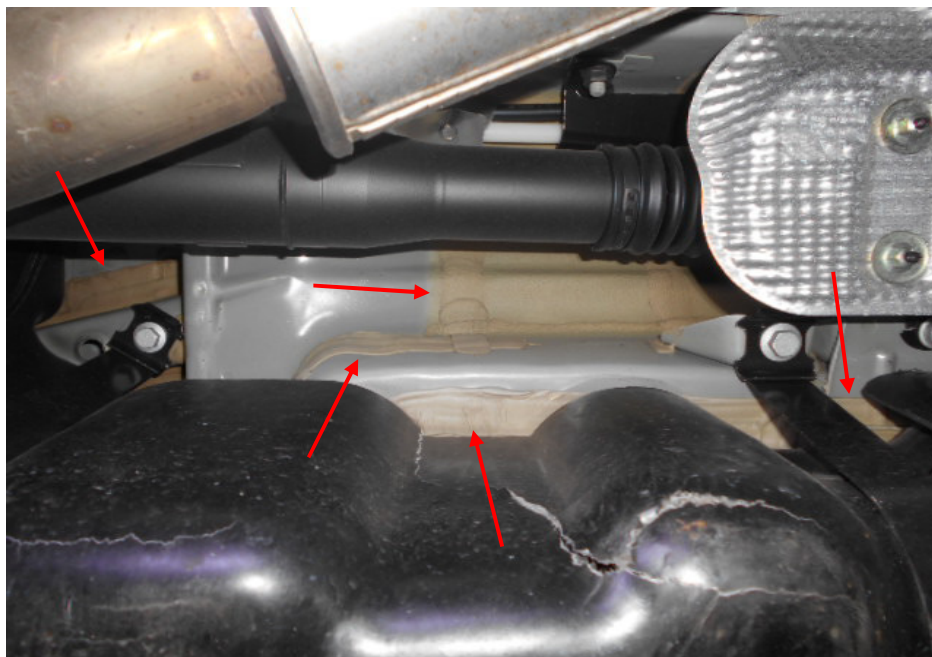
Photo 15 shows the chassis/structural body at the centre underside of the Motor Car. The original factory sealant (arrowed) at the joints along the chassis/structural body was untouched, indicating no work was done on the chassis/structural body of the Motor Car and that the chassis/structural body was originally fitted.

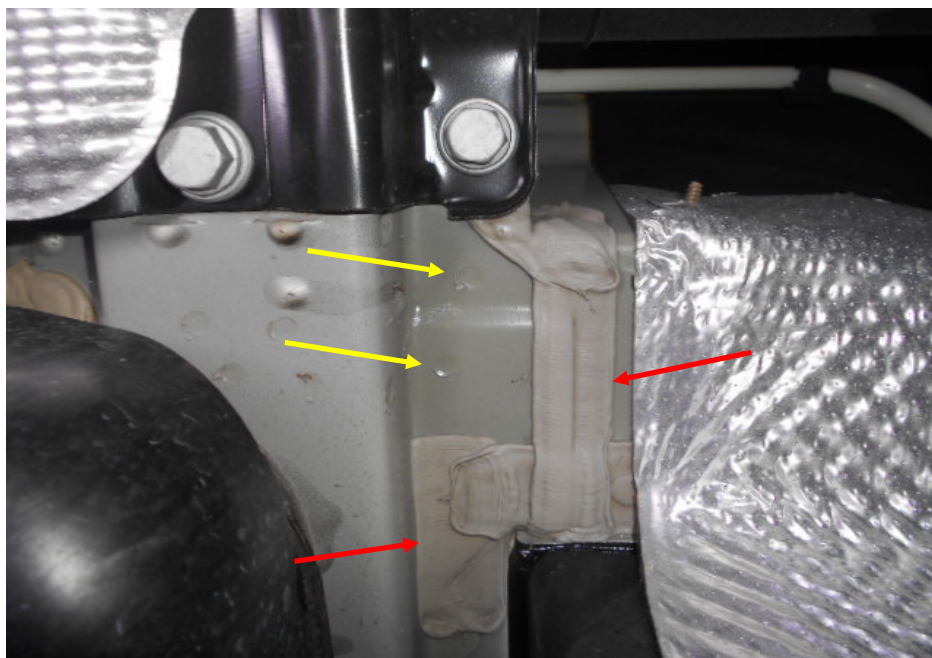
Photo 16 shows the chassis/structural body at the rear right underside of the Motor Car. Visually, I did not find any weld marks other than original spot weld marks (yellow arrow) on the chassis/structural body of the Motor Car. The original factory sealant (red arrow) at the joints along the chassis/structural body was also untouched, indicating no work was done on the chassis/structural body of the Motor Car and that the chassis/structural body was originally fitted.

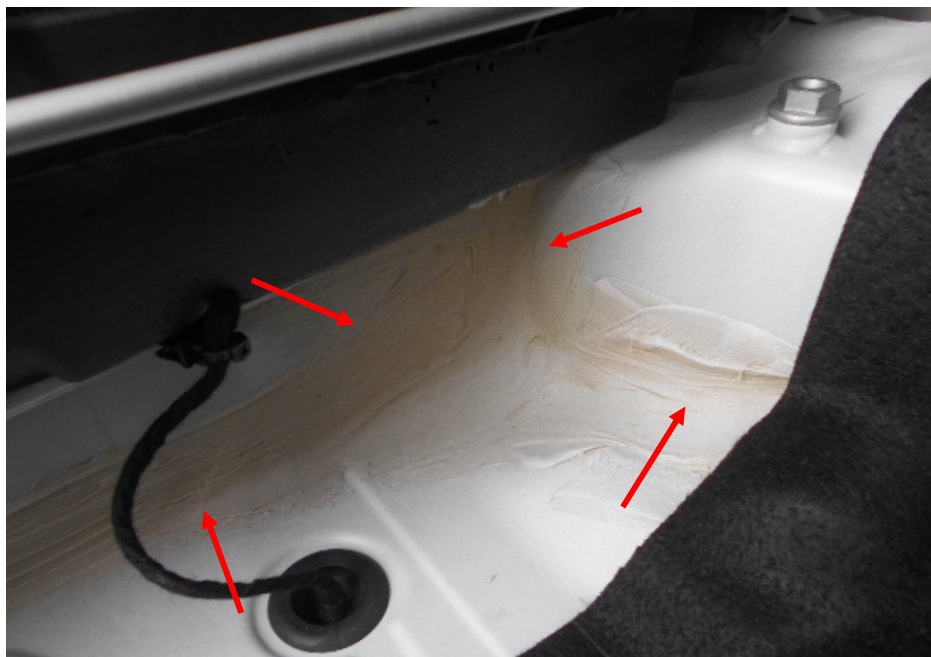
Photo 17 shows the rear floor board of the Motor Car. The original factory sealant (arrowed) at the joints along the chassis/structural body was untouched. In general, I had found no work done on the structure/chassis body of the Motor Car and that the structure/chassis body was originally fitted.
