Your Ref: TP/IP/47301/2019
Our Ref : CI/TPD19013960/N

19 September 2019

Fatal Accident Investigation Team

MECHANICAL INSPECTION REPORT OF MOTOR LORRY YN 668D

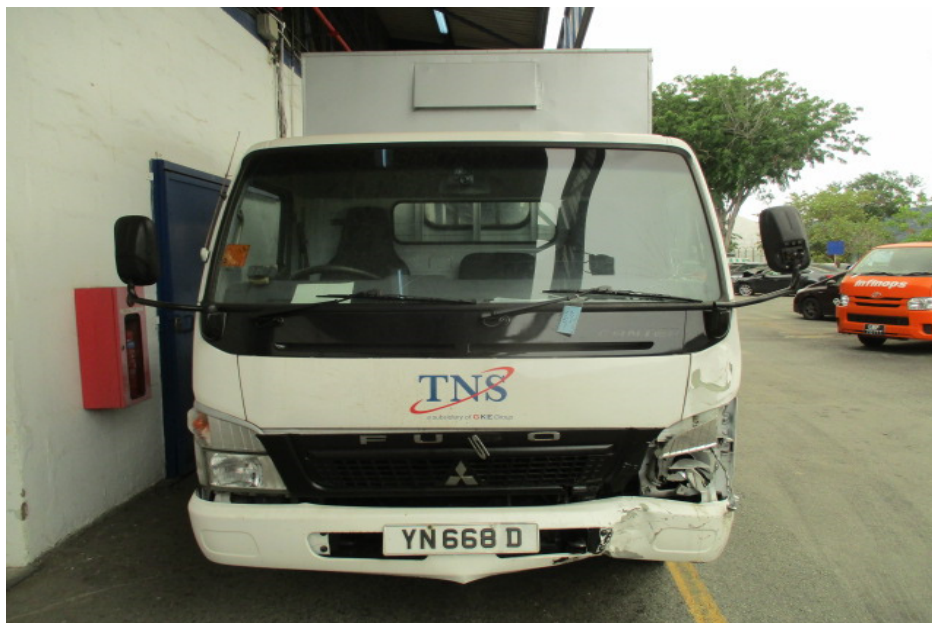
4. The mileage of the Motor Lorry at the time of our inspection was 5, 791km.
5. The Motor Lorry had sustained relatively moderate impact damage that was confined to its frontal portion. Its front bumper was observed to be deformed; its front left panel was observed to have been dented; its front windscreen was observed to be shattered while its left headlight was observed to be cracked.

Photo 1 shows a general view of the front body of the Motor Lorry at the time of our inspection. The Motor Lorry had sustained relatively moderate impact damage that was confined to its frontal portion. Its front bumper was observed to be deformed; its front left panel was observed to have been dented, its front windscreen was observed to be shattered while its left headlight was observed to be cracked. The mileage of the Motor Lorry at the time of our inspection was 5,791km.

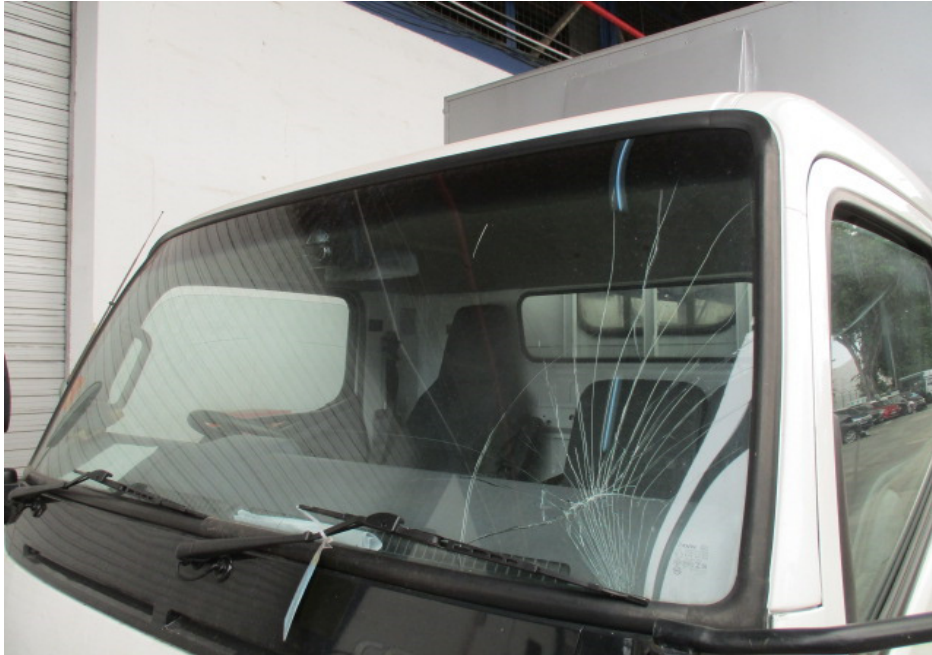
Photo 2 shows a closer view of the shattered front windscreen of the Motor Lorry at the time of our inspection.

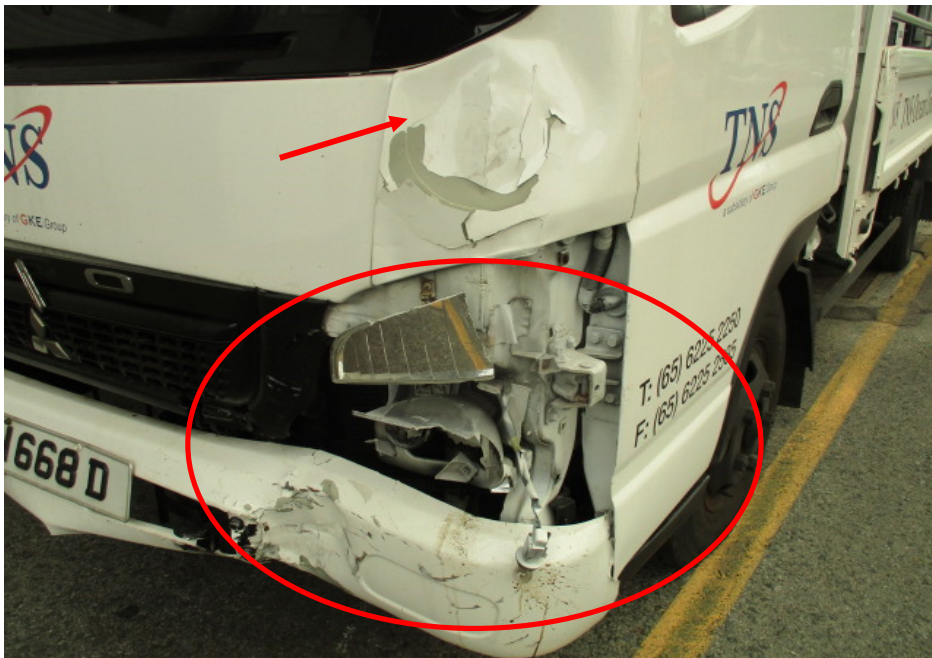
Photo 3 shows a closer view of the deformed front bumper and cracked left headlight (circled) as well as the dented front left panel (arrowed) of the Motor Lorry at the time of our inspection.

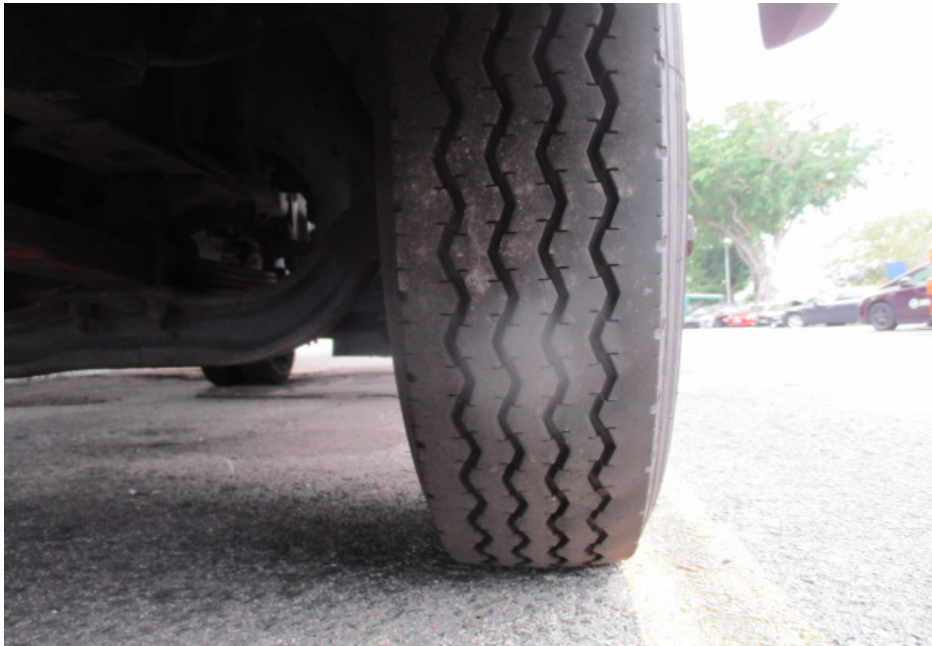
Photo 4 shows the condition of the front left tyre of the Motor Lorry, which was observed to be in serviceable condition with remaining tread depth of approximately 6mm. The tyre, which was wrapped around standard alloy wheel rim, was also observed to be sufficiently inflated for vehicular operation. There was no tear, cut or burst mark(s) on the outer and the inner sidewalls as well as across the tread of the 6 tyres that were fitted on the Motor Lorry.

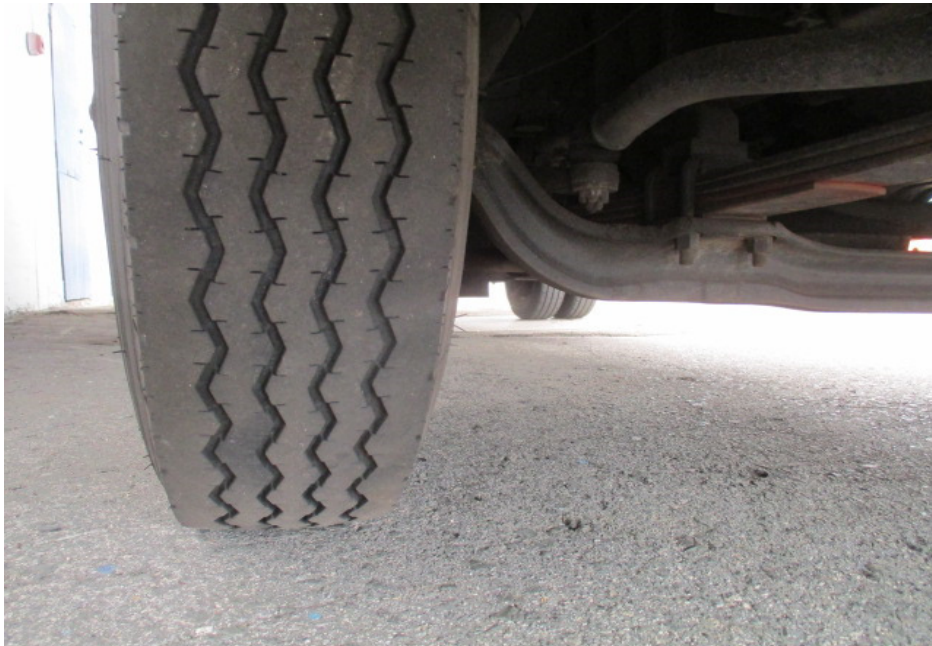
Photo 5 shows the condition of the front right tyre of the Motor Lorry, which was observed to be in serviceable condition with remaining tread depth of approximately 5mm. The tyre, which was wrapped around standard alloy wheel rim, was also observed to be sufficiently inflated for vehicular operation.

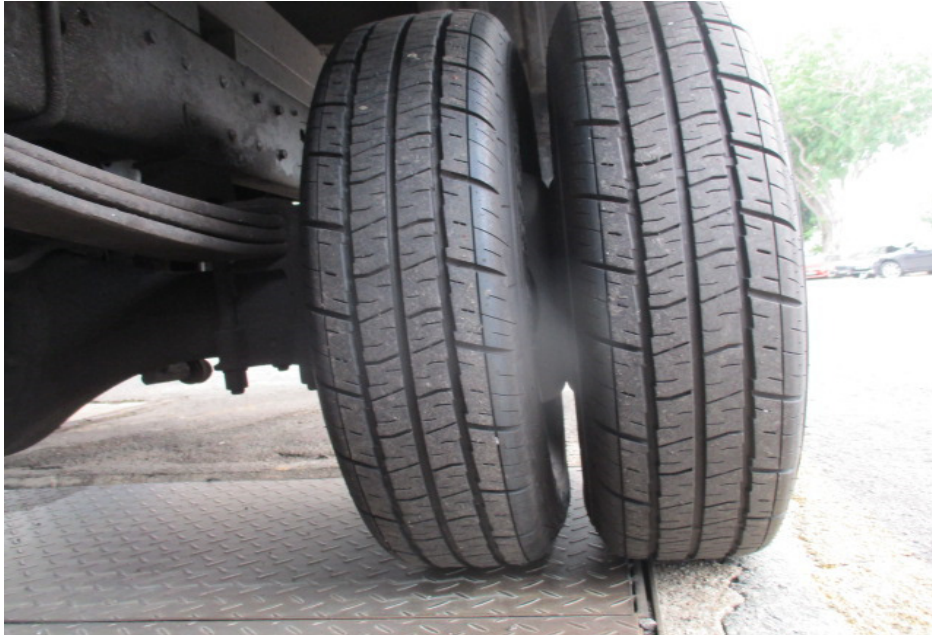
Photo 6 shows the condition of the rear left tyres of the Motor Lorry, which was observed to be in serviceable condition with remaining tread depth of approximately 5mm and 6mm. The tyres, which were wrapped around standard alloy wheel rim, were also observed to be sufficiently inflated for vehicular operation. There was also no damage found on all 6 alloy wheel rims of the Motor Lorry.

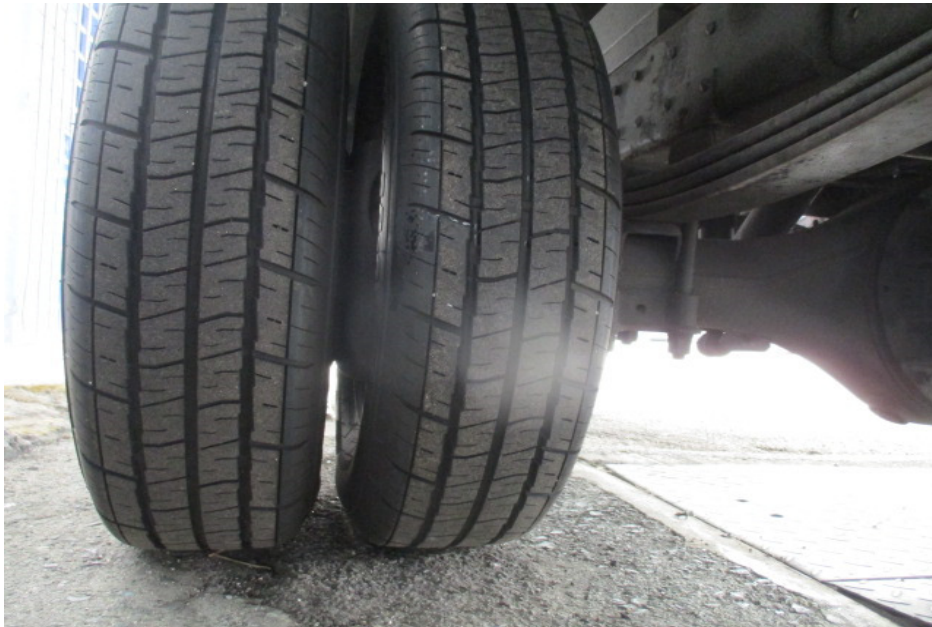
Photo 7 shows the condition of the rear right tyres of the Motor Lorry, which were observed to be in serviceable condition with remaining tread depth of approximately 5mm and 6mm. There was also no tear, cut or burst mark(s) on the outer and the inner sidewalls as well as across the tread of the 6 tyres that were fitted on the Motor Lorry.

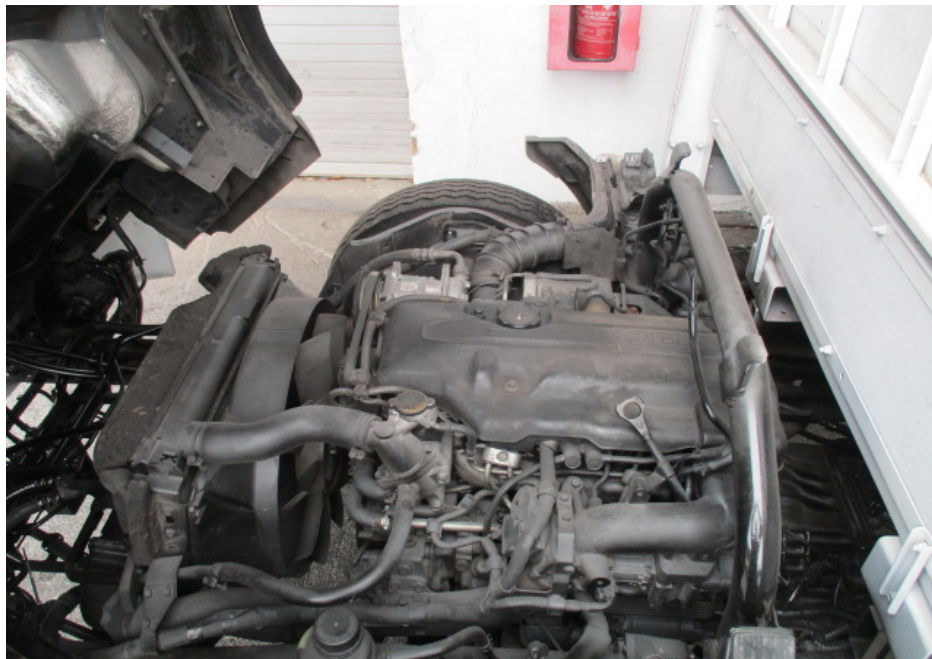
Photo 8 shows a general view of the Motor Lorry's engine compartment, which was accessed by lifting the front cabin of the Motor Lorry. The various parts and components inside the engine compartment were unaffected by the accident. There was also no sign(s) or indication(s) of fresh fluid leakage and/or fluid stain within the engine compartment (photograph shows the engine compartment as viewed from the left front side of the Motor Lorry).

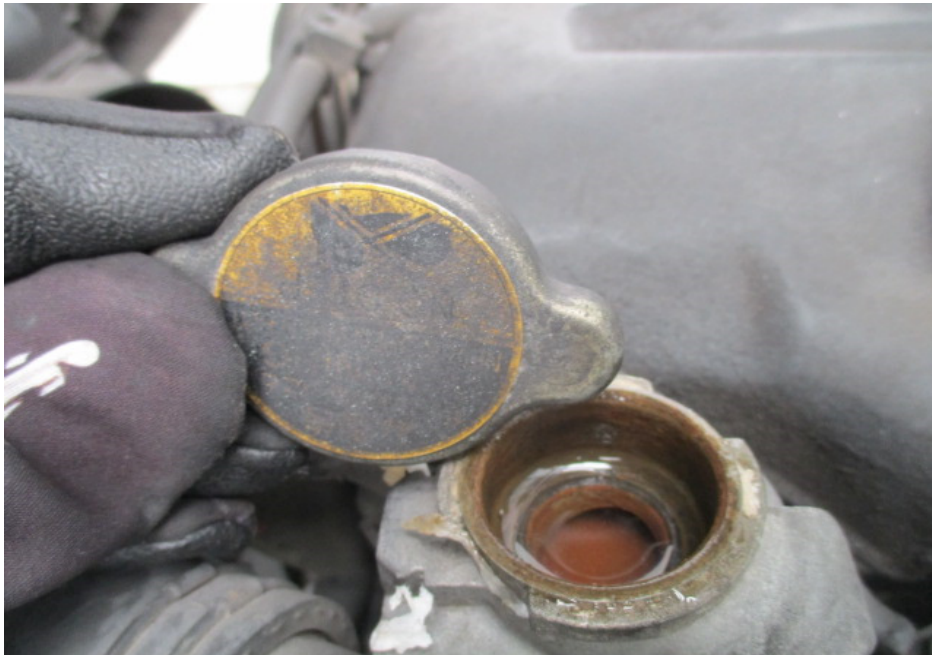
Photo 9 shows the engine coolant of the Motor Lorry at the time of our inspection. The engine coolant was observed to be of sufficient level and without any visible contamination.

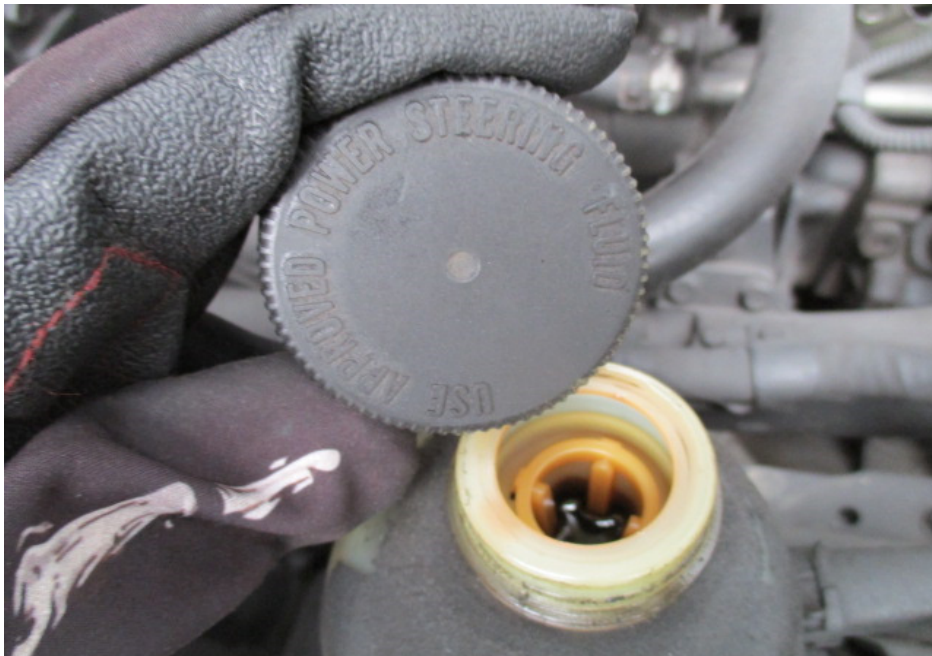
Photo 10 shows the power steering fluid reservoir of the Motor Lorry at the time of our inspection. The power steering fluid was observed to be of sufficient level and without any visible contamination.

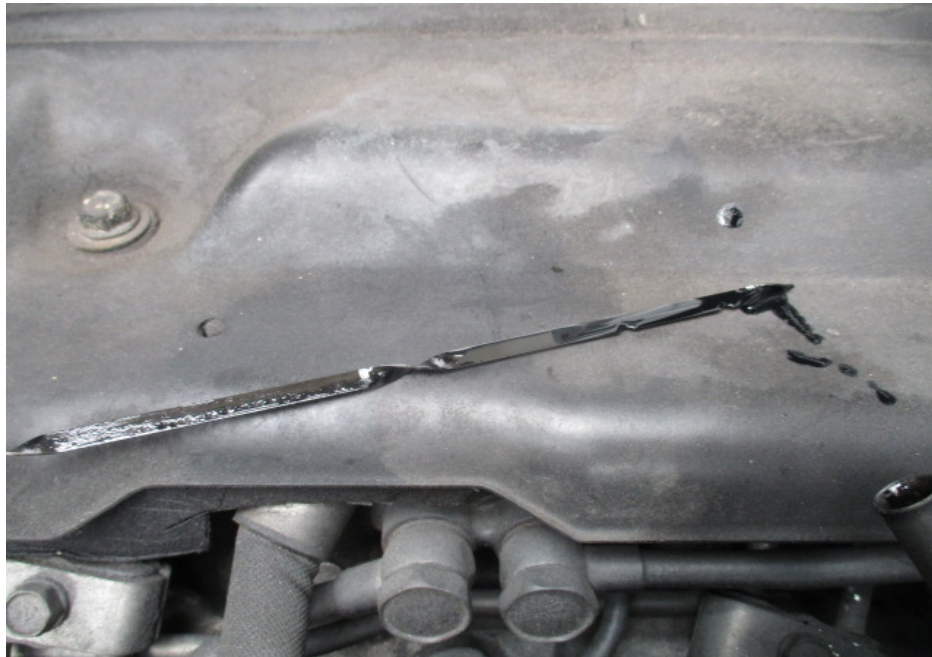
Photo 11 shows the engine dip stick of the Motor Lorry at the time of our inspection. The engine oil was observed to be of sufficient level and without any visible contamination.

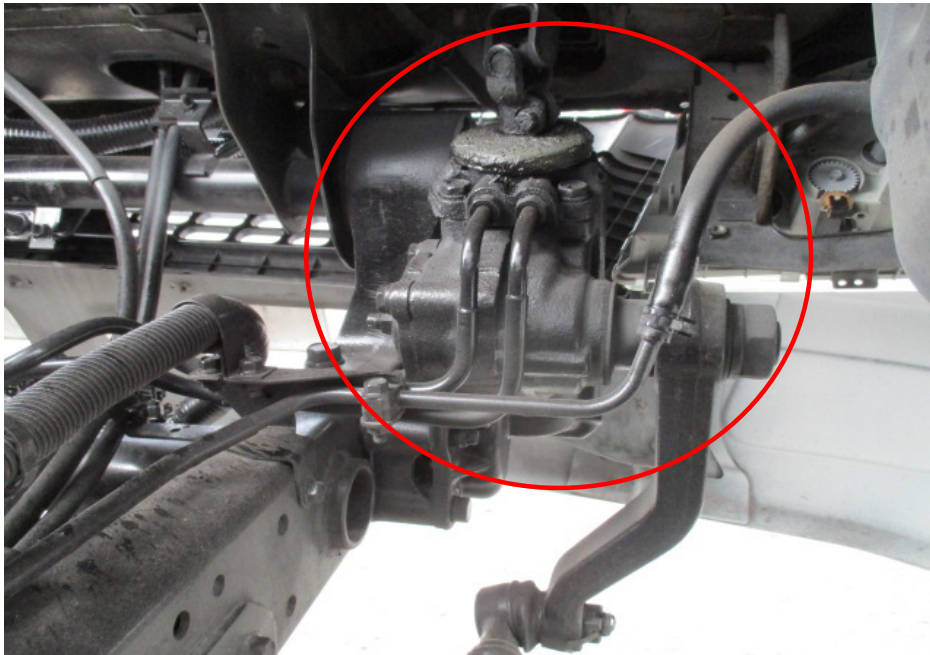
12. Static brake tests conducted on the Motor Lorry revealed no abnormality. The brake booster had responded well to the various tests conducted. There was also no abnormal movement of the brake pedal when it was depressed. In general, the static brake tests had suggested that there was no internal leakage of pressure/vacuum in the braking system of the Motor Lorry. The braking system of the Motor Lorry was likely to be in serviceable condition at the material time. This was also taking into consideration that the brake fluid was of sufficient level, and also that there was no sign(s) of brake fluid leakage along the brake hoses and brake pipes.

Photo 12 shows the brake master pump, brake booster and brake pipes (circled). These components, which are part of the braking system of the Motor Lorry, were all observed to be intact, with no sign(s) or indication(s) of brake fluid leakage.

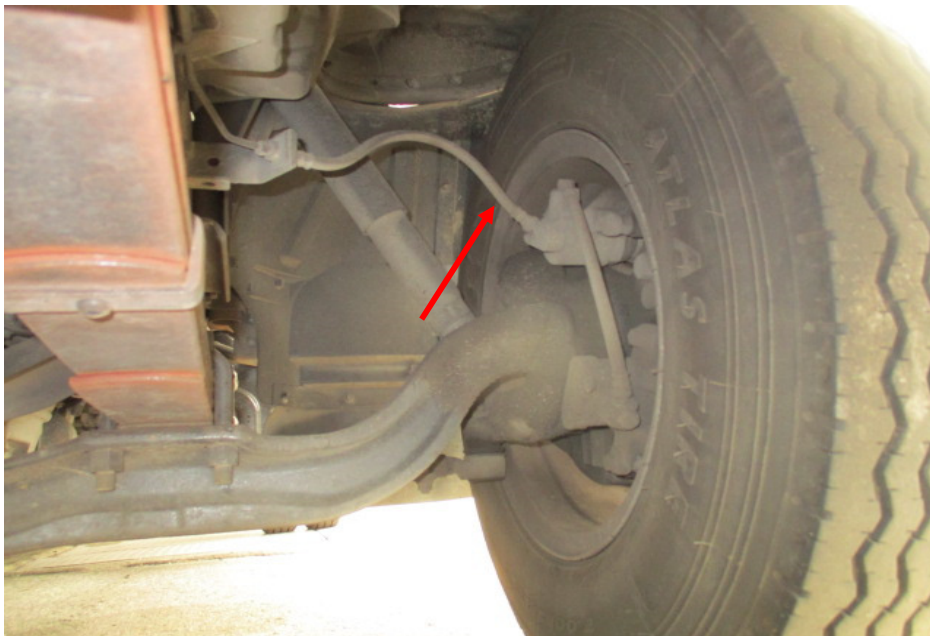
Photo 13 shows the brake pipe (arrowed) at the rear right wheel of the Motor Lorry. We did not observe any leakage of brake fluid at the time of our inspection of the Motor Lorry. Our static tests of the Motor Lorry's braking system, along with our visual examination of the various mechanical components in the braking system, had indicated that there was no internal leakage of pressure/vacuum. Hence the braking system of the Motor Lorry was likely to be in serviceable condition at the material time of accident.

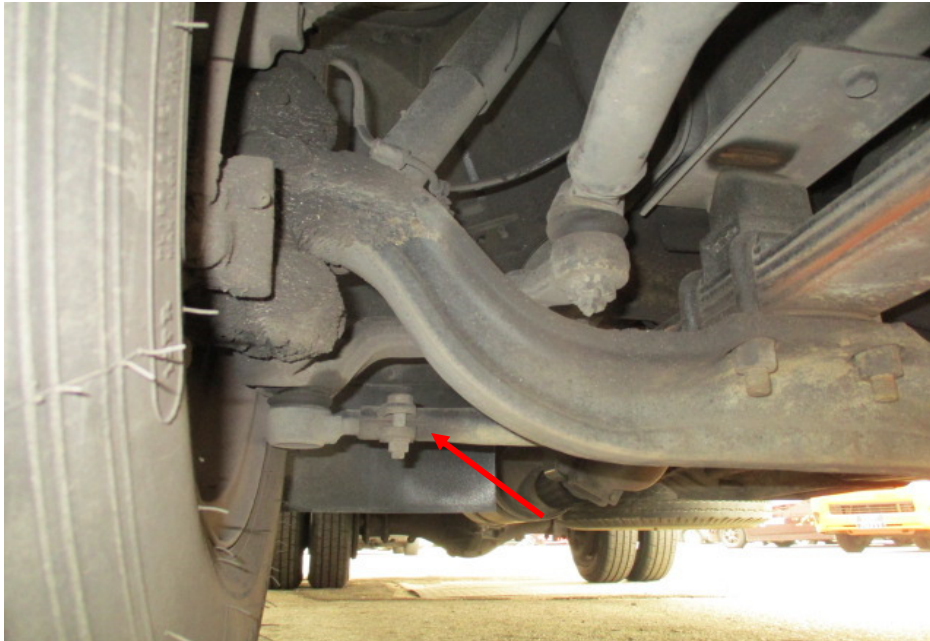
Photo 16 shows the various undercarriage components at the front right wheel of the Motor Lorry, in particular the steering tie rod end (arrowed). The various steering components were all found to be intact, suggesting that the steering system of the Motor Lorry was likely to be in serviceable condition at the material time of accident. There was also no sign of fluid stain(s) observed on the various undercarriage components.

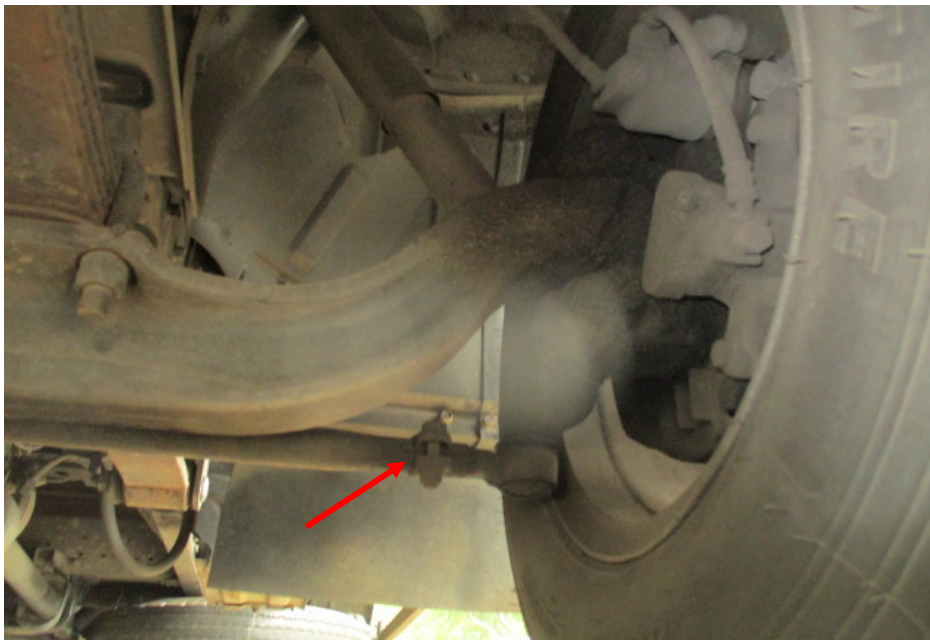
Photo 17 shows the various undercarriage components at the front left wheel of the Motor Lorry, in particular the steering tie rod end (arrowed). The various undercarriage components of the Motor Lorry were all found to be intact without any visible damage. There was also no sign of fluid stain(s) observed on the various undercarriage components.

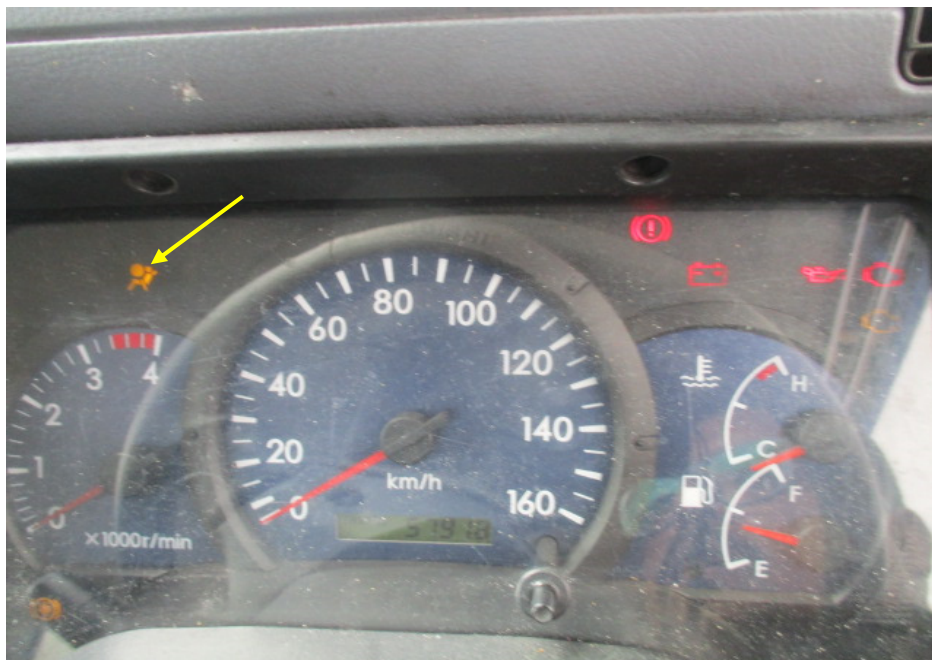
14. The Motor Lorry's automatic self-test of the functionality of its various electronic operating systems like the Supplemental Restraint System (SRS) during cranking of the engine had indicated that these systems were in working condition and without abnormality. This can be established from the warning lights disappearing from the instrument panel after the self-test. See photos 18 & 19 below.

Photo 18 shows the warning lights for the various electronic operating systems of the Motor Lorry appearing on its instrument panel during the self-test when the engine is cranked, in particular the SRS light (arrowed).

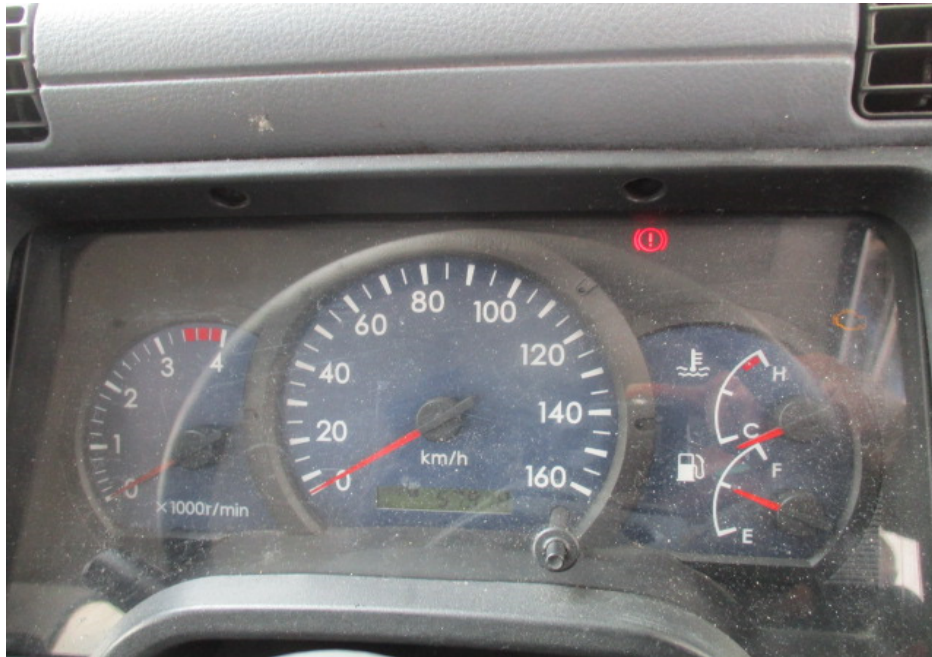
Photo 19 shows the SRS warning light was not illuminated on the instrument panel of the Motor Lorry after the engine was cranked. This would suggest that there was no abnormality to the various electronic operating systems of the Motor Lorry, like the SRS.
