Your Ref: TP/IP/42055/2019
Our Ref : CI/TPD19013963/N

Fatal Accident Investigation Team

MECHANICAL INSPECTION REPORT OF MOTOR LORRY YN 5091J

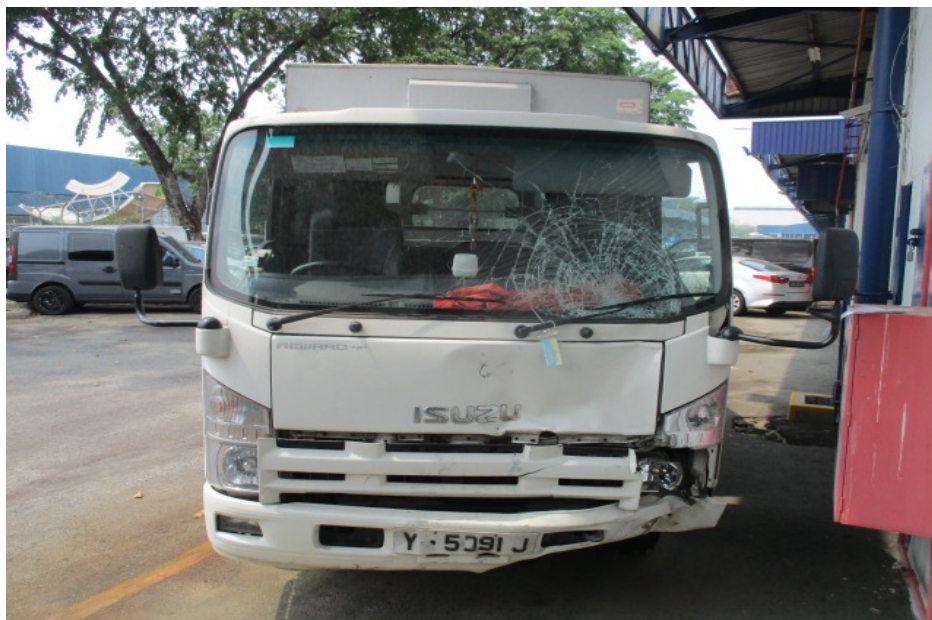
4. The mileage of the Motor Lorry at the time of our inspection was 148, 638km.
5. The Motor Lorry had sustained relatively moderate impact damage that was confined to its frontal portion. Its front bumper was observed to be dislodged; its front bonnet as well as front panel was observed to have been dented; its front windscreen was observed to be shattered while its left headlight was observed to be cracked.

Photo 1 shows a general view of the front body of the Motor Lorry at the time of our inspection. The Motor Lorry had sustained relatively moderate impact damage that was confined to its frontal portion. Its front bumper was observed to be dislodged; its front bonnet as well as front panel was observed to have been dented, its front windscreen was observed to be shattered while its left headlight was observed to be cracked. The mileage of the Motor Lorry at the time of our inspection was 148, 638km.

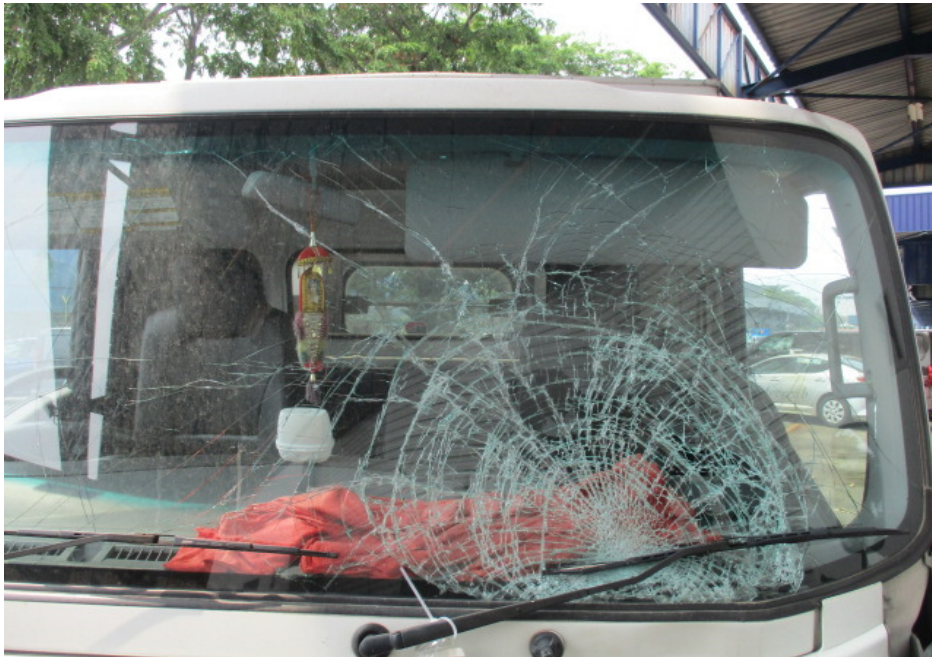
Photo 2 shows a closer view of the shattered front windscreen of the Motor Lorry at the time of our inspection.

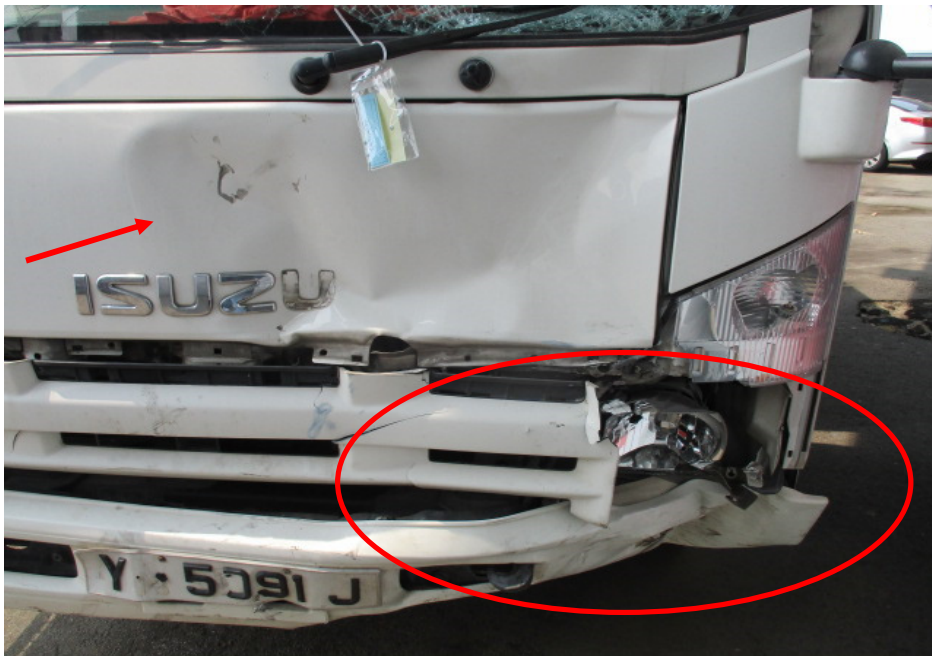
Photo 3 shows a closer view of the deformed front bumper and cracked left headlight (circled) as well as the dented front panel (arrowed) of the Motor Lorry at the time of our inspection.

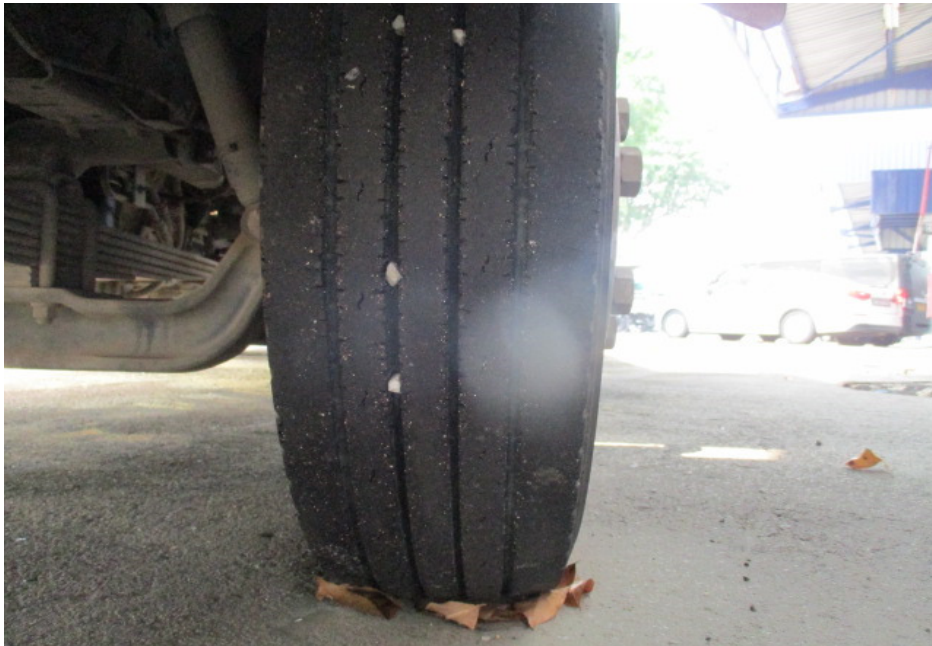
Photo 4 shows the condition of the front left tyre of the Motor Lorry, which was observed to be in serviceable condition with remaining tread depth of approximately 6mm. The tyre, which was wrapped around standard alloy wheel rim, was also observed to be sufficiently inflated for vehicular operation. There was no tear, cut or burst mark(s) on the outer and the inner sidewalls as well as across the tread of the 6 tyres that were fitted on the Motor Lorry.

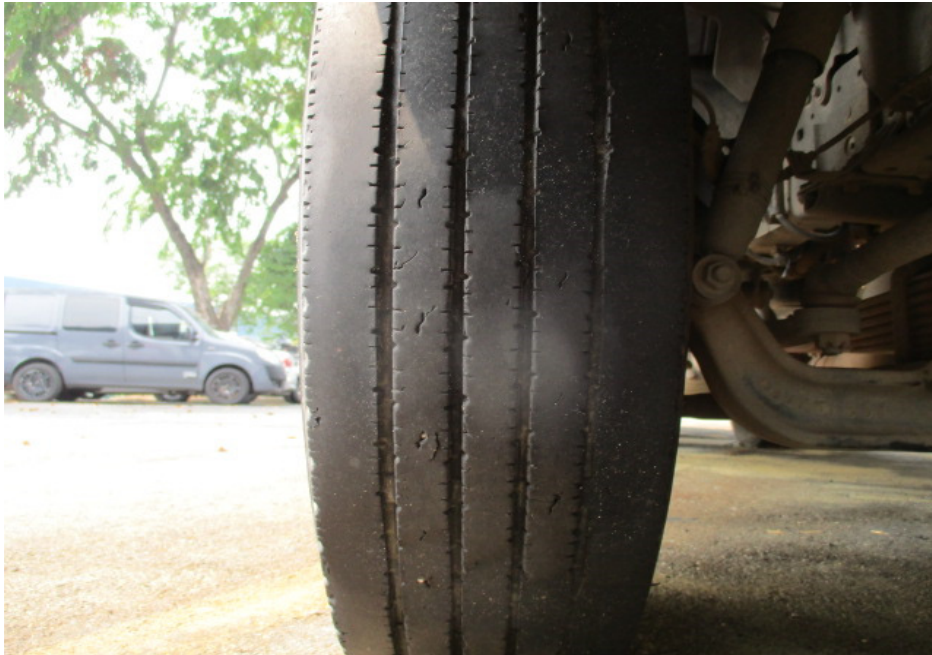
Photo 5 shows the condition of the front right tyre of the Motor Lorry, which was observed to be in serviceable condition with remaining tread depth of approximately 6mm. The tyre, which was wrapped around standard alloy wheel rim, was also observed to be sufficiently inflated for vehicular operation.

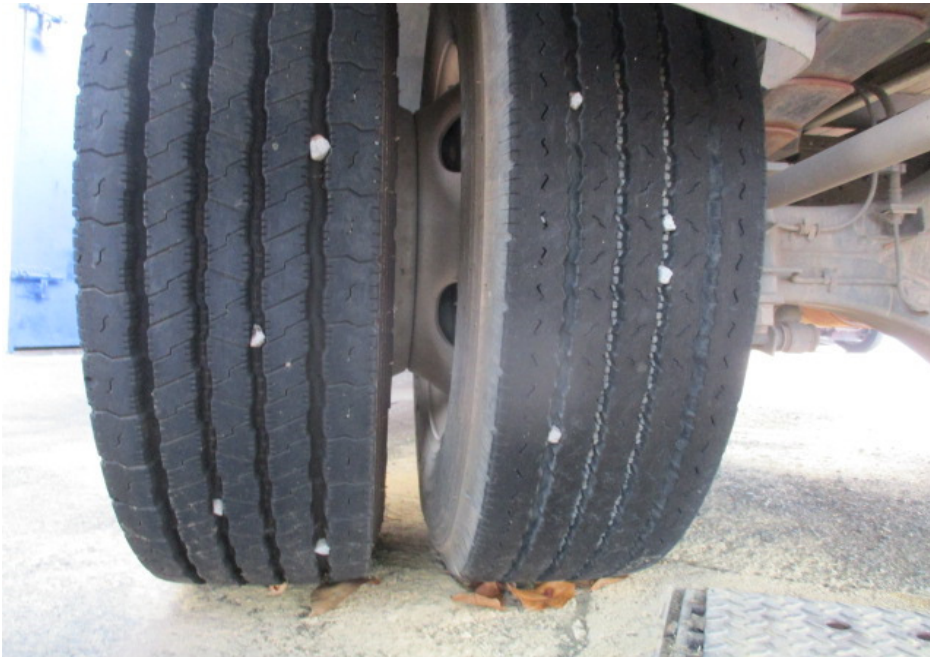
Photo 6 shows the condition of the rear left tyres of the Motor Lorry, which was observed to be in serviceable condition with remaining tread depth of approximately 11mm. The tyres, which were wrapped around standard alloy wheel rim, were also observed to be sufficiently inflated for vehicular operation. There was also no damage found on all 6 alloy wheel rims of the Motor Lorry.

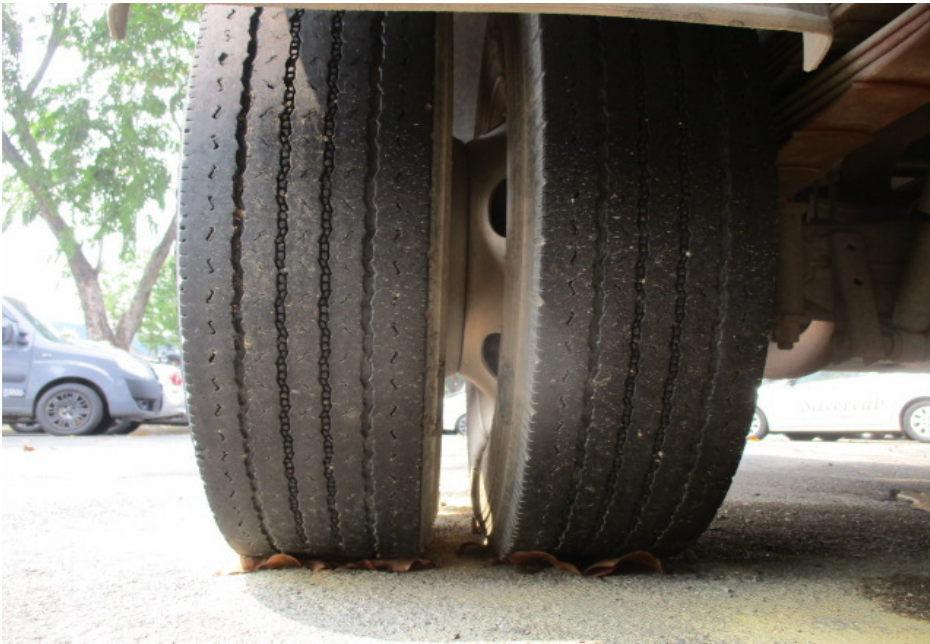
Photo 7 shows the condition of the rear right tyres of the Motor Lorry, which were observed to be in serviceable condition with remaining tread depth of approximately 5mm. There was also no tear, cut or burst mark(s) on the outer and the inner sidewalls as well as across the tread of the 6 tyres that were fitted on the Motor Lorry.

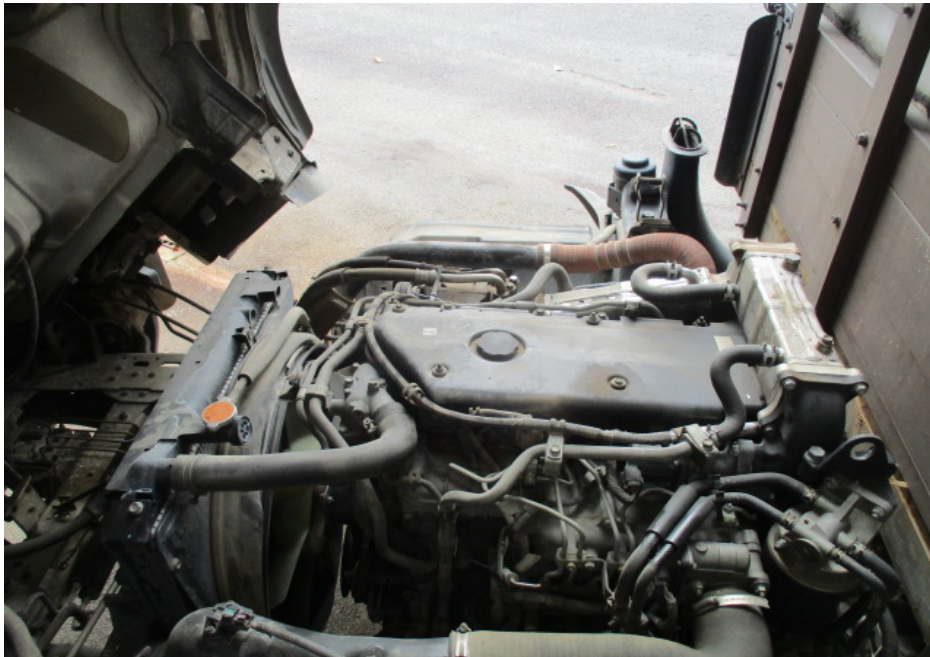
Photo 8 shows a general view of the Motor Lorry's engine compartment, which was accessed by lifting the front cabin of the Motor Lorry. The various parts and components inside the engine compartment were unaffected by the accident. There was also no sign(s) or indication(s) of fresh fluid leakage and/or fluid stain within the engine compartment (photograph shows the engine compartment as viewed from the left front side of the Motor Lorry).

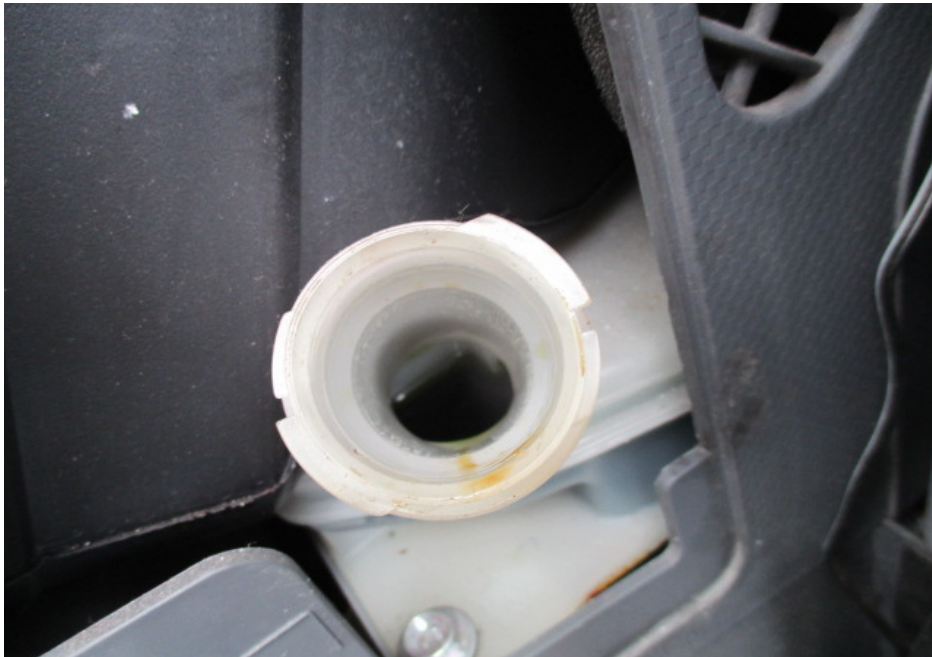
Photo 9 shows the brake fluid reservoir of the Motor Lorry at the time of our inspection. The brake fluid was observed to be of sufficient level and without any visible contamination.

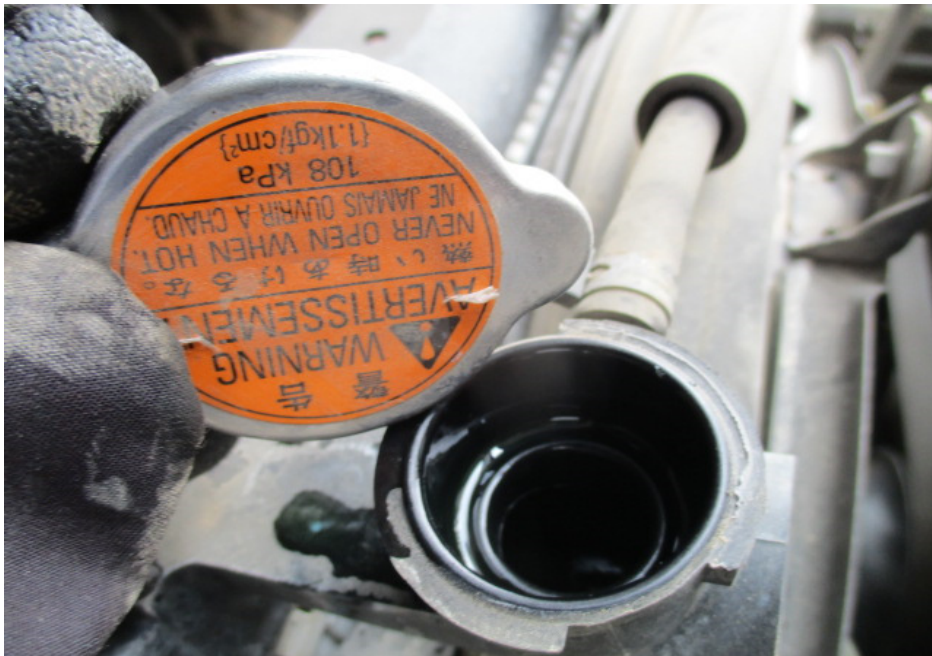
Photo 10 shows the engine coolant of the Motor Lorry at the time of our inspection. The engine coolant was observed to be of sufficient level and without any visible contamination.

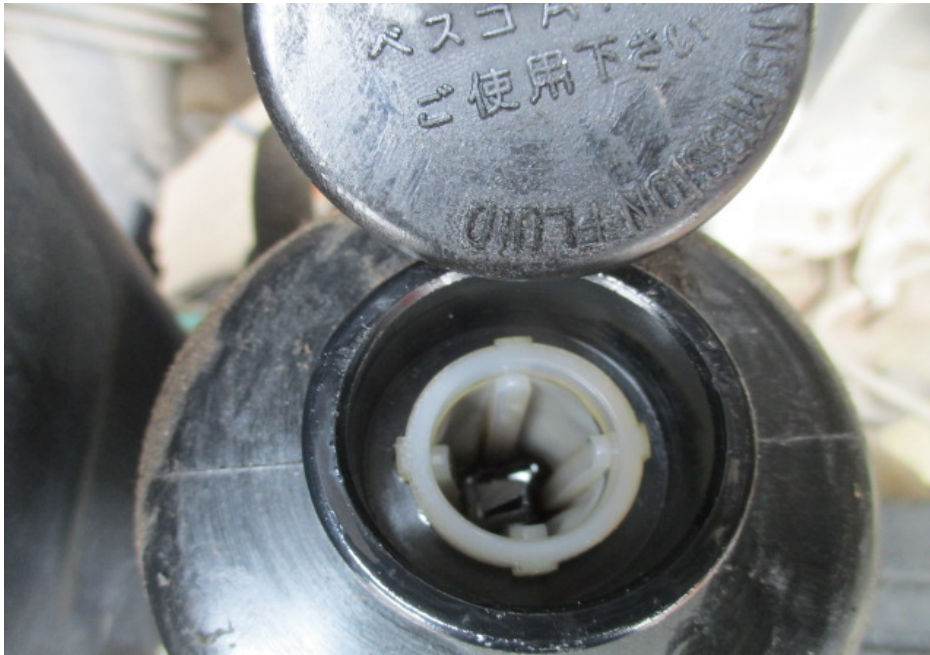
Photo 11 shows the auto transmission fluid (ATF) reservoir of the Motor Lorry at the time of our inspection. The power steering fluid was observed to be of sufficient level and without any visible contamination.

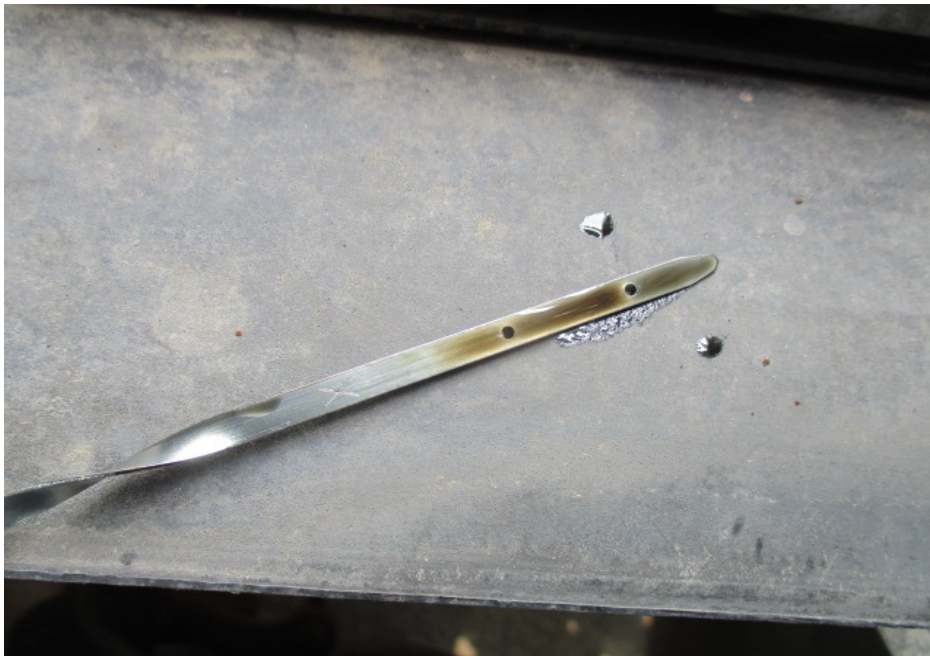
Photo 12 shows the engine dip stick of the Motor Lorry at the time of our inspection. The engine oil was observed to be of sufficient level and without any visible contamination.

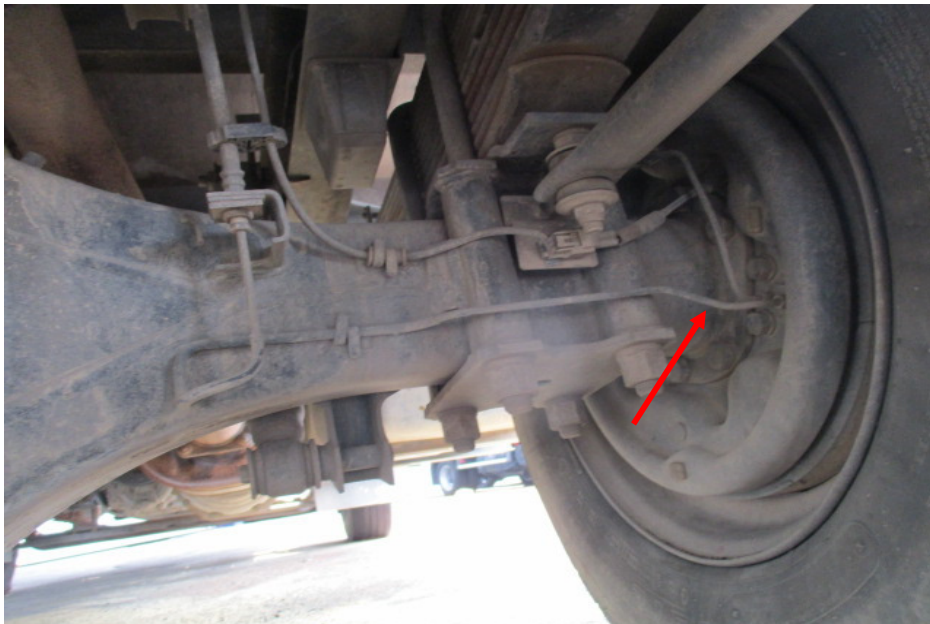
12. Static brake tests conducted on the Motor Lorry revealed no abnormality. The brake booster had responded well to the various tests conducted. There was also no abnormal movement of the brake pedal when it was depressed. In general, the static brake tests had suggested that there was no internal leakage of pressure/vacuum in the braking system of the Motor Lorry. The braking system of the Motor Lorry was likely to be in serviceable condition at the material time. This was also taking into consideration that the brake fluid was of sufficient level, and also that there was no sign(s) of brake fluid leakage along the brake hoses and brake pipes.

Photo 13 shows the brake pipe (arrowed) at the rear right wheel of the Motor Lorry. We did not observe any leakage of brake fluid at the time of our inspection of the Motor Lorry. Our static tests of the Motor Lorry's braking system, along with our visual examination of the various mechanical components in the braking system, had indicated that there was no internal leakage of pressure/vacuum. Hence the braking system of the Motor Lorry was likely to be in serviceable condition at the material time of accident.

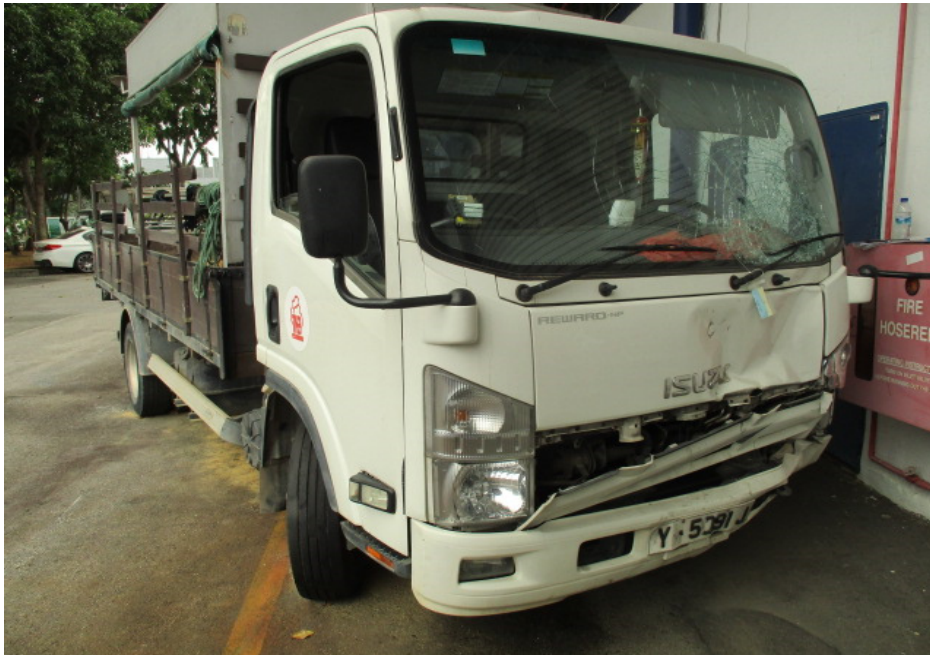
Photo 14 shows the front right wheel of the Motor Lorry turned to its full right. During our steering system test, we did not experience any abnormal free play and/or resistance when we had turned the steering wheel towards full left and full right. This would suggest that the steering system of the Motor Lorry was likely to be in serviceable condition at the material time of accident.

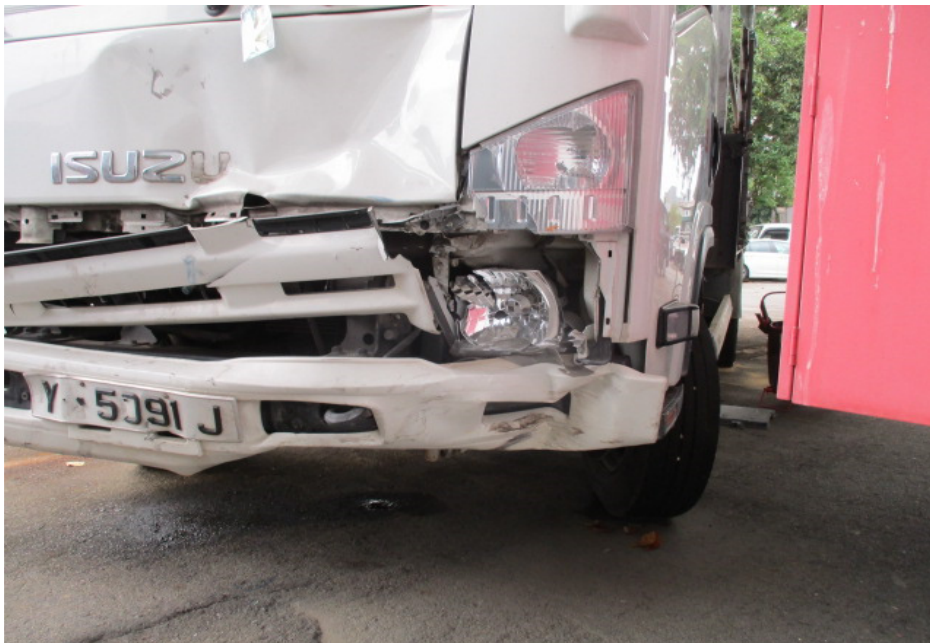
Photo 15 shows the front left wheel of the Motor Lorry turned to its full left. During our steering system test, we did not experience any abnormal free play and/or resistance when we had turned the steering wheel towards full left and full right. This would suggest that the steering system of the Motor Lorry was likely to be in serviceable condition at the material time of accident.

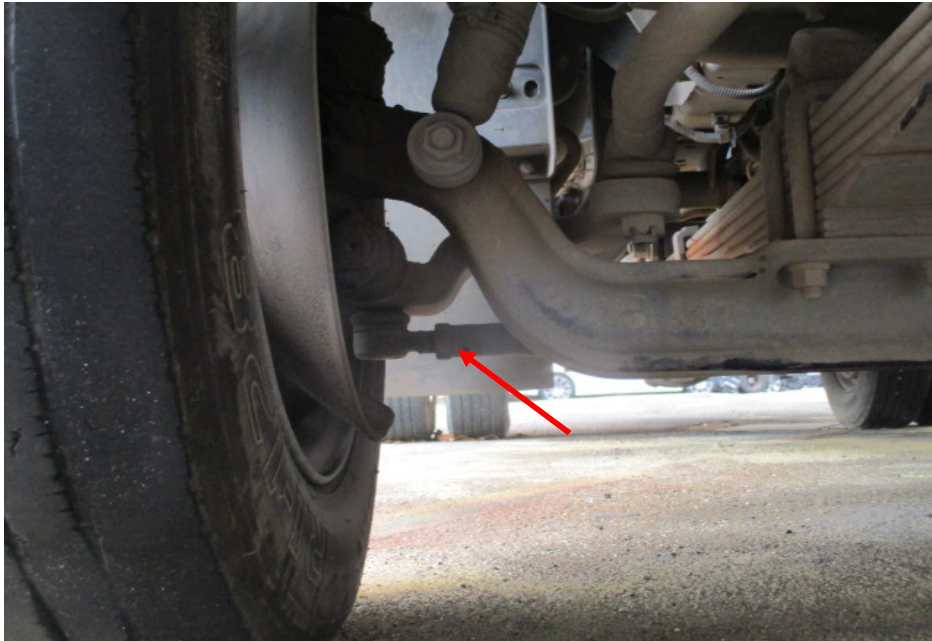
Photo 16 shows the various undercarriage components at the front right wheel of the Motor Lorry, in particular the steering tie rod end (arrowed). The various steering components were all found to be intact, suggesting that the steering system of the Motor Lorry was likely to be in serviceable condition at the material time of accident. There was also no sign of fluid stain(s) observed on the various undercarriage components.

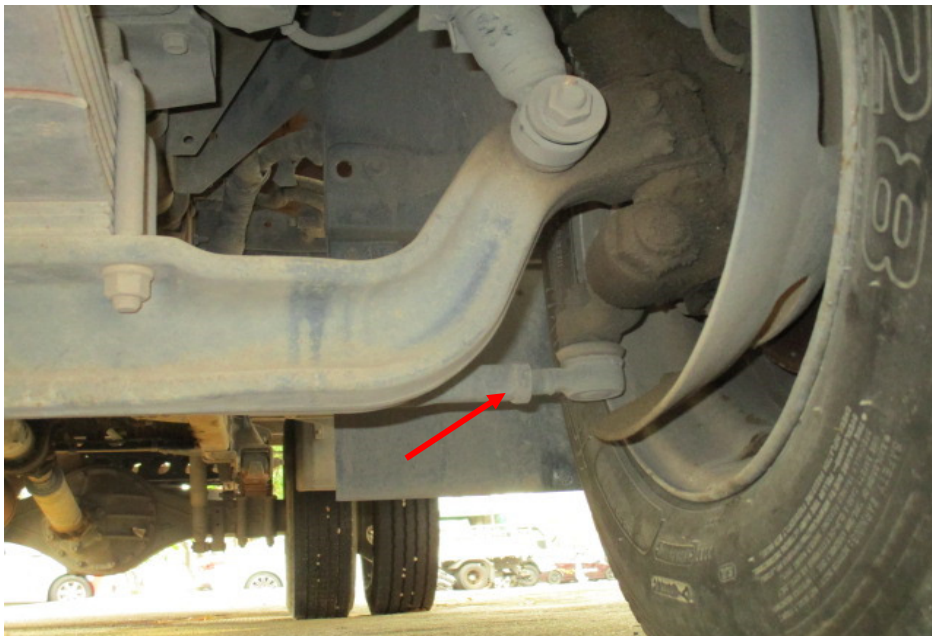
Photo 17 shows the various undercarriage components at the front left wheel of the Motor Lorry, in particular the steering tie rod end (arrowed). The various undercarriage components of the Motor Lorry were all found to be intact without any visible damage. There was also no sign of fluid stain(s) observed on the various undercarriage components.

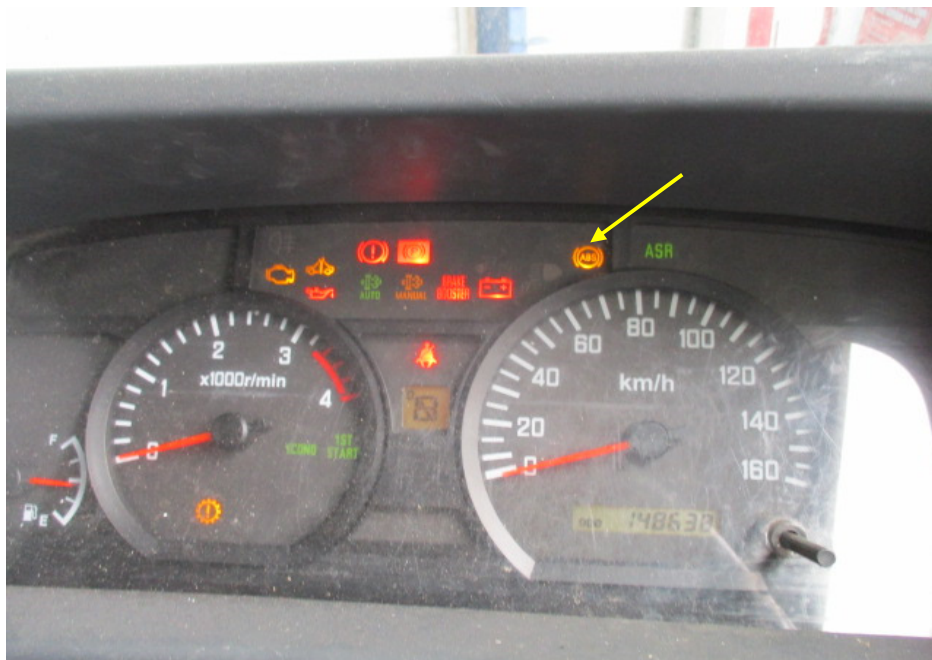
Photo 18 shows the warning lights for the various electronic operating systems of the Motor Lorry appearing on its instrument panel during the self-test when the engine is cranked, in particular the ABS light (arrowed).

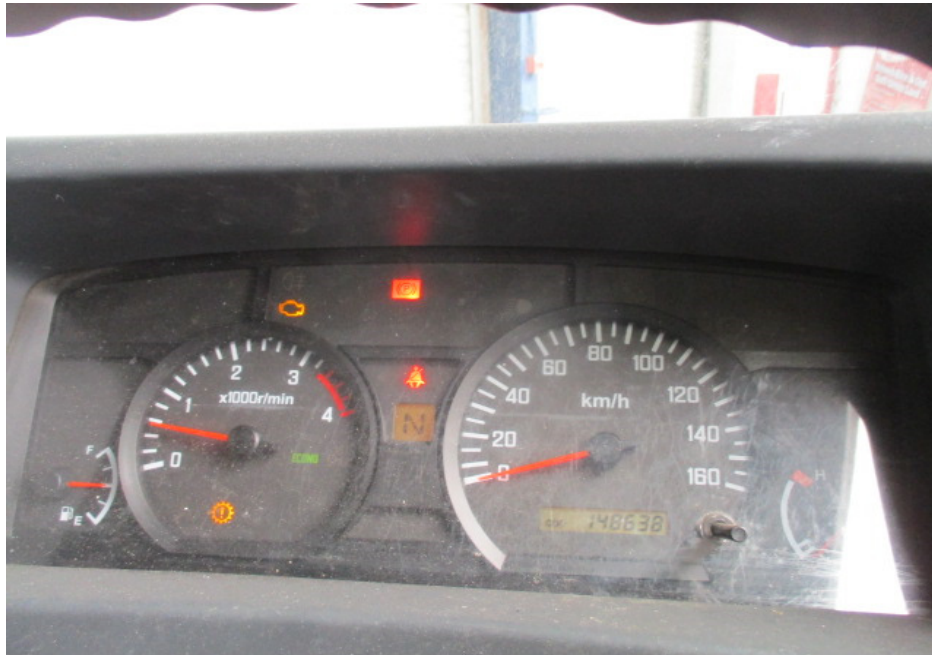
Photo 19 shows the ABS warning light was not illuminated on the instrument panel of the Motor Lorry after the engine was cranked. This would suggest that there was no abnormality to the various electronic operating systems of the Motor Lorry, like the ABS.
