Your Ref: TP/IP/44541/2019
Our Ref : CI/TPD19013964/N

Fatal Accident Investigation Team

MECHANICAL INSPECTION REPORT OF MOTOR CAR SJY 7402C

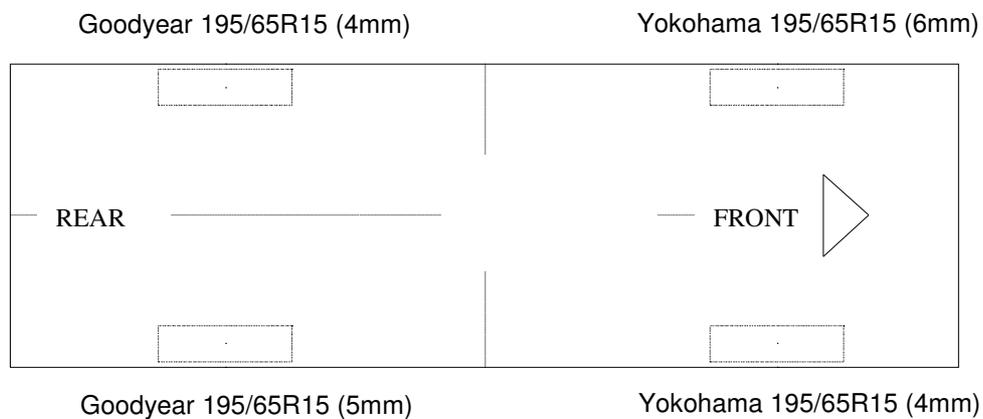
6. The condition of the Motor Car's 4 tyres was observed to be in serviceable condition. We did not find any tear, cut or burst mark(s) on the outer and the inner sidewalls as well as across the tread of the 4 tyres. The 4 tyres were also observed to be sufficiently inflated for vehicular operation. The tyre brand, tyre size and remaining tread depth of the 4 tyres were recorded as follows:-

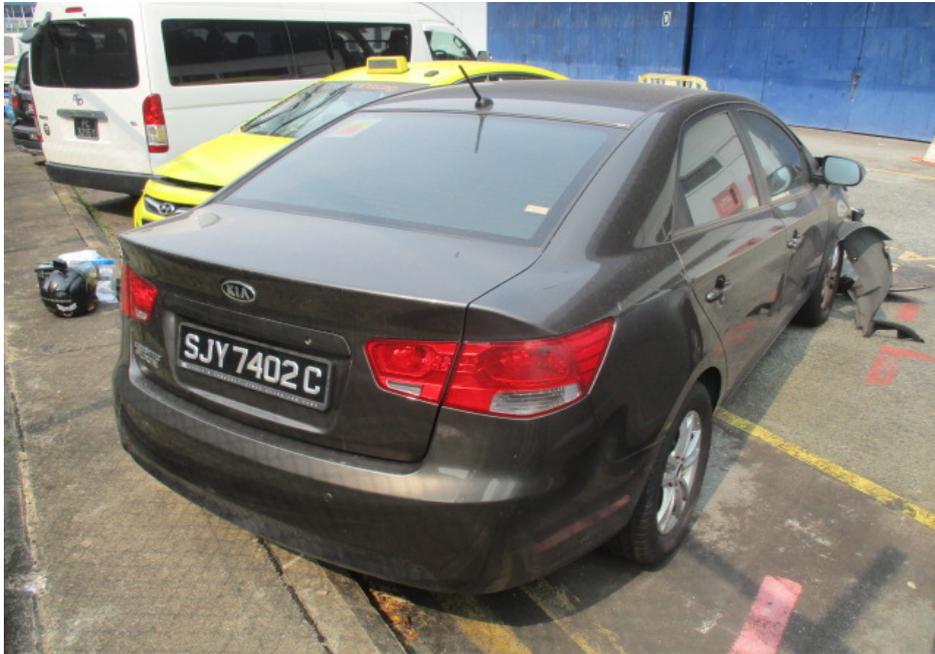
Photo 1 shows a general view of the rear portion of the Motor Car at the time of our inspection. The Motor Car was observed to be in good general condition except for some impact damage at its frontal portion and right body. The rear portion of the Motor Car was relatively unaffected by the accident. The mileage of the Motor Car was recorded to be 16, 119km.

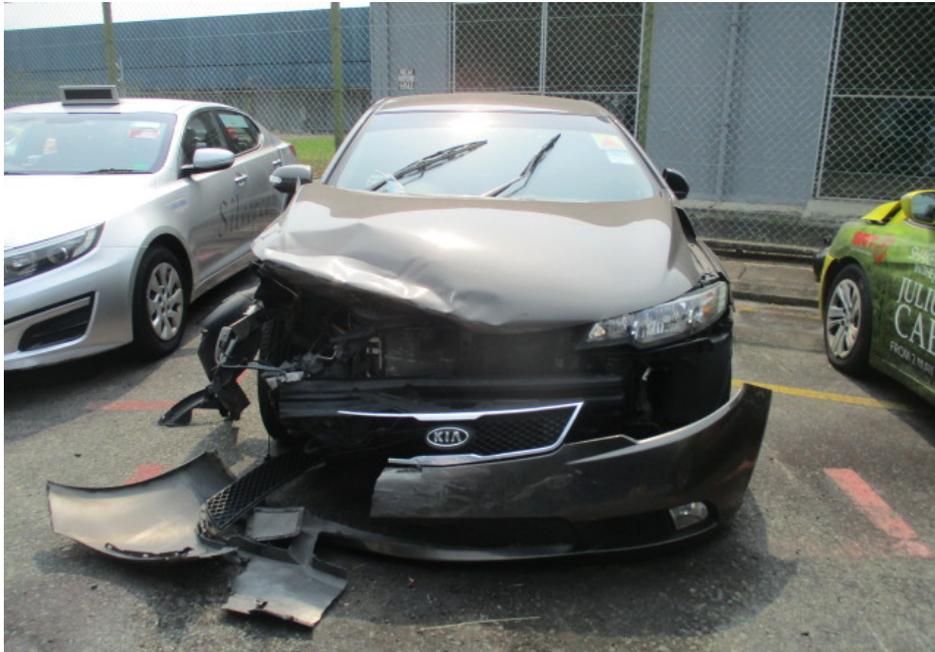
4. The mileage of the Motor Car at the time of our inspection was 16, 119km.
5. The Motor Car had sustained impact damage that was confined to its frontal portion and right body. Its front bonnet and right front fender was observed to have been dented; its front bumper was observed to have been dislodged; its front support panel and front bumper reinforcement panel was observed to be deformed; its right front fender protector was observed to be torn. The Supplementary Restraint System (SRS) airbag was deployed as a result of the accident.

Photo 2 shows a general view of the frontal portion of the Motor Car at the time of our inspection. The Motor Car was observed to be in good general condition. However we had observed impact damage that was confined to frontal portion and right body. Its front bonnet and right front fender was observed to have been dented; its front bumper was observed to have been dislodged; its front support panel and front bumper reinforcement panel was observed to be deformed; its right front fender protector was observed to be torn.

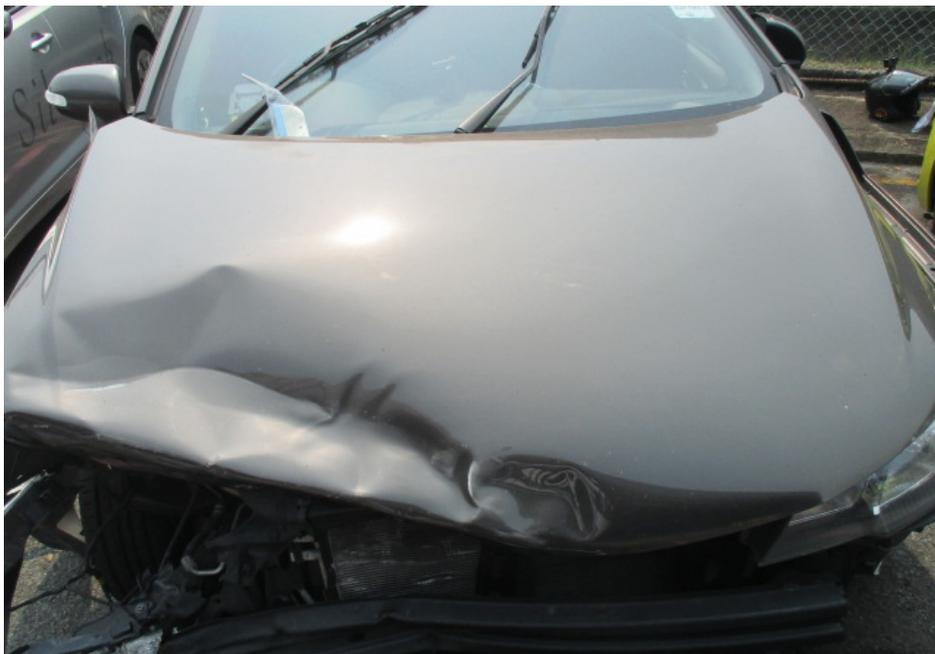
Photo 3 shows a closer view of the dented front bonnet of the Motor Car at the time of our inspection.

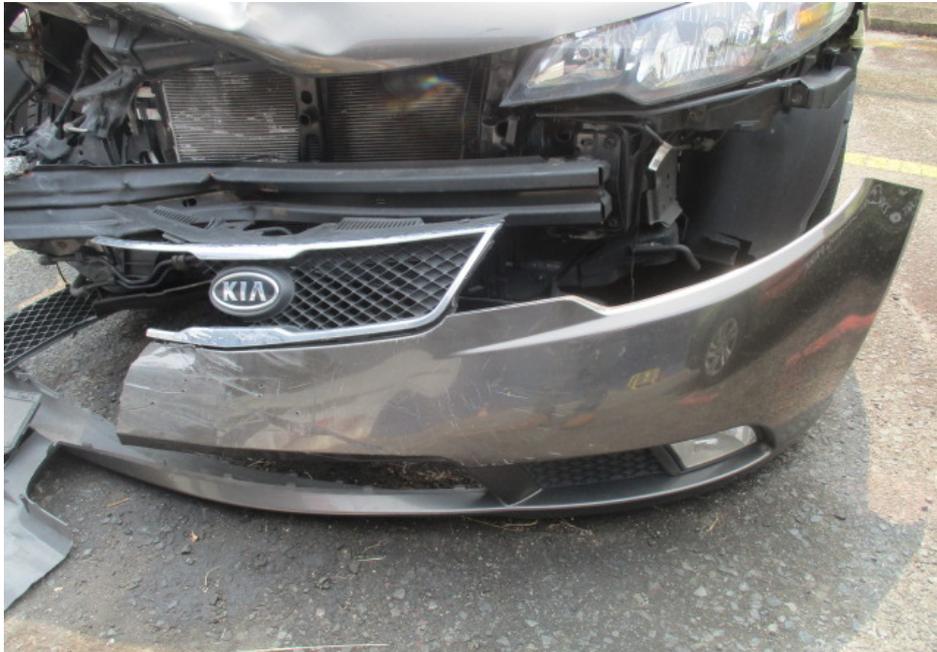
Photo 4 shows a closer view of the dislodged front bumper of the Motor Car at the time of our inspection.

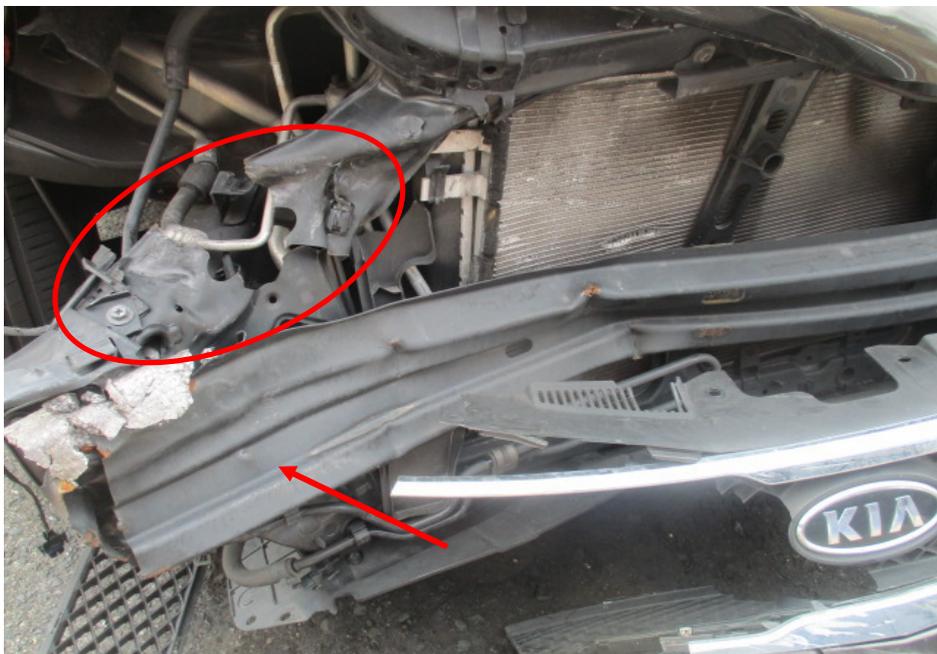
Photo 5 shows a closer view of the deformed front support panel (circled) and front bumper reinforcement panel (arrowed) of the Motor Car at the time of our inspection.

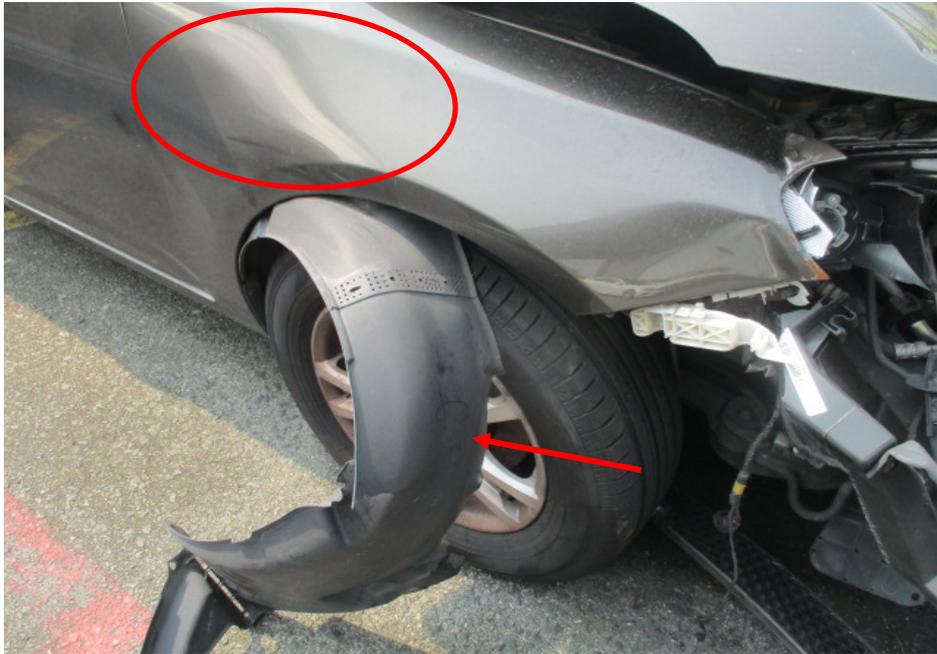
Photo 6 shows a closer view of the dented right front fender (circled) and torn right fender protector (arrowed) of the Motor Car at the time of our inspection.

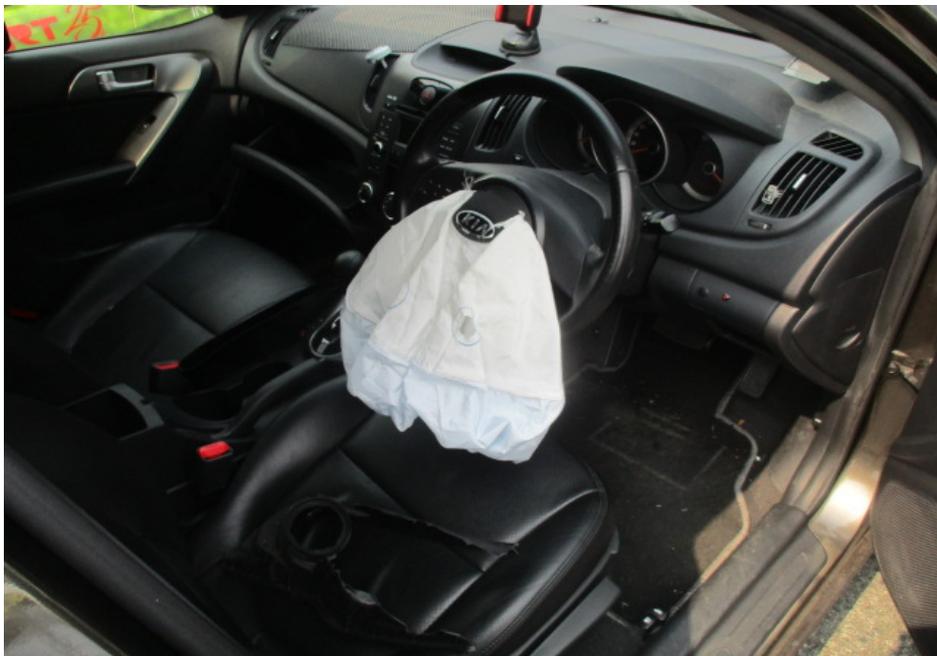
Photo 7 shows the deployed Supplementary Restraint System (SRS) airbag of the Motor Car as a result of the accident at the time of our inspection.

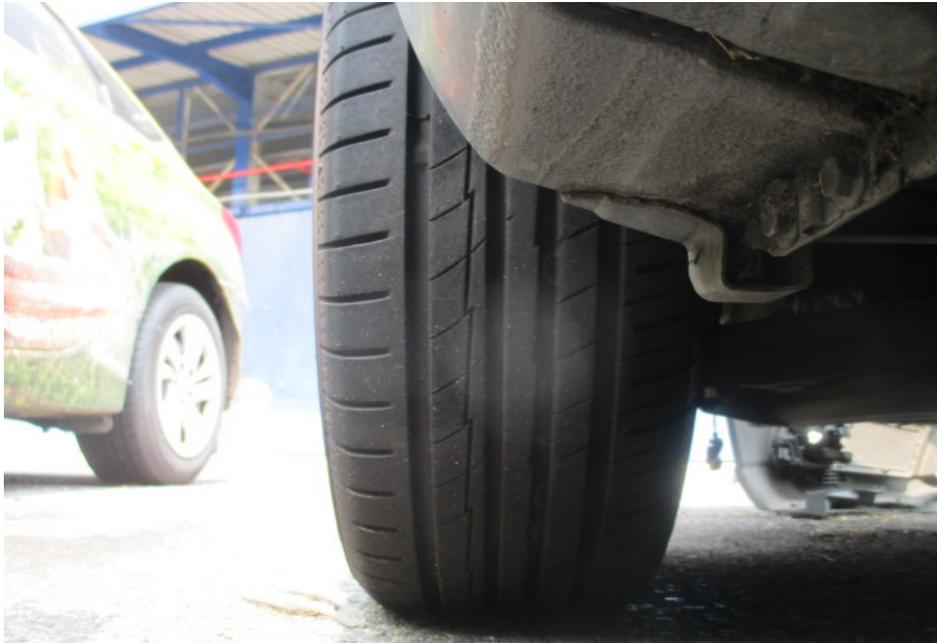
Photo 8 shows the condition of the front left tyre of the Motor Car, which was observed to be in serviceable condition with remaining tread depth of approximately 6mm. The tyre, which was wrapped around alloy wheel rim, was also observed to be sufficiently inflated for vehicular operation. There was no tear, cut or burst mark(s) on the outer and the inner sidewalls as well as across the tread of the 4 tyres.

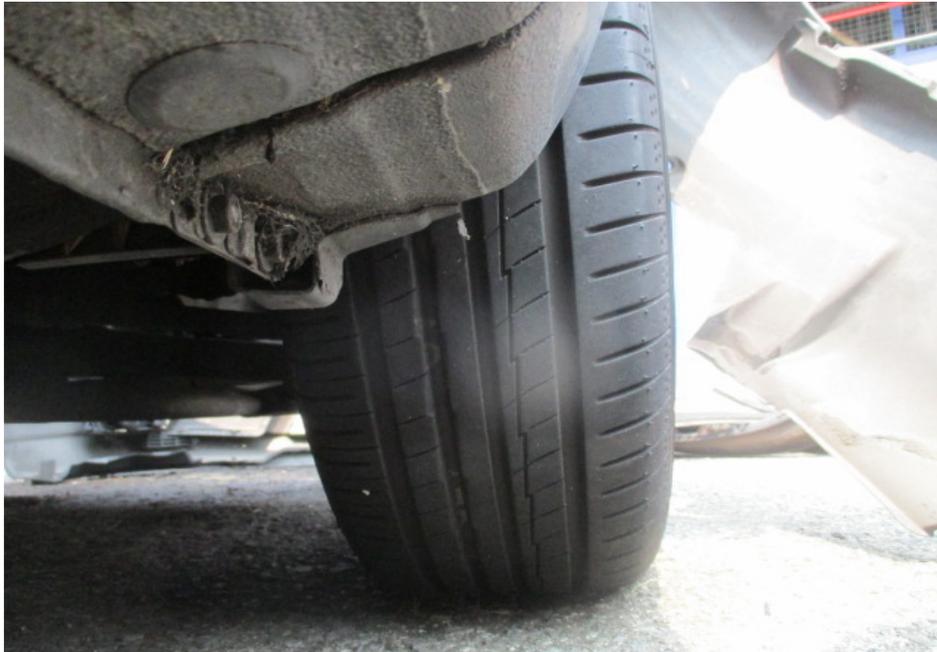
Photo 9 shows the condition of the front right tyre of the Motor Car, which was observed to be in serviceable condition with remaining tread depth of approximately 4mm. The tyre, which was wrapped around alloy wheel rim, was also observed to be sufficiently inflated for vehicular operation.

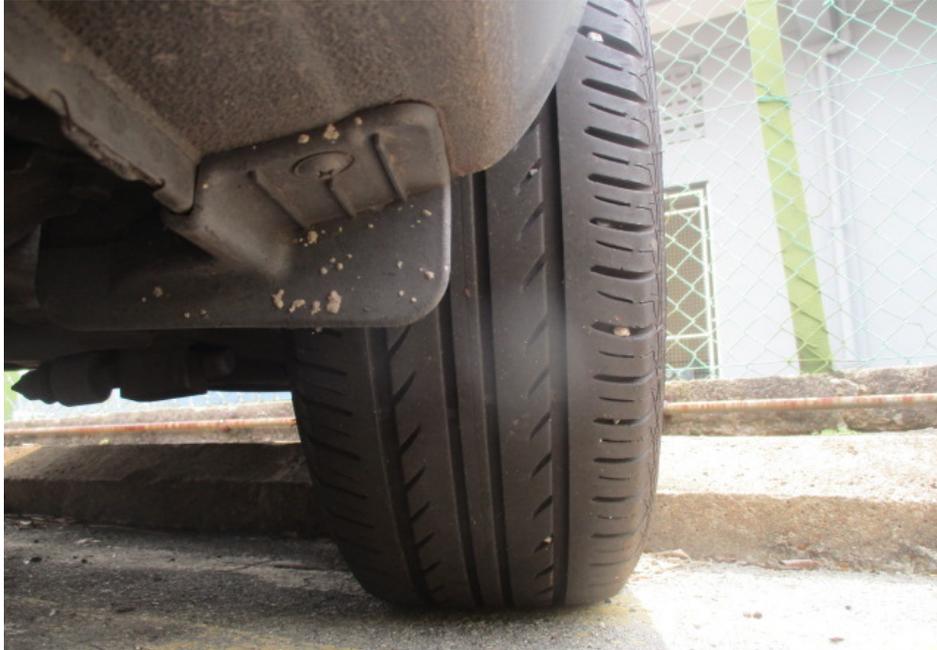
Photo 10 shows the condition of the rear left tyre of the Motor Car, which was observed to be in serviceable condition with remaining tread depth of approximately 4mm. The tyre, which was wrapped around alloy wheel rim, was also observed to be sufficiently inflated for vehicular operation. There was also no damage found on the 4 wheel rims of the Motor Car.

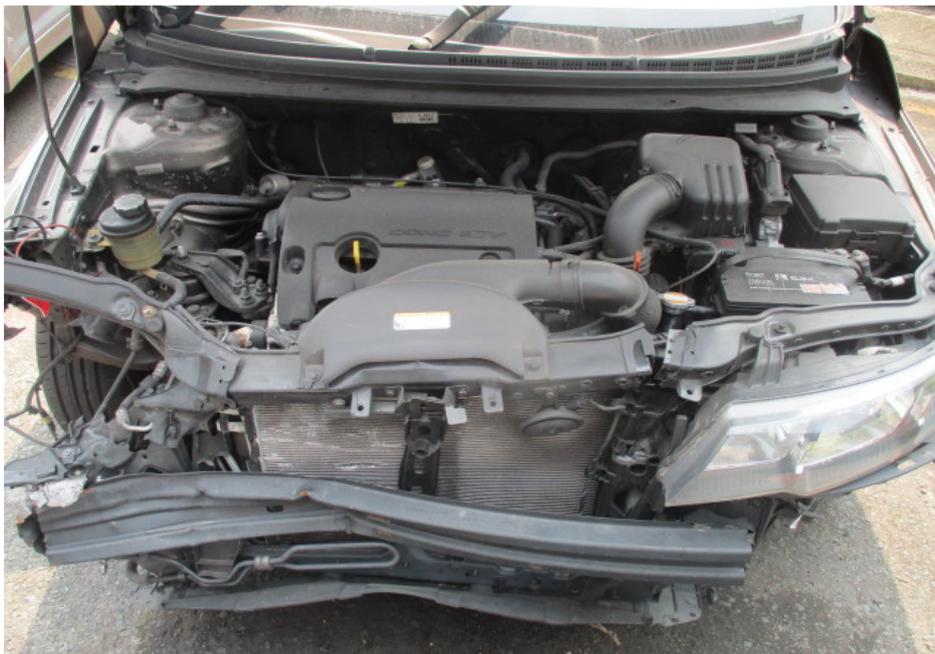
8. Upon examination of the engine compartment of the Motor Car, we had observed although the frontal portion of the engine compartment had been pushed inwards due to the impact of the accident, all the parts and components inside the engine compartment were observed to be intact and unaffected by the accident. The power steering fluid, brake fluid, engine oil, automatic transmission fluid (ATF) and engine coolant were all found to be of sufficient level for operating purposes. Visually, there was also no contamination found to these fluids.

Photo 12 shows a general view of the Motor Car's engine compartment. Upon examination of the engine compartment of the Motor Car, although the frontal portion of the engine compartment had been pushed inwards due to the impact of the accident, all the parts and components inside the engine compartment were observed to be intact and unaffected by the accident. There was also no sign(s) or indication(s) of fluid leakage and/or fluid stain within the engine compartment.

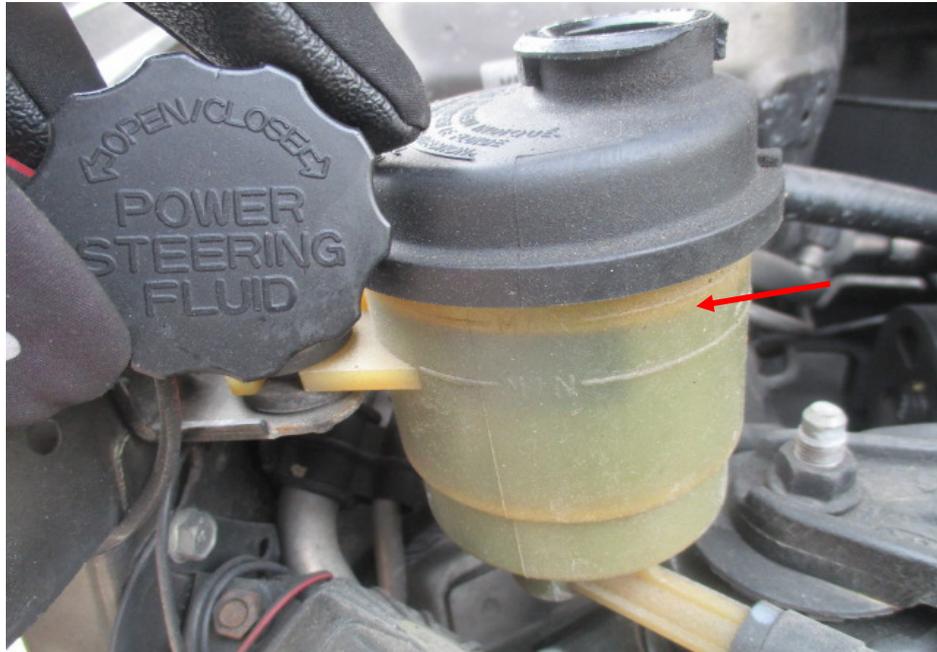
Photo 13 shows the power steering fluid reservoir of the Motor Car at the time of our inspection. The power steering fluid was observed to be of sufficient level and without any visible contamination (arrowed).

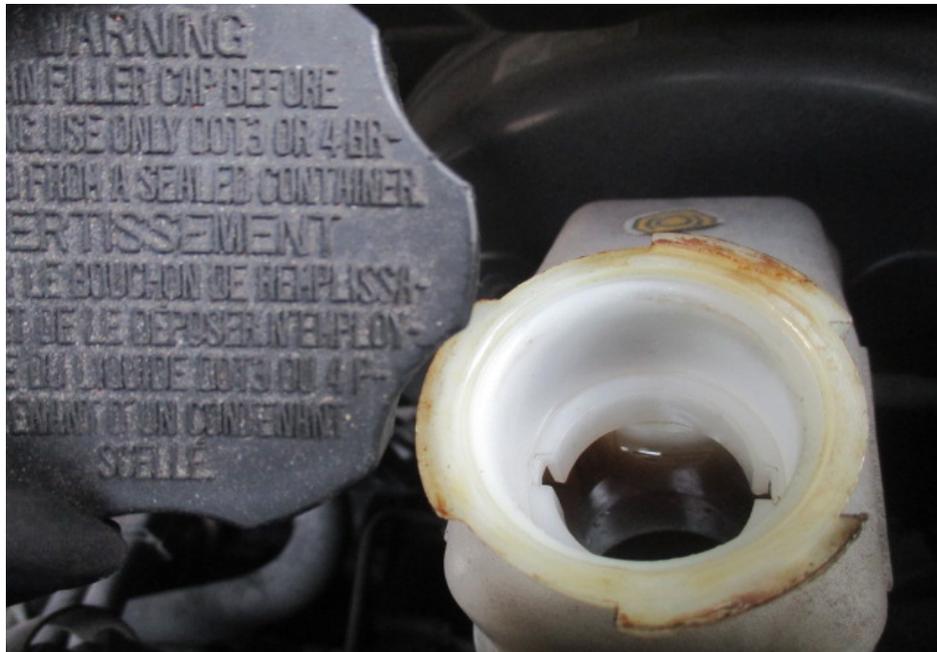
Photo 14 shows the brake fluid reservoir of the Motor Car at the time of our inspection. The brake fluid was observed to be of sufficient level and without any visible contamination.

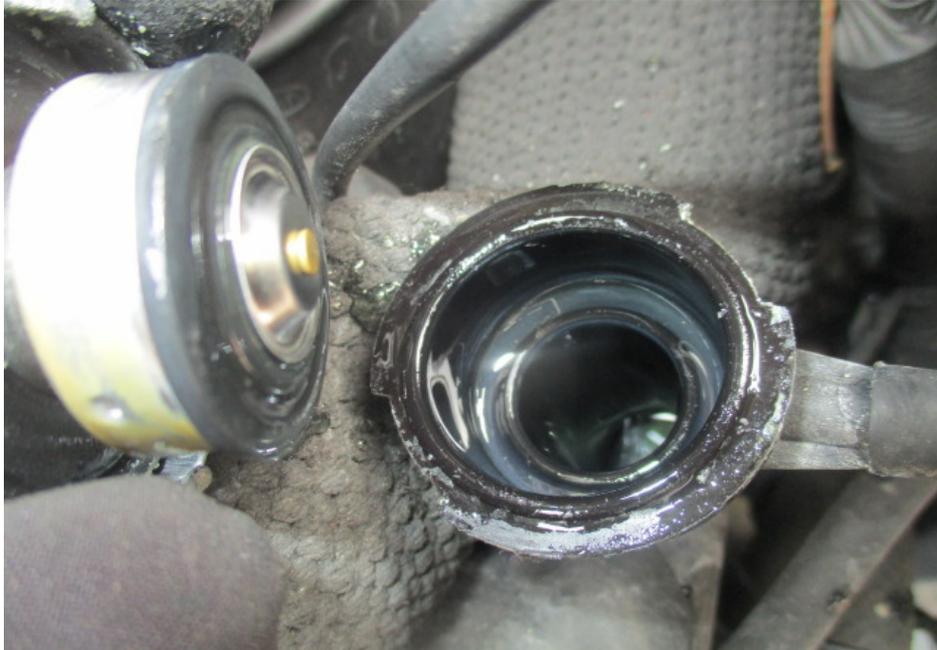
Photo 15 shows checks being carried out to the engine coolant of the Motor Car at the time of our inspection. The engine coolant was observed to be of sufficient level and without any visible contamination.

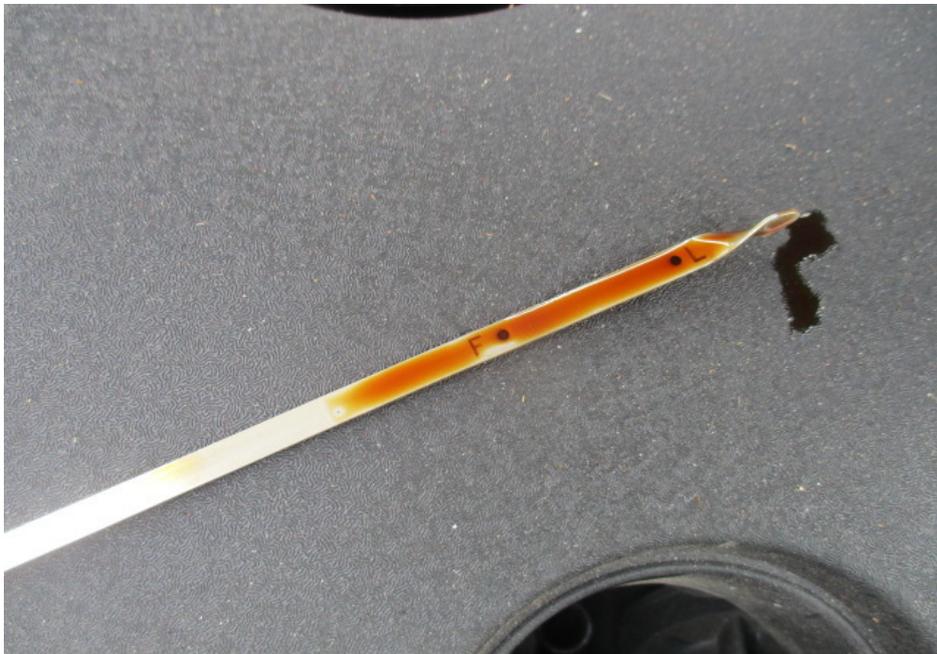
Photo 16 shows the engine oil dip stick of the Motor Car at the time of our inspection. The engine oil was observed to be of sufficient level and without any visible contamination.

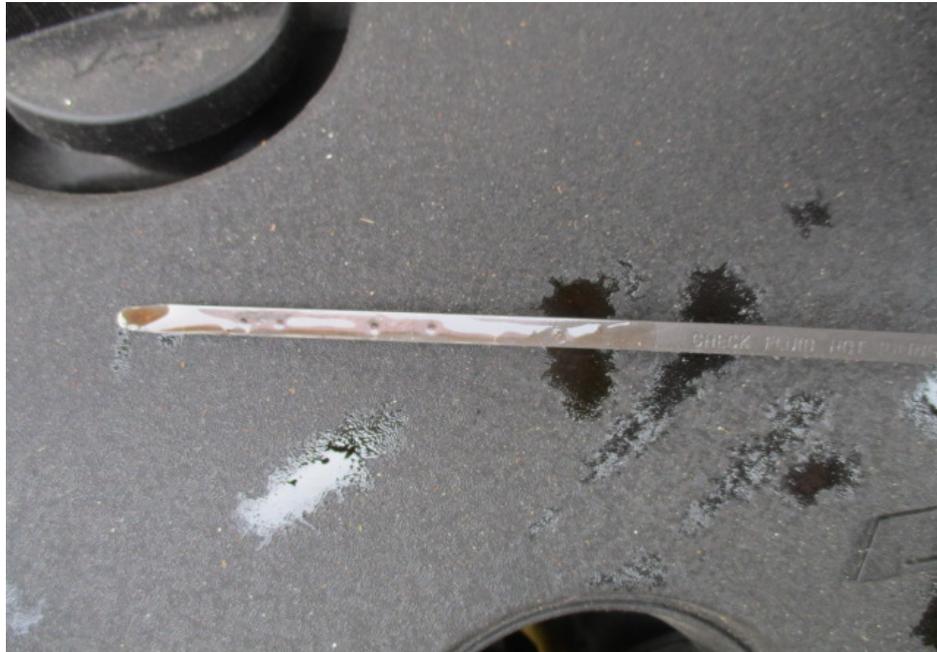
Photo 17 shows the automatic transmission fluid (ATF) dip stick of the Motor Car at the time of our inspection. The ATF was observed to be of sufficient level and without any visible contamination.

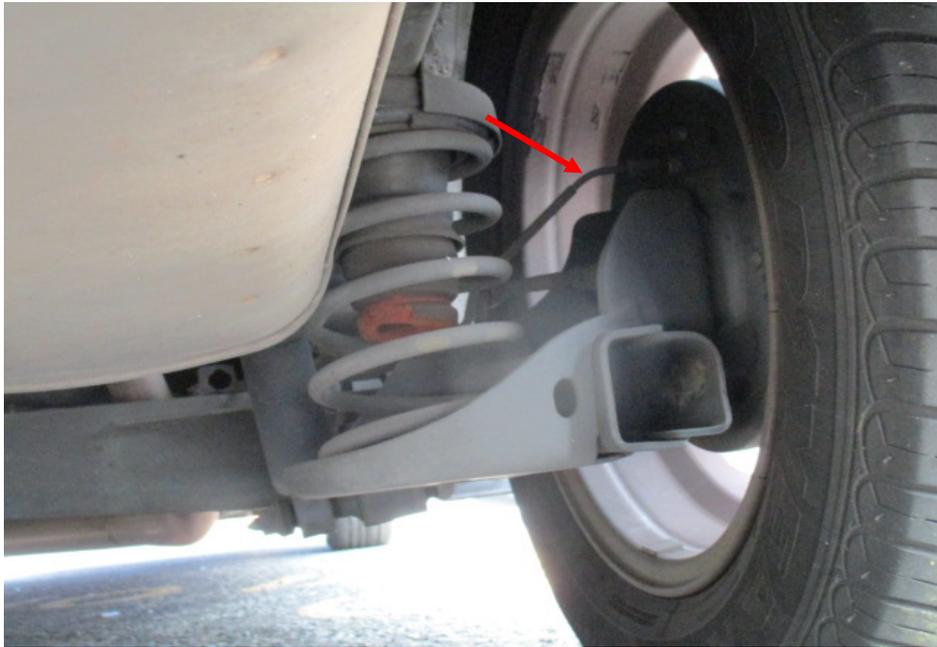
Photo 18 shows the brake hose/pipe (arrowed) at the rear right wheel of the Motor Car. We did not observe any leakage of brake fluid at the time of our inspection of the Motor Car. Static tests of the Motor Car's braking system had indicated that there was no internal leakage of pressure/vacuum. Hence the braking system was likely to be in serviceable condition at the material time of accident. The undercarriage components of the Motor Car were also all found to be intact and without any visible damage.

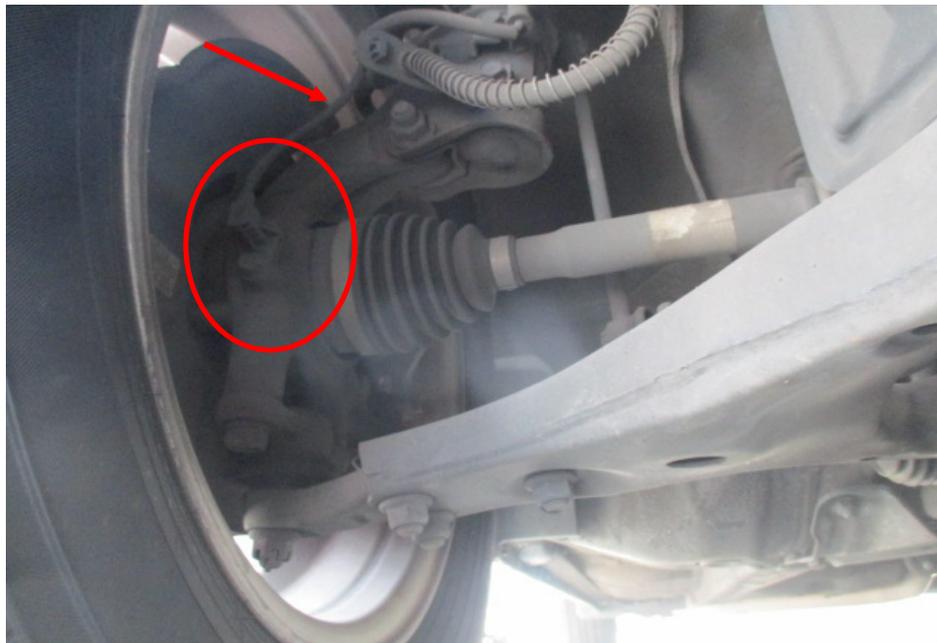
Photo 19 shows the brake hose/pipe (arrowed) at the front right wheel of the Motor Car. No leakage of brake fluid was observed. Visual examination of the various components of the braking system like the brake caliper (circled), brake pedal etc. had revealed all to be intact and without visible damage.

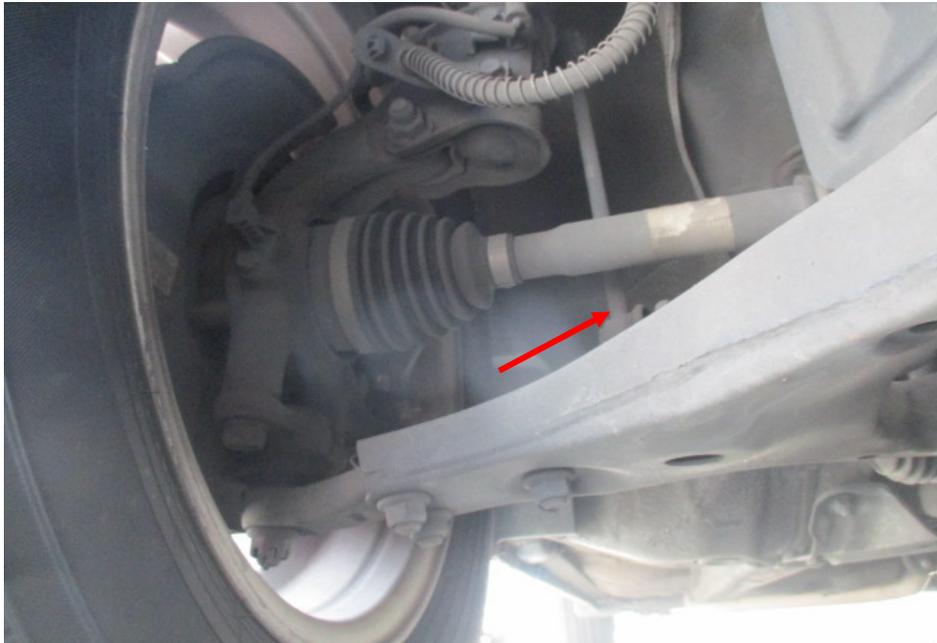
Photo 20 shows the various undercarriage components at the front right wheel of the Motor Car, in particular the steering tie rod (arrowed). The various steering components were all found to be intact, suggesting that the steering system of the Motor Car was likely to be in serviceable condition at the material time of accident. There was also no sign of fluid stain observed on the various undercarriage components at the front right wheel of the Motor Car.

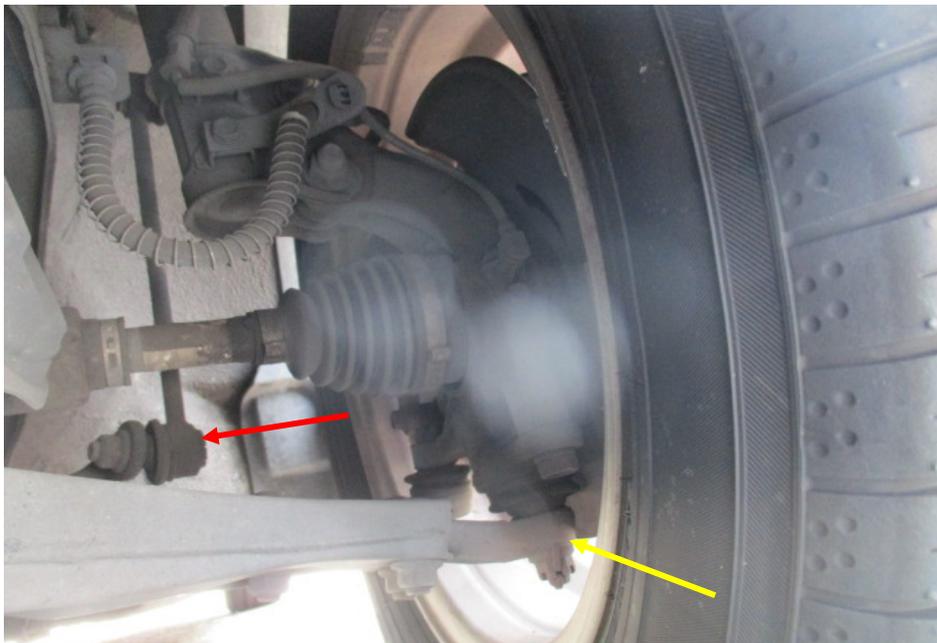
Photo 21 shows the various undercarriage components at the front left wheel of the Motor Car, which had included the steering tie rod (red arrow) and left drive shaft (yellow arrow). The various undercarriage components of the Motor Car were all found to be intact without any visible damage.

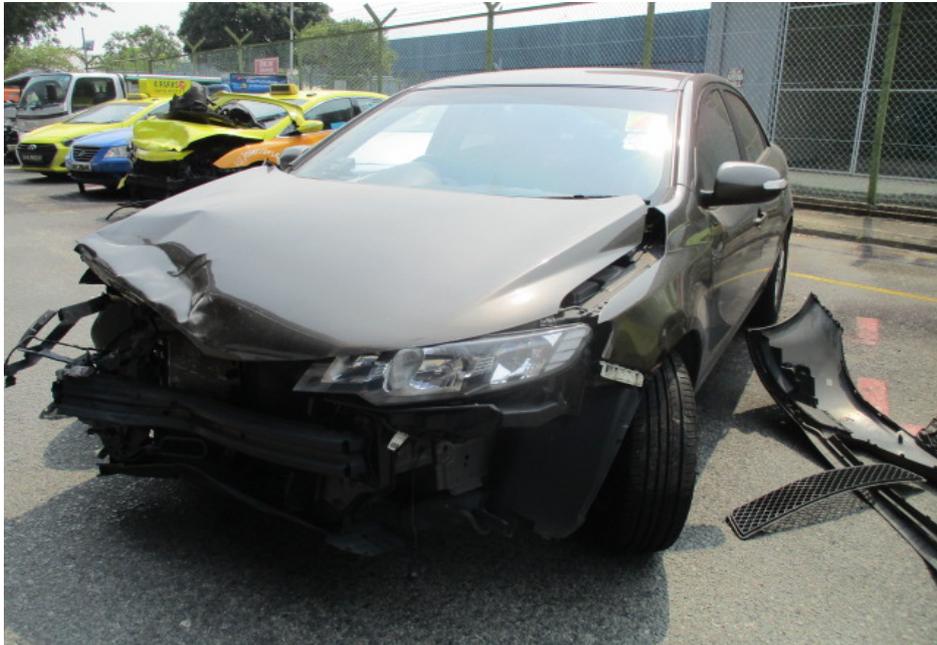
Photo 22 shows the front left wheel of the Motor Car turned to its full left. During our steering system test, we did not experience any abnormal free play and/or resistance when we had turned the steering wheel towards the left and right. This would suggest that the steering system of the Motor Car was likely to be in serviceable condition at the material time of accident.

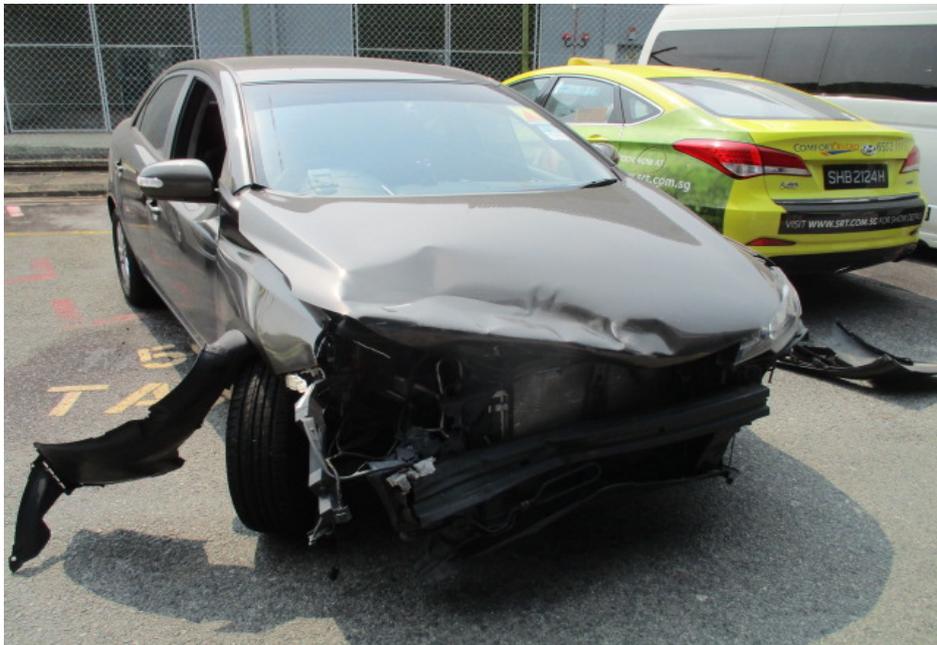
Photo 23 shows the front right wheel of the Motor Car turned to its full right. During our steering system test, we did not experience any abnormal free play and/or resistance when we had turned the steering wheel towards the left and right. This would suggest that the steering system of the Motor Car was likely to be in serviceable condition at the material time of accident.

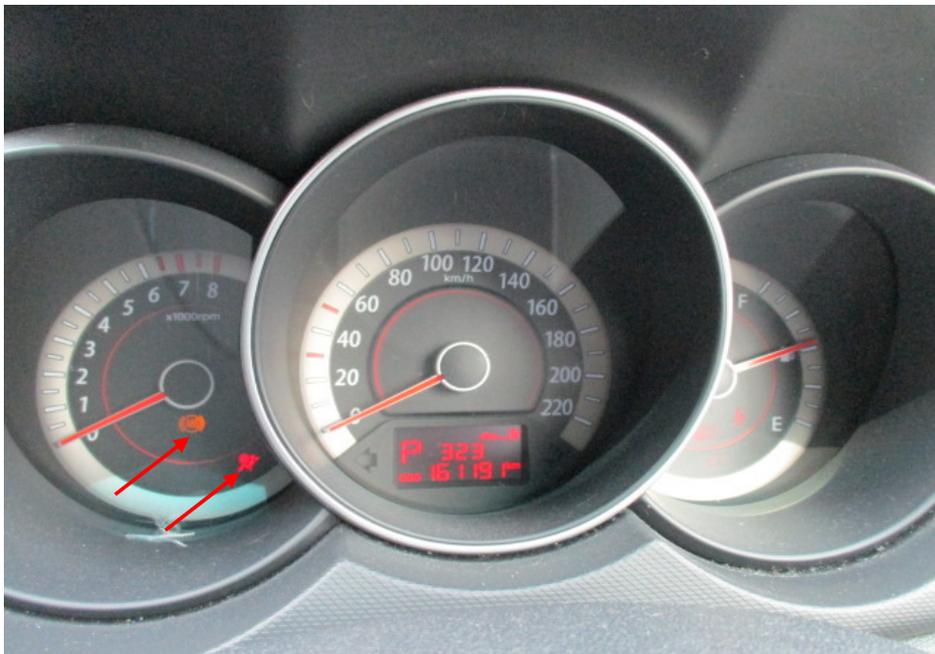
Photo 24 shows the warning lights for the various electronic operating systems of the Motor Car appearing on its instrument panel during the self-test when the engine is cranked, in particular the ABS light and SRS light (arrowed).

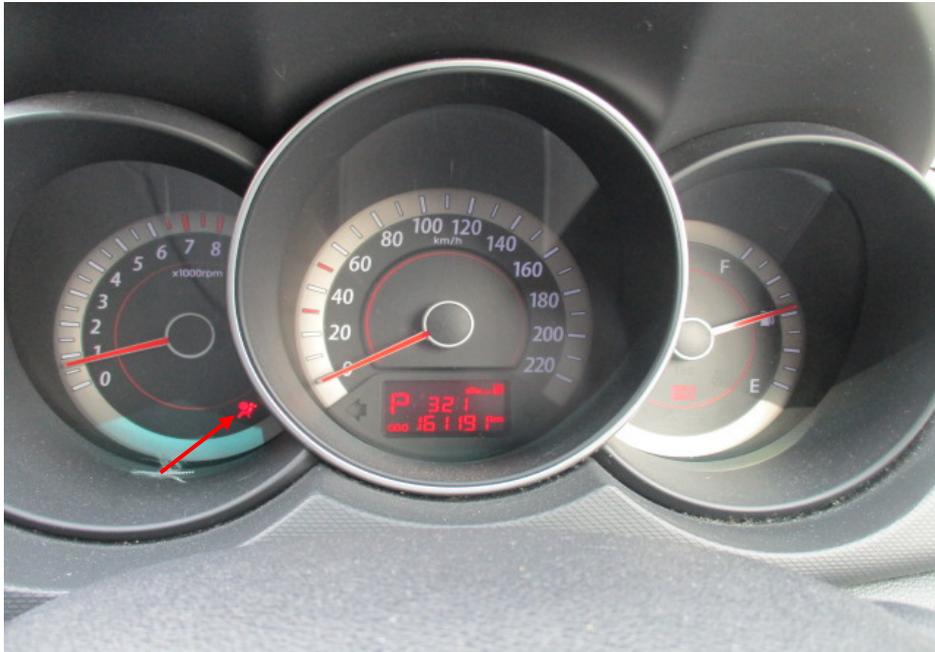
Photo 25 shows no warning lights illuminated on the instrument panel of the Motor Car after the engine was cranked. This would suggest that there was no abnormality to the various electronic operating systems of the Motor Car, like the ABS. However the SRS light had remained illuminated after the self-test (arrowed) due to the airbag being deployed as a result of the accident.
