Your Ref: TP/IP/47933/2019
Our Ref : CI/TPD19013965/P

5th September 2019

MECHANICAL INSPECTION REPORT OF POLICE HILUX GZ 3294D

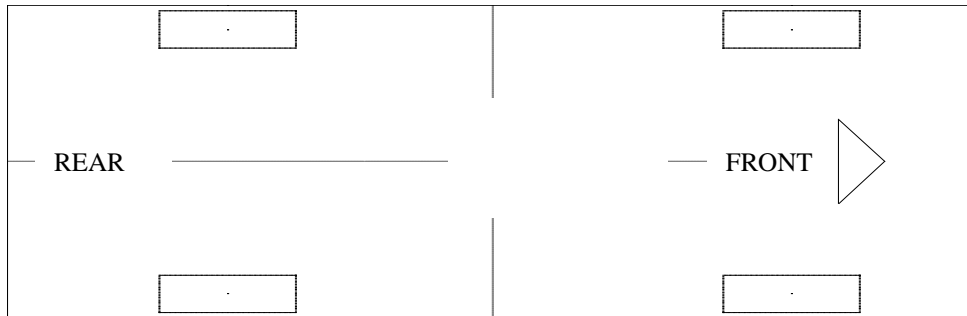
6. The condition of the Police Hilux's 4 tyres was observed to be in serviceable condition. I did not find any tear, cut or burst mark(s) on the outer and the inner sidewalls as well as across the tread of the 4 tyres. The 4 tyres were also observed to be sufficiently inflated for vehicular operation. The tyre brand, tyre size and remaining tread depth of the 4 tyres were recorded as follows:-

Falken 205/70R15C (6.4 mm)

Falken 205/70R15C (6.6mm)

Falken 205/70R15C (6.5mm)

Falken 205/70R15C (7.2mm)

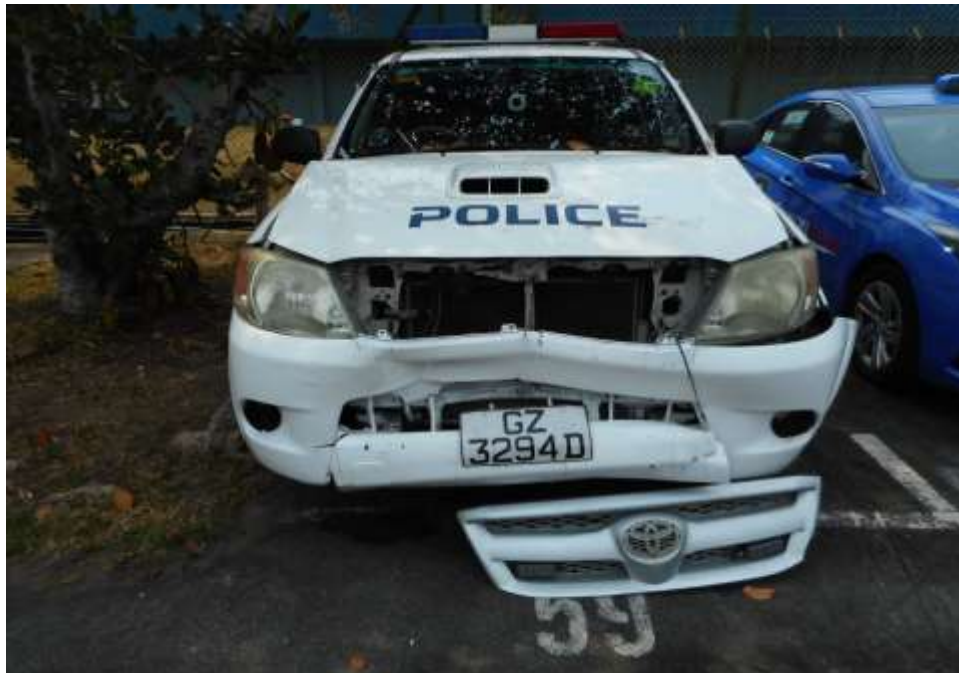
Photo 1 shows a general view of the Police Hilux's front body at the time of my inspection. The Police Hilux was observed to have sustained damage at its front portion. Its front bonnet, front bumper, front grille, front number plate, front radiator, left and right fender were amongst the body parts that were damaged as a result of the accident.

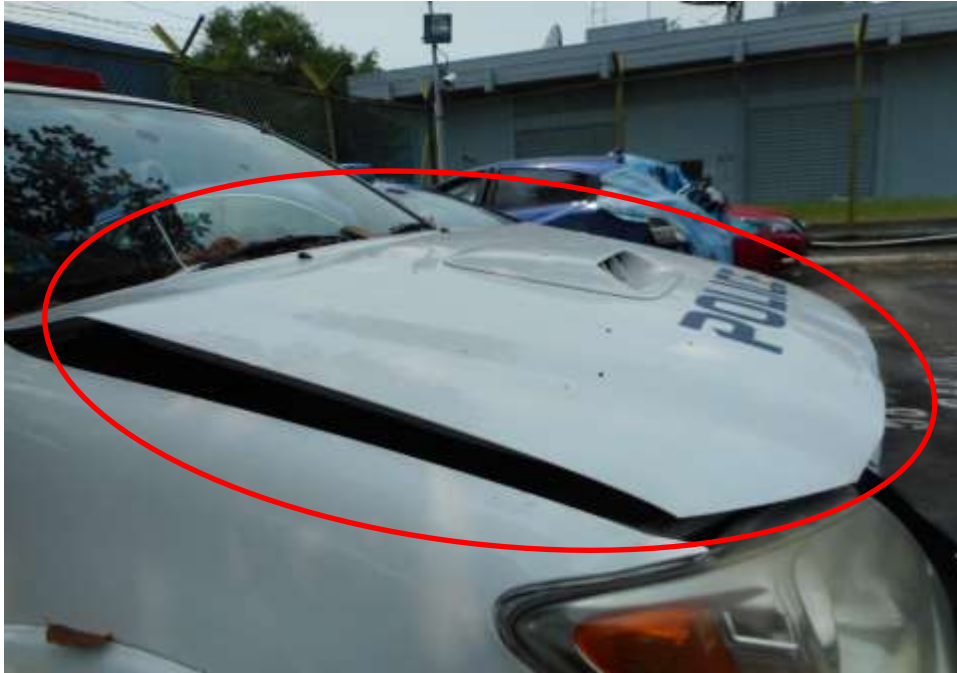
Photo 2 shows the close up view of the Police Hilux's front body at the time of my inspection. The Police Hilux was observed to have sustained damage at its front bonnet (circled) as a result of the accident.

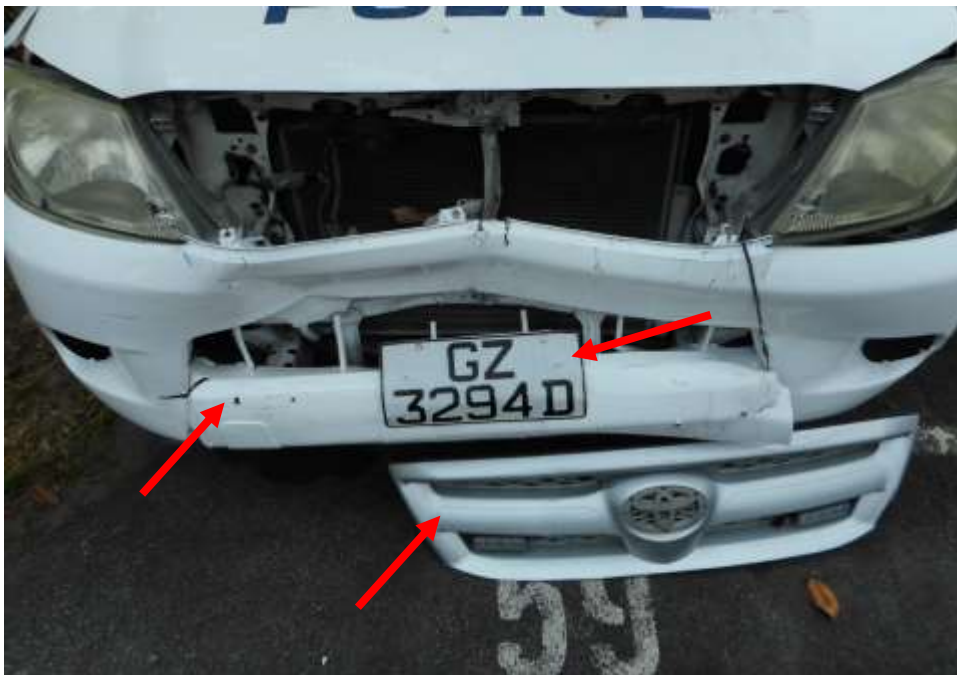
Photo 3 shows a close up view of the Police Hilux's front body at the time of my inspection. The front portion of the Police Hilux was observed to have sustained damage, its front grille, front bumper and number plate (arrowed) as a result of the accident.

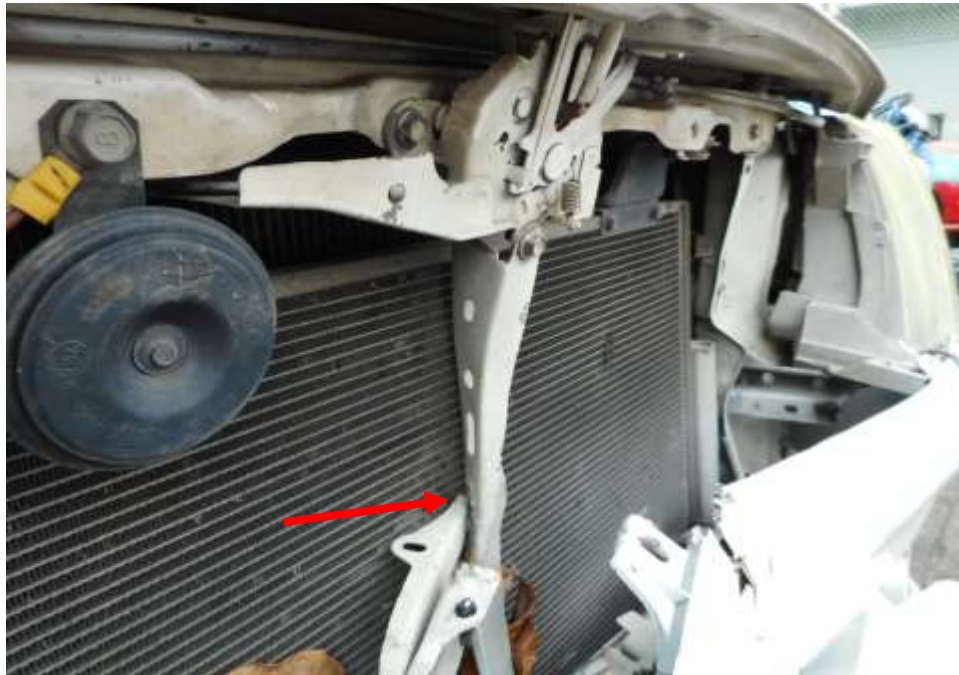
Photo 4 shows a close up view of the Police Hilux's front body at the time of my inspection. The front portion of the Police Hilux was observed to have sustained damage, its front radiator (arrowed) as a result of the accident.

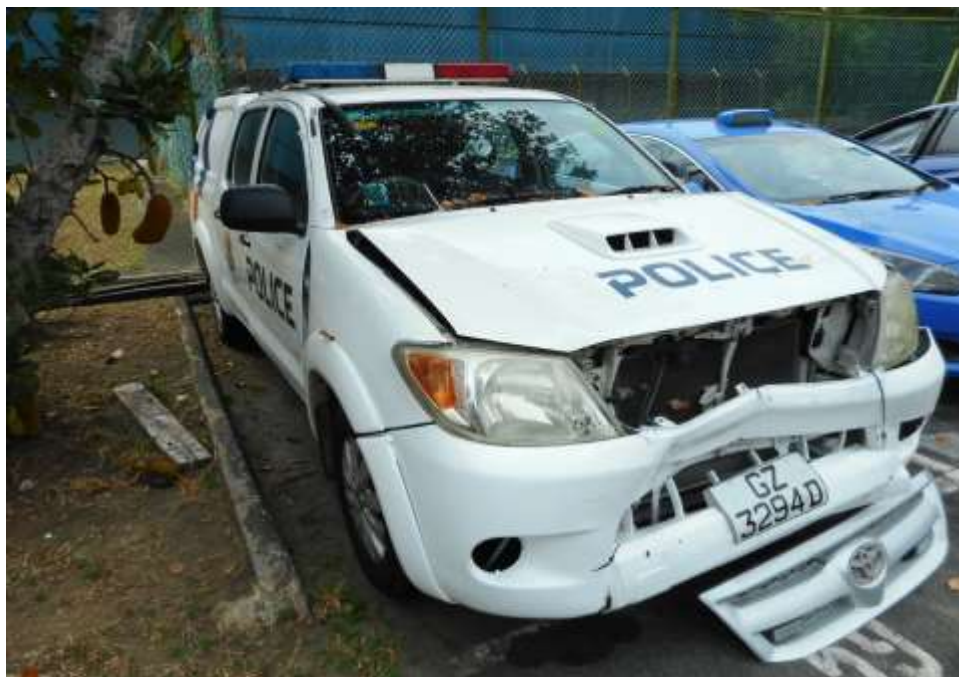
Photo 5 shows a general view of the Police Hilux's right body at the time of my inspection. The right portion of the Police Hilux was observed to have sustained damage; its right fender was damaged as a result of the accident.

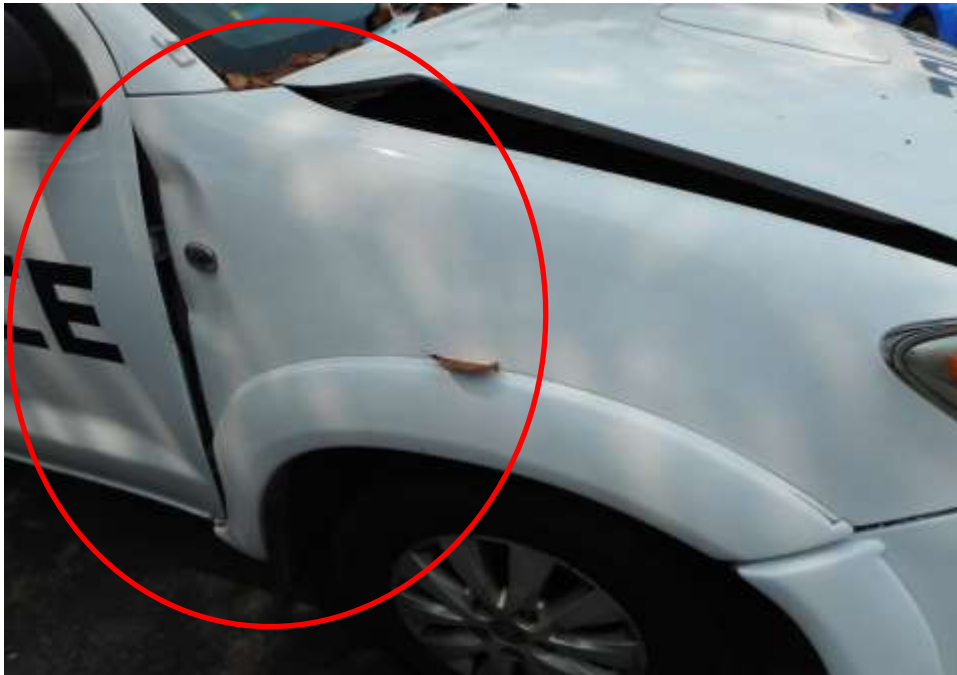
Photo 6 shows a close up view of the Police Hilux's right body at the time of my inspection. The right portion of the Police Hilux was observed to have sustained damage; its right fender (circled) was damaged as a result of the accident.

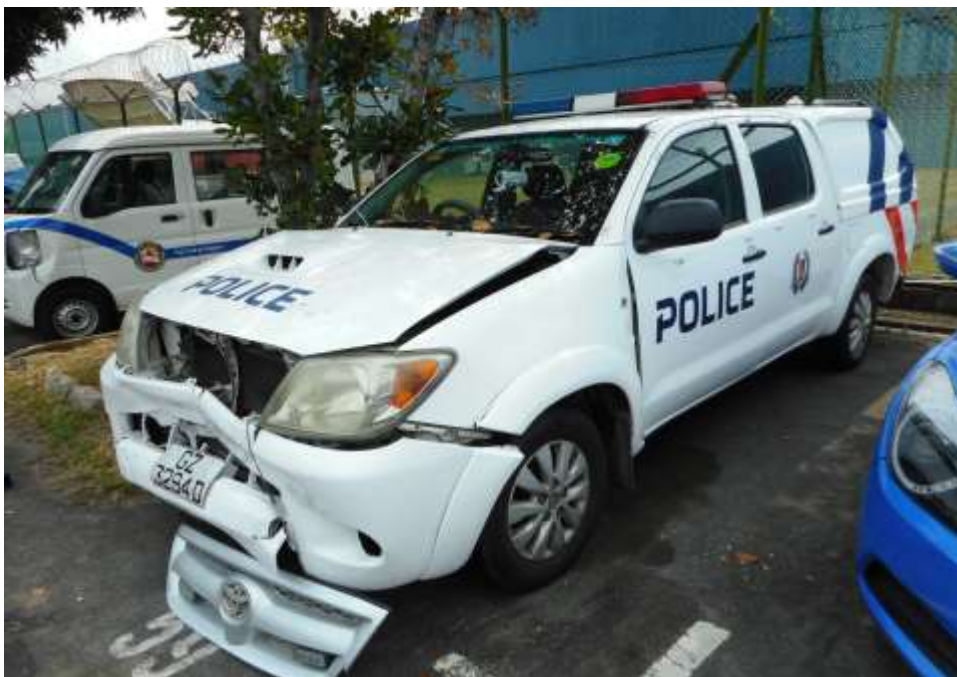
Photo 7 shows a general view of the Police Hilux's left body at the time of my inspection. The left portion of the Police Hilux was observed to have sustained damage; its left fender was damaged as a result of the accident.

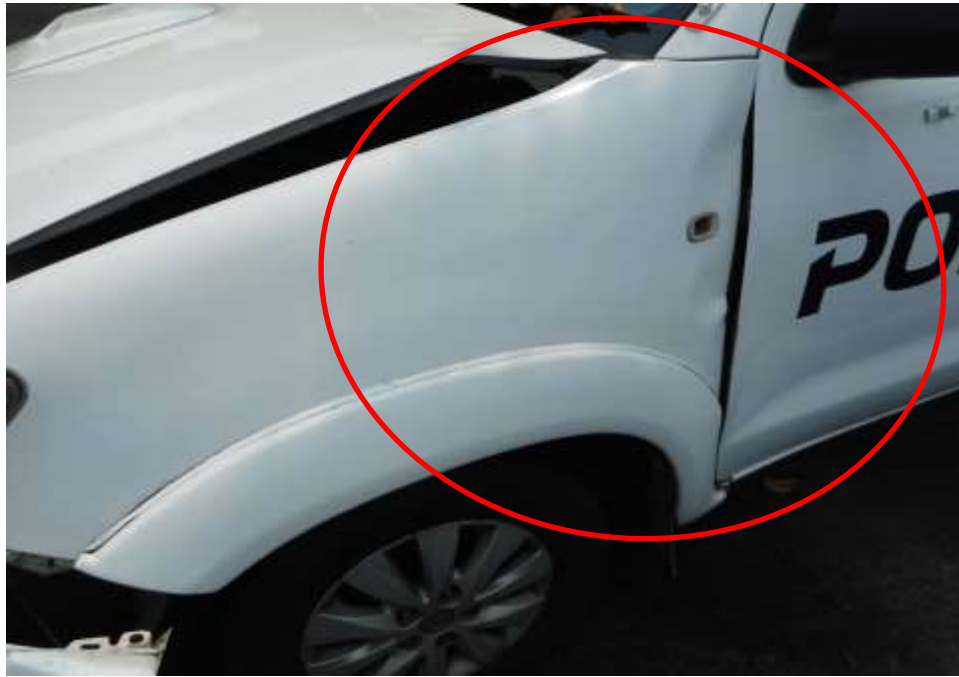
Photo 8 shows a close up view of the Police Hilux's left body at the time of my inspection. The left portion of the Police Hilux was observed to have sustained damage; its left fender (circled) was damaged as a result of the accident.

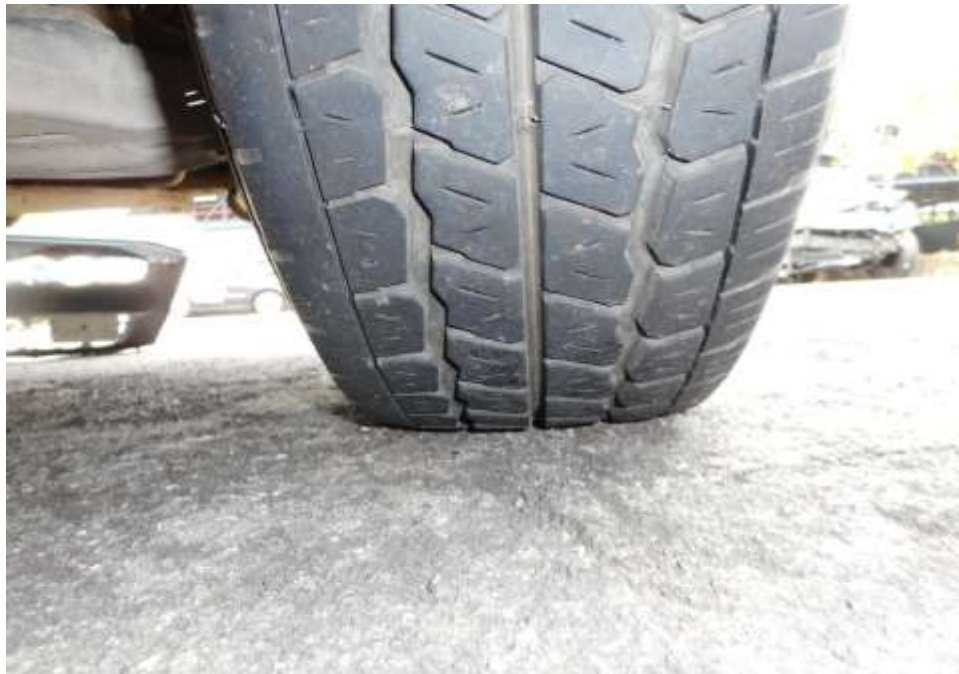
Photo 9 shows the condition of the front right tyre of the Police Hilux, which was observed to be in serviceable condition with remaining tread depth of approximately 7.2mm. The tyre was sufficiently inflated for vehicular operation with no tear, cut or burst mark(s) on the outer and the inner sidewalls as well as across the tread. The 4 tyres of the Police Hilux were wrapped around standard alloy wheel rims without any damage.

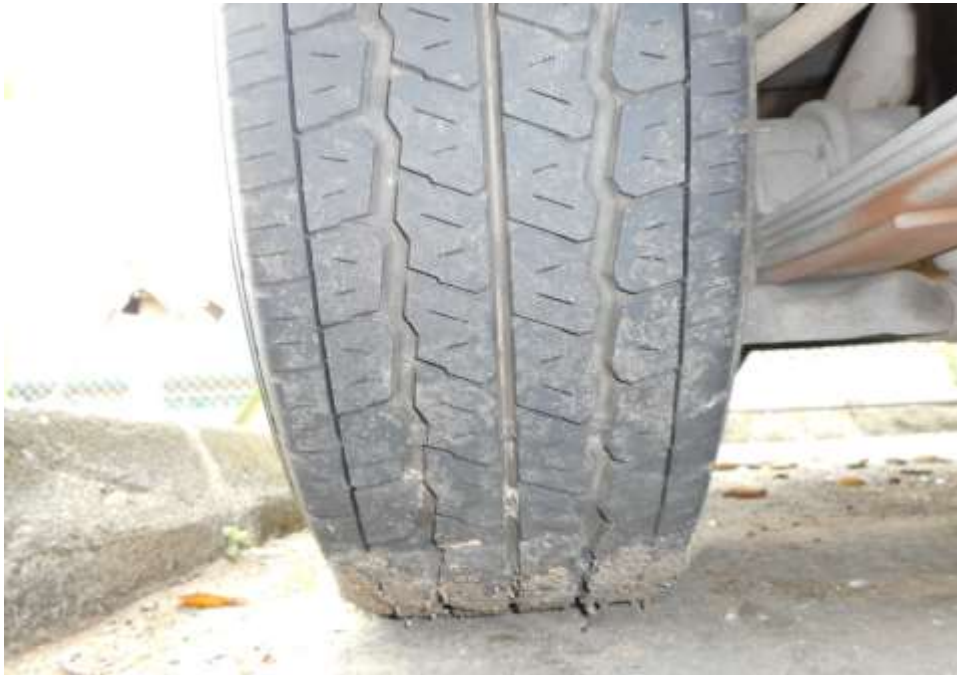
Photo 10 shows the condition of the rear right tyre of the Police Hilux, which was observed to be in serviceable condition with remaining tread depth of approximately 6.5mm. The tyre was also observed to be sufficiently inflated for vehicular operation with no tear, cut or burst mark(s).

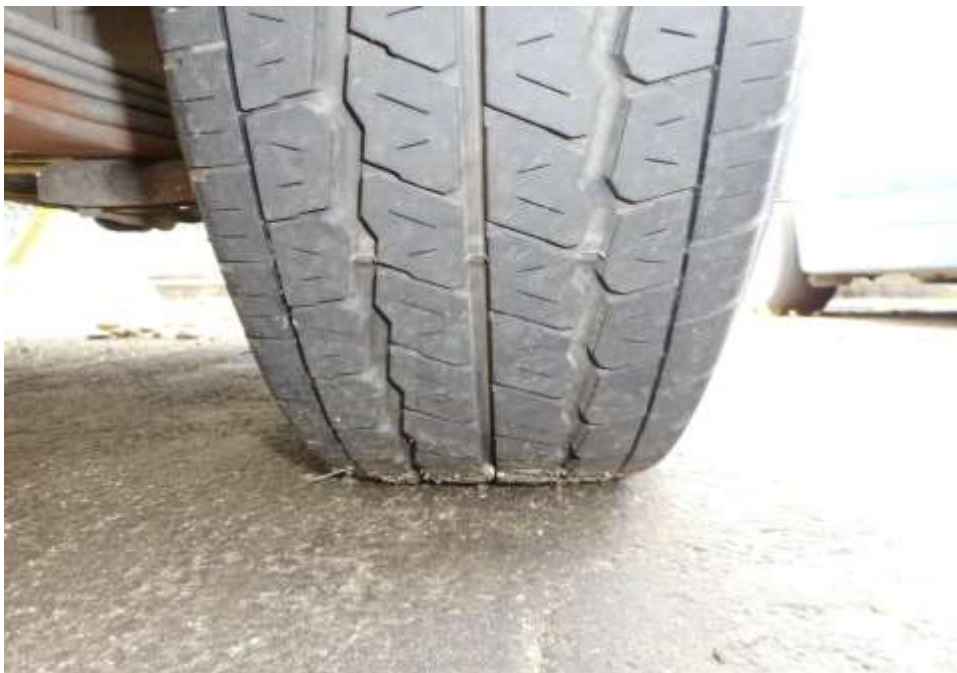
Photo 11 shows the condition of the rear left tyre of the Police Hilux, which was observed to be in serviceable condition with remaining tread depth of approximately 6.4mm. The tyre, which was wrapped around alloy wheel rim, was also observed to be sufficiently inflated for vehicular operation. The 4 tyres of the Police Hilux were wrapped around standard alloy wheel rims.

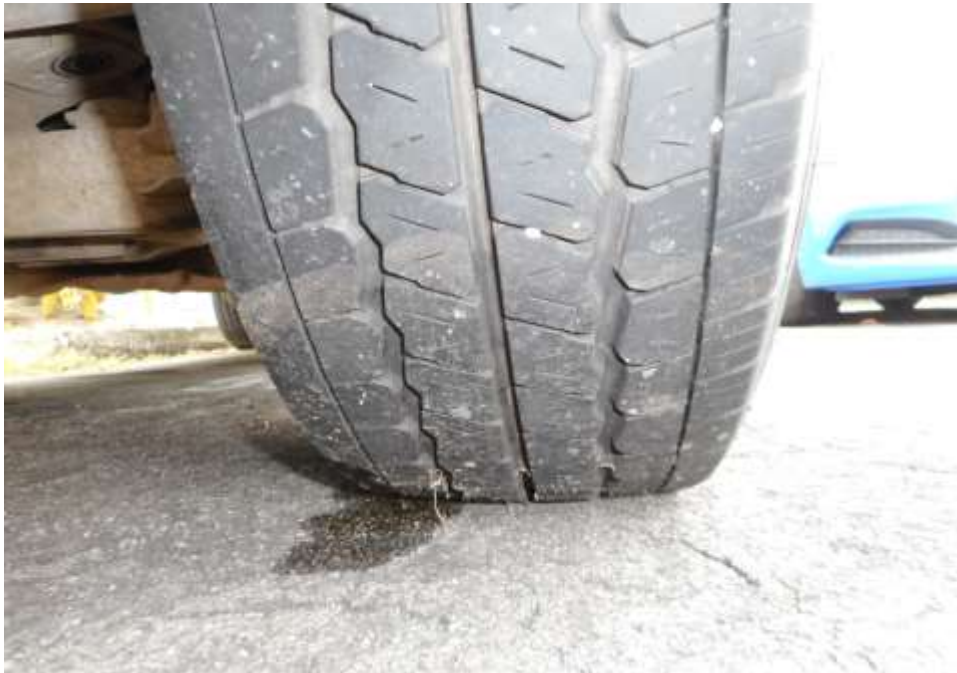
Photo 12 shows the condition of the front left tyre of the Police Hilux, which was observed to be in serviceable condition with remaining tread depth of approximately 6.6mm. There was also no tear, cut or burst mark(s) on the outer and the inner sidewalls as well as across the tread of the Police Hilux's 4 tyres.

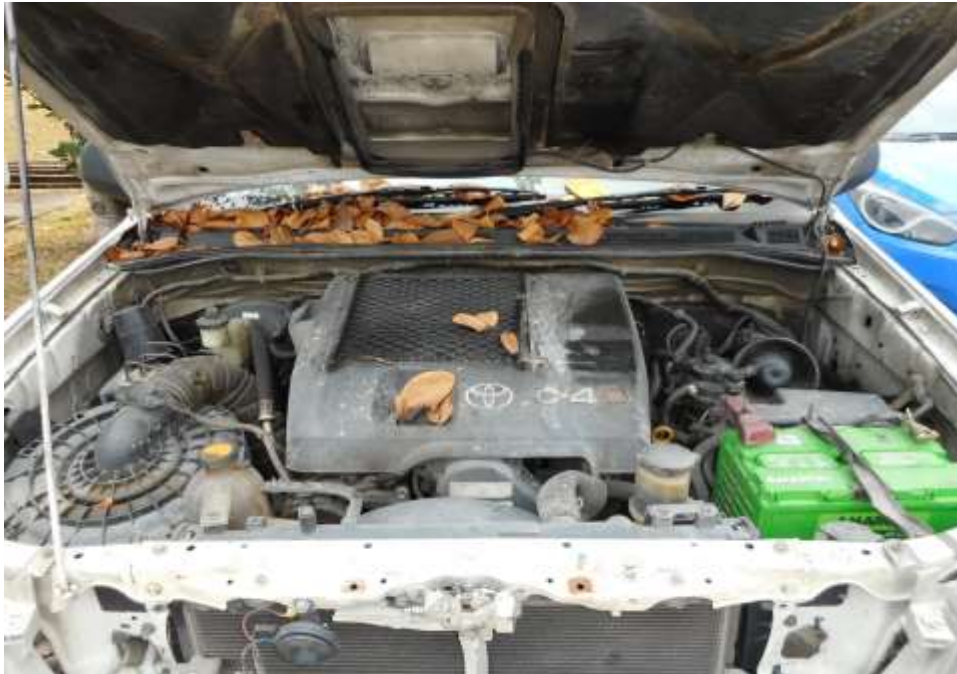
Photo 13 shows a general view of the Police Hilux's engine compartment. The various parts and components inside the engine compartment were unaffected by the accident. There was also no sign(s) or indication(s) of fluid leakage and/or fluid stain within the engine compartment.

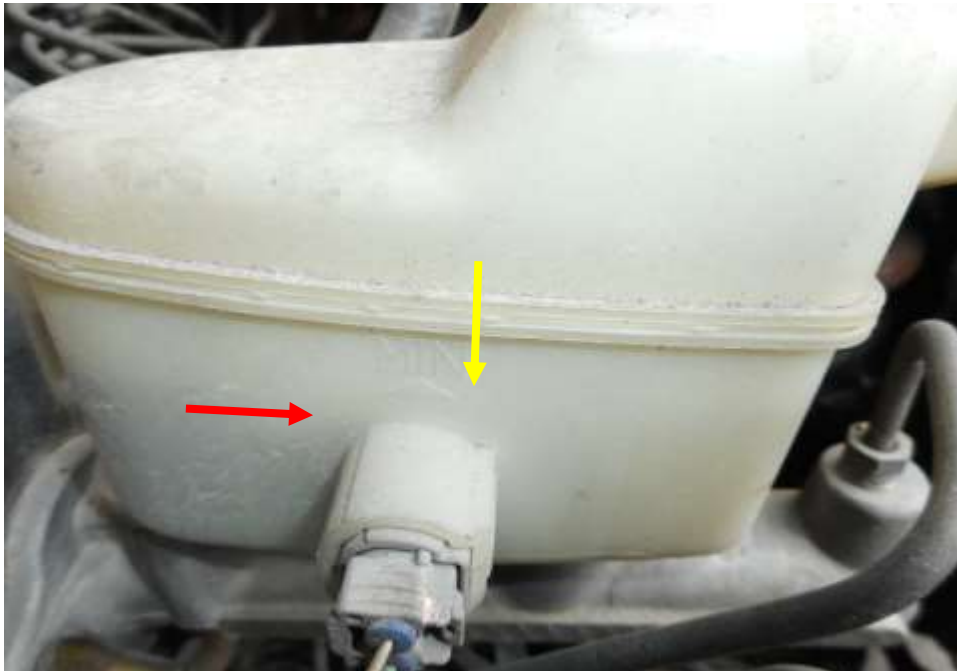
Photo 14 shows the brake fluid reservoir of the Police Hilux at the time of my inspection. The brake fluid was observed to be of insufficient level (red arrow) due to a leakage at the brake capliers. The brake fluid was found to be below the minimum mark (yellow arrow)

12. The brake fluid was also of insufficient level. There was sign(s) of old and fresh brake fluid stains leaking out from the front left brake caplier and old stains on the front right caplier and rear left drum brake as well.

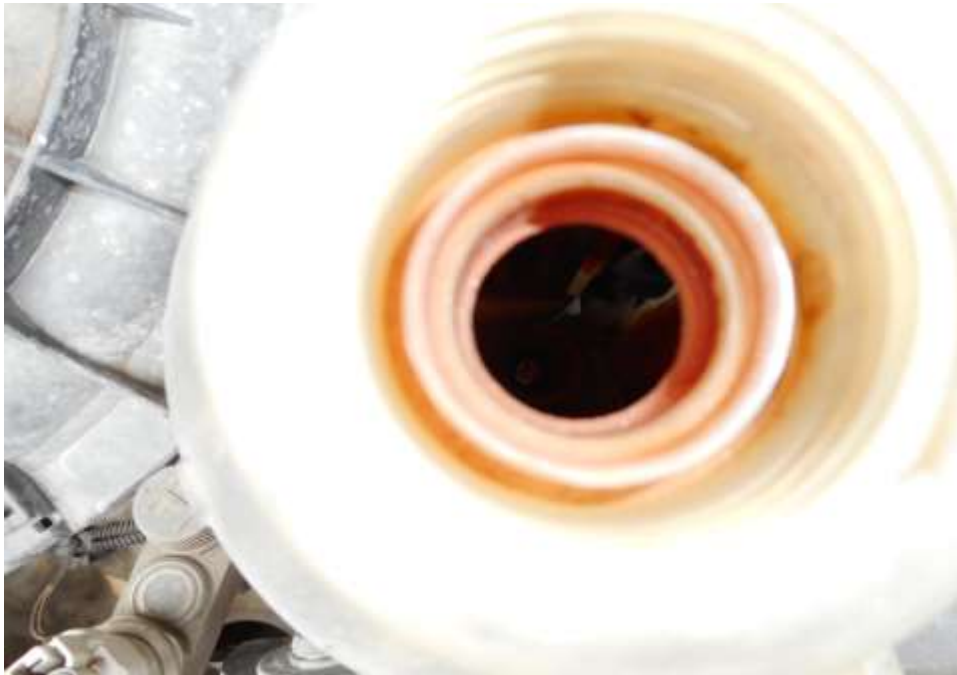
Photo 15 shows checks being carried out to the engine coolant of the Police Hilux at the time of my inspection. The engine coolant was observed to be of insufficient level due to the damage to the front radiator which causes a leakage of coolant fluids.

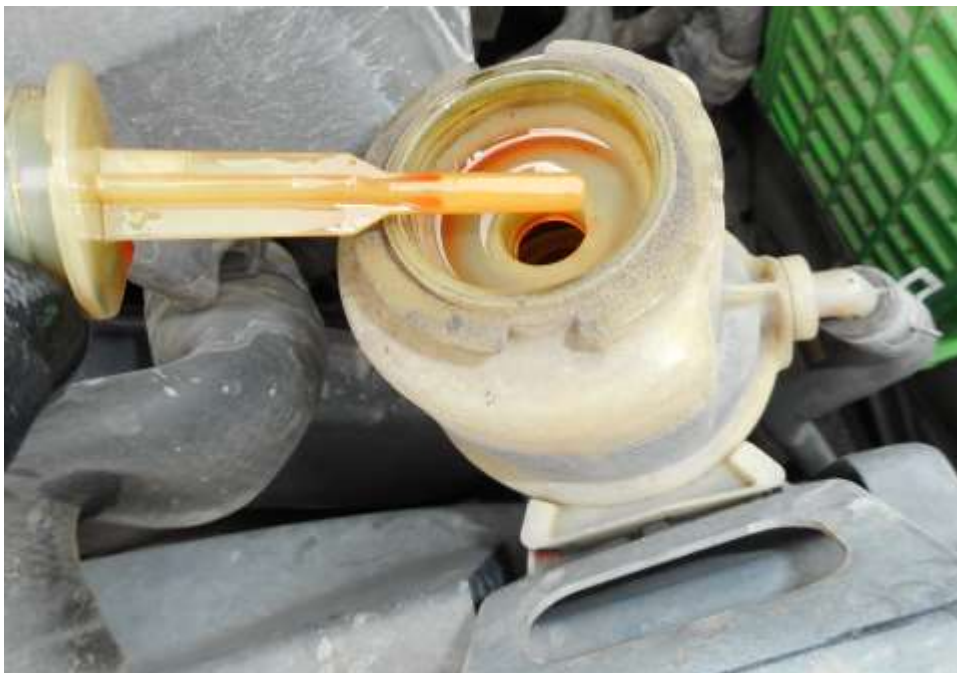
Photo 16 shows checks being carried out to the Power steering fluid of the Police Hilux at the time of my inspection. The steering fluid was observed to be of sufficient level and without any visible contamination.

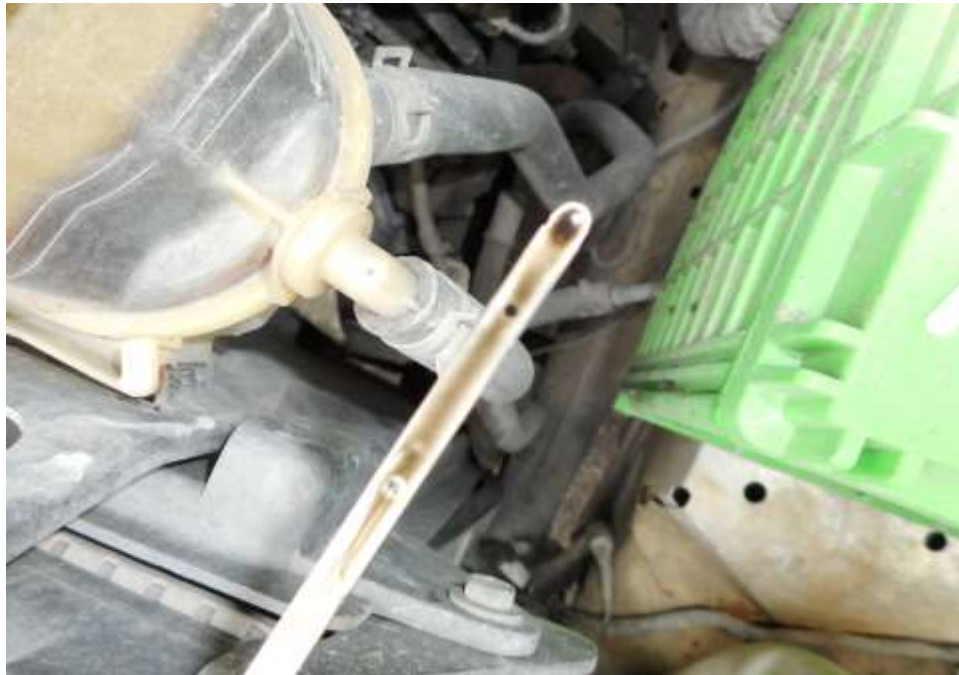
Photo 17 shows the engine oil dip stick of the Police Hilux at the time of my inspection. The engine oil was observed to be of sufficient level and without any visible contamination.

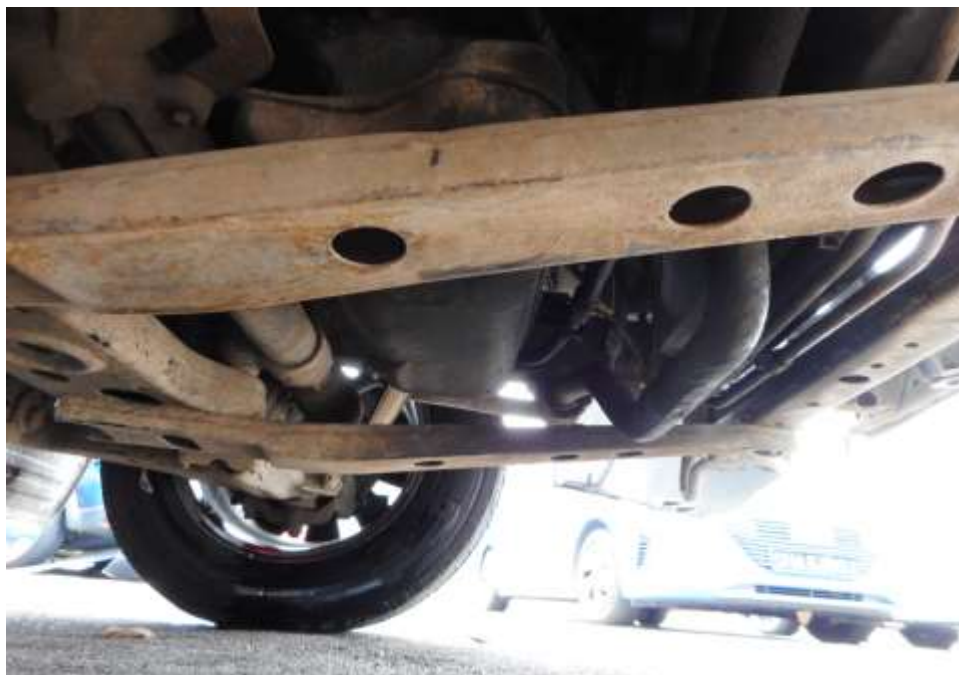
Photo 18 shows the undercarriage of the Police Hilux, at the area where the engine housing and transmission housing are located. I did not find any sign(s) or indication(s) of fluid leak and/or fluid stain(s) on the underside of the Police Hilux.

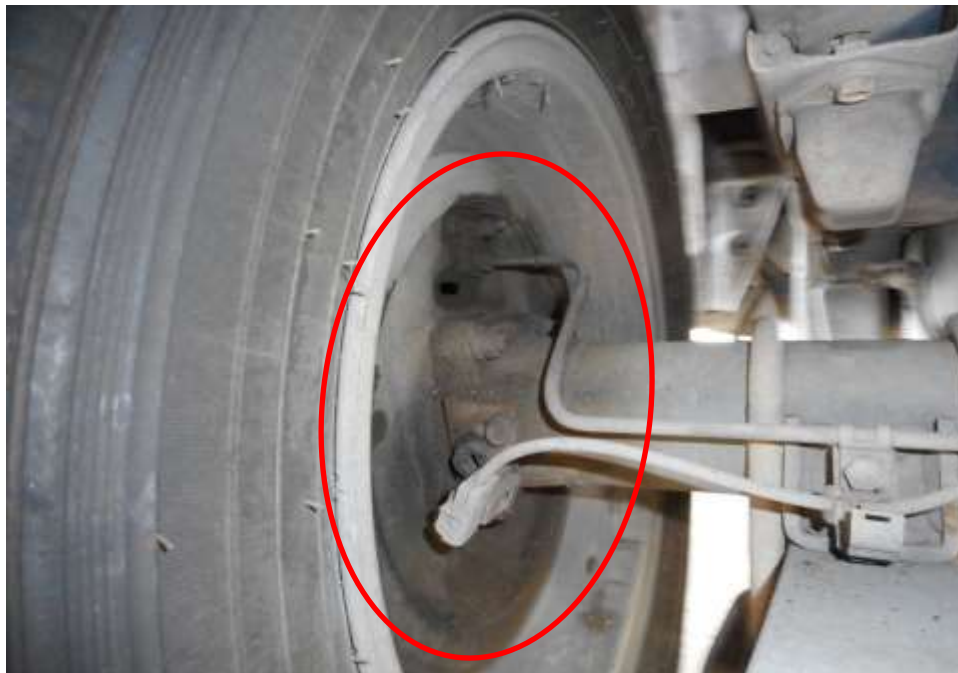
Photo 19 shows the old stain of brake fluids leakage on the rear left drum brake surface (circled) at the time of my inspection of the Police Hilux. Static tests of the Police Hilux's braking system had indicated that there was internal leakage of pressure/vacuum.

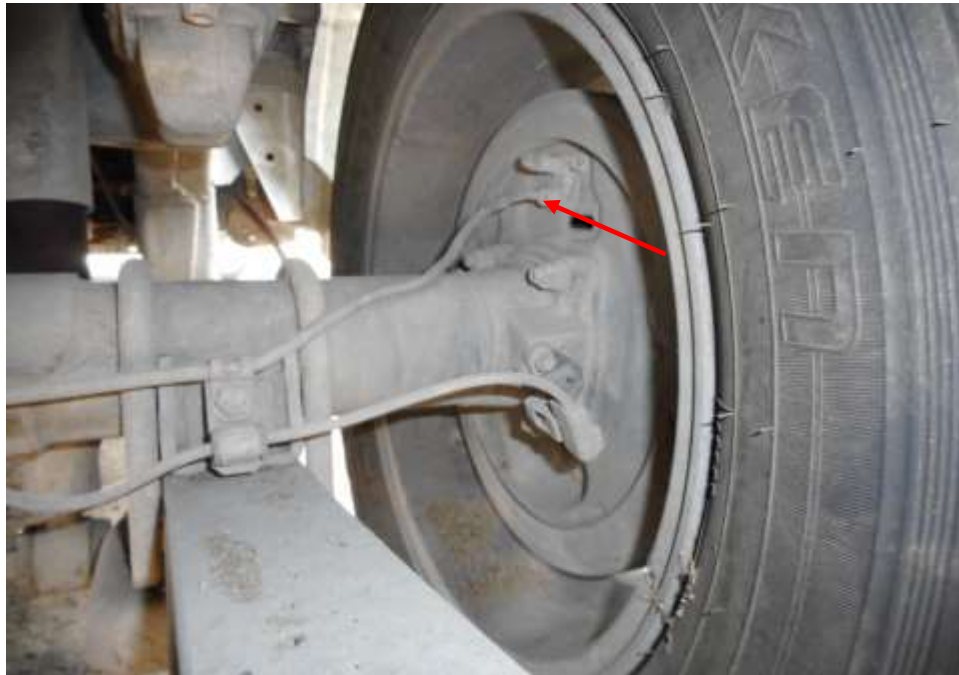
Photo 20 shows the brake hose/pipe (arrowed) of the drum brake at the rear right wheel of the Police Hilux. No leakage of brake fluid was observed.

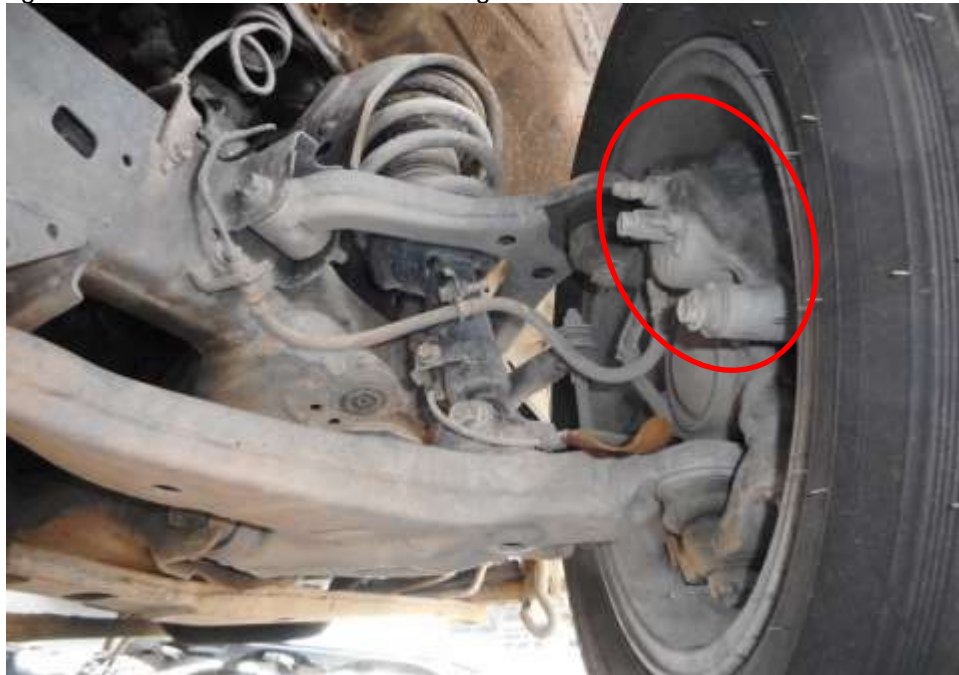
Photo 21 shows the old stain of brake fluids leakage on the front right brake caplier surface (circled) at the time of my inspection of the Police Hilux. Static tests of the Police Hilux's braking system had indicated that there was internal leakage of pressure/vacuum.

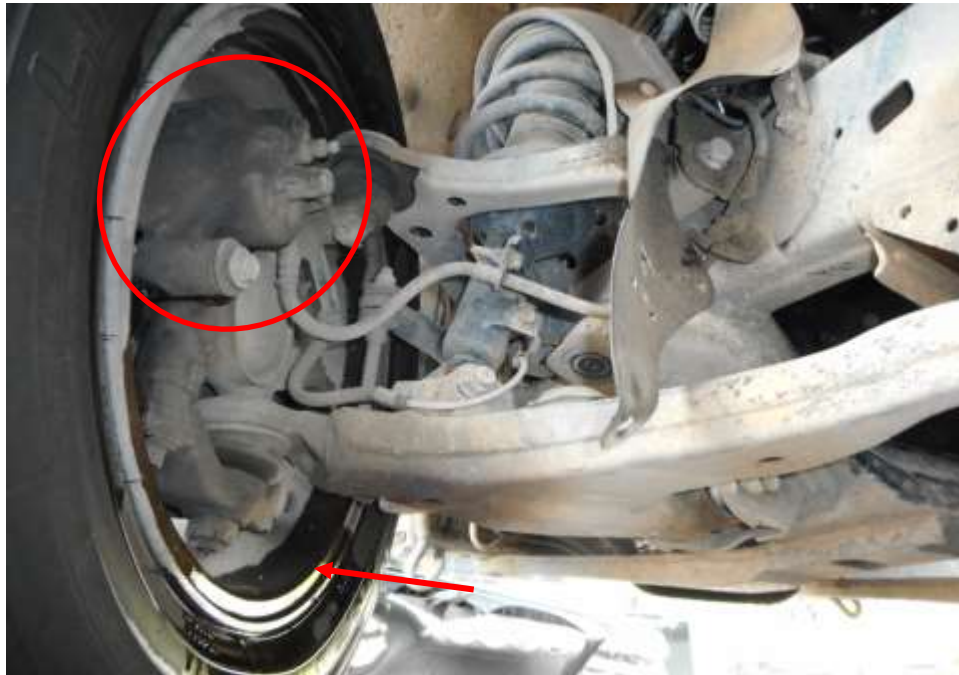
Photo 22 shows the old stain and fresh brake fluids leakage on the front left brake caplier (circled) and rims surface (arrowed) at the time of my inspection of the Police Hilux. Static tests of the Police Hilux's braking system had indicated that there was internal leakage of pressure/vacuum.

19. A short operational test of the Police Hilux, which I had conducted, revealed that applying of the foot brake was not able to slow down and bring the Police Hilux to a complete stop and thus the emergency handbrake had to be applied to slow and stop the Vehicle. This was due to internal leakage of pressure/vacuum and external brake fluid leakage from the braking system.

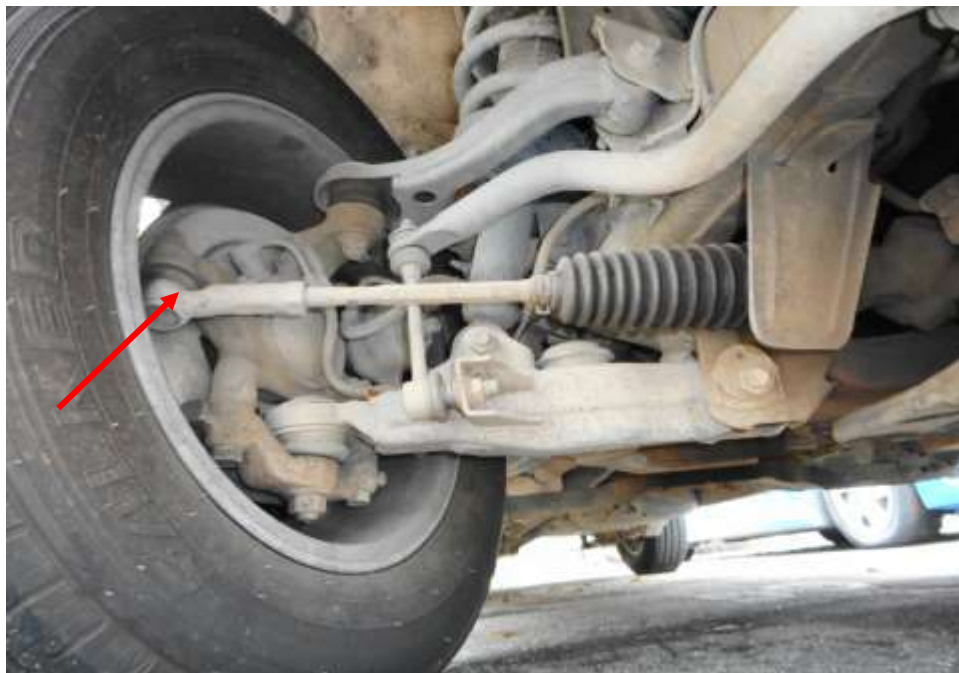
Photo 23 shows the various undercarriage components at the front right wheel of the Police Hilux, in particular the steering tie rod (red arrow). The various steering components were all found to be intact, suggesting that the steering system of the Police Hilux was likely to be in serviceable condition at the material time of accident. There was also no sign of fluid stain observed on the various undercarriage components at the front right wheel of the Police Hilux.

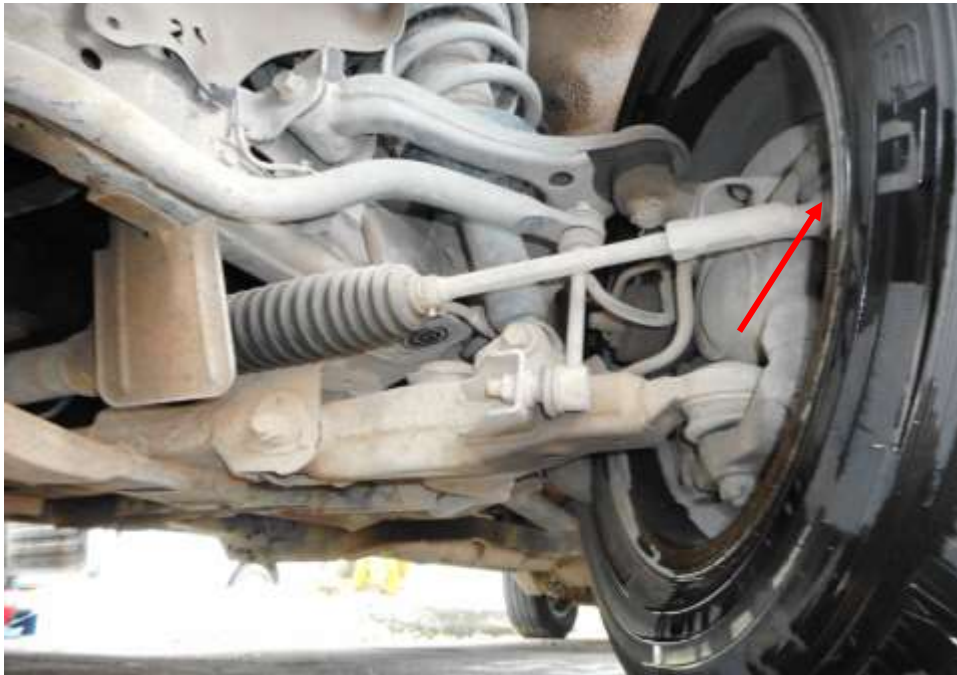
Photo 24 shows the various undercarriage components at the front left wheel of the Police Hilux, which had included the steering tie rod (red arrow). The various undercarriage components of the Police Hilux were all found to be intact without any visible damage.

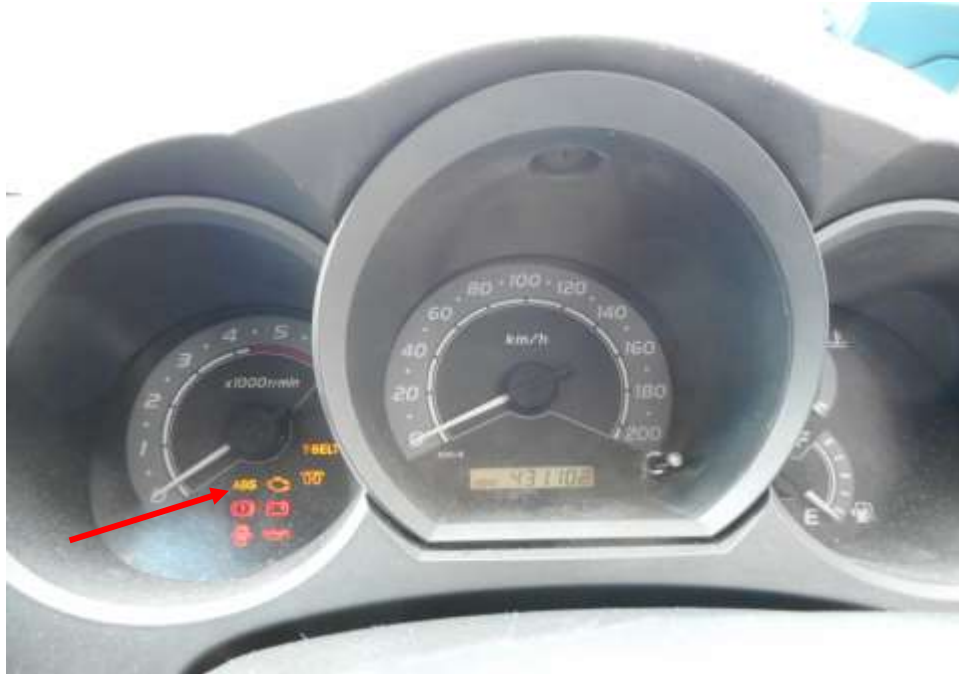
Photo 25 shows the warning light for Anti-Lock Brake System (ABS) appearing on the instrument panel of the Police Hilux during the self-test of its various electronic operating systems when its engine was cranked.

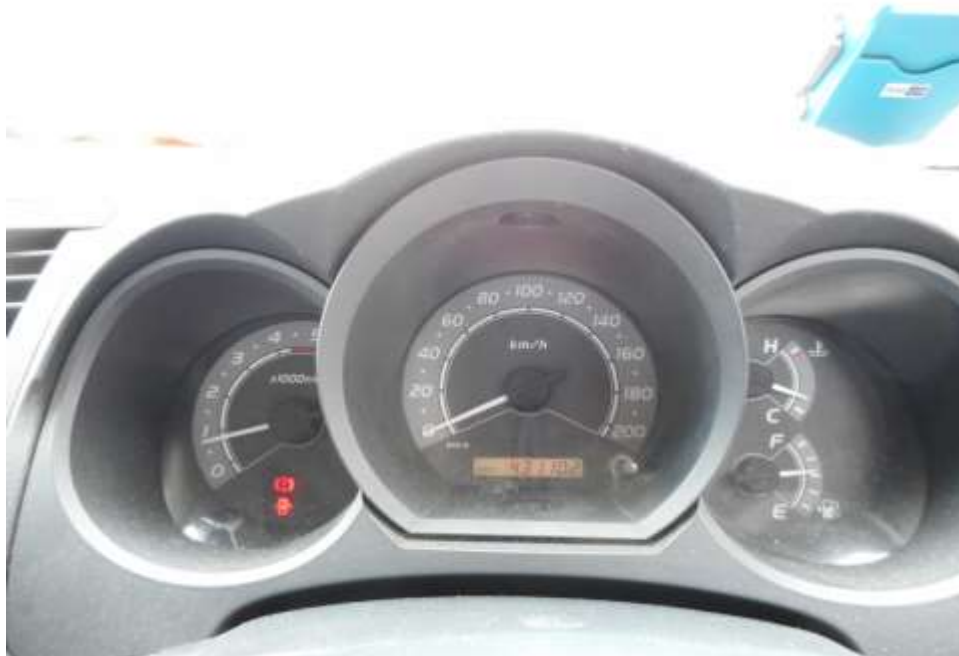
Photo 26 shows no warning lights illuminated on the instrument panel of the Police Hilux after the engine was cranked. This would suggest that there was no abnormality to the various electronic operating systems of the Police Hilux, like the ABS.

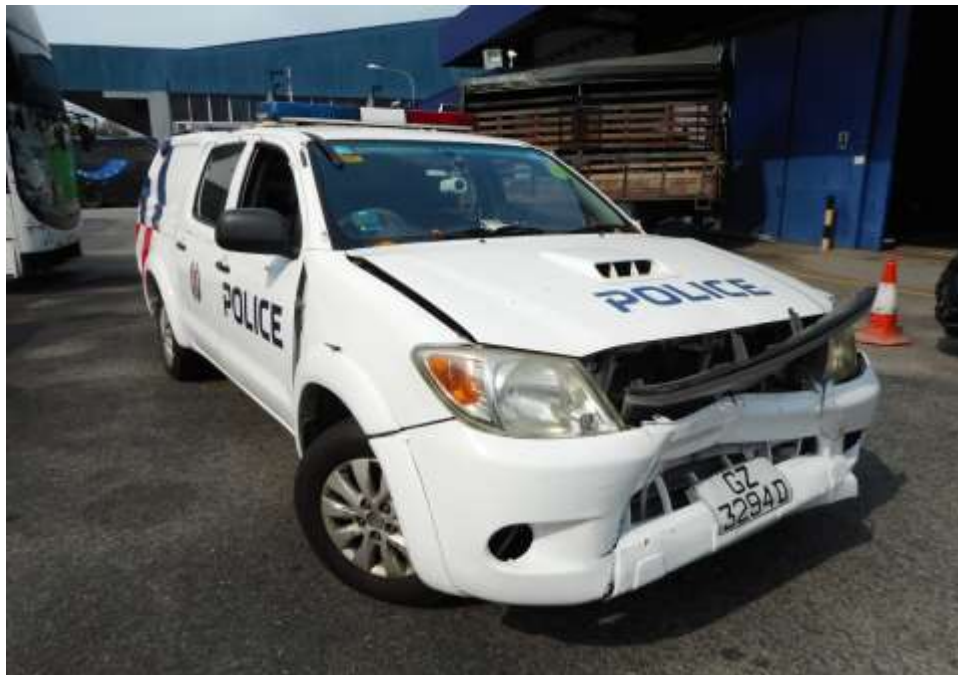
17. However the braking system was found to be in unserviceable condition as the Police Hilux was unable to fully slow down and come to a complete stop by depressing the brake pedal. The use of emergency handbrake was required to slow down and come to a complete stop, due to the was internal leakage of pressure/vacuum and external brake fluid leakage from the front left brake caplier of the braking system (Refer to photo 1 & 27)

Photo 27 shows the front left wheel of the Police Hilux turned to its full right. During my steering system test, I did not experience any abnormal free play and/or resistance when I had turned the steering wheel towards the left and right. However the braking system of the Police Hilux was found to be unserviceable and required the use of emergency handbrake to slow down and stop the vehicle.
