Your Ref: TP/IP/23457/2019  
Our Ref : CI/TPD19013966/P

**Fatal Accident Investigation Team**

**MECHANICAL INSPECTION REPORT OF MOTOR TAXI SHC 7245D**

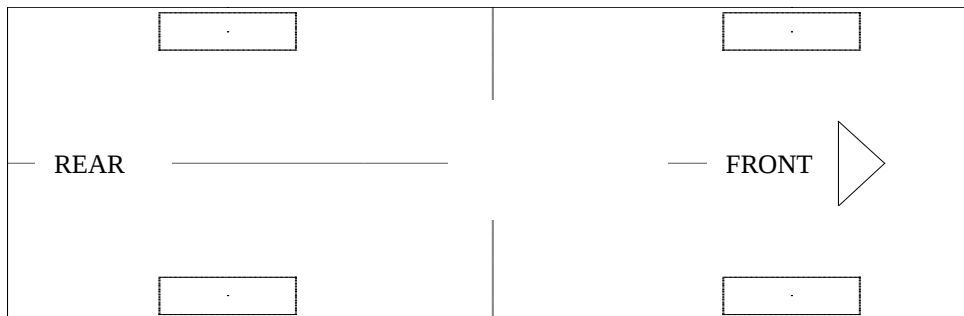
6. The condition of the Motor Taxi's 4 tyres was observed to be in serviceable condition. I did not find any tear, cut or burst mark(s) on the outer and the inner sidewalls as well as across the tread of the 4 tyres. The 4 tyres were also observed to be sufficiently inflated for vehicular operation. The tyre brand, tyre size and remaining tread depth of the 4 tyres were recorded as follows:-

Triangle 205/60R16 (5.6mm)

Triangle 205/60R16 (4.1mm)

Triangle 205/60R16 (6.4mm)

Triangle 205/60R16 (5.9mm)

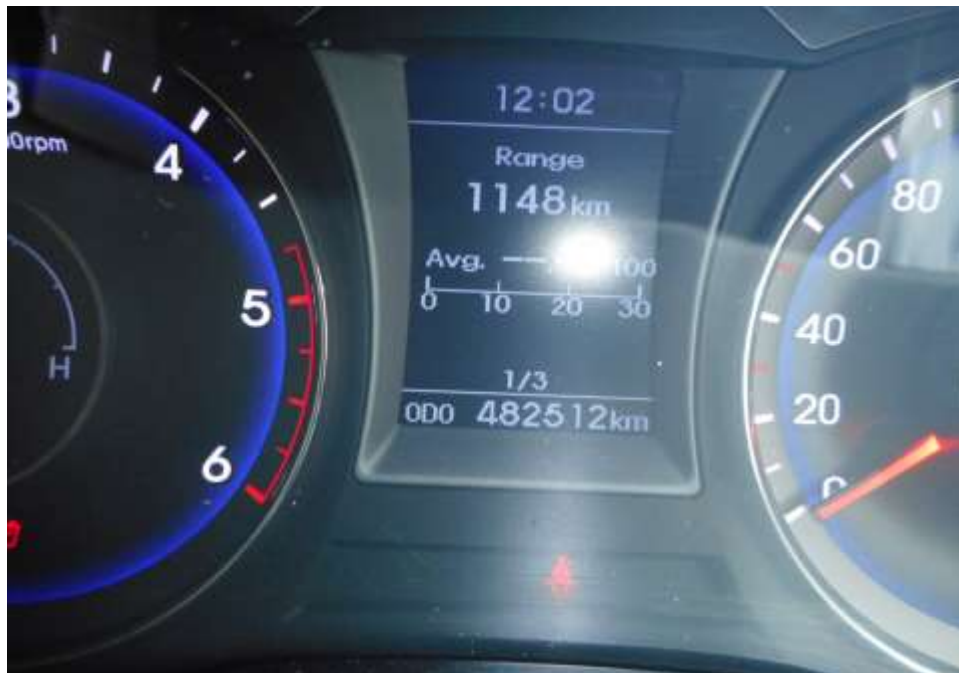
**Photo 1** shows the mileage of the Motor Taxi at the time of my inspection. The mileage observed was 482,512km.

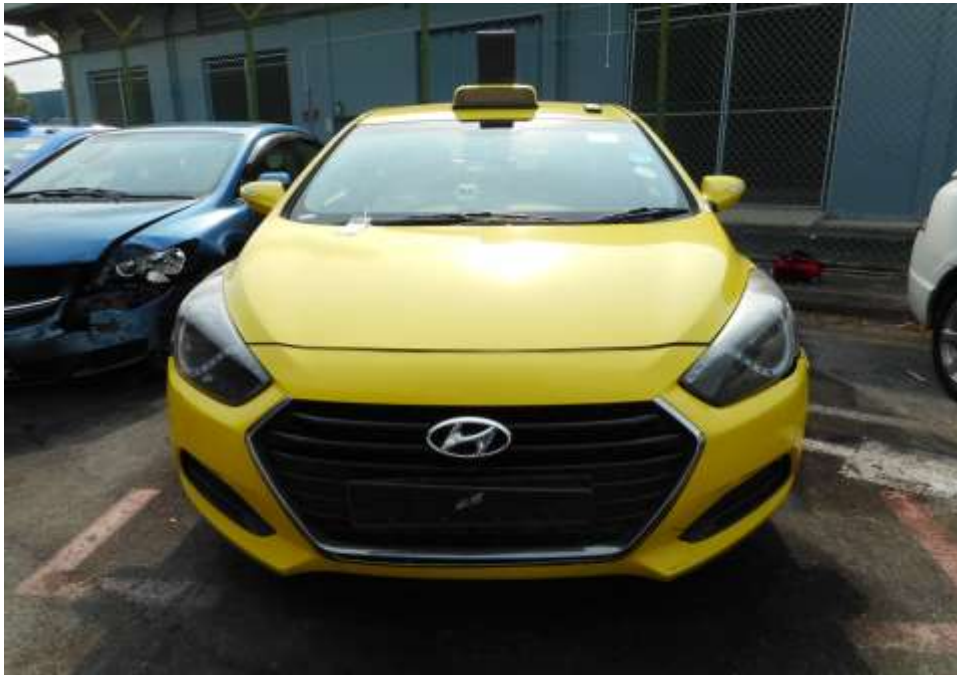
4. The mileage of the Motor Taxi at the time of my inspection was 482,512km.
5. The Motor Taxi was observed to have sustained damage at its front portion. Its front bumper and front number plate were amongst the body parts that were damaged as a result of the accident.

**Photo 2** shows a general view of the Motor Taxi's front body at the time of my inspection. The Motor Taxi was observed to have sustained damage at its frontal portion. Its front bumper and front number plate were amongst the body parts that were damaged as a result of the accident.

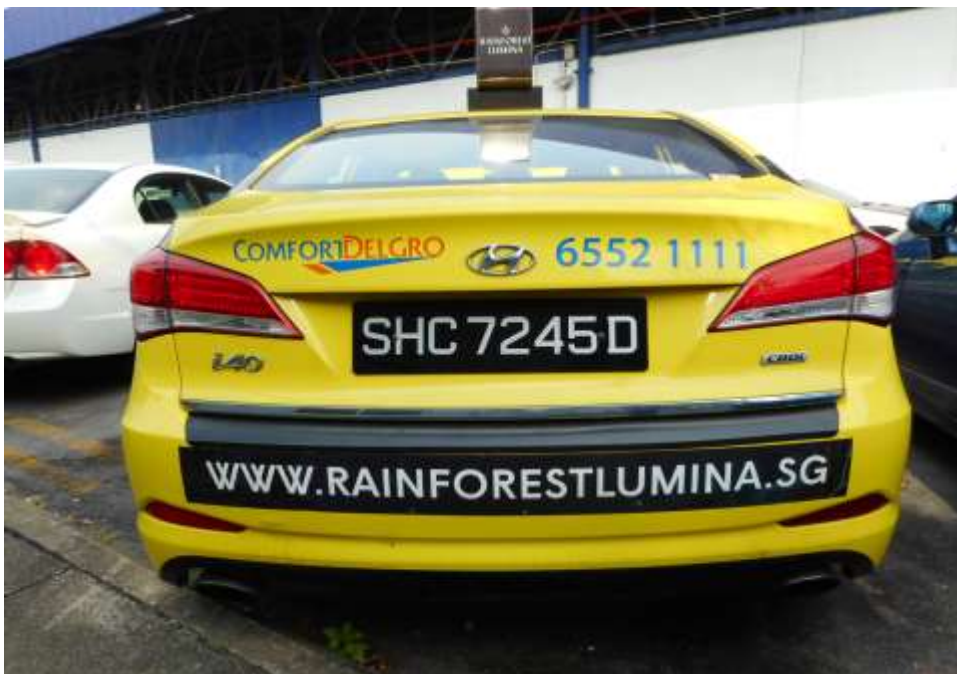
**Photo 3** shows the general view of the Motor Taxi's rear body at the time of my inspection. The Motor Taxi rear was observed to be unaffected by the accident.

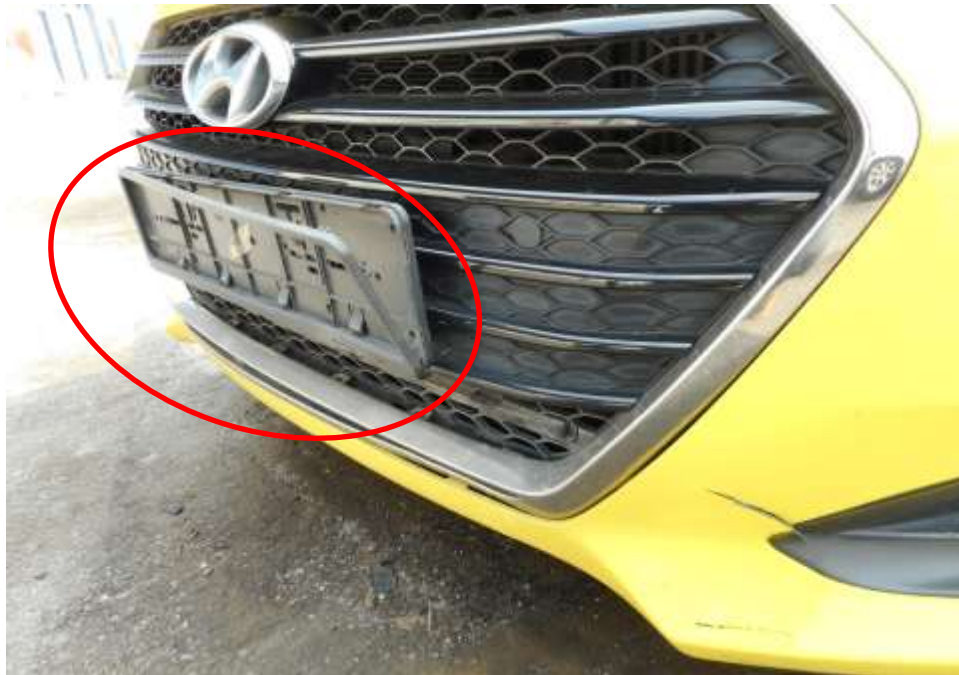
**Photo 4** shows the close up view of the Motor Taxi's front body at the time of my inspection. The Motor Taxi was observed to have sustained damage at its front number plate (circled) as a result of the accident.

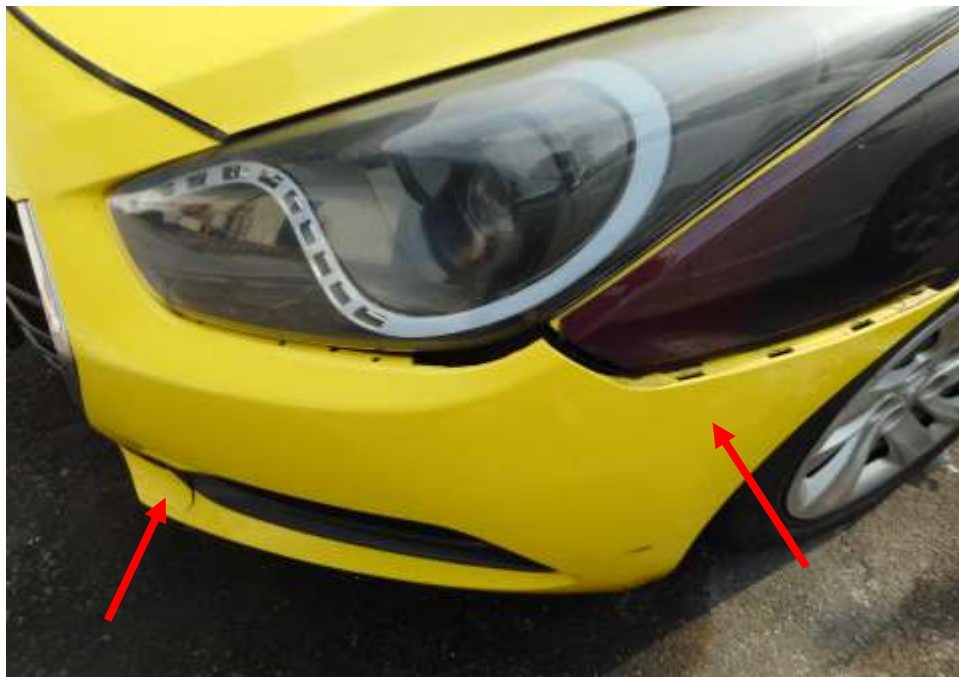
**Photo 5** shows the close up view of the Motor Taxi's front body at the time of my inspection. The Motor Taxi was observed to have sustained damage at its front bumper (arrowed) as a result of the accident.

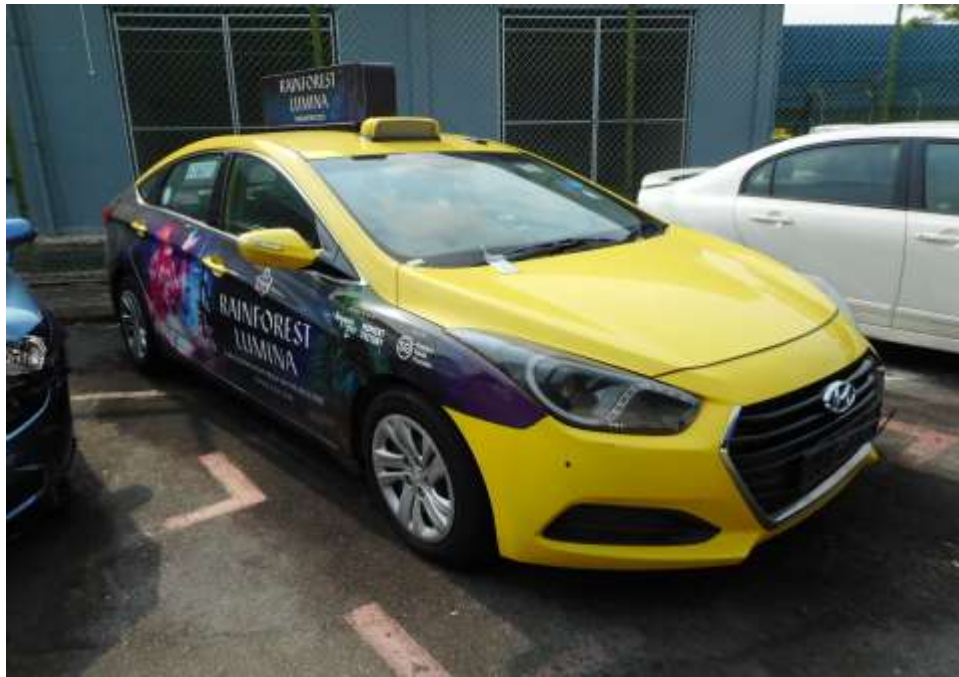
**Photo 6** shows a general view of the Motor Taxi's right body at the time of my inspection. The right portion of the Motor Taxi was observed to have been unaffected by the accident.

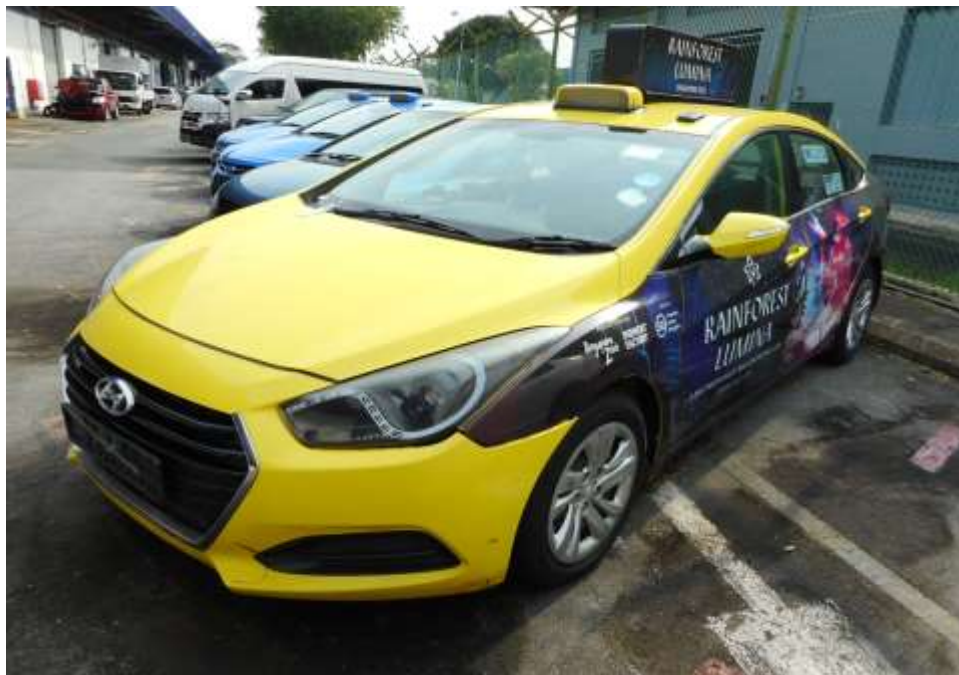
**Photo 7** shows a general view of the Motor Taxi's left body at the time of my inspection. The left portion of the Motor Taxi was observed to have been unaffected by the accident.

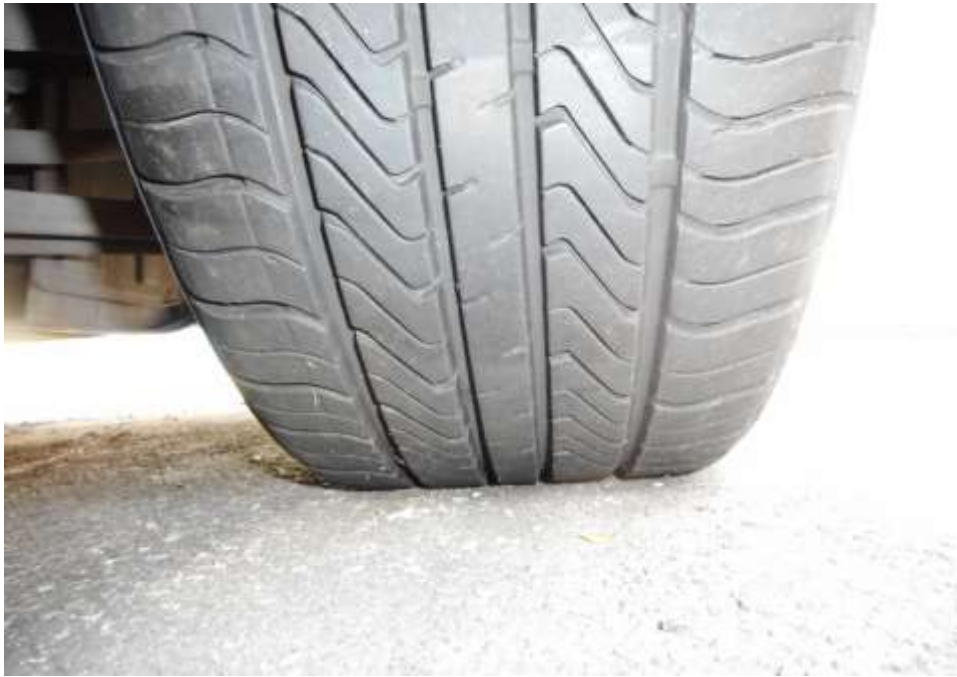
**Photo 8** shows the condition of the front right tyre of the Motor Taxi, which was observed to be in serviceable condition with remaining tread depth of approximately 5.9mm. The tyre was sufficiently inflated for vehicular operation with no tear, cut or burst mark(s) on the outer and the inner sidewalls as well as across the tread. The 4 tyres of the Motor Taxi were wrapped around standard steel wheel rims without any damage.

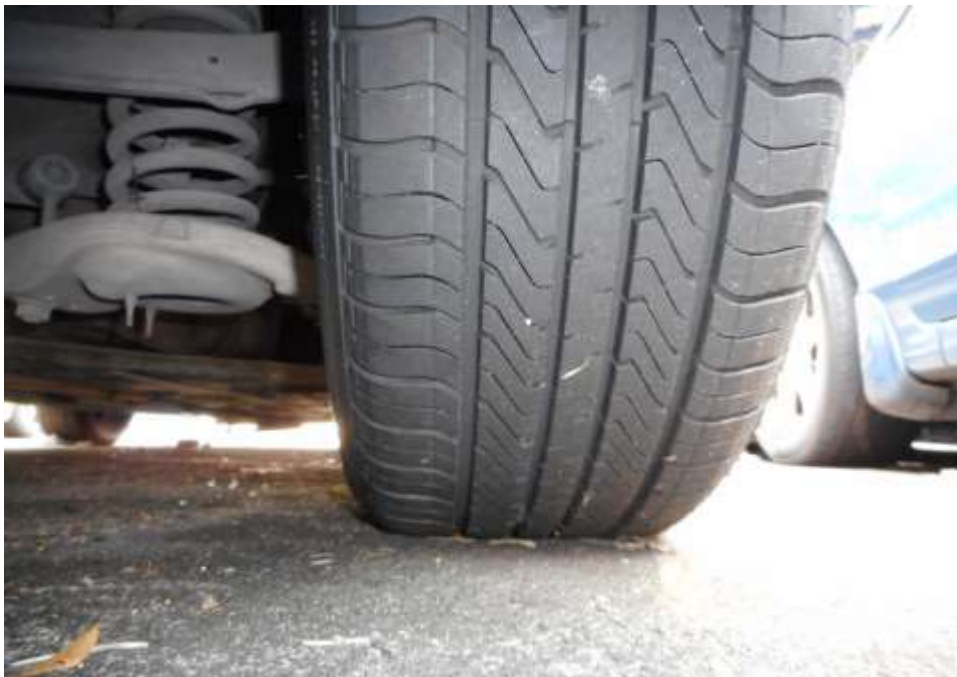
**Photo 9** shows the condition of the rear right tyre of the Motor Taxi, which was observed to be in serviceable condition with remaining tread depth of approximately 6.4mm. The tyre was also observed to be sufficiently inflated for vehicular operation with no tear, cut or burst mark(s).

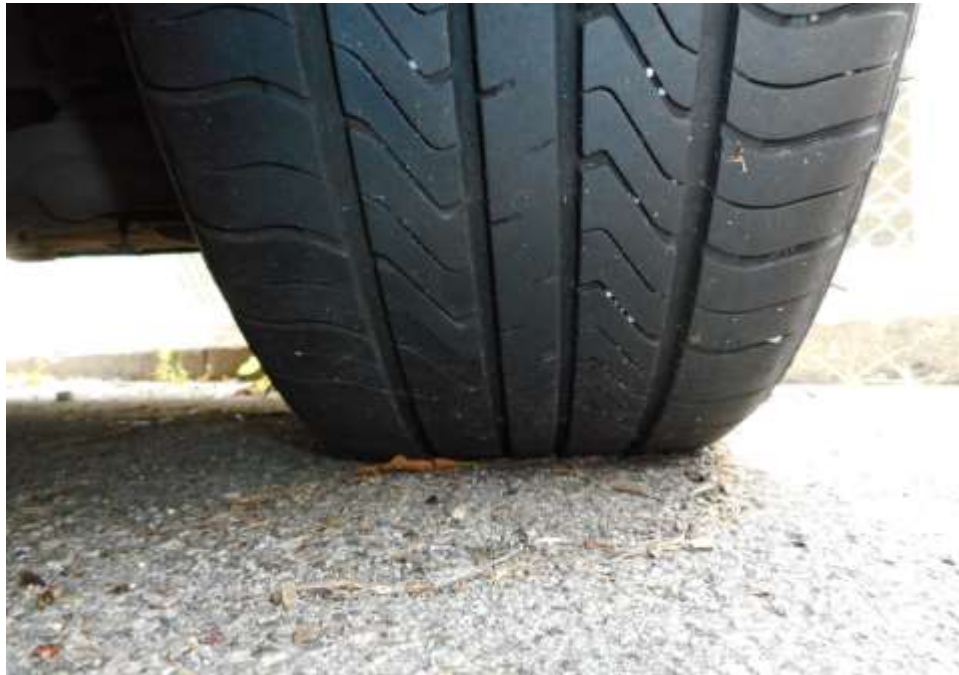
**Photo 10** shows the condition of the rear left tyre of the Motor Taxi, which was observed to be in serviceable condition with remaining tread depth of approximately 5.6mm. The tyre, which was wrapped around steel wheel rim, was also observed to be sufficiently inflated for vehicular operation. The 4 tyres of the Motor Taxi were wrapped around standard steel wheel rims.

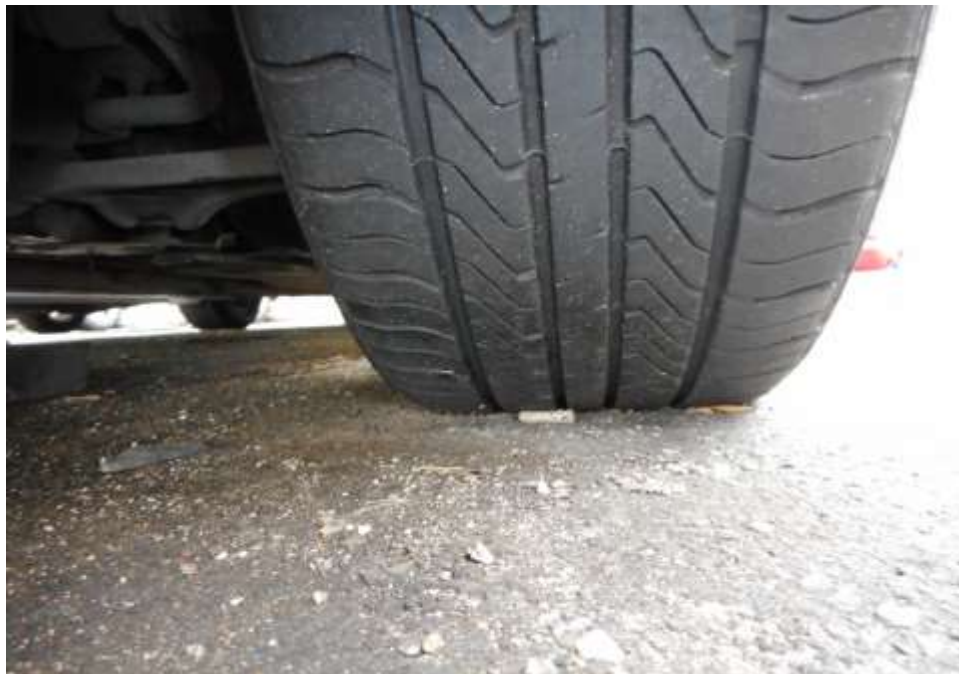
**Photo 11** shows the condition of the front left tyre of the Motor Taxi, which was observed to be in serviceable condition with remaining tread depth of approximately 4.1mm. There was also no tear, cut or burst mark(s) on the outer and the inner sidewalls as well as across the tread of the Motor Taxi's 4 tyres.

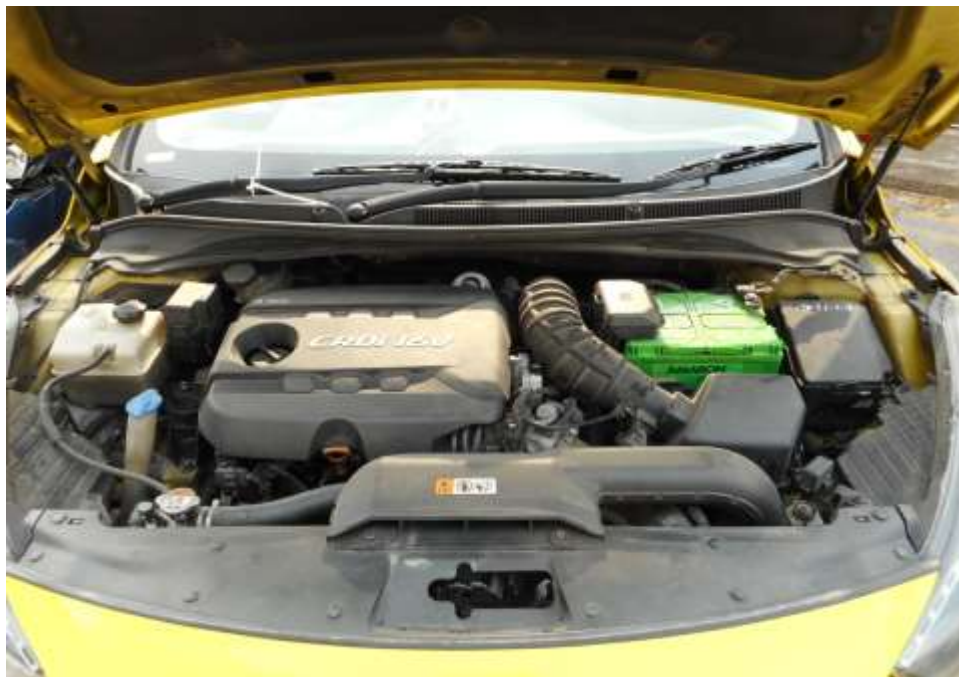
**Photo 12** shows a general view of the Motor Taxi's engine compartment. The various parts and components inside the engine compartment were unaffected by the accident. There was also no sign(s) or indication(s) of fluid leakage and/or fluid stain within the engine compartment.

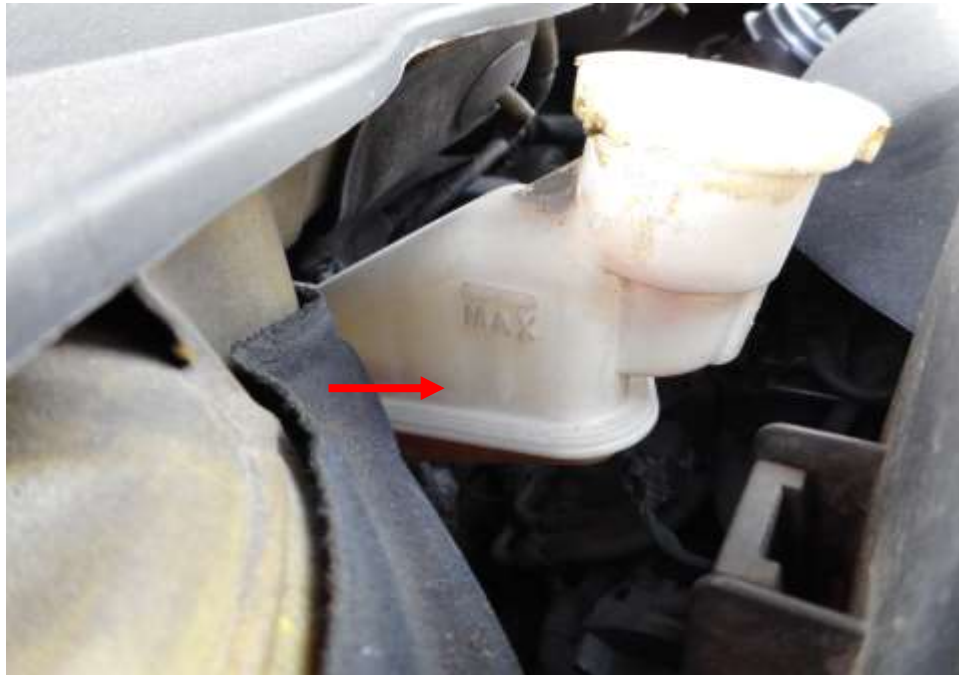
**Photo 13** shows the brake fluid reservoir of the Motor Taxi at the time of my inspection. The brake fluid was observed to be of sufficient level (arrowed) and without any visible contamination.

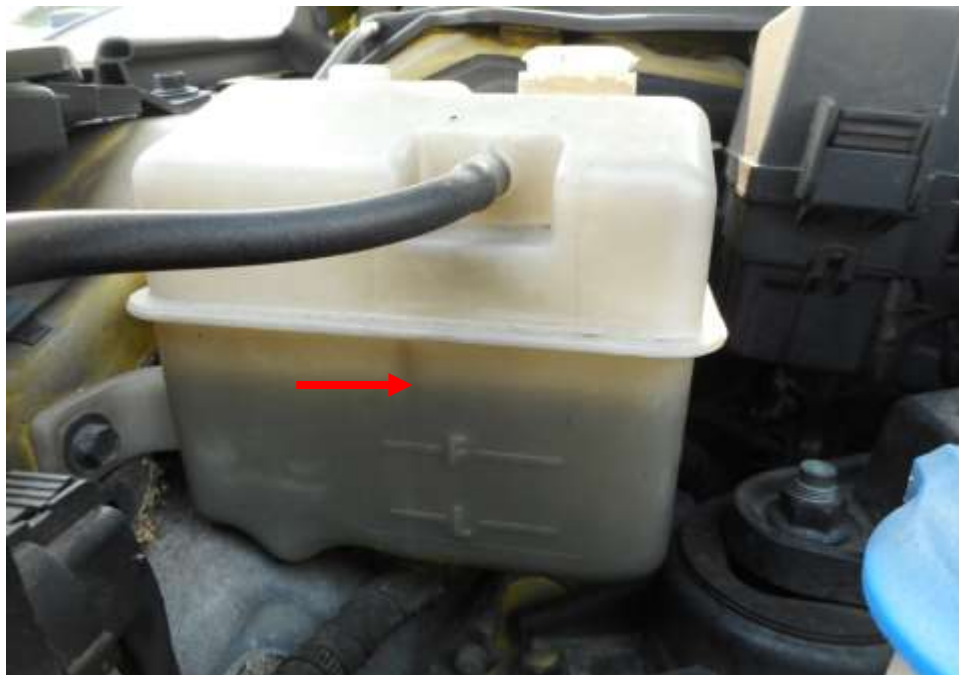
**Photo 14** shows checks being carried out to the engine coolant of the Motor Taxi at the time of my inspection. The engine coolant was observed to be of sufficient level (arrowed) and without any visible contamination.

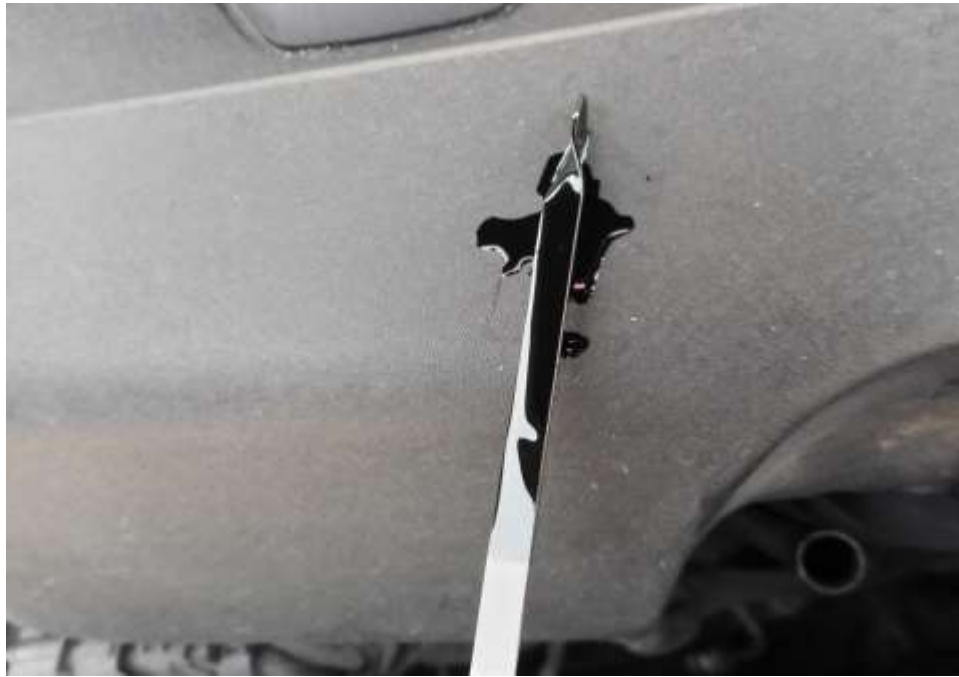
**Photo 15** shows the engine oil dip stick of the Motor Taxi at the time of my inspection. The engine oil was observed to be of sufficient level and without any visible contamination.

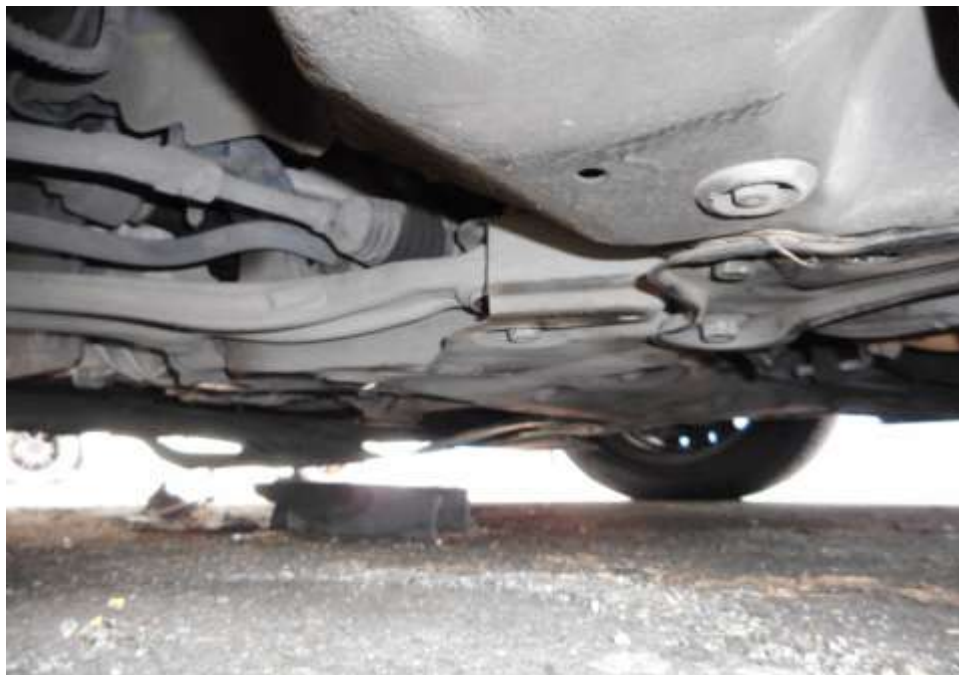
**Photo 16** shows the undercarriage of the Motor Taxi, at the area where the engine housing and transmission housing are located. I did not find any sign(s) or indication(s) of fluid leak and/or fluid stain(s) on the underside of the Motor Taxi.

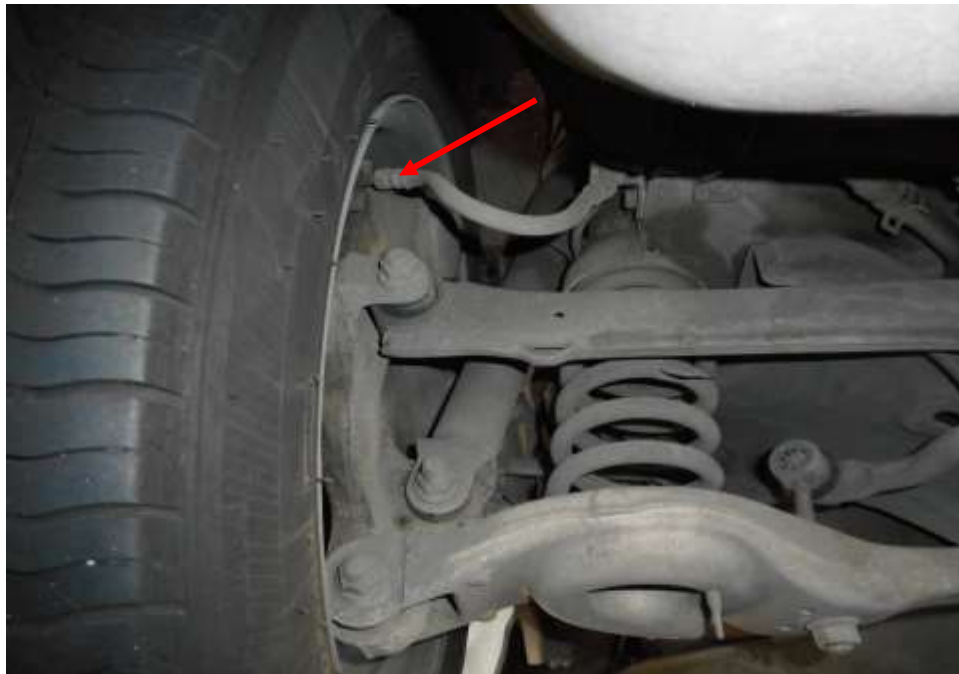
**Photo 17** shows the brake hose/pipe (arrowed) at the rear left wheel of the Motor Taxi. I did not observe any leakage of brake fluid at the time of my inspection of the Motor Taxi. Static tests of the Motor Taxi's braking system had indicated that there was no internal leakage of pressure/vacuum. The undercarriage components of the Motor Taxi were also all found to be intact and without any visible damage.

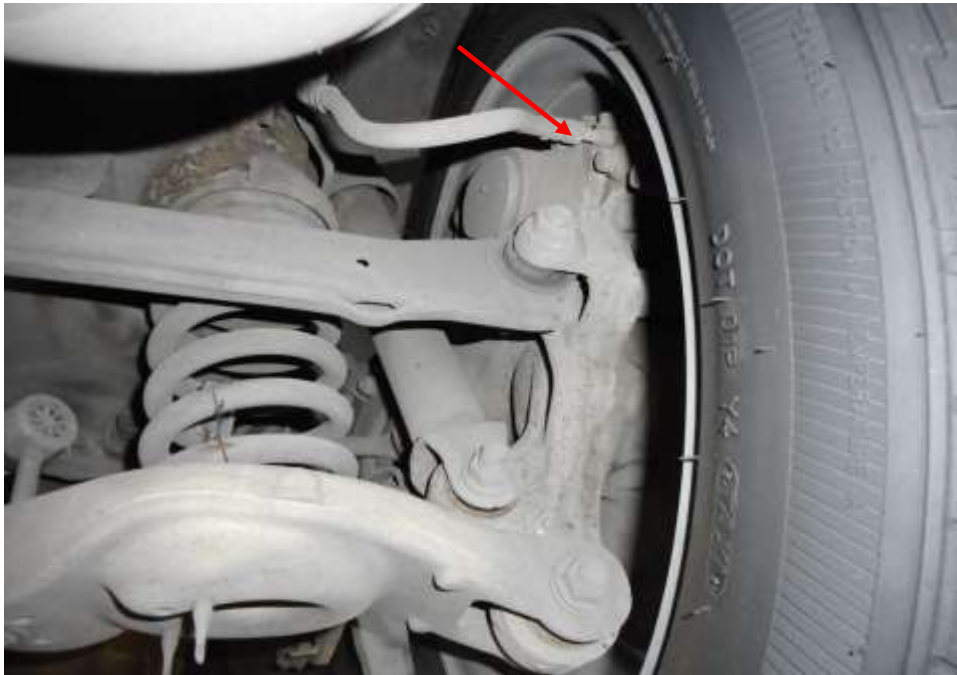
**Photo 18** shows the brake hose/pipe (arrowed) at the rear right wheel of the Motor Taxi. No leakage of brake fluid was observed. Visual examination of the various components of the braking system like the drum brake, brake booster, brake pedal etc had revealed all to be intact and without visible damage.

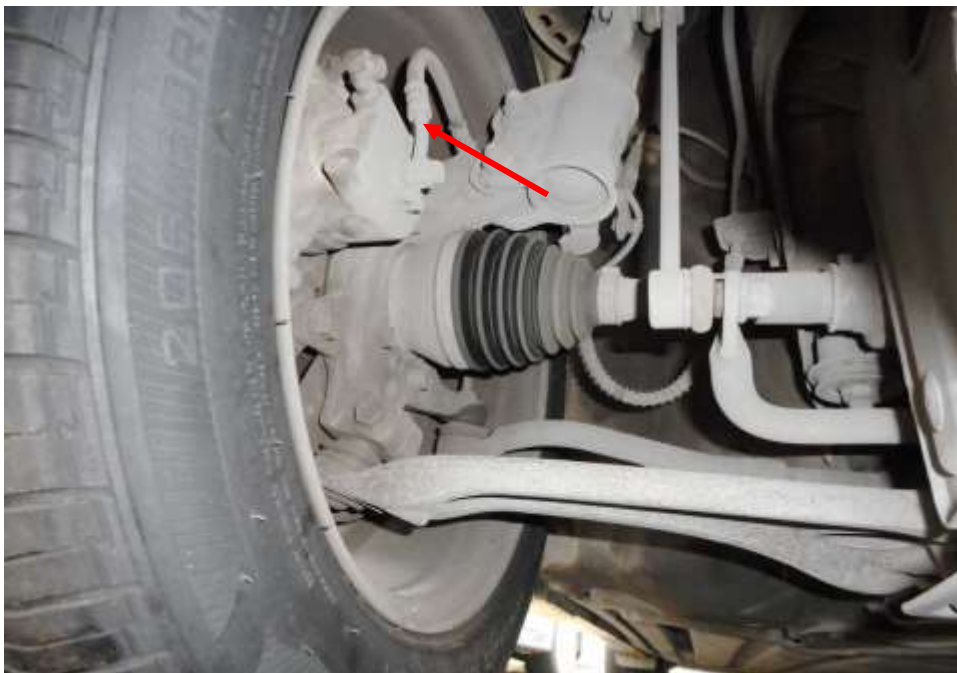
**Photo 19** shows the brake hose/pipe (arrowed) at the front right wheel of the Motor Taxi. I did not observe any leakage of brake fluid at the time of my inspection of the Motor Taxi. Static tests of the Motor Taxi's braking system had indicated that there was no internal leakage of pressure/vacuum. The undercarriage components of the Motor Taxi were also all found to be intact and without any visible damage.

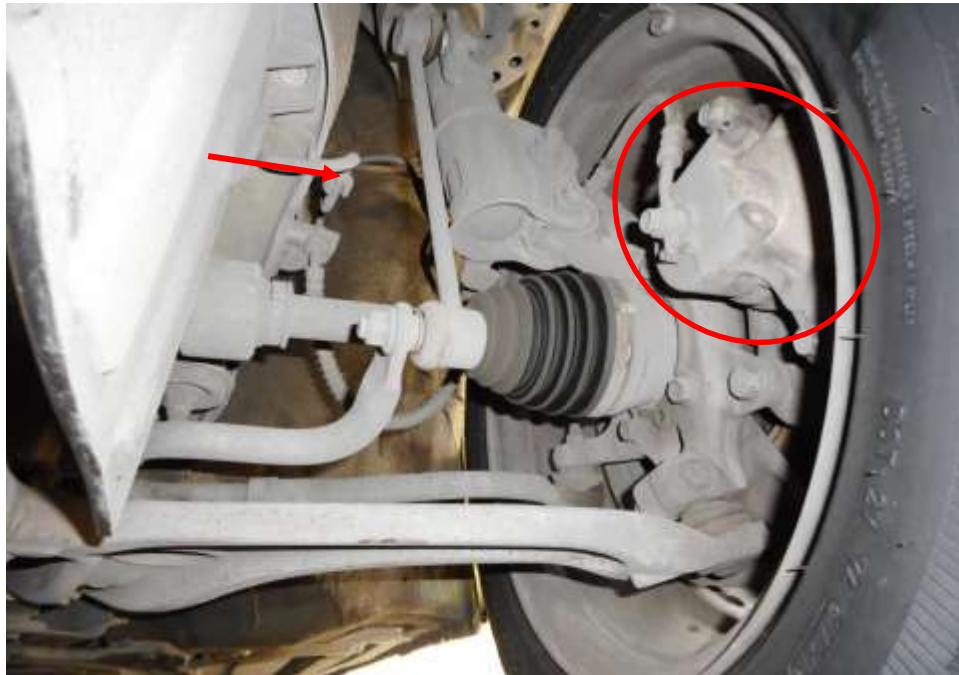
**Photo 20** shows the brake hose/pipe (arrowed) at the front left wheel of the Motor Taxi. No leakage of brake fluid was observed. Visual examination of the various components of the braking system like the brake caliper (circled), brake booster, brake pedal etc had revealed all to be intact and without visible damage.

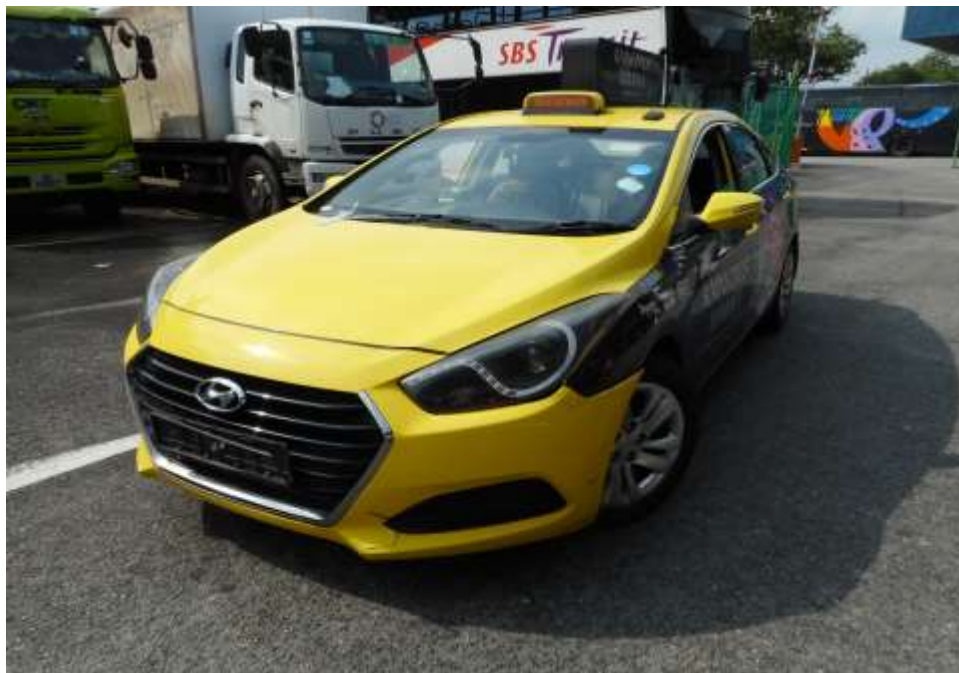
**Photo 21** shows the front left wheel of the Motor Taxi turned to its full right. During my steering system test, I did not experience any abnormal free play and/or resistance when I had turned the steering wheel towards the left and right. This would suggest that the steering system of the Motor Taxi was likely to be in serviceable condition at the material time of accident.

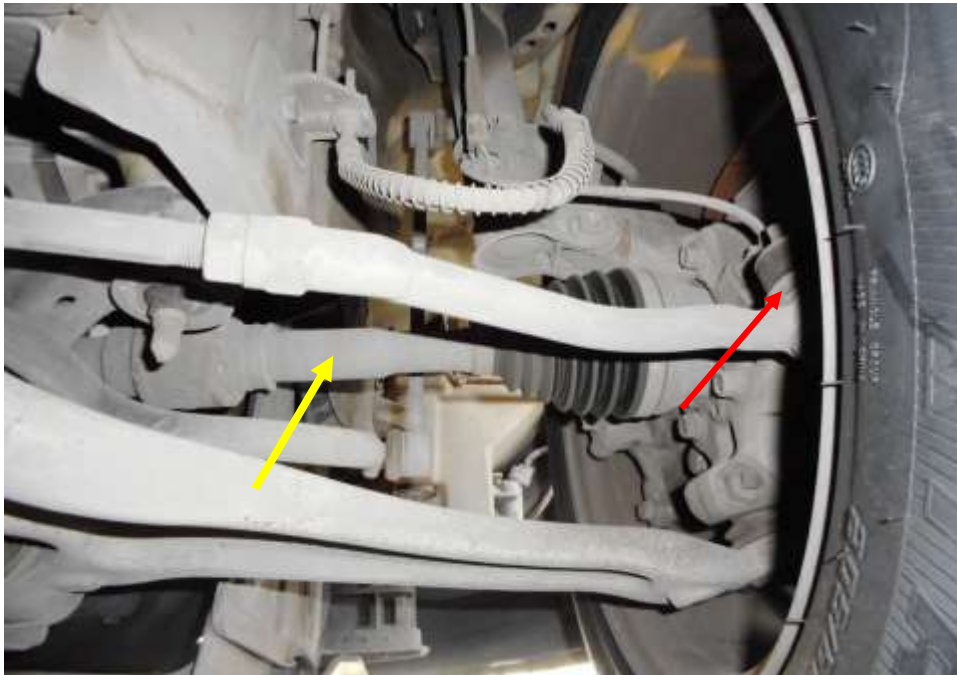
**Photo 22** shows the various undercarriage components at the front right wheel of the Motor Taxi, in particular the steering tie rod (red arrow) and drive shaft (yellow arrow). The various steering components were all found to be intact, suggesting that the steering system of the Motor Taxi was likely to be in serviceable condition at the material time of accident. There was also no sign of fluid stain observed on the various undercarriage components at the front right wheel of the Motor Taxi.

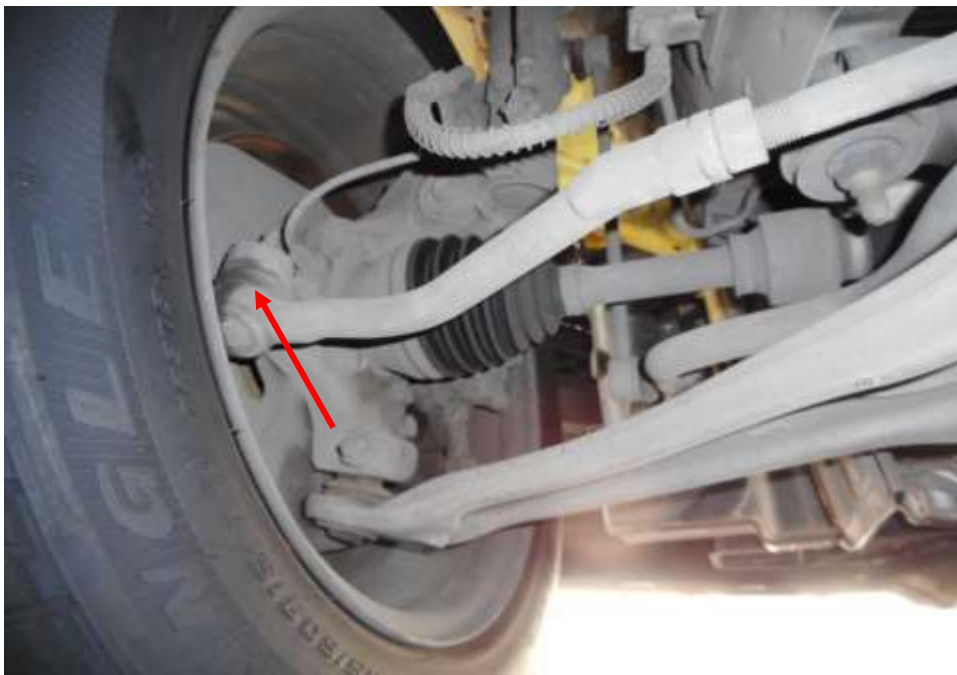
**Photo 23** shows the various undercarriage components at the front left wheel of the Motor Taxi, which had included the steering tie rod (red arrow). The various undercarriage components of the Motor Taxi were all found to be intact without any visible damage.

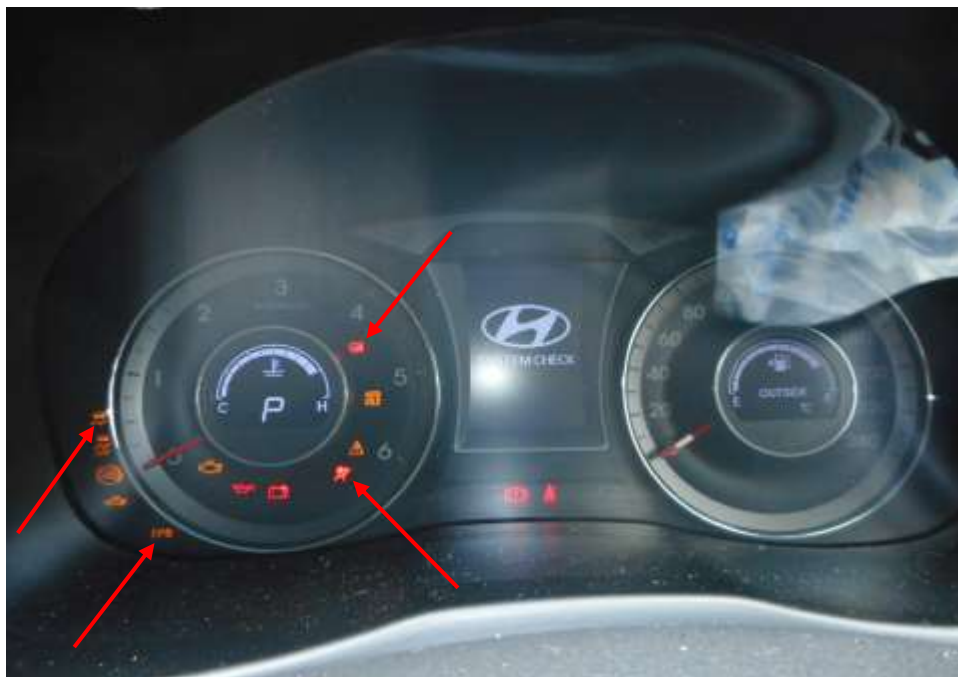
**Photo 24** shows the warning light for Anti-Lock Brake System (ABS), Electric Power Steering System (EPS) Traction control (TC) and Supplemental Restraint System (SRS) appearing on the instrument panel of the Motor Taxi during the self-test of its various electronic operating systems when its engine was cranked.

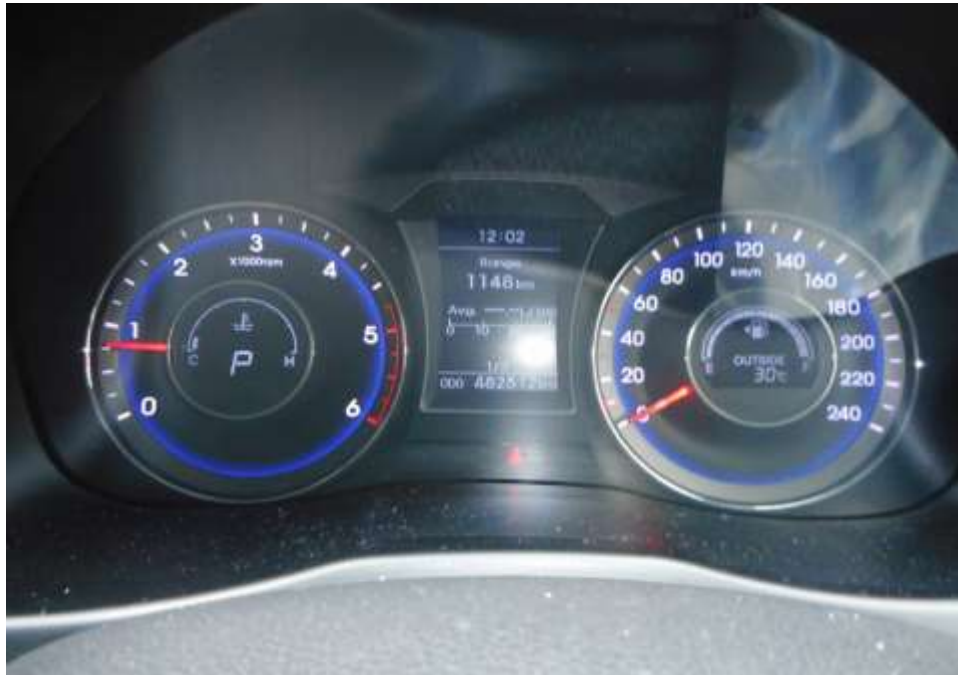
**Photo 25** shows no warning lights illuminated on the instrument panel of the Motor Taxi after the engine was cranked. This would suggest that there was no abnormality to the various electronic operating systems of the Motor Taxi, like the ABS, EPS, TC and SRS etc.
