Your Ref: TP/IP/39529/2019
Our Ref : CI/TPD19013851/N

14 August 2019

INSPECTION REPORT OF MOTORCYCLE FBK 2748G

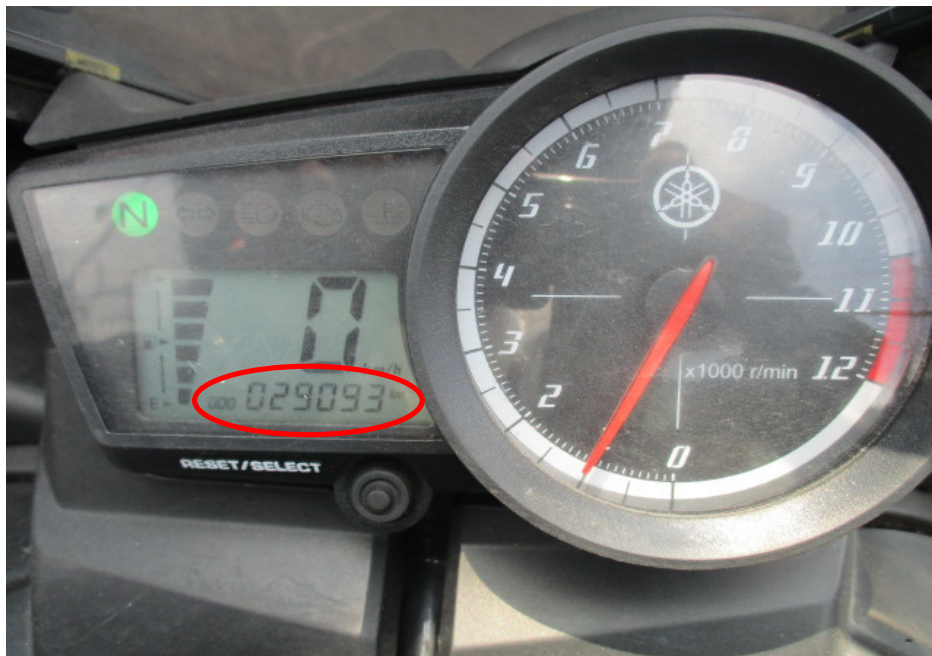
Photo 1 shows the speedometer gauge of the Motorcycle where the mileage recorded at the time of our inspection was 29, 093km (circled).

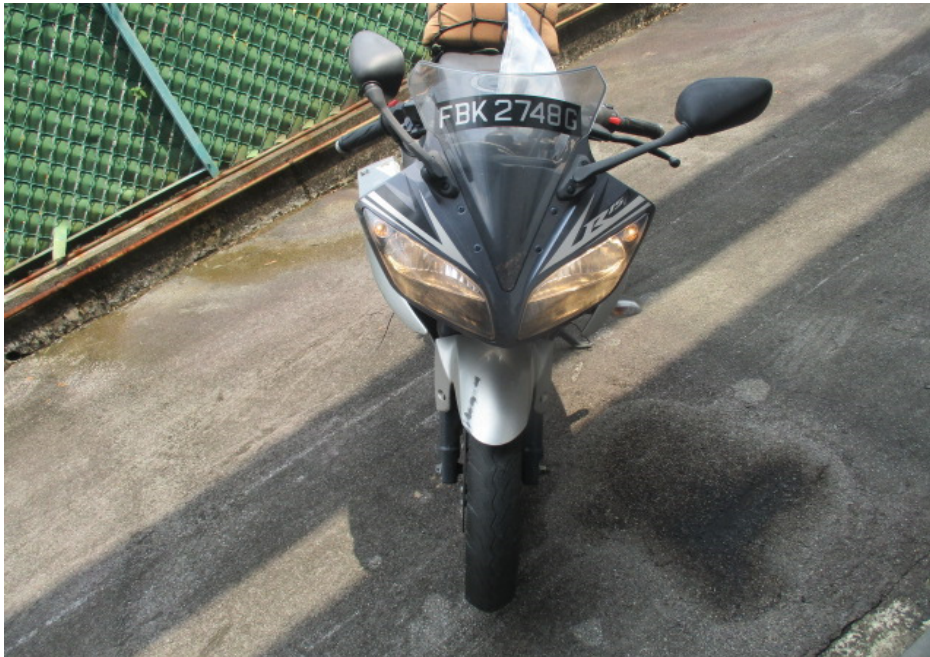
Photo 2 shows a general view of the frontal portion of the Motorcycle at the time of our inspection. The Motorcycle was observed to have sustained damages at its frontal portion and right body.

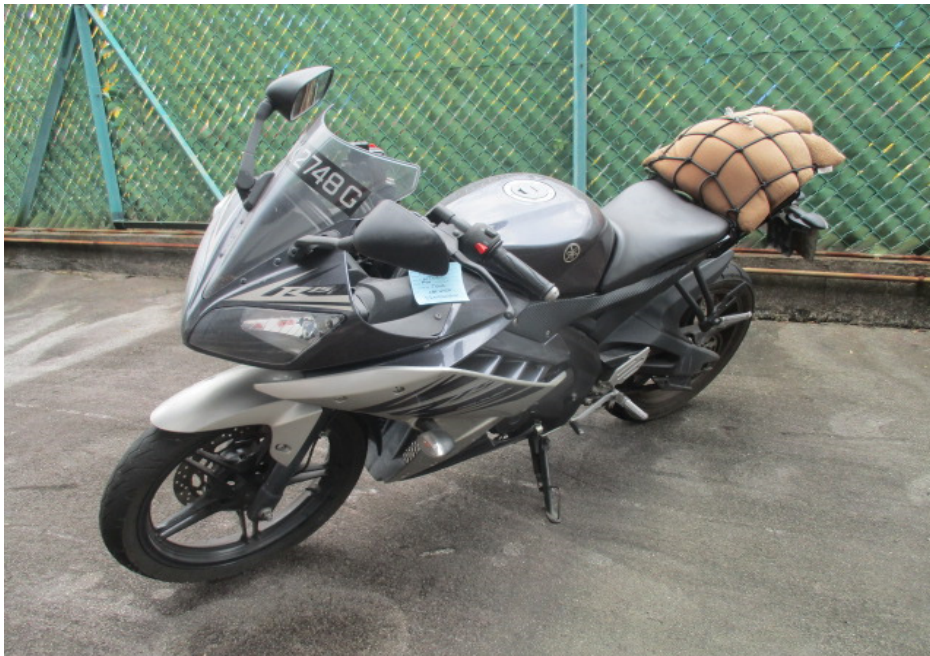
Photo 3 shows a general view of the left body of the Motorcycle at the time of our inspection. The Motorcycle was observed to have sustained damages at its frontal portion and right body.

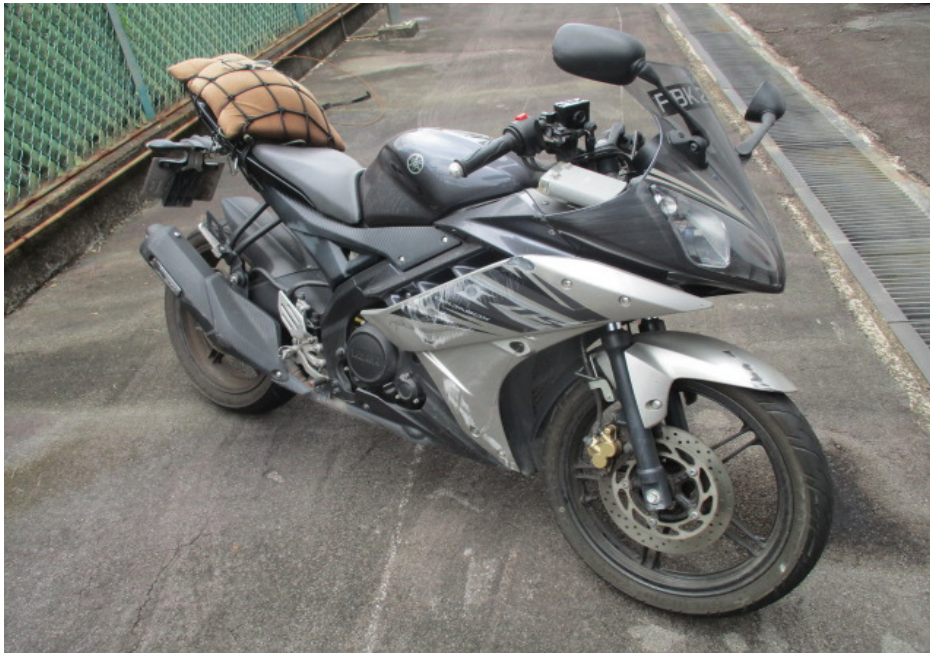
4. The mileage of the Motorcycle at the time of our inspection was 29, 093km.
5. The Motorcycle was observed to have sustained damages at its frontal portion and right body. The body parts that were found to have been damaged include its head cowling, right side cowling, right handlebar end, right side mirror, front brake lever, rear brake pedal, right front footrest, right rear side cover and exhaust muffler, amongst others.

Photo 4 shows a general view of the right body of the Motorcycle at the time of our inspection. The Motorcycle was observed to have sustained damages at its frontal portion and right body. Amongst the body parts that were found to have been damaged include its head cowling, right side cowling, right handlebar end, right side mirror, front brake lever, rear brake pedal, right front footrest, right rear side cover and exhaust muffler, amongst others.

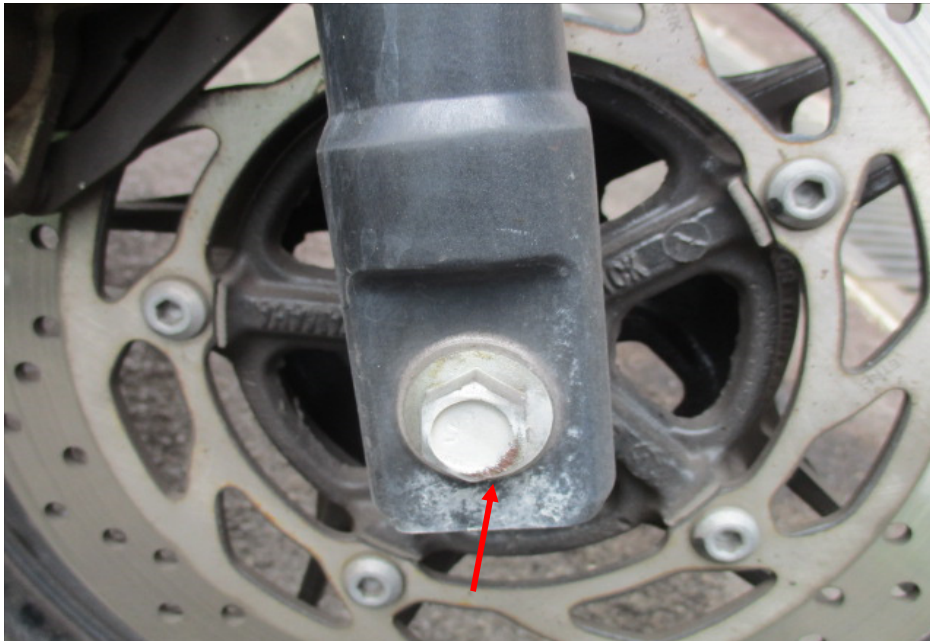
Photo 5 shows a closer view of the front wheel nut (arrowed) which was amongst the body parts at the front body of the Motorcycle that had sustained damage as a result of the accident.

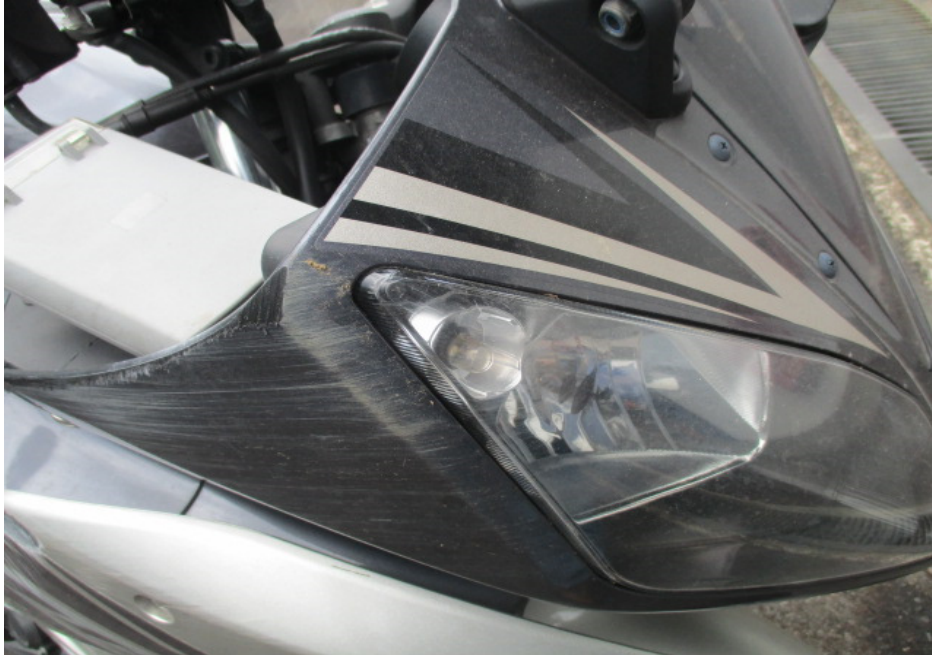
Photo 6 shows a close up view of the head cowling which was amongst the body parts of the Motorcycle that had sustained damage as a result of the accident.

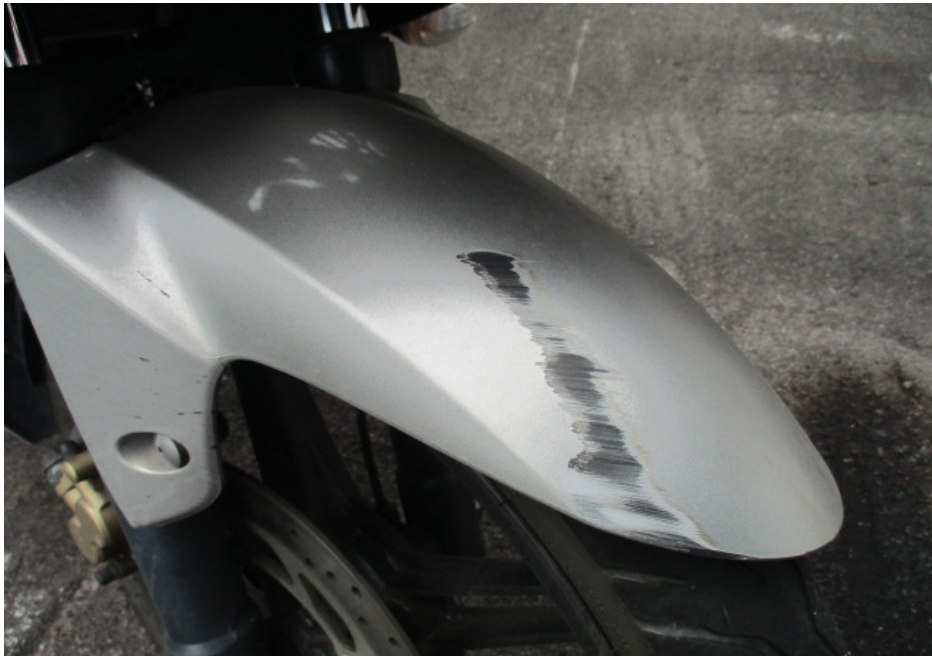
Photo 7 shows a closer view of the front mudguard which was amongst the body parts at the front body of the Motorcycle that had sustained damage as a result of the accident.

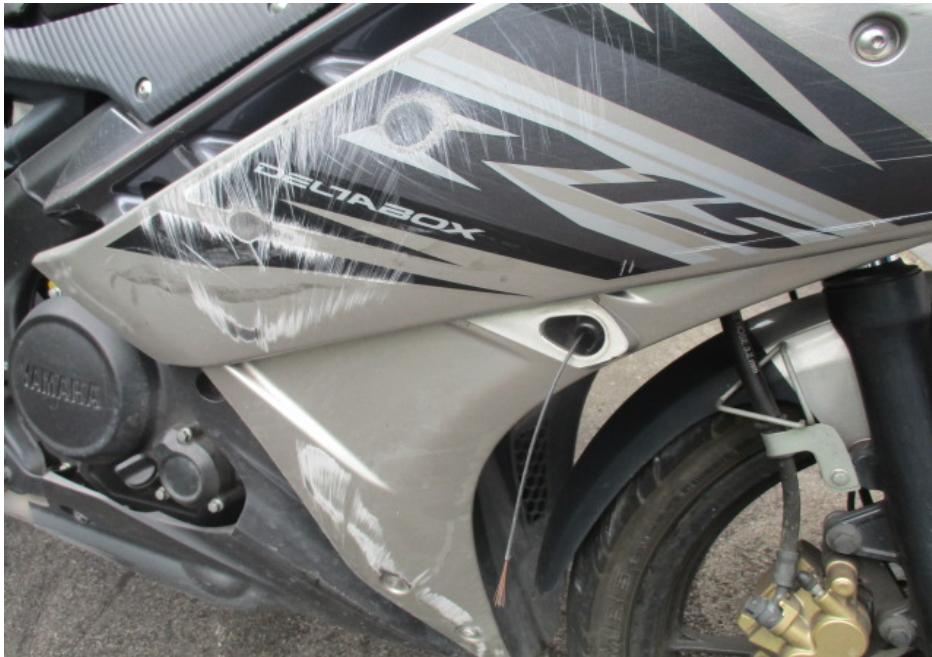
Photo 8 shows a closer view of the right cowling of the Motorcycle that had sustained damages of grazing nature as a result of the accident.

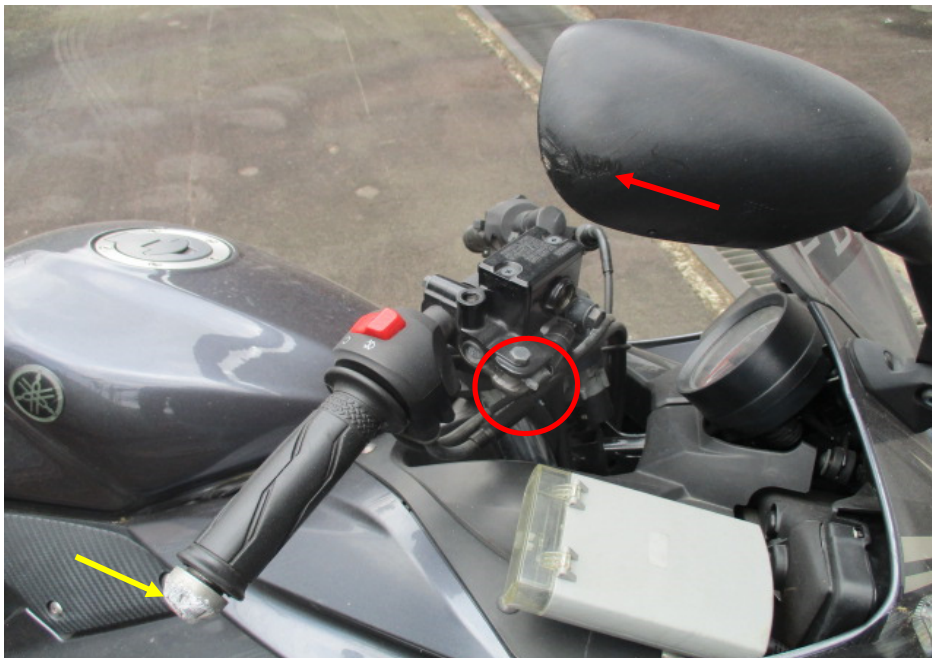
Photo 9 shows a closer view of the right handlebar end (yellow arrow), right side mirror (red arrow) and broken front brake lever (circled) which were amongst the body parts of the Motorcycle that had sustained damage as a result of the accident.

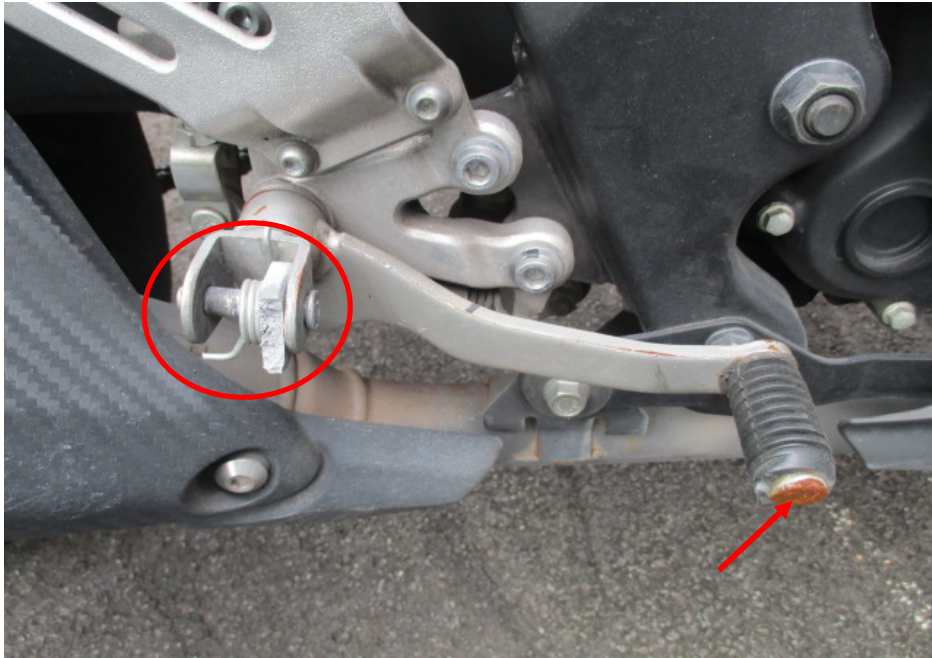
Photo 10 shows a closer view of the rear brake pedal (arrowed) and right front footrest (circled) which were amongst the body parts of the Motorcycle that had sustained damage as a result of the accident.

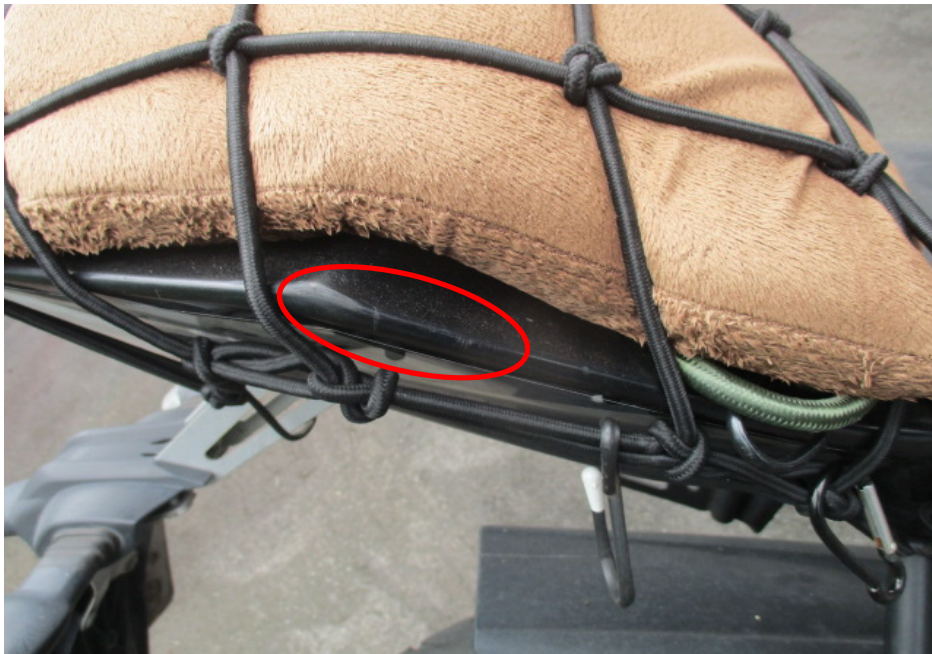
Photo 11 shows a closer view of the right rear side cover which was amongst the body parts of the Motorcycle that had sustained damages of grazing nature as a result of the accident (circled).

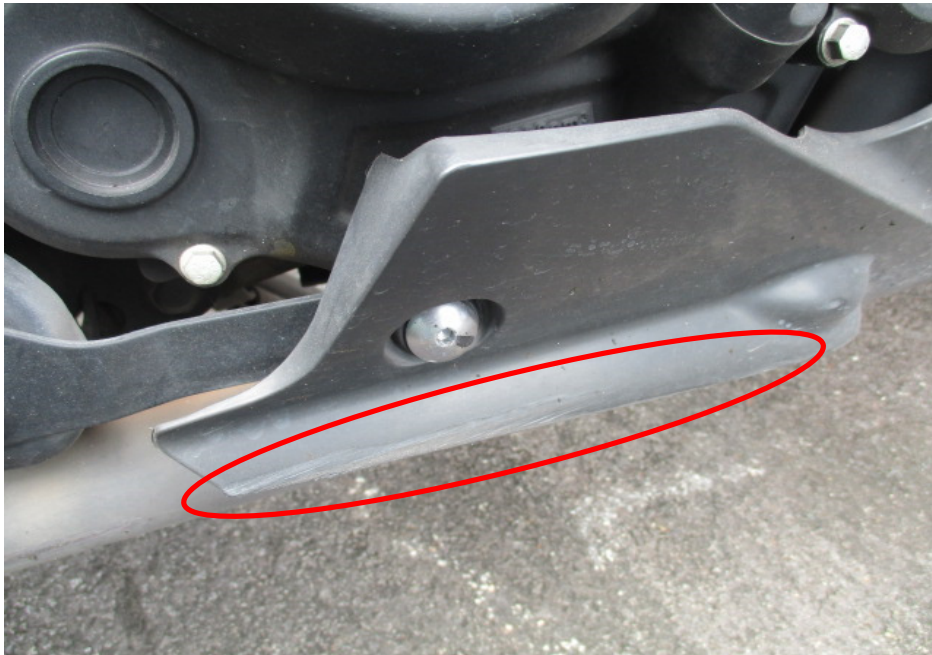
Photo 12 shows a closer view of the right bottom cowling which was amongst the body parts of the Motorcycle that had sustained damages of grazing nature as a result of the accident (circled).

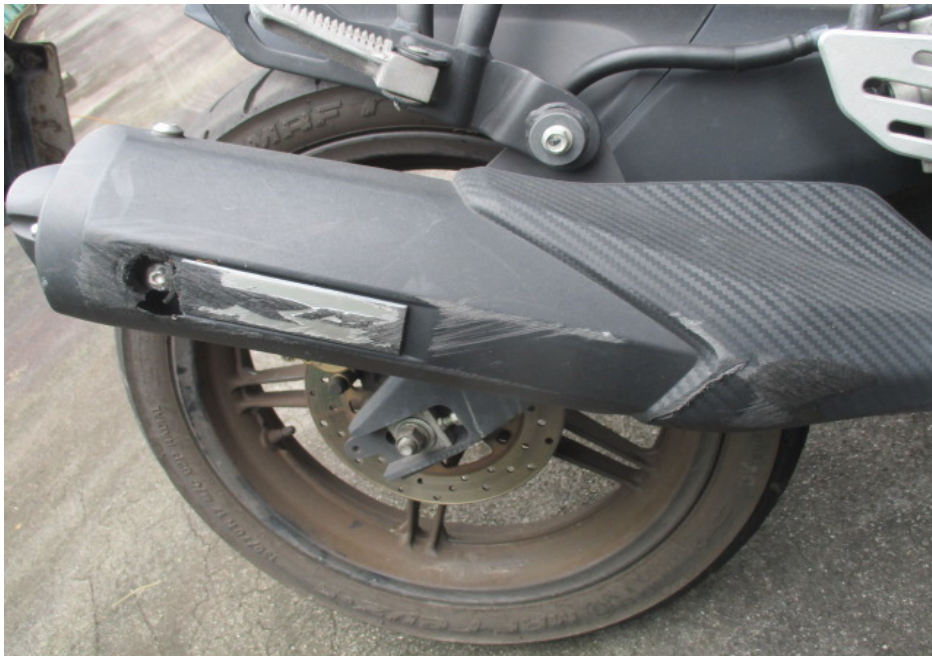
Photo 13 shows a closer view of the exhaust muffler and exhaust muffler heat shield of the Motorcycle that had sustained damages of grazing nature as a result of the accident.

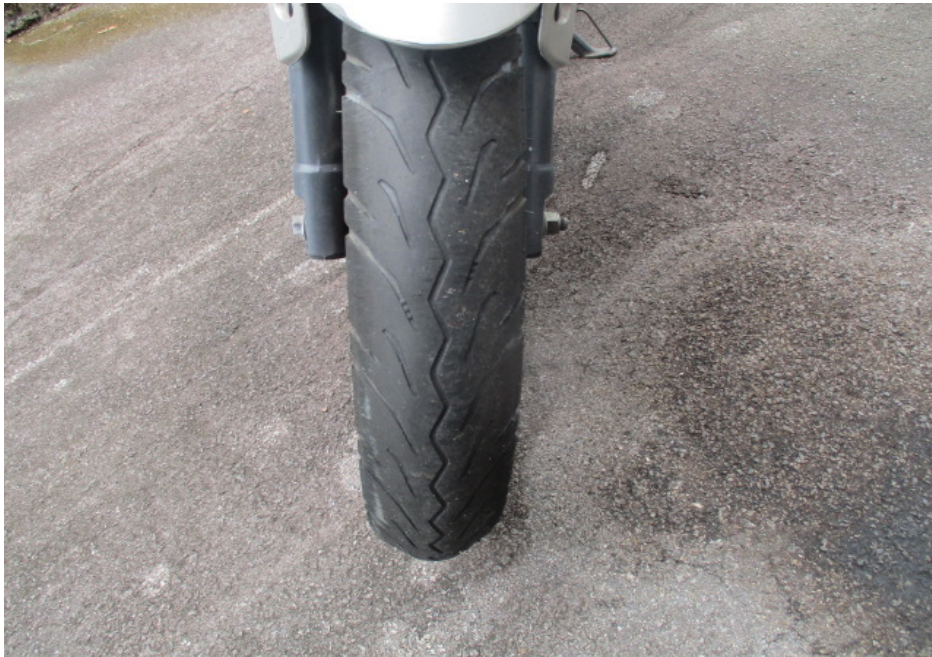
Photo 14 shows the condition of the Motorcycle's front tyre. The front tyre was observed to be in serviceable condition with remaining tread depth of approximately 3mm. There was no tear, burst mark(s) and/or punctured hole(s) on the sidewalls as well as across the tread of the front tyre.

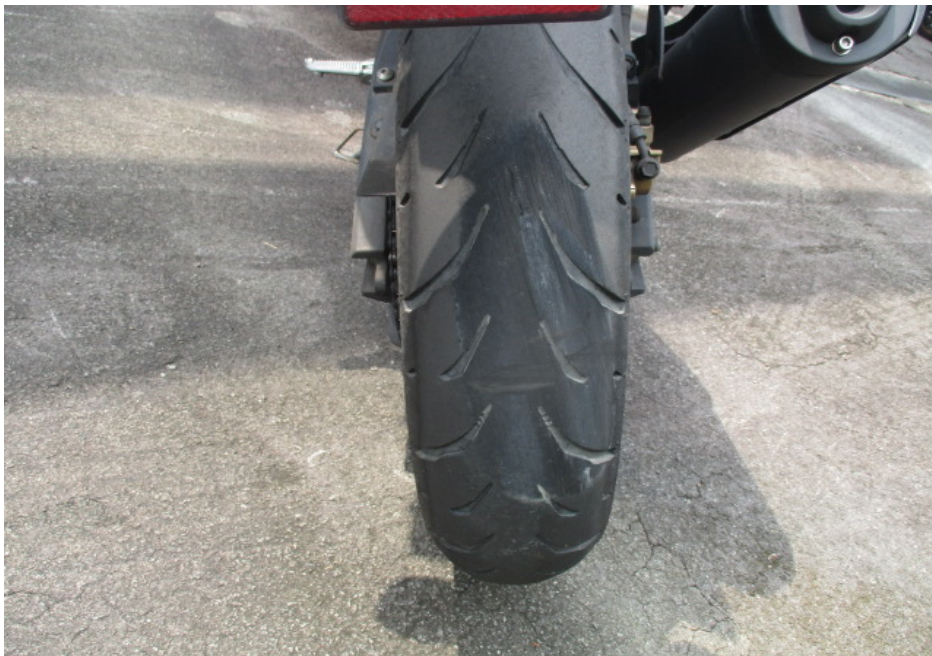
Photo 15 shows the condition of the Motorcycle's rear tyre. The rear tyre was observed to be in serviceable condition with remaining tread depth of approximately 3mm. The tyre was also observed to be sufficiently inflated for vehicular operation. We did not observe any tear, burst mark(s) and/or punctured hole(s) on the sidewalls as well as across the tread of the rear tyre.

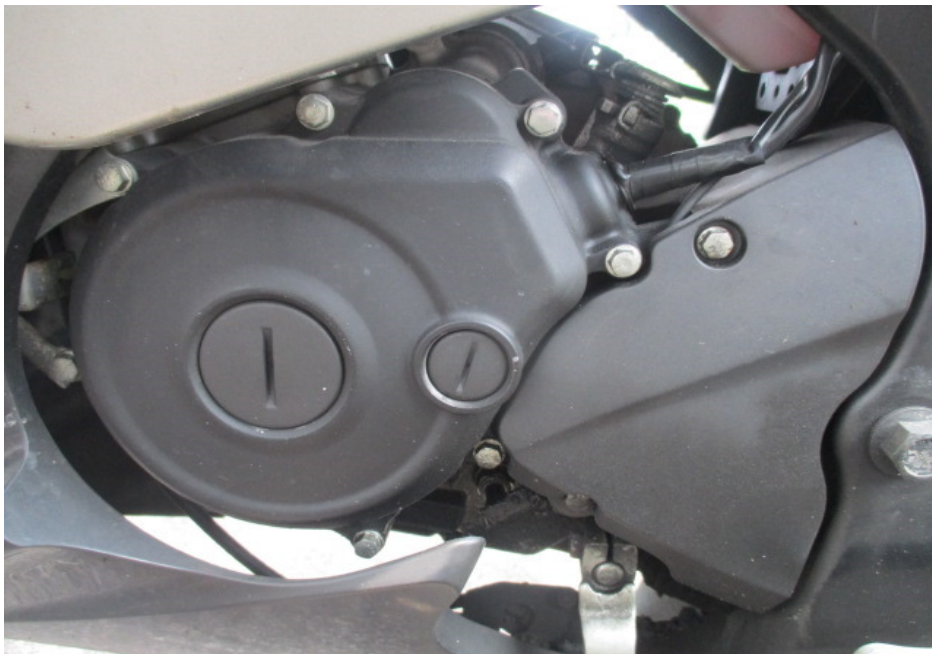
Photo 16 shows the left side of the engine of the Motorcycle at the time of our inspection. The various engine related parts and components were found to be intact with no visible damage. There was also no sign(s) or indication(s) of fluid leak observed around the left engine area of the Motorcycle.

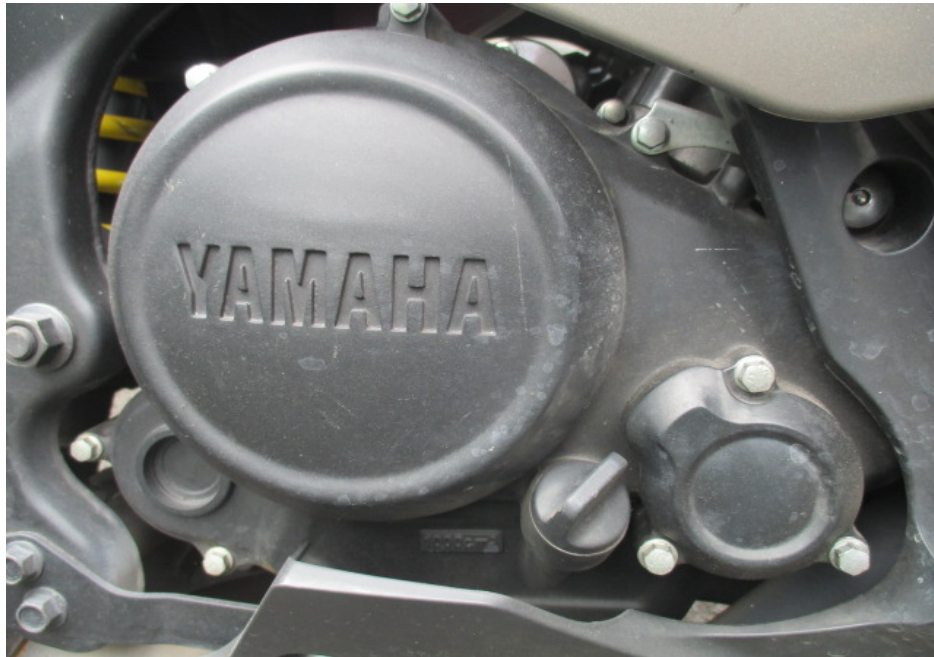
Photo 17 shows the right side of the engine of the Motorcycle at the time of our inspection. The various engine related parts and components were found to be intact with no visible damage. There was also no sign(s) or indication(s) of fluid leak observed around the right engine area of the Motorcycle.

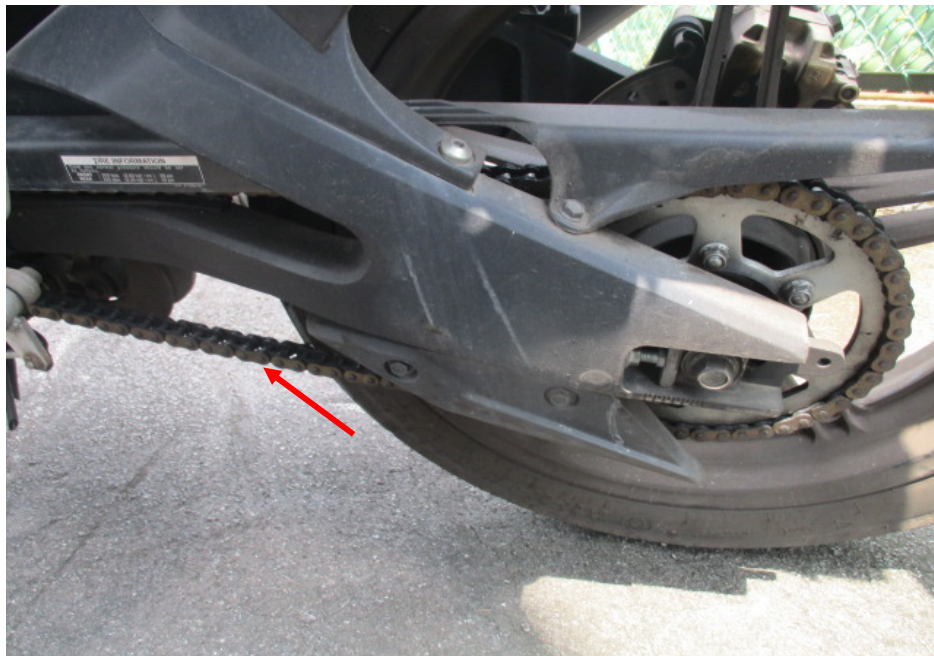
Photo 18 shows the general view of the gear train (arrowed) of the Motorcycle, which was observed to be intact with no misalignment. It was also adequately lubricated for operating purposes.

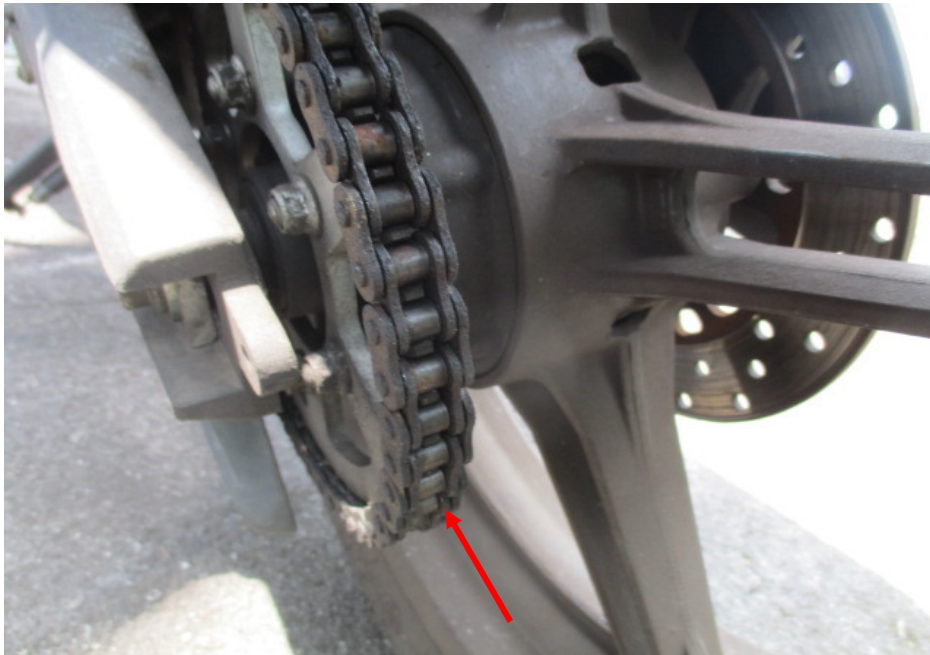
Photo 19 shows a closer view of the gear train (arrowed) of the Motorcycle, which was observed to be intact with no misalignment. It was also adequately lubricated for operating purposes.

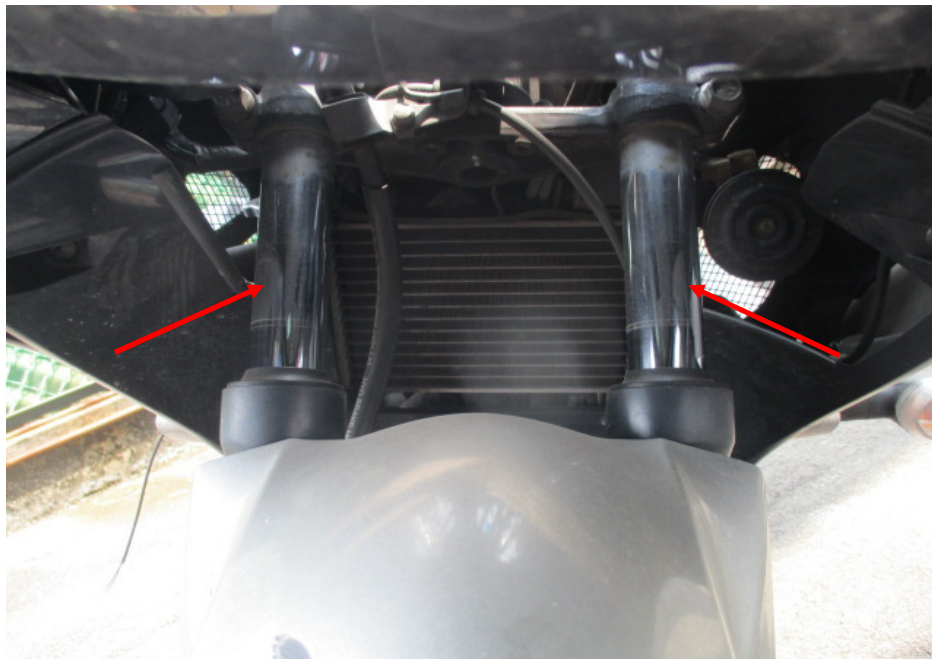
Photo 20 shows the front fork (arrowed) of the Motorcycle. The front fork and fork bracket of the Motorcycle were both found to be intact and undamaged. Turning the Motorcycle's handle bar towards the left and right did not produce any abnormal free play and/or resistance. The steering system of the Motorcycle was in serviceable condition at the time of our inspection.

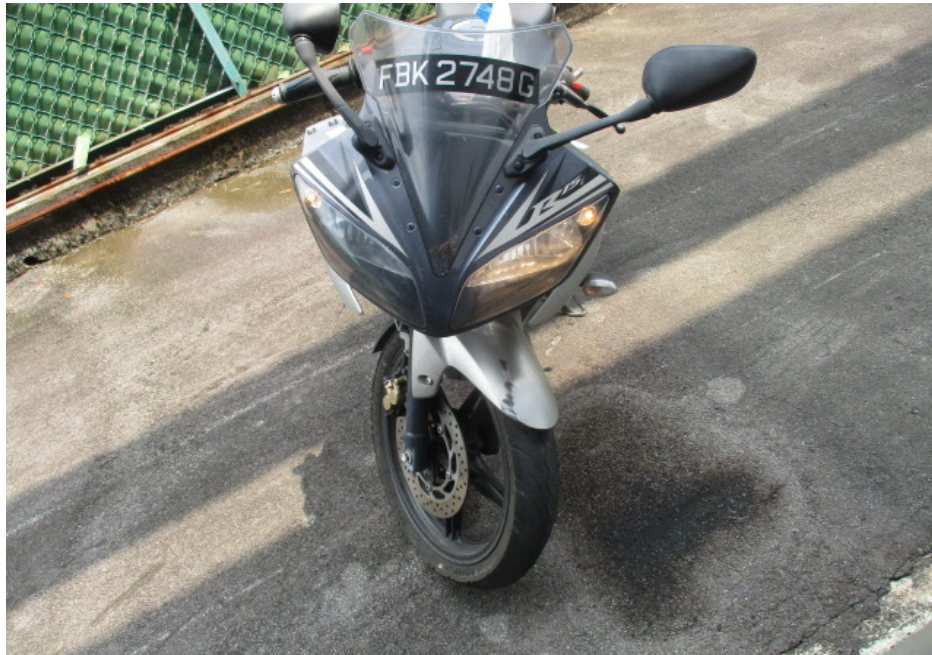
Photo 21 shows the front wheel of the Motorcycle turned towards its full left. Turning the Motorcycle's handle bar towards the left and right did not produce any abnormal free play and/or resistance. This would indicate that the steering system of the Motorcycle was in serviceable condition at the time of our inspection.

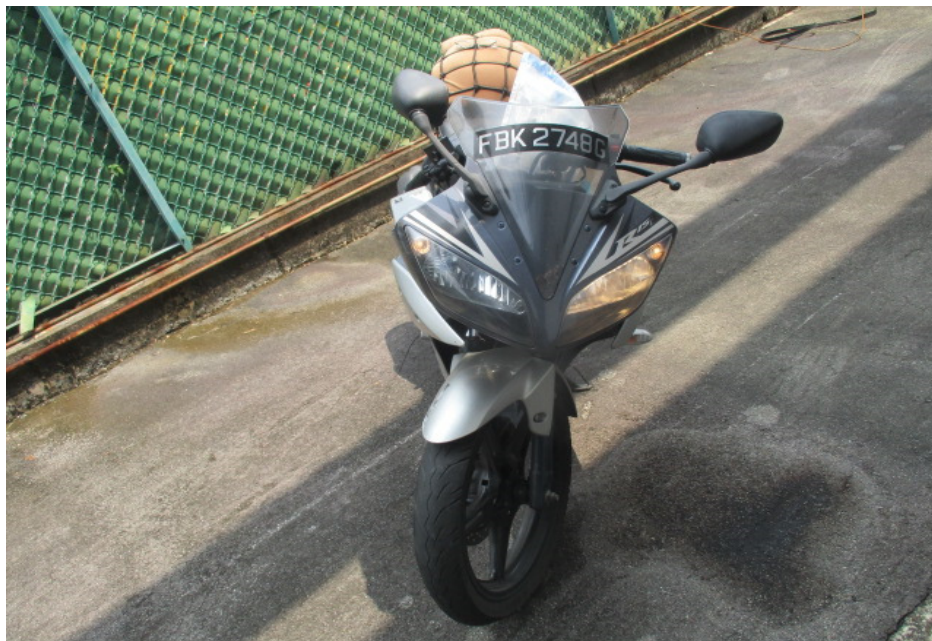
Photo 22 shows the front wheel of the Motorcycle turned towards its full right. Turning the Motorcycle's handle bar towards the left and right did not produce any abnormal free play and/or resistance. This would indicate that the steering system of the Motorcycle was in serviceable condition at the time of our inspection.

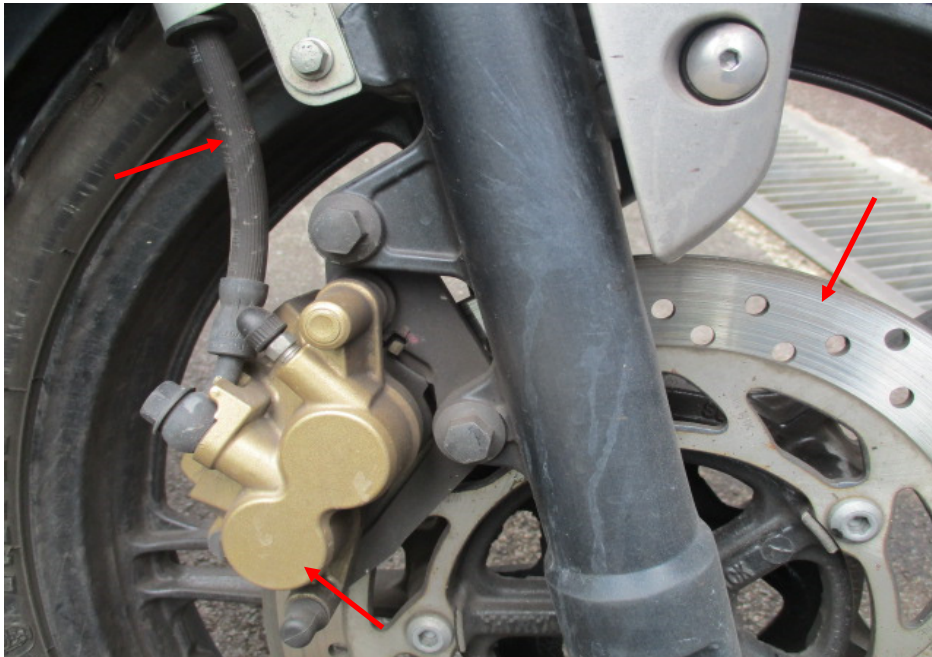
Photo 23 shows a close up view of the front brake caliper, front brake disc and front brake hose (arrowed) of the Motorcycle, which are all part of the components in the hydraulic front brake system of the Motorcycle. Our visual checks of these various components had revealed all to be intact with no visible damage. No leakage of brake fluid was also observed.

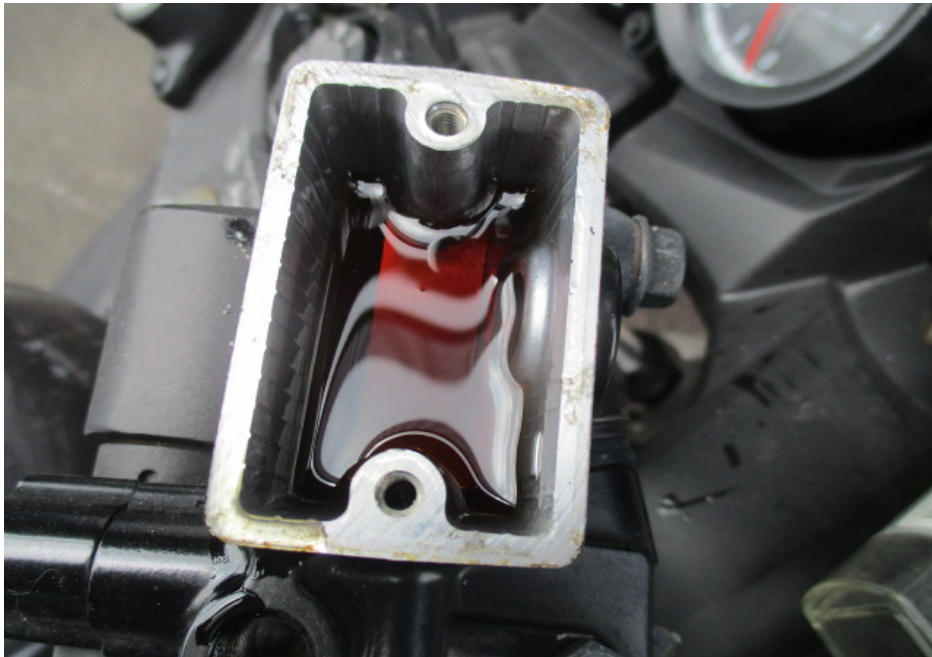
Photo 24 shows the brake fluid reservoir for the front brake of the Motorcycle. The brake fluid was observed to be of sufficient level and without contamination for operational purposes.

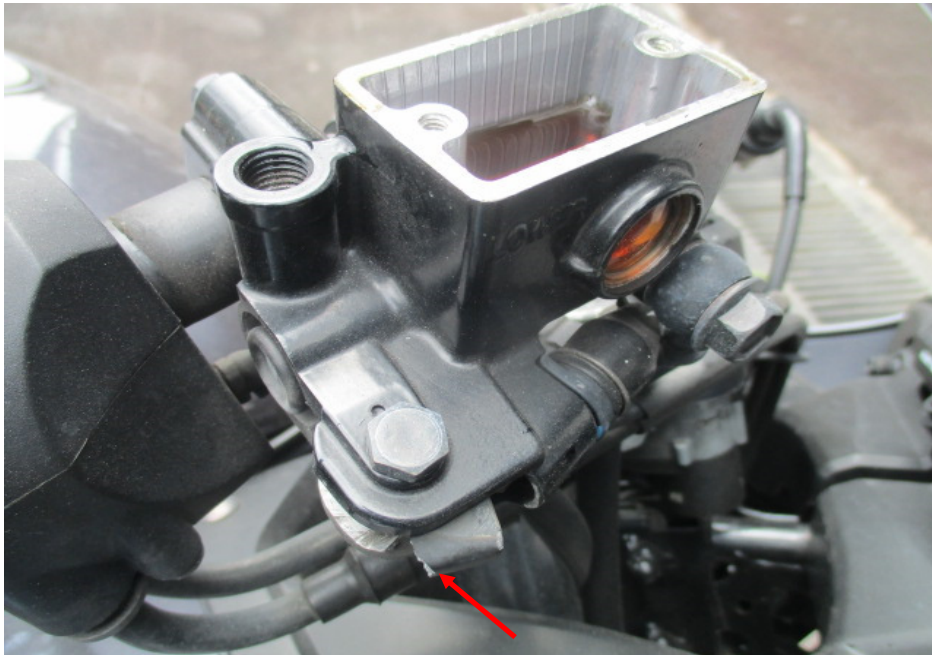
14. However we observed that part of the front brake lever had broken off as a result of the accident. Hence static as well as operational brake tests could not be conducted on the Motorcycle front braking system. We were unable to determine if there was any leakage of pressure/vacuum in the front brake system.
15. We subsequently carried out an operational test of the Motorcycle's rear braking system. This was done by manually pushing the Motorcycle forward and backward, simulating the Motorcycle in motion, and thereafter engaging the rear brake of the Motorcycle. At the end of the short operational test, we did not observe any abnormal behaviour of the Motorcycle's rear braking system. The rear wheel of the Motorcycle was able to stop rotating immediately upon stepping on the brake pedal. See photos 20 – 26 below.

Photo 25 shows the front brake reservoir. We were unable to depress the front brake lever as part of it had broken off as a result of the accident (arrowed). Hence we were unable to determine if there was any leakage of pressure/vacuum in the front brake system.

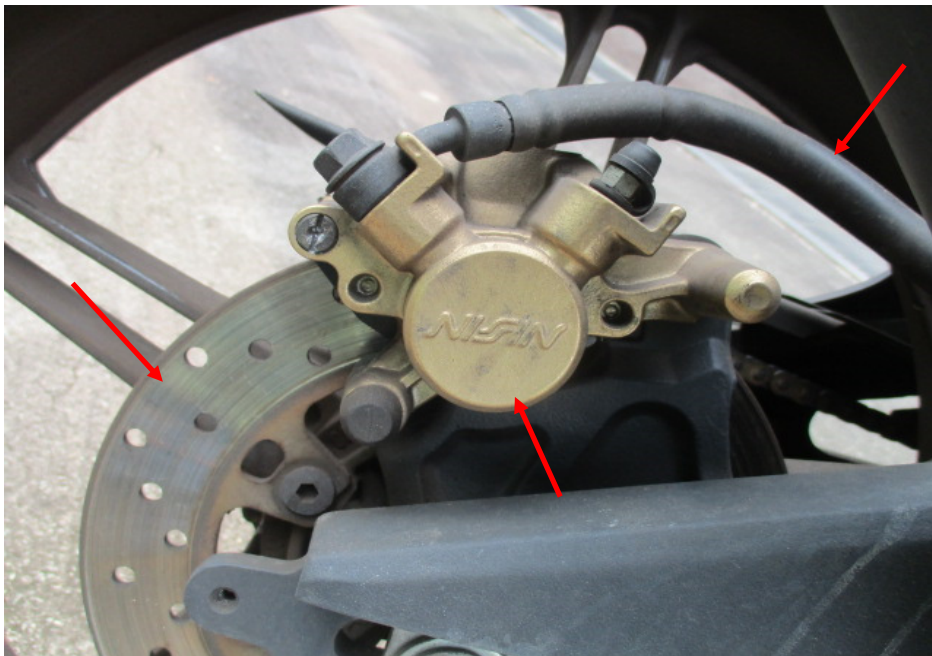
Photo 26 shows a close up view of the rear brake caliper, rear brake disc and rear brake hose (arrowed) of the Motorcycle, which are all part of the components in the hydraulic rear brake system of the Motorcycle. Our visual checks of these various components had revealed all to be intact with no visible damage. No leakage of brake fluid was also observed.
