Your Ref: TP/IP/43851/2019  
Our Ref :CI/TPD19013990/N

**Fatal Accident Investigation Team**

**INSPECTION REPORT OF MOTORCYCLE JNF 9548**

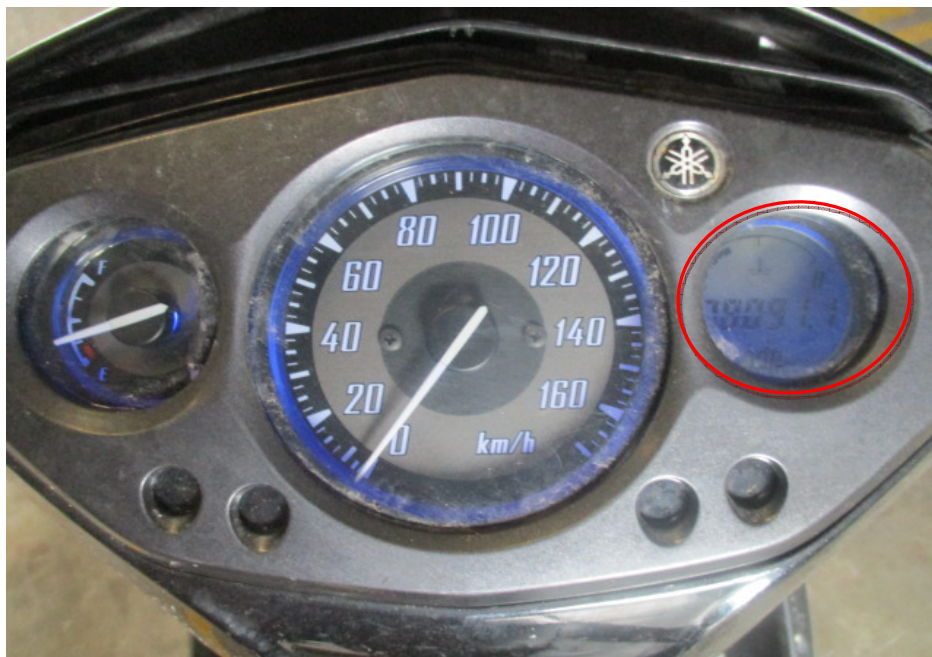
4. The mileage of the Motorcycle recorded at the time of our inspection was 78,091km.
5. The Motorcycle was observed to have sustained minor damages at the frontal portion and left body. The body parts that were found to have been damaged include its front cowling, headlamps, front mudguard, rear brake lever, left side mirror, left side cowling, left rear side cover, left pillion foot rest, left rear signal lamp and top box, amongst others as a result of the accident. See photos 1 – 12 below.

**Photo 1** shows the speedometer gauge of the Motorcycle where the mileage recorded at time of our inspection was 78, 091km.

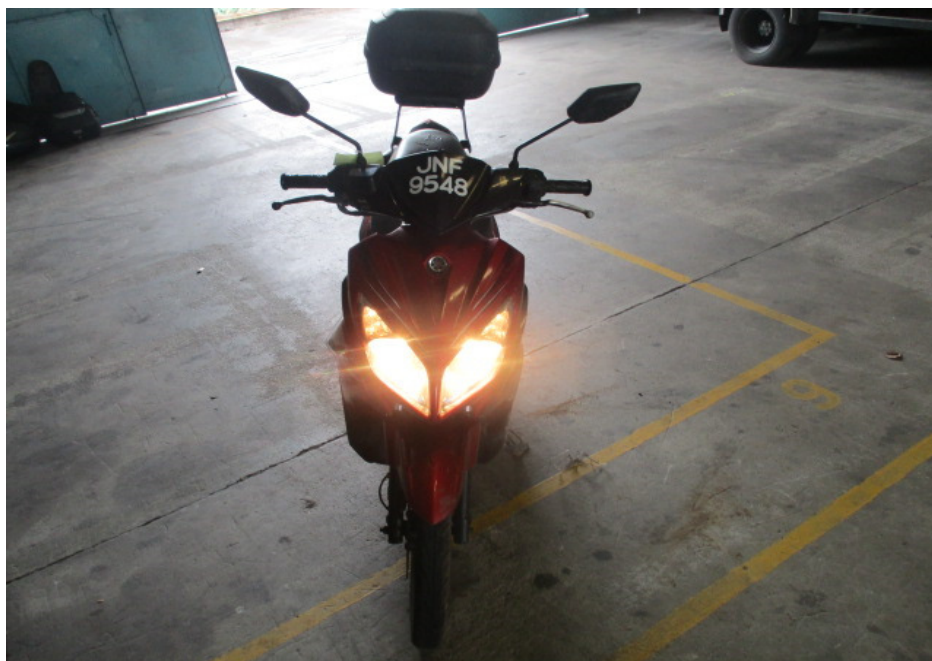
**Photo 2** shows a general view of the frontal portion of the Motorcycle at the time of our inspection. The Motorcycle was observed to have sustained minor damages at the frontal portion and left body.

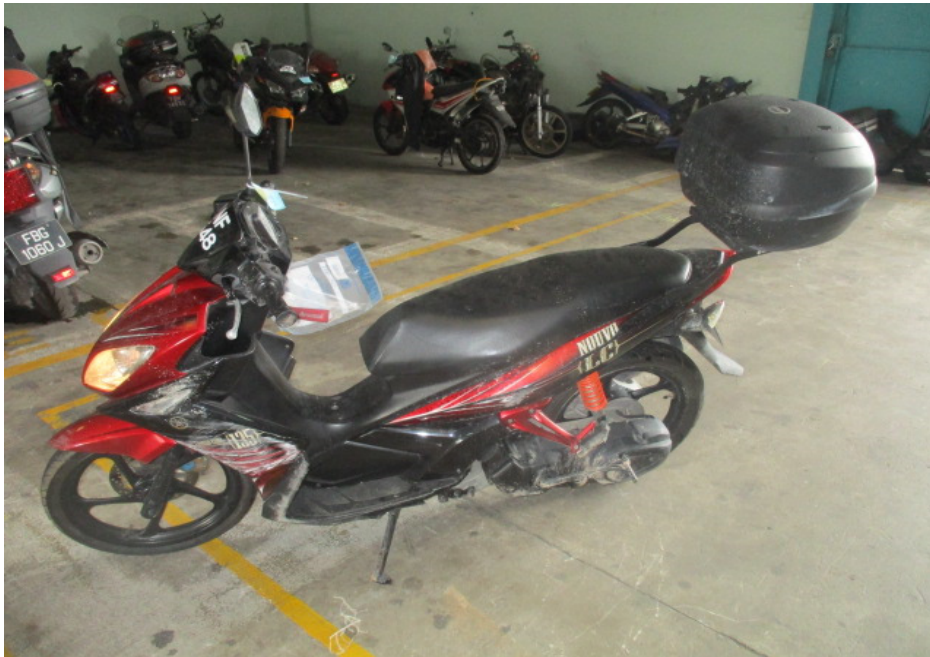
**Photo 3** shows a general view of the left body of the Motorcycle at the time of our inspection. The body parts that were found to have been damaged include its front cowling, headlamps, front mudguard, rear brake lever, left side mirror, left side cowling, left rear side cover, left pillion foot rest, left rear signal lamp and top box, amongst others as a result of the accident.

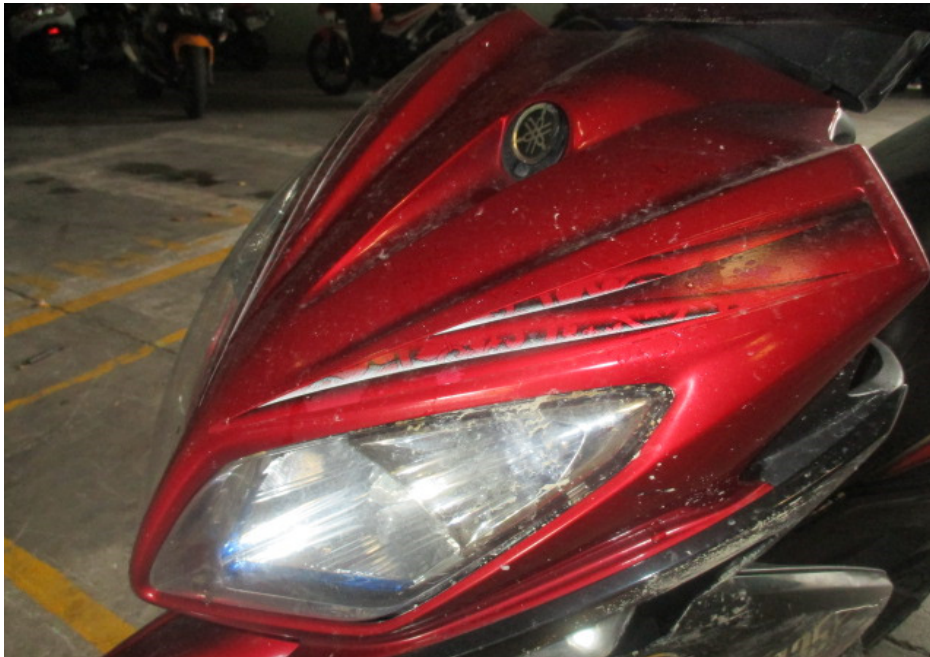
**Photo 4** shows a closer view of the front cowling of the Motorcycle at the time of our inspection. The Motorcycle was also observed to have sustained cracked headlights due to the accident.

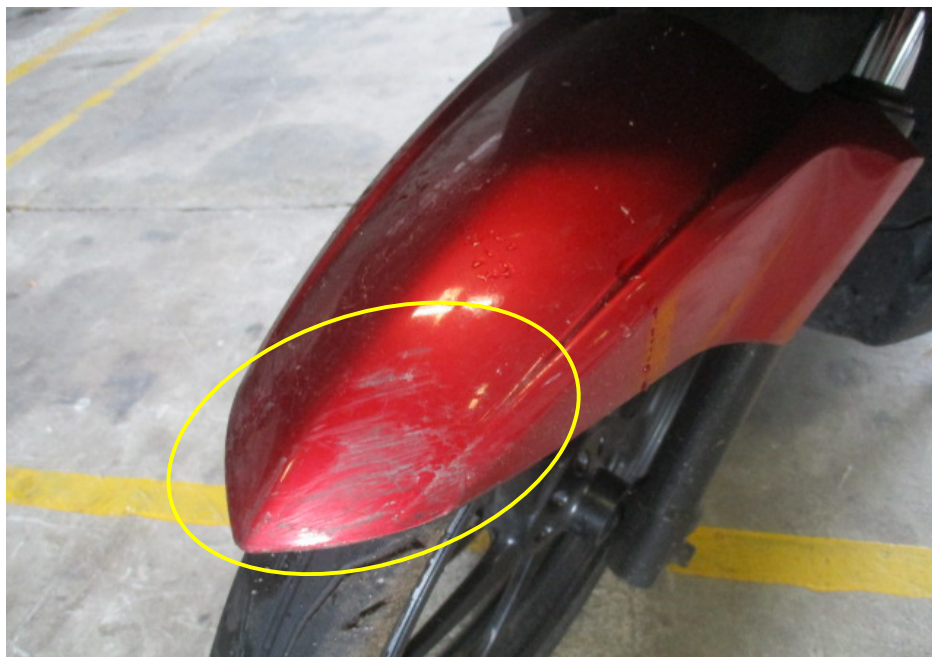
**Photo 5** shows a closer view of the front mudguard which was amongst the body parts at the front body of the Motorcycle that had sustained damage as a result of the accident (circled.)

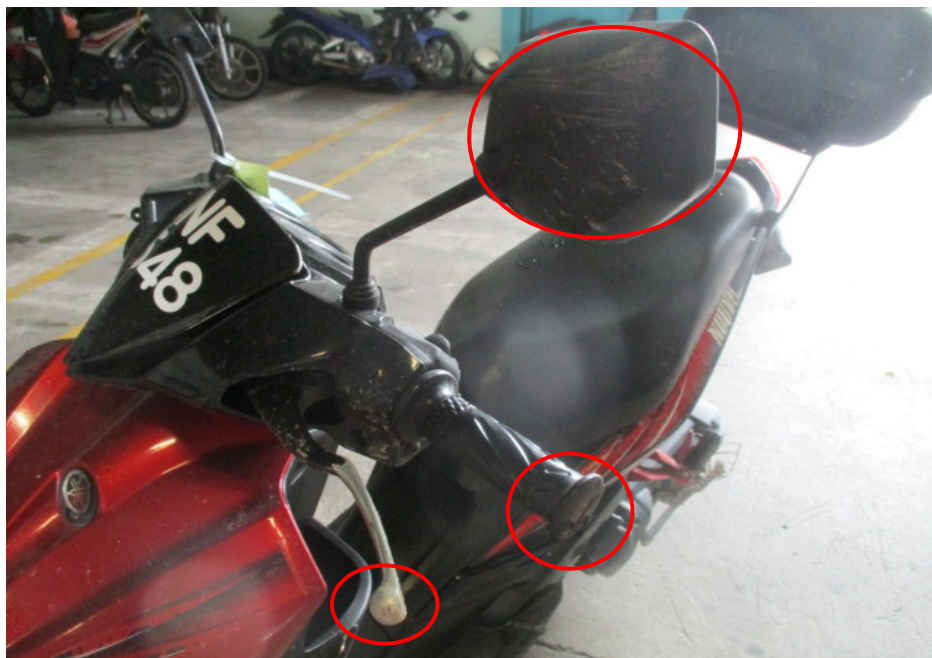
**Photo 6** shows a closer view of the left side mirror, left handlebar end and rear brake lever of the Motorcycle which were observed to be damaged due to the accident (circled).

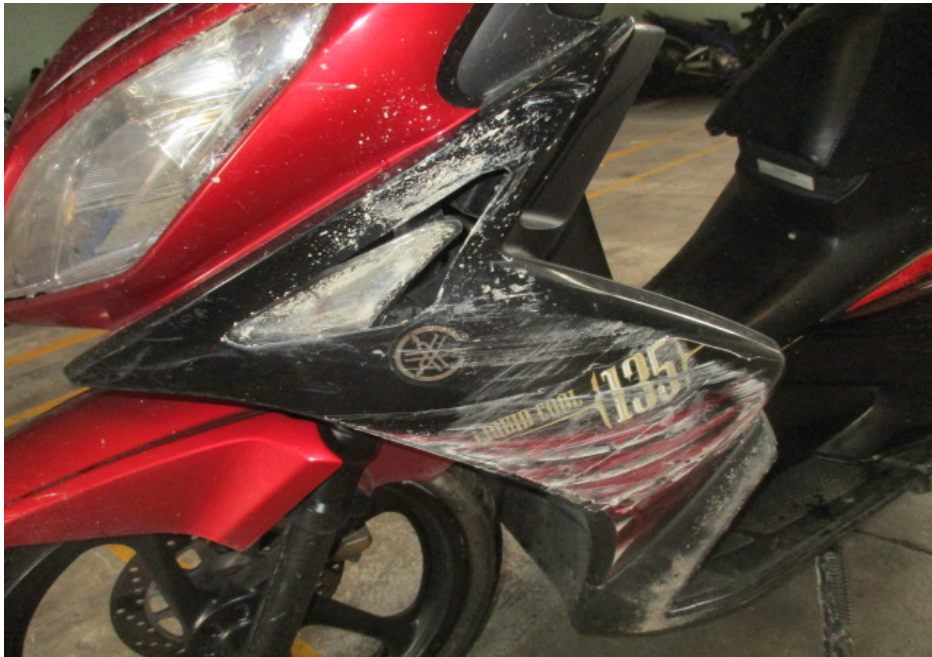
**Photo 7** shows the damaged left side cowling of the Motorcycle. The damage sustained was mainly of grazing nature.

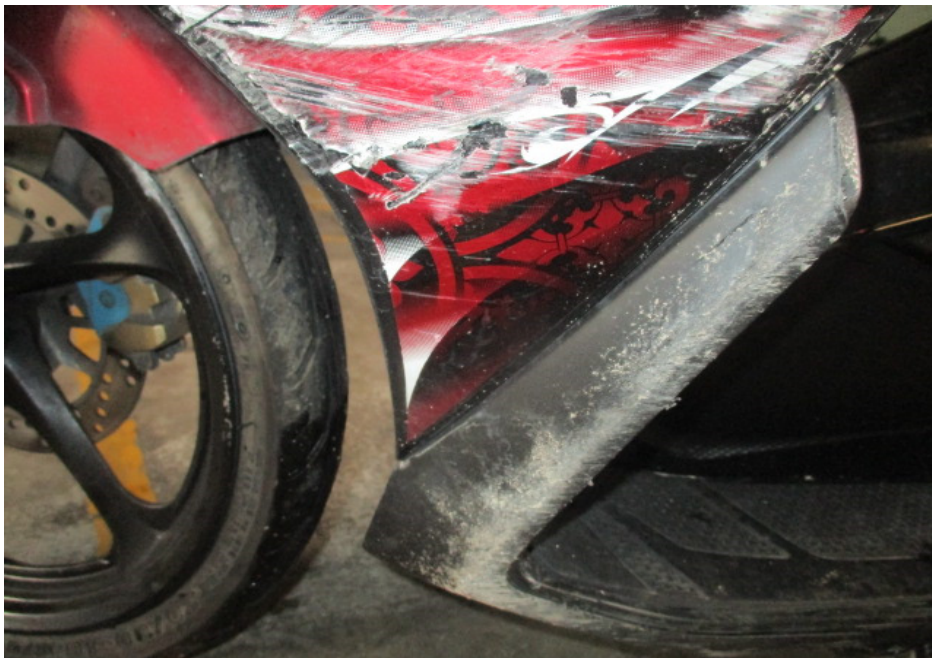
**Photo 8** shows a close-up view of the left lower side cowling of the Motorcycle at the time of our inspection. The damage sustained was mainly of grazing nature.

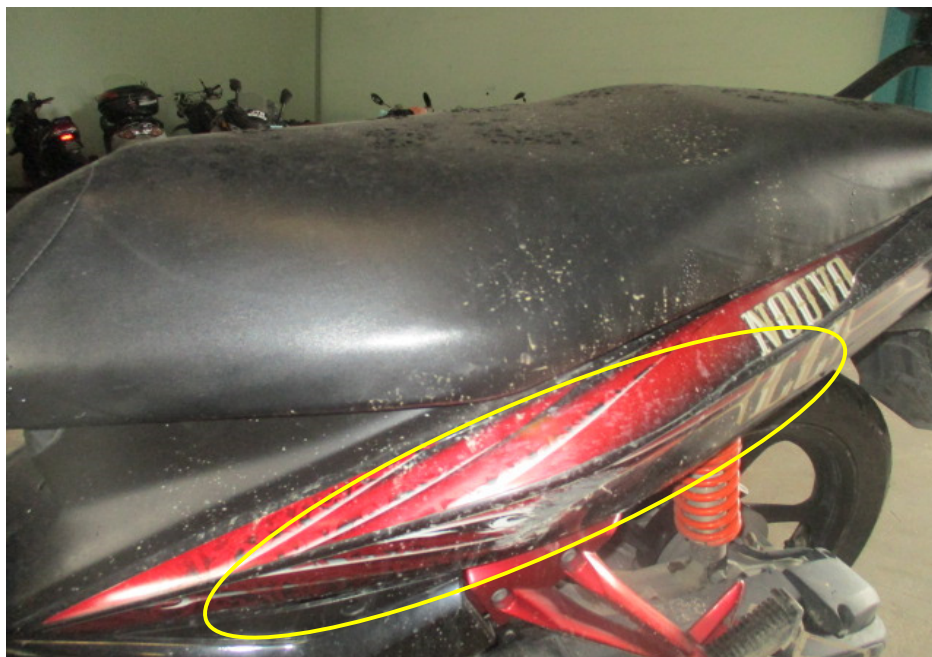
**Photo 9** shows a closer view of the damaged left rear side cover of the Motorcycle which was observed to have sustained scratches due to the accident (circled).

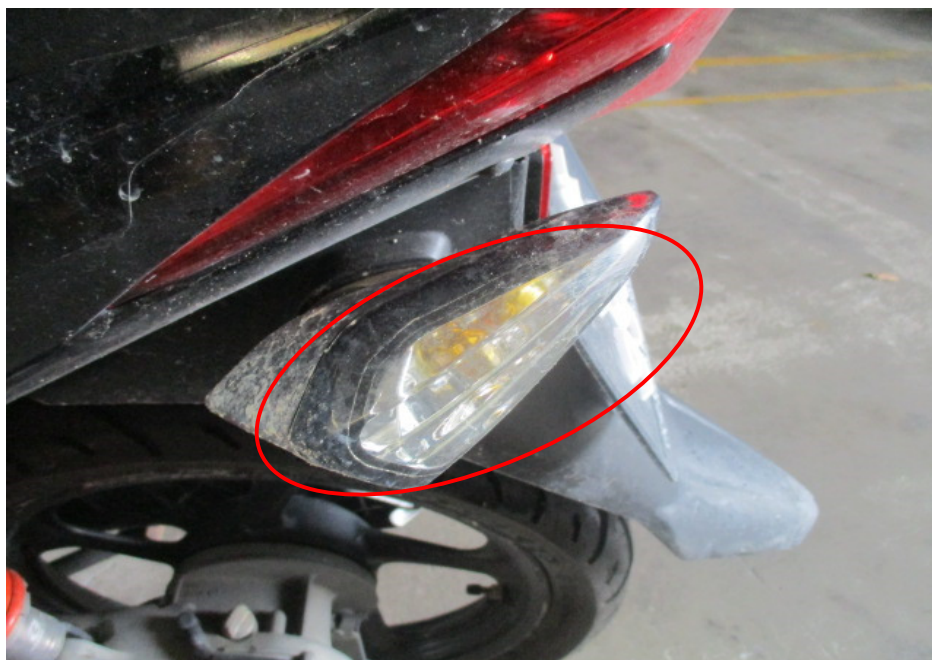
**Photo 10** shows a closer view of the grazed left rear signal lamp of the Motorcycle at the time of our inspection (circled).

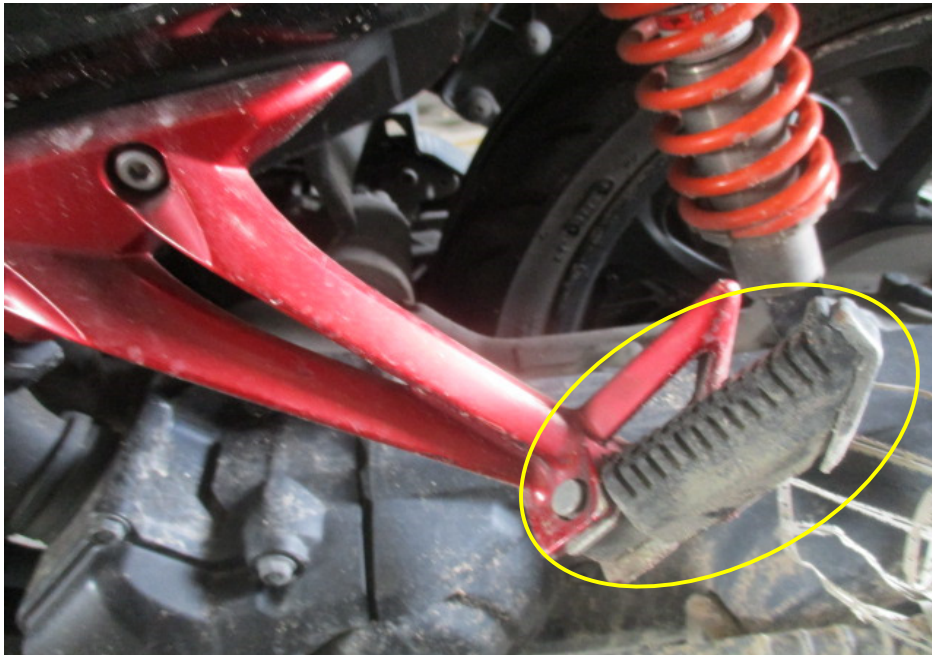
**Photo 11** shows a closer view of the damaged left pillion footpeg of the Motorcycle at the time of our inspection (circled).

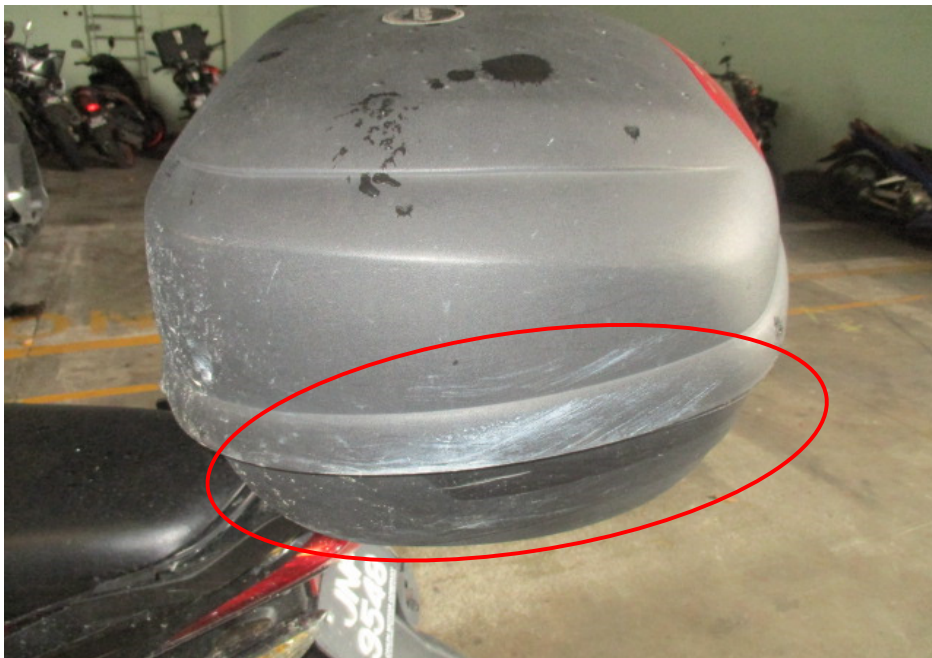
**Photo 12** shows a closer view of the top box of the Motorcycle which had sustained damage due to the accident (circled).

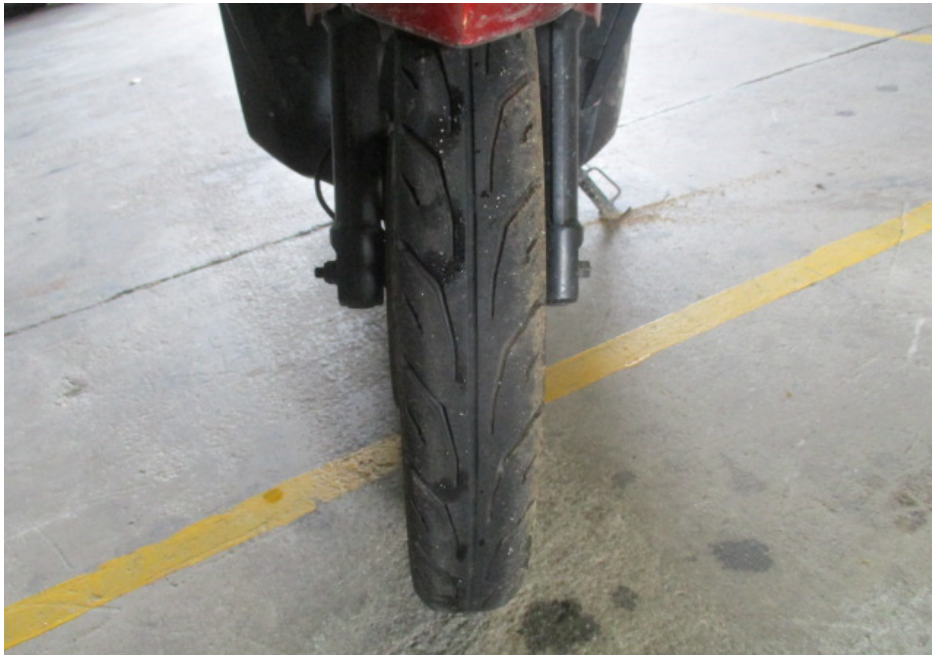
**Photo 13** shows the condition of the Motorcycle's front tyre. The front tyre was observed to be in serviceable condition with remaining tread depth of approximately 3mm. There was no tear, burst mark(s) and/or punctured hole(s) on the sidewalls as well as across the tread of the front tyre.

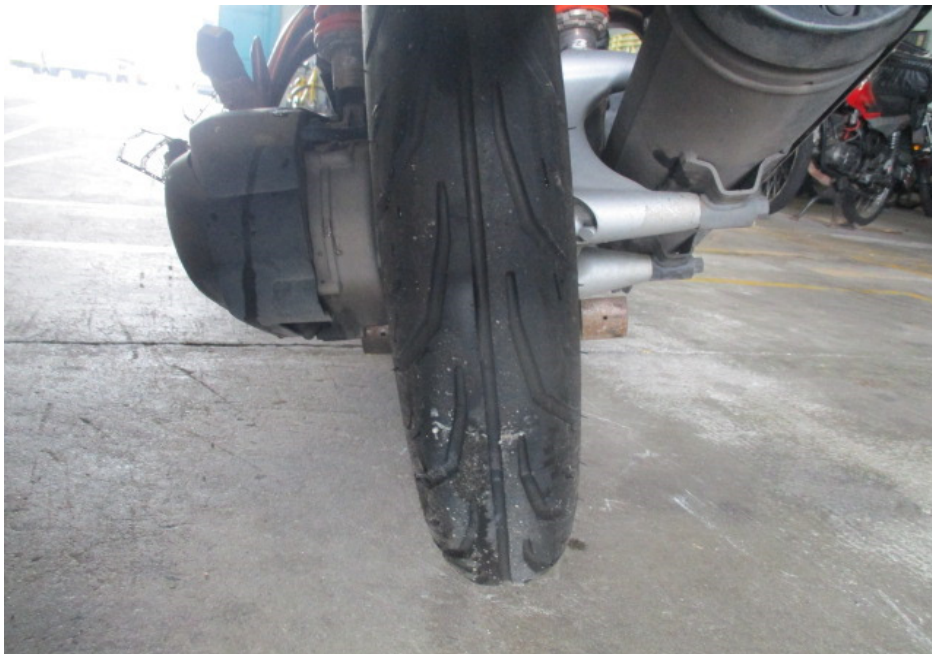
**Photo 14** shows the condition of the Motorcycle's rear tyre. The rear tyre was observed to be in serviceable condition with remaining tread depth of approximately 3mm. The tyre was also observed to be sufficiently inflated for vehicular operation. We did not observe any tear, burst mark(s) and/or punctured hole(s) on the sidewalls as well as across the tread of the rear tyre.

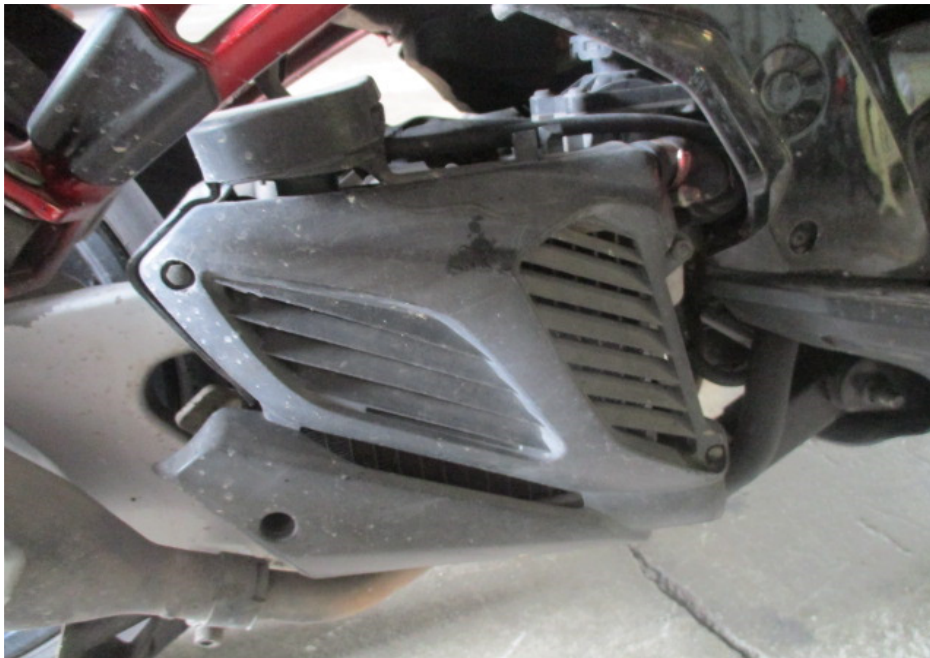
**Photo 15** shows the radiator of the Motorcycle at the time of our inspection. The radiator was found to be intact with no visible damage. There was also no sign(s) or indication(s) of fluid leak observed around the radiator of the Motorcycle.

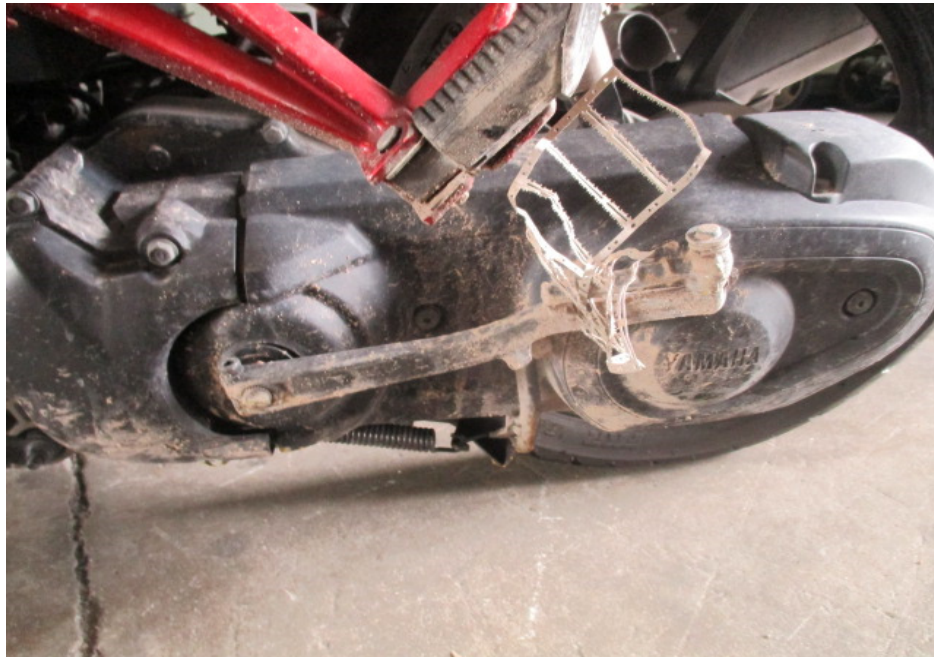
**Photo 16** shows the drive train of the Motorcycle which was found to be intact without any misalignment.

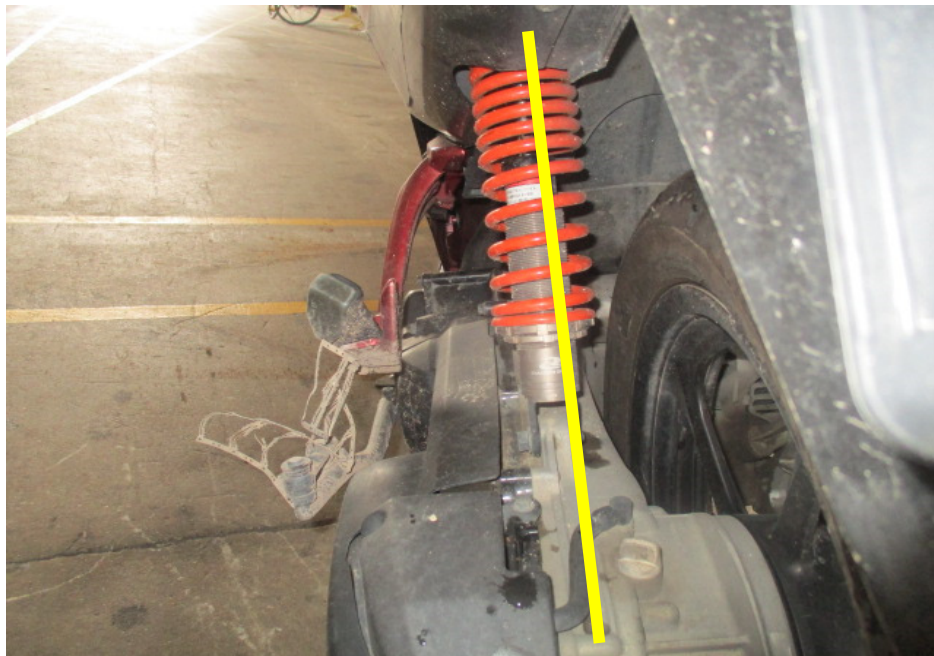
**Photo 17** shows the left shock absorber of the Motorcycle which was found to be intact without any misalignment.

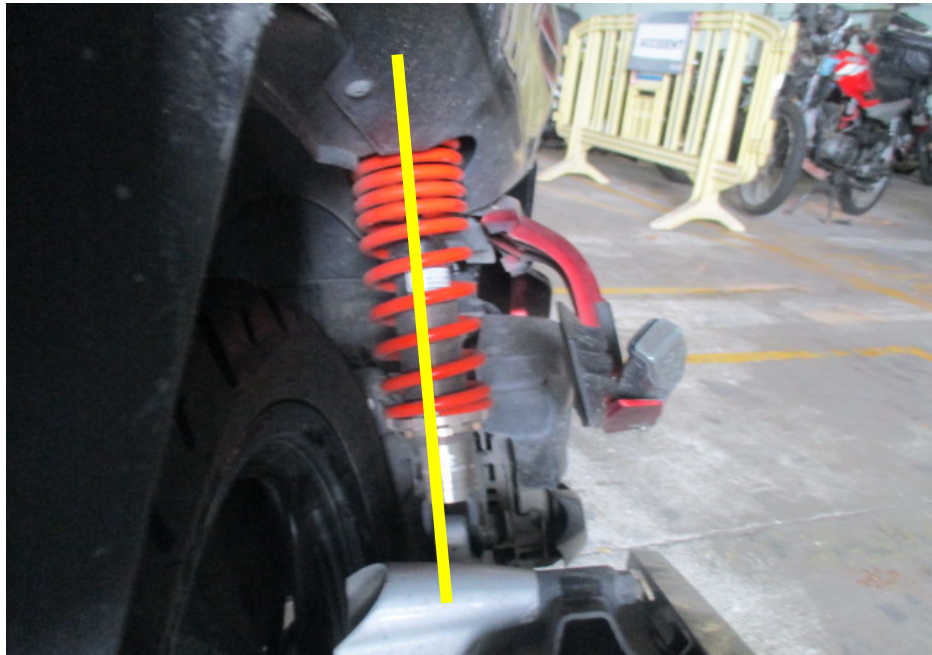
**Photo 18** shows the right shock absorber of the Motorcycle which was found to be intact without any misalignment.

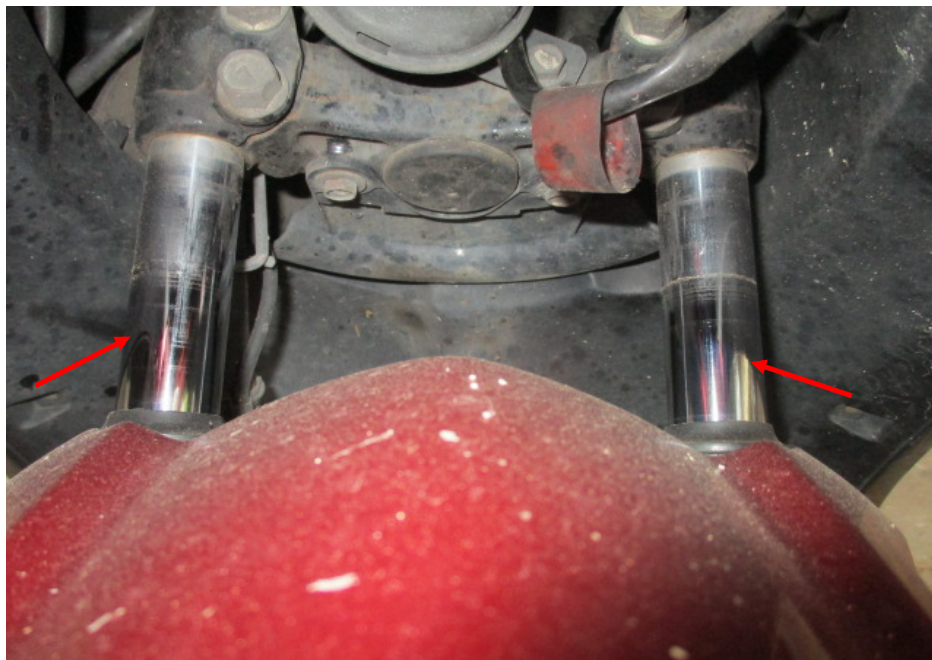
**Photo 19** shows the front forks (arrowed) of the Motorcycle. The front forks and fork brackets of the Motorcycle were both found to be intact and undamaged. Turning the Motorcycle's handle bar towards the left and right did not produce any abnormal free play and/or resistance. The steering system of the Motorcycle was in serviceable condition at the time of our inspection.

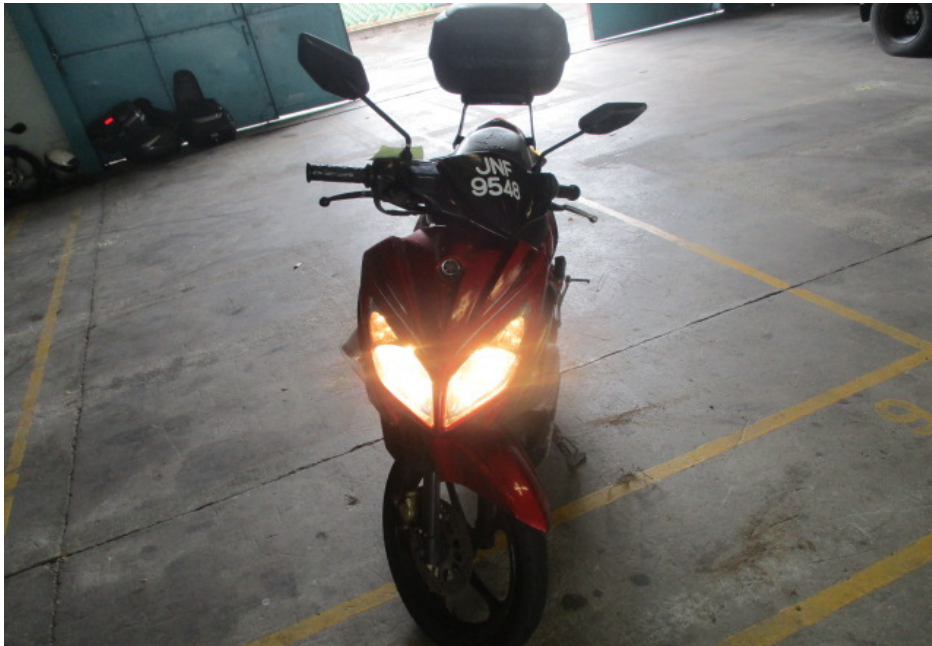
**Photo 20** shows the front wheel of the Motorcycle turned towards its full left. Turning the Motorcycle's handle bar towards the left and right did not produce any abnormal free play and/or resistance. This would indicate that the steering system of the Motorcycle was in serviceable condition at the time of our inspection.

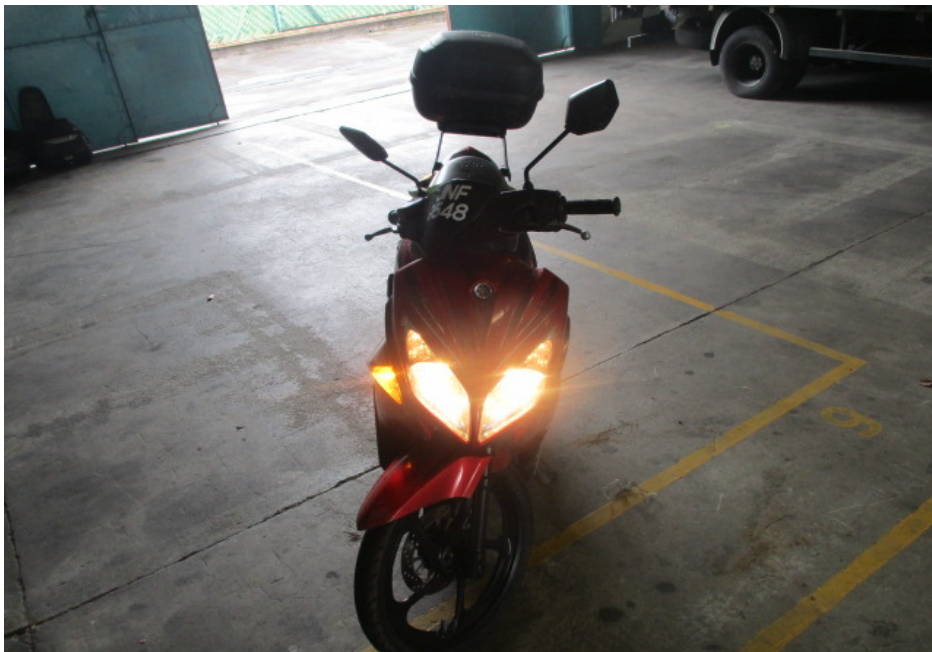
**Photo 21** shows the front wheel of the Motorcycle turned towards its full right. Turning the Motorcycle's handle bar towards the left and right did not produce any abnormal free play and/or resistance. This would indicate that the steering system of the Motorcycle was in serviceable condition at the time of our inspection.

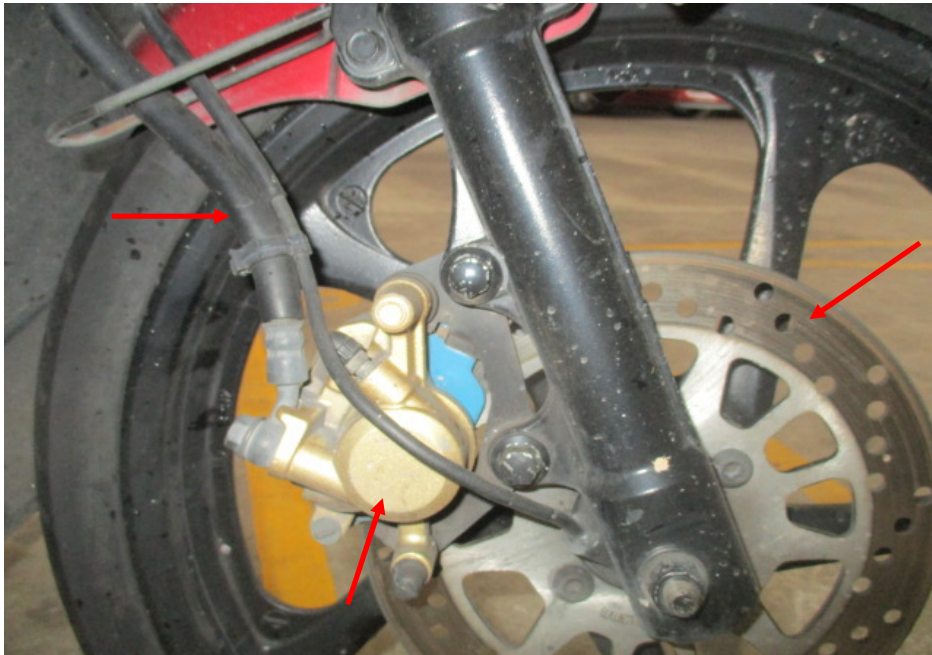
**Photo 22** shows a close up view of the front brake caliper, front brake disc and front brake hose (arrowed) of the Motorcycle, which are all part of the components in the hydraulic front brake system of the Motorcycle. Our visual checks of these various components had revealed all to be intact with no visible damage. No leakage of brake fluid was also observed.

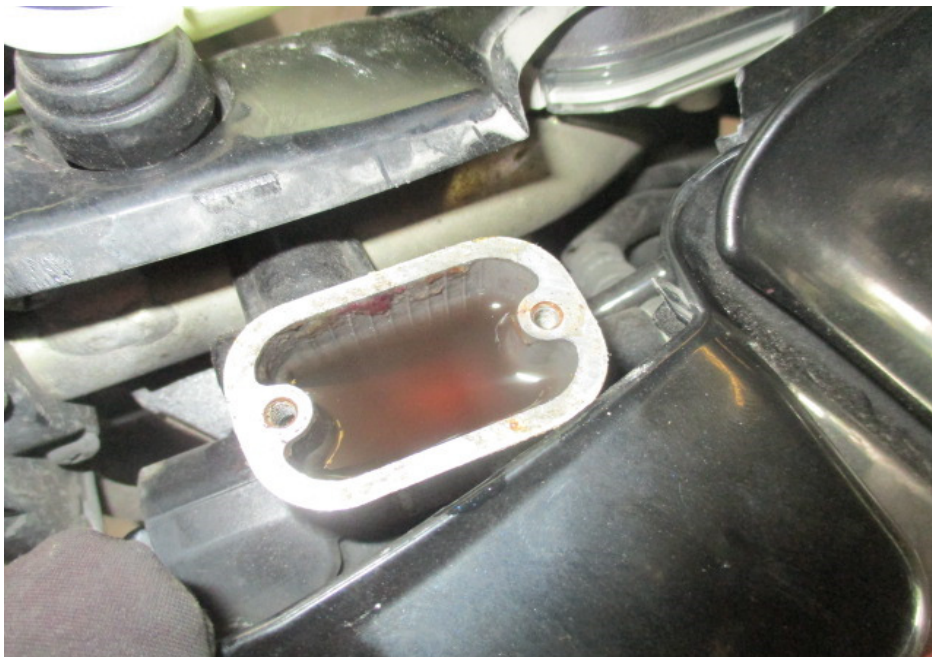
**Photo 23** shows the brake fluid reservoir for the front brake of the Motorcycle. The brake fluid was observed to be of sufficient level and without contamination for operational purposes.

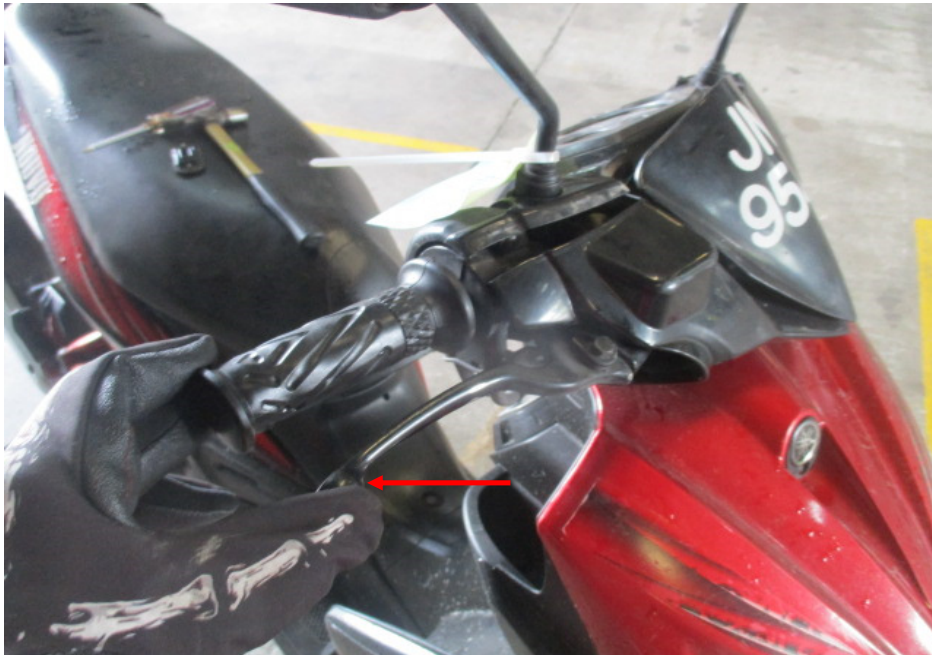
**Photo 24** shows the front brake lever being depressed. There was some resistance felt (spongy like feel) upon pressing the front brake lever (arrowed). This would indicate that there is no leakage of pressure/vacuum in the brake system.

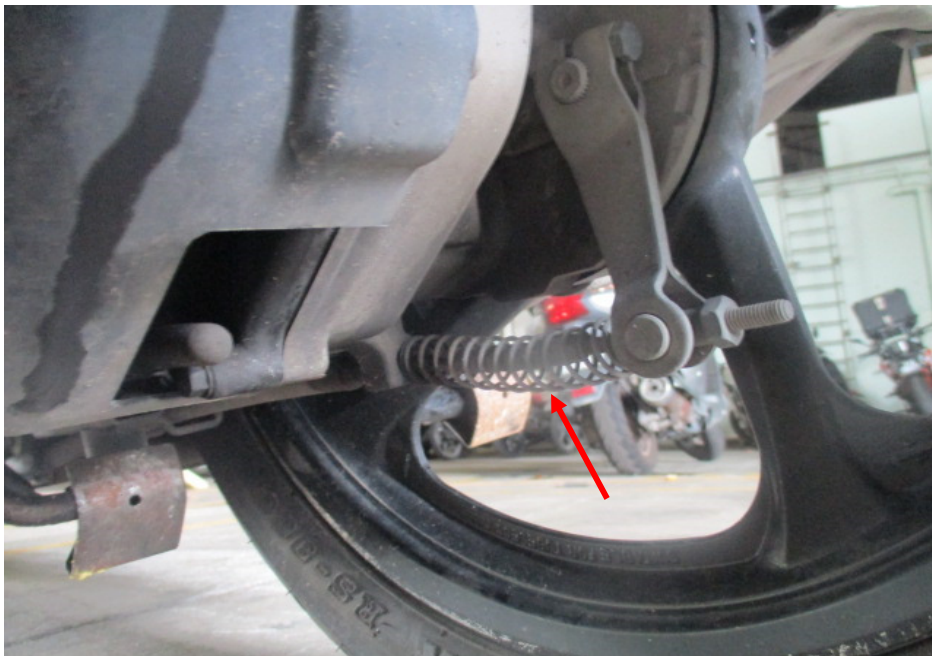
**Photo 25** shows the rear wheel of the Motorcycle. The type of brake system for the rear wheel was of a mechanical type, controlled by the brake foot pedal of the Motorcycle. Our checks of the cable (arrowed), spring and drum which are all part of the components in the rear brake system of the Motorcycle reveal all to be intact and without damage.
