Your Ref: TP/IP/45247/2019
Our Ref : CI/TPD19013991/N

Fatal Accident Investigation Team

INSPECTION REPORT OF MOTORCYCLE JSK 1728

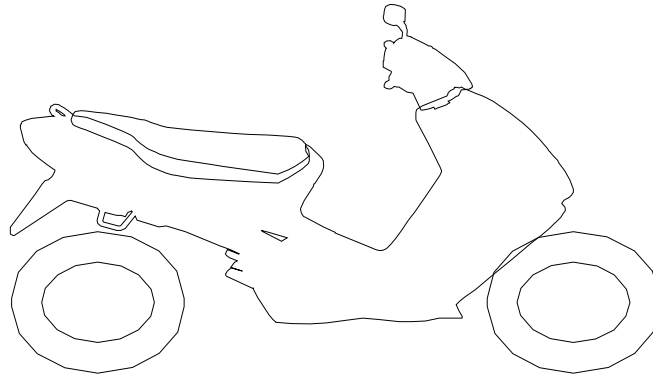
Energi 80/90 - 17 (3mm)

Vee Rubber 70/90 - 17 (3mm)

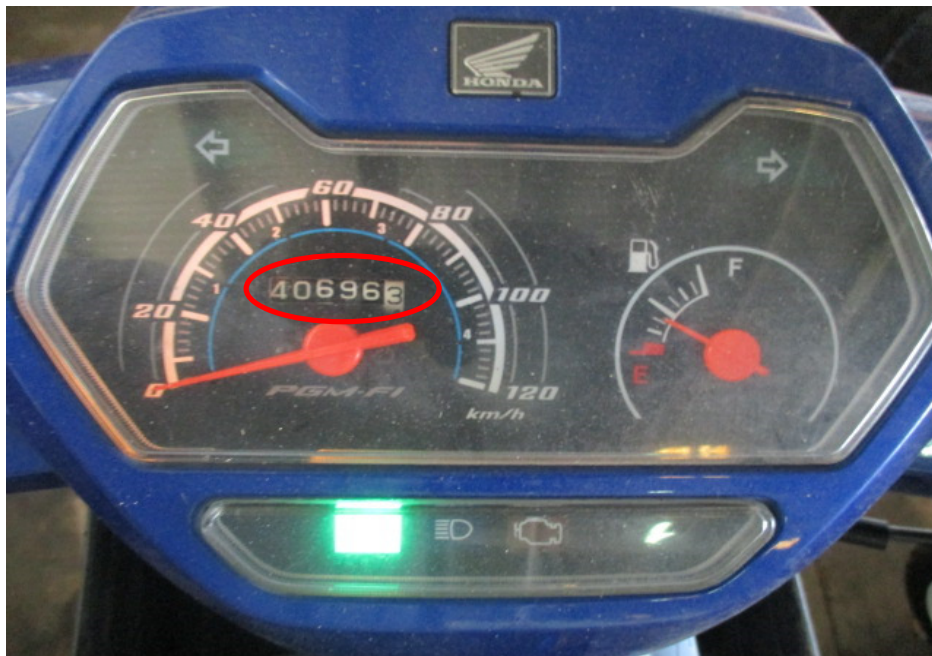
Photo 1 shows the speedometer gauge of the Motorcycle where the mileage recorded at the time of our inspection was 40, 696km (circled).

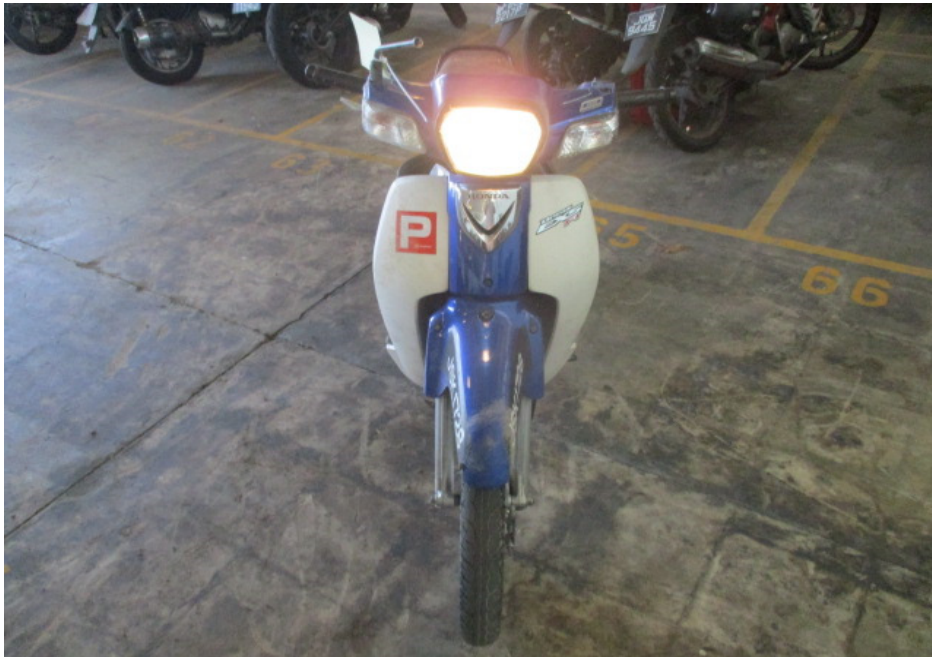
Photo 2 shows a general view of the frontal portion of the Motorcycle at the time of our inspection. The Motorcycle was observed to have sustained damages all around.

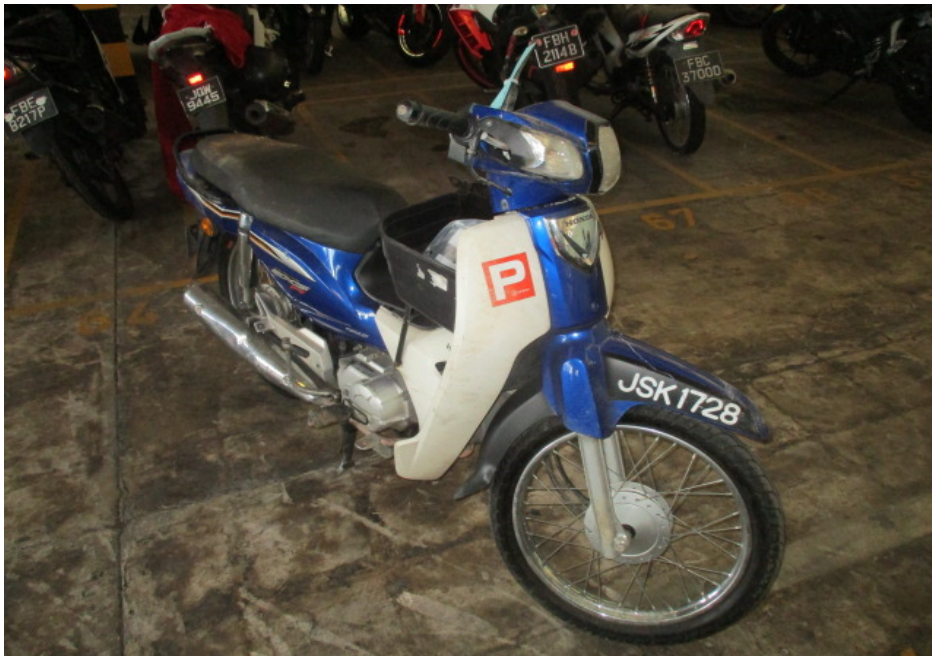
Photo 3 shows a general view of the right body of the Motorcycle at the time of our inspection. The Motorcycle was observed to have sustained damages all around.

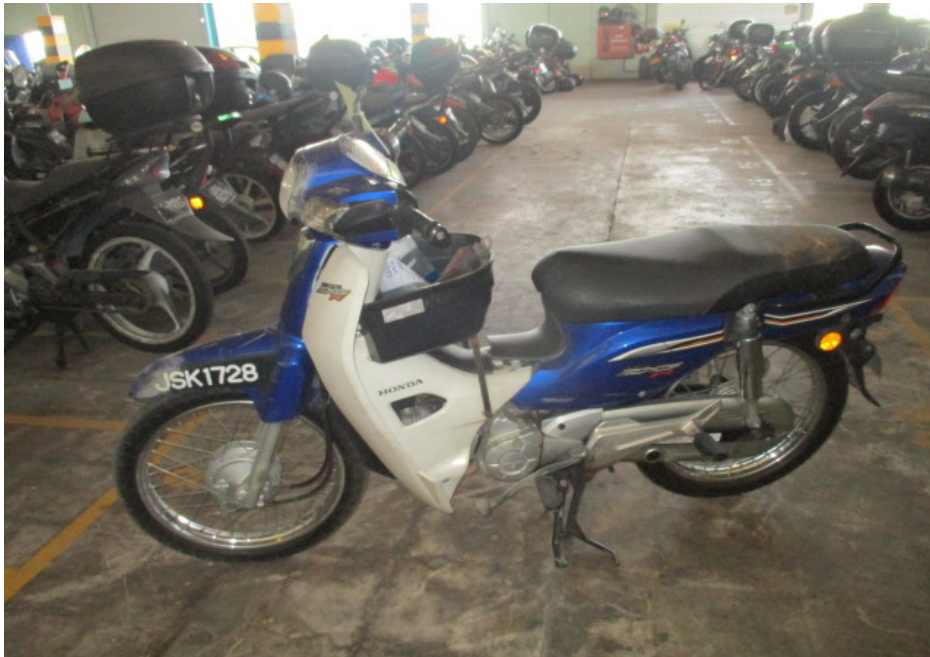
Photo 4 shows a general view of the left body of the Motorcycle at the time of our inspection. The Motorcycle was observed to have sustained damages all around. Amongst the body parts that were found to have been damaged include its headlamp assembly, side mirrors, front brake lever, left front footrest, left pillion foot peg, exhaust muffler heat shield and right rear side cover, amongst others.

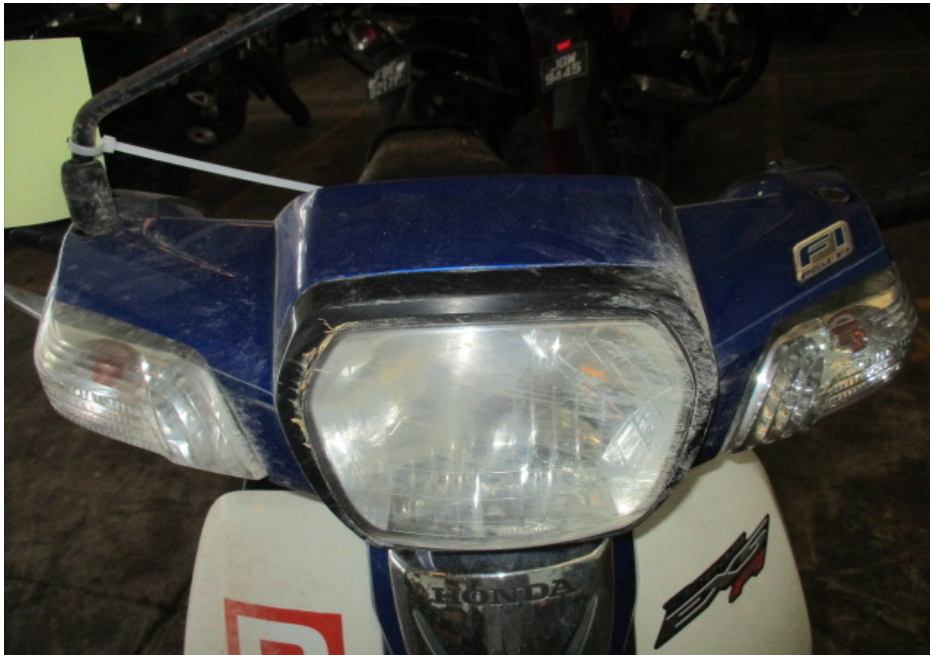
Photo 5 shows a closer view of the headlamp assembly which was amongst the body parts at the front body of the Motorcycle that had sustained damage as a result of the accident.

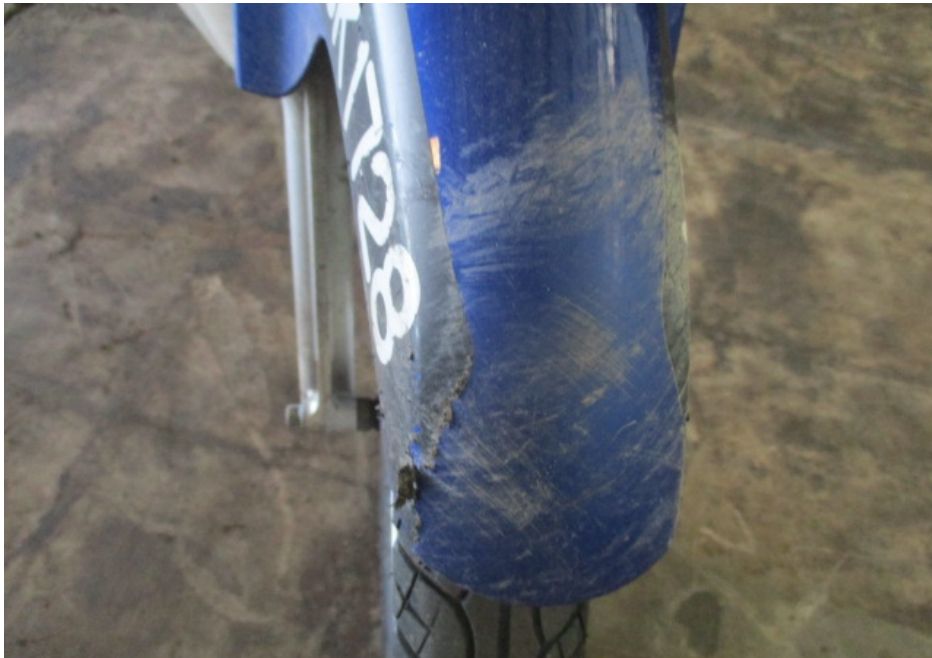
Photo 6 shows a close up view of the front mudguard which was amongst the body parts of the Motorcycle that had sustained damage as a result of the accident.

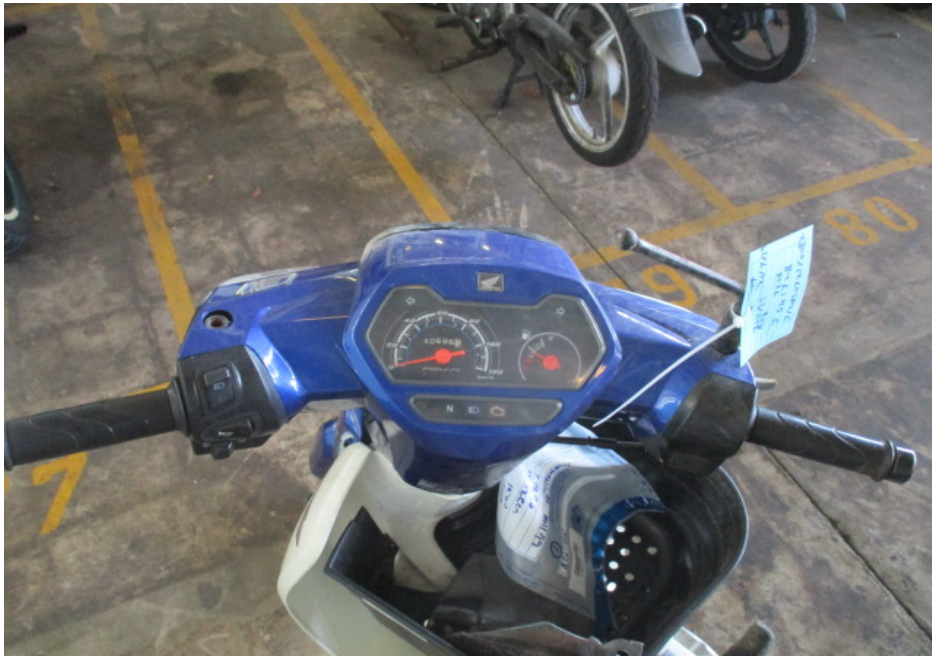
Photo 7 shows a closer view of the missing side mirrors of the Motorcycle as a result of the accident.

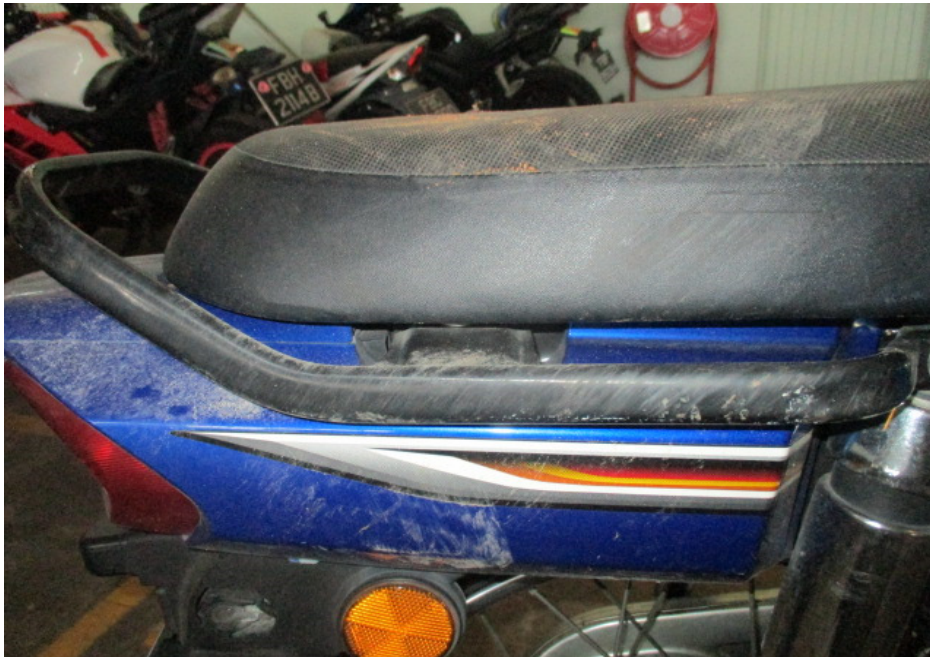
Photo 8 shows a closer view of the pillion grab rail of the Motorcycle that had sustained damages of grazing nature as a result of the accident.

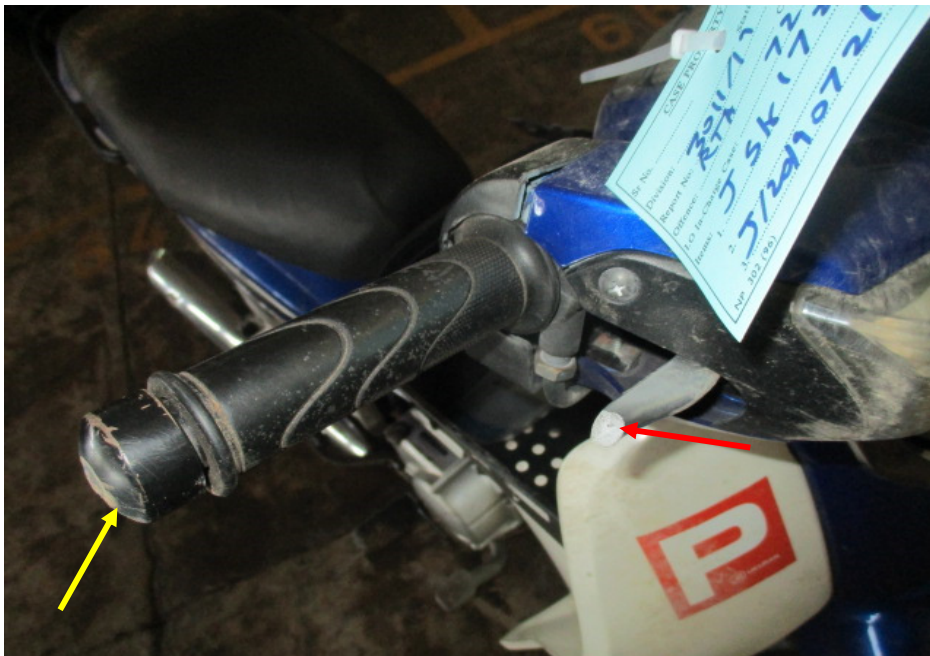
Photo 9 shows a closer view of the right handlebar end (yellow arrow) and broken front brake lever (red arrow) which were amongst the body parts of the Motorcycle that had sustained damage as a result of the accident.

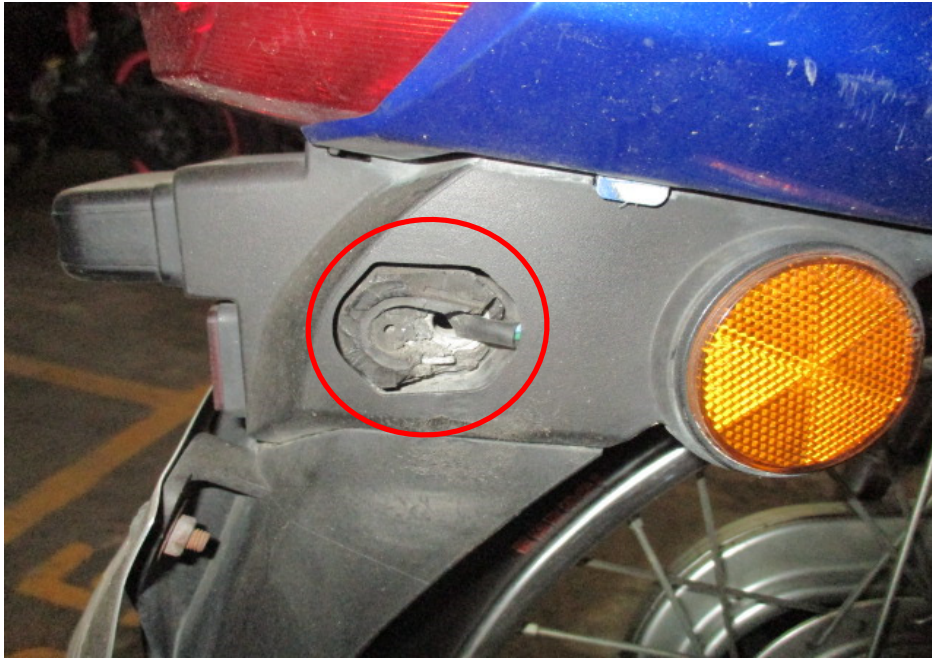
Photo 10 shows a closer view of the broken right rear signal lamp of the Motorcycle as a result of the accident (circled).

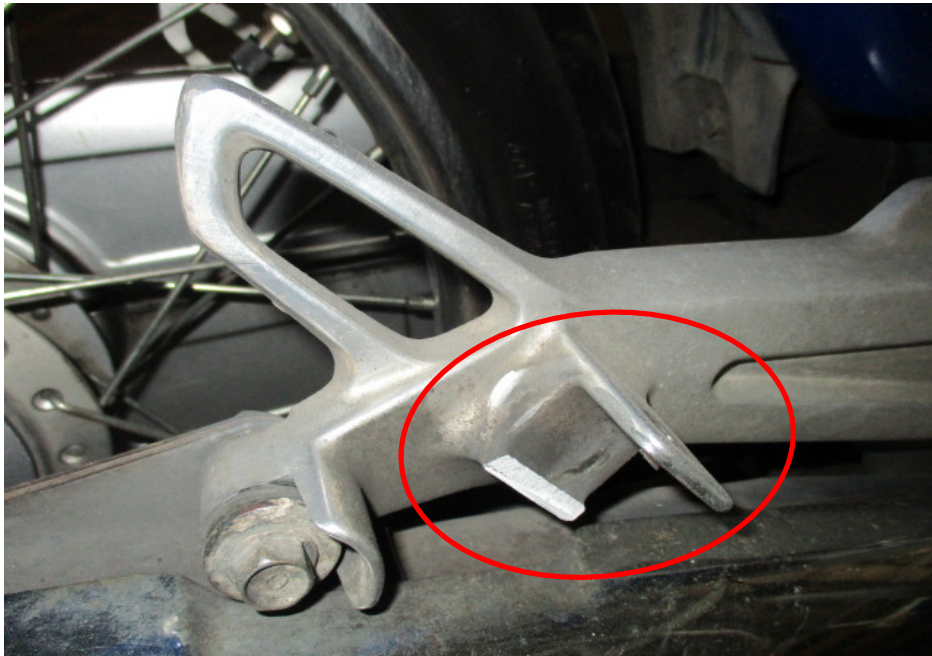
Photo 10 shows a closer view of the broken right pillion foot peg of the Motorcycle as a result of the accident (circled).

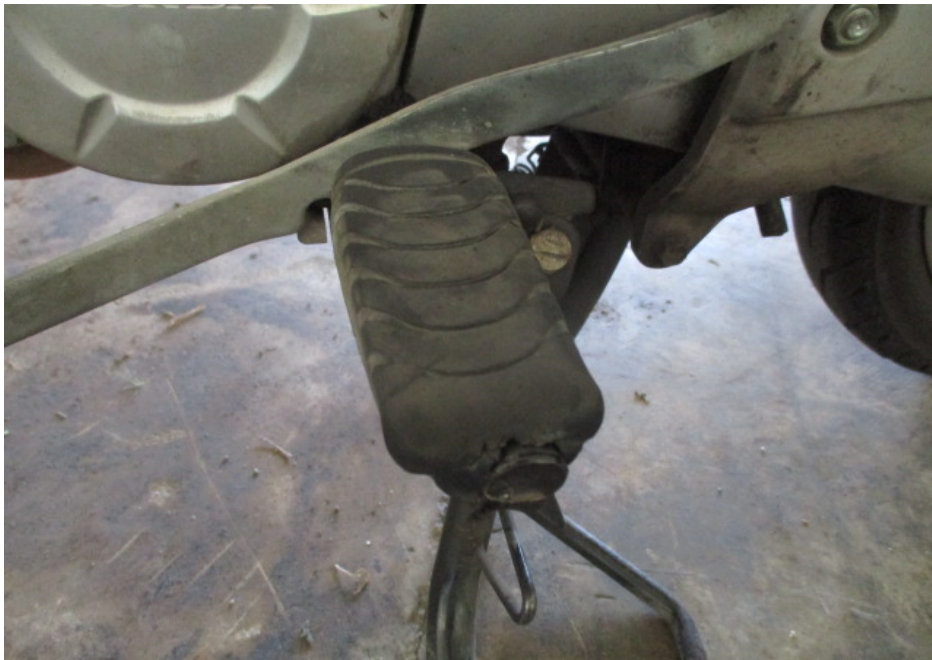
Photo 11 shows a closer view of the left front footrest which was amongst the body parts of the Motorcycle that had sustained damage as a result of the accident.

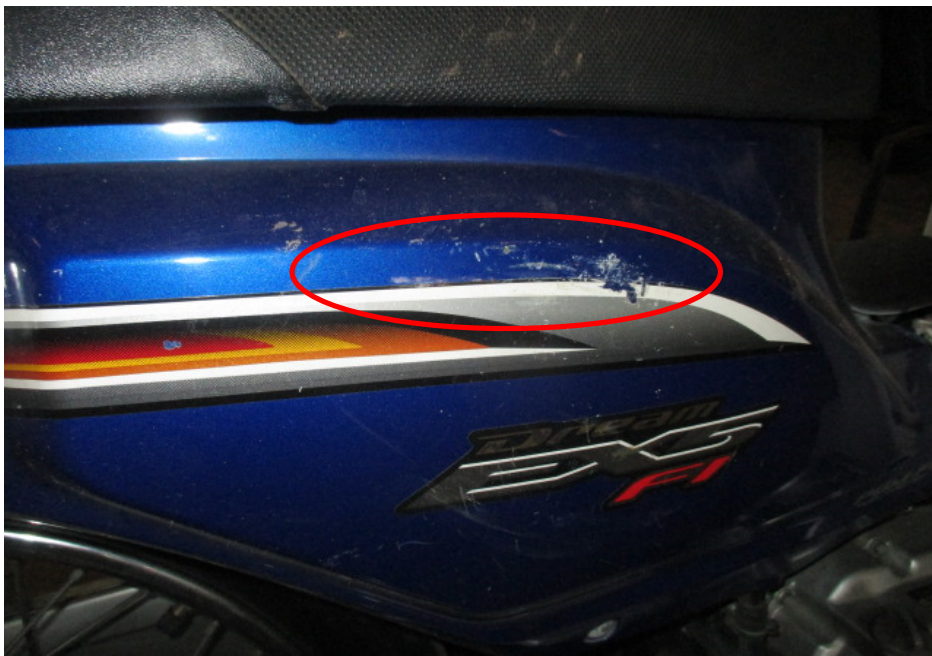
Photo 12 shows the right rear side cover of the Motorcycle that had sustained damages of grazing nature as a result of the accident (circled).

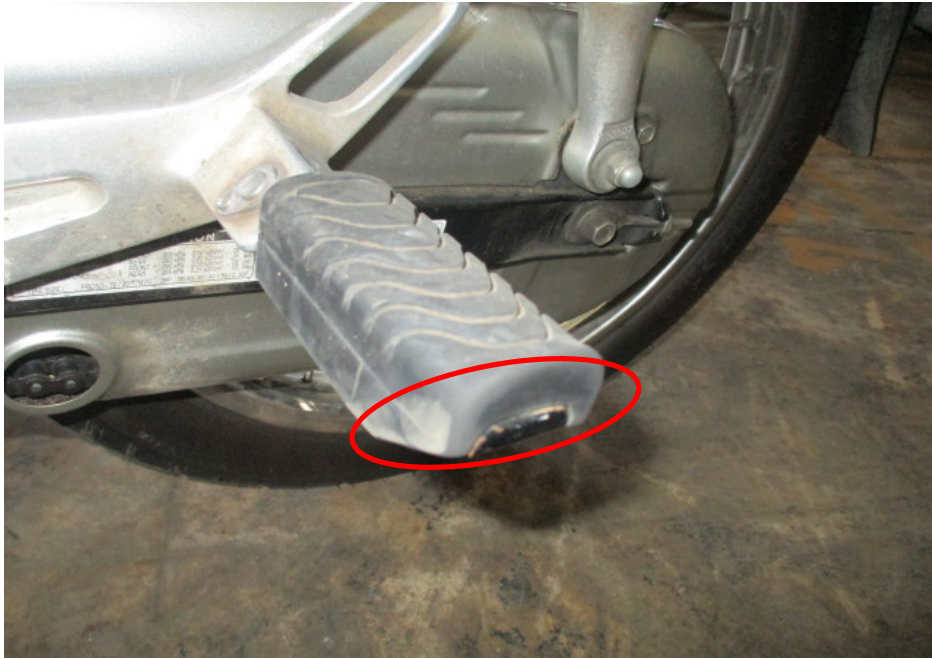
Photo 13 shows a closer view of the left pillion foot peg which was amongst the body parts of the Motorcycle that had sustained damages of grazing nature as a result of the accident (circled).

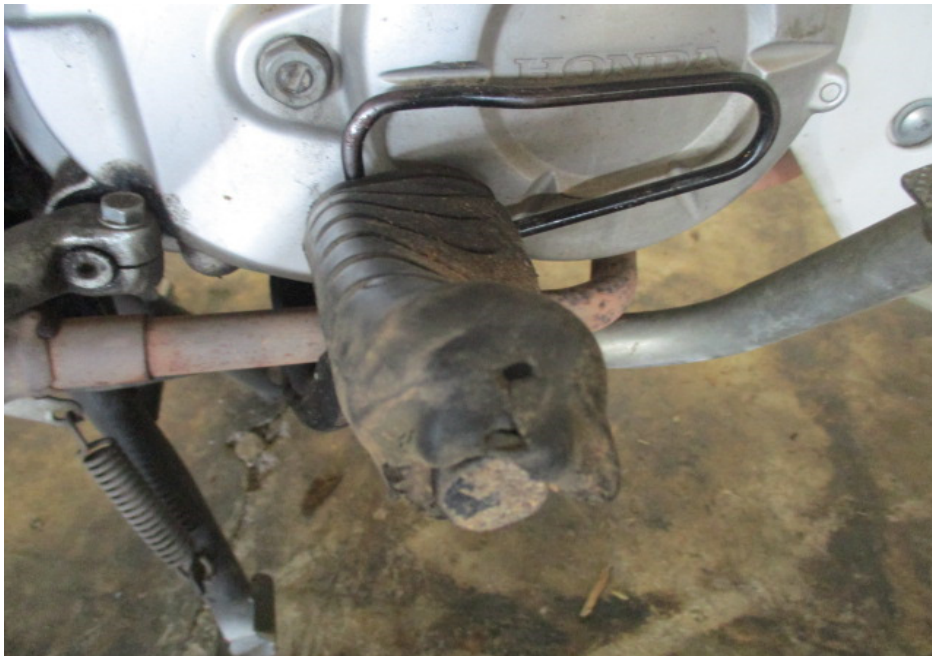
Photo 14 shows a closer view of the right front foot rest which was amongst the body parts of the Motorcycle that had sustained damage as a result of the accident.

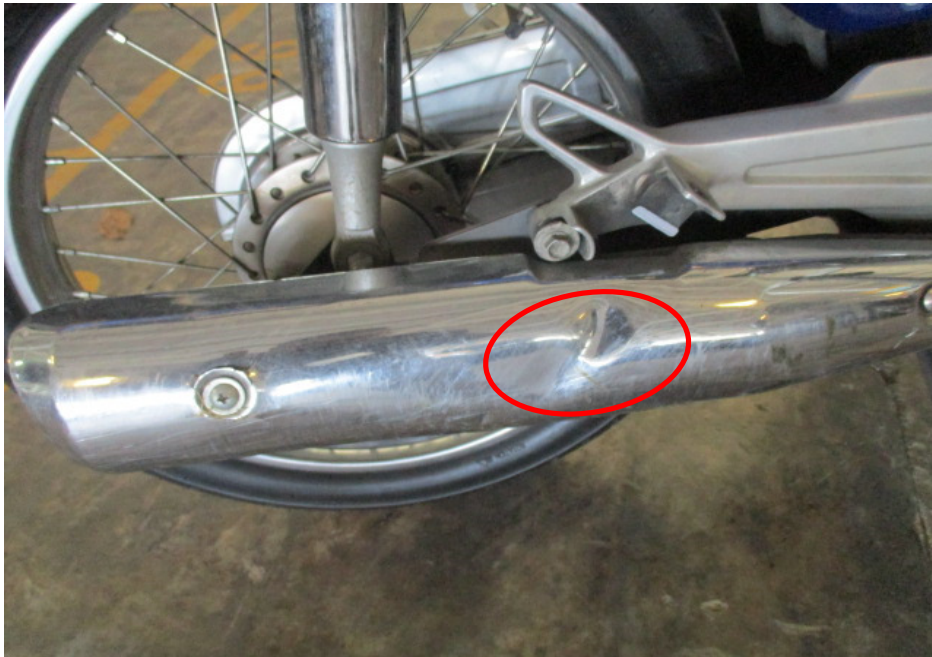
Photo 15 shows a closer view of the dented exhaust muffler heat shield of the Motorcycle as a result of the accident (circled).

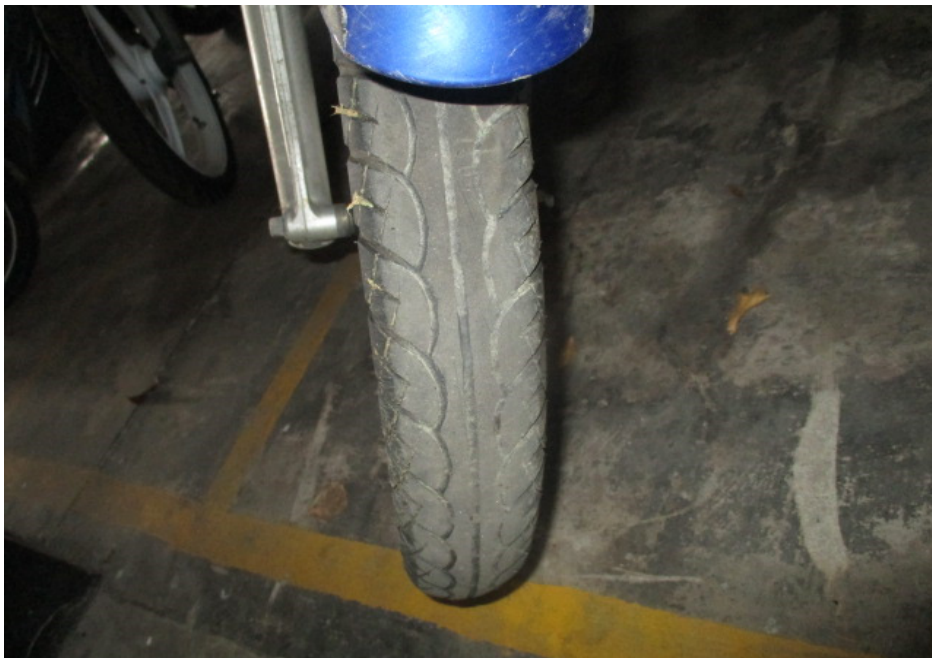
Photo 16 shows the condition of the Motorcycle's front tyre. The front tyre was observed to be in serviceable condition with remaining tread depth of approximately 3mm. There was no tear, burst mark(s) and/or punctured hole(s) on the sidewalls as well as across the tread of the front tyre.

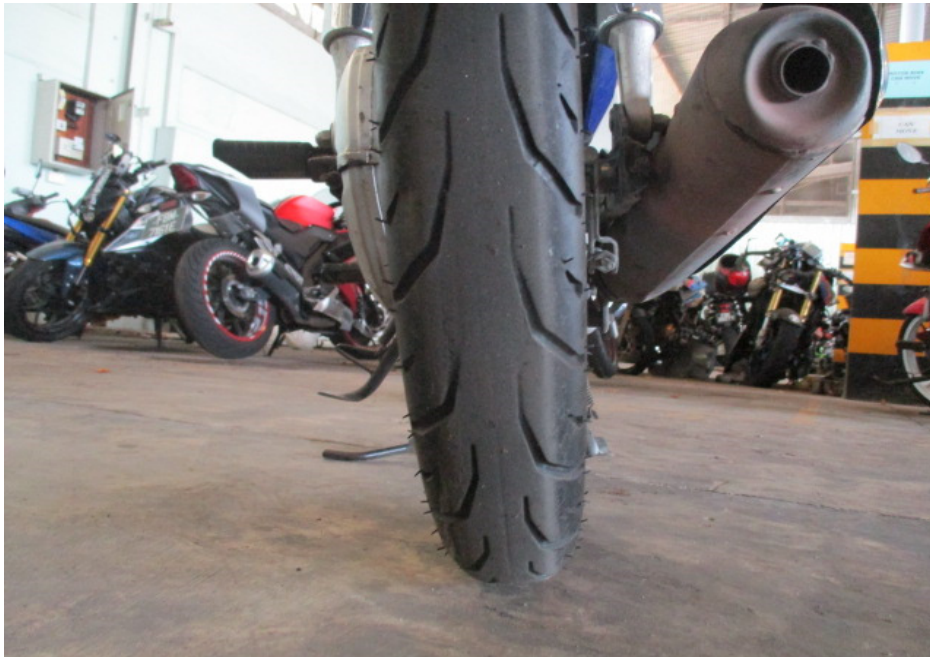
Photo 17 shows the condition of the Motorcycle's rear tyre. The rear tyre was observed to be in serviceable condition with remaining tread depth of approximately 3mm. The tyre was also observed to be sufficiently inflated for vehicular operation. We did not observe any tear, burst mark(s) and/or punctured hole(s) on the sidewalls as well as across the tread of the rear tyre.

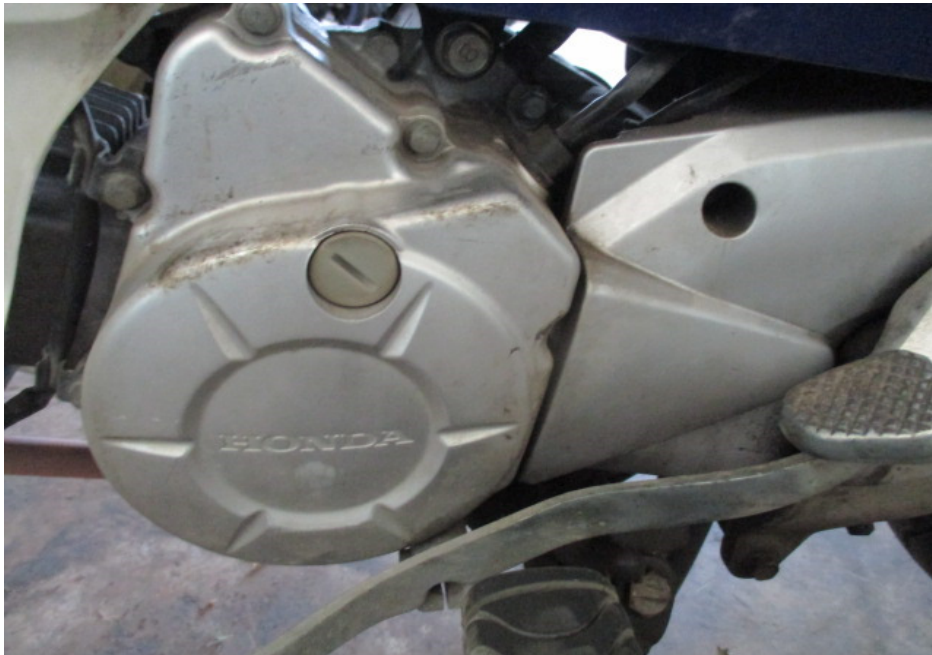
Photo 18 shows the left side of the engine of the Motorcycle at the time of our inspection. The various engine related parts and components were found to be intact with no visible damage. There was also no sign(s) or indication(s) of fluid leak observed around the left engine area of the Motorcycle.

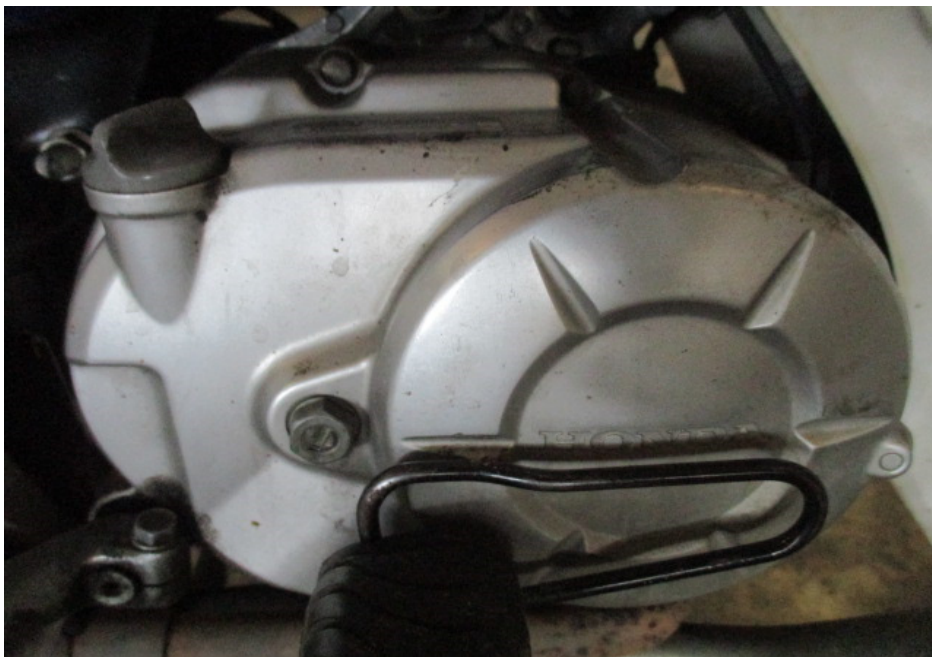
Photo 19 shows the right side of the engine of the Motorcycle at the time of our inspection. The various engine related parts and components were found to be intact with no visible damage. There was also no sign(s) or indication(s) of fluid leak observed around the right engine area of the Motorcycle.

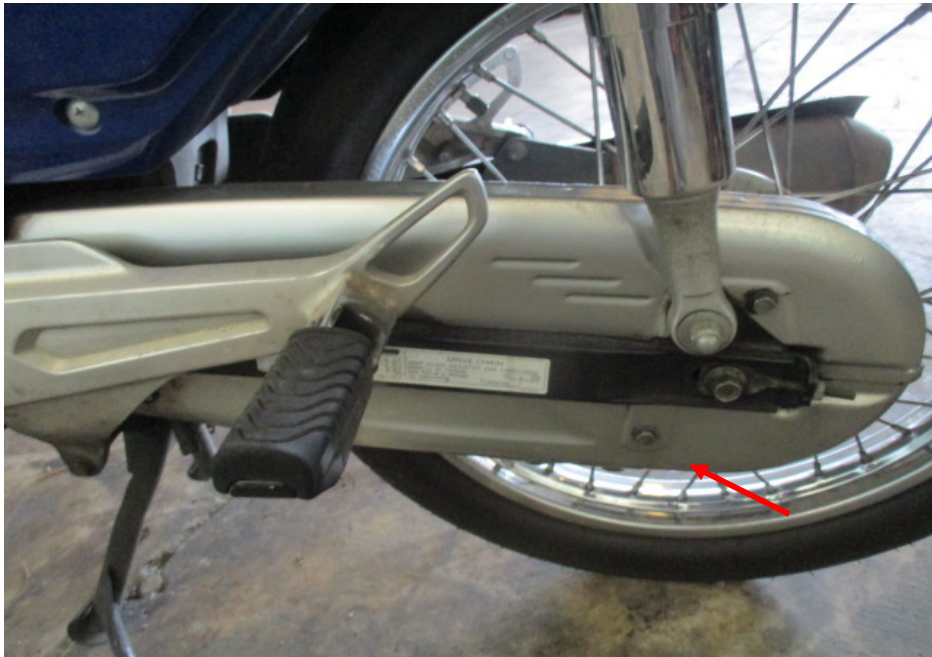
Photo 20 shows the general view of the gear train (arrowed) of the Motorcycle, which was observed to be intact with no misalignment. It was also adequately lubricated for operating purposes.

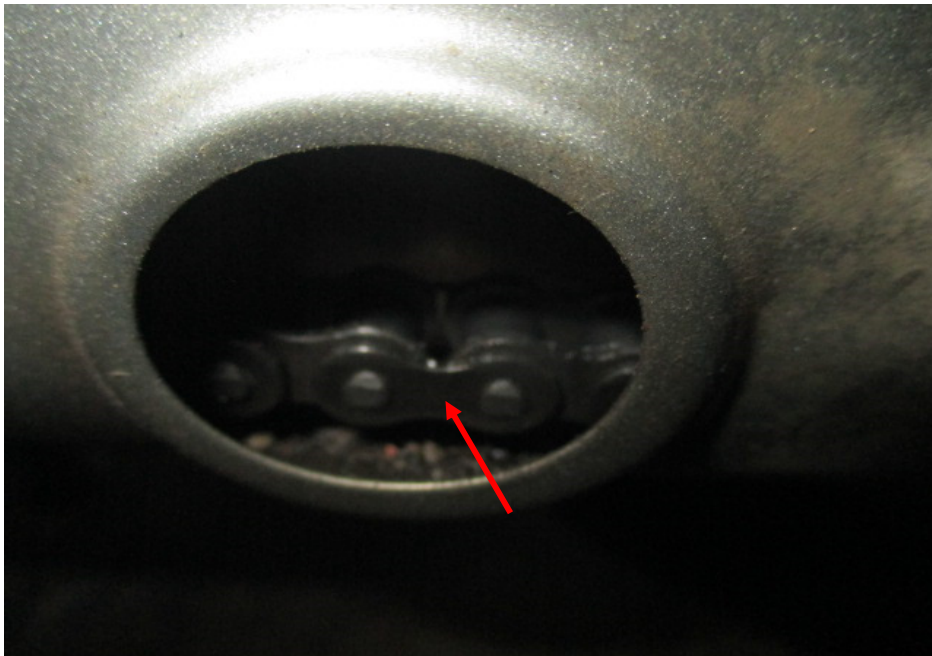
Photo 21 shows a closer view of the gear train (arrowed) of the Motorcycle, which was observed to be intact with no misalignment. It was also adequately lubricated for operating purposes.

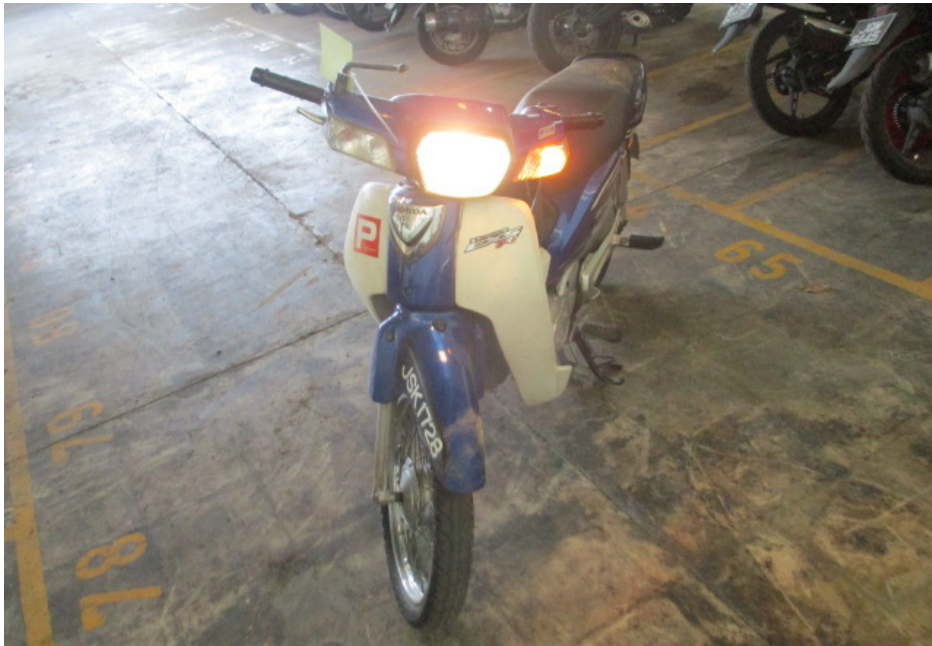
Photo 22 shows the front wheel of the Motorcycle turned towards its full left. Turning the Motorcycle's handle bar towards the left and right did not produce any abnormal free play and/or resistance. This would indicate that the steering system of the Motorcycle was in serviceable condition at the time of our inspection.

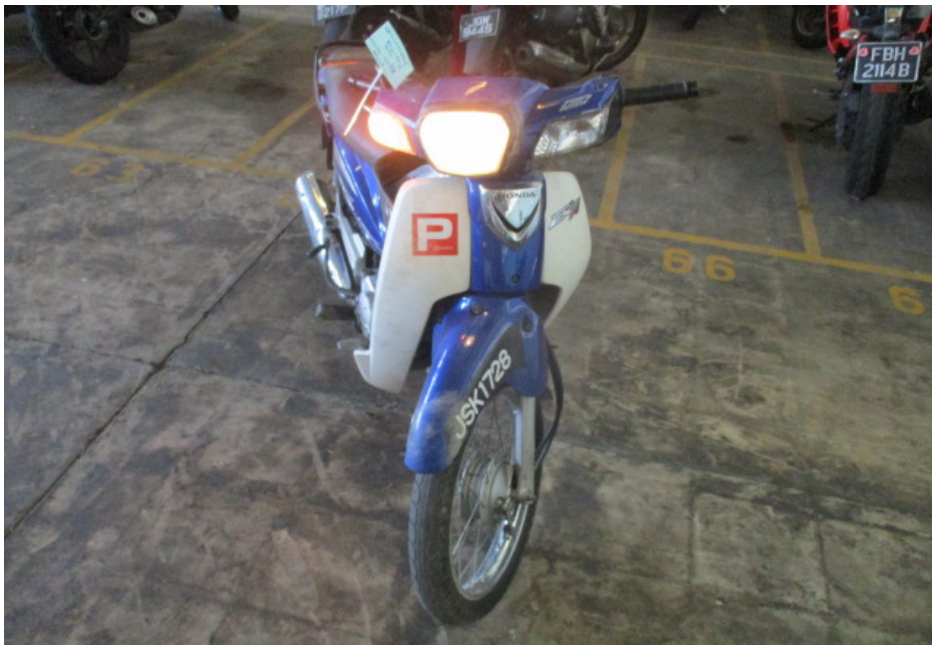
Photo 23 shows the front wheel of the Motorcycle turned towards its full right. Turning the Motorcycle's handle bar towards the left and right did not produce any abnormal free play and/or resistance. This would indicate that the steering system of the Motorcycle was in serviceable condition at the time of our inspection.

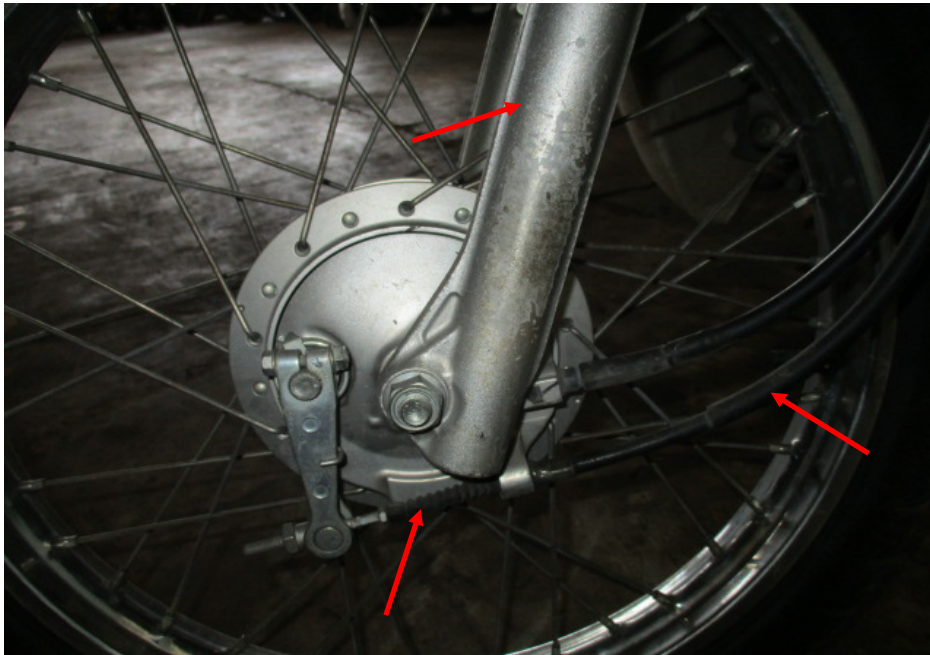
Photo 24 shows a close up view of the front fork, front brake cables and spring of the Motorcycle (arrowed), which are all part of the components in the mechanical front brake system of the Motorcycle. Our visual checks of these various components had revealed all to be intact with no visible damage.

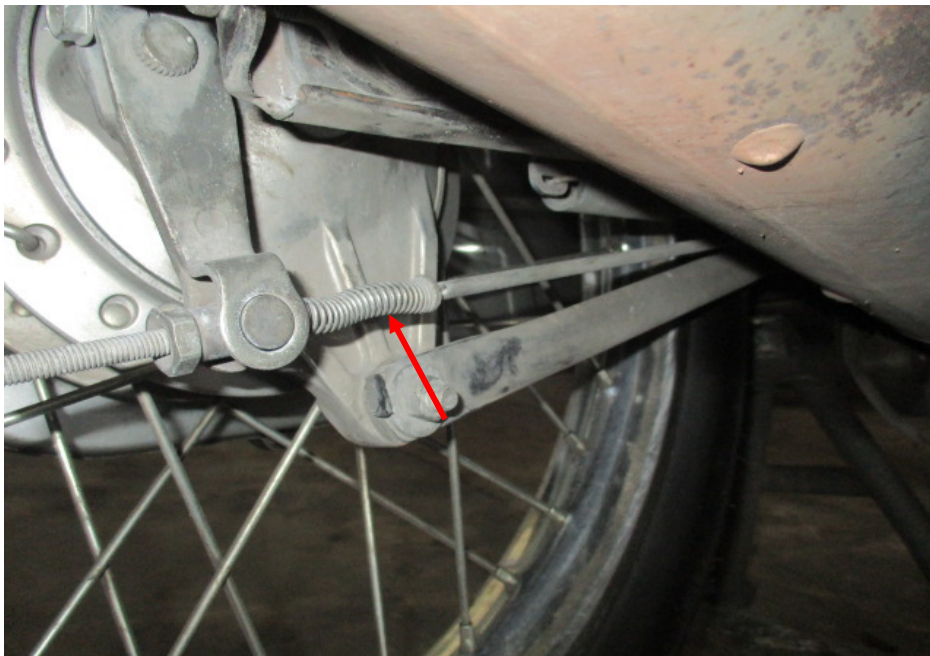
Photo 25 shows the rear wheel of the Motorcycle. The type of brake system for the rear wheel was of a mechanical type, controlled by the brake foot pedal of the Motorcycle. Our checks of the cable (arrowed), spring and drum which are all part of the components in the rear brake system of the Motorcycle reveal all to be intact and without damage.
