Your Ref: TP/IP/42055/2019  
Our Ref : CI/TPD19013995/N

**Fatal Accident Investigation Team**

**INSPECTION REPORT OF MOTORCYCLE FBC 4128A**

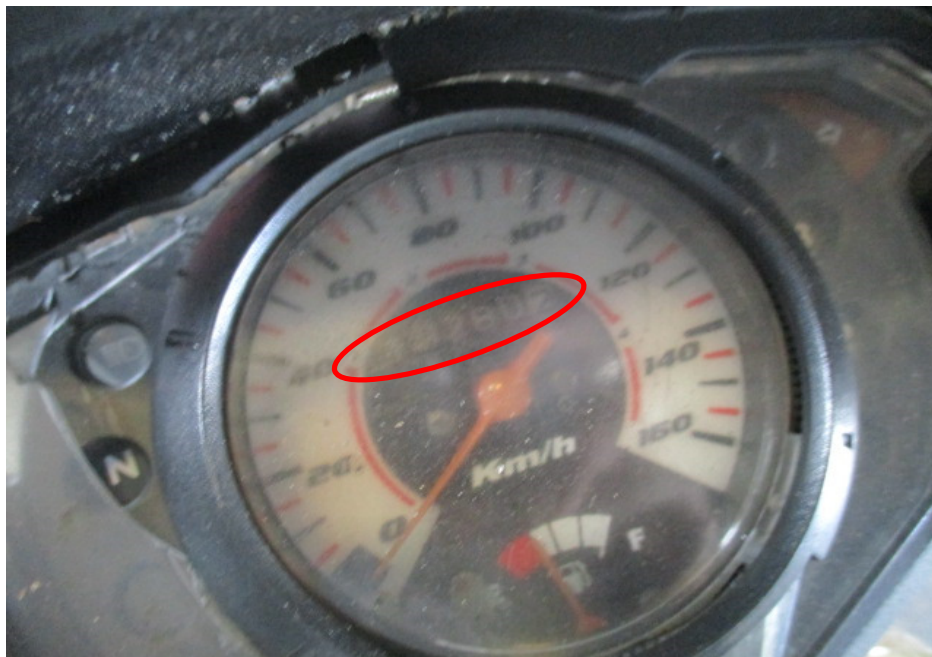
**Photo 1** shows the speedometer gauge of the Motorcycle where the mileage recorded at the time of our inspection was 10,280km (circled).

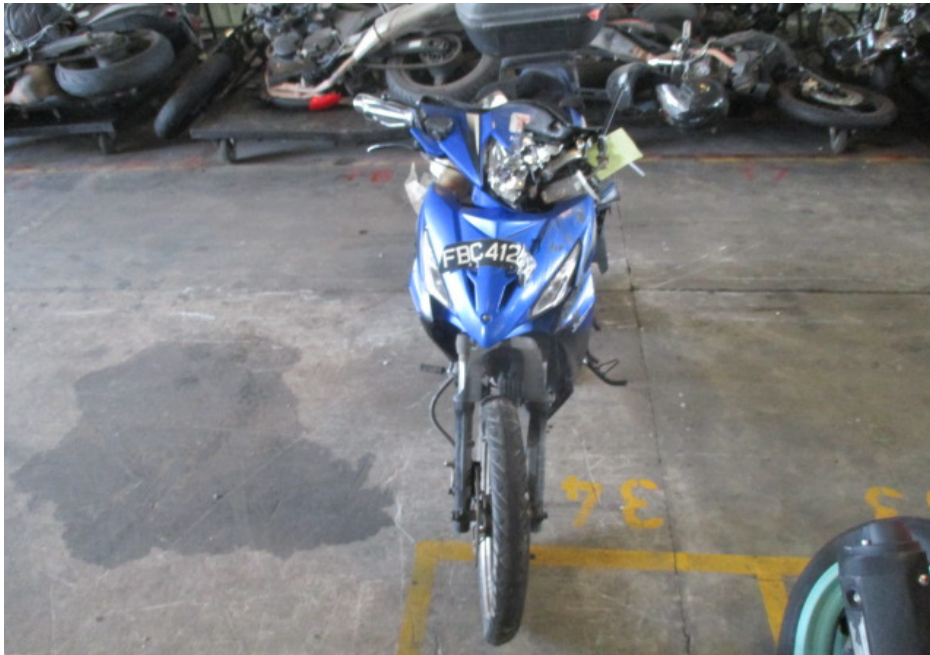
**Photo 2** shows a general view of the front portion of the Motorcycle at the time of our inspection. The Motorcycle was observed to have sustained damages all around.

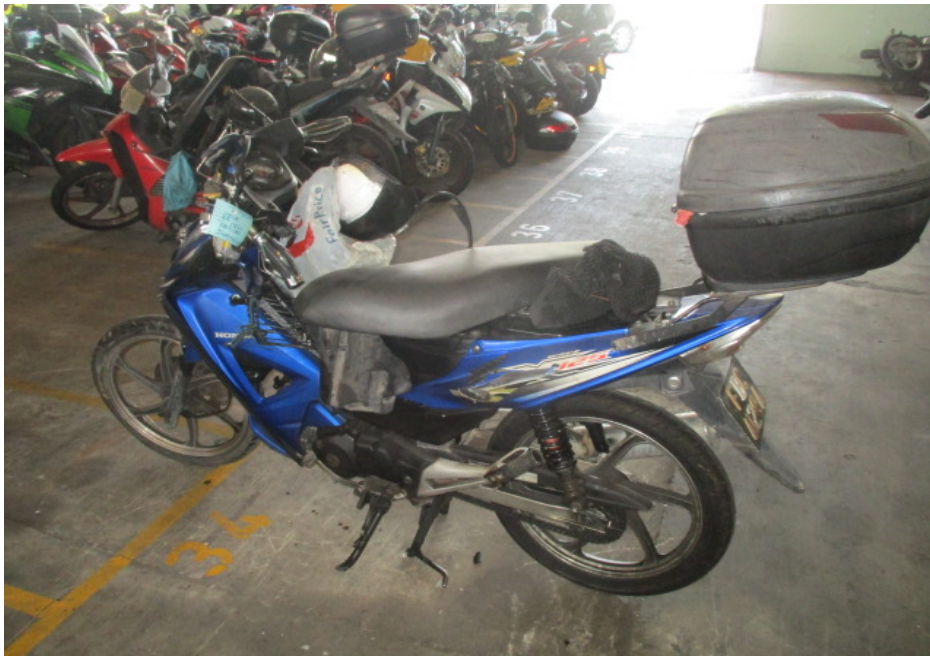
**Photo 3** shows a general view of the left body of the Motorcycle at the time of our inspection. The Motorcycle was observed to have sustained damages all around. Amongst the body parts that were found to have been damaged include its headlamp assembly, front cowling, side cowlings, left handlebar grip, left side mirror, left front footrest, gear shift pedal, rear side covers and exhaust muffler, amongst others.

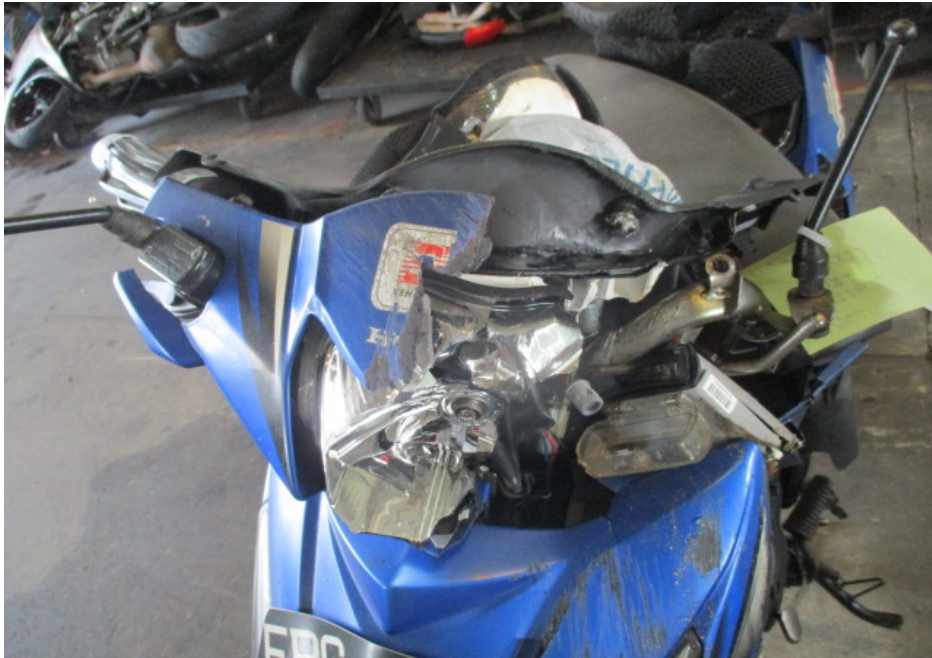
**Photo 4** shows a closer view of the cracked headlamp assembly which was amongst the body parts at the front body of the Motorcycle that had sustained damage as a result of the accident.

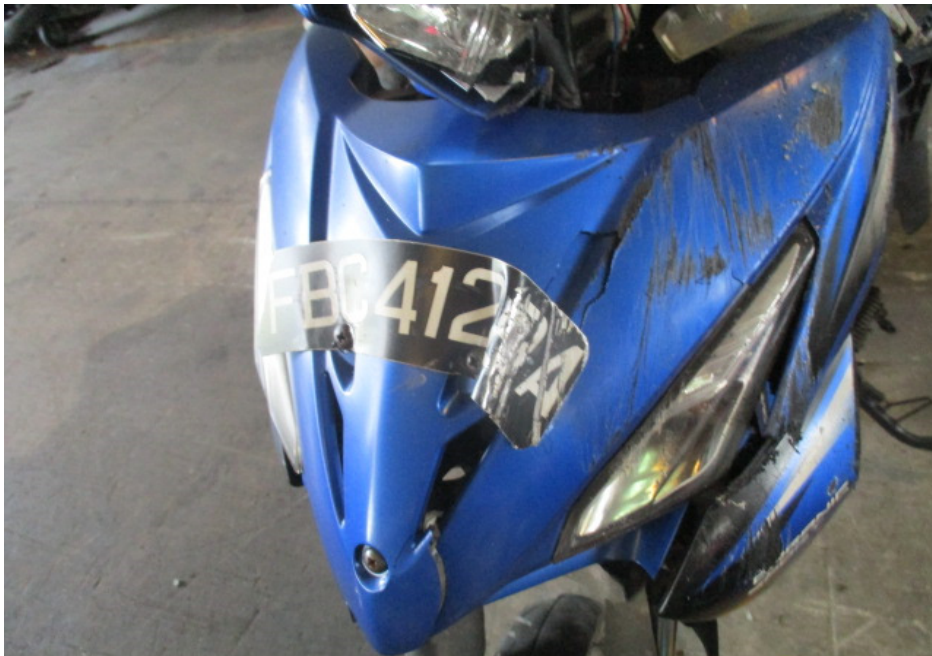
**Photo 5** shows a close up view of the cracked front cowling which was amongst the body parts of the Motorcycle that had sustained damage as a result of the accident.

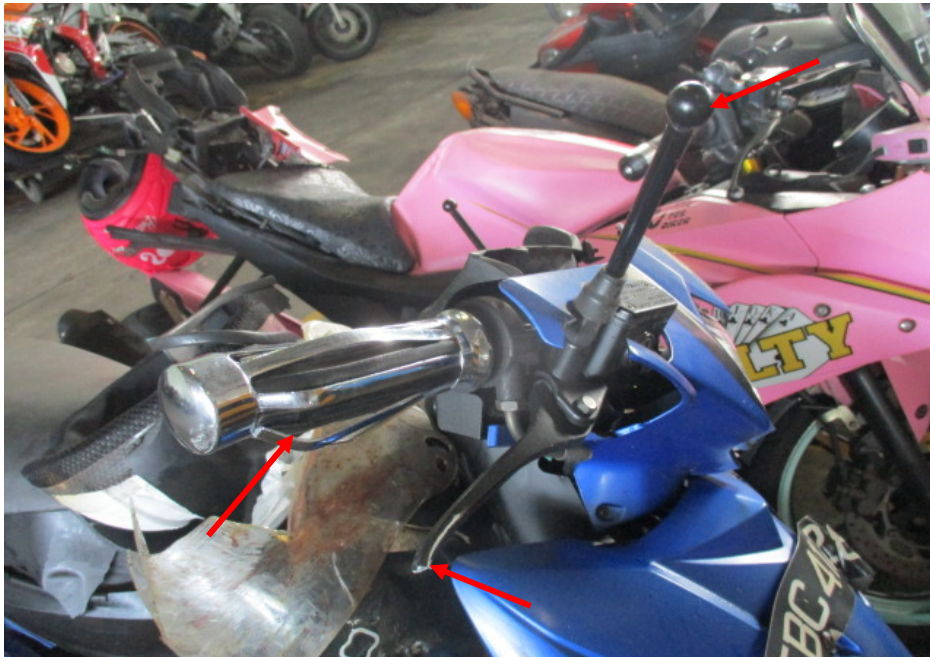
**Photo 6** shows a closer view of the front brake lever, left side mirror and right handlebar grip (arrowed) which were amongst the body parts at the front body of the Motorcycle that had sustained damage as a result of the accident.

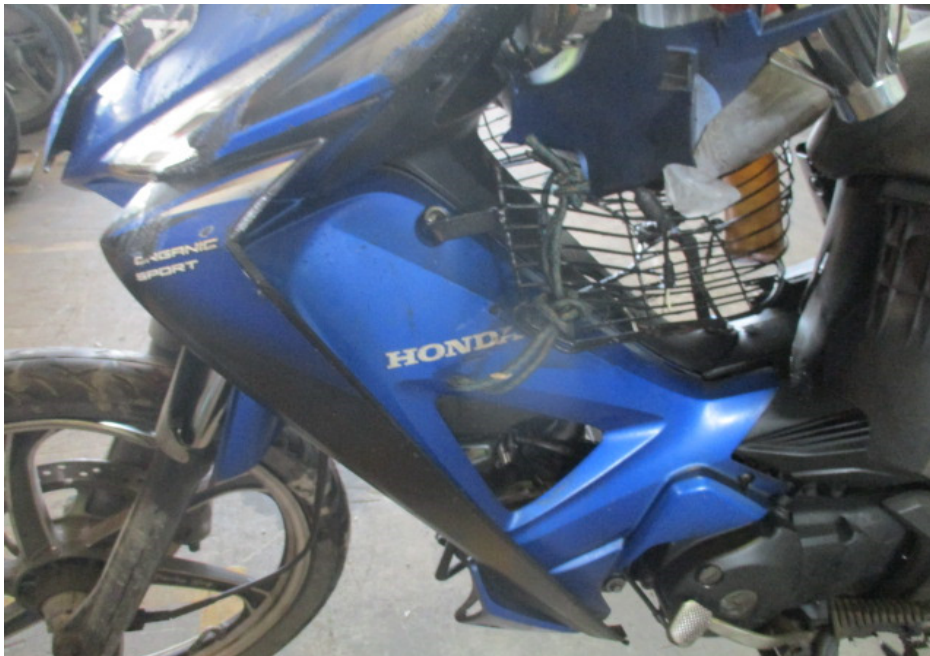
**Photo 7** shows a closer view of the left cowling of the Motorcycle that had sustained damages as a result of the accident.

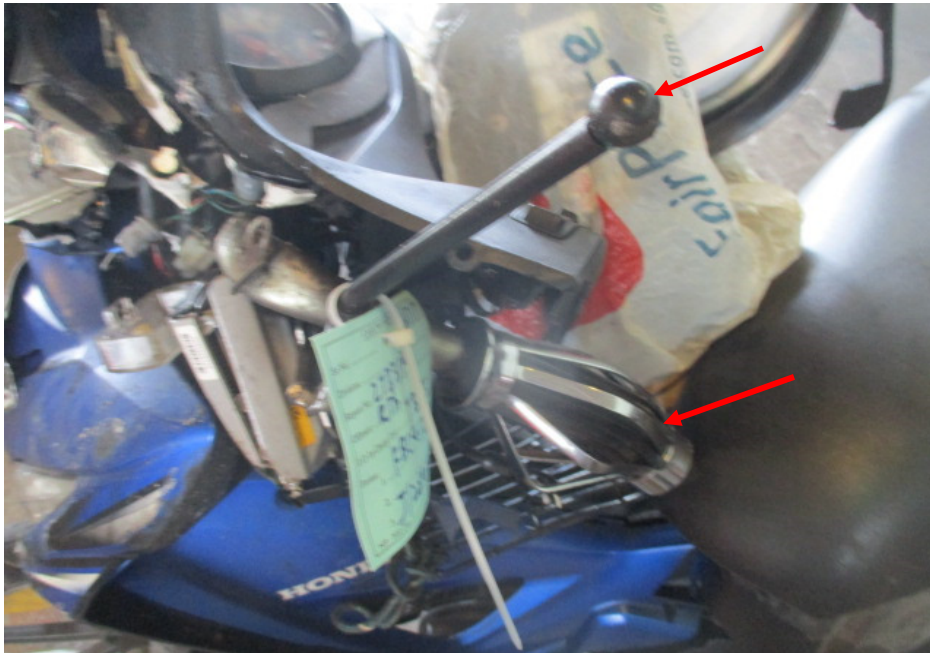
**Photo 8** shows a closer view of the left handlebar grip and left side mirror (arrowed) which were amongst the body parts of the Motorcycle that had sustained damage as a result of the accident.

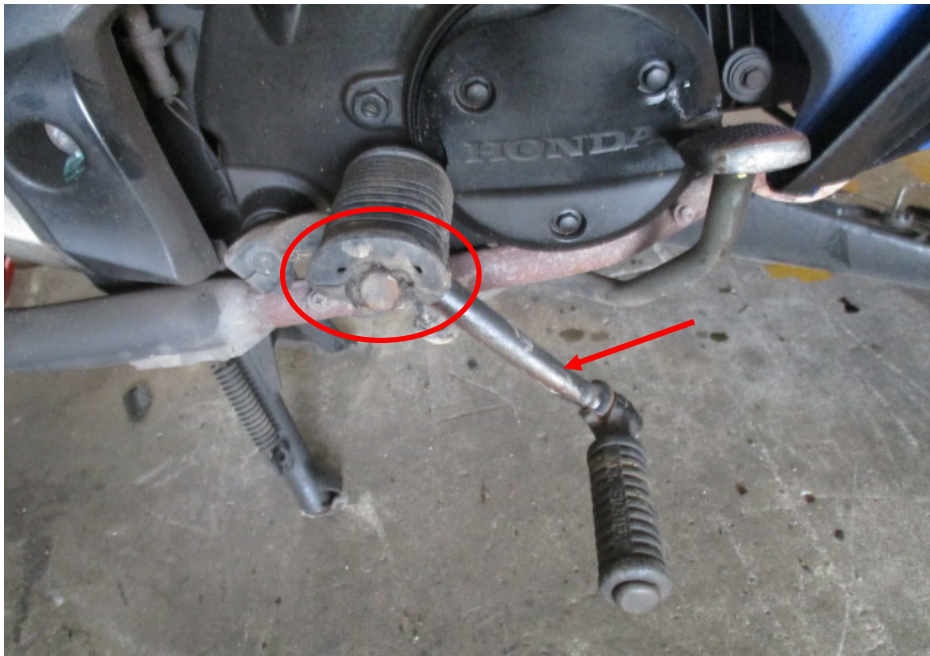
**Photo 9** shows a closer view of the right front footrest (circled) and the kickstart pedal (arrowed) which were amongst the body parts of the Motorcycle that had sustained damage as a result of the accident.

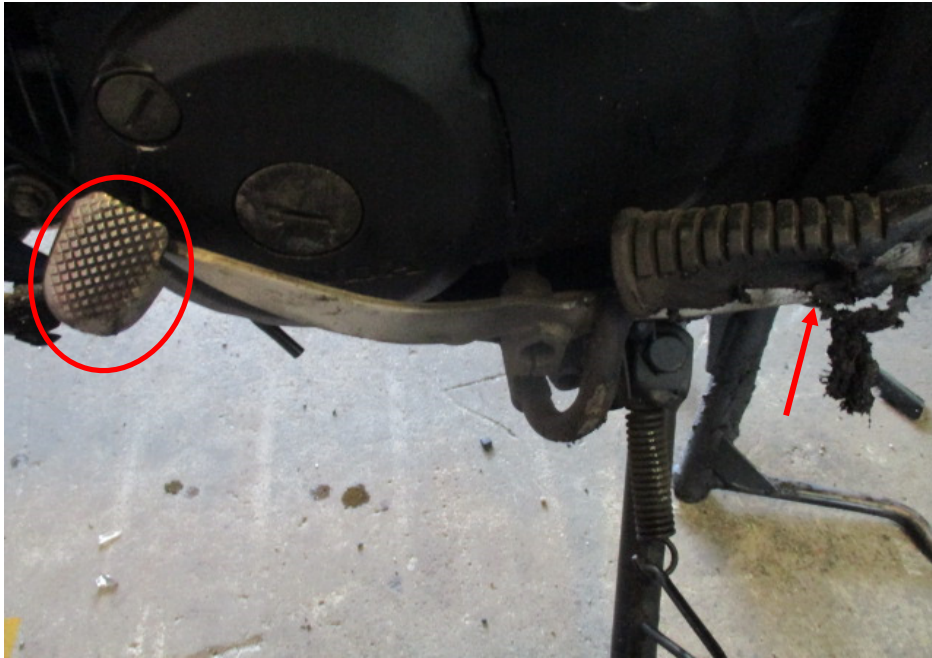
**Photo 10** shows a closer view of the left front footrest (arrowed) and gear shift pedal (circled) which were amongst the body parts of the Motorcycle that had sustained damage as a result of the accident.

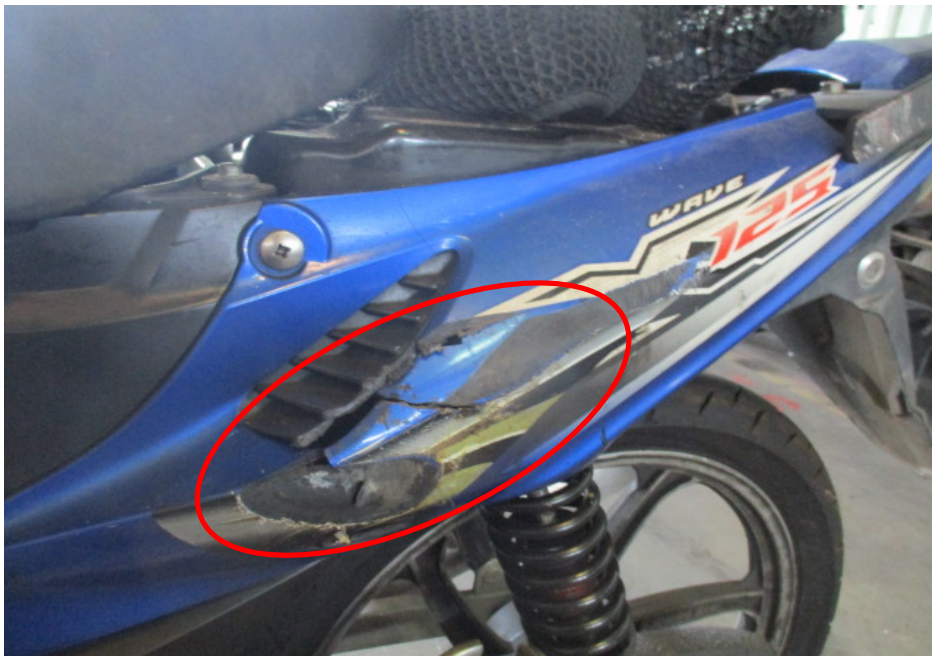
**Photo 11** shows the left rear side cover of the Motorcycle which was observed to be cracked as a result of the accident (circled).

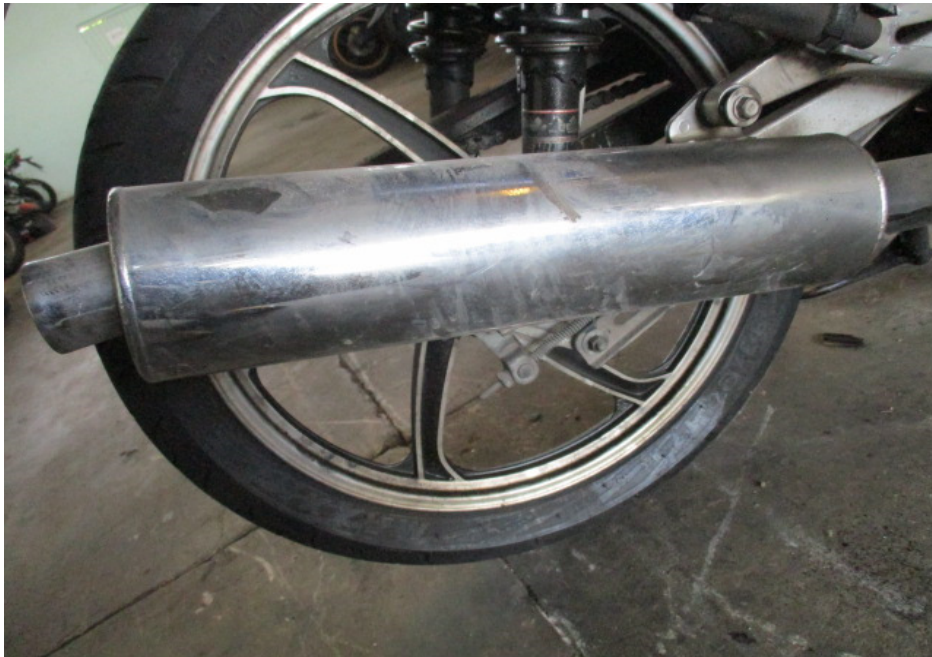
**Photo 12** shows the exhaust muffler which was amongst the body parts of the Motorcycle that had sustained damages of grazing nature as a result of the accident.

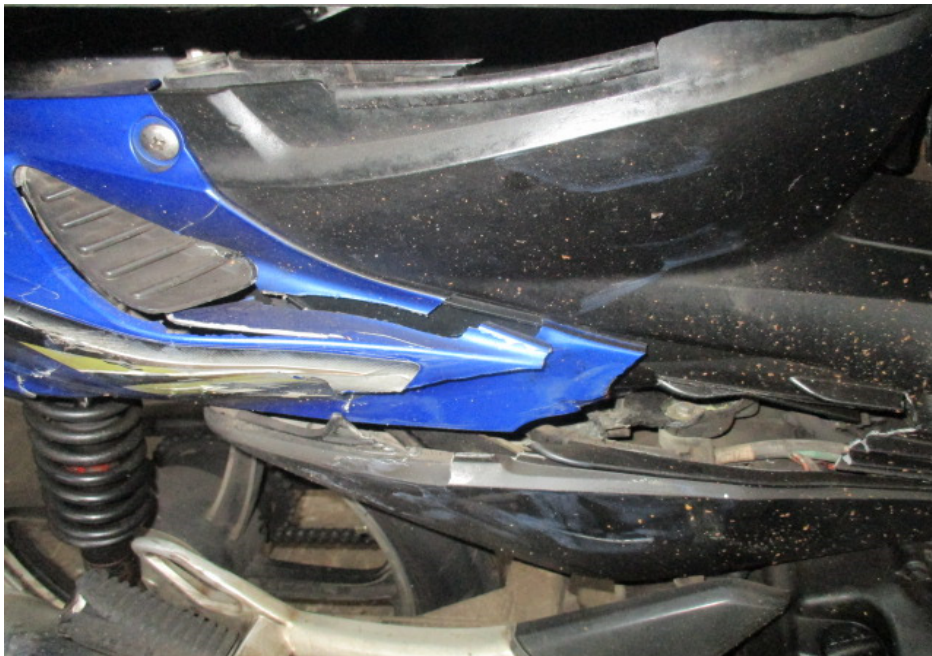
**Photo 13** shows a closer view of the right rear side cover of the Motorcycle that had cracked as a result of the accident.

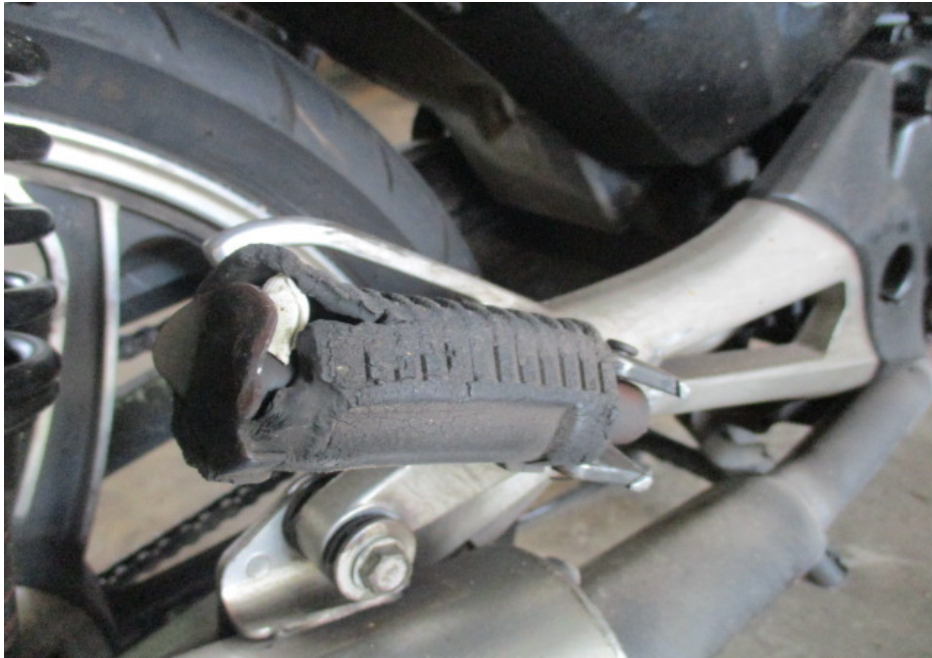
**Photo 14** shows a closer view of the right pillion foot peg which was amongst the body parts of the Motorcycle that had sustained damage as a result of the accident.

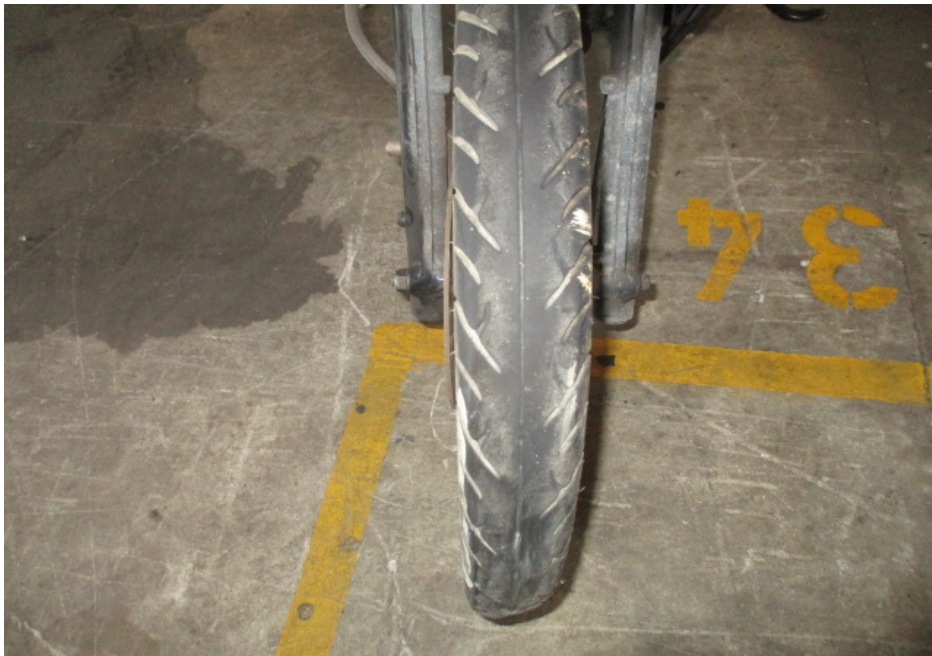
**Photo 15** shows the condition of the Motorcycle's front tyre. The front tyre was observed to be in serviceable condition with remaining tread depth of approximately 3mm. There was no tear, burst mark(s) and/or punctured hole(s) on the sidewalls as well as across the tread of the front tyre.

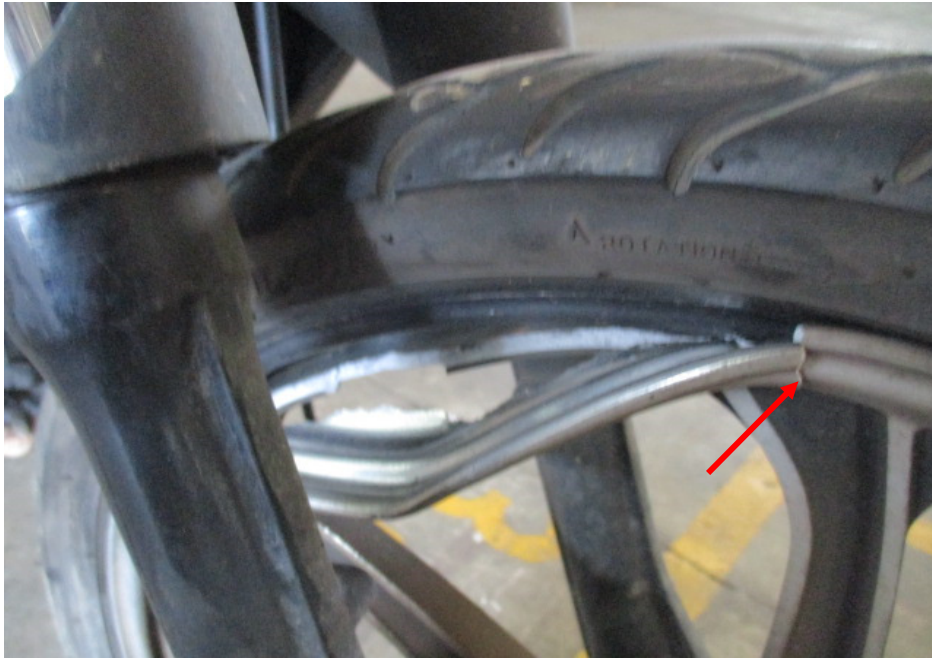
8. The 2 tyres were wrapped around alloy wheel rims. At the time of our inspection, we did not observe any visible damage on the rear wheel rim of the Motorcycle. However we did observe that the front wheel rim was broken as a result of the accident. See photos 1 – 17 below.

**Photo 16** shows a closer view of the broken front wheel rim of the Motorcycle as a result of the accident (arrowed).

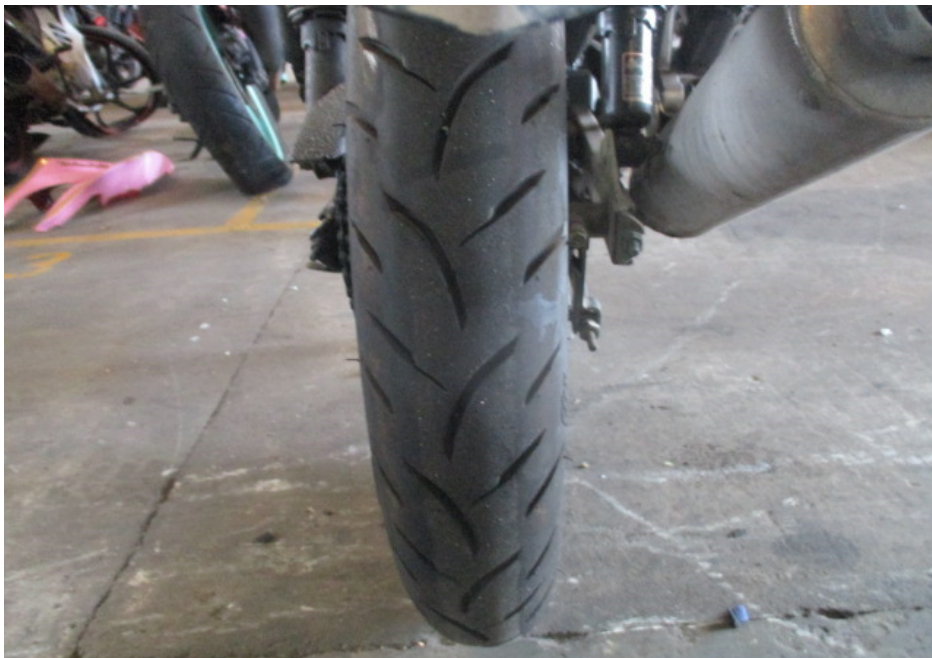
**Photo 17** shows the condition of the Motorcycle's rear tyre. The rear tyre was observed to be in serviceable condition with remaining tread depth of approximately 3mm. The tyre was also observed to be sufficiently inflated for vehicular operation. We did not observe any tear, burst mark(s) and/or punctured hole(s) on the sidewalls as well as across the tread of the rear tyre.

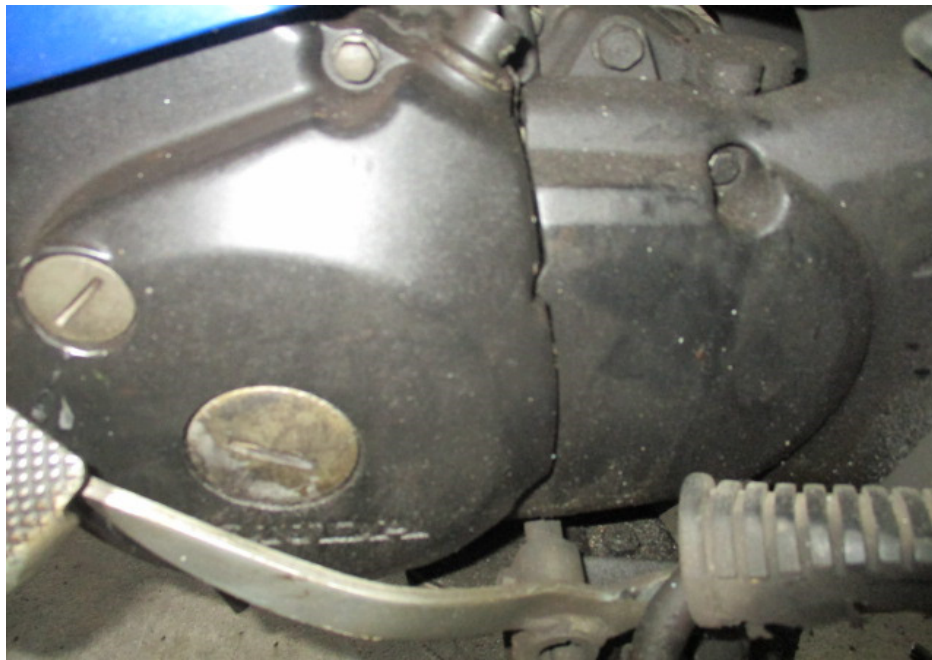
**Photo 18** shows the left side of the engine of the Motorcycle at the time of our inspection. The various engine related parts and components were found to be intact with no visible damage. There was also no sign(s) or indication(s) of fluid leak observed around the left engine area of the Motorcycle.

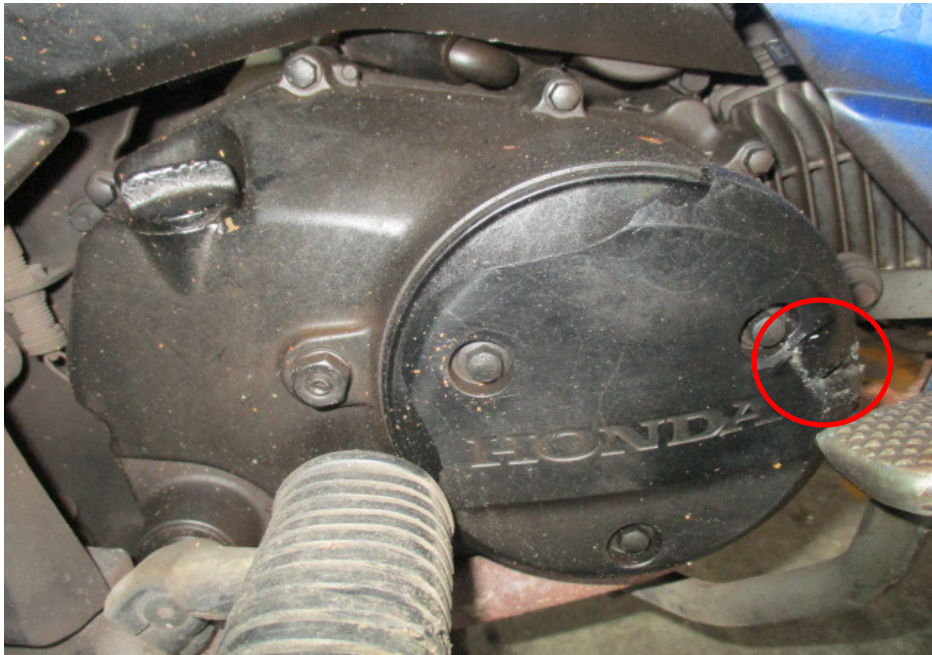
**Photo 19** shows the right side of the engine of the Motorcycle at the time of our inspection. The outer engine cover at the right side of the Motorcycle had cracked as a result of the accident (circled) however the engine components were still intact. There was also no fluid leak and/or fluid stain found around the right engine area of the Motorcycle.

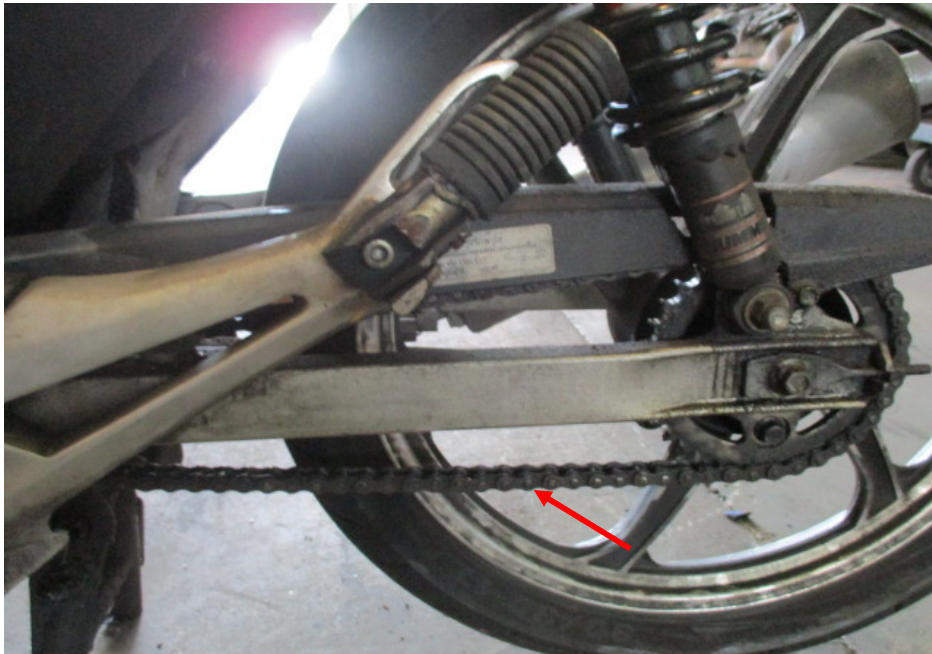
**Photo 20** shows the general view of the gear train (arrowed) of the Motorcycle, which was observed to be intact with no misalignment. It was also adequately lubricated for operating purposes.

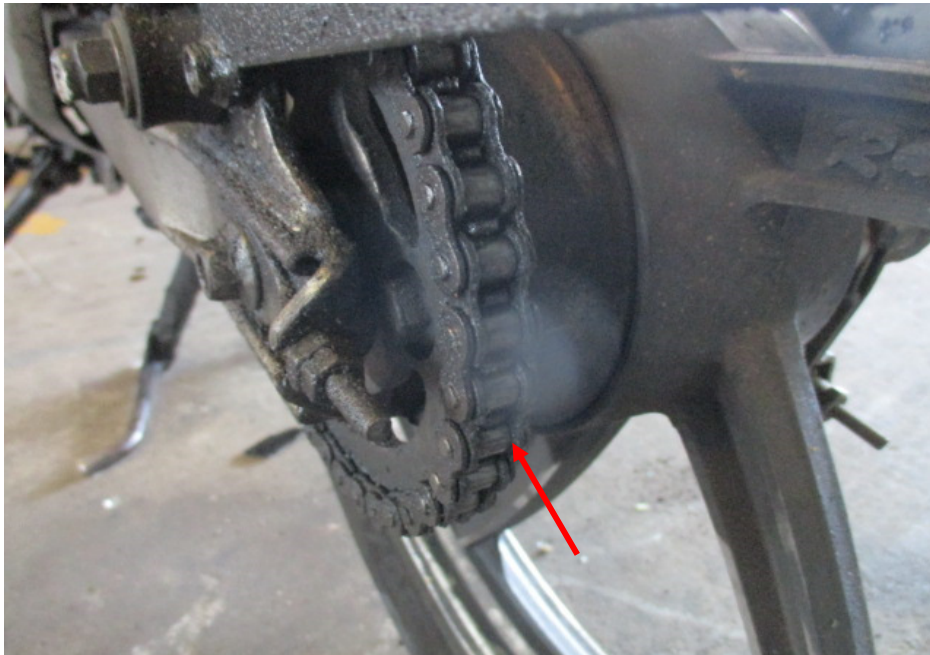
**Photo 21** shows a closer view of the gear train (arrowed) of the Motorcycle, which was observed to be intact with no misalignment. It was also adequately lubricated for operating purposes.

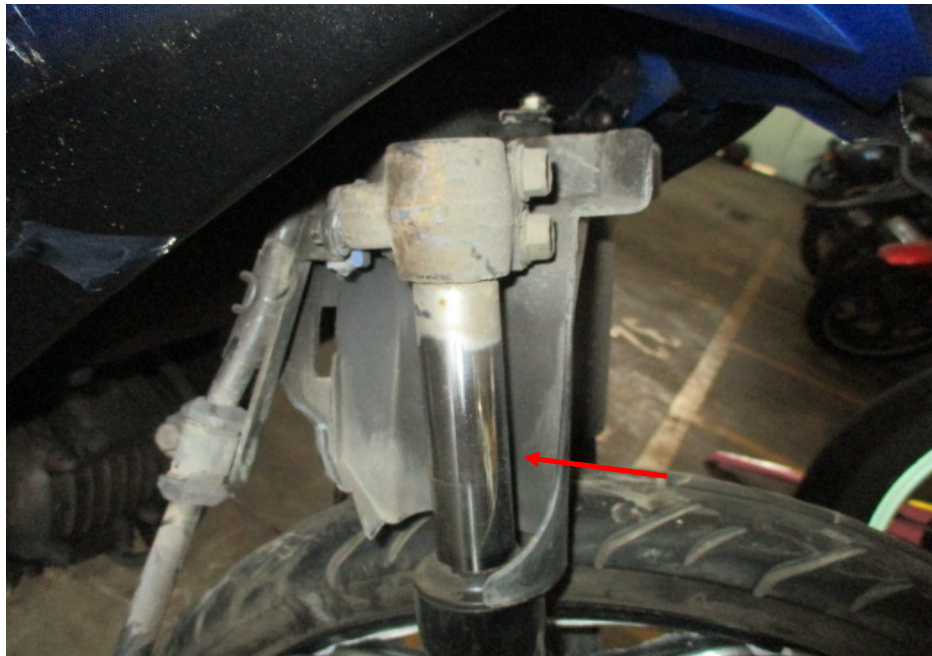
11. For this case, we were not able to conduct any test(s) on the steering system of the Motorcycle due to the damage of its right front fork. The right front fork was found to be bent as a result of the accident.

**Photo 22** shows the front right fork of the Motorcycle. The front right fork was observed to be bent (arrowed) as a result of the accident. We were hence not able to conduct any tests on the steering system of the Motorcycle.

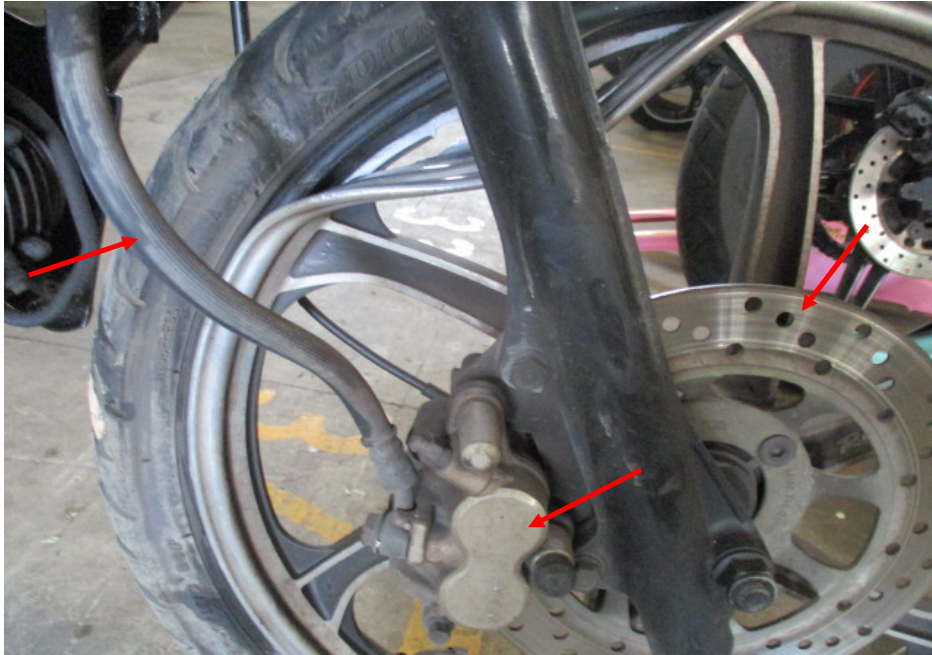
**Photo 23** shows a close up view of the front brake caliper, front brake disc and front brake hose (arrowed) of the Motorcycle, which are all part of the components in the hydraulic front brake system of the Motorcycle. Our visual checks of these various components had revealed all to be intact with no visible damage. No leakage of brake fluid was also observed.

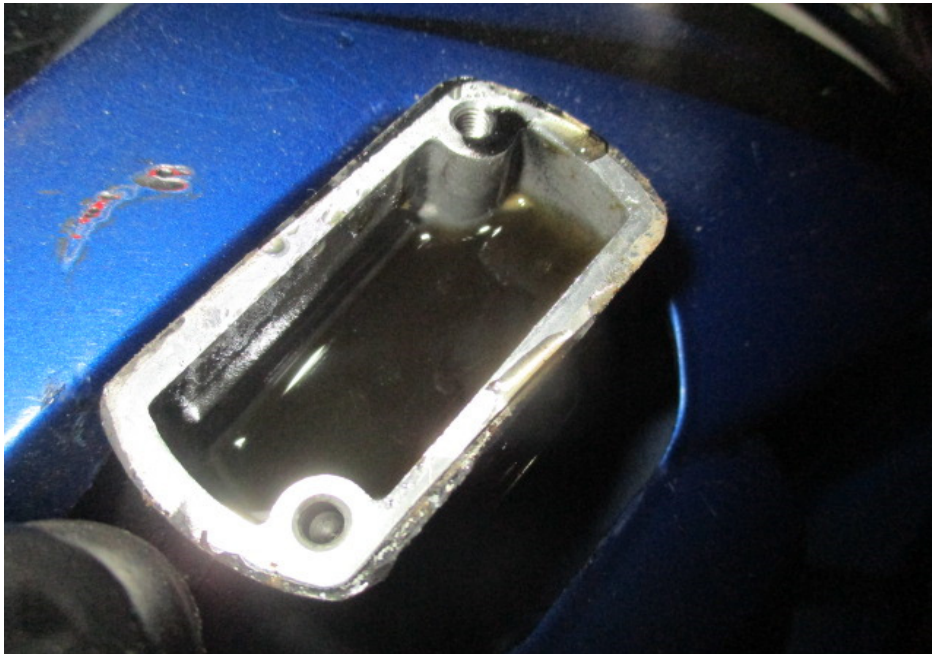
**Photo 24** shows the brake fluid reservoir for the front brake of the Motorcycle. The brake fluid was observed to be without contamination and of sufficient level for operational purposes.

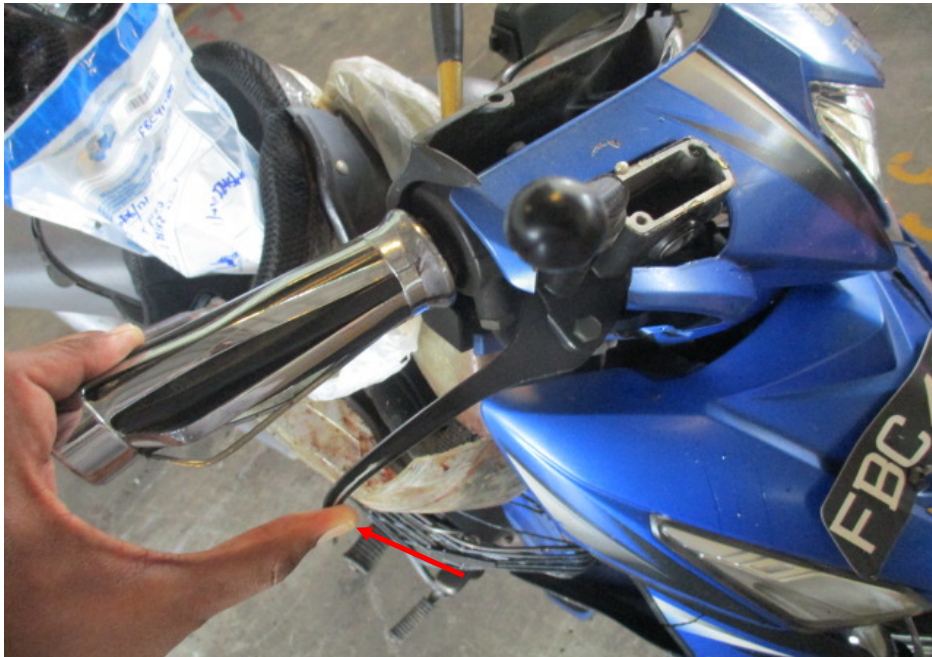
13. Static brake tests conducted on the Motorcycle had appear to indicate that the front braking system of the Motorcycle was in serviceable condition. There was some resistance felt (spongy like feel) upon pressing the brake lever. This would indicate that there was no leakage of pressure/vacuum in the front brake system.

**Photo 25** shows the front brake lever being depressed. There was some resistance felt (spongy like feel) upon pressing the front brake lever (arrowed). This would indicate that there is no leakage of pressure/vacuum in the brake system.

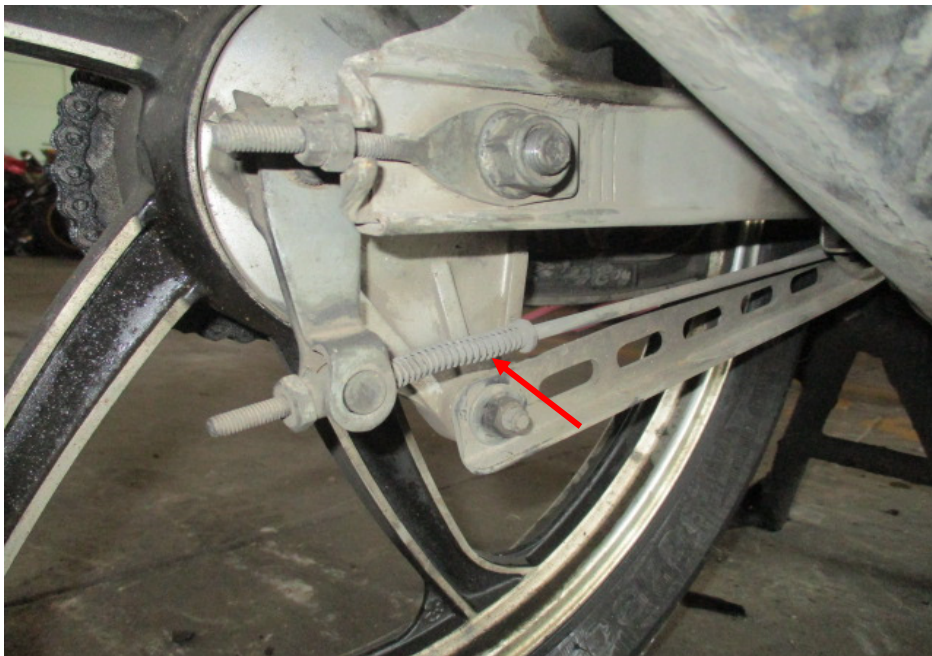
**Photo 26** shows the rear wheel of the Motorcycle. The type of brake system for the rear wheel was of a mechanical type, controlled by the brake foot pedal of the Motorcycle. Our checks of the cable (arrowed), spring and drum which are all part of the components in the rear brake system of the Motorcycle reveal all to be intact and without damage.
