Your Ref: TP/IP/43523/2019  
Our Ref : CI/TPD19013996/N

**Fatal Accident Investigation Team**

**MECHANICAL INSPECTION REPORT OF MOTORCYCLE FBD 3852H**

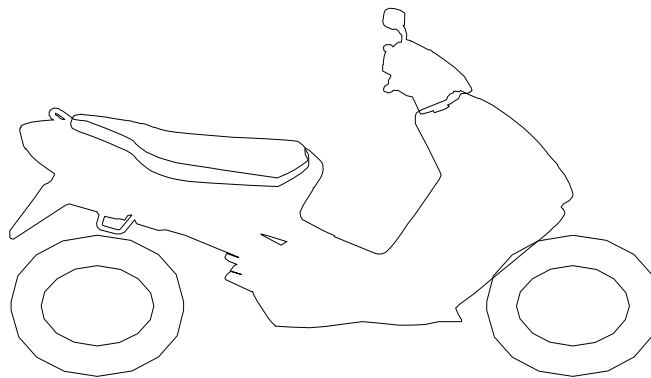
6. The condition of the 2 tyres of the Motorcycle was observed to be in serviceable condition. We did not observe any tear, burst mark(s) and/or punctured hole(s) on the sidewalls as well as across the tread of the 2 tyres. Both the tyres were observed to be sufficiently inflated for vehicular operation.
7. The tyre brand, tyre size and remaining tread depth of the 2 tyres of the Motorcycle were recorded as follows:-

Zeneos 150/60 R17 (6mm)

Zeneos 110/70 R17 (3mm)

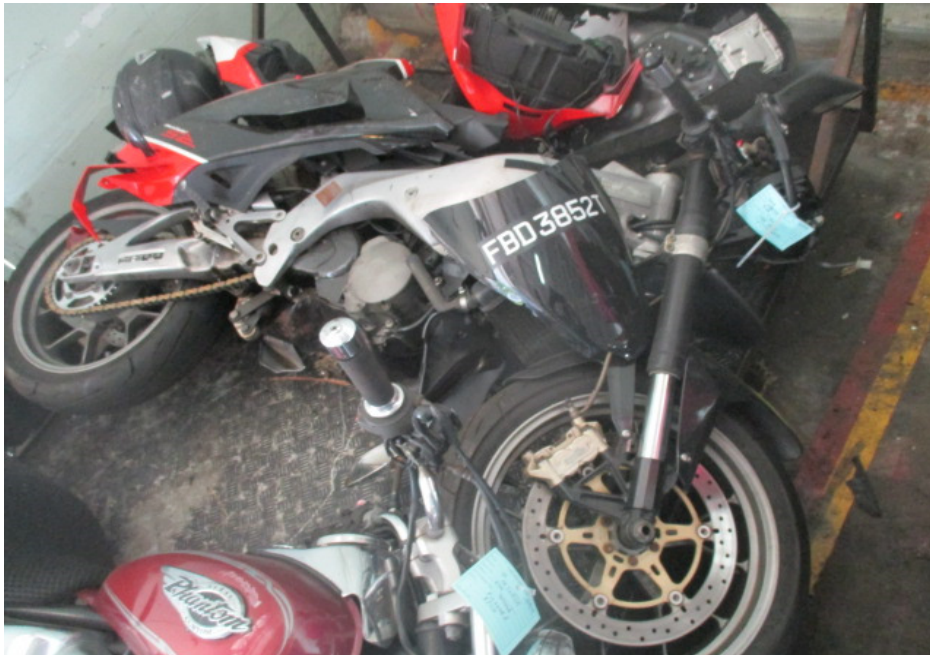
4. The mileage of the Motorcycle at the time of our inspection was not recorded due to the damage sustained to the speedometer display screen as a result of the accident.
5. The Motorcycle had sustained damages all around. Body parts that were found to have been damaged include its windshield, head cowl, speedometer gauge, side mirrors, top clamp, handlebars, right cowling, fuel tank, rear brake pedal bracket and exhaust pipe, amongst others.

**Photo 1** shows a general view of the right body of the Motorcycle at the time of our inspection. The Motorcycle had sustained damages all around. Body parts that were found to have been damaged include its windshield, head cowl, speedometer gauge, side mirrors, top clamp, handlebars, right cowling, fuel tank, rear brake pedal bracket and exhaust pipe, amongst others.

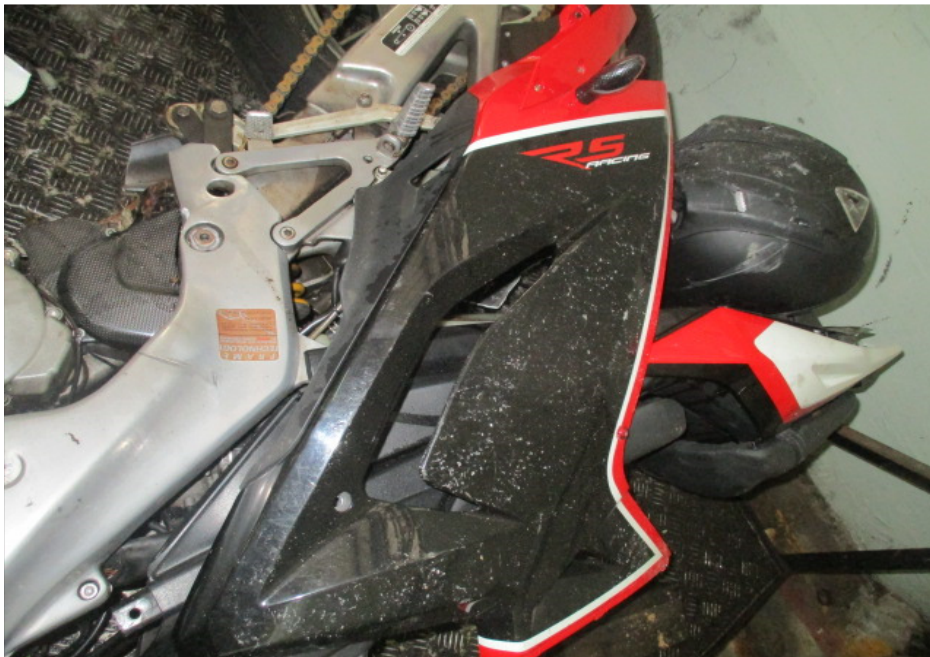
**Photo 2** shows a closer view of the right cowling which was amongst the body parts of the Motorcycle that had sustained damage as a result of the accident.

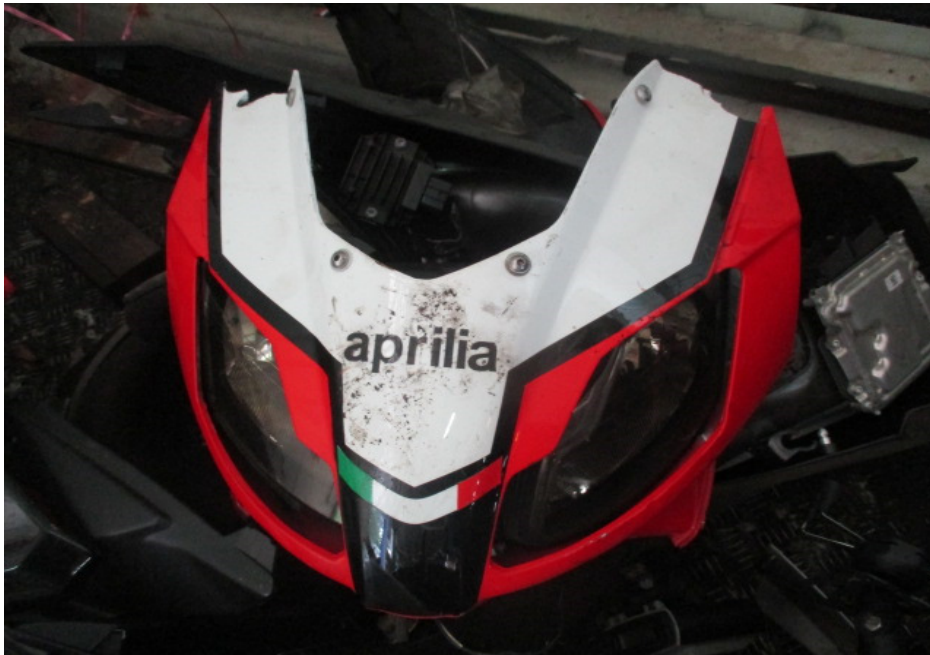
**Photo 3** shows a closer view of the head cowling which was amongst the body parts at the front body of the Motorcycle that had sustained damage as a result of the accident.

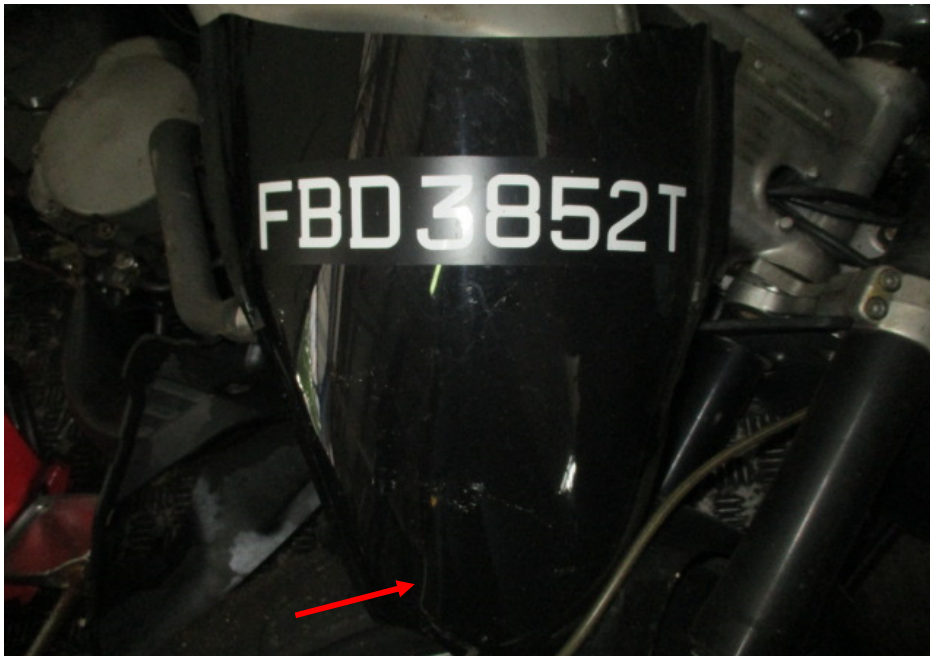
**Photo 4** shows a closer view of the cracked windshield the Motorcycle as a result of the accident (arrowed).

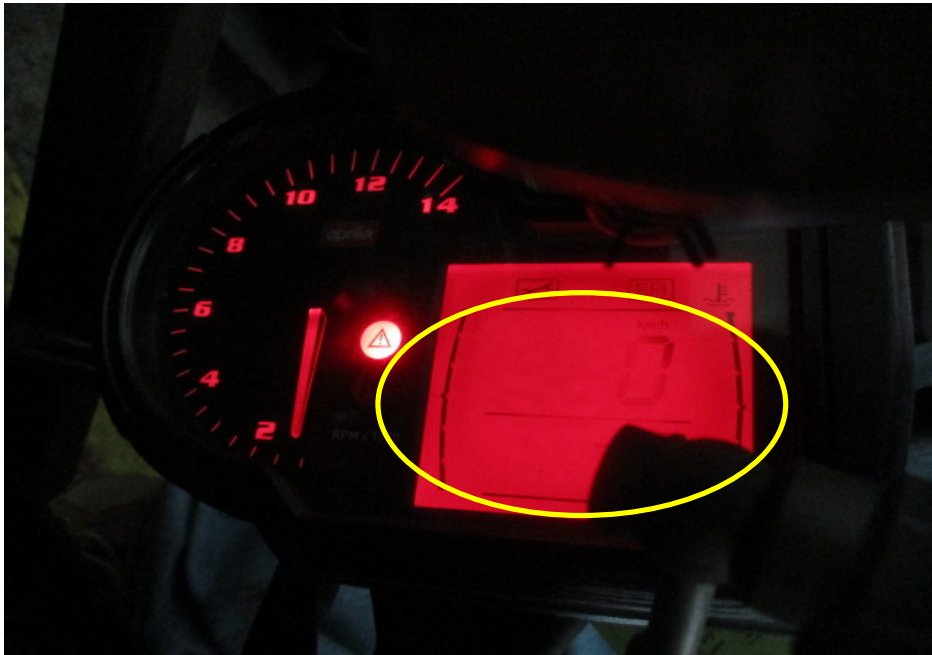
**Photo 5** shows a closer view of the speedometer gauge of the Motorcycle. The mileage of the Motorcycle at the time of our inspection was not recorded due to the damage sustained to the speedometer display screen as a result of the accident (circled).

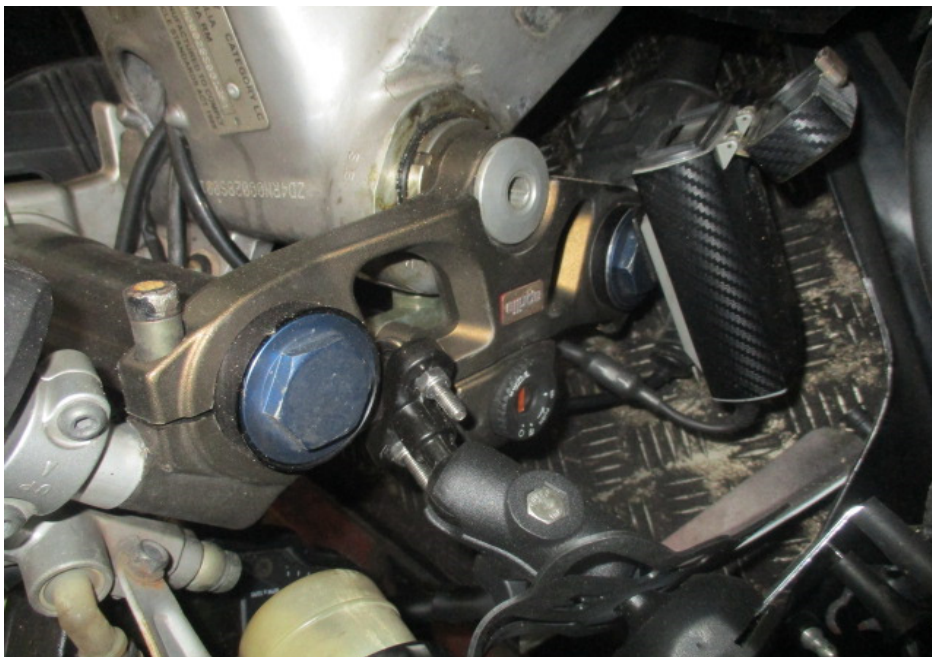
**Photo 6** shows a closer view of the top clamp, side mirrors and handlebars of the Motorcycle. These parts were amongst the body parts of the Motorcycle which were damaged as a result of the accident.

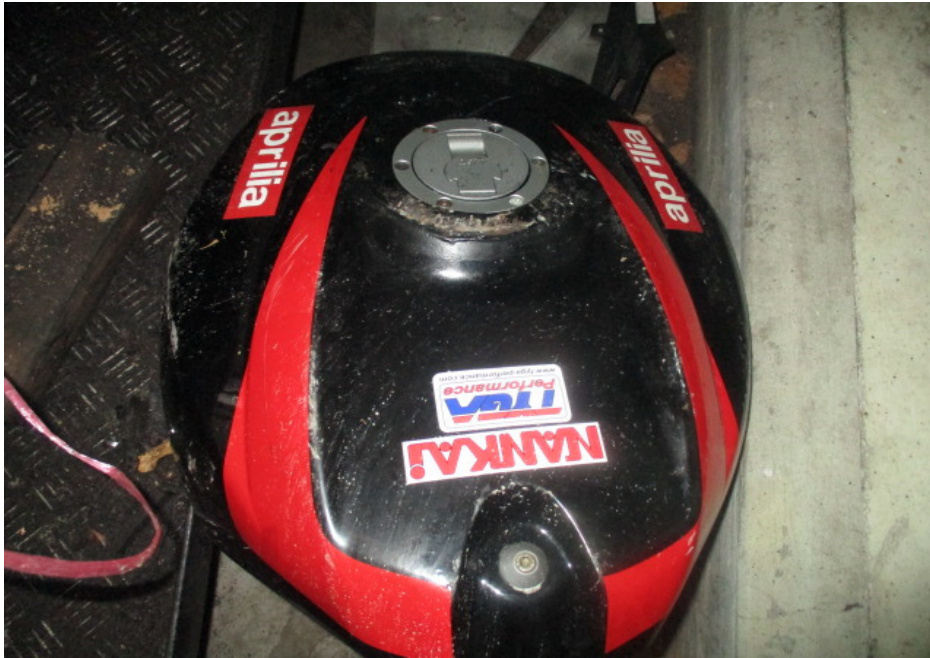
**Photo 7** shows a closer view of the petrol tank, which was amongst the body parts of the Motorcycle that had sustained damage as a result of the accident.

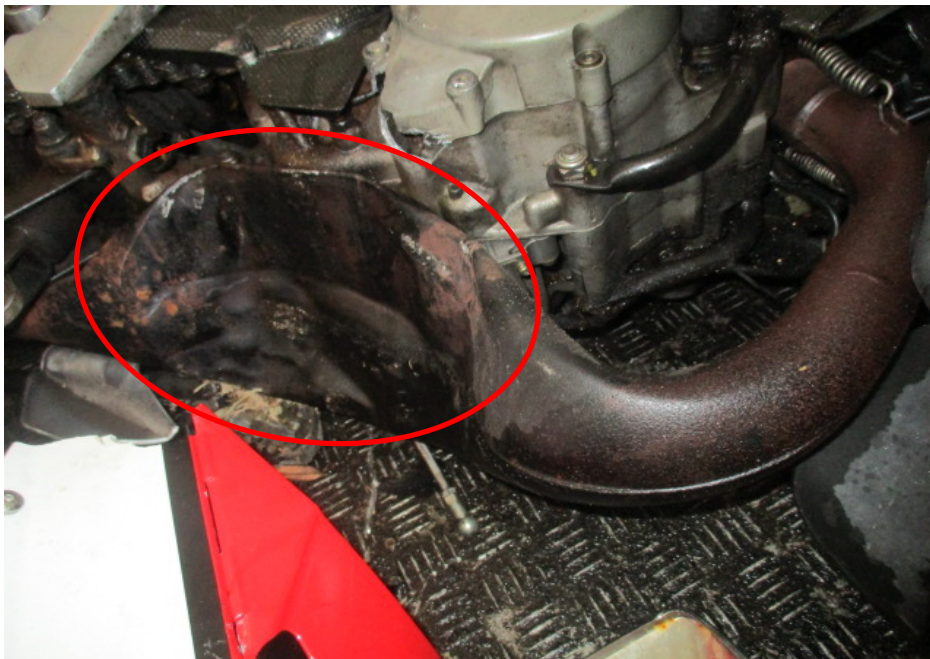
**Photo 8** shows a closer view of the dented exhaust pipe of the Motorcycle as a result of the accident (circled).

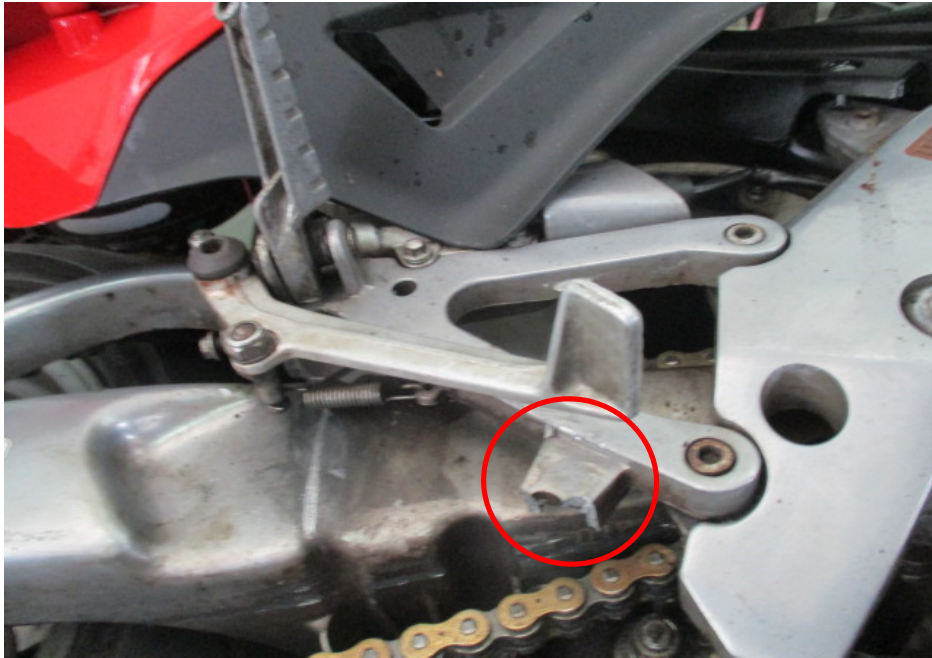
**Photo 9** shows a closer view of the broken rear brake pedal bracket of the Motorcycle as a result of the accident (circled).

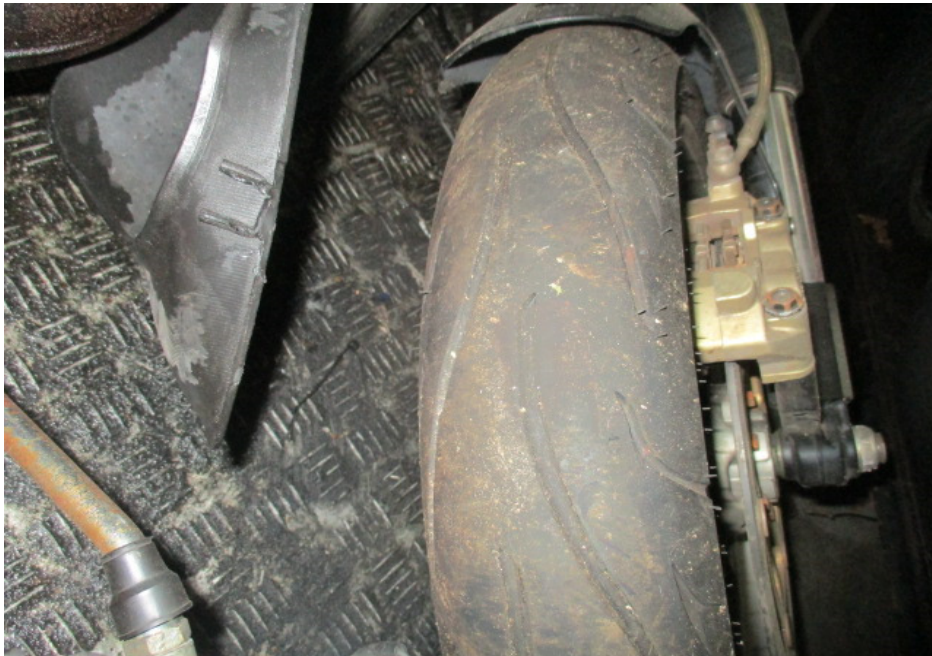
**Photo 10** shows the condition of the Motorcycle's front tyre. The front tyre was observed to be in serviceable condition with remaining tread depth of approximately 3mm. The tyre was also observed to be sufficiently inflated for vehicular operation. We did not observe any tear, burst mark(s) and/or punctured hole(s) on the sidewalls as well as across the tread of the front tyre.

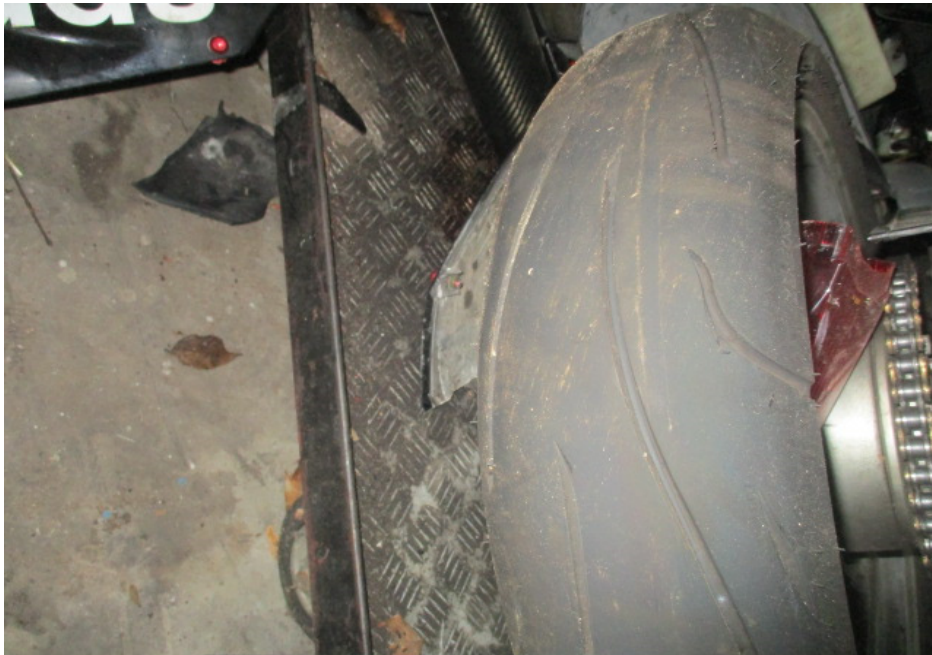
**Photo 11** shows the condition of the Motorcycle's rear tyre. The rear tyre was observed to be in serviceable condition with remaining tread depth of approximately 6mm. The tyre was also observed to be sufficiently inflated for vehicular operation. We did not observe any tear, burst mark(s) and/or punctured hole(s) on the sidewalls as well as across the tread of the rear tyre.

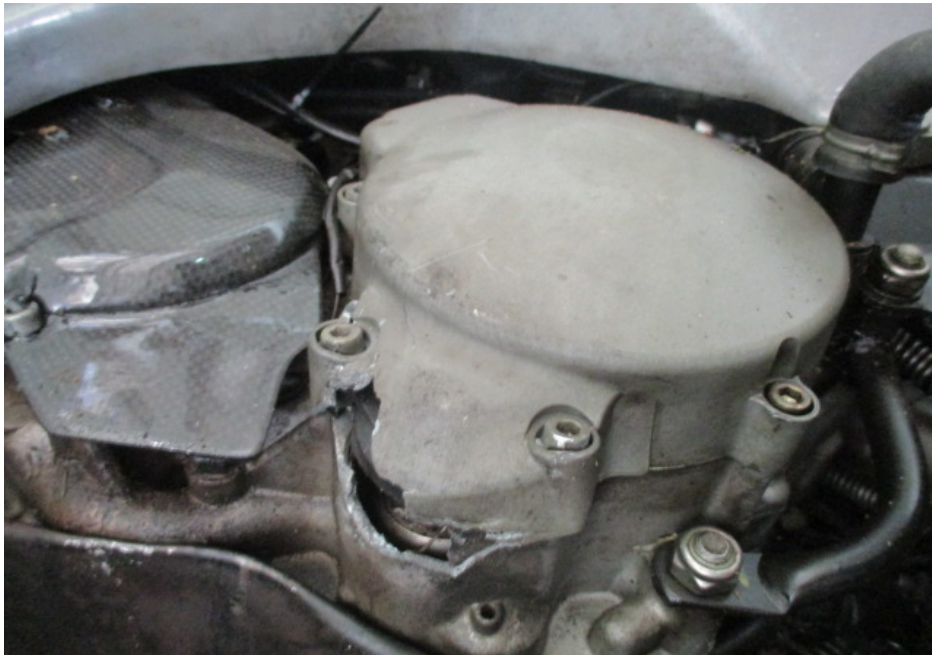
9. Upon examination of the Motorcycle's right engine area, we had observed a crack at the bottom of the right engine cover which was a result of the accident. However there was no sign(s) or indication(s) of fluid leak observed around the right engine area of the Motorcycle.
10. The gear chain of the motorcycle was found to be intact without any misalignment. It was also adequately lubricated for operating purposes. See photos 12 – 14 below.

**Photo 12** shows the right side of the engine of the Motorcycle at the time of our inspection. We had observed a crack at the bottom of the right engine cover which was a result of the accident. However there was no sign(s) or indication(s) of fluid leak observed around the right engine area of the Motorcycle.

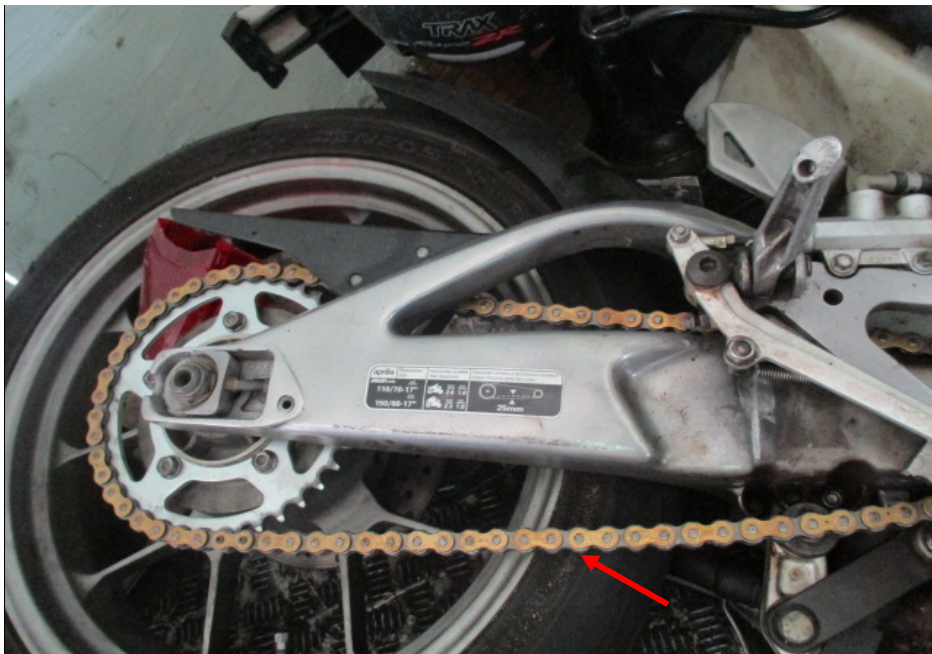
**Photo 13** shows the gear chain (arrowed) of the Motorcycle, which was observed to be intact with no misalignment. It was also adequately lubricated for operating purposes. The gear chain rotates the rear wheel of the Motorcycle.

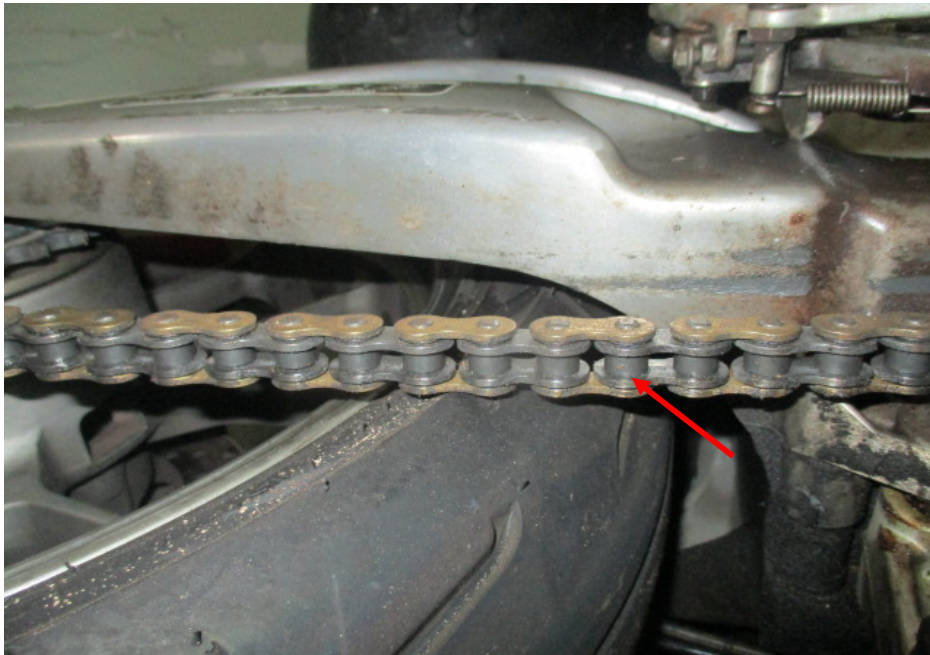
**Photo 14** shows the closer view of the gear chain (arrowed) of the Motorcycle, which was observed to be intact with no misalignment. It was also adequately lubricated for operating purposes.

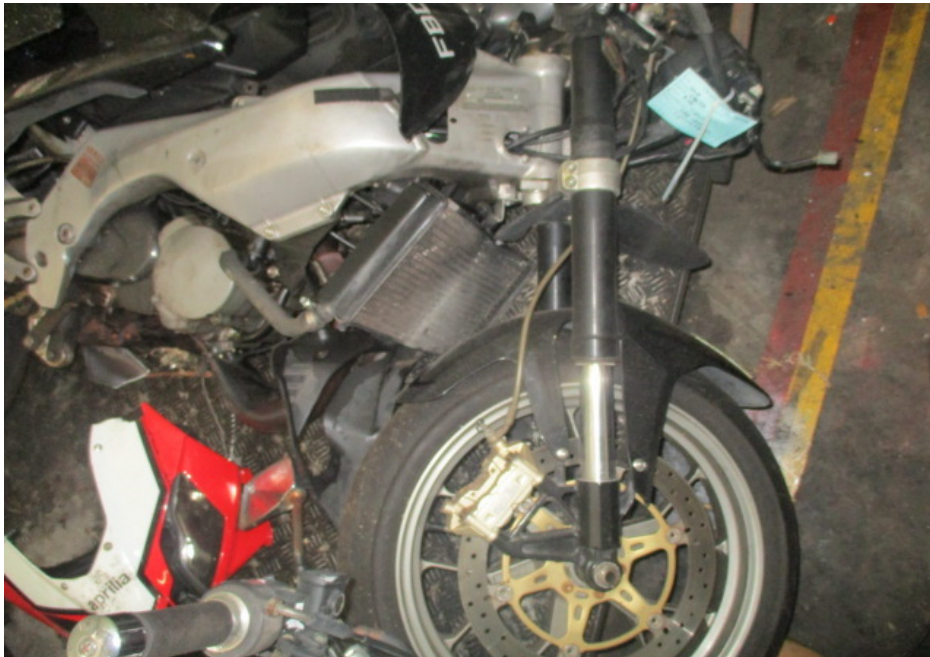
11. For this case, we were not able to conduct any test(s) on the steering system of the Motorcycle as the accident had rendered the Motorcycle immobile.

**Photo 15** shows the front forks of the Motorcycle. The accident had rendered the Motorcycle immobile. We were hence not able to conduct any tests on the steering system of the Motorcycle.

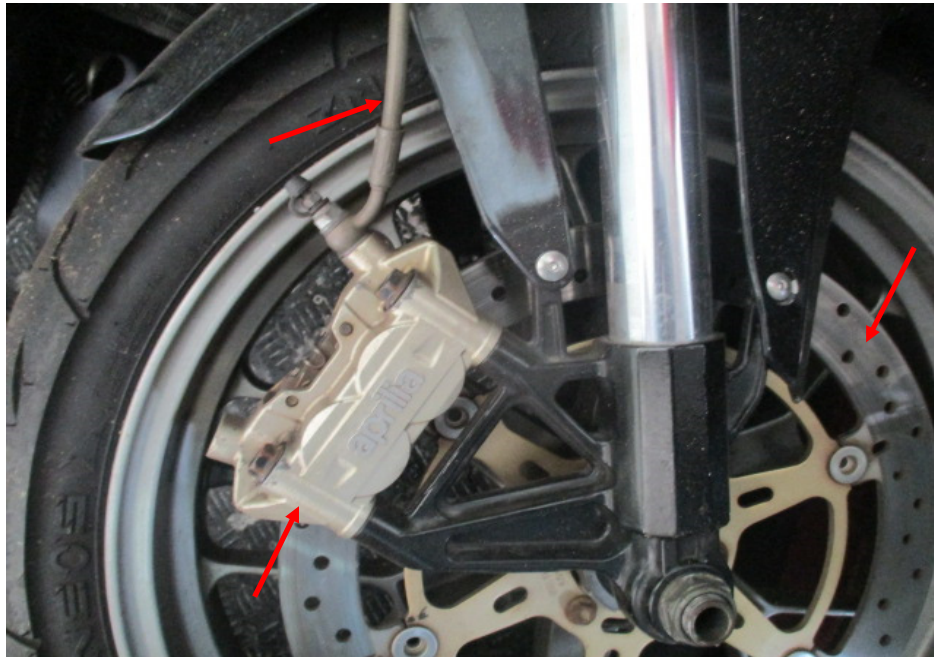
**Photo 16** shows a close up view of the front brake caliper, front brake disc and front brake hose (arrowed) of the Motorcycle, which are all part of the components in the hydraulic front brake system of the Motorcycle. Our visual checks of these various components had revealed all to be intact with no visible damage. No leakage of brake fluid was also observed.

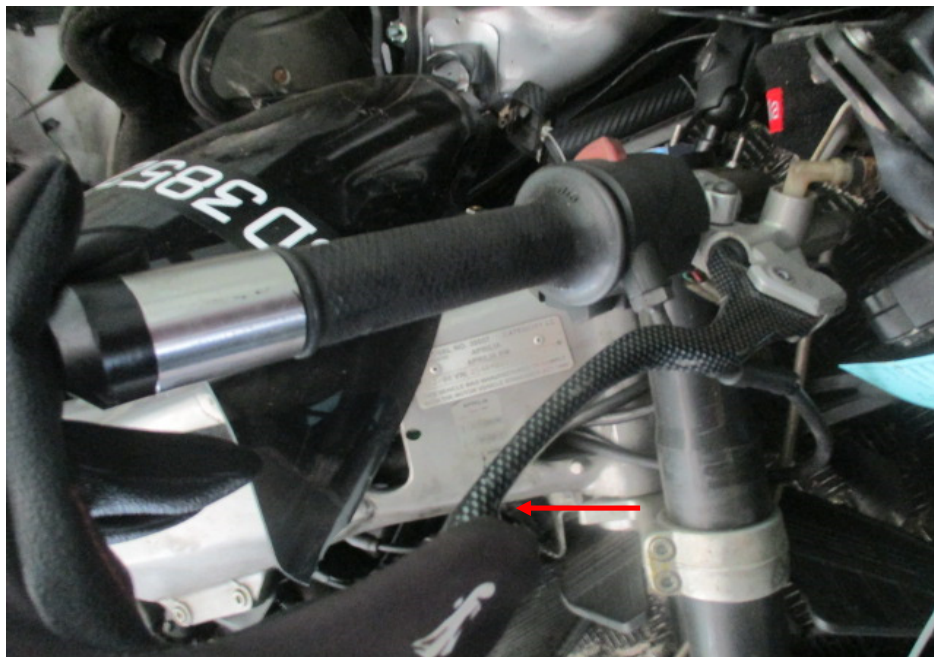
14. Static brake tests conducted on the Motorcycle had appear to indicate that the braking system of the Motorcycle was in serviceable condition. There was some resistance felt (spongy like feel) upon pressing the brake lever as well as upon stepping on the rear brake pedal. This would indicate that there was no leakage of pressure/vacuum in the brake system.
15. For this case, we were not able to carry out any operational tests to the steering system and braking system of the Motorcycle as the accident had rendered the Motorcycle immobile for the operational tests. We were not able to push the motorcycle manually forward and backward, simulating movement of the Motorcycle, for the operational tests. See photos 15 – 19 below.

**Photo 17** shows the front brake lever being depressed. There was some resistance felt (spongy like feel) upon pressing the front brake lever (arrowed). This would indicate that there is no leakage of pressure/vacuum in the brake system.

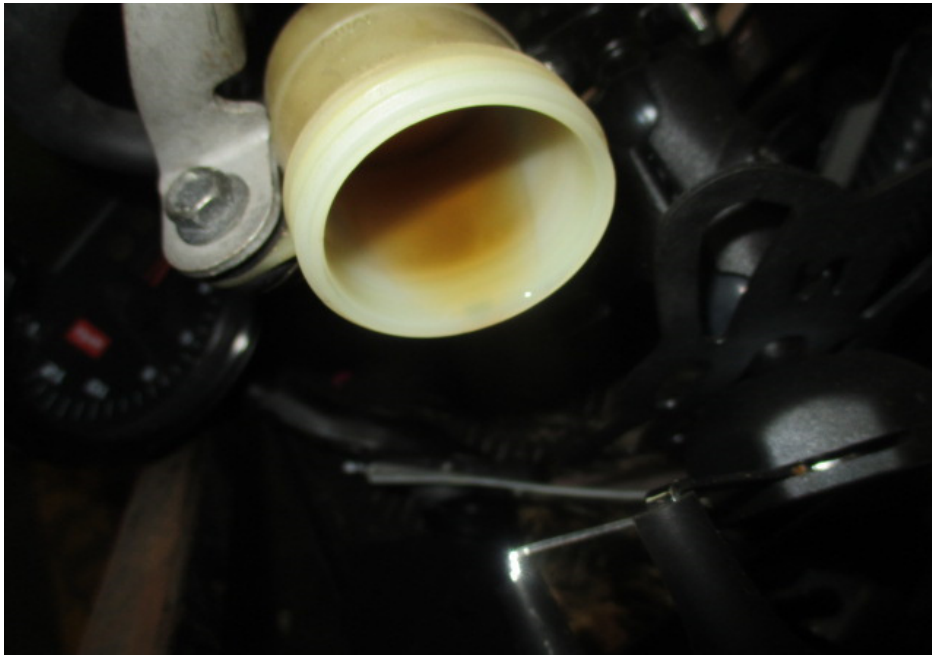
**Photo 18** shows the brake fluid reservoir for the front brake of the Motorcycle. The brake fluid was observed to be of sufficient level and without contamination for operational purposes.

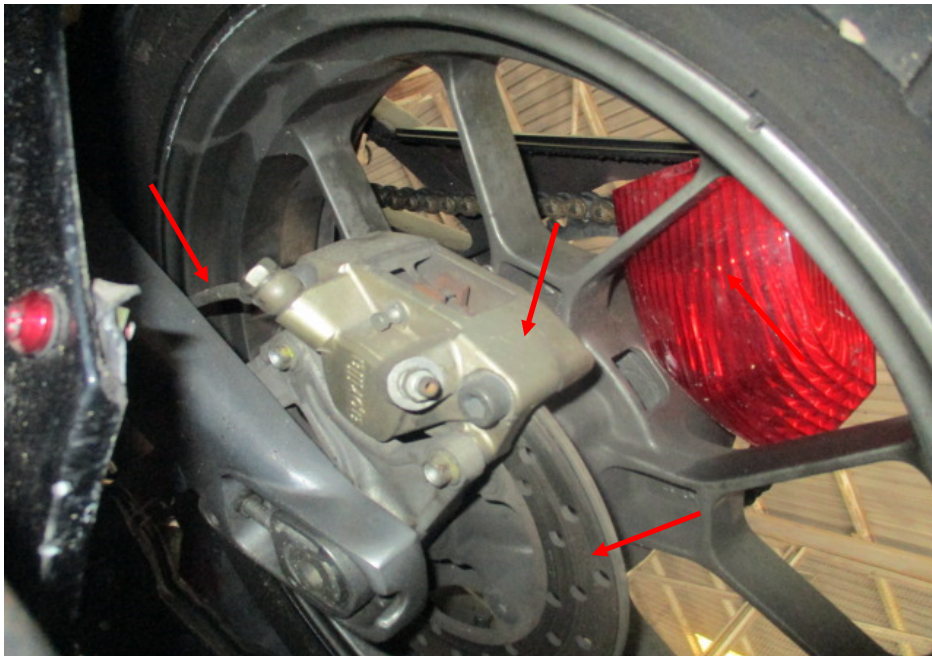
**Photo 19** shows a close up view of the rear brake caliper, rear brake disc and rear brake hose (arrowed) of the Motorcycle, which are all part of the components in the hydraulic rear brake system of the Motorcycle. Our visual checks of these various components had revealed all to be intact with no visible damage. No leakage of brake fluid was also observed.
