Your Ref: TP/IP/44541/2019  
Our Ref : CI/TPD19013997/N

**Fatal Accident Investigation Team**

**MECHANICAL INSPECTION REPORT OF MOTORCYCLE FBG 4881H**

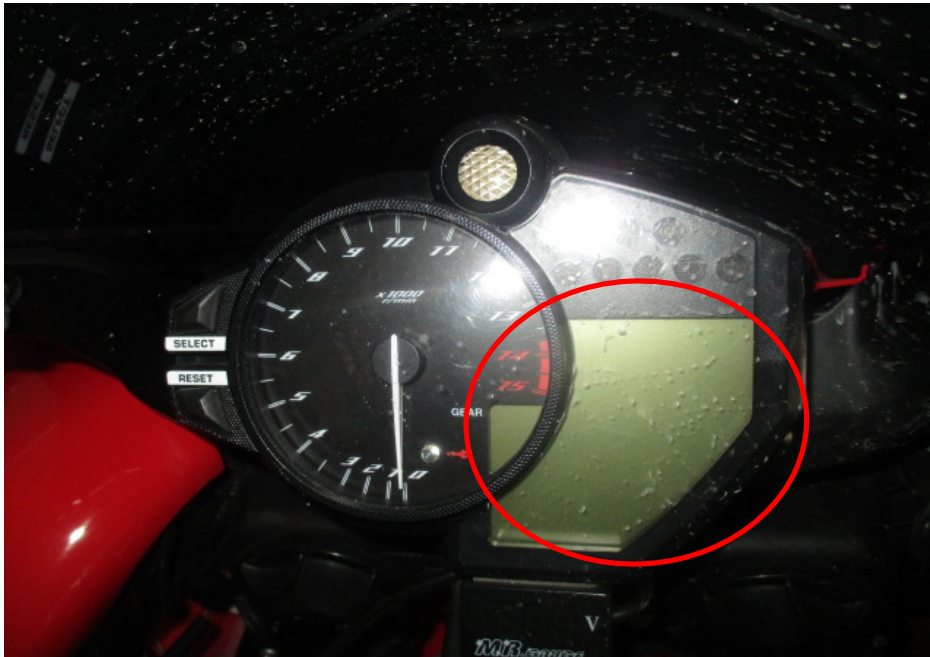
4. The mileage of the Motorcycle at the time of our inspection was not recorded due to the damage sustained to the speedometer display screen as a result of the accident.
5. The Motorcycle had sustained damages at its frontal portion and right body. Body parts that were found to have been damaged include its head cowling, speedometer gauge, right side mirror, front brake lever, petrol tank, radiator, right cowling, right frame cover, right rear frame slider, rear brake pedal, right front footrest, right swingarm spool, exhaust muffler and tail lamp, amongst others.

**Photo 1** shows a closer view of the speedometer gauge of the Motorcycle. The mileage of the Motorcycle was not recorded at the time of our inspection due to the damage sustained to the odometer display screen as a result of the accident (circled).

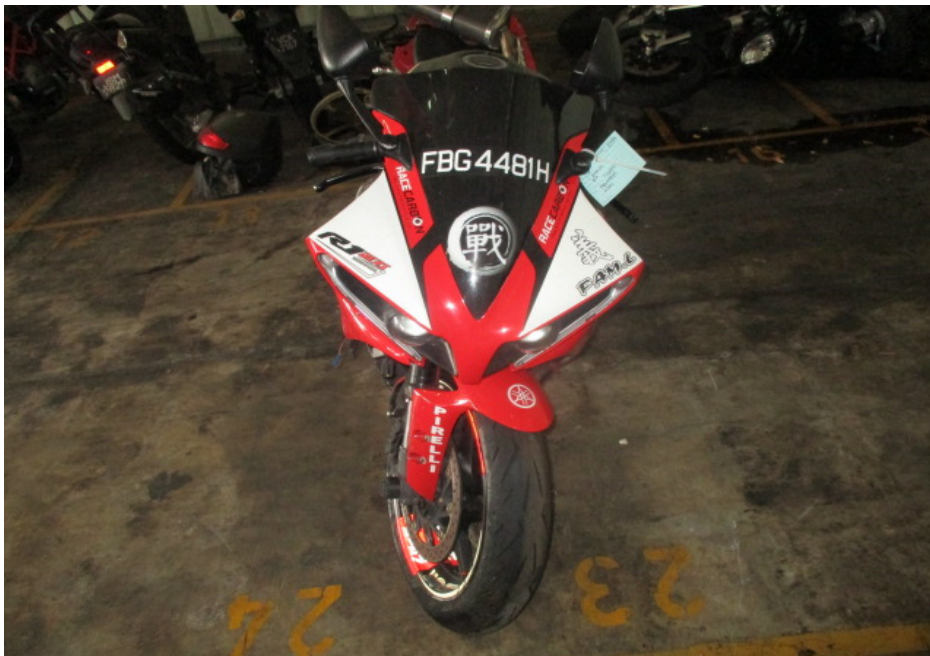
**Photo 2** shows a general view of the frontal portion of the Motorcycle at the time of our inspection. The Motorcycle had sustained damages at its frontal portion and right body.

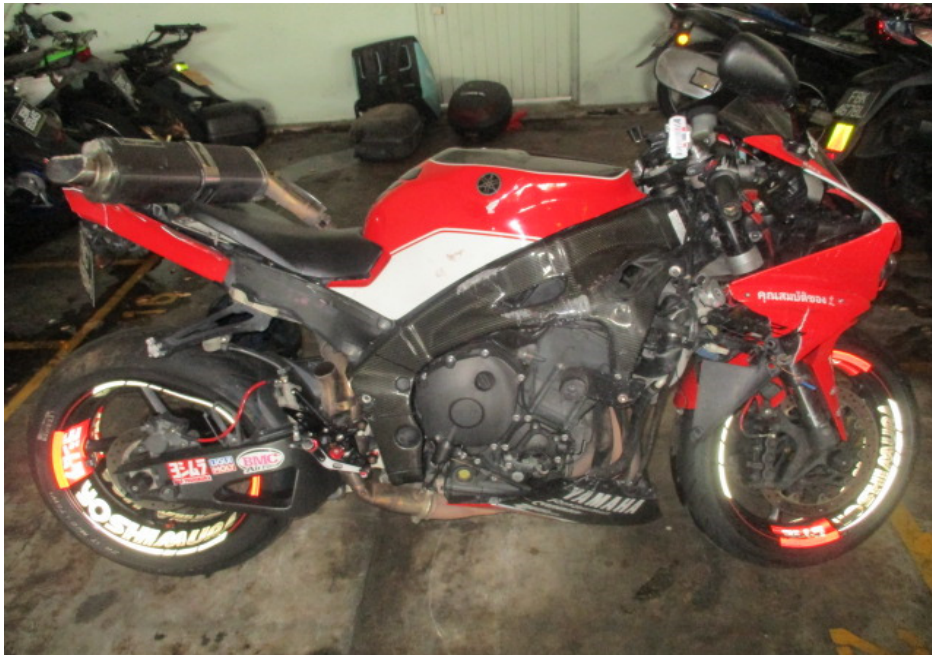
**Photo 3** shows a general view of the right body of the Motorcycle at the time of our inspection. The Motorcycle had sustained damages at its frontal portion and right body. Body parts that were found to have been damaged include its head cowling, speedometer gauge, right side mirror, front brake lever, petrol tank, radiator, right cowling, right frame cover, right rear frame slider, rear brake pedal, right front footrest, right swingarm spool, exhaust muffler and tail lamp, amongst others.

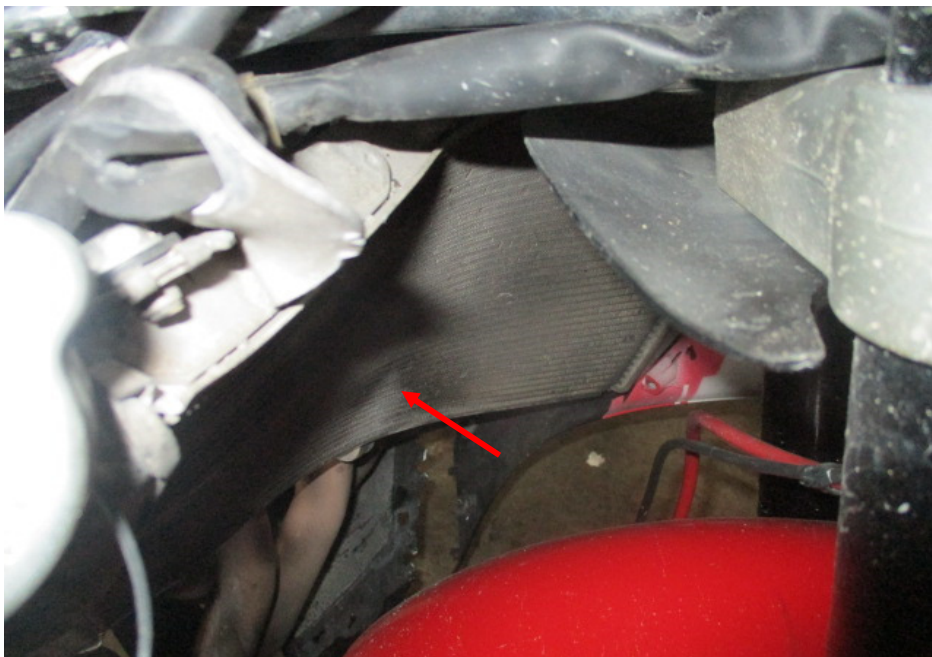
**Photo 4** shows a closer view of the radiator (arrowed) of the Motorcycle which had sustained damages as a result of the accident.

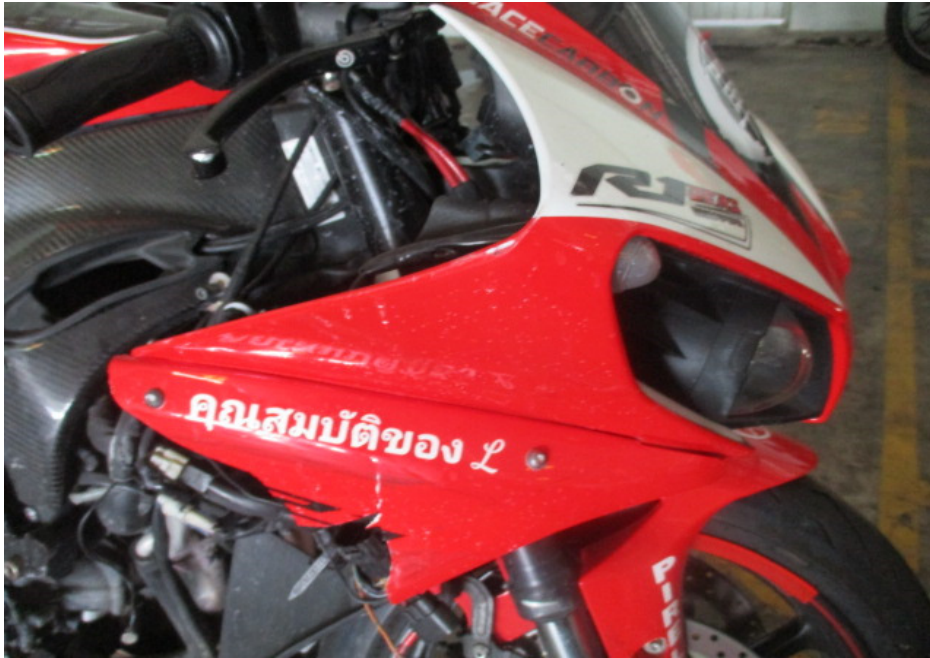
**Photo 5** shows a closer view of the head cowl which was amongst the body parts at the front body of the Motorcycle that had sustained damage as a result of the accident.

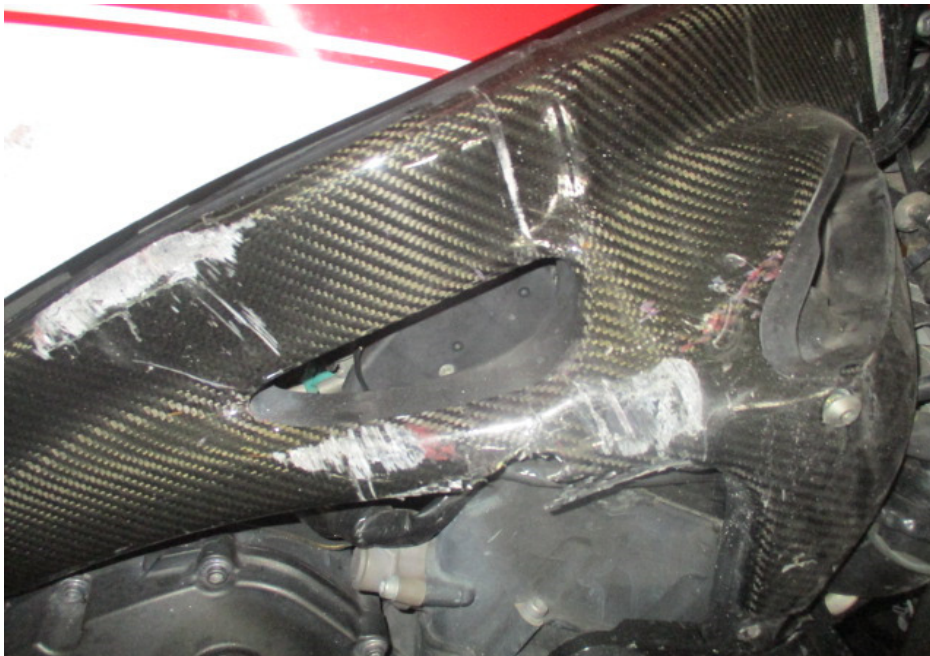
**Photo 6** shows a closer view of the cracked right frame cover of the Motorcycle which was amongst the body parts of the Motorcycle damaged as a result of the accident.

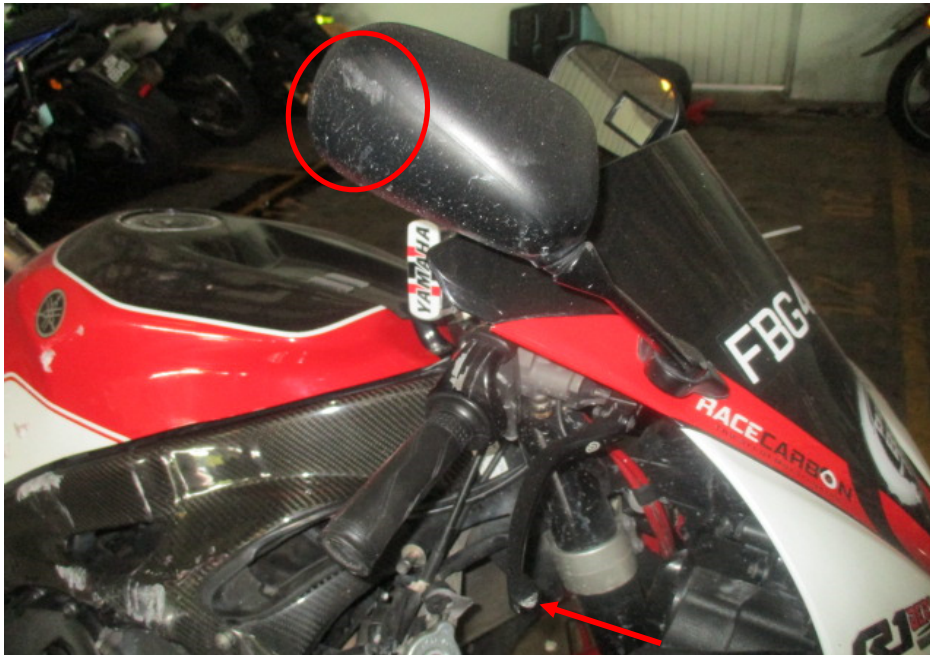
**Photo 7** shows a closer view of the front brake lever (arrowed) and right side mirror (circled) which were amongst the body parts at the front body of the Motorcycle that had sustained damage as a result of the accident.

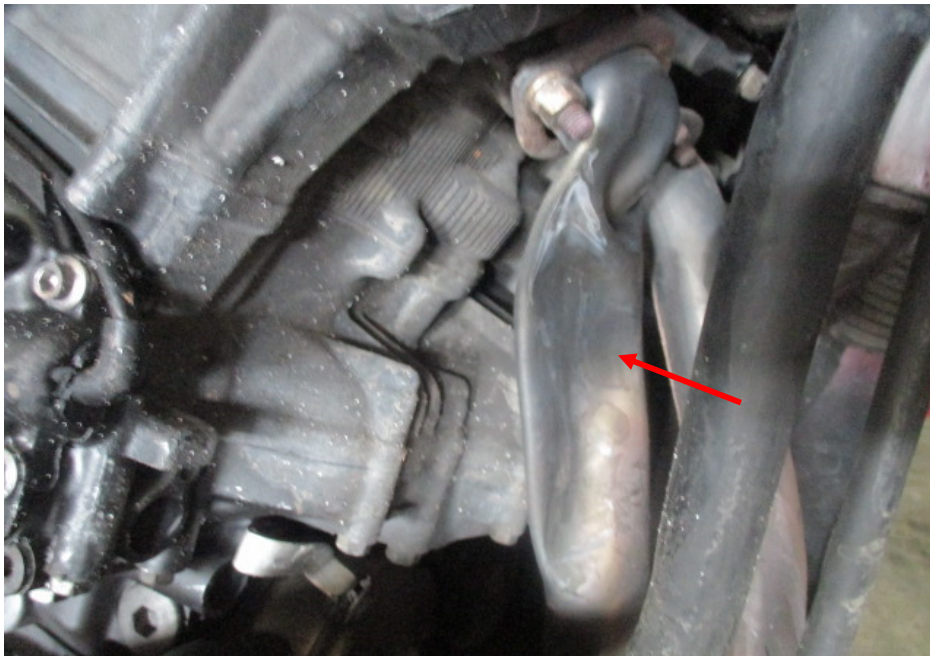
**Photo 8** shows the dented exhaust header of the Motorcycle as a result of the accident (arrowed).

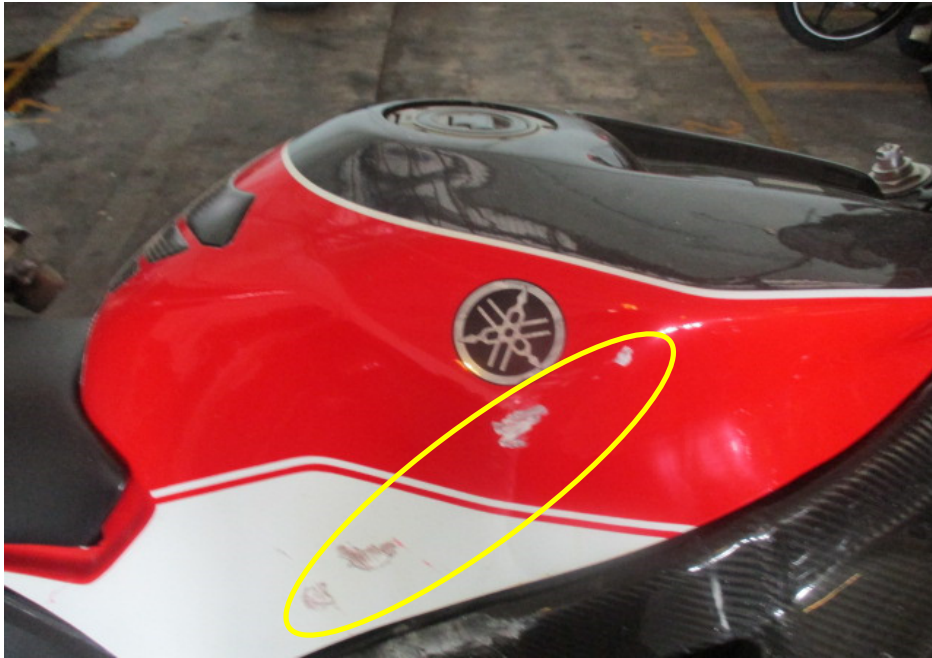
**Photo 9** shows a closer view of the petrol tank, which was amongst the body parts of the Motorcycle that had sustained damage as a result of the accident (circled).

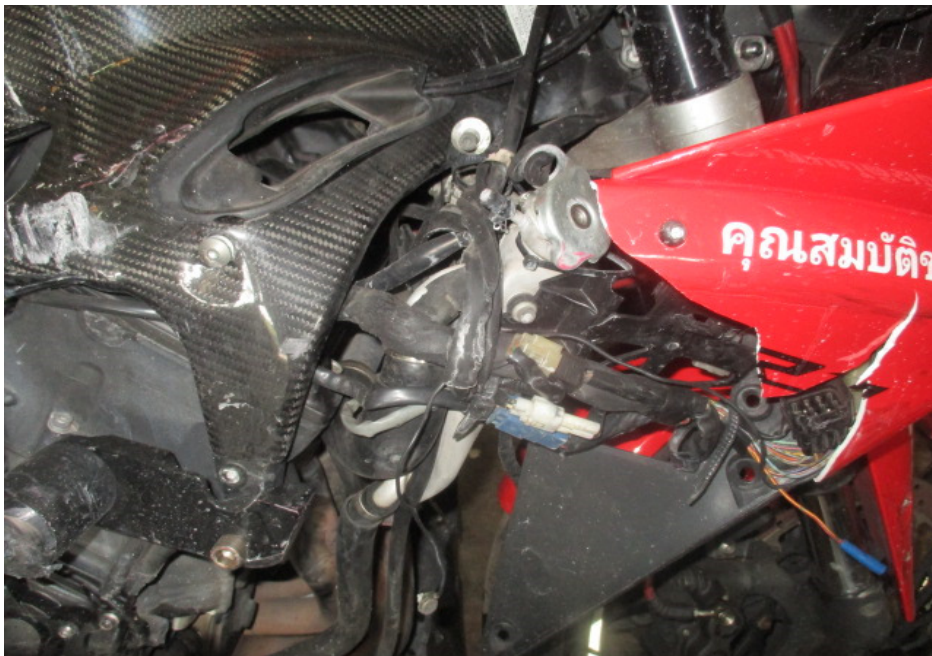
**Photo 10** shows a closer view of the broken right cowling of the Motorcycle as a result of the accident.

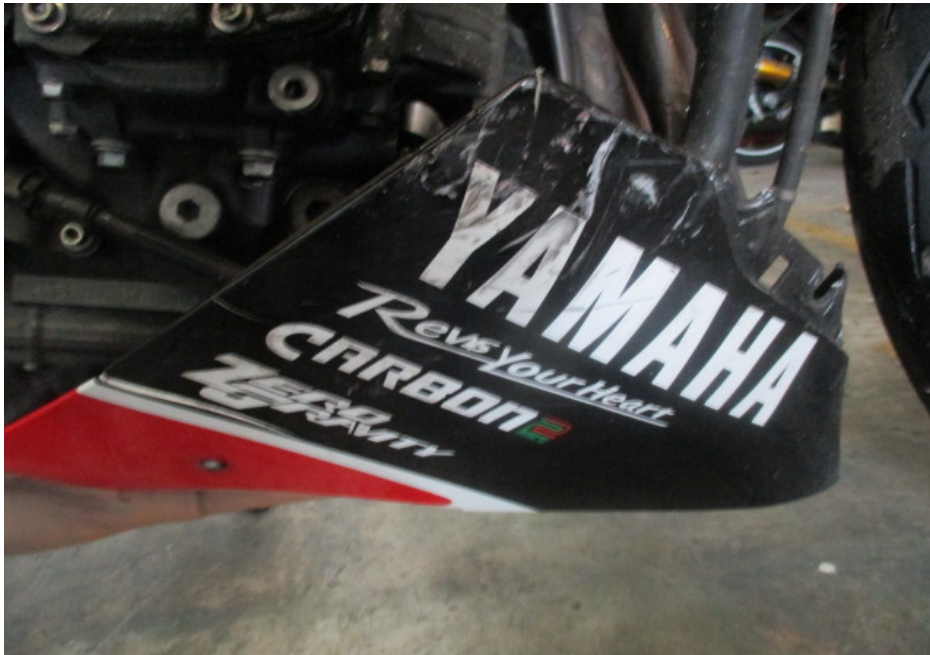
**Photo 11** shows a closer view of the right bottom cowling which was amongst the body parts of the Motorcycle that had sustained damage as a result of the accident.

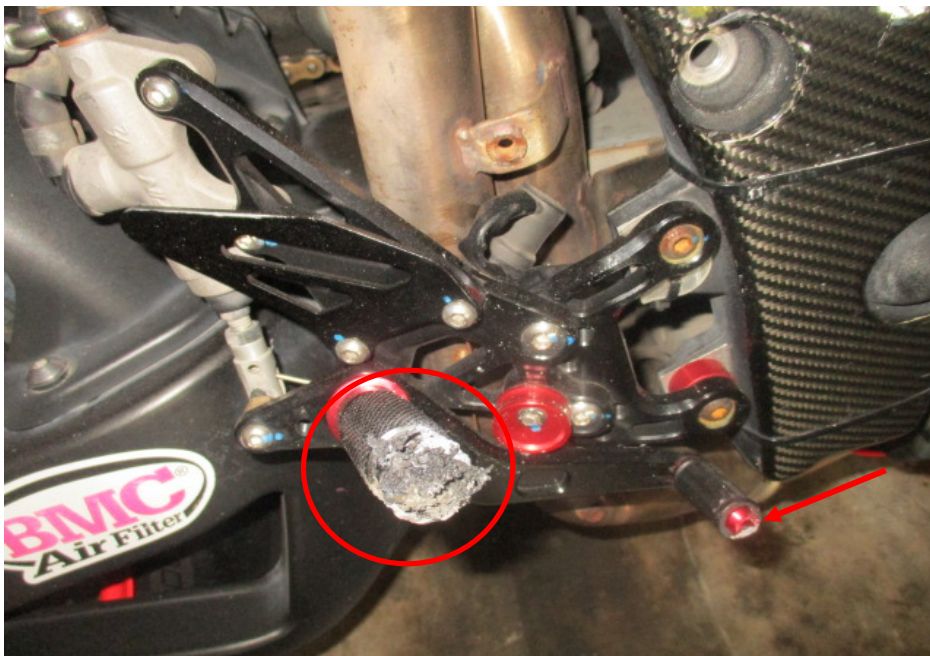
**Photo 12** shows a closer view of the right front footrest (circled) and rear brake pedal (arrowed) which were amongst the body parts of the Motorcycle that had sustained damage as a result of the accident.

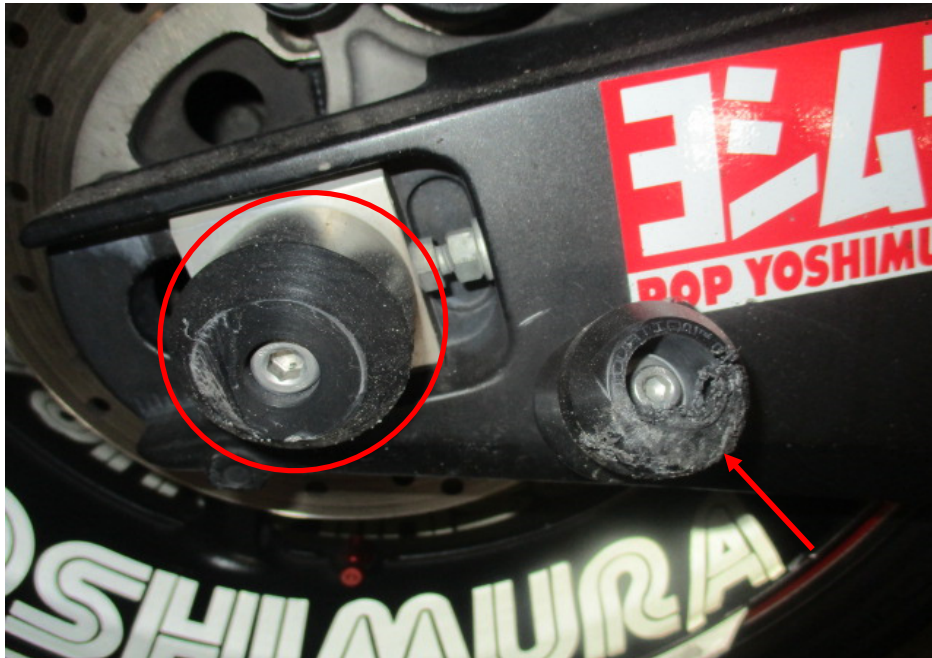
**Photo 13** shows a closer view of the right rear slider (arrowed) and swingarm spool (circled) which were amongst the body parts of the Motorcycle that had sustained damages of grazing nature as a result of the accident.

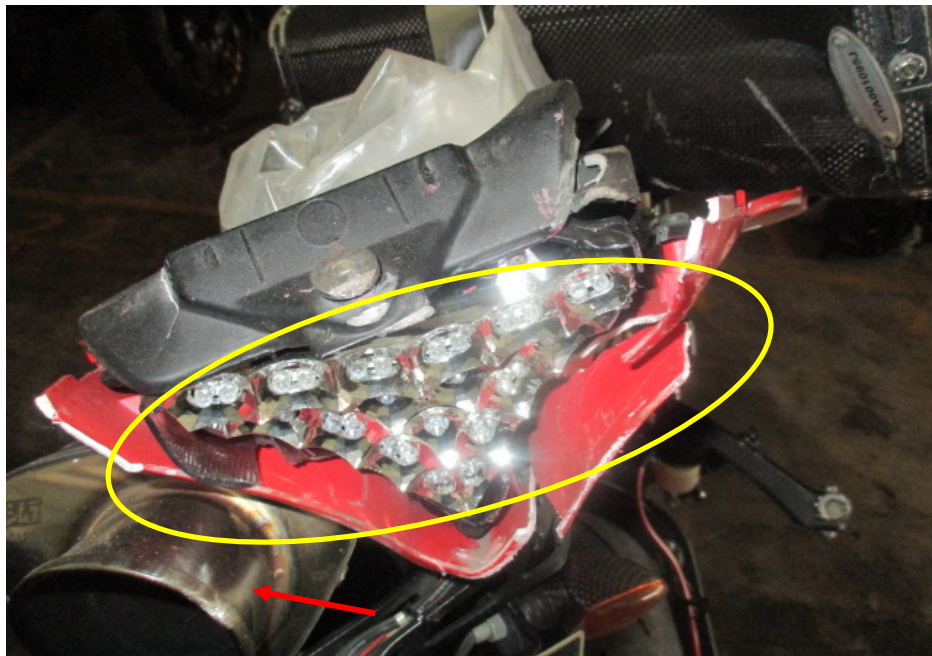
**Photo 14** shows the broken tail lamp (circled) and dented exhaust muffler (arrowed) of the Motorcycle as a result of the accident.

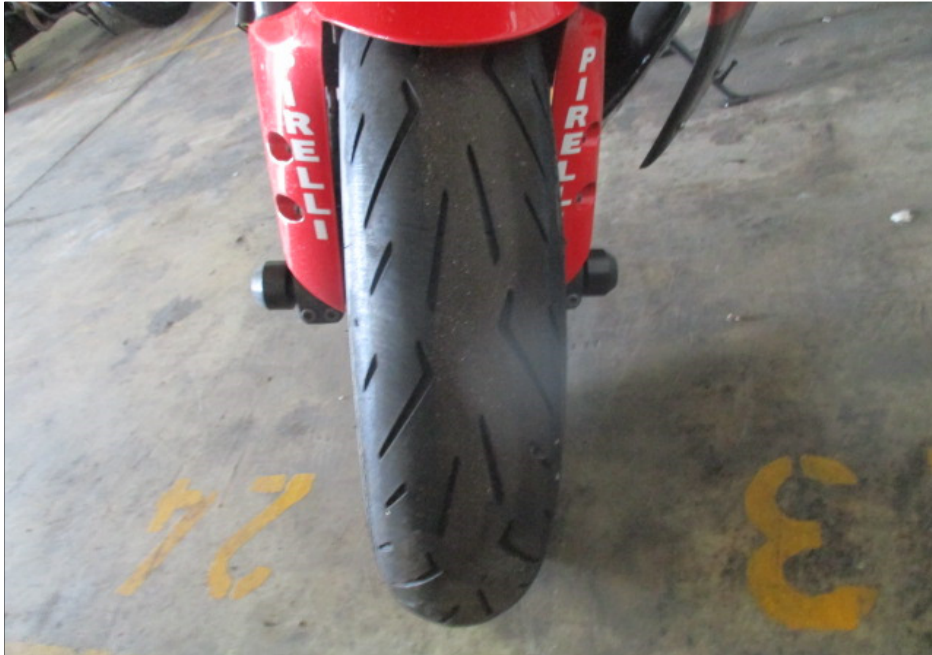
**Photo 15** shows the condition of the Motorcycle's front tyre. The front tyre was observed to be in serviceable condition with remaining tread depth of approximately 3mm. The tyre was also observed to be sufficiently inflated for vehicular operation. We did not observe any tear, burst mark(s) and/or punctured hole(s) on the sidewalls as well as across the tread of the front tyre.

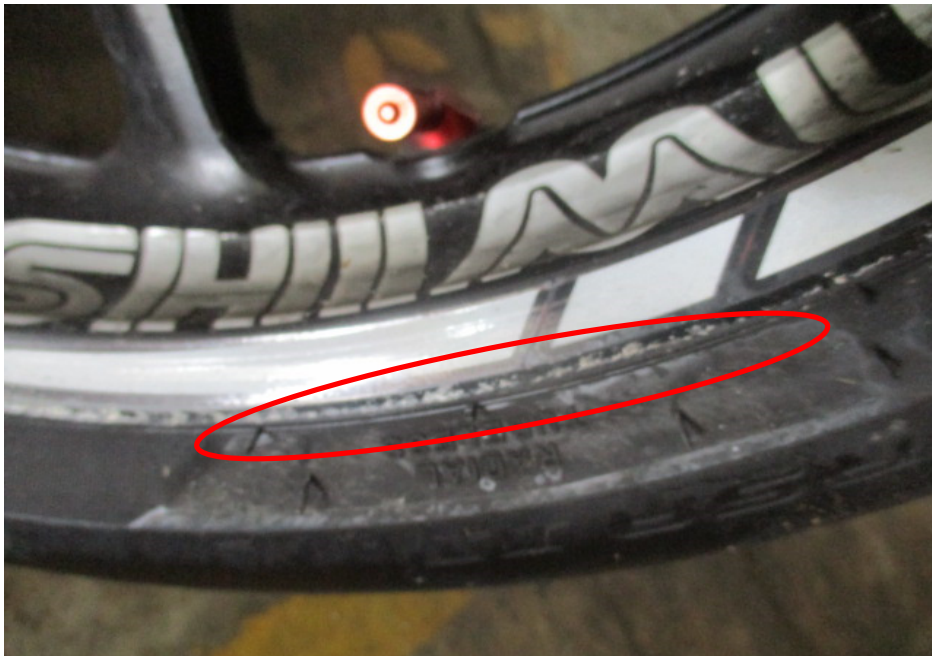
8. The 2 tyres were wrapped around alloy wheel rims. At the time of our inspection, we observed that the rear wheel rim of the Motorcycle was bent. We also found some relatively minor marks of grazing nature on the edges of the front wheel rim, at the right side of the Motorcycle. See photos 1 – 19 below.

**Photo 16** shows the front wheel rim of the Motorcycle at the time of our inspection. Some relatively minor marks of grazing nature were observed on the edges of the front wheel rim (circled), at the right side of the Motorcycle.

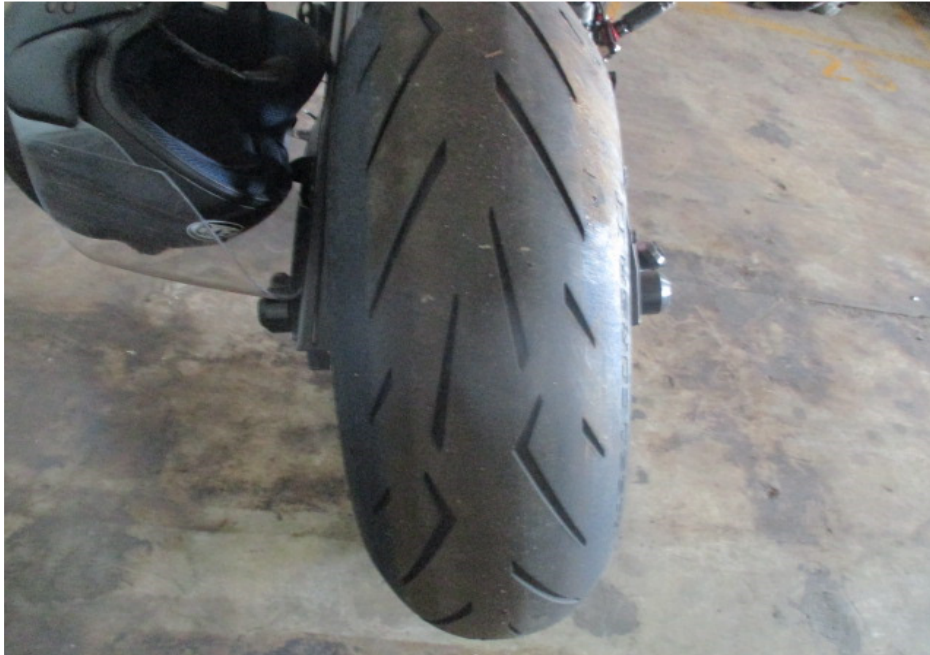
**Photo 17** shows the condition of the Motorcycle's rear tyre. The rear tyre was observed to be in serviceable condition with remaining tread depth of approximately 3mm. The tyre was also observed to be sufficiently inflated for vehicular operation. We did not observe any tear, burst mark(s) and/or punctured hole(s) on the sidewalls as well as across the tread of the rear tyre.

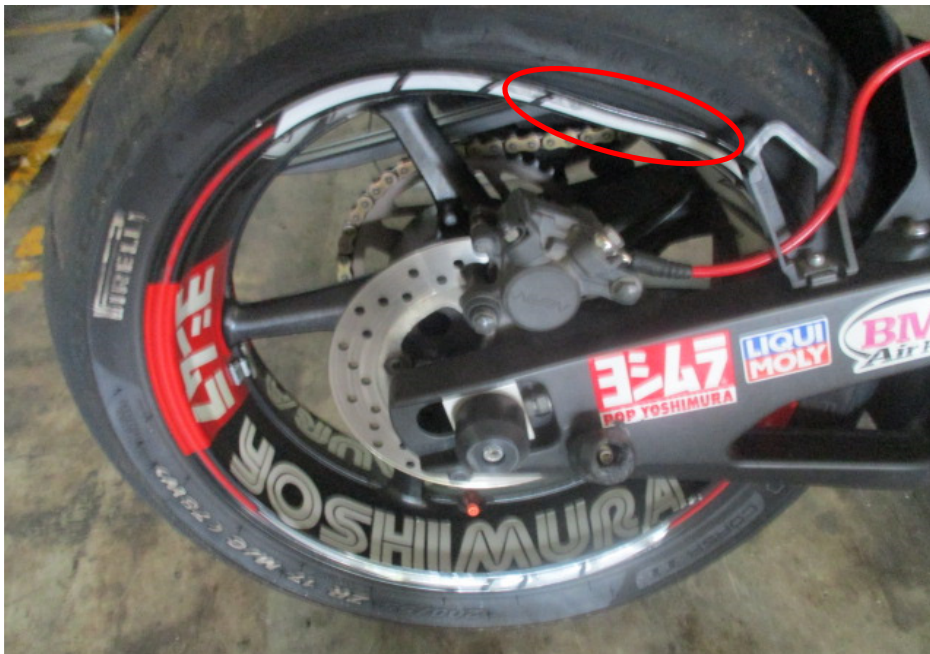
**Photo 18** shows the bent rear wheel rim of the Motorcycle at the time of our inspection (circled).

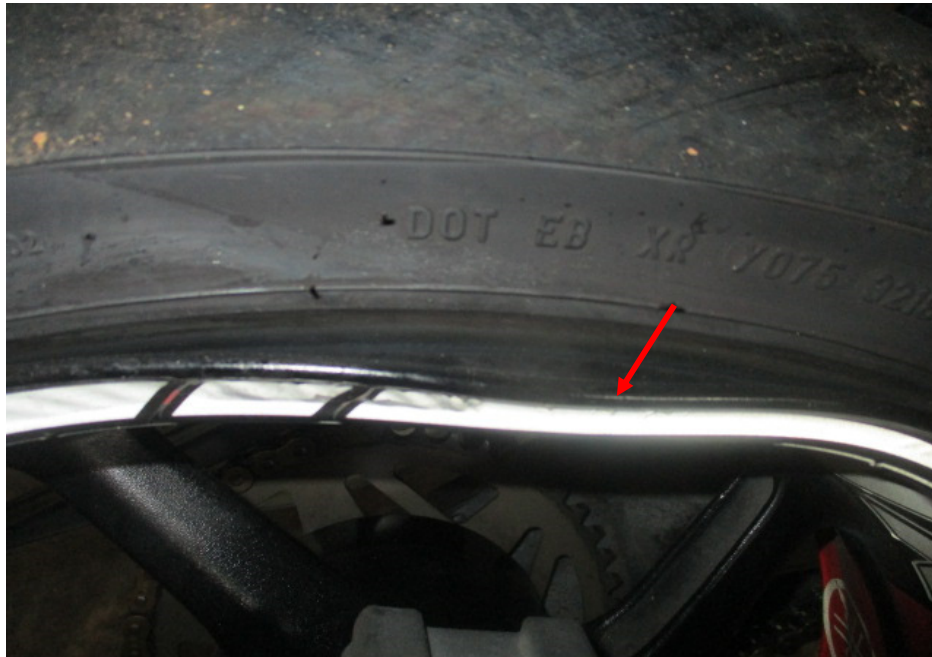
**Photo 19** shows a close up view of the bent rear wheel rim of the Motorcycle at the time of our inspection (arrowed).

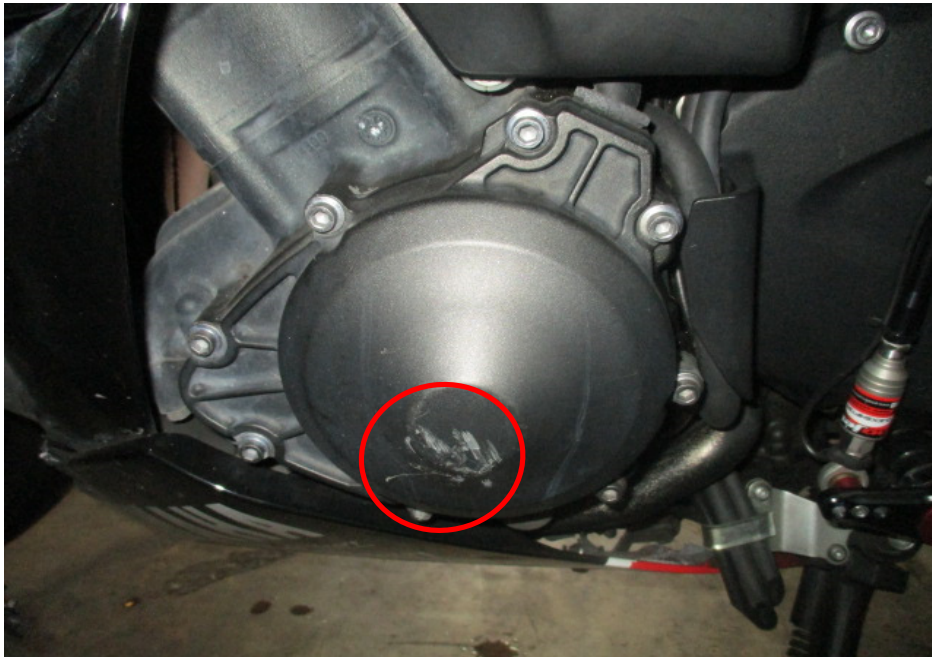
**Photo 20** shows the left side of the engine of the Motorcycle at the time of our inspection. The various left engine components had sustained damage of grazing nature as a result of the accident (circled) however the engine components were still intact. There was also no fluid leak and/or fluid stain found around the left engine area of the Motorcycle.

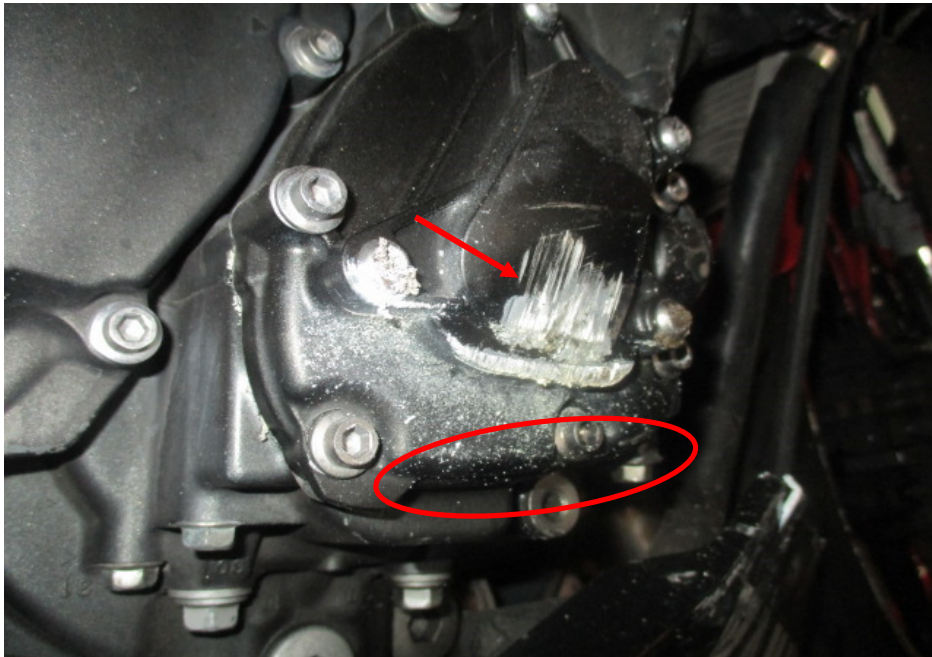
**Photo 21** shows the right side of the engine of the Motorcycle at the time of our inspection. The various left engine components had sustained damage of grazing nature as a result of the accident (arrowed). Wet fluid stains were observed on the underside of the damaged right engine cover of the Motorcycle (circled).

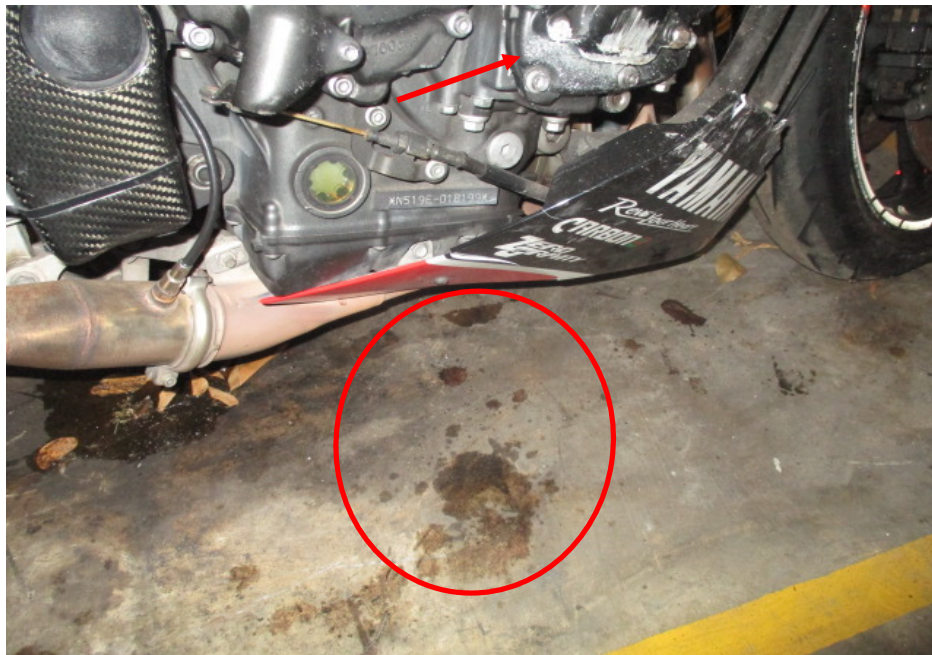
**Photo 22** shows wet fluid stains observed on the ground (circled) directly below the damaged right engine cover of the Motorcycle (arrowed), indicating that a fluid leak had occurred as a result of the accident.

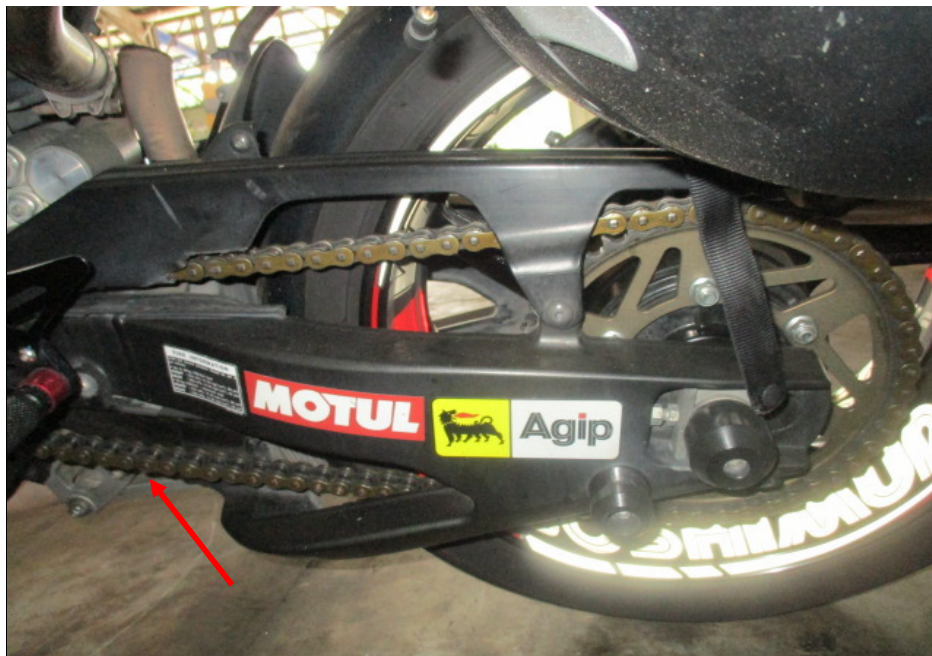
**Photo 23** shows the gear chain (arrowed) of the Motorcycle, which was observed to be intact with no misalignment. It was also adequately lubricated for operating purposes. The gear chain rotates the rear wheel of the Motorcycle.

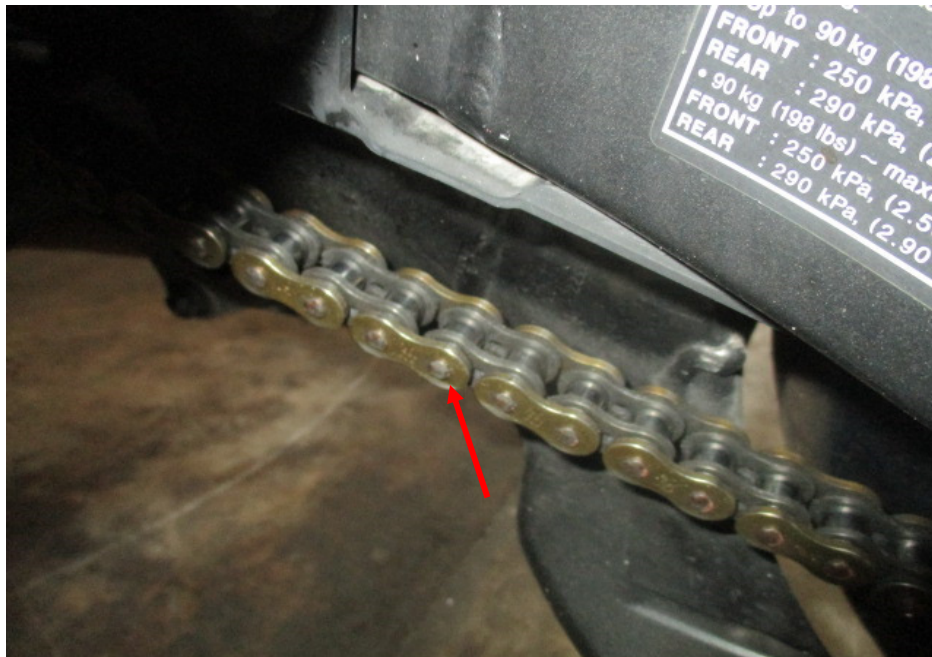
**Photo 24** shows the closer view of the gear chain (arrowed) of the Motorcycle, which was observed to be intact with no misalignment. It was also adequately lubricated for operating purposes.

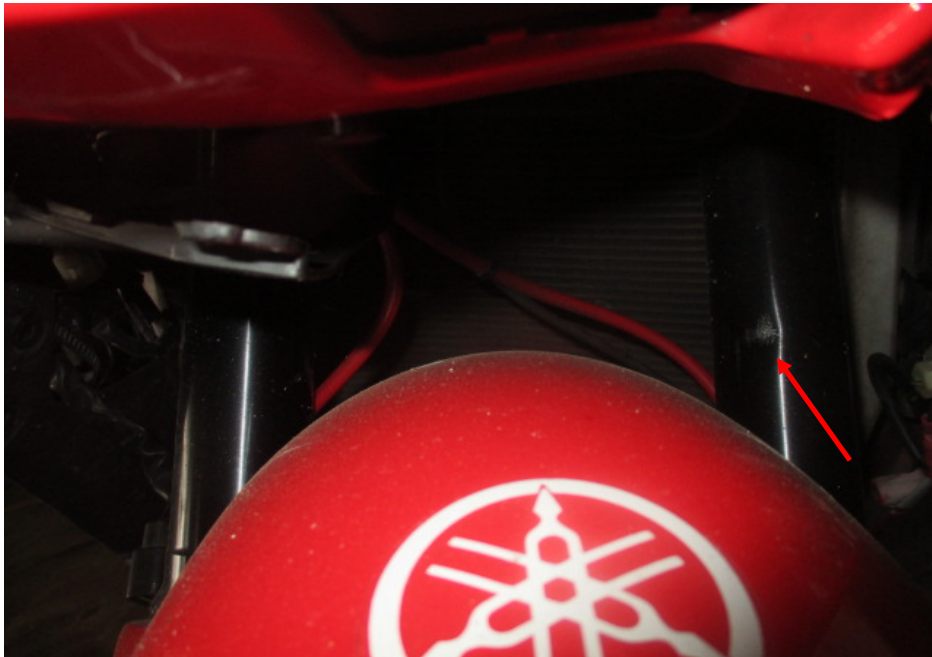
**Photo 25** shows the front forks (arrowed) of the Motorcycle. The fork bracket of the Motorcycle was observed to be intact and undamaged. However the left outer fork tube was slightly dented as a result of the accident (arrowed).

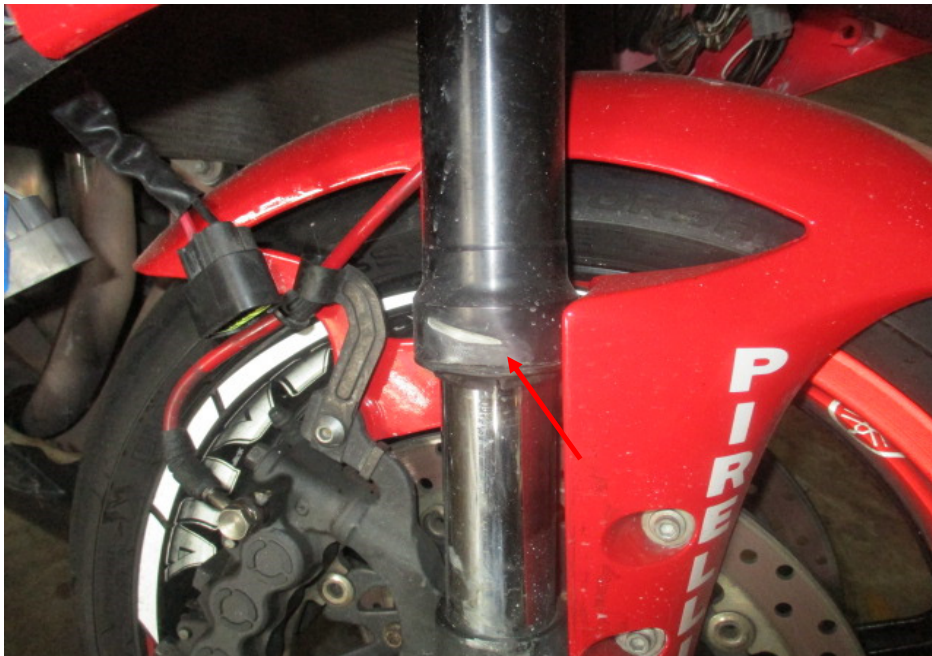
**Photo 26** shows the front forks (arrowed) of the Motorcycle. The fork bracket of the Motorcycle was observed to be intact and undamaged. However the right outer fork tube was slightly dented as a result of the accident (arrowed).

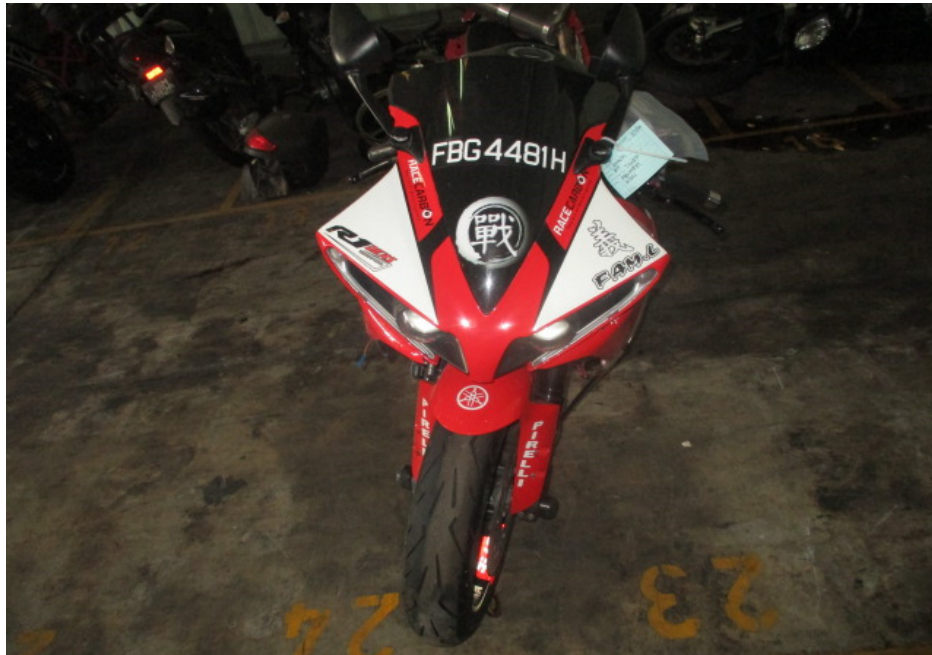
**Photo 27** shows the front wheel of the Motorcycle turned slightly towards the right. We were unable to fully turn the handle bar towards the right due to the resistance from the broken components of the head cowl which were found to be pushed inwards as a result of the accident.

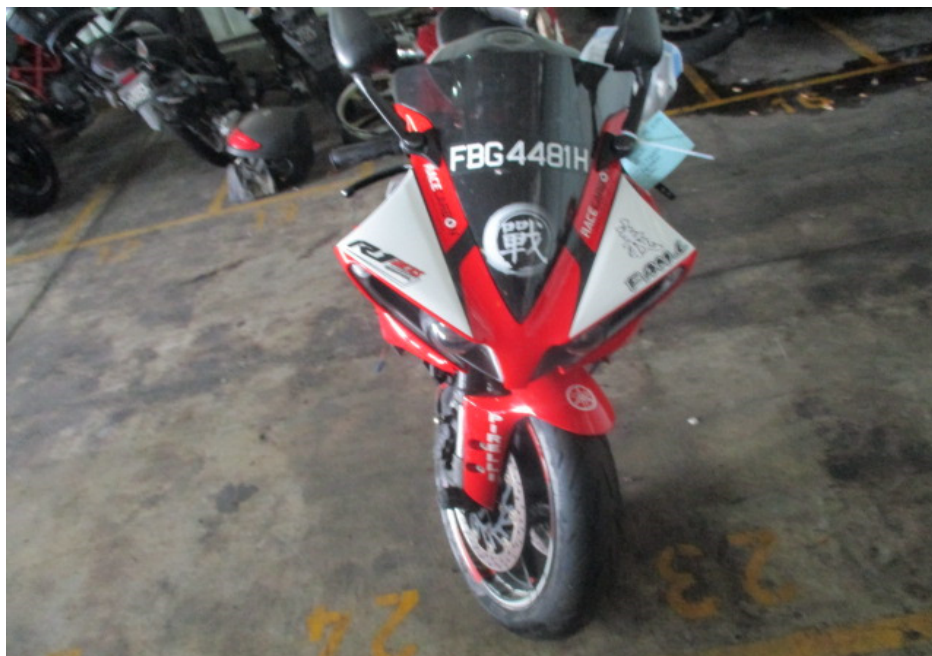
**Photo 28** shows the front wheel of the Motorcycle turned towards its full left. Turning the Motorcycle's handle bar towards the left did not produce any abnormal free play and/or resistance. This would indicate that the steering system of the Motorcycle was in serviceable condition at the time of our inspection.

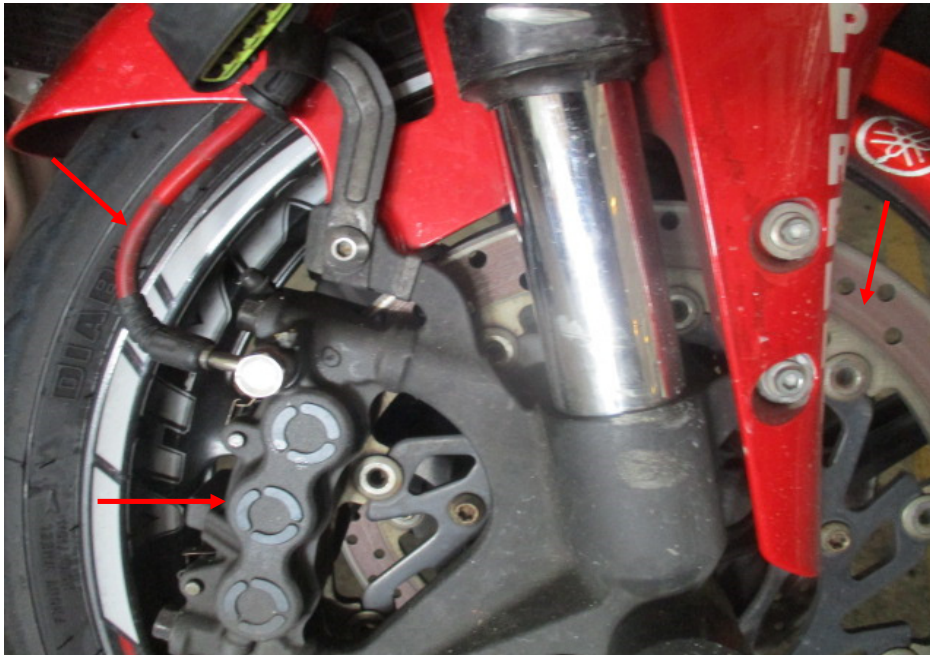
**Photo 29** shows a close up view of the front brake caliper, front brake disc and front brake hose (arrowed) at the right side of the Motorcycle's front wheel, which are all part of the components in the hydraulic front brake system of the Motorcycle. Our visual checks of these various components had revealed all to be intact with no visible damage. No leakage of brake fluid was also observed.

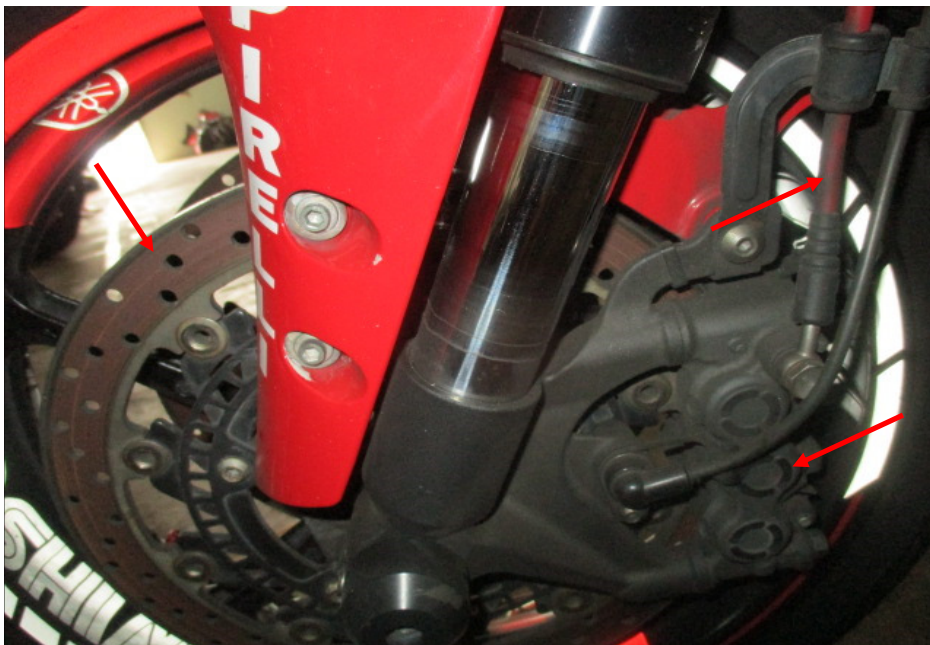
**Photo 30** shows a close up view of the front brake caliper, front brake disc and front brake hose (arrowed) at the left side of the Motorcycle's front wheel, which are all part of the components in the hydraulic front brake system of the Motorcycle. Our visual checks of these various components had revealed all to be intact with no visible damage. No leakage of brake fluid was also observed.

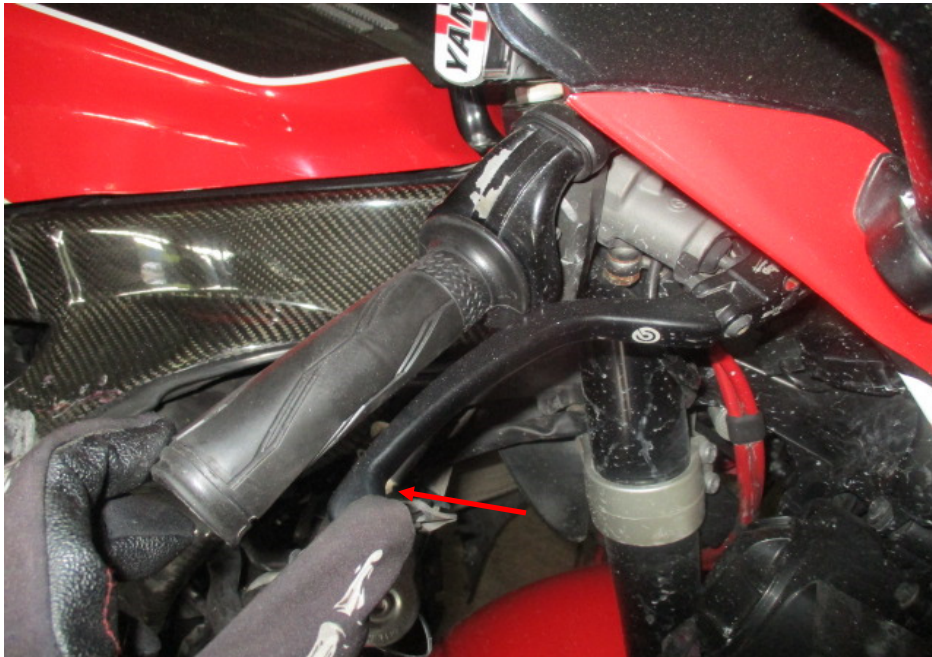
15. Static brake tests conducted on the Motorcycle had appear to indicate that the front braking system of the Motorcycle was not in serviceable condition. There was no resistance felt (spongy like feel) upon pressing the front brake lever. This would indicate that there was a leakage of pressure/vacuum in the brake system. Upon closer examination of the front braking system, a leakage of brake fluid was observed from the right front brake banjo bolt when the front brake lever was depressed. The leakage of brake fluid from the front brake banjo bolt could have been due to the accident.

**Photo 31** shows the front brake lever being depressed. There was no resistance felt (spongy like feel) upon pressing the front brake lever (arrowed). This would indicate that there is a leakage of pressure/vacuum in the brake system.

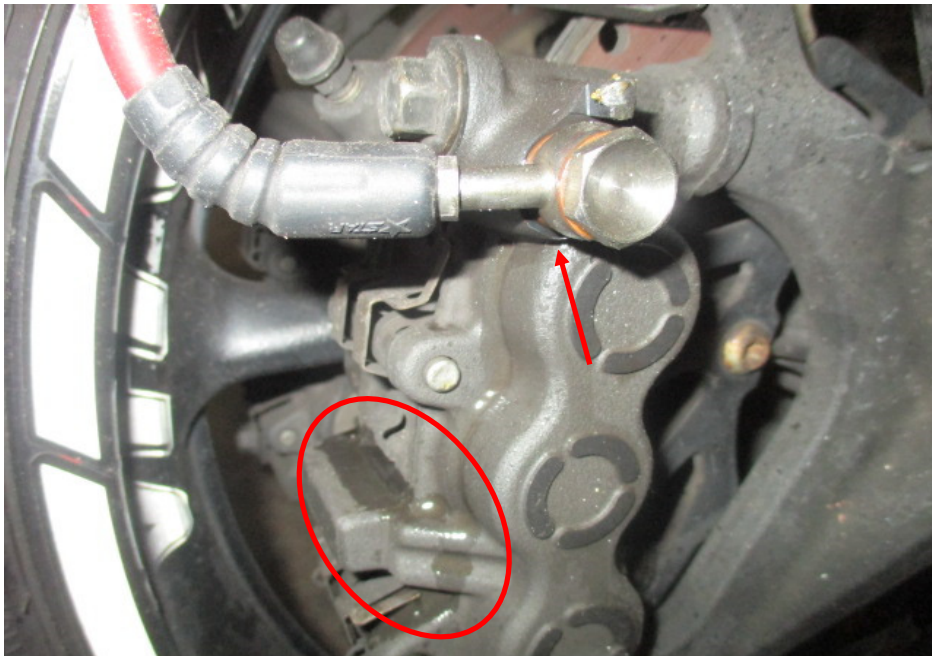
**Photo 32** shows the right front brake caliper for the front brake of the Motorcycle. A leakage of brake fluid (circled) was observed from the right front brake banjo bolt (arrowed) when the front brake lever was depressed.

18. Basing on our physical inspection of the Motorcycle, it appears that the steering system and rear braking system of the Motorcycle were all in serviceable condition. However, it appears that the front braking system of the Motorcycle was not in serviceable condition. We observed leakage of brake fluid from the front brake banjo bolt which could have been due to the accident.
19. The 2 tyres of the Motorcycle were found to be in serviceable condition. There was no tear, cut or burst mark(s) on the outer and the inner sidewalls as well as across the tread of the 2 tyres. The 2 tyres were sufficiently inflated for vehicular operation with remaining tread depth of approximately 3mm each.

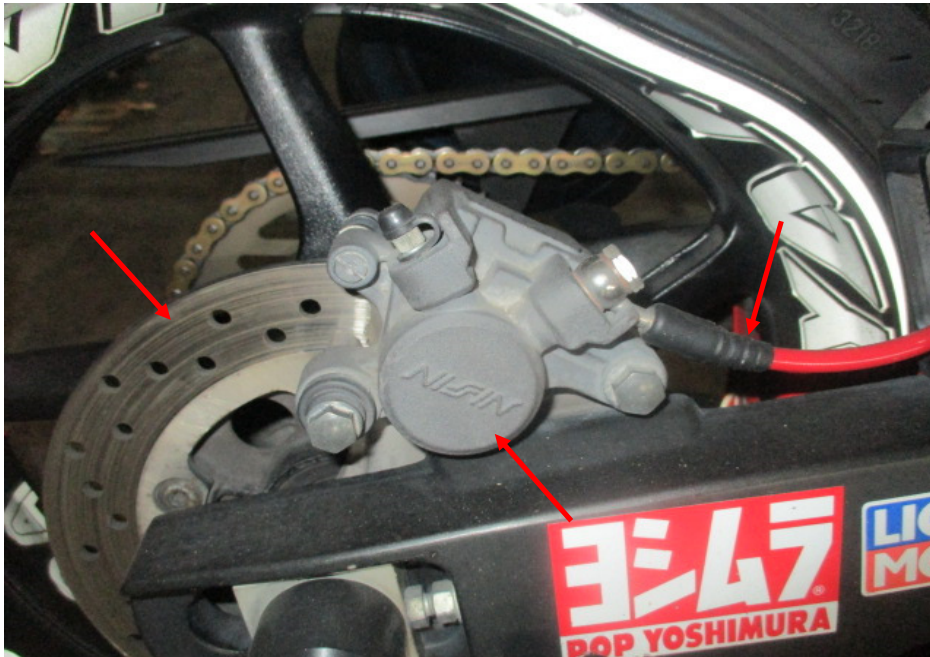
**Photo 33** shows a close up view of the rear brake caliper, rear brake disc and rear brake hose (arrowed) of the Motorcycle, which are all part of the components in the hydraulic rear brake system of the Motorcycle. Our visual checks of these various components had revealed all to be intact with no visible damage. No leakage of brake fluid was also observed.
