Your Ref: TP/IP/44541/2019  
Our Ref : CI/TPD19013997/N

**Fatal Accident Investigation Team**

**MECHANICAL INSPECTION REPORT OF MOTORCYCLE FBG 4881H**

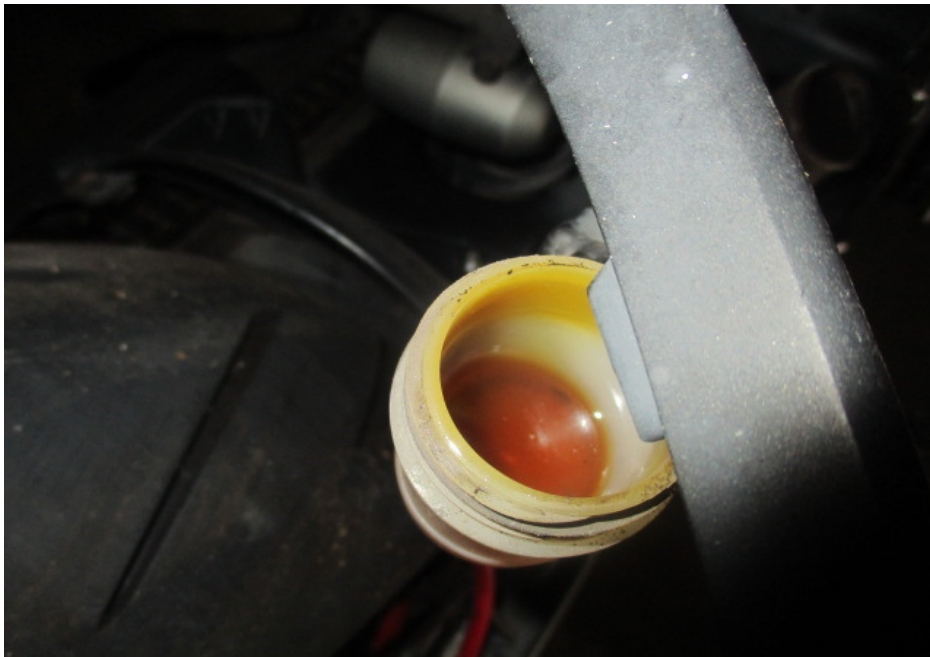
**Photo 34** shows the brake fluid reservoir for the rear brake of the Motorcycle. The brake fluid was observed to be of sufficient level and without contamination for operational purposes.
