To Inspect Vehicle No: SHA 7890B Insured: GX 9411D

Veh No: SHIA 7890 B Yr Regn: 2015 July

**From:** Denise Tay (LKKAuto)  
**Sent:** Monday, 26 August 2019 2:28 PM  
**To:** Admin-D (LKKAuto); 'Chong Boon Sen'; assignments  
**Cc:** SUR  
**Subject:** RE: OUR REF: SNM19D203728-GX9411D-CBS - FW: Accident involving veh no: SHA 7890B & GX 9411D on 07.08.19

## VEHICLE DAMAGE INSPECTION REPORT

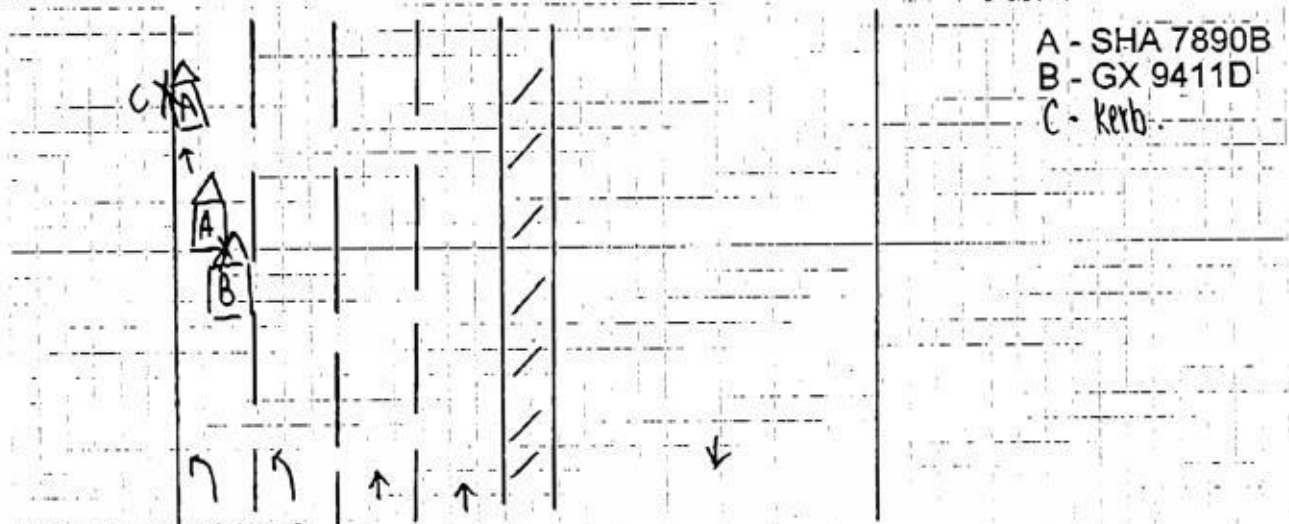
## SKETCH PLAN

Along Clementi Ave. 6

Third party lose control and collided into my taxi A - Rear Right Portion , as the impact cause my taxi to surged to the left and collided into the road kerb on my left .

After the accident my taxi sustain damages on both front left and Right Rear Portion .
