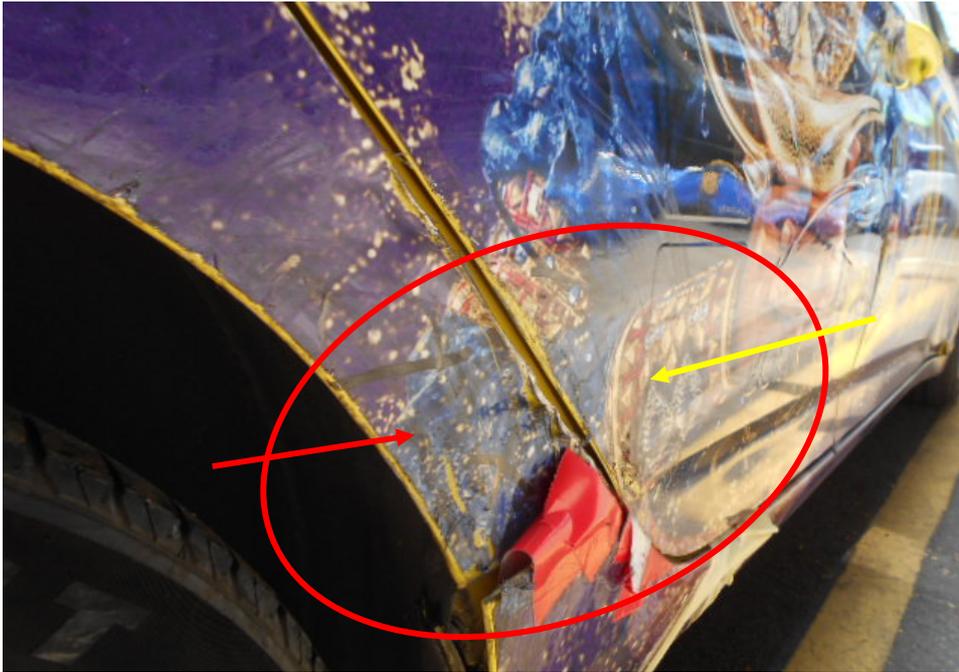
Photo 1 shows the area of damage at the right rear portion of the taxi before the advertisement was peeled off. Damage (circled) seen to be relatively minor however it is not the true extent of damage. The red arrow shows the damage to the rear right fender as compared to photo 2 below. The yellow arrow shows the damage to the rear right door as shown in photo 3 below.

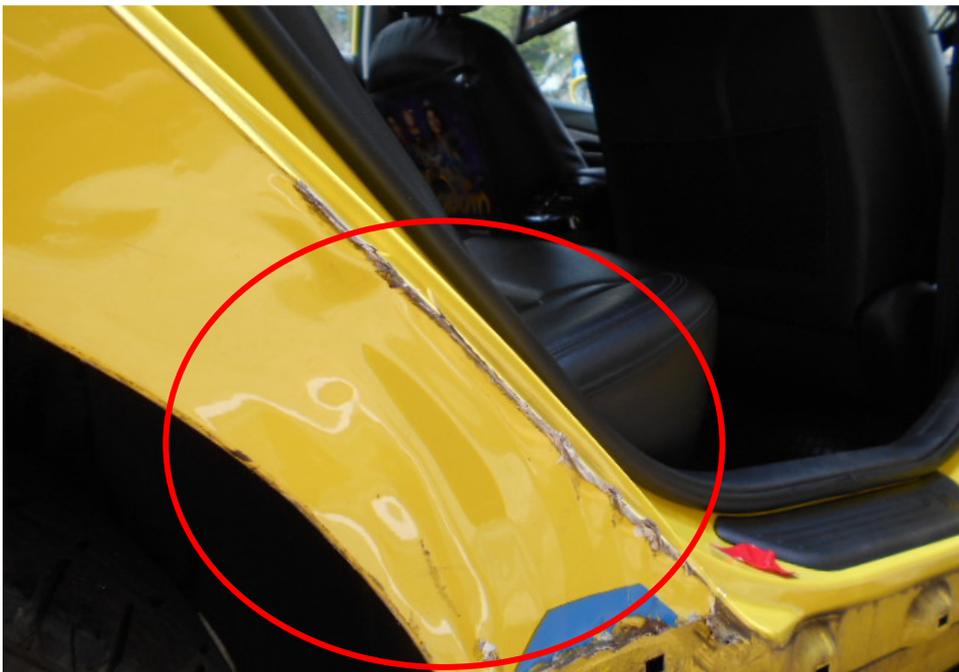
Photo 2 shows the same area as indicated by the red arrow in photo 1. When the advertisement was peeled off, the rear right fender was found to be dented/crumpled (circled).

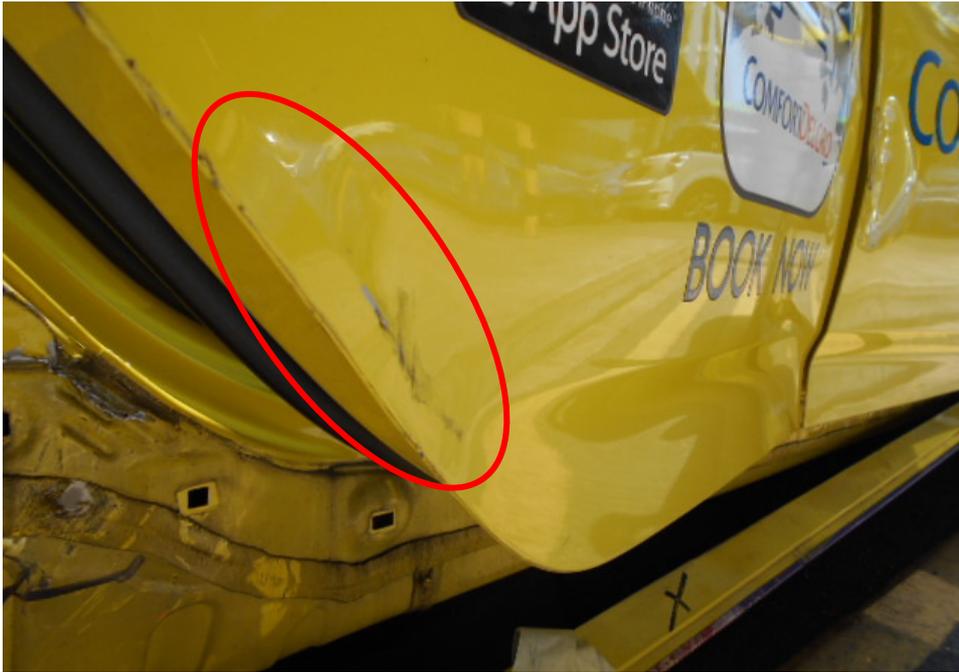
Photo 3 shows the same area as indicated by the yellow arrow in photo 1. When the advertisement was peeled off, the rear right door was found to be dented (circled).

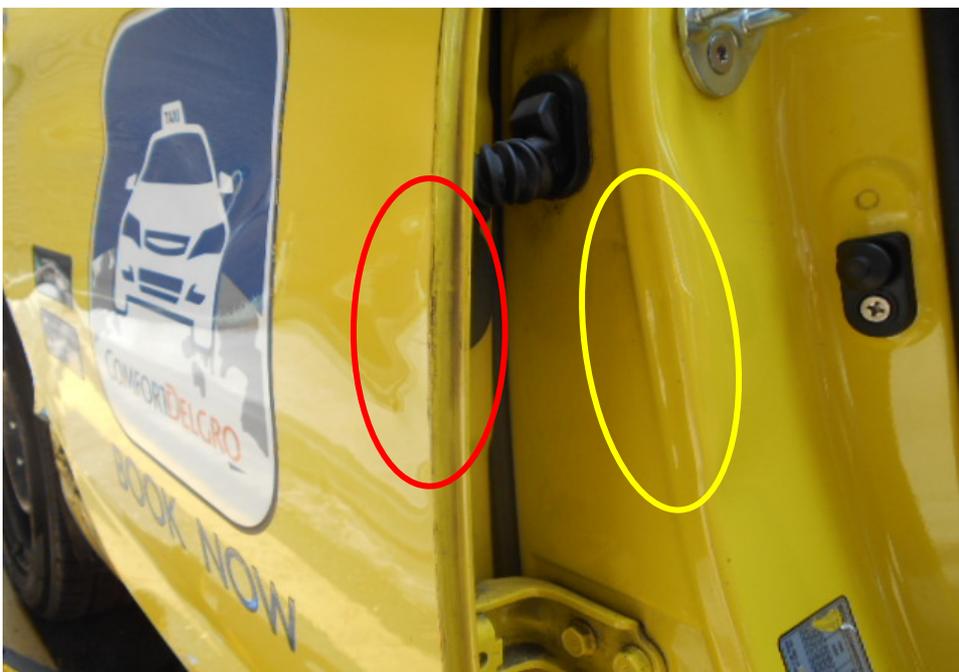
Photo 4 shows the damage to the rear right door and right side centre pillar of the taxi after the advertisement was peeled off. The red circle shows the dent at the edge of the rear right door while the yellow circle shows the dent at the right side centre pillar. The height above ground level for both these damages were similar and hence are caused by the same impact.

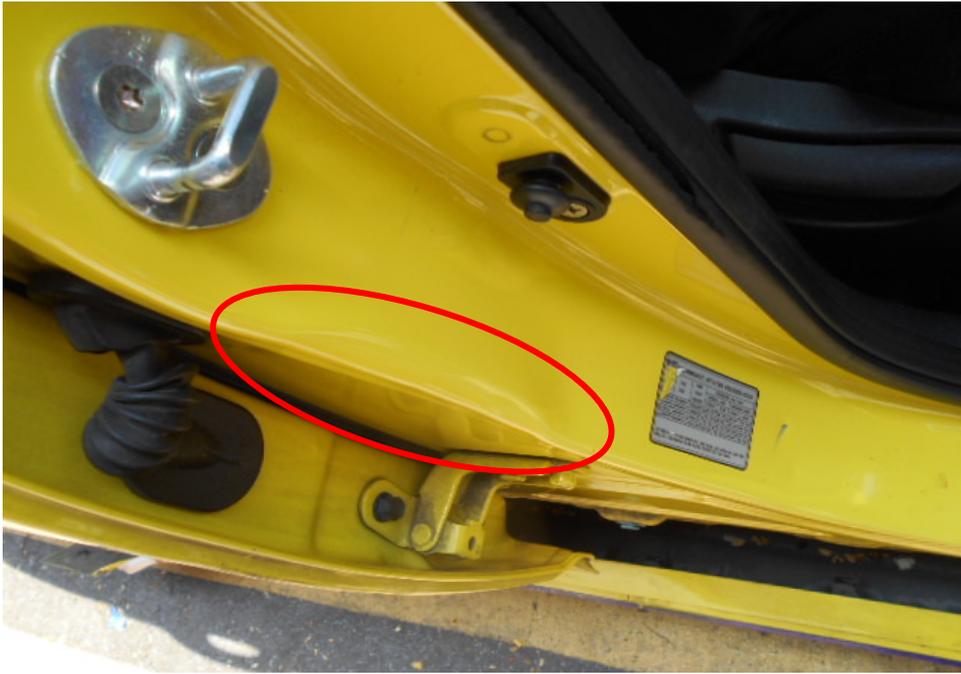
Photo 5 shows another view of the dent at the right side centre pillar (circled). This damage was caused by the front right door dented in as shown in photo 6 below. Together with the dent at the rear right door, which is shown in photo 4 above, this damage to the centre pillar was caused by the same impact, as all these damages were of similar height above ground level.

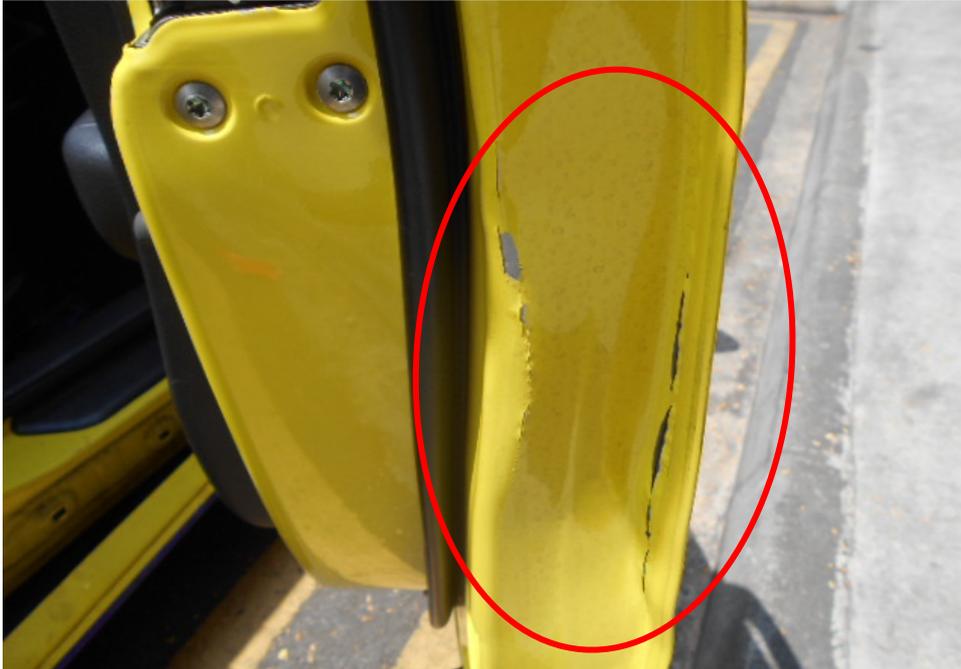
Photo 6 shows the front right door dented (circled). The damage to the centre pillar as shown in photo 5 above was a result of the front right door dented in at this area.

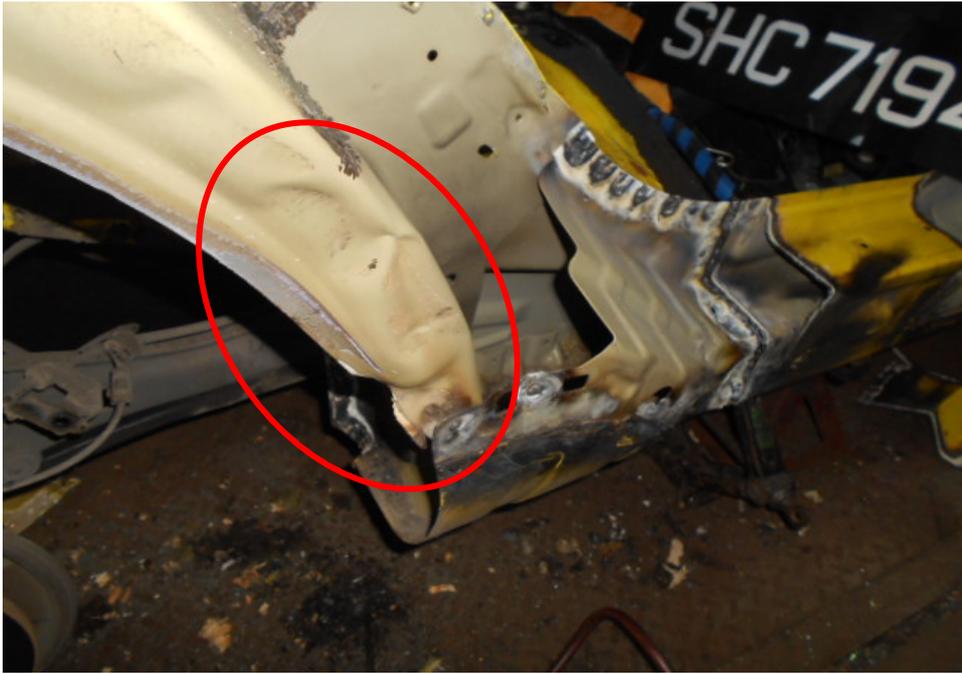
Photo 7 shows the rear right fender wheel house dented (circled) at the same area as the dented area of the rear right fender as shown in photo 2 above. This was after the rear right fender was removed.

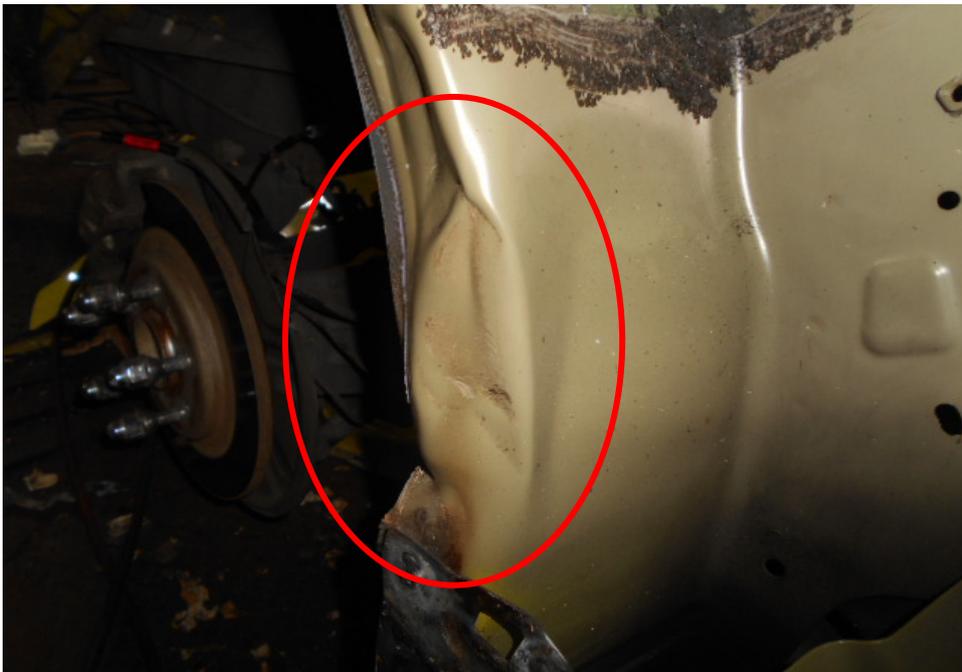
Photo 8 shows another view of the dent to the rear right fender wheel house dented (circled).

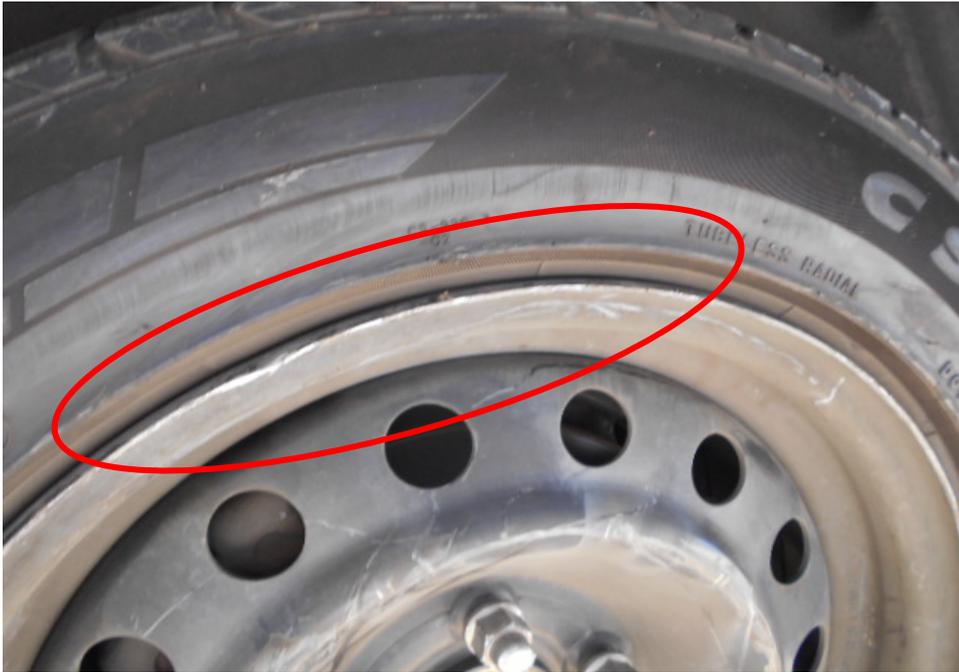
Photo 9 shows the rear right wheel rim of the taxi distorted (out of shape). For this case, there was contact by the insured vehicle onto the rear wheel of the taxi. This is supported by the broken wheel cap shown in photo 10 below, and also the dent to the rear right wheel rim (circled). The contact onto the wheel rim could result in induced damage to the undercarriage parts at the rear right wheel of the taxi from a sudden change in rotational and/or torsional stress arising from the contact (both vehicles moving at time of contact). Wheel alignment report of the taxi also showed that the rear right wheel could not be align to within the manufacturer specifications hence confirming the damage to the undercarriage parts.

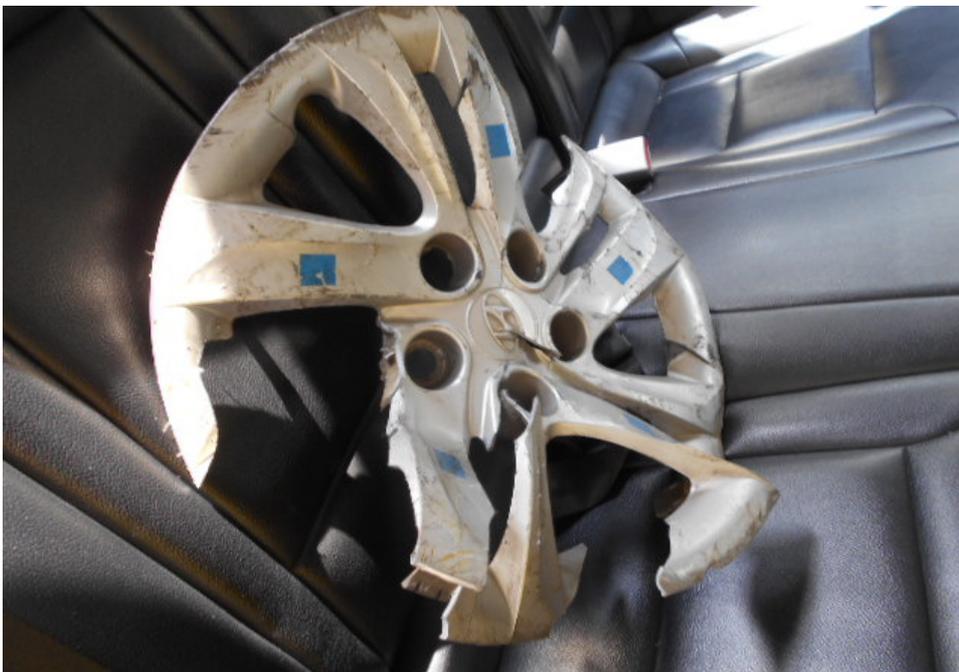
Photo 10 the broken wheel cap of the taxi, indicating that there was contact by the insured vehicle onto the rear right wheel of the taxi at the material time.
