## AUTOMOBILE ASSESSMENT REPORT

Assessment of Vehicle No : SMG 1566L

Date of Accident : 29/05/2019

## VEHICLE DAMAGE INSPECTION REPORT

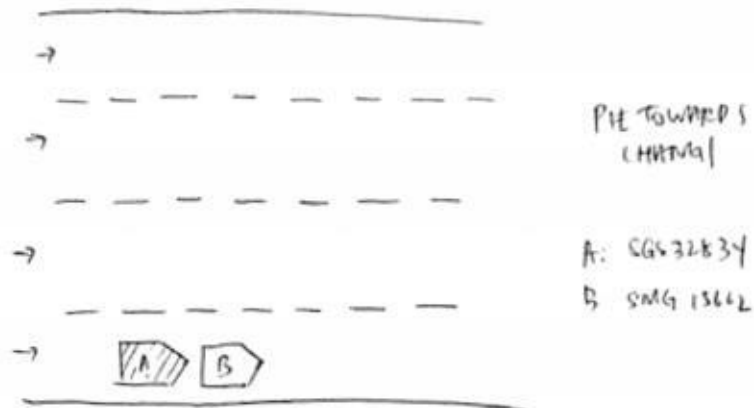
I was driving<sup>(h)</sup> at Lane 1 of PIE (towards chungi), the traffic is moving. I was in the car with my friend. Suddenly a car ~~in front~~ (which is 2 car before mine) e-brake, causing the car before me to have a sudden e-brake. I also did a e-brake, but due to ~~not~~ insufficient of time & false signal, ~~into~~ my car skid and hit the rear of B.
