Your Ref: M1906193  
Our Ref :CS/TMI19014180/D

29 August 2019

**TECHNICAL INVESTIGATION REPORT OF FIRE INCIDENT INVOLVING THE INSURED VEHICLE SMK 422D ON 11 AUGUST 2019**

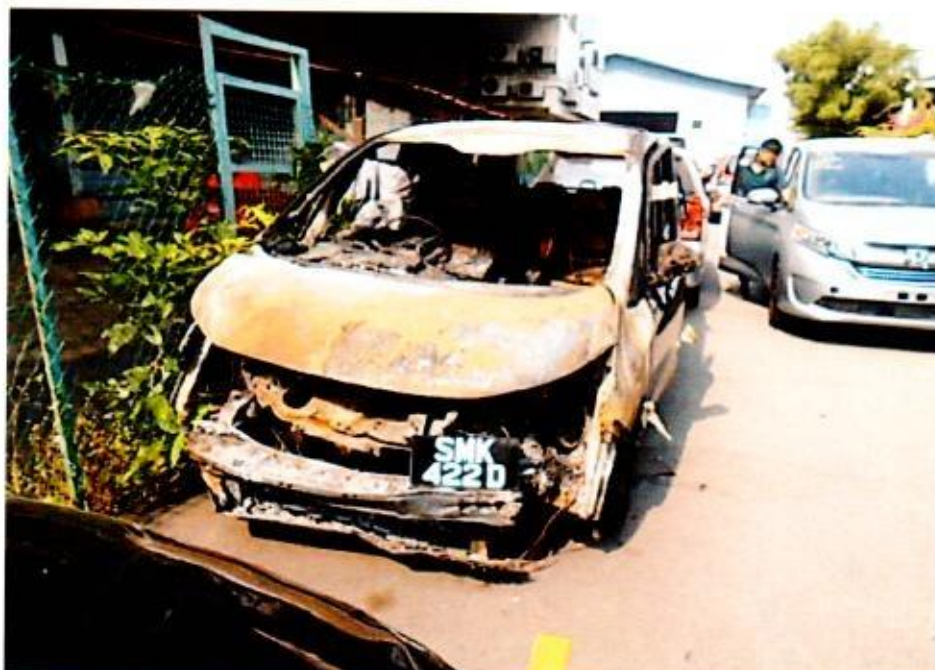
**Photo 1** shows a general view of the front left body of the Insured Vehicle at the time of inspection. The Insured Vehicle was noted to have sustained severe fire damage at its frontal portion. Its front bumper, front bonnet, front grille, front headlamps, front windscreen and front fenders were amongst the body parts that were found to have been affected as a result of the fire.

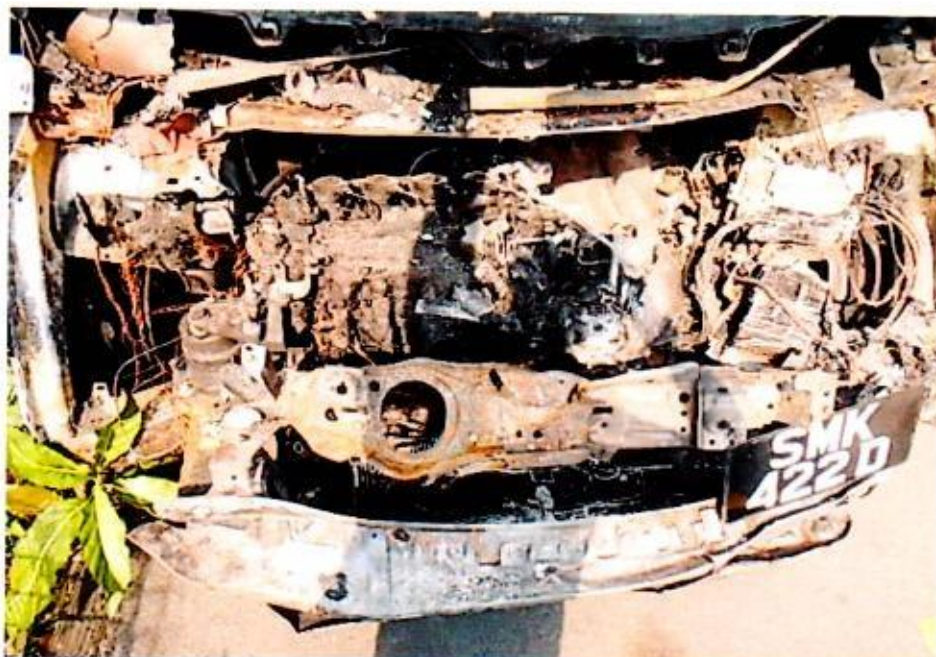
**Photo 2** shows the engine compartment of the Insured Vehicle at the time of inspection. The entire engine compartment of the Insured Vehicle was observed to be severely burnt. Almost all the parts inside the engine compartment were burnt to char.

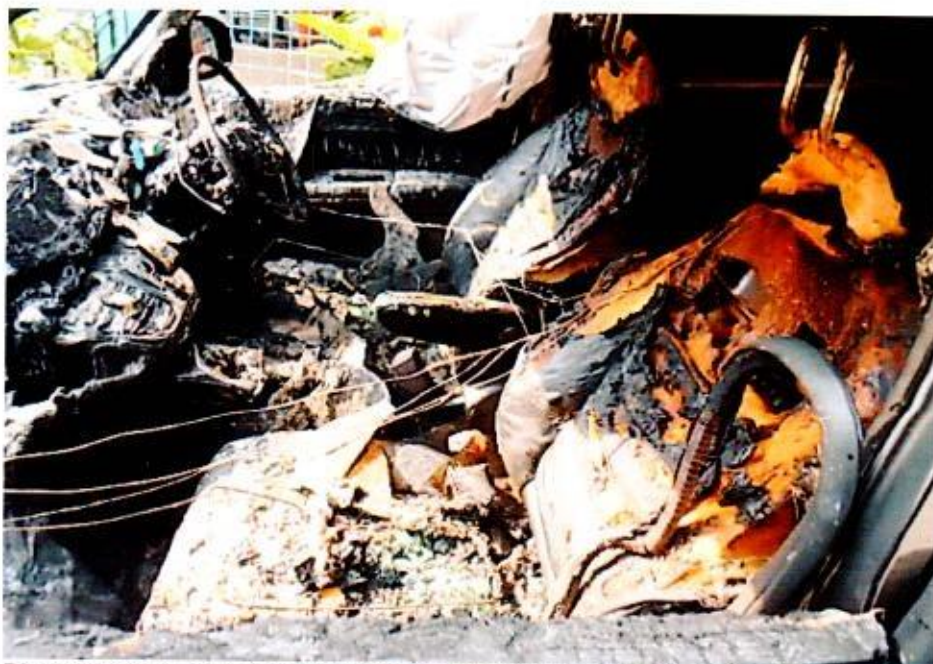
**Photo 3** shows the interior compartment of the Insured Vehicle, which had also sustained severe damage of fire nature. The front dashboard, roof upholstery, carpet and seats amongst others, inside the interior compartment were burnt and/or melted.

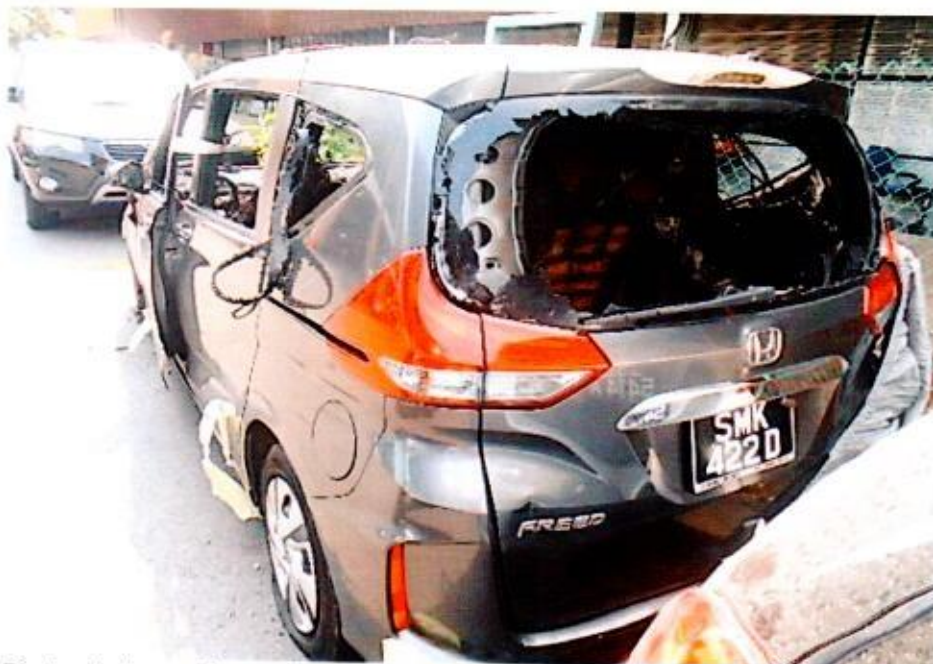
**Photo 4** shows the rear left body of the Insured Vehicle. Exterially, the body panels at the rear of the Insured Vehicle were unaffected, apart from a shattered rear windscreen.

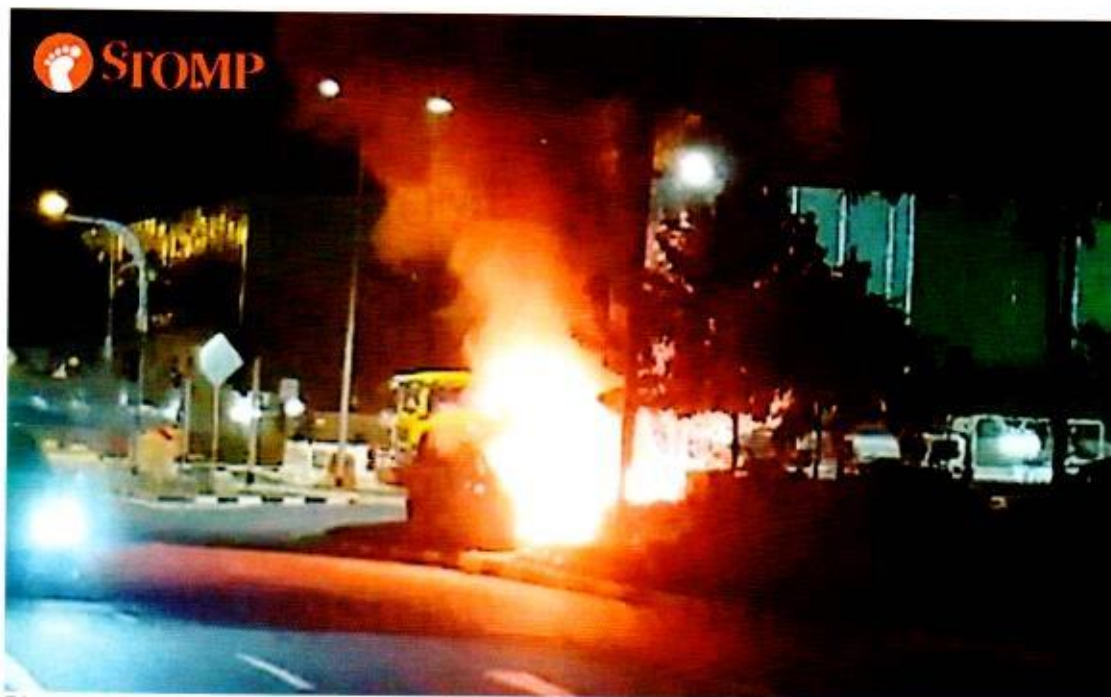
**Photo 5** shows the Insured Vehicle at the material time of incident with flames engulfing its frontal portion. The Insured Vehicle could also be seen completely mounted the road kerb. Multiple explosion sounds and sparks were heard and seen from video recordings that were uploaded in the social media website, STOMP.

17. The electrical spark(s) created by the dislodged high voltage live electrical power cable(s) could have then either dispersed onto the grass patch and/or onto combustible material of the Insured Vehicle, igniting the fire. The multiple explosion sounds, and sparks heard and seen even after fire had engulfed the frontal portion of the Insured Vehicle, as seen from the video recordings that were uploaded in the social media website, STOMP, corresponds to the presence of electrical sparks at the material time of incident.

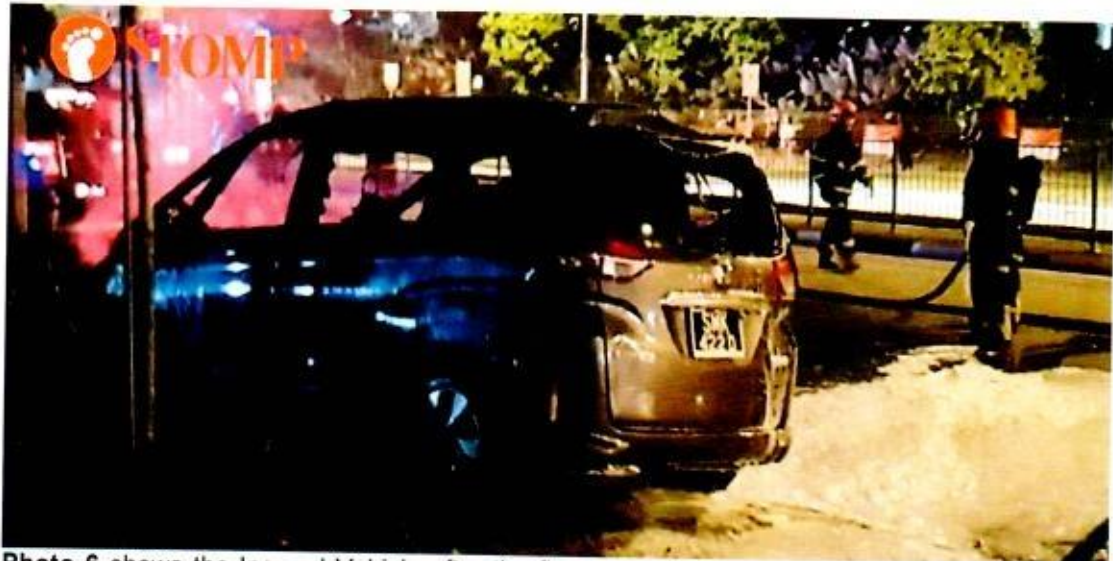
Photo 6 shows the Insured Vehicle after the fire was extinguished. Multiple explosion sounds and sparks, before the fire was extinguished, were heard and seen from video recordings that were uploaded in the social medial website, STOMP.

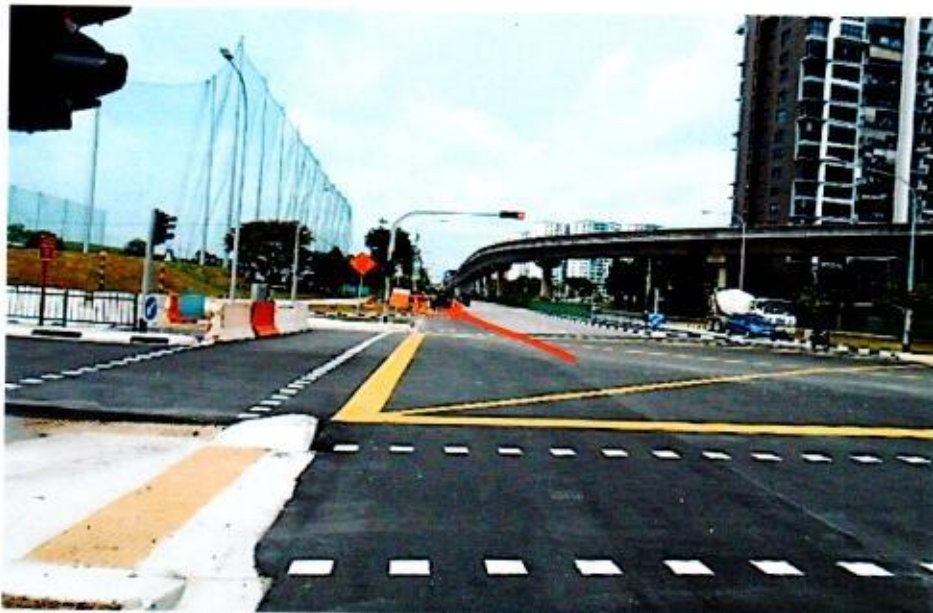
Photo 7 shows the signalized junction of Punggol East and Punggol Drive. The Insured Vehicle was initially stationary at this junction due to red traffic signal. It ended up colliding into an electrical box (arrowed) after Mr Osman dozed off when driving the Insured Vehicle into the junction after the traffic signal turned green. The fire to the Insured Vehicle occurred after the collision with the electrical box.

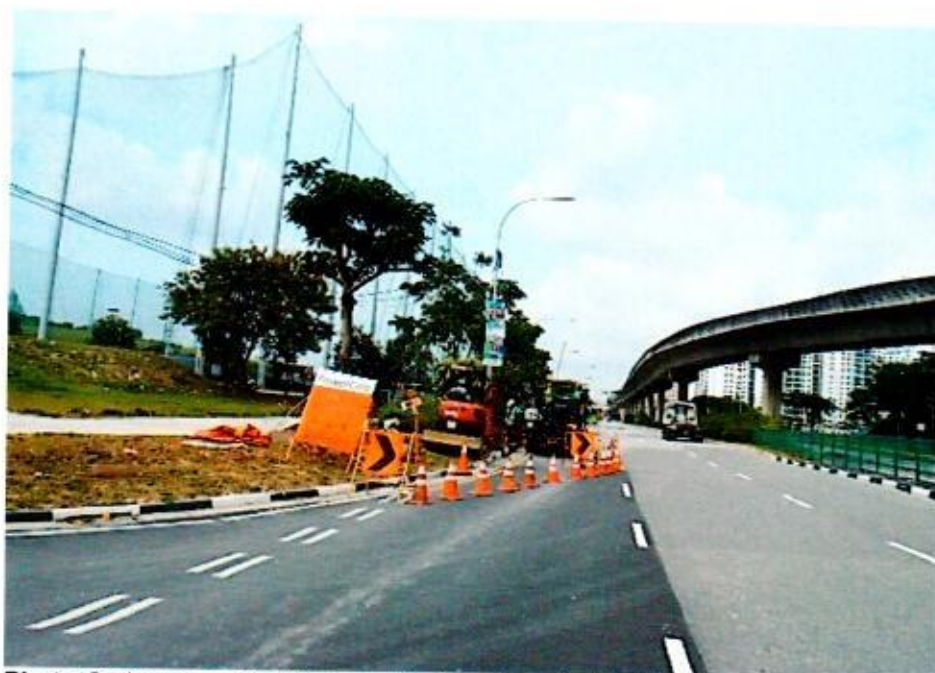
Photo 8 shows a general view of where the electrical box was located. At the time of my visit, repair/re-construction works to the electrical box and electrical cables were ongoing.

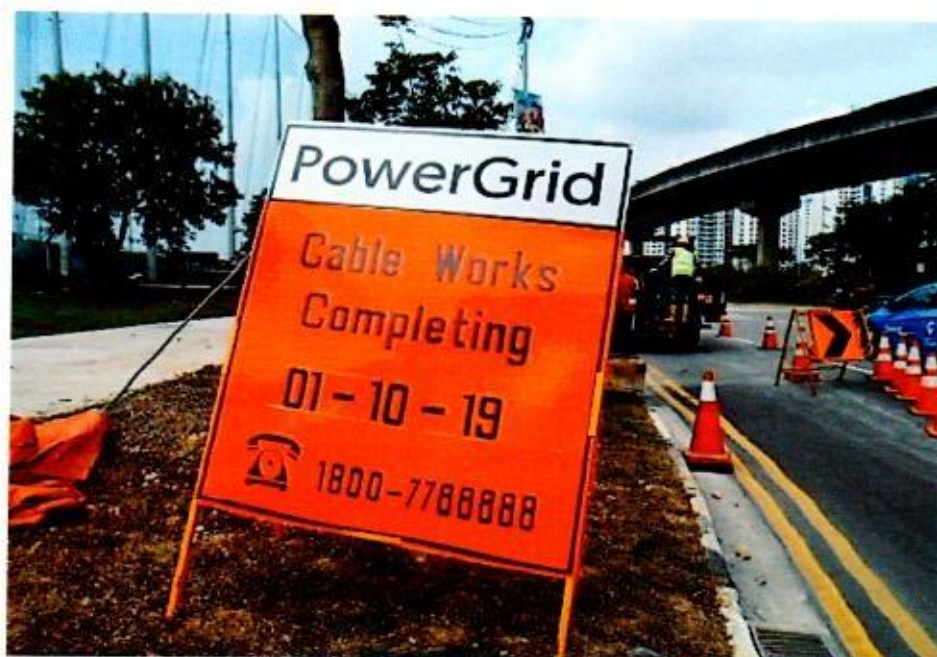
Photo 9 shows the signboard that was put up by the contractor pertaining to ongoing repair/re-construction works to the electrical box and electrical cables.

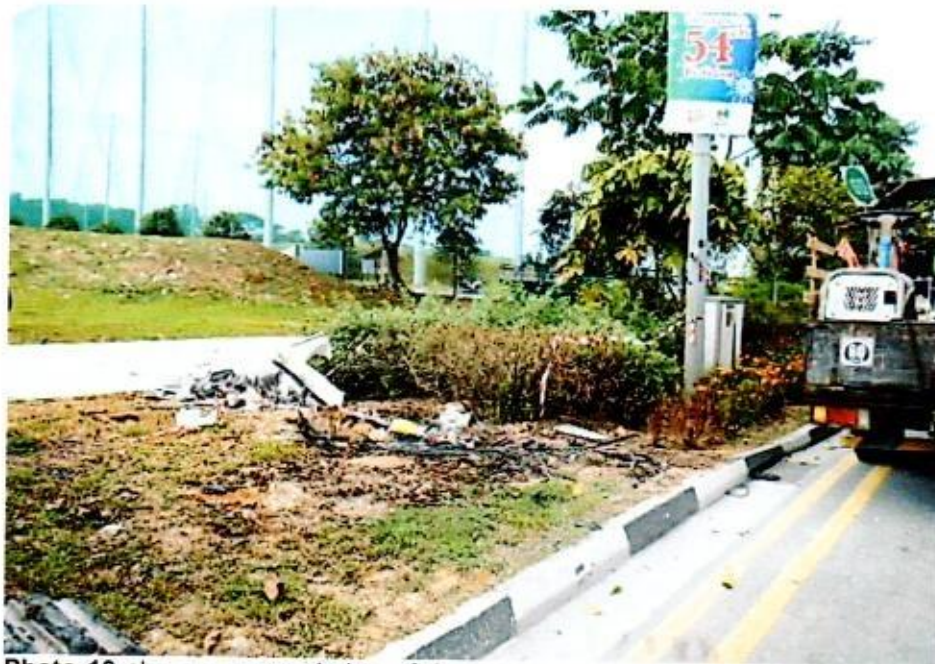
**Photo 10** shows a general view of the burnt remains at the location where the electrical box was located. The grass and vegetation surrounding the electrical box were burnt. Vehicular debris that were burnt was also found on the burnt grass patch.

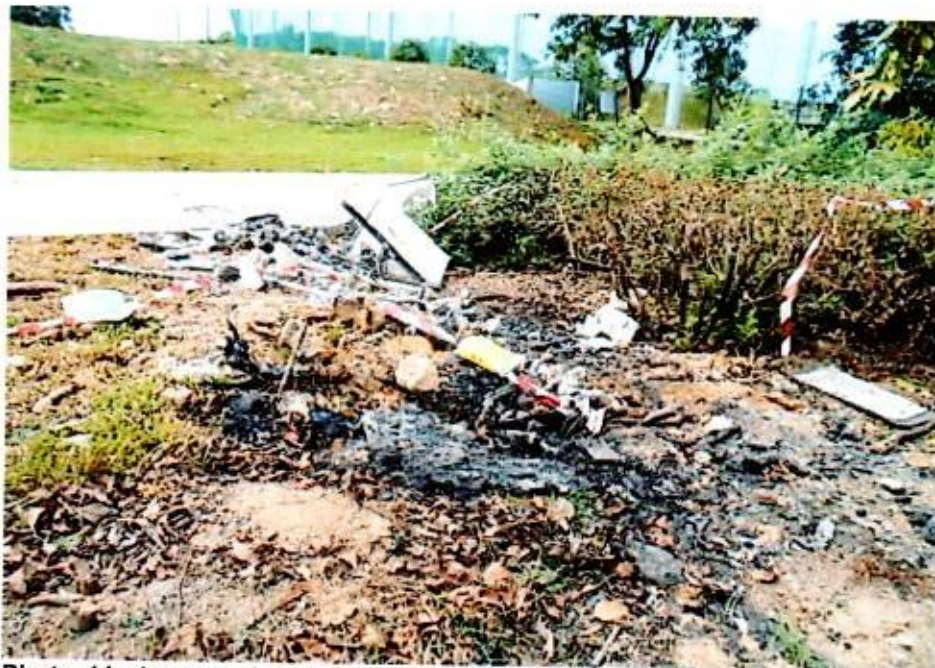
**Photo 11** shows a closer view of the burnt remains at the location where the electrical box was located. The grass and vegetation surrounding the electrical box were burnt. Vehicular debris that were burnt was also found on the burnt grass patch.

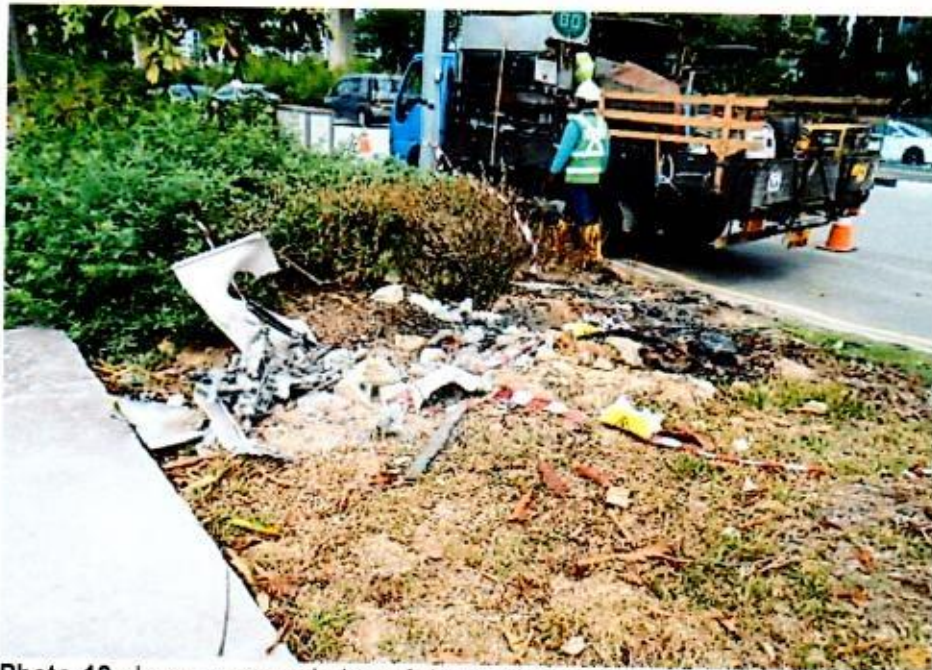
**Photo 12** shows a general view of the burnt remains at the location where the electrical box was located. Repair/re-construction works to the electrical box and electrical cables were ongoing at the time of my inspection.
