Inspection Report

Preliminary Advice

TO : **MSIG** MOTOR CLAIMS DEPTS
 VEHICLE NO : **SDW1050E**
 MODEL : **HONDA JAZZ** 12/2016
 DATE OF ACCIDENT : 26.07.19
 TIME OF ACCIDENT : 18:40HRS

VEHICLE DAMAGE INSPECTION REPORT

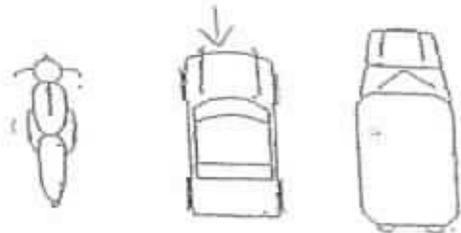
Point of Impact / Damages :

Front

Proposed : Part by Part / Lump Sum Repair \$142001- Excess : \$ -

Estimate Repair Period : 10 days
