Your Ref: S9M01X83
Our Ref : CS/ASM19014457/P

TECHNICAL INVESTIGATION REPORT OF FIRE INCIDENT INVOLVING THE INSURED VEHICLE YN 5078Z ON 8th AUGUST 2019

Vehicle Registration No.	: YN 5078Z
Make / Model	: MISTSUBISHI CANTER
Chassis No	: FEB21EA00275
Year of Registration	: 17 APRIL 2014
Mileage	: 178,916KM

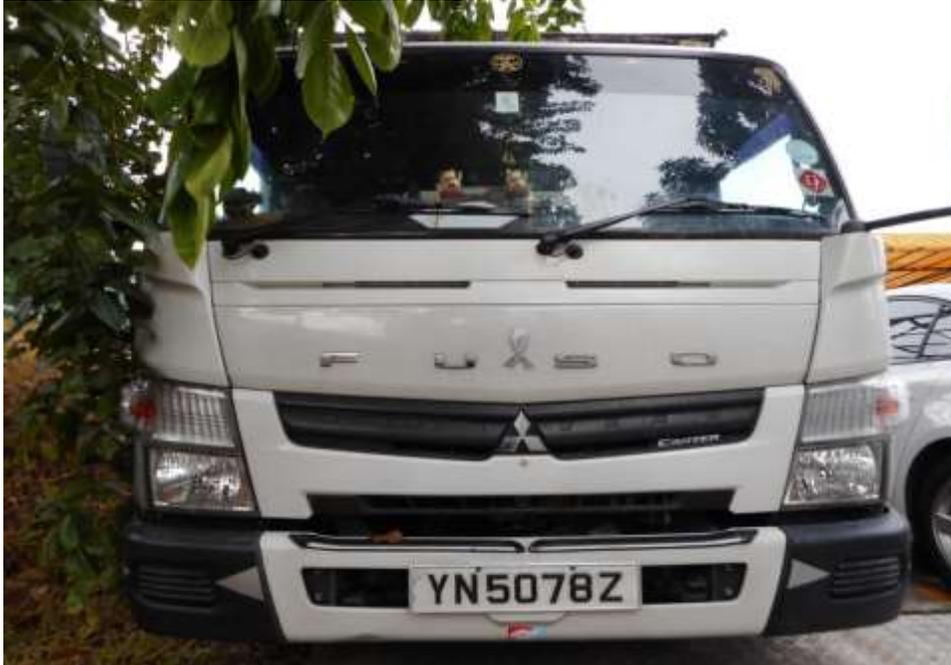
Photo 1 shows the front view of the Insured Vehicle at the time of our inspection. The fire damage to the Insured Vehicle was confined to its rear cargo compartment. The front cabin portion of the Insured Vehicle was relatively unaffected by the fire except for the rear cargo portion.

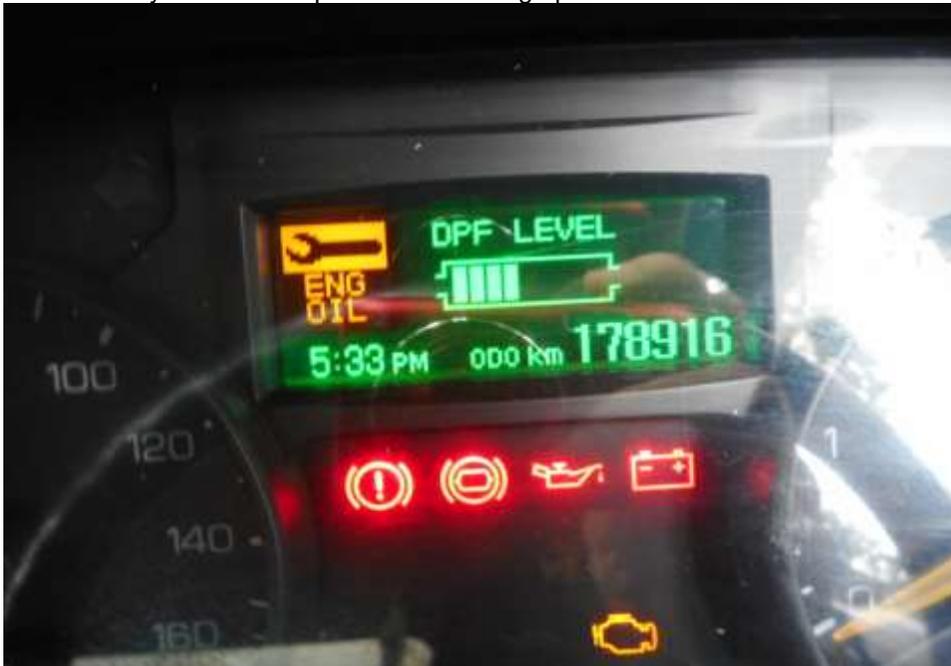
Photo 2 shows the recorded mileage of the Insured Vehicle at the time of inspection 178,916km.

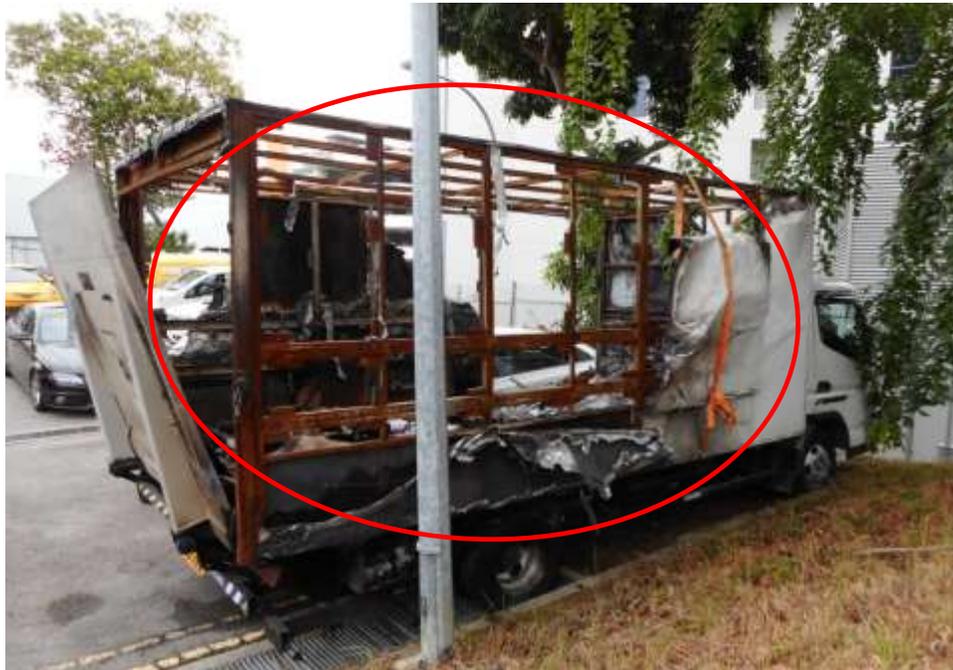
Photo 3 shows the right side view of the Insured Vehicle at the time of our inspection. The front cabin portion of the Insured Vehicle was relatively unaffected by the fire except for the rear cargo compartment. The fire damage to the Insured Vehicle was confined to its rear cargo compartment (circled).

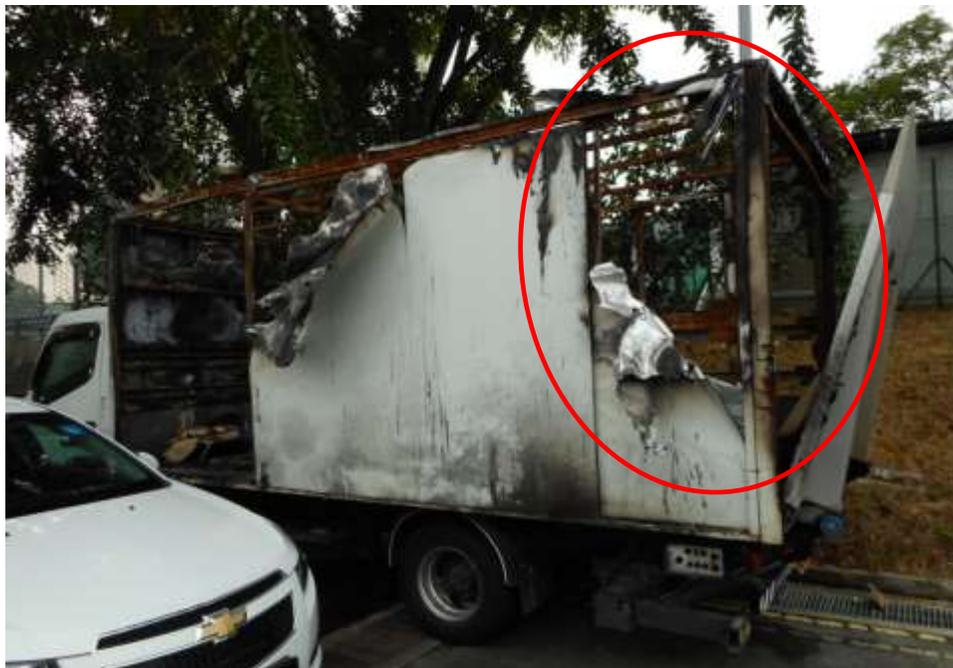
Photo 4 shows the left rear view of the Insured Vehicle at the time of our inspection. The front cabin of the Insured Vehicle was relatively unaffected by the fire except for the rear cargo compartment. The fire damage to the Insured Vehicle was confined to its rear cargo compartment. The fire damage was observed to be most severe at its rear cargo compartment (circled).

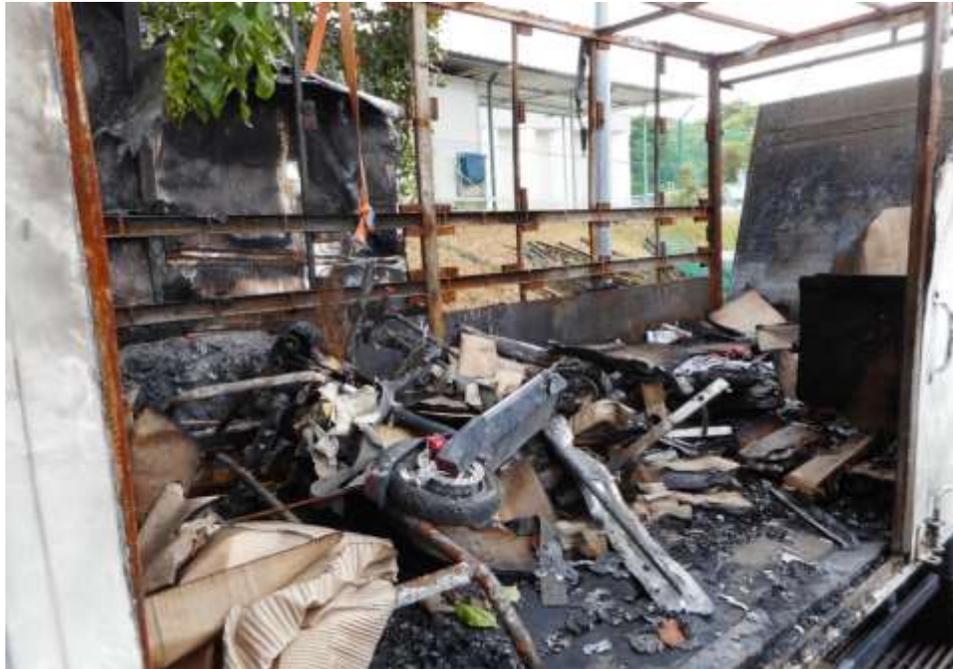
Photo 5 shows the interior contents in the rear cargo compartment of the Insured Vehicle at the time of our inspection. The fire damage to the Insured Vehicle was confined to its rear cargo compartment.

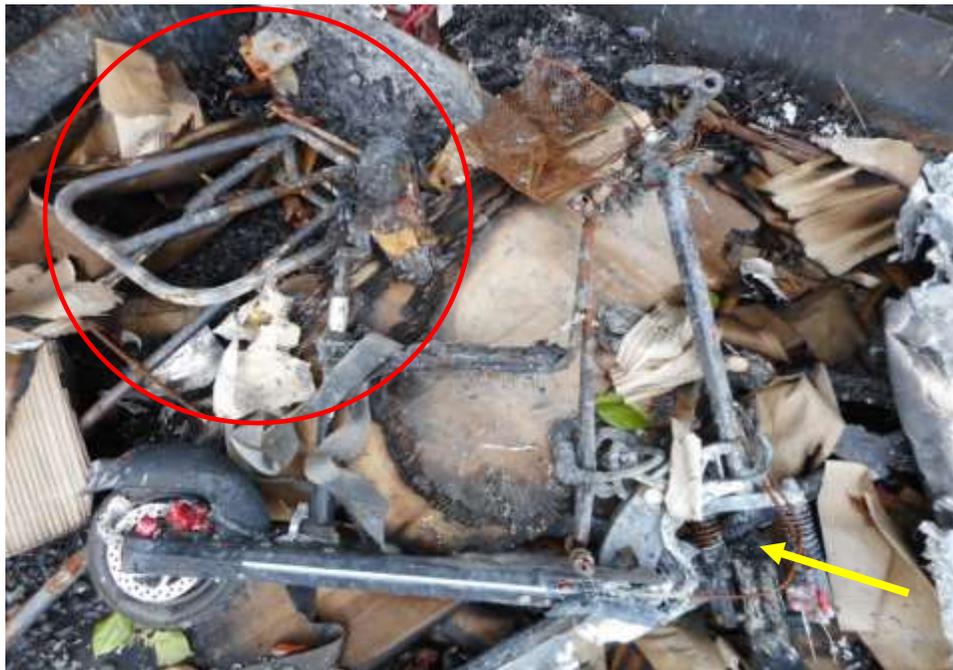
Photo 6 shows the interior contents in rear cargo compartment of the Insured Vehicle at the time of our inspection. The contents included a Personal Mobility Device (PMD) (circled) and a hand push trolley (yellow arrowed) which was observed to have sustained heat and smoke damage, a result of the fire incident.

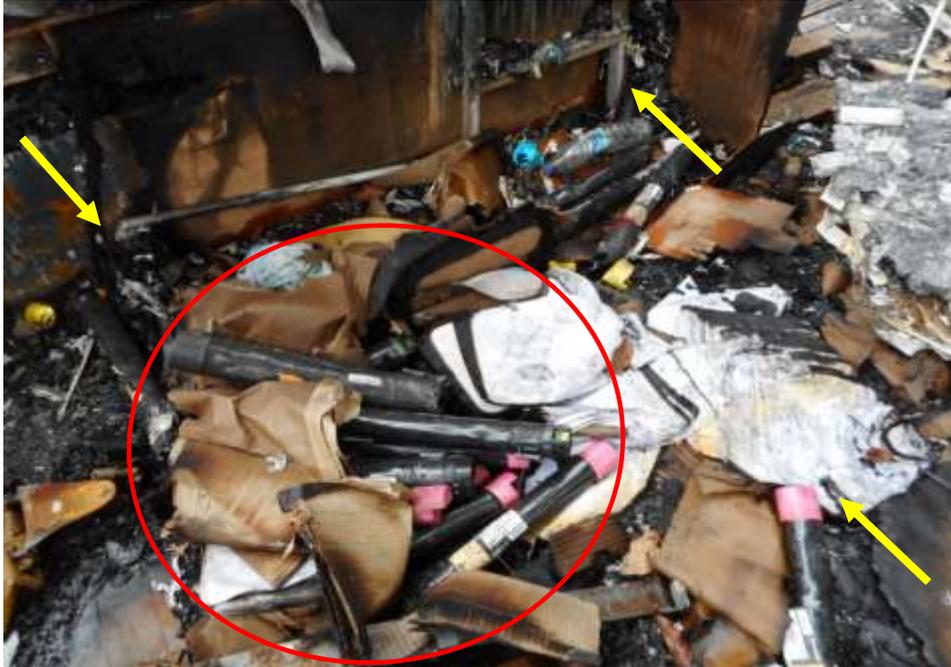
Photo 7 shows the interior contents in rear cargo compartment of the Insured Vehicle at the time of our inspection. The contents included a several printer toner cartridges (circled) and other items around the area were also damaged (yellow arrowed), as a result of the fire.

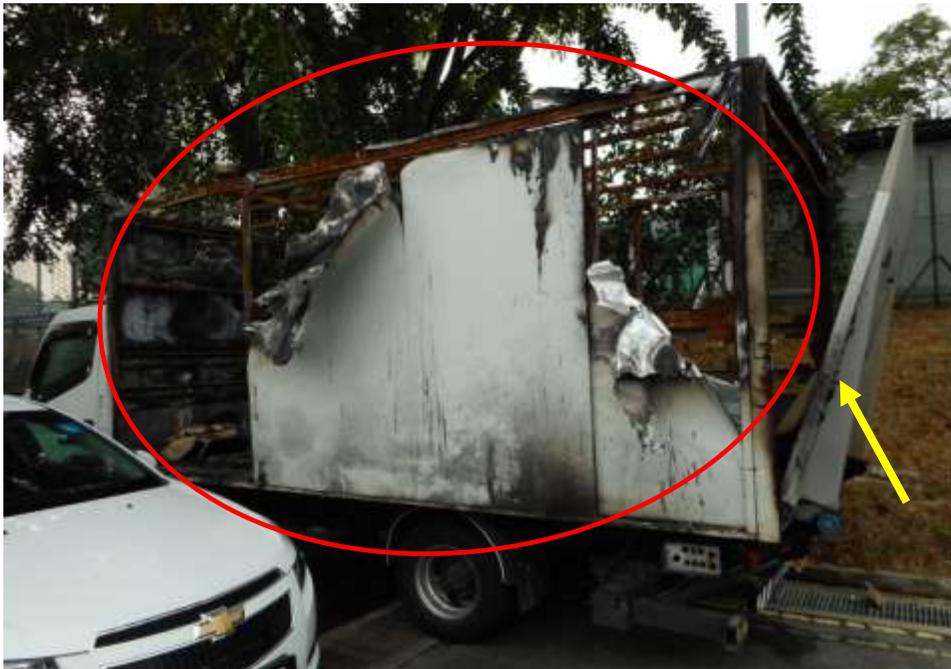
Photo 8 shows the exterior body of the rear cargo compartment of the Insured Vehicle at the time of our inspection. The contents included a sliding door, the ceiling, walls (circled) and the rear lift gate (yellow arrowed), as a result of the fire.

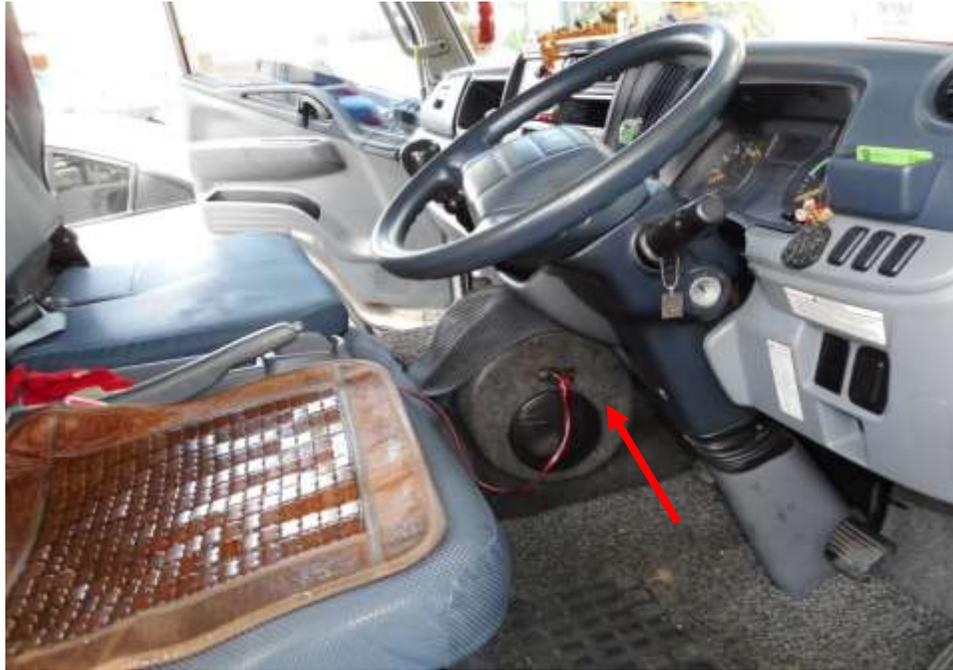
Photo 9 shows a subwoofer (arrowed) mounted at the foot well area in the front cabin compartment of the Insured Vehicle at the time of our inspection.

28. There were additional electronic audiophile equipment, which included a subwoofer, an audio amplifier and a set of stereo bookshelf speaker fitted in the front cabin compartment of the Insured Vehicle. However they are inspected and not related to the cause of fire.

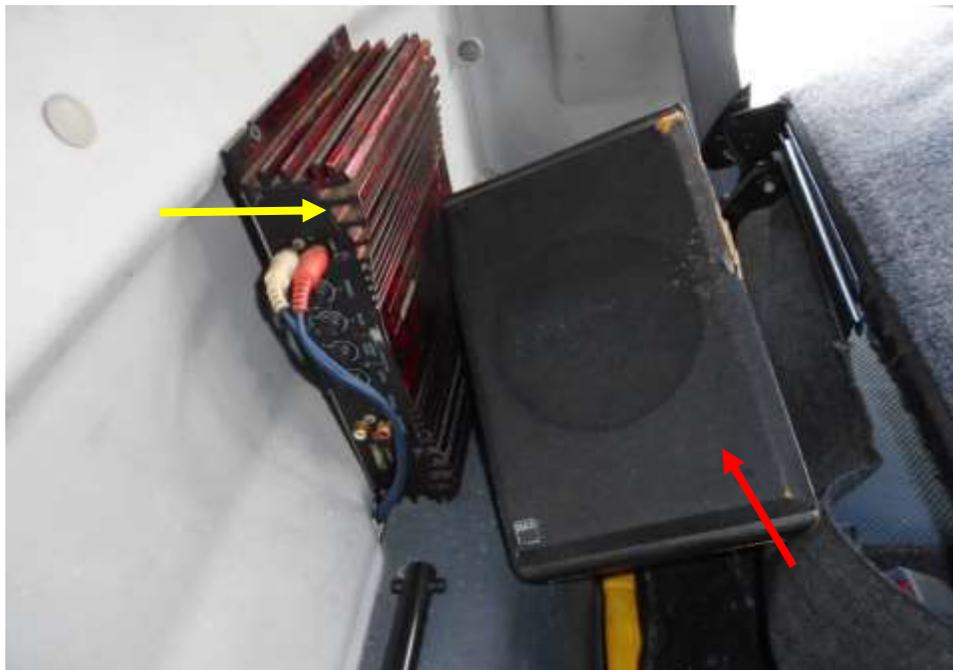
Photo 10 shows the audio amplifier (yellow arrow) and the stereo bookshelf speaker (red arrow) mounted behind the passenger seat of the front cabin compartment of the Insured Vehicle at the time of our inspection.

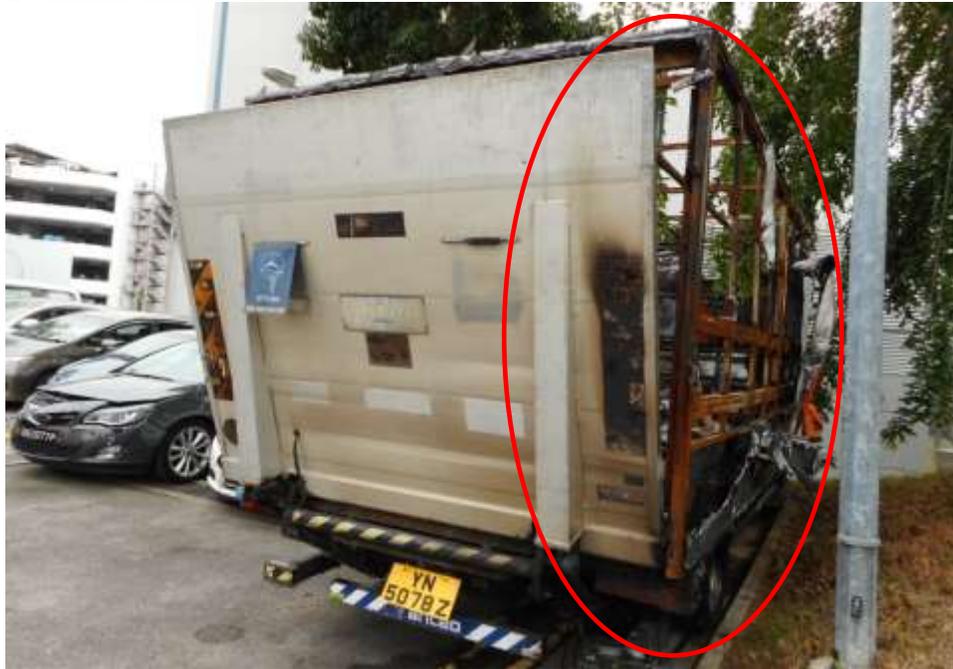
9. The whitish burn marks are a result of exposure to prolonged heat intensity. Rust would normally start to develop around these areas soon after a fire as prolonged exposure to high heat intensity usually causes steel/metal material body parts to be exposed to natural environmental condition. The whitish burn marks on the rear tail gate surface and the rust that had developed on the metal frames of the rear cargo compartment is an indication that the rear portion of the Insured Vehicle had sustained exposure to prolonged high heat intensity. See photos 11 - 12 below.

Photo 11 shows the exterior view of the rear tailgate as well as the exposed rear cargo compartment of the Insured Vehicle which is situated at the rear of the Insured Vehicle at the time of our inspection. The rear right portion of the tailgate belonging to the Insured Vehicle was observed to be significantly burned by the fire (circled).

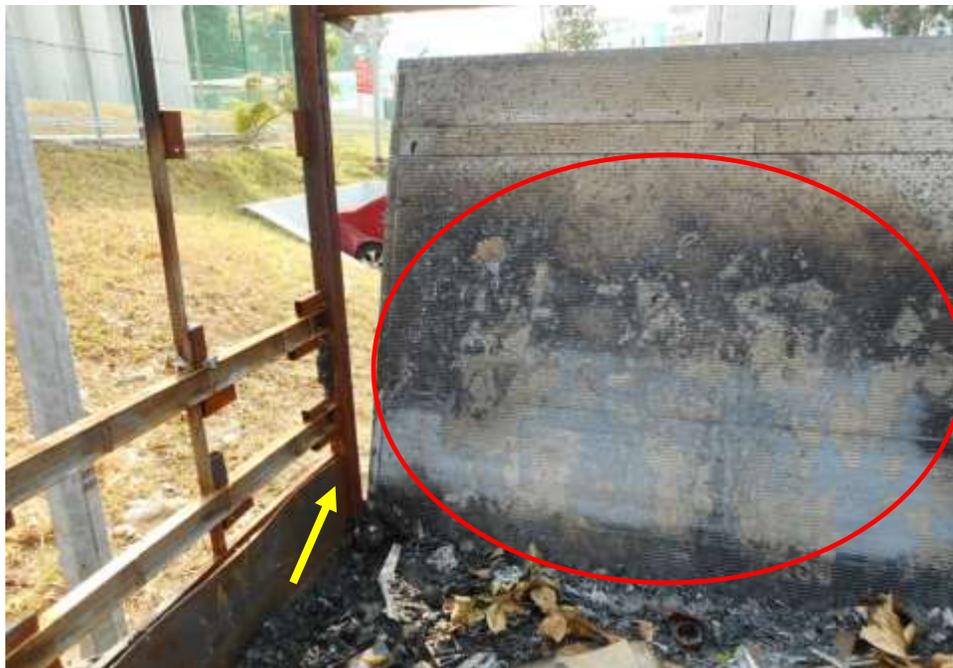
Photo 12 shows the rear interior portions of the Insured Vehicle, where the rear tail gate and rear cargo compartment frame are located. Whitish burn marks and rust on the metal frame of the cargo compartment (yellow arrow) was observed as a result of exposure to prolonged heat intensity. The nature of fire damage was confined to these particular areas (circled).

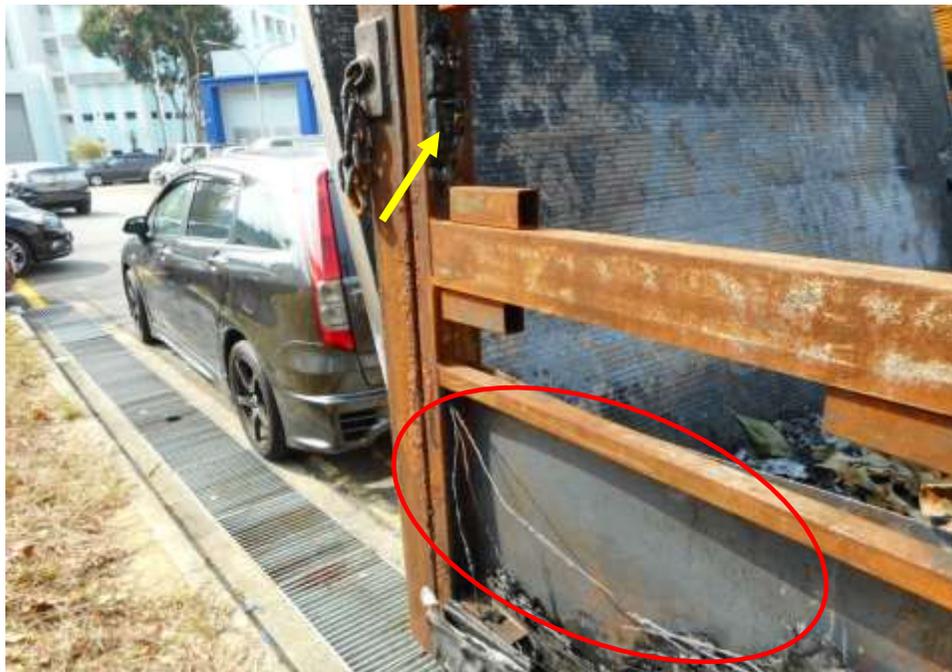
10. Upon closer examination of the rear cargo compartment portion of the Insured Vehicle which was where the fire had likely started, we had found traces of greenish residue on the wirings leading from the switch panel to the ceiling light. The presence of greenish residue indicates internal heating of copper wires, a sign of an electrical short circuit occurring. The greenish residue is normally left behind from oxidation as a result of chemical reaction involving the copper wires.
11. Due to the intensity of the fire, the ceiling light of the Insured Vehicle was burned into ashes. However, we were able to trace the likely cause of where the fire had started. This physical evidence would then appear to suggest that the cause of fire to the Insured Vehicle could have possibly been due to electrical in nature. See photos 13 - 18 below.

Photo 13 shows the rear right portion of the Insured Vehicle, where the fire had likely started. We observed the switch panel of the ceiling light mounted on the metal frame of the rear cargo compartment. The switch panel (yellow arrow) was burnt with expose wiring and traces of greenish residue on these wirings (circled). The wirings lay out from the switch panel through the metal frame and body panels to the ceiling lights of the Insured vehicle. The presence of such greenish residue indicates internal heating of copper wires, a sign of an electrical short circuit occurring. The greenish residue is normally left behind from oxidation as a result of chemical reaction involving the copper wires. This physical evidence would then appear to suggest that the cause of fire to the Insured Vehicle could have possibly been due to electrical in nature.

26. Having investigated and technically analysed the damages of burnt nature to the Insured Vehicle, we are of the view that the cause of fire to the Insured Vehicle was of electrical in nature. For this particular case, the fire had originated along the ceiling light wirings leading from the switch of the Insured Vehicle due short circuit.

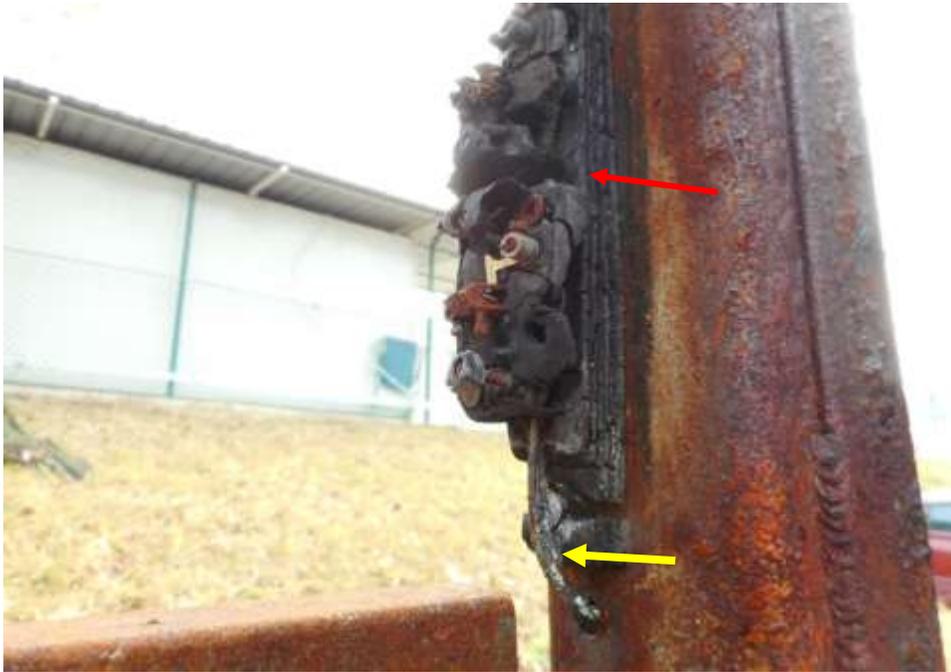
Photo 14 shows a closer view of the ceiling light switch panel (red arrowed) and the wirings to the ceiling light of the rear cargo compartment of the Insured Vehicle. We observed traces of greenish residue on these wirings (arrowed). The presence of such greenish residue indicates internal heating of copper wires, a sign of an electrical short circuit occurring. The greenish residue is normally left behind from oxidation as a result of chemical reaction involving the copper wires. This physical evidence would then appear to suggest that the cause of fire to the Insured Vehicle could have possibly been due to electrical in nature.

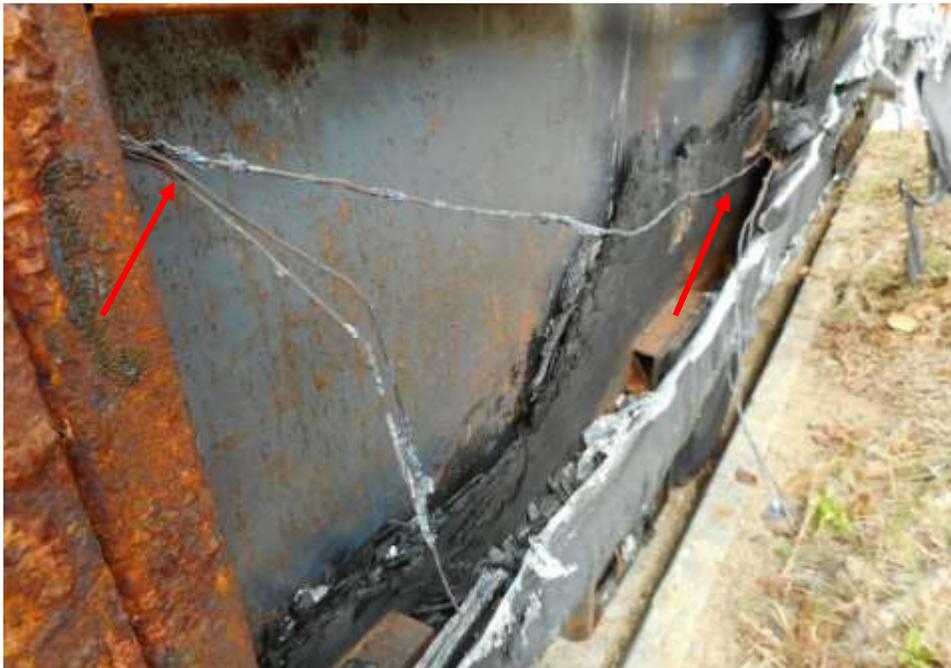
Photo 15 shows a closer view of the wirings from the switch panel running through the right side body panel. Greenish residue found on the wirings leading to the ceiling lights of the Insured Vehicle (arrowed). This seems to suggest the occurrence of an electrical short circuit.

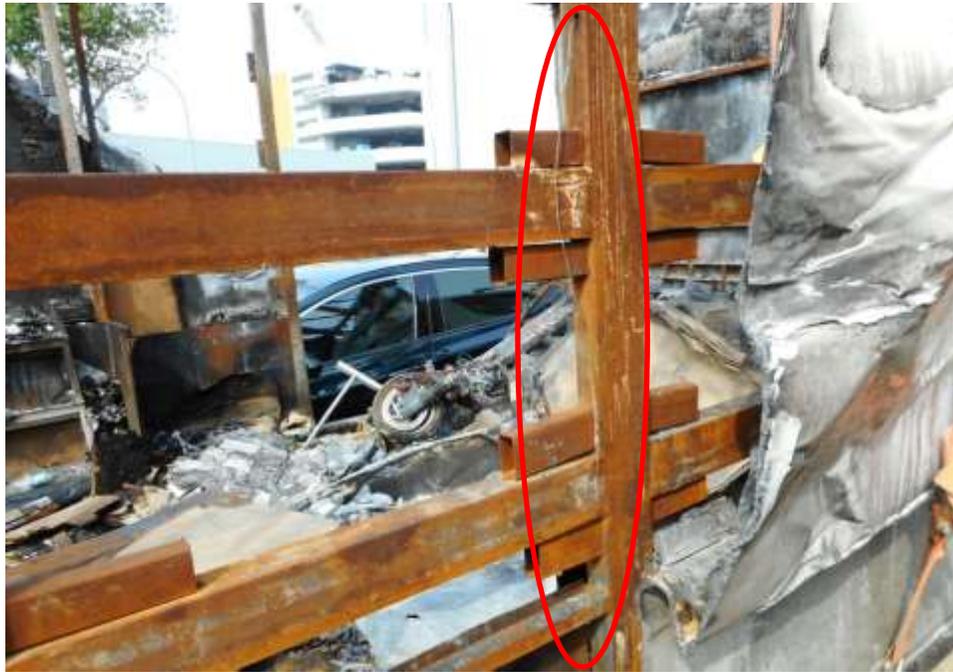
Photo 16 shows a view of the wirings from the right side panel body panel laid through a hole on the centre metal frame up to the ceiling light. We observed that the wirings from the exterior of the centre metal frame laid back into the inside of the metal frame. Greenish residue found on the wirings leading to the ceiling lights of the Insured Vehicle (circled). This seems to suggest the occurrence of an electrical short circuit.

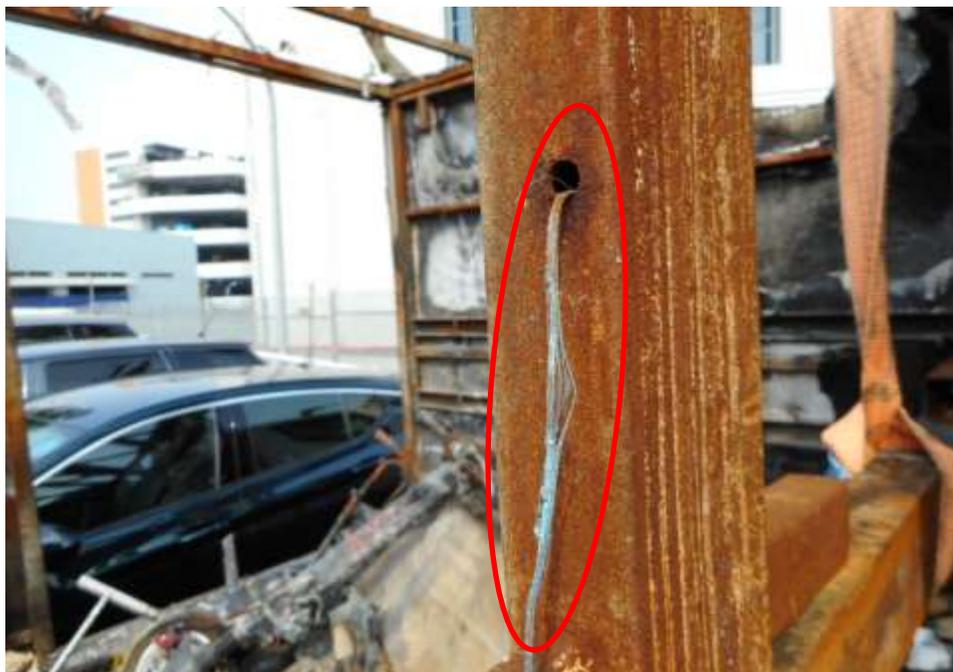
Photo 17 shows a closer view of the wirings from the right side panel body panel laid through a hole on the centre metal frame up to the ceiling light. Greenish residue found on the wirings leading to the ceiling lights of the Insured Vehicle (circled). This seems to suggest the occurrence of an electrical short circuit.

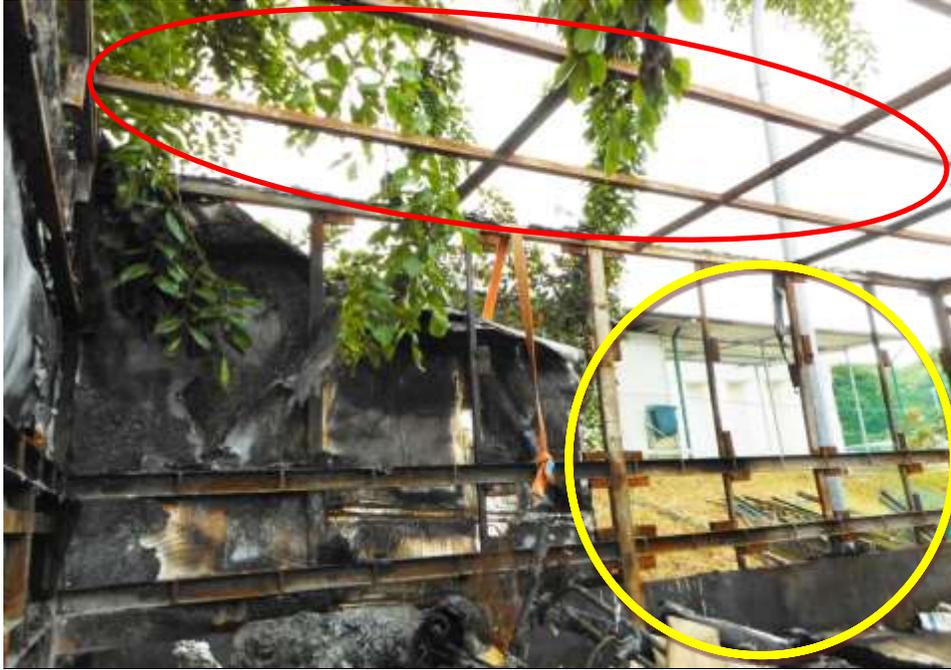
Photo 18 shows a view of the ceiling and body panels of the rear cargo compartment of the Insured vehicle. The fire observed to have likely started from the wiring of the ceiling light to the switch panel, due to the intensity of the fire that have melted the whole of the ceiling (red circle) and rear right body panel (yellow circle).
