LKK Auto Consultants Pte Ltd

Affiliated to Federation Internationale Des Experts En Automobile				
CHINA TAIPING INSURANCE (S) PTE LTD 3 ANSON ROAD #16-00 SPRINGLEAF TOWERSINGAPORE 079909			Ref: CC6/CTI19014538/Kea3q2	Date: 09/05/2022
			Code: CTI

ADJUSTMENT ON REPAIR COST FOR VEHICLE NO. GX 1576P

PHOTOGRAPHS FOR VEHICLE NO. GX 1576P

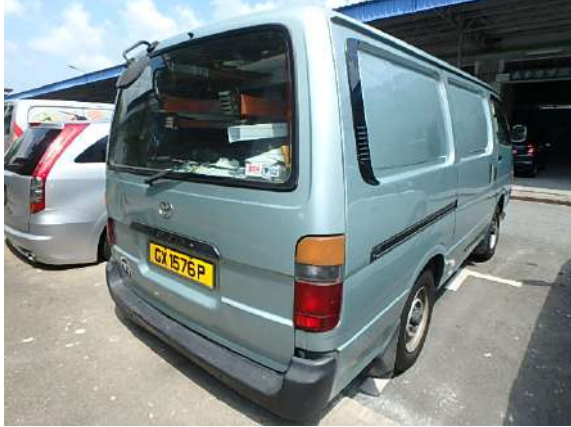
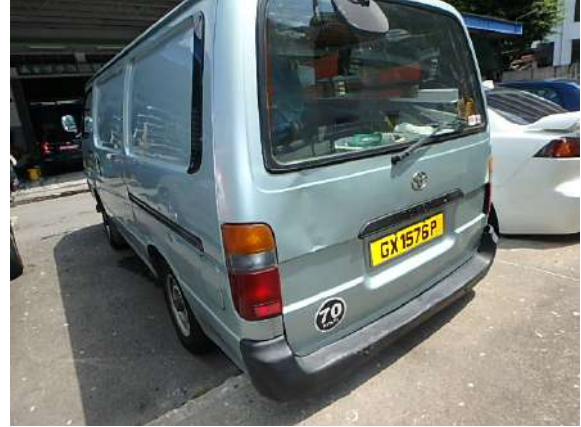
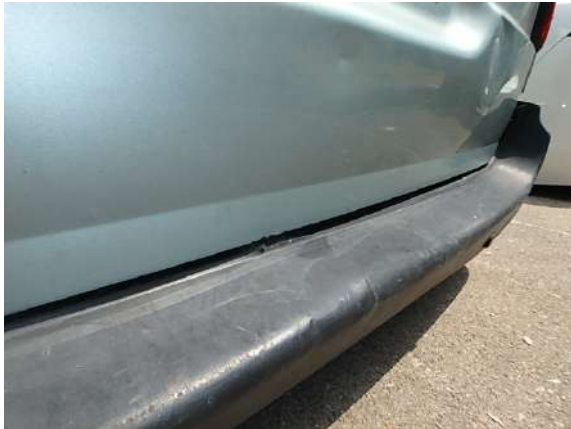
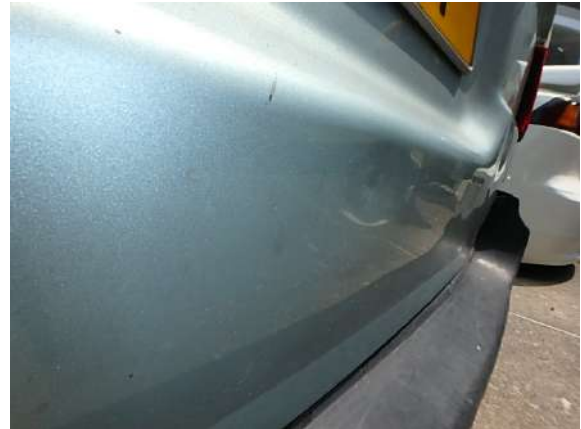
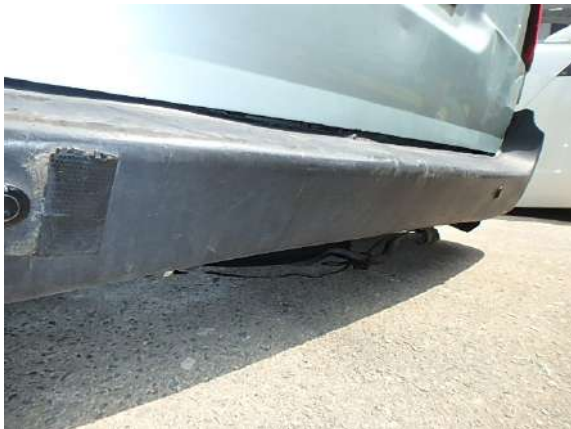
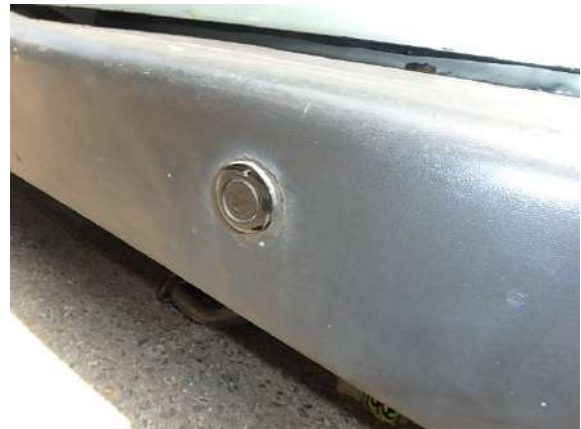
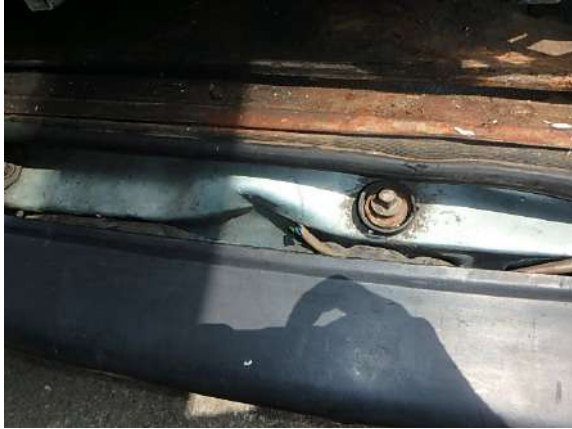
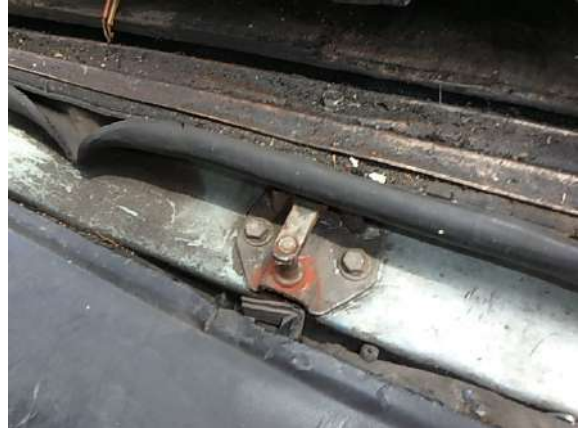
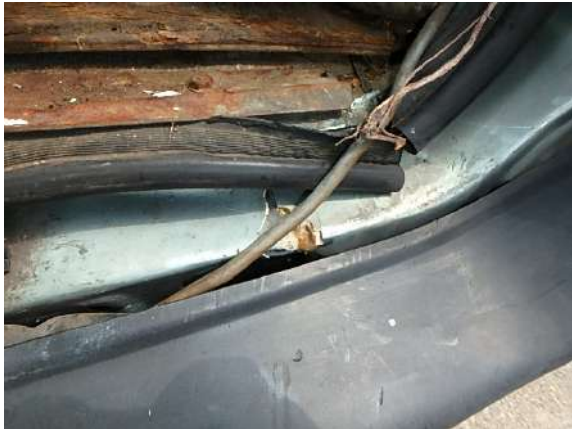
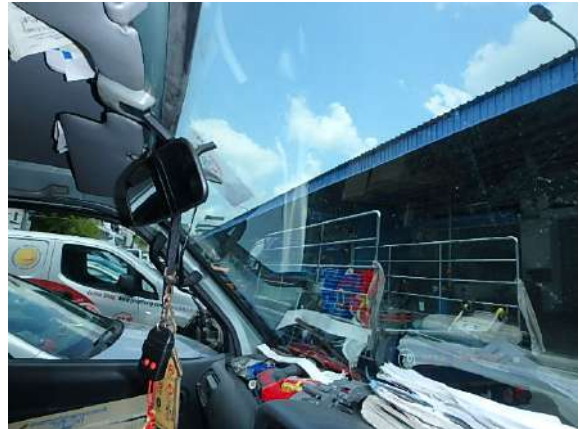
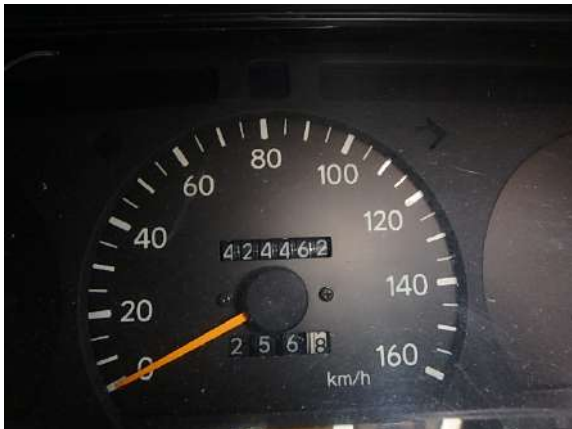
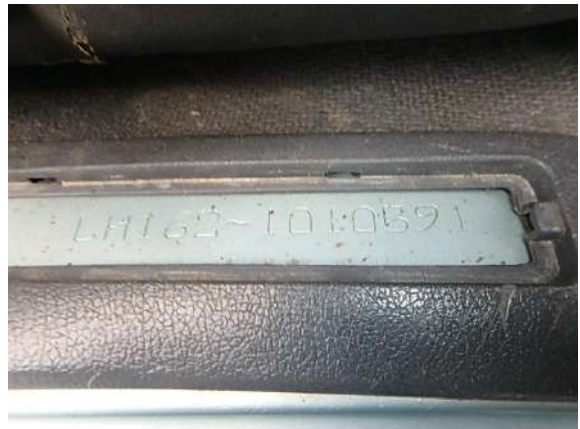
4. Description of Damages				
THE VEHICLE SUSTAINED DAMAGES AT THE REAR PORTION. DAMAGES SEE DETAILS.				
5. General Information				
Accident Date	14/08/2019	Inspection Date	19/08/2019	
Survey held at	ALAN'S UNITED AUTO PTE LTD BLK 7 SIN MING INDUSTRIAL ESTATE #01-76 SINGAPORE 575642			
5a. Remarks				
A)THE INSPECTION WAS CONDUCTED ON A"WITHOUT PREJUDICE" BASIS. B)IN ACCORDANCE TO YOUR INSTRUCTIONS, WE HAVE NOT AUTHORISED REPAIRS.				
5b. Estimate Days of Repair				
ESTIMATED NORMAL PERIOD FOR REPAIR:			5 Working Days

Qty	Description of Parts	Condition	Estimate By Workshop (\$)	Our Adjusted (\$)
	<u>REPLACEMENT OF PARTS</u>			
1	REAR BUMPER FASCIA	BUCKLED	442.10	442.10
1	REAR BUMPER REINFORCEMENT	BENT	305.30	305.30
1	REAR END PANEL -OUTER	BENT	359.10	359.10
1	REAR END PANEL -INNER	* CHECK	688.50	-
1	TAIL GATE LOCK	* CHECK	234.90	-
1	TAIL GATE CENTRE LOGO	NECESSARY	42.50	42.50
	LESS 25% DISCOUNT		-518.10	-287.25
			1,554.30	861.75
1	TAIL GATE RUBBER (50%) (SN)	TORN	293.10	146.55
	LESS 25% DISCOUNT		-73.28	-

219.82	146.55
	<u>SPECIAL NETT ITEMS</u>			
1	REAR BUMPER REVERSE SENSOR (SN)	SHORTED	300.00	200.00
1	TAIL GATE 70KM/H STICKER (SN)	NECESSARY	15.00	15.00

315.00	215.00
	<u>LABOUR</u>			
	TO APPLY UNDERSEALING.		60.00	30.00
	TO PUTTY AND SPRAY REPLACED PARTS.		600.00	500.00
	TO REMOVE ,CUT -OUT DAMAGED PARTS ,PANEL BEATING ,WELDING ,ALIGN,REFIX AND TO RENEW ABOVE PARTS.		700.00	600.00
			1,360.00	1,130.00
	GRAND TOTAL		3,449.12	2,353.30

RECOMMENDED COST OF LUMP SUM REPAIRS (TO ITS PRE-ACCIDENT CONDITION) (REPAIR COST NOT CONCLUDE) (EXCLUDE CHECK ITEMS S\$692.55 NETT)			1,900.00
---	--	--	-----------------
