SLQ 4312S

T. LEXUS IS 200T (AT) cc 1998

Dear Sir / Madam,  
PRE-REPAIR INSPECTION FOR SLQ4312S  
ACCIDENT INVOLVING GQ3808U AND SLQ4312S ON 17.08.2019.

## VEHICLE DAMAGE INSPECTION REPORT

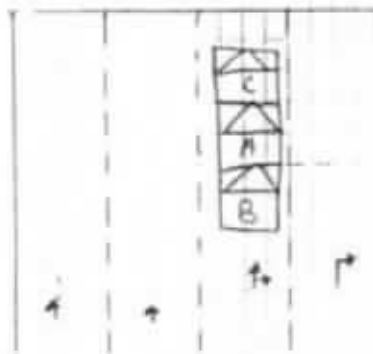
### SKETCH PLAN

A: SLQ43125  
B: GQ3808U  
C: SLP6426P

I WAS SATIONARY ALONG PAYA LEBAR ROAD TOWARDS GEYLANG AS THE TRAFFIC LIGHT WAS RED . OUT OF THE SUDDEN I FELT AN HUGE IMPACT FROM THE REAR PORTION OF MY VEHICLE WHICH CAUSE ME TO THRUST FORWARD AND COLLIDE ONTO VEHICLE C . I HAVE VIDEO FOOTAGE TO PROVE MY STATEMENT . TOTAL 3 CARS ARE INVOLVED .
