Your Ref: TP/IP/46503/2019
Our Ref : CI/TPD19014928/N

17 September 2019

MECHANICAL INSPECTION REPORT OF MOTOR VAN GBB 4314J

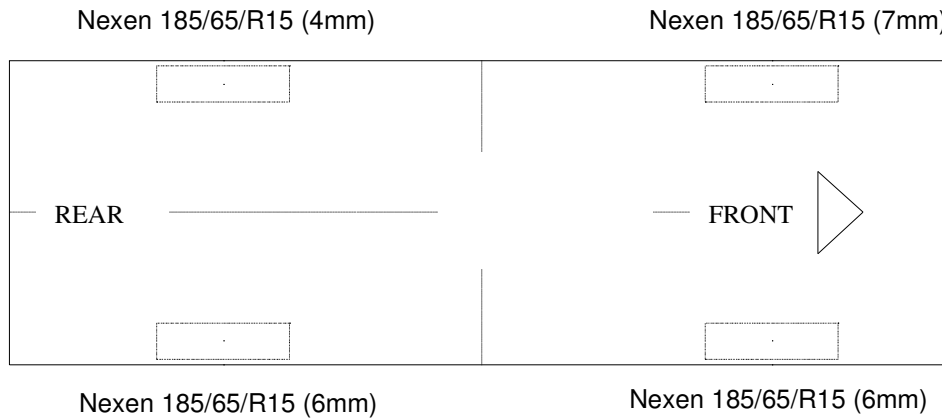
6. The 4 tyres were observed to be in serviceable condition and sufficiently inflated for vehicular operation. We did not find any tear, cut or burst mark(s) on the outer and the inner sidewalls as well as across the tread of the 4 tyres. The tyre brand, tyre size and remaining tread depth of the 4 tyres of the Motor Van were recorded as follows:-

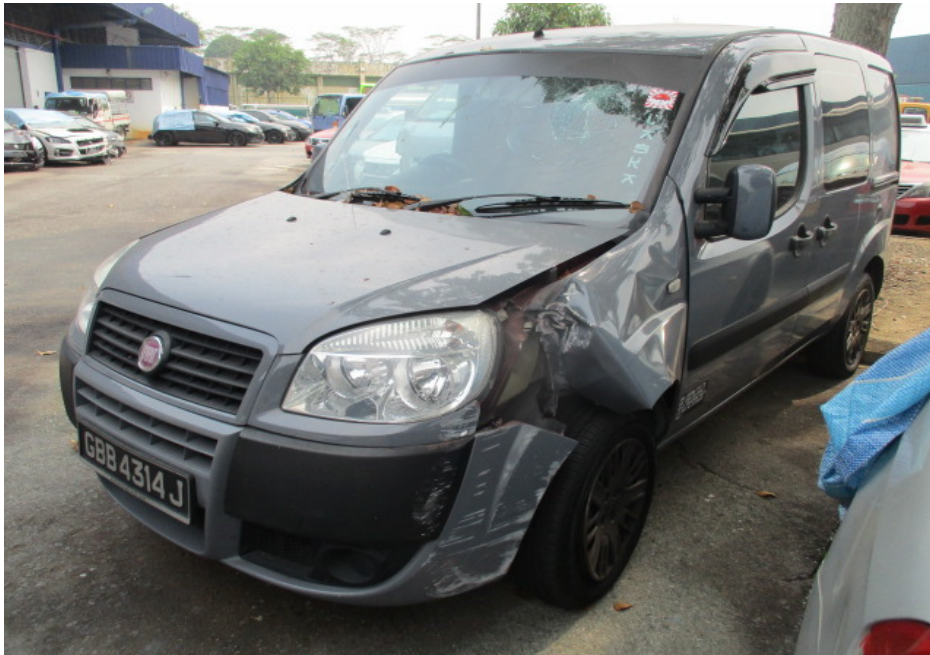
4. The mileage of the Motor Van at the time of our inspection was 236, 465km.
5. The Motor Van was observed to have sustained impact damage at its left front body. Its left front fender was observed to have been dented; its front bumper was observed to have been dislodged; its front windscreen was observed to be shattered.

Photo 2 shows a general view of the front left body of the Motor Van at the time of our inspection. The Motor Van was observed to have sustained minimal impact damage that was confined to its left front portion. Its left front fender was observed to have been dented; its front bumper was observed to have been dislodged; its front windscreen was observed to be shattered.

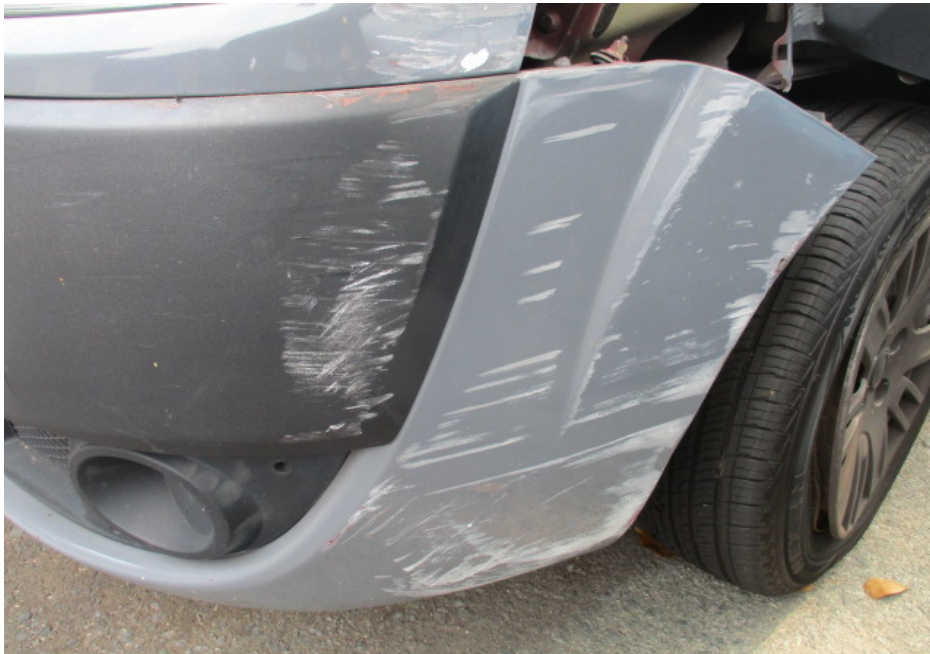
Photo 3 shows a close up view of the dislodged front bumper of the Motor Van at the time of our inspection.

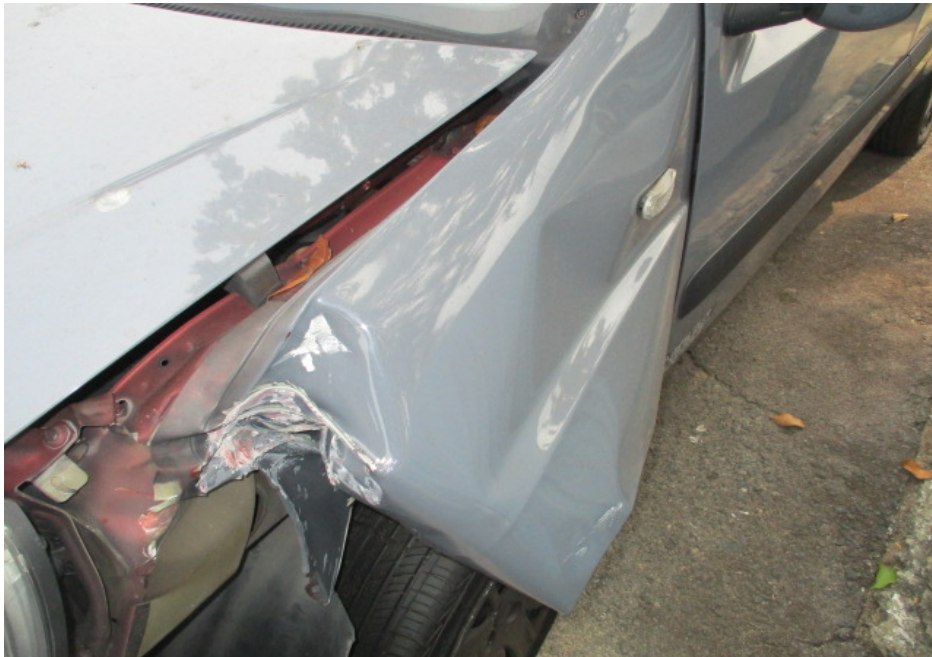
Photo 4 shows a close up view of the dented left front fender of the Motor Van at the time of our inspection.

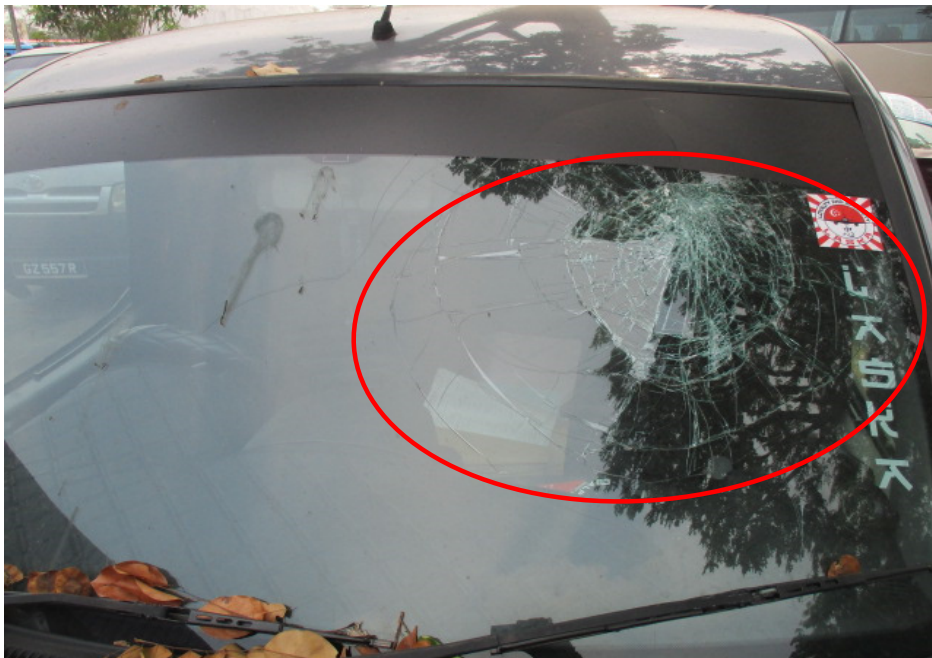
Photo 5 shows a close up view of the shattered front windscreen of the Motor Van at the time of our inspection (circled).

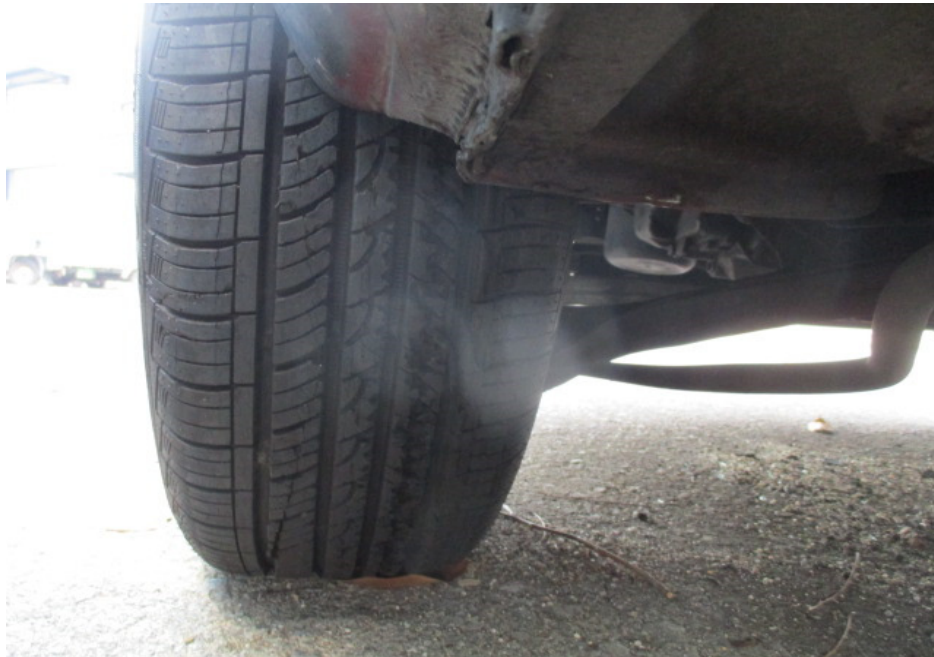
Photo 6 shows the condition of the front left tyre of the Motor Van, which was observed to be in serviceable condition with remaining tread depth of approximately 7mm. The tyre, which was wrapped around standard steel wheel rim, was also observed to be sufficiently inflated for vehicular operation. There was no tear, cut or burst mark(s) on the outer and the inner sidewalls as well as across the tread of the 4 tyres.

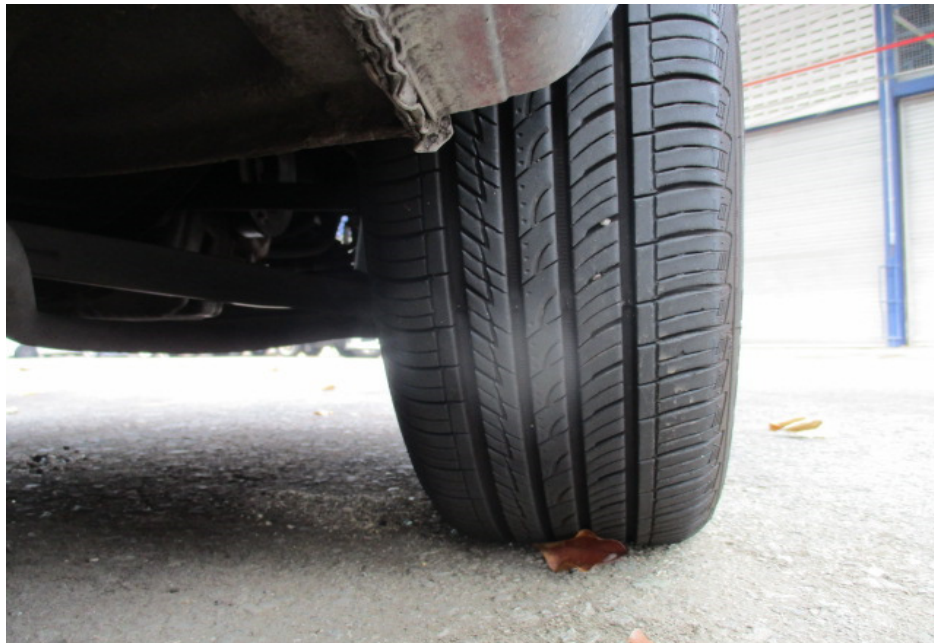
Photo 7 shows the condition of the front right tyre of the Motor Van, which was observed to be in serviceable condition with remaining tread depth of approximately 6mm. The tyre, which was wrapped around standard steel wheel rim, was also observed to be sufficiently inflated for vehicular operation.

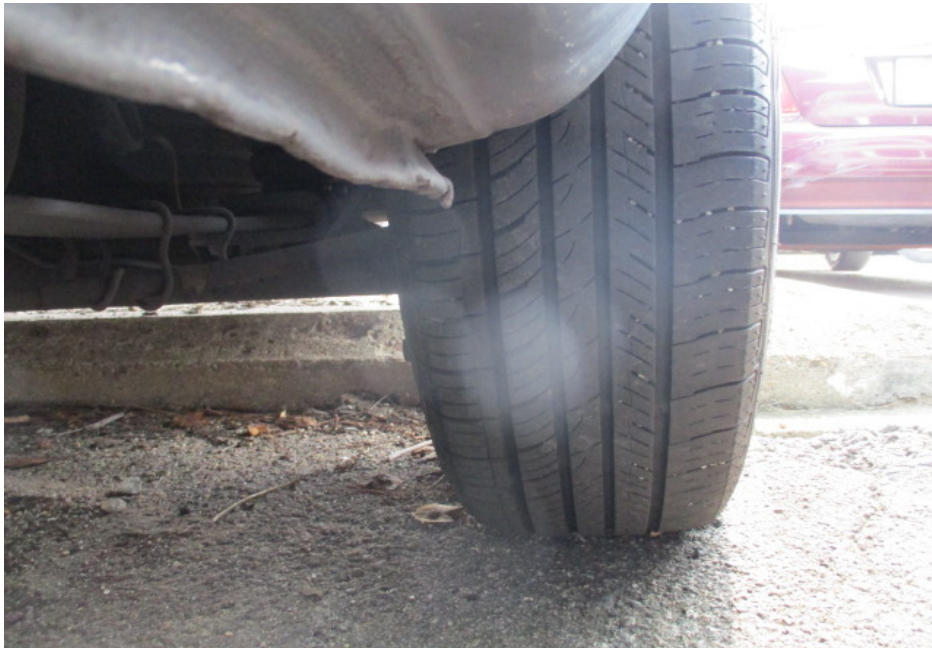
Photo 8 shows the condition of the rear left tyre of the Motor Van, which was observed to be in serviceable condition with remaining tread depth of approximately 4mm. The tyre, which was wrapped around standard steel wheel rim, was also observed to be sufficiently inflated for vehicular operation. There was also no damage found on the 4 wheel rims of the Motor Van.

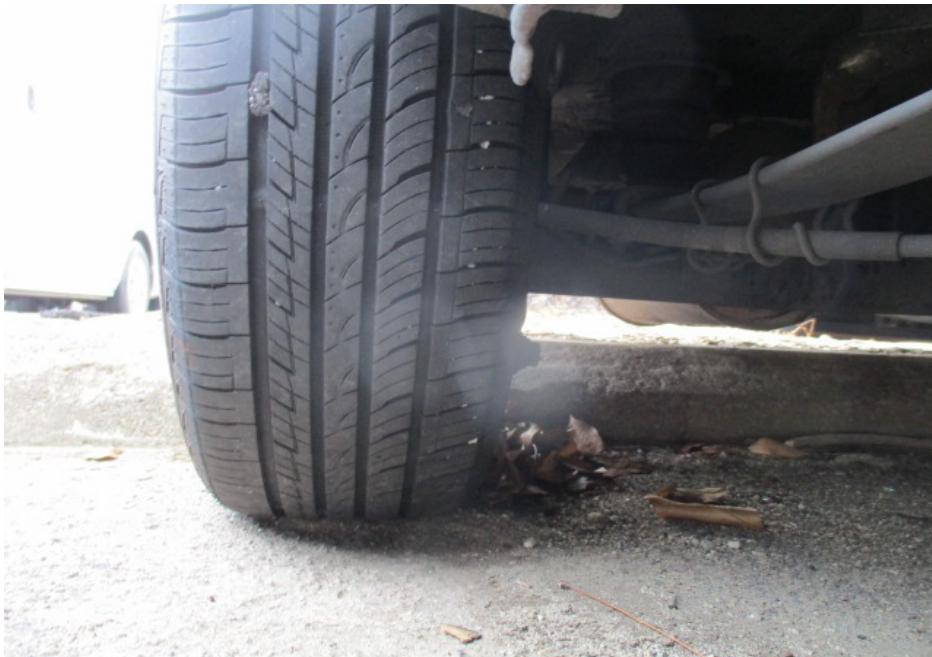
Photo 9 shows the condition of the rear right tyre of the Motor Van, which was observed to be in serviceable condition with remaining tread depth of approximately 6mm. There was also no tear, cut or burst mark(s) on the outer and the inner sidewalls as well as across the tread of the 4 tyres.

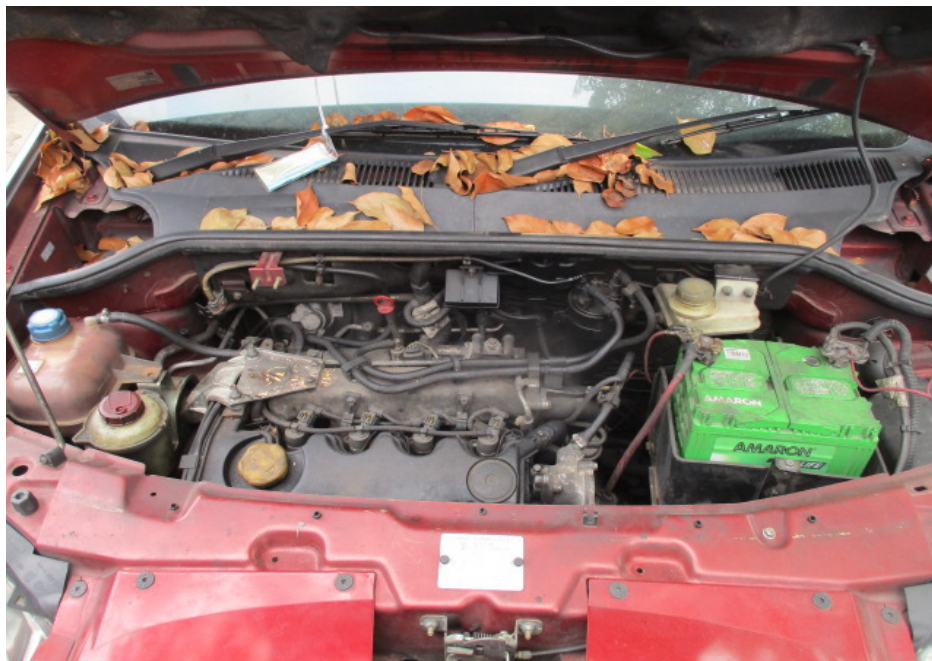
8. Upon examination of the Motor Van's engine compartment, we had observed all the parts and components inside the engine compartment to be intact and unaffected by the accident. The brake fluid, engine oil, power steering fluid and engine coolant were all found to be of sufficient level for operating purposes. Visually, there was also no contamination found to these fluids.

9. Further examination of the engine compartment revealed no sign(s) or indication(s) of fluid leakage and/or fluid stain within the engine compartment of the Motor Van. The wirings and cables were also observed to be intact and adequately secured to their respective connectors and/or connecting ports.

Photo 10 shows a general view of the Motor Van's engine compartment. The various parts and components inside the engine compartment were unaffected by the accident. There was also no sign(s) or indication(s) of fluid leakage and/or fluid stain within the engine compartment. The wirings and cables were all observed to be intact and adequately secured to their respective connectors and/or connecting ports.

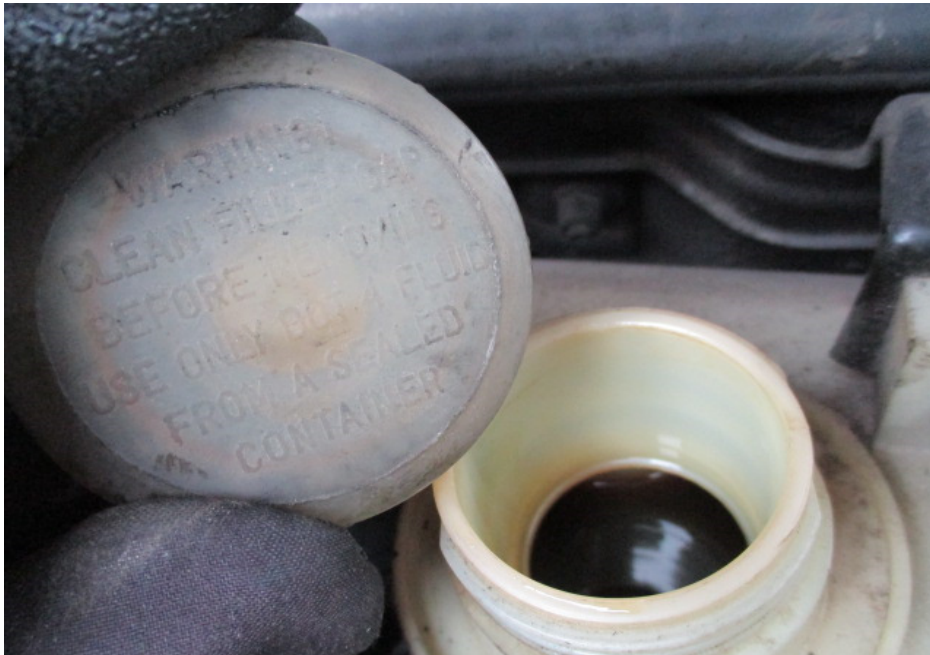
Photo 11 shows the brake fluid reservoir of the Motor Van at the time of our inspection. The brake fluid was observed to be of sufficient level and without any visible contamination.

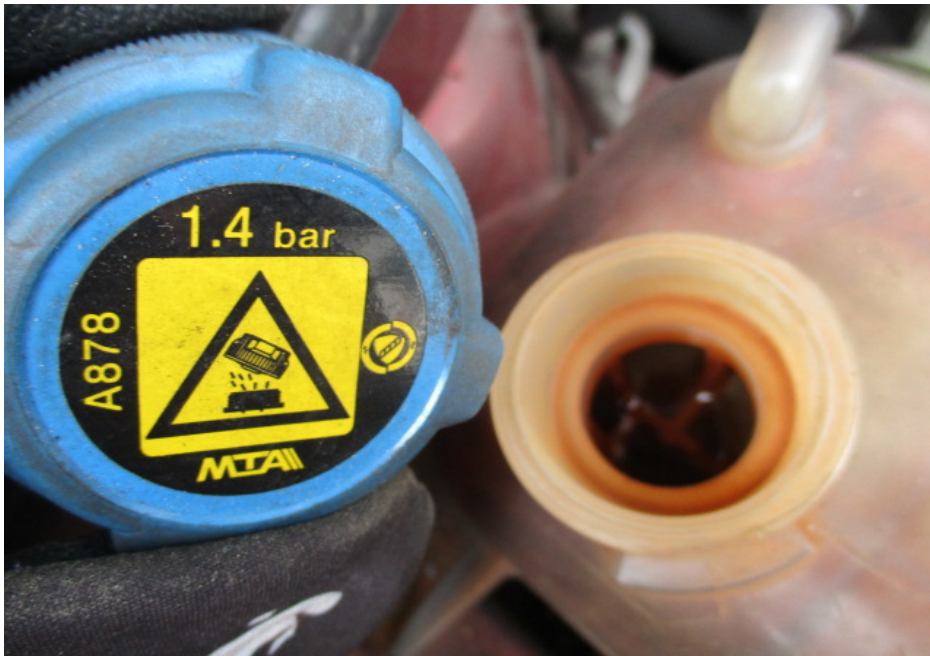
Photo 12 shows the engine coolant reservoir of the Motor Van at the time of our inspection. The engine coolant was observed to be of sufficient level and without any visible contamination.

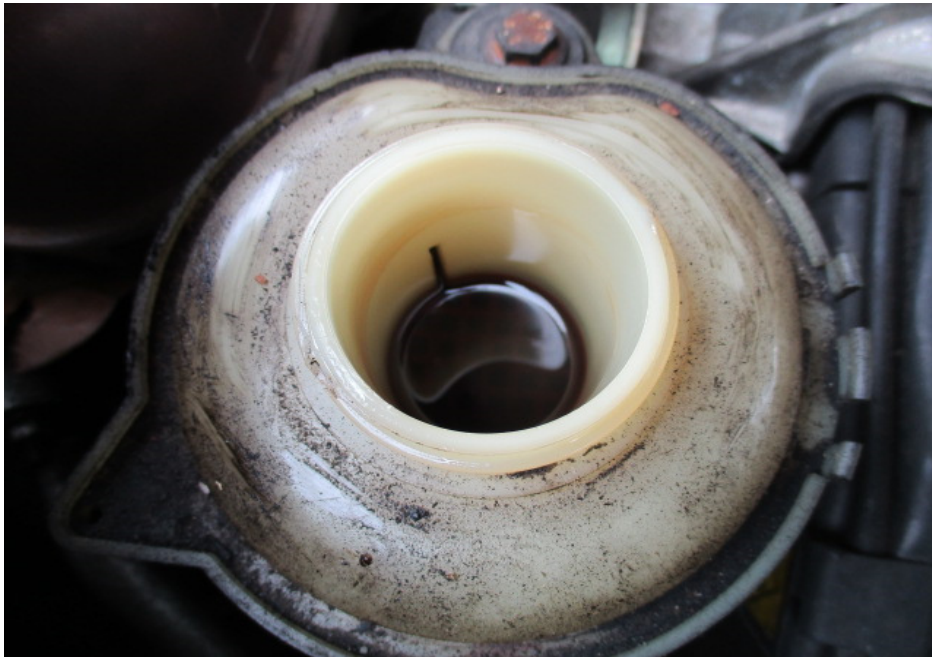
Photo 13 shows the power steering fluid reservoir of the Motor Van at the time of our inspection. The power steering fluid was observed to be of sufficient level and without any visible contamination.

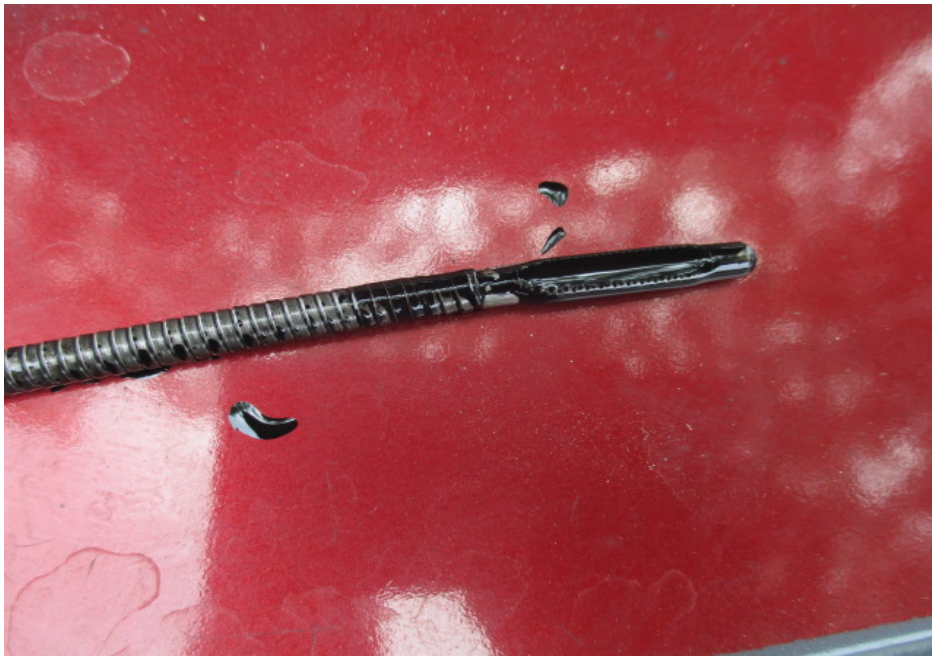
Photo 14 shows the engine dip stick of the Motor Van at the time of our inspection. The engine oil was observed to be of sufficient level and without any visible contamination.

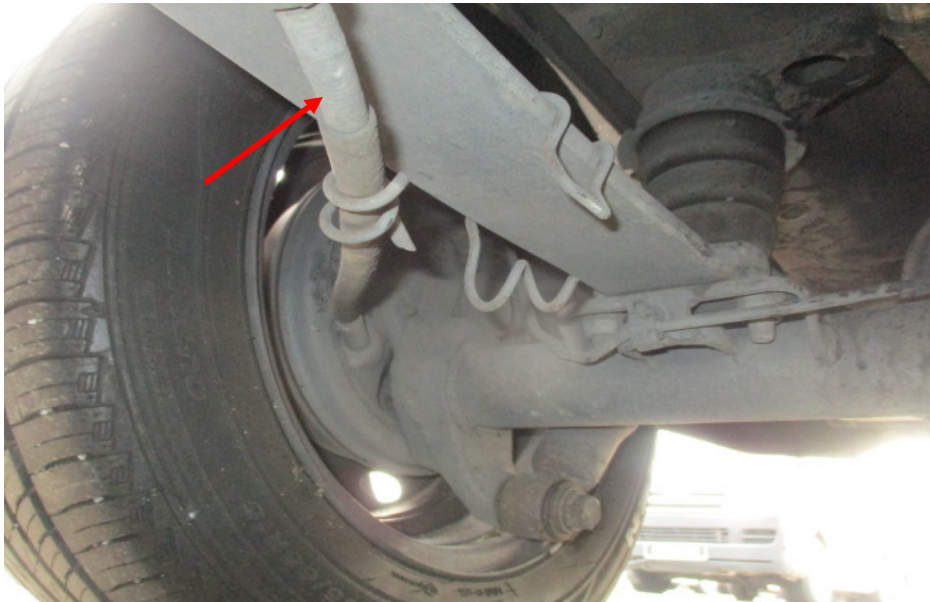
11. Static brake tests conducted on the Motor Van revealed no abnormality. The brake booster had responded well to the various tests conducted. There was also no abnormal movement of the brake pedal when it was depressed. In general, the static brake tests had suggested that there was no internal leakage of pressure/vacuum in the braking system of the Motor Van. The braking system of the Motor Van was likely to be in serviceable condition at the material time. This was also taking into consideration that the brake fluid was of sufficient level, and also that there was no sign(s) of brake fluid leakage along the brake hoses and brake pipes.

Photo 15 shows the brake pipe (arrowed) at the rear right wheel of the Motor Van. We did not observe any leakage of brake fluid at the time of our inspection of the Motor Van. Our static tests of the Motor Van's braking system had indicated that there was no internal leakage of pressure/vacuum. Hence the braking system was likely to be in serviceable condition at the material time of accident.

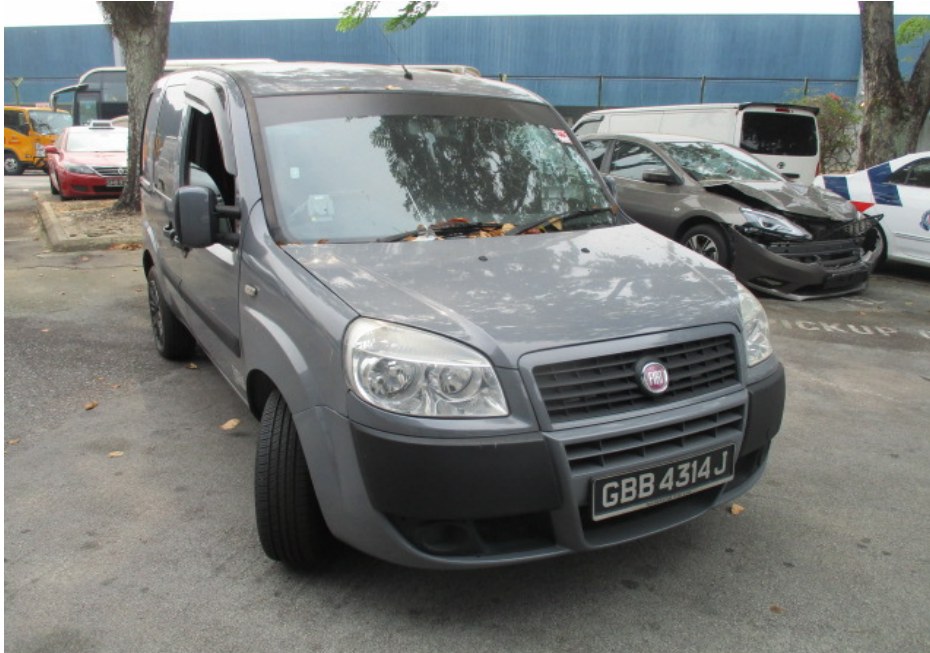
Photo 16 shows the front right wheel of the Motor Van turned to its full right. During our steering system test, we did not experience any abnormal free play and/or resistance when we had turned the steering wheel towards the right. This would suggest that the steering system of the Motor Van was likely to be in serviceable condition at the material time of accident.

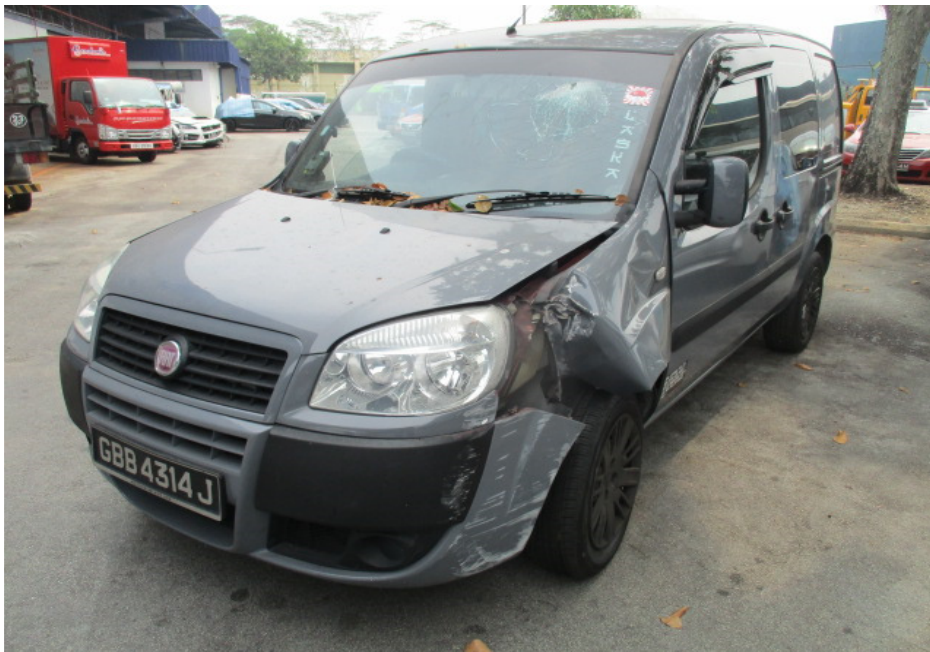
12. Static test on the steering system of the Motor Van also revealed no abnormality to the steering system. We did not experience any abnormal free play and/or other resistance when turning the steering wheel right to full lock position. We were however unable to turn the steering wheel left to full lock position due to the dented left front fender. Our visual examination of the various steering components which had included the rack and pinion, tie rods, tie rod ends and ball joints had revealed that these components were all generally in good condition. See photos 15 - 19 below.

Photo 17 shows the front left wheel of the Motor Van turned slightly to the left. We were unable to turn the steering wheel left to full lock position due to the dented left front fender.

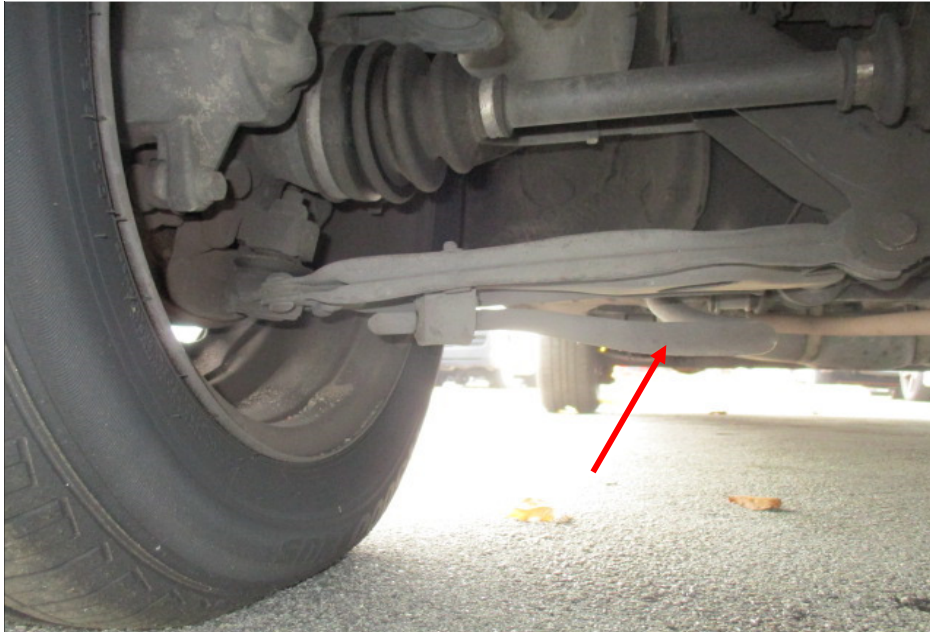
Photo 18 shows the various undercarriage components at the front right wheel of the Motor Van, in particular the steering tie rod (arrowed). The various steering components were all found to be intact, suggesting that the steering system of the Motor Van was likely to be in serviceable condition at the material time of accident. There was also no sign of fluid stain(s) observed on the various undercarriage components.

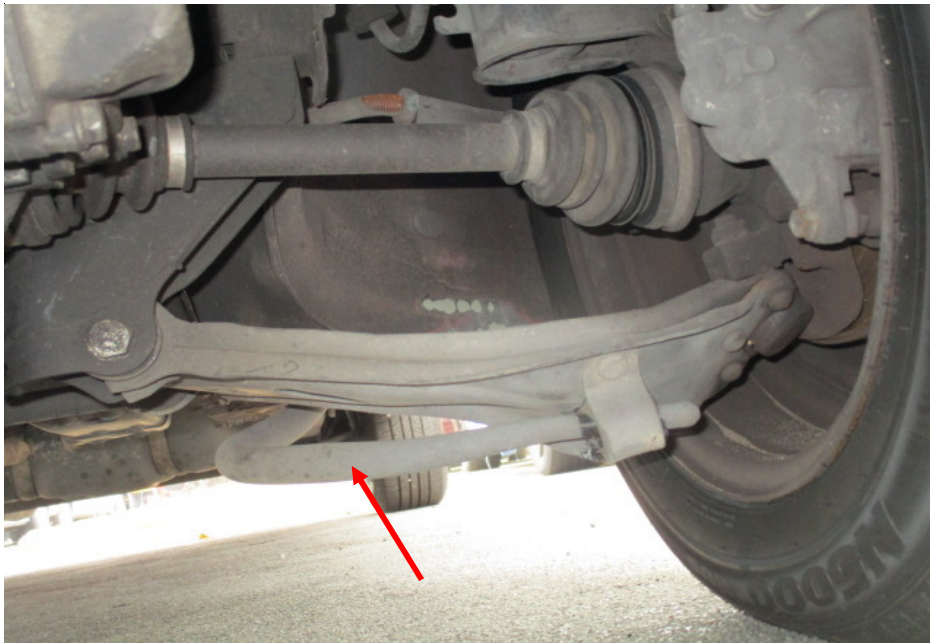
Photo 19 shows the various undercarriage components at the front left wheel of the Motor Van, in particular the steering tie rod (arrowed). The various undercarriage components of the Motor Van were all found to be intact without any visible damage. There was also no sign of fluid stain(s) observed on the various undercarriage components.

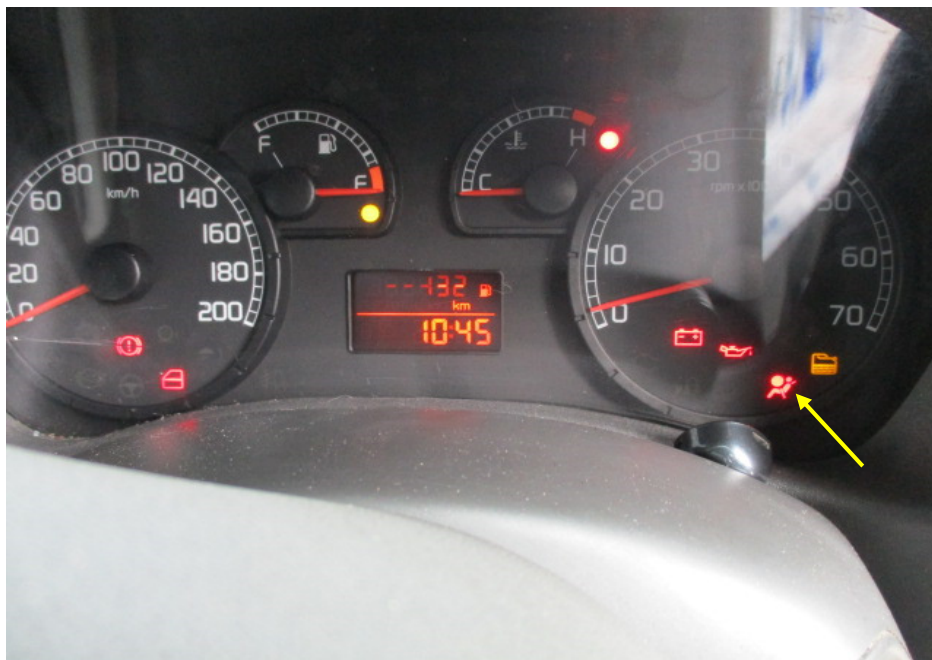
Photo 20 shows the warning lights for the various electronic operating systems of the Motor Van appearing on its instrument panel during the self-test when the engine is cranked, in particular the SRS light (arrowed).

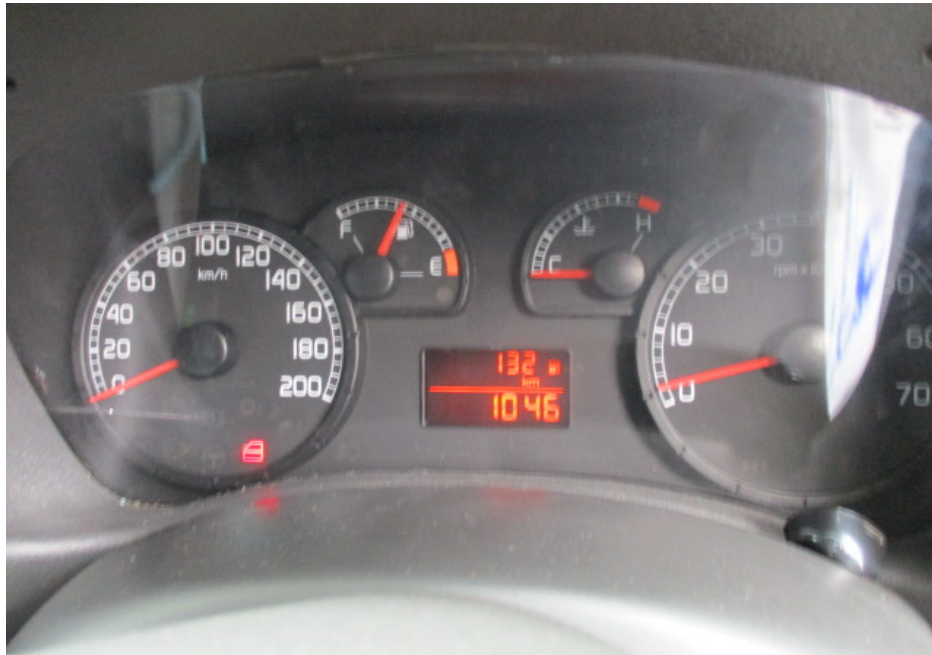
13. The Motor Van's automatic self-test of the functionality of its various electronic operating systems like the Supplemental Restraint System (SRS) during cranking of the engine had indicated that these systems were in working condition and without abnormality. This can be established from the warning lights disappearing from the instrument panel after the self-test. See photos 20 & 21 below.

Photo 21 shows no warning lights illuminated on the instrument panel of the Motor Van after the engine was cranked. This would suggest that there was no abnormality to the various electronic operating systems of the Motor Van, like the SRS.
