Your Ref: TP/IP/46503/2019
Our Ref : CI/TPD19014929/N

13 September 2019

MECHANICAL INSPECTION REPORT OF MOTOR CAR SMK 3217K

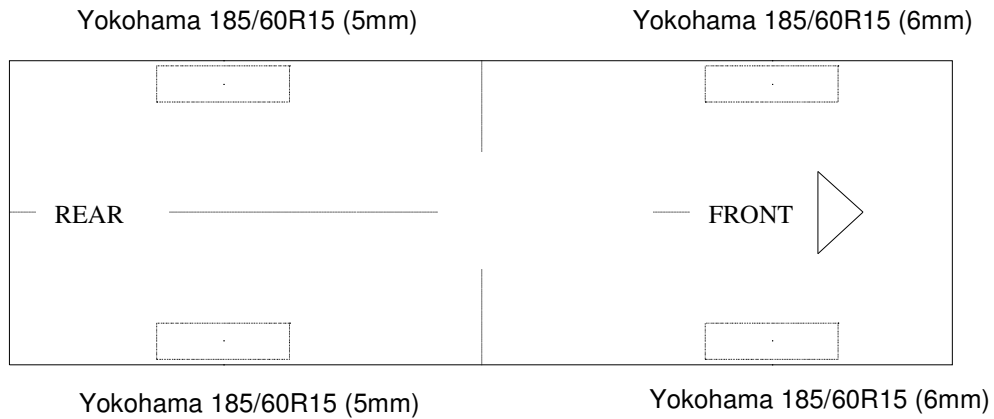
6. The condition of the Motor Car's 4 tyres was observed to be in serviceable condition. We did not find any tear, cut or burst mark(s) on the outer and the inner sidewalls as well as across the tread of the 4 tyres. The 4 tyres were also observed to be sufficiently inflated for vehicular operation. The tyre brand, tyre size and remaining tread depth of the 4 tyres were recorded as follows:-

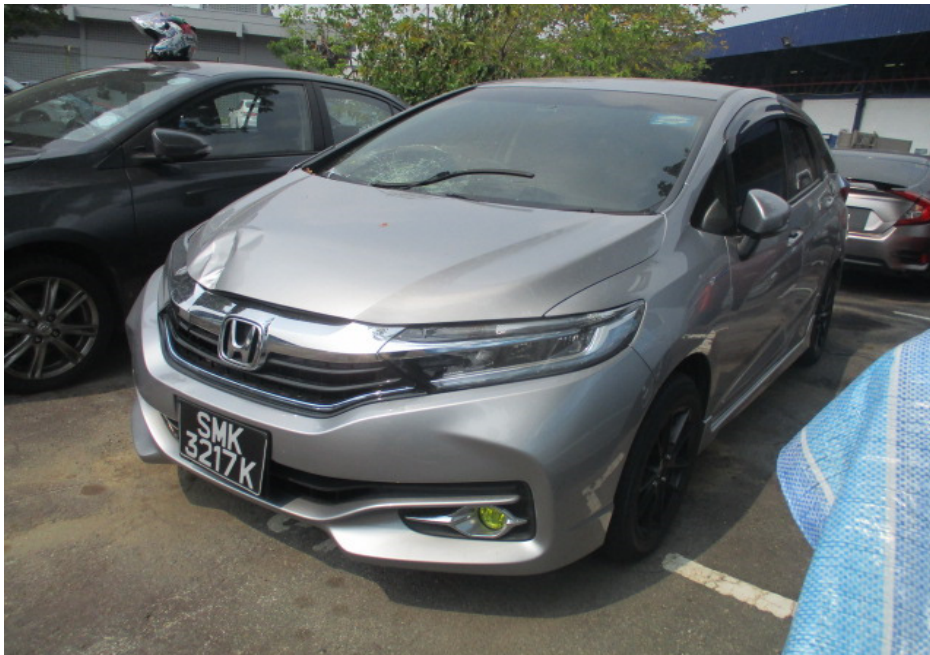
4. The mileage of the Motor Car at the time of our inspection was 15, 443km.
5. The Motor Car had sustained relatively minor impact damage that was confined to its right frontal portion. Its front bonnet was observed to have been dented; its radiator grille was observed to have cracked; its front windscreen was observed to have shattered.

Photo 1 shows a general view of the front left body of the Motor Car at the time of our inspection. The Motor Car was observed to be in good general condition except for some relatively minor impact damage at its right frontal portion. The mileage of the Motor Car was recorded to be 15, 443km.

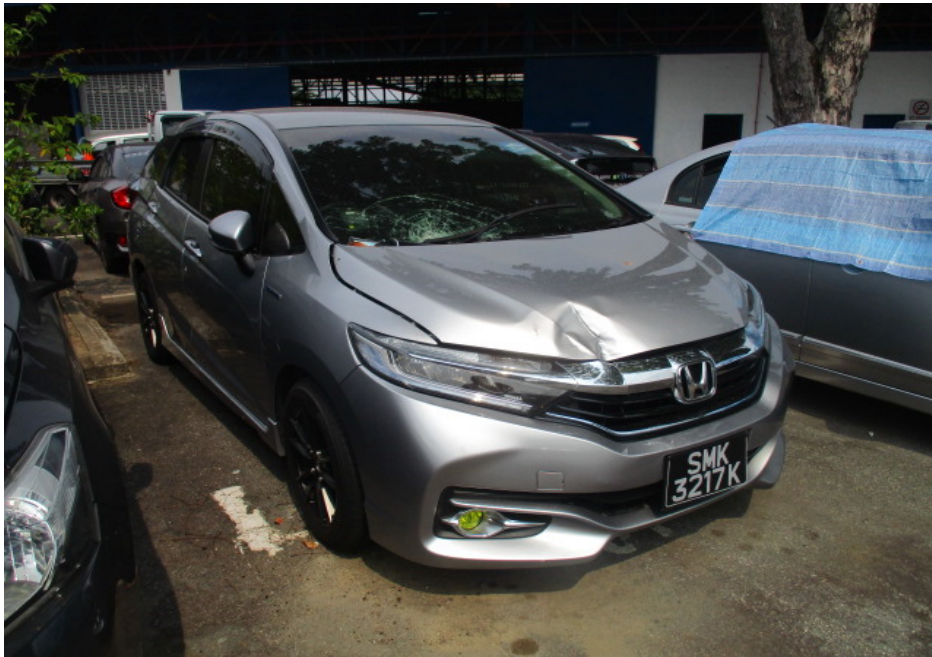
Photo 2 shows a general view of the front right body of the Motor Car at the time of our inspection. The Motor Car was observed to be in good general condition. However we had observed relatively minor impact damage that was confined to its right frontal portion. Its front bonnet was observed to have been dented; its radiator grille was observed to have cracked; its front windscreen was observed to have shattered.

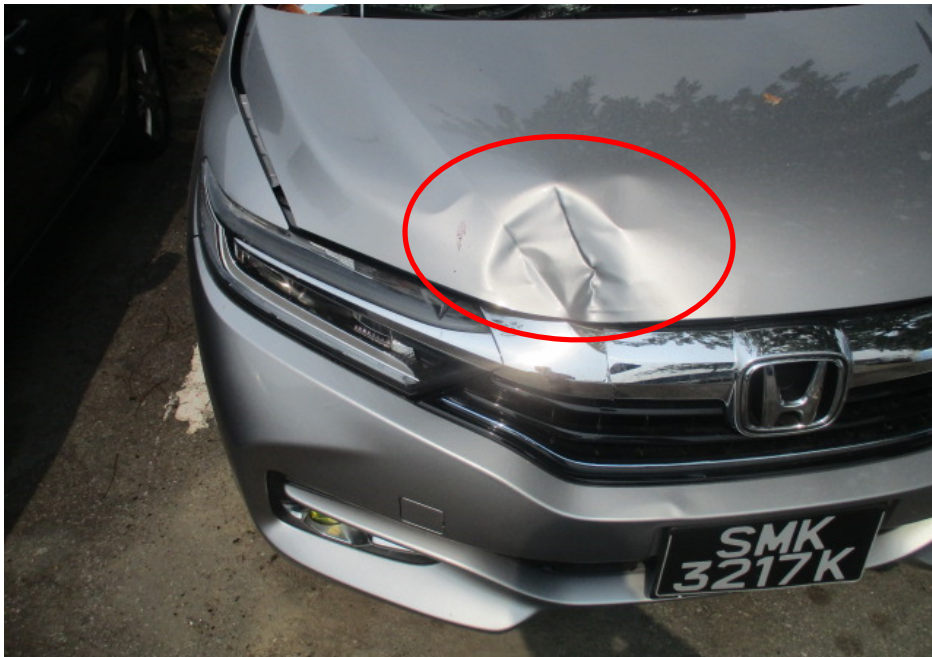
Photo 3 shows a closer view of the dented front bonnet of the Motor Car at the time of our inspection (circled).

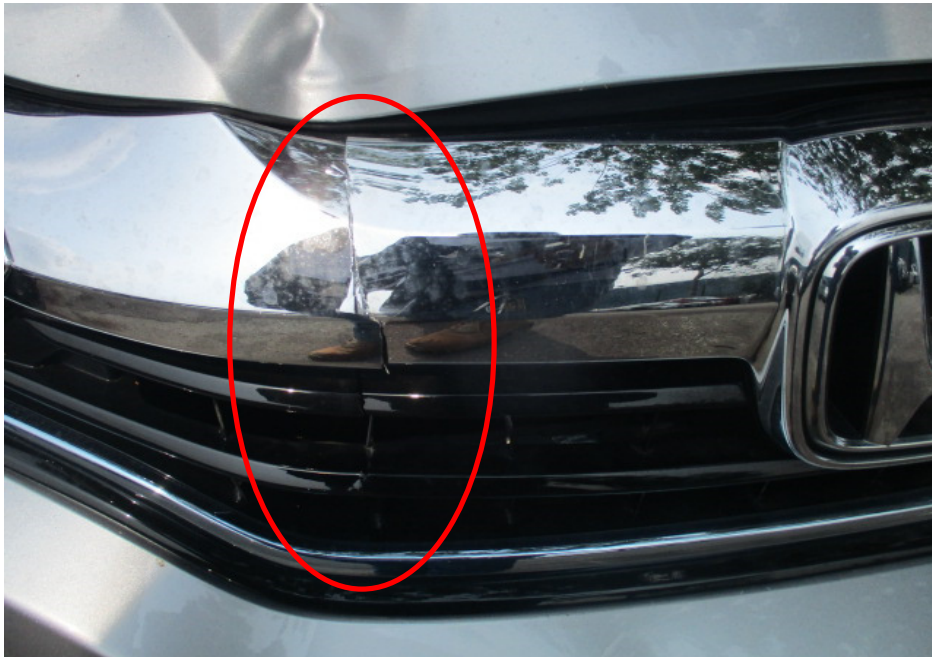
Photo 4 shows a closer view of the cracked radiator grille of the Motor Car at the time of our inspection (circled).

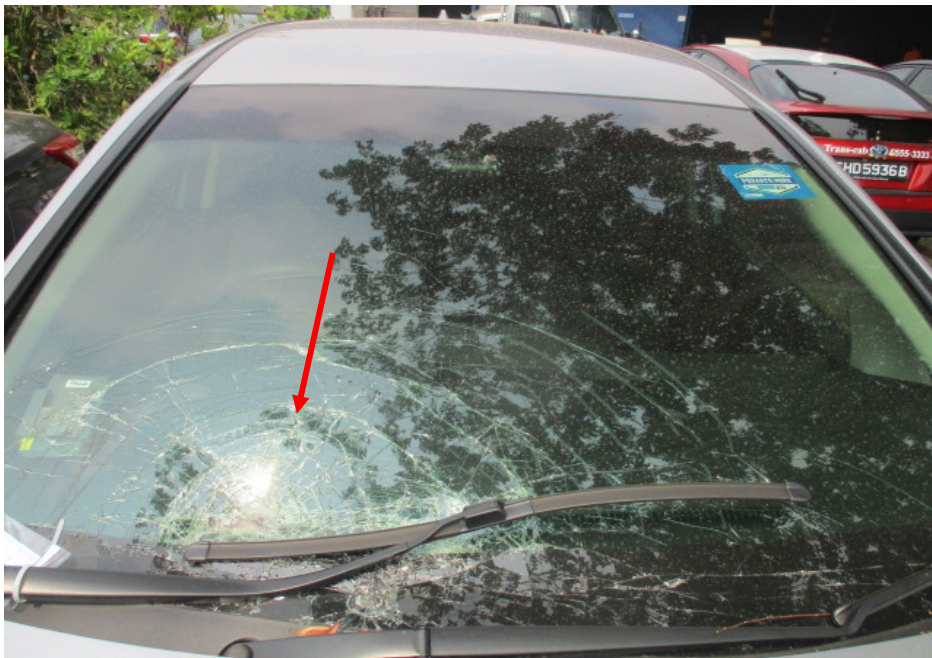
Photo 5 shows a closer view of the shattered front windscreen (arrowed) of the Motor Car at the time of our inspection.

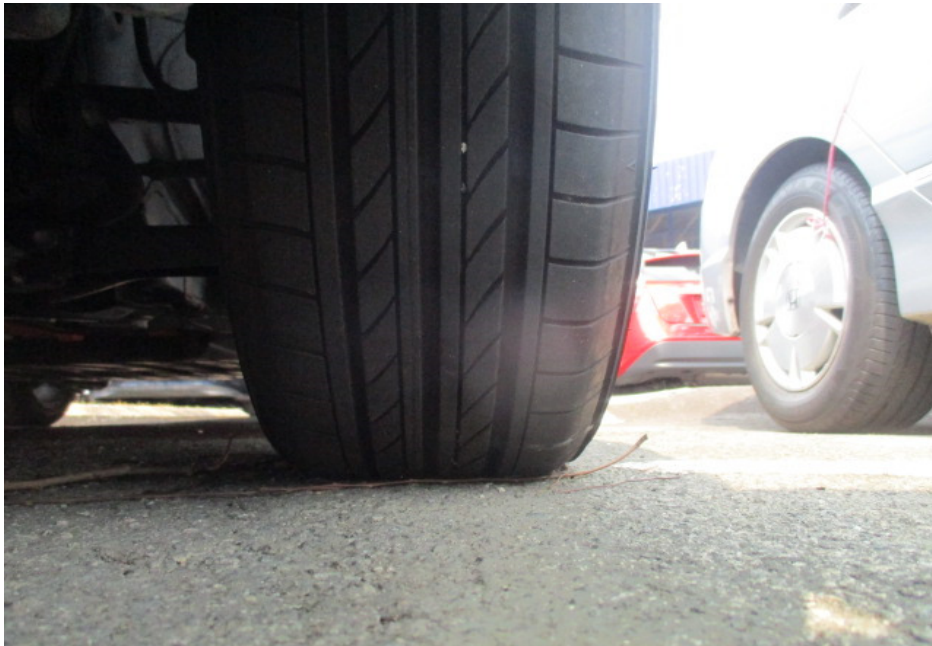
Photo 6 shows the condition of the front left tyre of the Motor Car, which was observed to be in serviceable condition with remaining tread depth of approximately 6mm. The tyre, which was wrapped around alloy wheel rim, was also observed to be sufficiently inflated for vehicular operation. There was no tear, cut or burst mark(s) on the outer and the inner sidewalls as well as across the tread of the 4 tyres.

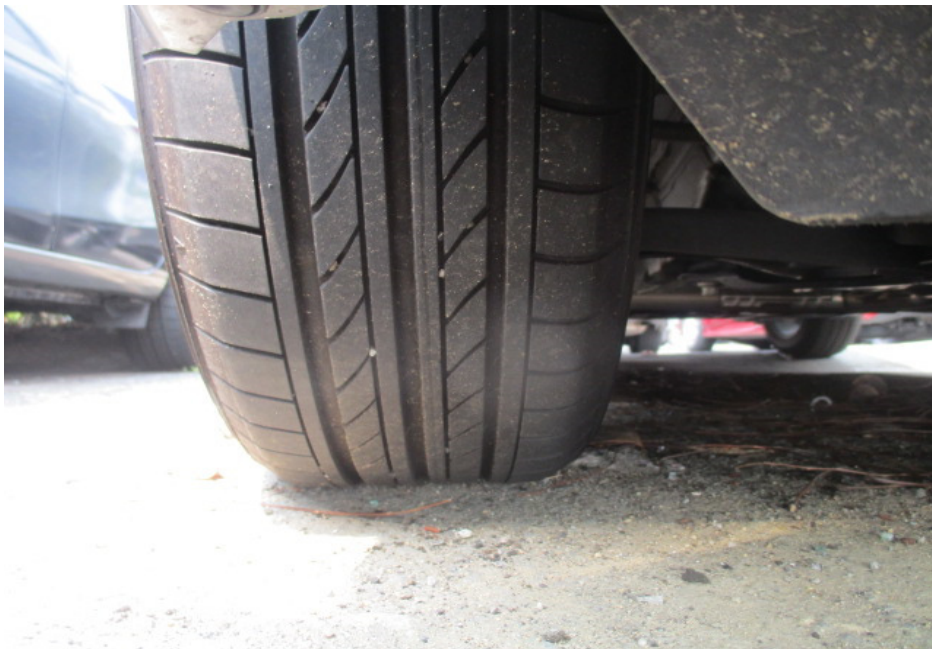
Photo 7 shows the condition of the front right tyre of the Motor Car, which was observed to be in serviceable condition with remaining tread depth of approximately 6mm. The tyre, which was wrapped around alloy wheel rim, was also observed to be sufficiently inflated for vehicular operation.

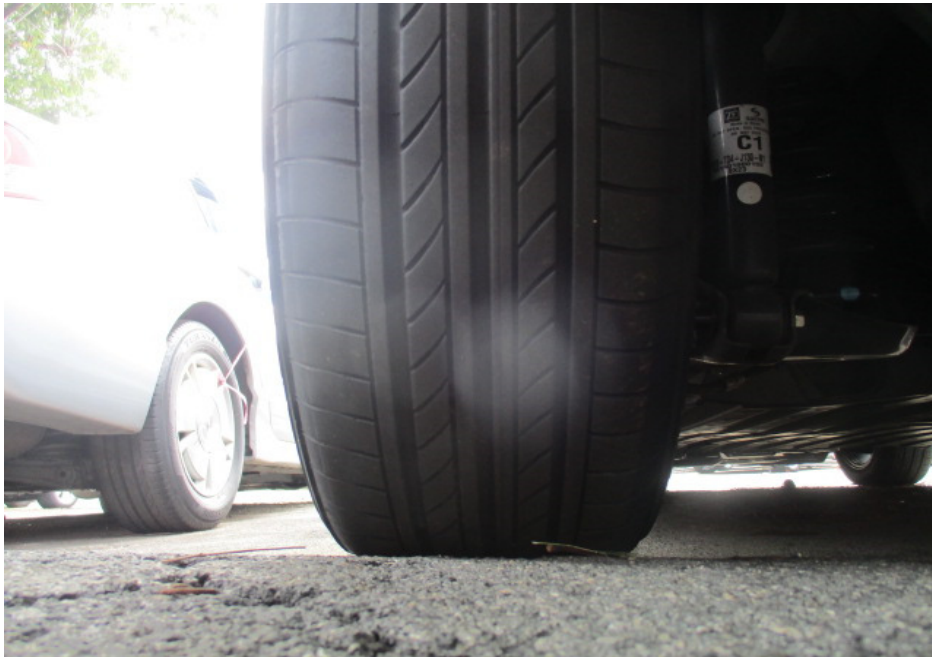
Photo 8 shows the condition of the rear left tyre of the Motor Car, which was observed to be in serviceable condition with remaining tread depth of approximately 5mm. The tyre, which was wrapped around alloy wheel rim, was also observed to be sufficiently inflated for vehicular operation. There was also no damage found on the 4 wheel rims of the Motor Car.

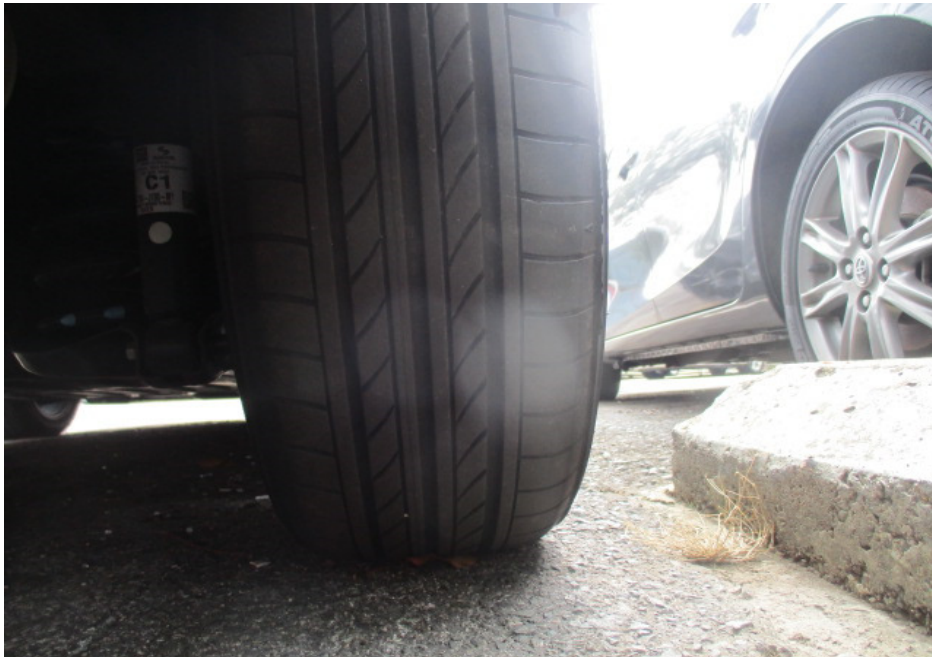
Photo 9 shows the condition of the rear right tyre of the Motor Car, which was observed to be in serviceable condition with remaining tread depth of approximately 5mm. There was also no tear, cut or burst mark(s) on the outer and the inner sidewalls as well as across the tread of the 4 tyres.

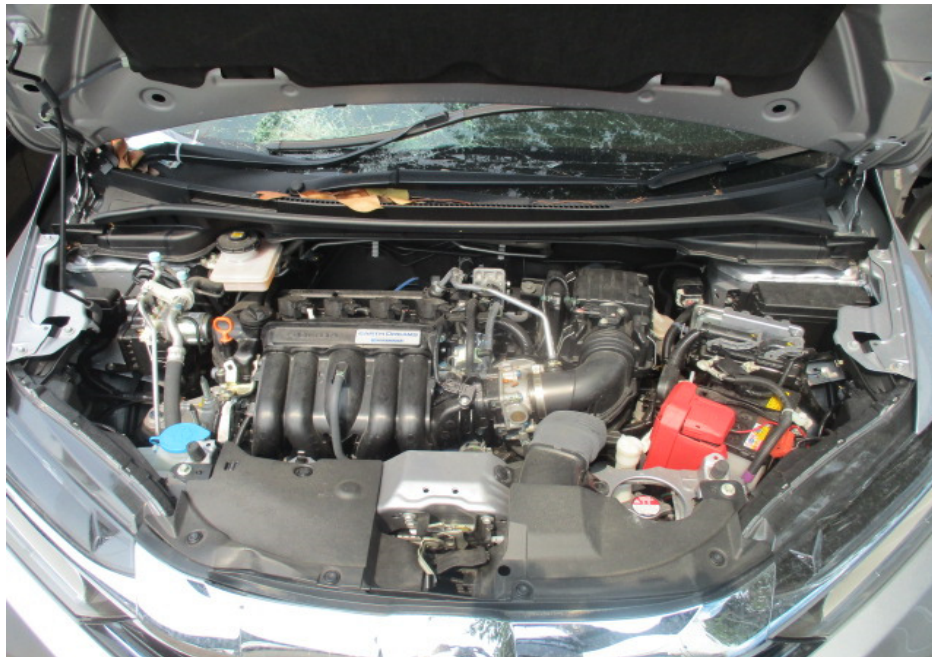
Photo 10 shows a general view of the Motor Car's engine compartment. The various parts and components inside the engine compartment were unaffected by the accident. There was also no sign(s) or indication(s) of fluid leakage and/or fluid stain within the engine compartment.

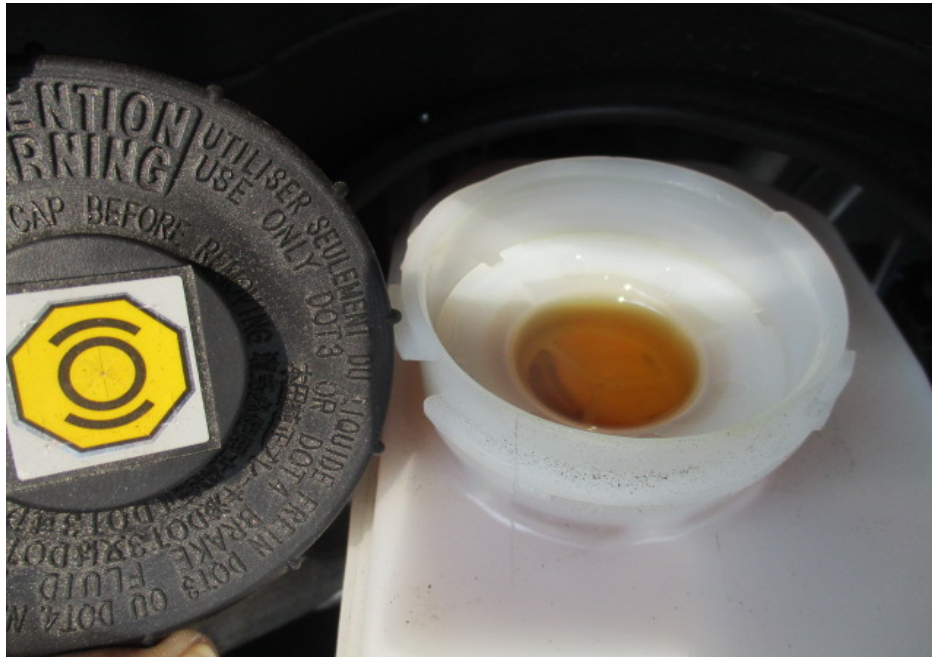
Photo 11 shows the brake fluid reservoir of the Motor Car at the time of our inspection. The brake fluid was observed to be of sufficient level and without any visible contamination.

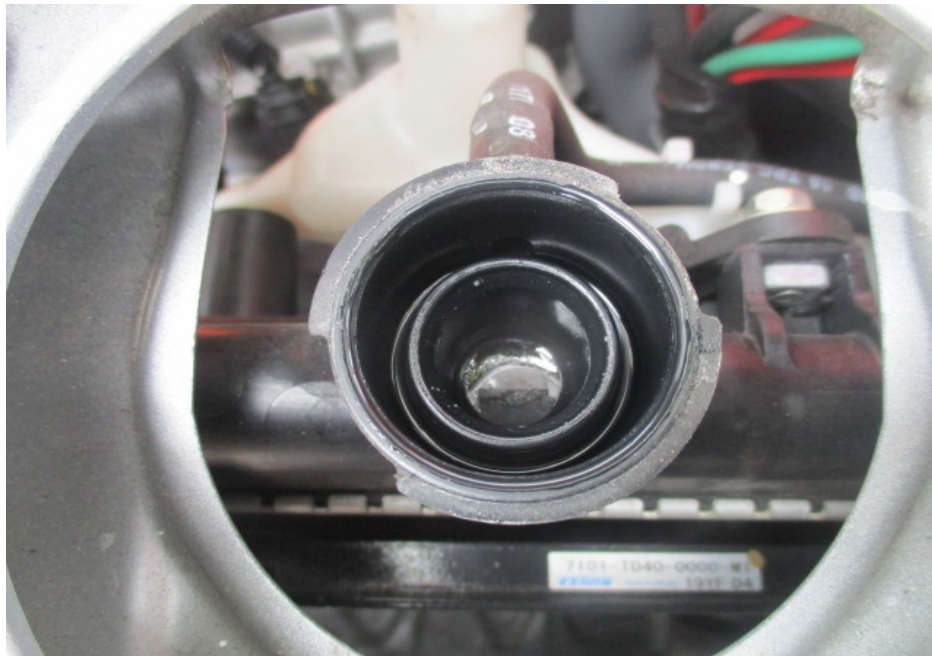
Photo 12 shows checks being carried out to the engine coolant of the Motor Car at the time of our inspection. The engine coolant was observed to be of sufficient level and without any visible contamination.

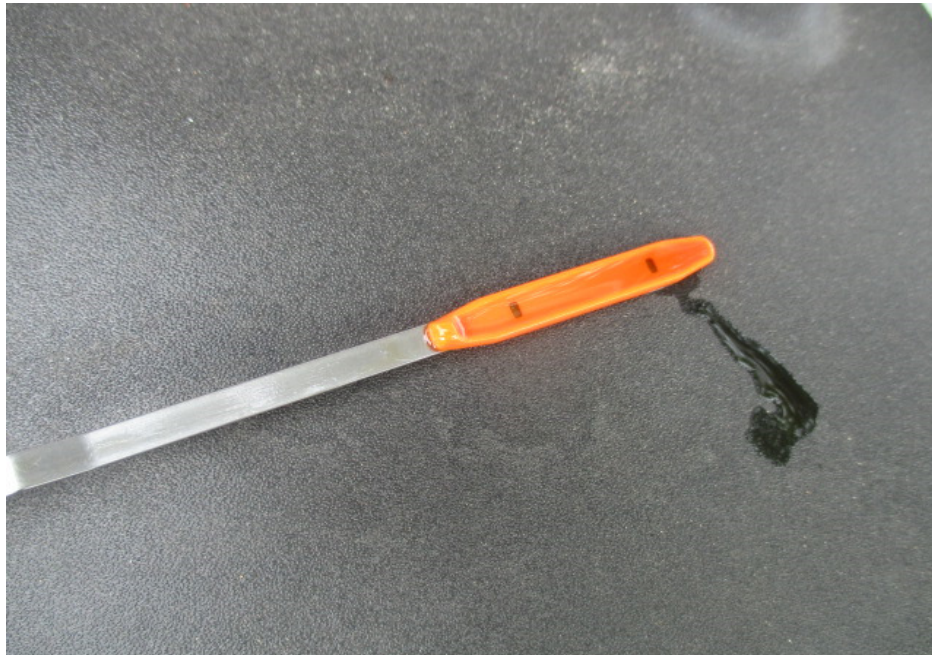
Photo 13 shows the engine oil dip stick of the Motor Car at the time of our inspection. The engine oil was observed to be of sufficient level and without any visible contamination.

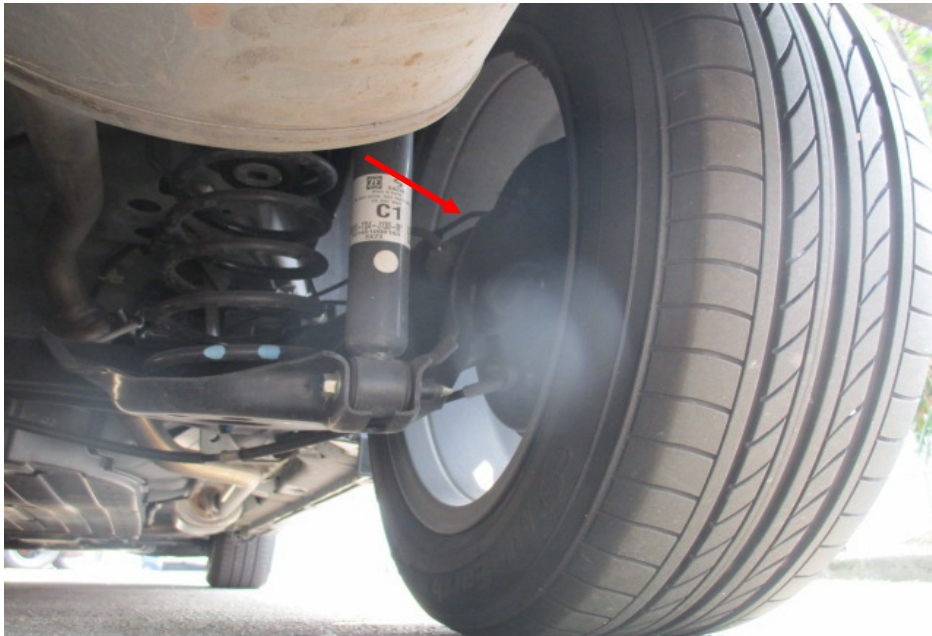
Photo 14 shows the brake hose/pipe (arrowed) at the rear right wheel of the Motor Car. We did not observe any leakage of brake fluid at the time of our inspection of the Motor Car. Static tests of the Motor Car's braking system had indicated that there was no internal leakage of pressure/vacuum. Hence the braking system was likely to be in serviceable condition at the material time of accident. The undercarriage components of the Motor Car were also all found to be intact and without any visible damage.

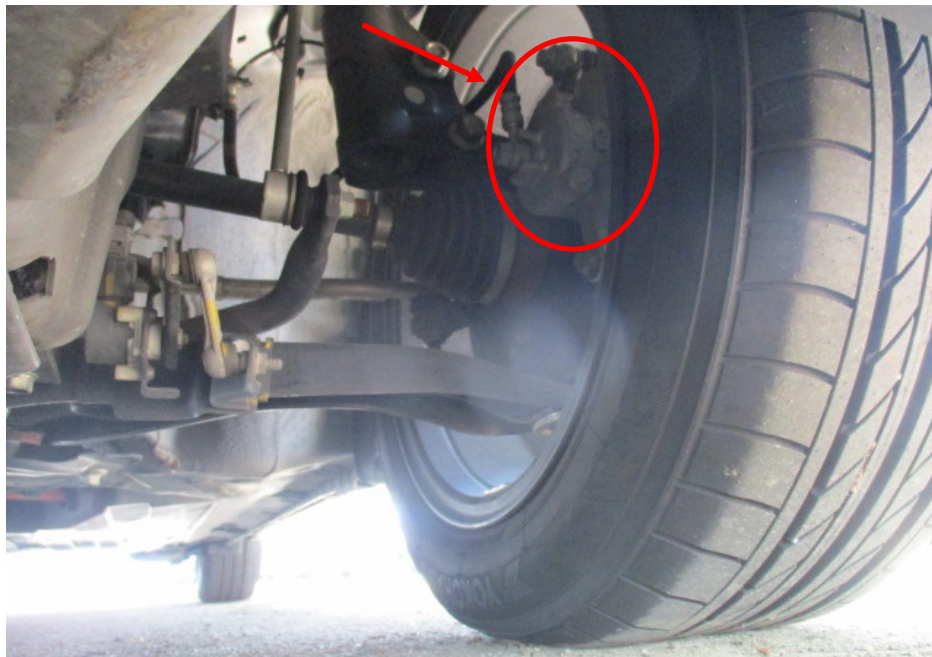
Photo 15 shows the brake hose/pipe (arrowed) at the front left wheel of the Motor Car. No leakage of brake fluid was observed. Visual examination of the various components of the braking system like the brake caliper (circled), brake pedal etc. had revealed all to be intact and without visible damage.

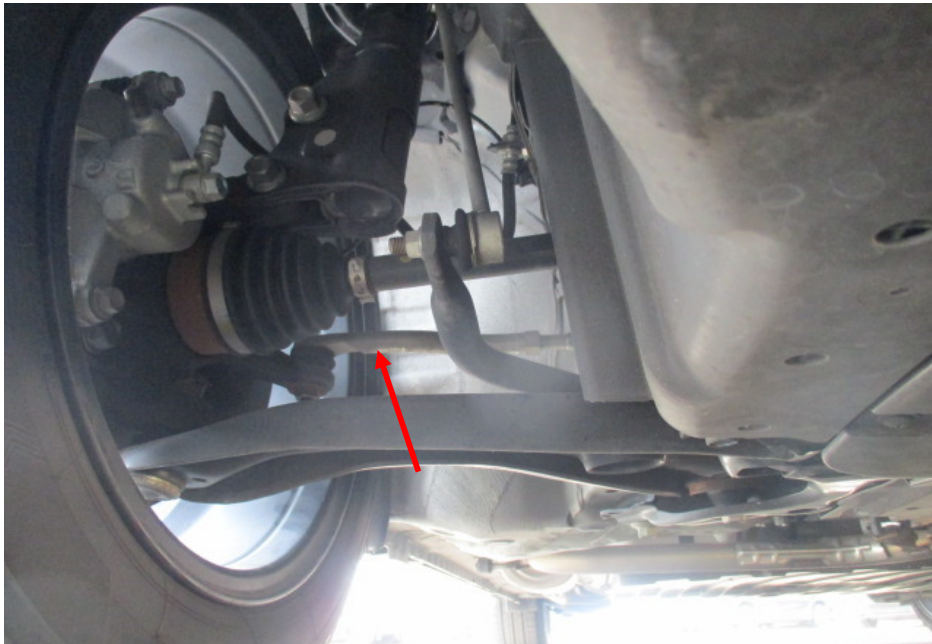
Photo 16 shows the various undercarriage components at the front right wheel of the Motor Car, in particular the steering tie rod (arrowed). The various steering components were all found to be intact, suggesting that the steering system of the Motor Car was likely to be in serviceable condition at the material time of accident. There was also no sign of fluid stain observed on the various undercarriage components at the front right wheel of the Motor Car.

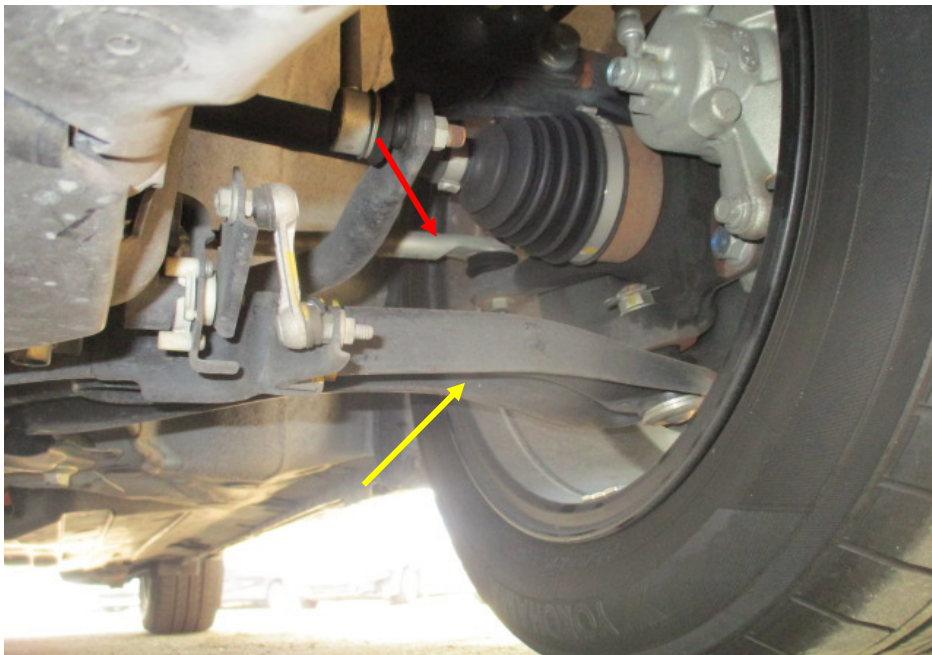
Photo 17 shows the various undercarriage components at the front left wheel of the Motor Car, which had included the steering tie rod (red arrow) and left drive shaft (yellow arrow). The various undercarriage components of the Motor Car were all found to be intact without any visible damage.

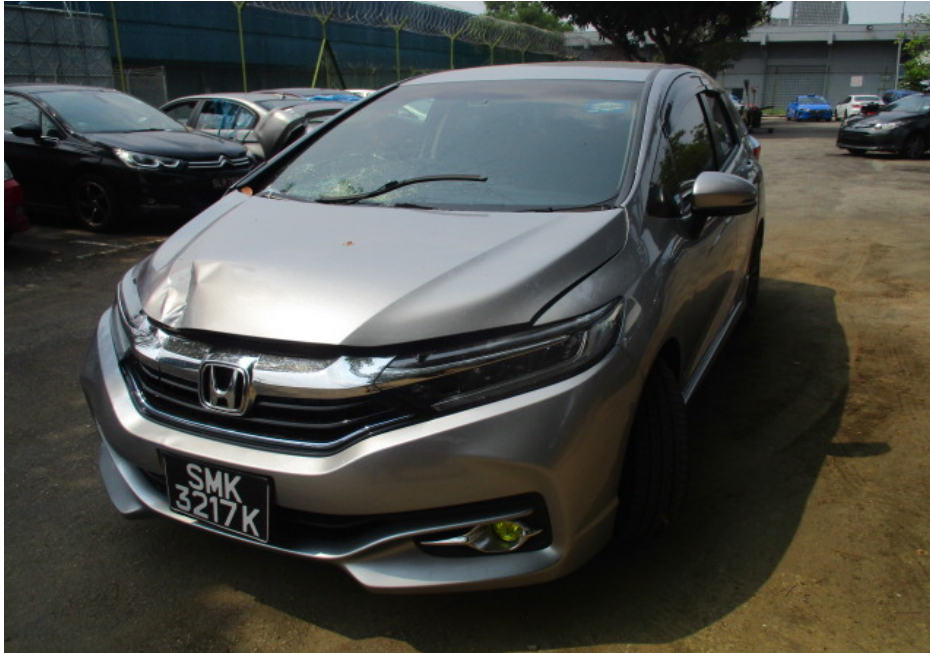
Photo 18 shows the front left wheel of the Motor Car turned to its full left. During our steering system test, we did not experience any abnormal free play and/or resistance when we had turned the steering wheel towards the left and right. This would suggest that the steering system of the Motor Car was likely to be in serviceable condition at the material time of accident.

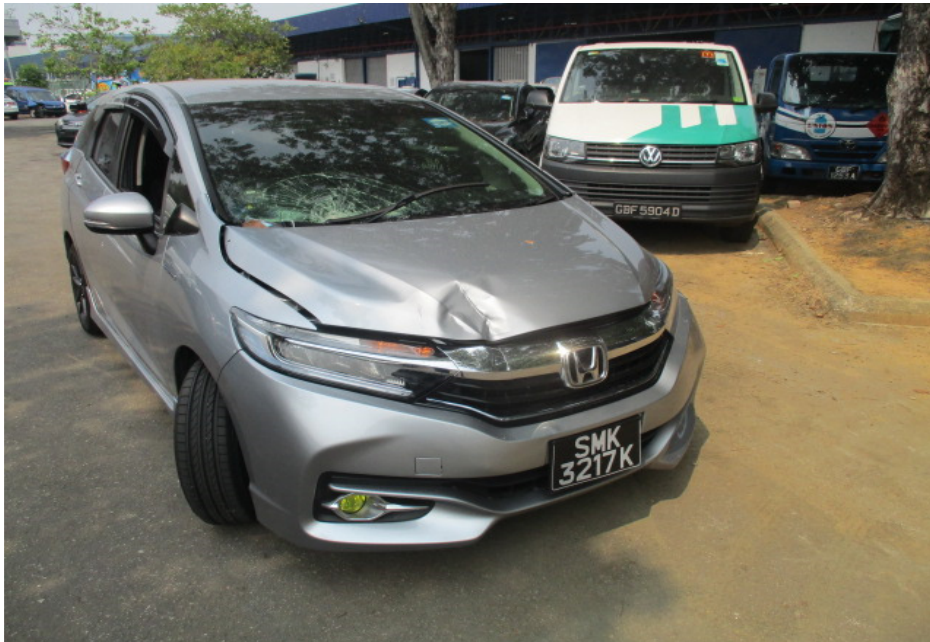
Photo 19 shows the front right wheel of the Motor Car turned to its full right. During our steering system test, we did not experience any abnormal free play and/or resistance when we had turned the steering wheel towards the left and right. This would suggest that the steering system of the Motor Car was likely to be in serviceable condition at the material time of accident.

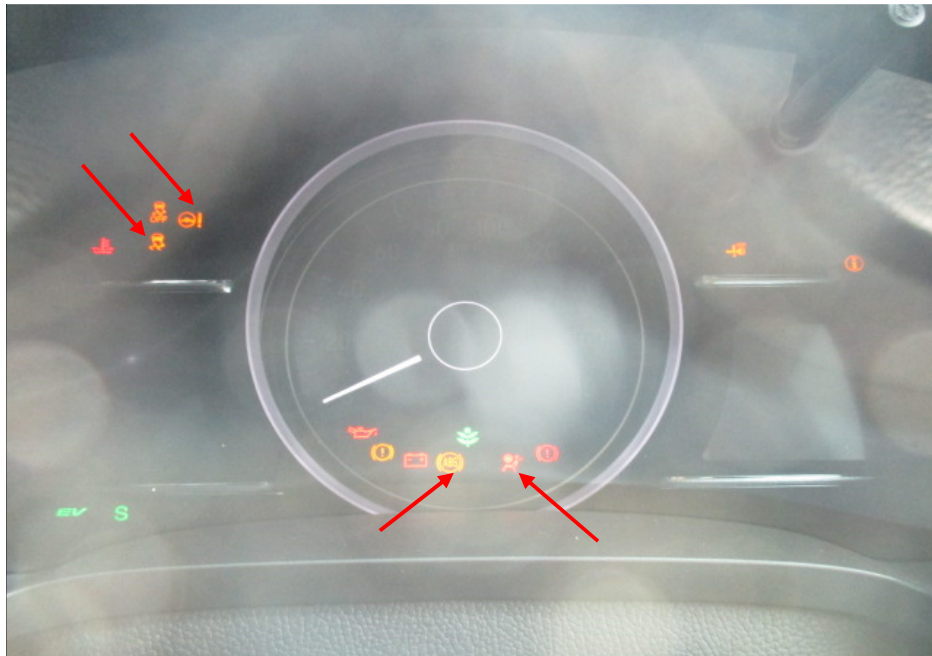
Photo 20 shows the warning lights for the various electronic operating systems of the Motor Car appearing on its instrument panel during the self-test when the engine is cranked, in particular the EPS light, ABS light, ESC light and SRS light (arrowed).

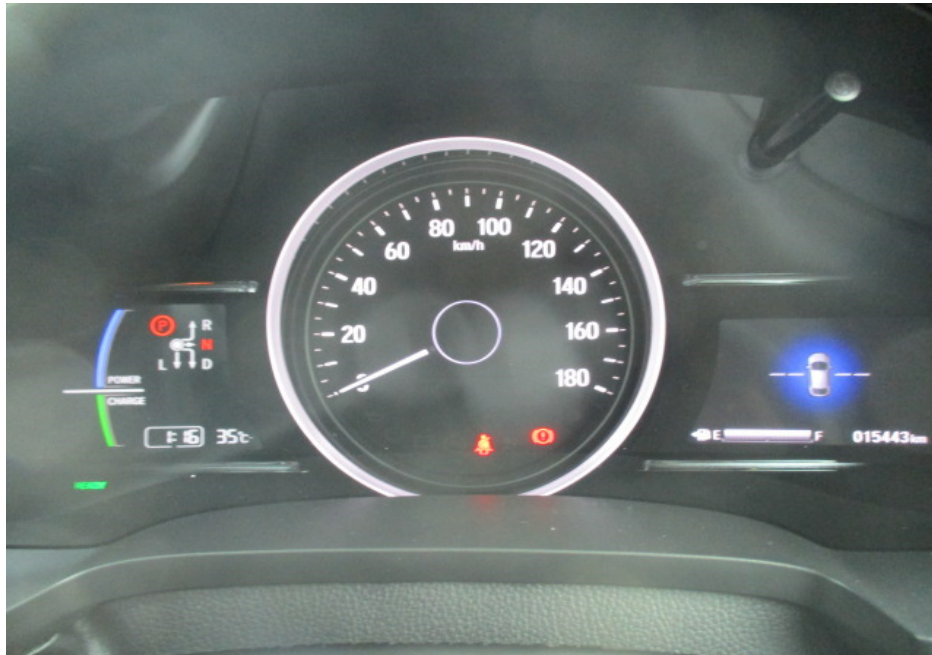
Photo 21 shows no warning lights illuminated on the instrument panel of the Motor Car after the engine was cranked. This would suggest that there was no abnormality to the various electronic operating systems of the Motor Car, like the EPS, ABS, ESC and SRS etc.
